# Appendix 1

## Hydrograph and High Water Mark Analysis

### Introduction

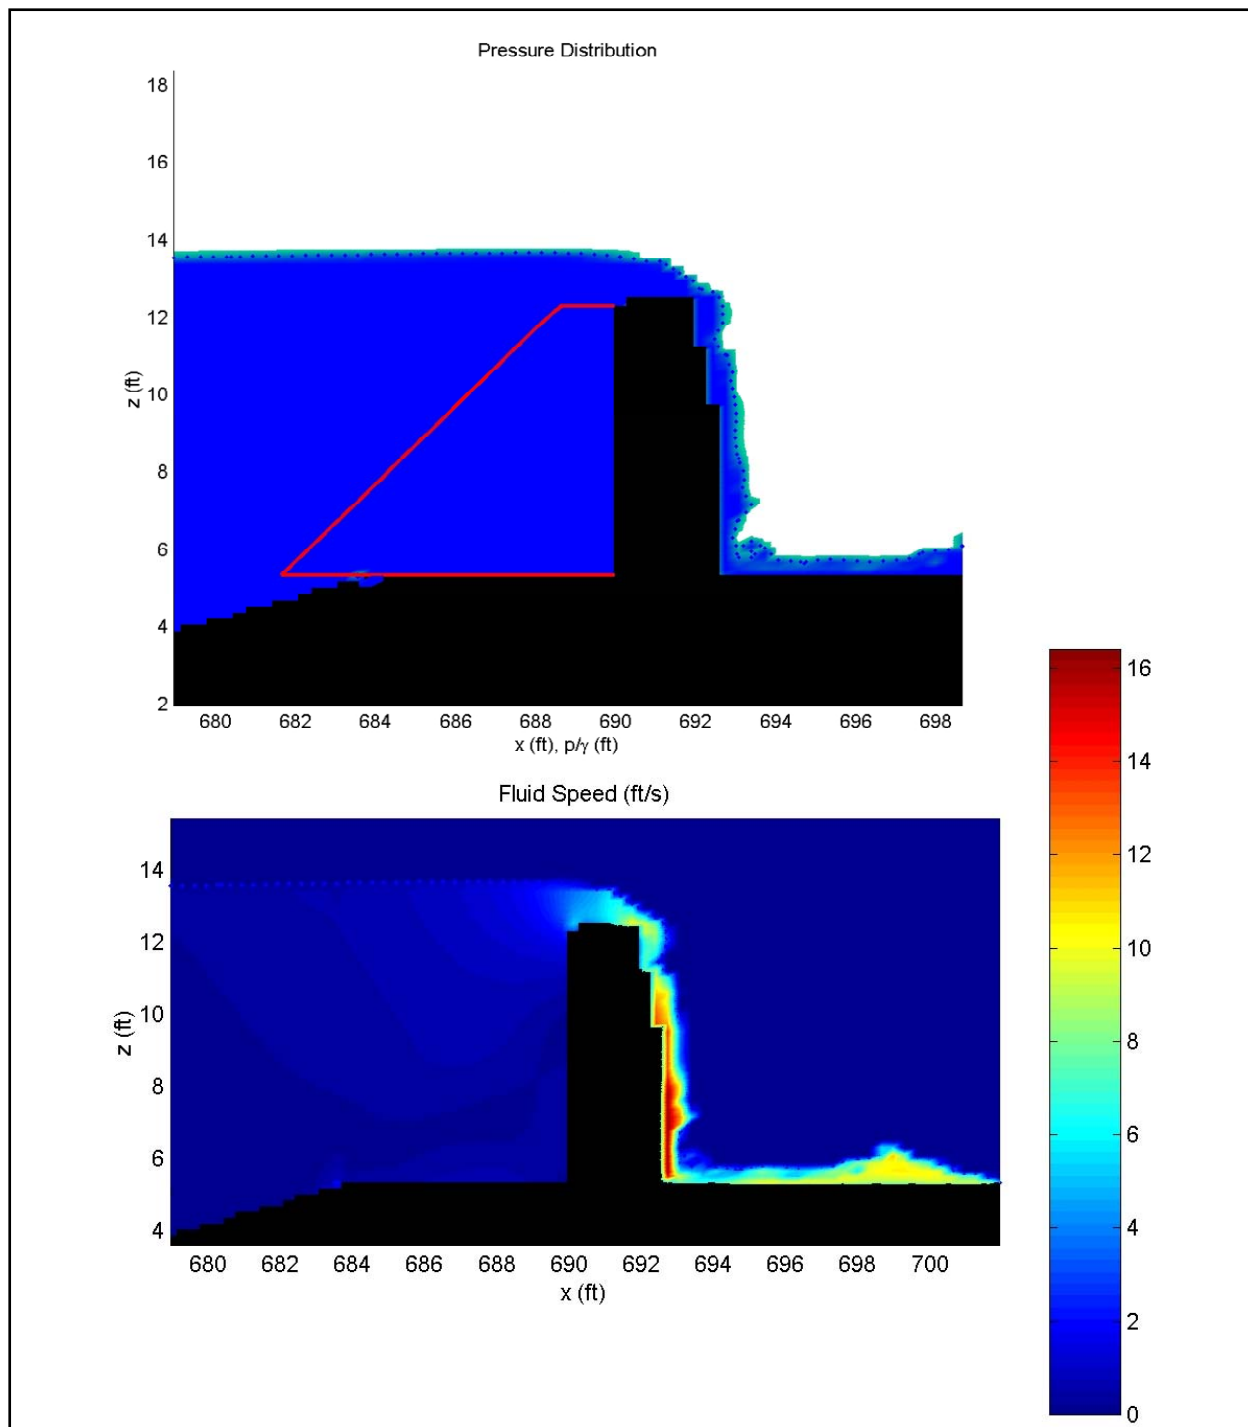
The general IHNC canal wall profile is taken from design memoranda. As the actual wall height is highly variable in the area of the failures, the simulations are reduced to a simple set where the surge is +1ft above the wall crest. Specifically, the surge is set as 13.5ft and the top of the wall at 12.5ft. Two simulations are run; one with no waves, and another with 1ft waves with a period of 5 seconds. Pressure distributions and fluid speeds are presented for both cases. Figure 15-29 shows the values for the no-wave case and Figure 15-30 for the wave case. What is evident here, as with all other canal simulations, is that the pressure is nearly hydrostatic, i.e. linearly varying from the instantaneous free surface elevation. The resulting force for the no-waves case is 1940 lb/ft, and 2260 lb/ft under the mean wave crest for the waves case. Note that this force is a mean value, not a 2 percent exceedence. The computational requirements of the Navier-Stokes simulations prohibit the long duration runs with input spectra required to derive statistical relations. Maximum fluid speeds on the backsides of the walls are close to free-fall speeds, near to 16 ft/s for both cases.

Figure 15-29. Surge overtopping an IHNC wall with no waves. The wall elevation is specified as 1ft below the surge. The top plot gives the water surface and pressure distribution, the lower plot gives the fluid speed field

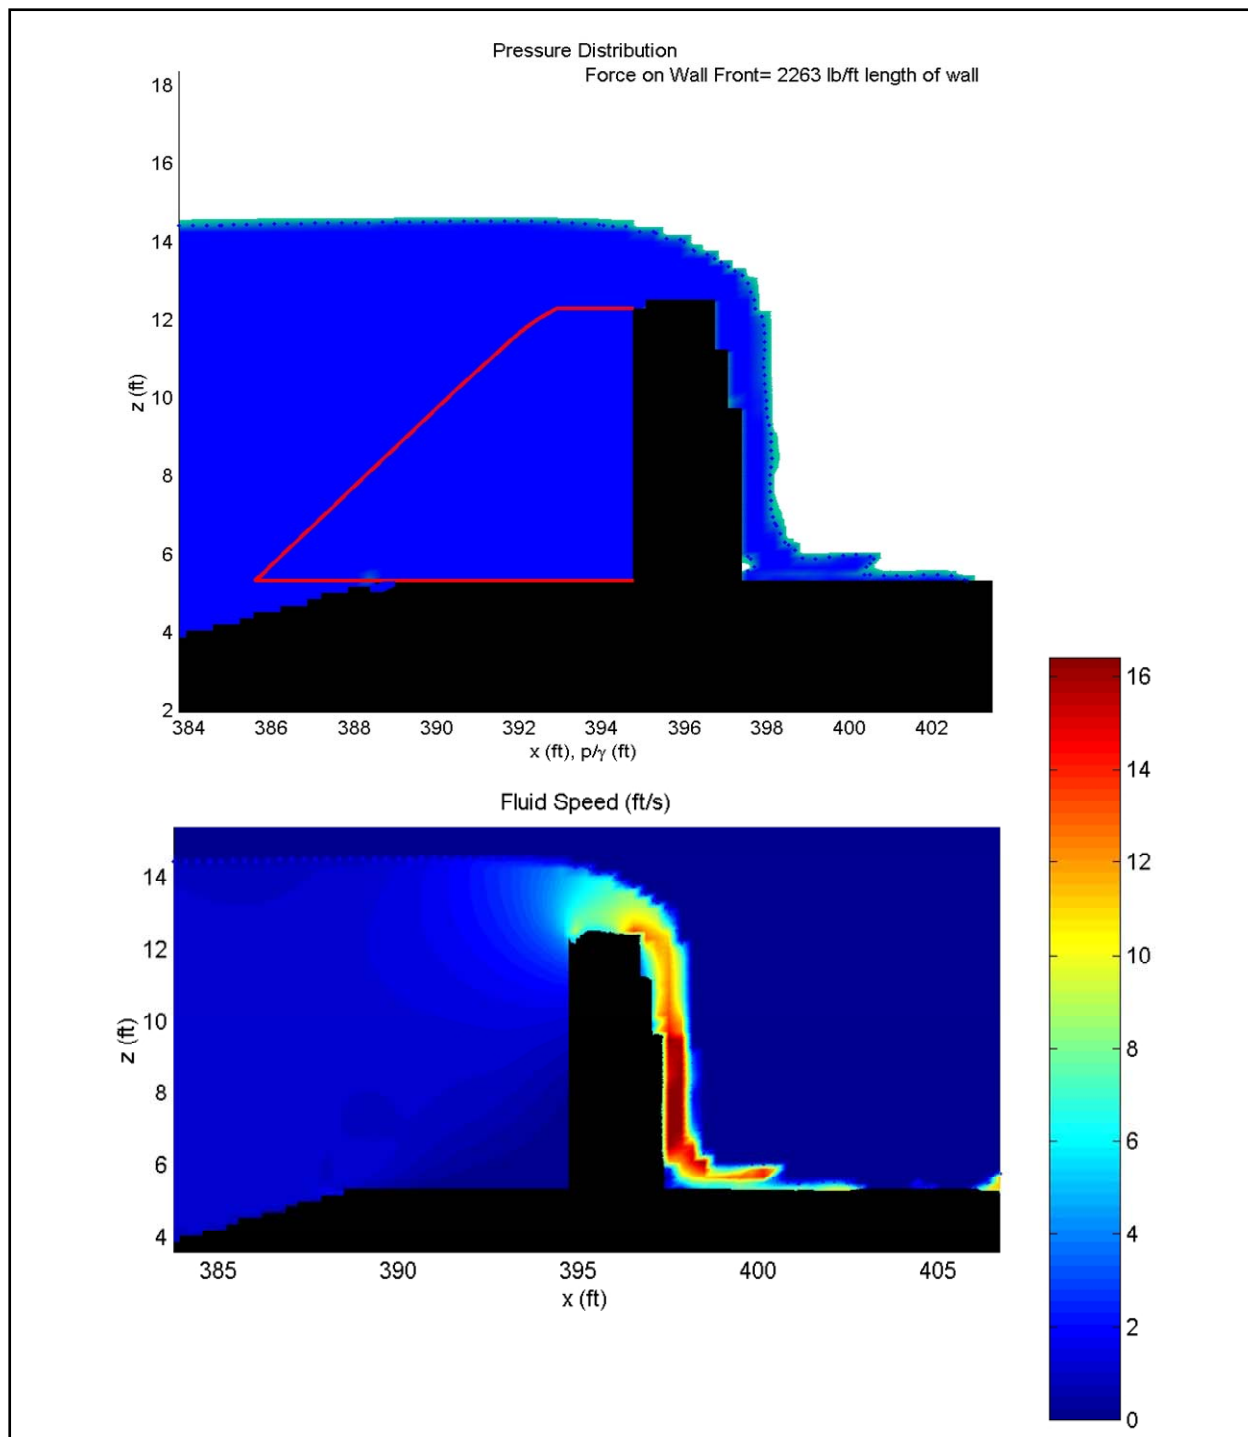
Figure 15-30. Surge overtopping an IHNC wall with 1 foot, 5 second waves. The wall elevation is specified as 1ft below the surge. The top plot gives the water surface and pressure distribution, the lower plot gives the fluid speed field.

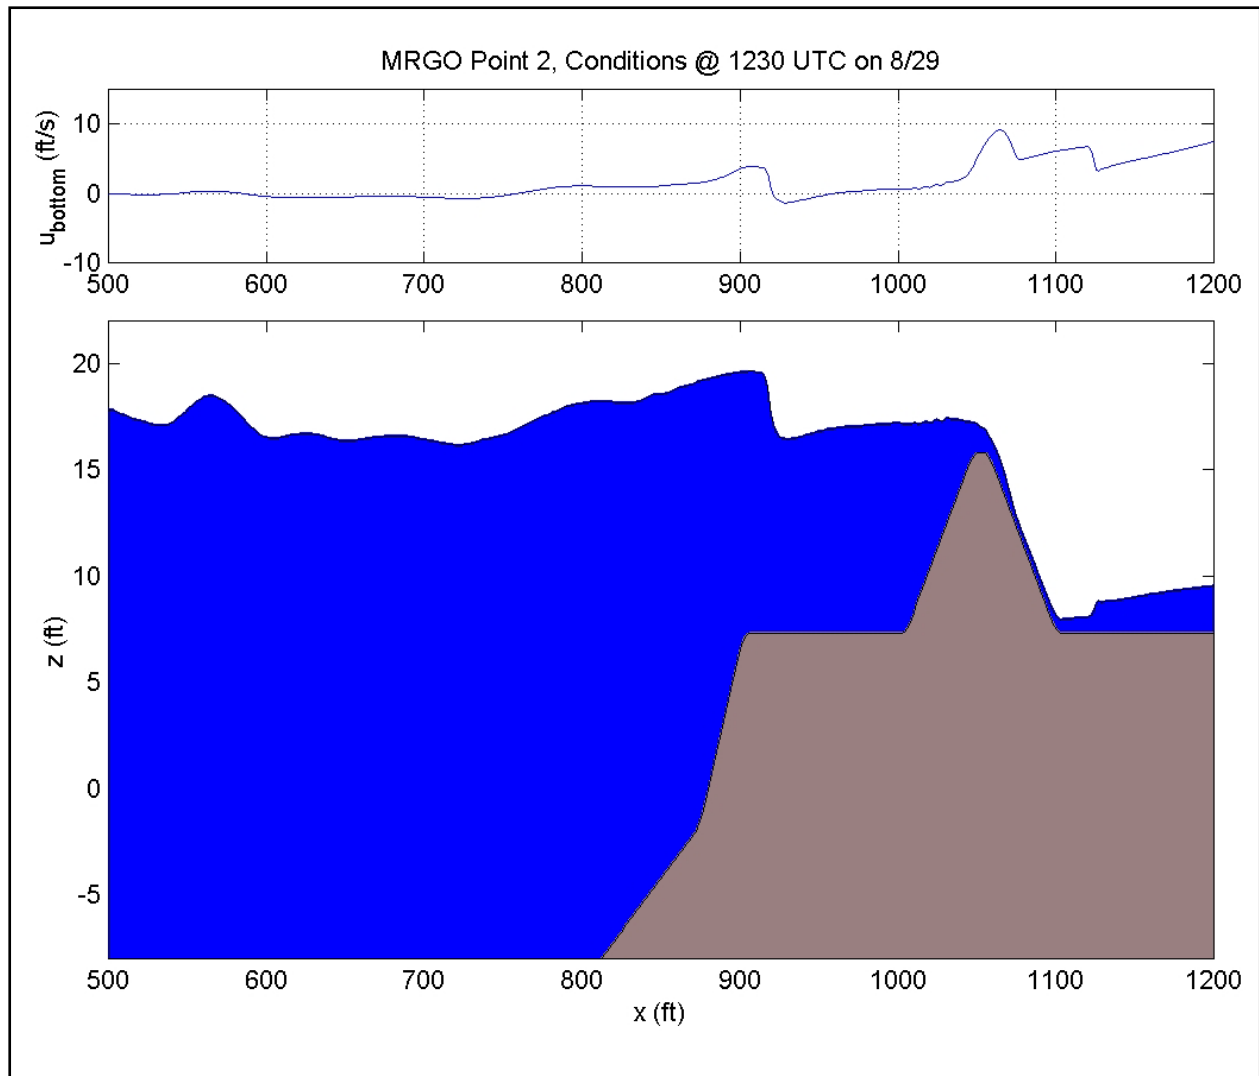
An example of the detail provided by these simulations is given in Figure 15-32. This figure is a single snapshot (i.e. just one of about 30,000 time steps) at location point 2. The physical time corresponding to this condition is 1230 UTC. For the four locations, 24 times are simulated, with a range of 0630-1500 UTC, in 30 minute increments. The simulations provide

Figure 15-32. Simulation snapshot for MRGO point 2 @ 1230 UTC, where  $H_{mo}=3.2$ ft, surge elevation=17.4ft, and levee crest elevation=15.8ft. Top plot shows the spatial profile of the near bottom velocity

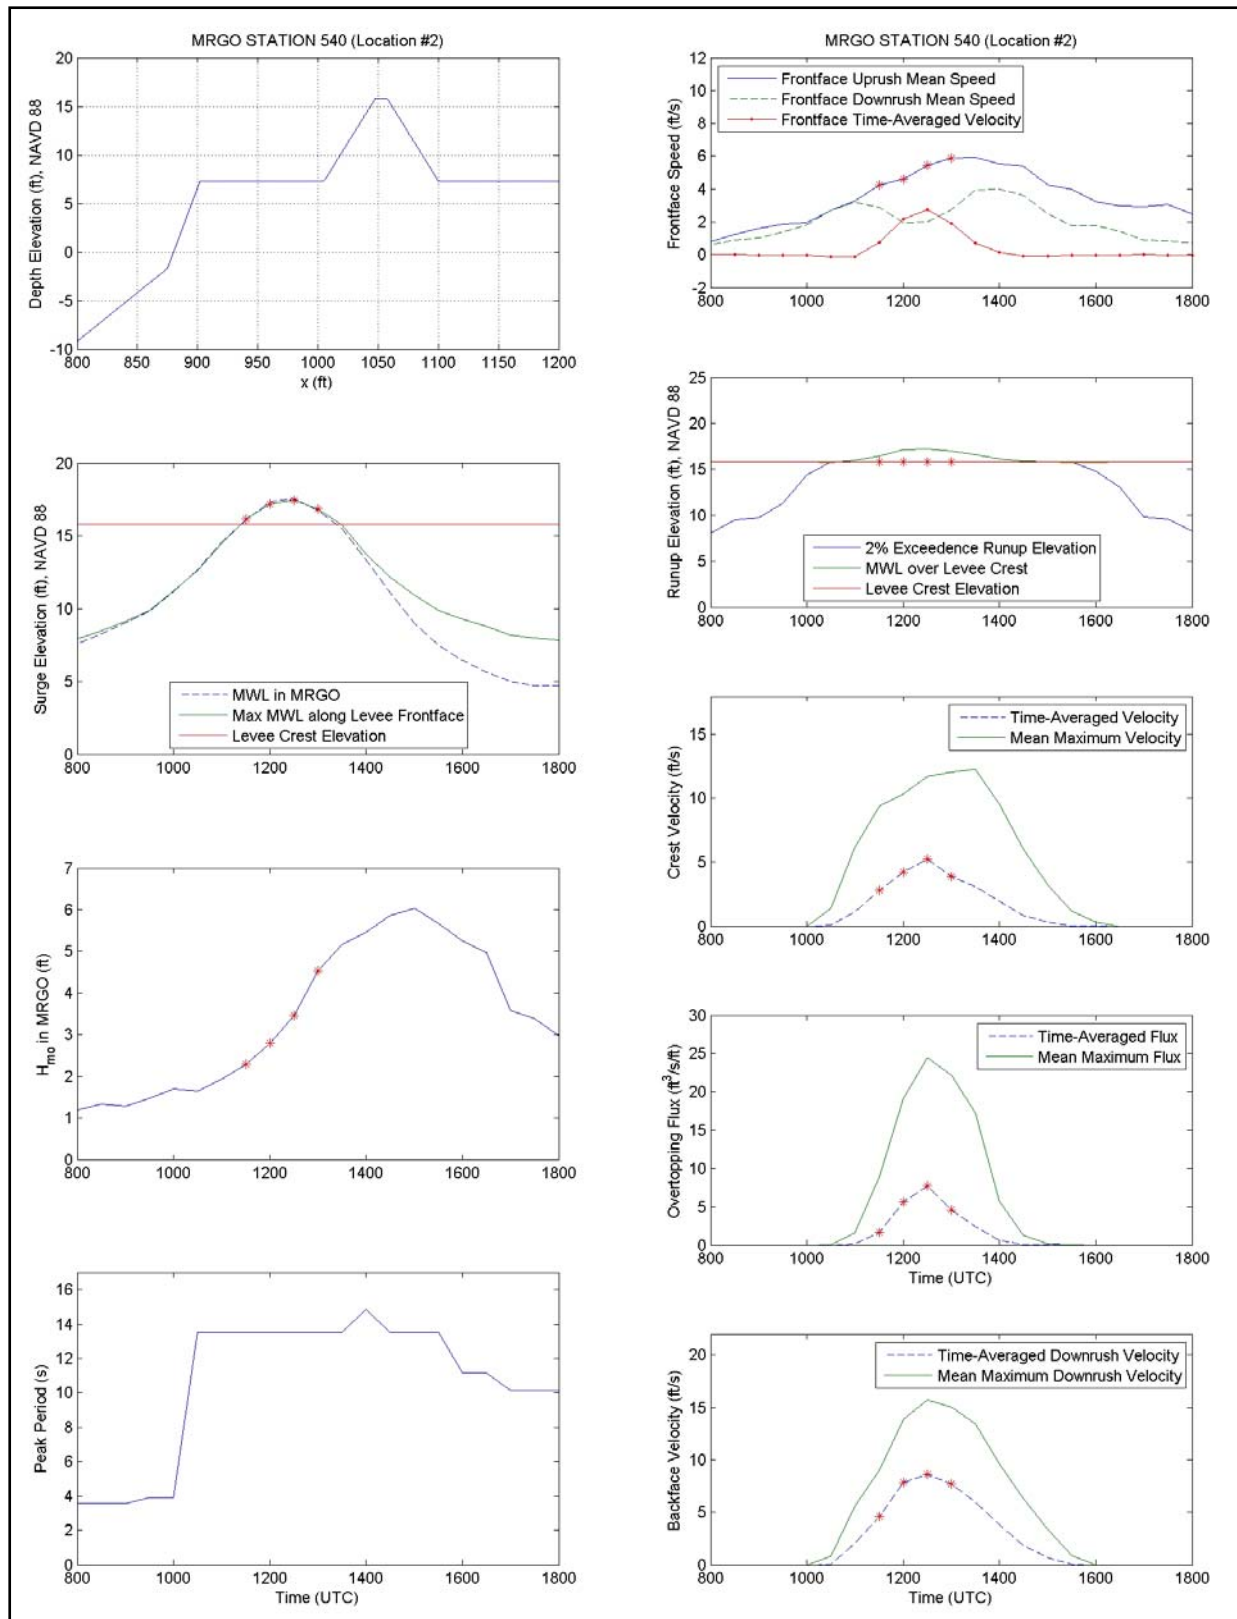
For all locations along the length of the MRGO, there is some overtopping from 1130-1430 UTC. The maximum overtopping flux takes place between 1230-1300, and occurs at the time of peak surge for all cases. Time-averaged overtopping rates range from 0.2-20 ft<sup>3</sup>/s/ft. Values on the low end of this range are due to wave overtopping with a surge less than the levee crest elevation, whereas values on the high end arise from surge elevations about 3.5ft above the levee crest, and likely represent the worst conditions experienced along the entire MRGO. Along the backface of the levees, time-averaged, near-bottom flow speeds range from 2.5-15 ft/s during peak conditions, while mean maximum speeds fall between 7-20 ft/s. Wave setup does not play a significant role during the peak conditions. This is due to small waves at the time (2-3ft), and the observation that the waves typically initiate breaking  $\frac{1}{4}$ - $\frac{1}{2}$  of a wavelength before overtopping the levee, and thus the wave momentum is carried over the levee, rather than through a dissipative surf zone. Later during the day, near 1500 UTC, the wave height reaches 5-6ft, and there is wave setup on the levee front face on the order of 1-2ft. At this time, however, overtopping is minimal. The levee profile geometry appears to play a strong role in setup. To estimate the wave-induced, longshore current, a single 3D simulation was run for point 2 during peak surge-induced currents (1230 UTC). A plan view snapshot of the wave field is given in Figure 15-33. The longshore current prediction is near 0.1 ft/s, and is dwarfed by both the surge-induced current (about 4.5 ft/s) and the cross-shore velocities on the levee front face (about 5 ft/s). The reason for the weak longshore current during peak surge conditions follows that for the small wave setup.

Figure 15-35. Simulation output summary for MRGO point #2. Red stars indicate time of continuous overtopping

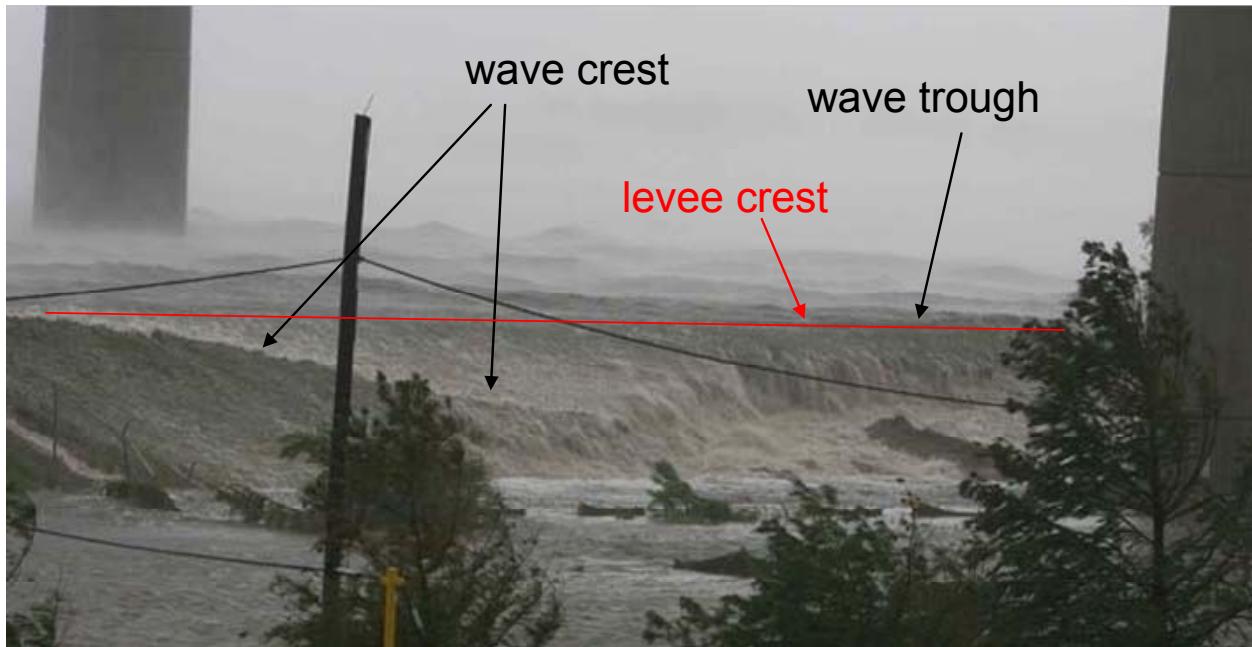
waves propagate through the GIWW, large-angle refraction along the channel side levee face causes a local decrease in the wave height. This refraction can be seen in Figure 15-41 by the bending of the wave crests before overtopping the levee. Of primary interest are the fluid velocities along the backface of the levee. Figure 15-42 gives a plan view snapshot of the fluid speed, taken at the same time as Figure 15-41. The numerical model predicts maximum velocities (under the wave crests) near 8 ft/s, while overtopping velocities under the troughs are much lower, near 3-5 ft/s. In fact, the levee crest will occasionally go “dry” along a wave trough, when the water elevation dips below the levee crest elevation. One such instance is shown in Figure 15-41. Time-averaging the backface velocity gives values near 4.5 ft/s along the levee crest, with little variation. The overtopping energy shown in this simulation, while significant, is on par with peak conditions predicted at “point 1” of the MRGO simulations. Near this MRGO location, there was only minor overtopping damage/erosion. Thus, while the overtopping shown in Figure 15-39 certainly appears impressive, it was likely not at the level required to cause serious levee damage. This may partially explain why there was only minor levee erosion in this area. It must also be noted again that the time of the photo in Figure 15-39 was probably an hour or so after the surge peak, and thus conditions may have been considerably worse before this photo was taken.

Figure 15-39. Photograph showing overtopping of levee under the Paris Road Bridge. Time of the photo is not known with certainty. View is from the north side of the levee, looking towards the southwest. Waves are traveling from the east (left side of photo) towards the IHNC

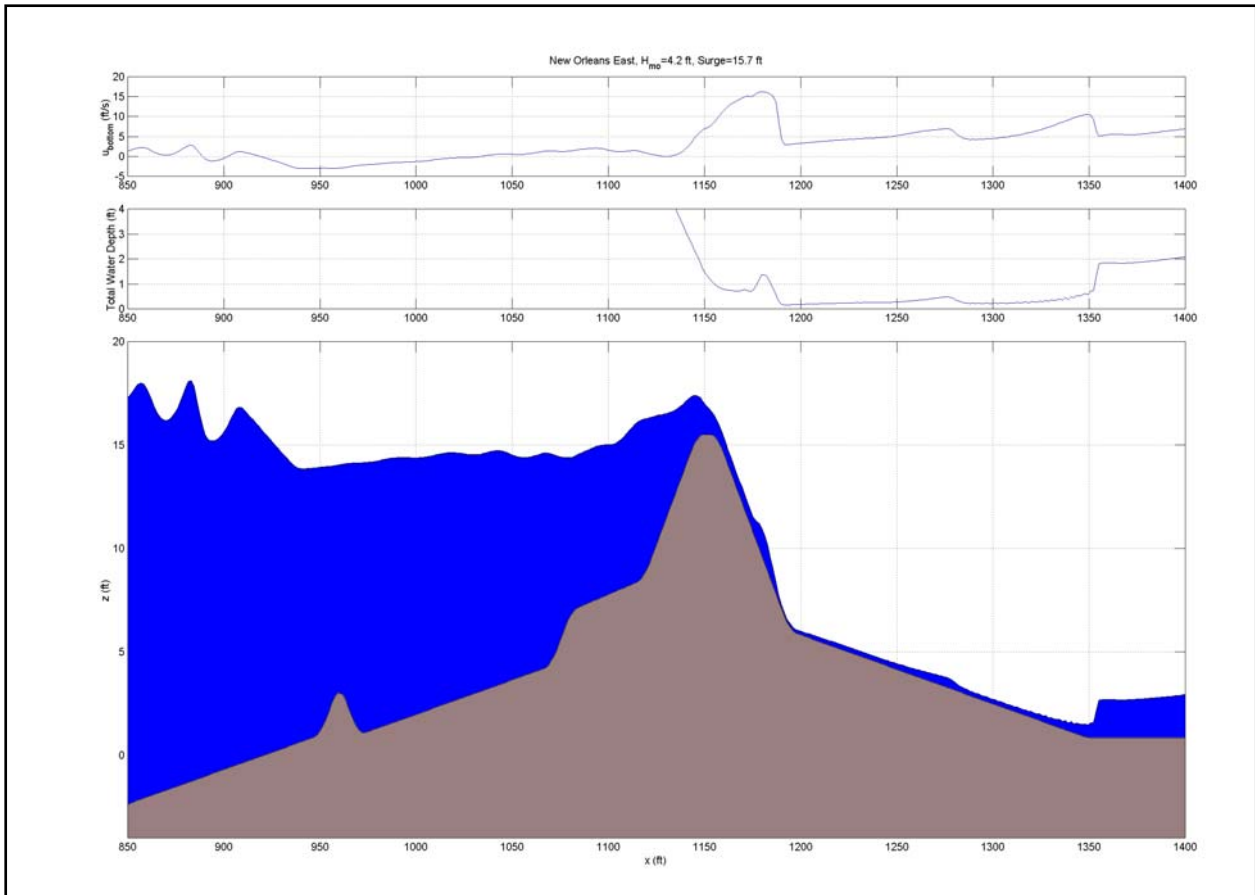
Firstly, the simulation at the far eastern levee along the GIWW is discussed. A snapshot of the numerical simulation is given in Figure 15-40. For this peak condition, the surge elevation is 15.7', the wave height is 4.2', and the peak wave period is 14 seconds. Time-averaged values of overtopping flux, crest velocity, and backface velocity are 1.0 ft<sup>3</sup>/s/ft, 2.0 ft/s, and 6.0 ft/s, respectively. The mean maximum values, associated with the wave crest, are 8.7 ft<sup>3</sup>/s/ft, 8.5 ft/s, and 12.5 ft/s, respectively

Figure 15-40. Snapshot from the numerical simulation of overtopping the far eastern GIWW levees. Conditions correspond to 1230 UTC on the 29<sup>th</sup>, with  $H_{mo}=4.2'$  and surge=15.7'. Spatial transects of near bottom velocity and total water depth are given in the top two subplots

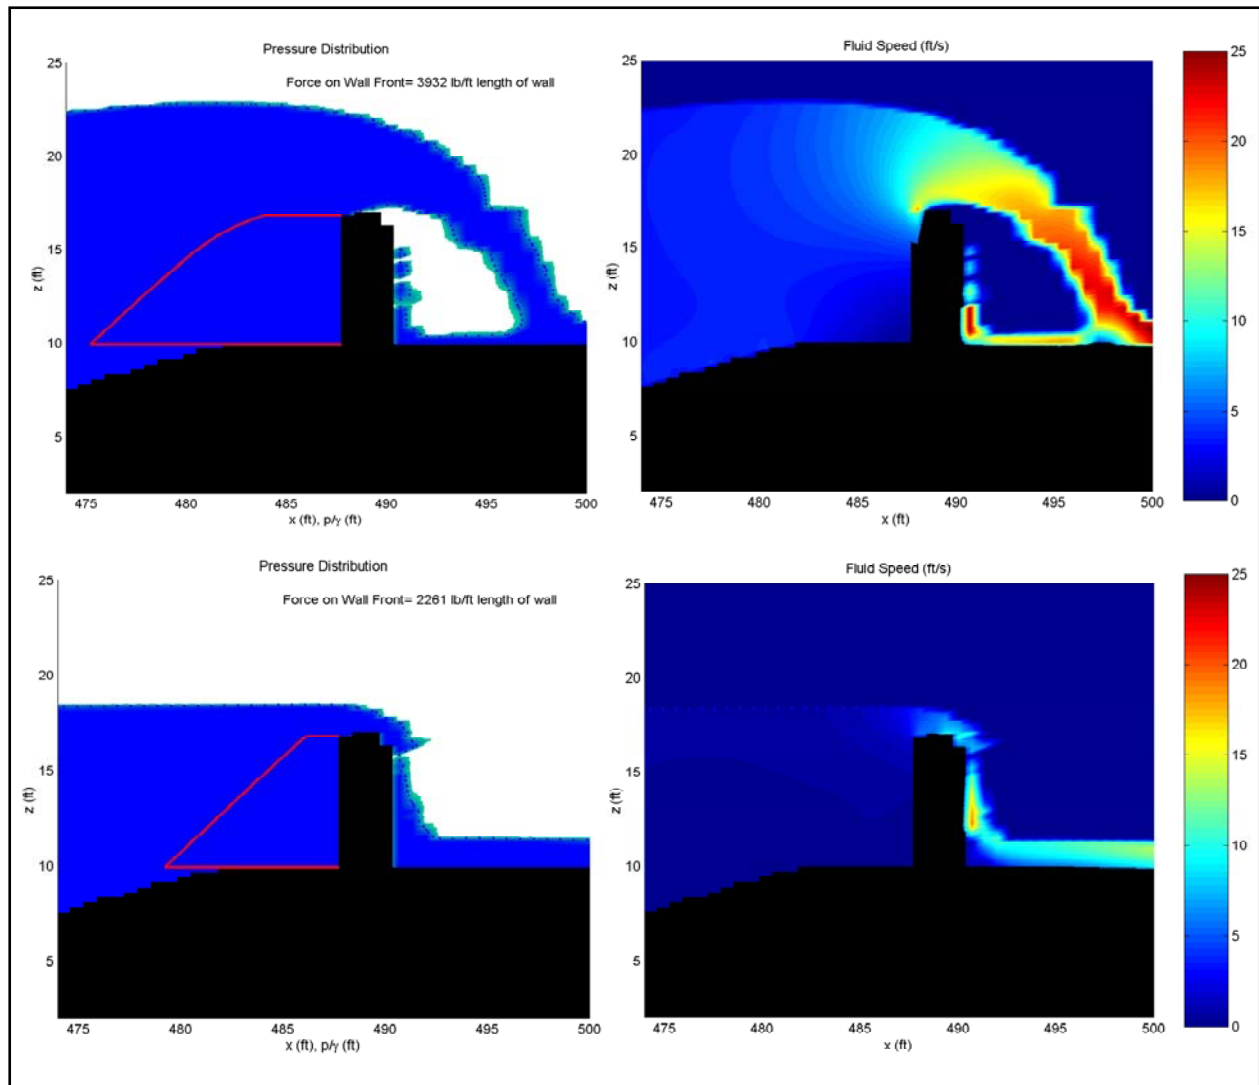
results of the simulation. Shown is the pressure distribution and speed field at the time of maximum (crest) and minimum (trough) force. Here, the dynamic impact can be seen in the pressure distribution under the wave crest, as the vertical distribution is not linear. Under the trough, however, the distribution is linear. This is an expected result with large amplitude waves. The force under the crest is 3930 lb/ft, and 2960 lb/ft under the wave trough. These forces are mean values, not a 2 percent exceedence. The computational requirements of the Navier-Stokes simulations prohibit the long duration runs with input spectrums required to derive statistical relations. Note that the dynamic effect under the crest adds approximately 6 percent to the total force acting on the wall; the hydrostatic load on this wall with a 23' instantaneous water surface elevation is 3710 lb/ft. Maximum fluid speeds on the backsides of the walls are extreme when the crest impacts the wall, near to 25 ft/s. Under the wave crest, there is sufficient horizontal velocity under the wave to create a jet which hits the soil 5-10' past the back of the T-wall. Overtopping flux under the wave crest is 67 ft<sup>3</sup>/s/ft; under the trough this dips to 9 ft<sup>3</sup>/s/ft. The wave-averaged value of overtopping flux is 22 ft<sup>3</sup>/s/ft, which is a value much closer to the trough due to the wave asymmetry.

Figure 15-44. Pressure distribution (left) and speed field (right) under the wave crest (top) and wave trough (bottom) for wave overtopping the levee wall

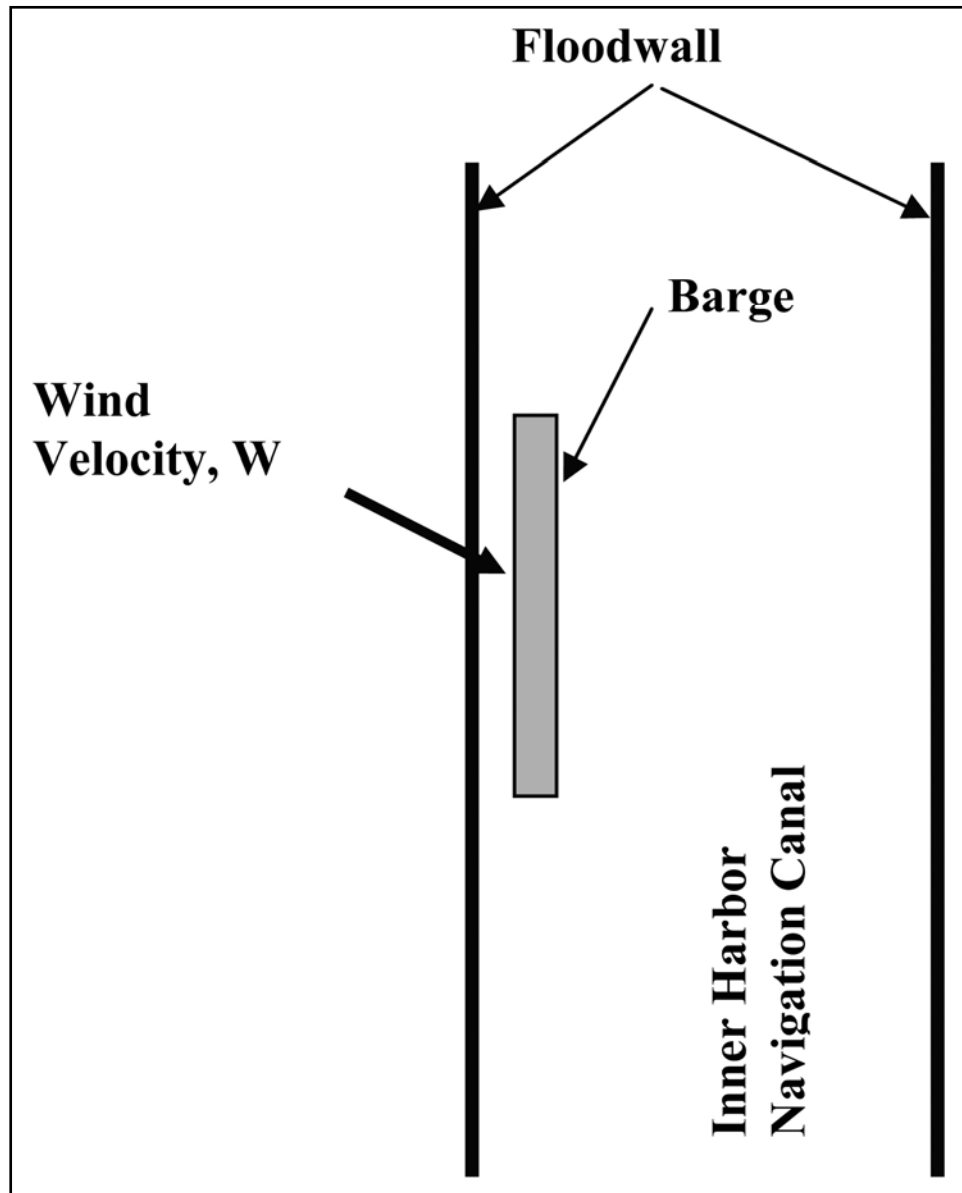
and other characteristics associated with the methodology. Figure 17-1 shows a plan view of the barge in the IHNC and the winds that were directed on the barge.

Figure 17-1. Definition sketch of Inner Harbor Navigation Canal and wind blowing on the barge

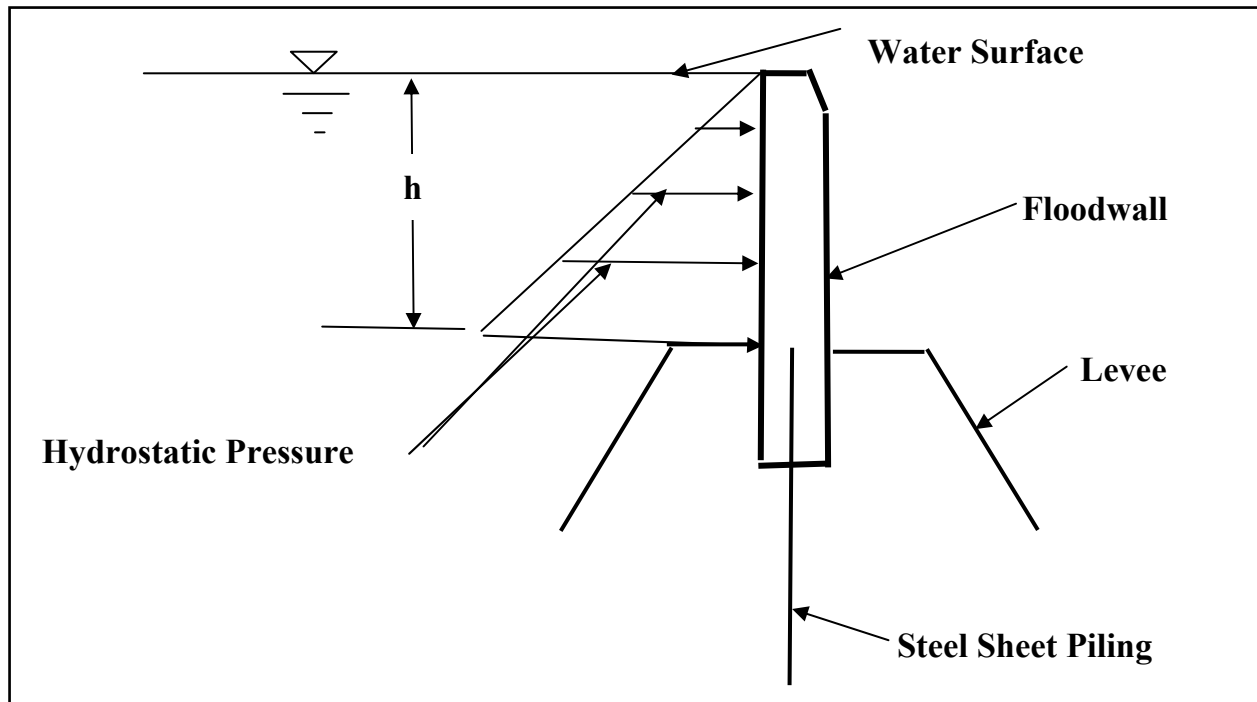
Figure 17-3 depicts a typical section of the flood wall at an imminent overtopping condition. The hydrostatic force,  $F_{HS}$  on the floodwall per unit floodwall length for the imminent overtopping condition shown in Figure 17-3 is

Figure 17-3. Definition sketch for east floodwall at imminent overtopping condition
