Performance Evaluation of the New Orleans and Southeast Louisiana Hurricane Protection System

Final Report of the Interagency Performance Evaluation Task Force

Volume V – The Performance — Levees and Floodwalls

June 2007

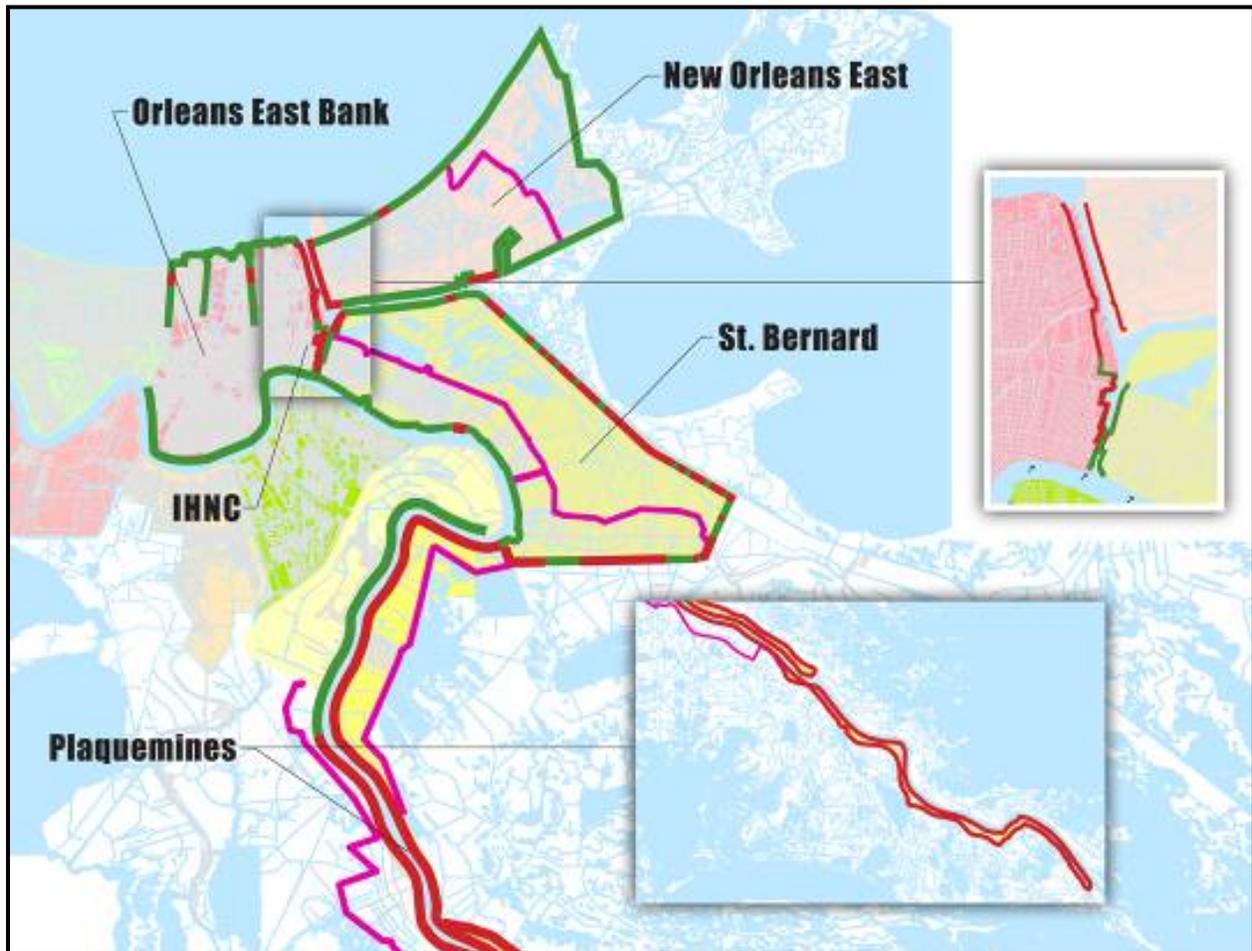
Figure 1. Damage to the New Orleans Hurricane Protection System.

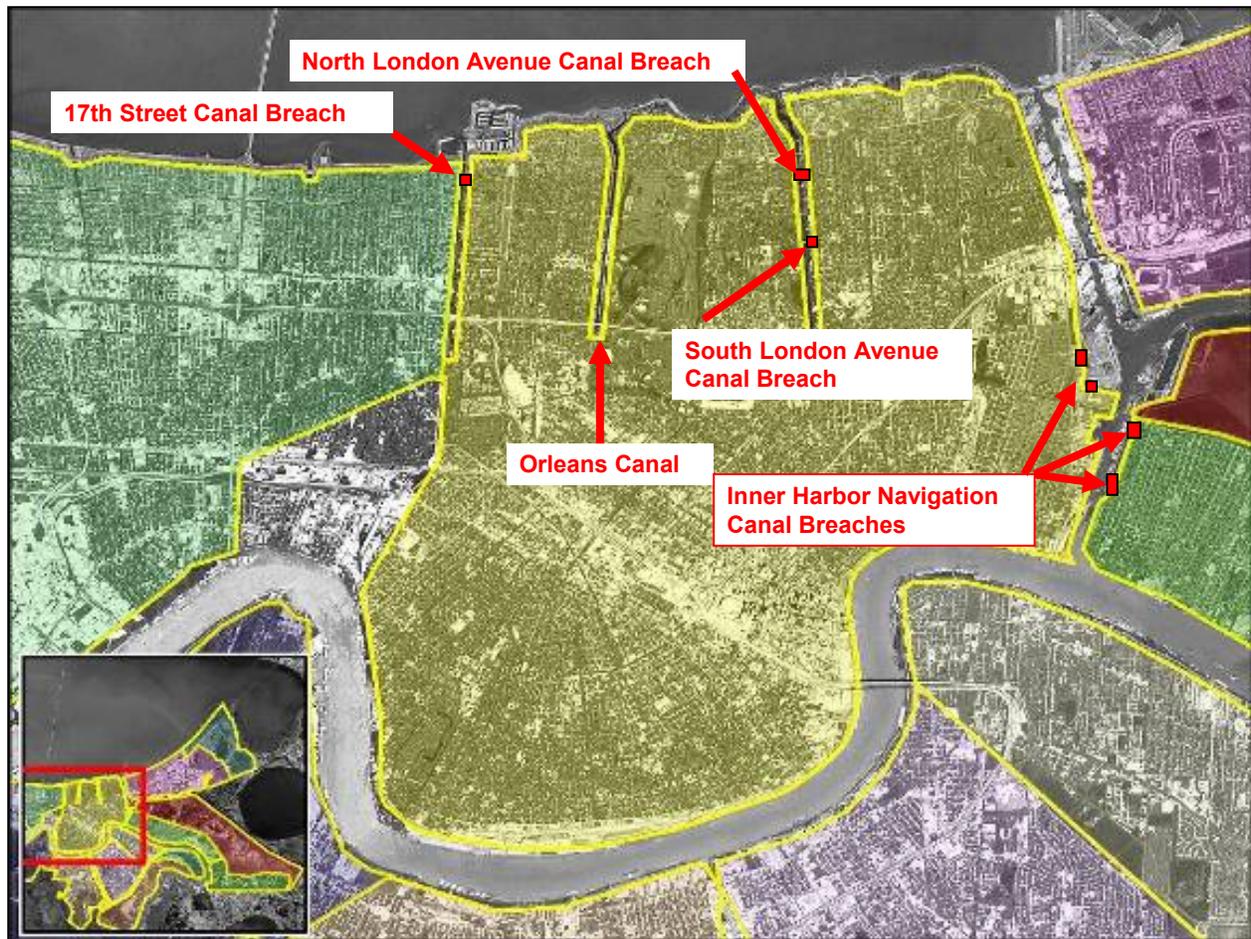
Breaches due to instability of floodwalls occurred at one location on the 17th Street Canal, at two locations on the London Avenue Canal, and at one location on the IHNC. Breaches due to erosion as a result of overtopping occurred at three locations on the IHNC and at many locations on the MRGO, the GIWW, and the Mississippi River levees. Figure 1 shows in red the extent of the damage to the levees and floodwalls. Of the 284 miles of levees and floodwalls, 169 miles were damaged. Figure 2 shows the locations of the major breaches in Orleans Parish.

Figure 2. Location of breaches in Orleans Parish, East Bank.

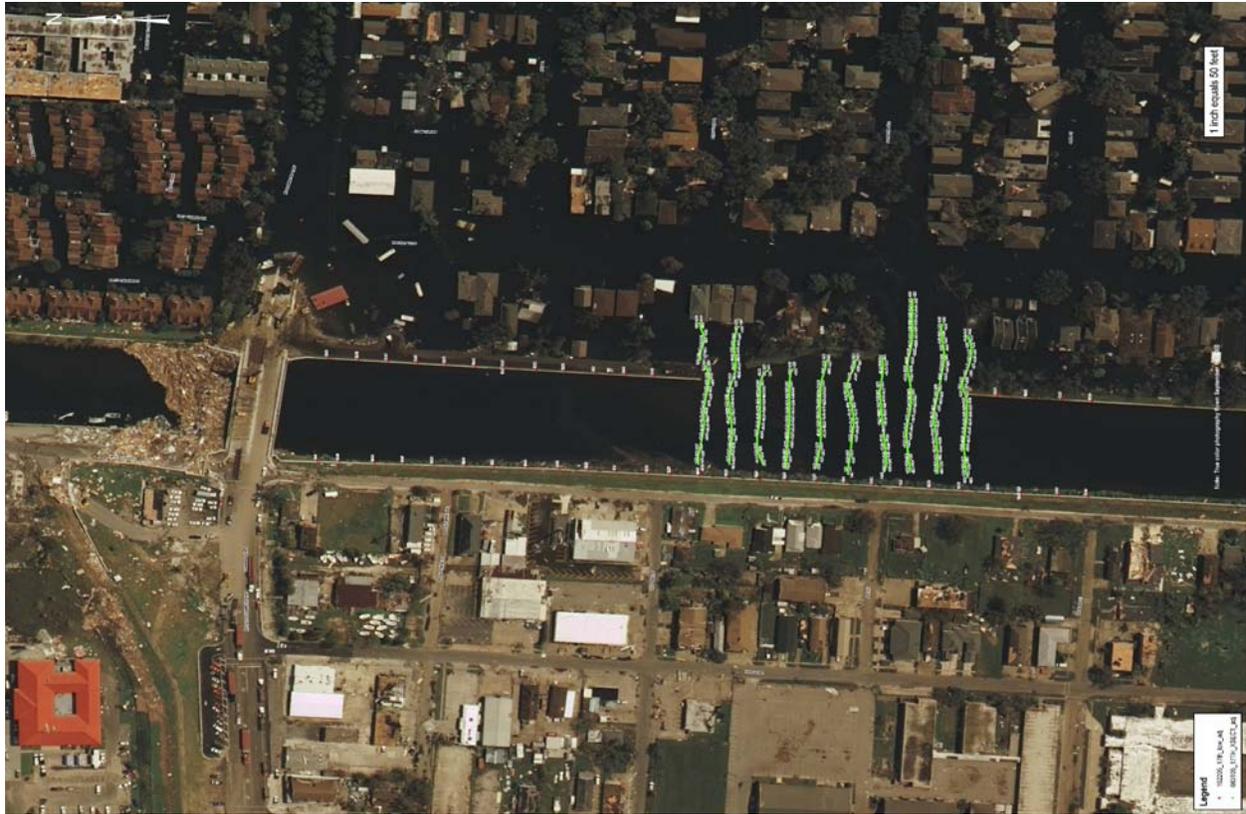
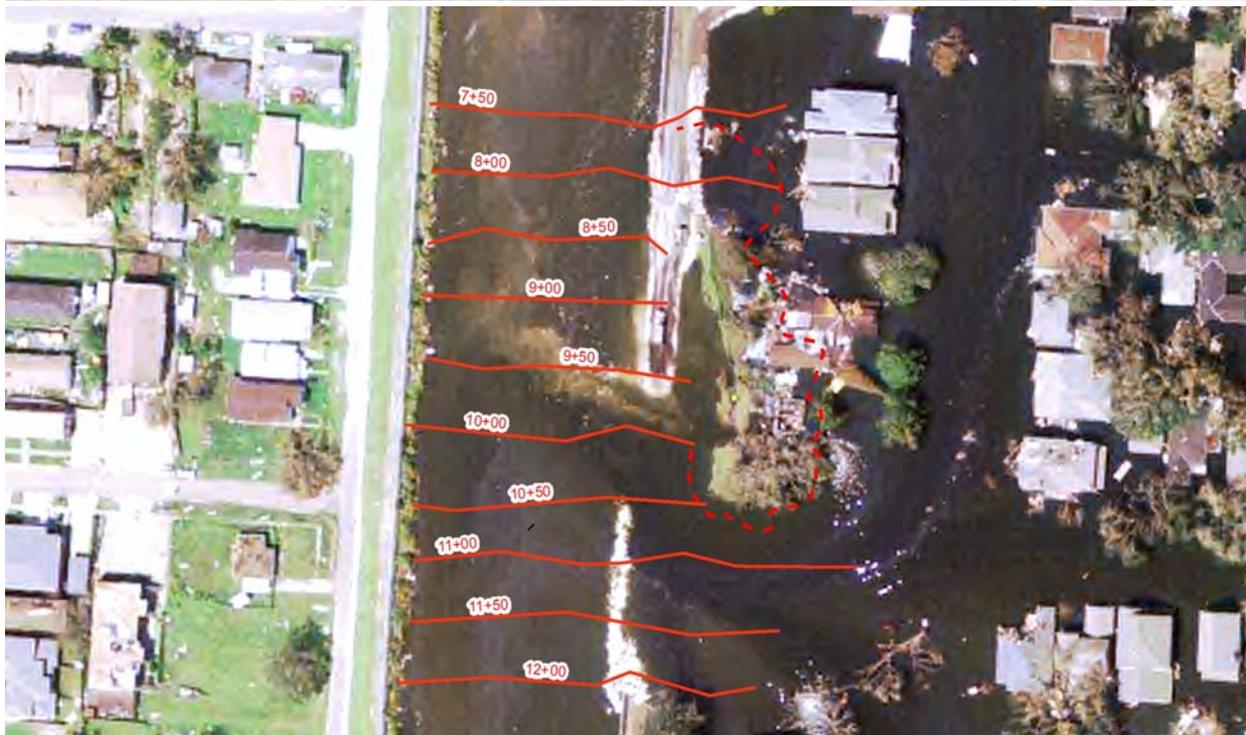
A transverse multi-beam sonar survey of the surface of the canal bottom and breach was conducted before construction of an emergency closure across the breach at the cross section shown in Figure 11. Topographic cross sections developed from the results of this survey are shown in Figures 12a and 12b. The survey showed that the crest of the levee on the canal side remained in place after the breach, as shown by the ground surface profile at Station 11+50 in Figure 13. It can be seen that the levee and floodwall moved about 40 ft laterally during the failure, and was tilted toward the landside at about 45 degrees after the failure.

Figure 11. Location of multi-beam sonar survey cross sections at the 17th Street Canal breach.

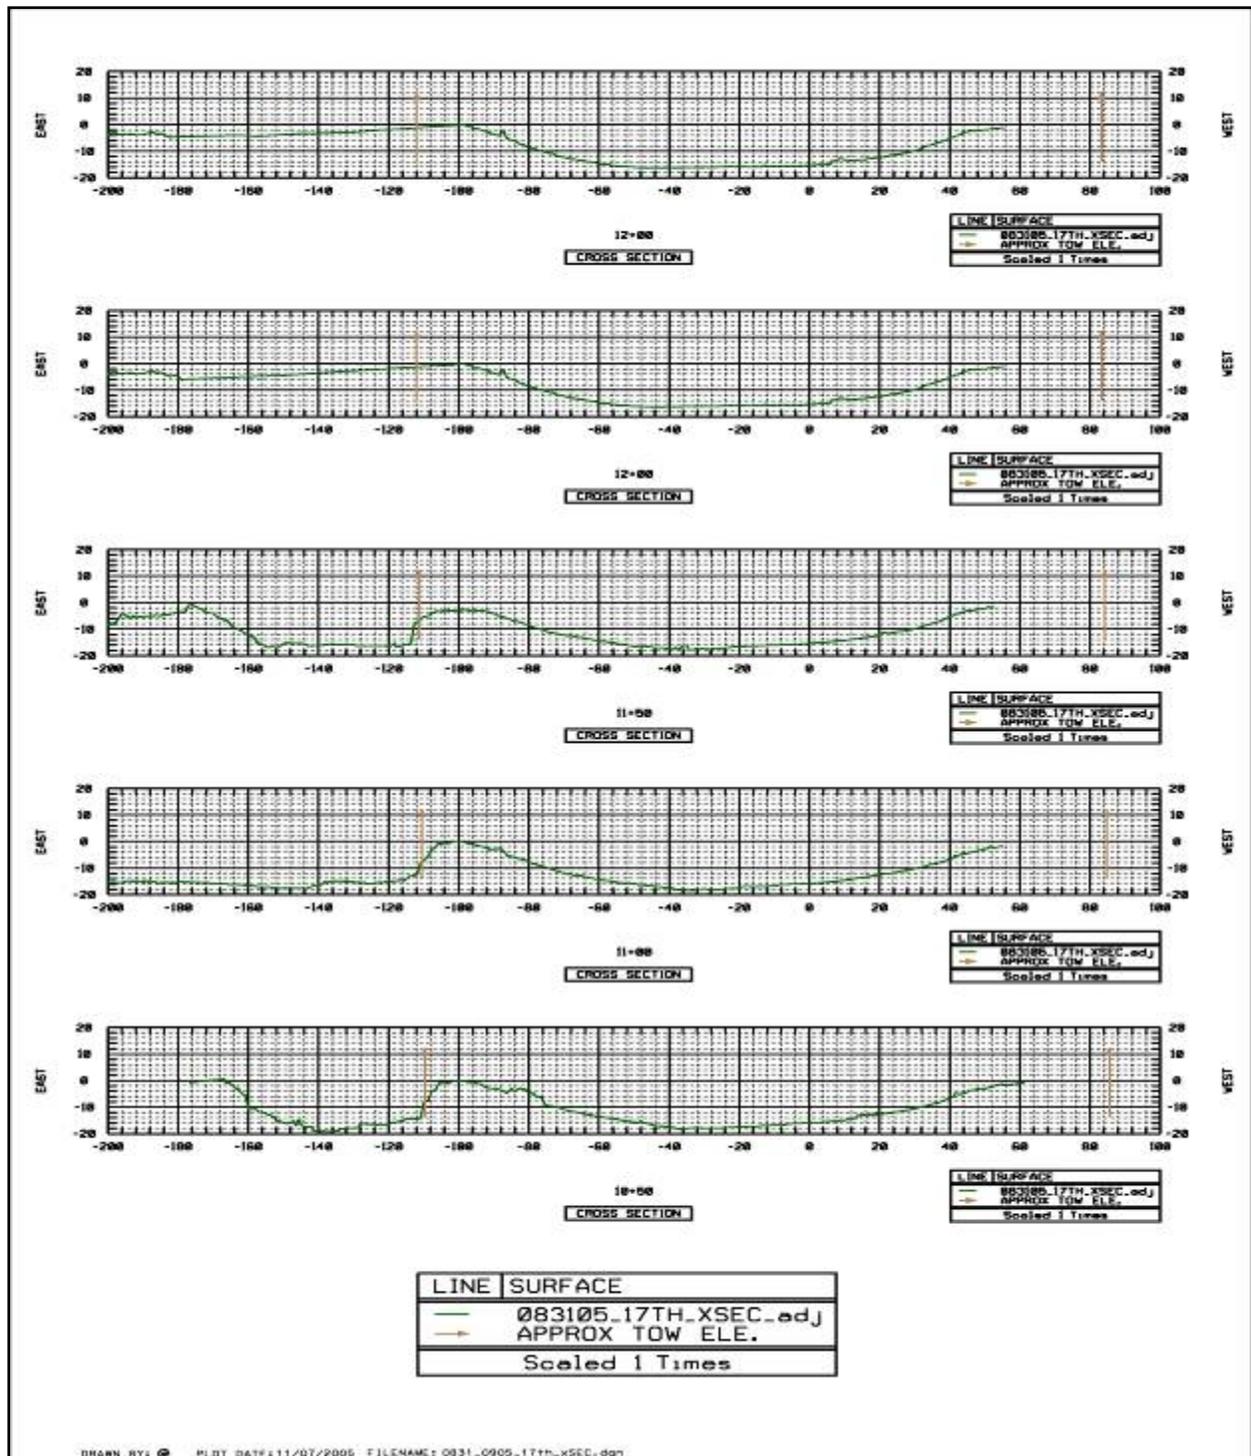
Figure 12a. Surface profiles at the 17th Street Canal breach.

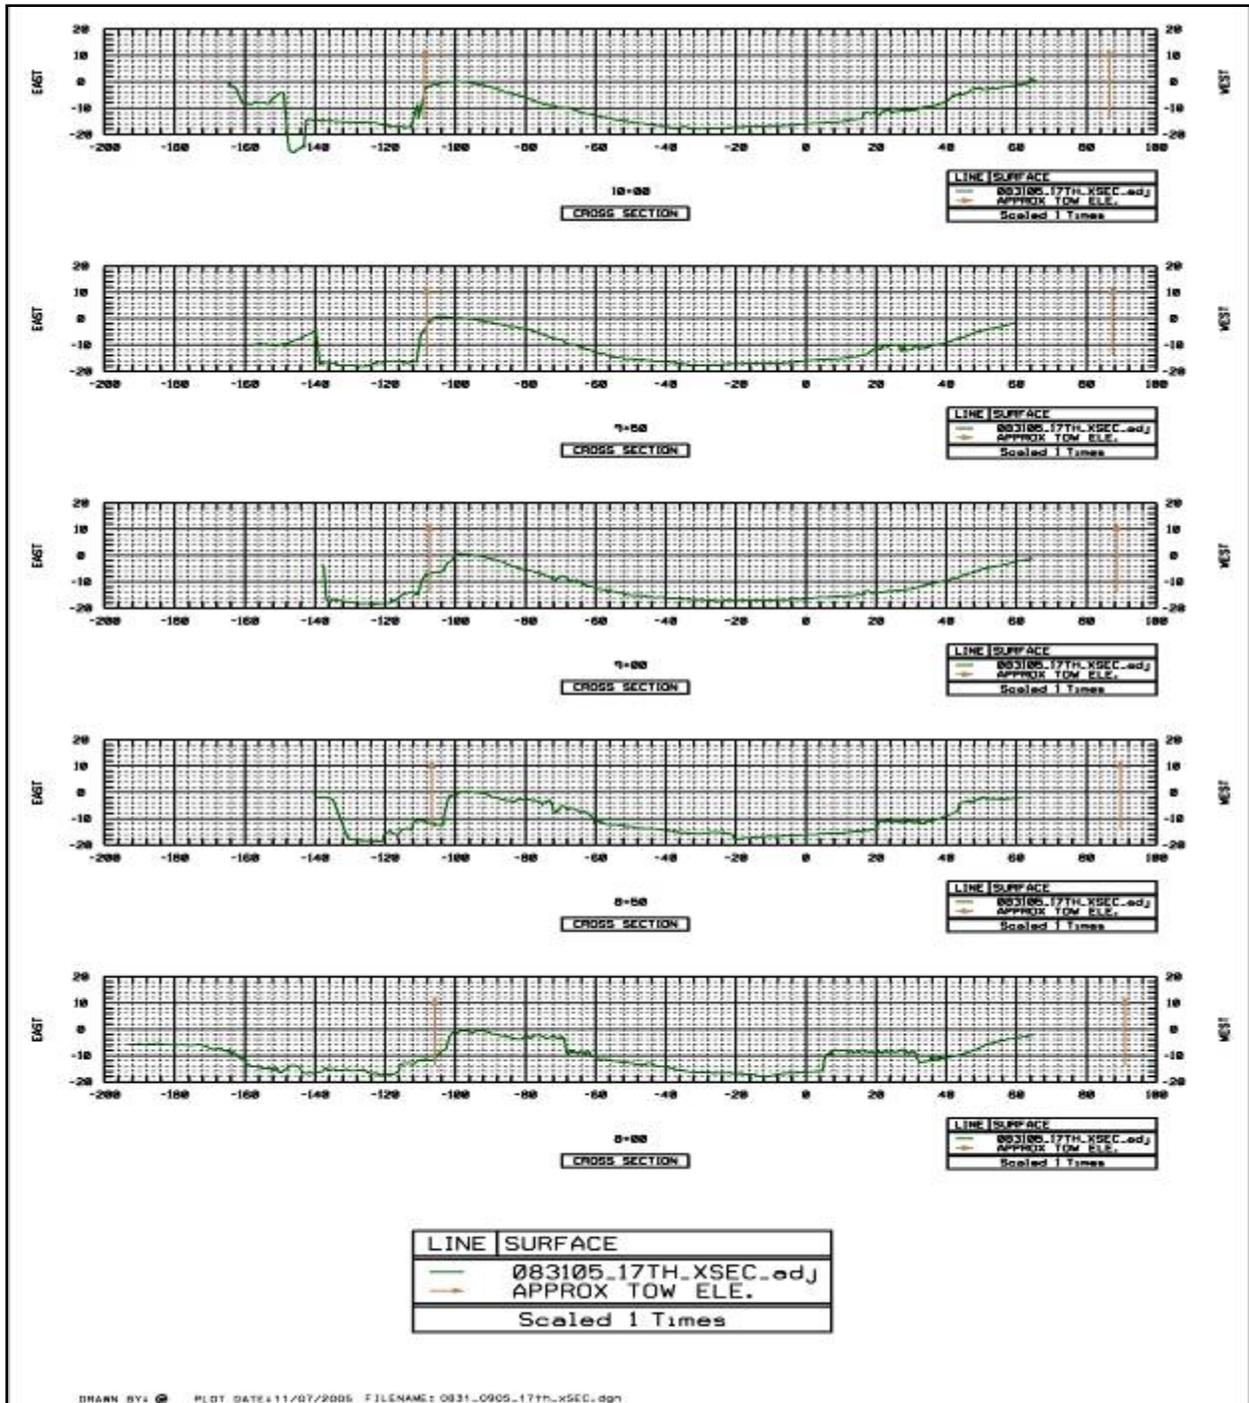
Figure 12b. Surface profiles at the 17th Street Canal breach.

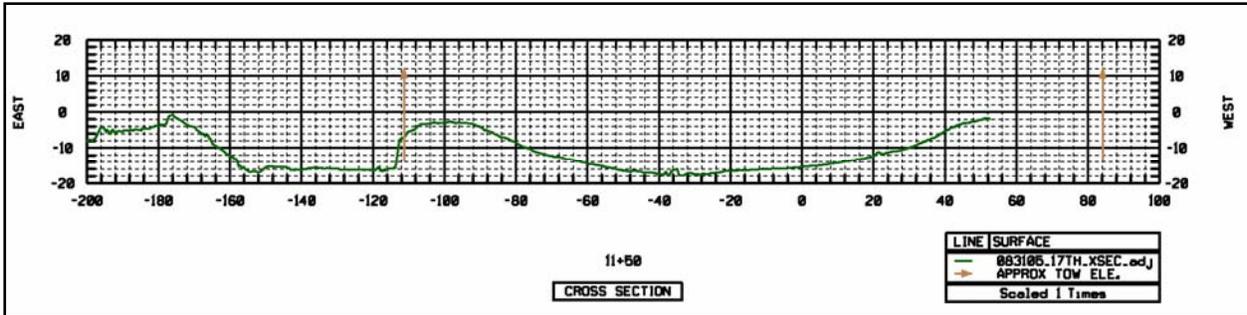
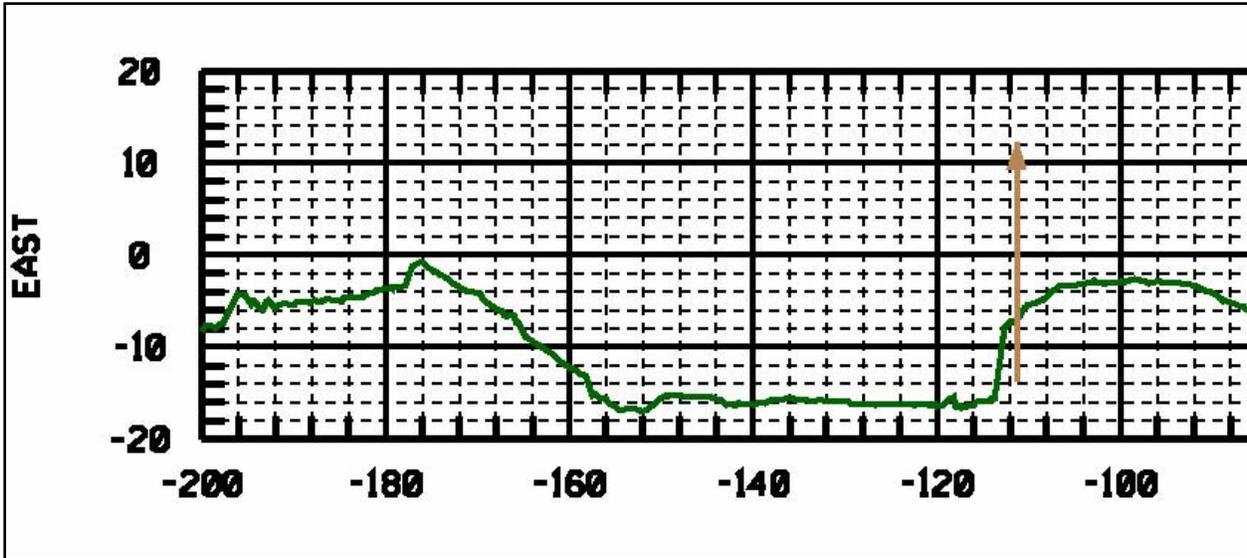
Figure 13. Profile for Station 11+50 through the 17th Street Canal breach.

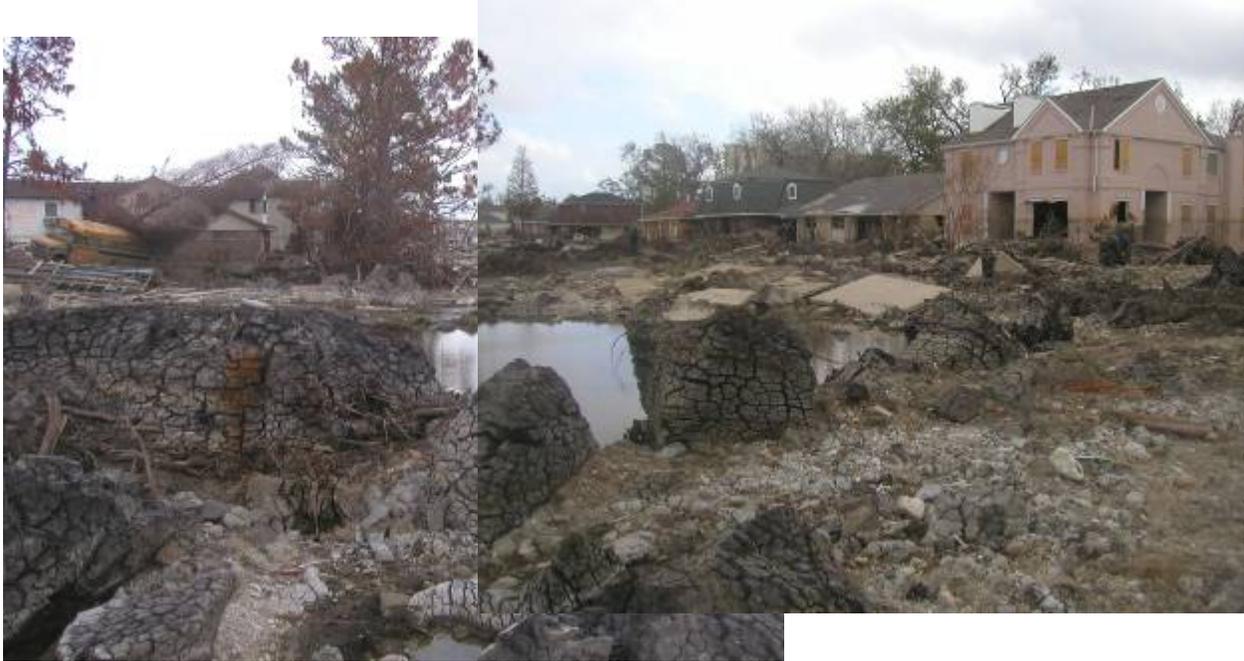
After the emergency closure was complete, and the water levels were drawn down, large blocks of the marsh were found strewn in neighborhoods surrounding the breach, as shown in Figure 14. A close examination of the marsh blocks reveals that an approximately 1-ft-thick clay layer is attached to the bottom of the marsh block (Figure 15). In order to inspect the failure plane or zone, a backhoe trench was excavated to expose a vertical surface through the slide block. A photograph of the side of this trench is shown in the upper left corner of Figure 16, and a closer view is shown in Figure 17. The photograph in Figure 17 shows a portion of the clay layer, which was initially located beneath the marsh layer, was displaced upward and over a portion of the marsh layer by the lateral displacement that occurred during the failure. The shearing mechanism that resulted in this condition is shown in Figure 18; the failure plane of the slide block was within the clay under the levee, and the failure plane came upward through the marsh layer further landward. A description of the geology and soil stratification in the area is discussed in the following section.

Figure 14. Marsh blocks from the levee embankment at the 17th Street Canal breach.

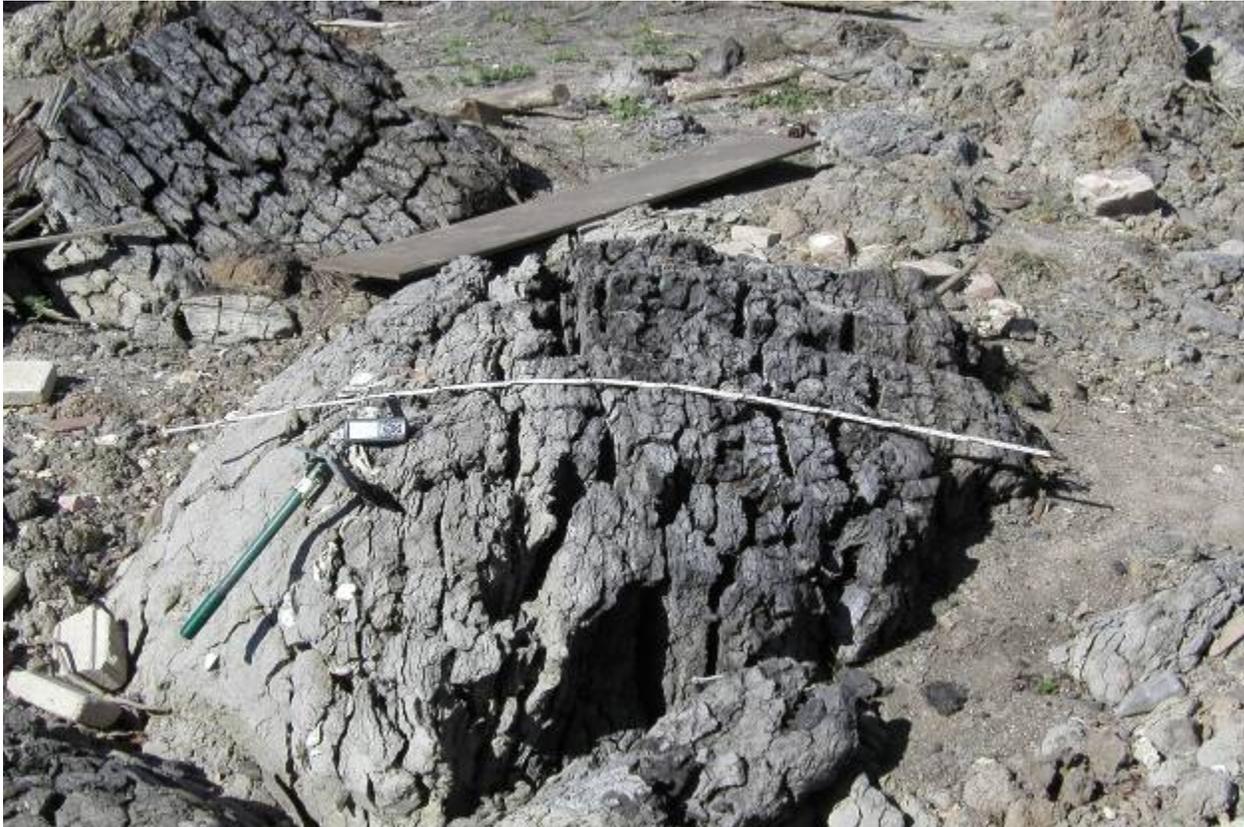
Figure 15. Clay attached to marsh blocks at the 17th Street Canal breach.

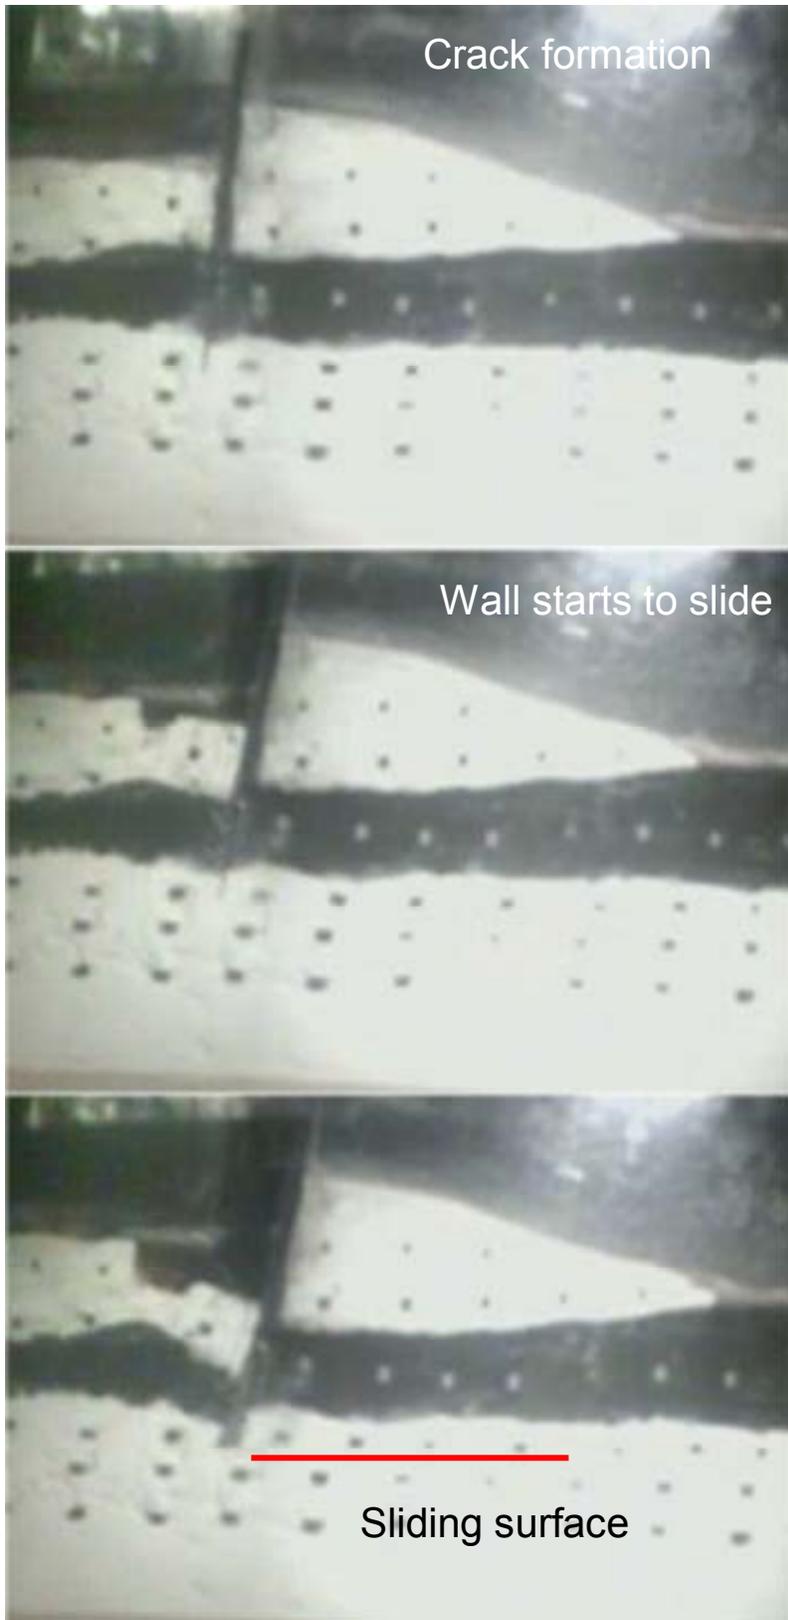
The centrifuge model results revealed that the gap formation had a major contribution to all of the beaches on the outfall canals. In all of the scale models where the toe of the sheet-pile wall terminated in the clay layer, such as the 17th Street Canal breach location, a translational failure occurred through the clay when the gap opened and filled with water. This is clearly seen in the instruments recording movement of the wall and in the video imagery (Figure 25).

The sliding surface developed near the top of the clay layer and progressed landwards until it was outside the levee, then turned upward to exit through the marsh layer. This mechanism is similar to the observations in the field from 17th Street. The movement of the model wall was arrested before larger displacements took place to capture the final state of the 17th Street model (Model 1) (Figure 25). Despite the fairly significant lateral movement, there is minimal heave of the swampy marsh layer on the landward side at the stage shown in Figure 26.

Figure 25. Sliding surface forms at top of clay layer in 17th Street Canal Model 1.

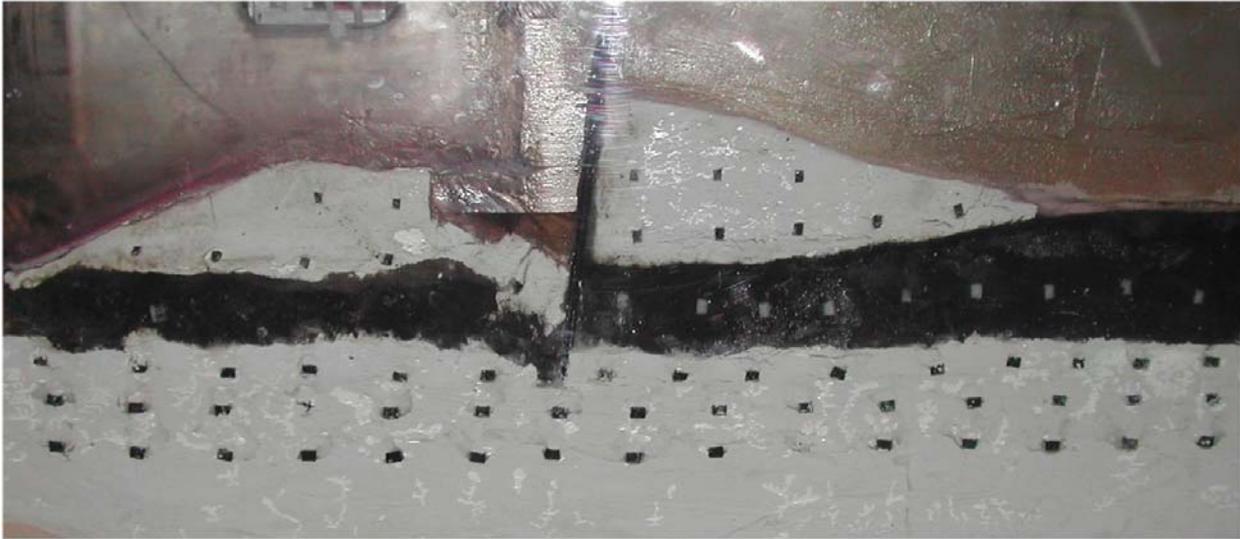
Figure 26. Final state of 17th Street Model 1 showing lateral translation on sliding surface starting at the toe of the wall and progressing landward.

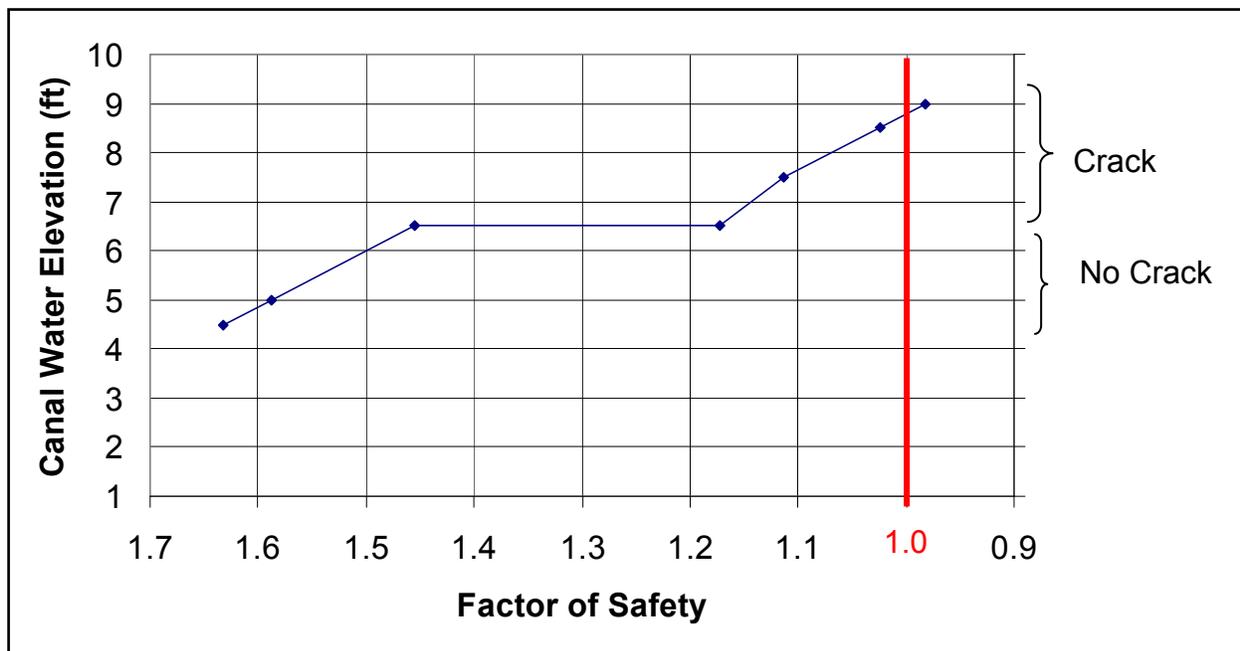
The finite element analyses show that gap formed as the water rose on the canal side of the wall. The criterion for gap formation was earth pressure against the wall less than the hydrostatic water pressure at that depth. When that condition was reached, the finite element mesh was adjusted to separate the soil elements from the wall elements with a gap. The gap began to open when the water in the canal rose to elevation 6.5 ft. Eventually, the gap extended to the tip of the sheet pile, which was at the lacustrine clay-marsh interface. Factors of safety were computed using the strength-reduction method. The strength-reduction method involves performing a series of finite element analyses using values of the strength parameters c and ϕ (or c' and ϕ') that are reduced by dividing them by assumed values of factor of safety. The correct factor of safety, as determined by this method, is the smallest value that results in unstable conditions in the analysis. When the gap developed and filled with water, the factor of safety decreased suddenly by about 25%, from 1.45 to 1.16, as shown in Figure 29.

Figure 29. Factor of safety versus canal water elevation computed in the soil-structure interaction analysis of Station 10+00 on the 17th Street Canal east side breach.

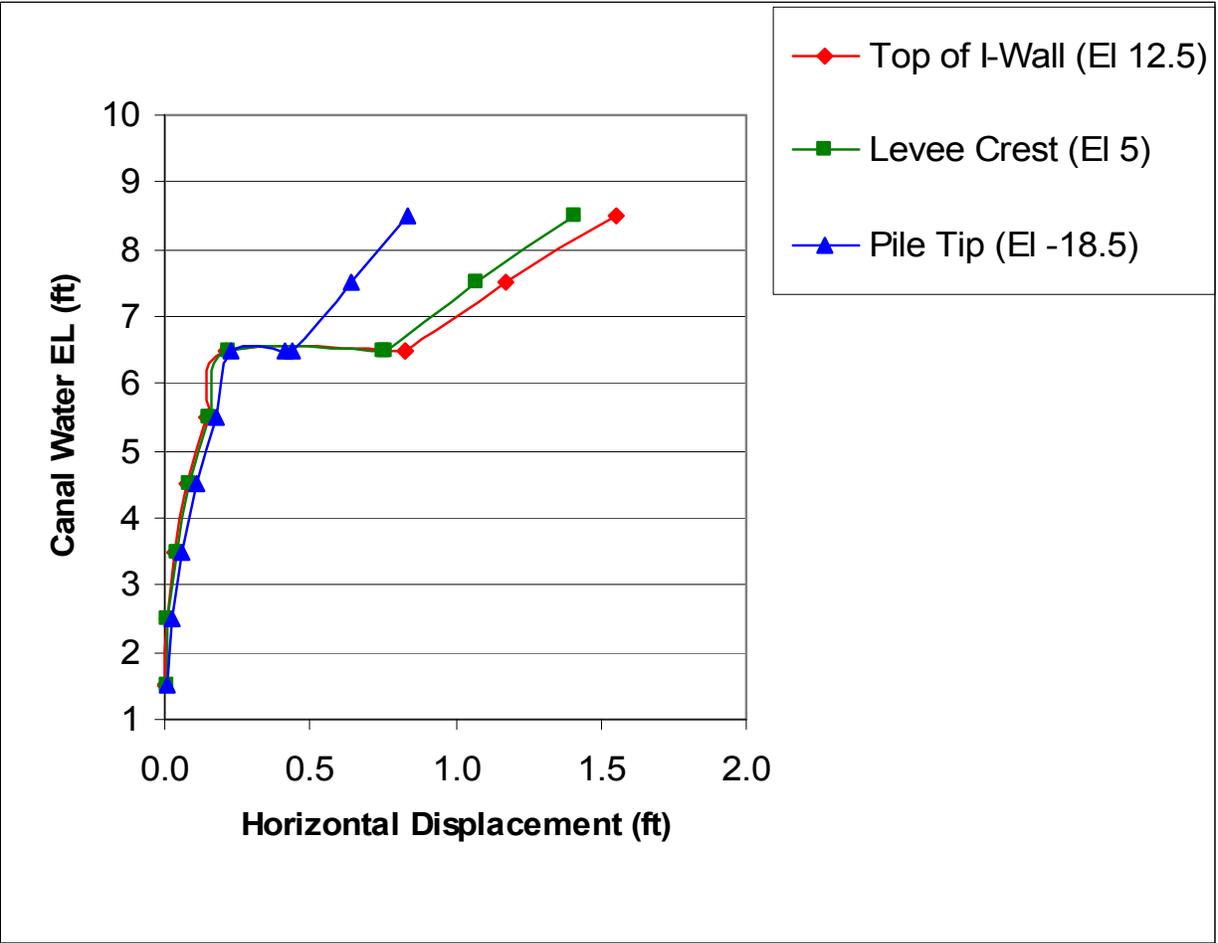
The development of a gap, which immediately filled with water, resulted in a marked increase in calculated displacements, as shown in Figure 30. As the water in the canal rises from 6.5 to 9.0 ft NGVD, the maximum lateral deformation increases from 1.6 ft, the condition shown in Figure 31, to 5.3 ft, the conditions shown in Figure 32; and the factor of safety decreases from 1.16 to 0.98. Figure 33 shows that the contours of maximum shear strains form a shear surface that compares well with the critical failure surface found in the limit equilibrium stability analysis, Figure 34.

Figure 30. Horizontal sheet pile deflections versus canal water elevation computed in the soil-structure interaction analysis of Station 10+00 on the 17th Street Canal east side breach.

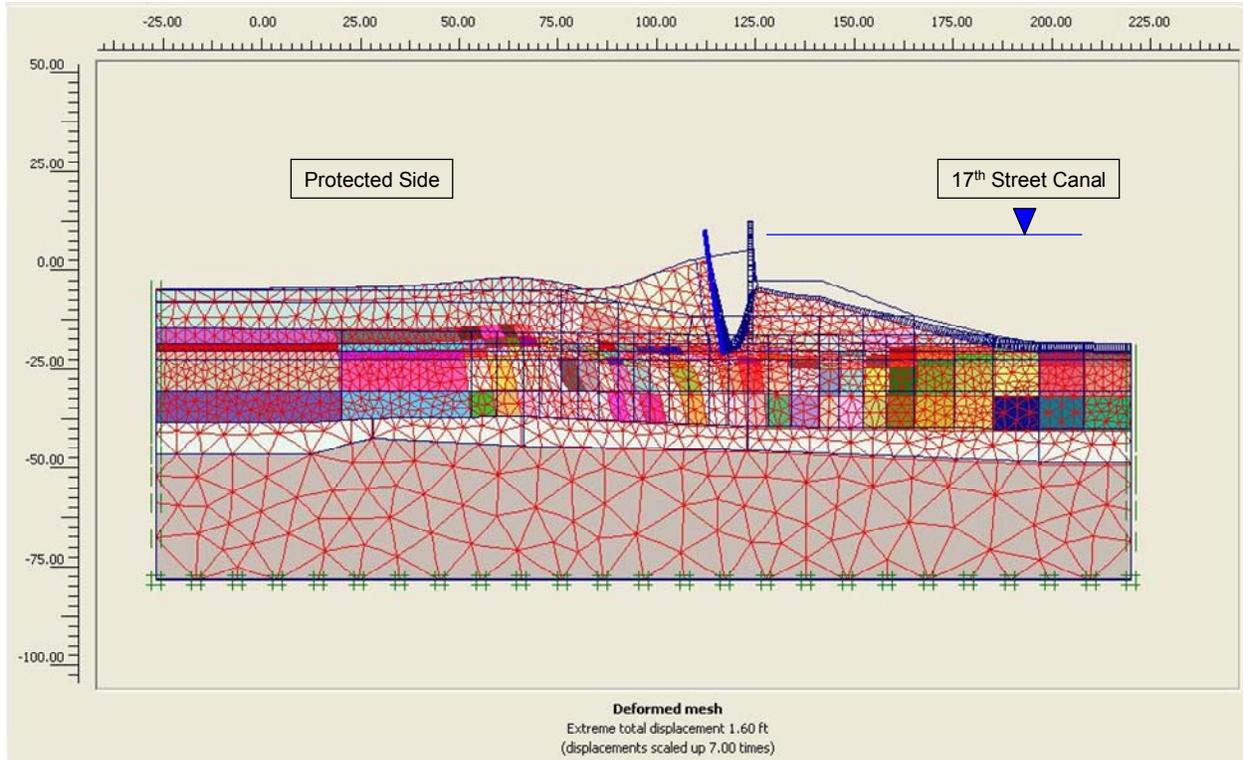
Figure 31. Deformed mesh for canal elevation 6.5 ft and gap to elevation -18.5 ft computed in the soil-structure interaction analysis of Station 10+00 on the 17th Street Canal east side breach (Note: Canal elevation not to scale in figure).

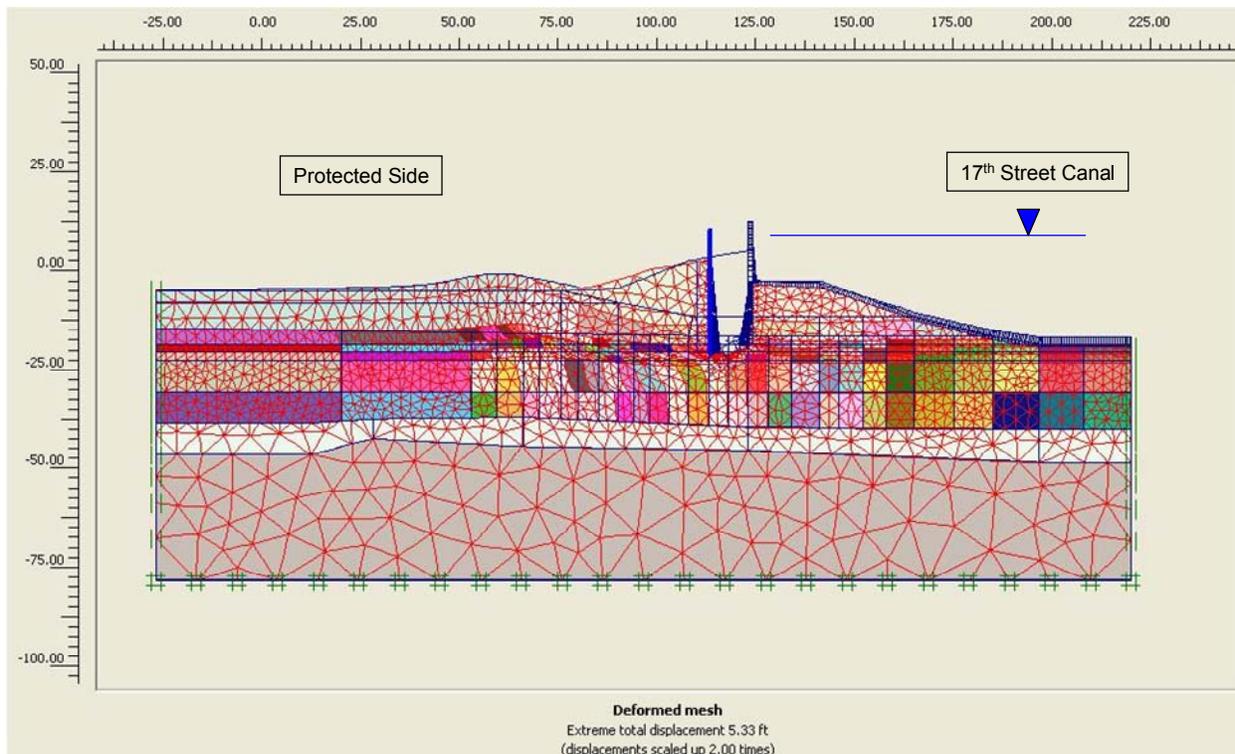
Figure 32. Deformed mesh for canal elevation 9.0 ft and gap to elevation -18.5 ft computed in the soil-structure interaction analysis of Station 10+00 on the 17th Street Canal east side breach (Note: Canal elevation not to scale in figure).

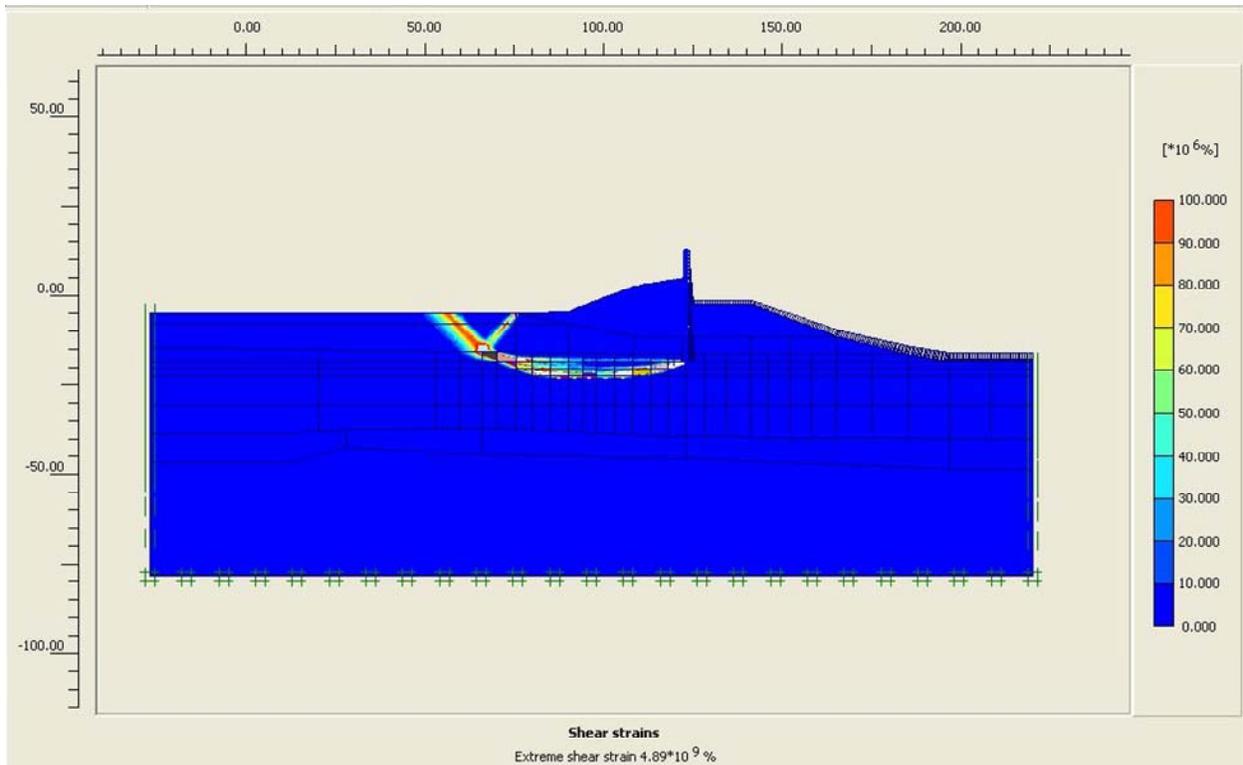
Figure 33. Reaches of large shear strains from strength reduction for canal elevation 9.0 ft and gap to elevation -18.5 ft computed in the soil-structure interaction analysis of Station 10+00 on the 17th Street Canal east side breach.

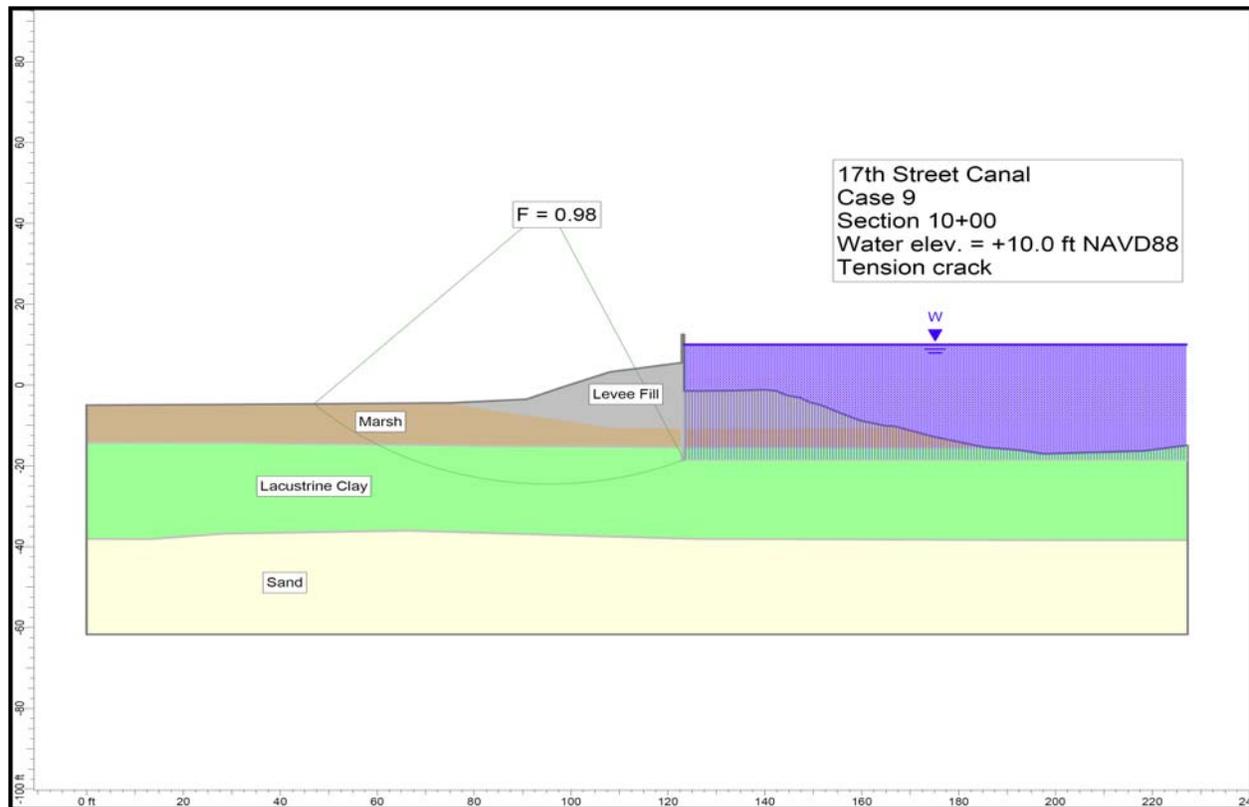
Figure 34. Critical circle for 17th Street Canal Station 10+00 – water elevation 10 ft, with a water-filled gap behind the wall.

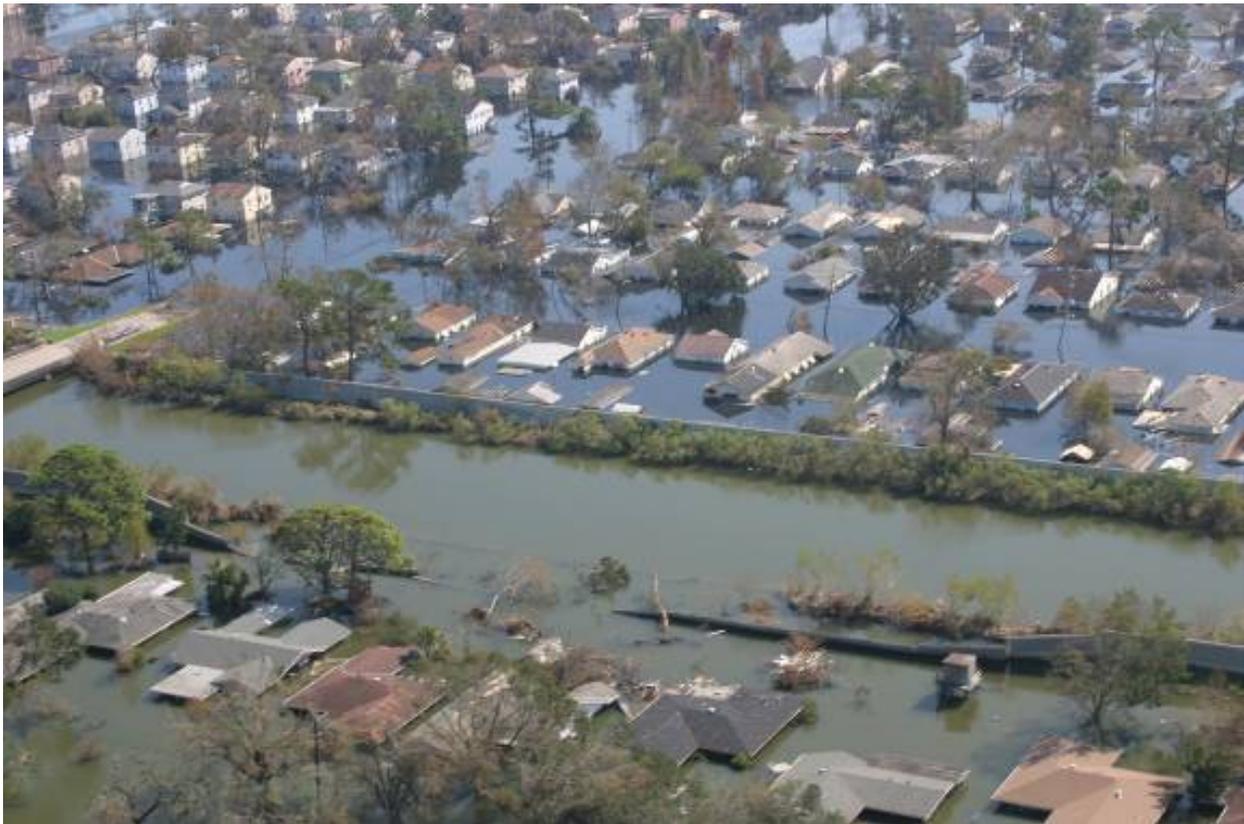
The north breach, shown in Figure 36, occurred about 7:00 a.m. to 7:30 a.m. on 29 August, about an hour after the south breach, when the canal water level was 8.2 ft to 8.9 ft NAVD88. The breach was about 410 ft wide, approximately the same width as the breach at 17th Street. As the breach occurred, the ground surface on the protected side of the levee heaved upward, taking with it the playhouse shown in Figure 37. The upward movement of the playhouse can be discerned by comparing the before and after photos in Figure 37. The I-wall opposite the north breach (on the east side of the canal) moved and tilted significantly, presumably at about the same time as the breach occurred on the west side, but the east I-wall did not breach; this tilted but intact I-wall is shown in Figure 38. A line of sinkholes was observed at the inland side of the distressed east I-wall, and a sand boil at the inboard embankment toe indicates that erosive seepage and piping had occurred beneath the levee.

Figure 36. North breach, London Avenue Canal.

As shown in Figure 36, a long section of the floodwall at the north breach was displaced laterally, and it seems likely that sliding instability was likely the primary mode of failure, with seepage and high pore pressures in the sand as a significant contributing factor. It seems likely that the failure and breach were the result of insufficient passive resistance to counteract the water pressure forces to which the wall was subjected. The passive resistance was likely reduced by the effects of water seeping through the foundation soils beneath the levee and the marsh layer inland, inducing uplift pressures and reducing shear strengths. Analyses have been performed to examine the likelihood of erosion and piping, and instability due to uplift and reduced shear resistance.

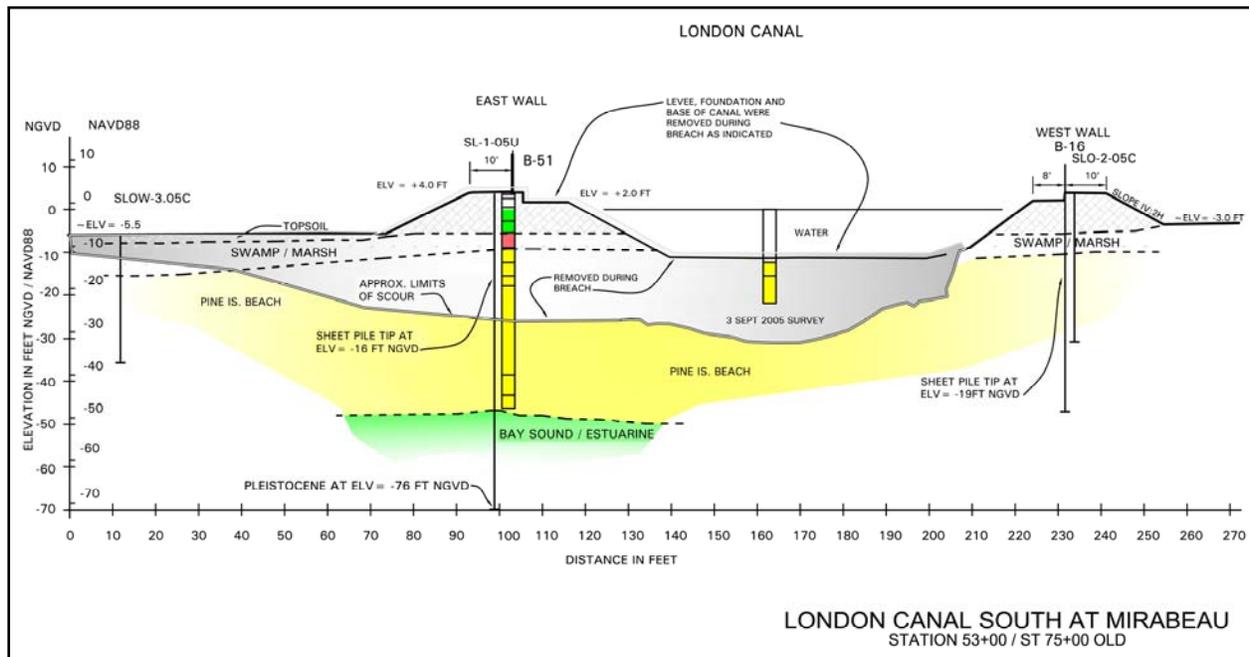
Figure 39. London Avenue Canal south breach cross section.
