Performance Evaluation of the New Orleans and Southeast Louisiana Hurricane Protection System

Final Report of the Interagency Performance Evaluation Task Force

Volume V – The Performance — Levees and Floodwalls

June 2007

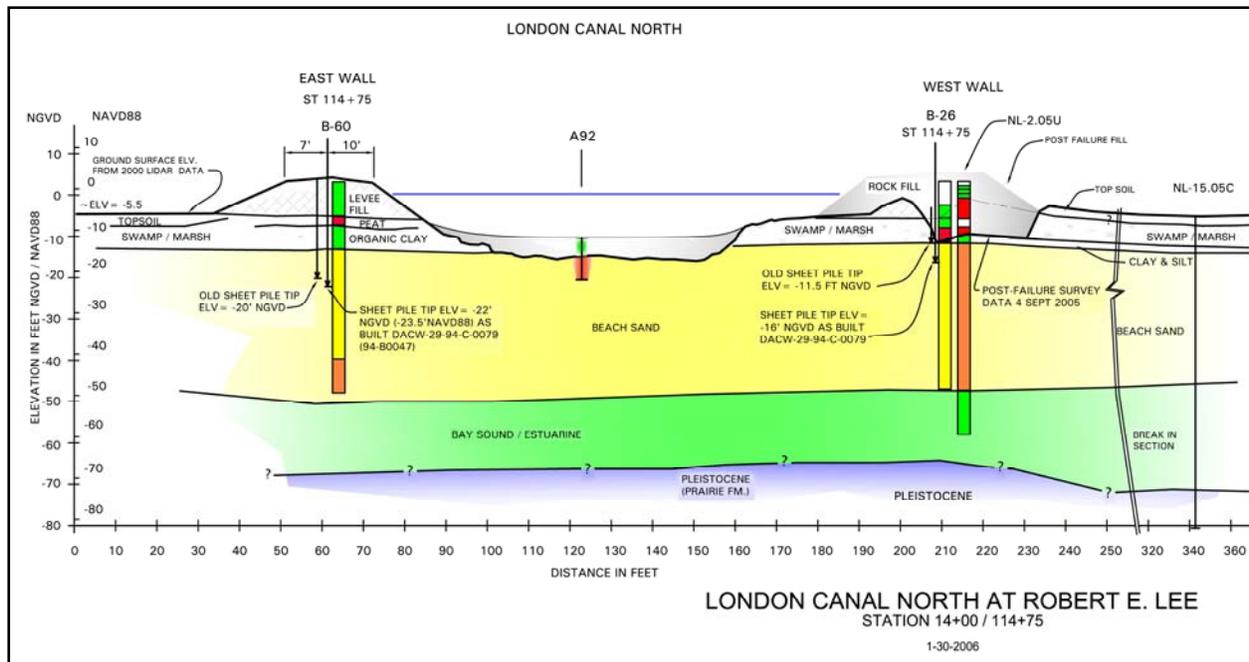
Figure 40. London Avenue Canal north breach cross section.

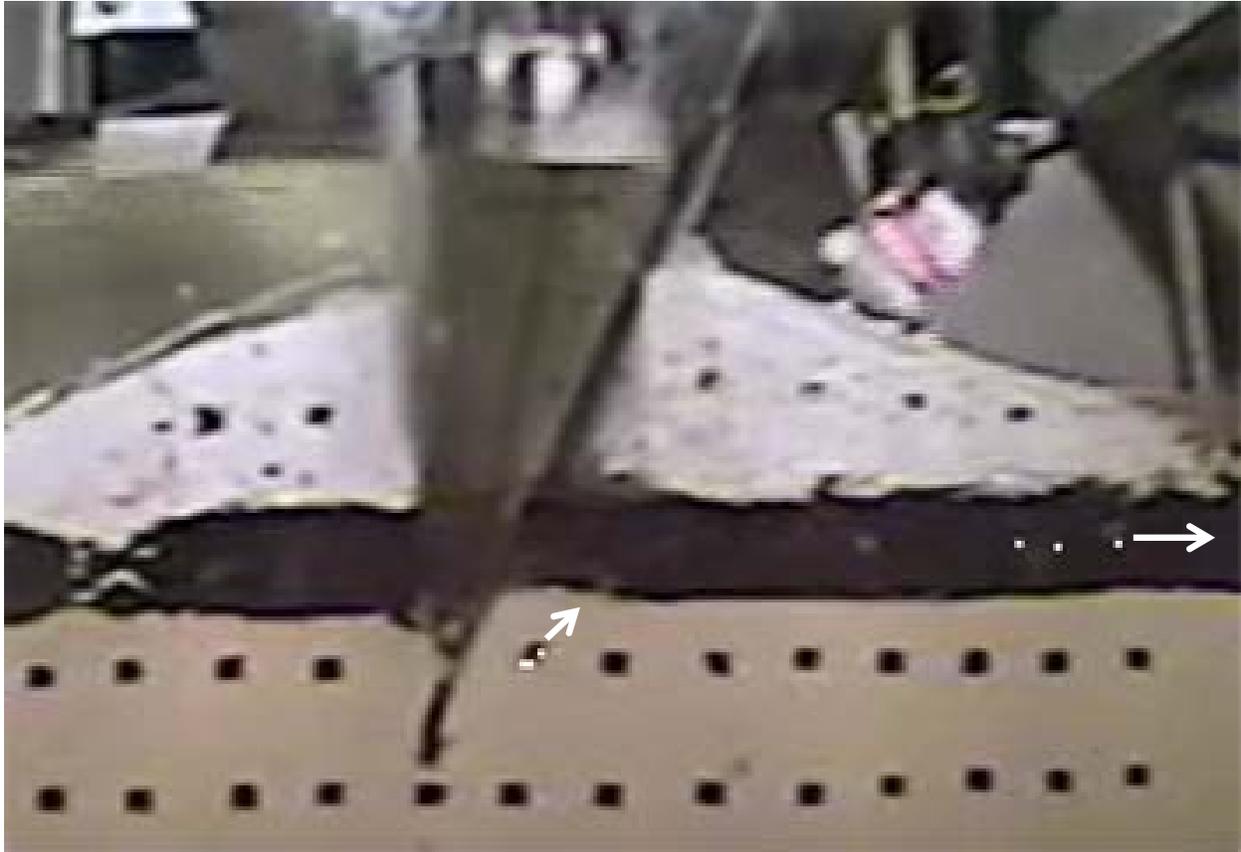
In the London Avenue Canal model tests, where the toe of the sheet pile wall penetrated into the sand and was restrained from lateral movement by the sand, the opening of the gap on the canal side of the floodwall was followed by rotation of the top of the wall landward. With the opening of the gap, the model tests for the London south breach and the London north breach both showed gross movements indicative of wall failure, as may be seen in Figure 41. Rotation of the wall was accompanied by a translational sliding of the landward part of the levee and marsh layer, on top of the underlying sand. Rotation of the wall is linked to reduction in effective stress on the sand layer beneath the landward side of the levee. Once the gap was fully opened, pore pressure transducers in the foundation sand layer showed that the pore pressure in the sand rose very significantly. The increasing water pressure in the sand layer reduced the effective stress at the base of the marsh layer. The reduction in vertical effective stress has two effects: the first is to increase the likelihood of uplift of the swampy marsh (as the increasing water pressure in the foundation balances or exceeds the weight of the levee and marsh layer above), and the second is to reduce the stiffness of the sand surrounding the toe of the sheet pile wall, reducing the passive resistance that the sand provides.

Figure 41. Superposition of video images of the rotational failure of the London south model wall, Model 1.

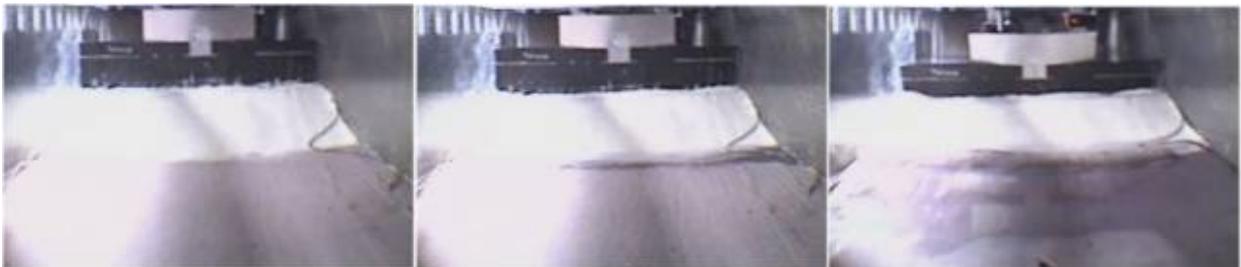
The high pore water pressures under the toe of the levee on the landward side and under the swampy marsh led to water being ejected from the ground at the toe of the levee. This may be deduced from the piezometric heads near the toe of the levee, and can be seen clearly in the video images of the landward toe. Figure 42 shows a view of the levee and floodwall as seen from the backyard of houses behind the levee, showing black water emerging from the toe of the levee as the floodwall rotates landward. This supports the earlier assessment based on seepage analyses that a rupture through the marsh layer overlying the sand at the south breach led to a failure initiated by erosion and piping.

Figure 42. Water emerging from toe of levee as failure progresses, London south Model 2.

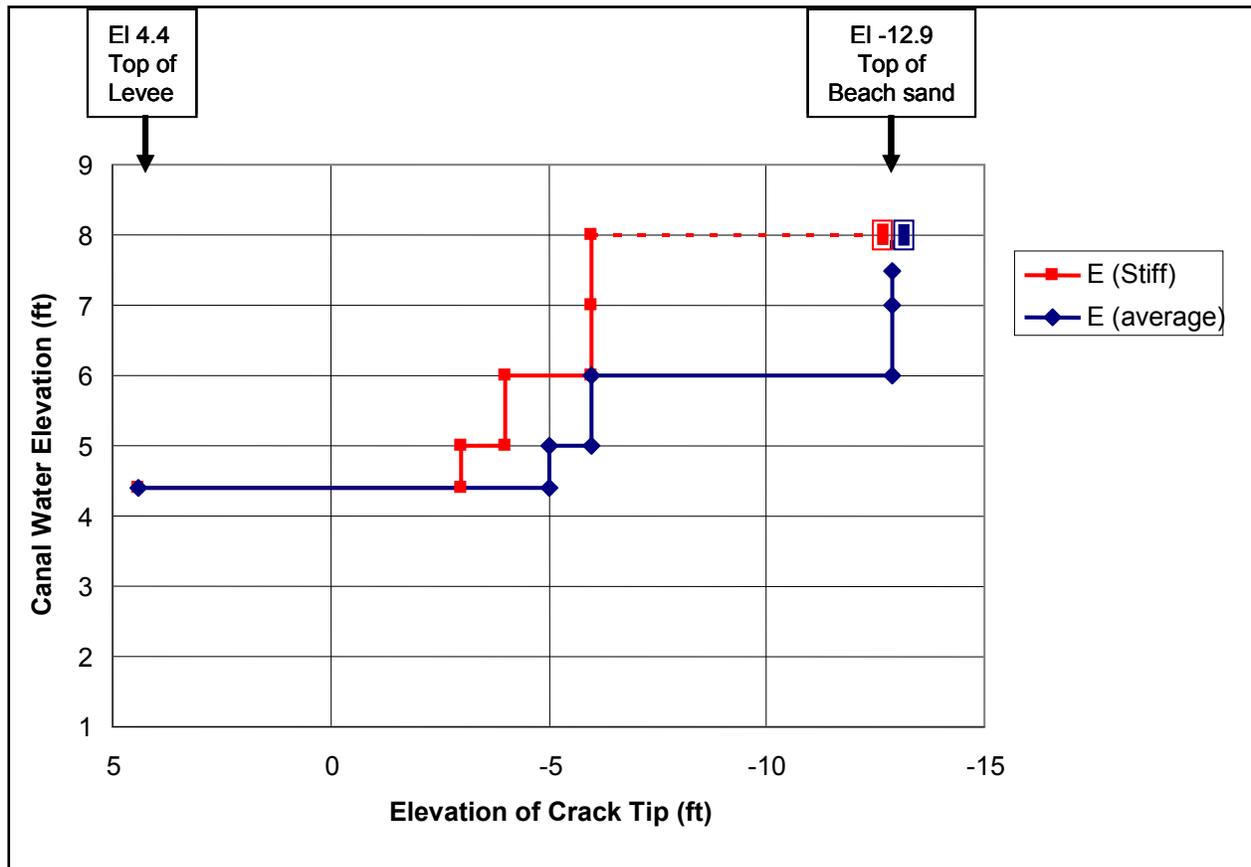
The factor of safety decreased substantially when the gap opened fully, as may be seen in Figures 48 and 49. When the crack (or gap) opened, the factor of safety decreased with no change in water level, as shown by the horizontal line segments in Figures 48 and 49. For the low-stiffness soil, the gap opened fully at a canal water elevation of 6.0 ft, and the factor of safety decreased from 2.5 to 1.8. For the stiff soil, the gap opened fully at a canal water elevation of 8.0 ft, and the factor of safety decreased immediately from 2.1 to below 1.0. If the canal bottom was covered with silt, and the sand layer was therefore not connected to the canal, the opening of the gap would be the means for connecting the sand layer to the canal.

Figure 45. Elevation of gap tip versus canal water elevation.

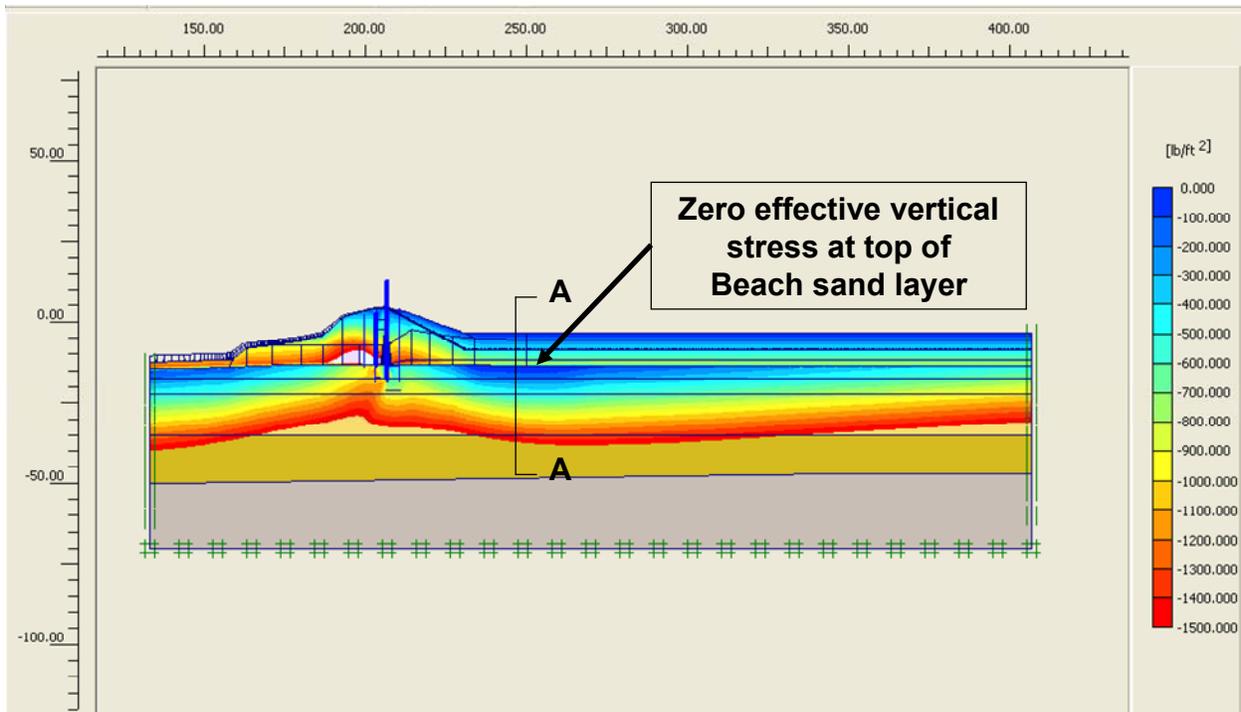
Once the gap extended full depth, the water pressure in the sand rose rapidly, and the elevated water pressure in the sand layer reduced the vertical effective stress at the base of the marsh layer (Figure 46). The reduction in vertical effective stress has two effects: the first is to increase the uplift pressure on the bottom of the marsh layer, as shown in Figure 46; and the second is to reduce the stiffness of the sand surrounding the tip of the sheet-pile wall, reducing the passive resistance provided by the sand.

Figure 46. Effective vertical stress in the beach sand for the analysis using average stiffness values with canal elevation 6.0 ft and gap to elevation -12.9 for the London Avenue north breach.

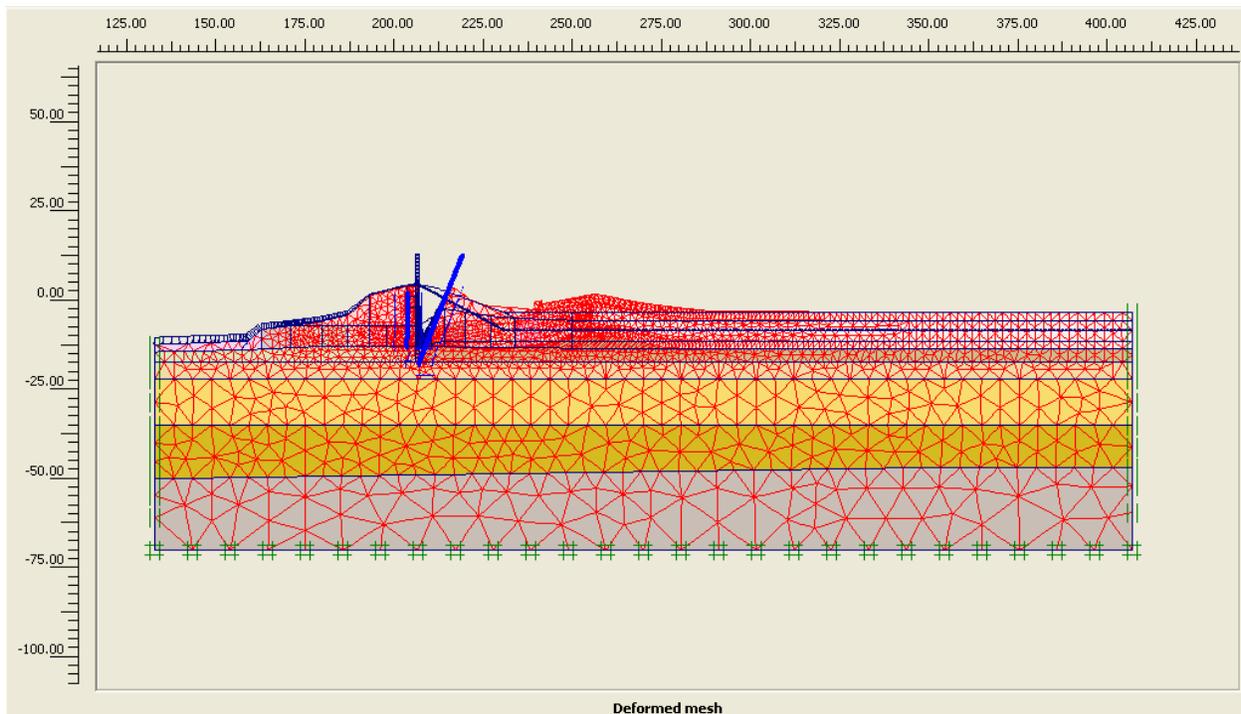
The finite element soil-structure interaction analyses are consistent with the behavior observed in the centrifuge tests, where the opening of the gap on the canal side of the floodwall was followed by rotation of the wall landward, as shown in Figure 47. Figure 48 shows the horizontal displacement of the top and tip of the wall as the canal water rises. It shows that the

Figure 47. Ultimate mechanism from strength reduction analysis using average stiffness values with canal elevation 6.0 ft and gap to elevation -12.9 ft, London Avenue north breach (displacements are exaggerated).

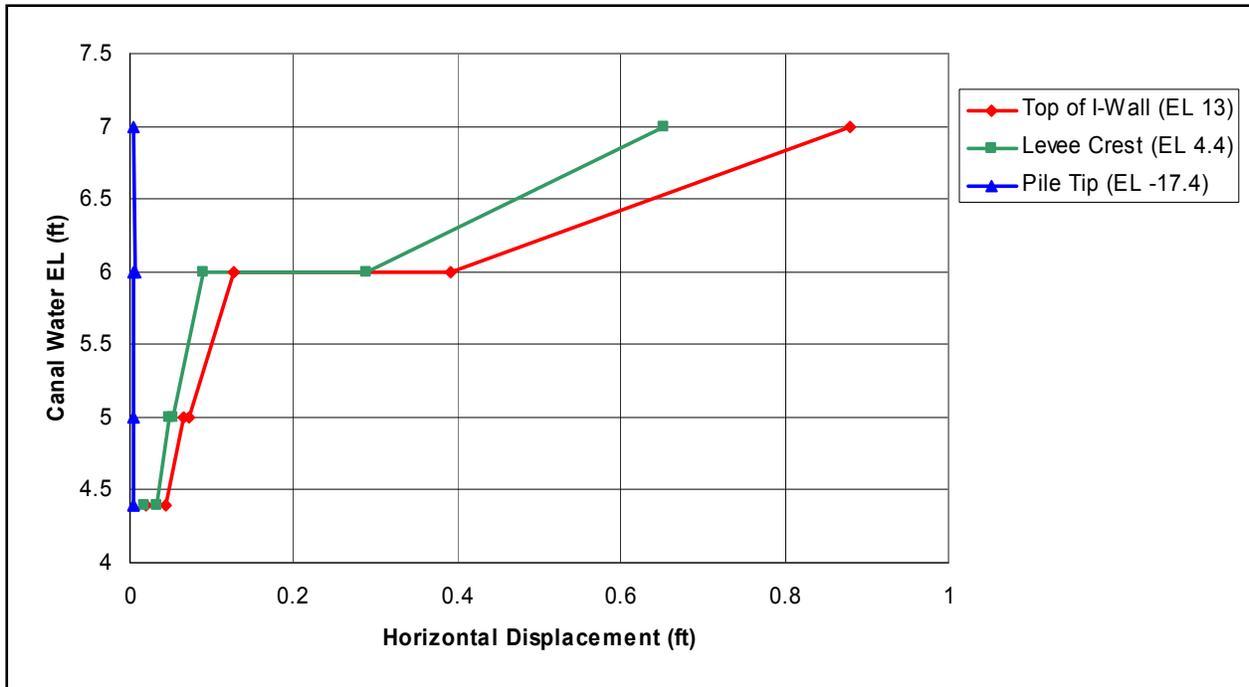
tip did not translate horizontally; instead, the wall rotated about the tip. Figure 48 also shows the significant increase in rotation of the wall once the gap reached the sand layer.

Figure 48. Horizontal sheet pile deformations versus canal water elevation computed using average stiffness values for the London Avenue Canal north breach.

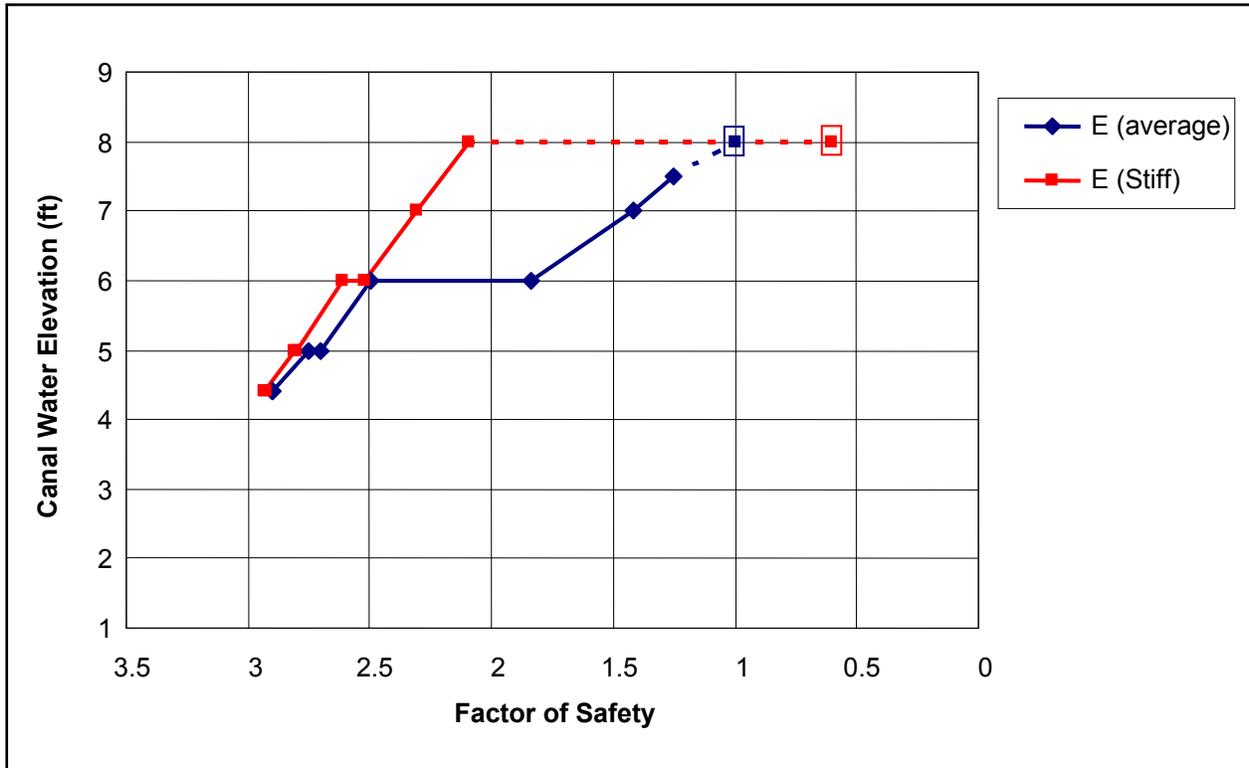
Figure 49. Factor of safety versus canal water elevation calculated using the strength reduction method for the London Avenue Canal north breach.

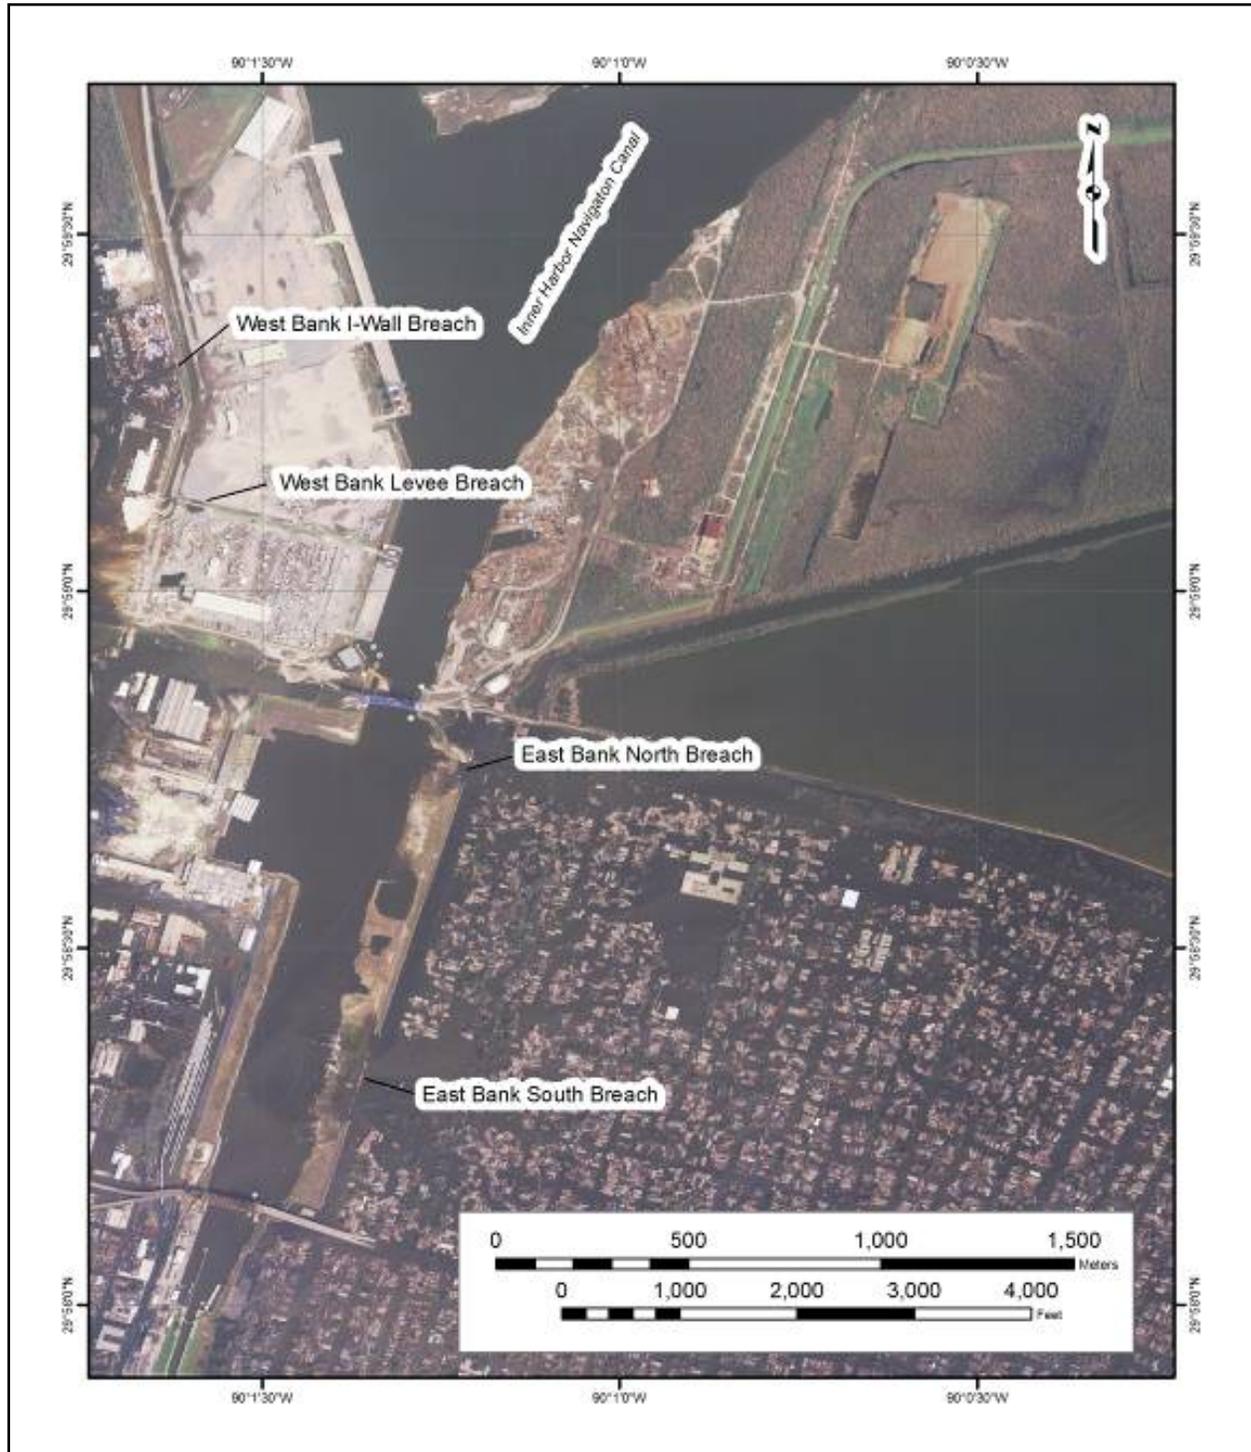
Initial observations after the hurricane revealed that overtopping had eroded at least one section of levee (without floodwall) along the west bank and had eroded the soil adjacent to the wall at three other locations along the east and west bank (Figure 50). It appeared that water flowing over the floodwall scoured and eroded the levee on the protected side of the I-wall, exposing the supporting sheet piles and reducing the passive resistance, as can be seen in Figure 52. The erosion appeared to be so severe at the breach locations that the sheet piles may have lost all foundation support, resulting in failures of the type shown in Figure 53. Perhaps the best evidence of this scour can be seen along the unbreached reaches of the east bank I-walls, where U-shaped scour trenches were found adjacent to the I-walls. As the scour increased, the I-wall may have moved laterally and leaned toward the protected side, causing the scour trench to grow as the water cascaded farther down the slope until sufficient soil resistance was lost and complete failure occurred.

Figure 50. Four breach locations on the Inner Harbor Navigation Canal.

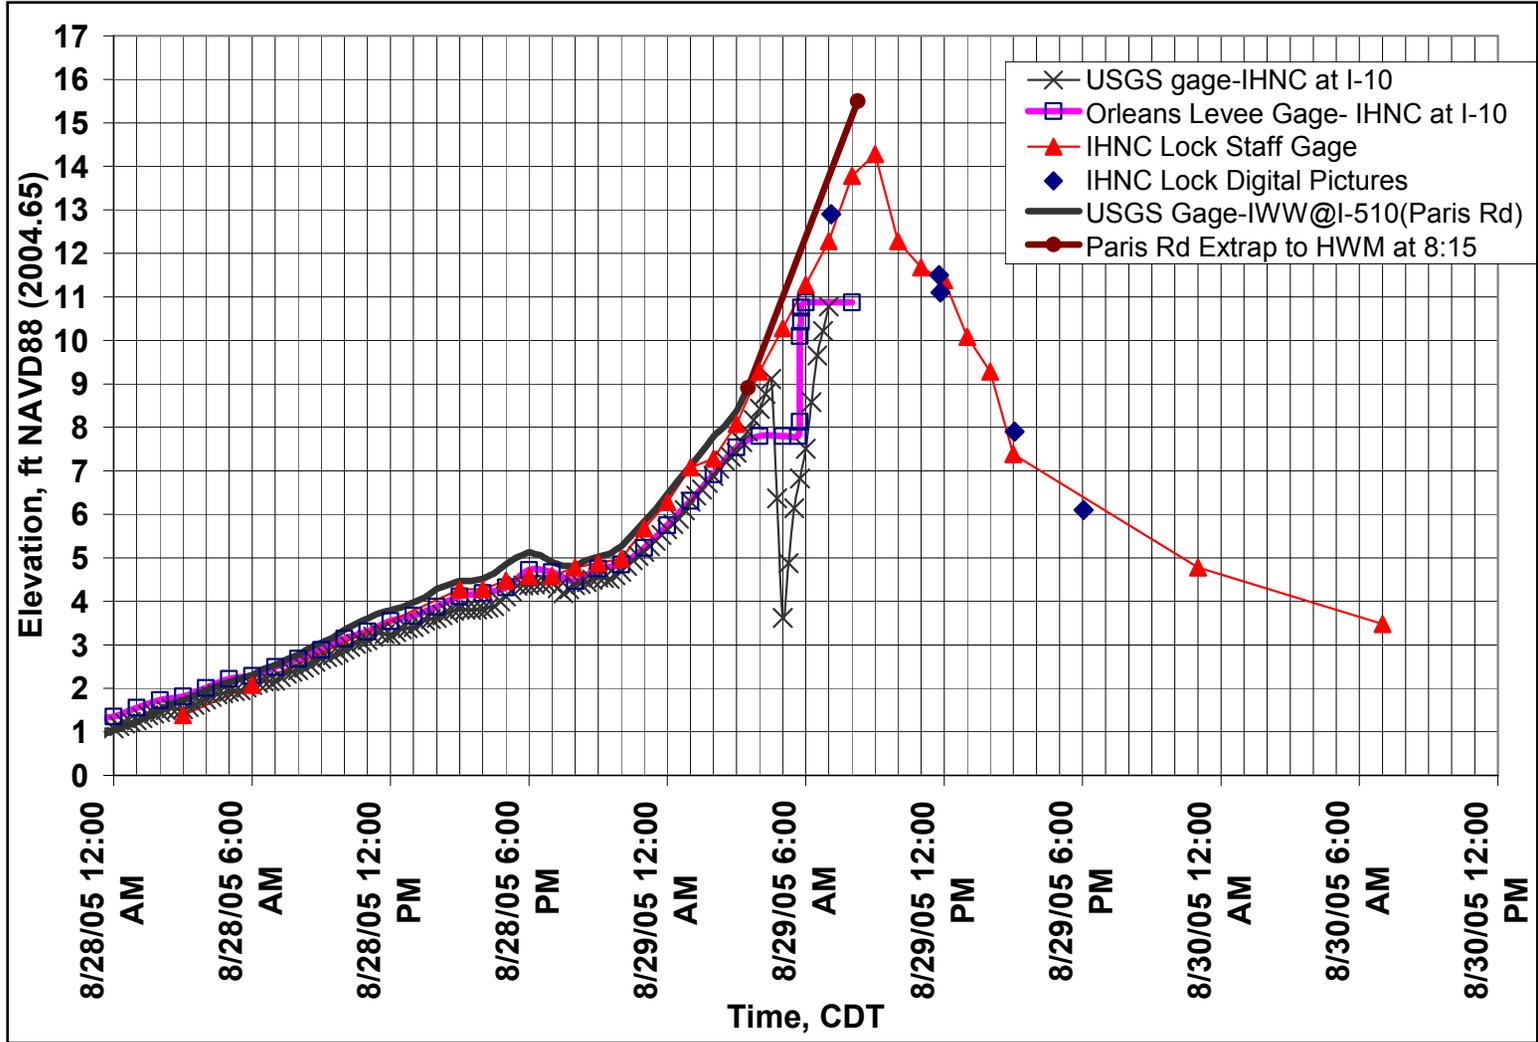
All of the IHNC floodwalls and levees were overtopped on 29 August. The peak storm surge elevation in the IHNC was 14.2 ft at 9:00 a.m., as can be seen in Figure 51. This peak water level is about 1.7 ft above the tops of the floodwalls and levees. The reaches where the floodwalls and levees did not collapse have, therefore, survived water loading considerably higher than the design loading.

Figure 51. Hydrograph for IHNC.

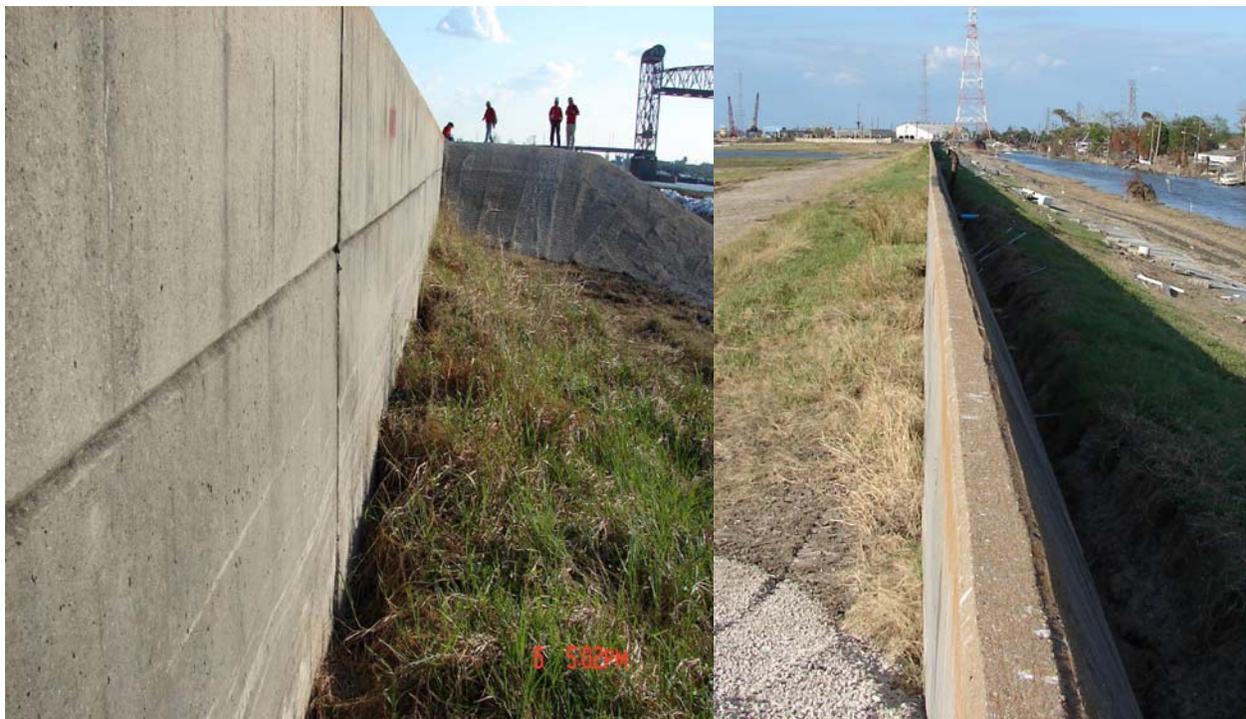
Formation of a gap on the canal side of the wall, allowing hydrostatic water pressure acting through the full depth of the gap, causes a very significant reduction in the value of the calculated factor of safety. Evidence that a gap did form behind the wall near the breaches can be seen in Figures 55 and 56.

Figure 55. IHNC East Bank – south breach – wall movement.

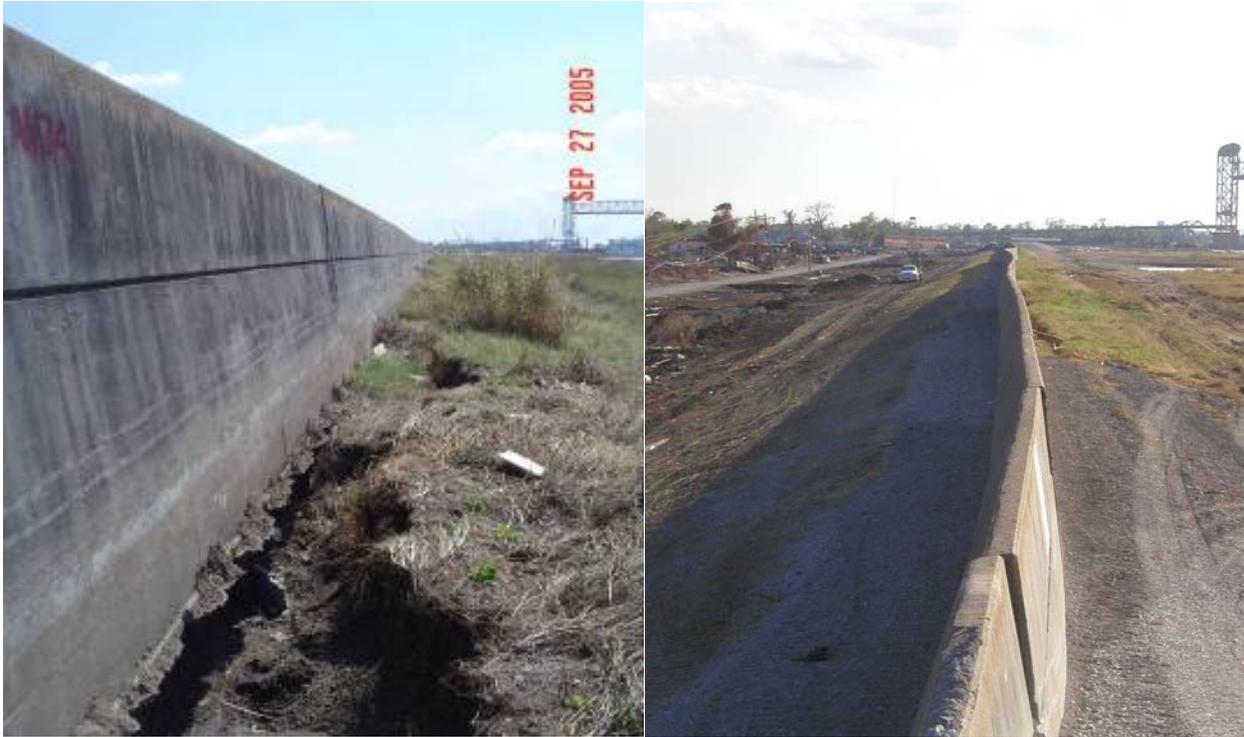
Figure 56. IHNC East Bank – north breach – wall movement.

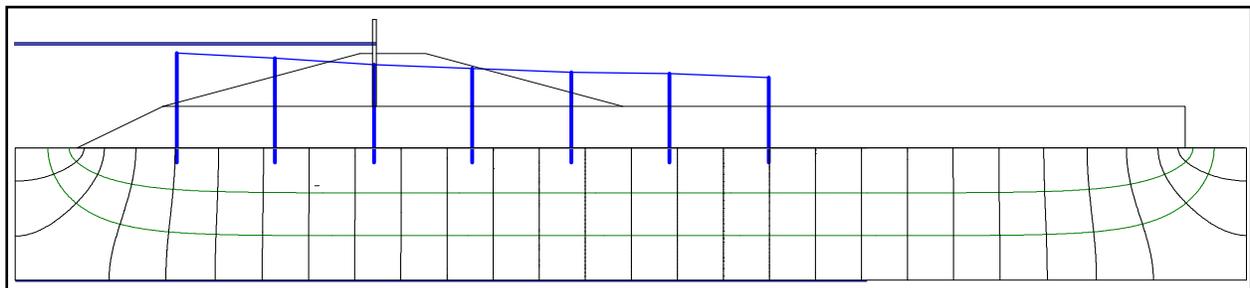
As with the other levee sections, the instruments beneath the model levee responded to the rising water in the canal by increased water pressures in the sand, reducing nearly linearly from a maximum near the canal to a minimum to the landward side of the levee, as shown in Figure 59. As the water level rose in the Orleans Avenue Canal, the floodwall did not show any movement to indicate the opening of a gap. A cross section through the centrifuge model at the maximum water level reached during Hurricane Katrina is shown in Figure 60.

Figure 59. Seepage flow net for Orleans Avenue south with piezometric levels under the swampy marsh at Katrina flood level.

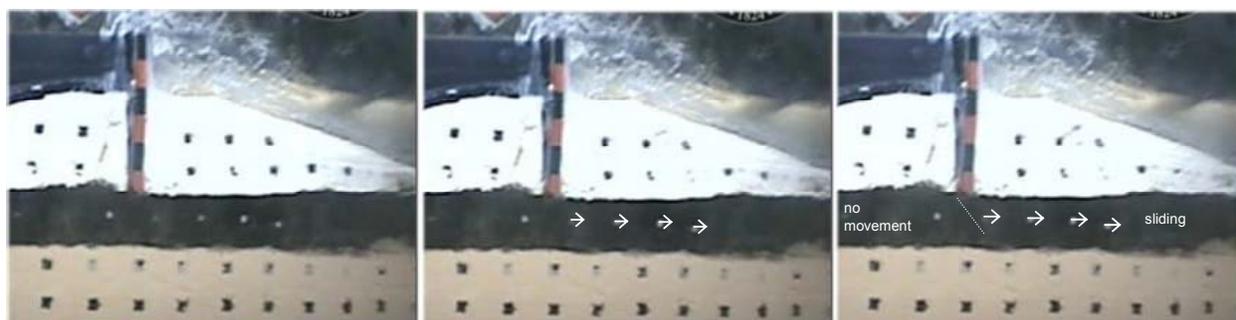
As the water level was raised above the Katrina flood level in the Orleans south model, a gap was seen to open at the toe of the floodwall, associated with small movements of the floodwall landward, as shown in Figure 62. Unlike the other models, this gap did not develop into a full failure condition; and no unstable movement of the floodwall was observed, despite the water level reaching the top of the floodwall. Translational movements were observed to be controlled by compression of the swampy marsh layer. Relative movement between the top of the sand and the swampy marsh was apparent, in a similar manner, to the uplift mechanism in the London Avenue models.

Figure 62. Small sliding movement of marsh as gap forms, Orleans south model

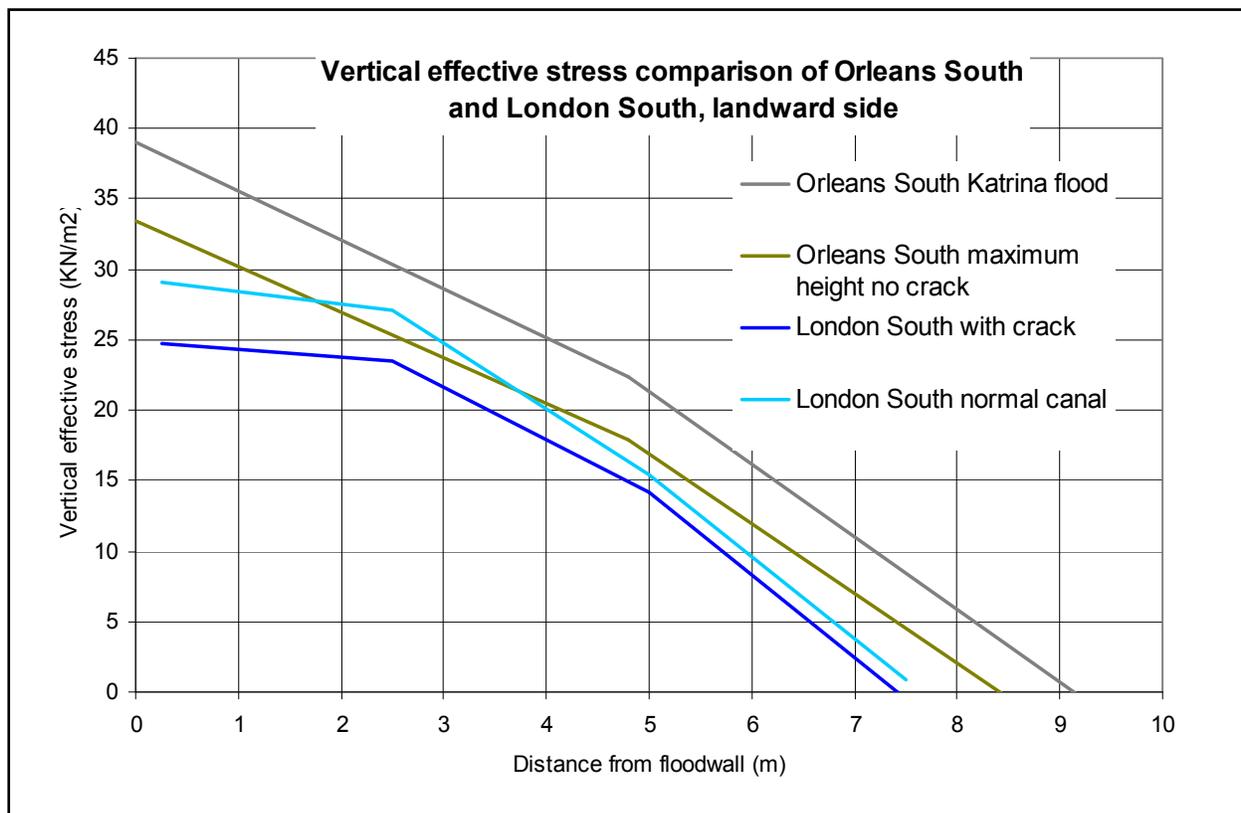
Comparison between the geometries of Orleans and London Avenue shows that the vertical effective stress in the sand foundation below the levee was considerably higher under the Orleans levee than under the London Avenue levees. Figure 63 shows the vertical effective stress on the underside of the marsh layer measured in the Orleans south and, for comparison, the London south models. The total stress for London south ranged from 1400 psf at the crest of the levee to 600 psf at the toe of the levee on the protected side, over a levee width of 25 ft. The total

Figure 63. Vertical effective stress comparison between Orleans south and London south.

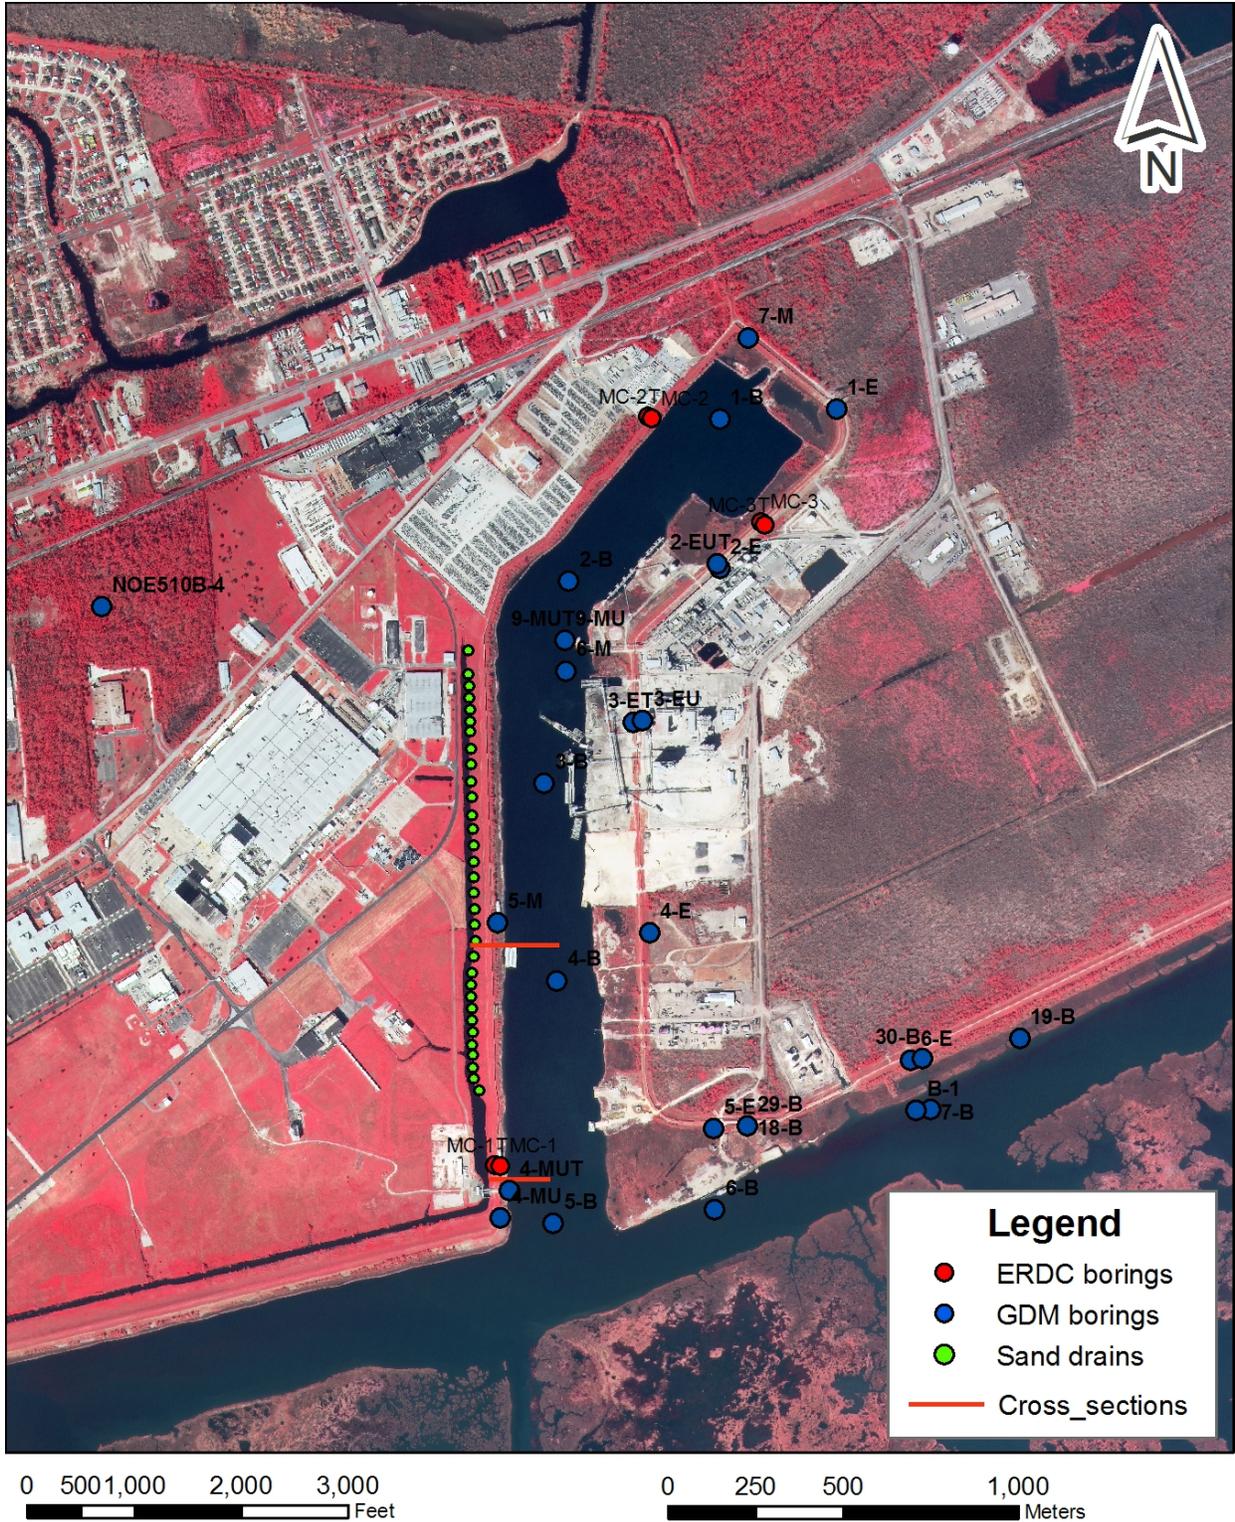
Figure 64. Aerial photograph of Michoud Canal.

The post-Katrina reconnaissance revealed that overtopping by waves had eroded some soil adjacent to the wall on the protected side along some sections of the I-wall. Along a portion of the west I-wall is a series of sand drains that were installed to relieve the high pore pressures during high water events. Sections of the I-wall were overtopped by wave action, but this did not lead to breaching of the levee. Post-Katrina damage reports identify a section of I-wall along the west bank, approximately 200 ft south of the pump station, as leaning a few inches toward the canal side. It is uncertain whether this displacement occurred before or during Hurricane Katrina. A photograph showing this section of the I-wall is shown in Figure 65a. Figure 65b shows erosion that occurred on the protected side due to overtopping of the I-wall. Figure 65b shows some minor scour damage on the protected side of the levee on the west bank near the pump house area. It appeared that waves breaking over the top of the floodwall scoured and eroded the levee on the protected side of the I-wall, exposing the supporting sheet piles. This erosion was not severe enough to cause the sheet piles to lose their foundation support.

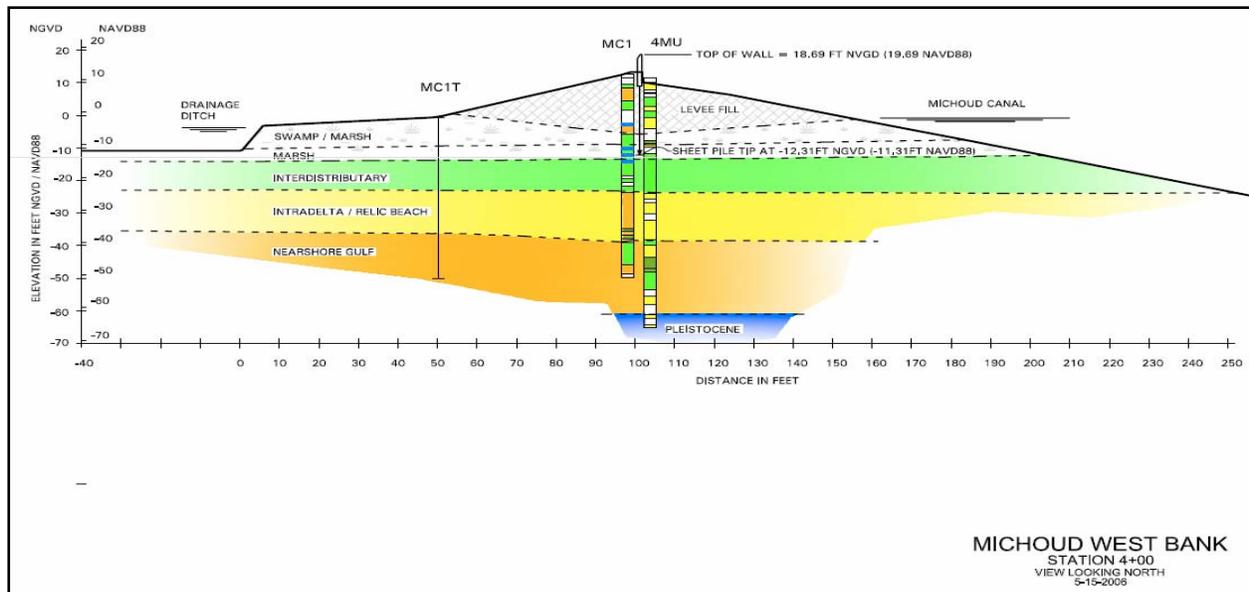
Figure 66. Geologic cross section of Sta. 4+00.

The cross section developed for analysis, located on the west side of the Michoud Canal at Station 4+00, is shown in Figure 66. This cross section is approximately 100 ft north of the pump house, at the south end of the west wall. This section was selected for analysis because of the close proximity to existing exploratory borings. No sand drains were located at this section; therefore this section has the potential to be more unstable than I-wall sections to the north containing sand drains. The sand drains are located along the protected side of the levee near a drainage ditch to relieve pressures in the underlying foundation sands beginning at Station 11+00 and ending at Station 52+50.

The calculated factors of safety for Station 4+00 were about 20% lower for the gap condition compared to the no gap condition. The undrained strength of the interdistributary clay is important in the stability analyses since the majority of the failure plane is located in this layer. The beach sand layer, modeled as a drained material, did not influence the analysis because failure surfaces did not extend down to this layer.

At Station 4+00, the top of the earthen levee was approximately 14.0 ft (NAVD 88). With the canal water level at the peak of the hydrograph (15.5 ft NAVD 88), only 1.5 ft of water acted on the cantilever I-wall. Since the factor of safety is greater than unity for the gap condition, it seems likely that the I-wall would have remained stable even if a gap had formed behind the wall. For the *no gap* case, the probability of failure was only 2%. For the case with a gap, the calculated probability of failure was much higher (40%).

If the static water level had reached the top of a wall and a gap did not form, the calculated factor of safety is still greater than unity, indicating that the wall would remain stable. However, had a gap formed under this high water level, the calculations indicate that the wall would have failed.

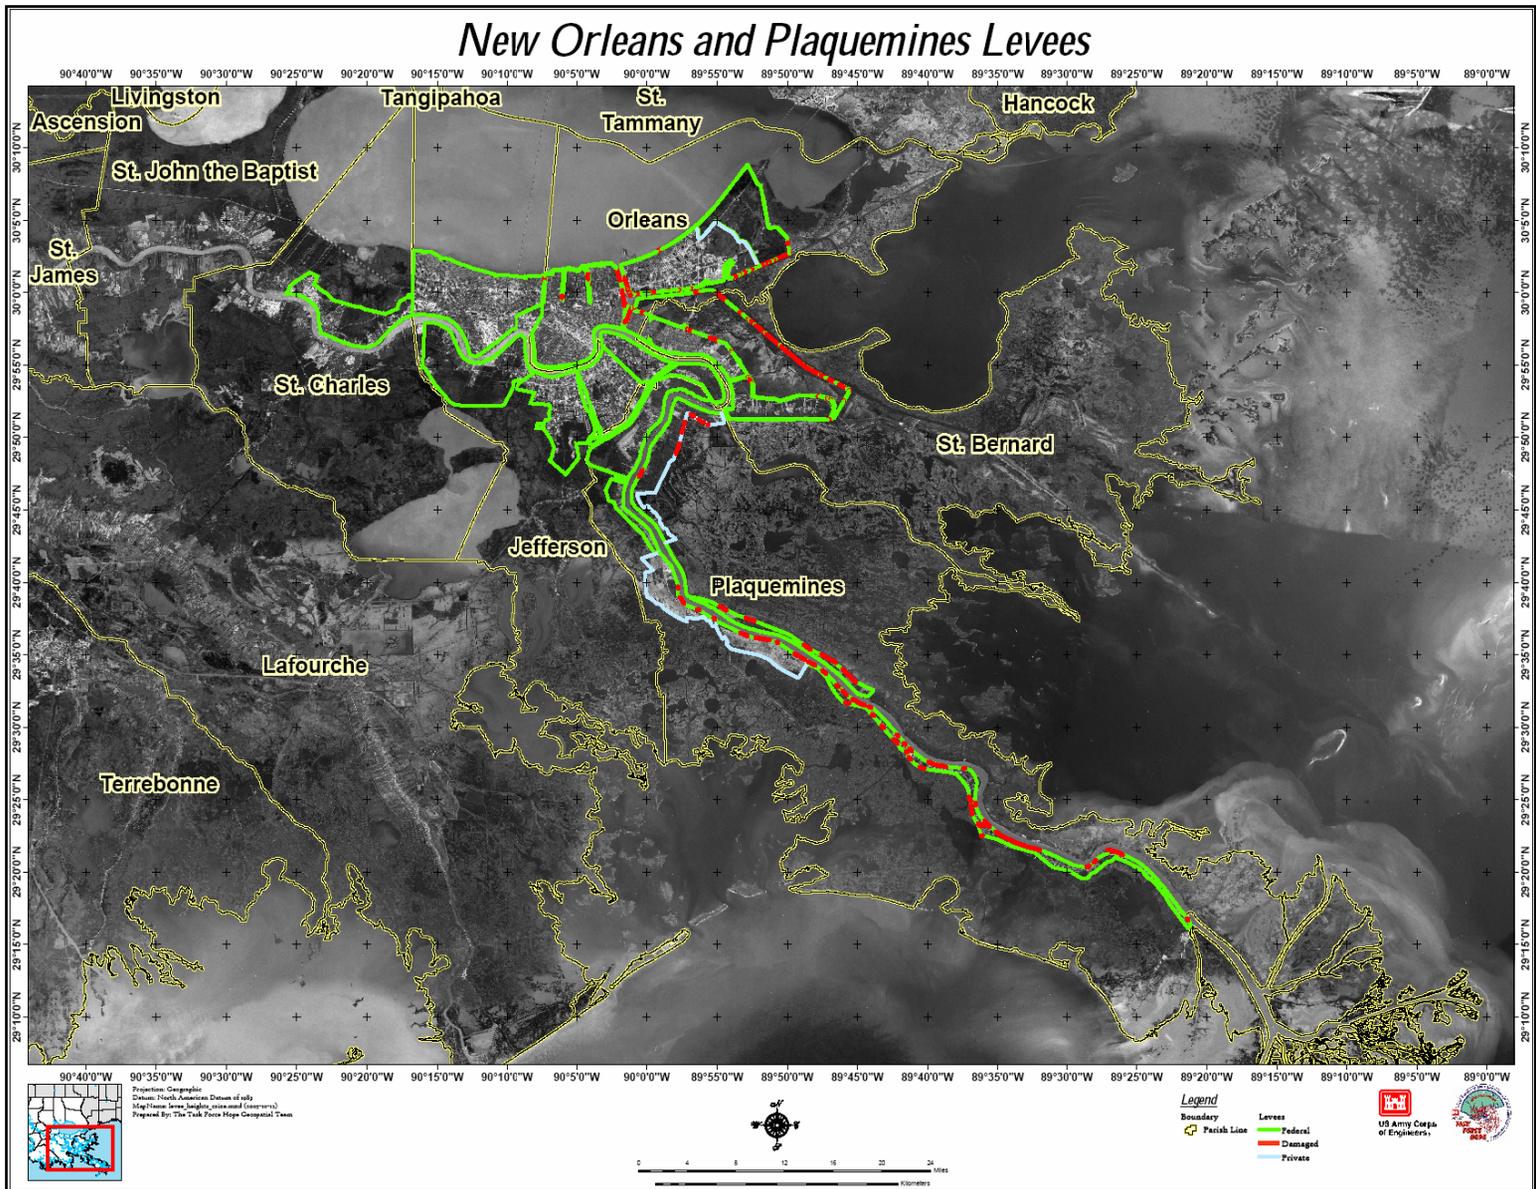
Lengthy reaches (miles) of earthen levees and capped levees were overtopped. Some reaches showed signs of initial erosion, others showed signs of progressive erosion, and other reaches contained significant breaching. Similar to levees, lengthy reaches of floodwall were overtopped and were left in various stages of damage, ranging from minor scour at the wall base to breaches where complete floodwall sections were flattened (Figure 67).

Figure 67. Locations (in red) of severe damage to hurricane protection structures resulting from Hurricane Katrina.

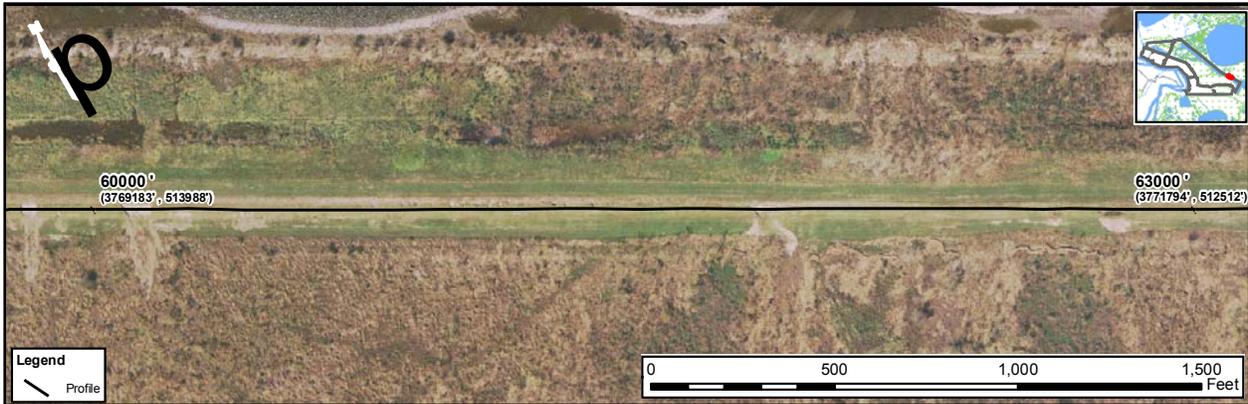
The erosion of levees and floodwalls in the New Orleans area was predominantly due to overtopping. There are several locations along the levees adjacent to the MRGO facing Lake Borgne that show signs of some minor front side erosion from wave action, Figure 62. Figure 63 shows an aerial photograph of the area shown in Figure 62. Figure 64 shows the elevation of the levee before and after Katrina and the water levels due to the hurricane. The pre-Katrina levee elevations along this section where the front side erosion occurred are the highest along MRGO facing Lake Borgne and would have been the location with the longest period of time with the waves breaking on the front side of the levee. This may be the reason why there was erosion on the front side of the levee at this location.

Figure 69. Aerial photo of front side erosion on the MRGO.
