Performance Evaluation of the New Orleans and Southeast Louisiana Hurricane Protection System

Final Report of the Interagency Performance Evaluation Task Force

Volume V – The Performance — Levees and Floodwalls

June 2007

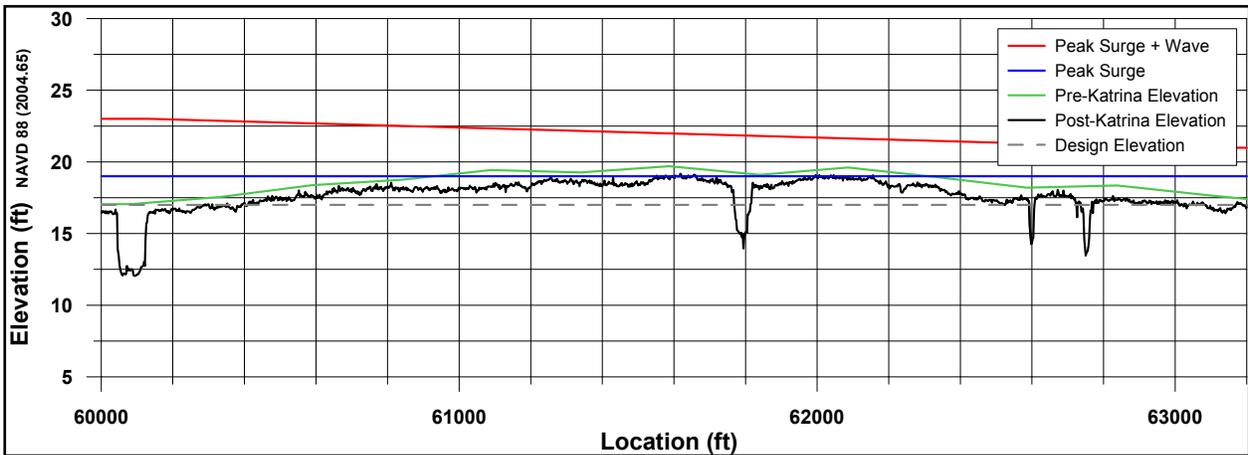
Figure 70. Pre- and post-elevation of the levee with water levels along the MRGO.

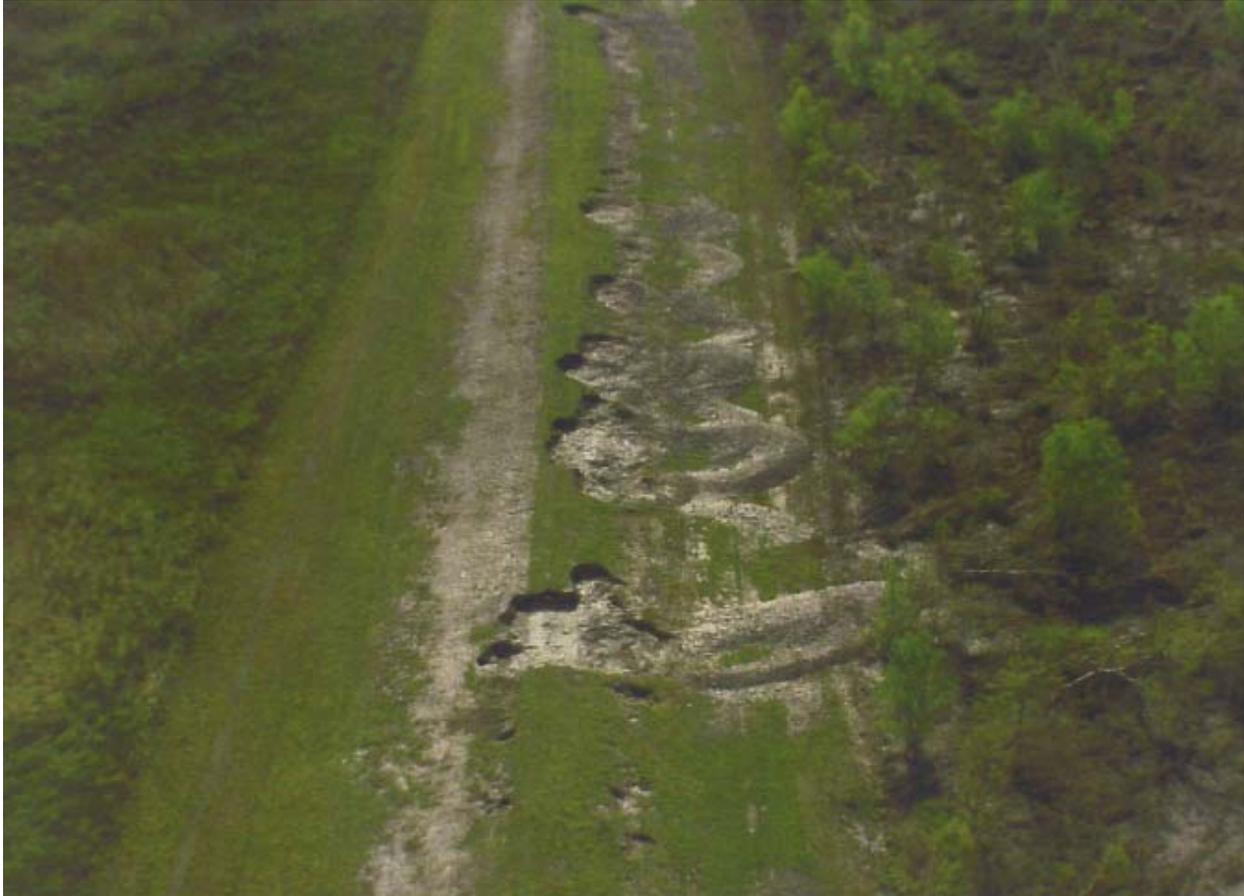
Figure 73 is a photograph that shows all four stages of progressive erosion:

Stage A. Initial overtopping causes surface sheet and rill erosion which develops into a series of cascading overfalls. The highest forces develop from the backside slope down to the backside toe, and the crown is not initially exposed to these large hydraulic forces. The cascading overfalls develop into one large headcut that migrates from the slope to the crest such that the erosion width approximately matches the overtopping width.

Stage C. The crest drops as a breach begins to develop.

Stage D. The breach opening erodes out to the toe and the breach widens.

Figure 73. Four stages of progressive erosion.

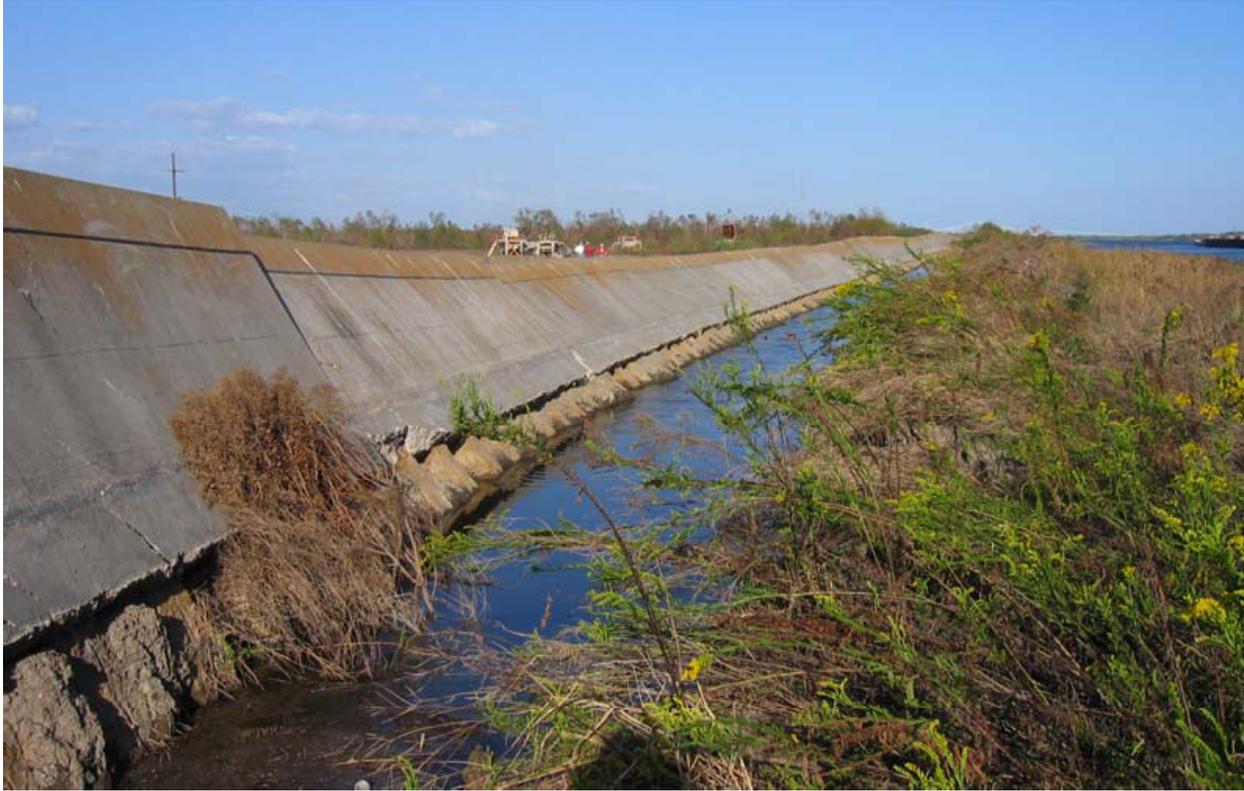
Figure 79. Deflection and tilting of the Citrus Back Levee I-wall.

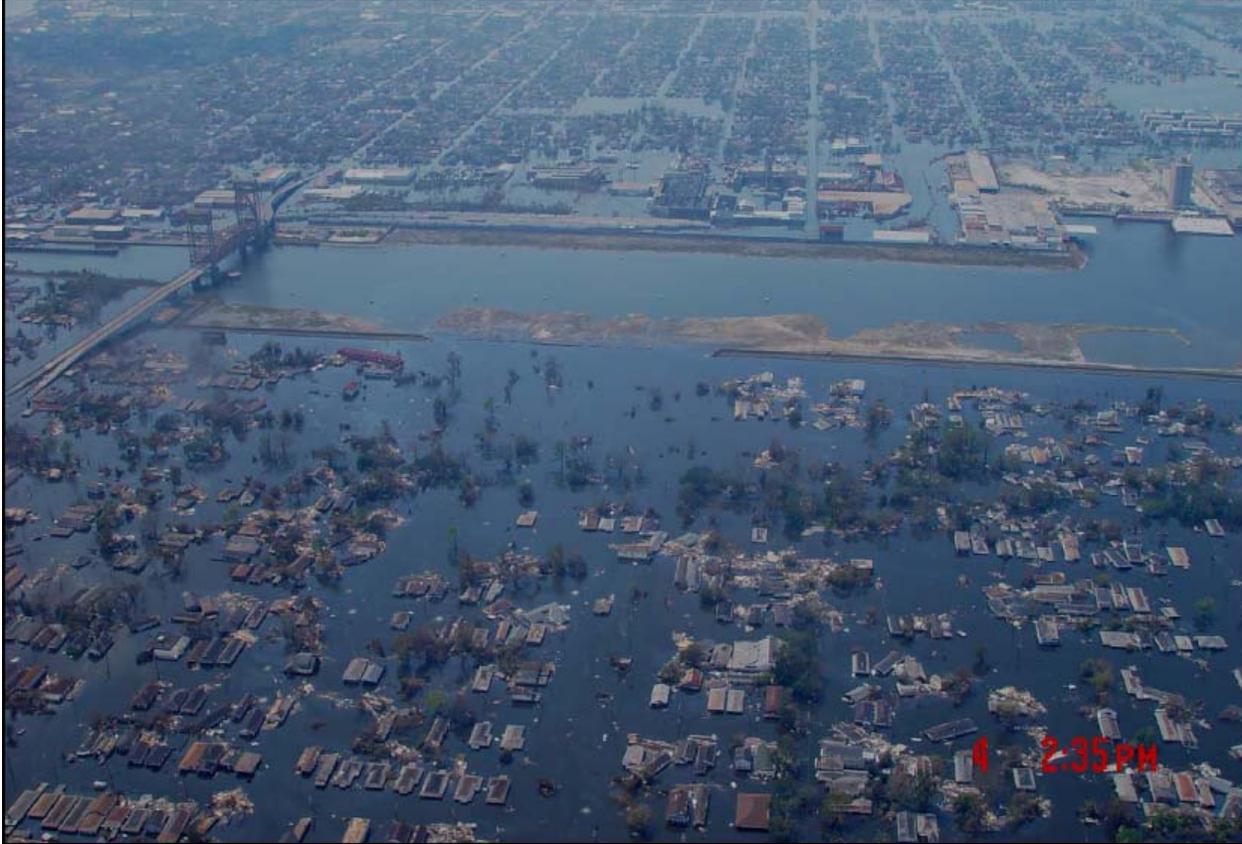
Figure 80. Aerial photo of the breached floodwall along the eastern side of IHNC adjacent to the Lower Ninth Ward.

Water overtopping the floodwalls led to extensive scour and erosion in some locations, which ultimately resulted in breaches. This was most dramatic along the IHNC adjacent to the Lower 9th Ward where I-wall breaches were caused by overtopping erosion. It appeared that water flowing over the floodwall scoured and eroded the levee on the protected side of the I-wall, exposing the supporting sheet piles and reducing the passive resistance. The water flowing over the top of the walls may have scoured significant amounts of soil from the levee adjacent to the wall. Evidence of this scour can be seen along the unbreached reaches of the I-walls on the IHNC where U-shaped scour trenches could be found adjacent to the I-walls, as can be seen in Figure 82. As the scour increased, the I-wall may have moved laterally and leaned to the

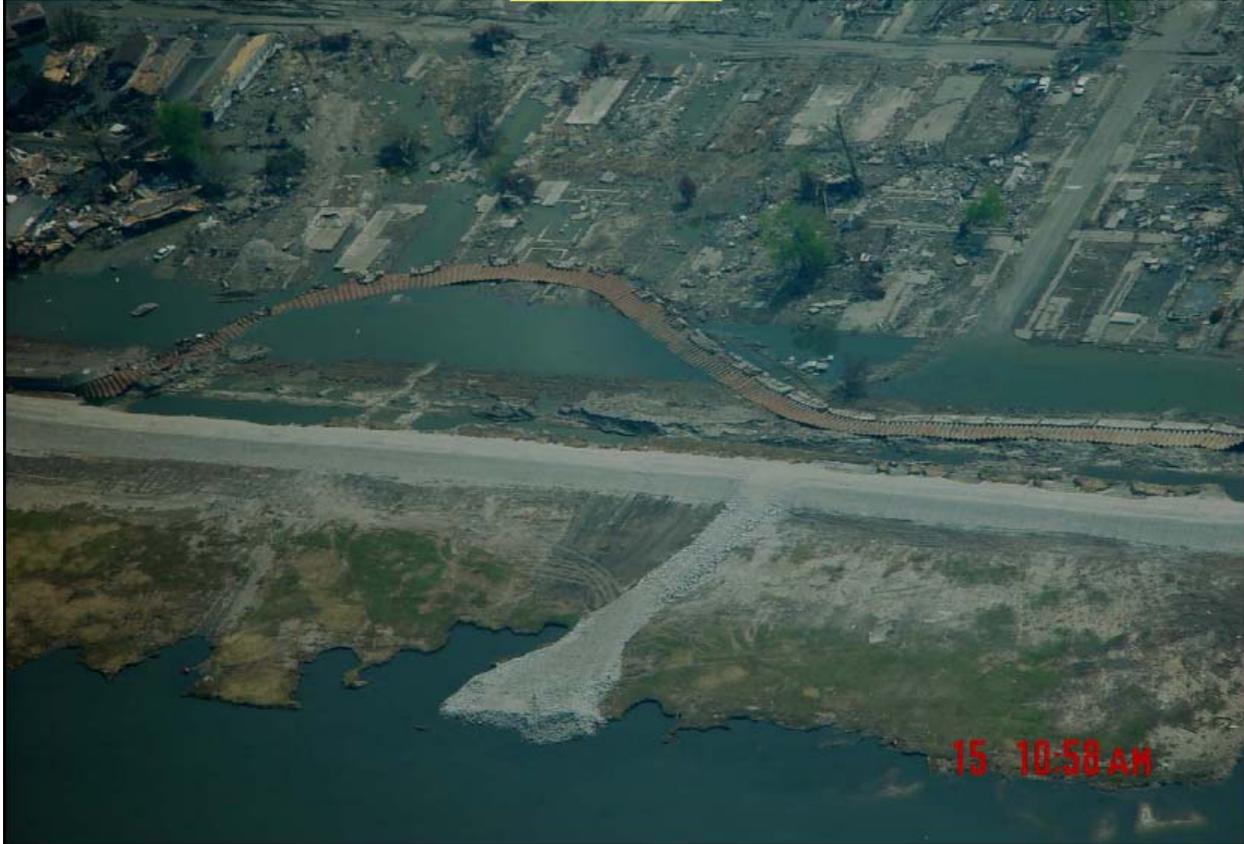
Figure 81. Displaced floodwall along the eastern side of the IHNC adjacent to the Lower Ninth Ward.

protected side, causing the scour trench to grow as the water cascaded farther down the slope until sufficient soil resistance was lost and the wall failed, as shown in Figure 83. I-walls along the MRGO and the Mississippi River in Plaquemines Parish suffered similar damage due to overtopping where the greater the scour, the greater the lateral translation and tilting of walls.

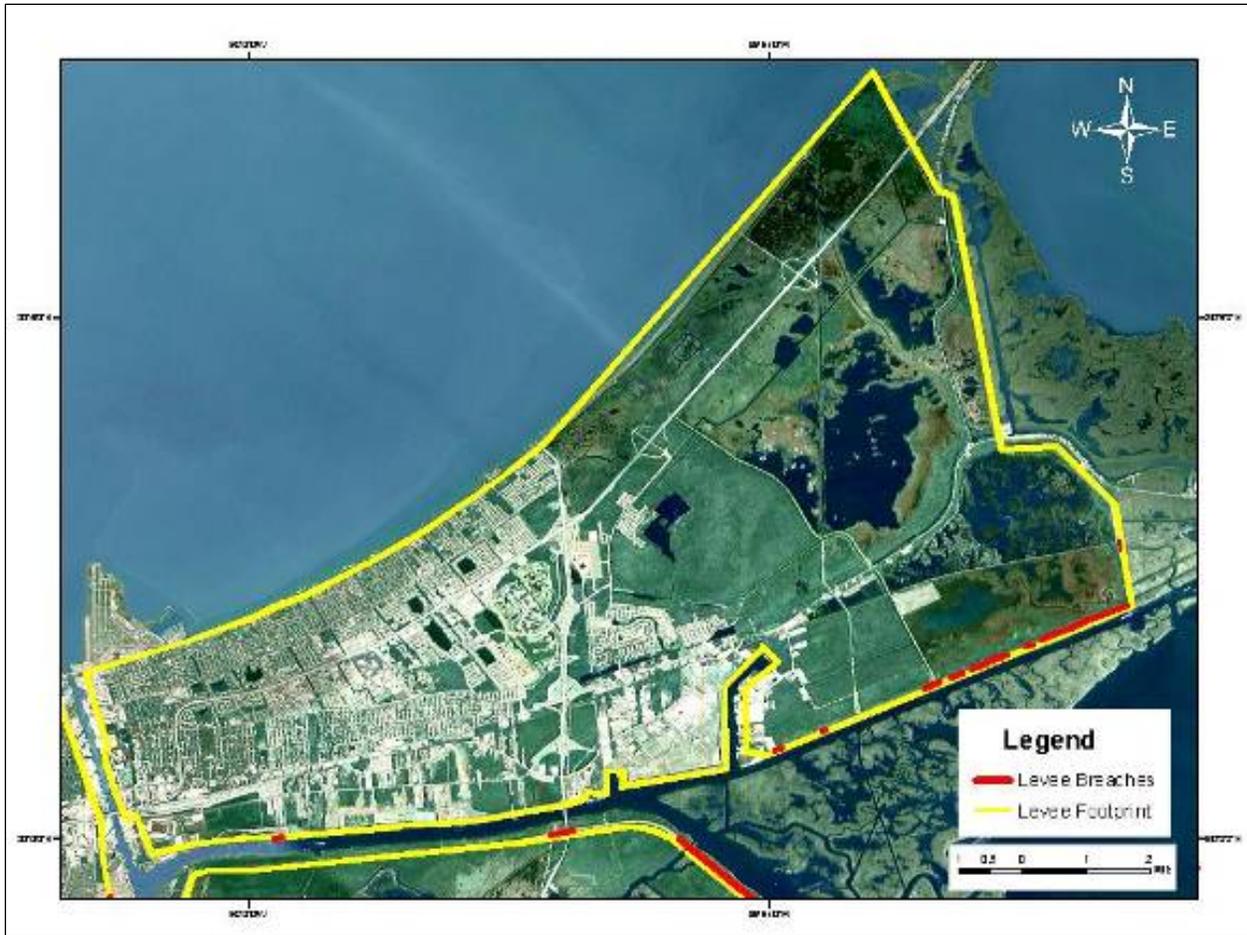
The New Orleans East back levee suffered considerable erosion. Figure 84 shows the major levee segments. The locations of the levee breaches caused by erosion are shown in Figure 85 and the hydraulic fill and hauled fill segments are indicated in Figure 86. It can be noted that the breaches are located in sections that were constructed of hydraulic fill. However, this is not an exact correlation, and other factors need to be considered. Figure 87 shows locations where the surge and wave hydrographs have been determined from calculations and high-water marks. Figure 88 shows a plot of pre-Katrina levee elevations and the surge height plus the peak wave height at these locations. It can be seen that the greatest erosion of the hydraulically filled levees occurs when the surge height plus the peak wave height had the greatest level above the crest of the levee. Examination of this information has shown that the peak wave height is the most important component of the surge. The figure also shows that levees constructed of rolled fill had equal to or greater surge plus the peak wave height over their crest, yet did not breach. Therefore, it is concluded that the combination of hydraulically filled levees and high surge and wave action leads to breaches by erosion.

Figure 85. NOE basin post-Katrina breaches.

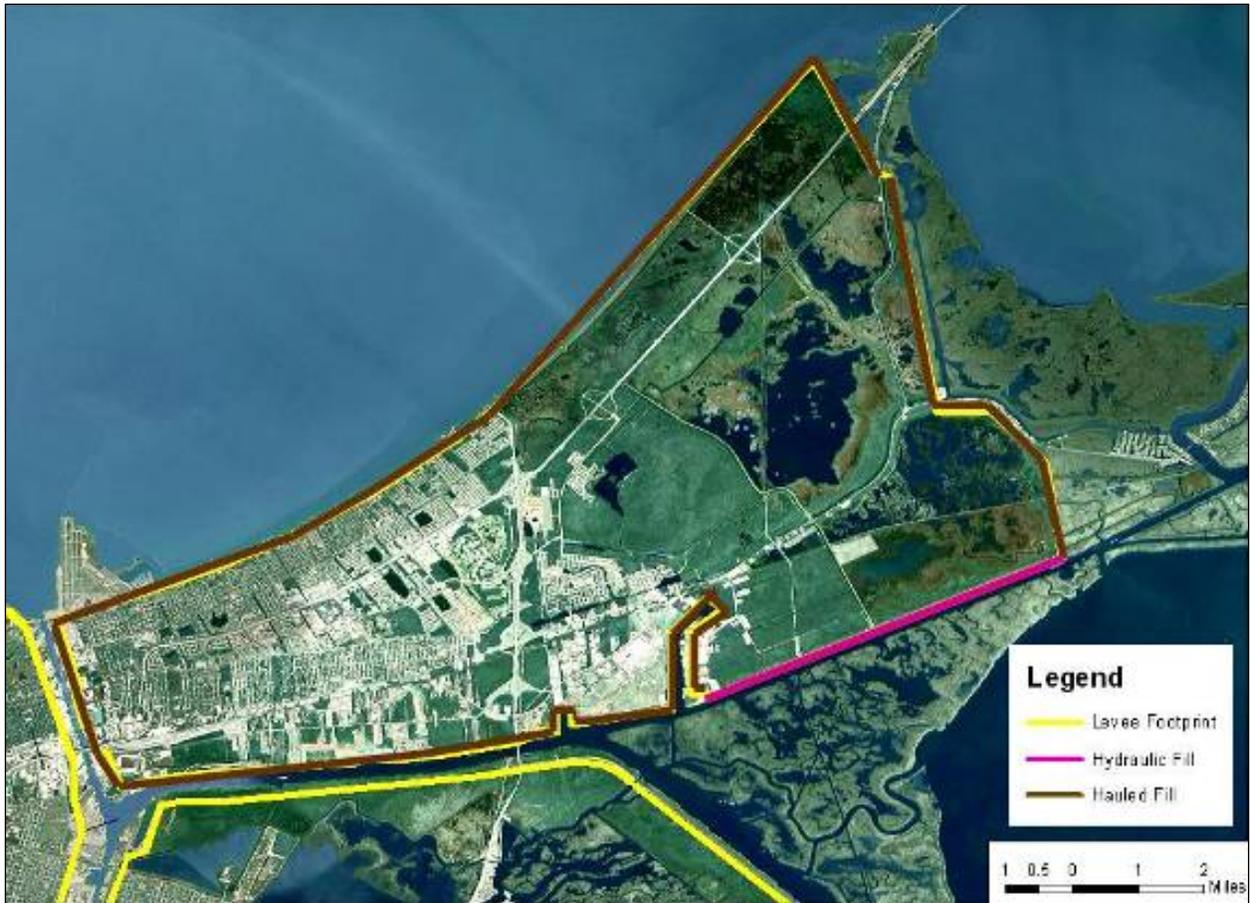
Figure 86. NOE Levee construction materials.

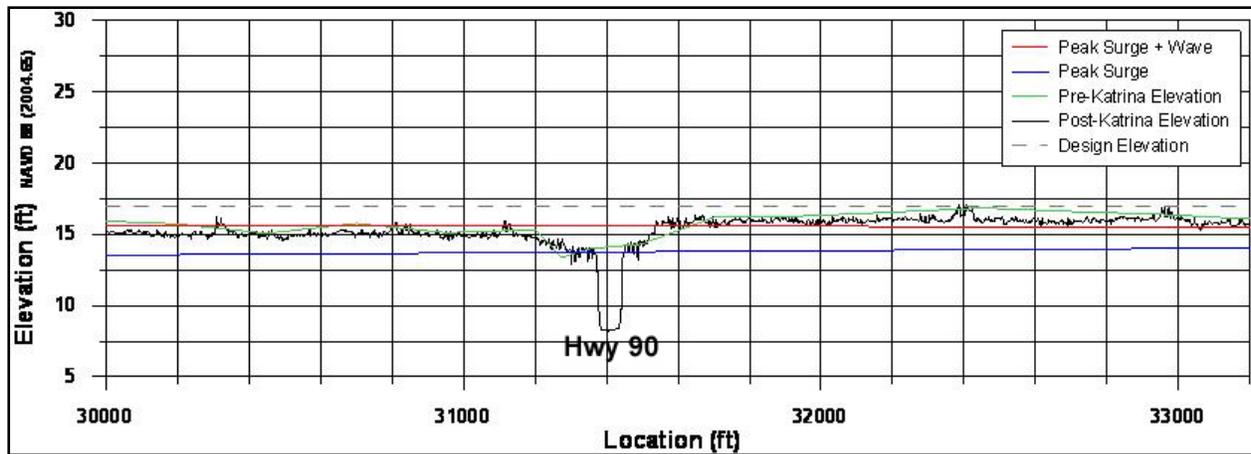
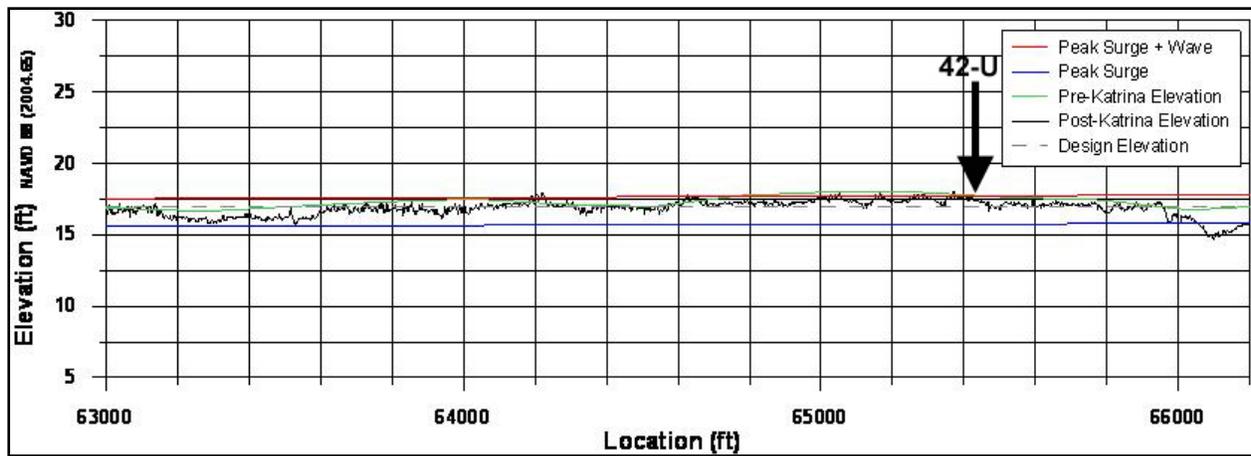
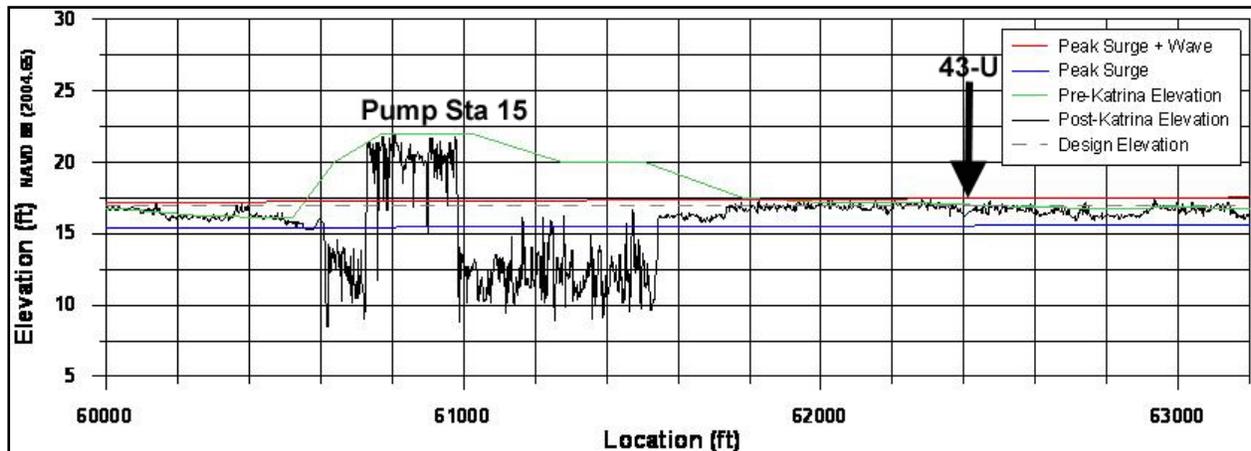
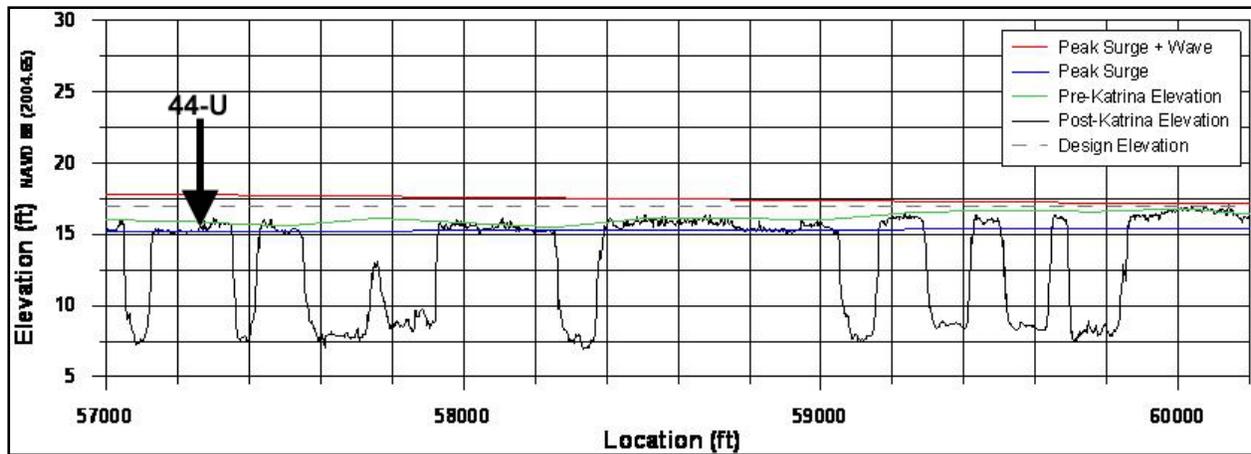
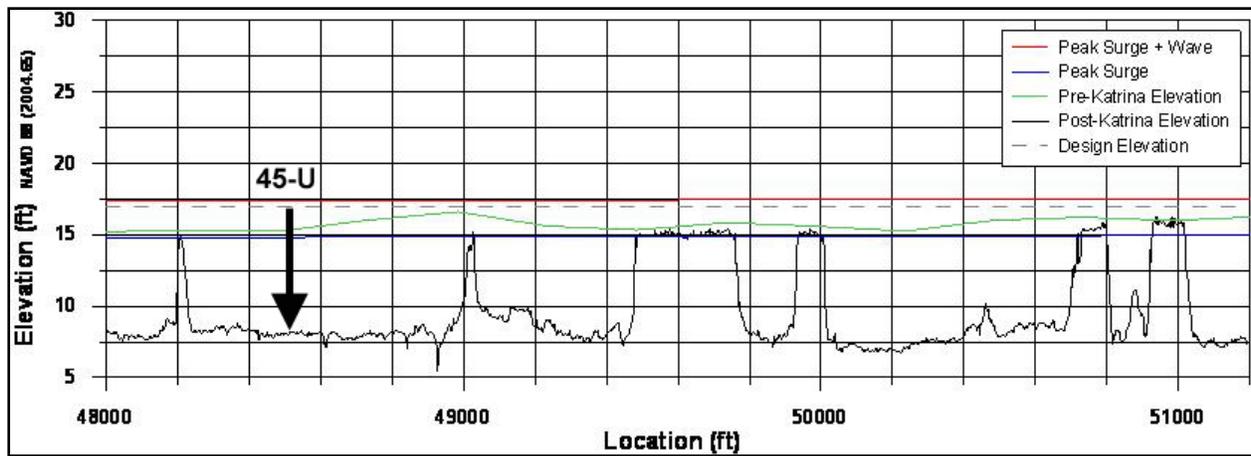
The LIDAR data along the levee crown can also be expressed as an elevation profile. Figure 89 is a plan view of the LIDAR stationing used in this investigation. Figures 90 through 94 show selected post-storm LIDAR survey data along the NOE BL. These data allow comparison of scour depths to construction methods and associated soil types, in addition to wave height and surge elevation.

clay layers in the top 10 ft than the other two borings west of Pump Station 15. The presence of fat clay layers is not necessarily the sole controlling factor leading to higher erosion rates, since the levees east of Pump Station 15 typically had higher erosion, scour, and breaching frequency than those on the west side. The hydraulic loading (surge and wave action) is greater east of Pump Station 15, which is consistent with the greater erosion. Figure 88 shows that Station 366 had a high hydraulic loading and was constructed by hauled compacted fill. The levee was constructed from fat clays and lean clays, with dry densities ranging up to 103 lb/cu ft and subsequently had minimal erosion damage.

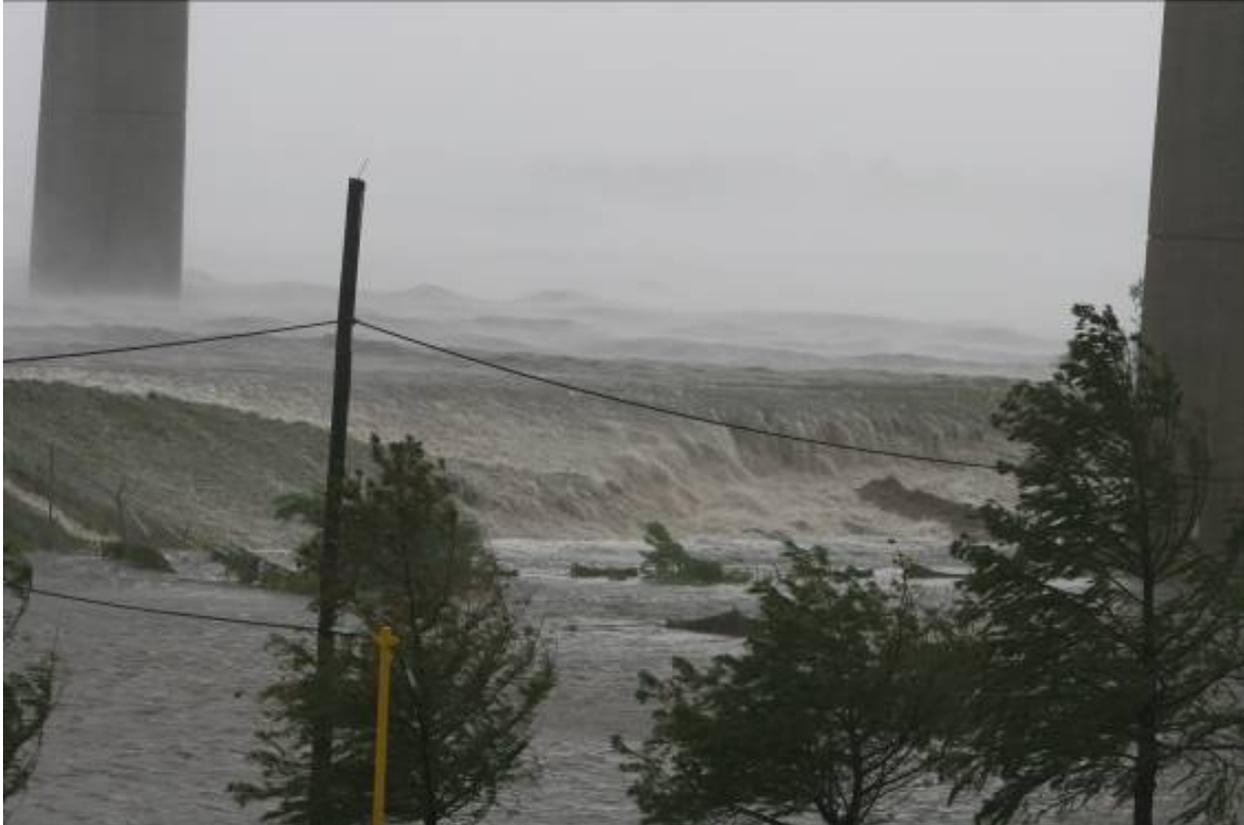
Another example is the levee at the Entergy power plant in the New Orleans East area near the Paris Road Bridge. This overtopping can be seen in the widely circulated picture taken by Entergy personnel during the storm, shown in Figure 95. Preliminary results of Cone Penetrometer Tests taken on the levee at the Entergy power plant indicate that the levee was constructed of clay (CH) and later, erodibility tests showing it was resistant to erosion. Figure 96 shows that it suffered only minor erosion due to overtopping.

Figure 95. Overtopped levee under the Paris Road Bridge adjacent to the Entergy power plant in New Orleans East, during Hurricane Katrina.

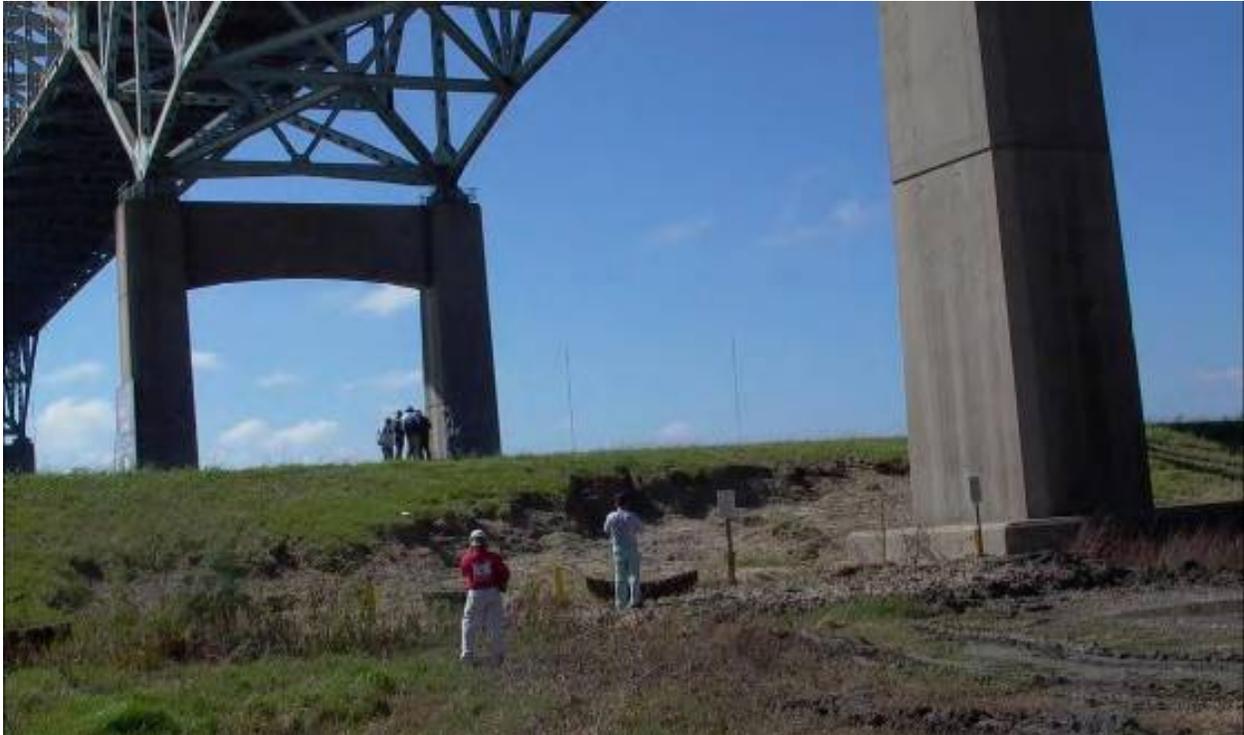
Figure 96. Overtopping of the levee under the Paris Road Bridge adjacent to the Entergy power plant in New Orleans East after the storm.

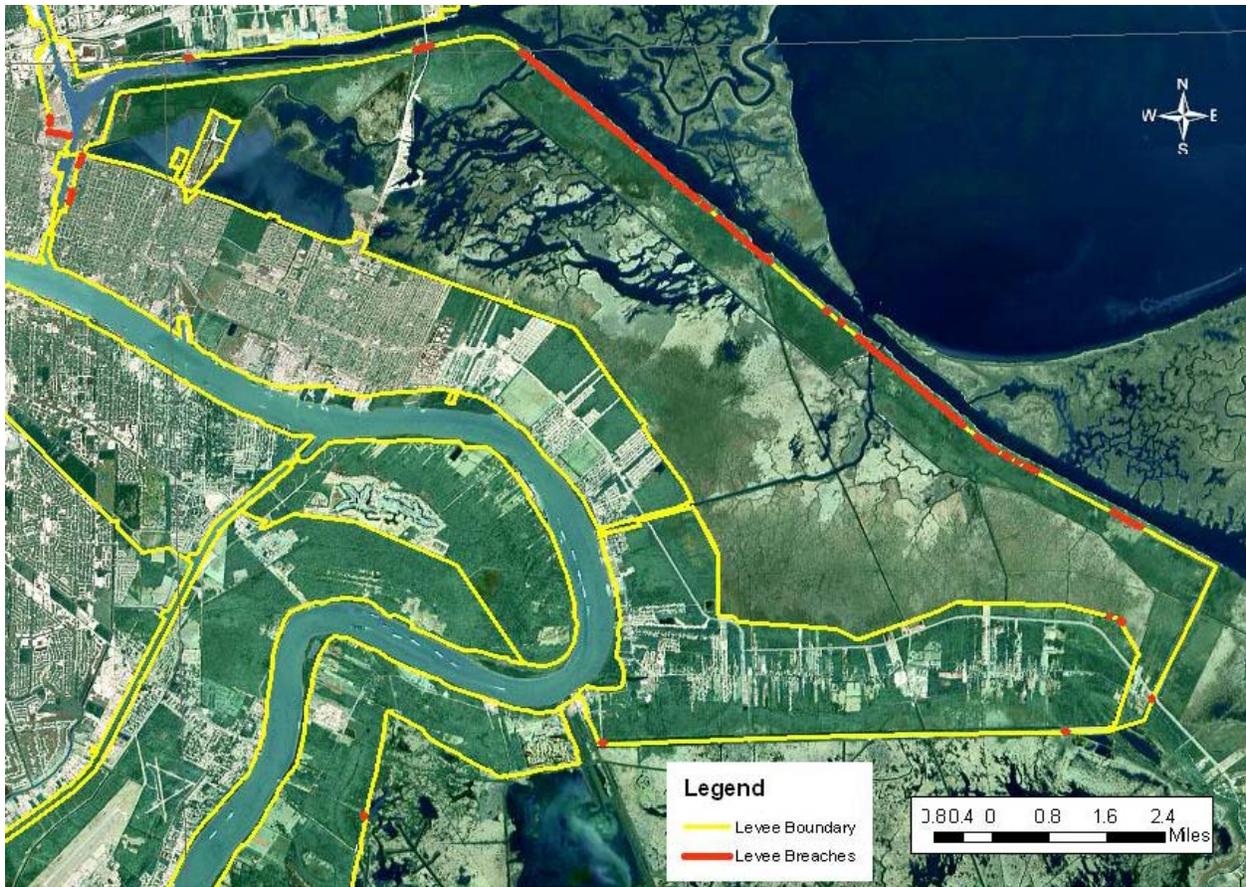
Figure 97 shows the breach locations for St. Bernard Parish, which includes nearly 70% of the levee along MRGO. Figure 98 highlights the levee's construction methods, including hauled, hydraulically filled, and walled reaches. Note the breach locations in Figures 97 and 98 coincide with the reaches constructed using hydraulic fill.

Figure 97. St. Bernard Parish breach locations.

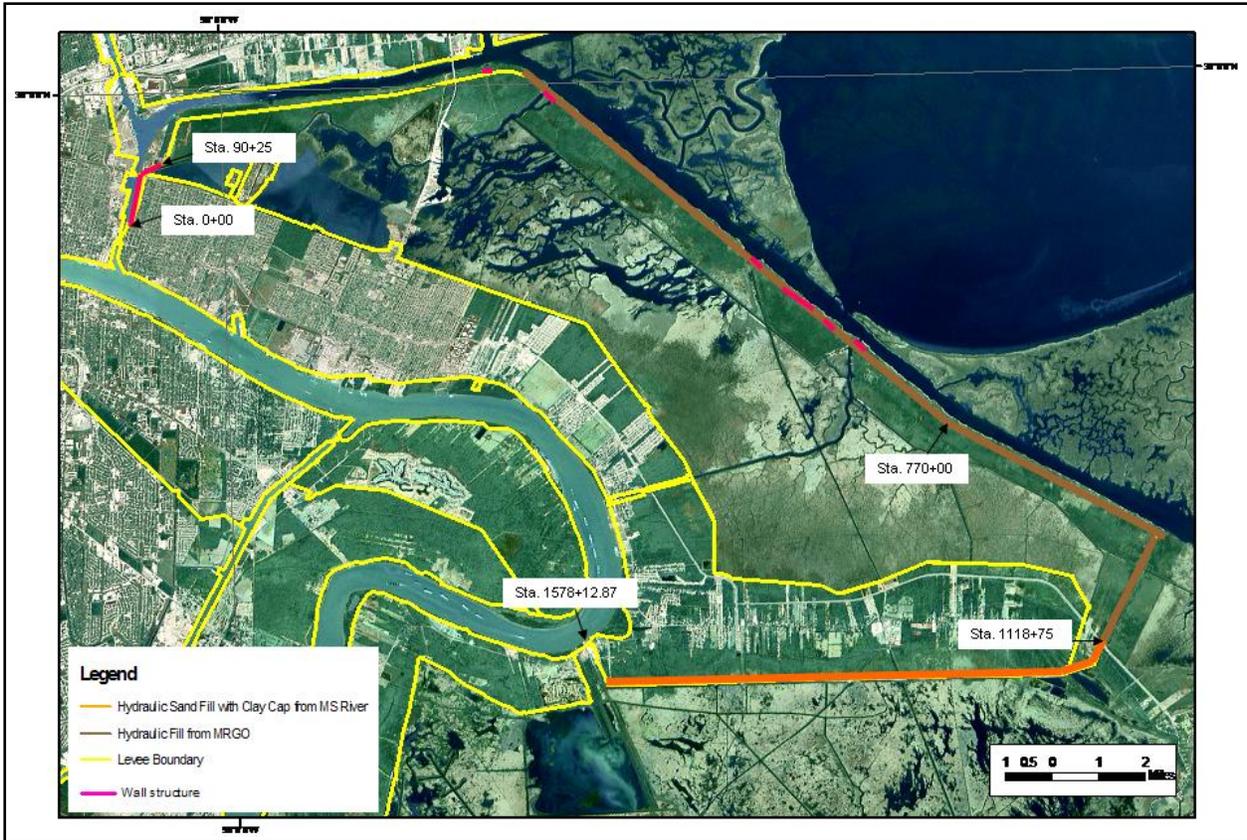
Figure 98. Constructed levee soil sources.

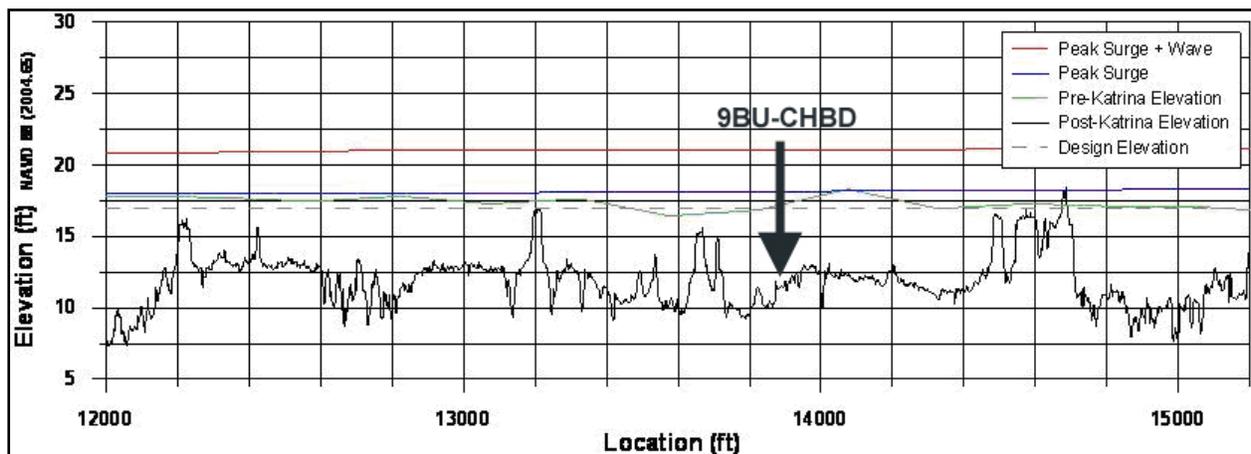
Figure 100. LIDAR plot showing soil boring 9BU-CHBD approximate location. Erosion depth was approximately 5 ft.

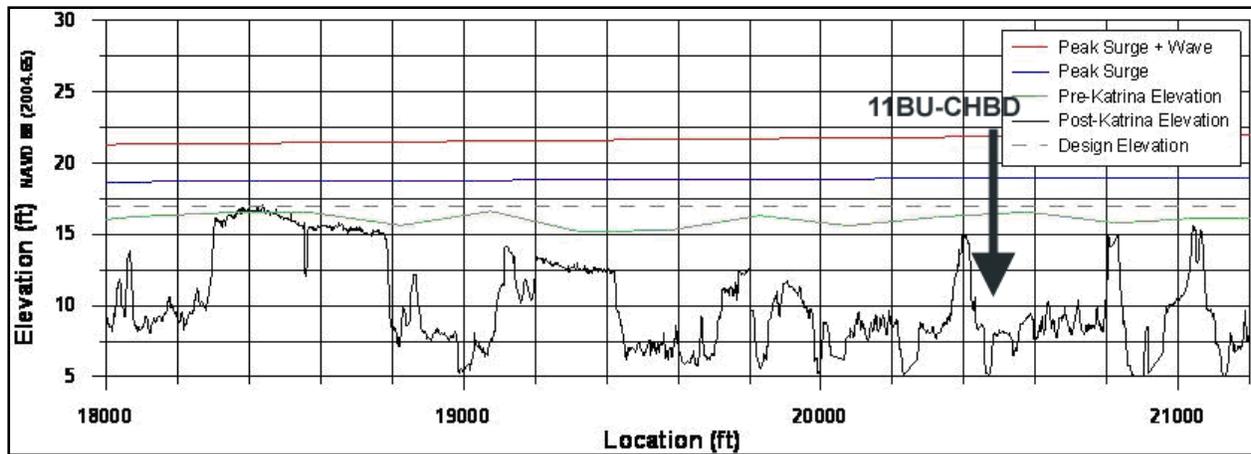
Figure 101. LIDAR plot showing soil boring 11BU-CHBD approximate location. Erosion depth was approximately 10 ft.

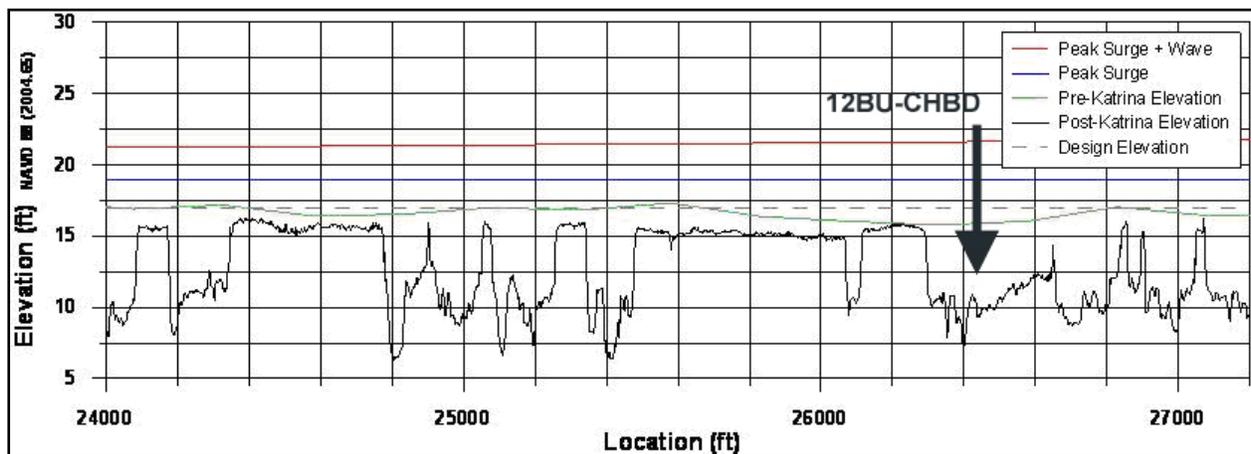
Figure 102. LIDAR plot showing approximate location of soil boring 12BU-CHBD. Approximate erosion depth was 6 ft.

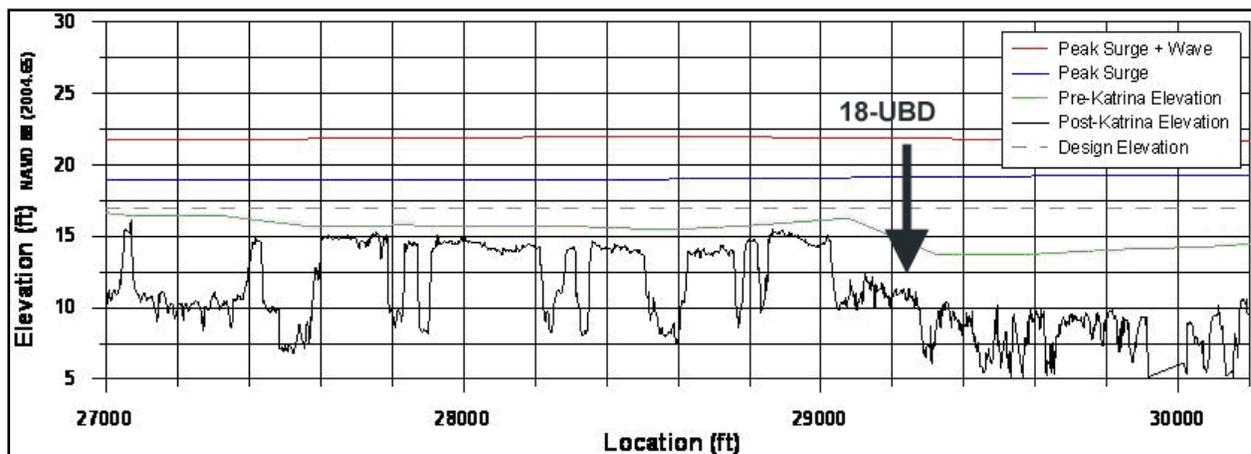
Figure 103. LIDAR plot showing approximate location of soil boring 18-UBD. Approximate erosion depth was 6 ft.

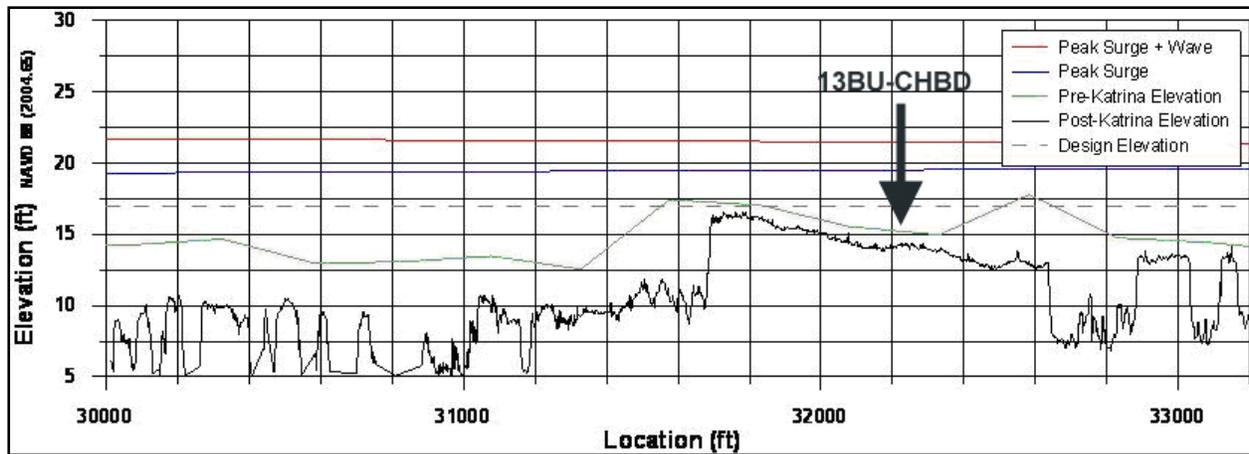
Figure 104. LIDAR plot showing soil boring 13BU-CHBD approximate location. Erosion depth was approximately 1 ft.

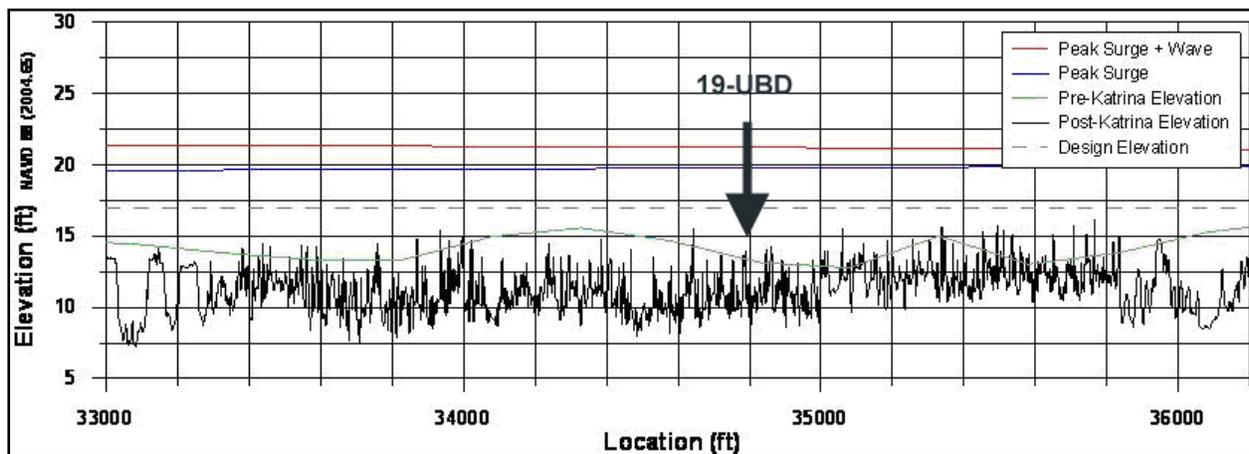
Figure 105. LIDAR plot showing soil boring 19-UBD approximate location. Sheet piling was present at this location as indicated by the LIDAR signature.

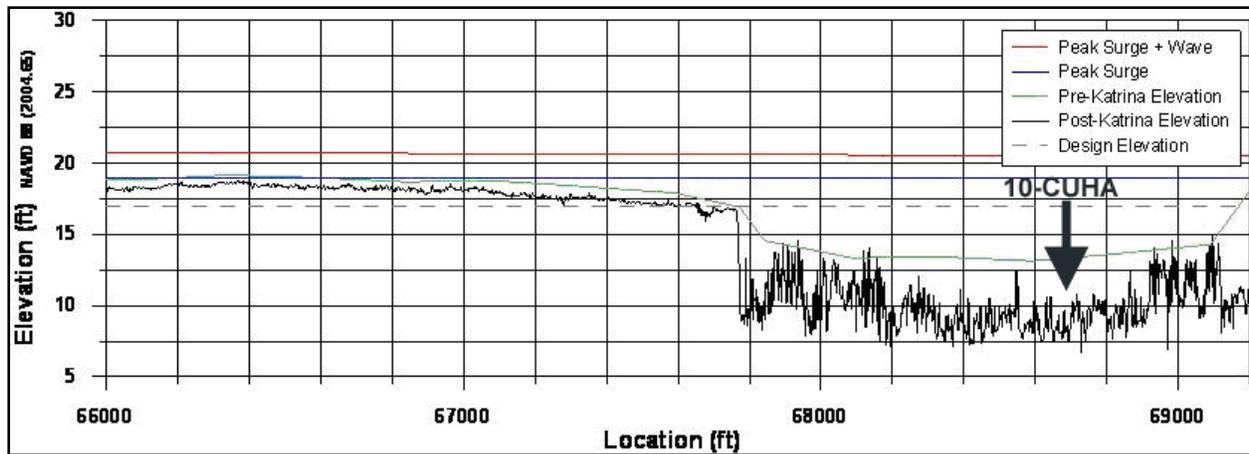
Figure 107. LIDAR plot showing approximate location of soil boring 10-CUHA. Sheet piling was present at this location as indicated by the LIDAR signature.

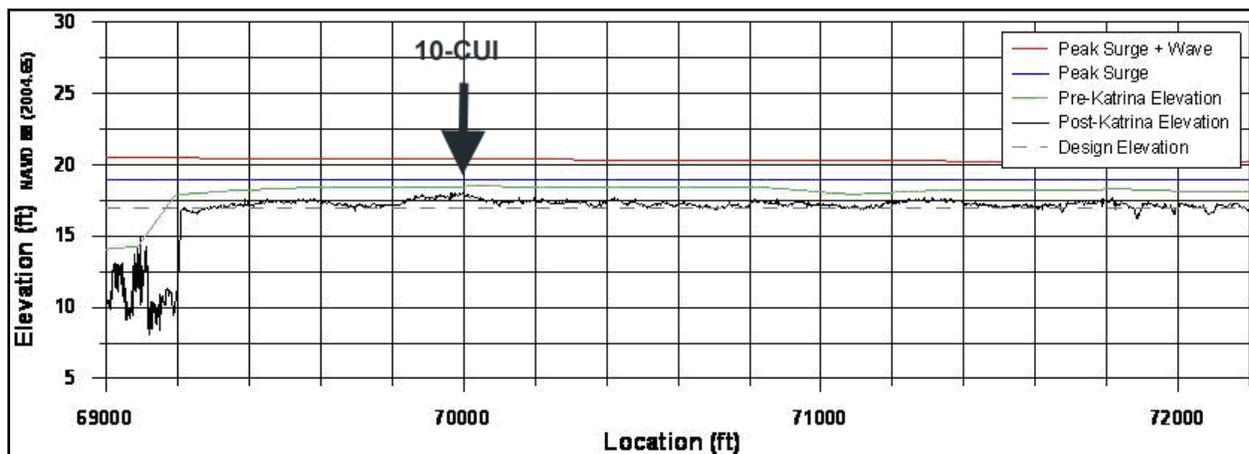
Figure 108. LIDAR plot showing approximate location of soil boring 10-CUI drilled in 1985. Erosion damage was minimal.

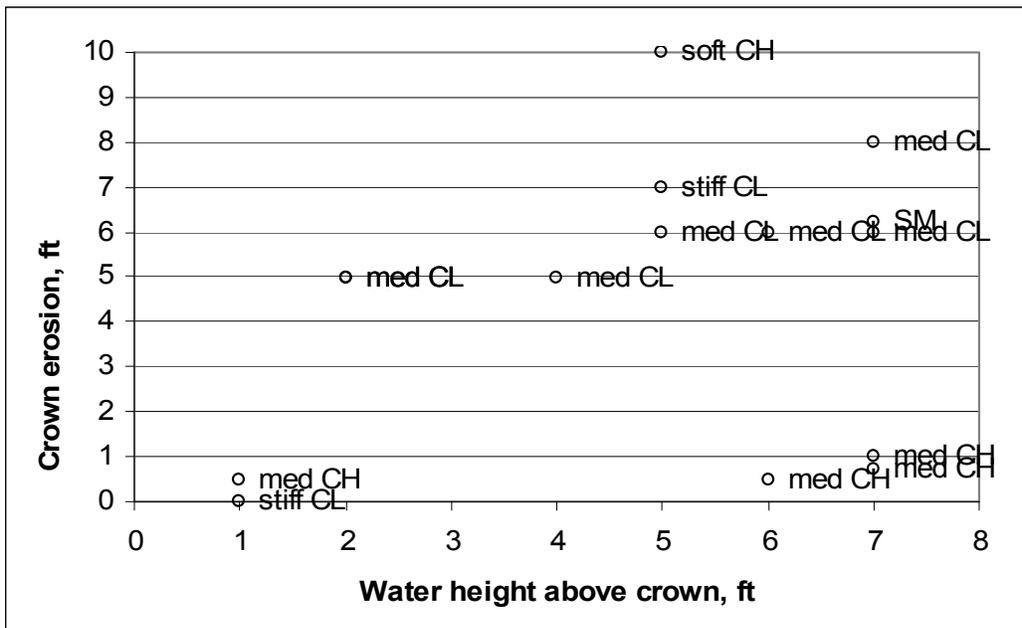
The soil type, scour depth, and hydraulic loading data from the above figures (Figures 100 through 108) are generalized in Table 4. The levee crown surface soil types and consistencies (strengths) are shown with approximate scour depths and approximate surge plus wave heights. Figure 109 is a plot of the Table 4 data and shows the relations between soil type, soil strength, hydraulic loading, and erosion depths at selected points along the levee crown. Note that no strong correlation between erosion depth and hydraulic loading was observed. From these selected points (Table 4), it appears that soil consistency (strength) and soil type correlate with erosion depth and hydraulic loading. The soil consistency is correlated in that soft fat clays performed poorly (i.e., had deeper erosion) compared to medium fat clays, and the medium fat clays performed better than the medium lean clays. The soil strengths (consistencies) are directly comparable to the construction compaction effort. For example, a compacted clayey soil will have higher density and strength than an uncompacted clayey soil at the same water content.

Figure 109. Scour depths versus surge/wave loading from soil borings and LIDAR data plotted from Table 4 levee surface soil stiffness (strength) and soil type are labeled. Note that medium-strength fat clay (med CH) had the least amount of erosion as the hydraulic loading increased.
