Appendix 1

Soil Data Report for 17th Street Canal

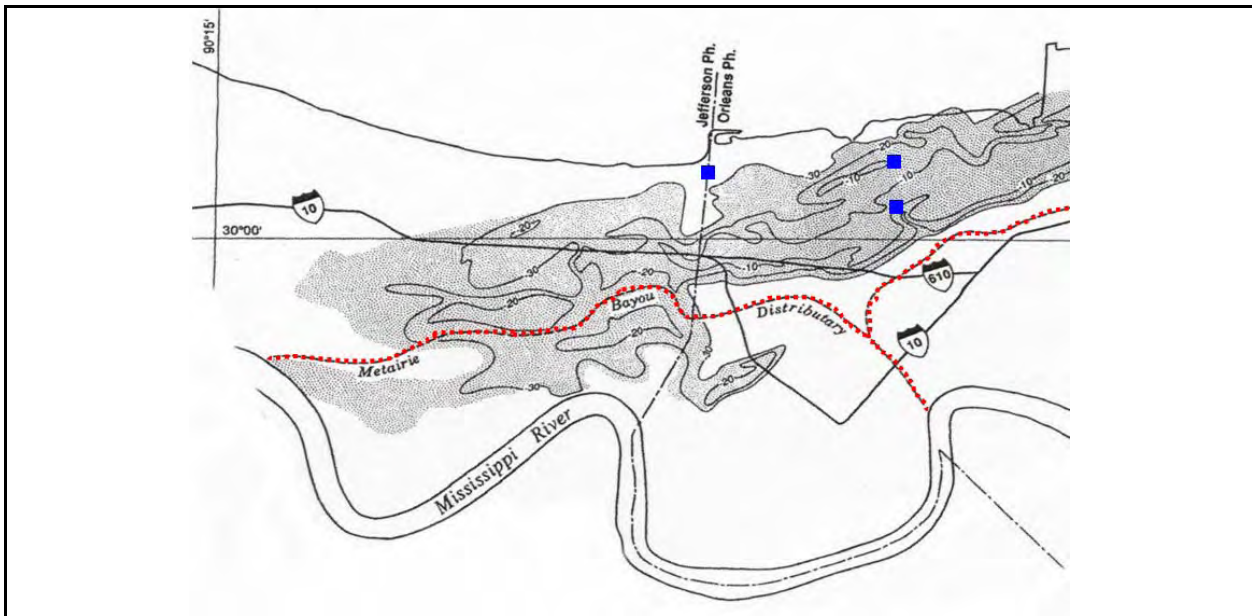
Figure 1-4b. Close-up view of the buried beach ridge, and the locations of the canal breaches to the buried beach (after Saucier 1994). The 17th Street breach is located behind the axis of the beach ridge while the London Canal breaches are located on the axis of the ridge. Bayou Metairie is identified in red and forms the Bayou Sauvage distributary course (No. 11) in Figure 1-2.

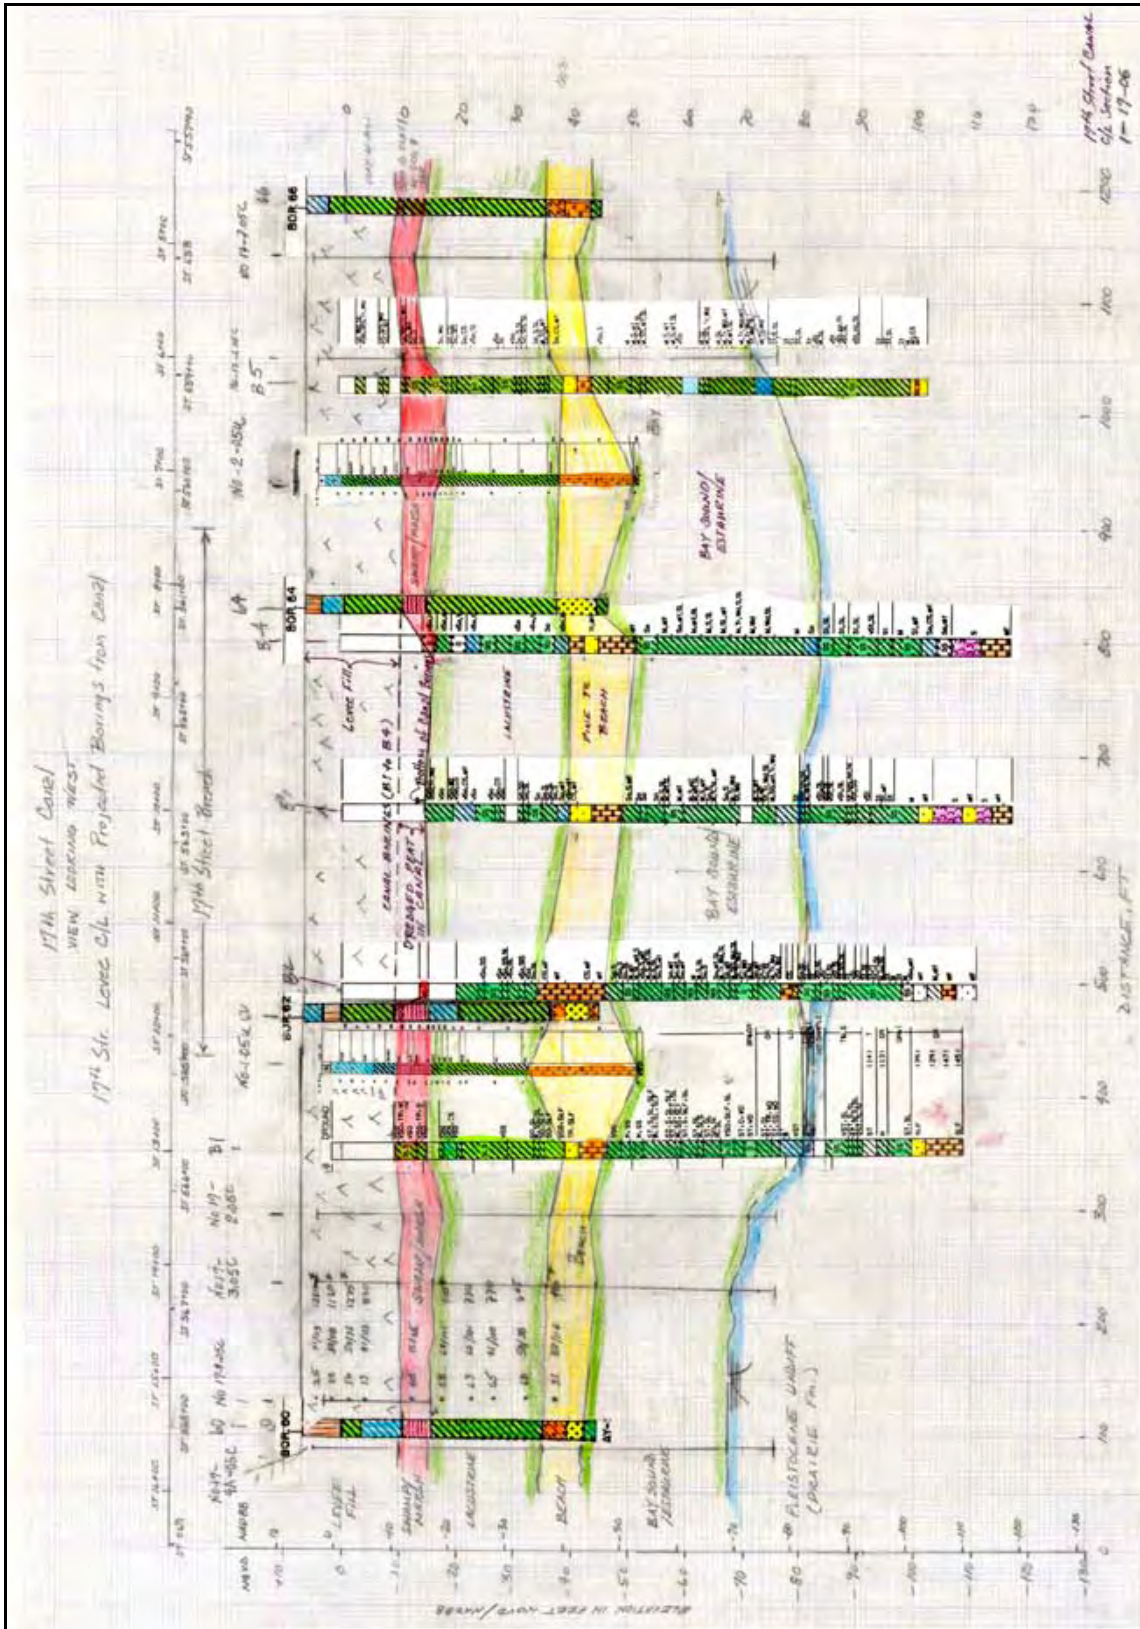
Figure 1-9. Centerline (CL) Cross-section of Breach

A more detailed representation of the soil stratigraphy profile along the centerline in the breach area is shown in Figure 1-9. This profile was constructed using additional soil data acquired during the post-Katrina soil exploration conducted during September through October 2006. The additional borings included B1, B2, B3, B4, B5, NO-1-05U, and NO-2-05U. A plan view showing the locations of both old and new borings is shown in Figure 1-10. The new borings were needed because only the two old borings, B62 and B64 (reported in GDM No. 20), were in the immediate vicinity of the breach. The new borings extended the depth of the investigation in this area from approximately Elevation -50 ft NGVD to Elevation -115 ft NGVD. Additionally, data from cone penetration testing, from the new exploration program, were used to supplement soil data from the old and new borings and refine the stratigraphy in the breach area. Since the levee was destroyed in the breach area during the storm, the new borings, B1 through B4, were drilled from a barge in the canal and were offset from the centerline. Data acquired from these borings were projected back to the centerline in an effort to improve the interpretation of the stratigraphy.

The information presented on Figure 1-9 yielded the following interpretation of the subsurface stratigraphy in the breach area. The subsurface in the breach area was simplified into six basic groups of soil types over the depth of the investigation:

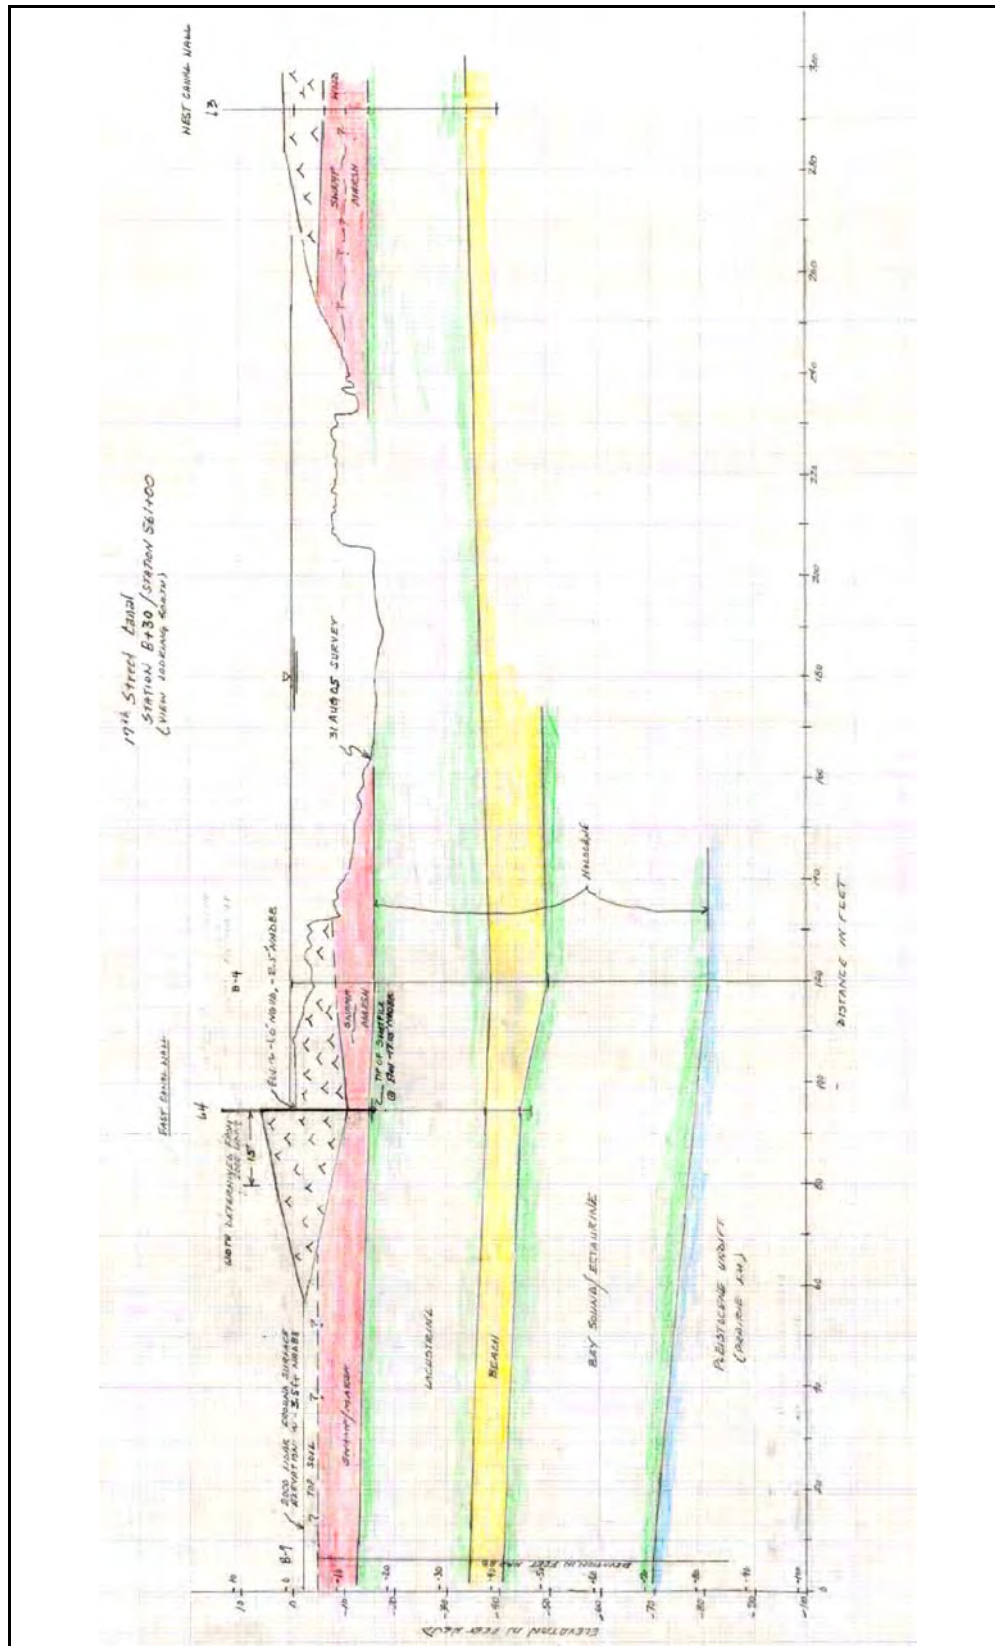
Figure 1-11. Prefailure Cross-Section at Sta 8+30 (New Stationing)/ Sta. 561+00 (GDM Stationing)

The three representative cross sections for Station 8+30, Station 10+00, and Station 11+50 are shown in Figures 1-11, 1-12, and 1-13, respectively. Three sections were prepared because the levee dimensions are variable in the breach area on the east bank. Each cross section shows the conditions across the entire canal from the west bank to the east bank where the breach site is located. A degree of interpretation was necessary, particularly pertaining to the east bank

protected side, to complete the cross sections because of the lack of soil boring data in this area. Thus, the marsh/peat layer was interpreted to be thinner under the centerline of the levee than at the toe due to consolidation from the surcharge caused by the weight of the levee. Also, an interpretation was made to include a 2- to 3-ft layer of topsoil over the top of the peat in this area. This effect may be cultural in nature because the protected side of the east bank was located in a residential area with houses having well-kept lawns.

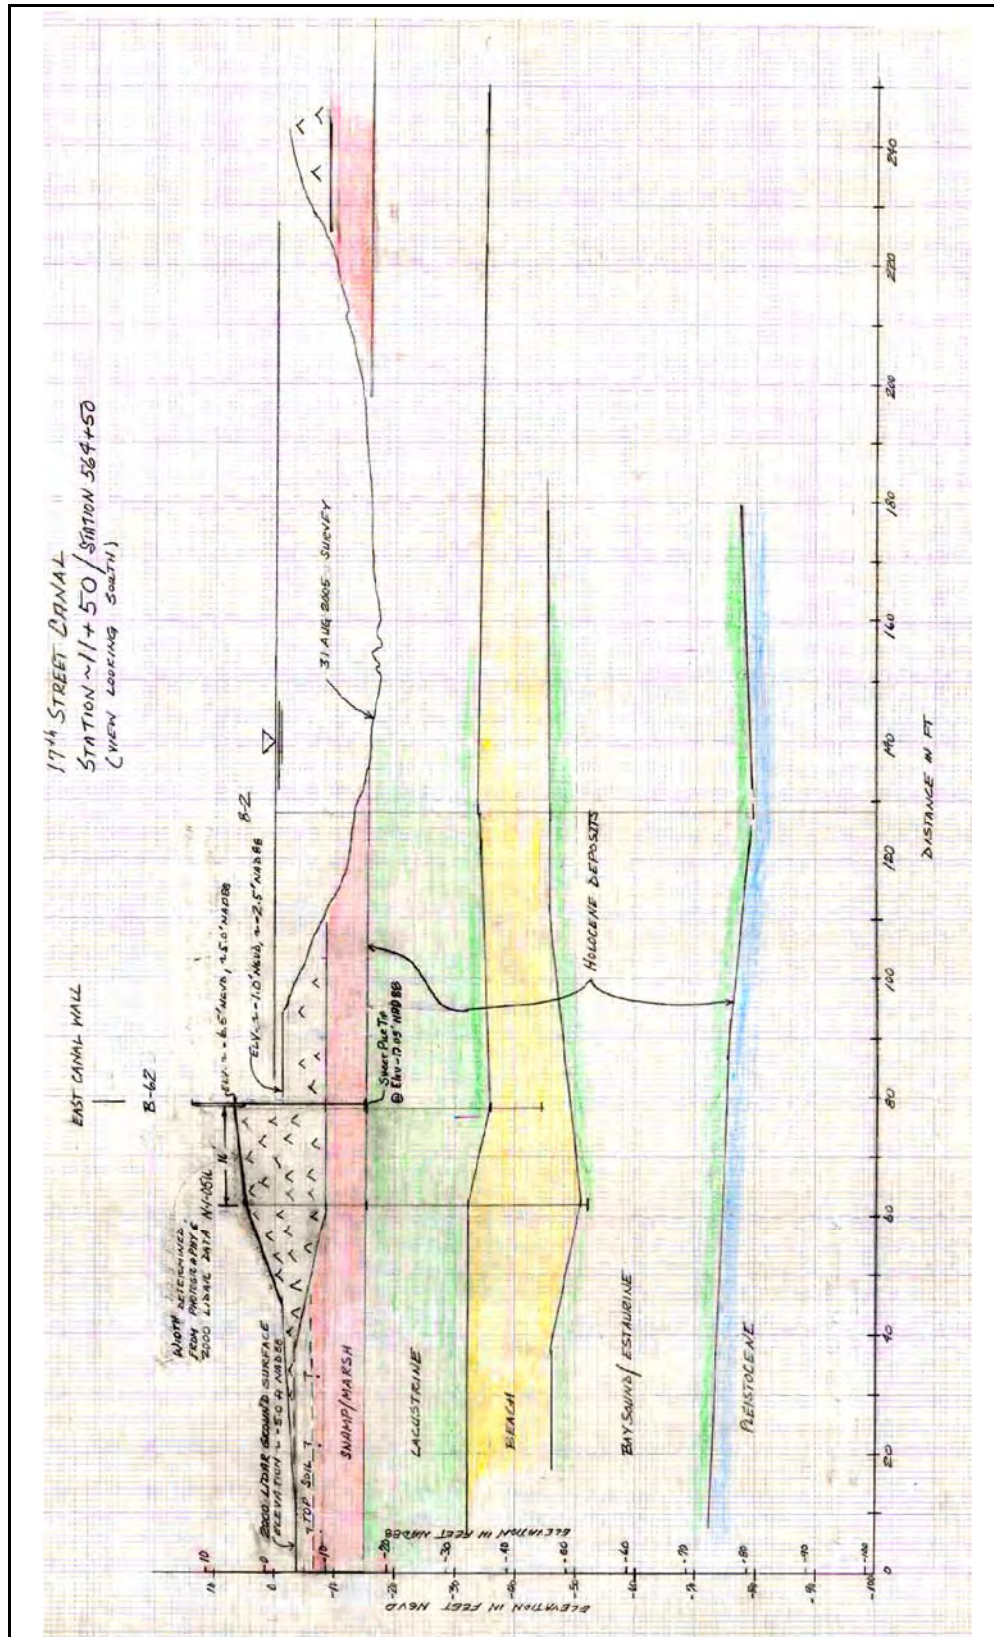
Figure 1-13. Prefailure Cross-Section at Sta 11+50 (New Stationing)/ Sta. 564+50 (GDM Stationing) (Note: Most scour occurred near this station)

It is also noted that the levee cross section at Station 11+50, the southernmost section of the three and shown in Figure 1-13, is the location where the post-Katrina surveys showed that the most scour occurred while water was flowing through the breach.

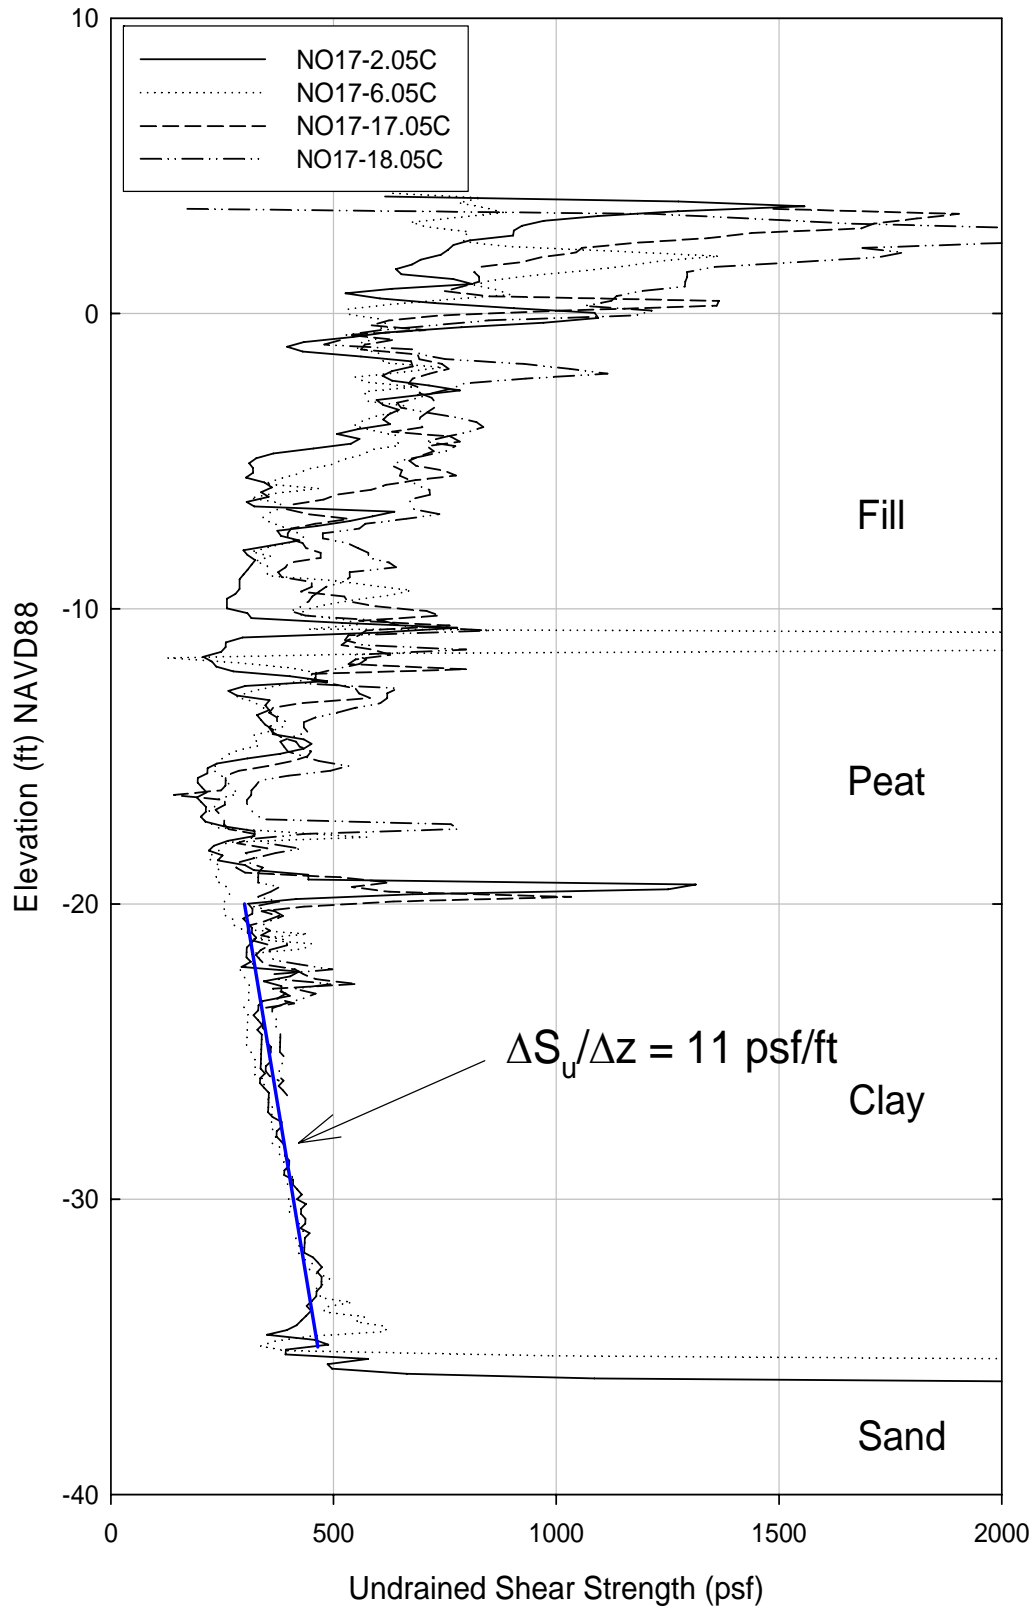
The clay is normally consolidated, and its undrained shear strength increases with depth. Figure 3-1 shows variations of undrained shear strength with depth determined using Mayne's method (Mayne 2003)¹ for determining undrained shear strength from CPTU test results. Mayne's method uses the relationship among undrained strength, effective overburden pressure, and preconsolidation pressure that was proposed by Ladd (1991)², and has been found to give more reasonable values of undrained shear strength than use of constant values of the cone factors N_k or N_{kt} .

Figure 3-1. Undrained Shear Strength Calculated from CPTU Tests using Mayne's Method

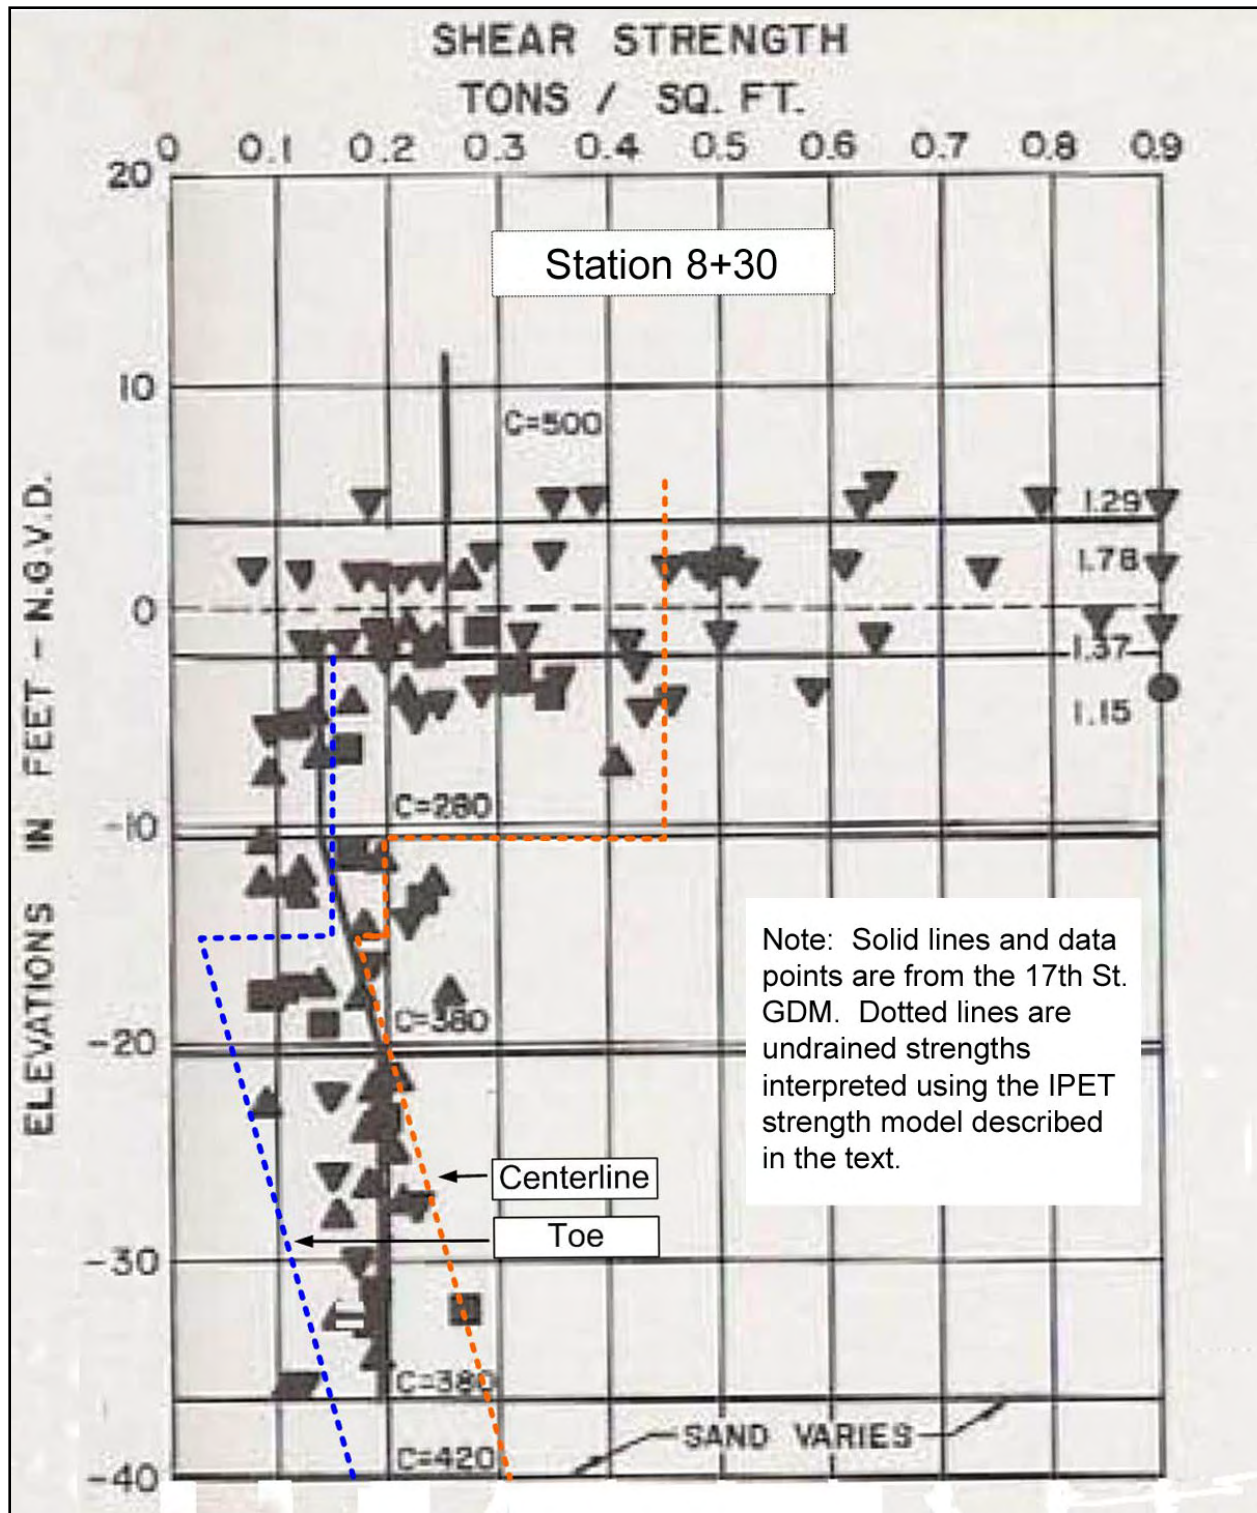
Figure 3-2. Comparison of Undrained Strength Profiles used for 17th Street I-Wall Design with Strength Profiles Interpreted from the IPET Strength Model for Station 8+30

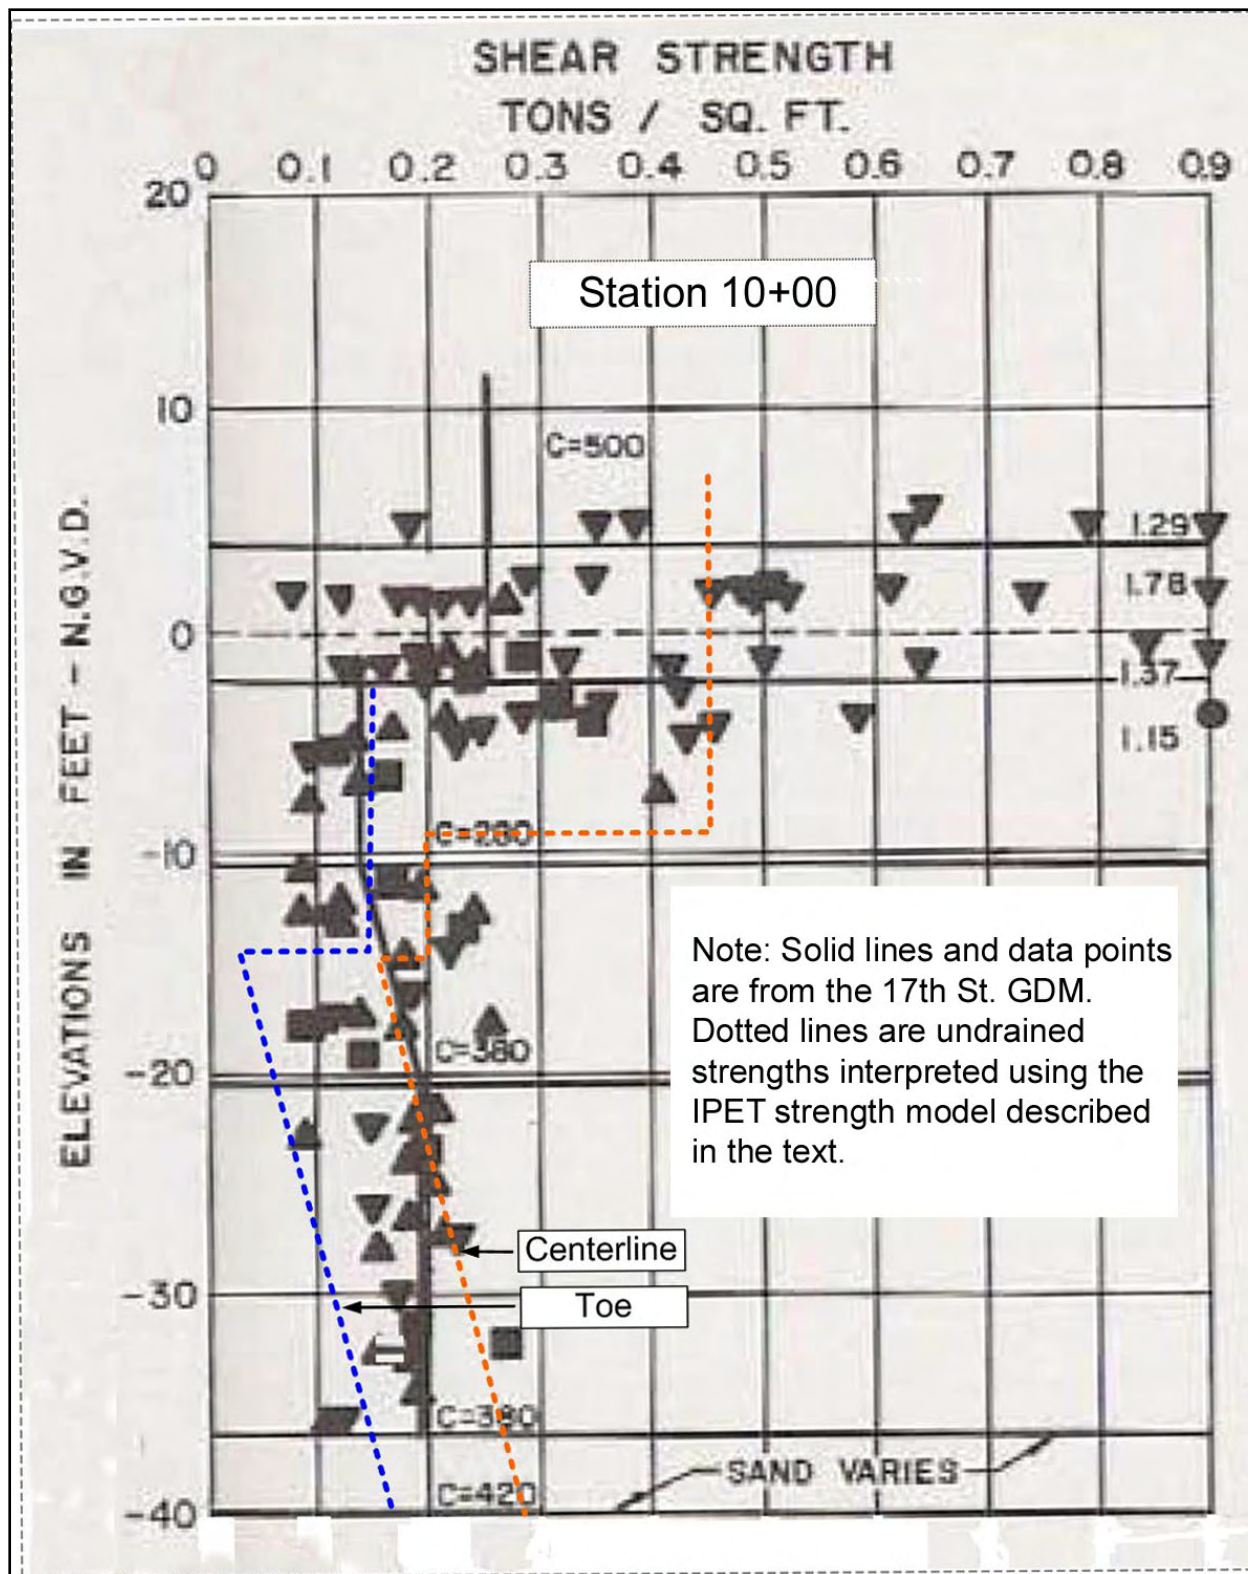
Figure 3-3. Comparison of Undrained Strength Profiles used for 17th Street I-Wall Design with Strength Profiles Interpreted from the IPET Strength Model for Station 10+00

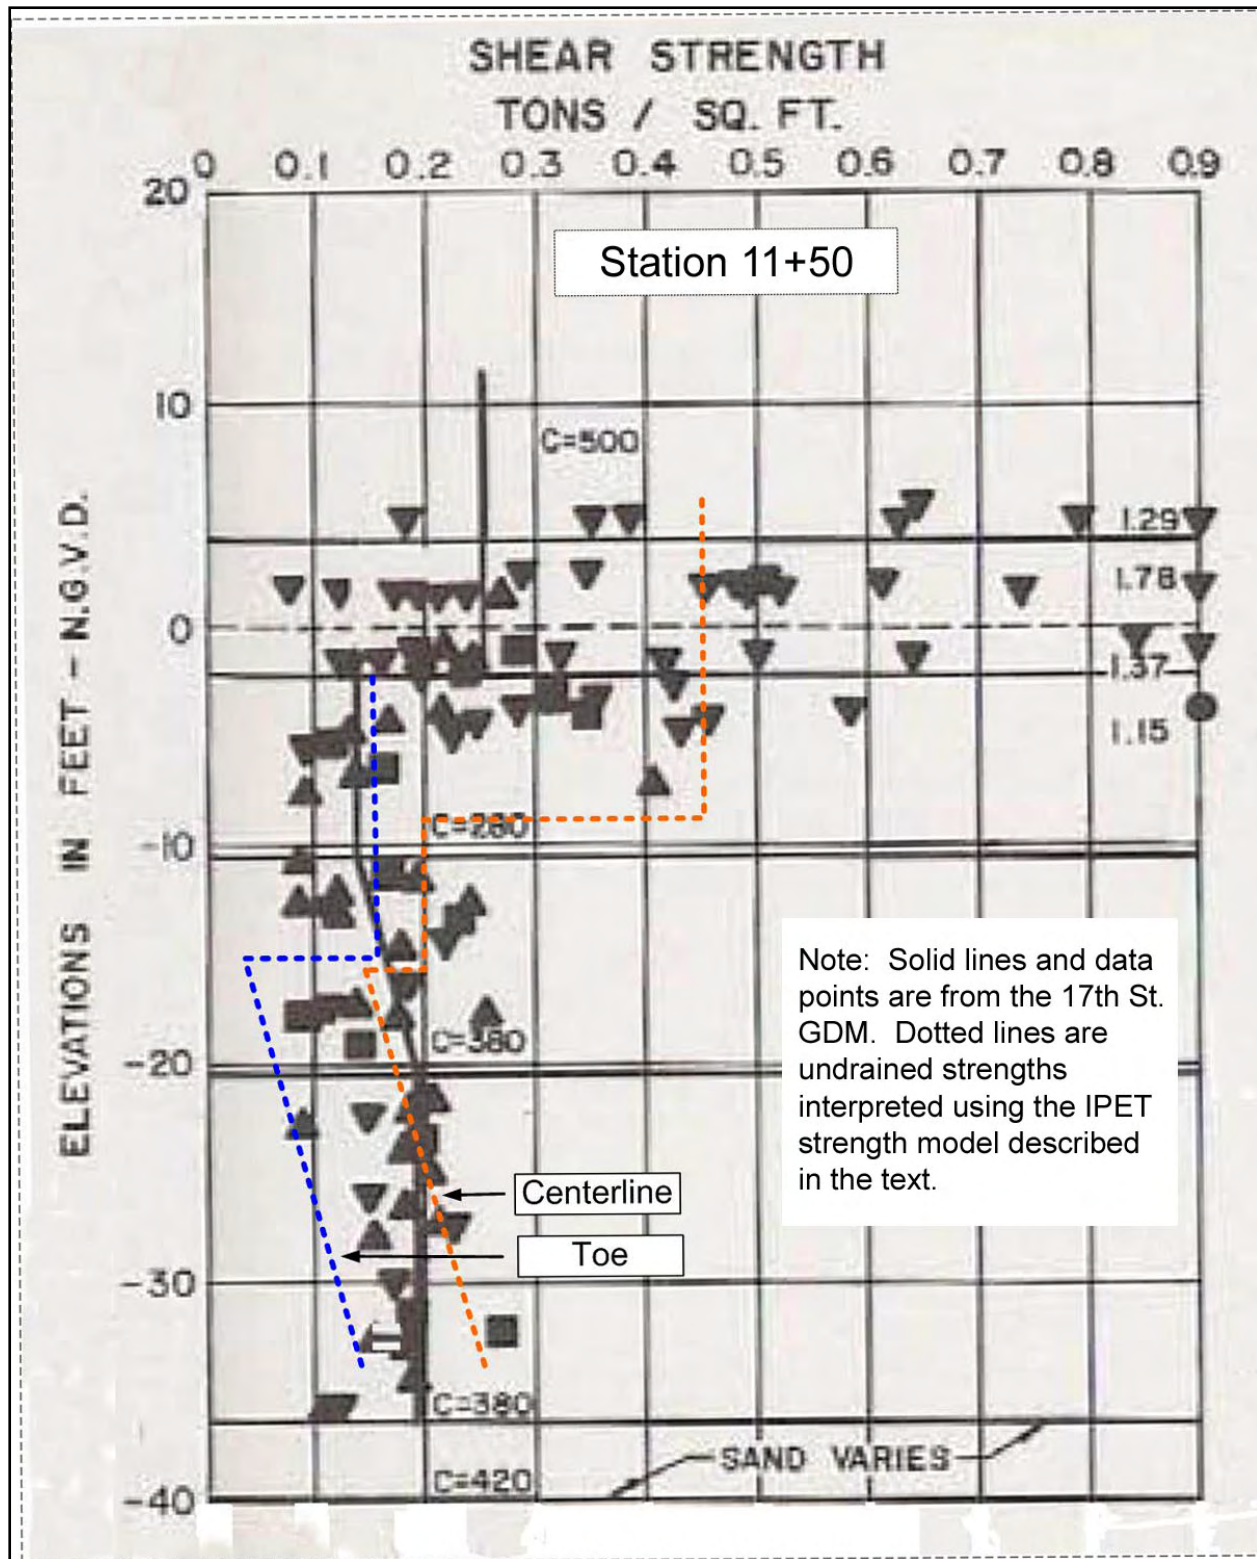
Figure 3-4. Comparison of Undrained Strength Profiles used for 17th Street I-Wall Design with Strength Profiles Interpreted from the IPET Strength Model for Station 11+50

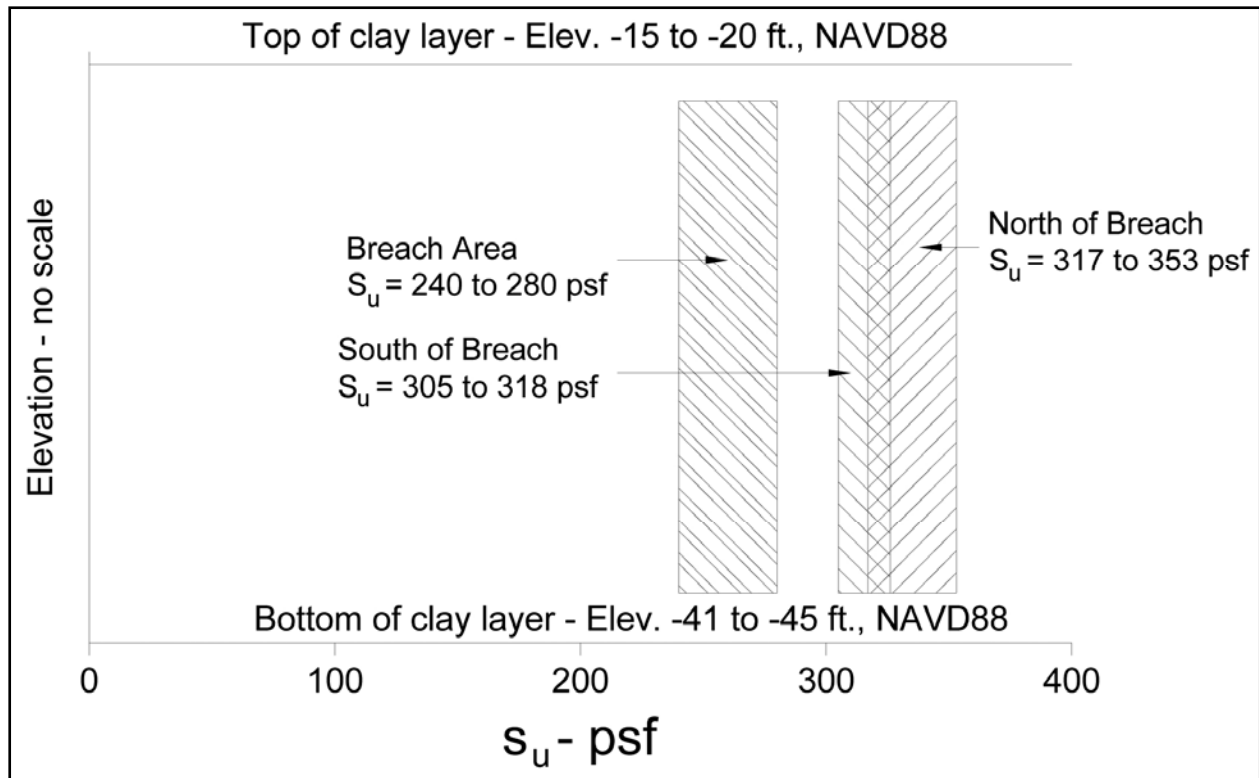
Area	Range of s_u	Average s_u
Breach (Borings 62 and 64)	240 psf to 280 psf	260 psf
North of breach (Borings 66 and 68)	317 psf to 353 psf	335 psf
South of breach (Borings 56, 58 and 60)	305 psf to 326 psf	318 psf

Figure 3-5. Comparison of Undrained Strengths from Breach Area Borings with Strengths from Borings North and South of Breach

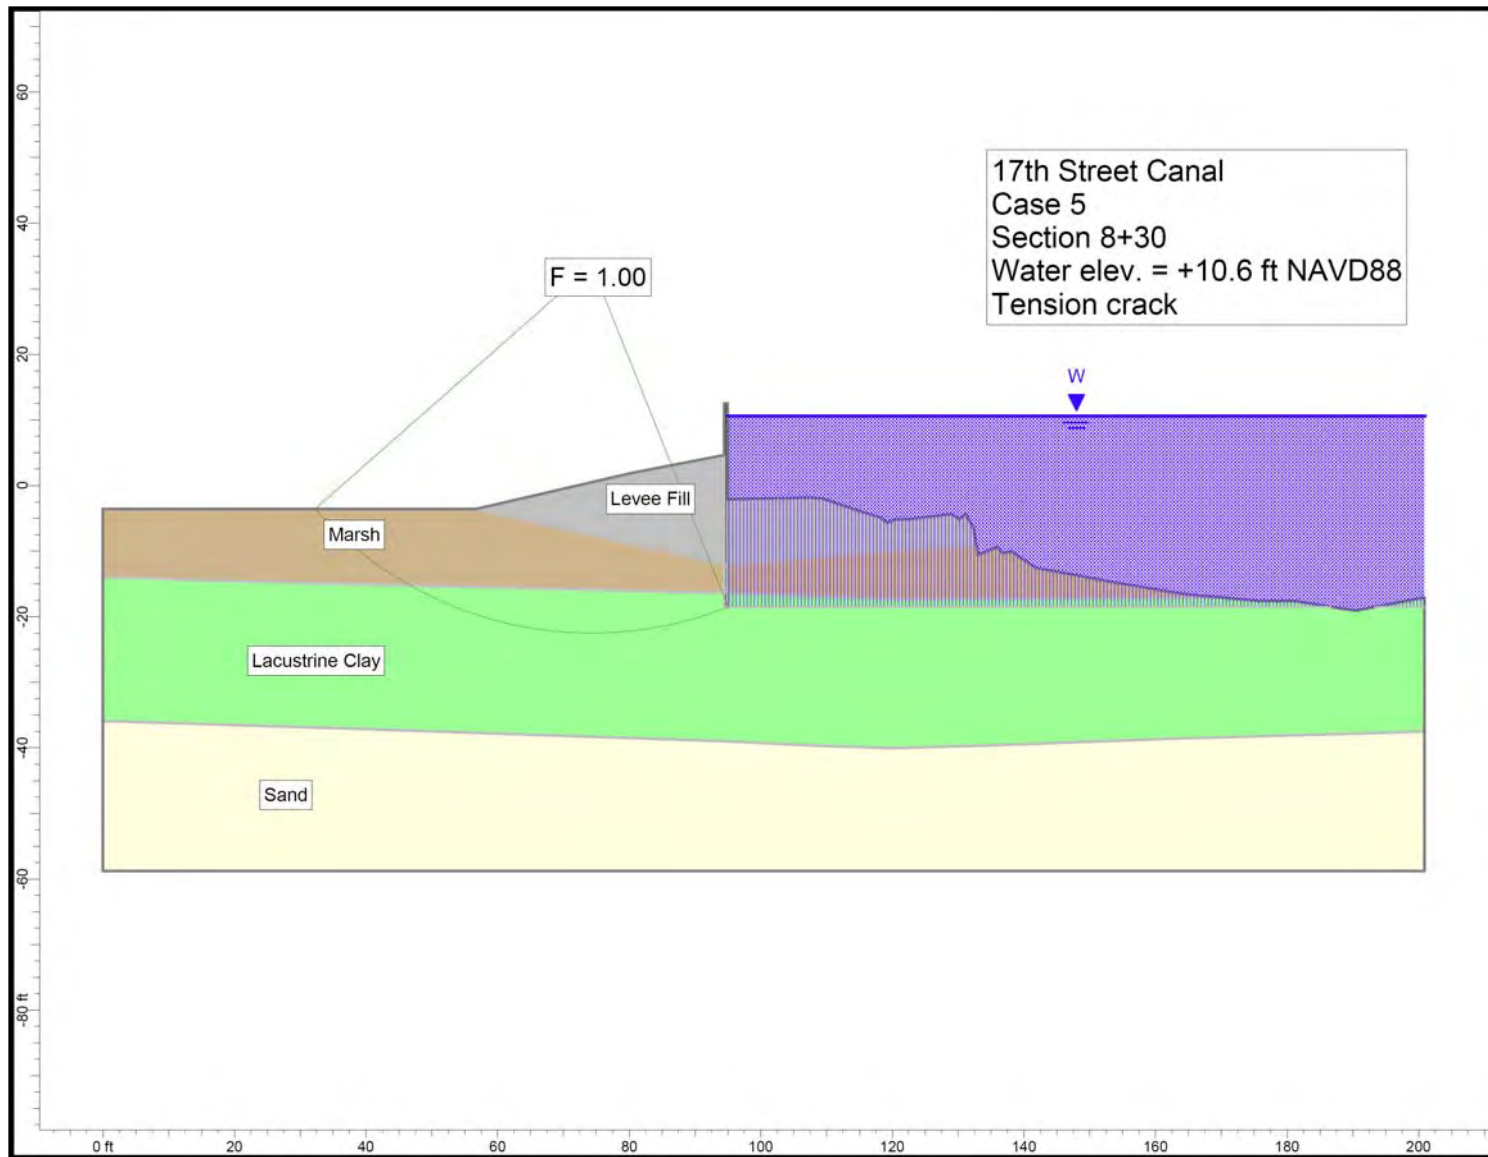
Figure 4-5. Critical Circle for 17th Street Canal Station 8+30 – Water Elevation 10.6 ft, Tension Crack.

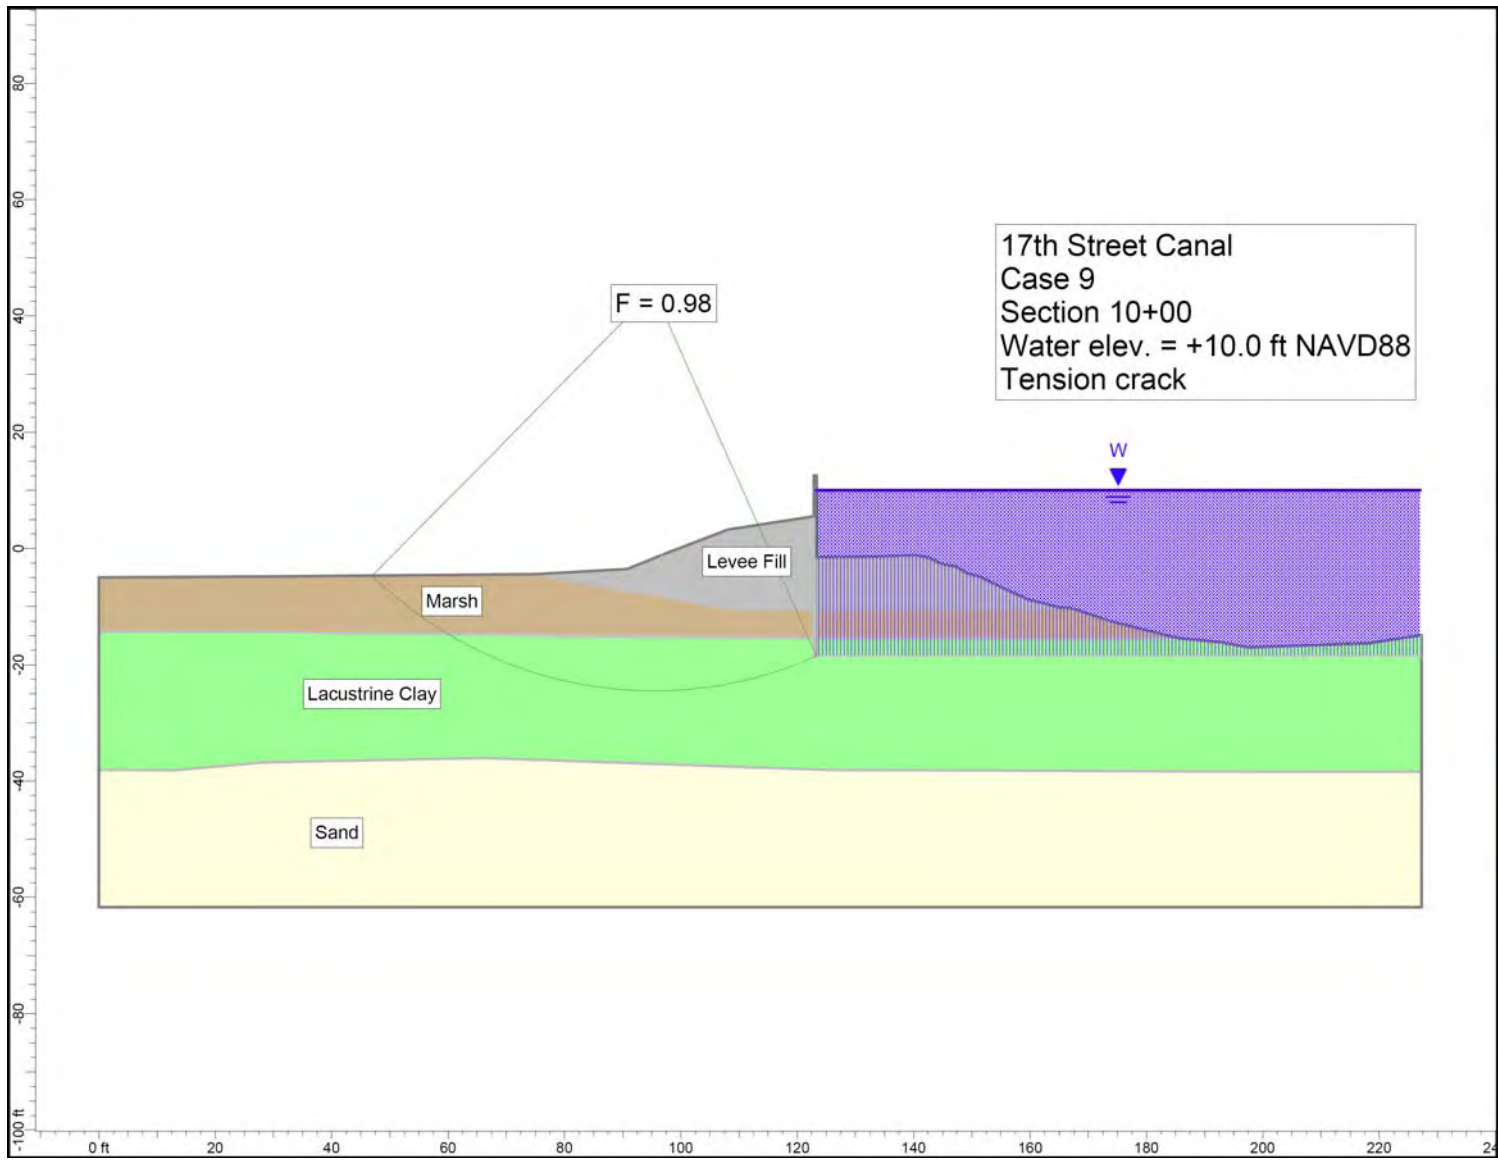
Figure 4-9. Critical Circle for 17th Street Canal Station 10+00 – Water Elevation 10 ft, Tension Crack

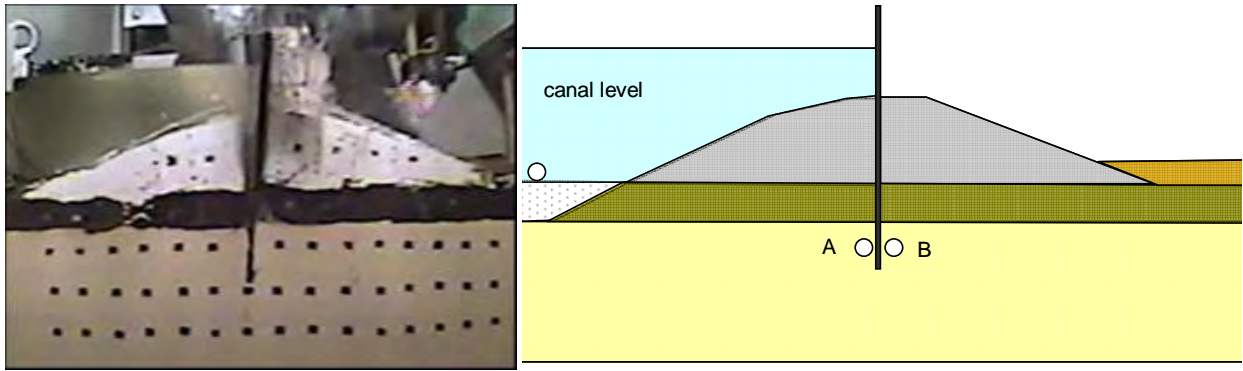
The evidence for the formation of the crack is clearly seen in the video imagery from the model tests, seen here in Figure 5.12, and also in the record of the pore pressure transducers located near the toe of the flood wall, Figure 5.13, which showed a rapid rise in water pressure to the full canal water level as the wall moved landward slightly.

Figure 5.12. Early stage of crack formation in London South model

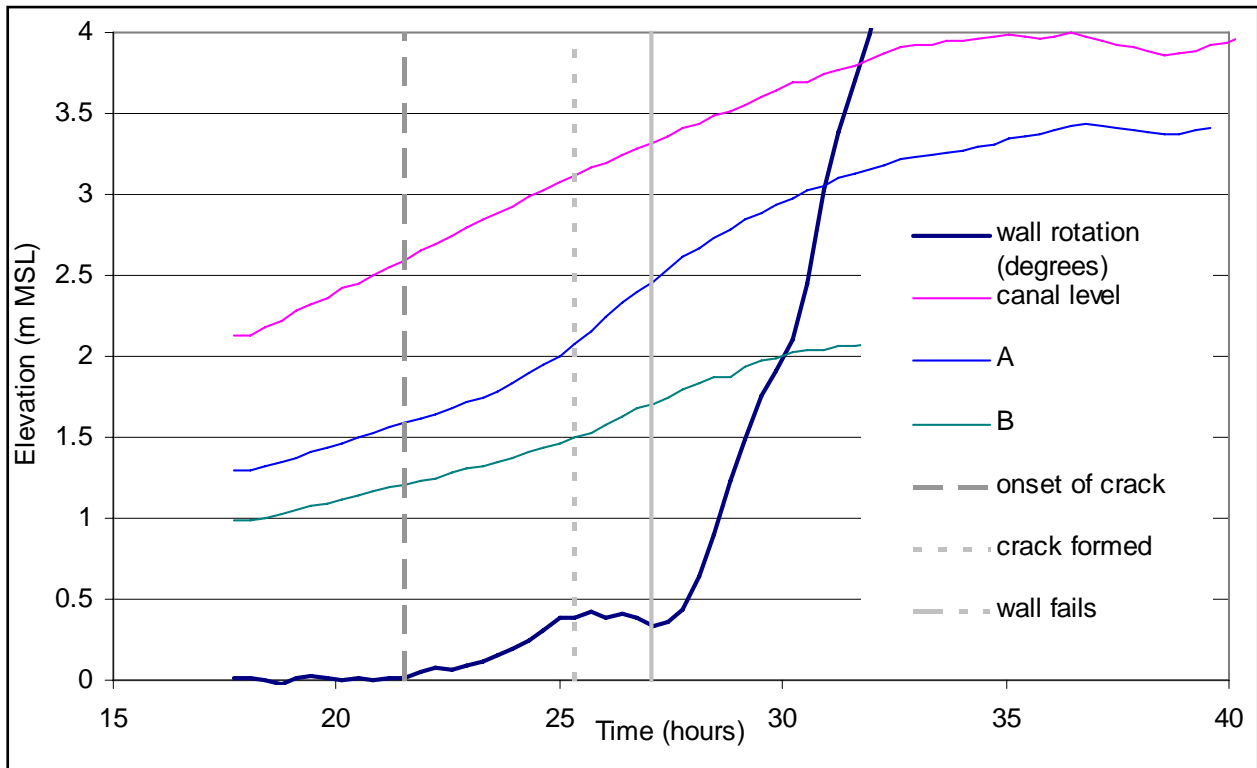
Figure 5.13. Comparison between canal level, water pressure at base of wall and wall rotation, London South Model 1, ERDC

Observations of the extent of crack rotation prior to failure show that the rotation reached around 0.5 degrees prior to a brief period of stabilisation, before the rising piezometric levels under the levee coupled with the rising canal level triggered the failure of the wall, Figure 5.13 above. As noted earlier, a passive rotation of less than 1% (around 0.5 degrees) in loose sand or less in dense sand (as at London South) is sufficient to mobilise the limiting passive resistance of sand.

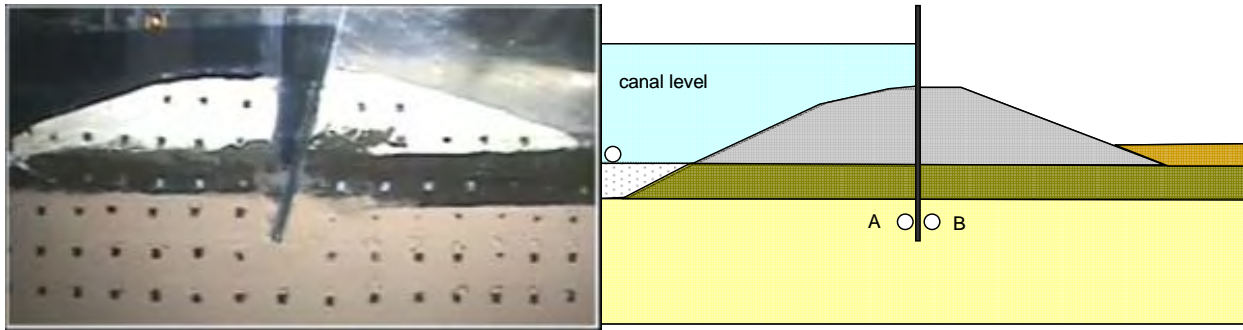
The same sequence of crack formation, wall stabilisation and then wall failure was observed in a repeat model of London South, Model 2, carried out at RPI, Figures 5.14 and 5.15.

Figure 5.14. Early stage of crack formation in London South Model 2

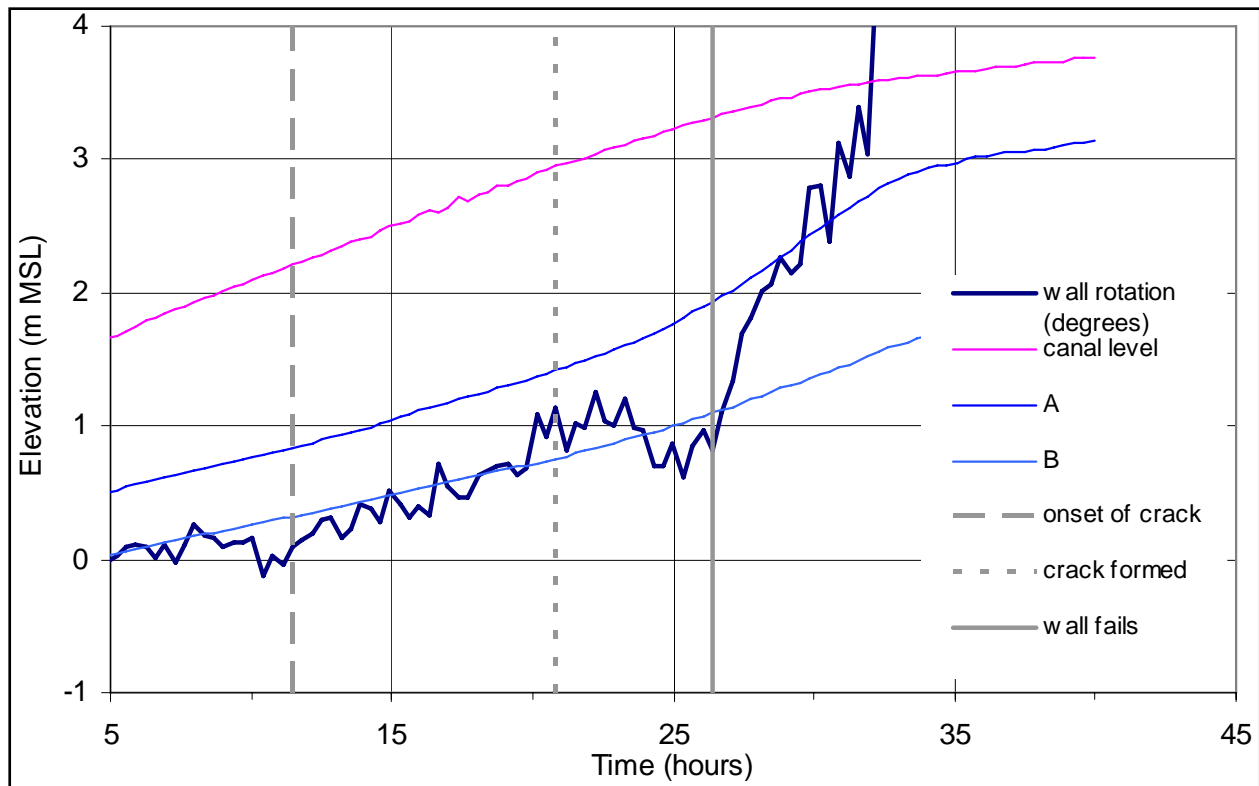
Figure 5.15. Comparison between canal level, water pressure at base of wall and wall rotation, London South Model 2
