Appendix 1

Soil Data Report for 17th Street Canal

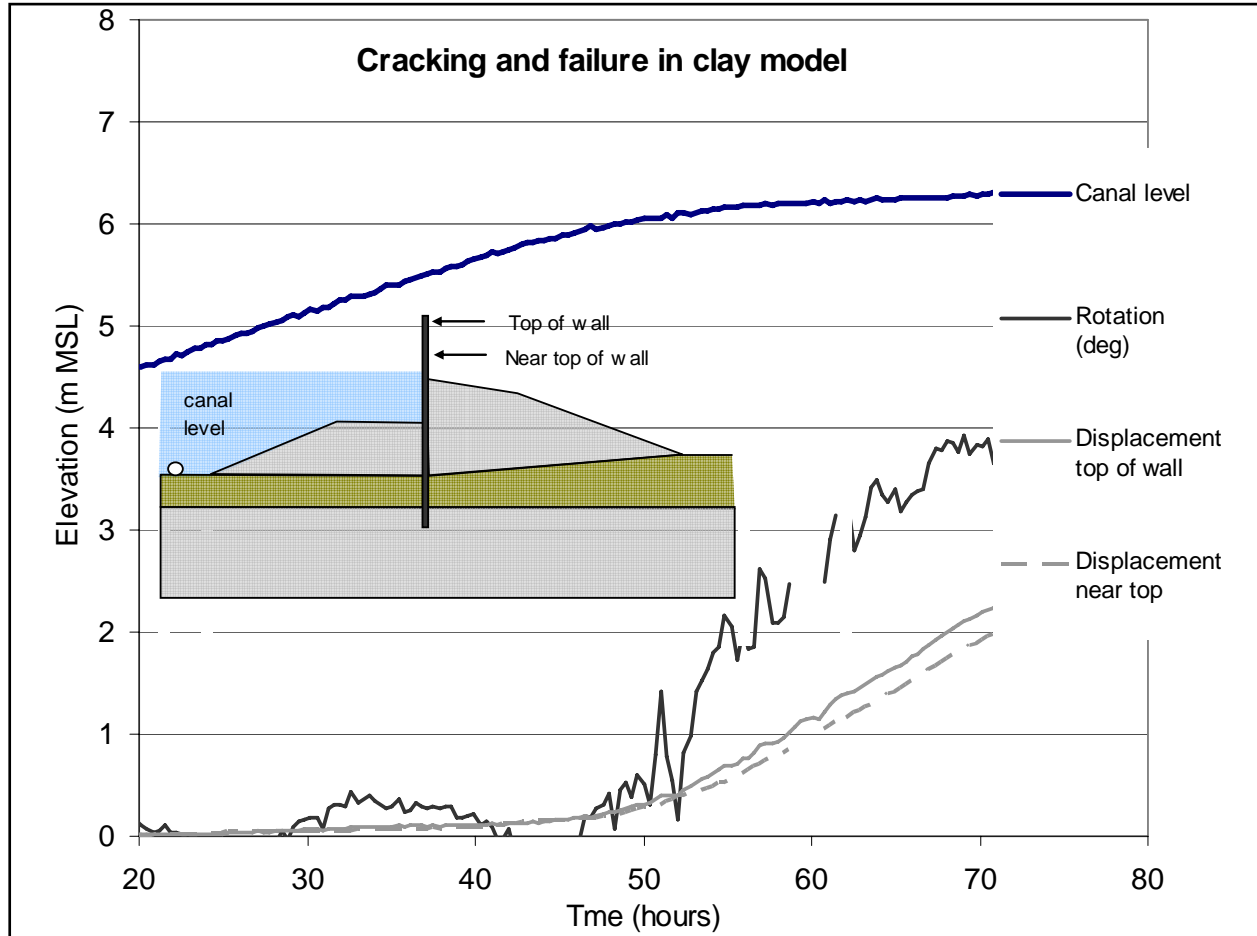
In the case of levees on clay foundations, a similar phenomenon was observed. Figure 5.16 shows the rotation of the wall followed by a brief period of stabilisation before the main failure ensued.

Figure 5.16. Rotation and translation evidence of crack formation prior to failure, 17th street model

The observation of crack formation in the 17th Street levee models has been described above and was shown in Figure 5.16 for one case. A second example is shown here, Figure 5.29, from 17th Street Model 1, which shows an early rotation that briefly stabilises before the main failure commences (Scale time 28 to 36). (Note time scales in the centrifuge models are unrelated to the actual time line of the Katrina flooding. Time in the centrifuge models is therefore referred to in the text here as ‘Scale time’ to distinguish the two time lines.) Video imagery of the phase between the initial opening of the crack and the onset of the main failure shows active slumping behind the wall, which may explain the increase in rotation between around Scale time 37 and 42 hours.

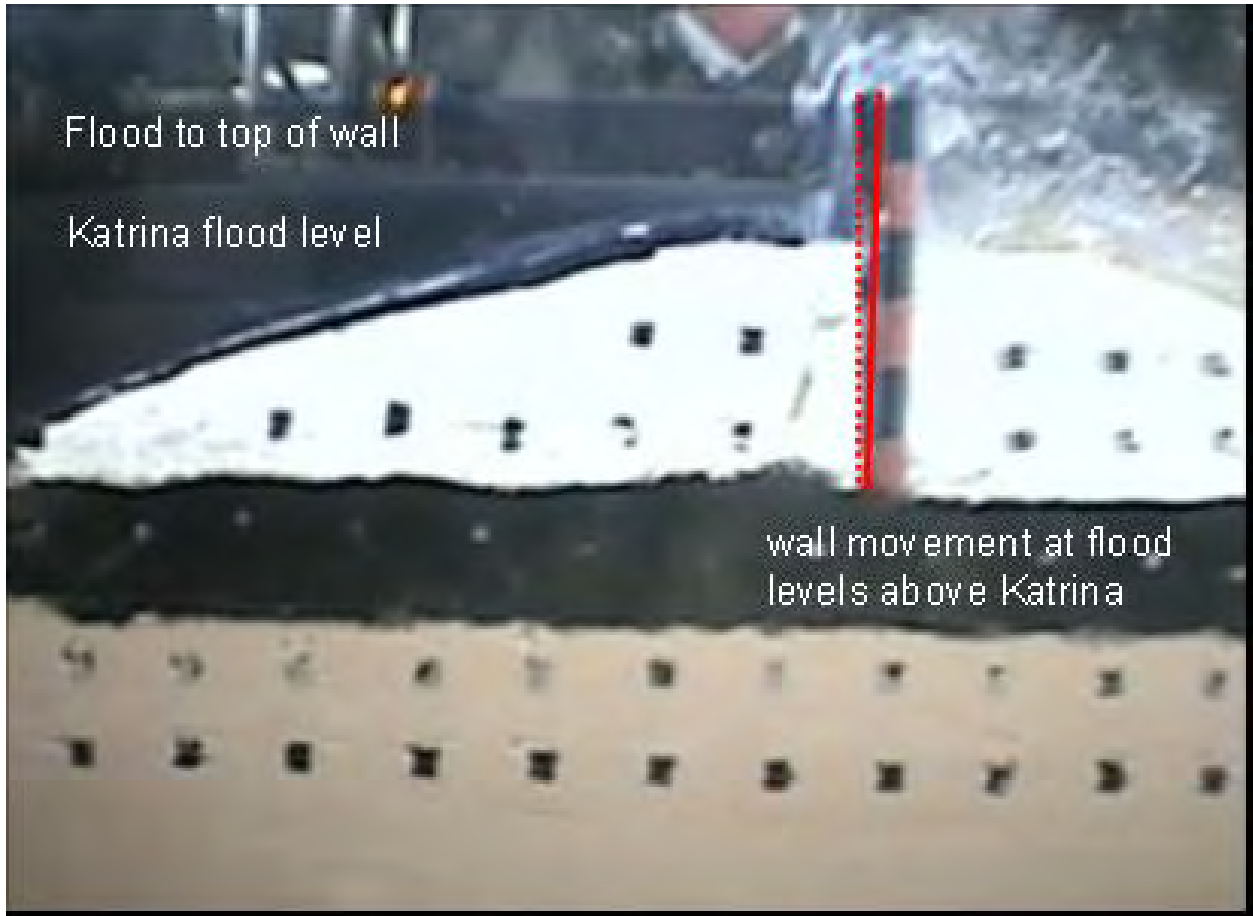
Model tests carried out on a cross section representative of the Orleans canal (Orleans South), which has a less deep flood wall that does not reach the underlying sand layer showed very small movements of the wall at flood levels up to Katrina. Beyond the Katrina flood level (over 1m higher) movement of the wall was observed indicative of crack formation. This is clearly seen in the video image, Figure 5.17. Plotting canal elevation against wall displacement, Figure 5.18, for Orleans South, shows the early time stiff response of the levee system up to the

Katrina flood level. At higher flood levels, the rate of landward movement of the wall increases sharply as the crack forms. The formation of the crack increased both the load and the moment on the wall. In this model test the flood wall remained in place and did not show the same unstable response to high flood levels as the levee sections on 17th Street and London Avenue though its performance did appear to be close to failure (discussed below).

Figure 5.17. Crack forming at Orleans South levee section at flood level above Katrina

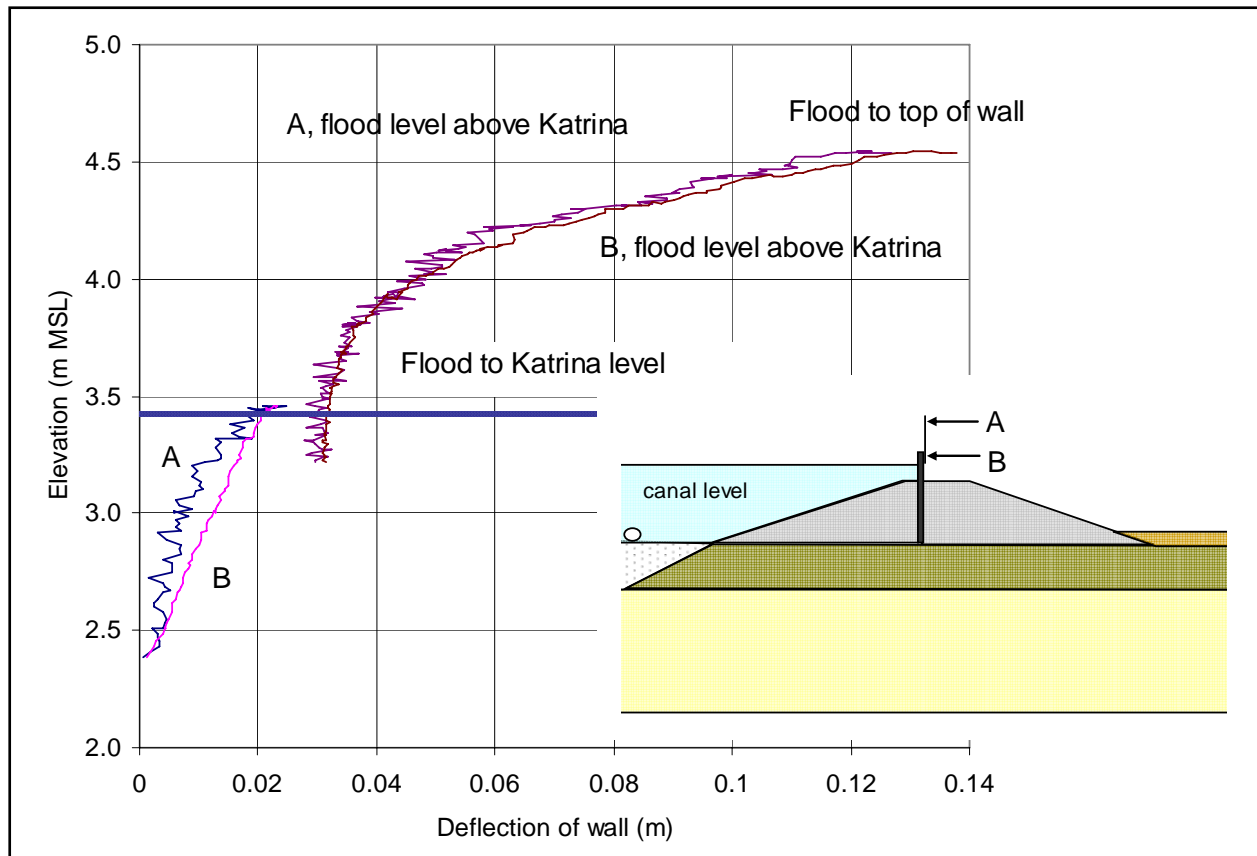
Figure 5.18. Small translation of wall at Orleans South at Katrina flood level, larger movement at higher flood levels indicative of crack formation

observations of small but continuing displacements of the wall under full flood conditions, Figure 5.18 above.

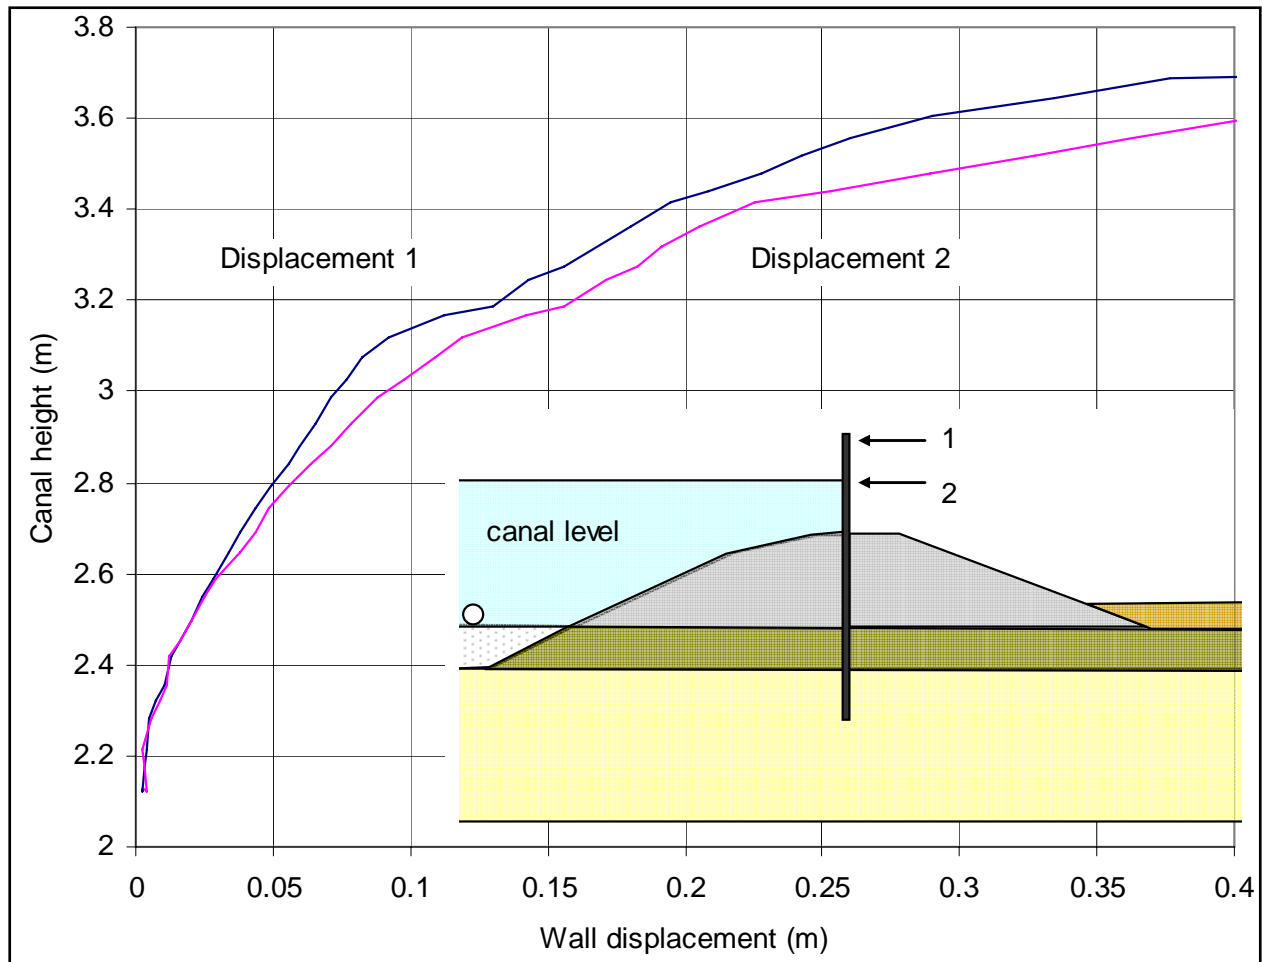
Figure 5.19 shows rotation of the wall in a London South model and Figure 5.20 shows a sequence of video images of the rotational movement in progress. A similar sequence was found for the repeat model of London South, Model 2, Figure 5.21.

Figure 5.19. Rotation of the wall as canal level increases followed by failure, London South, Model 1

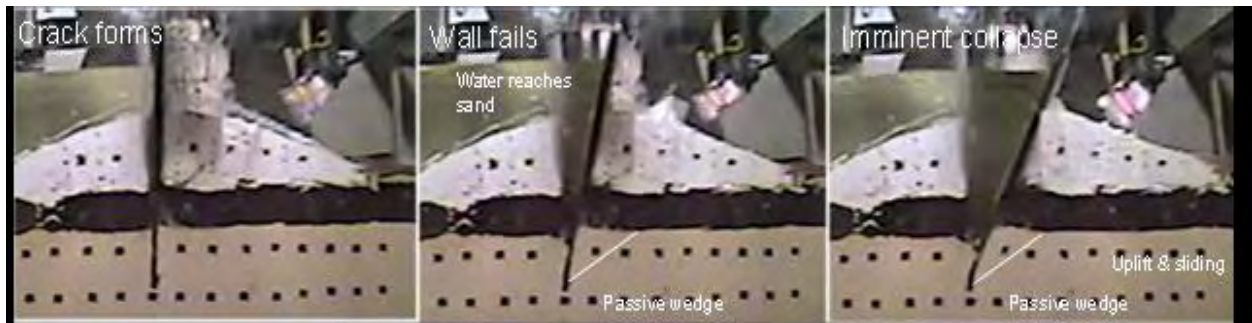
Figure 5.20. Wall failure follows crack formation, London South model, Model 1

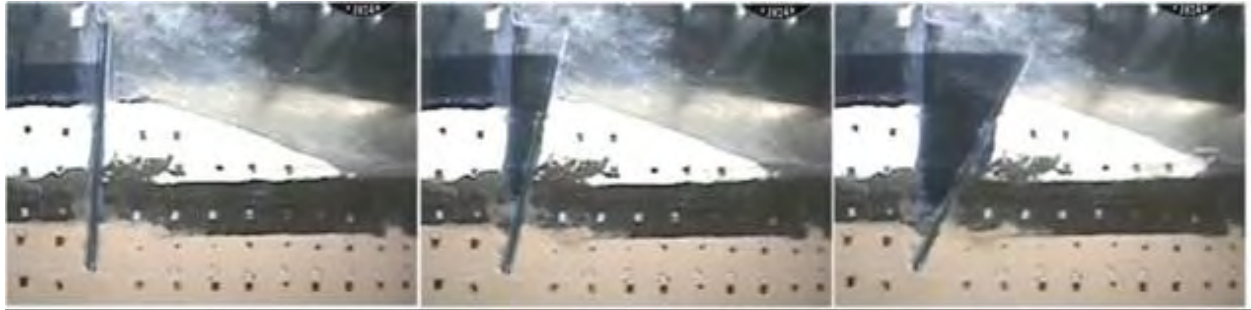
Figure 5.21. Crack formation, wall rotation and sliding failure, London South Model 2

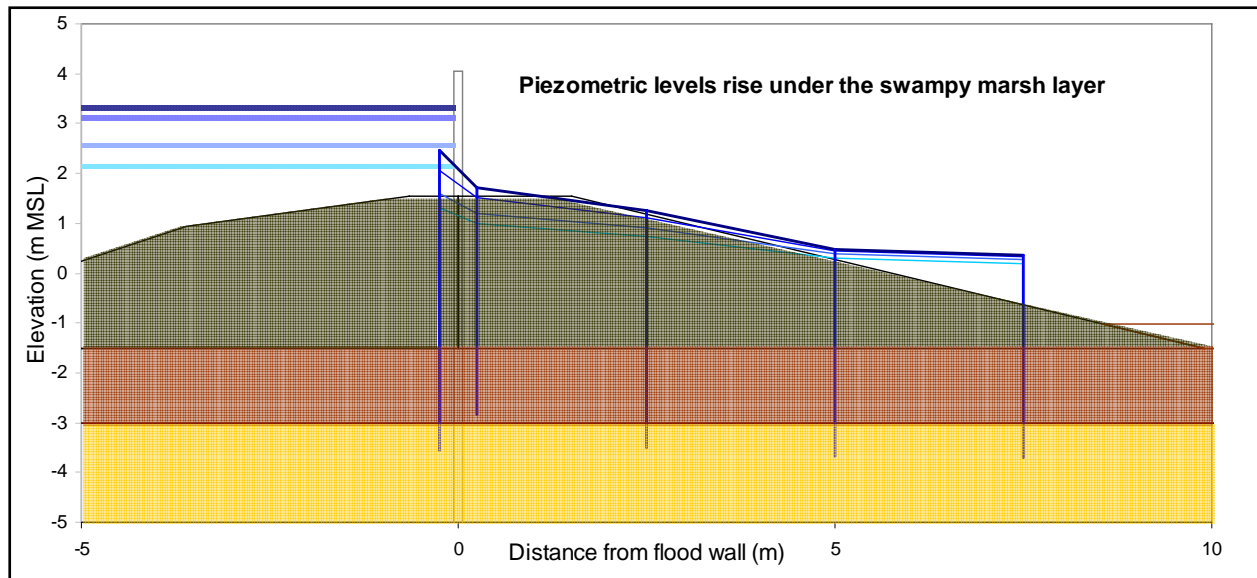
Figure 5.22. Piezometric levels immediately under the swampy marsh show increase under the levee as the wall rotates

The mechanism of failure in the sand models (London South, London North) was analysed as follows. Piezometric levels under the levee on the landward side rise, reducing the vertical effective stress on the swampy marsh – sand interface as the canal level rises, Figure 5.22. Rotation of the wall under the hydrostatic load on the exposed section of floodwall above the crest is resisted by the embedment of the wall in the sand layer, the elastic stiffness of the swampy marsh layer and the clay levee (landward side).

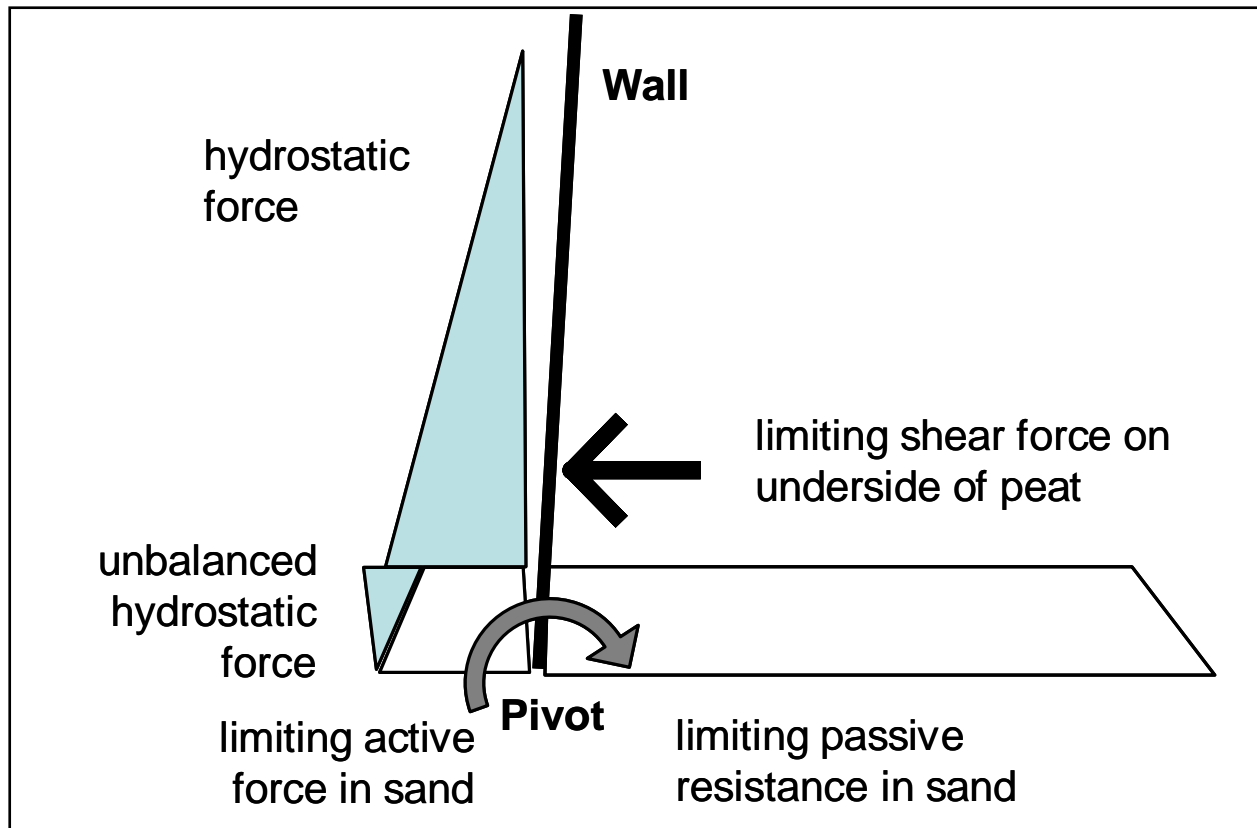
Figure 5.23. Equilibrium stress analysis for the collapse of the wall

Figure 5.23 shows an equilibrium stress analysis for the wall at the onset of failure used for the analysis of the London Avenue models. Hydrostatic pressure from the canal reaches the base of the swampy marsh. Below this level, an active stress condition exists to the base of the wall (for simplicity). Differences in the hydrostatic pressure on either side of the toe of the wall in the sand lead to a small resultant ‘unbalanced’ force landward. On the passive side, full passive pressure is mobilised in the sand, and a limiting shear stress is mobilised along the underside of the swampy marsh beyond the passive zone, where the vertical effective stress is greater than zero. Forces acting on the swampy marsh are discussed further below (Figure 5.25).

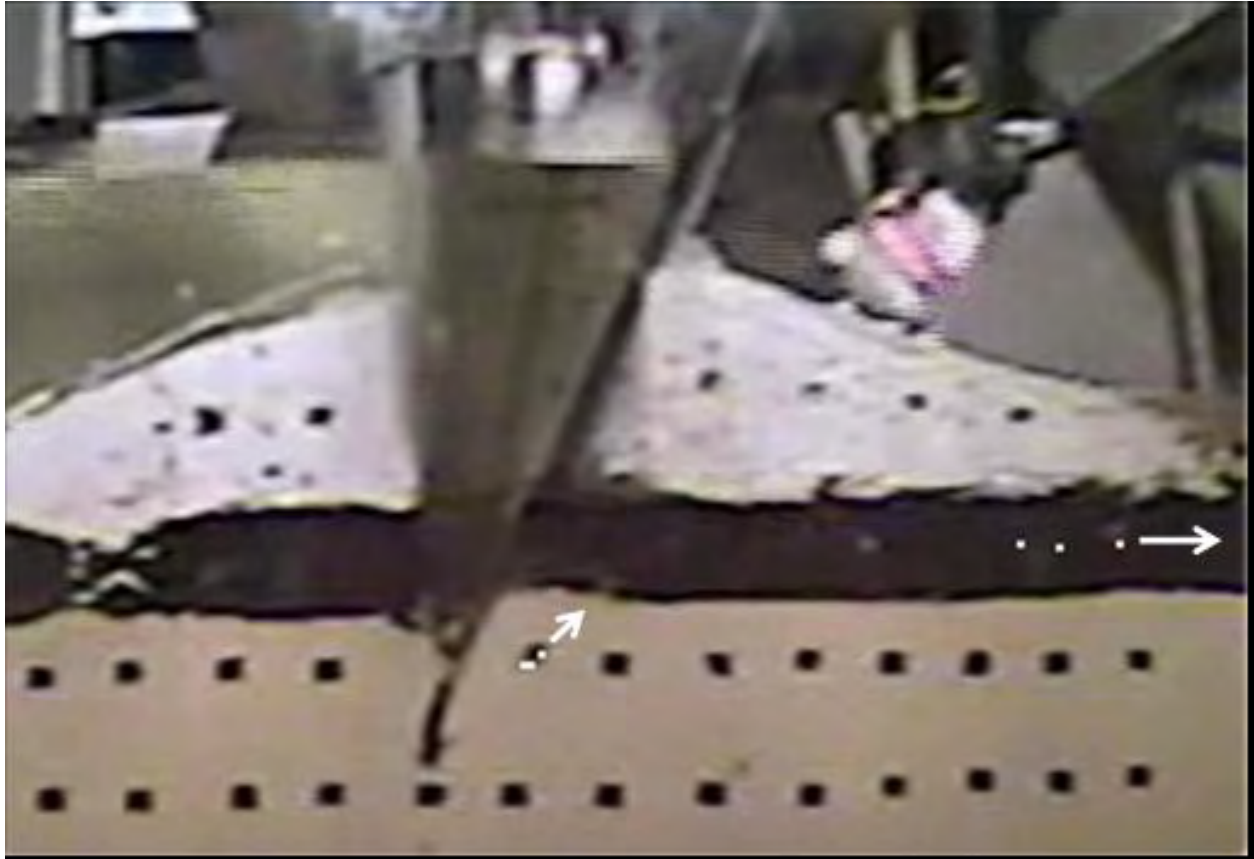
Figure 5.24. Overlay of video images of the rotational failure of the London South model wall, Model 1

Figure 5.24 shows a superposition of three images at different stages of the levee failure, with two marker points highlighted in the passive zone and in the swampy marsh near to the levee toe. It is clear that the swampy marsh is moving laterally while a wedge shaped passive zone develops in the sand showing both a slip surface extending from near the toe of the wall and some heave at the top of the sand layer, below the levee crest.

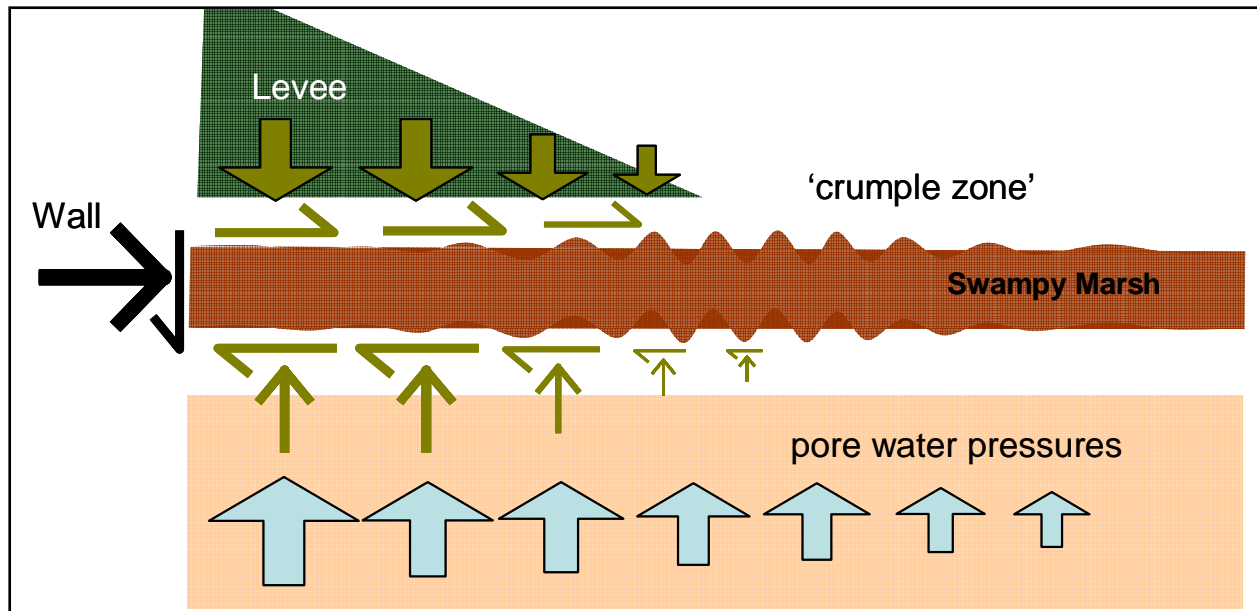
Figure 5.25. Diagram of forces acting on the swampy marsh towards the toe of the levee

Figure 5.25 shows diagrammatically the forces acting on the swampy marsh towards the landward side of the levee and beyond the passive wedge in the sand layer at the toe of the wall (Figure 5.24). The compressibility of the swampy marsh landward of the levee means that no significant passive resistance from this layer can be mobilised in the ‘crumple zone’. Near the toe of the levee, water pressures in the sand layer are sufficiently high that the vertical effective stress between the swampy marsh and the sand layer is near zero (Figure 5.27), and hence the shear stress that may be carried across this interface in this area is also near zero. Forces acting on the levee from the wall must be transferred through the swampy marsh to the sand below, and therefore the maximum horizontal force that may be applied from the wall is controlled by the maximum shear force that can be mobilised on the underside of the swampy marsh layer.

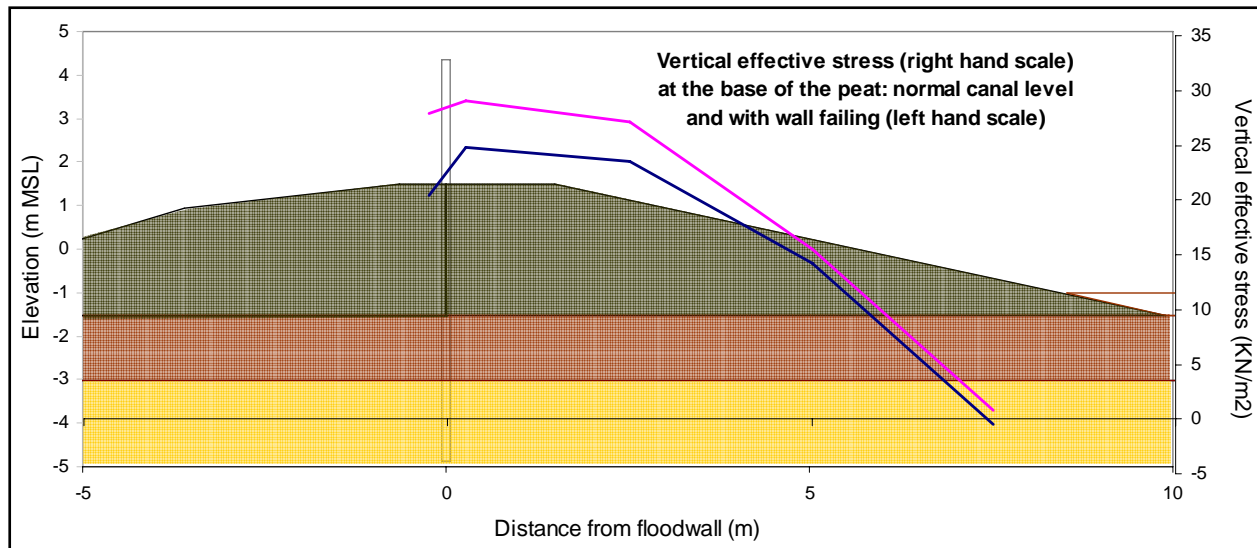
Figure 5.26. Reduction of vertical effective stress on landward side of flood wall at onset of failure

Figure 5.22 showed the piezometric levels under the swampy marsh at different canal levels. Figure 5.26 shows the reduction in vertical effective stress under the swampy marsh as the wall starts to fail. Near the wall, vertical effective stresses are slightly lower on the canal side of the levee, compared to the landward side. Towards the toe of the levee, the vertical effective stress falls to near zero.

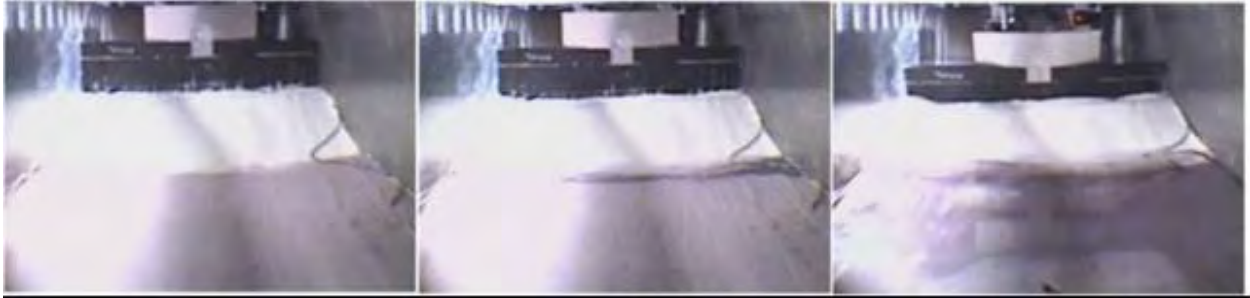
Figure 5.28. Water emerging from toe of levee as failure progresses, London South Model 2

The high pore water pressures under the toe of the levee on the landward side and under the swampy marsh led to water being ejected from the ground at the toe of the levee. This may be deduced from the piezometric heads near the toe of the levee, and may be seen in the video images of the landward toe. Figure 5.28 shows a view of the levee and floodwall as seen from the ‘backyard’ of houses behind the levee showing ‘black’ water emerging from the toe of the levee as the flood wall rotates landward.

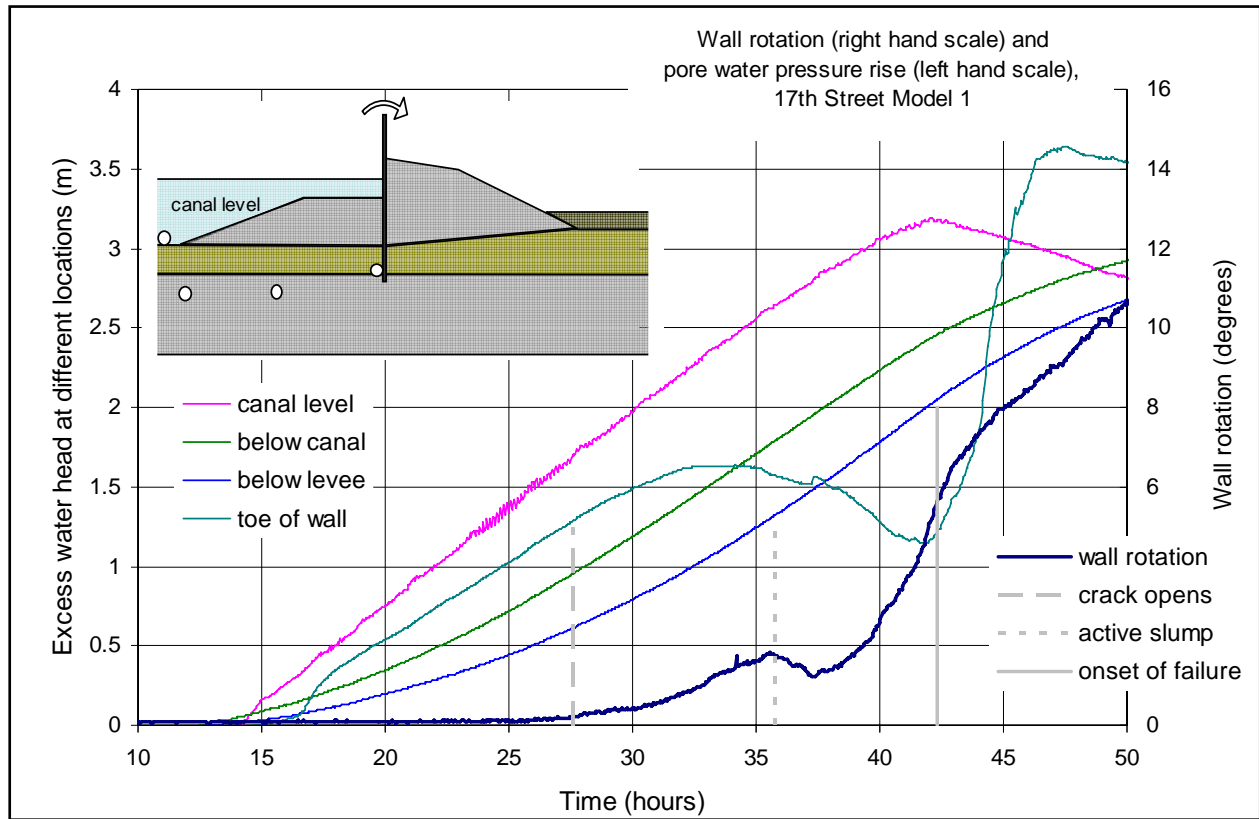
Figure 5.30. Comparison between wall rotation and excess head at onset of failure, 17th Street, Model 1

Comparing the wall rotation with the pore water pressure measurements at locations in the clay on the canal side of the wall, at the toe of the wall and the canal level (expressed as head in m of water) with the wall rotation gives further insight into the mechanism of failure, Figure 5.30. The crack formation phase is marked by a small rotation, up to 2 degrees movement, following which the wall briefly stabilises. As noted above, active slumping starts towards the end of the crack formation phase, perhaps as early as Scale time 30, indicated by the change of slope and reduction in excess head near the toe of the wall on the canal side. During this period, the pore pressures beneath the levee on the canal side reflect the increase in total stress but show no evidence of the wall movement.

The reduction in excess head near the toe of the wall continues as the wall ceases to rotate but continues to translate (between Scale time 36 – 37.5) before rotation starts again, leading to a sharp transition in performance around Scale time 42 as the wall fails. At this moment, the canal

level drops due to the rapid lateral movement, the water pressure at the bottom of the wall changes slope again and rapidly rises (to reach and exceed the canal level), and the rate of rotation slightly decreases as the main translational movement commences.

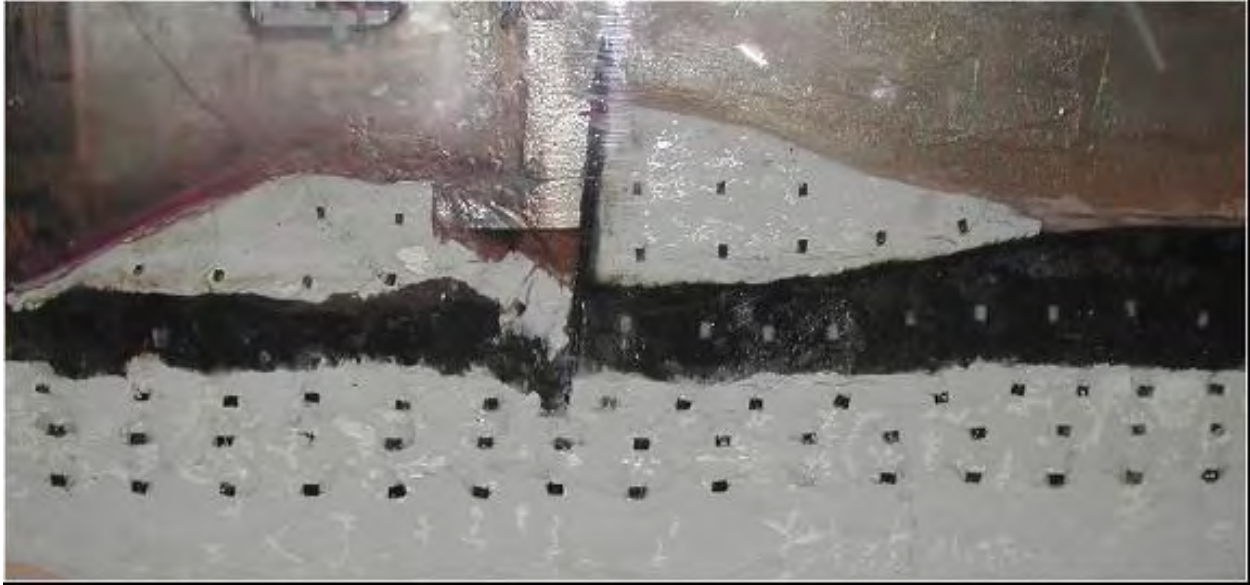
Figure 5.31. Final state of 17th Street Model 1 showing lateral translation on sliding surface starting at the toe of the wall and progressing landwards.

The sliding failure of the model wall was arrested before a full breach took place to capture the final state of the 17th Street model (Model 1), Figure 5.31. Despite the large lateral movement, there is minimal heave of the swampy marsh layer on the landward side.

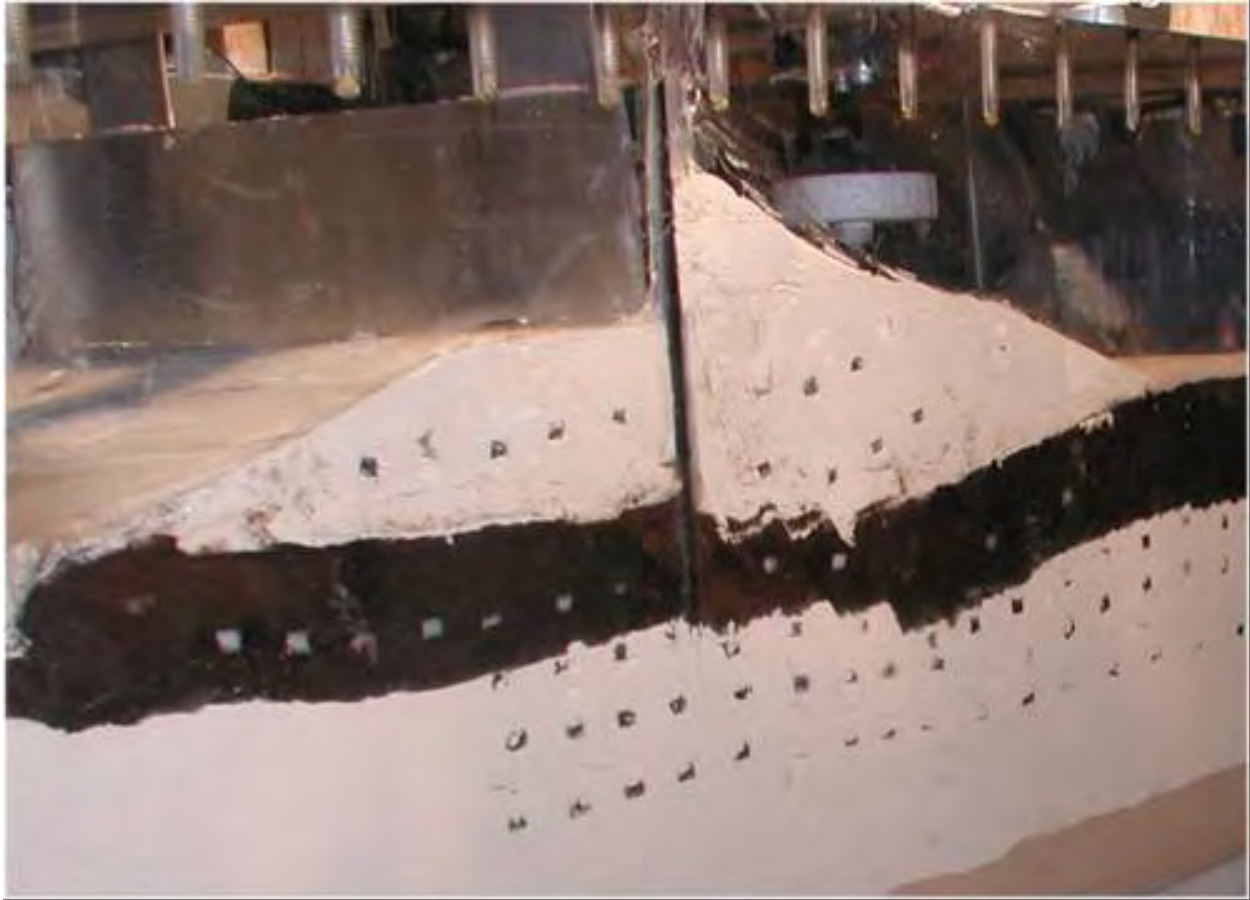
Figure 5.33. Bearing failure and multiple slip planes in the clay foundation caused by rapid construction on landward side, 17th Street Model 2

In one model of the 17th Street levee, the weight of the levee on the landward side was sufficient to provoke bearing failure in the clay foundation, Figure 5.33, with the formation of inclined slip planes, prior to the flood condition. This is a situation analogous in the field to raising the height of the levee too rapidly, without allowing time for the high excess pore pressures in the foundation to dissipate and the strength of the clay to develop. On the surface, the only evidence is increased settlement. At depth, however, local slip surfaces form in the soft clay and swampy marsh

On flooding of this model, the same mechanism of translational failure was observed, independent of the initial disturbance in the clay foundation of the levee. The new sliding surface cut ‘horizontally’ through the pre-existing inclined surfaces along the top of the clay layer as in previous models. The new surface exited through the swampy marsh along the pre-existing surface, forming an up thrust on the ground surface. The bearing failure in the foundation had no significant effect on the height of flood water to cause translational failure.

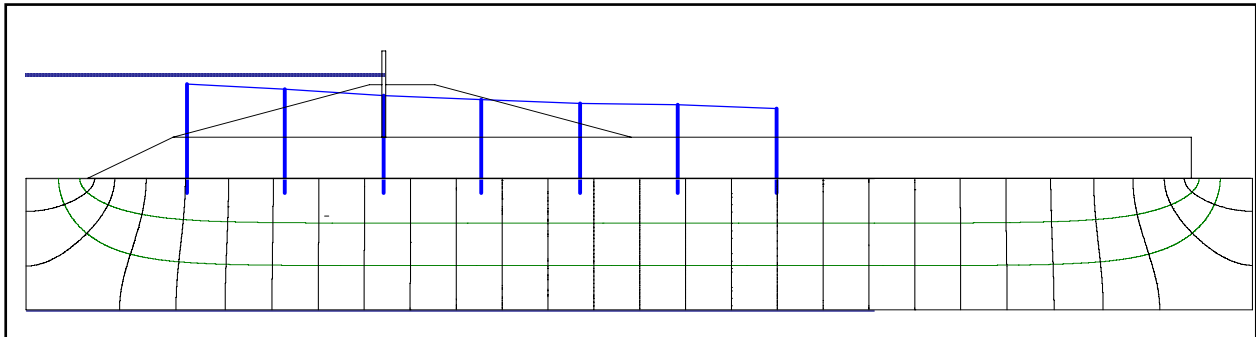
Figure 5.34. Seepage flow net for Orleans Avenue South with piezometric levels under the swampy marsh at Katrina flood level

As with the other levee sections, the instruments beneath the model levee responded to the rising water in the canal by an increased excess water pressures in the ground, reducing linearly

from a maximum near the canal to a minimum to the landward side of the levee, Figure 5.34. At the water level experienced in Orleans Avenue canal, the floodwall did not show any movement to indicate the opening of a crack, Figure 5.35.

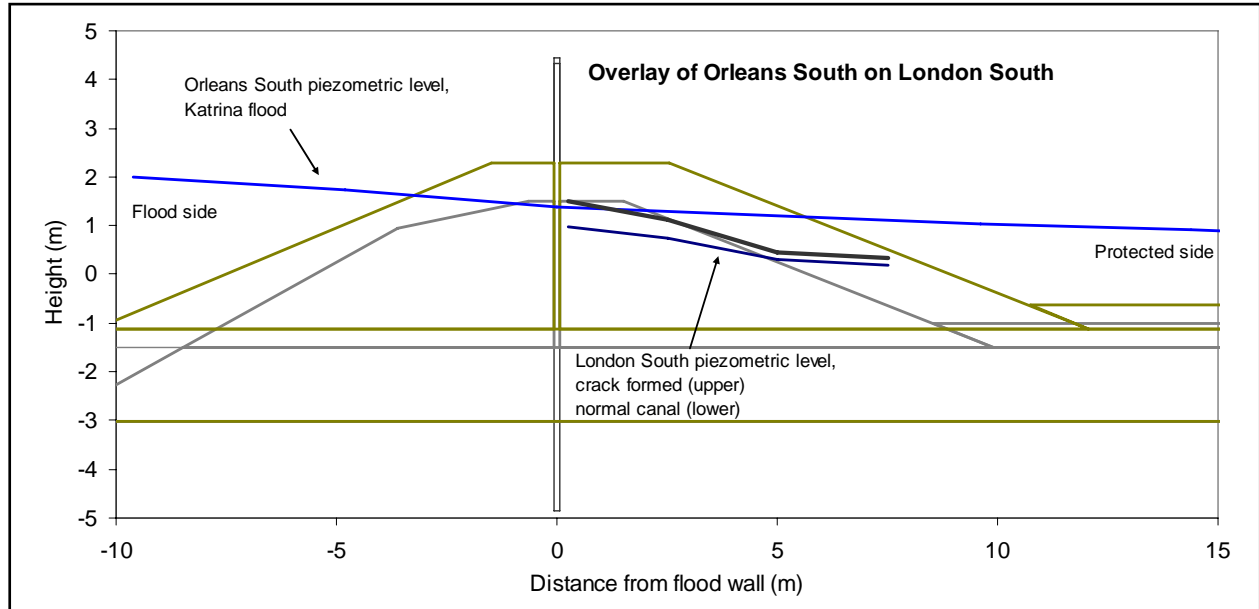
Figure 5.36. Comparison of piezometric levels in Orleans South (Katrina flood) and London South, with the base of the swampy marsh assumed to be at a common elevation

The piezometric levels below the swampy marsh in the Orleans South model showed a declining level from the canal side to the protected side of the levee, Figure 5.36. The additional height and width of the Orleans South levee, seen overplotted in the figure for both Orleans South and London South, significantly increase its capacity to resist the flood levels and no evidence was seen of a crack opening through the swampy marsh and providing a hydraulic

connection to the sand below. The London South piezometric levels, shown in the figure for comparison together with its cross section (aligned at the elevation of the top of the sand layer) show a more critical condition in terms of uplift under the landward side of the levee. Both models however show high piezometric levels near the toe of the levee on the landward side, sufficient to lead to hydraulic fracture.

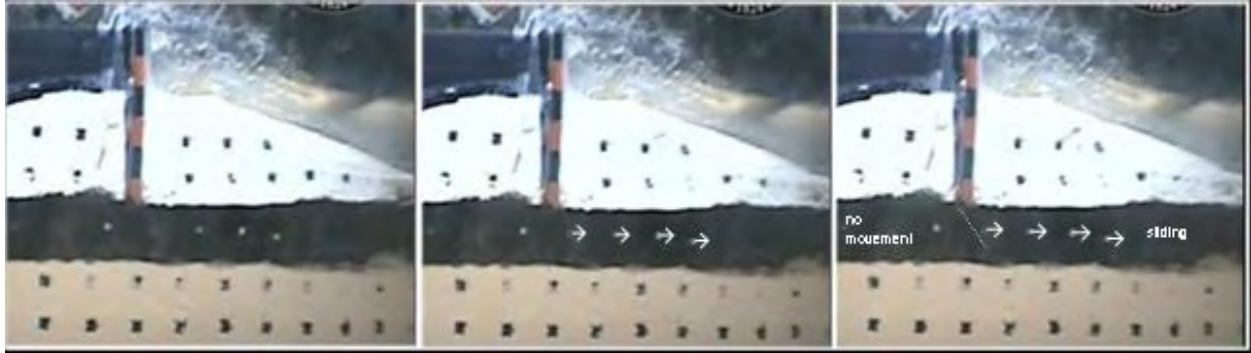
Figure 5.37. Sliding movement of swampy marsh as crack forms, Orleans South model

As the water level was increased above the Katrina flood level in the Orleans South model, a crack was seen to open to the toe of the flood wall, associated with small movements of the flood wall landward, as shown in Figure 5.37. Unlike the other models, this crack did not develop into a full failure condition; no unstable movement of the flood wall was observed, despite the water level reaching the top of the flood wall. Translational movements were observed to be controlled by compression of the swampy marsh layer. Relative movement between the top of the sand and the swampy marsh was apparent, in a similar manner to the uplift mechanism in the London Avenue models.

Examining the stability of the Orleans South model, Figure 5.37 shows that the formation of the crack during the raising of the water level to the top of the wall was accompanied by lateral sliding or translation of the swampy marsh layer. The landward movement was small but noticeable and appeared uniform under the landward side of the levee, extending close to the canal side of the wall. A shearing zone appears to dip steeply downwards from the canal side toe of the wall landwards.

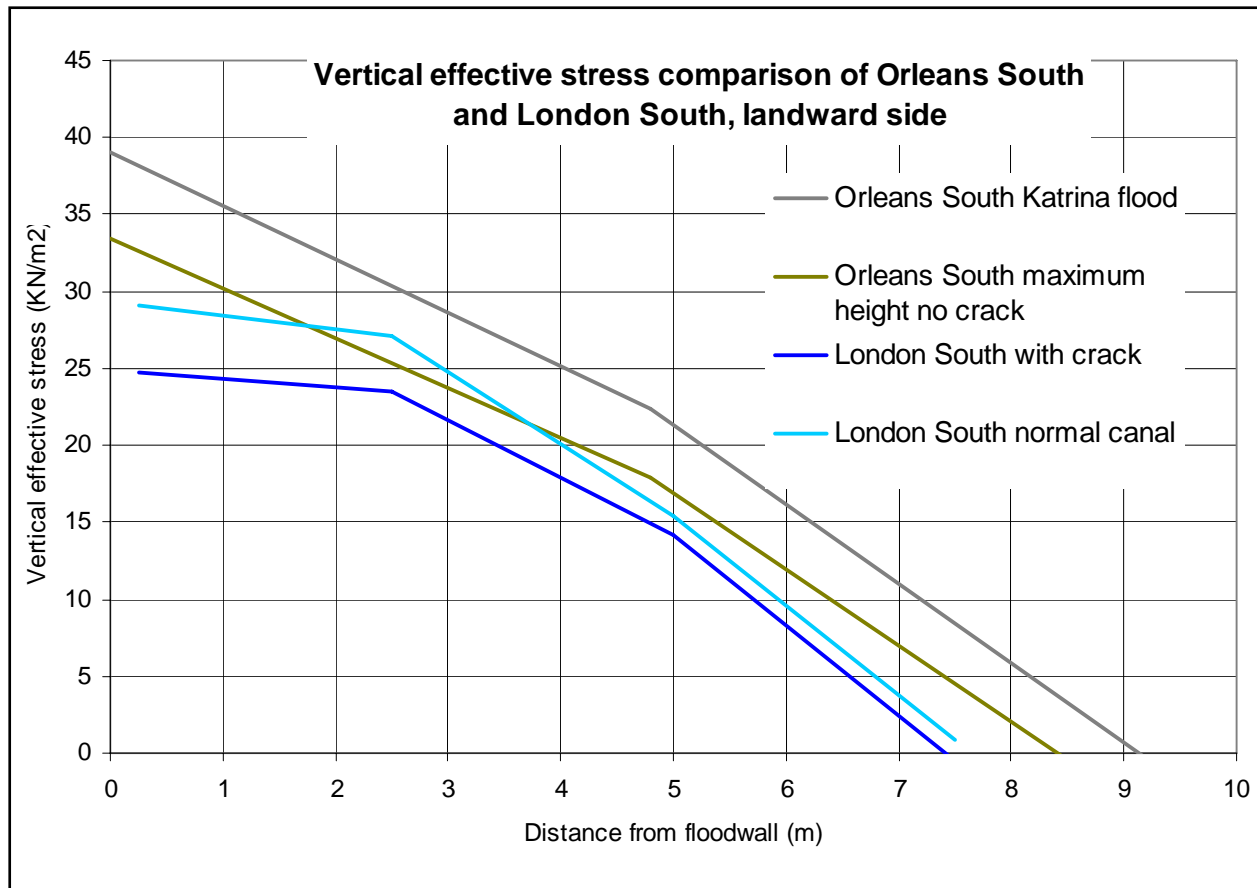
Figure 5.38. Vertical effective stress comparison between Orleans South and London South

Comparison between the geometry of Orleans and London Avenue shows that the vertical effective stress in the sand foundation below the levee was considerably higher under the Orleans levee than under the London Avenue levees. The capacity of the flood wall to rotate is reduced by the height and weight of the landward section of the Orleans levee. Figure 5.38 shows the vertical effective stress on the underside of the swampy marsh layer measured in the Orleans South and, for comparison, the London South models. Although the Orleans levee section is higher than London South, the piezometric levels near the landward toe are sufficiently high that a zero vertical effective stress condition is created near the landward toe of the Orleans South levee in both the Katrina flood and full flood condition.

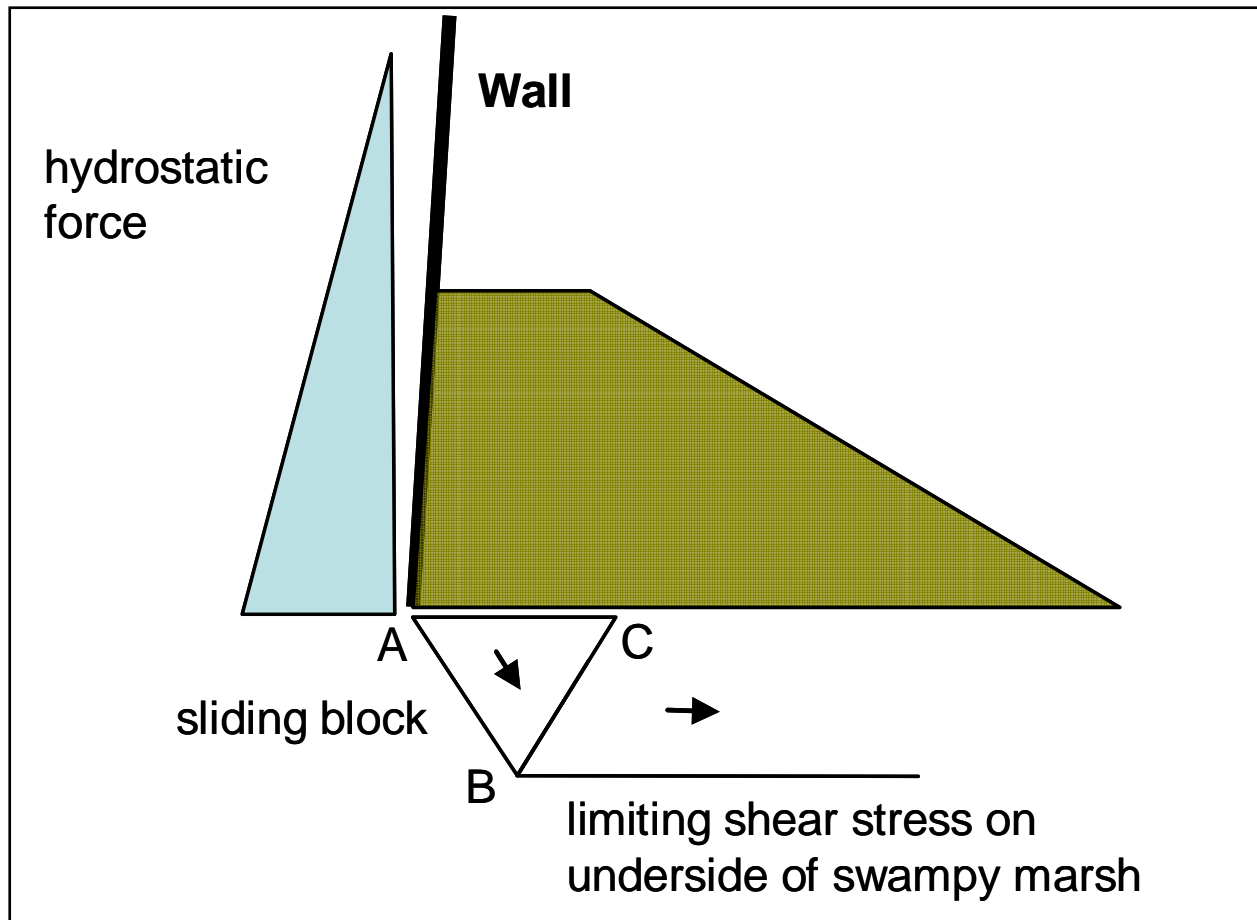
Figure 5.39. Possible upper bound mechanism for Orleans South

The stability of the landward section of the Orleans South levee may be analysed using the simple mechanism shown in Figure 5.39. Video imagery show sliding of the swampy marsh on the top of the sand layer. The sliding surfaces through the swampy marsh forming a triangular sliding block ABC are chosen to lie at angles of 60 degrees for simplicity. Assuming the levee block is free to move laterally with the swampy marsh, then work is only done on the lower surface of the swampy marsh, and on the internal sliding surfaces AB, BC and CA.

Solving this equation for H , the critical depth of water in the crack, and using the actual measured excess pore water pressures in the Orleans South model (Figure 5.36) suggests that the Orleans South model was close to failure at full flood level. Using the value of undrained shear strength adopted for the slope stability calculations for the swampy marsh ($S_u = 400$ psf) and a limiting angle of shearing resistance of 33 degrees in the sand, a Factor of Safety may be calculated of 1.50 under Katrina flood conditions (Figure 5.35) and 1.07 under full flood conditions (flood to the top of the wall, as seen in Figure 5.37). This is consistent with the

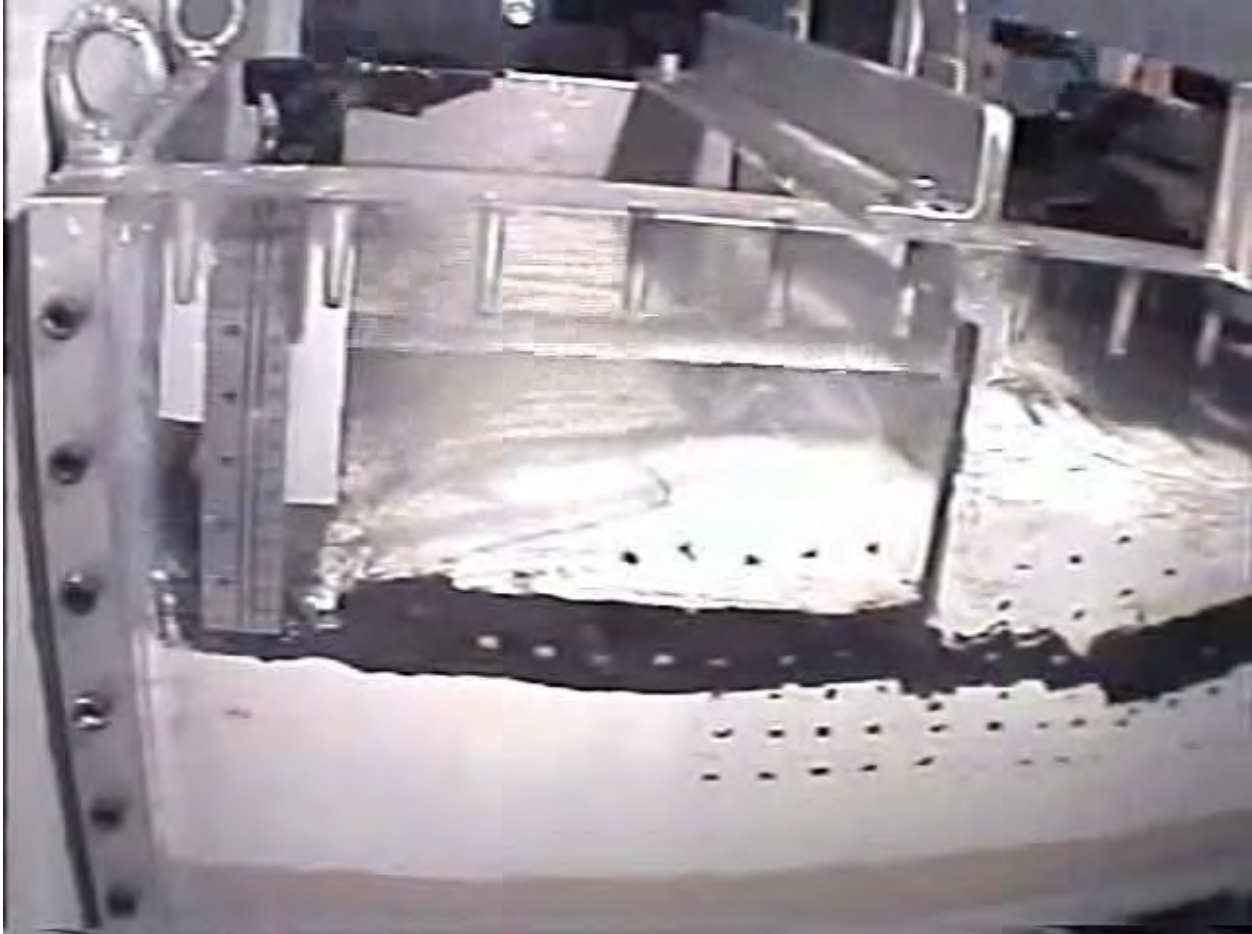
Figure 5.46a. ERDC 17th street model at flood load just prior to development of crack
