Appendix 1

Soil Data Report for 17th Street Canal

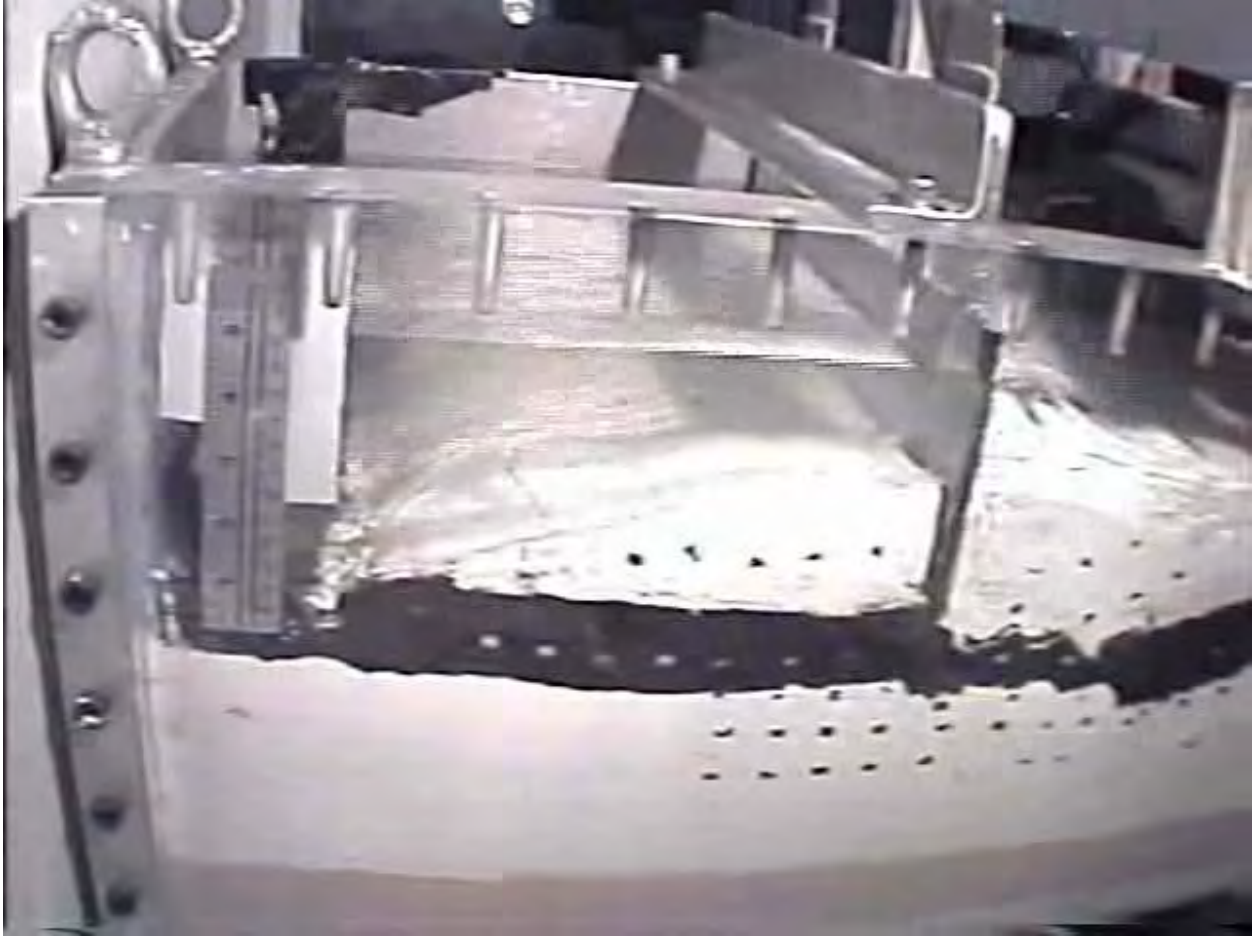
1. Water level increases to a point on the wall where initial movement of the wall begins to occur. This movement starts out as a rotation of the wall.
2. A crack begins to form between the sheet wall and canal side levee.

Figure 5.46b. ERDC 17th street model just after wall movement and crack formation

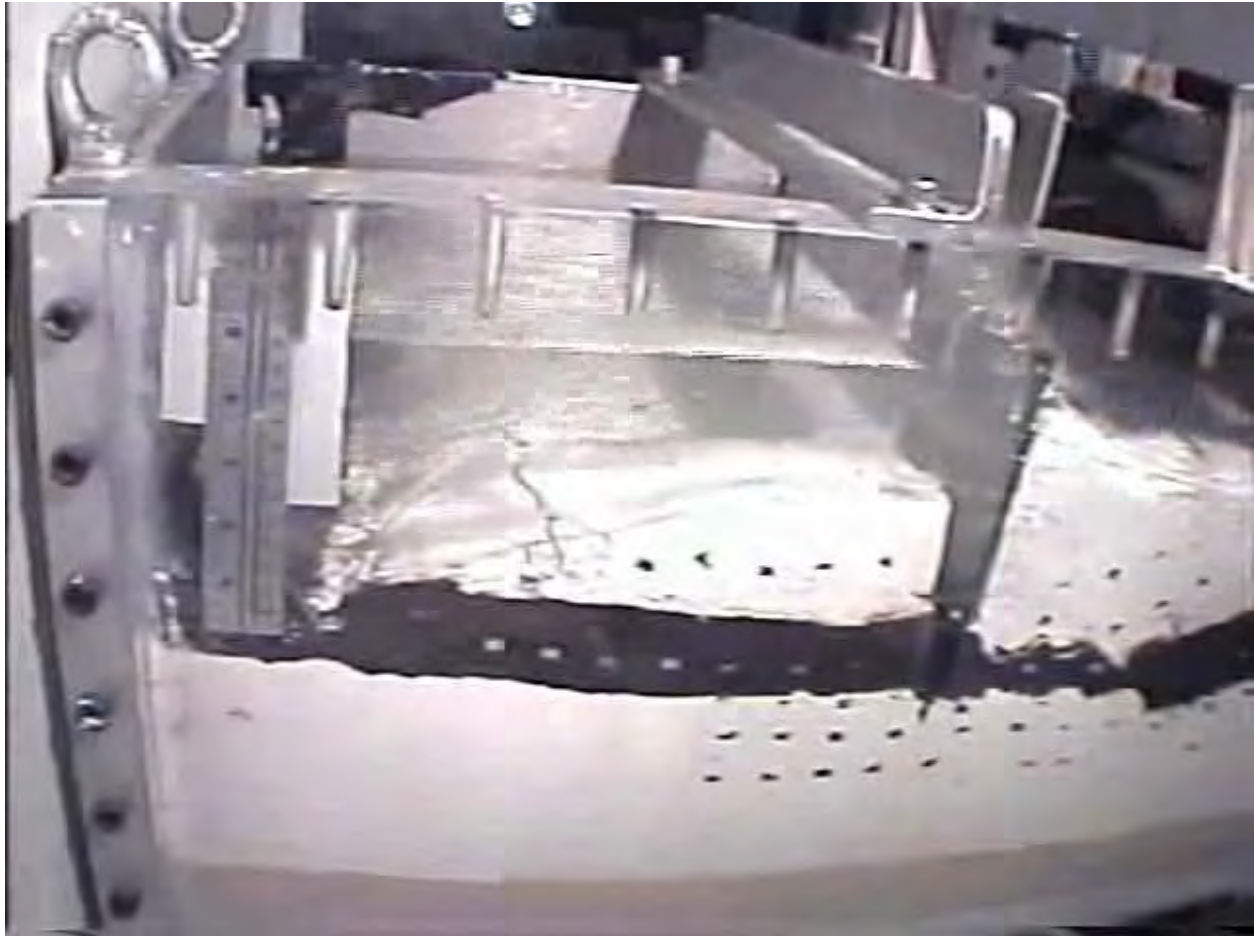
3. As the crack reaches the bottom of the sheet pile, hydrostatic pressure increases in the foundation soil. The low shear strength in the clay layer just beneath the swampy/marsh is not enough to resist the driving force of the flood load.
4. A near horizontal shear failure surface forms in the clay layer and the entire wall/land side levee begins to translate toward the land side.
5. As the flood load is maintained the translational failure continues.

Figure 5.46c. ERDC 17th street model near end of failure

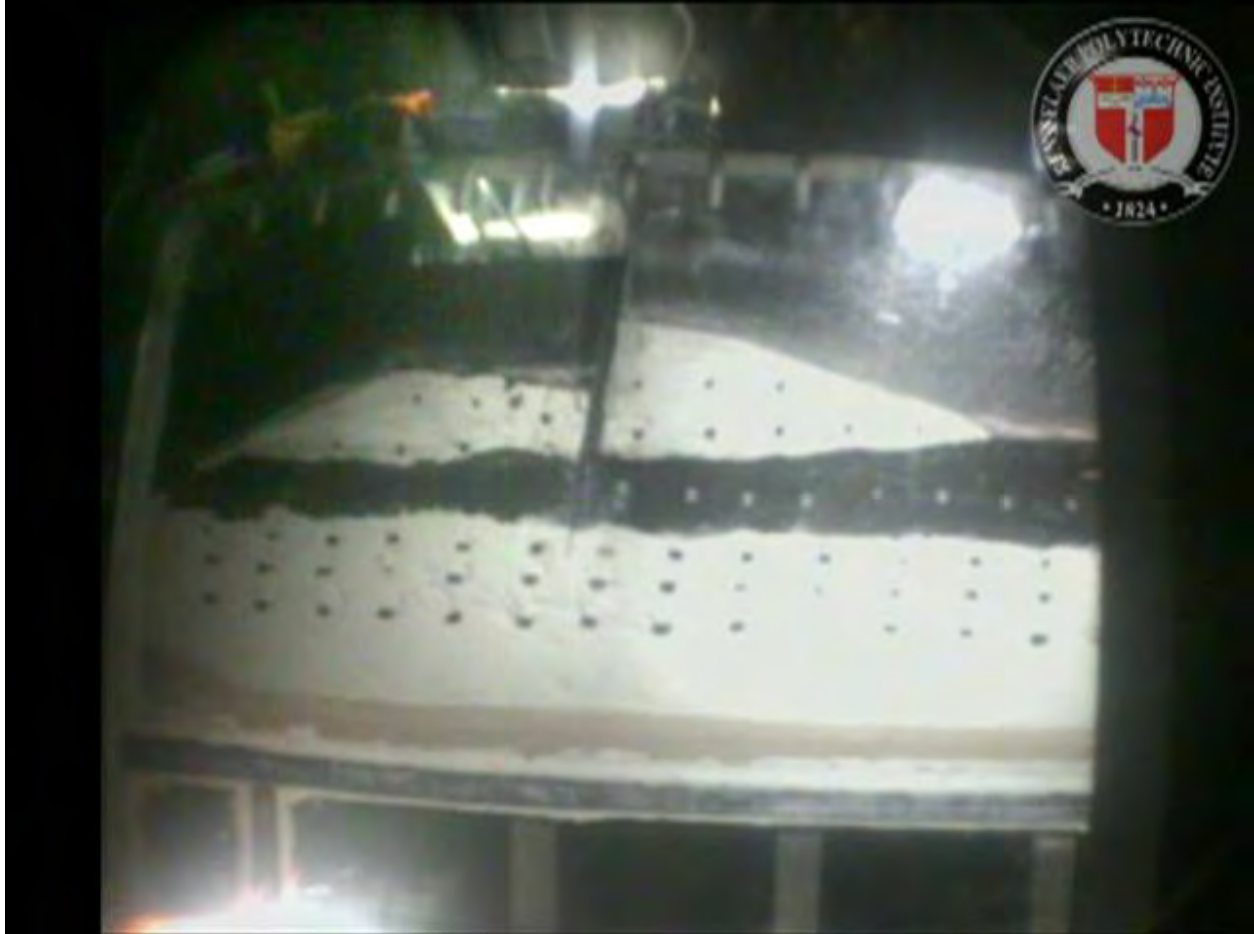
In Figure 5.57, the wall has moved toward the land side, a crack has formed between the sheet pile wall and canal levee. The crack has penetrated through the levee, through the swampy/marsh and into the top surface of the clay layer.

Figure 5.57. RPI 17th street model just after movement of wall and crack formation

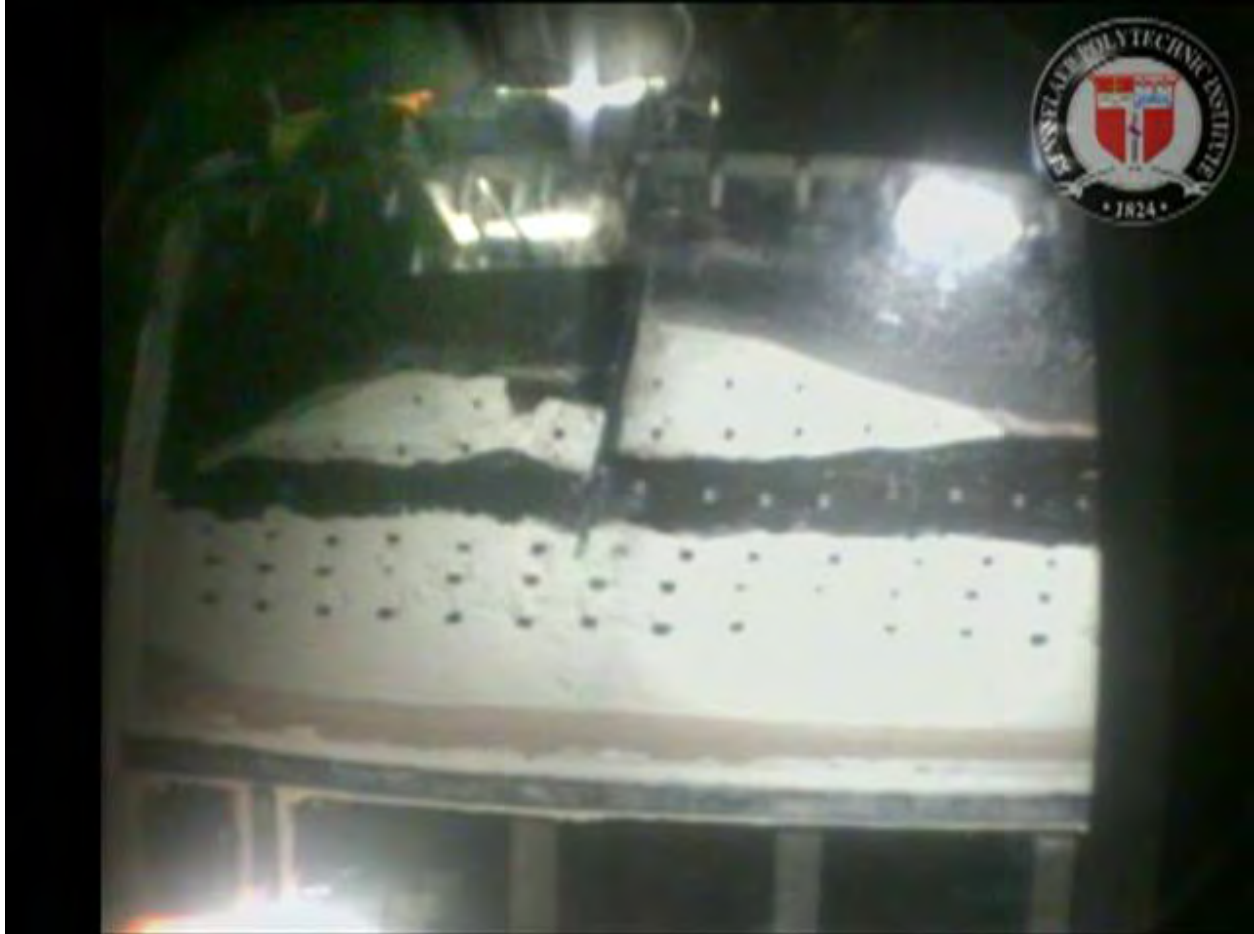
Figure 5.58. RPI 17th street model in process of translational failure

Figure 5.58 shows the model at a time where the failure is well in progress. Attention should be given to the row of markers just below the swampy/marsh layer in the clay on the land side of the sheet pile. Notice that the entire row of markers has moved to the right while the row of markers below remains unmoved. Also notice that the wall has remained at a similar angle as in Figure 5.57. All of this information indicates that there is a horizontal failure plane in the clay and that the wall-land side levee-land side swampy/marsh is translating to the right. Figure 5.59 is a view near the end of failure. Notice the row of markers displaced well to the right and the non-rotated nature of the sheet pile wall. Again indications of translational failure along a horizontal failure plane in the foundation clay layer.

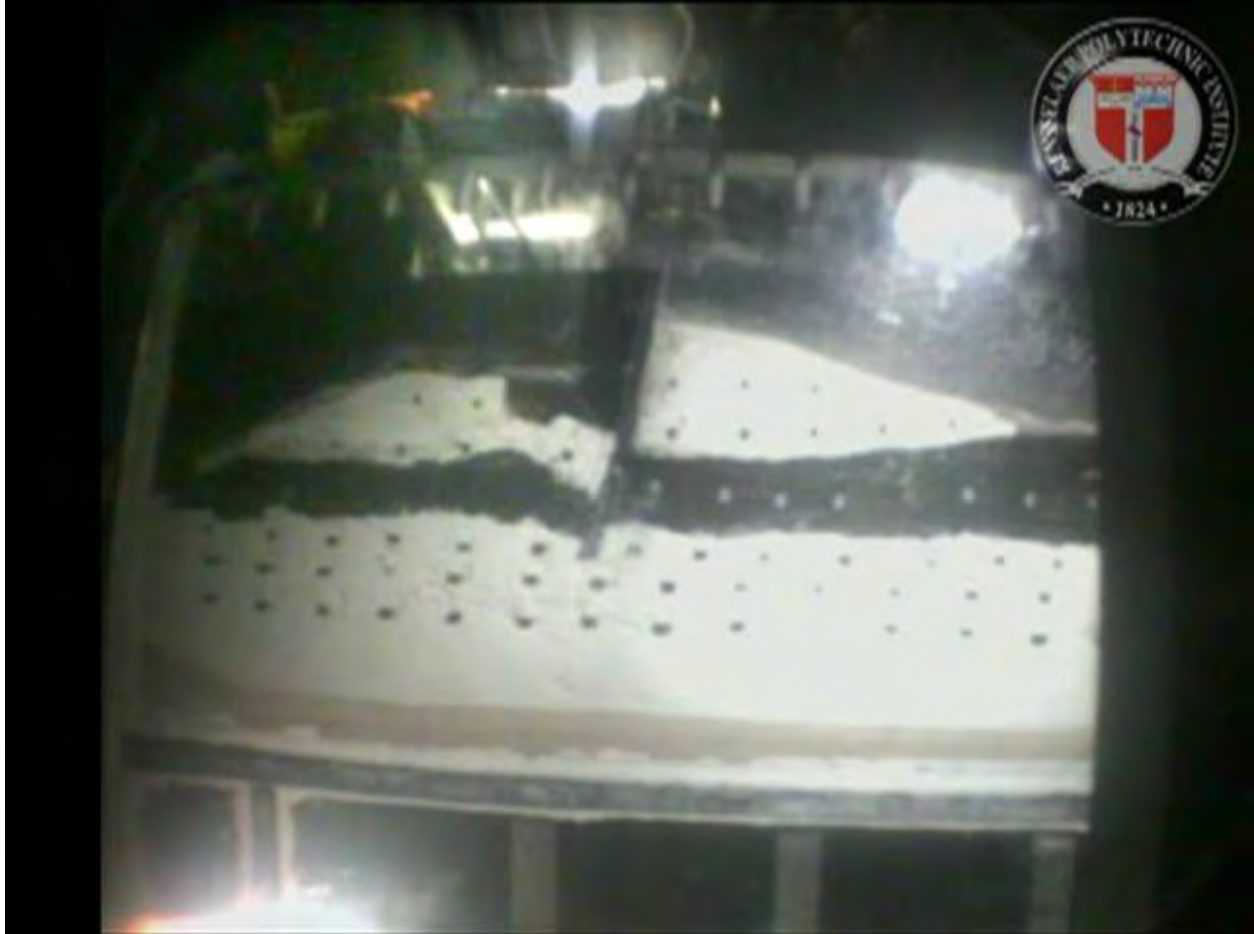
Figure 5.59. RPI 17th street model near end of flood failure

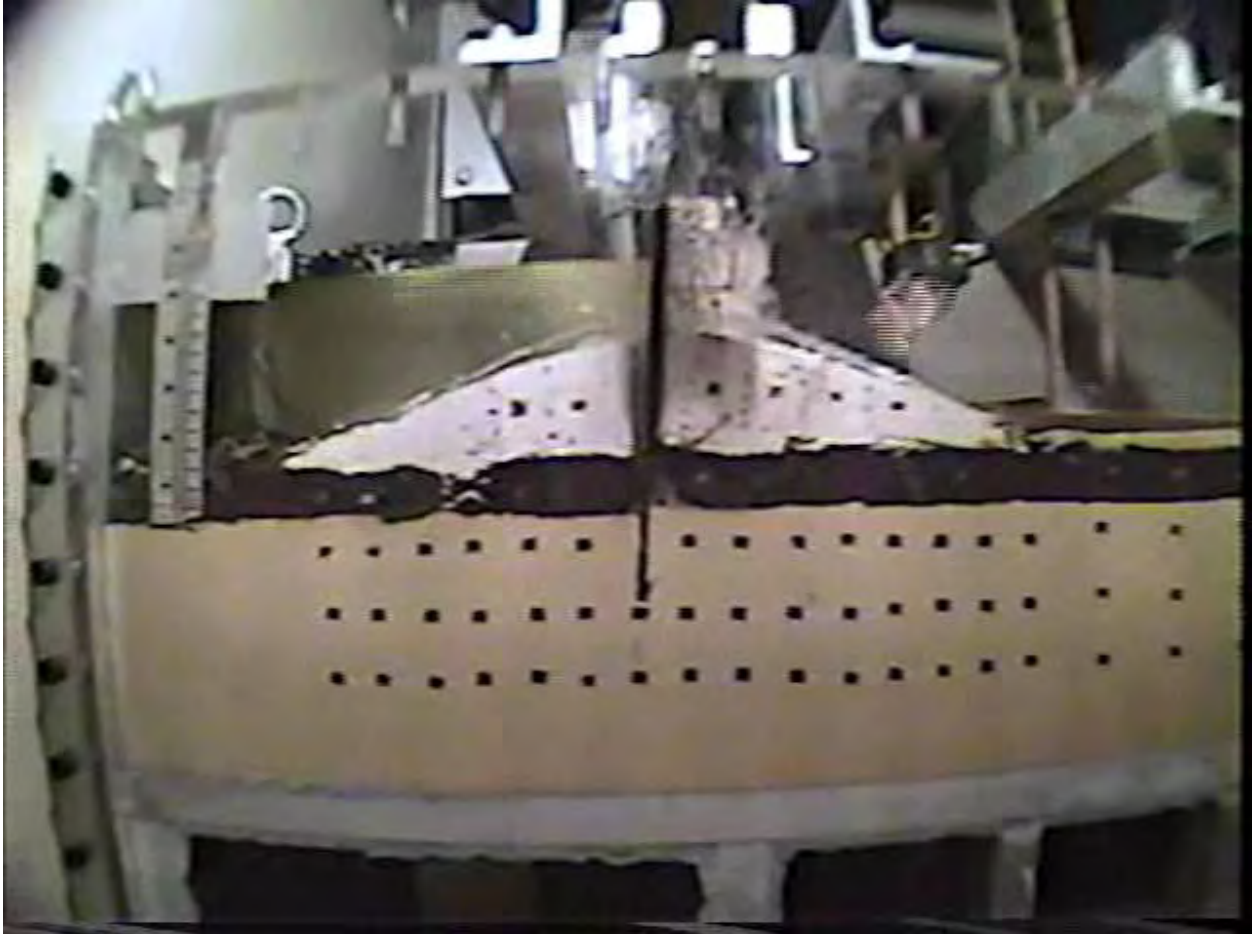
2. A crack begins to form between the sheet wall and canal side levee and propagates downward.
3. The crack extends all the way through the levee and the swampy/marsh layer to the top of the sand layer.
4. Full hydrostatic pressure is allowed to reach the foundation sand layer causing a sudden increase in pore water pressure.
5. This increase in pore water pressure reduces the vertical effective stress of the overlying swampy/marsh and levee material. Effectively the land side material approaches zero effective stress and begins to 'float'.
6. Load from the flood pushes the wall over in a rotational manner with no resisting force from the land side material.

Figure 5.66c. ERDC London Avenue south model after wall movement and crack formation

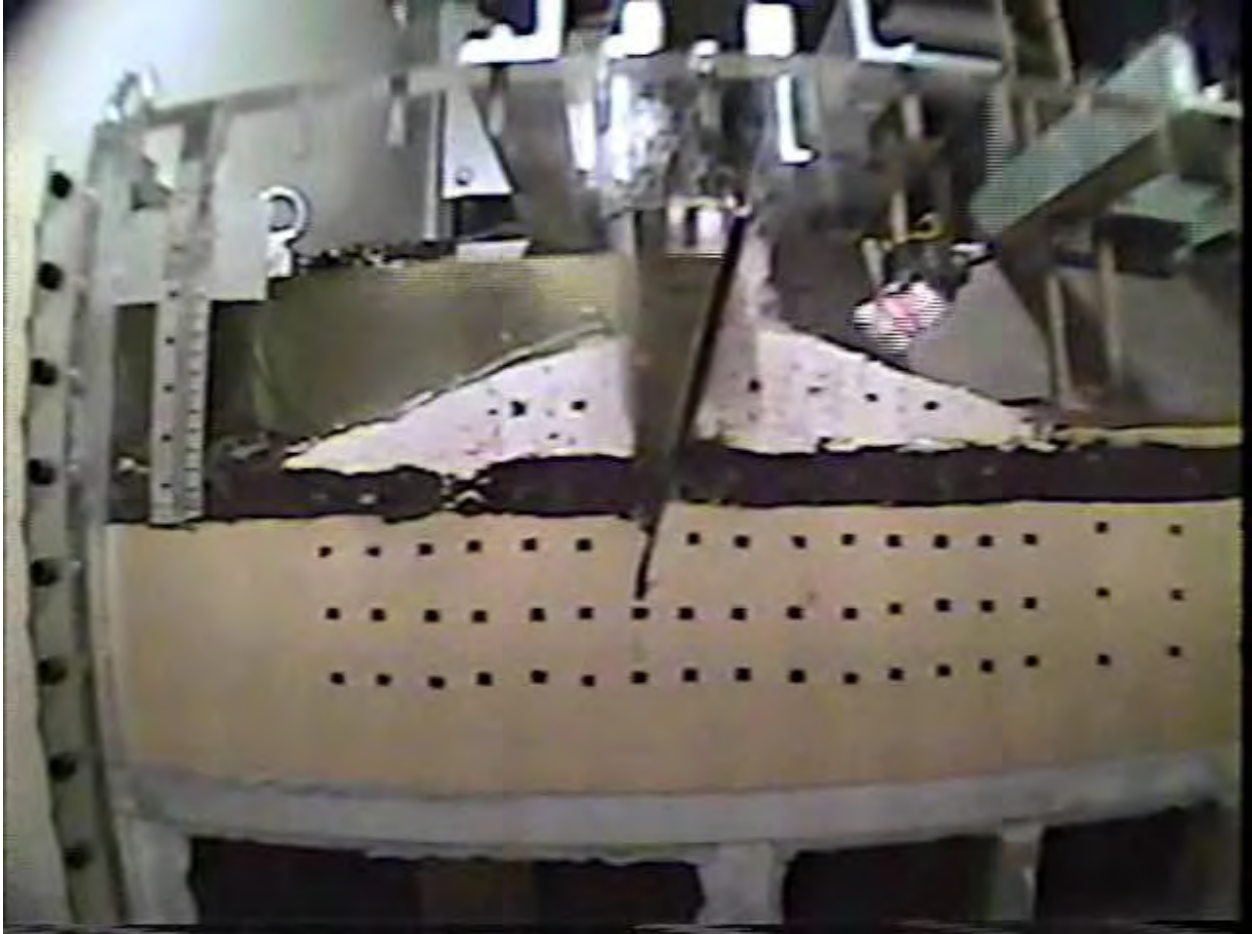
Figure 5.66d. ERDC London Avenue south model well into failure model

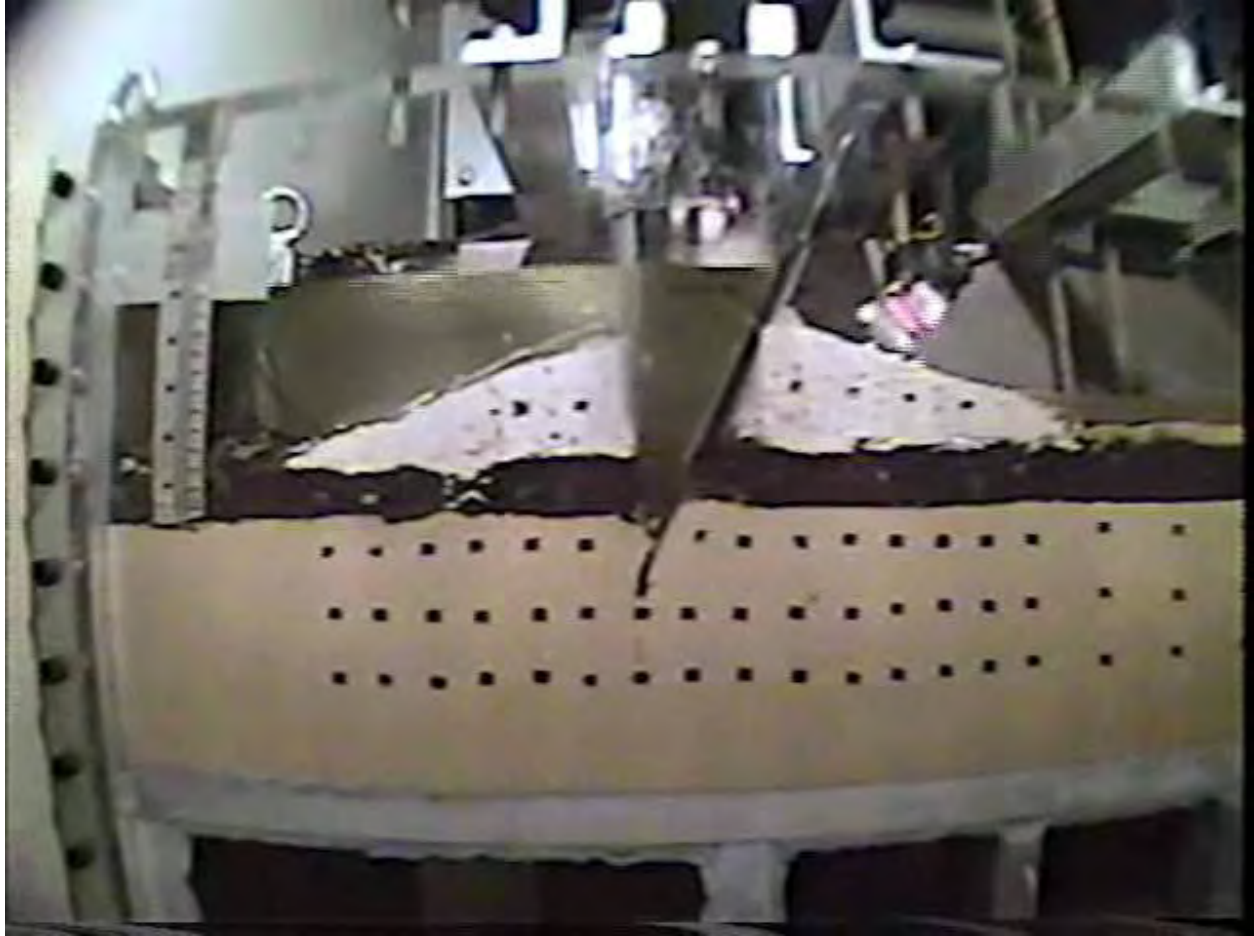
Figure 5.66e. ERDC London Avenue south model at end of test

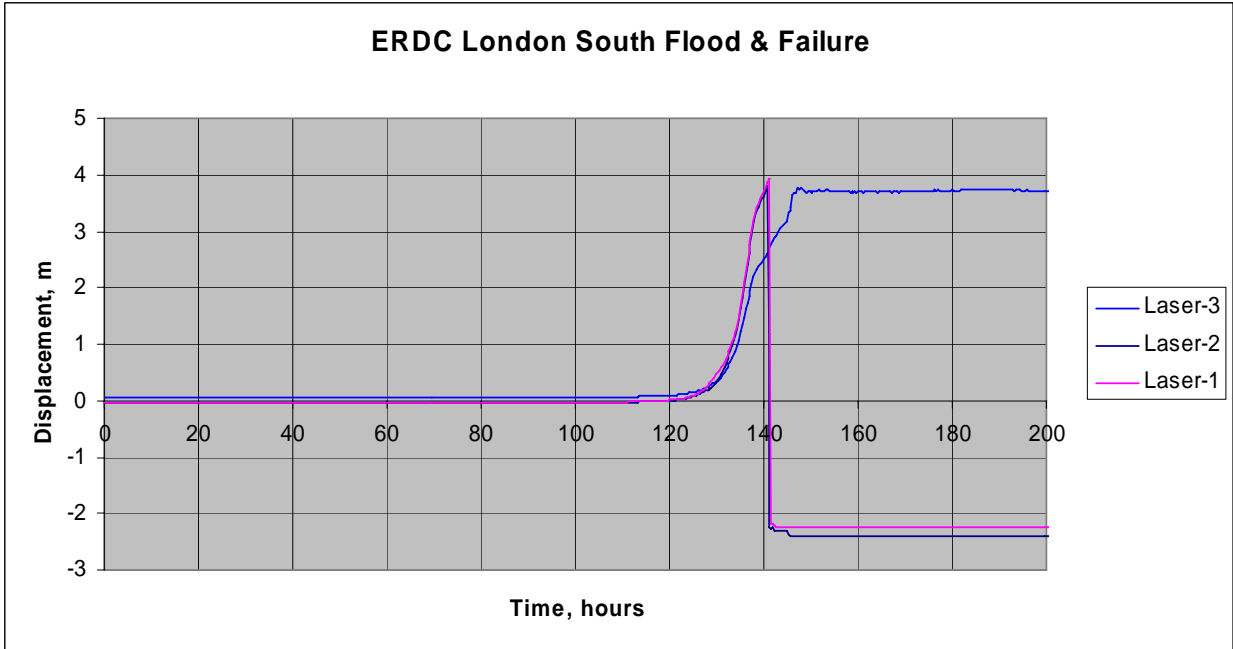
Figure 5.70. Displacement of the wall during flood load

displacement of the wall during the flood load. Notice that laser one and two are perfectly in sync. These are at the same elevation on the wall and reveal that wall movement remains constant along the plane of the wall (there is no twisting from front side to back side of the model). Secondly, notice that all lasers are moving together until later in time where laser three begins to change slope. This is an indication that the movement is becoming much more rotational in nature as the failure proceeds.

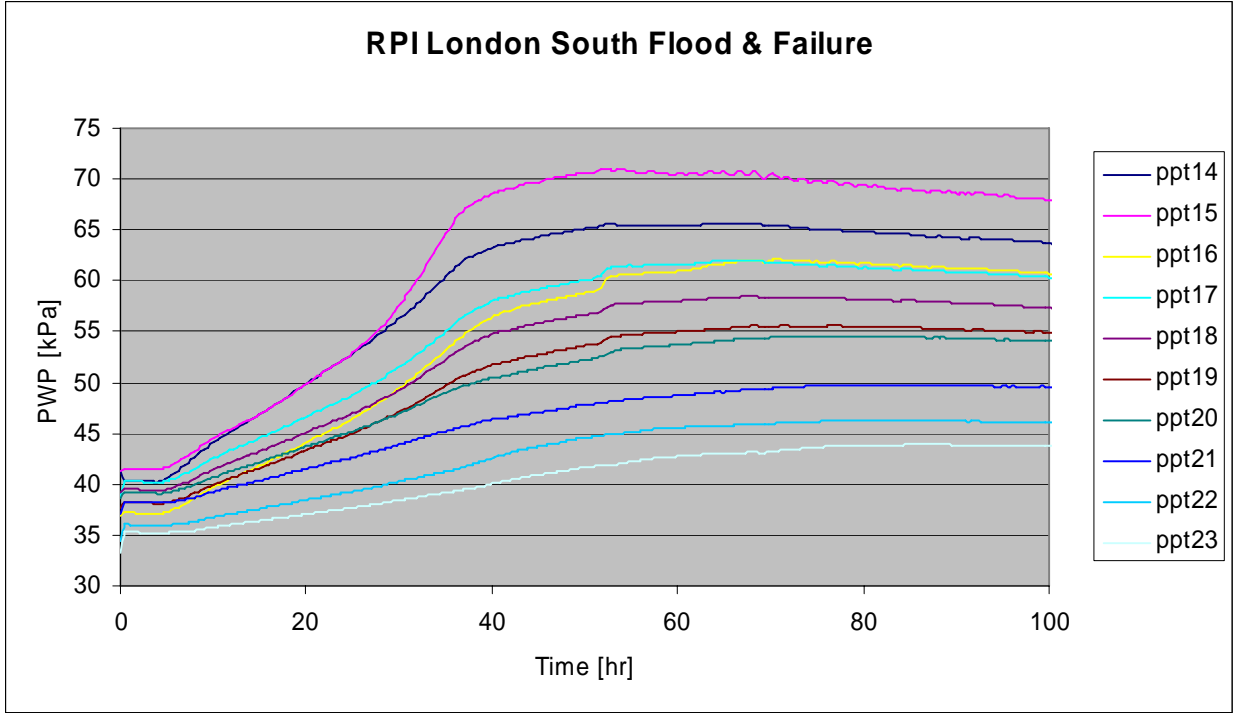
Figure 5.74. PPT data at the interface of the sand layer and the swampy/marsh layer during flood

Figure 5.74 is a plot of the PPT data in the sand layer just at the interface of the sand layer and the swampy/marsh layer. Notice that PPT 15 has nearly reached full hydrostatic pressure as the crack has formed all the way to this elevation. This is true for PPT 7 in Figure 5.73 also. Figure 5.75 is a plot of the PPT data in the levee and swampy/marsh layer during the flood event. Measurement of displacement data of the sheet pile wall is presented in Figure 5.76.

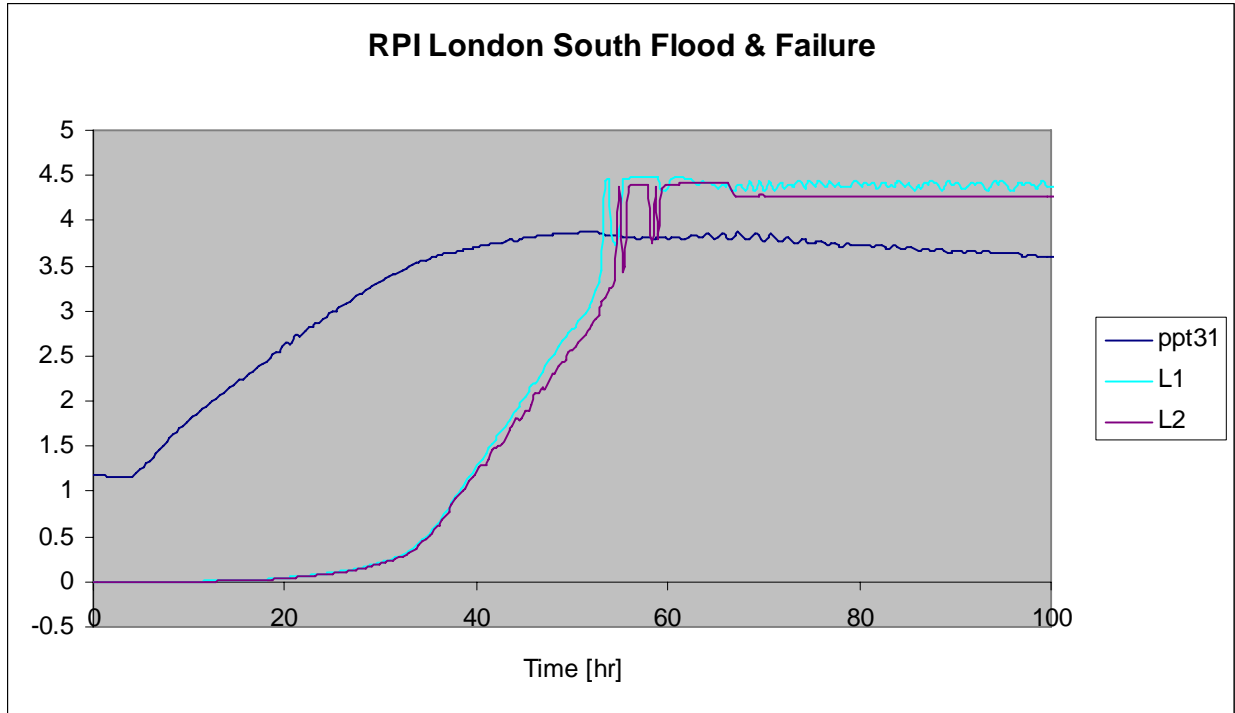
Figure 5.76. Displacement of the sheet pile wall during flood load

The increase in water level is shown to occur at time five hours and steadily increase to a depth of around 4 m (y-axis is water depth, m and displacement, m). The movement of the wall begins at around time ten hours with a small initial movement that is associated with the crack. At time 30 hours, the wall movement is seen to greatly increase, which is associated with failure of the wall. The two readings are parallel for most of the recorded time indicating that the wall is failing in a rotational manner. The following sequence of images shown in Figure 5.77 are stills taken from the video recording during the flood event. In the sequence the entire flood and failure event is shown.

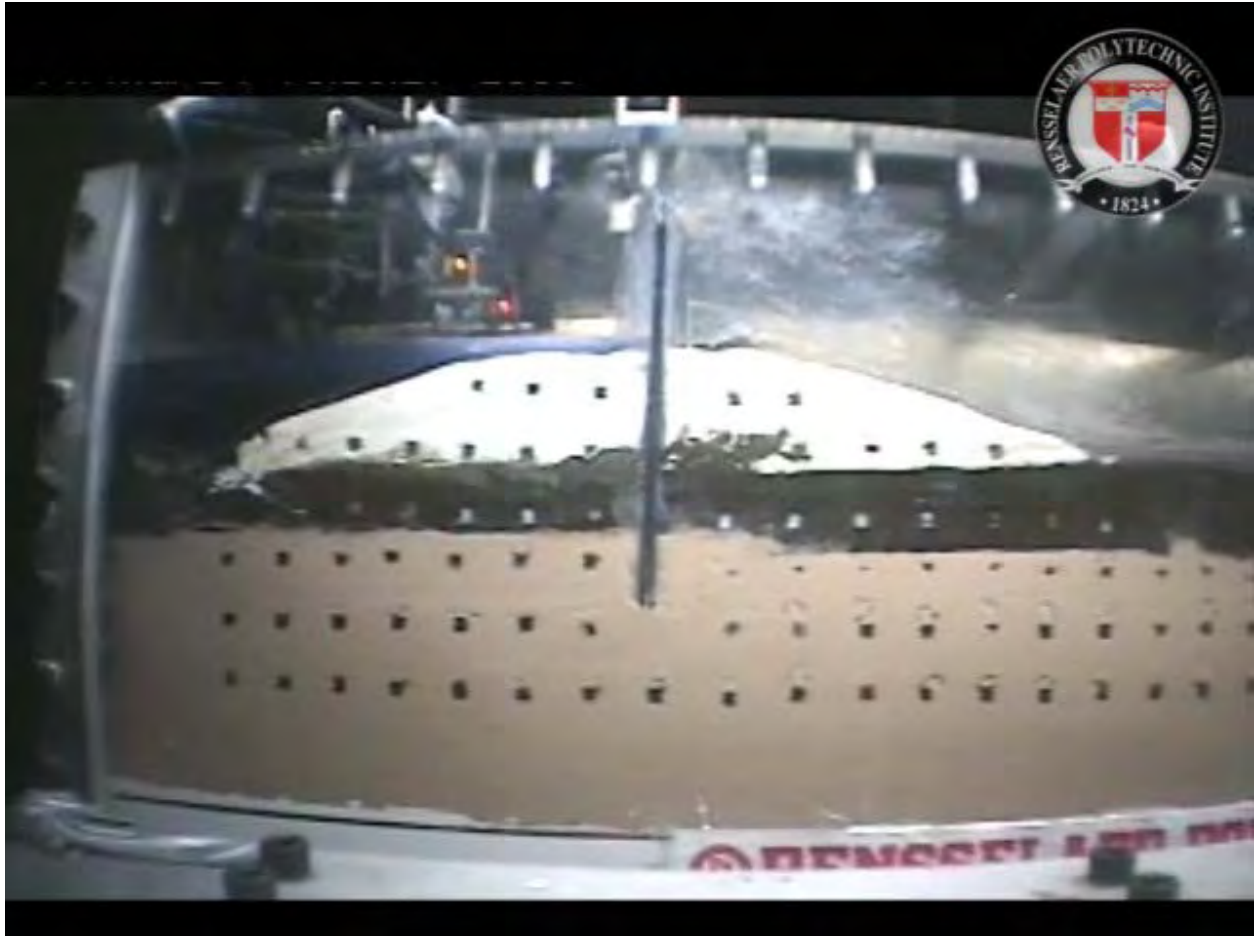
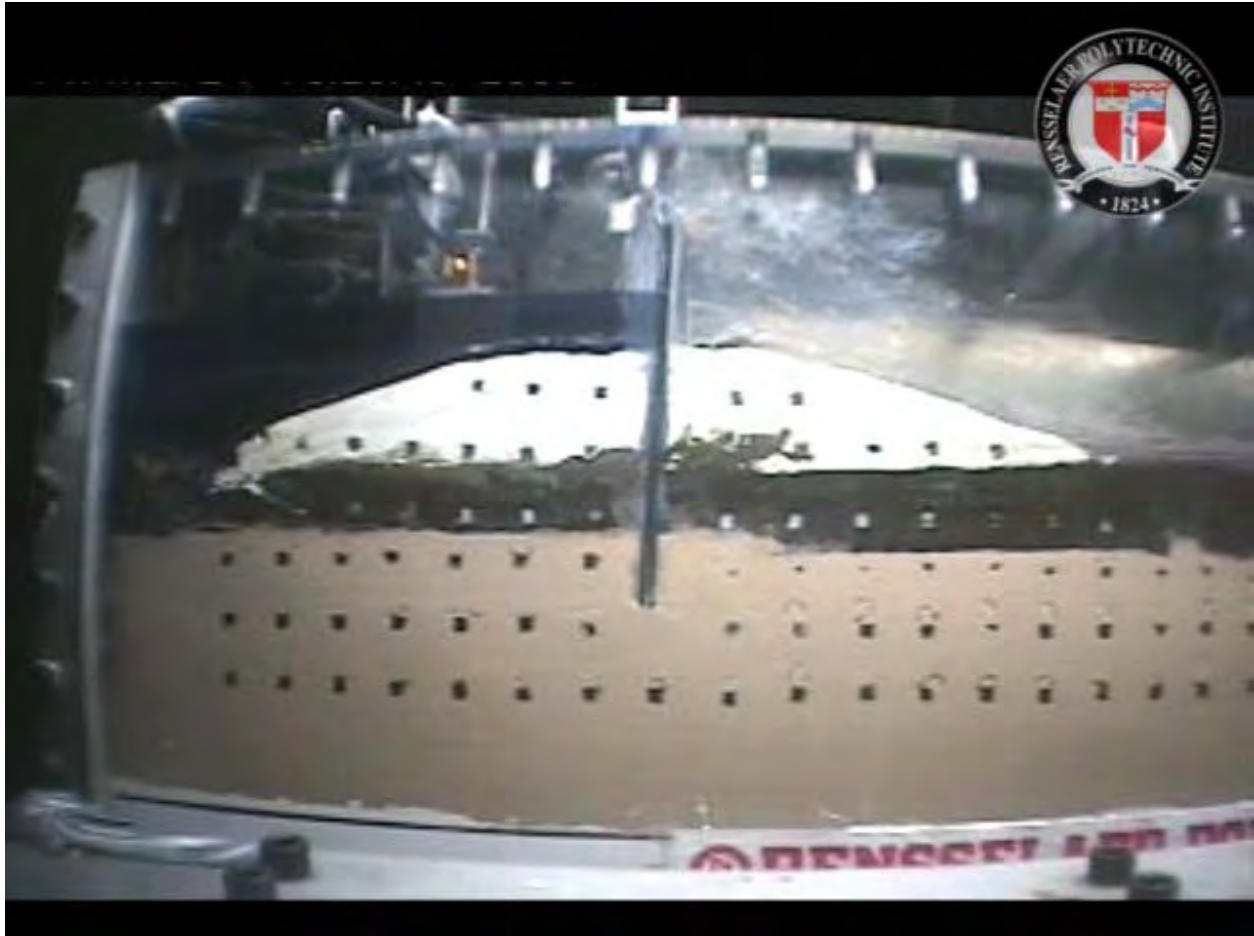
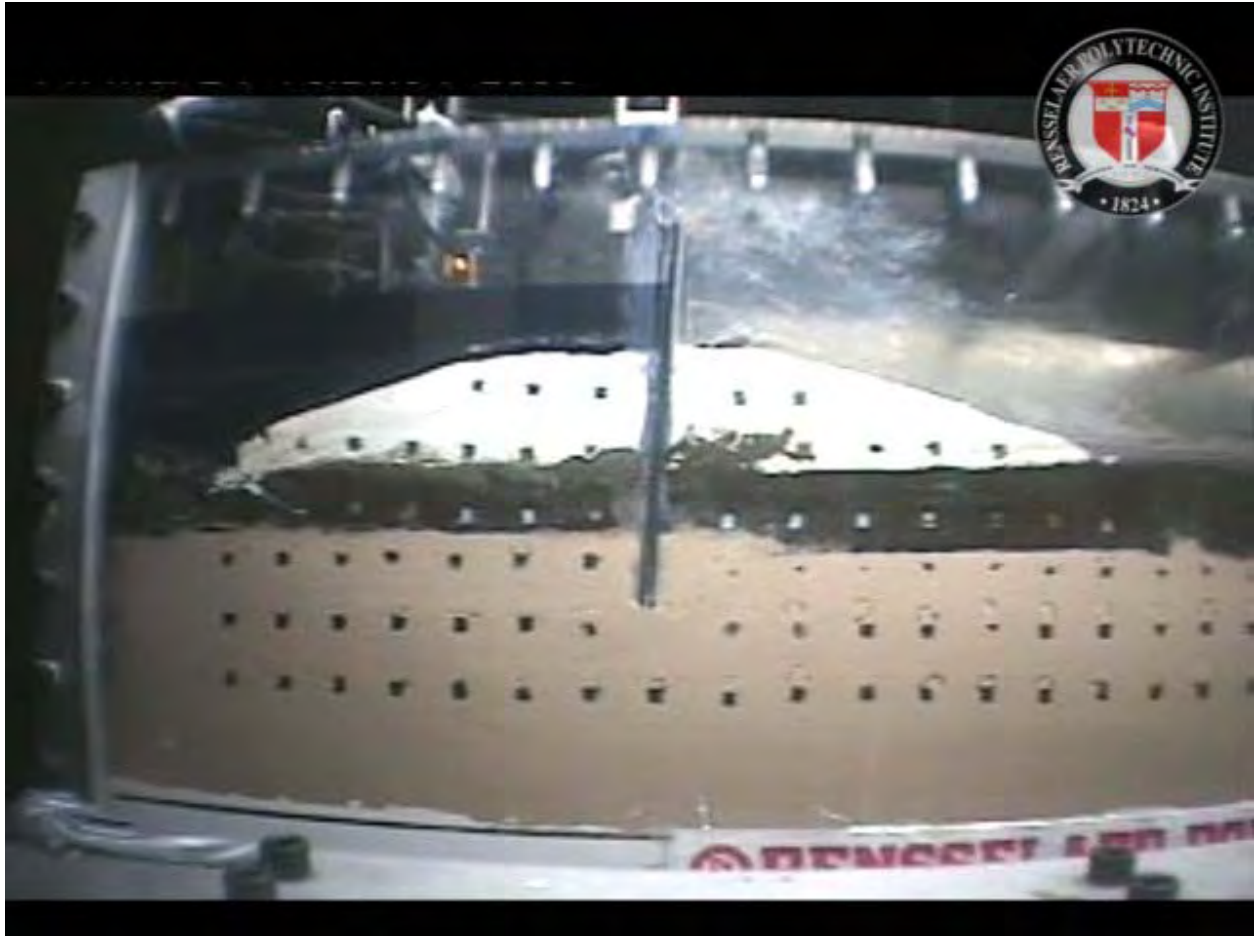
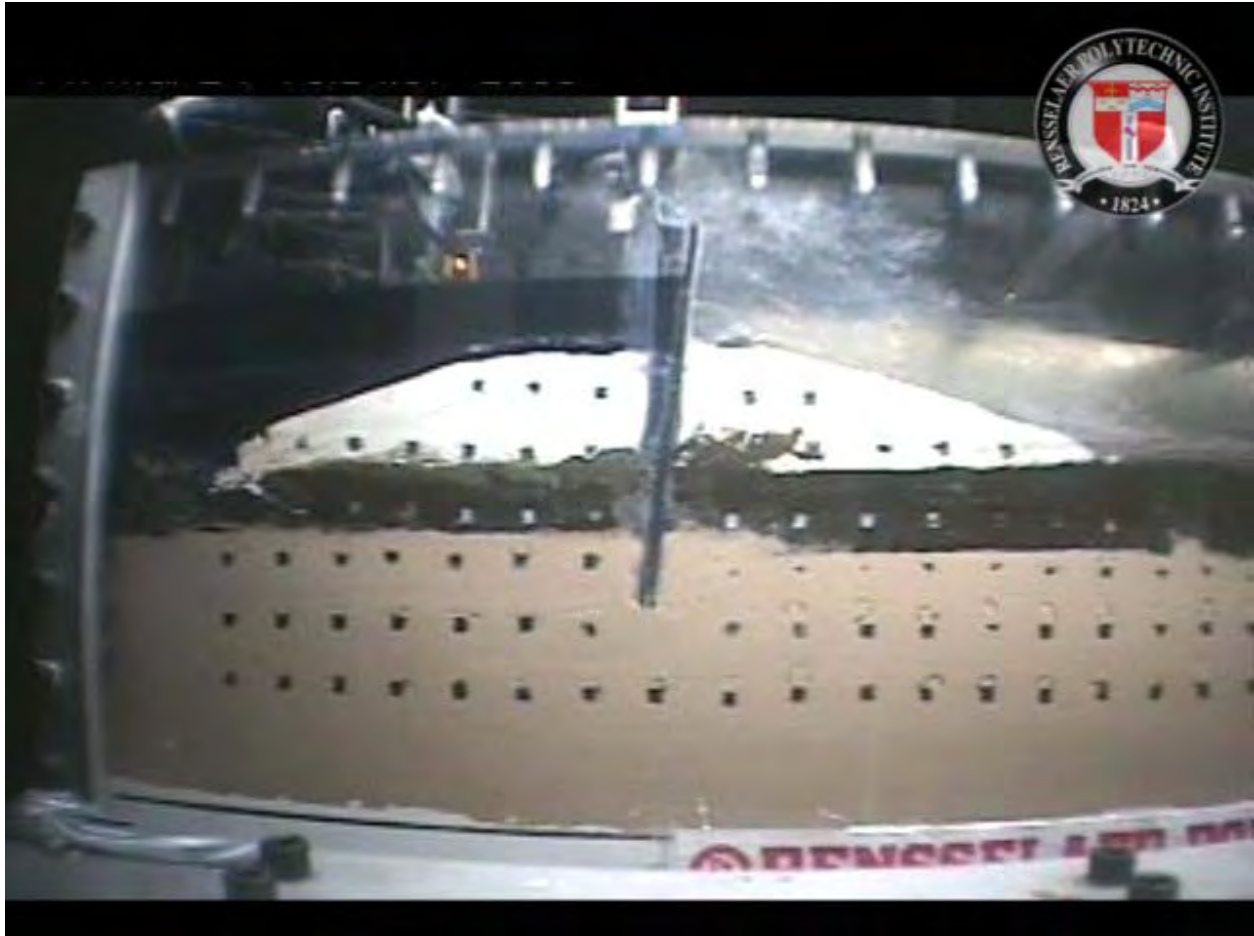
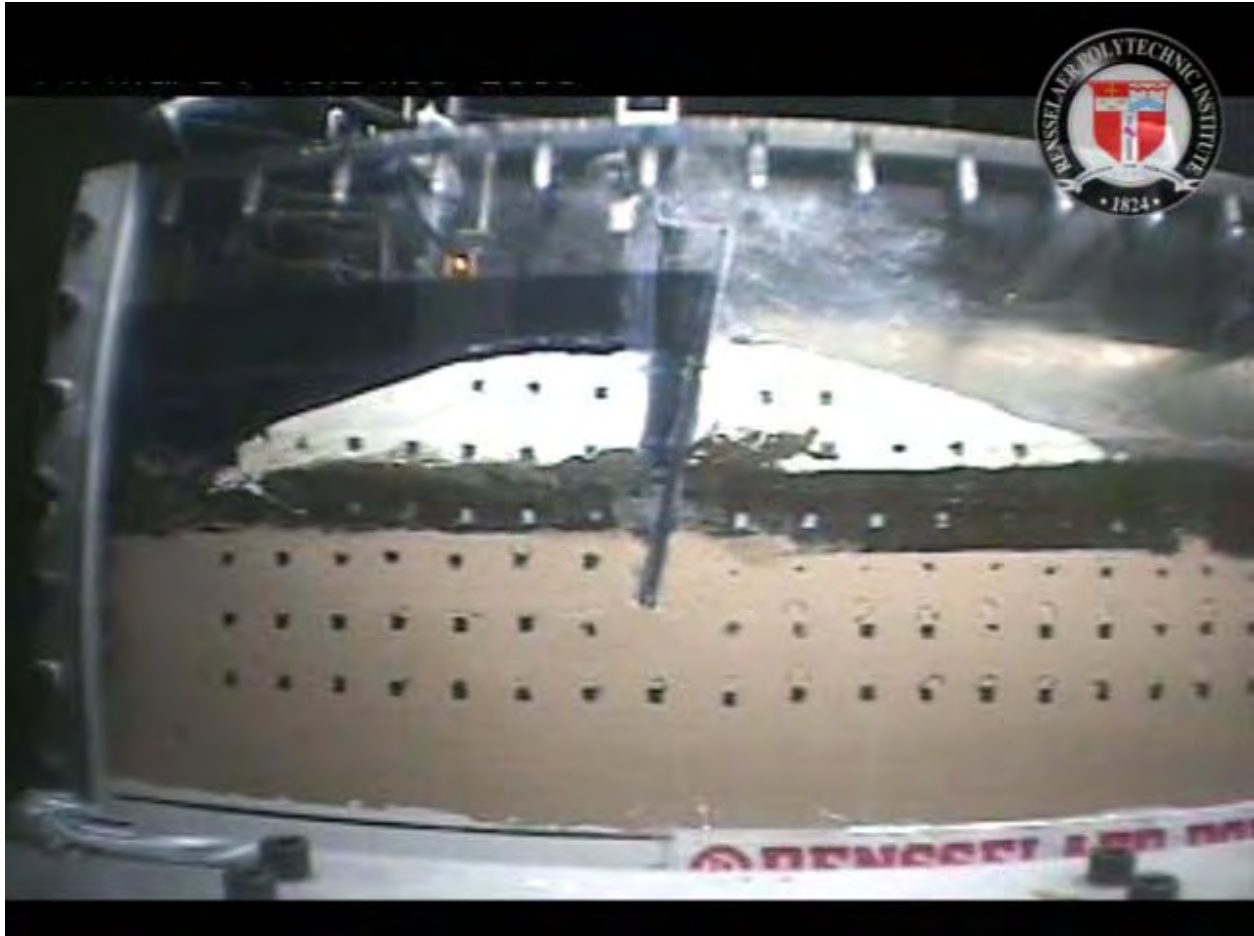
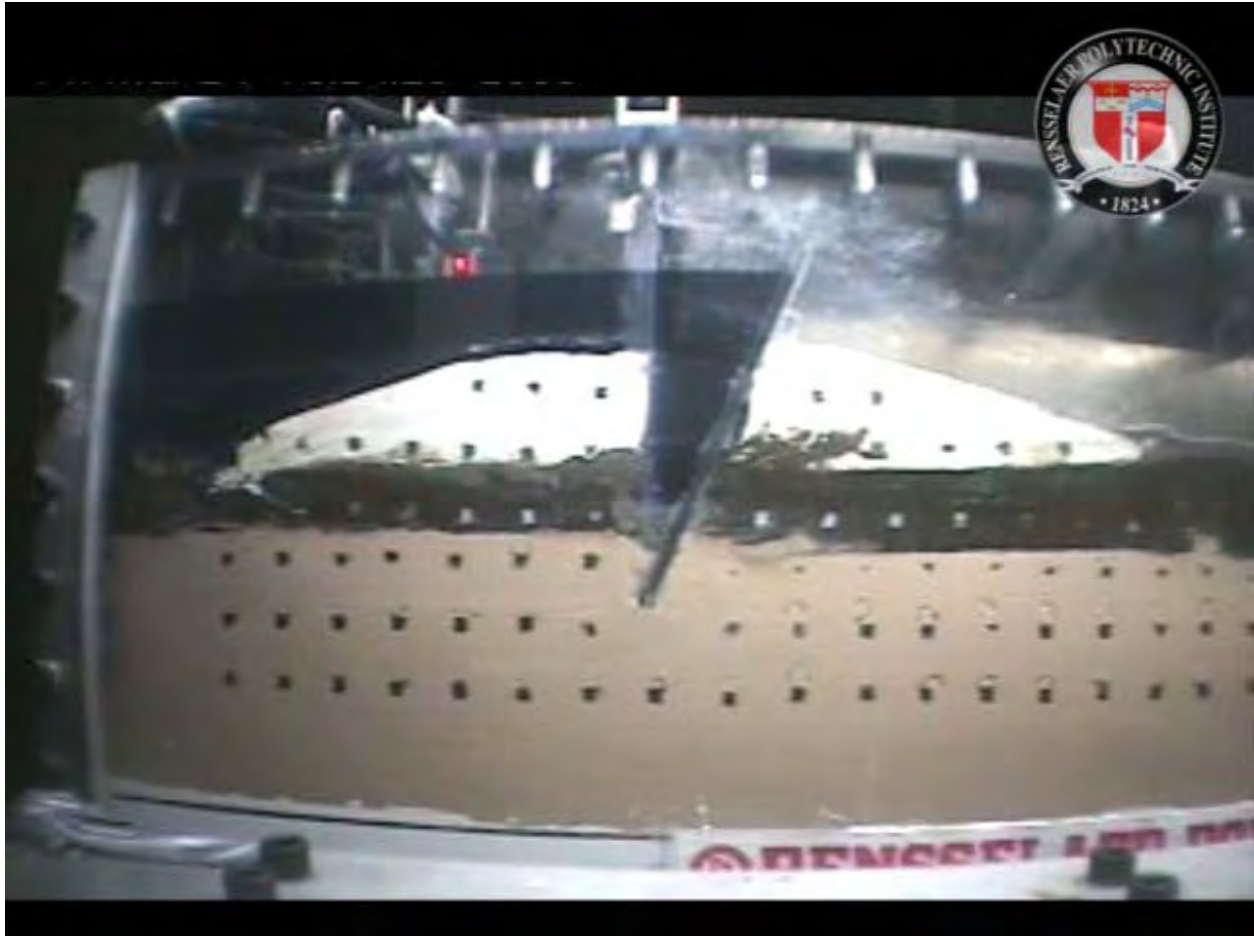
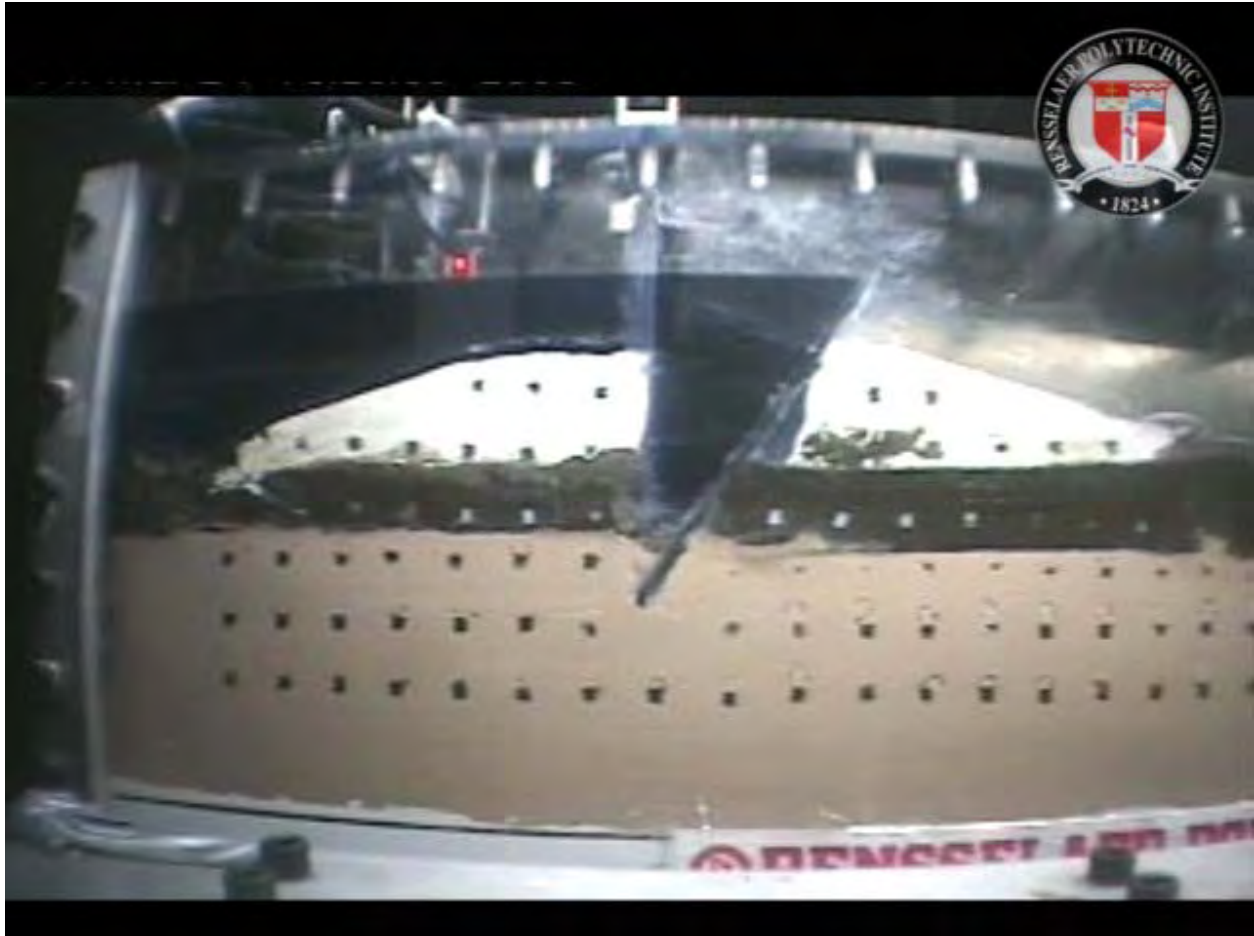
Figure 5.77a. RPI London south model at normal canal water elevation

Figure 5.77b. RPI London south model flood level prior to any wall movement

Figure 5.77c. RPI London south model just after wall movement and crack formation

Figure 5.77d. RPI London south model in process of failure

Figure 5.77e. RPI London south model in failure showing rotation of wall

Figure 5.77f. RPI London south model during failure, note how the swampy/marsh layer is moving as evidenced by the white markers

Figure 5.77g. RPI London south model at end of failure

A synopsis of the failure event that occurred in the RPI London south model is as highlighted following. This is exactly the same failure event as was observed in the ERDC London south model and confirms the event.

1. Water level increases to a point on the wall where initial movement of the wall begins to occur. This movement starts out as a rotation of the wall.
2. A crack begins to form between the sheet wall and canal side levee and propagates downward.
3. The crack extends all the way through the levee and the swampy/marsh layer to the top of the sand layer.
4. Full hydrostatic pressure is allowed to reach the foundation sand layer causing a sudden increase in pore water pressure.
5. This increase in pore water pressure reduces the vertical effective stress of the overlying swampy/marsh and levee material. Effectively the land side material approaches zero effective stress and begins to 'float'.
6. Load from the flood pushes the wall over in a rotational manner with no resisting force from the land side material.

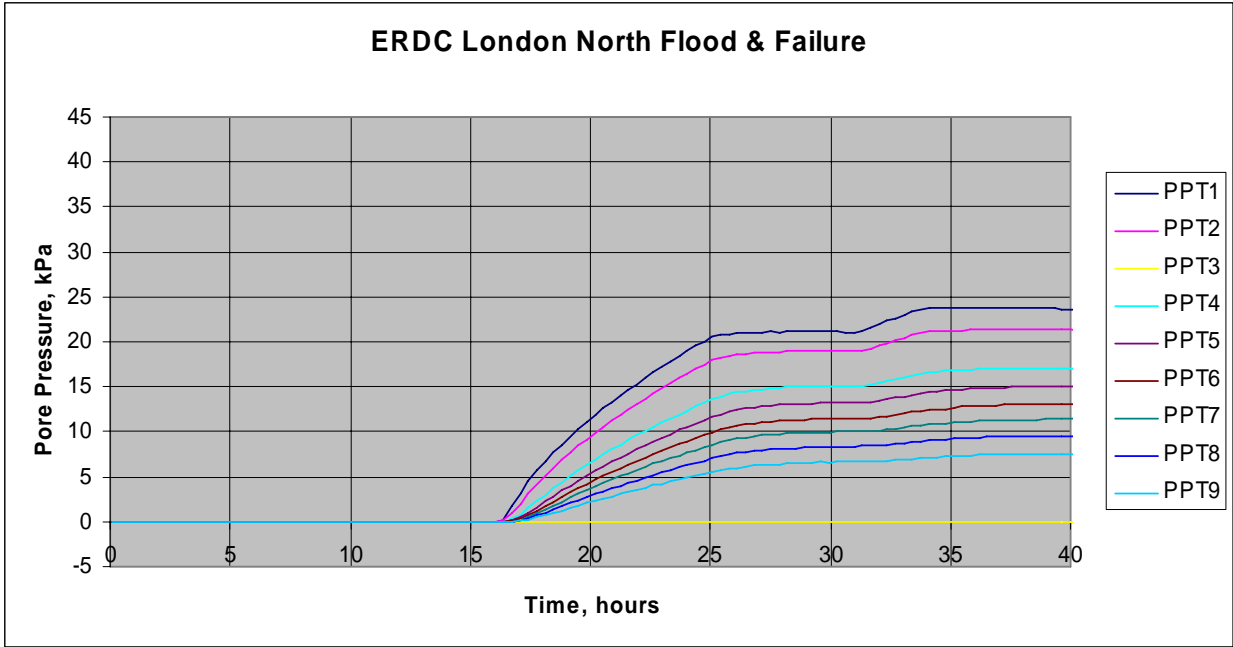
Figure 5.82. PPT data in the sand layer, mid-depth during flood event

This section will present the data recorded during the flood and failure event. As mentioned previously the displacement transducers on the wall failed to operate, therefore only PPT data will be shown. That data is given in Figures 5.82 through 5.84. Figure 5.82 is the PPT data in the sand layer about mid-depth. The small short plateau is associated with wall movement forming a crack that leads to eventual failure.
