Appendix 1

Soil Data Report for 17th Street Canal

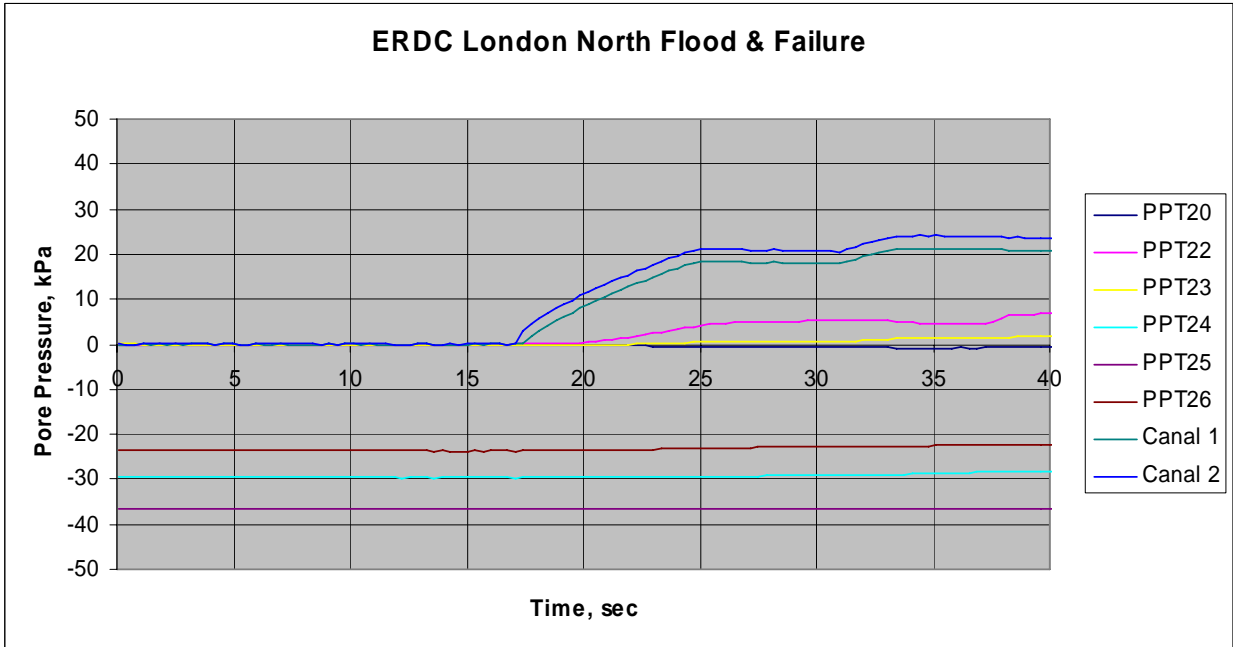
Figure 5.84. PPT data in the levee and swampy/marsh layer during flood

Figure 5.83 is a plot of PPT data in the sand layer just near the top of that layer. The behavior is exactly as described above. Finally, the PPT data from the levee and swampy/marsh recorded during the flood are shown in Figure 5.84. The PPT's in the clay are very erratic. This response is attributed to a combination of the clay material drying out during the long spin time and to changes in the clay geometry as the failure is occurring.

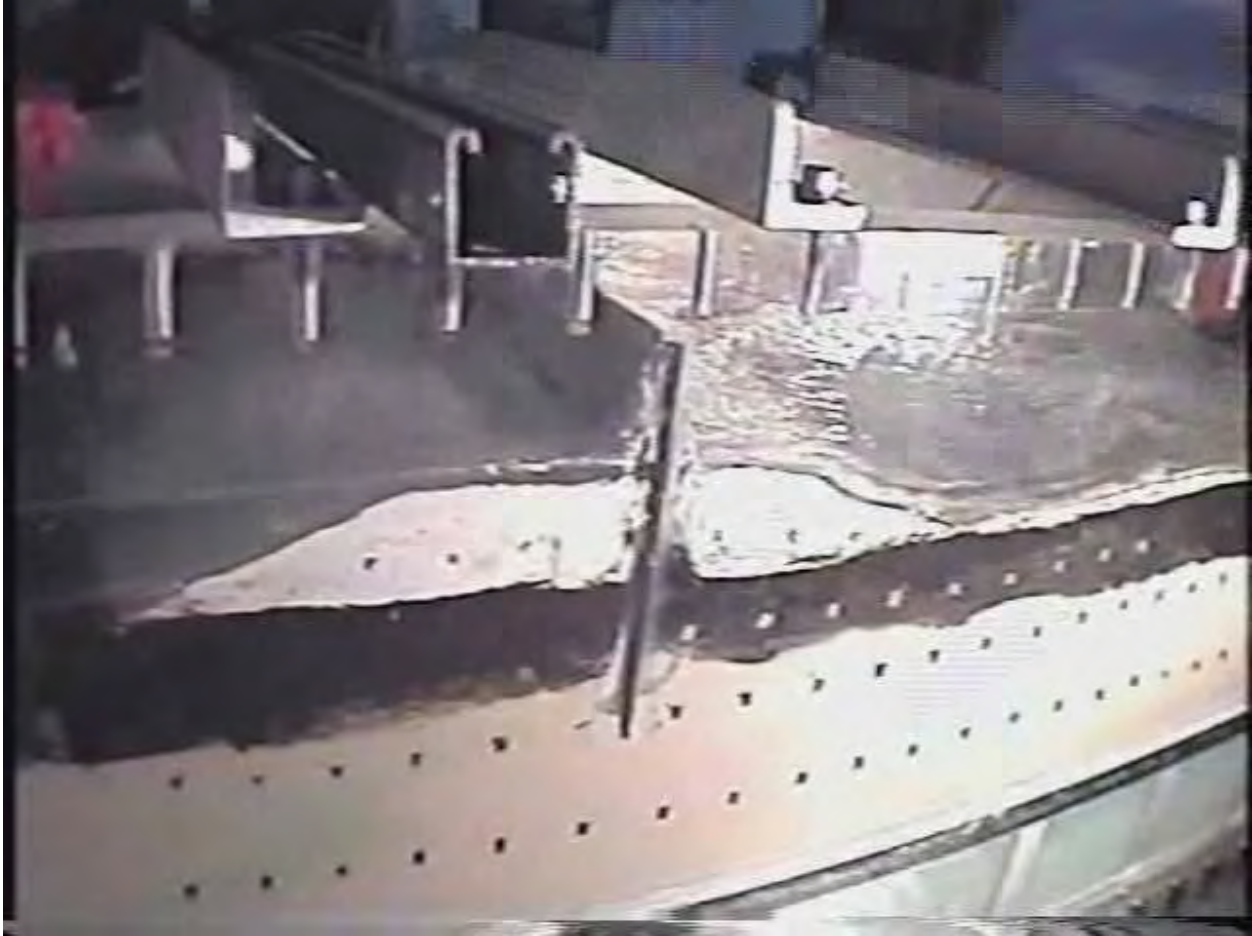
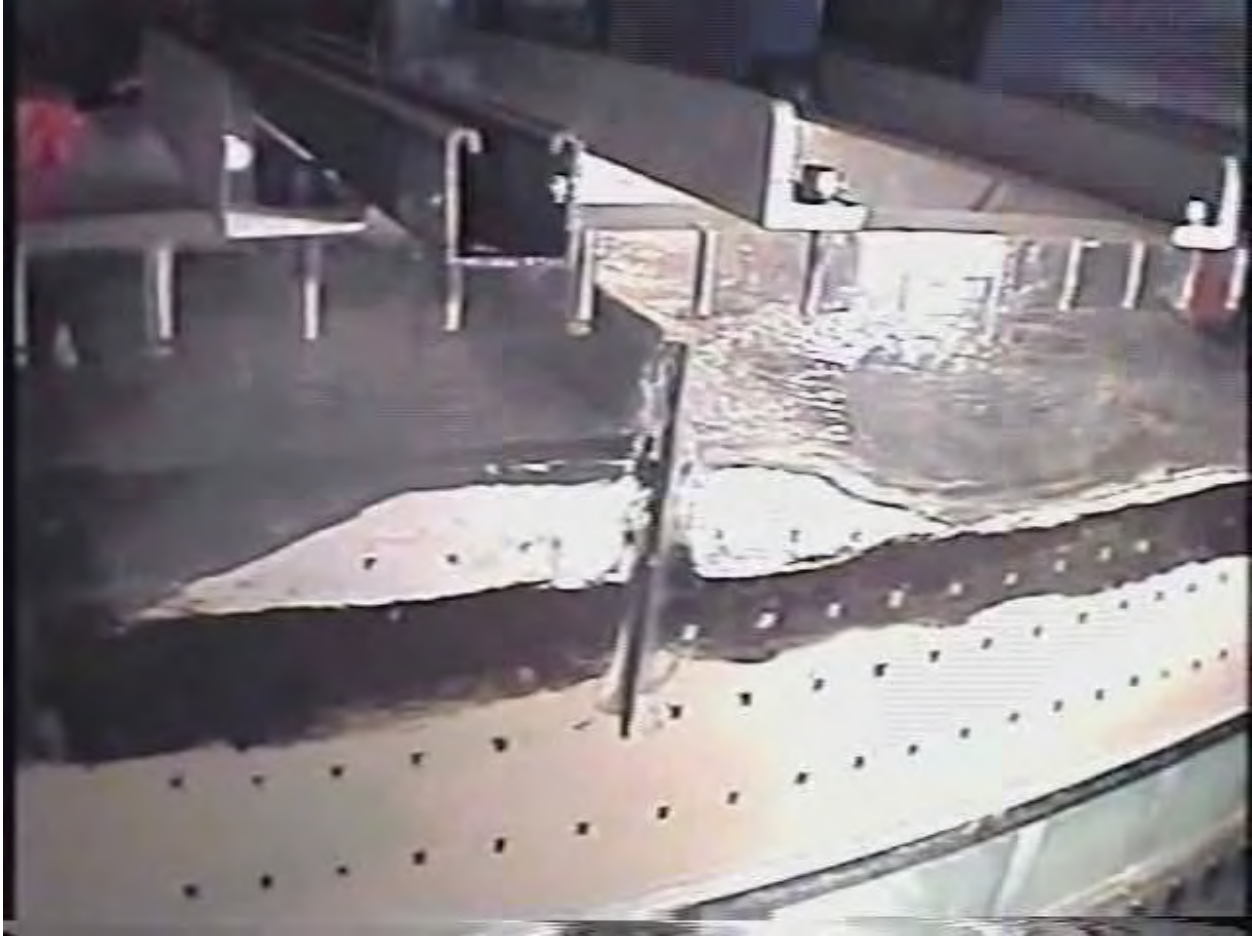
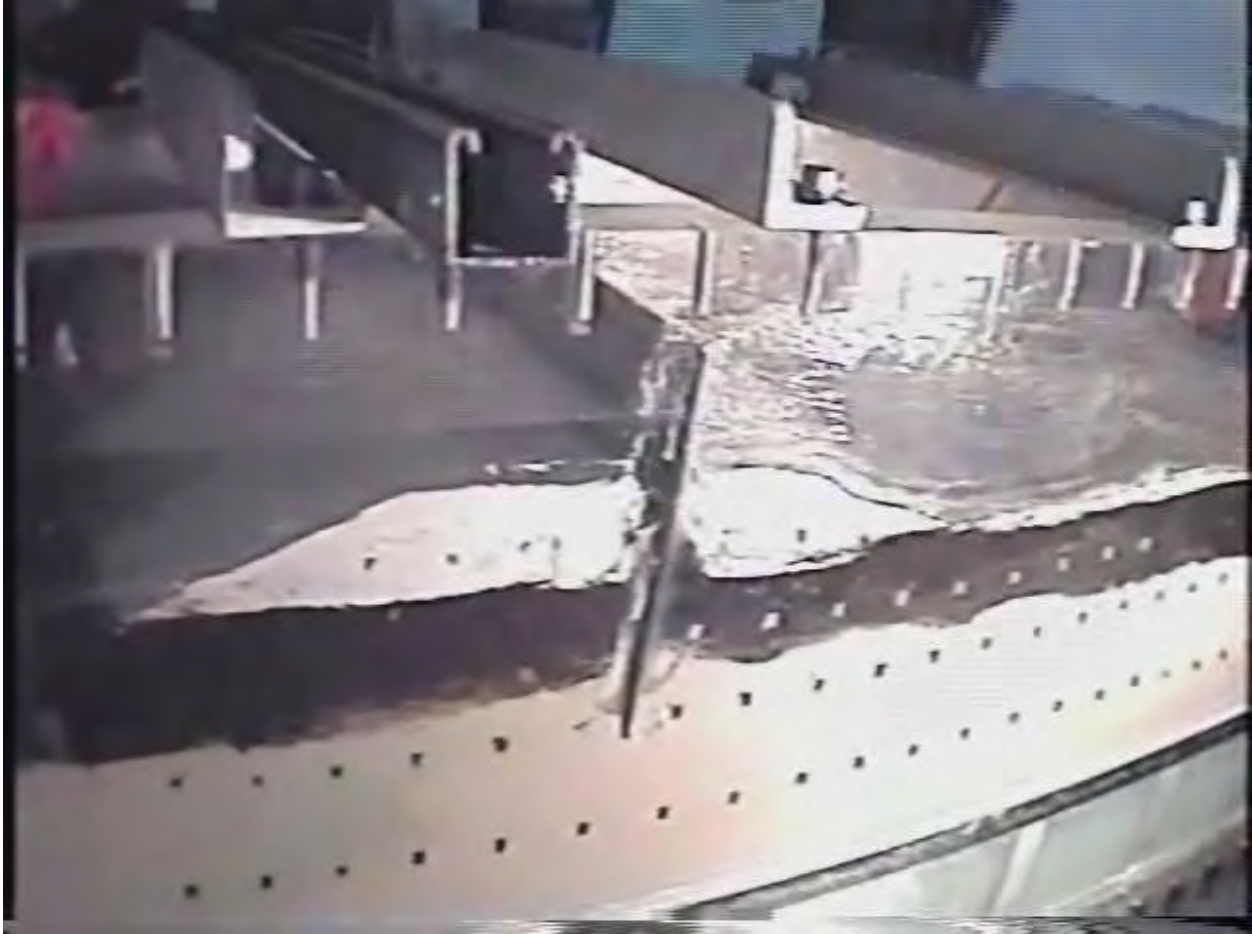
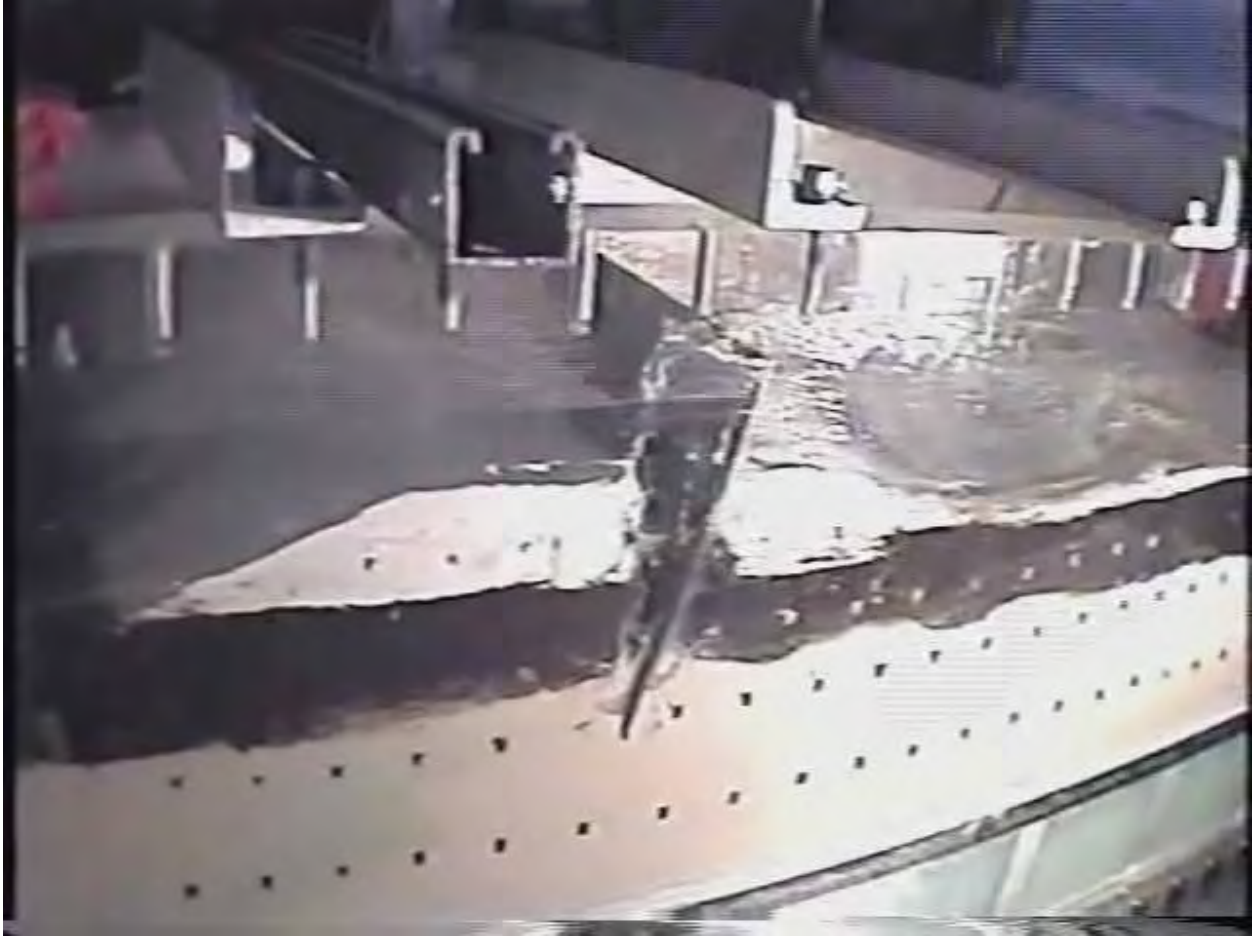
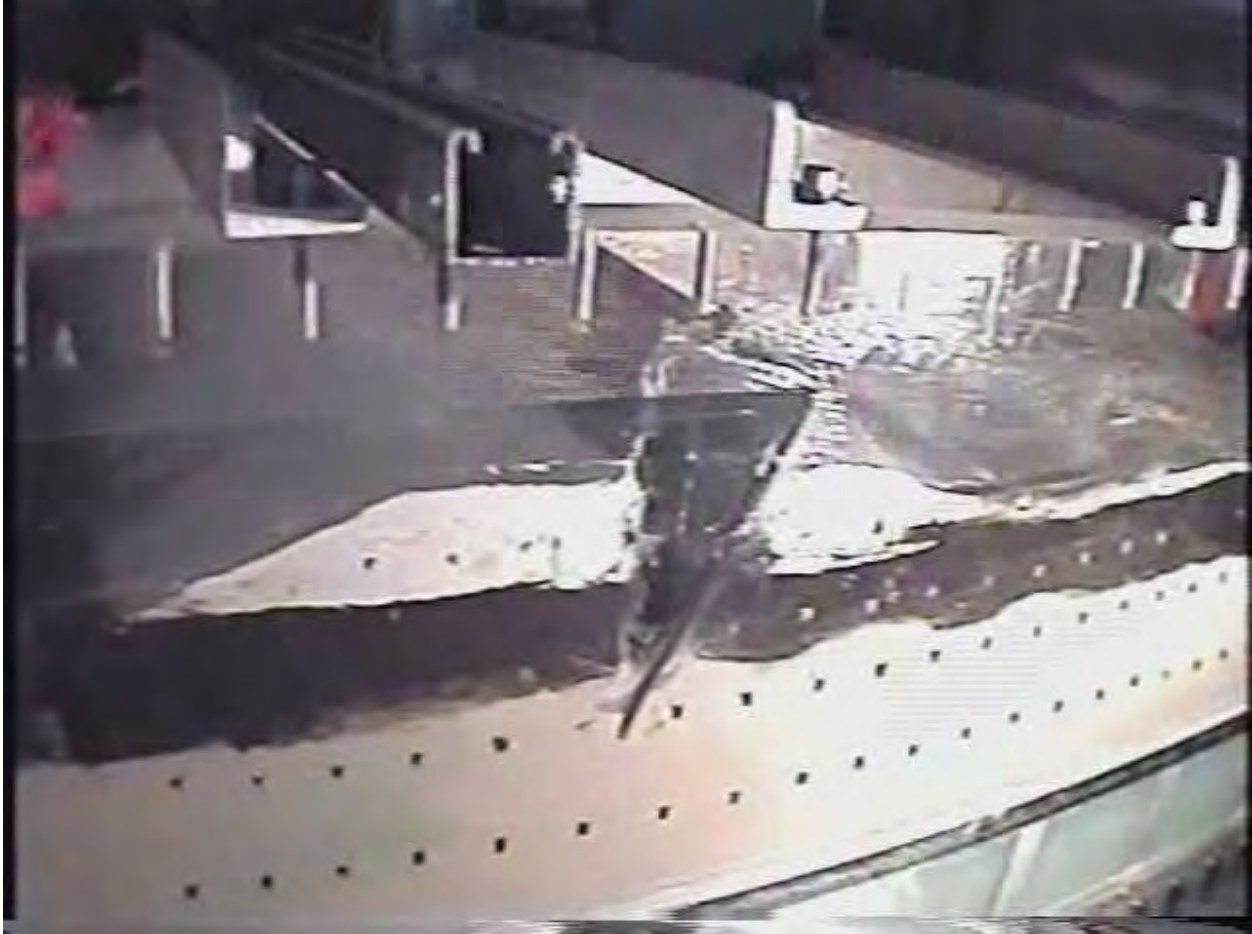
Figure 5.85a. View of ERDC London north model at normal canal water elevation

Figure 5.85b. View of ERDC London north model at flood level prior to wall movement

Figure 5.85c. View of ERDC London north model at flood level just after wall movement and opening of crack between wall and canal side levee

Figure 5.85d. View of ERDC London north model at flood level well into failure

Figure 5.85e. View of ERDC London north model at flood level end of failure

In a manner very similar to what was revealed in the two London south models, the description of failure mechanism for this London north model follows.

1. Water level increases to a point on the wall where initial movement of the wall begins to occur. This movement starts out as a rotation of the wall.
2. A crack begins to form between the sheet wall and canal side levee and propagates downward.
3. The crack extends all the way through the levee and the swampy/marsh layer to the top of the sand layer.
4. Full hydrostatic pressure is allowed to reach the foundation sand layer causing a sudden increase in pore water pressure.
5. This increase in pore water pressure reduces the vertical effective stress of the overlying swampy/marsh and levee material. Effectively the land side material approaches zero effective stress and begins to 'float'.
6. Load from the flood pushes the wall over in a rotational manner with no resisting force from the land side material.

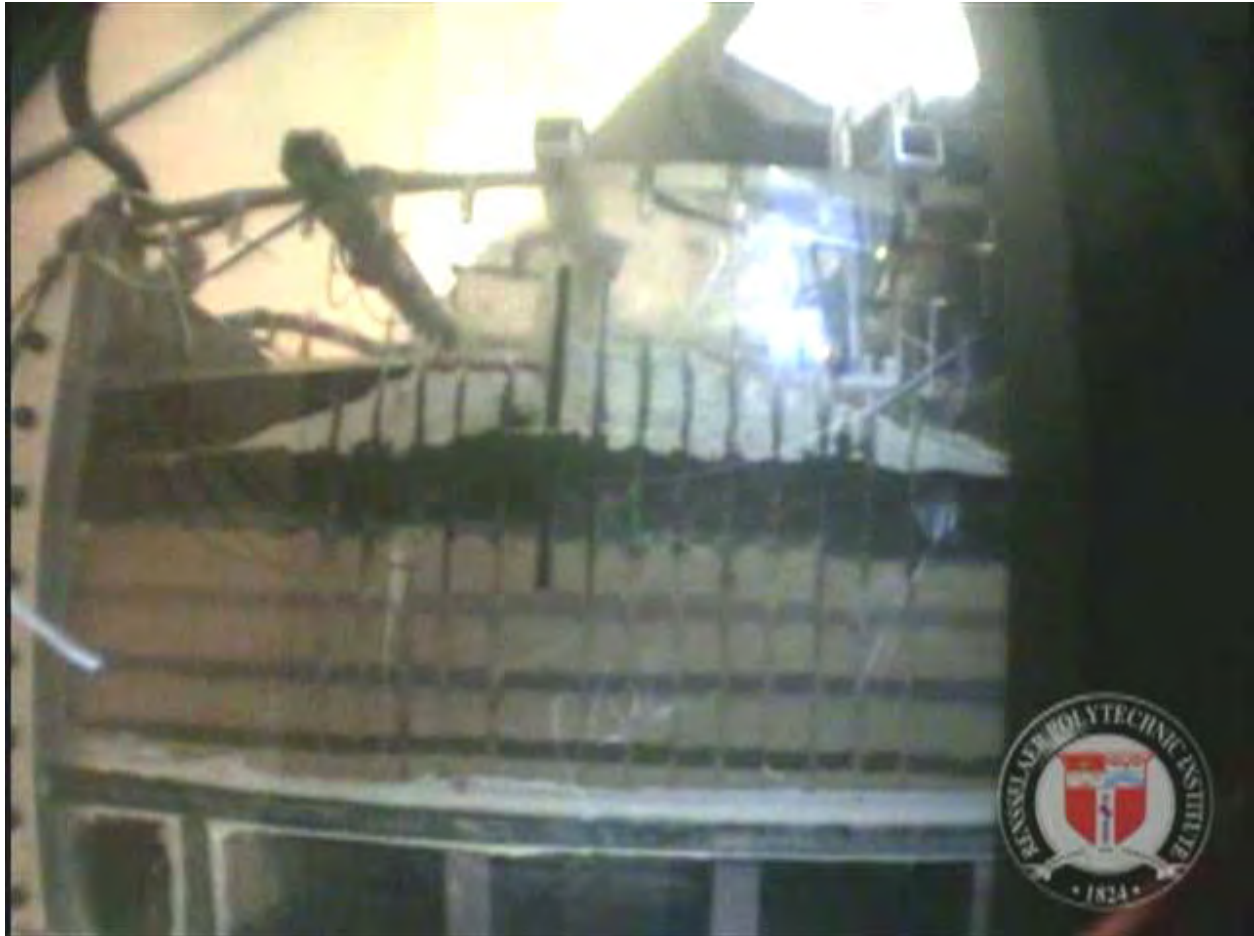
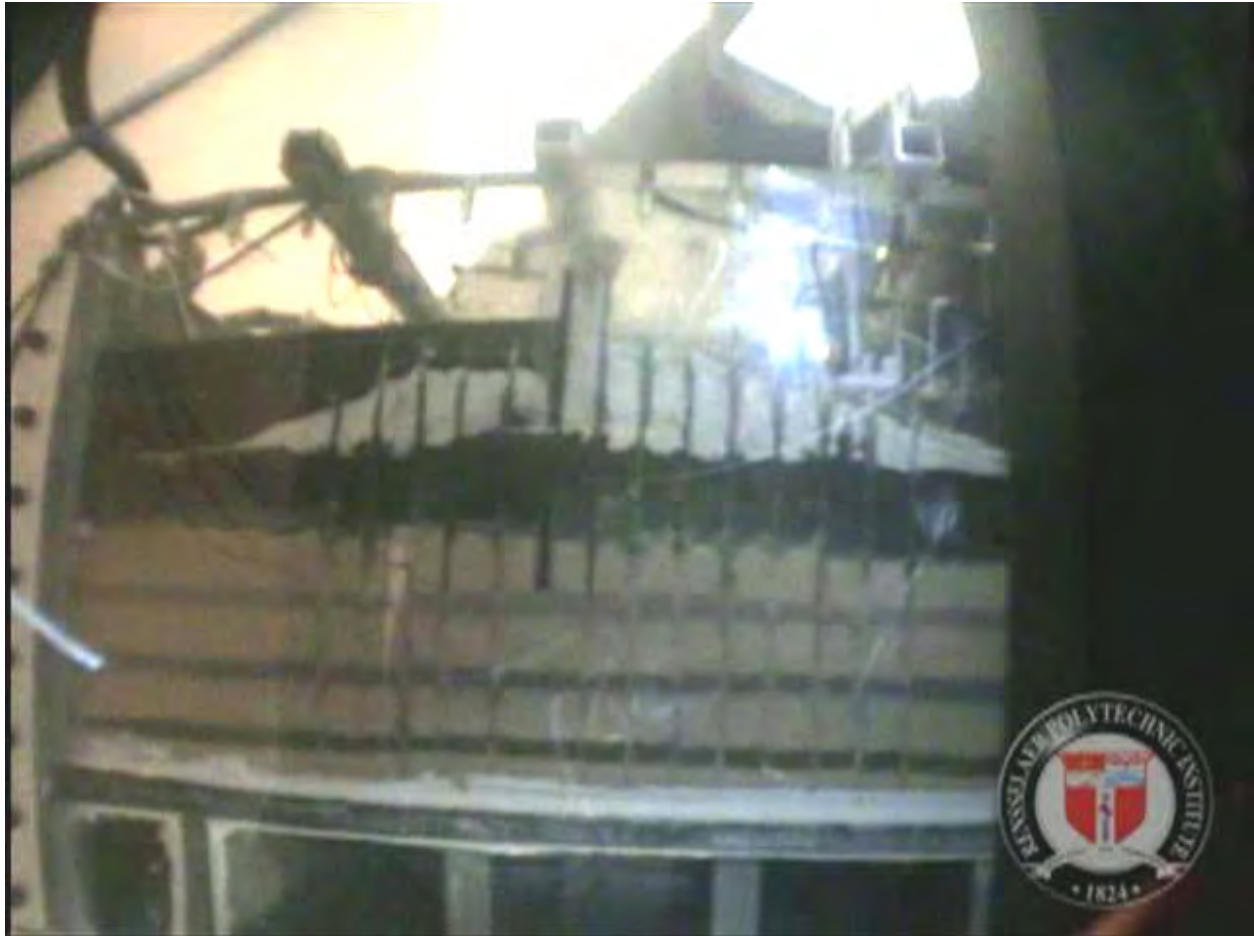
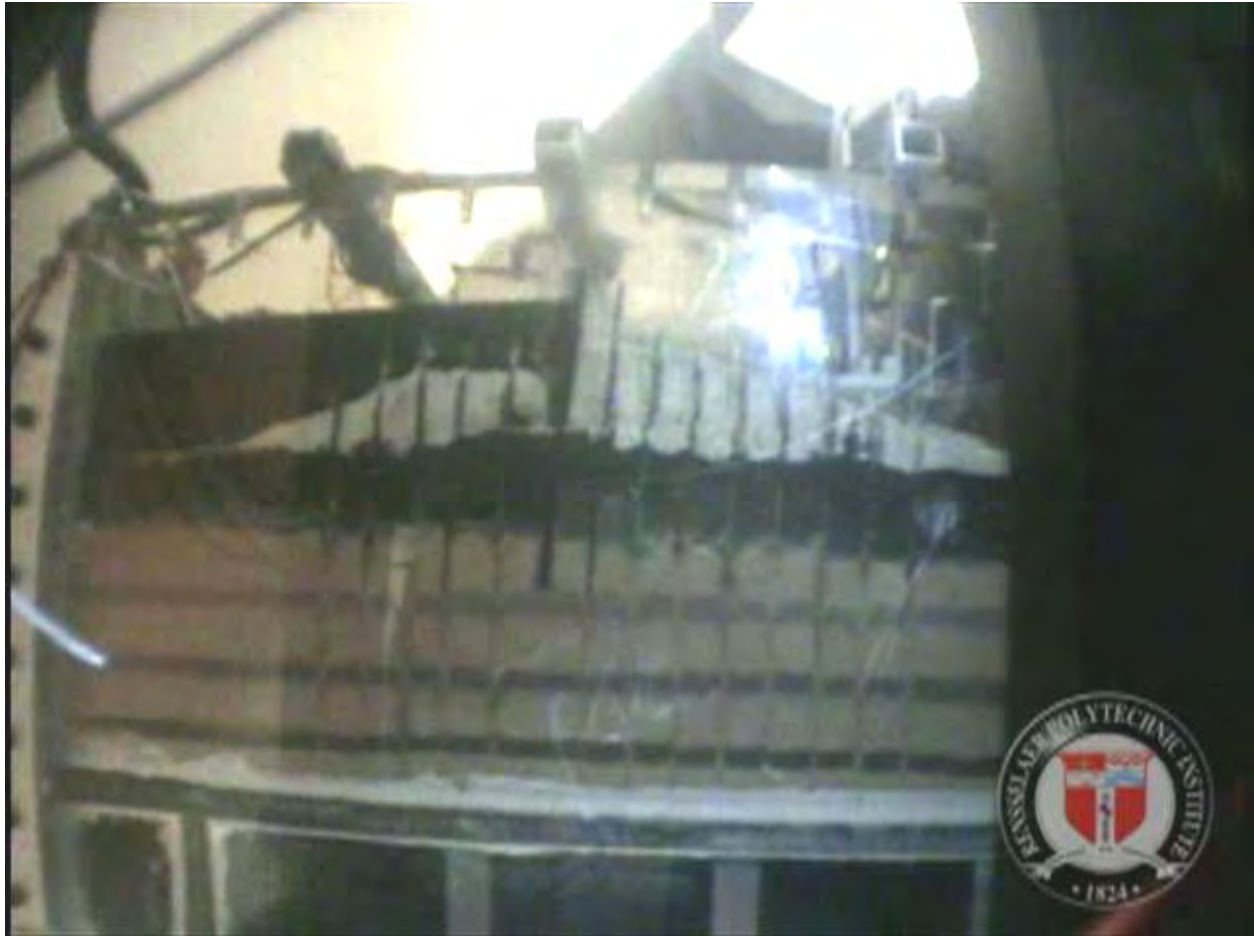
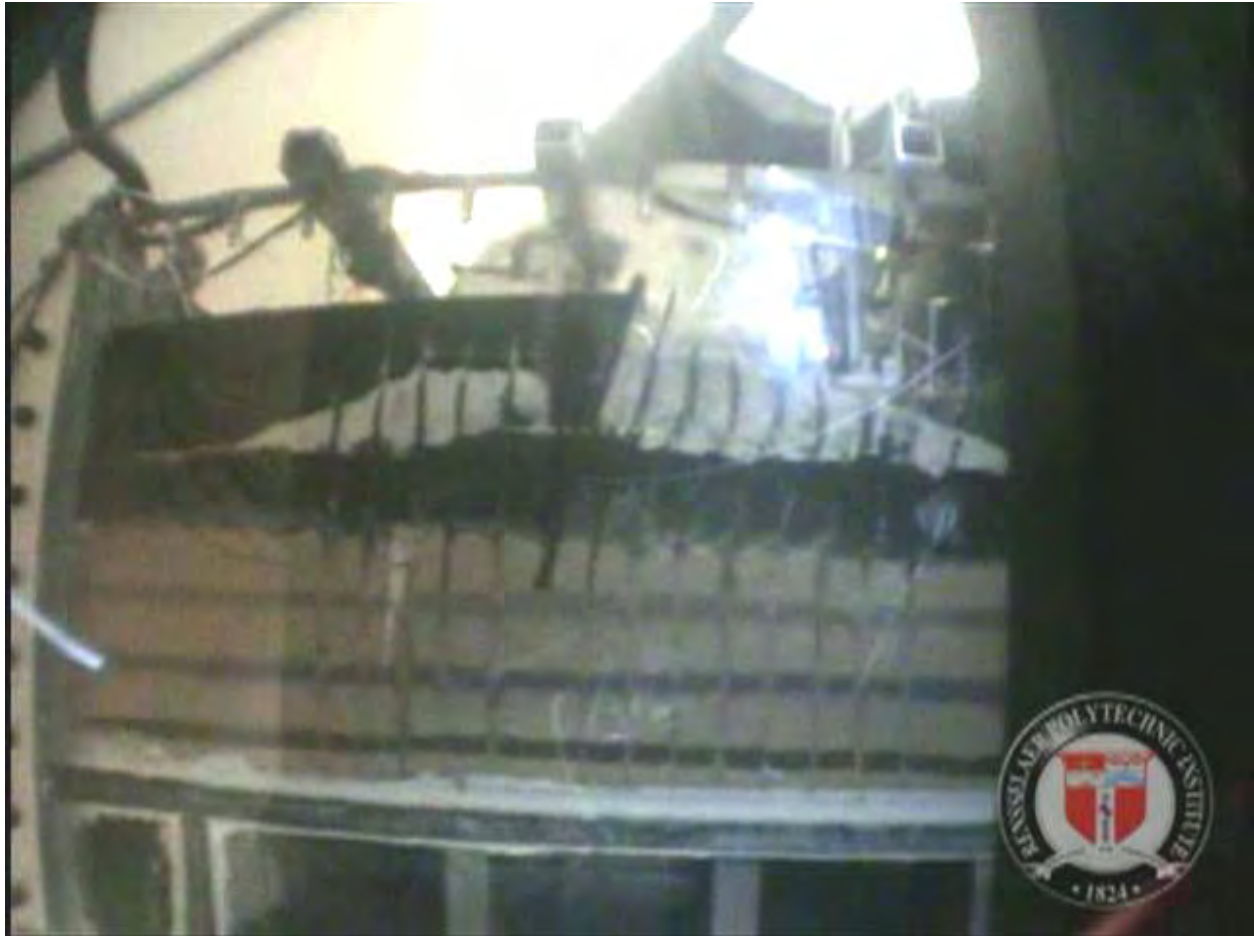
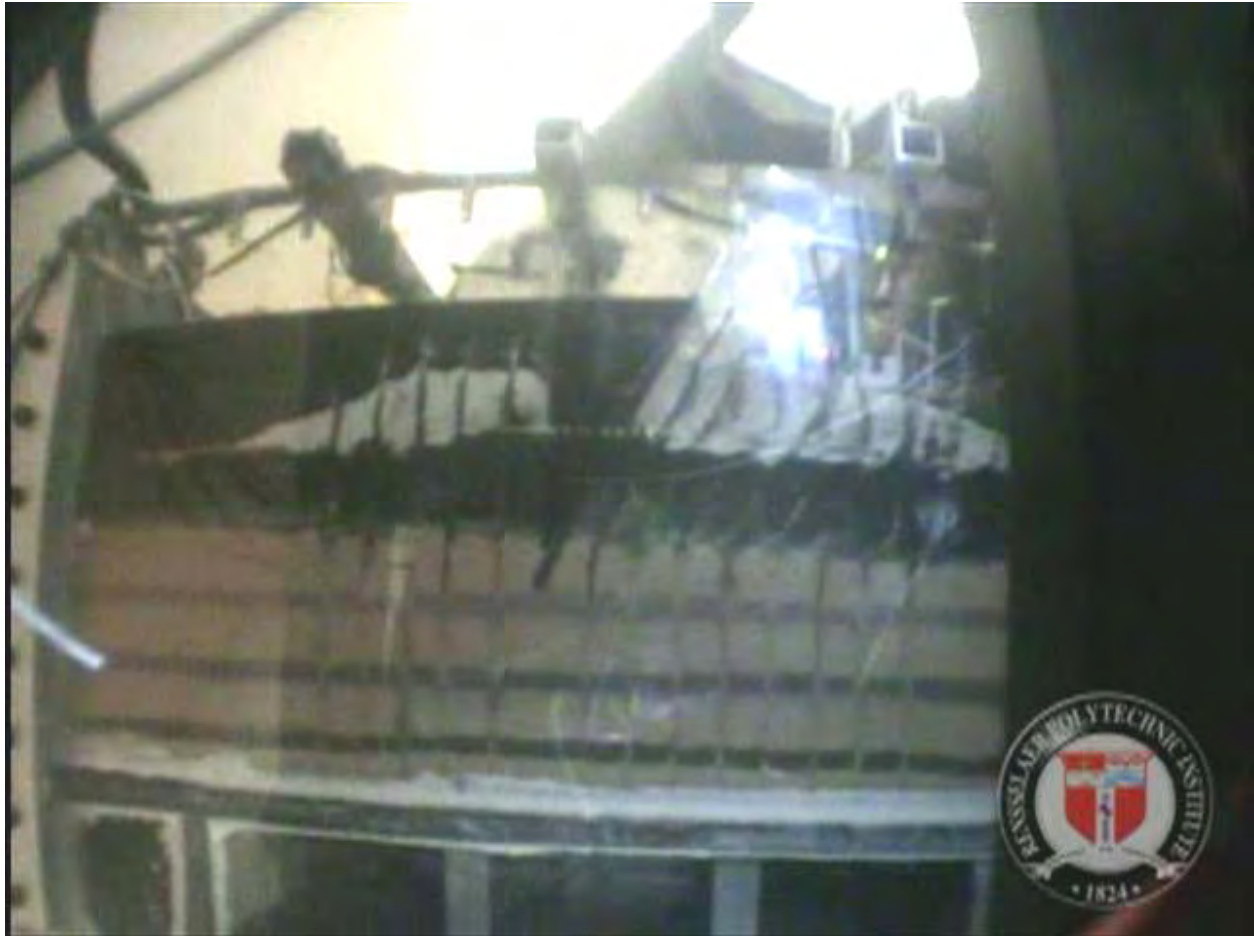
Figure 5.91a. RPI London north model at normal canal water elevation

Figure 5.91b. RPI London north model at flood level just prior to any wall movement

Figure 5.91c. RPI London north model at flood level just after wall movement when crack has opened

Figure 5.91d. RPI London north model at flood level well into failure

Figure 5.91e. RPI London north model at flood level end of failure

A synopsis of the failure event that occurred in the RPI London north model is as highlighted following. This is exactly the same failure event as was observed in the ERDC London north model and confirms the event.

1. Water level increases to a point on the wall where initial movement of the wall begins to occur. This movement starts out as a rotation of the wall.
2. A crack begins to form between the sheet wall and canal side levee and propagates downward.
3. The crack extends all the way through the levee and the swampy/marsh layer to the top of the sand layer.
4. Full hydrostatic pressure is allowed to reach the foundation sand layer causing a sudden increase in pore water pressure.
5. This increase in pore water pressure reduces the vertical effective stress of the overlying swampy/marsh and levee material. Effectively the land side material approaches zero effective stress and begins to 'float'.
6. Load from the flood pushes the wall over in a rotational manner with no resisting force from the land side material.

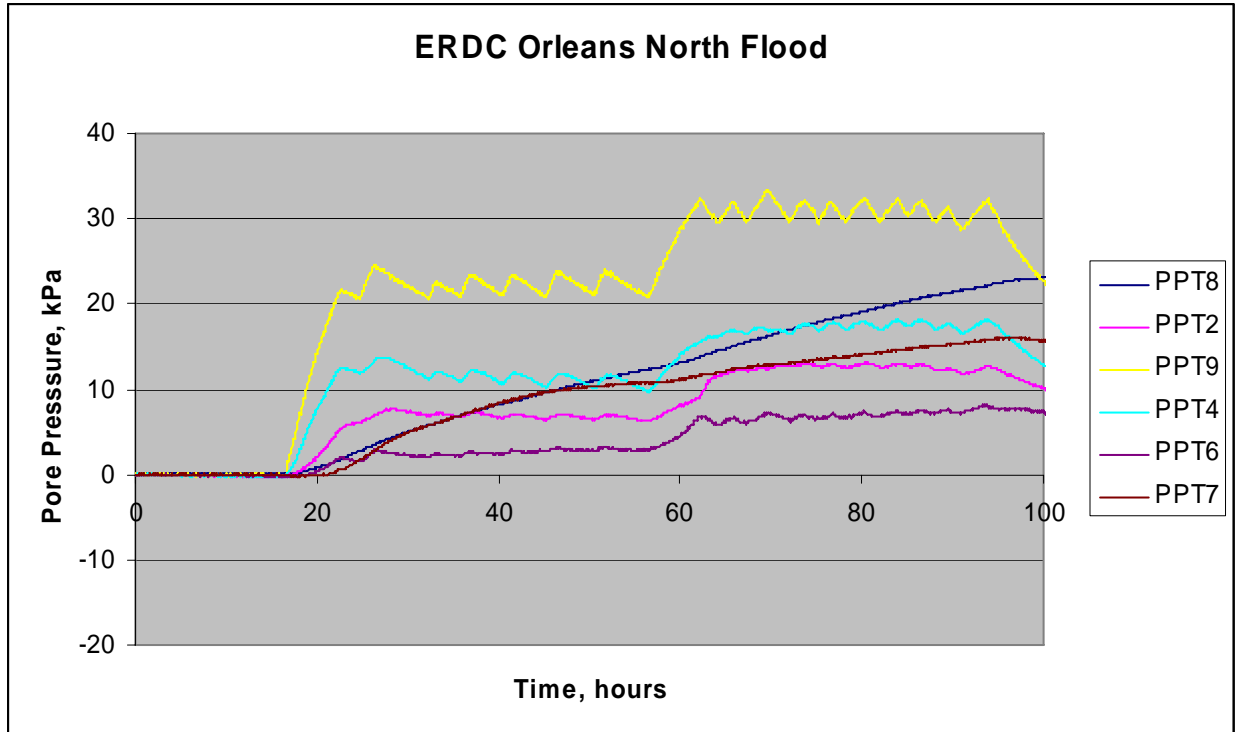
Figure 5.93. PPT data recorded in the ERDC Orleans North model during the flood

There is a step in the PPT data from shortly after the flood event associated with the rise in water level from the normal canal elevation to that at hurricane Katrina. Starting at time 20 hours until approximately 55 hours is the water level being held at the Katrina flood level. A second increase in pressure that is associated with increase in water level to the top of the wall occurs between time 60 hours and 95 hours. This was done to explore the behavior of the wall should the water elevation have gone up to a higher level.

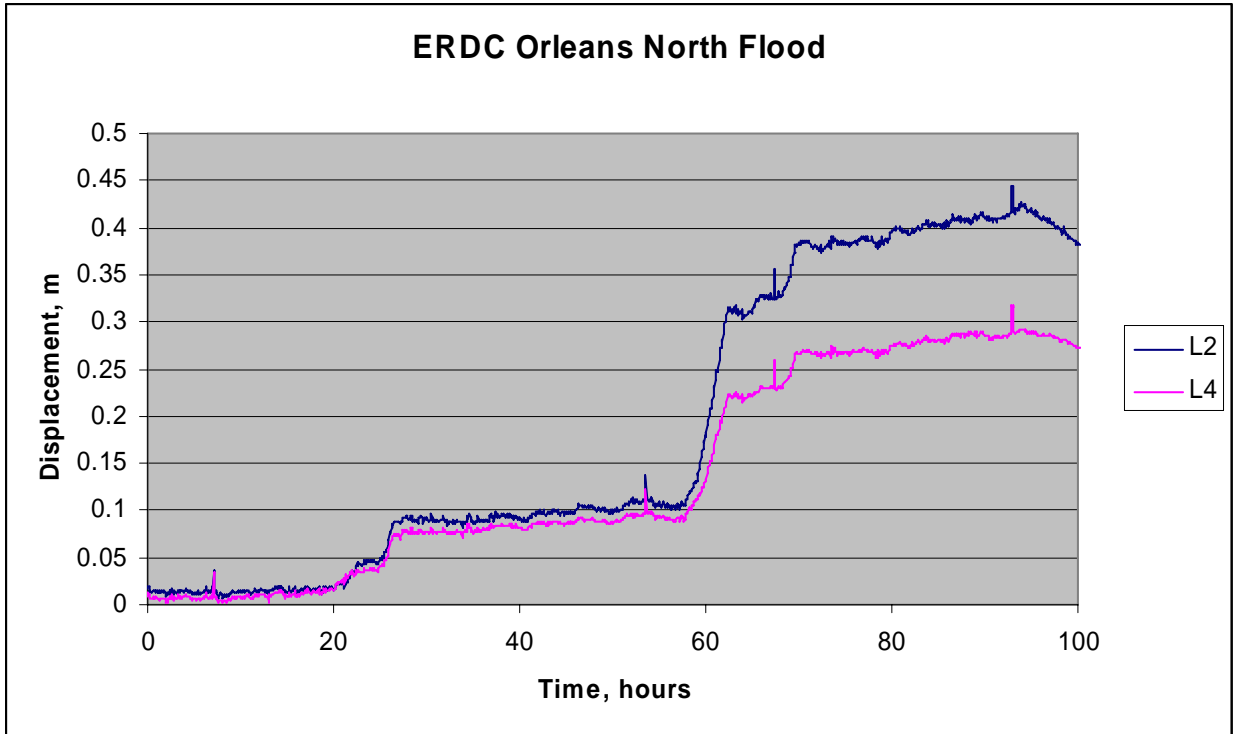
Figure 5.94. Displacement of wall during flood event, Katrina level and additional flood to top of wall

Displacement of the wall as recorded during the flood event is shown in Figure 5.94. As the water level increases there is a point where the wall moves slightly, this is seen as a movement of less than 0.1 m that quickly stops and remains constant for the period of water being held at flood level. At a time of approximately 25 hours the water level was increased to the top of the wall. The displacement data shows that the wall moved an additional 0.2 m. At this point the wall continued a slow movement of an additional 0.1 m. In the video to be shown following, there was a clear formation of a crack at the increased water elevation but this did not develop into a failure of any type.

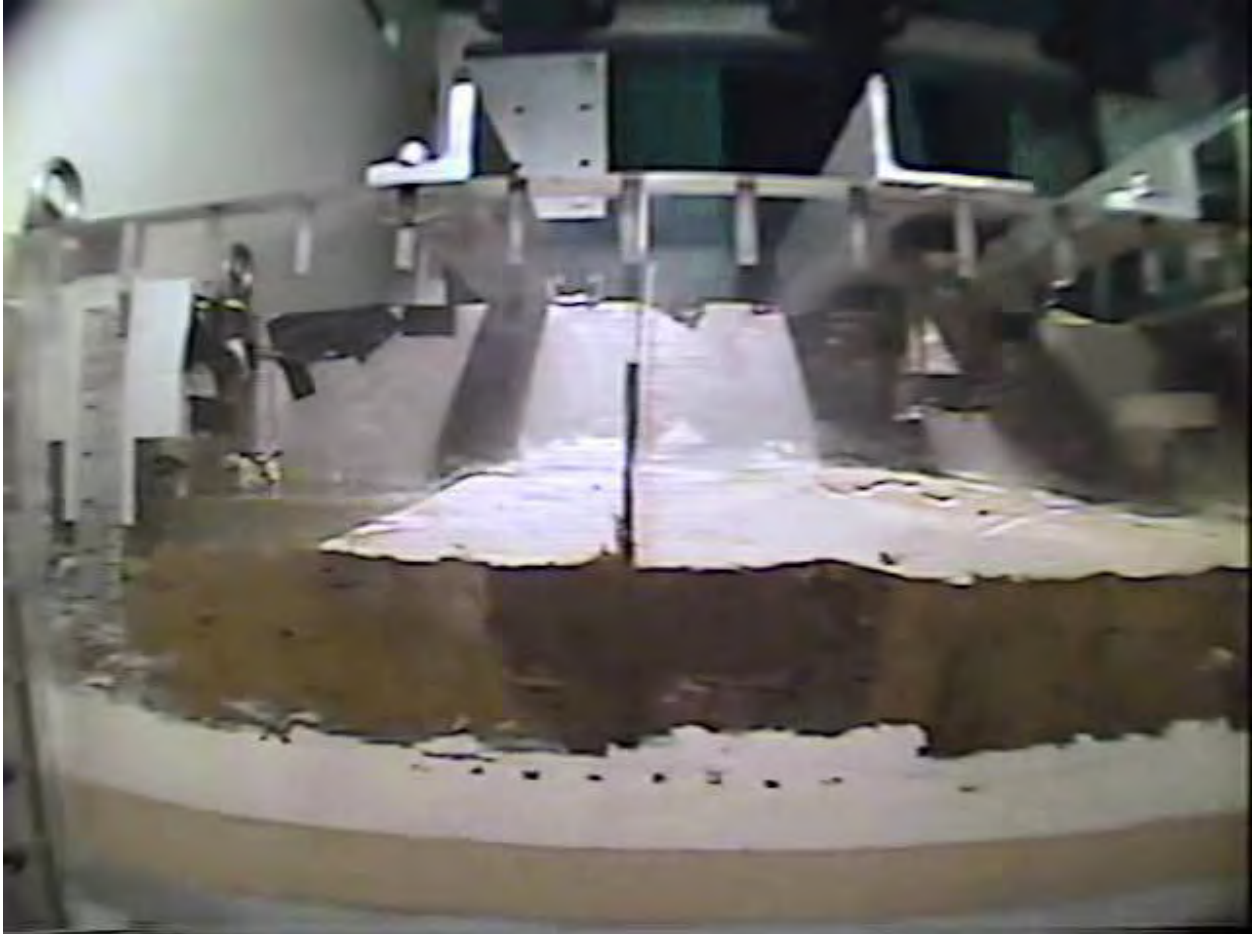
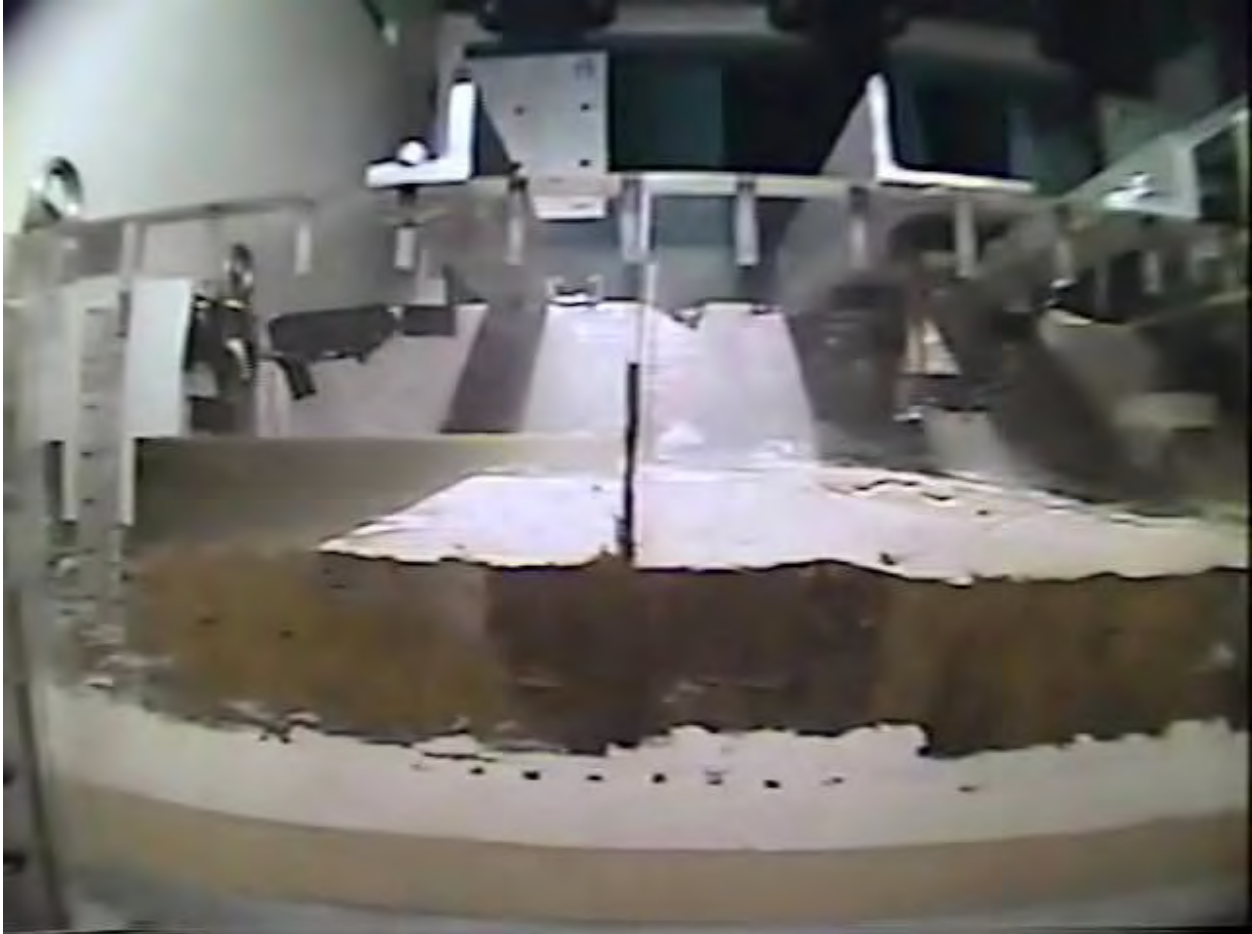
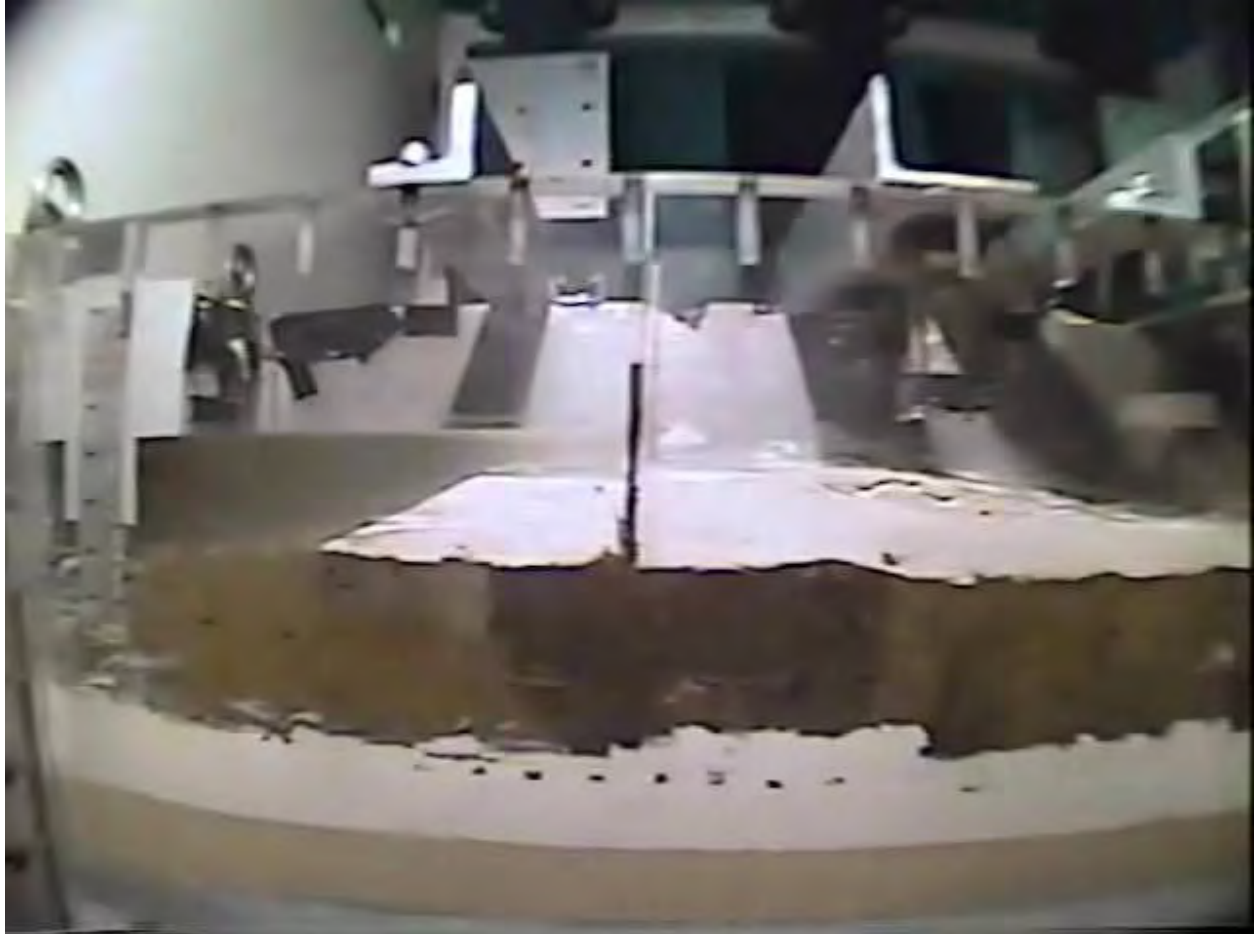
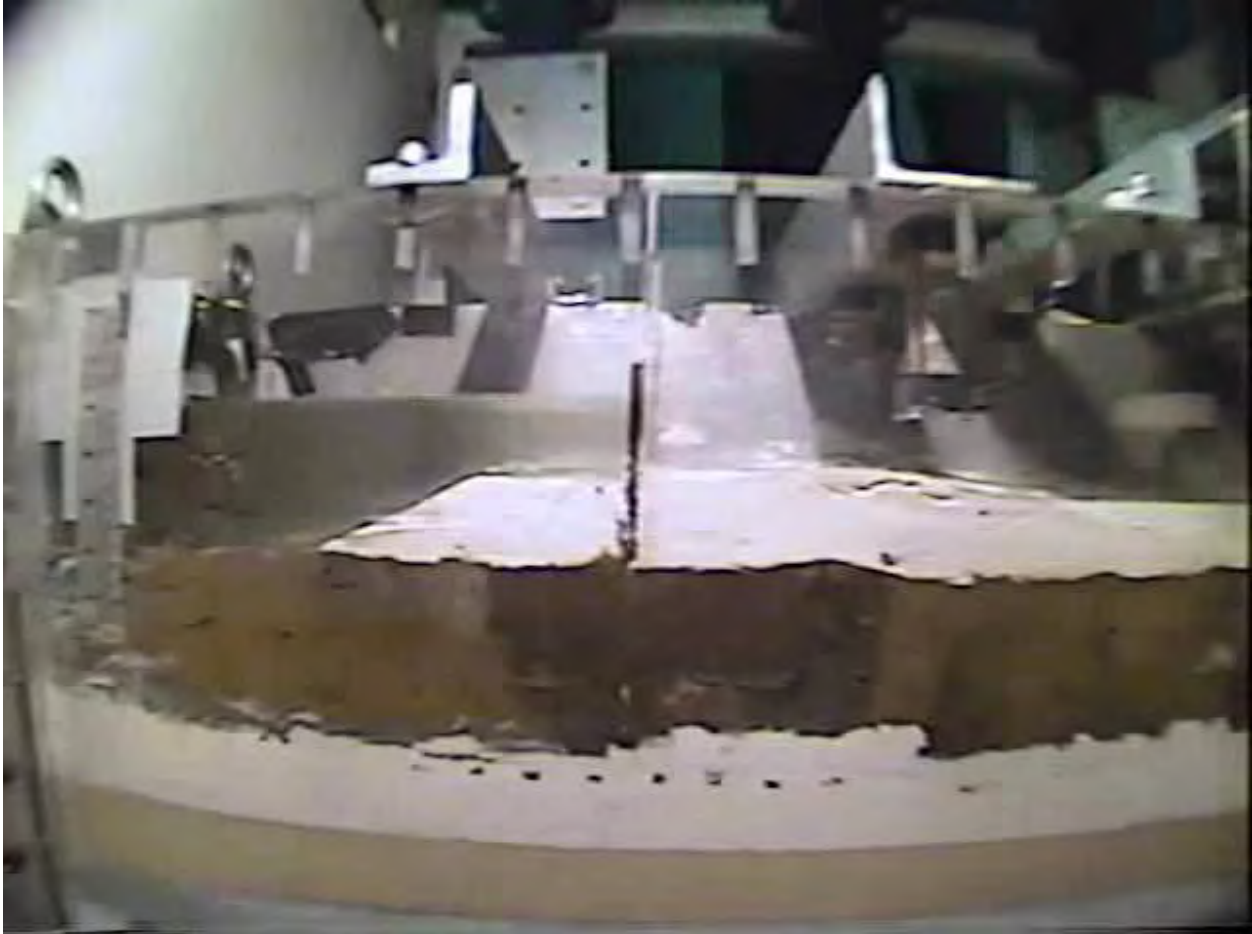
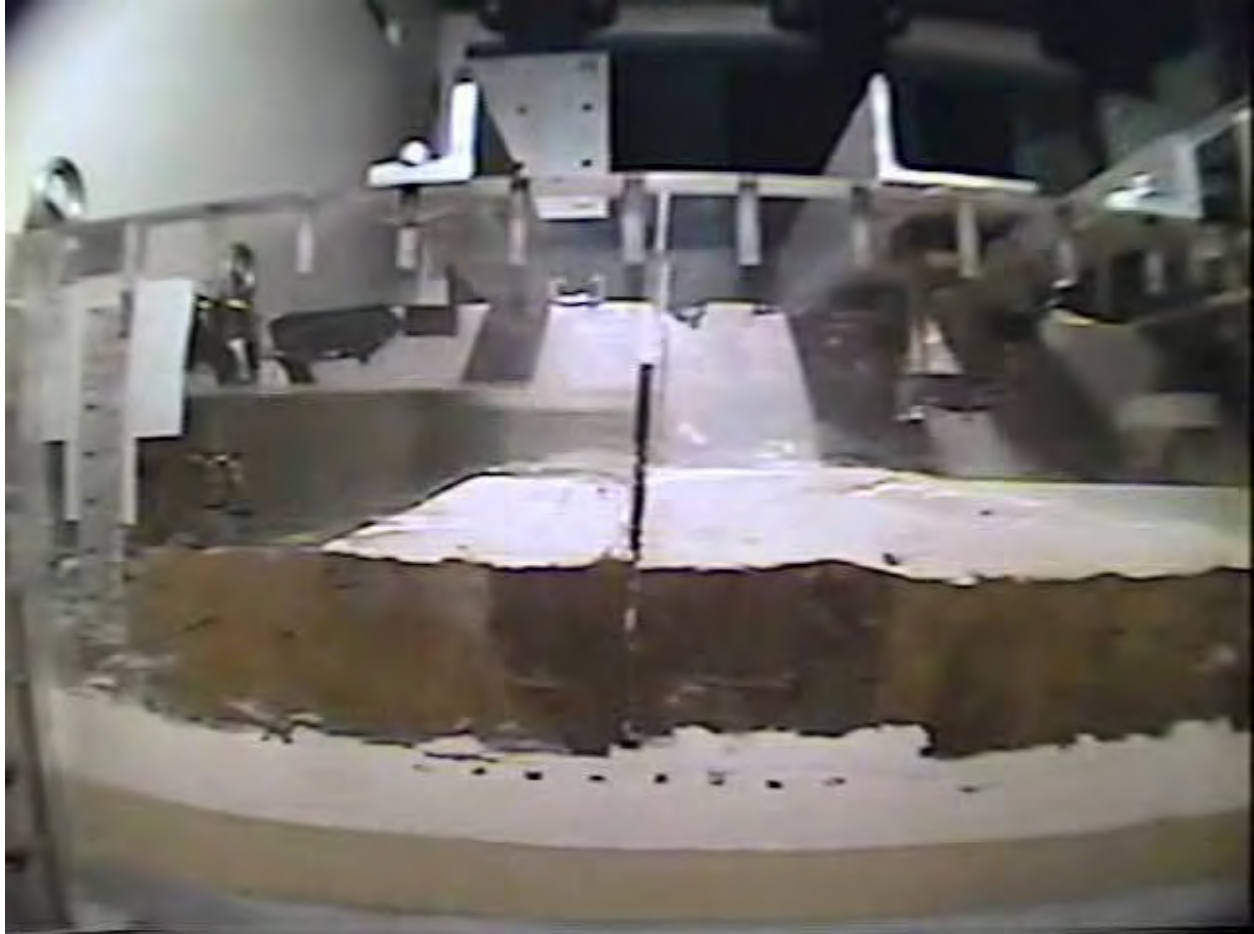
Figure 5.95a. View of model at normal canal elevation prior to flood

Figure 5.95b. View of model at hurricane Katrina flood level

Figure 5.95c. View of model at hurricane Katrina flood level, extended time at flood

Figure 5.95d. View of model where water has been increased above hurricane Katrina level to explore wall behavior

Figure 5.95e. View of model at flood level greater than hurricane Katrina, wall has moved

1. The canal water elevation was increased from normal elevations to those of hurricane Katrina where a very small movement in the wall occurred.
2. Water was held at this level for a long period of time and no further movement of the wall occurred, and the levee was completely stable.
3. Water level was increased from hurricane Katrina level to near top of wall. The wall had an additional movement that formed a crack between the wall and canal side levee.
4. The wall continued to move a very small amount toward the land side but did not lead to failure of any kind in the levee.

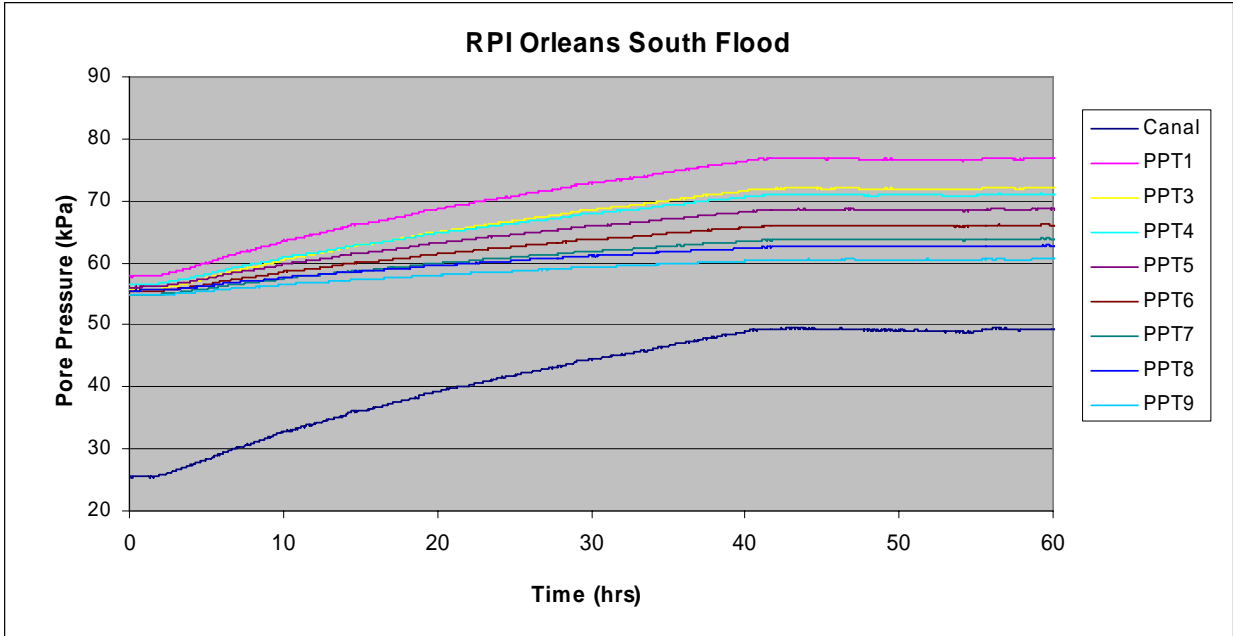
Figure 5.97. PPT data recorded in the sand layer, mid-depth during flood

The model was slowly spun to 50 g, water level increased to that at normal canal operation and all instrumentation allowed to stabilize. Once this was accomplished, the flood load was applied. Results of the flood loading are presented in Figures 5.97 through 5.100. Figure 5.97 is a plot of the PPT data recorded in the sand layer at mid-depth. Notice that there is a steady increase in the pore pressures reaching a level where they remain constant through the flood load.
