Appendix 1

Soil Data Report for 17th Street Canal

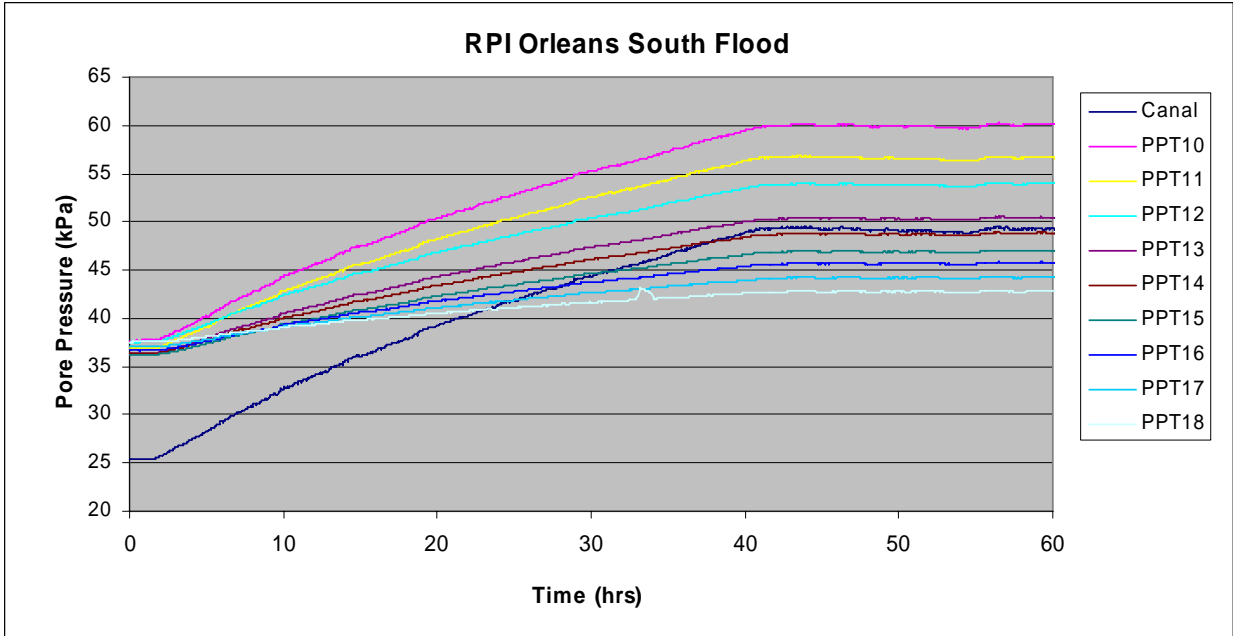
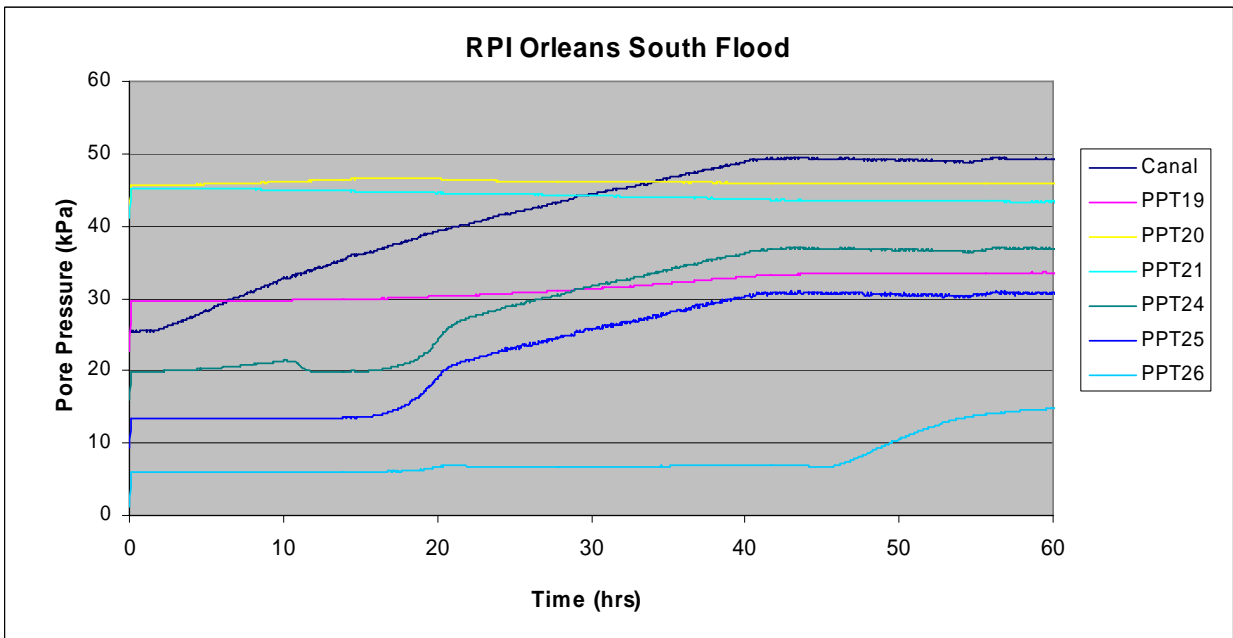
Figure 5.98 is a plot of the PPT data in the sand layer near top during flood event. The character is very much like that of the data in Figure 5.97. Figure 5.99 is the PPT data recorded in the levee and swampy/marsh layer during the flood. There is very little to no response from any of the PPT's located in the swampy/marsh layer. This is not an unexpected event since increase in canal water level would have little effect on these readings over the relatively short duration of the flood event. Notice that there is an increase in PPT's 24, 25 and 26. Instruments 24 and 25 are located near the wall on the canal side and are feeling the load of the increased water level. There is a delayed response in the rise of pressure recorded by PPT 26 which would be expected.

Figure 5.98. PPT data in the sand layer, near top during flood event

Figure 5.99. PPT data in the levee and swampy/marsh layer during flood

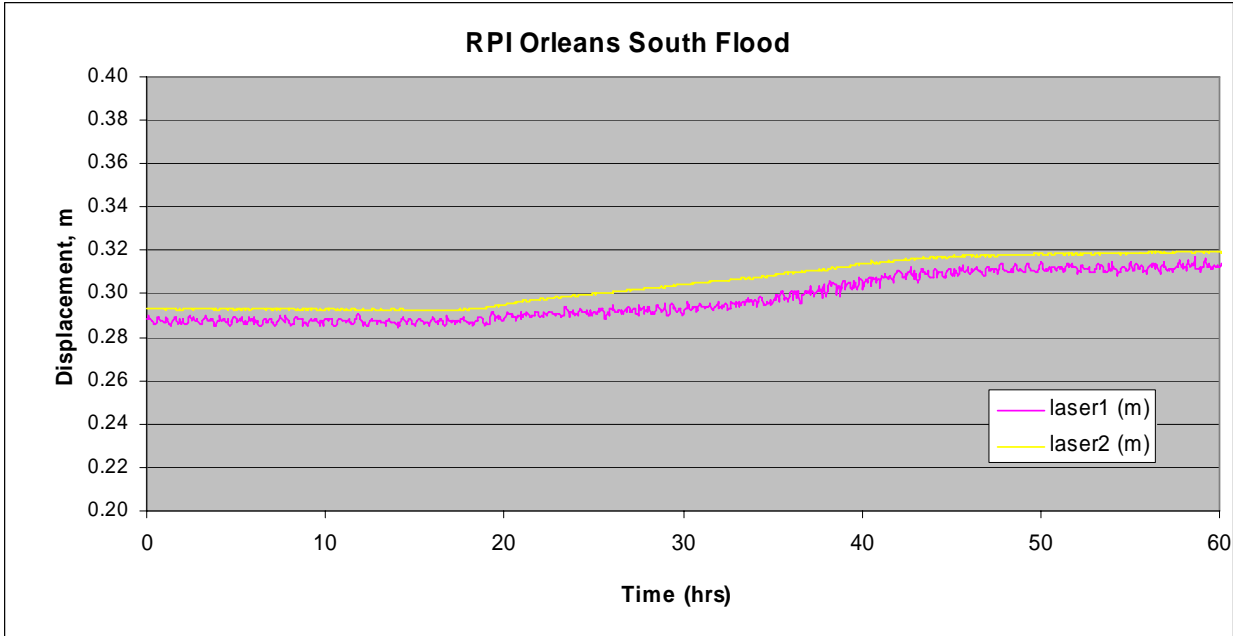
Figure 5.100. Displacement of the wall during flood loading

Measurement of wall movement is shown in Figure 5.100. There is a very small movement in the wall of only 0.03 m but the wall remains constant with no movement thereafter. Although this movement may have opened a very small crack behind the wall, this did not lead to any further movement of the wall or failure of the levee.

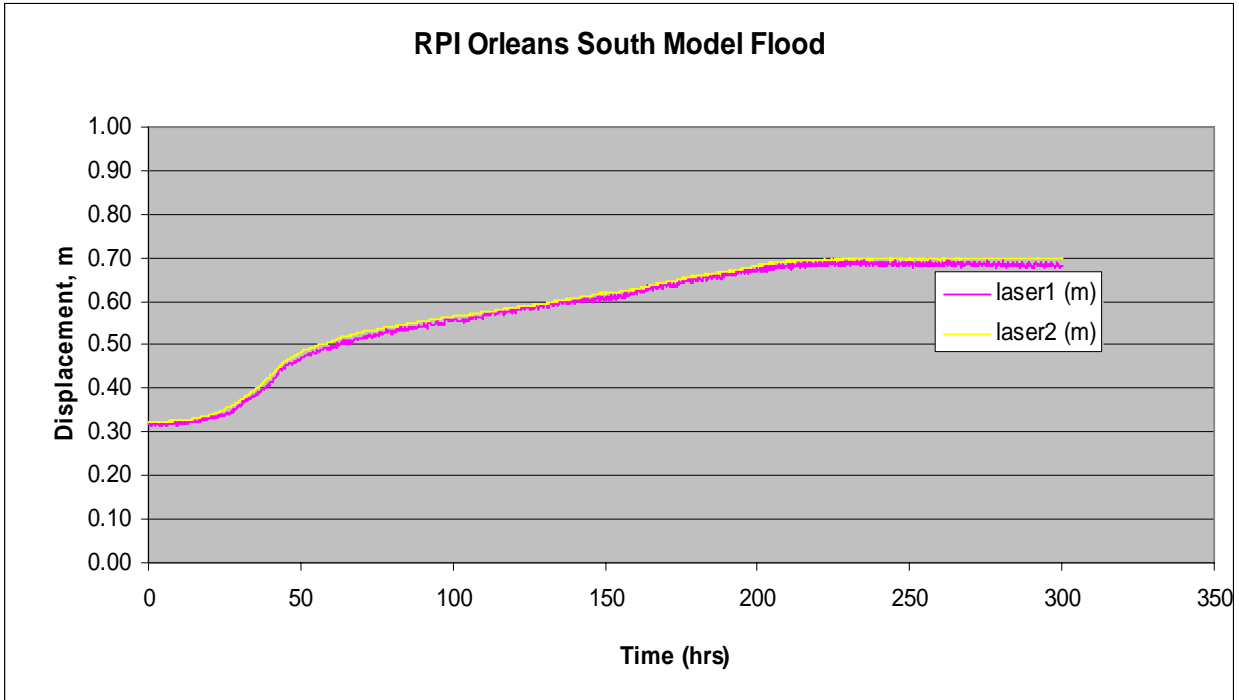
Figure 5.101. Displacement of wall during increased flood load above hurricane Katrina level

After the model was held at the hurricane Katrina level for a period sufficient to show that no failure of the levee would occur, the water elevation was increased to near the top of the wall to explore the behavior of the levee. This was done simply as an exercise to determine what would have happened had the flood level actually reached that high. Just showing the movement of the wall, Figure 101, is enough to show the behavior. The zero time on the plot corresponds to the time when the water elevation is at hurricane Katrina level and risen to the top of the wall. Therefore, all wall movements were as a result of the increased water load above hurricane Katrina level. Notice that the wall starts to move immediately and continues on a fixed slope until about 50 hours. This movement is associated with opening of a crack behind the wall. From this point on, there is a slow steady movement of the wall amounting to about 0.2 m total. This movement would have been enough to cause concern about future stability of the wall.

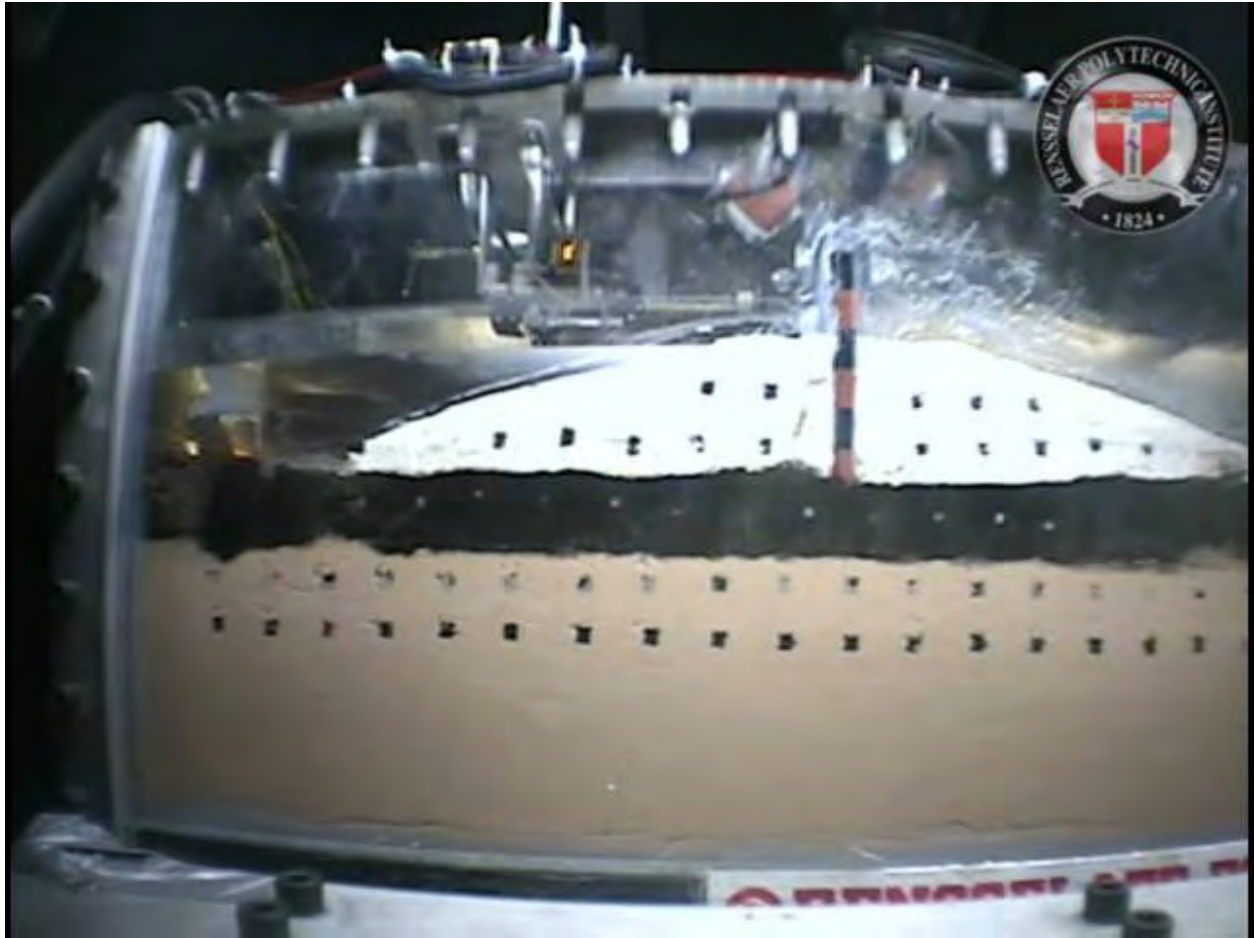
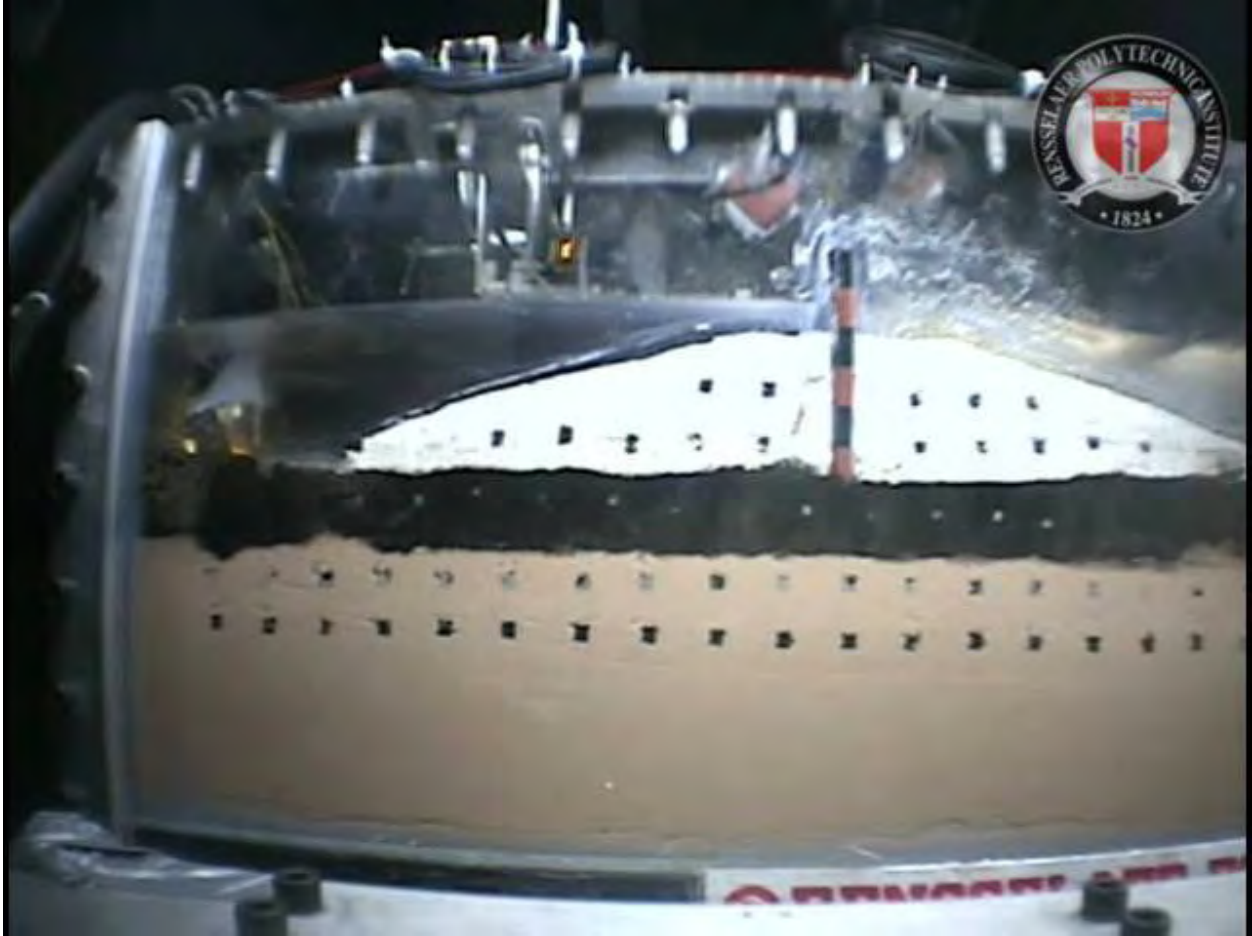
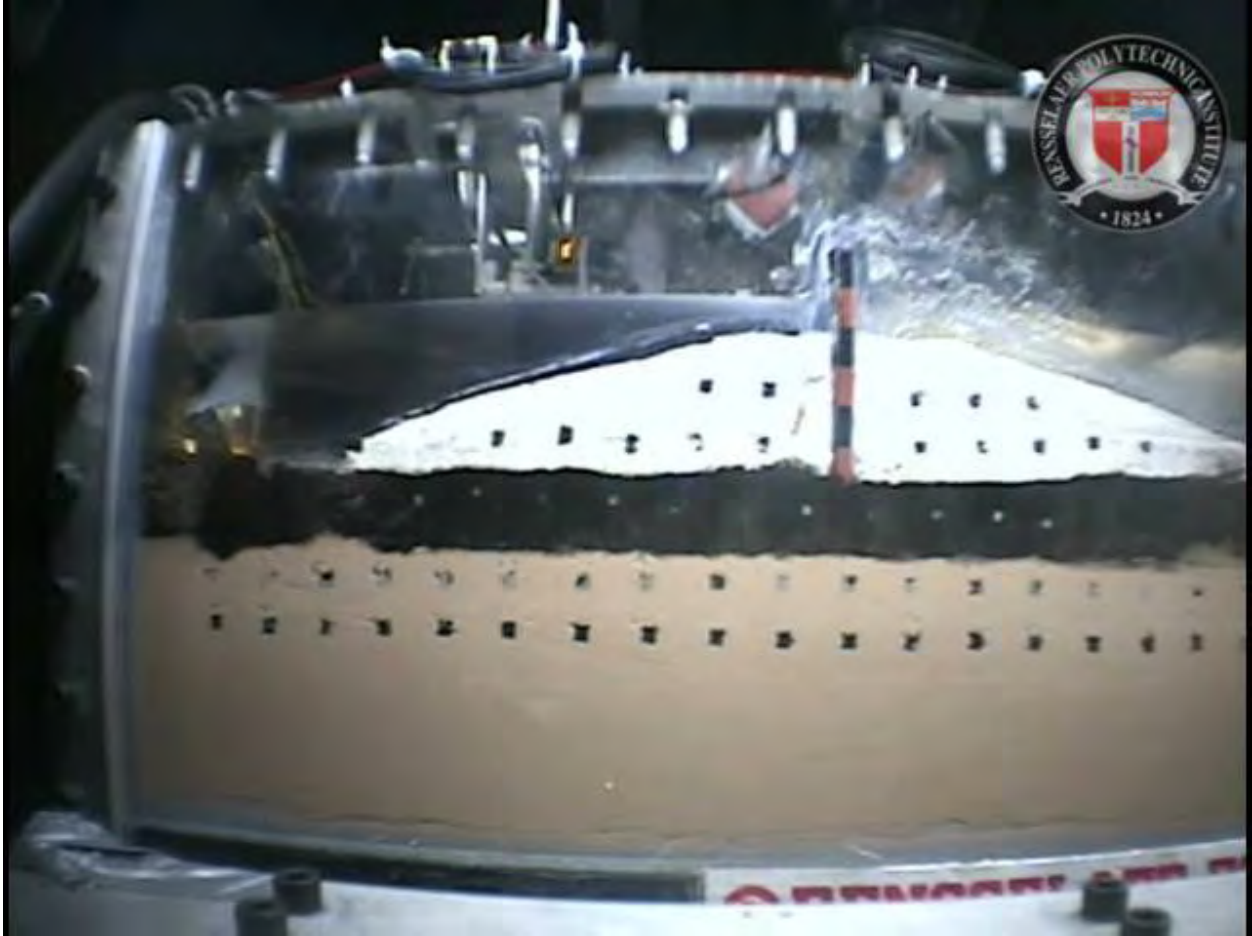
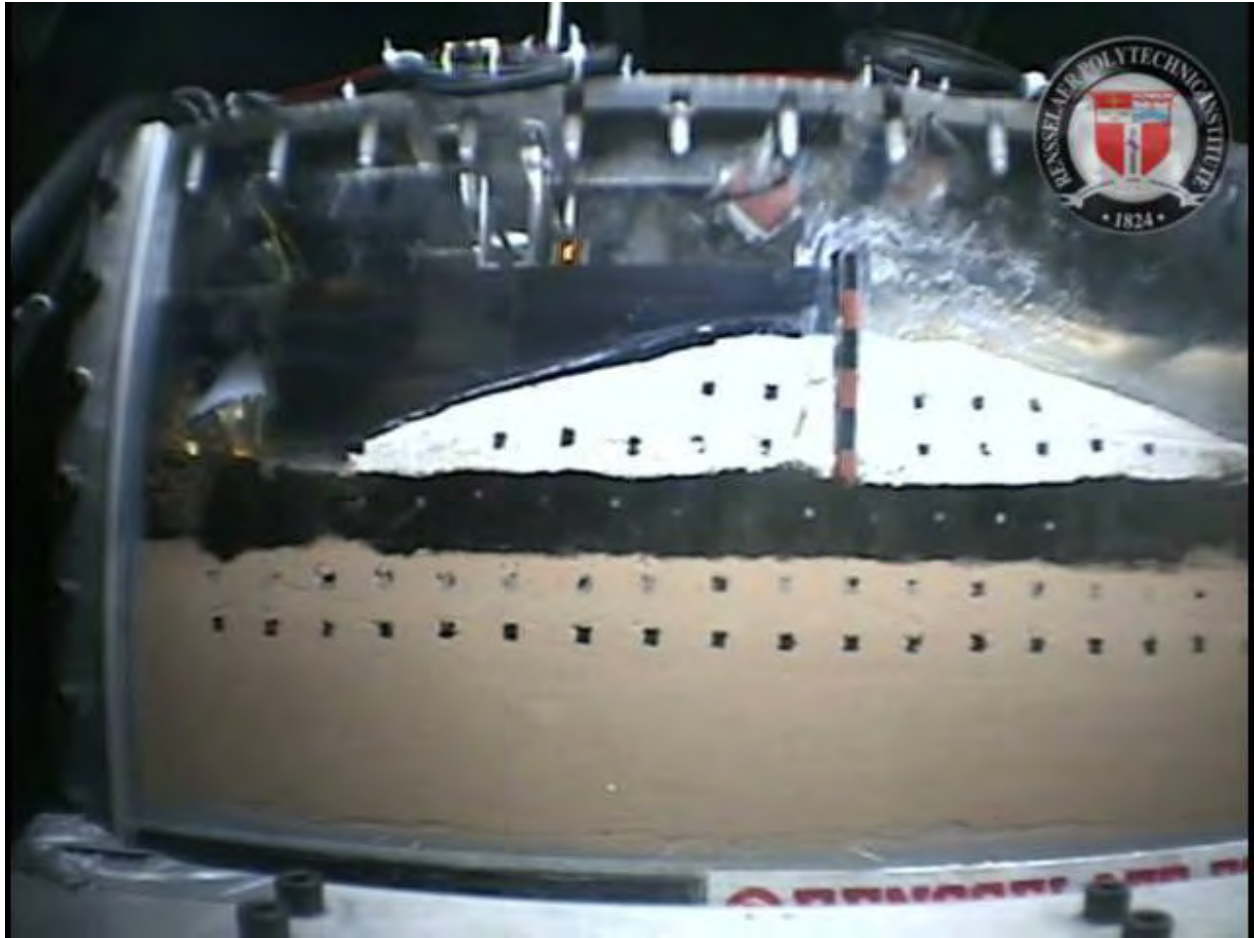
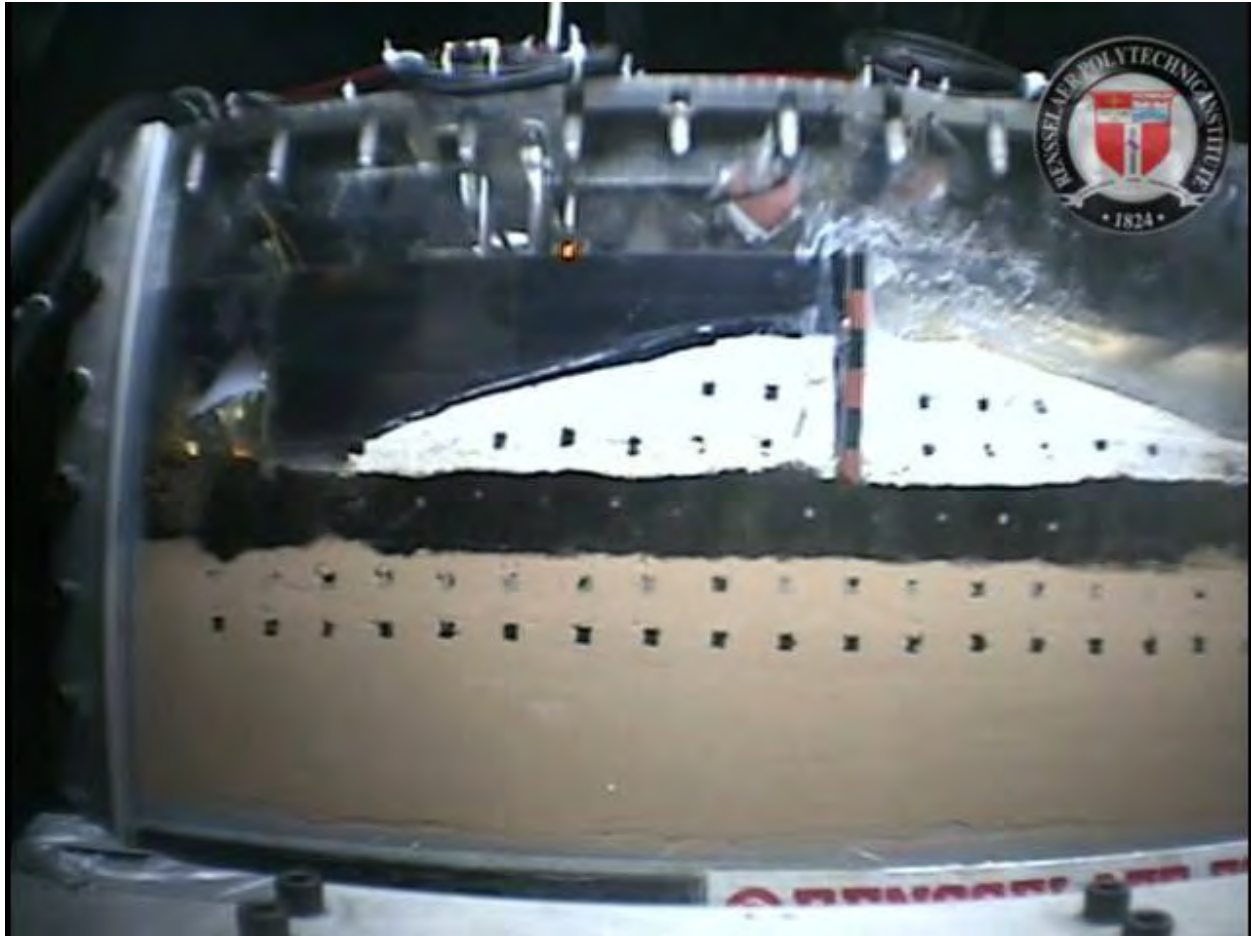
Figure 5.102a. View of RPI Orleans south model at normal canal elevation

Figure 5.102b. View of RPI Orleans south model at hurricane Katrina flood level

Figure 5.102c. View of RPI Orleans south model at hurricane Katrina flood level, held here for long period

Figure 5.102d. View of RPI Orleans south model with water elevation raised above hurricane Katrina level to near top of wall

Figure 5.102e. View of RPI Orleans south model with water elevation raised above hurricane Katrina level showing movement of wall

1. Water was raised to the level of hurricane Katrina and allowed to remain there for an extended period of time
2. The wall moved slightly but did not lead to any failure of the levee or subsequent movement in the wall.
3. Water elevation was then taken to the top of the wall, above hurricane Katrina level. The wall moved an additional amount forming a crack behind the wall as was observed in the other canal walls.
4. This crack opening was preceded by slow steady movement of the wall that did not lead to catastrophic failure, but would have placed the stability of the levee in jeopardy.

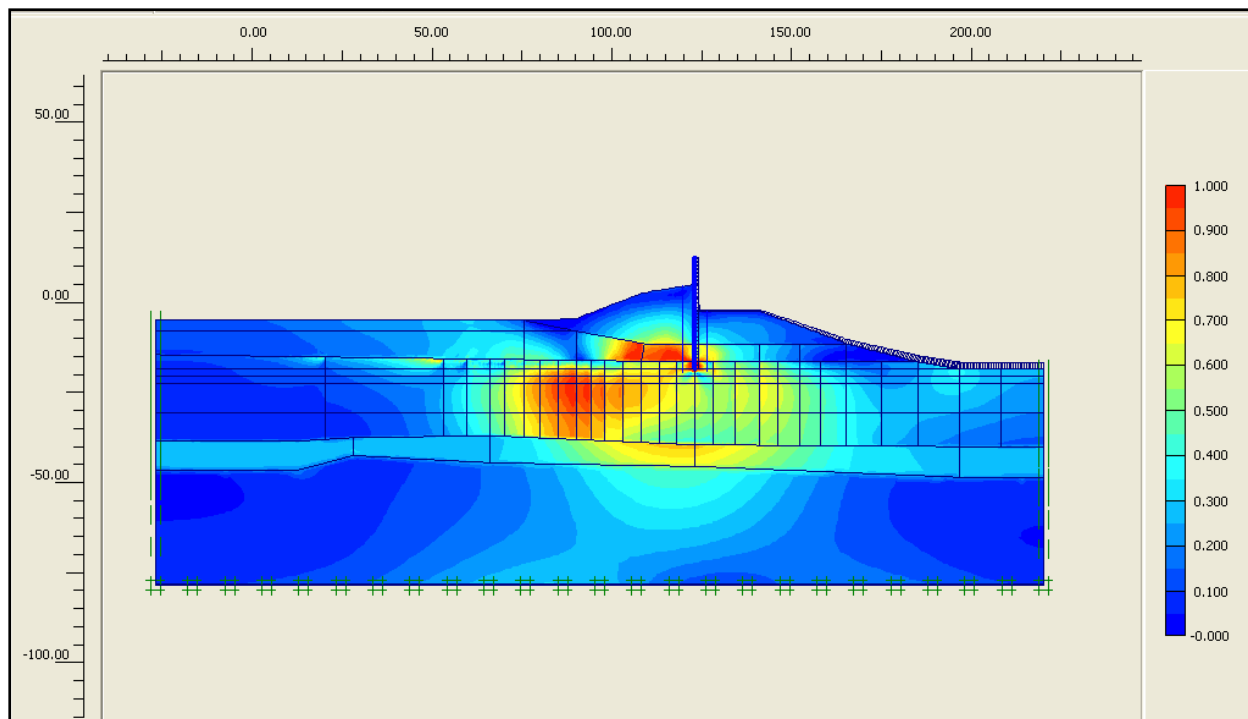
Figure 6-4. Fraction of Mobilized Shear Strength for Canal El 1

The initial steady-state, total stress condition for the usual canal water elevation of 1 is established by adjusting modulus values for the Mohr-Coulomb soil model until a suitable total stress regime is obtained within the mesh for loading phases 0 through 13. The results from the IPET Task 7 slope stability analyses for this usual canal elevation indicate a stable cross section with an ample factor of safety, i.e., above 1.5. Consequently, an important aspect of the total stress regime achieved within the Figure 6-2 finite-element mesh is that the mobilized shear stress at the strain integration points within the finite-elements contained in the soil clusters shown in this figure be less than the shear strength of the soil. The resulting computed fraction of mobilized shear strength (referred to as relative shear stress in Plaxis output) from the resulting initial total stress condition is shown in Figure 6-4. The fraction of mobilized shear strength is less than or equal to 0.95 at the stress integration points for the five soil types.

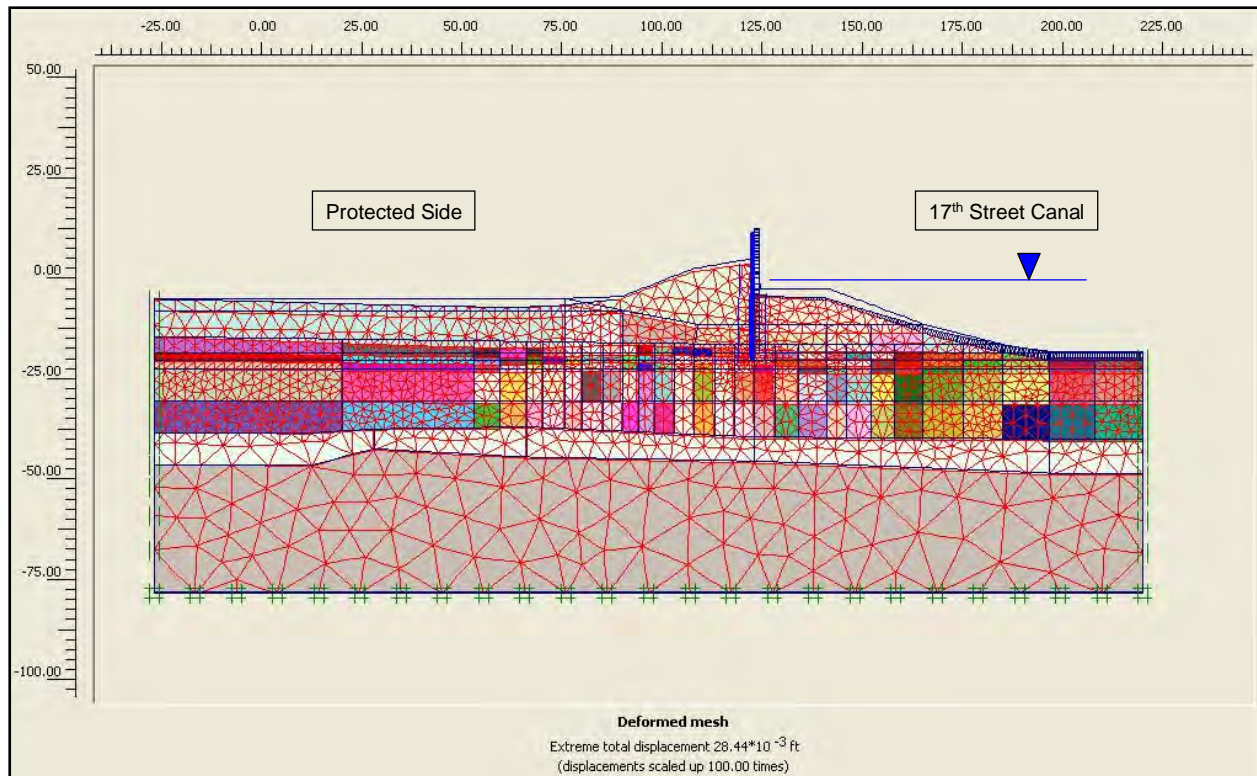
Figure 6-5. Deformed Mesh, Exaggerated by a Factor of 100, for Canal EI 1.5 (Note: Canal EI not to scale in figure)

Canal El 1.5: The first increment in flood loading, designated loading phase 14, corresponds to a 0.5-ft increase in canal water, i.e., from canal steady state El 1 to El 1.5. Hydrostatic canal water pressures are applied as boundary water pressures normal to the wetted side of the I-wall and normal to the wetted exposed face of the levee and clays below the canal. The deformed mesh is shown in Figure 6-5. Note that the nodal deformations are increased by a factor of 100 in order to show the deformed mesh relative to its position at a canal water elevation of 1.0 (shown as a blue outline in this figure). The general trend of deformations is downward and towards the protected side due to the boundary water pressure loading applied within the canal. The maximum (relative) displacement within the mesh is 0.028 ft ($< 3/8$ in.). There is no indication of a fully developed failure mechanism occurring at this flood stage.

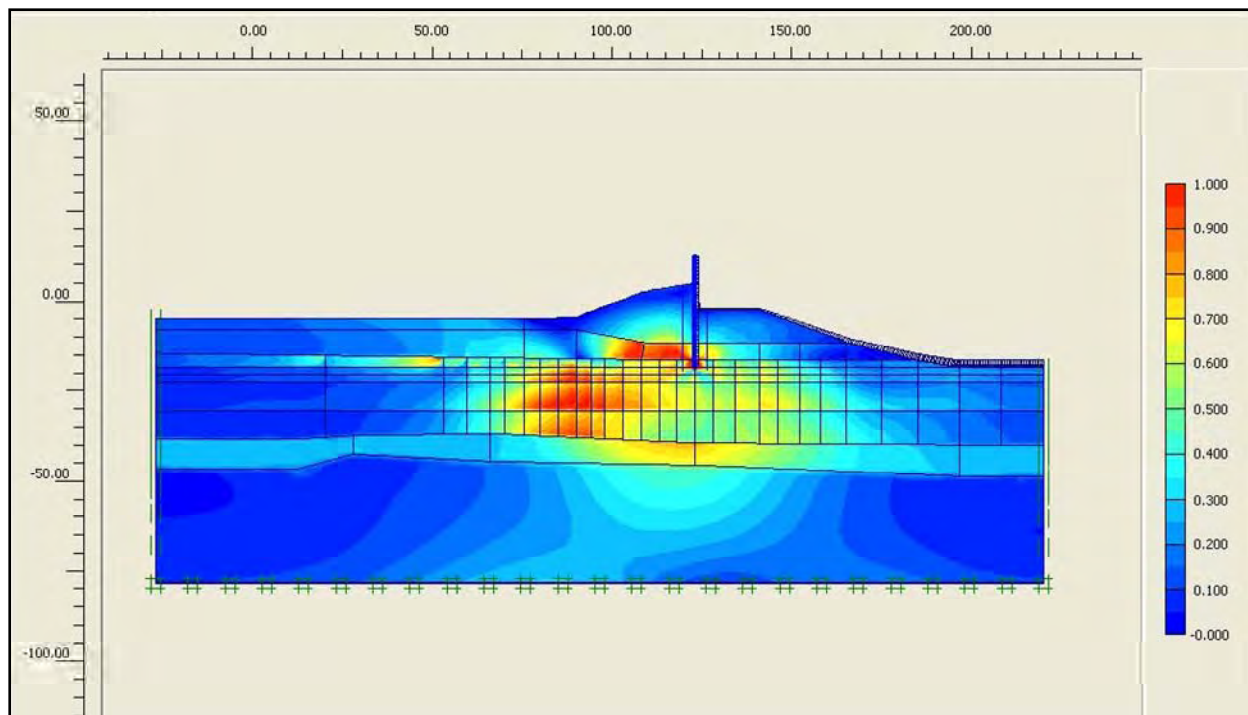
Figure 6-6. Fraction of Mobilized Shear Strength for Canal El 1.5

The mobilized shear stress at the strain integration points within the finite elements contained in the soil clusters is shown in Figure 6-6 to be less than the shear strength of the soil. The resulting computed fraction of mobilized shear strength is less than or equal to 0.96 at the stress integration points for the five soil types. The horizontal total stress state at the top of the submerged levee berm on the canal side and adjacent to the sheet pile does not indicate that a crack will open at this canal water elevation.

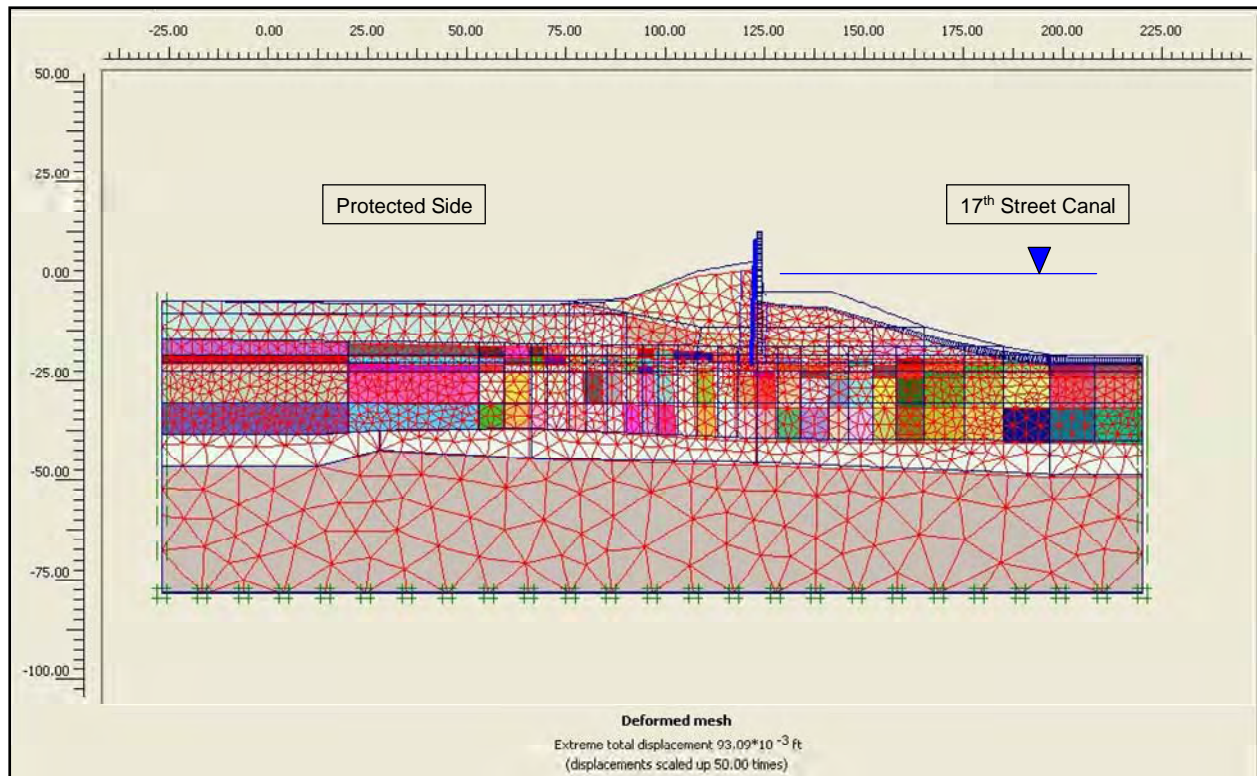
Figure 6-7. Deformed Mesh, Exaggerated by a Factor of 50, for Canal EI 2.5 (Note: Canal EI not to scale in figure)

Canal El 2.5: The second increment in flood loading, designated loading phase 15, raises the canal water to El 2.5. This is a 1.5-ft increase in canal water relative to canal steady state El 1 or, equivalently, a 1-ft increase in canal flood water elevation from canal El 1.5 of loading phase 14. The loading applied to the mesh is again solely due to hydrostatic canal water pressures applied as boundary water pressures normal to the wetted side of the I-wall and normal to the wetted exposed face of the levee and clays forming the sides and base of the canal. The deformed mesh is shown in Figure 6-7. Note that the nodal deformations are increased by a factor of 50 in order to show the deformed mesh relative to its position at a canal water elevation of 1.0 (shown as a blue outline in this figure). The general trend of deformations is downward and towards the protected side due to the boundary water pressure loading applied within the canal. The maximum (relative) displacement within the mesh is 0.093 ft ($< 1\text{-}1/8$ in.). There is no indication of a fully developed failure mechanism occurring at this flood stage.

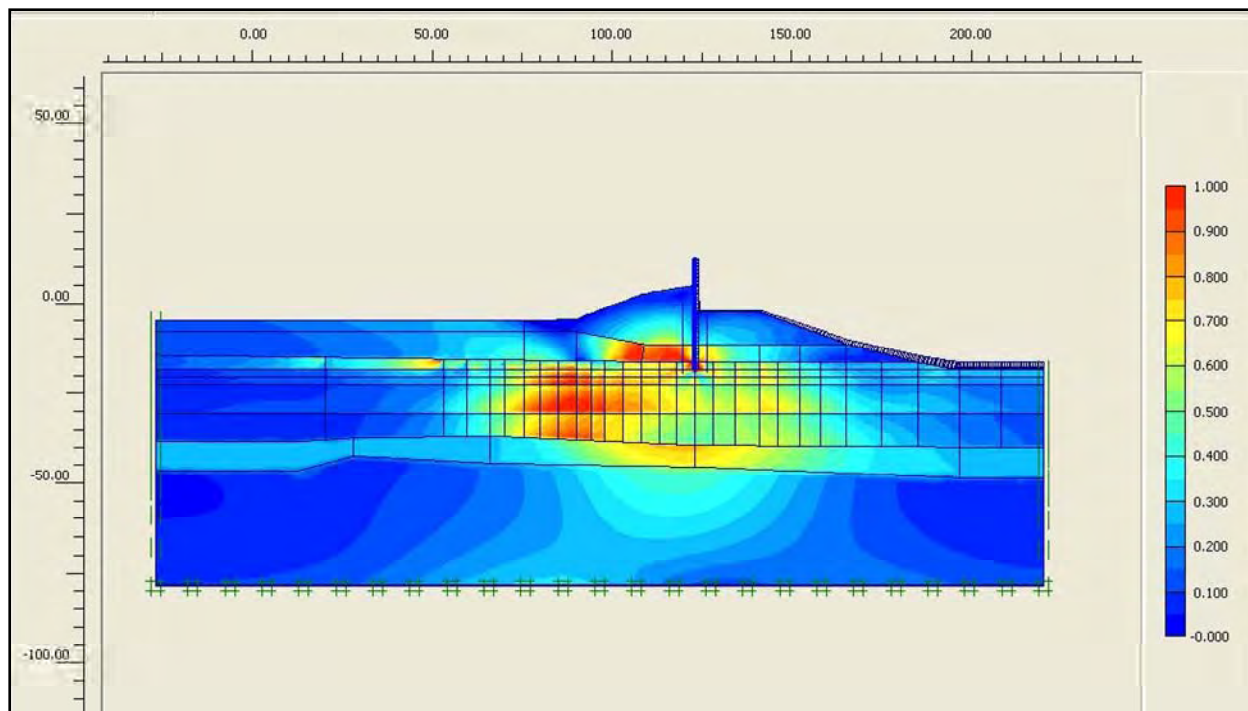
Figure 6-8. Fraction of Mobilized Shear Strength for Canal El 2.5

The mobilized shear stress at the strain integration points within the finite elements contained in the soil clusters is shown in Figure 6-8 to be less than the shear strength of the soil. The resulting computed fraction of mobilized shear strength is less than or equal to 0.96 at the stress integration points for the five soil types. The horizontal total stress state at the top of the submerged levee berm on the canal side and adjacent to the sheet pile does not indicate that a crack will open at this canal water elevation.

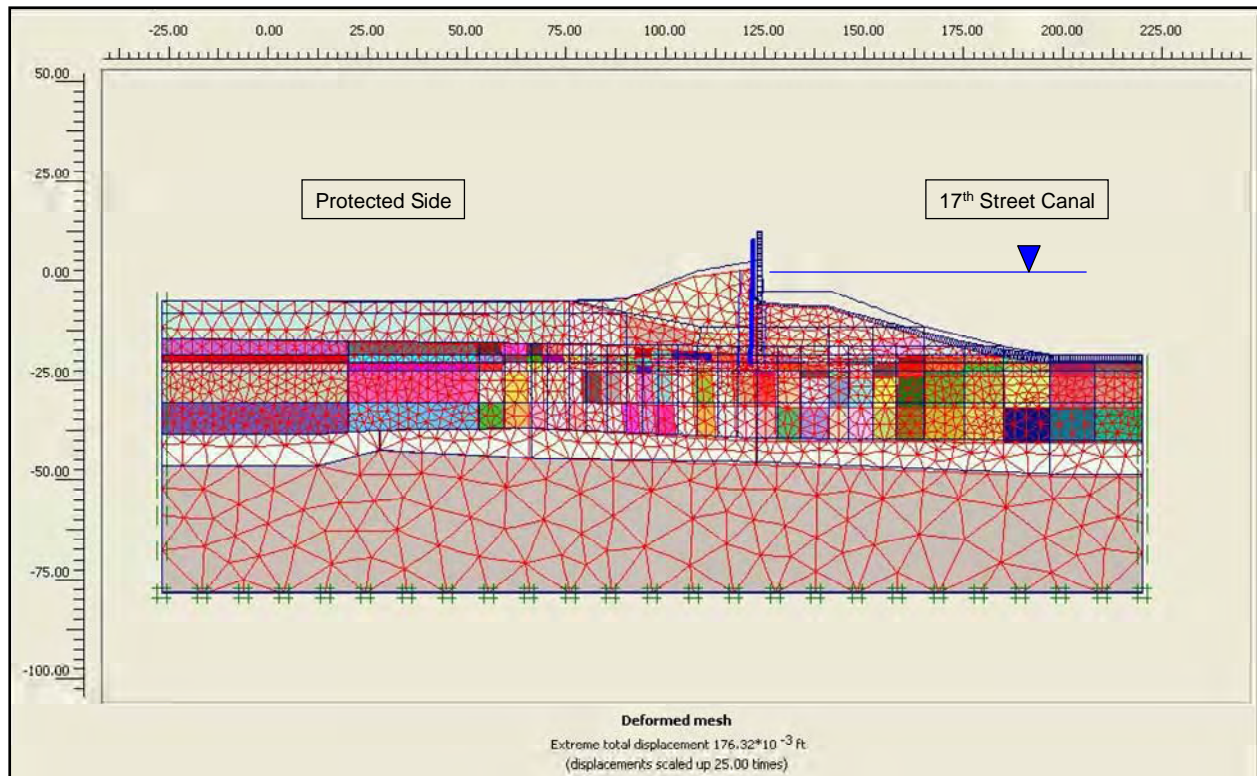
Figure 6-9. Deformed Mesh, Exaggerated by a Factor of 25, for Canal EI 3.5 (Note: Canal EI not to scale in figure)

Canal El 3.5: The third increment in flood loading, designated loading phase 16, raises the canal water to El 3.5. This is a 2.5-ft increase in canal water relative to canal steady state El 1 or, equivalently, a 1-ft increase in canal flood water elevation from canal El 2.5 of loading phase 15. The loading applied to the mesh is again solely due to hydrostatic canal water pressures applied as boundary water pressures normal to the wetted side of the I-wall and normal to the wetted exposed face of the levee and clays forming the sides and base of the canal. The deformed mesh is shown in Figure 6-9. Note that the nodal deformations are increased by a factor of 25 in order to show the deformed mesh relative to its position at a canal water elevation of 1.0 (shown as a blue outline in this figure). The general trend of deformations is downward and towards the protected side due to the boundary water pressure loading applied within the canal. The maximum (relative) displacement within the mesh is 0.176 ft ($< 2\text{-}1/8$ in.). There is no indication of a fully developed failure mechanism occurring at this flood stage.

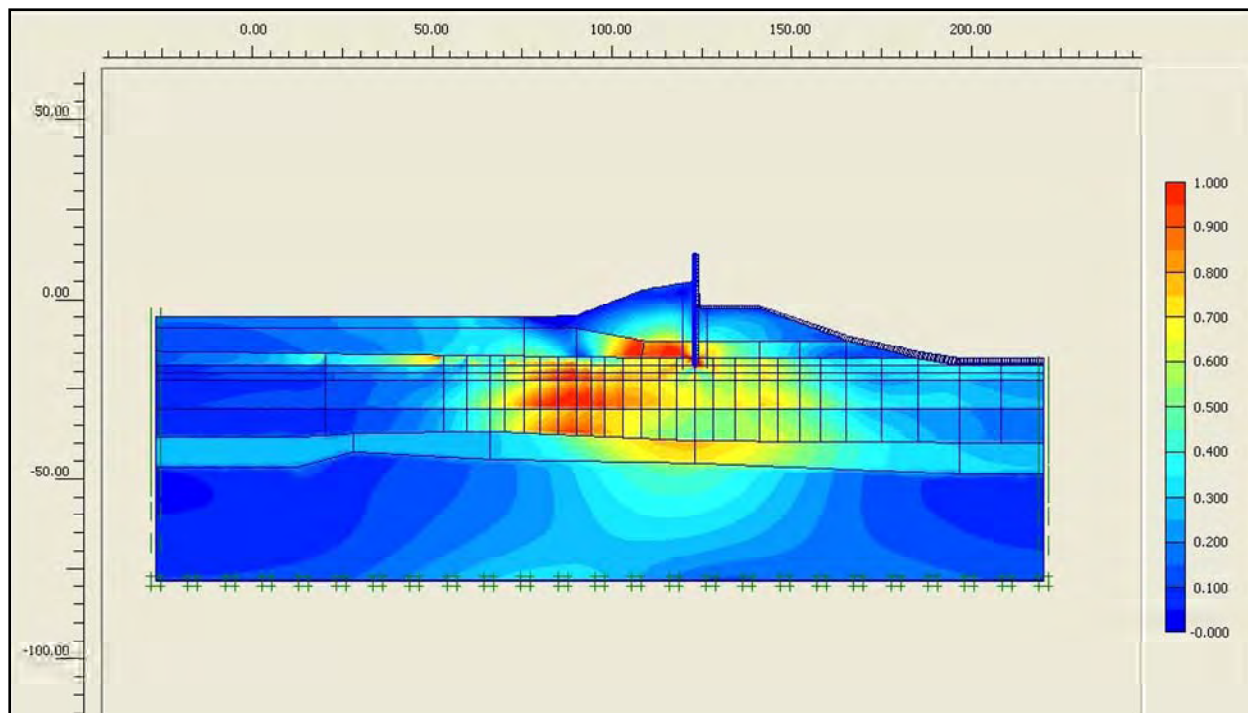
Figure 6-10. Fraction of Mobilized Shear Strength for Canal El 3.5

The mobilized shear stress at the strain integration points within the finite elements contained in the soil clusters is shown in Figure 6-10 to be less than the shear strength of the soil. The resulting computed fraction of mobilized shear strength is less than or equal to 0.96 at the stress integration points for the five soil types. The horizontal total stress state at the top of the submerged levee berm on the canal side and adjacent to the sheet pile does not indicate that a crack will open at this canal water elevation.

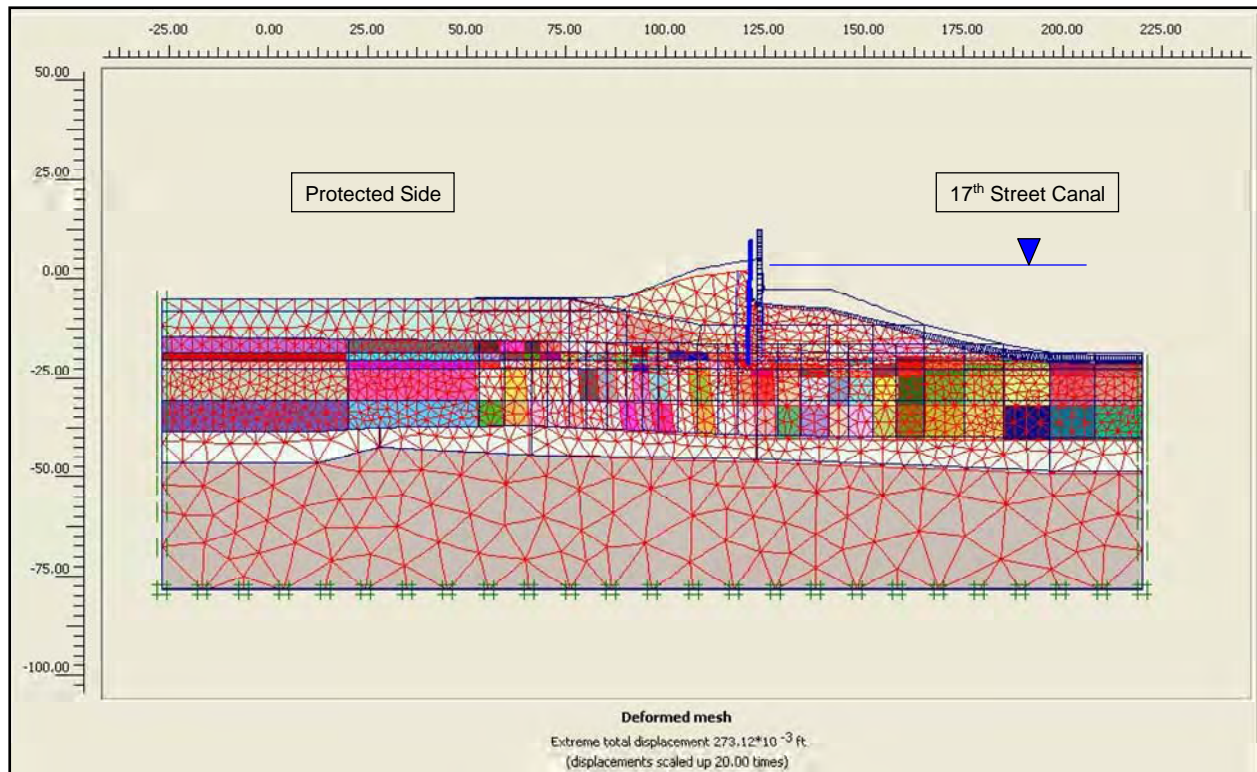
Canal El 4.5: The fourth increment in flood loading, designated loading phase 17, raises the canal water to El 4.5. This is a 3.5-ft increase in canal water relative to canal steady state El 1 or, equivalently, a 1-ft increase in canal flood water elevation from canal El 3.5 of loading phase 16. The loading applied to the mesh is again solely due to hydrostatic canal water pressures applied as boundary water pressures normal to the wetted side of the I-wall and normal to the wetted exposed face of the levee and clays forming the sides and base of the canal. The deformed mesh is shown in Figure 6-11. Note that the nodal deformations are increased by a factor of 20 in order to show the deformed mesh relative to its position at a canal water elevation of 1.0 (shown as a blue outline in this figure). The general trend of deformations is downward and towards the protected side due to the boundary water pressure loading applied within the canal. The maximum (relative) displacement within the mesh is 0.273 ft (approximately 3-1/4 in.). There is no indication of a fully developed failure mechanism occurring at this flood stage.

Figure 6-11. Deformed Mesh, Exaggerated by a Factor of 20, for Canal EI 4.5 (Note: Canal EI not to scale in figure)

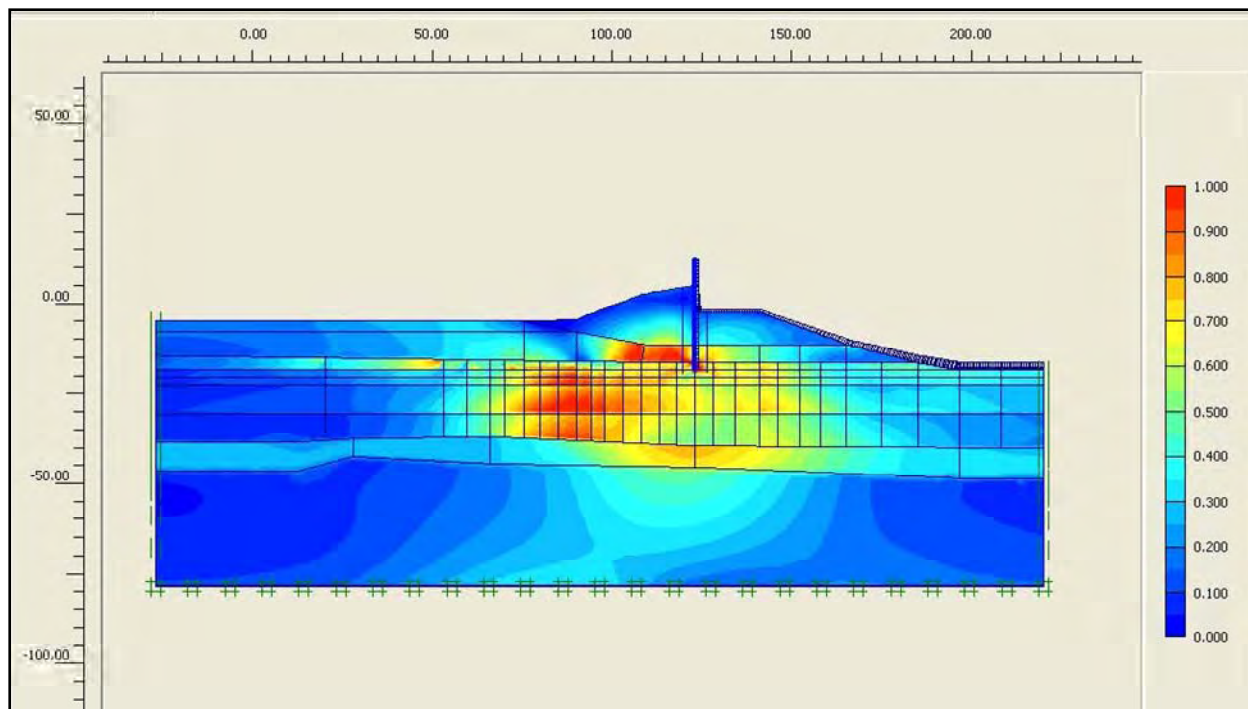
The mobilized shear stress at the strain integration points within the finite elements contained in the soil clusters is shown in Figure 6-12 to be less than the shear strength of the soil. The resulting computed fraction of mobilized shear strength is less than or equal to 0.96 at the stress integration points for the five soil types. The horizontal total stress state at the top of the submerged levee berm on the canal side and adjacent to the sheet pile does not indicate that a crack will open at this canal water elevation.

Figure 6-12. Fraction of Mobilized Shear Strength for Canal El 4.5

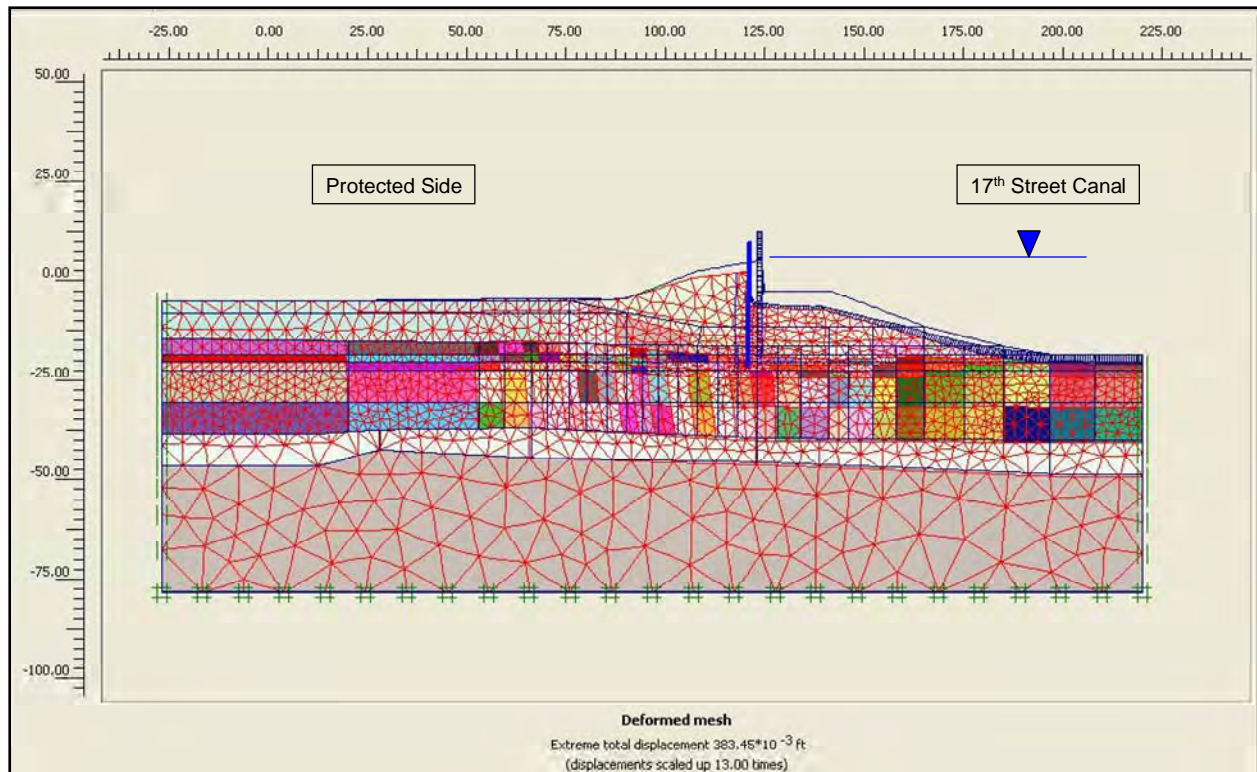
Canal El 5.5: The fifth increment in flood loading, designated loading phase 18, raises the canal water to El 5.5. This is a 4.5-ft increase in canal water relative to canal steady state El 1 or, equivalently, a 1-ft increase in canal flood water elevation from canal El 4.5 of loading phase 17. The loading applied to the mesh is again solely due to hydrostatic canal water pressures applied as boundary water pressures normal to the wetted side of the I-wall and normal to the wetted exposed face of the levee and clays, forming the sides and base of the canal. The deformed mesh is shown in Figure 6-13. Note that the nodal deformations are increased by a factor of 13 in order to show the deformed mesh relative to its position at a canal water elevation of 1.0 (shown as a blue outline in this figure). The general trend of deformations is downward and towards the protected side due to the boundary water pressure loading applied within the canal. The maximum (relative) displacement within the mesh is 0.383 ft ($< 4\text{-}5/8$ in.). There is no indication of a fully developed failure mechanism occurring at this flood stage.

Figure 6-13. Deformed Mesh, Exaggerated by a Factor of 13, for Canal EI 5.5 (Note: Canal EI not to scale in figure)
