Appendix 1

Soil Data Report for 17th Street Canal

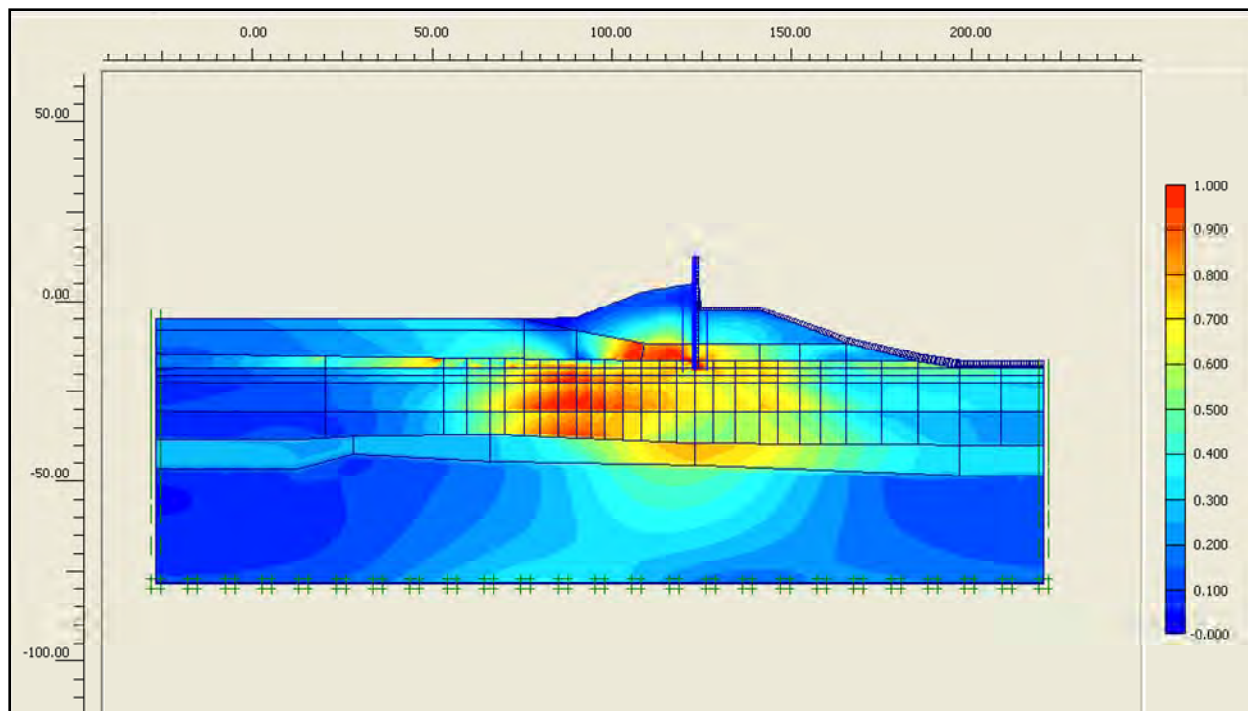
The mobilized shear stress at the strain integration points within the finite elements contained in the soil clusters is shown in Figure 6-14 to be less than the shear strength of the soil. The resulting computed fraction of mobilized shear strength is less than or equal to 0.96 at the stress integration points for the five soil types. The horizontal total stress state at the top of the submerged levee berm on the canal side and adjacent to the sheet pile does not indicate that a crack will open at this canal water elevation.

Figure 6-14. Fraction of Mobilized Shear Strength for Canal El 5.5

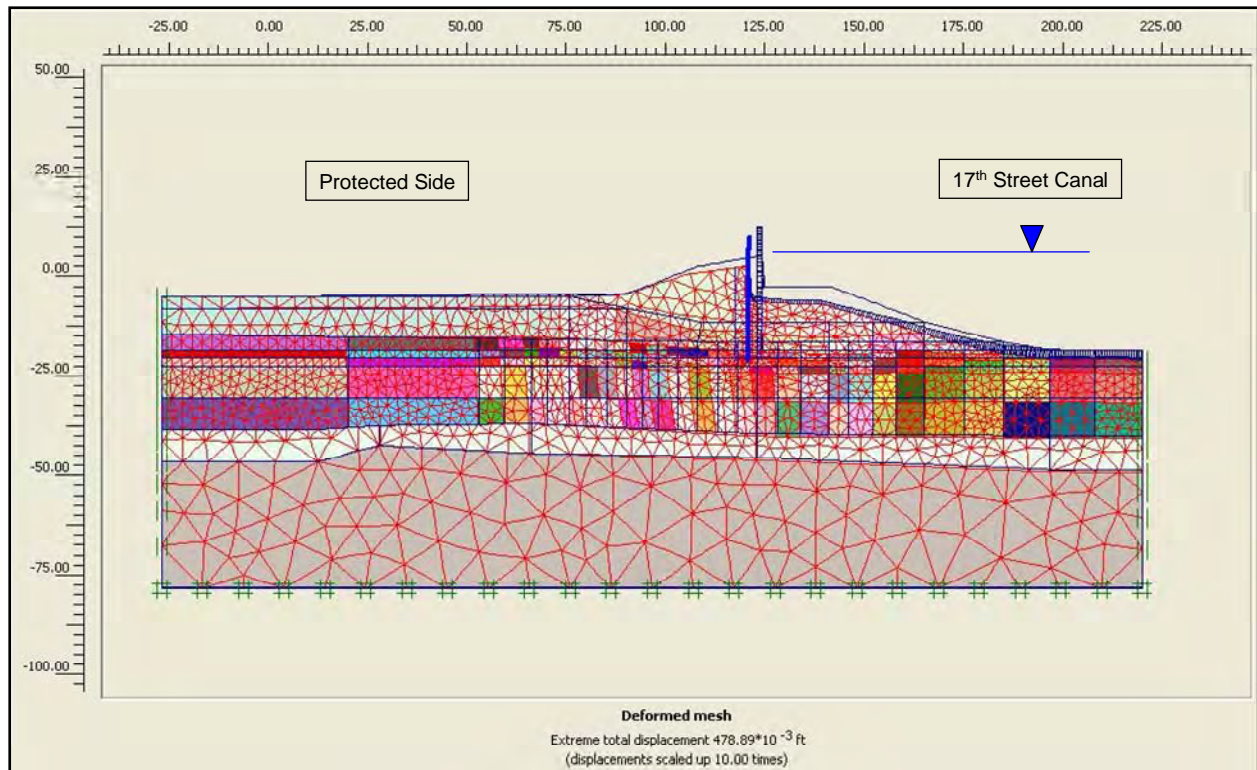
Canal El 6.5: The sixth increment in flood loading, designated loading phase 19, raises the canal water to El 6.5. This is a 5.5-ft increase in canal water relative to canal steady state El 1 or, equivalently, a 1-ft increase in canal flood water elevation from canal El 5.5 of loading phase 18. The loading applied to the mesh is again solely due to hydrostatic canal water pressures applied as boundary water pressures normal to the wetted side of the I-wall and normal to the wetted exposed face of the levee and clays forming the sides and base of the canal. The deformed mesh is shown in Figure 6-15. Note that the nodal deformations are increased by a factor of 10 in order to show the deformed mesh relative to its position at a canal water elevation of 1.0 (shown as a blue outline in this figure). The general trend of deformations is downward and towards the protected side due to the boundary water pressure loading applied within the canal. The maximum (relative) displacement within the mesh is 0.479 ft (approximately 5-3/4 in.). There is no indication of a fully developed failure mechanism occurring at this flood stage.

Figure 6-15. Deformed Mesh, Exaggerated by a Factor of 10, for Canal EI 6.5 (Note: Canal EI not to scale in figure)

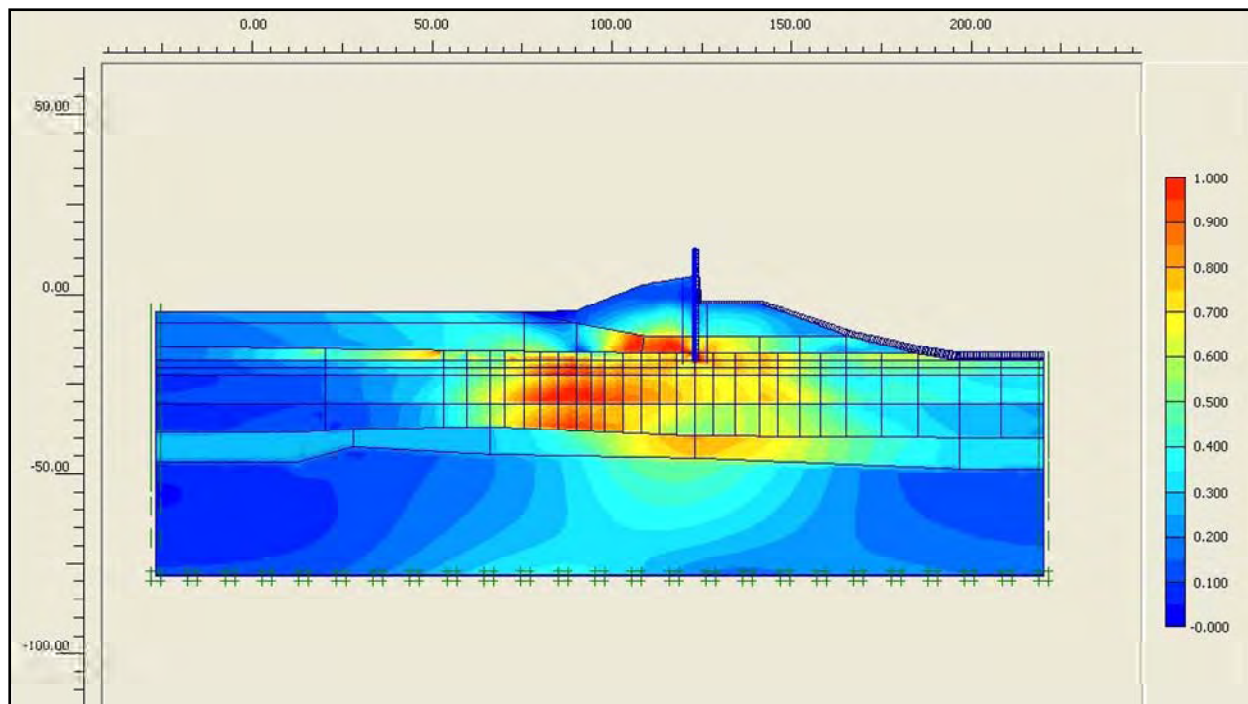
The mobilized shear stress at the strain integration points within the finite elements contained in the soil clusters is shown in Figure 6-16 to be less than the shear strength of the soil. The resulting computed fraction of mobilized shear strength is less than or equal to 0.96 at the stress integration points for the five soil types. The horizontal total stress state at the top of the submerged levee berm on the canal side and adjacent to the sheet pile indicates that a crack will open at this canal water elevation.

Figure 6-16. Fraction of Mobilized Shear Strength for Canal El 6.5

Crack initiation occurs at the top of the levee clay, on the canal side (at El -2.5) of the sheet pile wall when the total horizontal stress in the clay is less than the value for hydrostatic water pressure (i.e., γ_{water} times depth below canal water surface). This first occurs after raising canal water to El 6.5 (i.e., loading phase 19). Comparisons of values for hydrostatic water pressure, generated by hand computation, with the total horizontal stresses computed in the complete SSI analysis, indicate a crack will extend from El -2.5 down to EL -16.5, the elevation of the peat (or marsh) to lacustrine clay interface. For reference, the levee clay to peat (or marsh) interface is at EL -11.5. A 14-ft-long crack is introduced along the canal side interface of the sheet pile wall in the next loading phase.

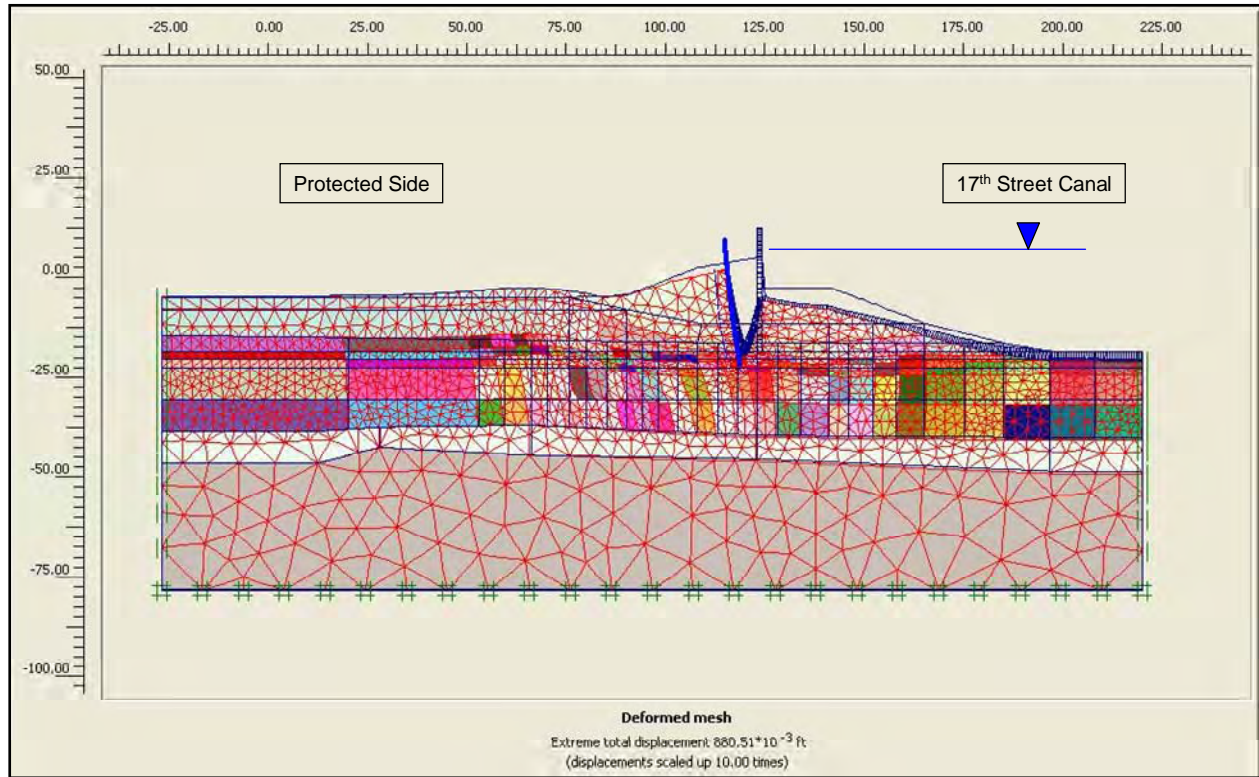
Canal El 6.5: In the seventh increment in loading, designated loading phase 20, a crack is introduced at the top of the levee soil (El -2.5) on the canal-side face of the sheet pile. This crack extends from the top of the canal side submerged levee to El -16.5. For reference, the sheet pile tip is at El -18.5. The development of the crack in loading phase 20 is accomplished by means of staged excavation of a narrow (i.e., 1-ft-wide) column of vertical clusters of levee and peat soils along this canal side face of the sheet pile wall to El -16.5. Additionally, loading phase 20 differs from loading phase 19 in that hydrostatic water pressures, corresponding to canal water at El 6.5, are applied to the now exposed canal-side sheet pile face, as well as the now exposed levee clay face that form the sides of the crack in these 1-ft-wide (excavated) vertical soil clusters. The deformed mesh is shown in Figure 6-17. Note that the nodal deformations are increased by a factor of 10 in order to show the deformed mesh relative to its position at a canal water elevation of 1.0 (shown as a blue outline in this figure). The general trend of deformations is downward and towards the protected side due to the boundary water pressure loading applied within the

canal and the crack. The maximum (relative) displacement within the mesh is 0.88 ft (approximately 10.5 in.).

Figure 6-17. Deformed Mesh, Exaggerated by a Factor of 10, for Canal EI 6.5 and Crack to EI -16.5 (Note: Canal EI not to scale in figure)

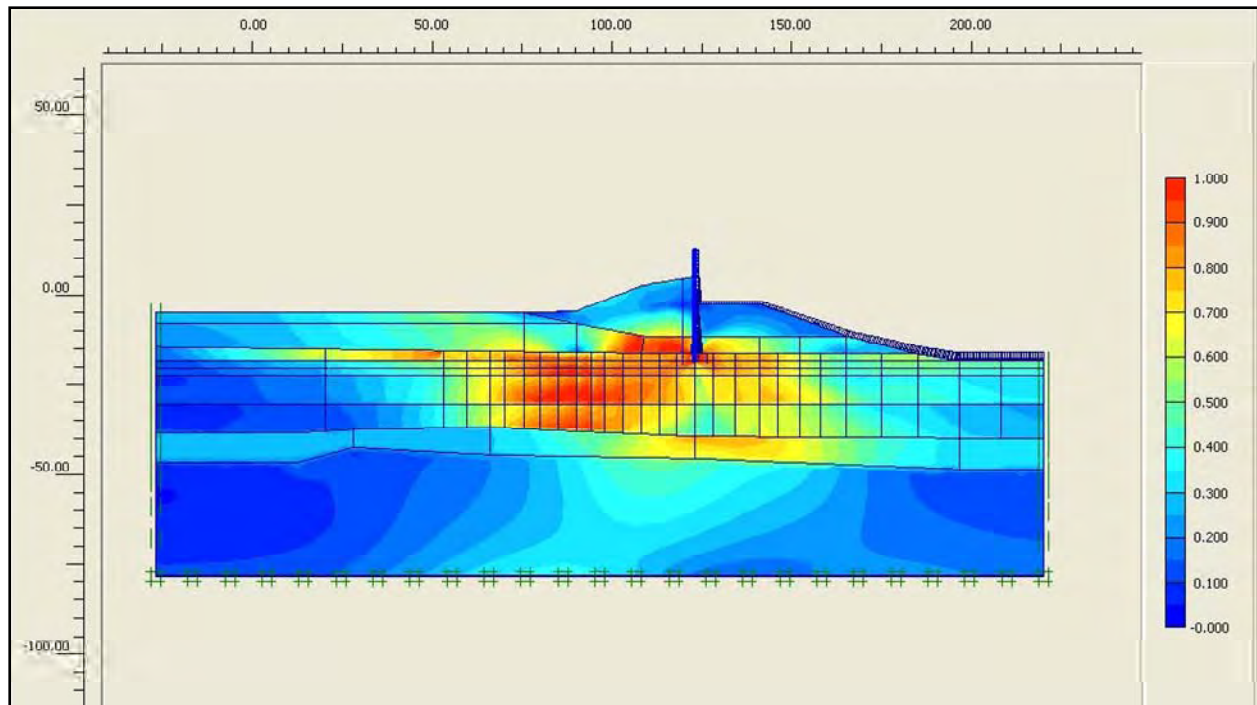
The mobilized shear stress at the strain integration points within the finite elements contained in the soil clusters is shown in Figure 6-18 to be less than the shear strength of the soil. The resulting computed fraction of mobilized shear strength is less than or equal to 0.96 at the stress integration points for the five soil types. Introduction of the crack to EI -16.5, as well as application of hydrostatic water pressures within the crack, results in more of the lacustrine clay being loaded, as indicated by comparison of Figure 6-18 fraction of mobilized shear strength results to the Figure 6-16 pre-crack results.

Figure 6-18. Fraction of Mobilized Shear Strength for Canal El 6.5 and Crack to El -16.5

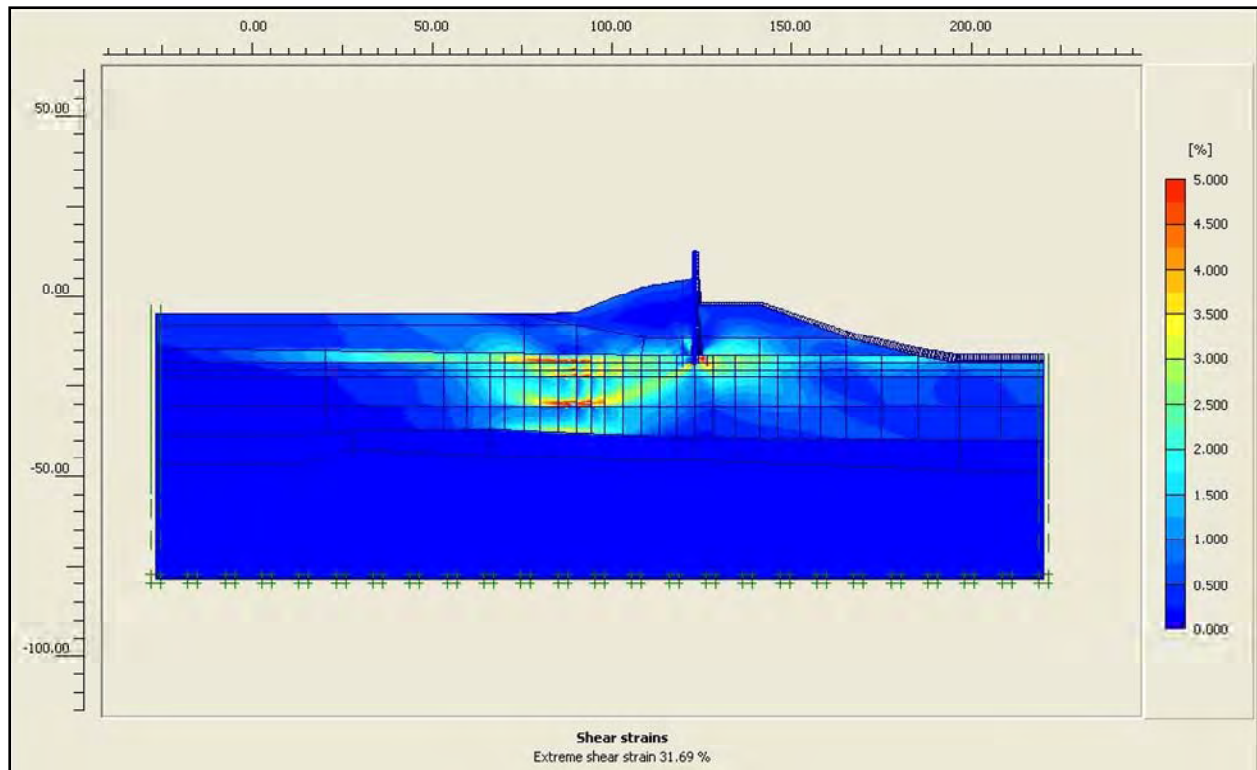
There is no indication of a fully developed failure mechanism at this flood stage for a crack to El -16.5. However, Figure 6-19 shows four distinct reaches of high shear strains (that may, with additional applied loadings, develop into a complete failure mechanism). Evaluation of the computed horizontal total stress state immediately below the El -16.5 crack tip region on the canal side of the sheet pile indicates that this crack will extend to the sheet pile tip, El -18.5. Consequently, in the next loading phase (21), the crack is extended by means of staged excavation of a narrow cluster of lacustrine clay from El -16.5 to El -18.5 and with hydrostatic water pressures applied along the exposed sheet pile and clay faces that form the sides of the crack.

Figure 6-19. Reaches of Large Shear Strains for Canal El 6.5 and Crack to El -16.5

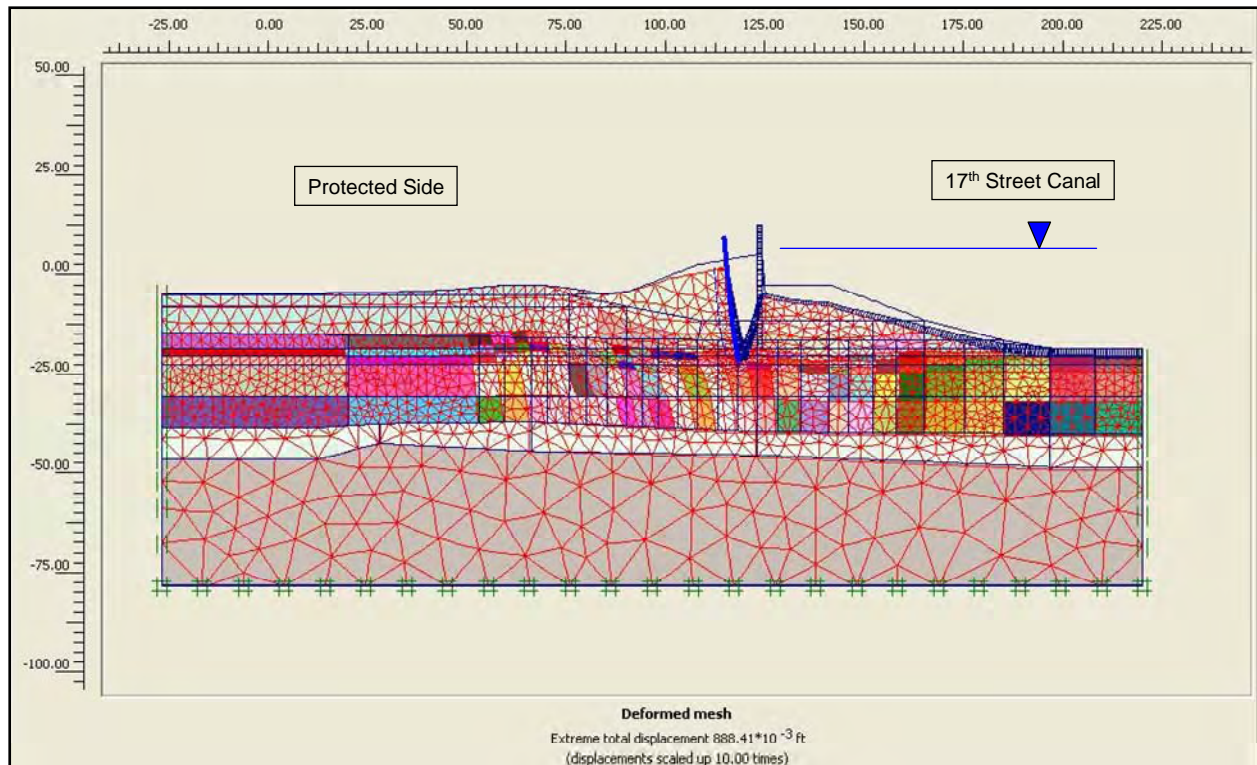
Canal El 6.5: In the eighth increment in loading, designated loading phase 21, the crack is extended to the sheet pile tip (El -18.5) on the canal-side face of the sheet pile. The development of the crack in loading phase 20 is accomplished by means of 2 ft of additional staged excavation of a narrow (i.e., 1-ft wide) column of vertical clusters of lacustrine clay soil along this canal-side face of the sheet pile wall. Additionally, loading phase 21 differs from loading phase 20 in that hydrostatic water pressures, corresponding to canal water at El 6.5, are applied along this additional 2 ft of newly exposed canal-side face of sheet pile, as well as the now exposed 2-ft-high lacustrine clay face that form the sides of this last segment of crack. The deformed mesh is shown in Figure 6-20. Note that the nodal deformations are increased by a factor of 10 in order to show the deformed mesh relative to its position at a canal water elevation of 1.0 (shown as a blue outline in this figure). The general trend of deformations is downward and towards the protected side due to the boundary water pressure loading applied within the canal and the 14-ft-deep crack. The maximum (relative) displacement within the mesh is 0.888 ft (approximately 10-5/8 in.).

Figure 6-20. Deformed Mesh, Exaggerated by a Factor of 10, for Canal EI 6.5 and Crack to EI -18.5 (Note: Canal EI not to scale in figure)

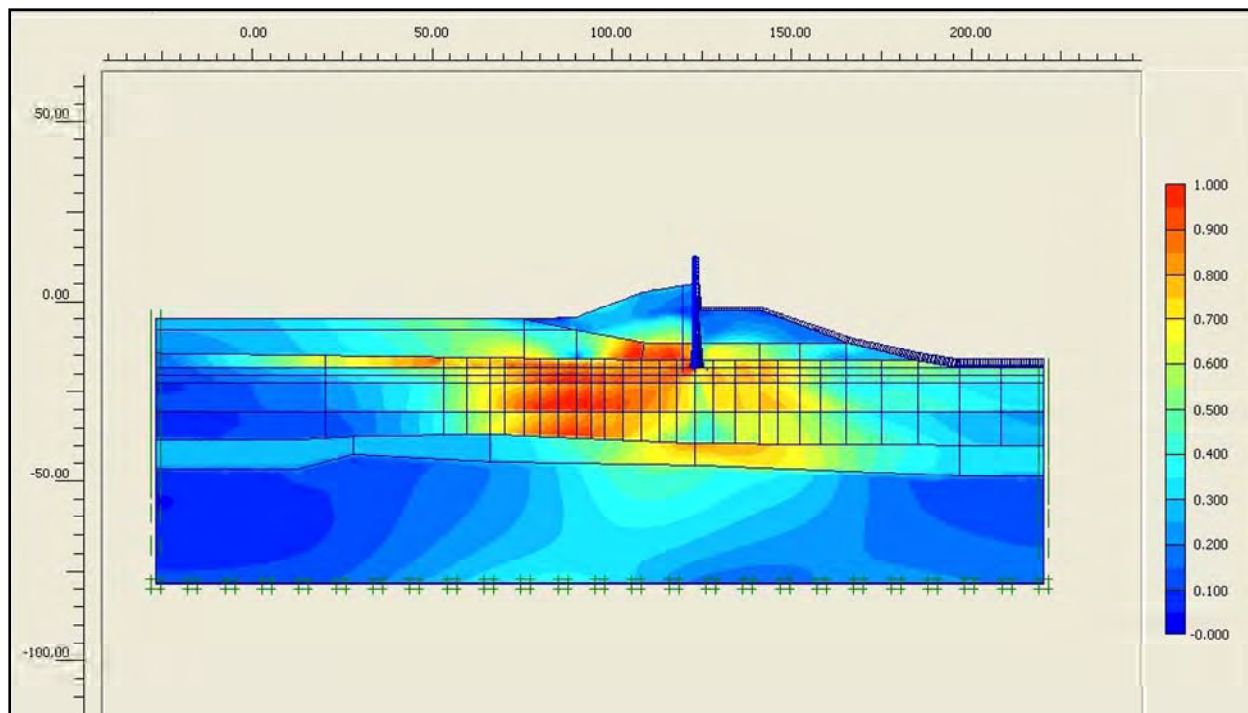
The mobilized shear stress at the strain integration points within the finite elements contained in the soil clusters is shown in Figure 6-18 to be less than the shear strength of the soil. The resulting computed fraction of mobilized shear strength is less than or equal to 0.96 at the stress integration points for the five soil types.

Figure 6-21. Fraction of Mobilized Shear Strength for Canal El 6.5 and Crack to El -18.5

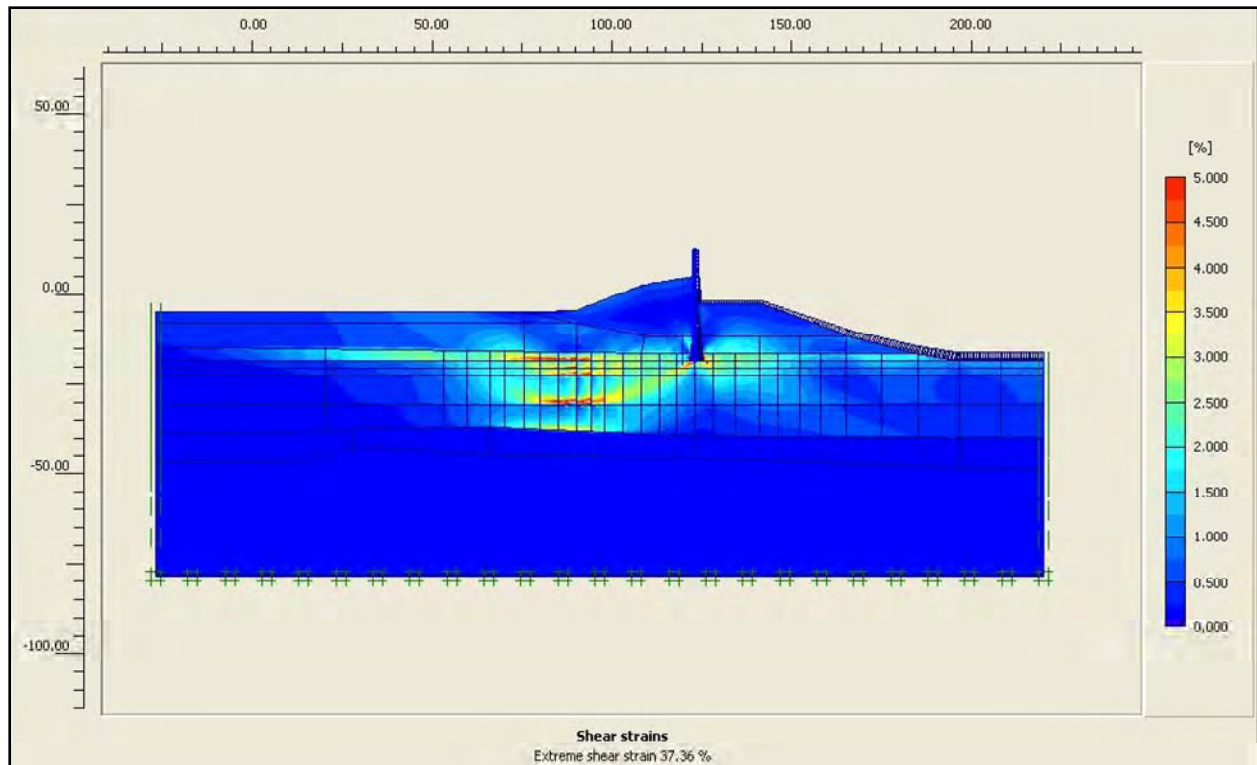
There is no indication of a fully developed failure mechanism at this flood stage for a crack to El -16.5. However, Figure 6-19 shows that at this stage of flood loading, there are four distinct reaches of high shear strains (that may, with additional applied loadings, develop into a complete failure mechanism).

Figure 6-22. Reaches of Large Shear Strains for Canal El 6.5 and Crack to El -18.5

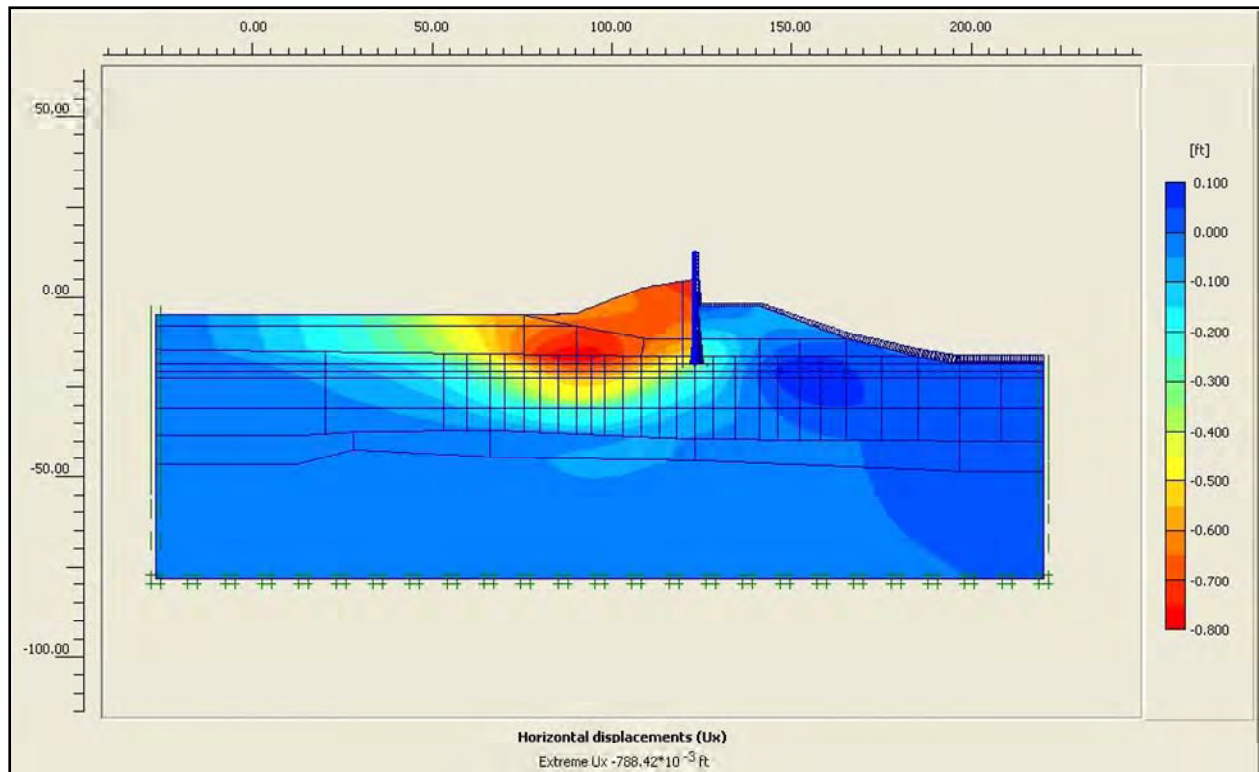
Figure 6-23 shows the horizontal displacements of the soil regions within the mesh, relative to their position at a canal water elevation of 1.0. This figure shows the deformation of the protected side levee, the peat below the levee, and the top layer of the lacustrine clay, all to be moving away from the canal with a displacement of between -0.6 to -0.8 ft under an El 6.5 flood loading and including a full crack. (Note negative Ux values denote movement towards the protected side.)

Figure 6-23. Horizontal Deformation Shadings for Canal EI 6.5 and Crack to EI -18.5

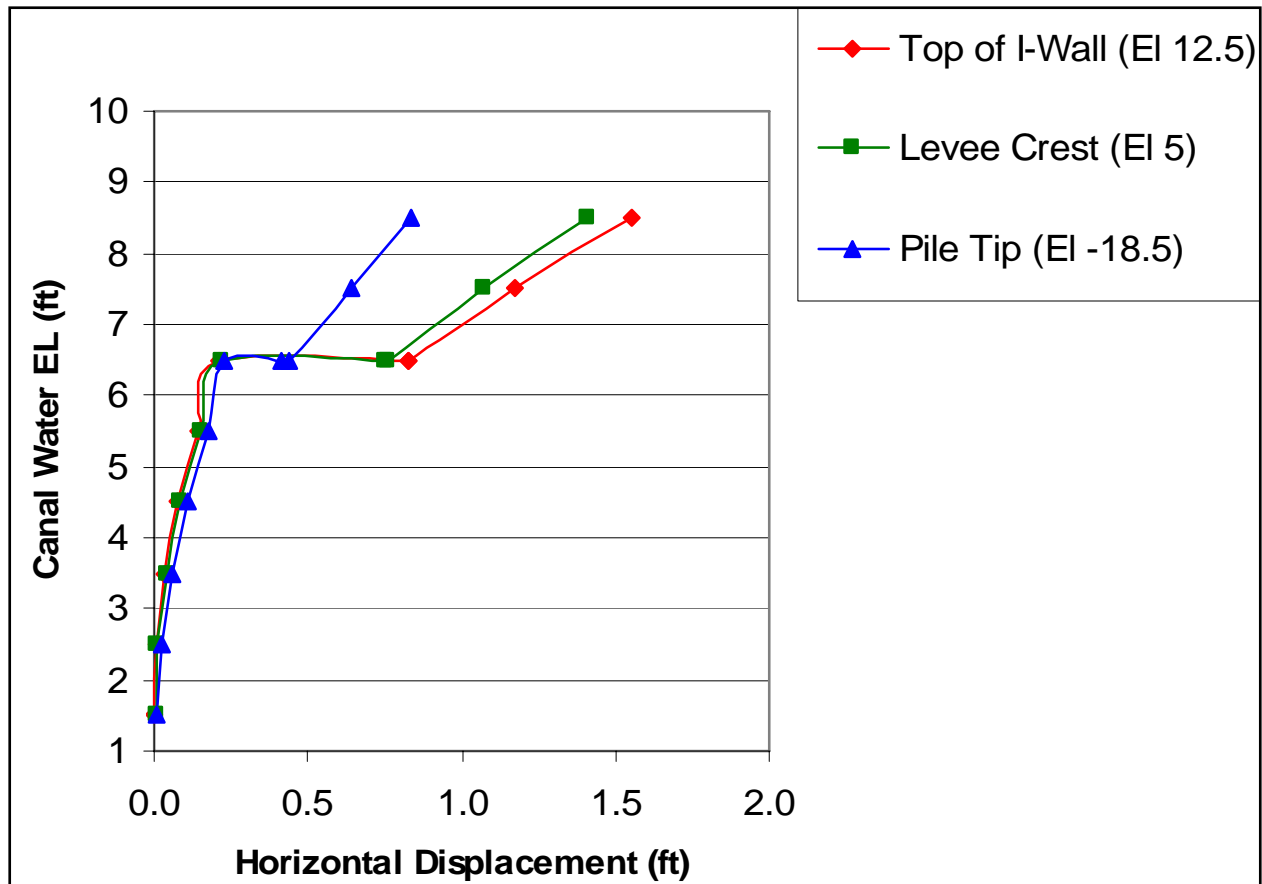
Figure 6-24 shows the horizontal displacements of three points within the flood wall, relative to its position at a canal water elevation of 1.0. The points monitored through the analyses are at the top of the I-wall, at El 5 (top of levee), and at sheet pile tip (El -18.5). This figure shows that prior to the crack opening at canal water El 6.5, the deformation of the sheet pile is uniformly translational. At canal water El 6.5 and prior to cracking, the flood wall translates towards the protected side by 0.21 ft (2.5 in.). After the crack opens to sheet pile tip and with the flood loading maintained at El -6.5, the horizontal deformation at the top of the I-wall and at the base of the I-wall (El 5) is identical, implying uniform translation of the I-wall by 0.79 ft (9.5 in.). However, the tip of the sheet pile undergoes less than half as much horizontal deformation as the I-wall, 0.44 ft (5-¼ in.).

Figure 6-24. Horizontal Sheet Pile Deflections versus Canal Water EL

Figure 6-24 shows the horizontal displacements of three points within the floodwall, relative to its position at a canal water elevation of 1.0. The points monitored through the analyses are at the top of the I-wall, at EI 5 (top of levee) and at sheet pile tip (EI -18.5). With an open crack to sheet pile tip and with the flood loading maintained at EI -7.5, the horizontal deformations at the top of the I-wall and at the base of the I-wall (EI 5) are nearly identical, 1.17 ft and 1.07 ft. This implies uniform translation of the I-wall. However, the tip of the sheet pile undergoes less than half as much horizontal deformation as the I-wall, 0.64 ft.

Figure 6-24 shows the horizontal displacements of three points within the floodwall, relative to its position at a canal water elevation of 1.0. The points monitored through the analyses are at the top of the I-wall, at El 5 (top of levee), and at sheet pile tip (El -18.5). With an open crack to sheet pile tip and with the flood loading maintained at El -8.5, the horizontal deformations at the top of the I-wall and at the base of the I-wall (El 5) are nearly identical, 1.55 ft and 1.41 ft. This implies uniform translation of the I-wall. However, the tip of the sheet pile undergoes less than half as much horizontal deformation as the I-wall, 0.84 ft.

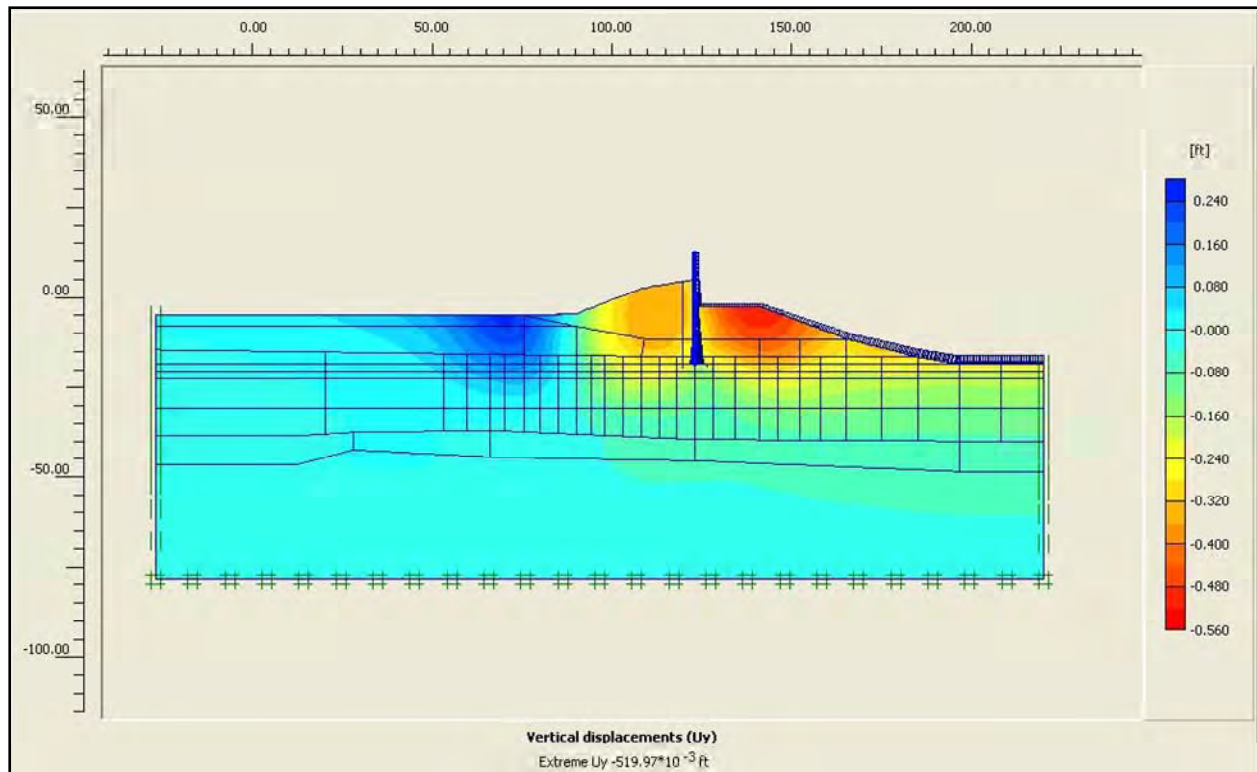
Figure 6-25 shows the vertical displacements of the soil regions within the mesh for canal EL 6.5 and with full crack, relative to its position at a canal water elevation of 1.0. This figure shows the deformation tendency of the peat to rise up (i.e., positive displacements) just beyond the toe of the levee on the protected side, and the levee berm to move downwards (i.e., negative displacements).

Figure 6-25. Vertical Deformation Shadings for Canal El 6.5 and Crack to El -18.5

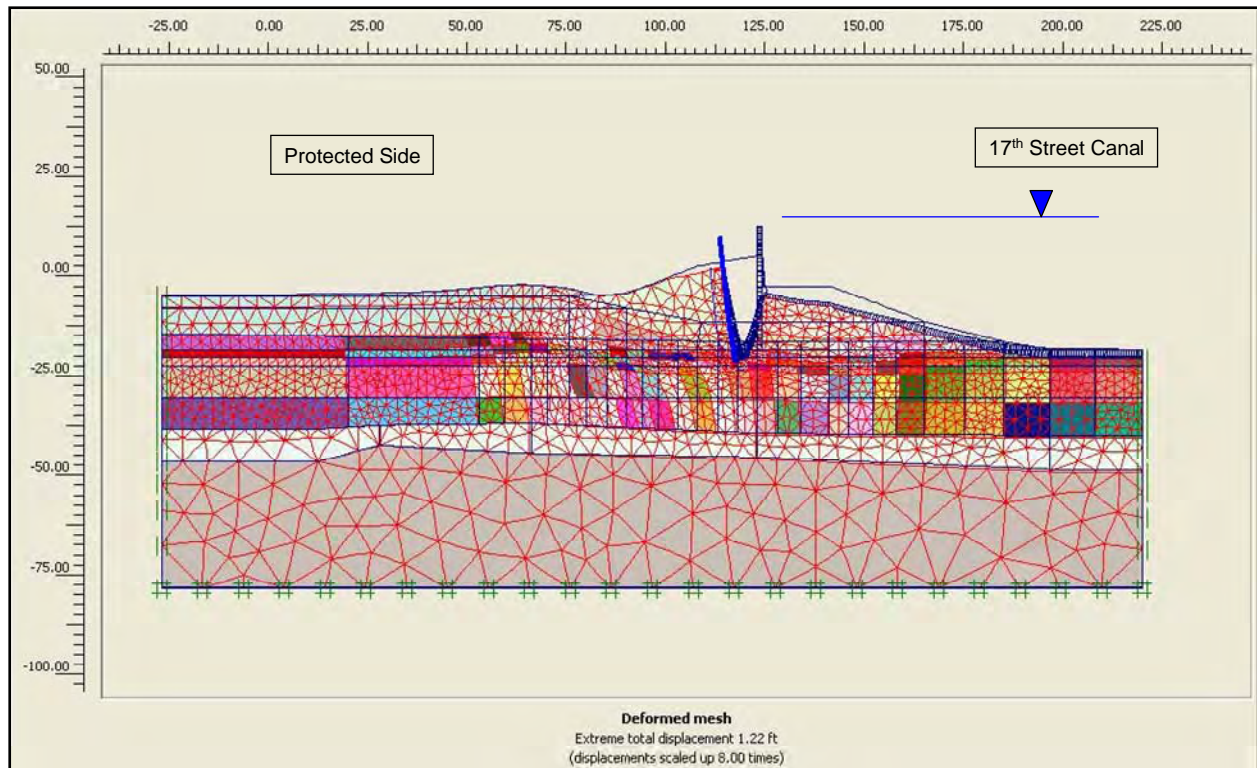
Canal El 7.5: The ninth increment in loading, designated loading phase 22, raises the canal water to El 7.5. This is a 6.5-ft increase in canal water relative to canal steady state El 1 or, equivalently, a 1-ft increase in canal flood water elevation from canal El 6.5 of loading phases 19, 20, and 21. The loading applied to the mesh is again solely due to hydrostatic canal water pressures applied as boundary water pressures normal to the wetted side of the I-wall, normal to the wetted exposed face of the levee and clays forming the sides and base of the canal, and normal to the sheet pile and soil that form the crack. The deformed mesh is shown in Figure 6-26. Note that the nodal deformations are increased by a factor of 8 in order to show the deformed mesh relative to its position at a canal water elevation of 1.0 (shown as a blue outline in this figure). The general trend of deformations is downward and towards the protected side due to the boundary water pressure loading applied within the canal. The maximum (relative) displacement within the mesh is 1.22 ft (approximately 14-5/8 in.). There is no indication of a fully developed failure mechanism occurring at this flood stage.

Figure 6-26. Deformed Mesh, Exaggerated by a Factor of 8, for Canal EI 7.5 and Crack to EI -18.5 (Note: Canal EI not to scale in figure)

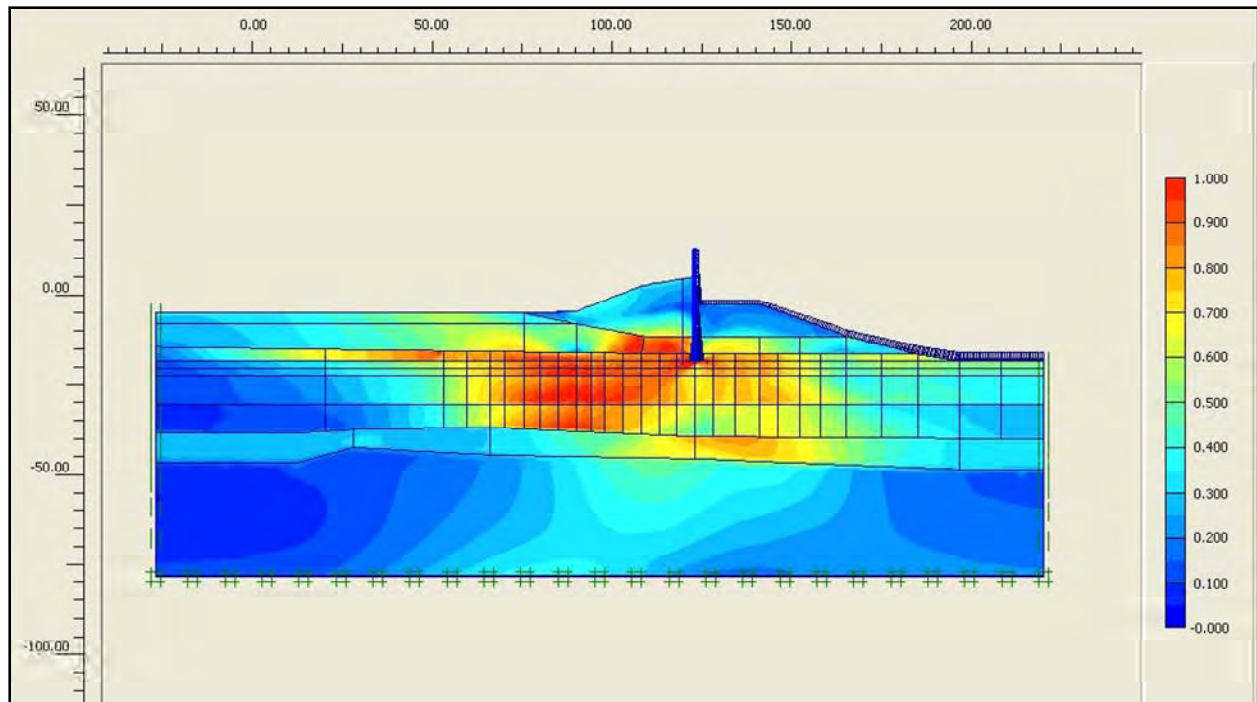
The mobilized shear stress at the strain integration points within the finite elements contained in the soil clusters is shown in Figure 6-27 to be less than the shear strength of the soil. The resulting computed fraction of mobilized shear strength is less than or equal to 0.96 at the stress integration points for the five soil types.

Figure 6-27. Fraction of Mobilized Shear Strength for Canal El 7.5 and Crack to El -18.5

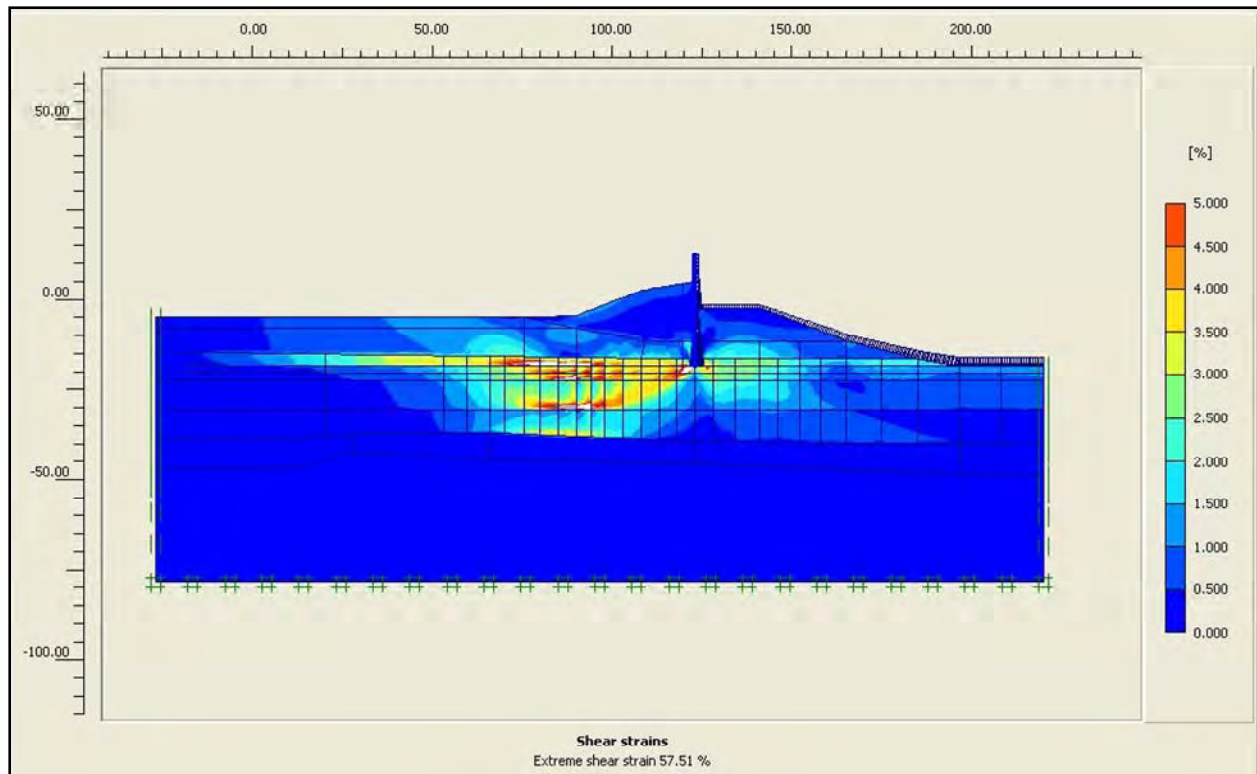
There is no indication of a fully developed failure mechanism at this flood stage for a crack to El -16.5. However, Figure 6-28 shows that at this stage of flood loading, there are four distinct reaches of high shear strains (that may, with additional applied loadings, develop into a complete failure mechanism).

Figure 6-28. Reaches of Large Shear Strains for Canal El 7.5 and Crack to El -18.5

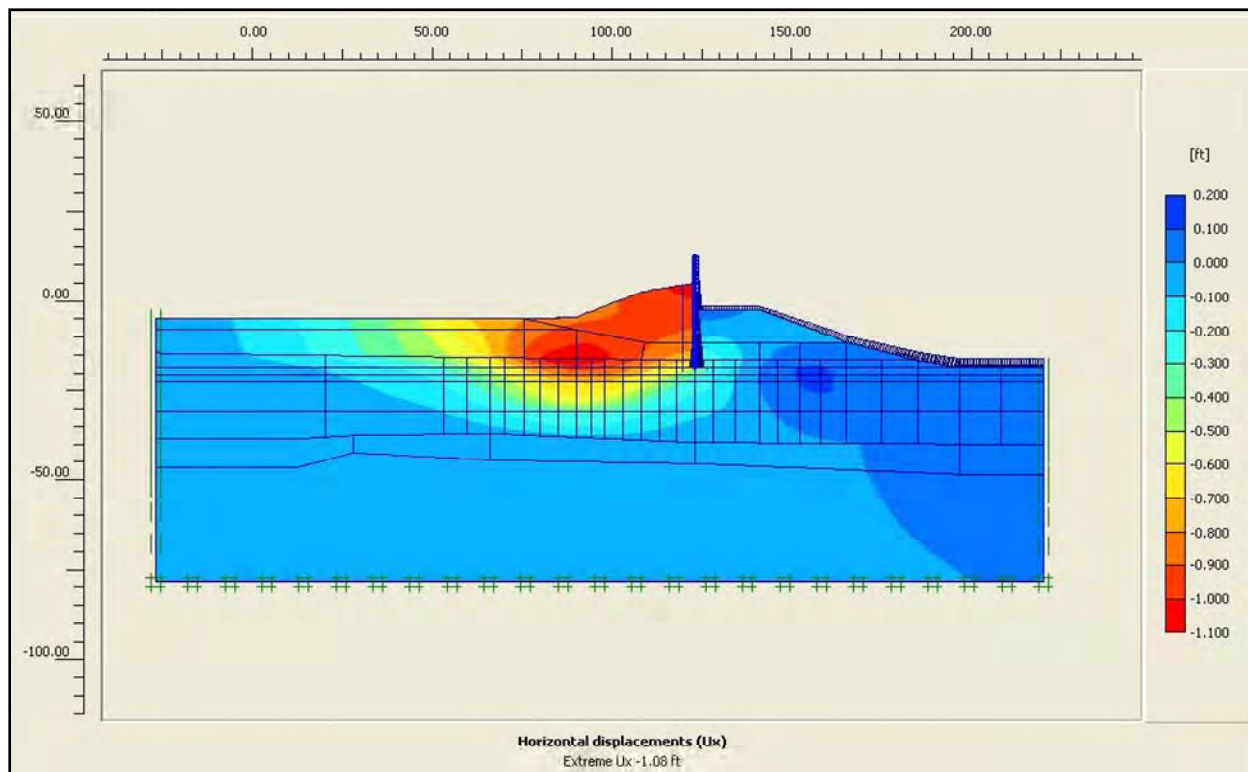
Figure 6-29 shows the horizontal displacements of the soil regions within the mesh, relative to their position at a canal water elevation of 1.0. This figure shows the deformation of the protected side levee, the peat below the levee, and the top layer of the lacustrine clay, all to be moving away from the canal with a displacement of between -0.7 to -1.1 ft under an El 7.5 flood loading and including a full crack.

Figure 6-29. Horizontal Deformation Shadings for Canal EI 7.5 and Crack to EI -18.5

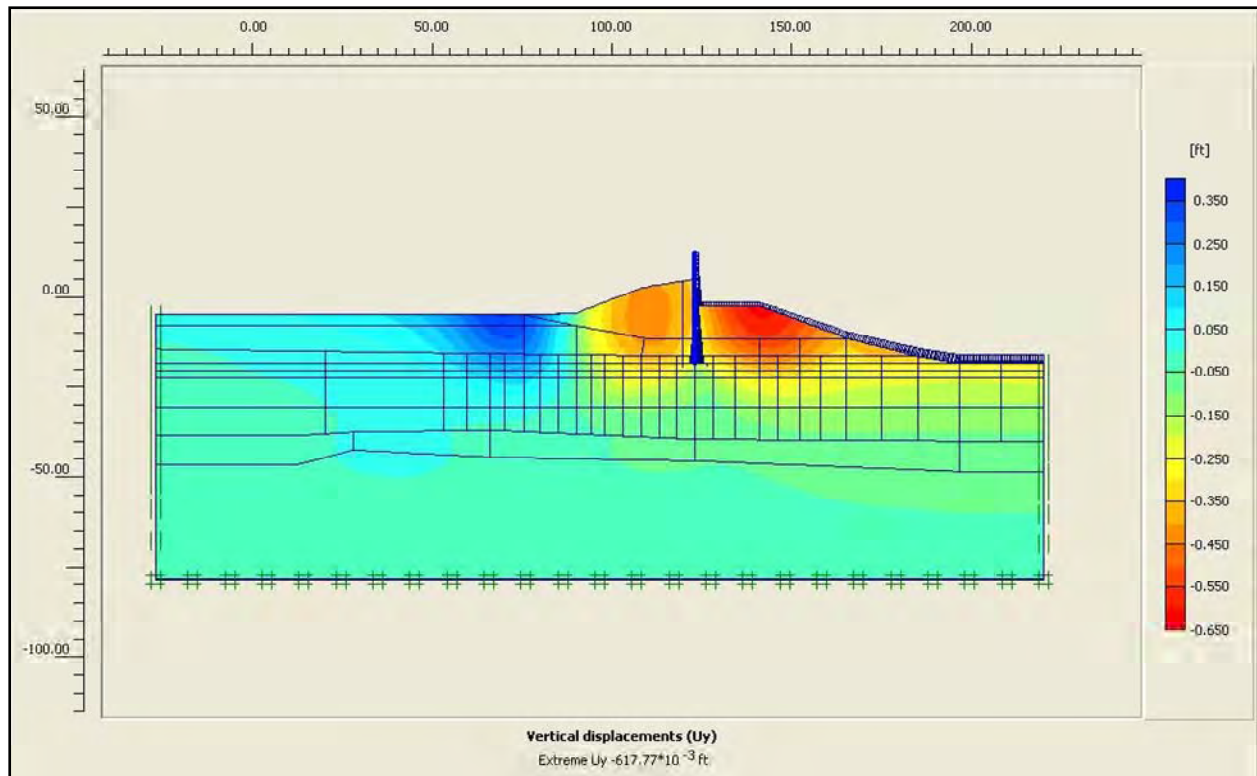
Figure 6-30 shows the vertical displacements of the soil regions within the mesh for canal EI 7.5 and with full crack, relative to its position at a canal water elevation of 1.0. This figure shows the deformation tendency of the peat to rise up (i.e., positive displacements) just beyond the toe of the levee on the protected side and the levee berm to move downwards (i.e., negative displacements).

Figure 6-30. Vertical Deformation Shadings for Canal El 7.5 and Crack to El -18.5

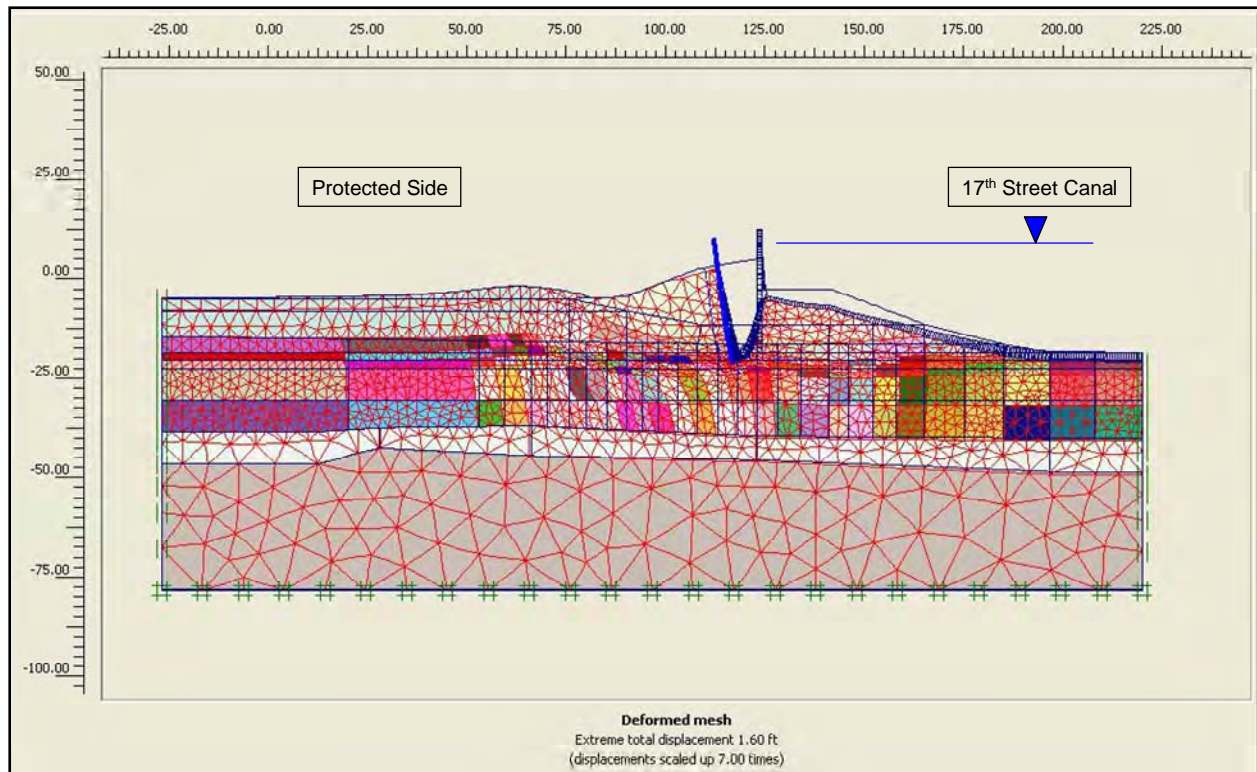
Canal El 8.5: The tenth increment in loading, designated loading phase 23, raises the canal water to El 8.5. This is a 7.5-ft increase in canal water relative to canal steady state El 1 or, equivalently, a 1-ft increase in canal flood water elevation from canal El 7.5 of loading phase 22. The loading applied to the mesh is again solely due to hydrostatic canal water pressures applied as boundary water pressures normal to the wetted side of the I-wall, normal to the wetted exposed face of the levee and clays forming the sides and base of the canal, and normal to the sheet pile and soil that form the crack. The deformed mesh is shown in Figure 6-31. Note that the nodal deformations are increased by a factor of 7 in order to show the deformed mesh relative to its position at a canal water elevation of 1.0 (shown as a blue outline in this figure). The general trend of deformations is downward and towards the protected side due to the boundary water pressure loading applied within the canal. The maximum (relative) displacement within the mesh is 1.6 ft (19.5 in.). There is no indication of a fully developed failure mechanism occurring at this flood stage.

Figure 6-31. Deformed Mesh, Exaggerated by a Factor of 7, for Canal El 8.5 and Crack to El -18.5 (Note: Canal El not to scale in figure)

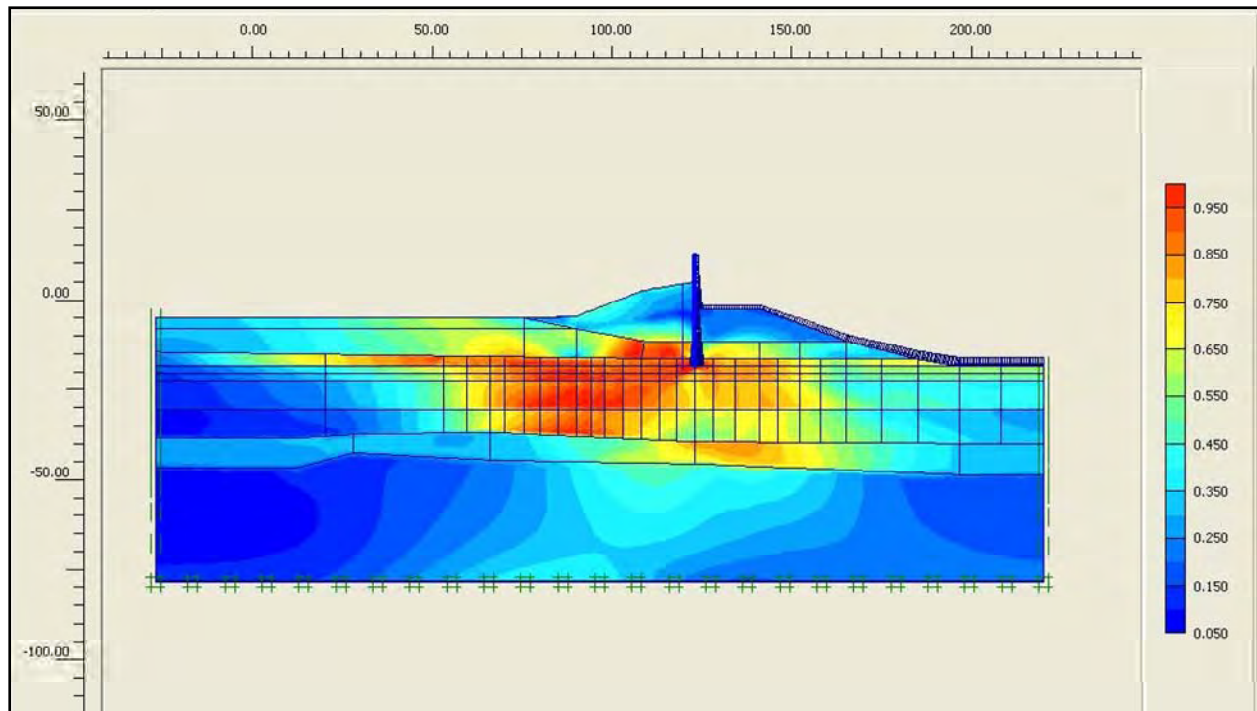
The mobilized shear stress at the strain integration points within the finite elements contained in the soil clusters is shown in Figure 6-32 to be less than the shear strength of the soil. The resulting computed fraction of mobilized shear strength is less than or equal to 0.96 at the stress integration points for the five soil types. Raising of canal water El 8.5 (as well as application of hydrostatic water pressures within the crack) results in more of the upper portion of the lacustrine clay layer being loaded, as indicated by comparison of Figure 6-32 fraction of mobilized shear strength results to the Figure 6-27 El 7.5 results.

Figure 6-32. Fraction of Mobilized Shear Strength for Canal EI 8.5 and Crack to EI -18.5
