Appendix 1

Soil Data Report for 17th Street Canal

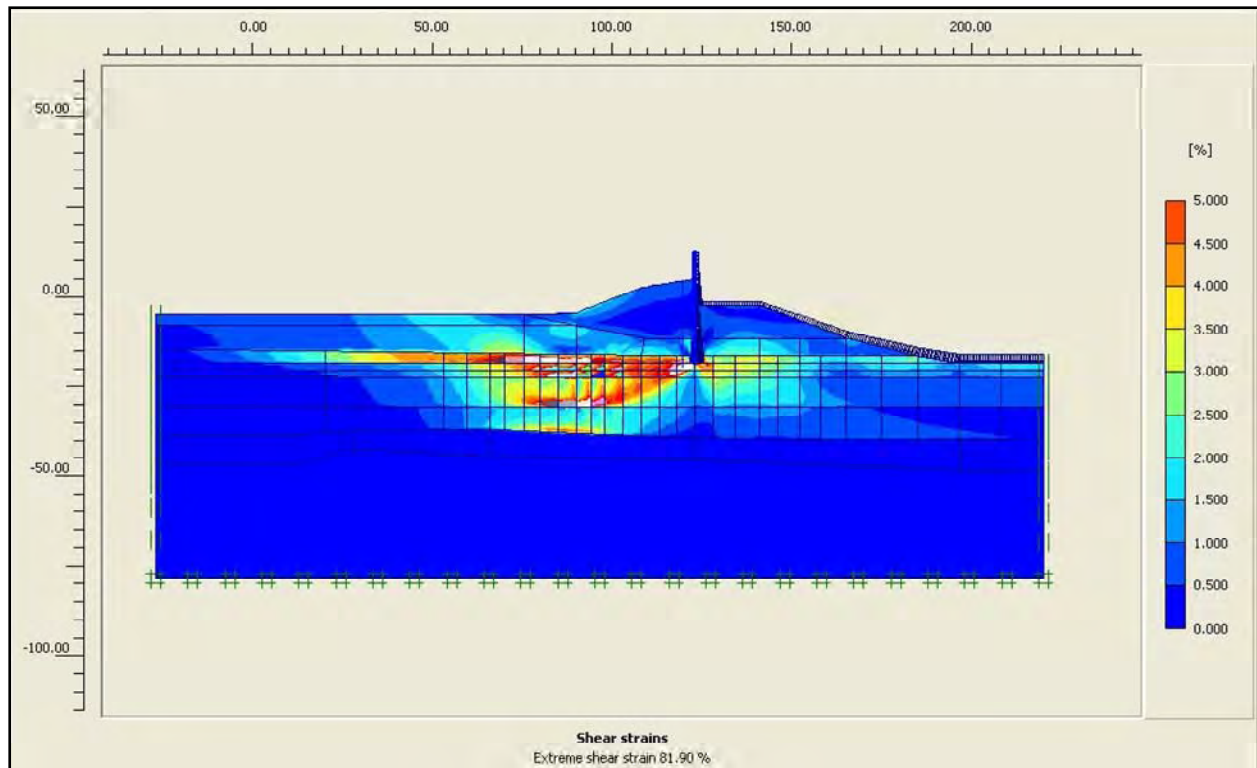
Figure 6-33 shows at this stage of flood loading the upper zone of high shear strains (beyond the toe of the levee), indicating a failure mechanism is developing.

Figure 6-33. Reaches of Large Shear Strains for Canal El 8.5 and Crack to El -18.5

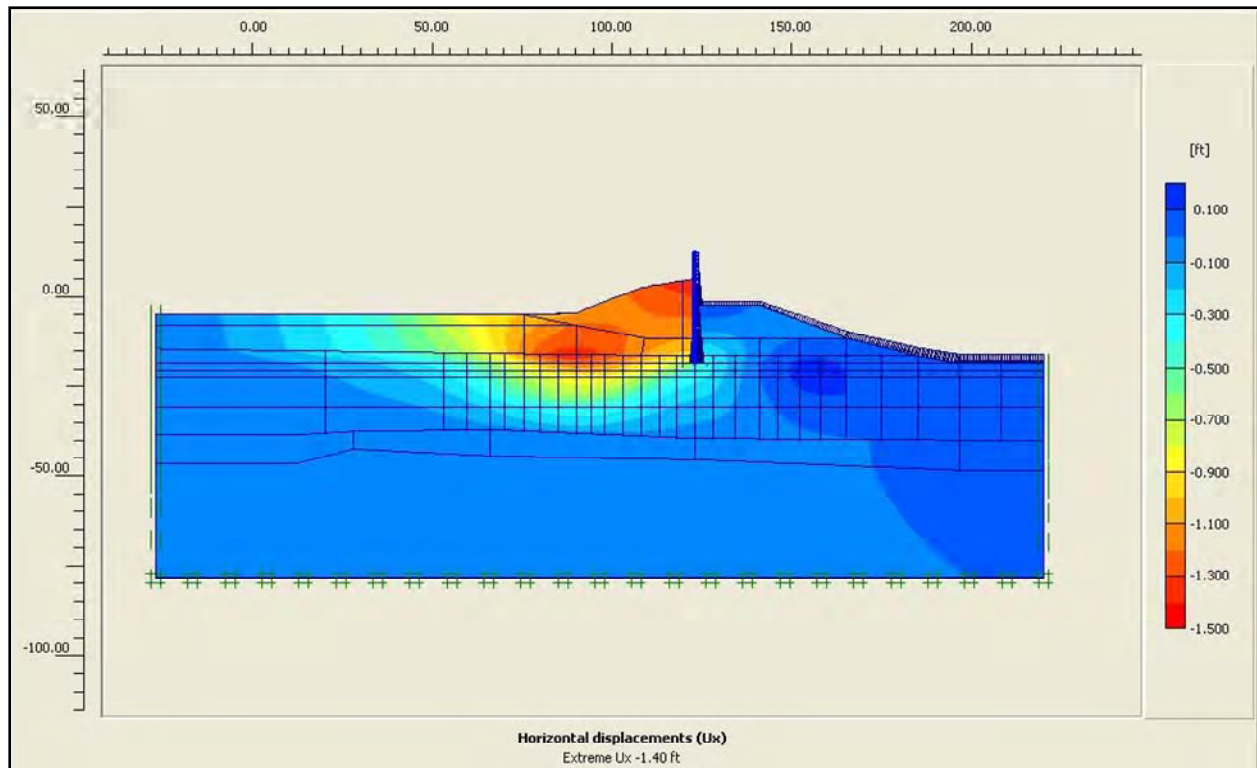
Figure 6-34 shows the horizontal displacements of the soil regions within the mesh, relative to their position at a canal water elevation of 1.0. This figure shows the deformation of the protected side levee, the peat below the levee, and the top layer of the lacustrine clay, all to be moving away from the canal, with a displacement of between -1.0 to -1.4 ft under an El 8.5 flood loading and including a full crack.

Figure 6-34. Horizontal Deformation Shadings for Canal El 8.5 and Crack to El -18.5

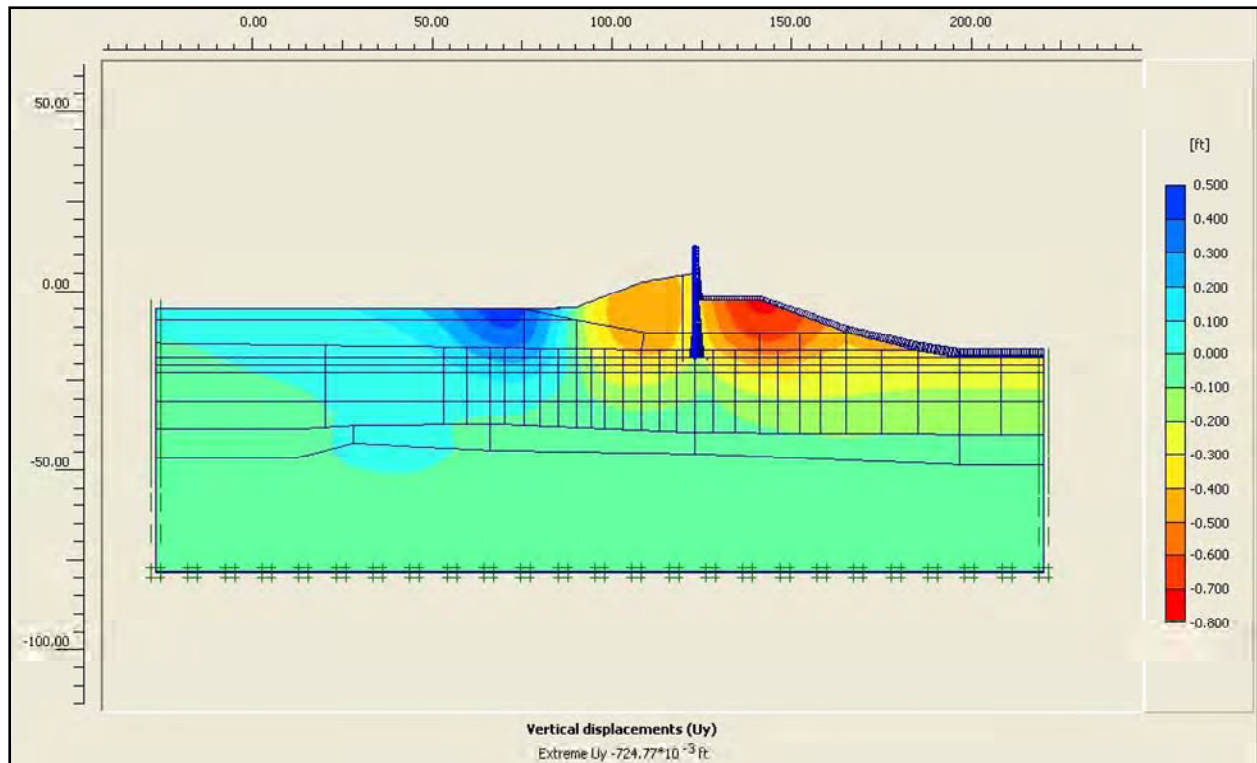
Figure 6-35. Vertical Deformation Shadings for Canal El 8.5 and Crack to El -18.5

Figure 6-35 shows the vertical displacements of the soil regions within the mesh for canal El 8.5 and with full crack, relative to its position at a canal water elevation of 1.0. This figure shows the deformation tendency of the peat to rise up (i.e., positive displacements) just beyond the toe of the levee on the protected side, and the levee berm to move downwards (i.e., negative displacements).

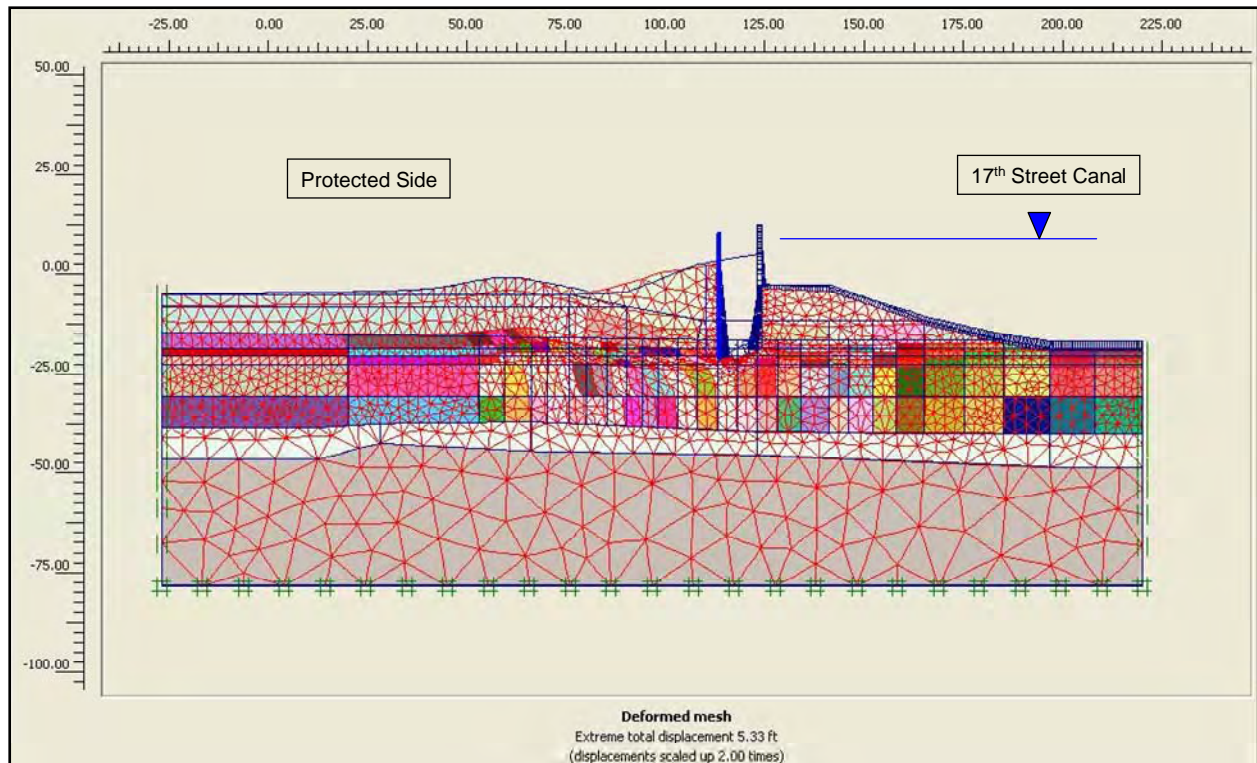
Figure 6-36. Deformed Mesh, Exaggerated by a Factor of 2, for Canal EI 9 and Crack to EI -18.5 (Note: Canal EI not to scale in figure)

Canal El 9: The eleventh increment in loading, designated loading phase 24, raises the canal water to El 9. This is an 8.5-ft increase in canal water relative to canal steady state El 1 or, equivalently, a 1-ft increase in canal flood water elevation from canal El 8.5 of loading phase 23. The loading applied to the mesh is again solely due to hydrostatic canal water pressures applied as boundary water pressures normal to the wetted side of the I-wall, normal to the wetted exposed face of the levee and clays forming the sides and base of the canal, and normal to the sheet pile and soil that form the crack. The deformed mesh is shown in Figure 6-36. Note that the nodal deformations are increased by a factor of 2 in order to show the deformed mesh relative to its position at a canal water elevation of 1.0 (shown as a blue outline in this figure). The general trend of deformations is downward and towards the protected side due to the boundary water pressure loading applied within the canal. The computed maximum (relative) displacement within the mesh is excessive, more than 5 ft. Note the upward bulge in the surface of the peat/marsh layer beyond the toe of the levee.

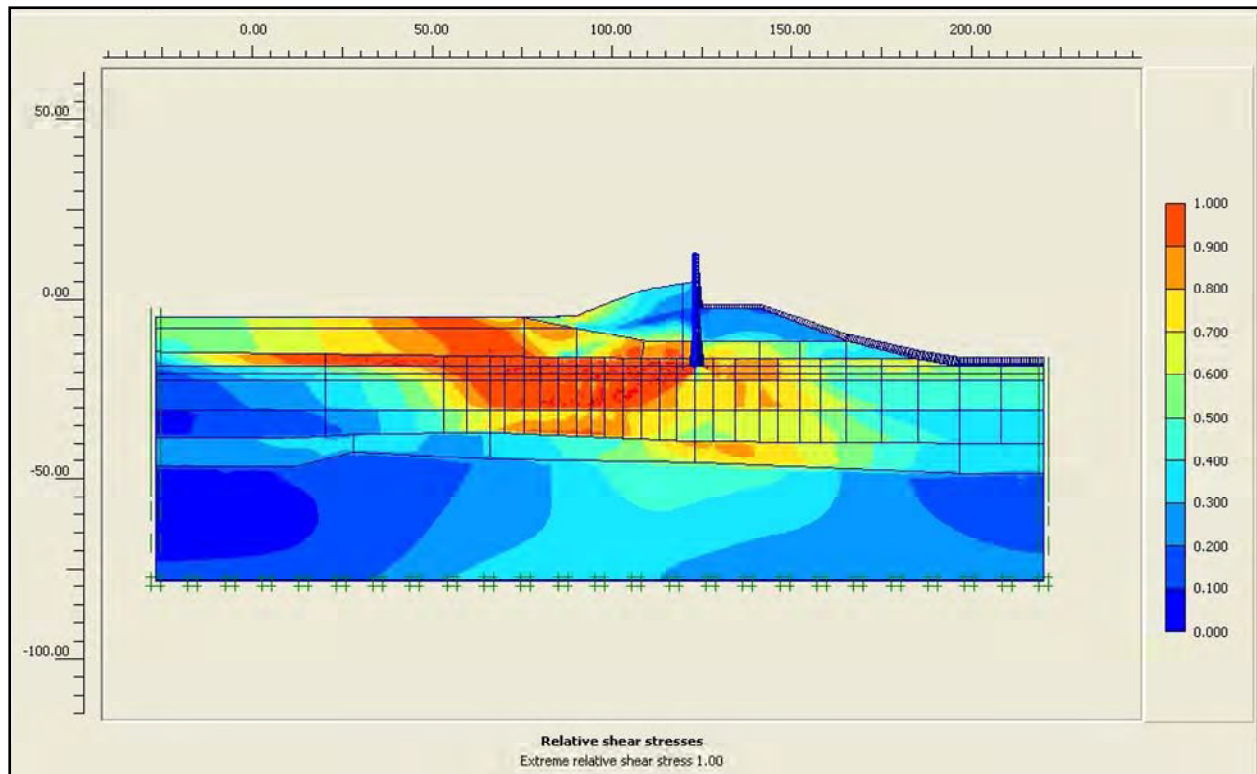
Figure 6-37. Fraction of Mobilized Shear Strength for Canal EI 9 and Crack to EI -18.5

The mobilized shear stress at the strain integration points within the finite elements contained in the soil clusters is shown in Figure 6-37. Note that the zone of high values for the computed fraction of mobilized shear strength now extends to the peat/marsh region beyond the toe of the levee. These and the Figure 6-36 results indicate the formation of a failure mechanism that “daylights” beyond the toe of the levee.

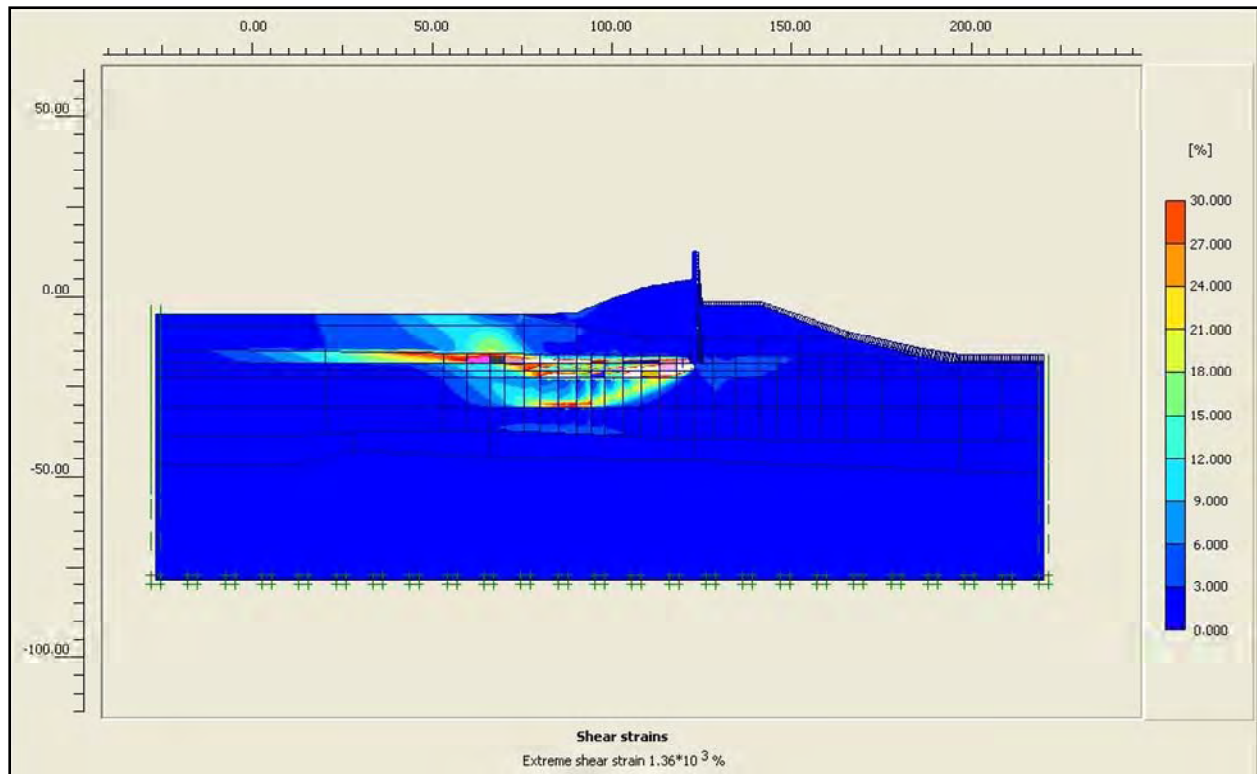
Figure 6-38. Reaches of Large Shear Strains for Canal El 9 and Crack to El -18.5

Figure 6-38 shows that at this stage of flood loading, the upper reach of high shear strains also now indicate the formation of a failure mechanism up through the peat/marsh region beyond the toe of the levee.

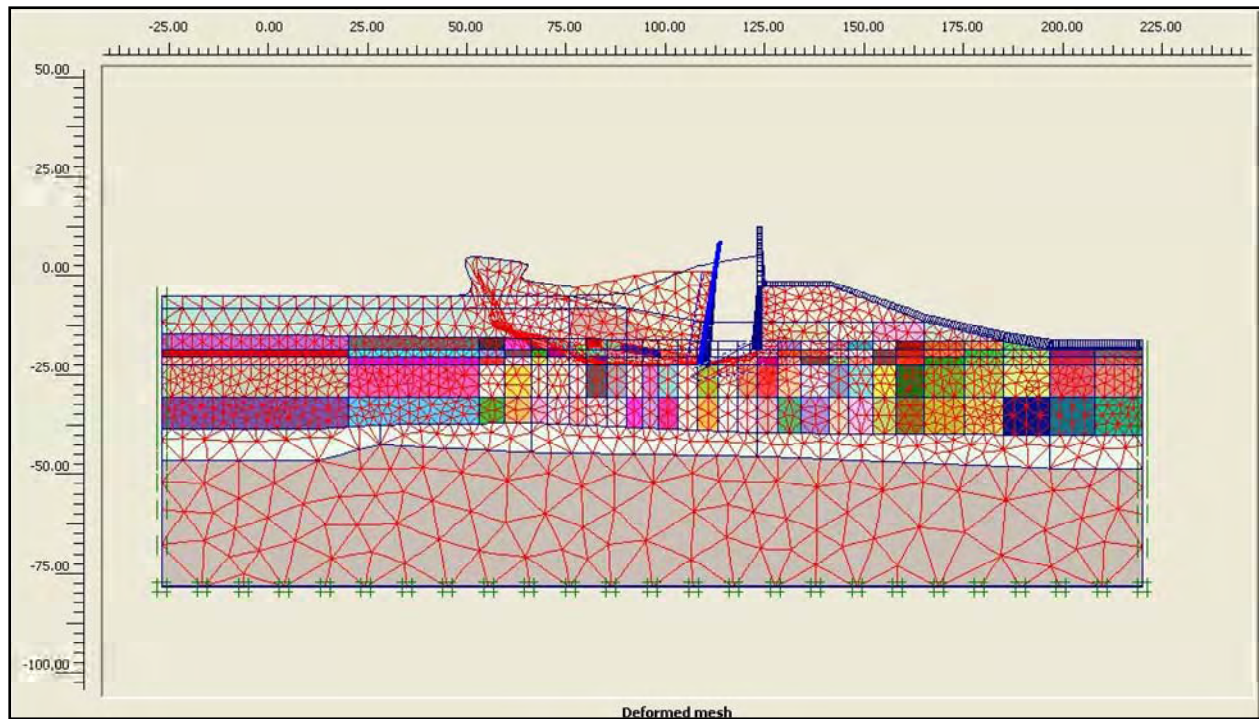
Figure 6-39. Failure Mechanism from Phi/C Reduction for Canal EI 9 and Crack to EI -18.5

Figure 6-39 shows the failure mechanism based on a Plaxis Phi/C reduction procedure resulting in a computed factor of safety against shear failure of 0.98, while the corresponding Figure 6-40 shear strains show that the zone of higher shear strains extend to the upper layer of the lacustrine clay. Note the mechanism “daylighting” beyond the toe of the levee. This result is consistent with the Figure 6-36 displacements, showing the bulging upwards of the peat/marsh layer beyond levee toe; the zone of high values for the computed fraction of mobilized shear strength within this region in Figure 6-37; and the Figure 6-38 high shear strains also computed within this region.

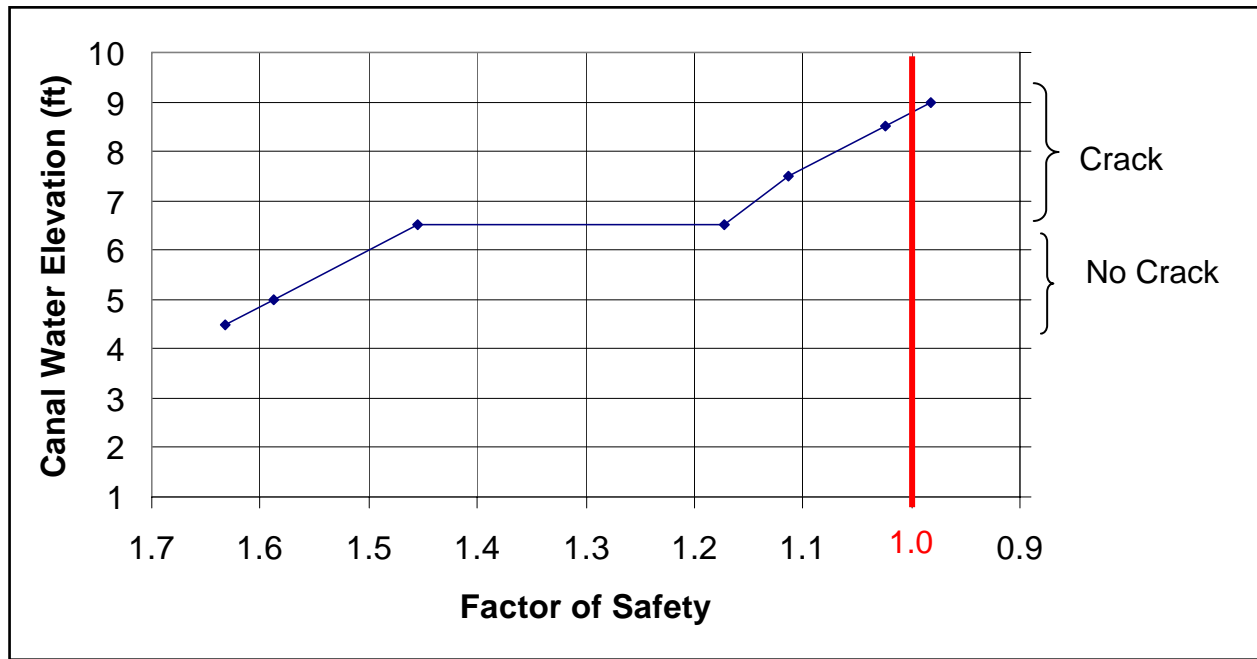
Figure 6-41. Factor of Safety Versus Canal Water El (Complete SSI results)

Subsequent complete SSI analyses are made to compute the factors of safety against shear failure for canal water less than El 9. The results summarized in Figure 6-41 indicate that the factor of safety is equal to unity for canal water El 8.8. These results demonstrate the reserve capacity of the levee/I-wall system for canal water less than El 8.8. For example, Figure 6-41 shows that at El 6.5, the factor of safety against shear failure is 1.46 prior to cracking. Figure 6-42 shows that the failure mechanism based on a Plaxis Phi/C reduction procedure, if allowed to develop, would also be “daylighting” beyond the toe of the levee, while the corresponding Figure 6-43 shear strains show that the zone of higher shear strains extend to mid-layer in the lacustrine clay. After the full crack is introduced to the sheet pile tip for canal water El 6.5, the factor of safety reduces to 1.17.

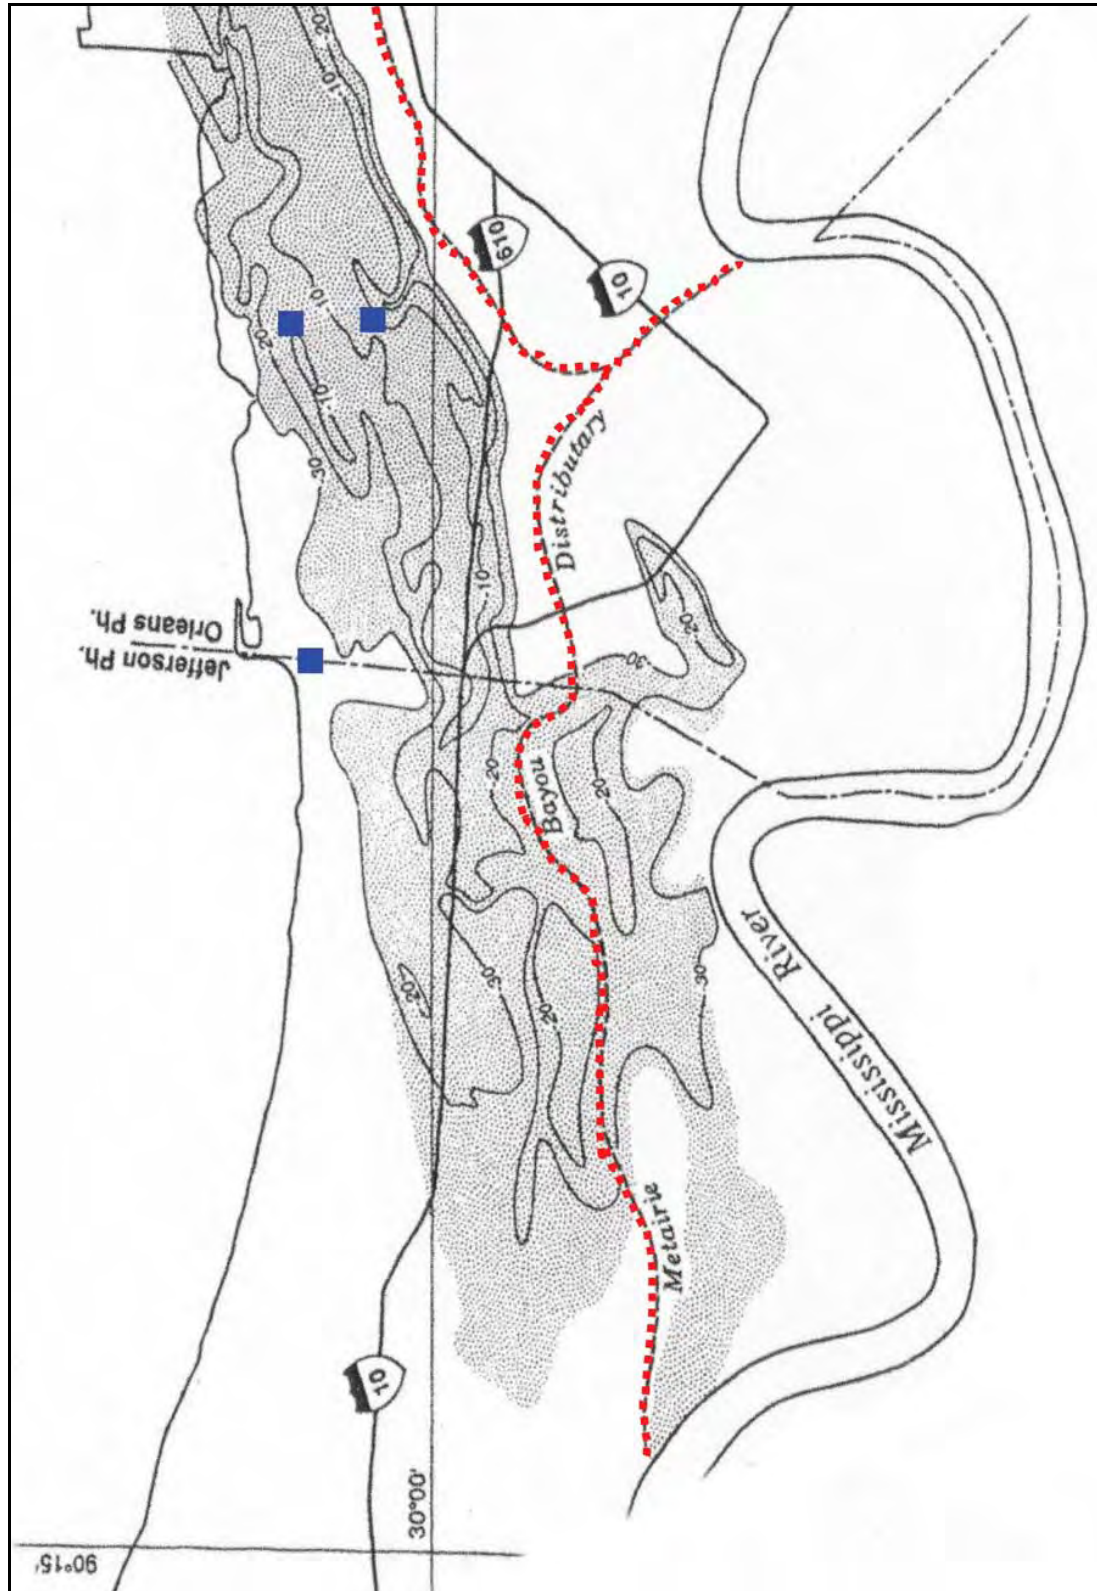
Figure 7-4b. Close-up View of the Buried Beach Ridge and the Locations of the Canal Breaches to the Buried Beach (After Saucier 1994). The 17th Street Breach is Located Behind the Axis of the Beach Ridge, while the London Canal Breaches are Located on the Axis of the Ridge. Bayou Metairie is Identified in Red and Forms the Bayou Sauvage Distributary Course (No. 11) in Figure 7-2.

The presence of the barrier beach affected sedimentation patterns and the subsequent locations for advancing distributary channels in the New Orleans area. The beach complex likely prevented the Mississippi River and later St. Bernard distributaries from completely filling Lake Pontchartrain with sediment. Consequently, foundation soils beneath the 17th and London Canal breaches are affected by their proximity to the buried beach complex. As shown by Figure 7-4, the breach at the 17th Street Canal is located on the protected or land side of the beach ridge, while both of the London Canal breaches are located over the thickest part or axis of this ridge complex.

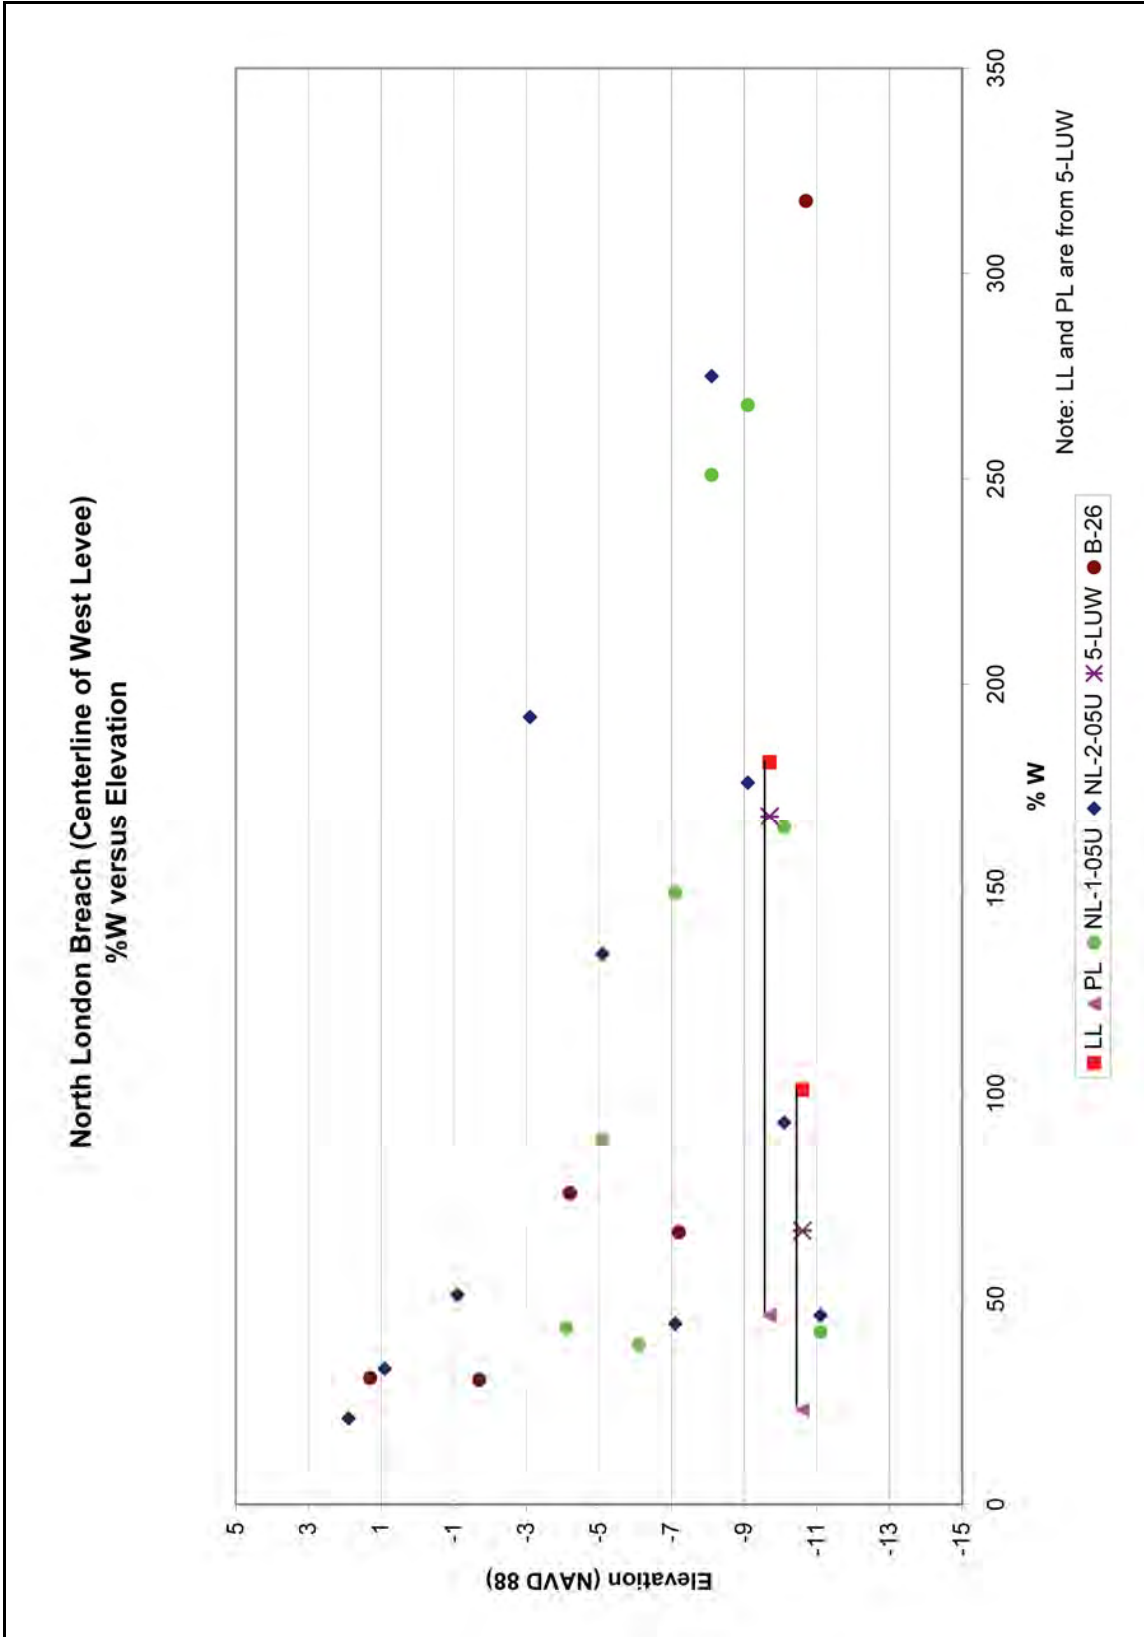
Figure 7-16. North London Breach (Centerline of West Levee), %w versus Elevation

The moisture content (%w) versus elevation (NAVD 88) for samples taken from the levee centerline and above the beach sand is shown in Figure 7-16. Generally, the borings from the levee centerline show levee fill on top of a marsh layer (which consists of peat or organic clay) and a 2-ft clay (CH) layer below the marsh layer. Boring NL-2-05 shows a 2-ft clay (CL) seam in the marsh layer from about elevation -5 to -8 (NAVD 88). However, GDM boring B-26 does not show the 2-ft clay layer at the bottom of the marsh layer.

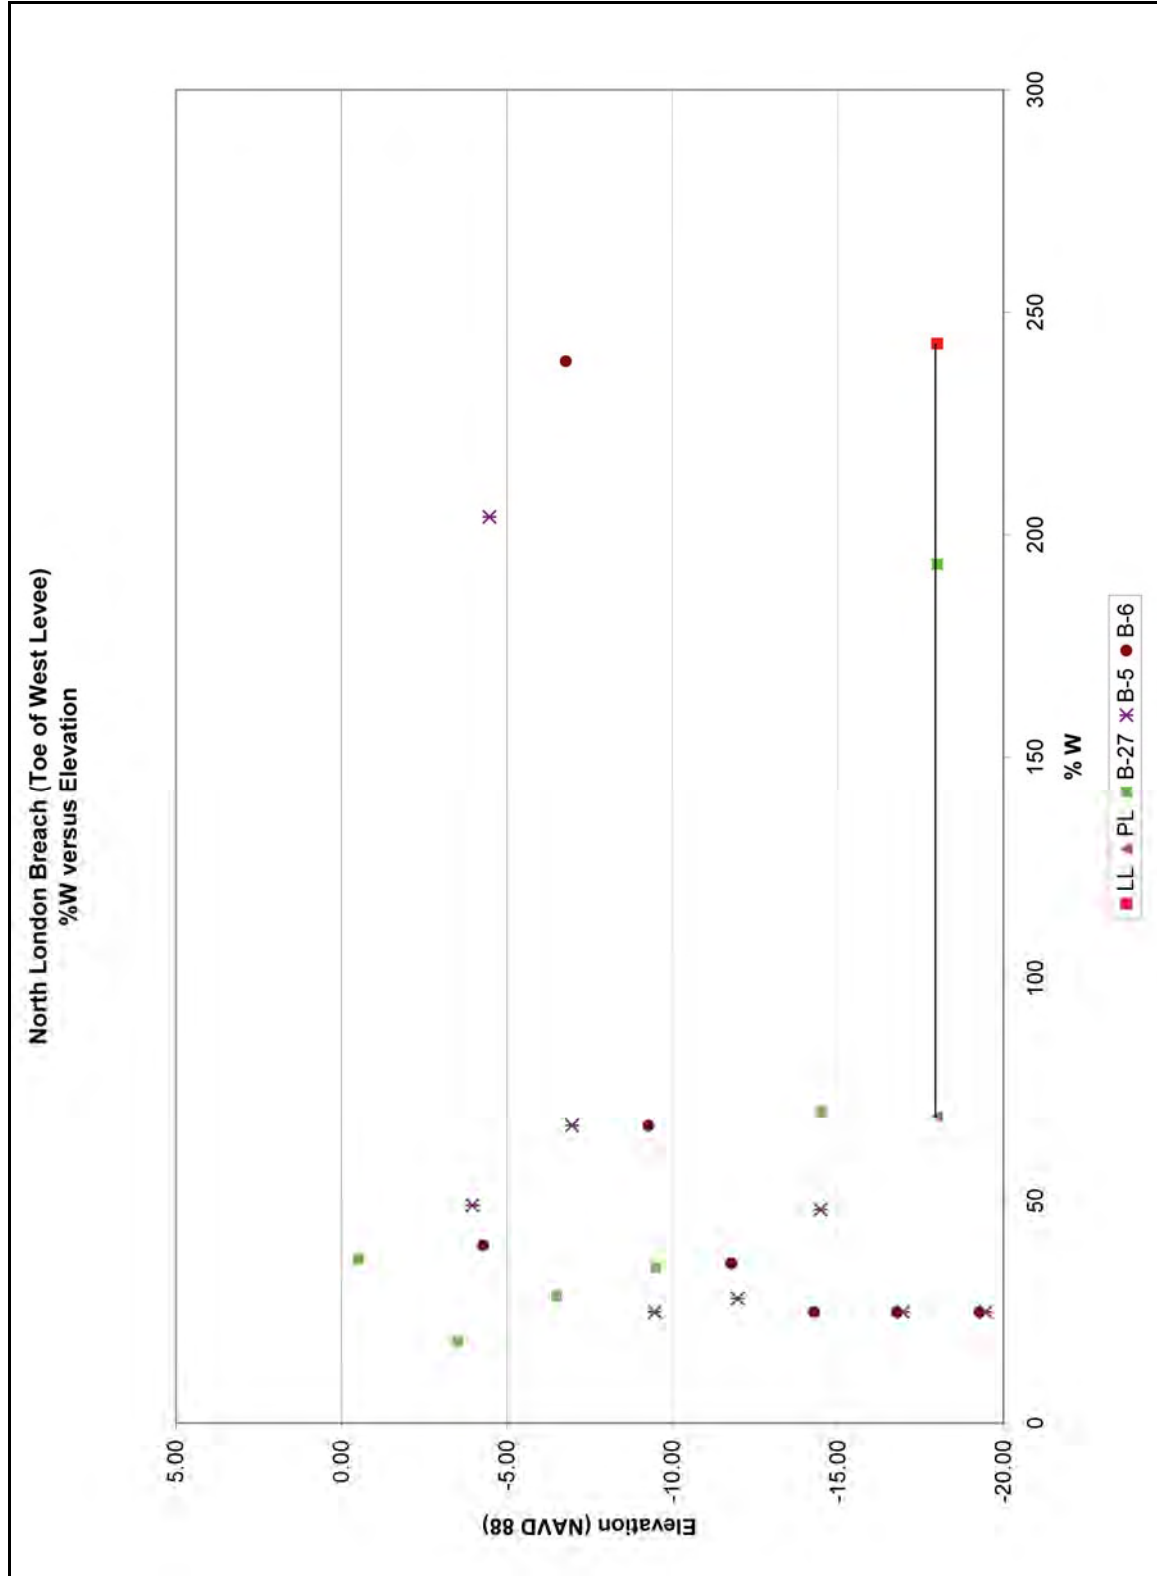
Figure 7-21. North London Breach (Toe of West Levee), %w versus Elevation

The moisture content (%w) versus elevation (NAVD 88) for samples taken from the levee toe and above the beach sand is shown in Figure 7-21. Generally, borings from the levee toe show a top soil layer on top of a marsh layer (which consists of peat or organic clay) and a 2-ft clay and silt layer below the marsh layer.

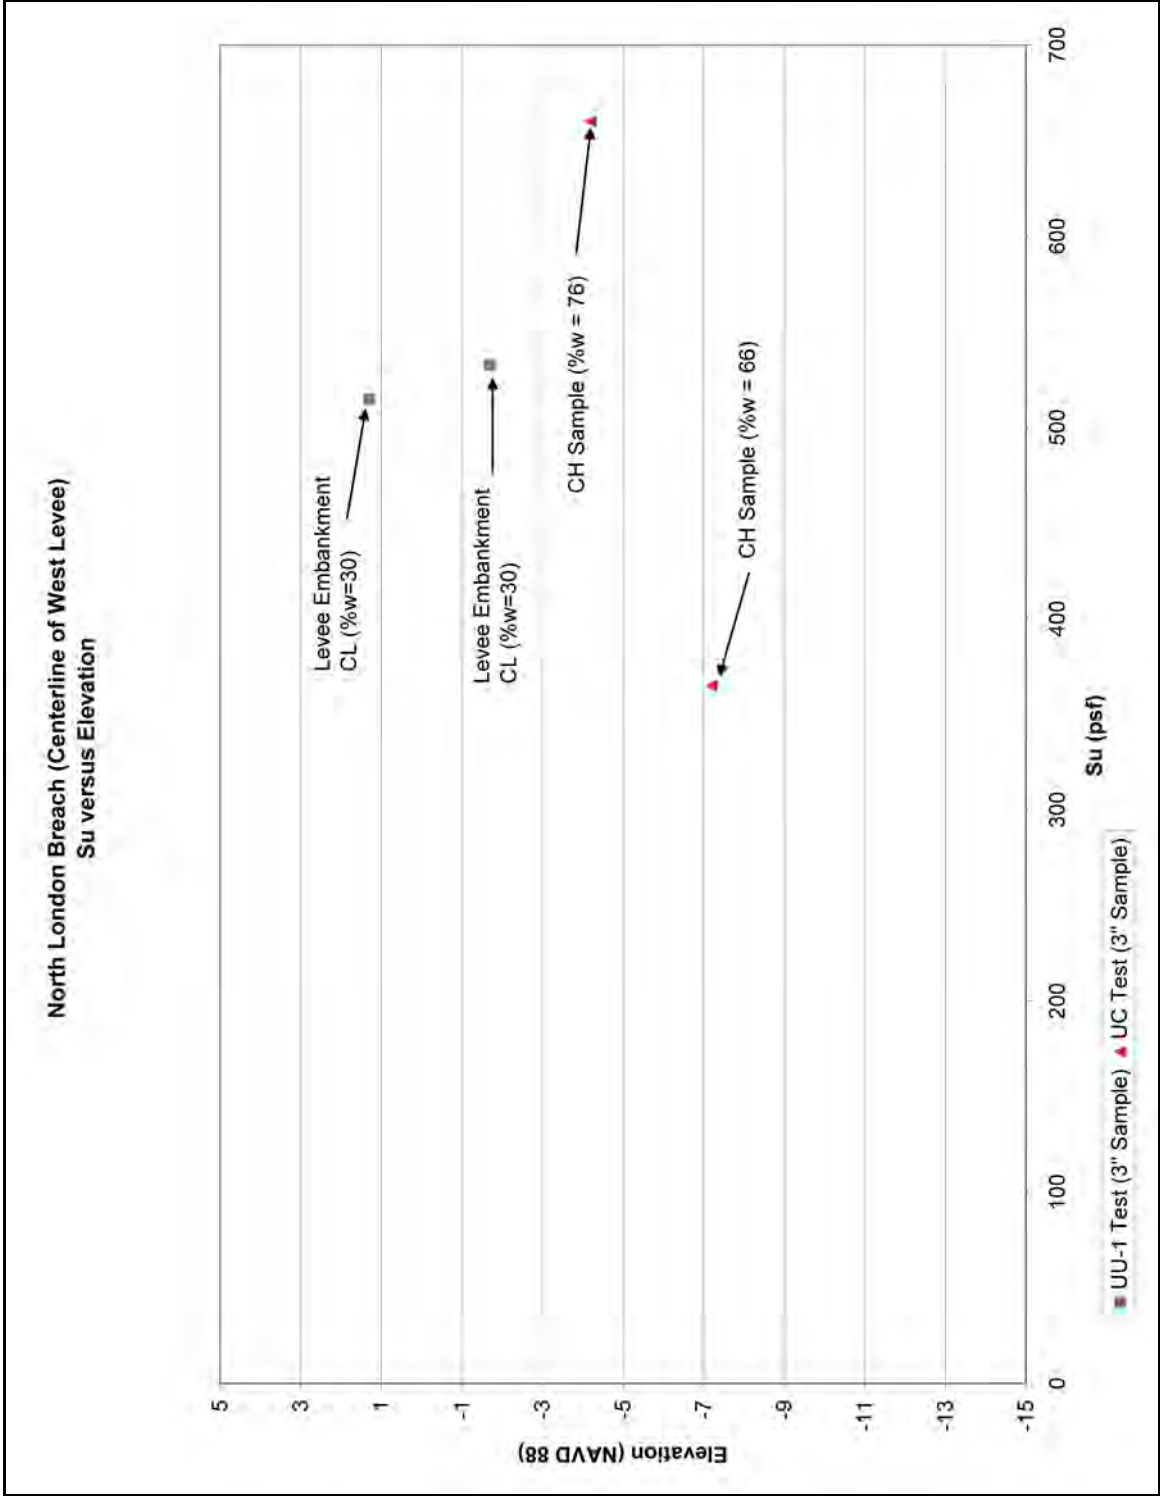
Figure 7-22. North London Breach (Centerline of West Levee), Su versus Elevation

Shear strengths from laboratory tests of the levee embankment and marsh unit (under the centerline) are fairly sparse. Figure 7-22 shows a plot of the four shear strength data points. However, two CPTs with pore pressure measurements were taken in the breach area through the centerline. Shear strength plots of CPT NLON-2.05C using the bearing capacity method ($N_k=15$) and Mayne's method are shown in Figure 7-23. Also shown in Figure 7-23 is boring NL-1-05U, which was drilled next to the CPT. From the plot on Figure 7-23, a clay layer between

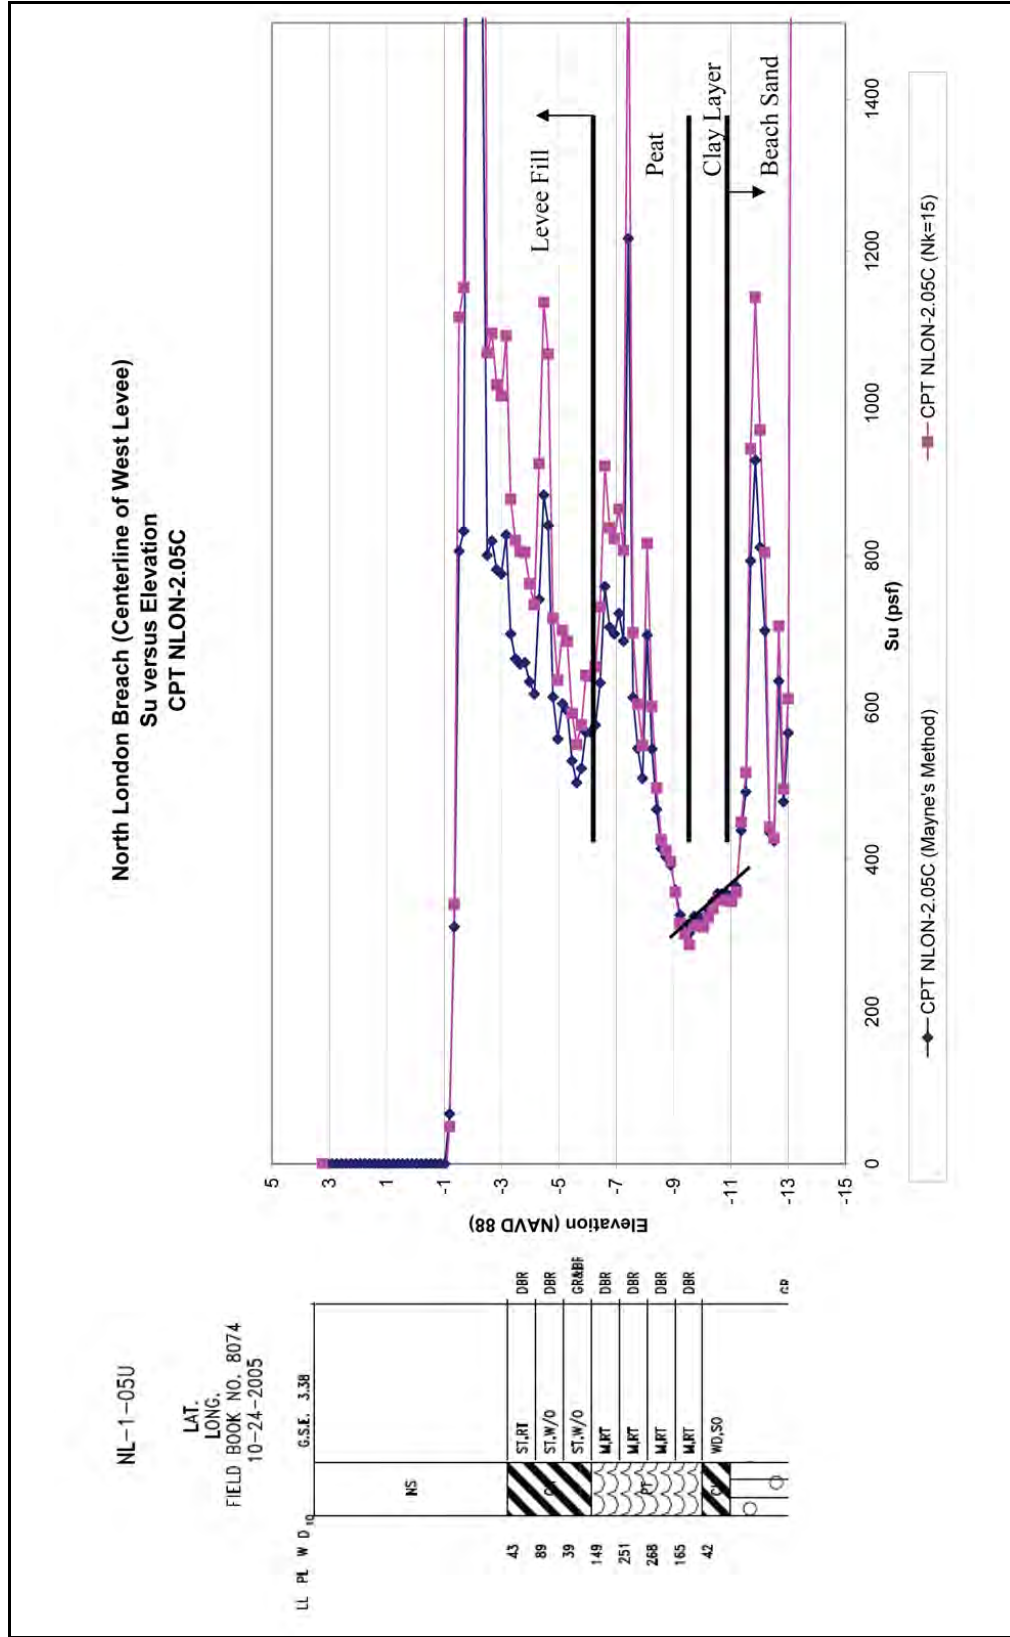
Figure 7-23. North London Breach (Centerline of West Levee), Su versus Elevation for CPT NLON-2.05C

elevations -9 and -11, which is at the top of the beach sand, is clearly detected by the CPT. The CPT shows that this clay layer has an Su/P ratio of 0.26 to 0.28.

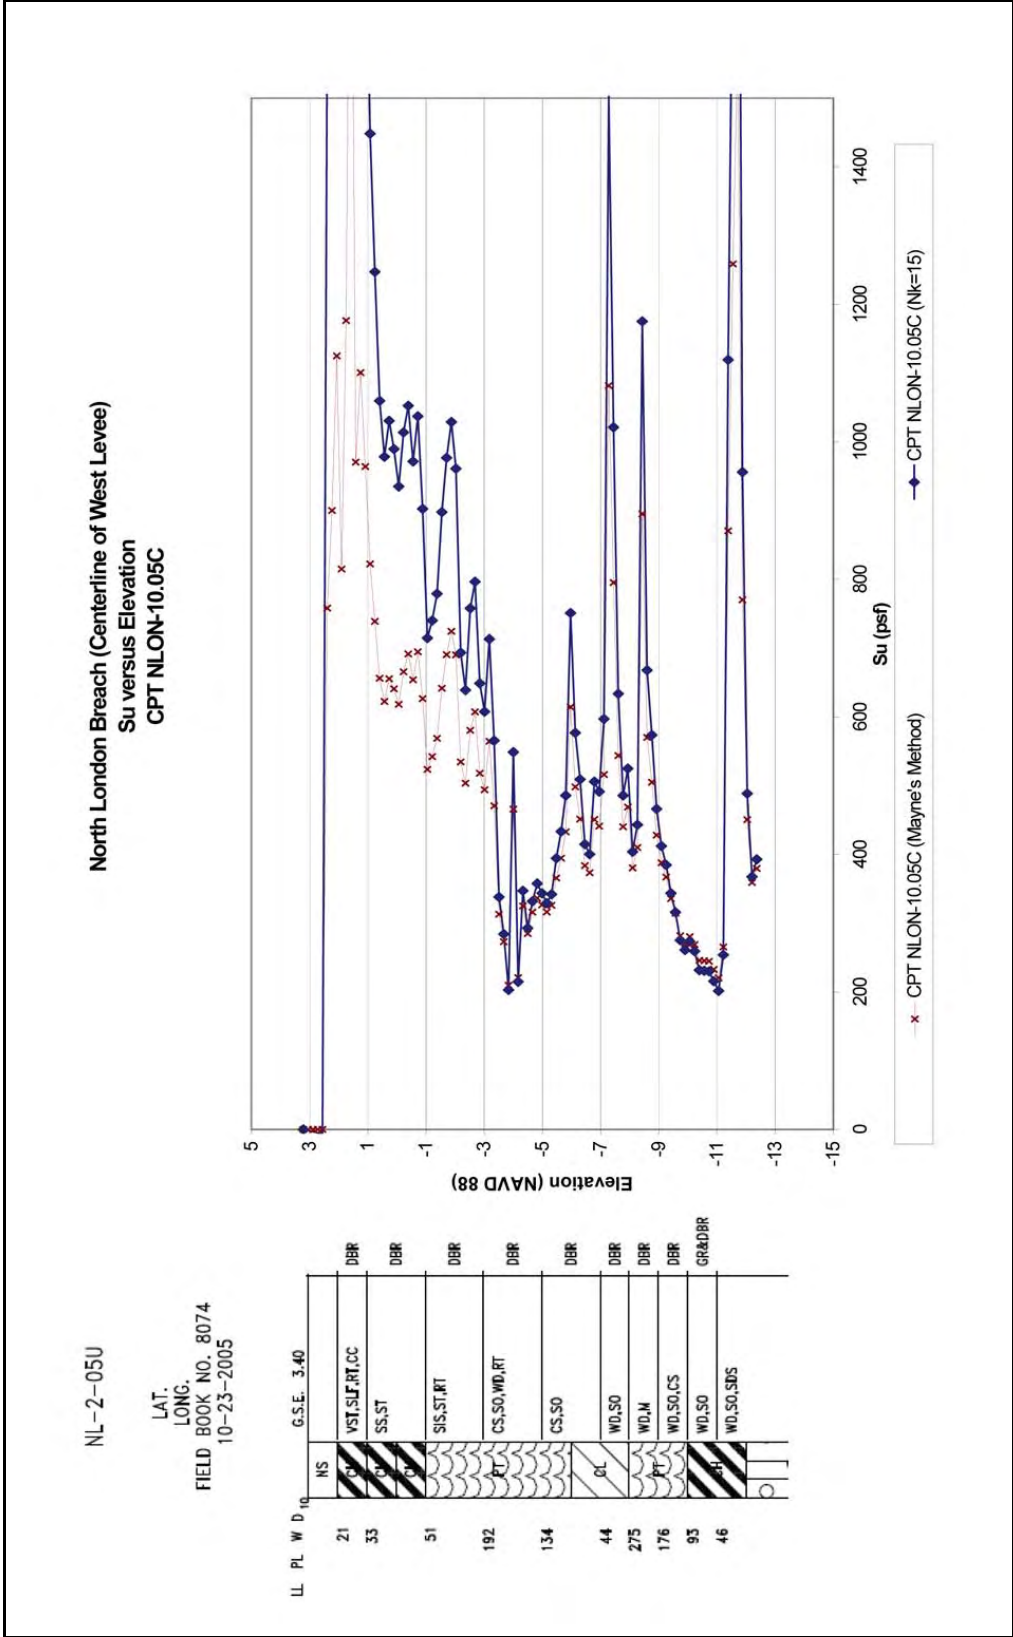
Figure 7-24. North London Breach (Centerline of West Levee), Su versus Elevation for CPT NLON-10.05C

Shear strength plots of CPT NLON-10.05C, using the bearing capacity method ($N_k=15$) and Mayne's method, are shown in Figure 7-24. However, an increase in strength per depth was not detected in the clay layer at the top of the beach sand. The shear strength versus elevation for both CPTs and laboratory test data is shown in Figure 7-25. Mayne's method was used to compute the shear strengths in this figure.

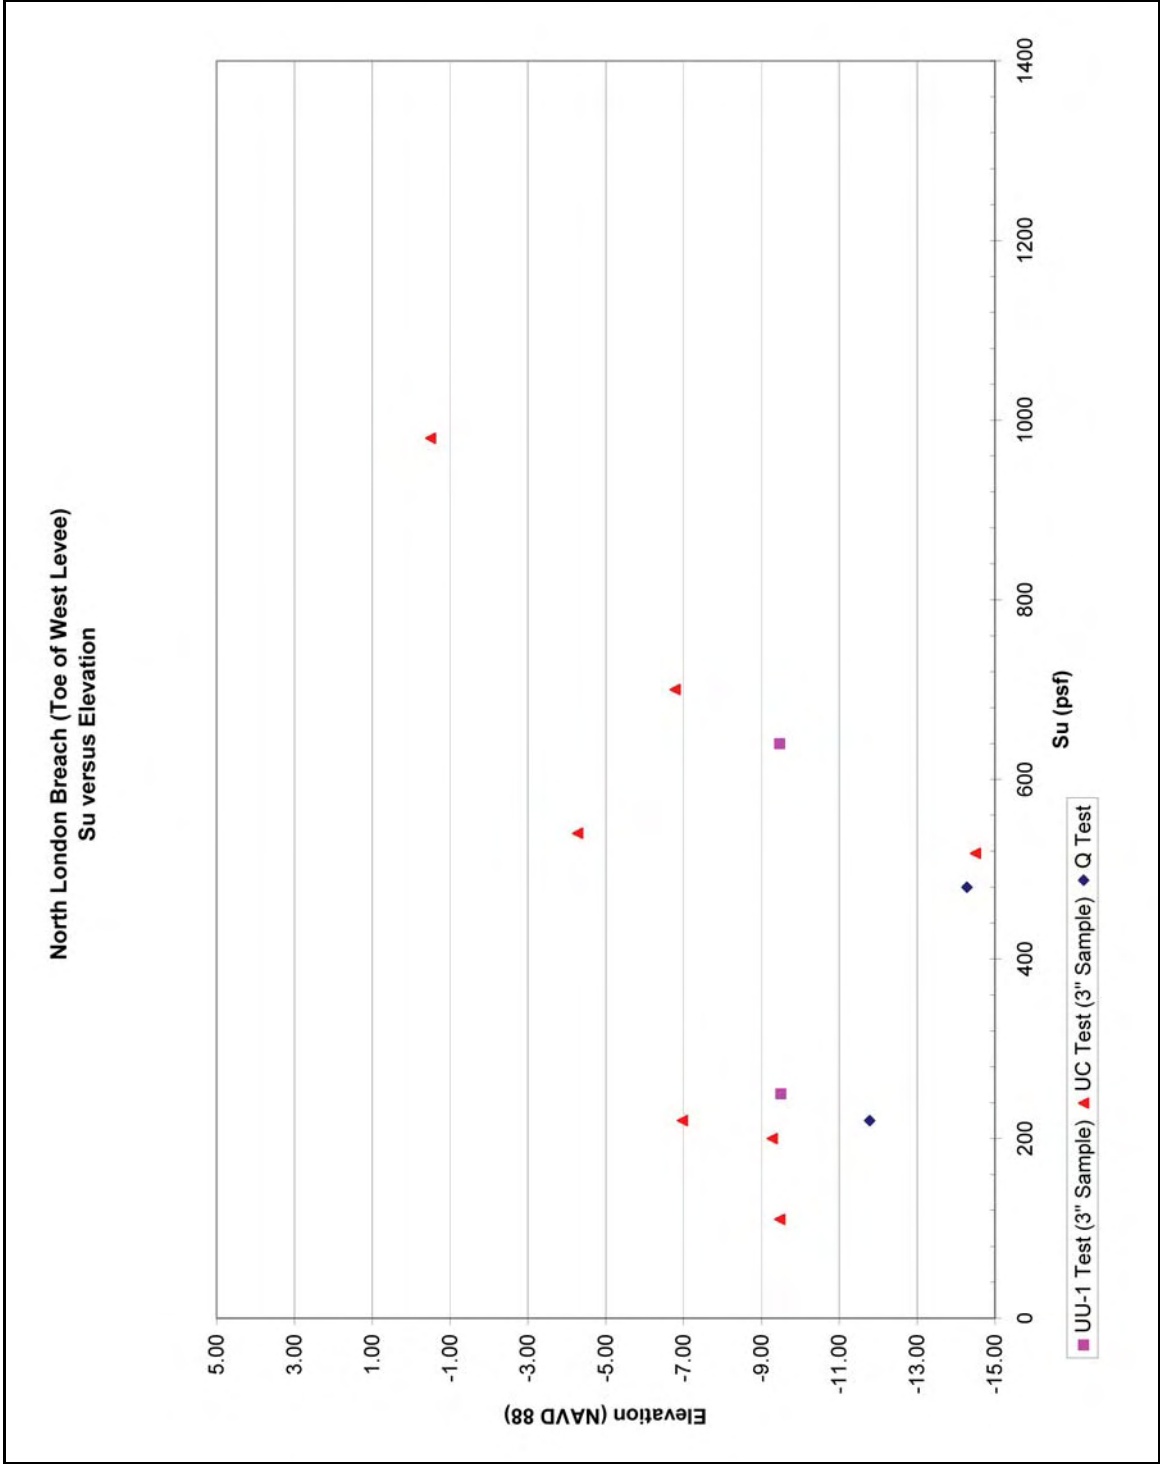
Figure 7-26. North London Breach (Toe of West Levee), Su versus Elevation

Shear strengths from laboratory tests of the marsh unit at the toe of the levee are shown in Figure 7-26. In addition, shear strength plots of laboratory tests and CPT data are shown in Figure 7-27. Because of equipment difficulties, CPT NLON-14a.05C was only pushed to a depth of 28 ft with pore pressure measurements. The CPT was pushed again to a depth of 80 ft, but no pore measurements were taken. Below is a table summarizing the available laboratory shear strength data from the toe.
