Appendix 1

Soil Data Report for 17th Street Canal

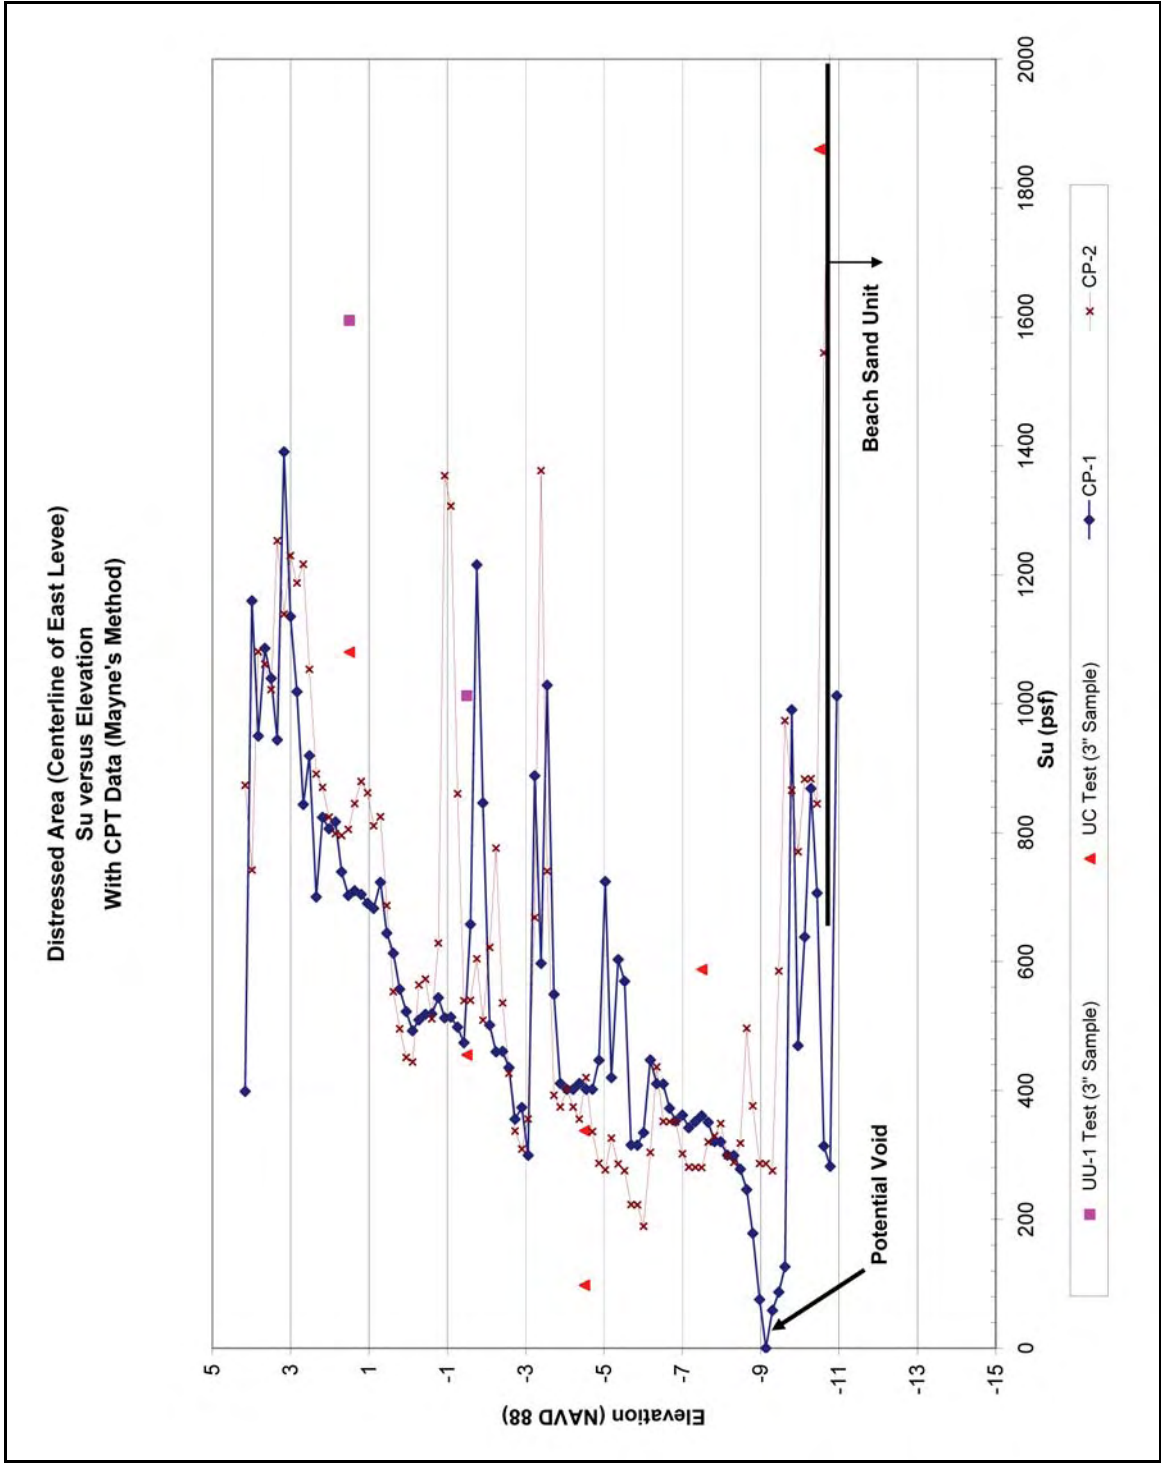
Figure 7-36. Distressed Area (Centerline of East Levee), Su versus Elevation with CPTs CP-1 and CP-2

Interpretation of the undrained shear strengths (using Mayne's method) of the material above the beach sand unit for CPTs CP-1 and CP-2 is shown in Figure 7-36. Also, plotted in Figure 7-36 is the shear strengths shown in Table 7-9. The shear strength plot for CP-1 shows a potential void at elevation -9 (NAVD 88). However, this void was not detected in CP-2.

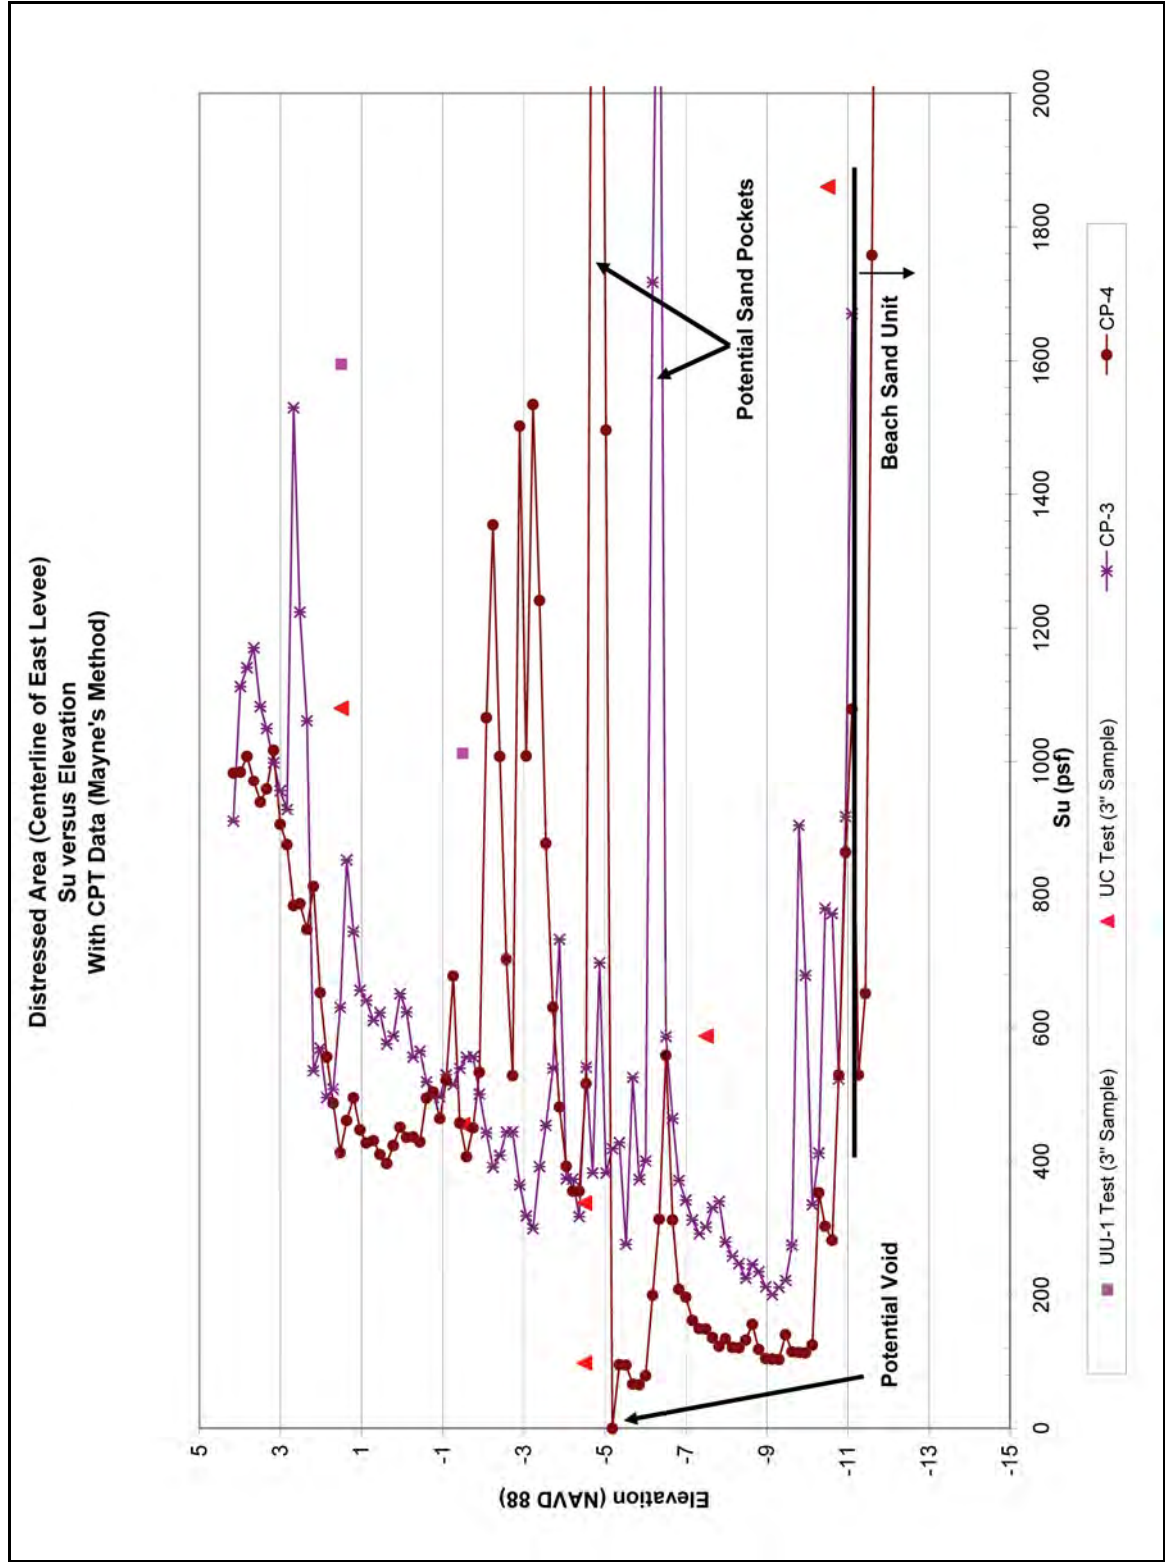
Figure 7-37. Distressed Area (Centerline of East Levee), Su versus Elevation with CPTs CP-1 and CP-2

Furthermore, interpretation of the undrained shear strengths for CPTs CP-3 and CP-4 is shown in Figure 7-37. CPT CP-3 shows a potential sand pocket at elevation -6.5 (NAVD 88) and CPT CP-4 also shows a potential sand pocket at elevation -4.5. Similar to CP-2, a potential void was detected in CP-4 at elevation -5.

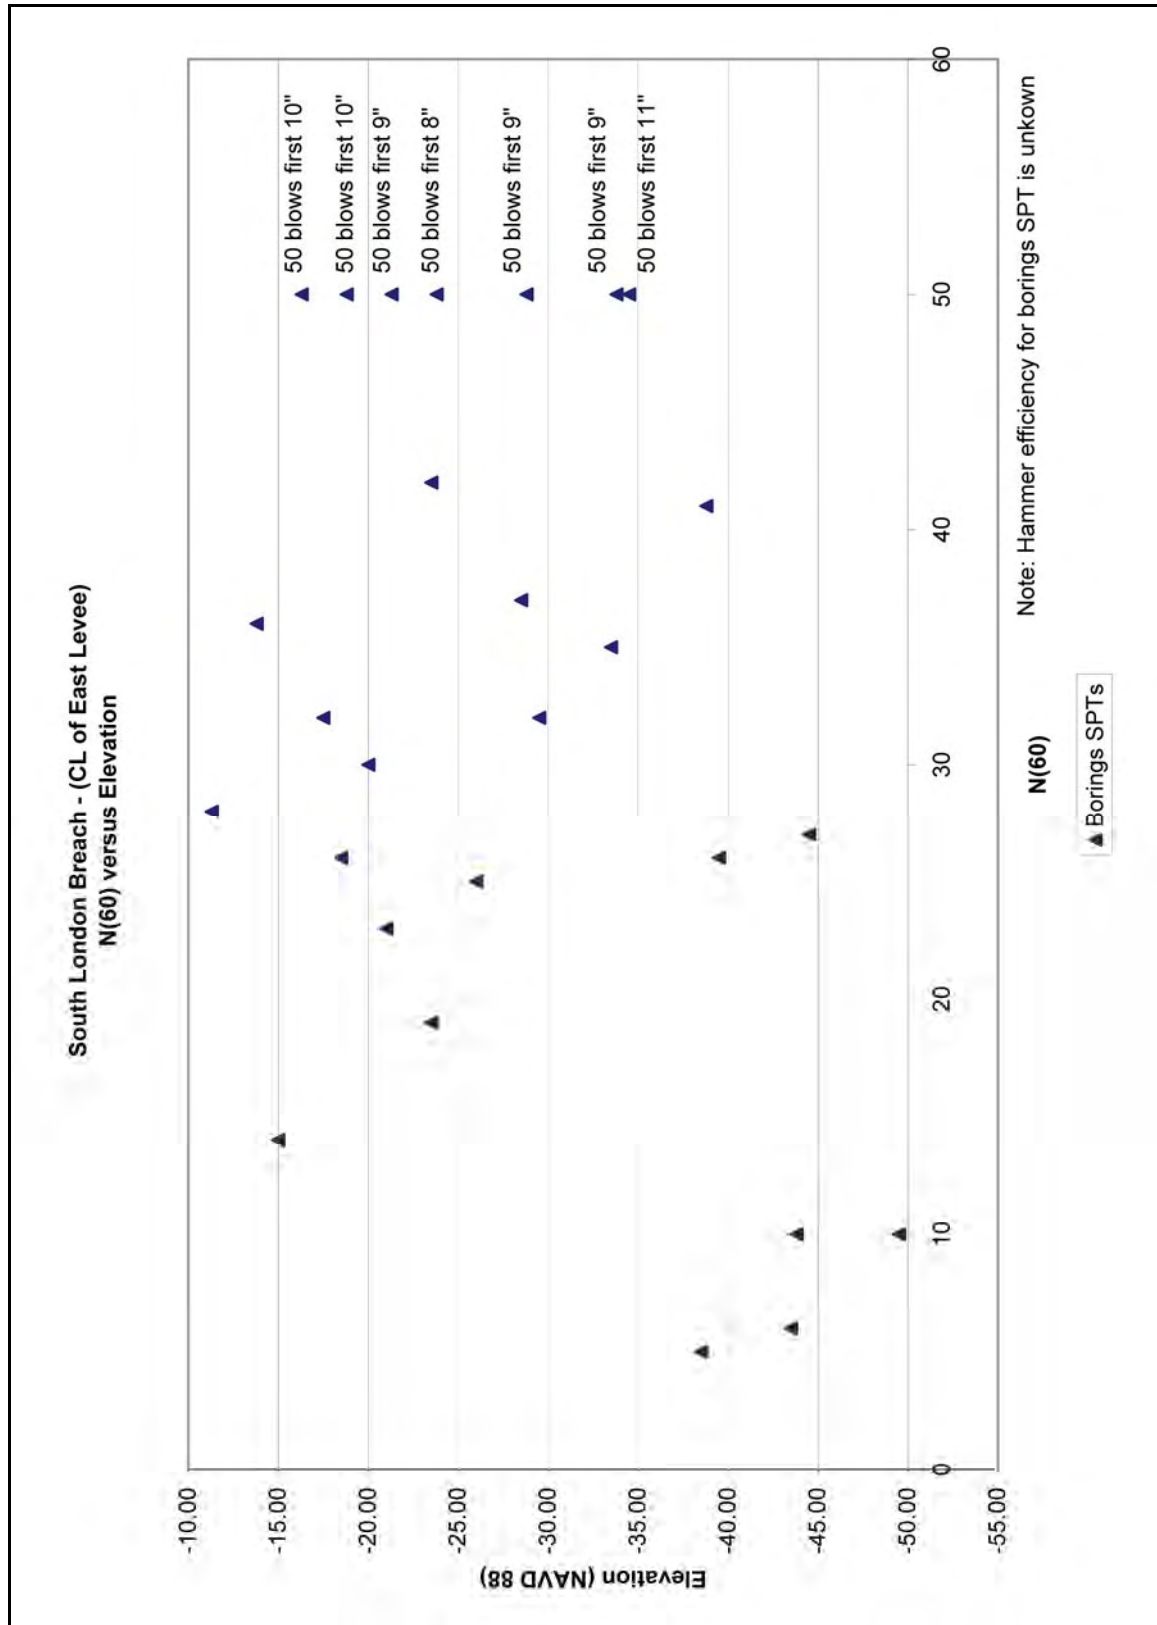
Figure 7-45. South London Breach – Beach Sand Unit (CL of East Levee), SPT versus Elevation

Figure 7-45 shows the SPT values obtained from the GDM borings at the breach. The hammer efficiency is unknown for these borings. Refusal was reached in some dense layers of sand between elevations -15 to -35 (NAVD 88).

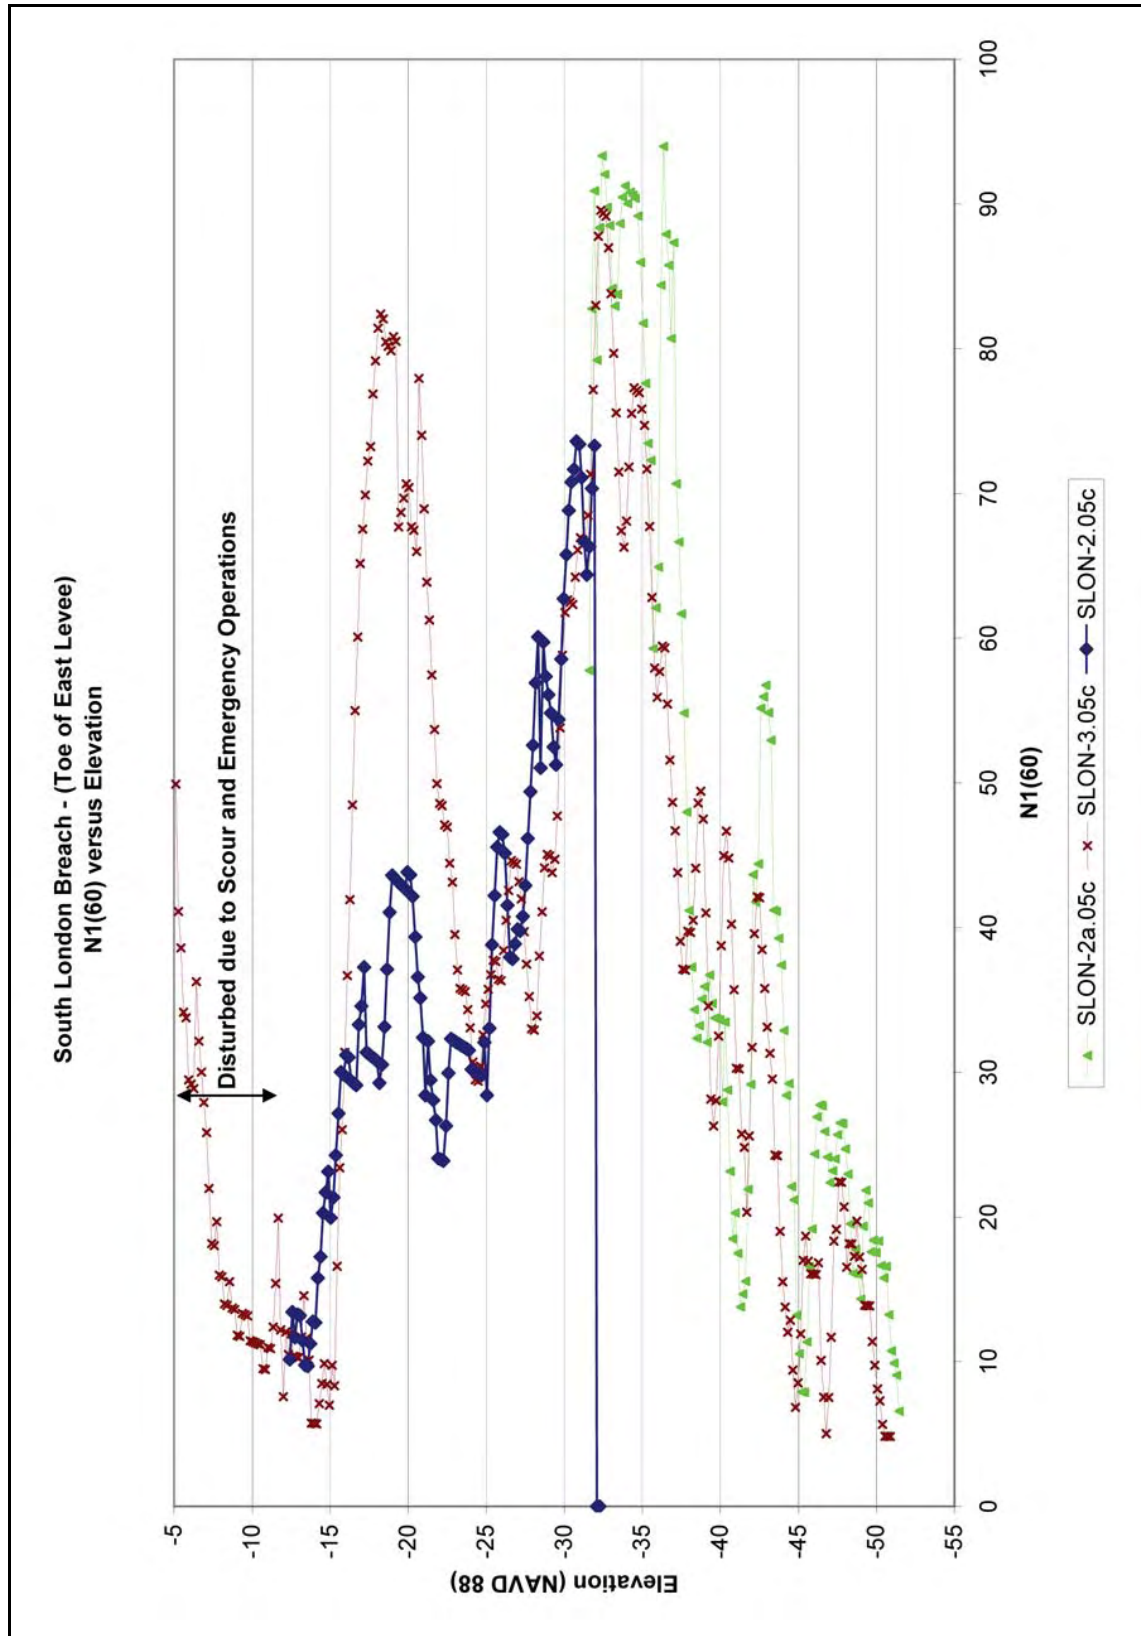
Figure 7-46. South London Breach – Beach Sand Stratum (Toe of East Levee), N1(60) versus Elevation for CPTs SLON-2.05c and SLON-3.05c

Figures 7-46 and 7-47 show the N₁₍₆₀₎ values of the beach sand unit as determined from the CPTs. CPT NLON-2.05C was first pushed with a 5-ton cone penetrometer, but because the tip loads were nearing the capacity of the device at about elevation -31, a 10-ton cone penetrometer was used. On Figure 7-46, NLON-3.05c shows a dense sand layer (N₁₍₆₀₎ values ranging from 50 to 90) from elevations -17 to -23, and elevations -30 to -37. NLON-2.05c shows a dense sand layer (N₁₍₆₀₎ values range from 50 to 90) from elevations -27 to -37.

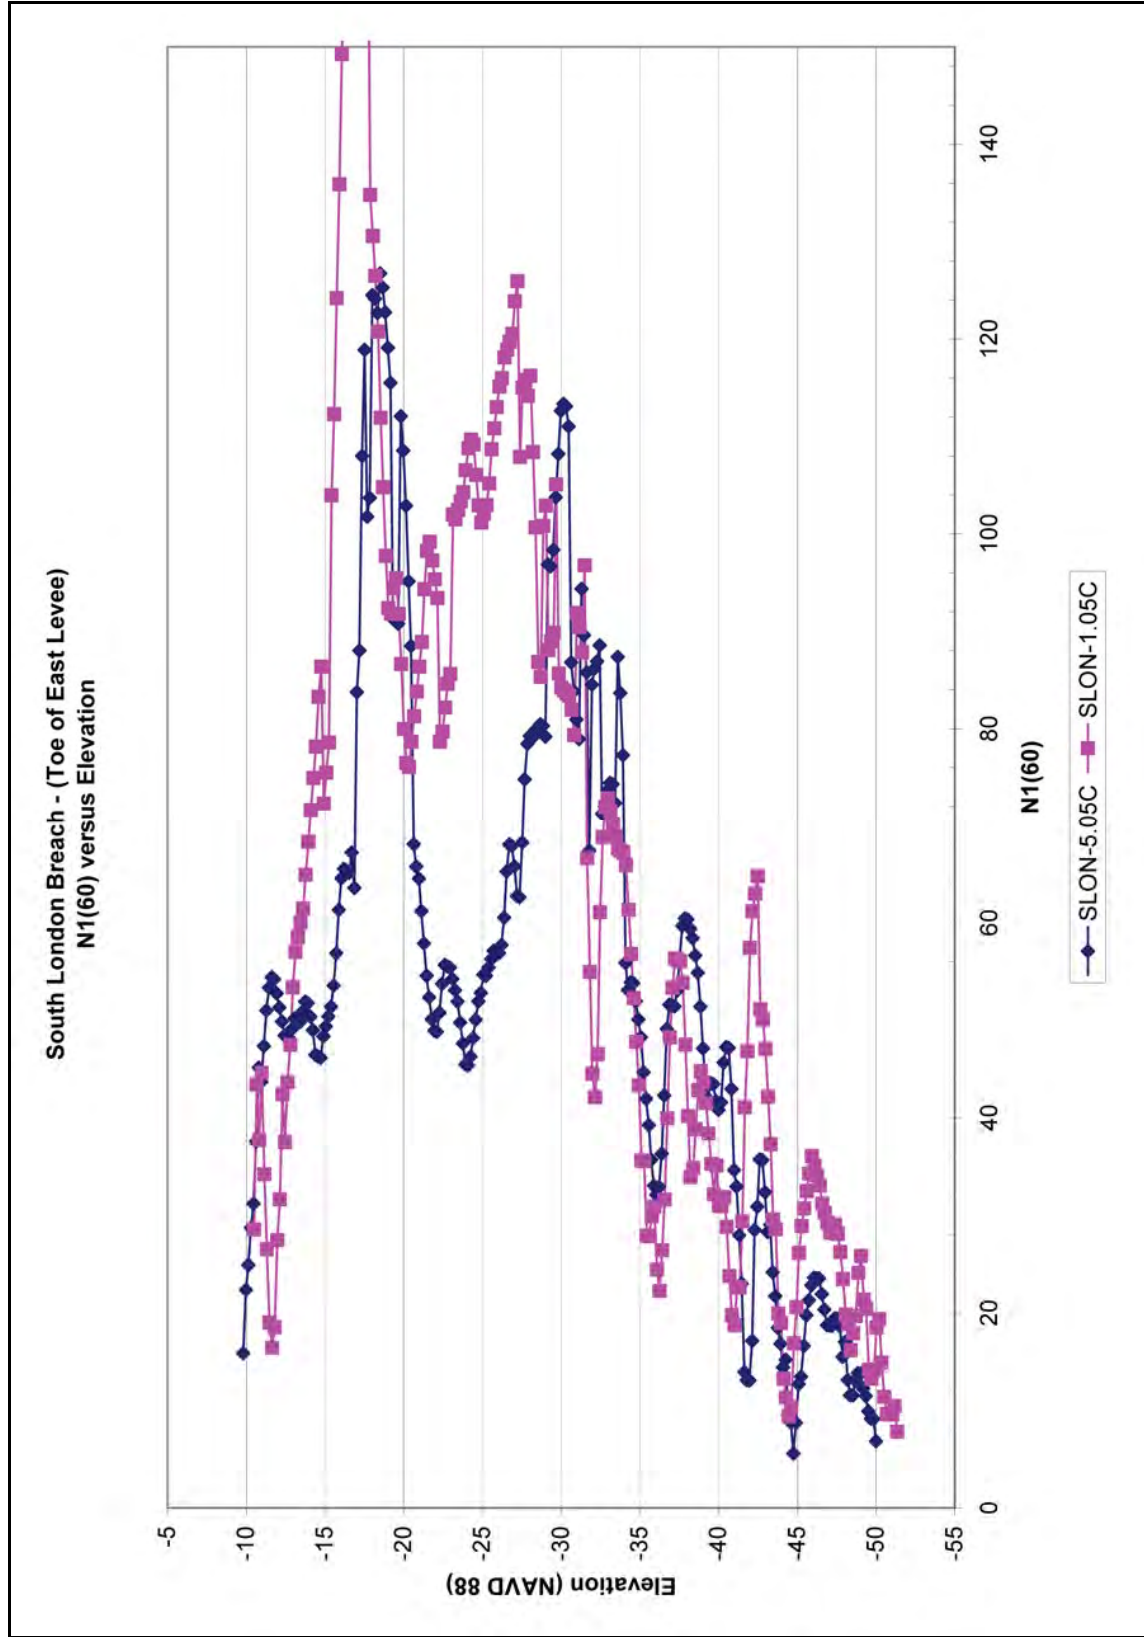
Figure 7-47. South London Breach – Beach Sand Stratum (Toe of East Levee), N1(60) versus Elevation for CPTs SLON-5.05c and SLON-1.05c

On Figure 7-47, NLON-5.05c also shows a dense sand layer (N₁₍₆₀₎ values range from 50 to over 100) from elevations -15 to -35. Both NLON-5.05c and NLON-1.05c show N₁₍₆₀₎ values over 100. This occurs because of the process in which the N₁₍₆₀₎ values are determined. Because of shallow depths and low overburden pressures, the C_n correction factor is greater than 1; and when multiplied to the N₍₆₀₎ values, will often produce an N₁₍₆₀₎ over 100. Liao and Whitman's (1986) relationship between C_n and vertical effective stress was used to convert the field blowcounts to their N₁₍₆₀₎ values. However, in some cases, the N₍₆₀₎ values are already near or at 100 at overburden pressures less than 1 tsf. Usually, N values greater than 50 are accepted as refusal. NLON-1.05c shows that dense sand layer N₁₍₆₀₎ values range from 50 to over 100) from elevations -13 to -35.

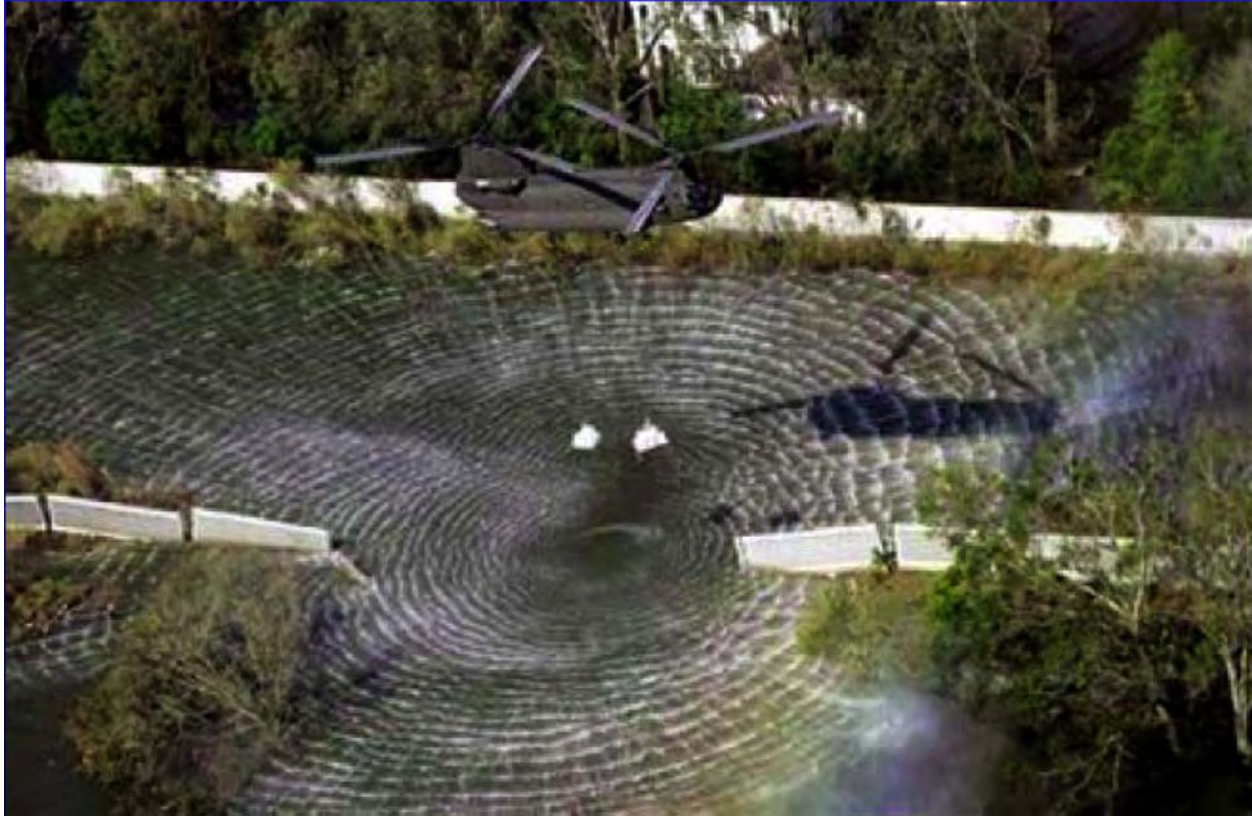
The south breach, shown in Figure 8-1, occurred about 6:00 AM to 7:00 AM on August 29th, when the water level in the canal was 7.1 ft to 8.2 ft NAVD88. The breach was narrower than the breach at 17th Street and the London Avenue north breach. A deep scour hole formed due to the inrush of water, and a large amount of eroded sand was deposited in the neighborhood inland of the breach. It appears that the breach was quite narrow when it formed, and subsequently widened to about 60 ft as wall panels adjacent to the initial breach were undermined by scour, and tilted into the scour hole.

It is not possible to establish the cause of the south breach with certainty based on the field observations made after the failure. The failed sections of the I-wall were not found, and large volumes of sand were moved by the inflow of water through the breach, covering the landscape. The failure might have resulted from underseepage erosion and piping, or from sliding instability

It has been reported that cold-rolled sheetpiles were used for the I-wall in the area of the south breach. Cold-rolled sheetpiles have lower interlock strengths than hot-rolled sheetpiles. Consequently, use of cold-rolled sheetpiles increases the likelihood that interlocks could have failed during driving, particularly because the sand in the south breach area was dense, and driving was hard. Interlock failure would result in gaps between adjacent sheets in the sheetpile wall, making it possible for water to seep through the wall as well as under the wall. Such through-flow would result in more severe seepage conditions than those reflected in the seepage analyses described here, and would make erosion and piping an even more likely mode of failure at the south breach.

Figure 8-1. The South Breach at the London Avenue Canal Occurred at 6:00 AM to 7:00 AM on August 29, 2005. The breach, on the east side of the canal, was approximately 60 feet wide.

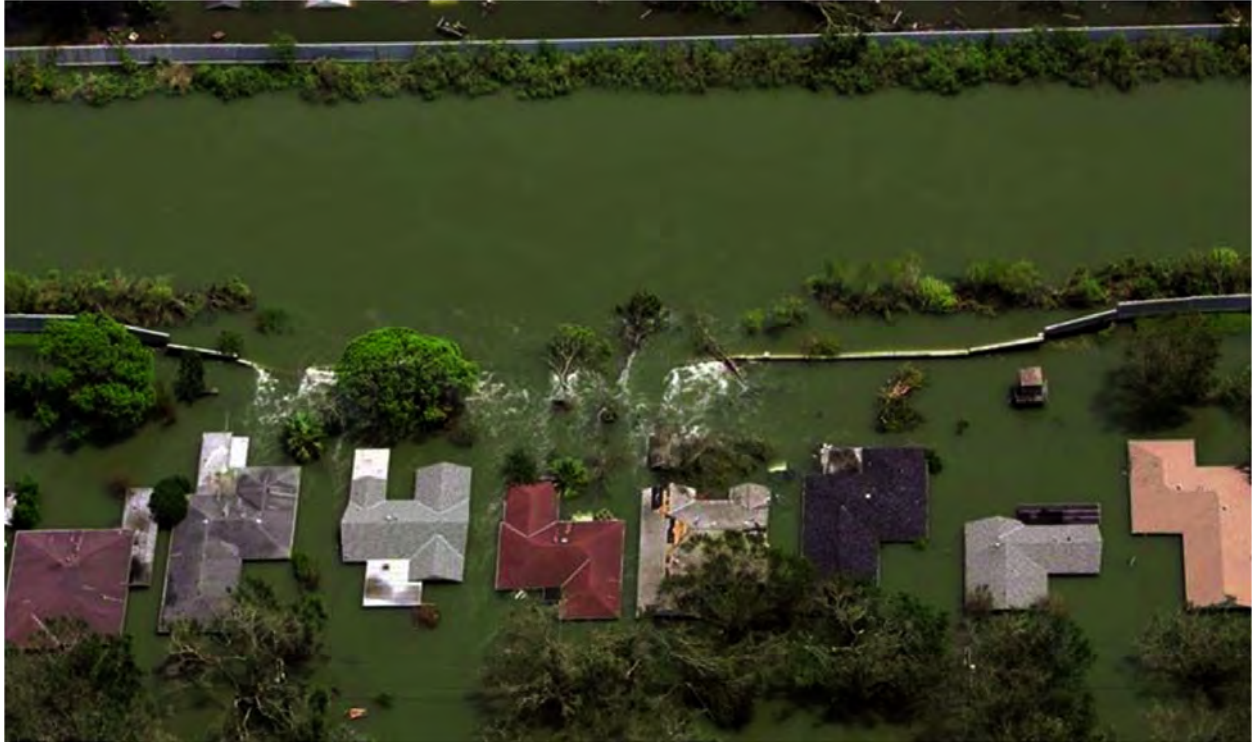
The north breach, shown in Figure 8-2, occurred about 7:00 AM to 8:00 AM on August 29th, about an hour after the south breach, when the canal water level was 8.2 ft to 9.5 ft NAVD88. The breach was about 410 ft wide, approximately the same width as the breach at 17th Street. A playhouse on the property adjacent to the breach was heaved upward when the breach occurred, indicating upward movement of the ground inboard of the levee toe. The I-wall opposite the north breach (on the east side of the canal) moved and tilted significantly, presumably at about the same time as the breach occurred on the west side, but the east I-wall did not breach. A line of sinkholes was observed at the inland side of the distressed east I-wall, and a sand boil at the inboard embankment toe indicate that erosive seepage and piping had occurred beneath the levee.

Field observations at the north breach indicate that sliding instability was likely the primary mode of failure, with seepage and high pore pressures in the sand as a significant contributing factor. It seems likely that the failure and breach were the result of insufficient passive resistance to counteract the water pressure forces to which the wall was subjected. The passive resistance was likely reduced by the effects of water seeping through the foundation soils beneath the levee and the marsh layer inland, inducing uplift pressures and reducing shear strengths. Analyses have been performed to examine the likelihood of erosion and piping, and instability due to uplift and reduced shear resistance.

Figure 8-2. The North Breach at the London Avenue Canal Occurred at 7:00 AM to 8:00 AM on August 29, 2005. The breach, on the west side of the canal, is approximately 410 feet wide.

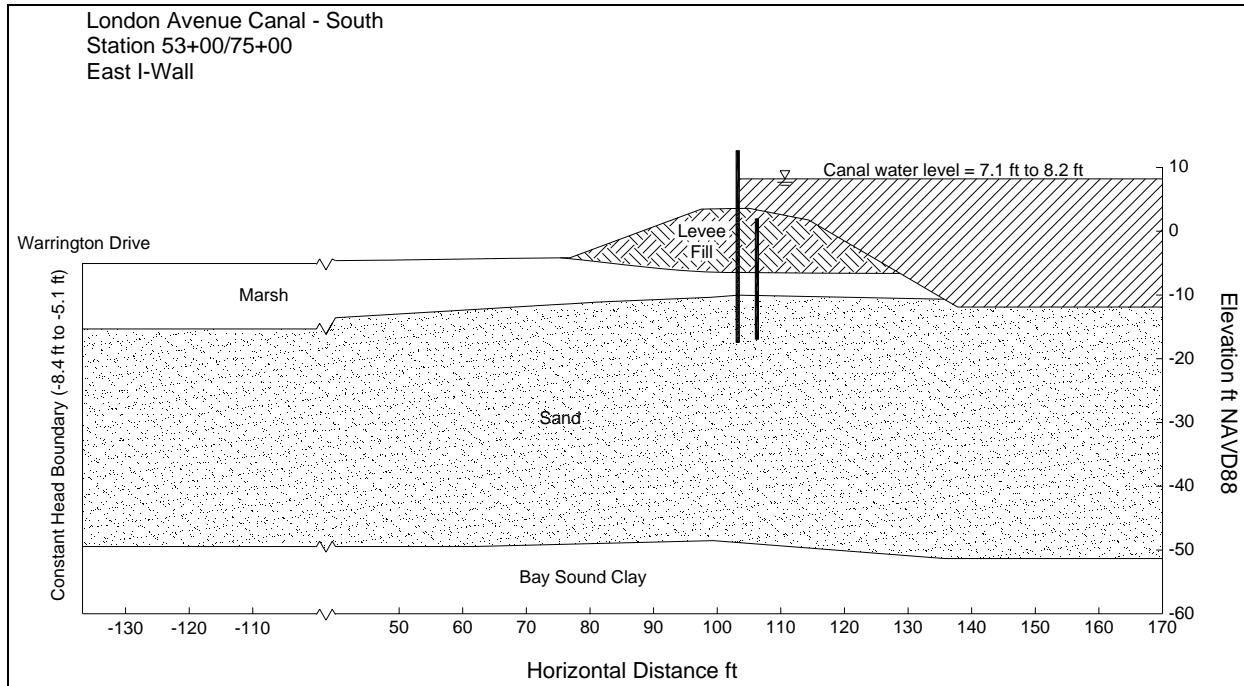
Figure 8-3. Schematic Cross Section at London South Breach, with Seepage Boundary Conditions

Finite element analyses of seepage beneath the I-wall were performed using the computer program SLIDE¹. The characteristics of the cross section analyzed are shown in Figure 8-3. The relevant materials are the sand at the base of the section, the overlying marsh (peat) layer, and the clayey levee fill. The permeability of the sand, based on field pumping tests, was 1.5×10^{-2} cm/sec. The permeability of the marsh layer was estimated as 1×10^{-5} cm/sec, and the permeability of the levee fill and the Bay Sound clay was estimated as 1×10^{-6} cm/sec. Thorough analyses of transient and steady seepage, described in a separate report, indicated that (a) steady seepage through the sand was established quickly, and (b) the pore pressures within the sand and the uplift pressures on the base of the marsh layer are not affected by the permeability values assigned to the marsh layer and the levee fill, provided that those materials are at least two orders of magnitude less permeable than the sand. The values of permeability of the marsh layer and the levee fill used in the seepage analyses described here were selected in accordance with these findings, and are considered to be reasonable estimates of the permeabilities of these materials.

The hydraulic boundary conditions used in these analyses are shown in Figure 8-3. The canal water level was either 7.1 ft or 8.2 ft NAVD88, a range consistent with the estimated canal water levels at the time of failure. A constant-head boundary condition was imposed at the location of the drain beneath Warrington Drive. This head value was either -8.4 ft (the normal ground water

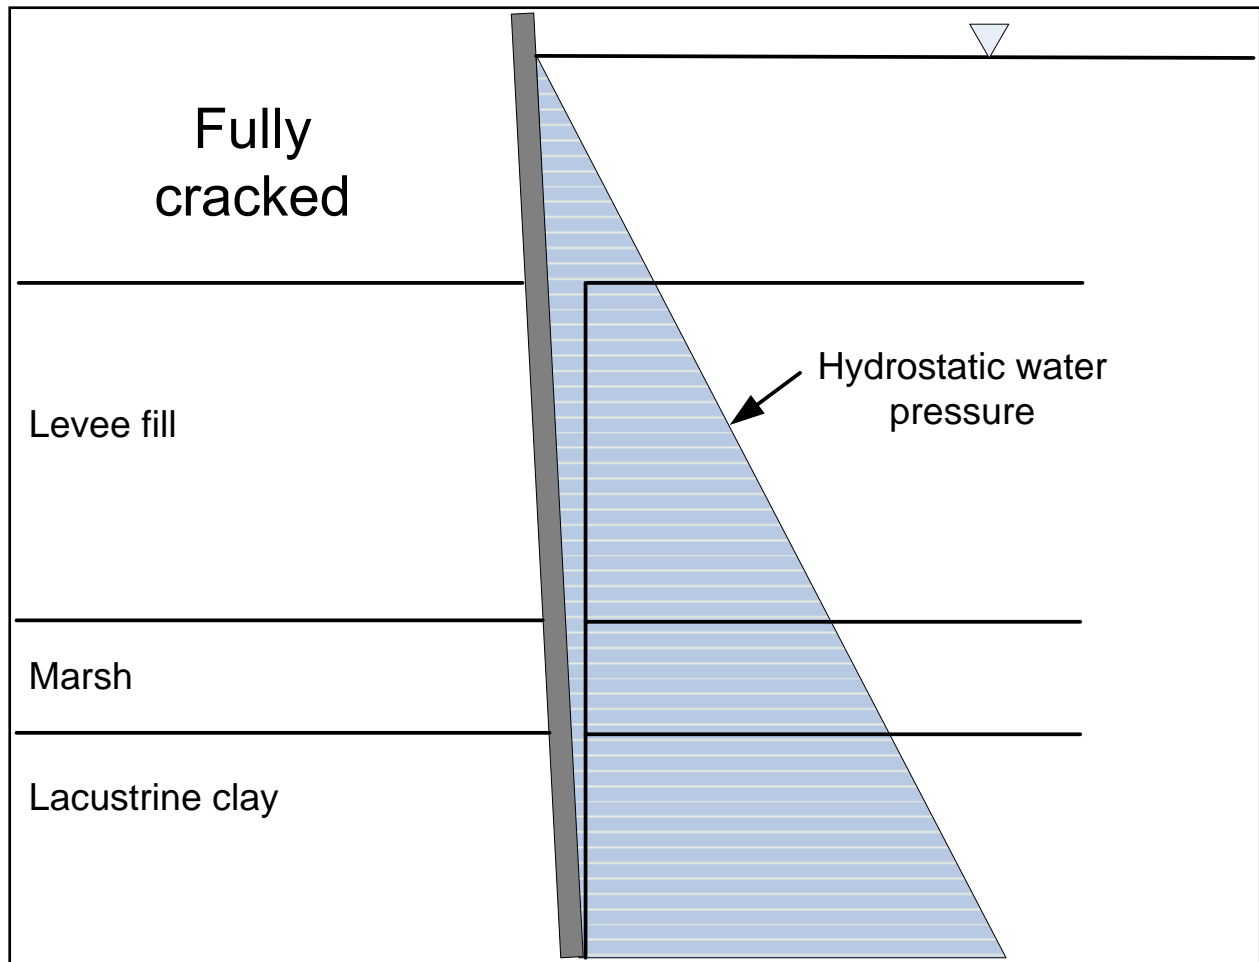
Figure 8-4. Schematic of Crack Used in 17th Street Canal Stability Analyses

Based on the study of the 17th Street Canal breach, it seems likely that a crack would form between the I-wall and the levee fill on the canal side of the wall. The type of crack assumed to have formed behind the 17th Street Canal I-wall, shown in Figure 8-4, does not seem feasible for the London Avenue foundation conditions, where the I-wall is driven into sand, because cohesionless sand would be unable to support a crack. A more likely condition for a wall driven into sand is shown in Figure 8-5. This “half-cracked” condition involves a crack through the levee fill and the marsh layer, down to the top of the sand. Water would fill this crack, loading the wall and introducing the canal head at the top of the sand. The part of the wall embedded in the sand would be loaded by water pressures that are somewhat lower than hydrostatic pressures, plus active earth pressures, as shown in Figure 8-5. The lower-than-hydrostatic water pressures were determined from the finite element seepage analyses. All of the seepage and stability analyses were performed based on this half-cracked condition.

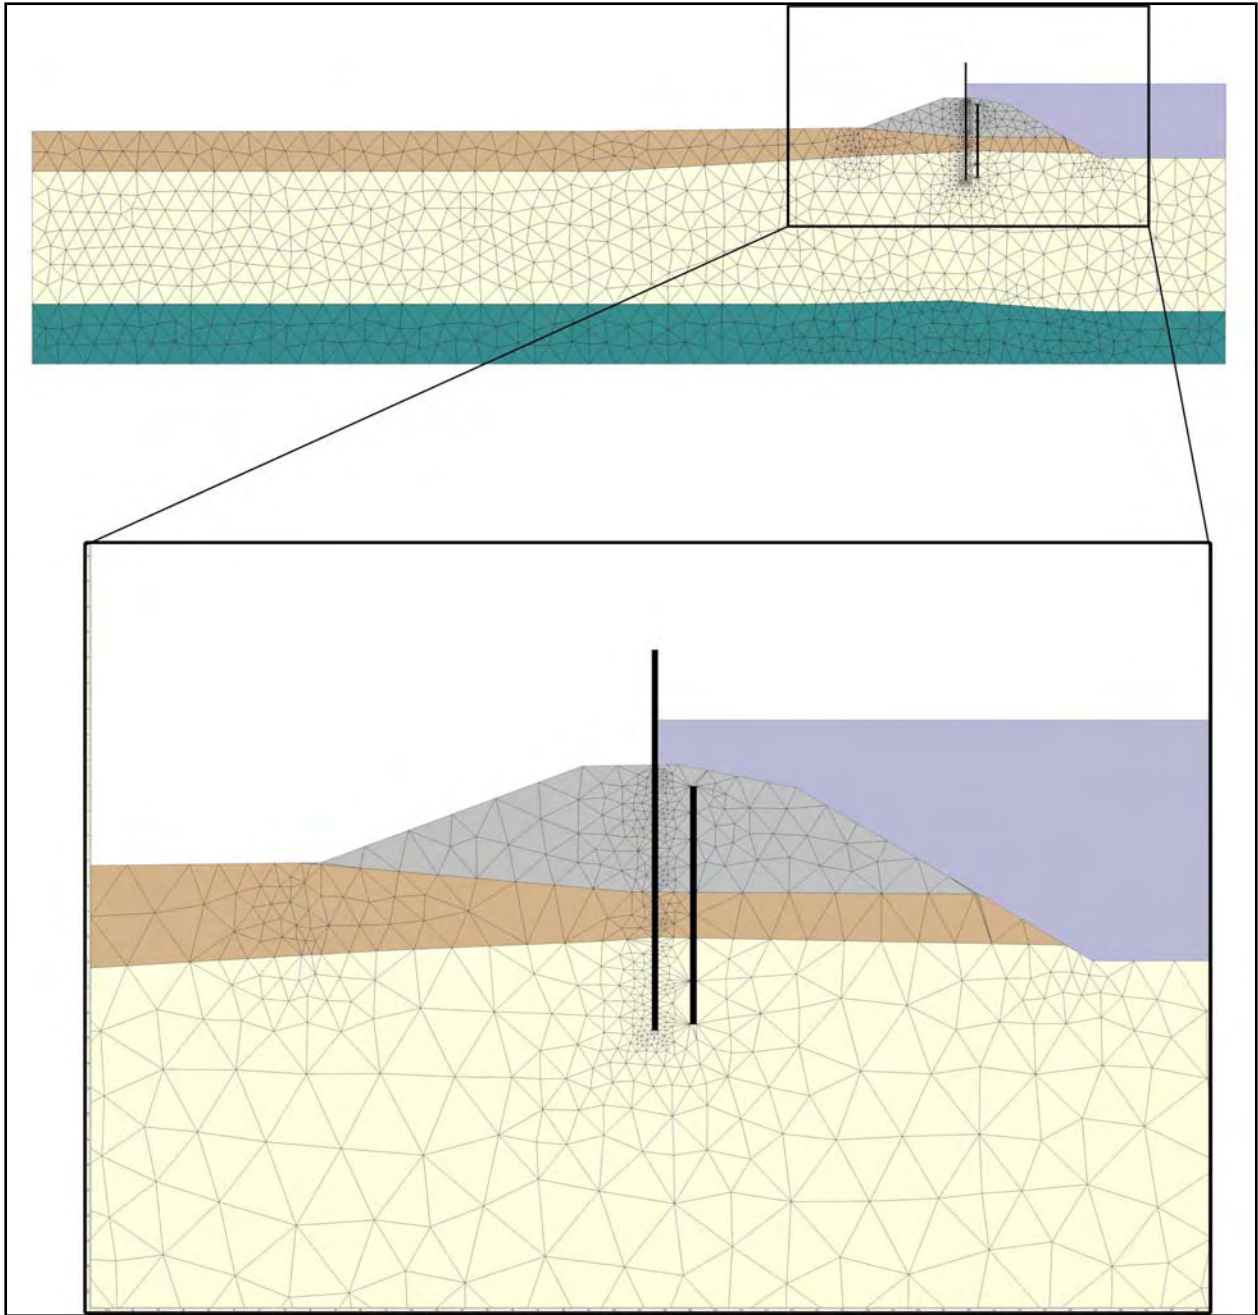
Figure 8-6. Finite Element Mesh Used for Seepage Analysis for London Avenue South Breach

Six-node triangular elements were used for the seepage analyses. The finite element mesh is shown in Figure 8-6. Computed total head contours for Case 1 are shown in Figure 8-7. It can be seen that the flow through the sand is predominantly horizontal, and that the total head on the landward side of the levee is above the ground surface, which is at elevation -5.1 ft. The head contours for the other three cases shown in Table 8-1 had similar shapes, although the values varied somewhat depending on the canal water level and the Warrington Drive water level.

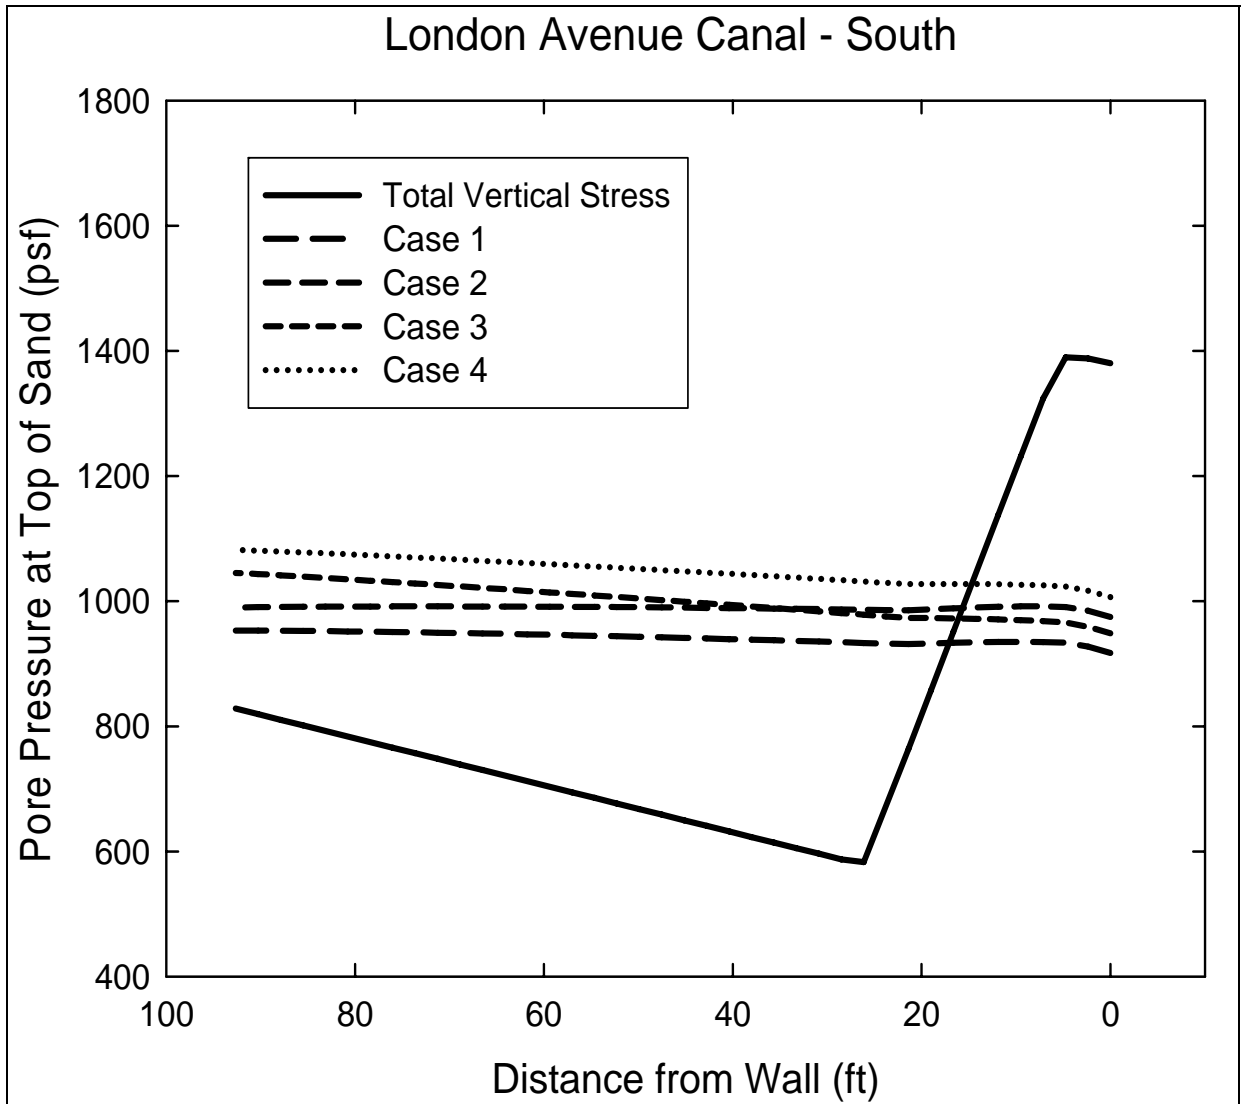
Figure 8-8. Calculated Uplift Pressures and Total Overburden Pressure for London South Breach

Computed pore pressures, or uplift pressures, at the base of the marsh layer are shown in Figure 8-8 for the four cases analyzed, together with the total overburden pressure at the base of the marsh layer. It can be seen that in all four cases the computed pore pressures exceed the total overburden pressure at the base of the marsh layer. This result indicates that the marsh layer would be heaved off the underlying sand by the high uplift water pressures. A likely result of this heave would be rupture of the marsh layer at one or more weak points, and upward flow of water through the rupture in the marsh material. This flow would relieve the high water pressure locally, and create a new hydraulic boundary condition at the point of rupture.

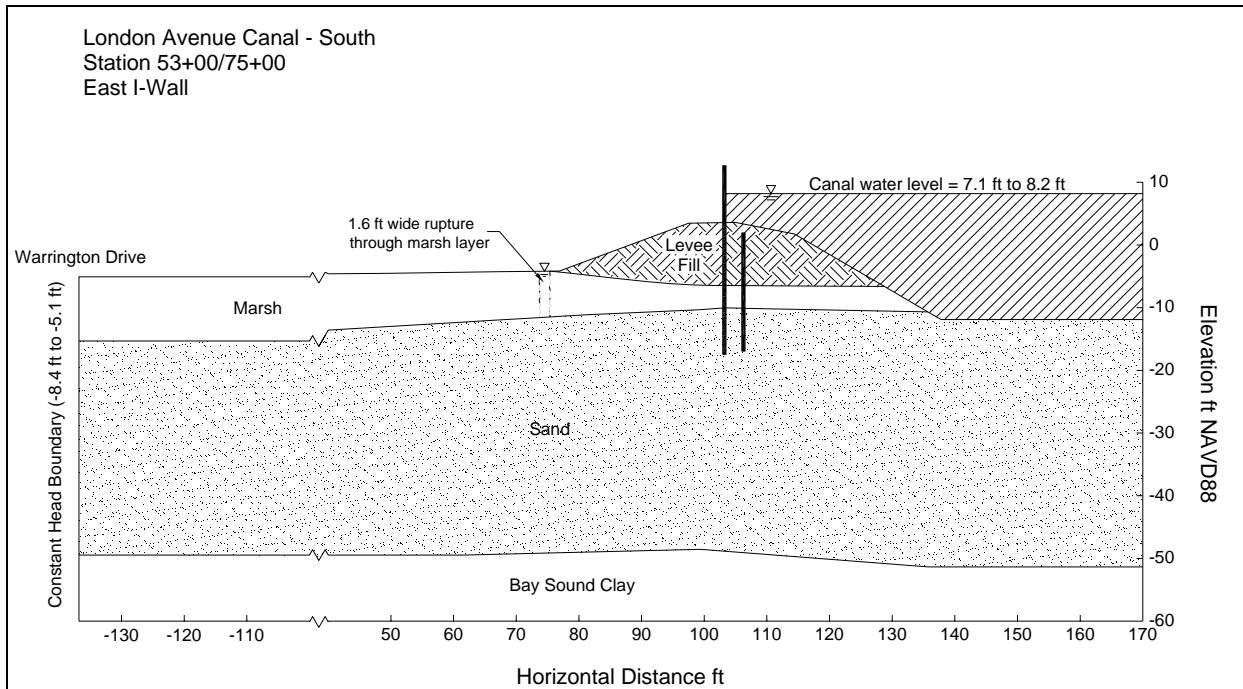
Figure 8-9. Schematic Cross Section at London South Breach, Showing Rupture Through Marsh Layer

Additional seepage analyses were performed to determine if the hydraulic gradients within the sand after rupture of the marsh layer would be large enough to cause erosion of the sand and begin a piping failure. The seepage boundary conditions used in these analyses are shown in Figure 8-9, where a rupture extends upward through the marsh layer, from the top of the sand to the ground surface. The hydraulic gradients computed in these analyses were found to depend on the assumed width of the rupture in the marsh layer. While it seems clear that the marsh layer would rupture when the uplift pressures exceeded the overburden pressures, the width of the rupture would depend on factors that cannot be evaluated, and it is thus necessary to assign a width to the rupture zone based on judgment. Even so, we believe that the analytical results that follow reflect the essential aspects of the situation. The results support the view that the London south breach developed as a result of erosion and piping.

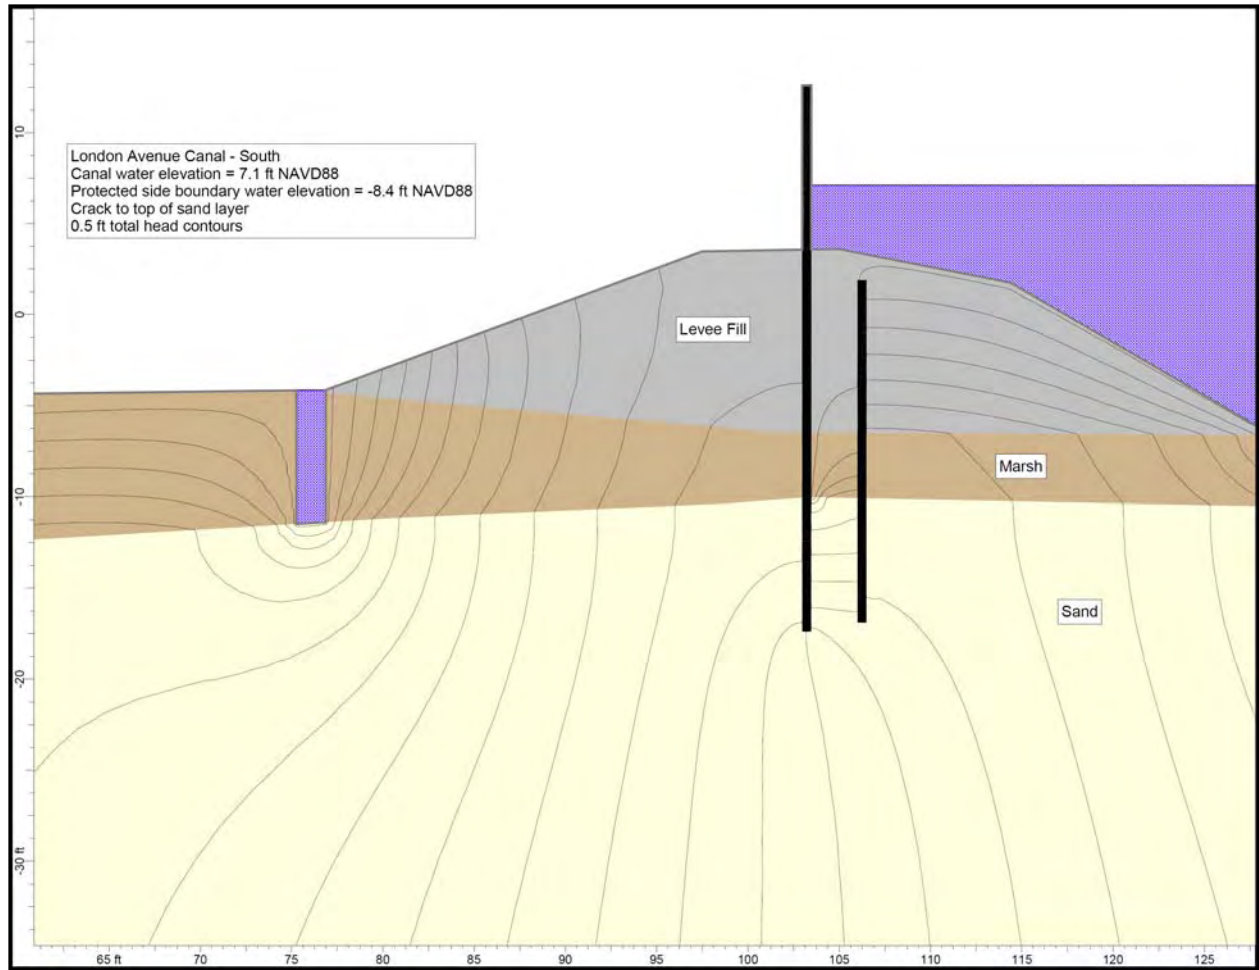
Figure 8-10. Total Head Contours in Vicinity of Rupture for London South Breach

The narrower the assumed rupture zone, the higher the computed hydraulic gradient at the top of the sand below the rupture, because flow converges toward the rupture, and the flow velocities increase near the rupture. This converging flow is shown by the total head contours in the sand near the rupture in Figure 8-10. A rupture zone width equal to 1.6 ft was used in the analyses, based on a judgment of what seemed a reasonable and possible rupture zone size. Doubling the width of the rupture zone was found to reduce the computed hydraulic gradient by 23%, and cutting the width in half increased the hydraulic gradient by 33%. In the real case, flow would converge in three dimensions rather than two dimensions, as represented in these two-dimensional seepage analyses. It therefore seems likely that the actual hydraulic gradients would be higher than the values discussed in the following sections, but the magnitude of this three-dimensional effect cannot be quantified.
