Appendix 1

Soil Data Report for 17th Street Canal

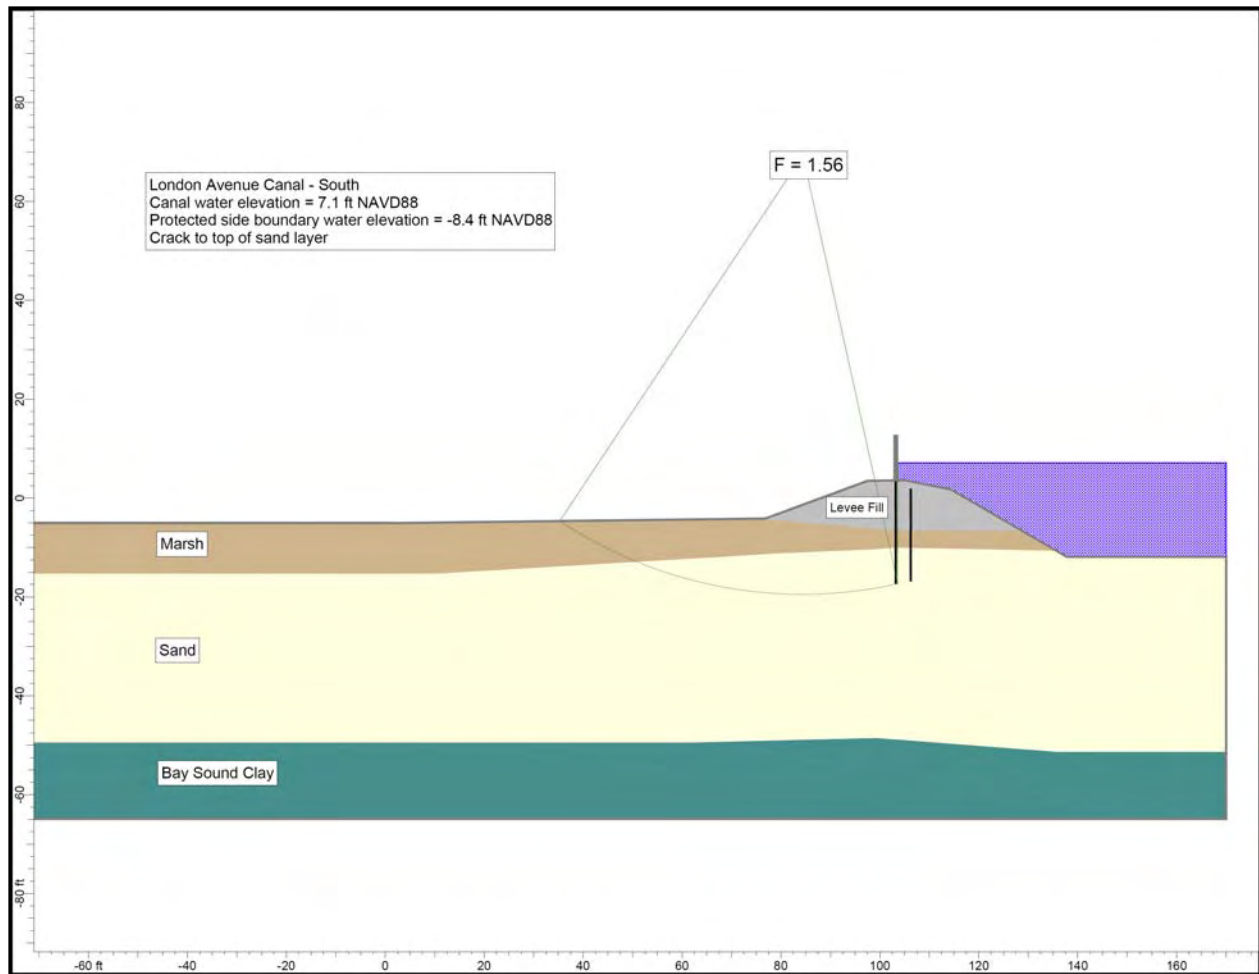
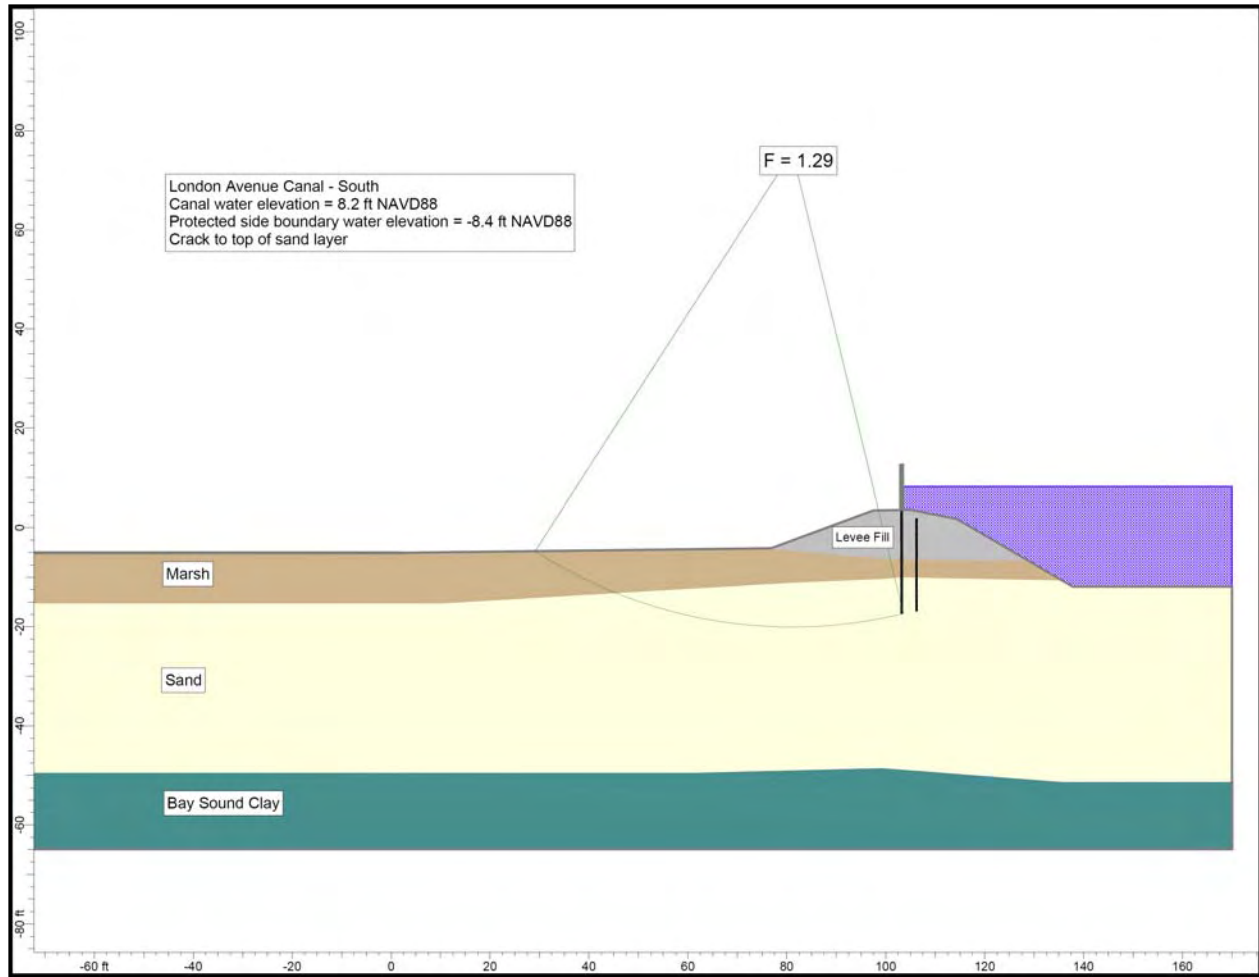
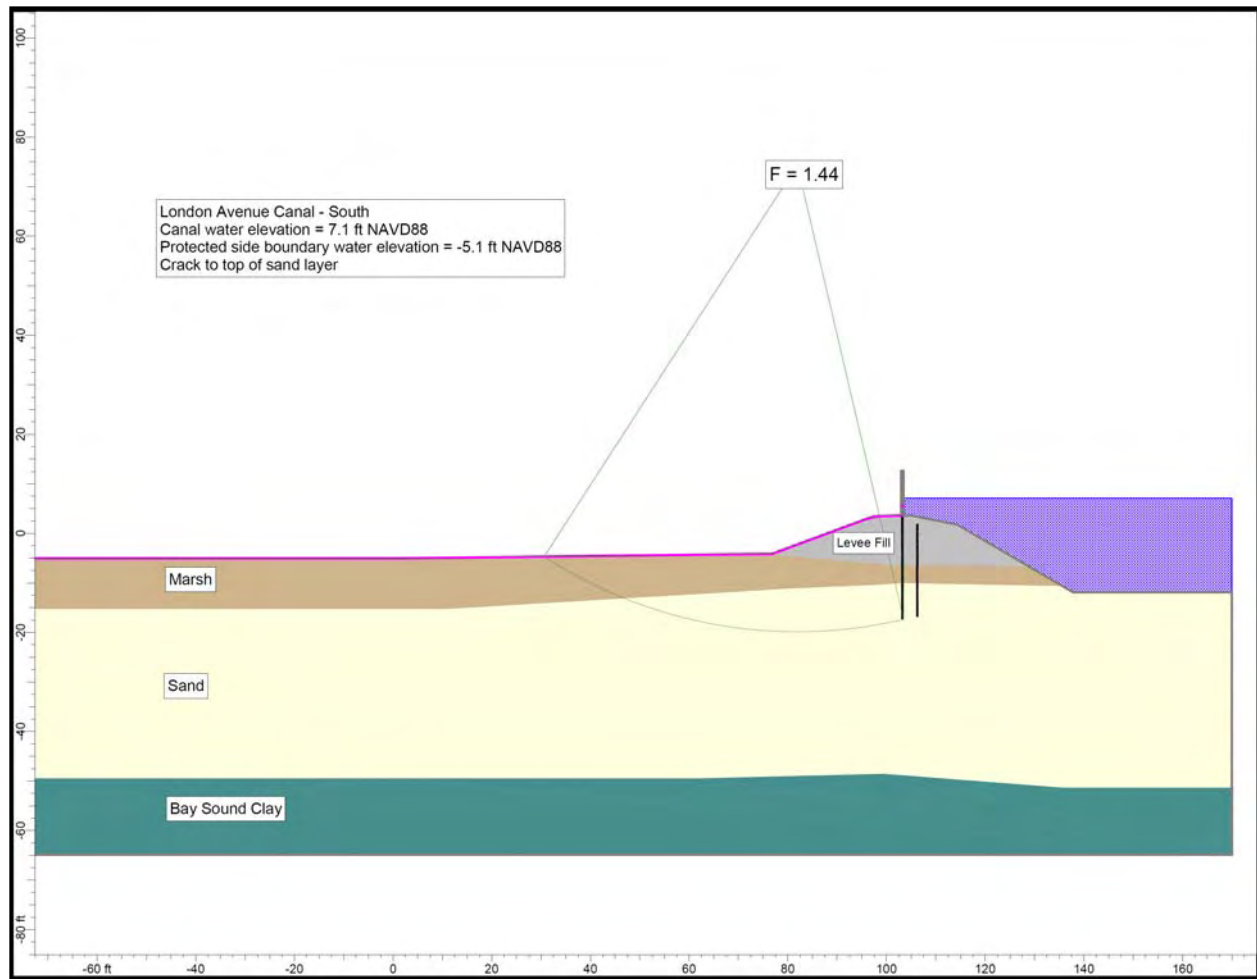
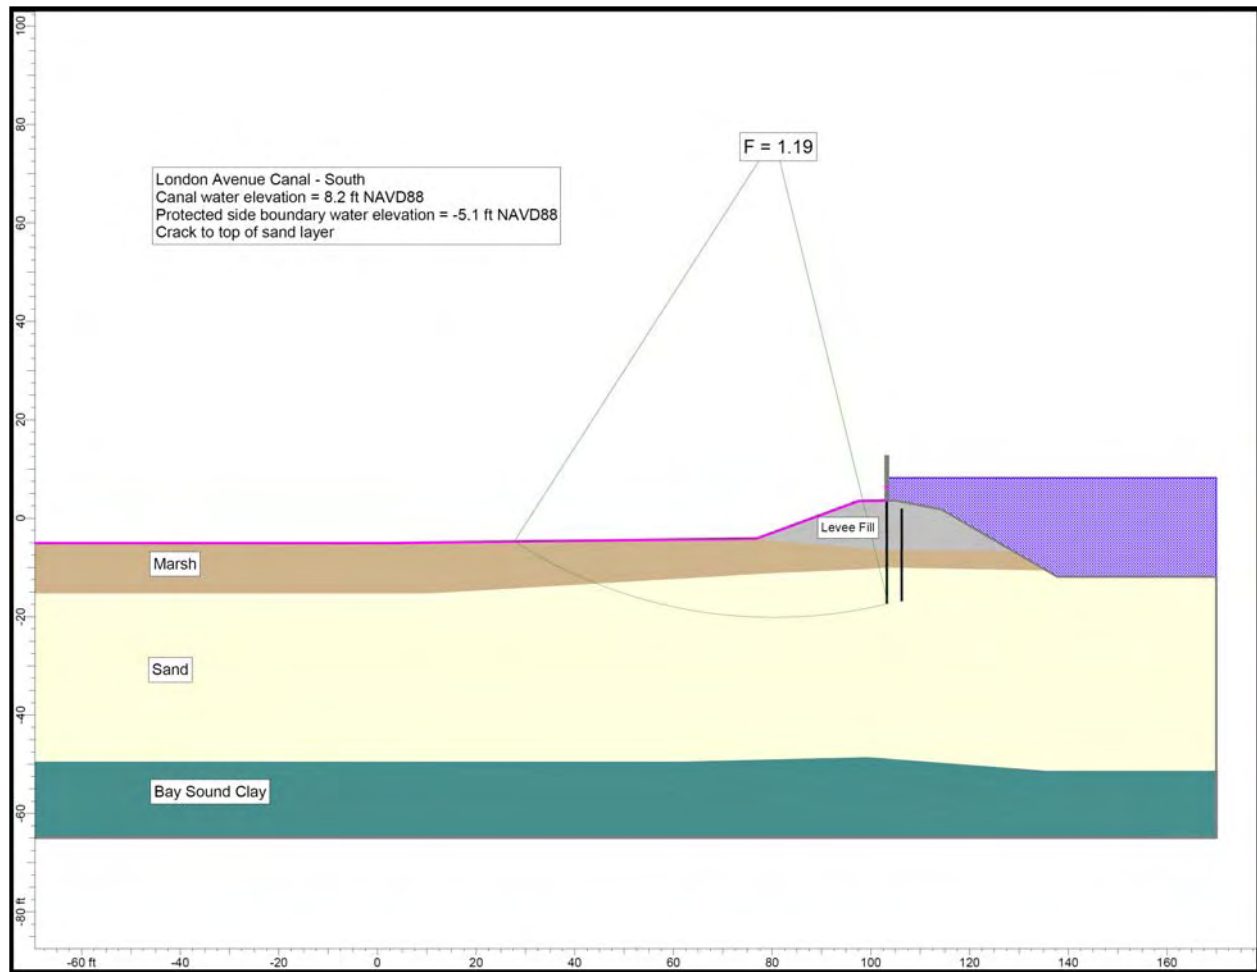
The stability analyses were performed for the cross section shown in Figures 8-11, 8-12, 8-13, and 8-14. This is the same cross section as used in the seepage analyses, and the same canal water levels and landside water levels were used.

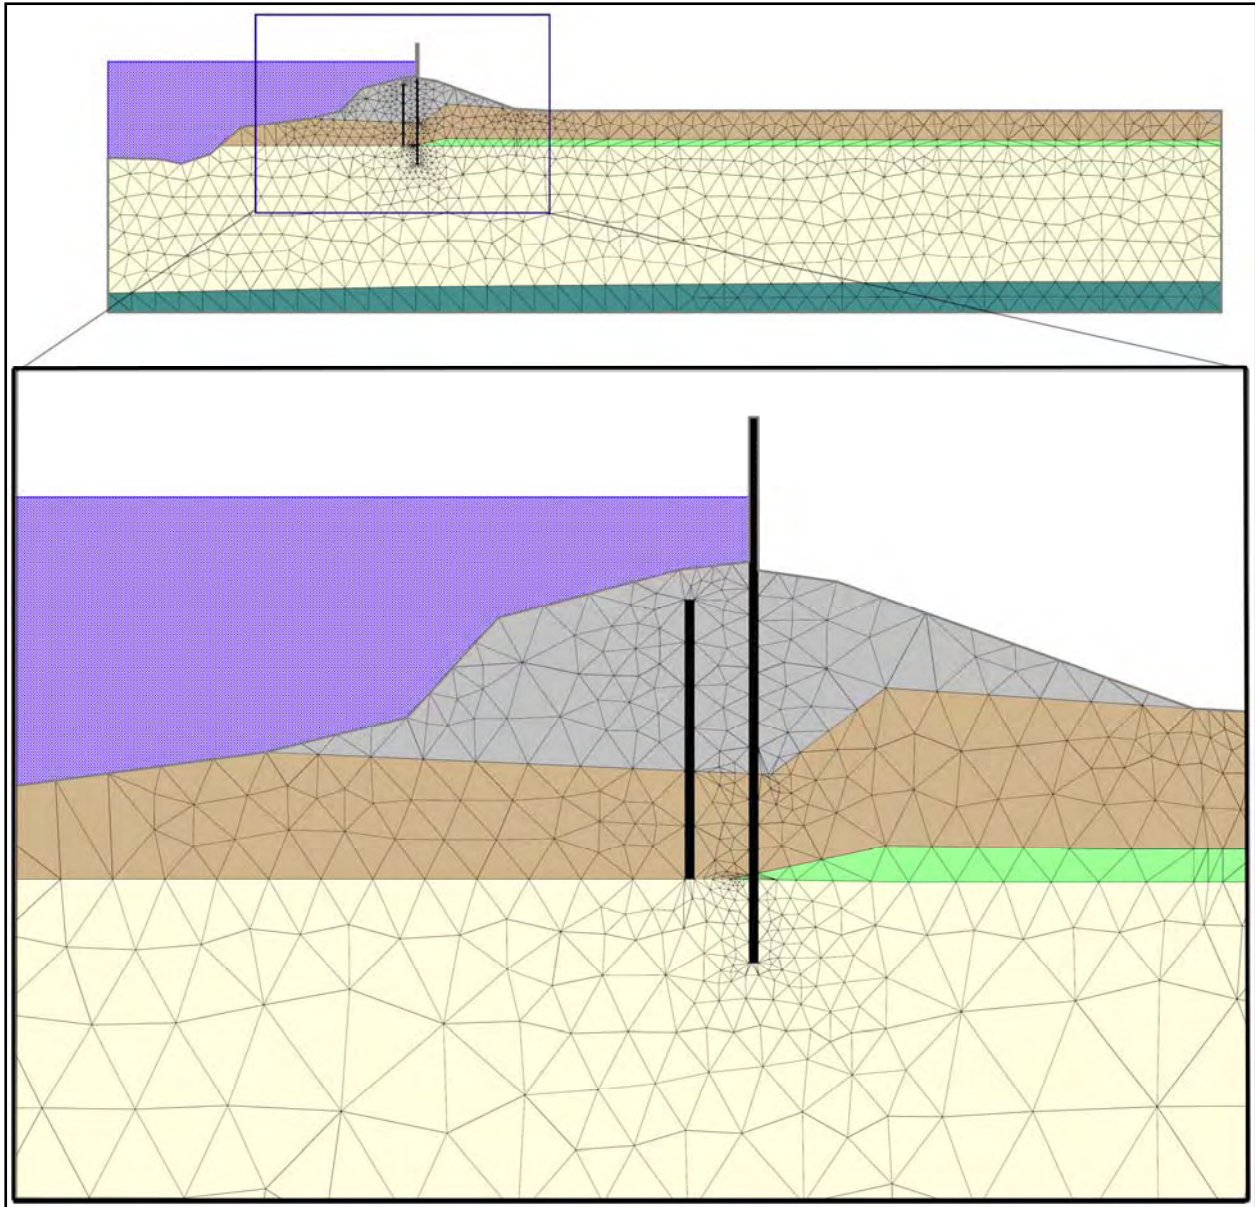
Figure 8-17. Finite Element Mesh Used for Seepage Analysis for London Avenue North Breach

Six-node triangular elements were used for the seepage analyses, as for the south breach. The finite element mesh for the north breach is shown in Figure 8-17. The same values of permeability were used as for the south breach. The lacustrine clay between the sand and the marsh layer was assumed to have a permeability of 1×10^{-6} cm/sec.

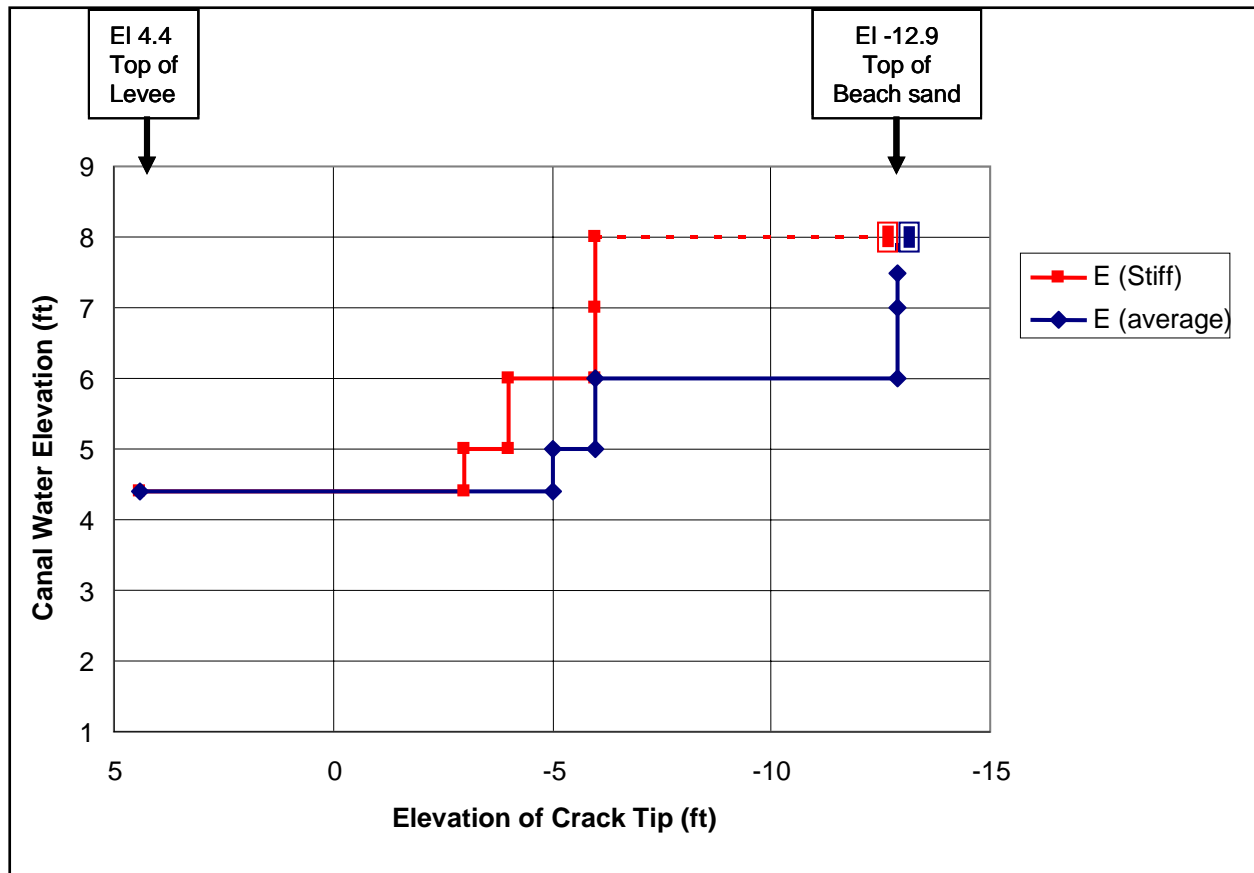
Figure 9-4. Elevation of Crack Tip Versus Canal Water Elevation

The results from first SSI set of analysis using Table 9-2 average soil stiffness values indicates that cracking commenced when Canal water reached the top of the Levee (i.e., El 4.4). Crack initiation occurs at the top of the Levee clay, on the canal side (at El 4.4) of the sheet pile wall when the total horizontal stress in the clay is less than the value for hydrostatic water pressure (i.e., γ_{water} times depth below canal water surface). This first occurs at Table 9-5 loading phase 5. Comparisons of values for hydrostatic water pressure, generated by hand computation, with the total horizontal stresses computed in the complete SSI analysis indicates a crack will extend from El 4.4 down to EL -5 in the Levee clay by loading phase 7. The line designated E_{average} in Figure 9-4 summarizes the Table 9-5 depth of cracking phases of analysis versus Canal water elevation. Depth of cracking to the top of Beach sand (El -12.9) occurs at Canal water El 6. Additional analyses using Table 9-2 E_{average} values are conducted for Canal water El's 7, 7.5 and 8 so as to establish the variation in Factor of Safety with Canal water elevation.

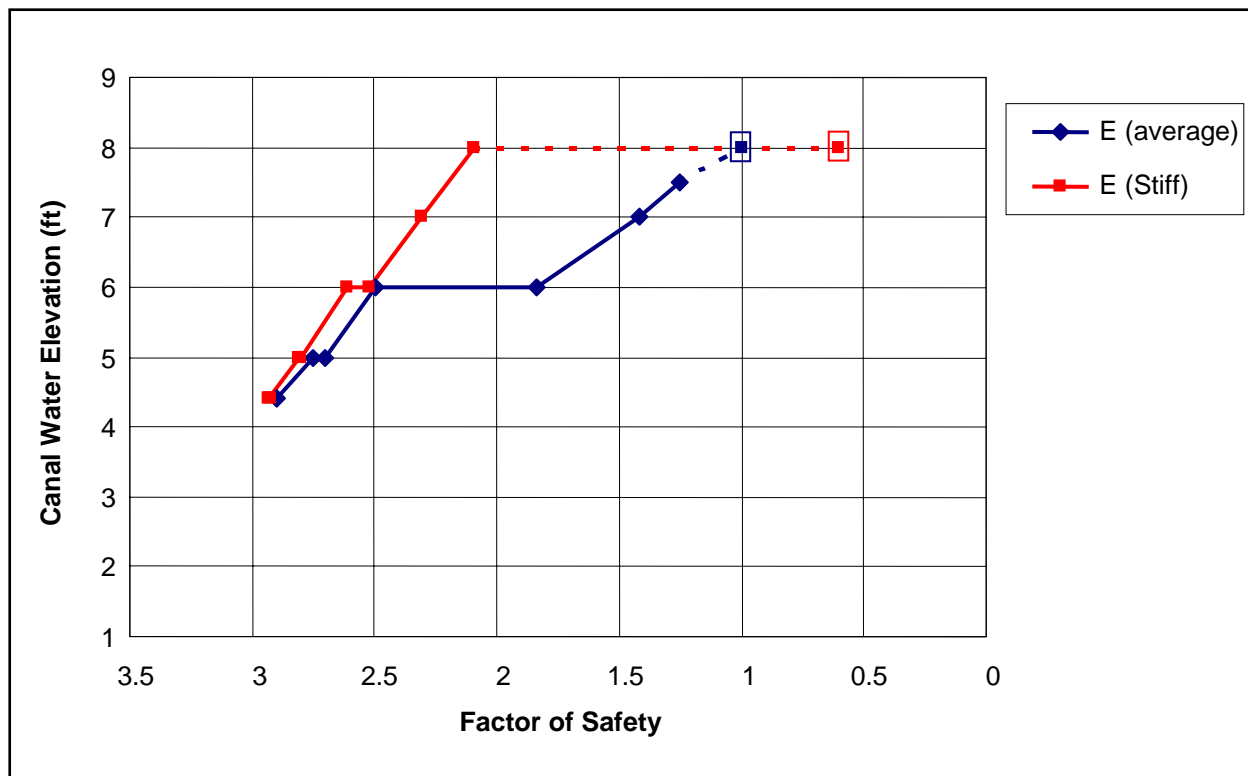
Figure 9-7. Factor of Safety Versus Canal Water Elevation

Factor of Safety: Figure 9-7 summarizes the computed Factor of Safety versus Canal water elevation for the Table 9-2 average stiffness material property values. As the canal elevation rises, the factor of safety decreases in these results labeled E_{average} in this figure. Note that when the Canal water is raised to El 6, the Factor of Safety decreases from 2.5 to 1.84 with the crack tip progressing from El -6 to El -12.9 (i.e., the top of the Beach sand). With a crack tip at El -12.9 a new flow regime is established within the beach sand layer using a linear phreatic surface assumption as demonstrated in Figure 9-6 for Canal water El 6. (Note that for each subsequent rise in Canal water, a new linear phreatic surface is established based on the elevation of the Canal water in each analysis phase.) As the Canal water elevation rises to El 7, 7.5 and 8, the computed Factor of Safety decreases to 1.42, 1.25 and (approximately) 1. (Due to convergence issues in the ϕ/c reduction analysis, the Factor of Safety for Canal water EL 8 is established by extrapolation of the Figure 9-7 data.) Again, these computed Factors of Safety results labeled E_{average} are greater than the actual values for these last four loading phases due to the linear phreatic surface assumption used within the Beach sand.

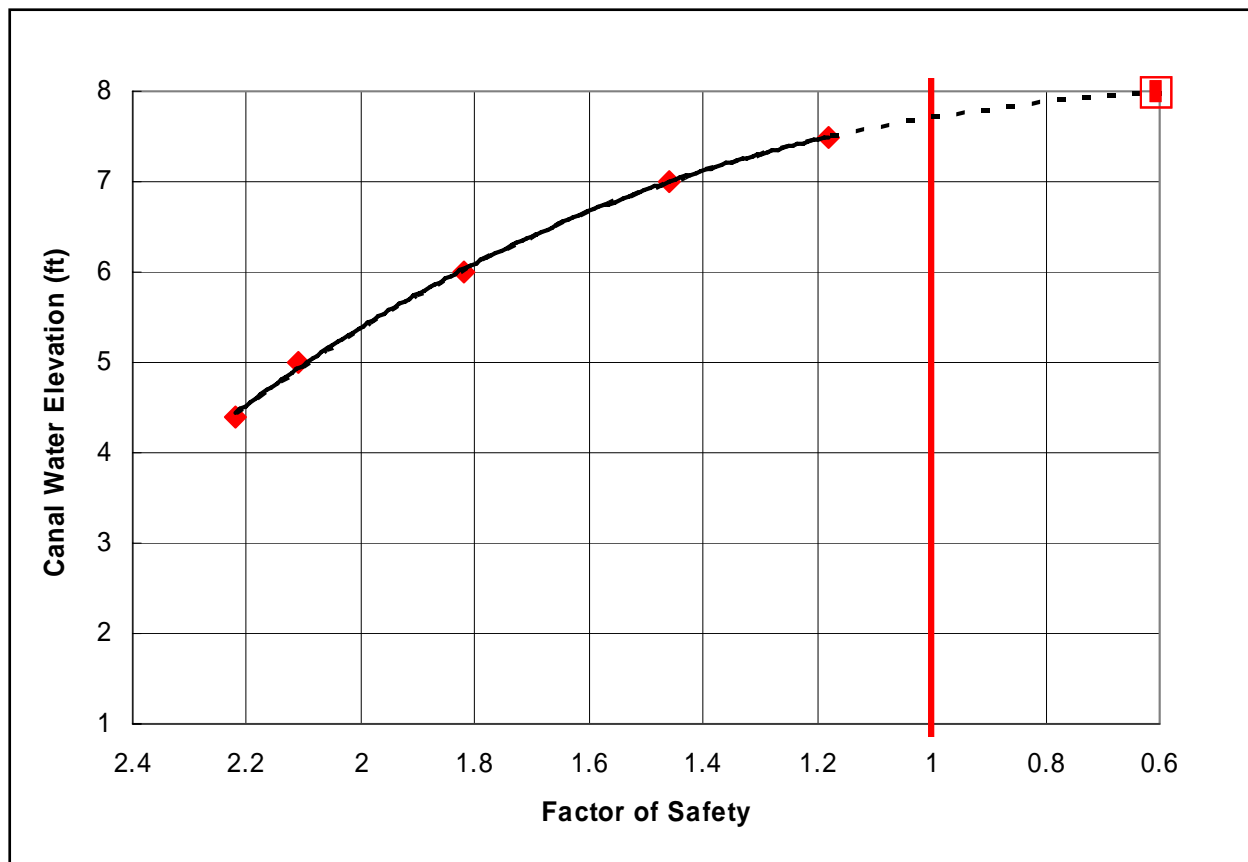
Figure 9-7 also summarizes the computed Factors of Safety versus Canal water elevations for the Table 9-3 second analysis set with stiff modulus values assigned to the Levee clay and the Marsh on the protected side of the I-wall. These results are labeled E_{stiff} in this figure. This figure shows that as the canal elevation rises, the Factor of Safety decreases. Note that when the Canal water is raised to El 8, the Factor of Safety decreases from 2.09 to 0.6 (approximately) with the crack tip progressing from El -6 to El -12.9 (i.e., the top of the Beach sand). With a crack tip at El -12.9 a new flow regime is established within the beach sand layer and is computed using a linear phreatic surface assumption. The Plaxis phi/c reduction analysis for Canal water El 8, with depth of crack to EL -12.9 (i.e., top of beach sand), did not converge. In order to establish an estimate for the value of the Factor of Safety for this case, a series of phi/c reduction calculations for Canal water El's of 4.4, 5, 6, 7, and 7.5 are conducted with a fictitious depth of crack specified to EL -12.9 (i.e., top of beach sand) in each of these calculations (designated phase 17 through 21 in Table 9-6). These results are summarized in Figure 9-8. A Factor of Safety of 0.6 is estimated for Canal water El 8 by extrapolating the computed Factors of Safety results for these lower canal water elevations to canal water El 8. Additionally, this data shows that a Factor of Safety equal to unity occurs at Canal water El 7.7 (approximately). Again, recognize that these Figure 9-8 computed Factors of Safety results and the Figure 9-7 data point of Factor of Safety equal to 0.6 for Canal water El 8 on the E_{stiff} labeled curve, are greater than the actual values due to the linear phreatic surface assumption used within the Beach sand.

Figure 9-8. Factor of Safety Versus Canal Water Elevation, Computed With Crack to Top of Beach Sand El -12.9 and Using Stiff Modulus Values for the Levee Clay and Marsh on the Protected Side

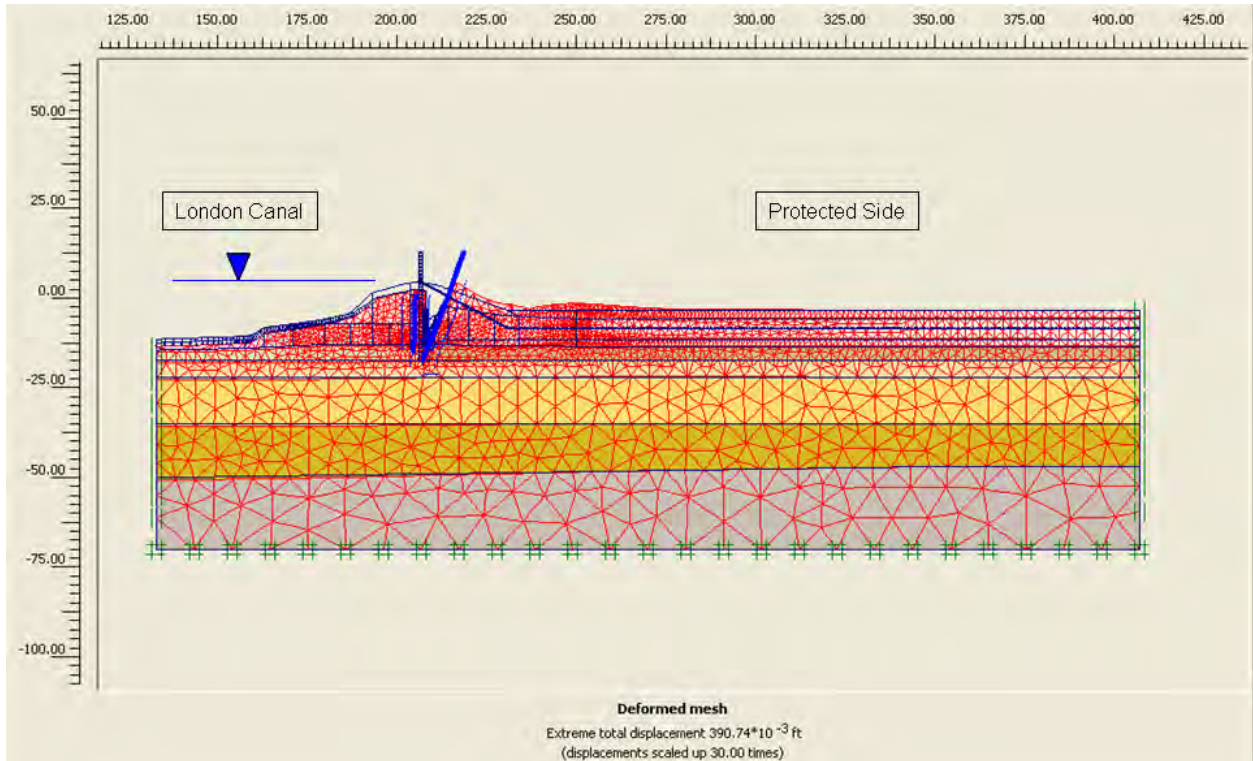
Deformations: Figure 9-9 summarizes the computed deformations for the first analysis set with average modulus values, Canal El 6 and Crack to El -12.9 (i.e., top of Beach sand). Note the nodal deformations are magnified by a factor of 30 in order to show the deformed relative mesh relative to its position at canal water elevation of 1.0 (shown as a blue outline in this figure). The general trend is a rotational plowing of the protected side Levee clay by the I-wall/new sheet pile wall and a bulging of the Marsh beyond the toe of the Levee on the protected side. Recall that the computed Factor of Safety for this condition is 1.84 (for E_{average} values).

Figure 9-9. Deformed Mesh for Average Stiffness Values, Exaggerated by a Factor of 30, for Canal El 6 and Crack to El -12.9 (Note: Canal El not to scale in figure)

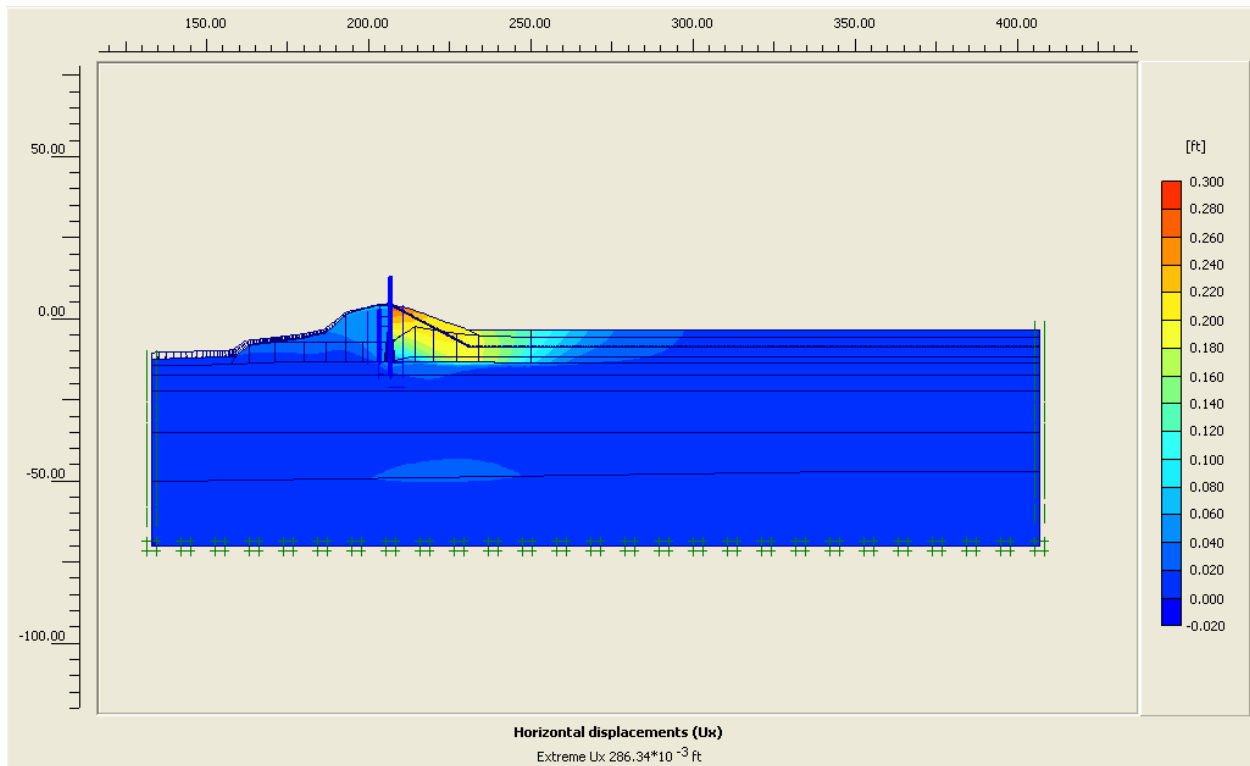
Figure 9-10 shows the horizontal displacements of the soil regions within the mesh, relative to their position at a canal water elevation of 1.0 for average stiffness values with Canal El 6 and Crack to El -12.9. This figure shows the horizontal deformations are concentrated within the protected region of the Levee and the Marsh immediately at the toe of the Levee on the protected side. The largest horizontal deformations are concentrated at the top of the Levee, on the protected side, approximately 0.29 ft (3½ inches).

Figure 9-10. Horizontal Deformation Shadings for Average Stiffness Values with Canal EI 6 and Crack to EI -12.9 (Note: Canal EI not to scale in figure)

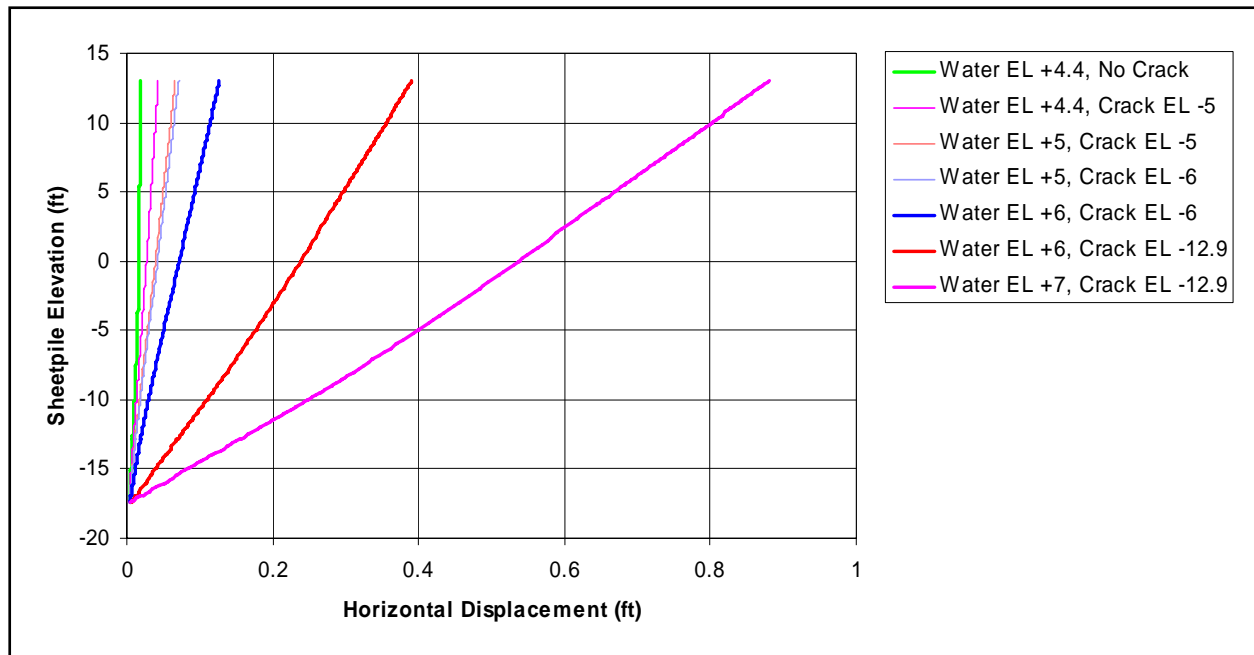
Figure 9-11 shows the variation in horizontal displacements of the sheet pile versus canal water elevation for average stiffness values. These displacements are relative to their position at a canal water elevation of 1.0 for average stiffness values. This figure shows the rotational nature of the I-wall/sheet pile wall deformations, with the toe of the sheet pile “anchored” in the Beach sand.

Figure 9-11. Horizontal Displacement of the I-Wall/Sheet Pile versus Canal Water El and Computed Using Average Stiffness Values

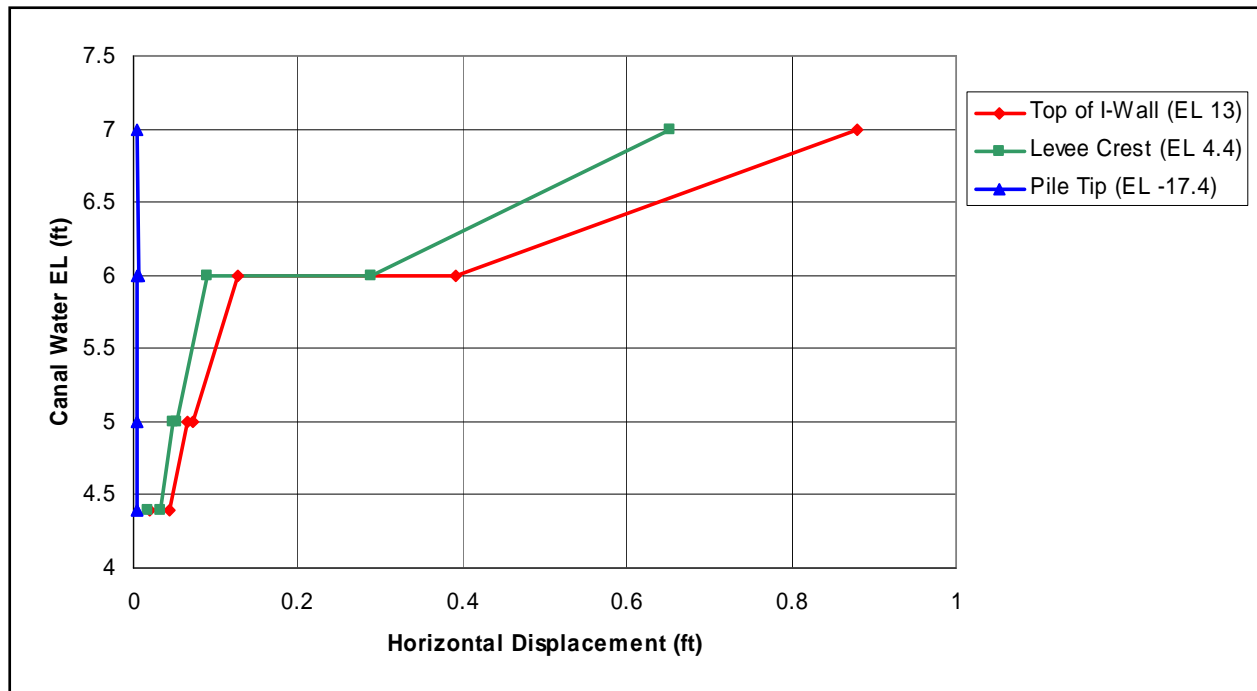
Figure 9-12 shows the horizontal displacements of three points within the flood wall, relative to its position at a canal water elevation of 1.0 for average stiffness values. The points monitored through the analysis are at the top of the I-wall (El 13), at El 4.4 (top of Levee) and at the sheet pile tip (El -17.4). Recall for Canal water El's of 6 and higher, the crack never extends into the Beach sand layer, it terminates at the top of the Beach sand layer (i.e., El -12.9). Note that there is a significant increase in horizontal deformations of the I-wall/sheet pile wall when the crack extends to El -12.9 at Canal El 6. Results in this figure shows the Beach sand is providing enough lateral support to prevent the sheet pile tip from moving laterally, therefore the deformation of the sheet pile is mostly a rotation about the sheet pile tip. Maximum horizontal movement at the top of the I-wall is 0.88 ft (10 ½ inches) for Canal Water El 7.

Figure 9-12. Horizontal Sheet Pile Deformations versus Canal Water El and Computed Using Average Stiffness Values

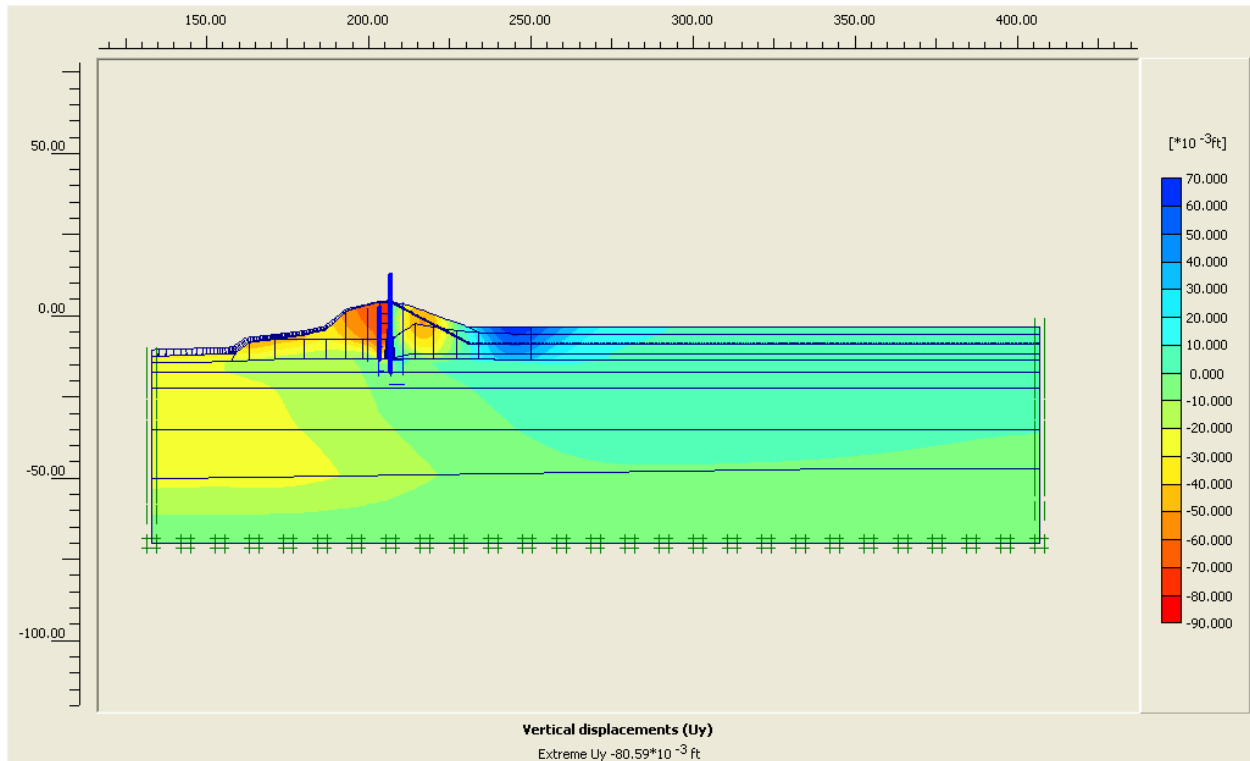
Figure 9-13 shows the vertical displacements of the soil regions within the mesh, relative to their position at a canal water elevation of 1.0 for average stiffness values with Canal El 6 and Crack to El -12.9. This figure shows the 0.07 ft (7/8 inch) uplift of the Marsh located beyond the toe of the Levee on the protected side.

Figure 9-13. Vertical Deformation Shadings for Average Stiffness Values with Canal EI 6 and Crack to EI - 12.9 (Note: Canal EI not to scale in figure)

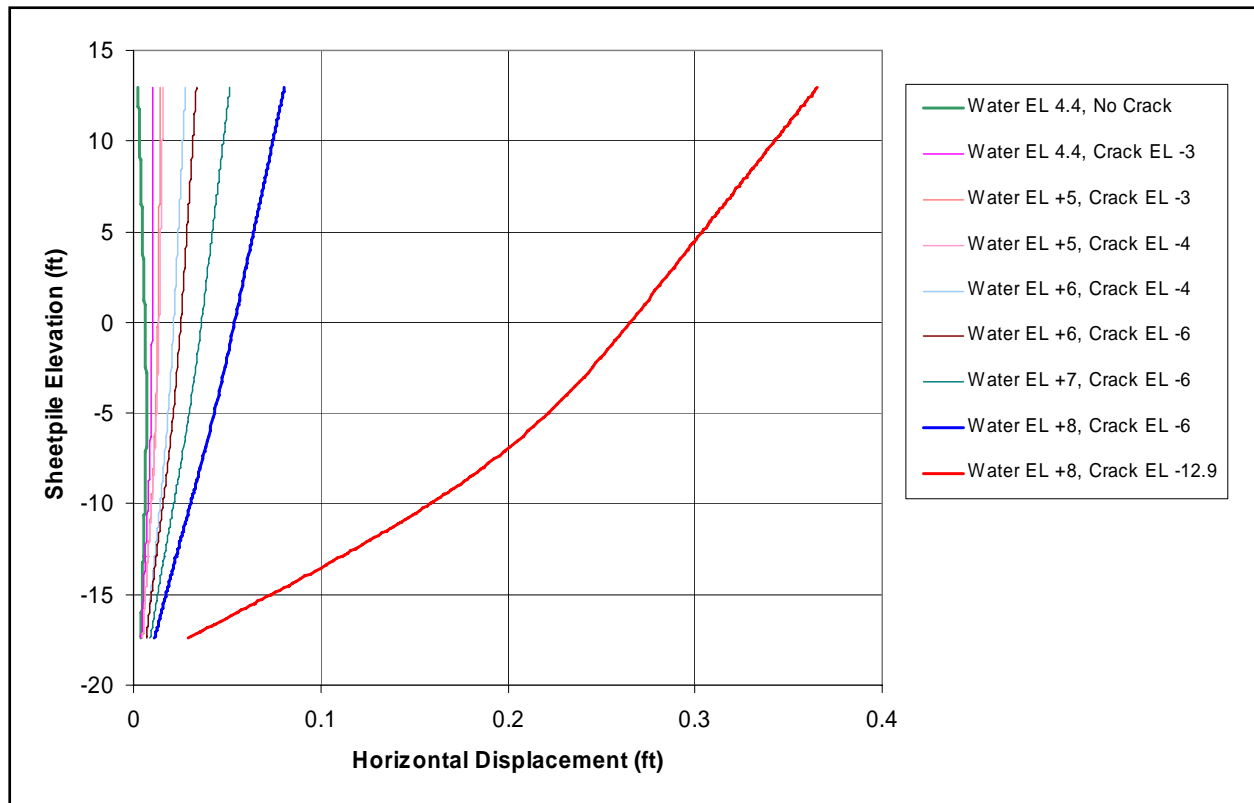
Figure 9-14 shows the variation in horizontal displacements of the sheet pile versus canal water elevation for the second analysis set with stiff modulus values assigned to the Levee clay and the Marsh on the protected side of the I-wall. These displacements are relative to their position at a canal water elevation of 1.0 for average stiffness values. This figure shows the rotational nature of the I-wall/sheet pile wall deformations, with the toe of the sheet pile “anchored” in the Beach sand. The shape of the deformed wall is the same for both sets of E_{average} and E_{stiff} analyses. However the magnitude of the horizontal displacements in Figure 9-14 are less than the Figure 9-11 displacements for the first analysis set made using average stiffness values.

Figure 9-14. Horizontal Displacement of the Sheet Pile versus Canal Water El and Computed Using Stiff Modulus Values for the Levee Clay and Marsh on the Protected Side

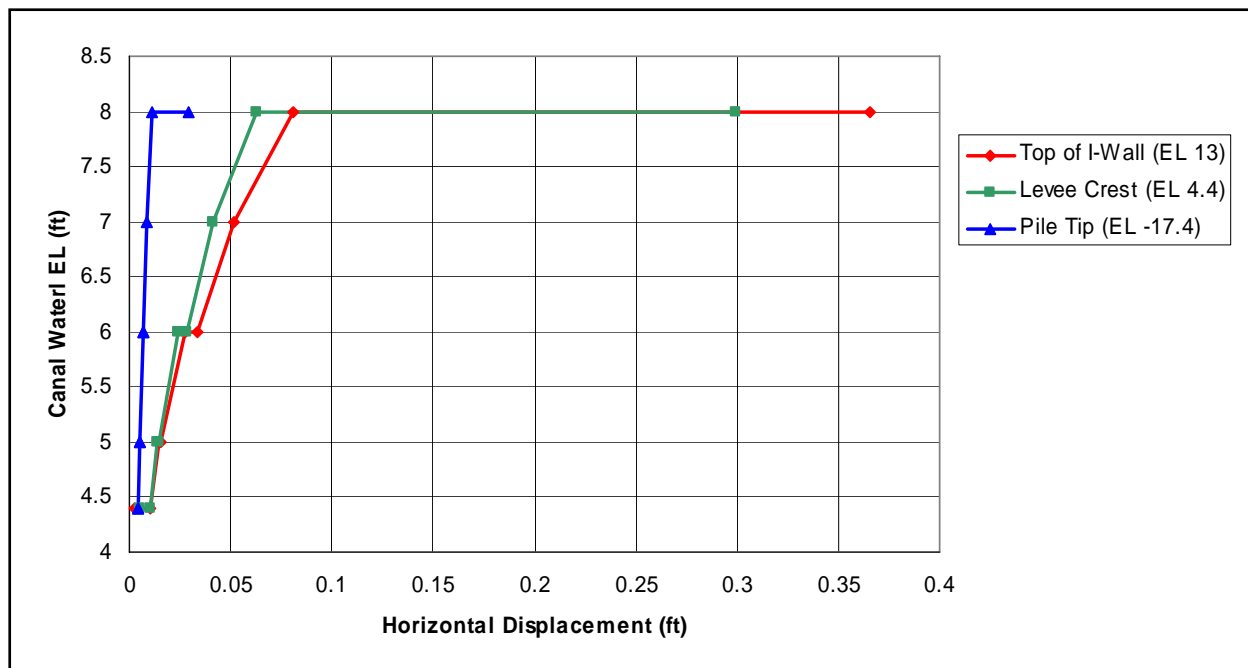
Figure 9-15 shows the horizontal displacements of three points within the flood wall, relative to its position at a canal water elevation of 1.0 for average stiffness values. The points monitored through the analysis are at the top of the I-wall (El 13), at El 4.4 (top of Levee) and at the sheet pile tip (El -17.4). Recall for Canal water El 8, the crack never extends into the Beach sand layer, it terminates at the top of the Beach sand layer (i.e., El -12.9). Note that there is a significant increase in horizontal deformations of the I-wall/sheet pile wall when the crack extends to El -12.9 at Canal El 8. Results in this figure shows the Beach sand is providing enough lateral support to prevent the sheet pile tip from moving laterally, therefore the deformation of the sheet pile is mostly a rotation about the sheet pile tip for both sets of $E_{average}$ and E_{stiff} analyses. Maximum horizontal movement at the top of the I-wall is 0.36 ft (4 1/3 inches) for this analysis with Canal water El 8 and using E_{stiff} values. Contrast this result with the Figure 9-12 maximum displacement at the top of I-wall is 0.88 ft (10 1/2 inches) for Canal Water El 7 computed using average stiffness values. For each canal water elevation, the displacements in Figure 9-15 are less than half the Figure 9-12 displacements calculated for the first analysis set using average stiffness values.

Figure 9-15. Horizontal Sheet Pile Deformations versus Canal Water El and Computed Using Stiff Modulus Values for the Levee Clay and Marsh on the Protected Side

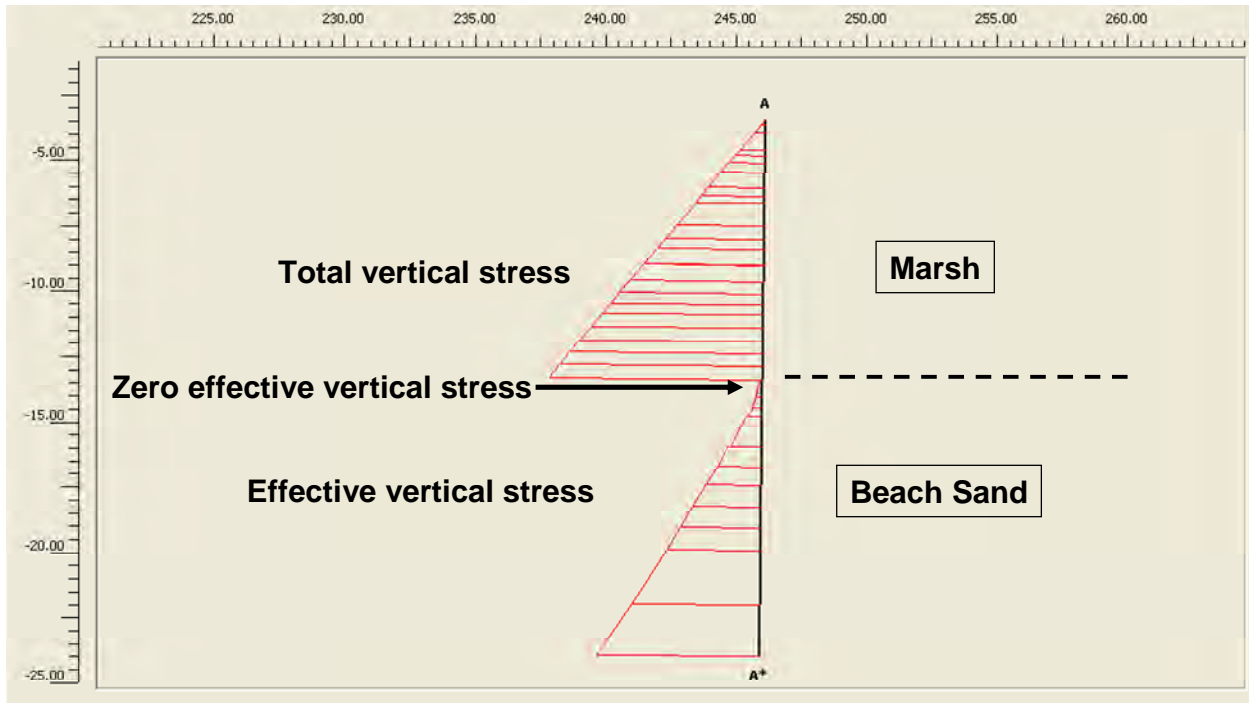
Failure Mechanism: Figures 9-16 and 9-17 show that for the analysis using average stiffness values with Canal El 6 and Crack to El -12.9, there is a loss of effective vertical stress at the top of the Beach sand layer within the region beyond the toe of the Levee. This results in zero shear strength along the top of the Beach sand layer as demonstrated in the Figure 9-18 fraction of mobilized shear strength being equal to unity within this Beach sand region. Figure 9-19 shows that this, in turn, results in the beginning of the development of a mechanism as demonstrated by the concentration of large shear strains within this region for Canal water El 6 and crack to El -12.9. Figures 9-20 and 9-21 show the development of the ultimate mechanism (i.e., the failure mechanism) computed in a phi/c reduction analysis for Canal water El 6 and crack to El -12.9, with the computed Factor of Safety of 1.84. Note the vertical “bulging” in the Marsh beyond the toe of the Levee. The reaches of large shear strain shown in Figure 9-21 shows the complete failure wedge will form along the top of the Beach sand layer and “day light” beyond the toe of the Levee. All subsequent phi/c computations for higher canal water elevations and for the E_{stiff} analyses show this same Figures 9-20 and 9-21 failure mechanism to form.

Figure 9-16. Shadings of Total Vertical Stress in the Levee Clay and Marsh and Effective Vertical Stress in the Beach Sand for the Analysis Using Average Stiffness Values with Canal EI 6 and Crack to EI -12.9

Figure 9-17. Vertical Section A-A Near the Toe of the Levee Showing Total Vertical Stress in the Marsh and Effective Vertical Stress in the Beach Sand for the Analysis Using Average Stiffness Values with Canal EI 6 and Crack to EI -12.9

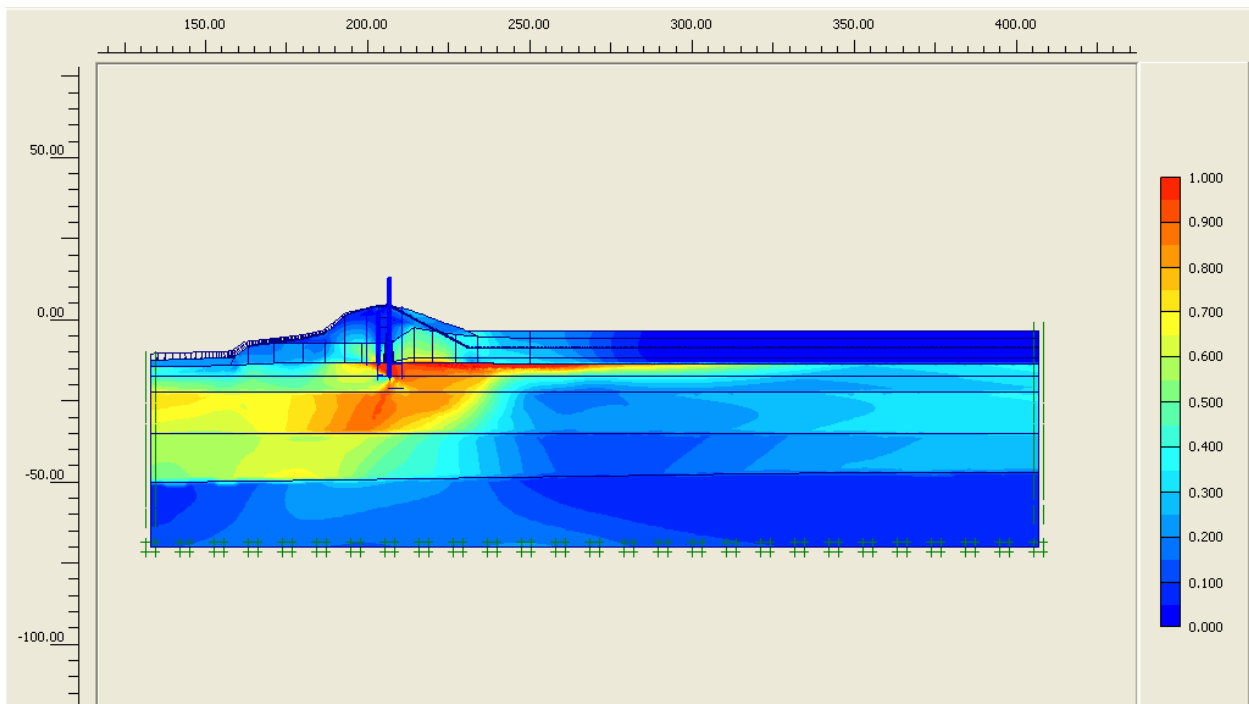
Figure 9-18. Fraction of Mobilized Shear Strength for the Analysis Using Average Stiffness Values with Canal EI 6 and Crack to EI -12.9

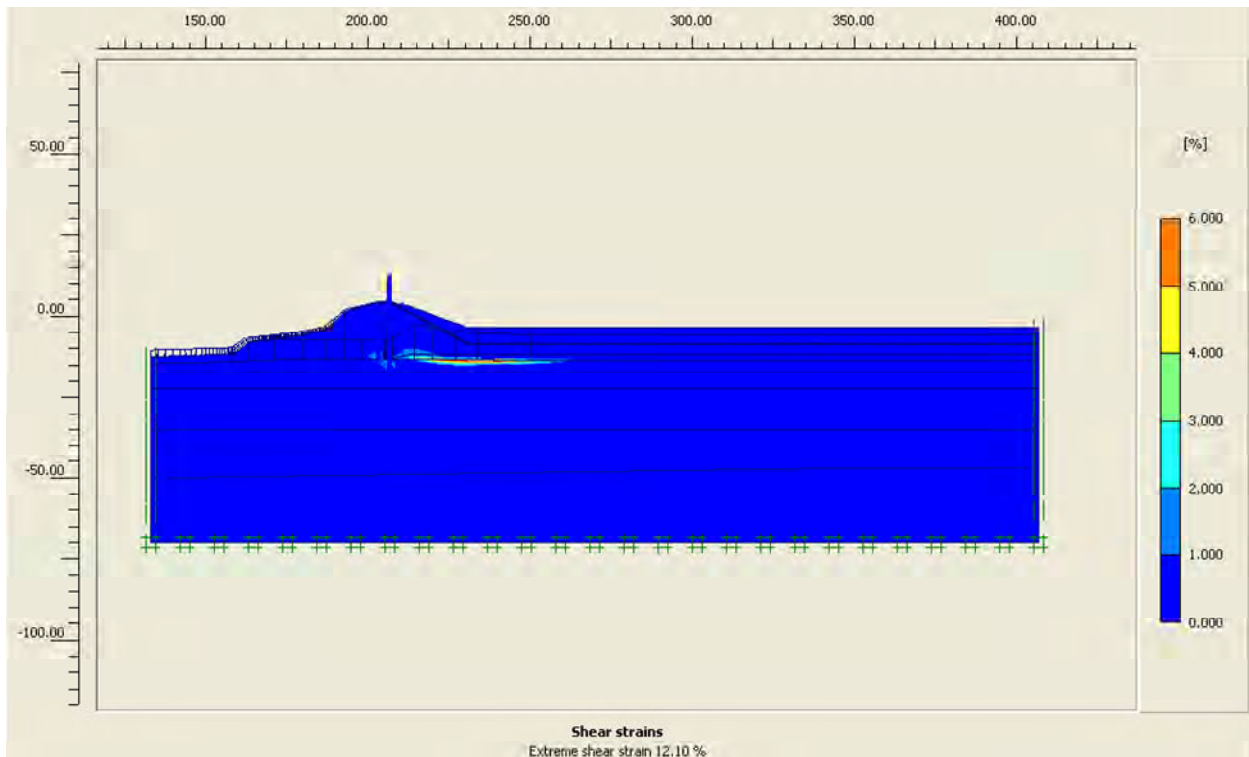
Figure 9-19. Reach of Large Shear Strains for the Analysis Using Average Stiffness Values with Canal EI 6 and Crack to EI -12.9
