Appendix 1

Soil Data Report for 17th Street Canal

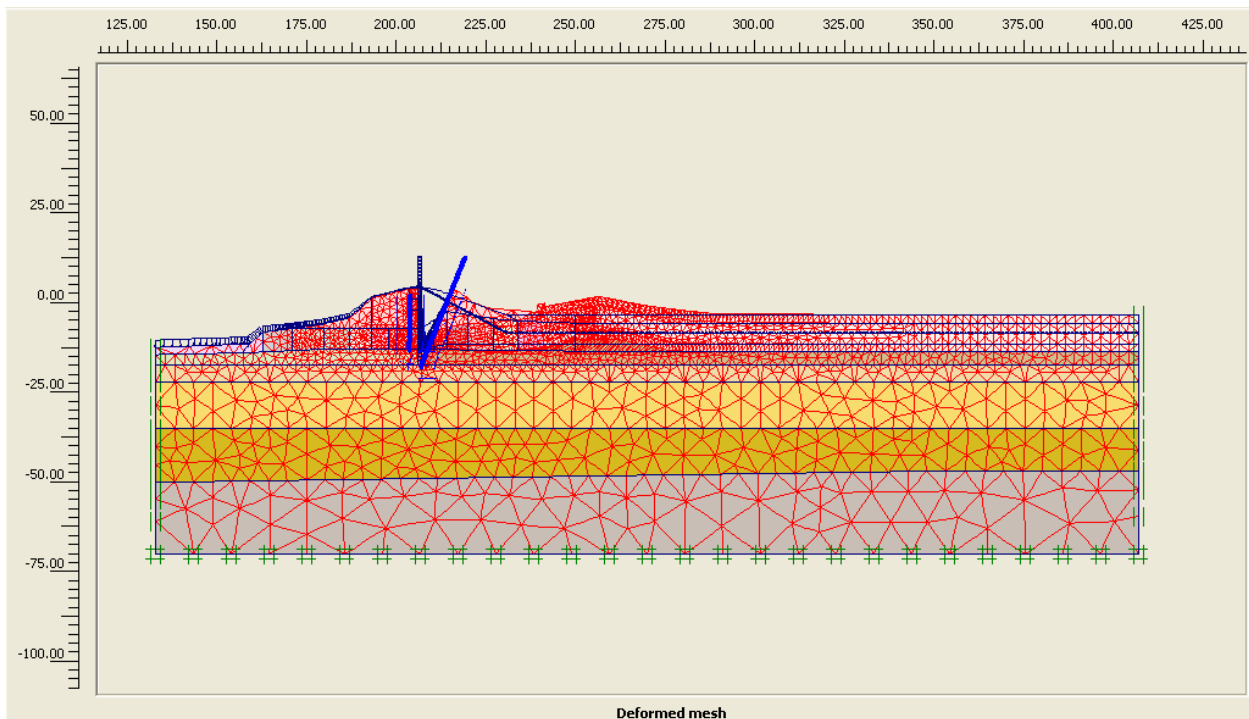
Figure 9-20. Ultimate Mechanism from Phi/C Reduction for the Analysis Using Average Stiffness Values with Canal EI 6 and Crack to EI -12.9

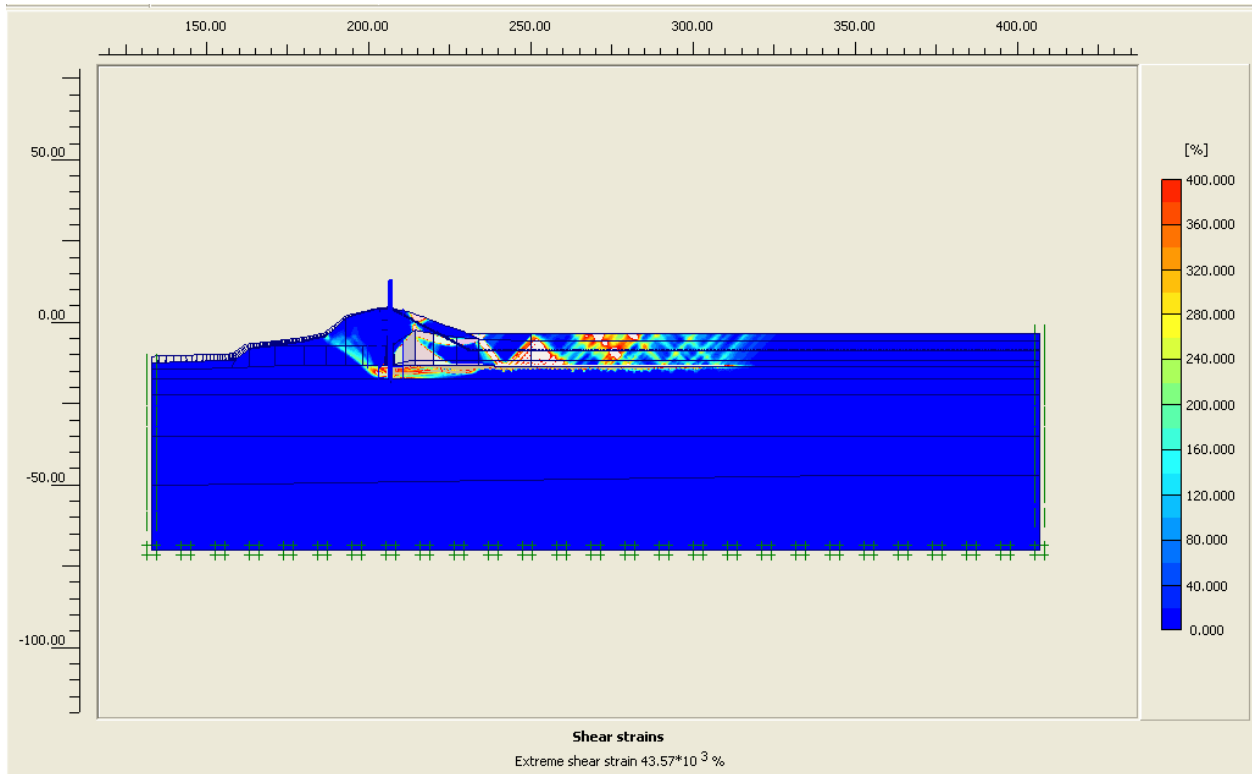
Figure 9-21. Reach of Large Shear Strains from the Phi/C Reduction Analysis Using Average Stiffness Values with Canal EI 6 and Crack to EI -12.9

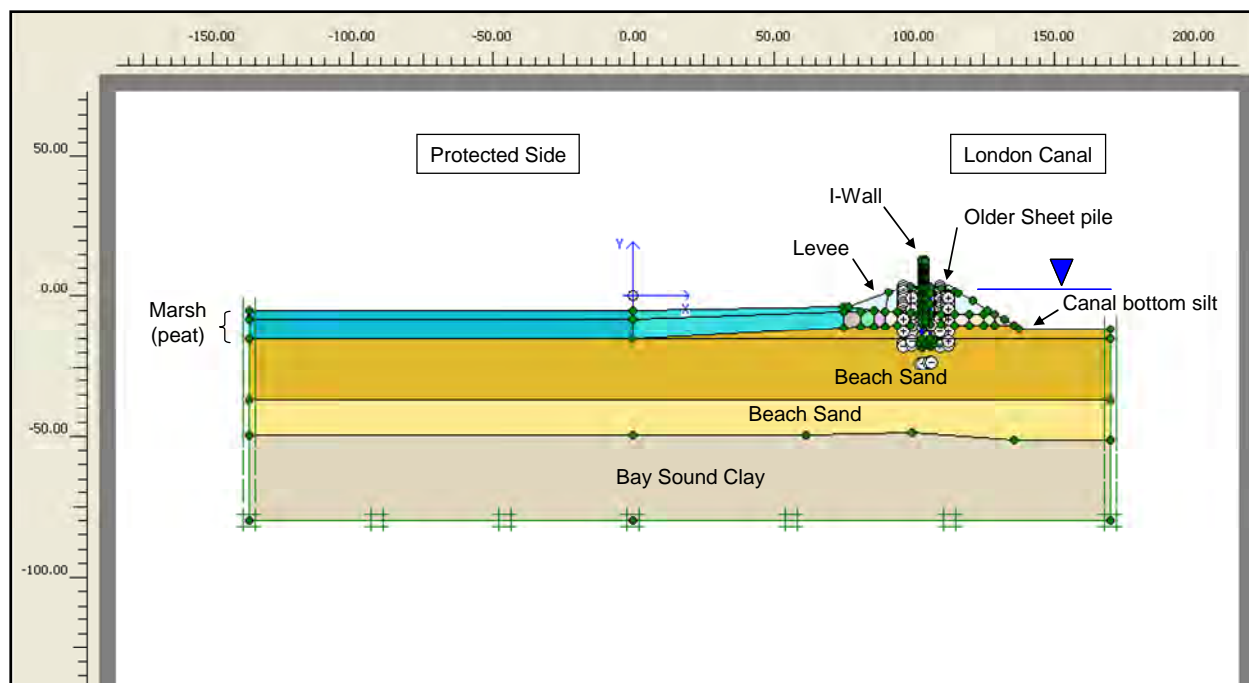
The two-dimensional cross section within the failed section of the East side of the London Canal at Station 53+00 analyzed for flood loading is shown in Figure 9-22.² The 2-D section is 307-ft wide and extends from x-coordinate equal to -137 ft to the center line of the canal at x equal to 170 ft. The top of the I-wall is at El 13 and sheet pile tip is at EL -17.4. An older sheet pile is embedded in the levee on the canal side of the I-wall, approximately 3 feet in front of the I-wall (centerline-to-centerline). This old sheet pile used to be part of a shorter flood wall that was removed when the existing I-wall was installed. The old sheet piling extends from the ground surface to within the Beach sand layer, El -16.9.

Figure 9-22. Two-Dimensional Cross Section Model used in the Complete SSI Analysis of Station 53+00 at London Canal – East Side

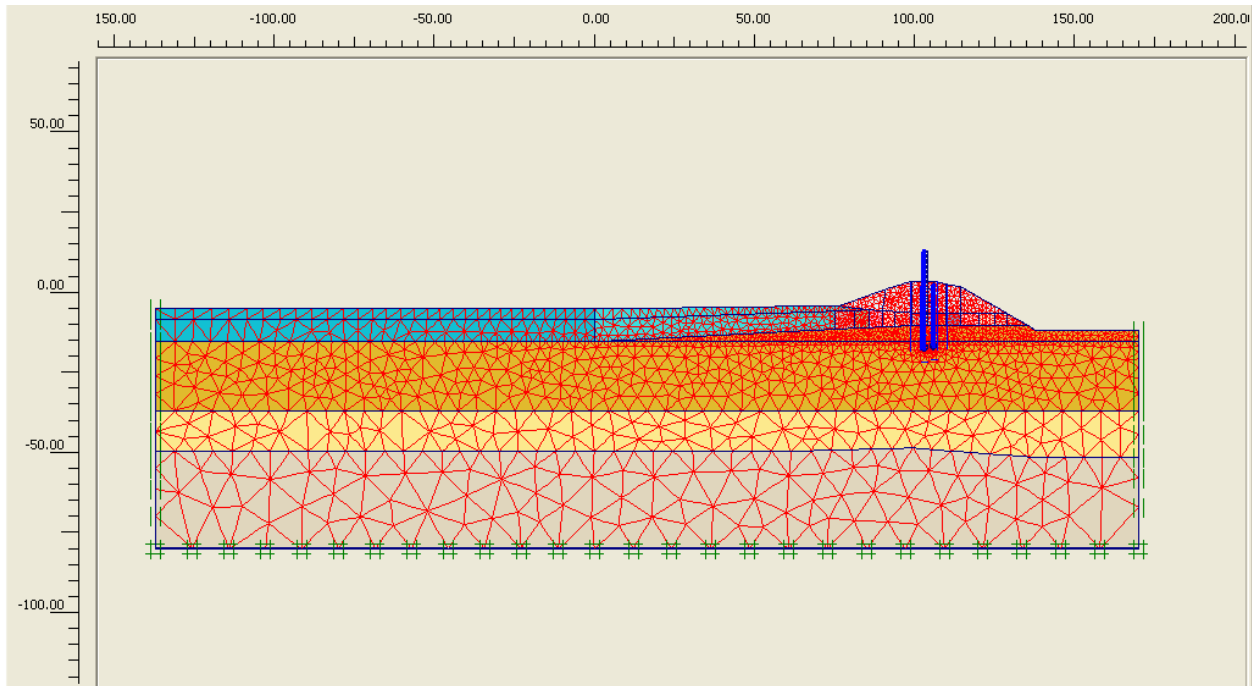
Figure 9-23. Finite Element Mesh used in the Complete SSI Analysis of Station 53+00 at London Canal – East Side

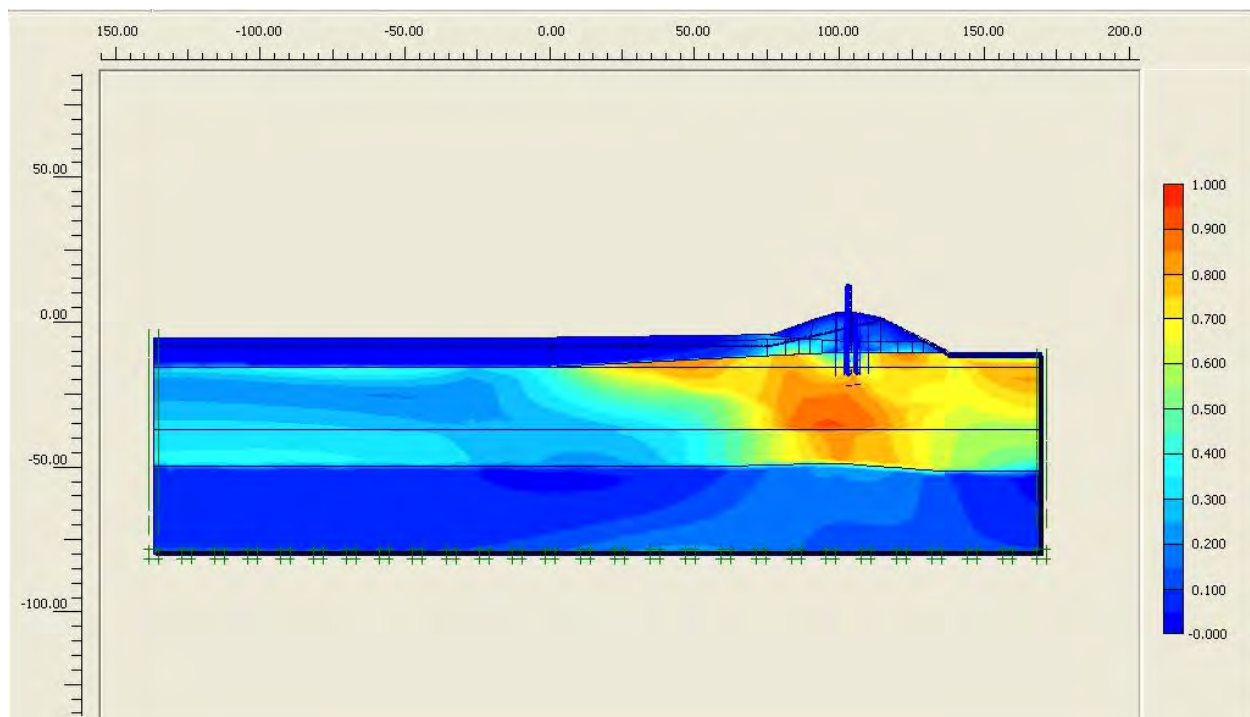
The initial steady-state, total stress condition for the usual canal water elevation of 1 is established by using the average stiffness modulus values given in Table 9-8 in the Mohr-Coulomb soil model for loading phases 0 through 3 for both sets of complete SSI analyses. The results from the IPET Task 7 slope stability analyses for this usual canal elevation indicate a stable cross-section with an ample Factor of Safety, i.e., above 1.5. Consequently, an important aspect of the total stress regime achieved within the Figure 9-23 finite element mesh is that the mobilized shear stress at the strain integration points within the finite elements contained in the soil clusters shown in this figure be less than the shear strength of the soil. The resulting computed fraction of mobilized shear strength (referred to as relative shear stress in Plaxis output) from the resulting initial total stress condition is shown in Figure 9-24. The fraction of mobilized shear strength is less than or equal to 0.9 at the stress integration points for the four soil types.

Figure 9-24. Fraction of Mobilized Shear Strength for Canal El 1

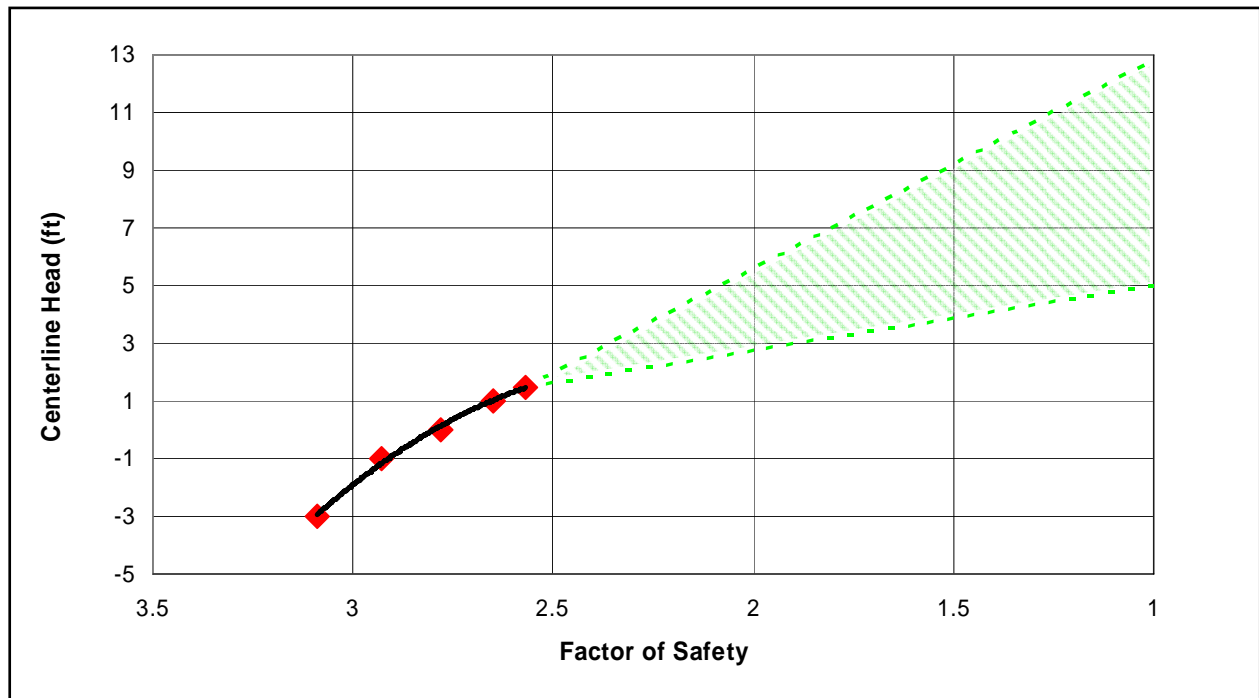
Factor of Safety: The factor of safety is computed for flood loading of the I-wall/sheet pile wall using the phi/c reduction method of analysis in Plaxis by means of incremental multipliers. Problems with numerical convergence occurred in nearly all Phi/c reduction analyses of this cross-section, even for the Canal water El 5 flood loading case with a crack extending to El -10.2 (i.e., the top of the Beach sand layer). It is speculated by the authors of this document that these numerical problems stem from the change in the hydraulic boundary condition when a crack forms to the top of the Beach sand, resulting in new, higher uplift pressures at the top of the Beach sand layer, below and immediately beyond the toe of the Levee combined with the shallow (total) overburden pressure of the Marsh layer within this region. Converting from a steady state seepage analysis to a linear phreatic surface assumption with a head specified at

Figure 9-25. Factor of Safety Versus Centerline Head

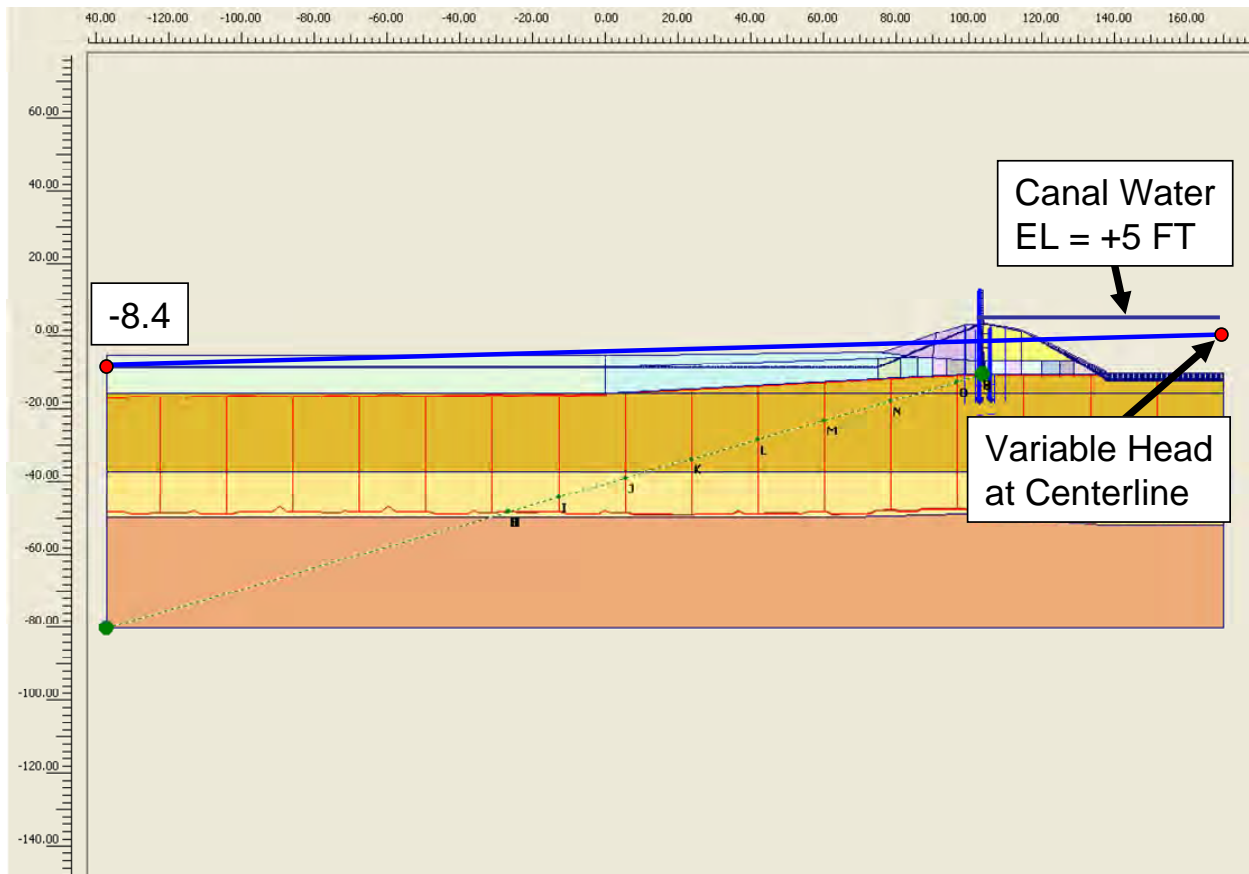
Figure 9-26. Graphical Definition of the Head at Canal Centerline for the Linear Phreatic Surface Assumption

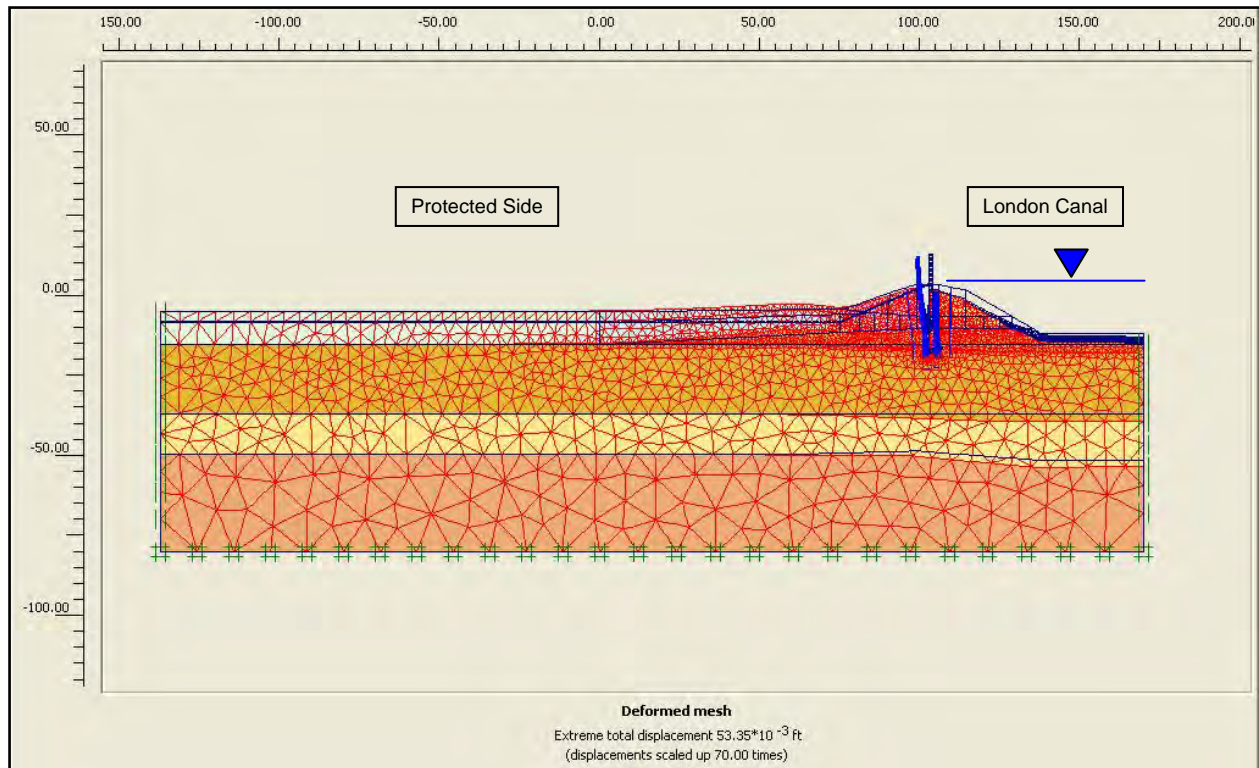
Deformations: Figure 9-27 summarizes the computed deformations for the analysis set with stiff modulus values assigned to the Levee clay and the Marsh on the protected side of the I-wall, Canal water El 5 and crack to El -10.2 (i.e., top of Beach sand). Note the nodal deformations are magnified by a factor of 70 in order to show the deformed relative mesh relative to its position at canal water elevation of 1.0 (shown as a blue outline in this figure). The general trend is a rotational plowing of the protected side Levee clay by the I-wall/new sheet pile wall and a bulging of the Marsh beyond the toe of the Levee on the protected side.

Figure 9-27. Deformed Mesh for Stiff Modulus Values for the Levee Clay and Marsh on the Protected Side, Exaggerated by a Factor of 70, for Canal EI 5 and Crack to EI -10.2 (Note: Canal EI not to scale in figure)

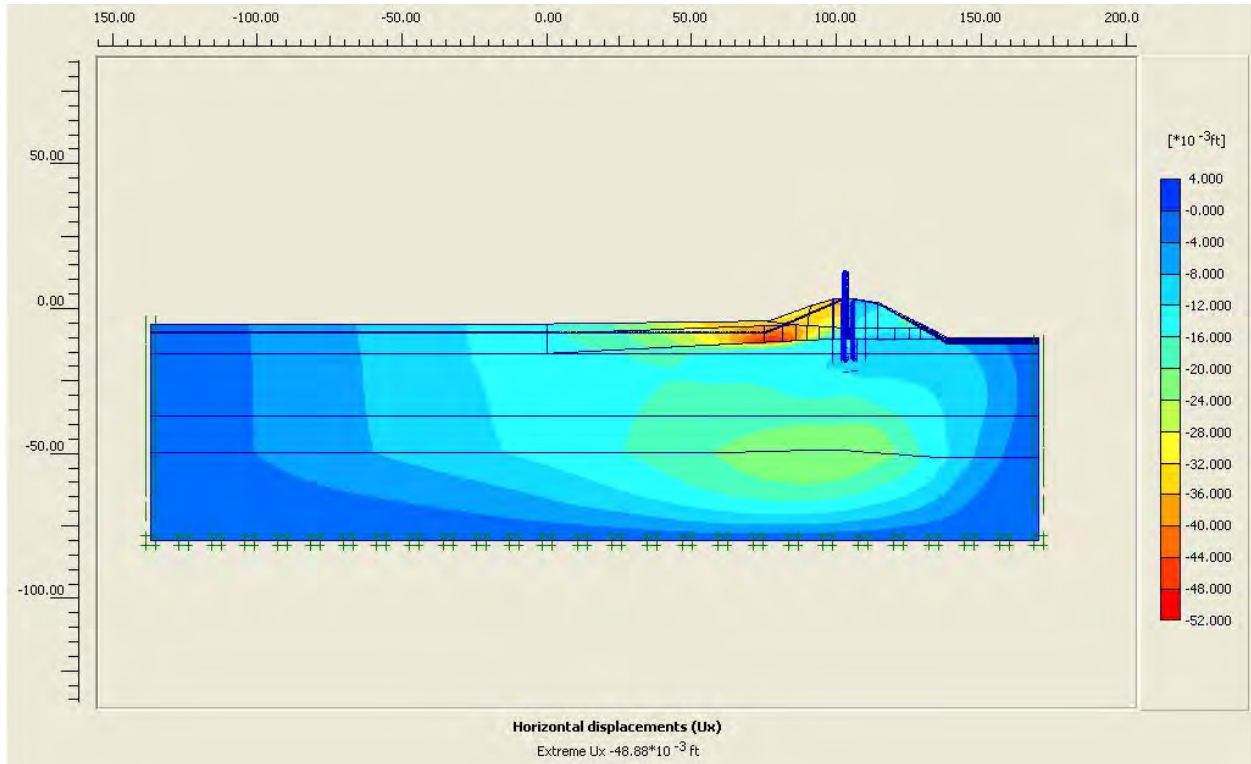
Figure 9-28 shows the horizontal displacements of the soil regions within the mesh, relative to their position at a canal water elevation of 1.0 for stiff modulus values assigned to the Levee clay and the Marsh on the protected side of the I-wall with Canal water EI 6 and crack to EI -10.2. This figure shows the horizontal deformations are concentrated within the protected region of the Levee and the Marsh immediately at the toe of the Levee on the protected side. The largest horizontal deformations are concentrated in the Marsh, on the protected side, (approximately equal to 0.05 ft (5/8 inch)).

Figure 9-28. Horizontal Deformation Shadings for the Levee Clay and Marsh on the Protected Side with Canal EI 5 and Crack to EI -10.2

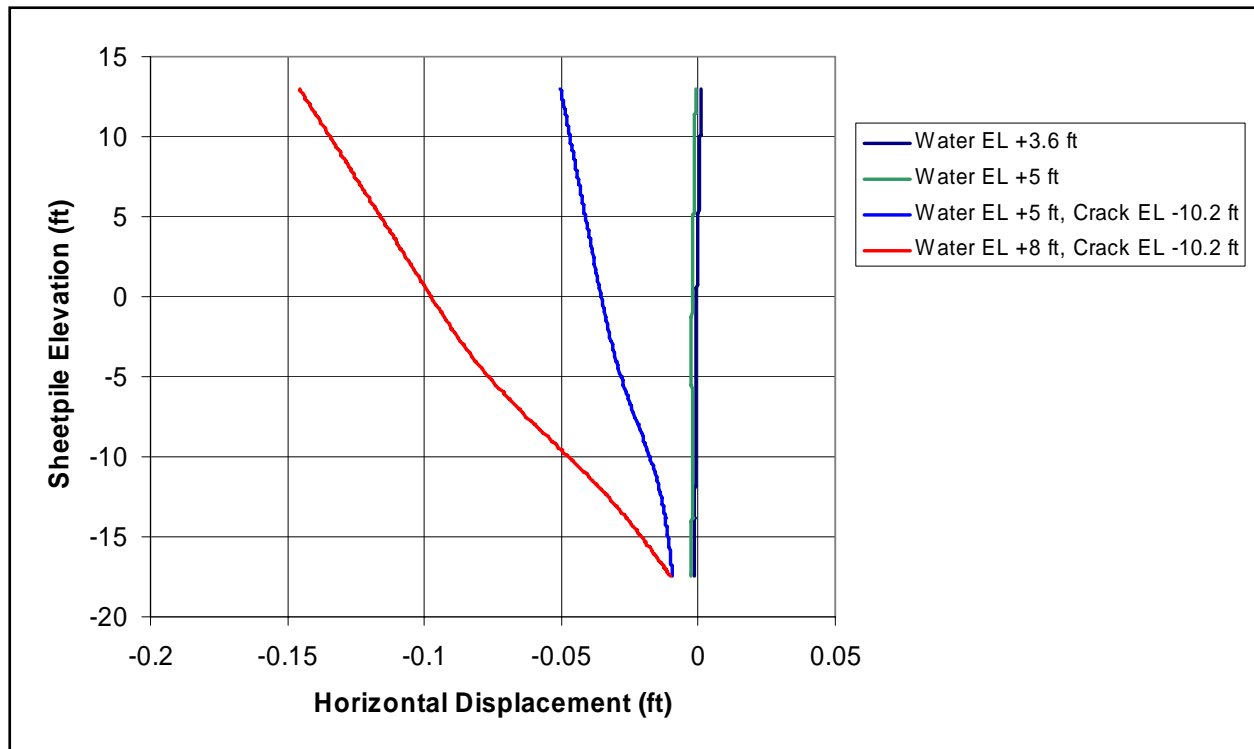
Figure 9-29 shows the variation in horizontal displacements of the sheet pile versus canal water elevation for the analysis set with stiff modulus values assigned to the Levee clay and the Marsh on the protected side of the I-wall. These displacements are relative to their position at a canal water elevation of 1.0. This figure shows the rotational nature of the I-wall/sheet pile wall deformations, with the toe of the sheet pile “anchored” in the Beach sand.

Figure 9-29. Horizontal Displacement of the I-Wall/Sheet Pile versus Canal Water El and Computed Using Stiff Modulus Values for the Levee Clay and Marsh on the Protected Side

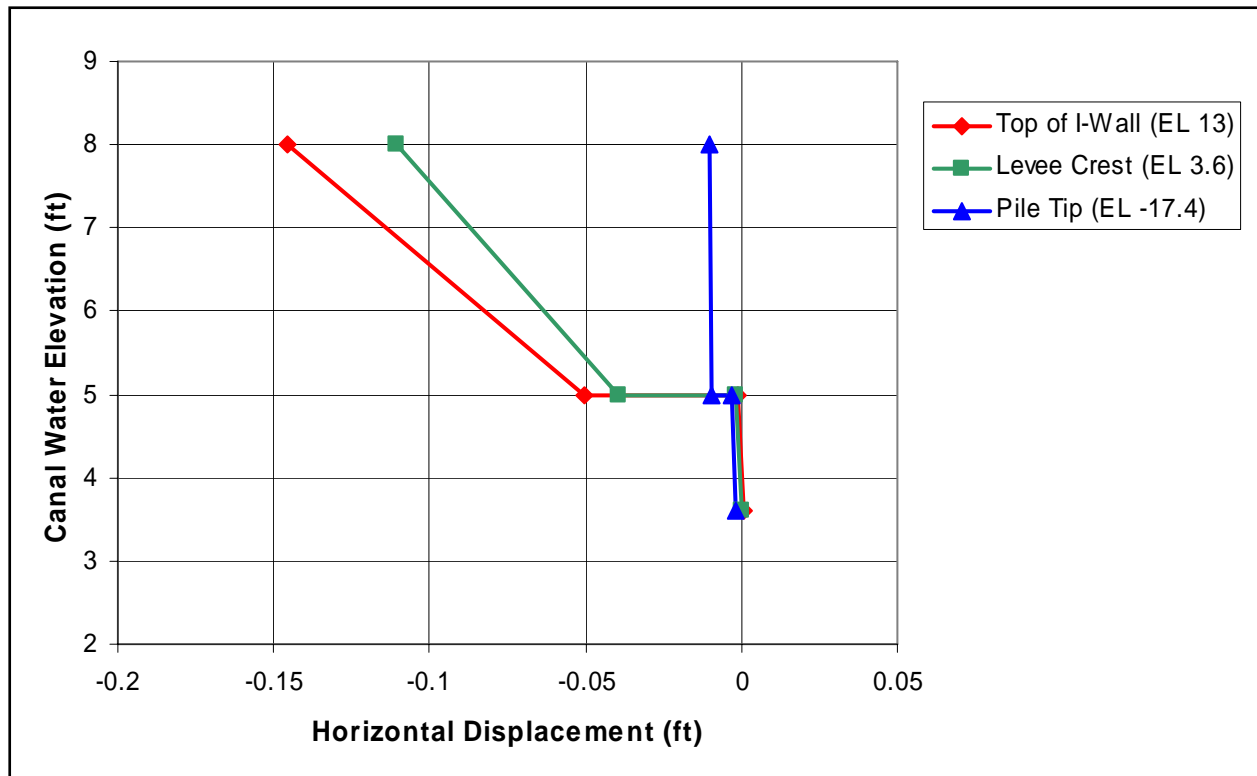
Figure 9-30 shows the horizontal displacements of three points within the flood wall, relative to its position at a canal water elevation of 1.0 for stiff modulus values assigned to the Levee clay and the Marsh on the protected side of the I-wall. The points monitored through the analysis are at the top of the I-wall (El 13), at El 3.6 (top of Levee) and at the sheet pile tip (El -17.4). Recall for Canal water El's of 5 and higher, the crack never extends into the Beach sand layer, it terminates at the top of the Beach sand layer (i.e., El -10.2). Note that there is a significant increase in horizontal deformations of the I-wall/sheet pile wall when the crack extends to El -10.2 at Canal water El 5. Results in this figure shows the Beach sand is providing enough lateral support to prevent the sheet pile tip from moving laterally, therefore the deformation of the sheet pile is mostly a rotation about the sheet pile tip. Maximum horizontal movement at the top of the I-wall is 0.145 ft (1 3/4 inches) for Canal water El 8.

Figure 9-30. Horizontal Sheet Pile Deformations versus Canal Water El and Computed Using Stiff Modulus Values for the Levee Clay and Marsh on the Protected Side

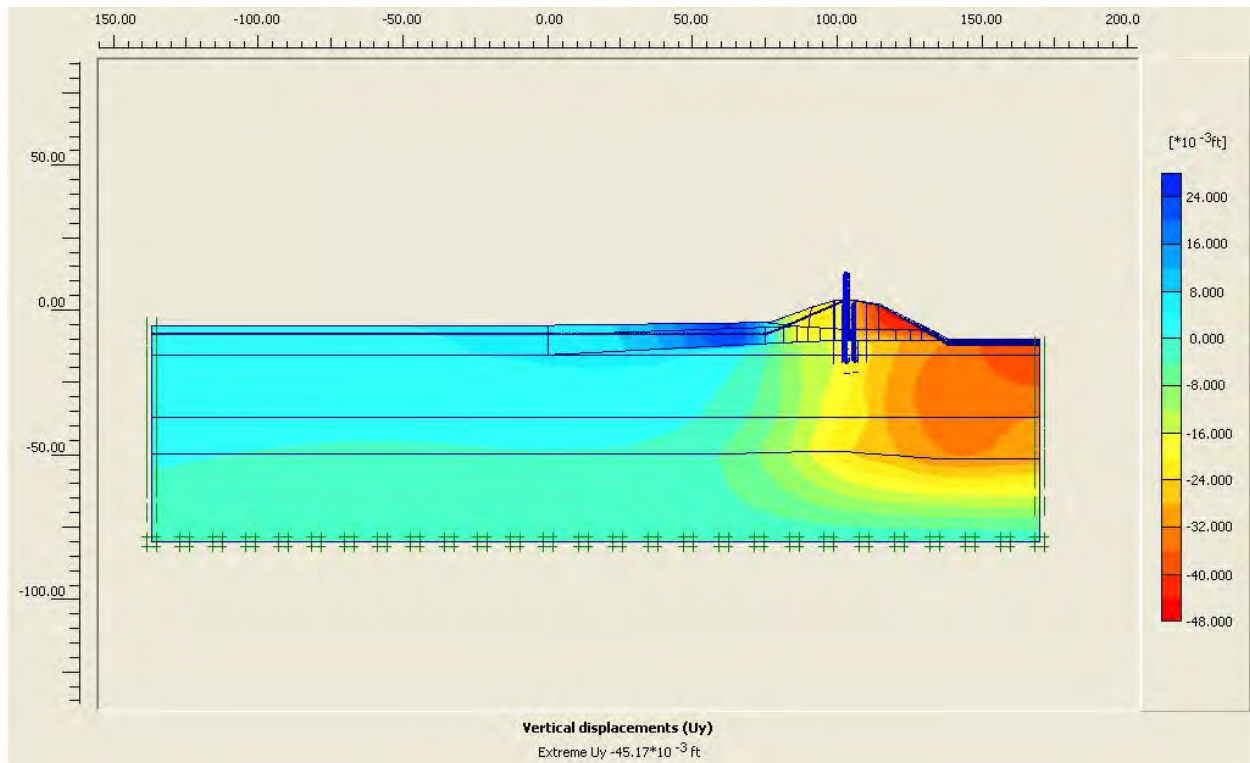
Figure 9-31 shows the vertical displacements of the soil regions within the mesh, relative to their position at a canal water elevation of 1.0 for stiff modulus values assigned to the Levee clay and the Marsh on the protected side of the I-wall with Canal water El 5 and crack to El -10.2. This figure shows the 0.024 ft (1/4 inch) uplift of the Marsh located beyond the toe of the Levee on the protected side.

Figure 9-31. Vertical Deformation Shadings for Stiff Modulus Values for the Levee Clay and Marsh on the Protected Side with Canal El 5 and Crack to El -10.2

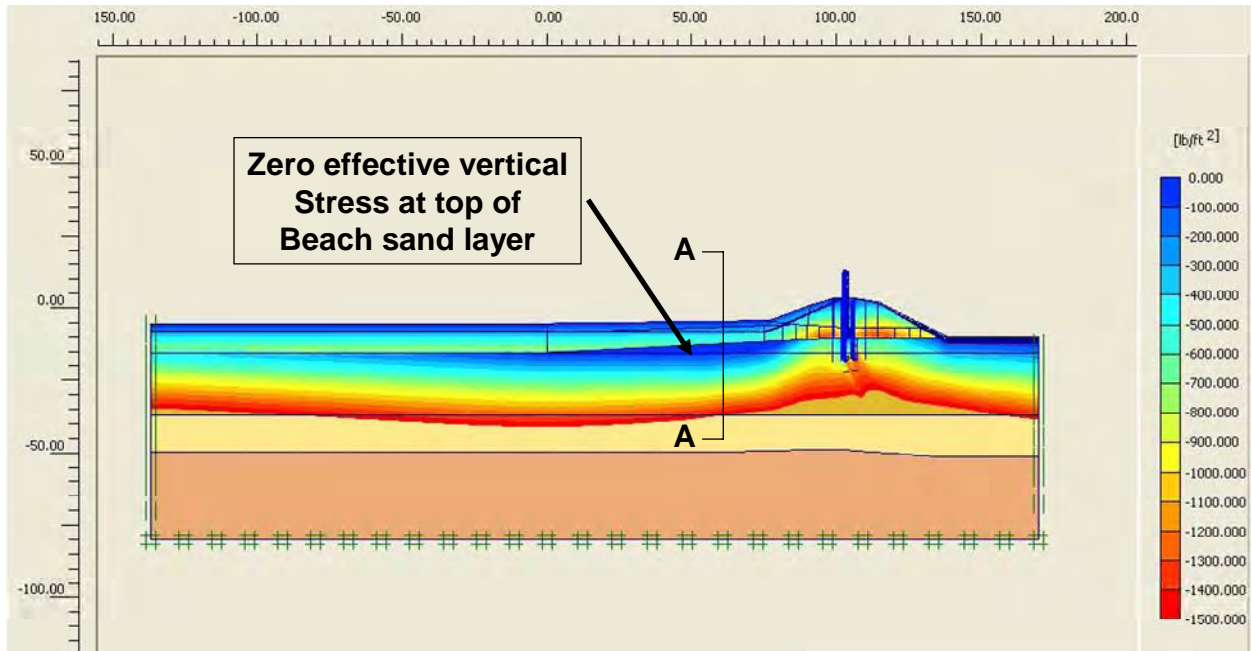
Failure Mechanism: Figures 9-32 and 9-33 show that for the analysis set using stiff modulus values assigned to the Levee clay and the Marsh on the protected side of the I-wall with Canal water El 5 and Crack to El -10.2, there is a loss of effective vertical stress at the top of the Beach sand layer within the region beyond the toe of the Levee. This results in zero shear strength along the top of the Beach sand layer as demonstrated in the Figure 9-34 fraction of mobilized shear strength being equal to unity within this Beach sand region. Figure 9-35 shows that this, in turn, results in the beginning of the development of a mechanism as demonstrated by the concentration of large shear strains within this region for Canal water El 5 and crack to El -10.2. Figure 9-36, with a close-up of the Levee region shown in Figure 9-37, and Figure 9-38 show the development of the ultimate mechanism (i.e., the failure mechanism) computed in a phi/c reduction analysis for Canal water El 5 and crack to El -10.2, for a linear phreatic surface Canal centerline head at El 0 with the computed Factor of Safety of 2.78 (actual value will be lower when the more realistic, larger pore water pressures are specified in an analysis). Note the vertical “bulging” in the Marsh beyond the toe of the Levee. The reaches of large shear strain shown in Figure 9-38 shows the complete failure wedge will form along the top of the Beach sand layer and “day light” beyond the toe of the Levee. All subsequent phi/c computations (that converged to a solution) for higher canal water elevations and for the E_{stiff} analyses show this same Figures 9-36, 9-37 and 9-38 failure mechanism to form.

Figure 9-32. Shadings of Total Vertical Stress in the Levee Clay and Marsh and Effective Vertical Stress in the Beach Sand for the Analysis Using Stiff Modulus Values for the Levee Clay and Marsh on the Protected Side with Canal EI 5 and Crack to EI -10.2

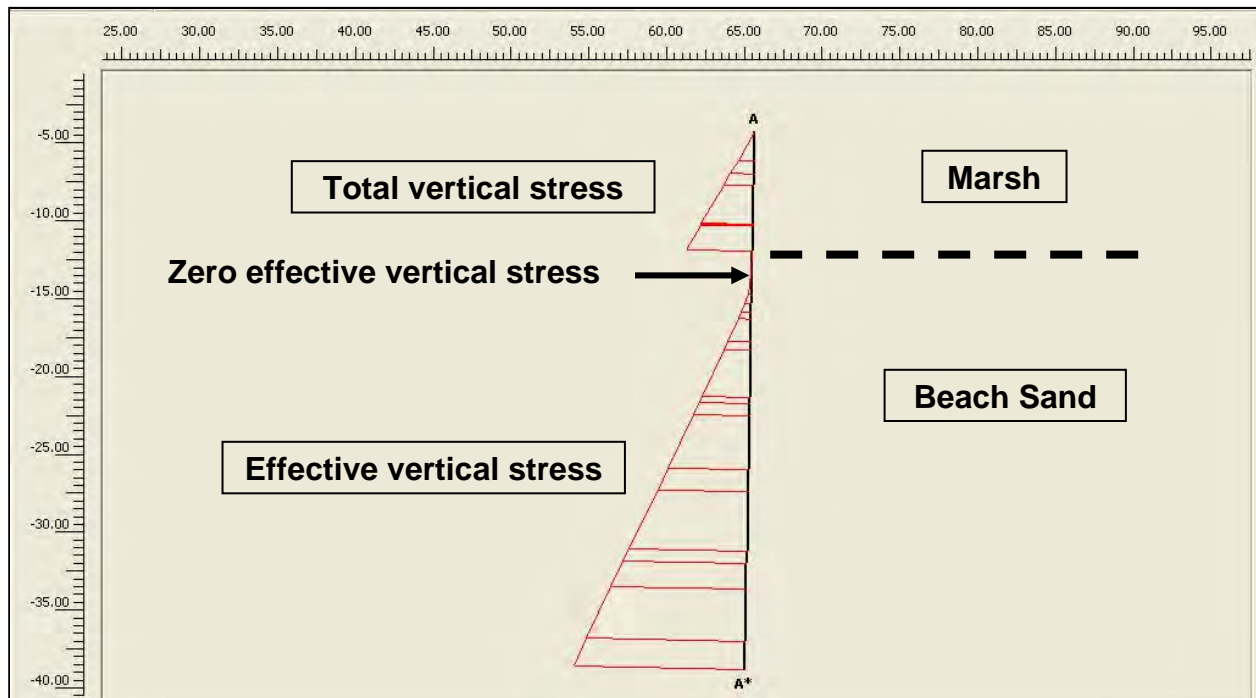
Figure 9-33. Vertical Section A-A Near the Toe of the Levee Showing Total Vertical Stress in the Marsh and Effective Vertical Stress in the Beach Sand for the Analysis Using Stiff Modulus Values for the Levee Clay and Marsh on the Protected Side with Canal EI 5 and Crack to EI -10.2

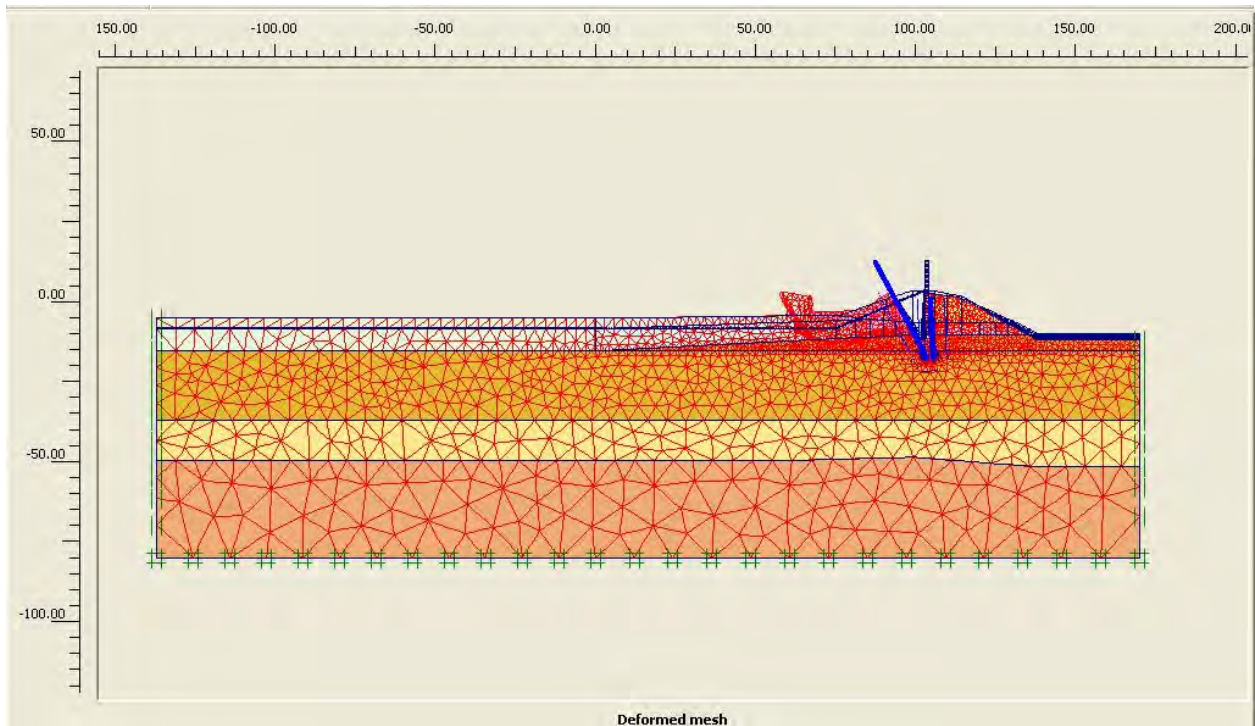
Figure 9-36. Ultimate Mechanism from Phi/C Reduction for the Analysis Using Stiff Modulus Values for the Levee Clay and Marsh on the Protected Side with Canal EI 5 and Crack to EI -10.2

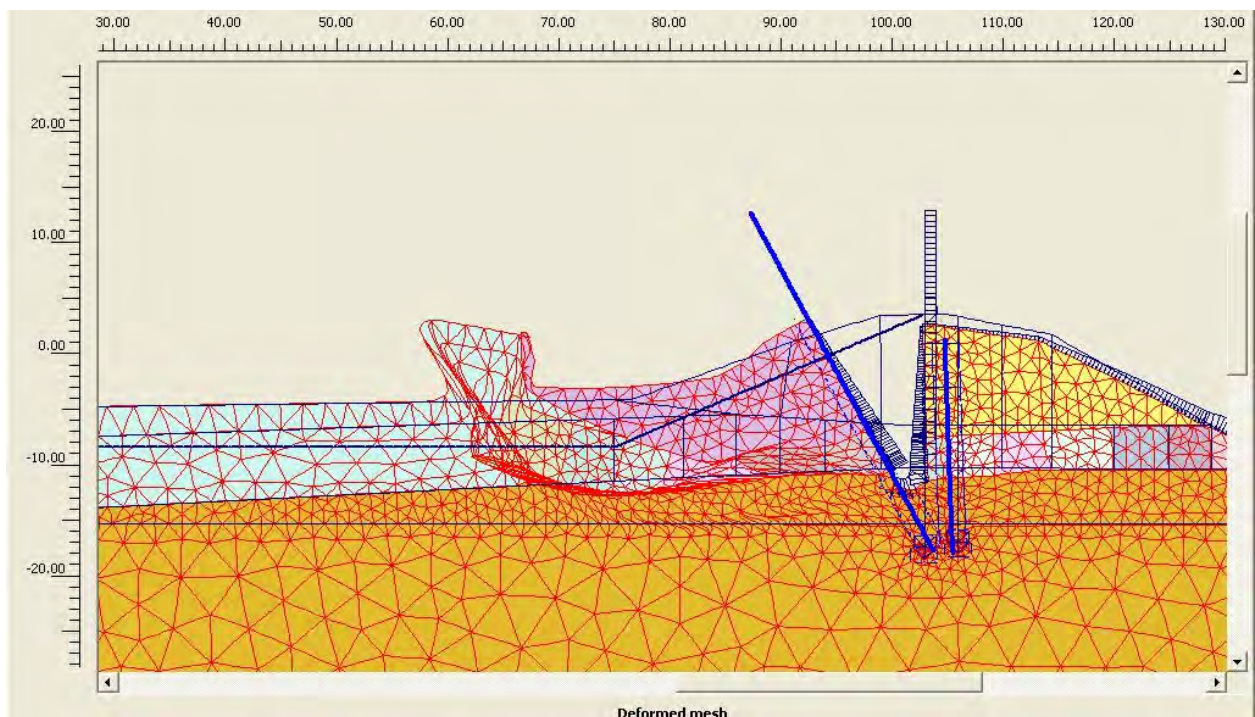
Figure 9-37. Close-up of the Ultimate Mechanism from Phi/C Reduction for the Analysis Using Stiff Modulus Values for the Levee Clay and Marsh on the Protected Side with Canal EI 5 and Crack to EI -10.2

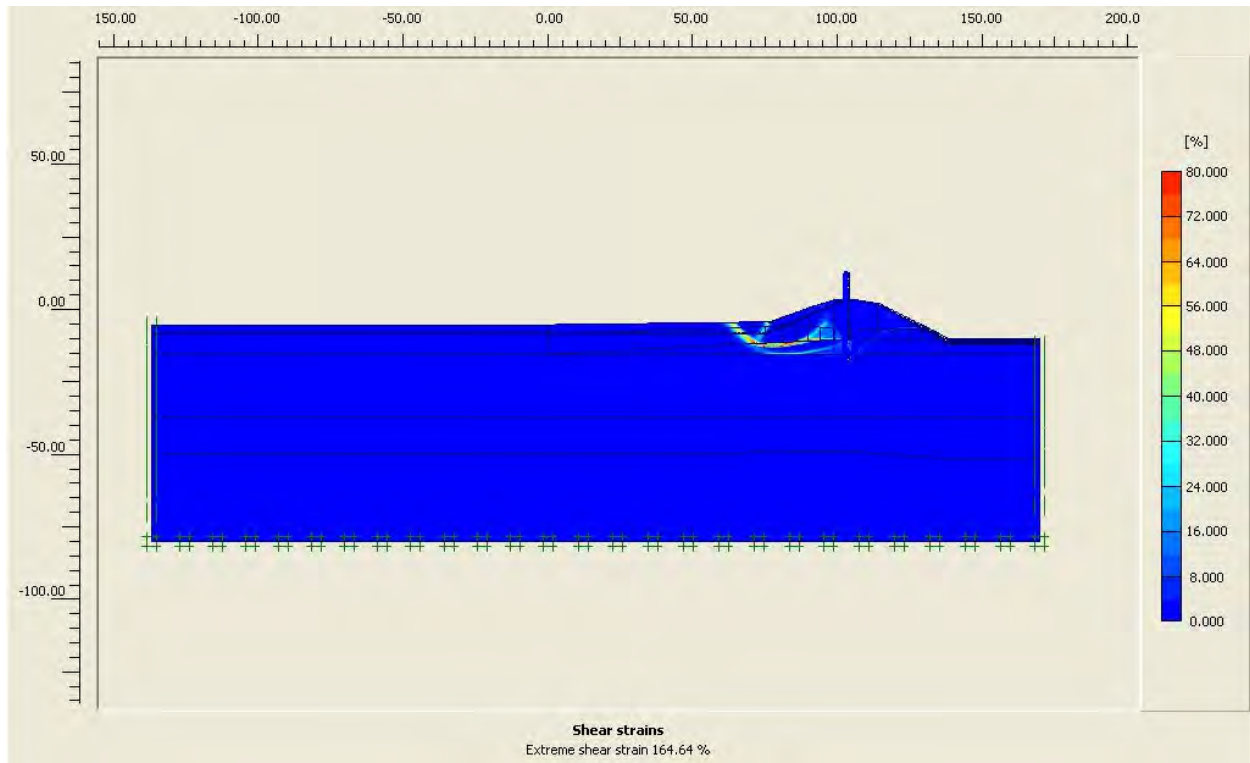
Figure 9-38. Reach of Large Shear Strains from the Phi/C Reduction Analysis Using Stiff Modulus Values for the Levee Clay and Marsh on the Protected Side with Canal El 5 and Crack to El -10.2
