Appendix 1

Soil Data Report for 17th Street Canal

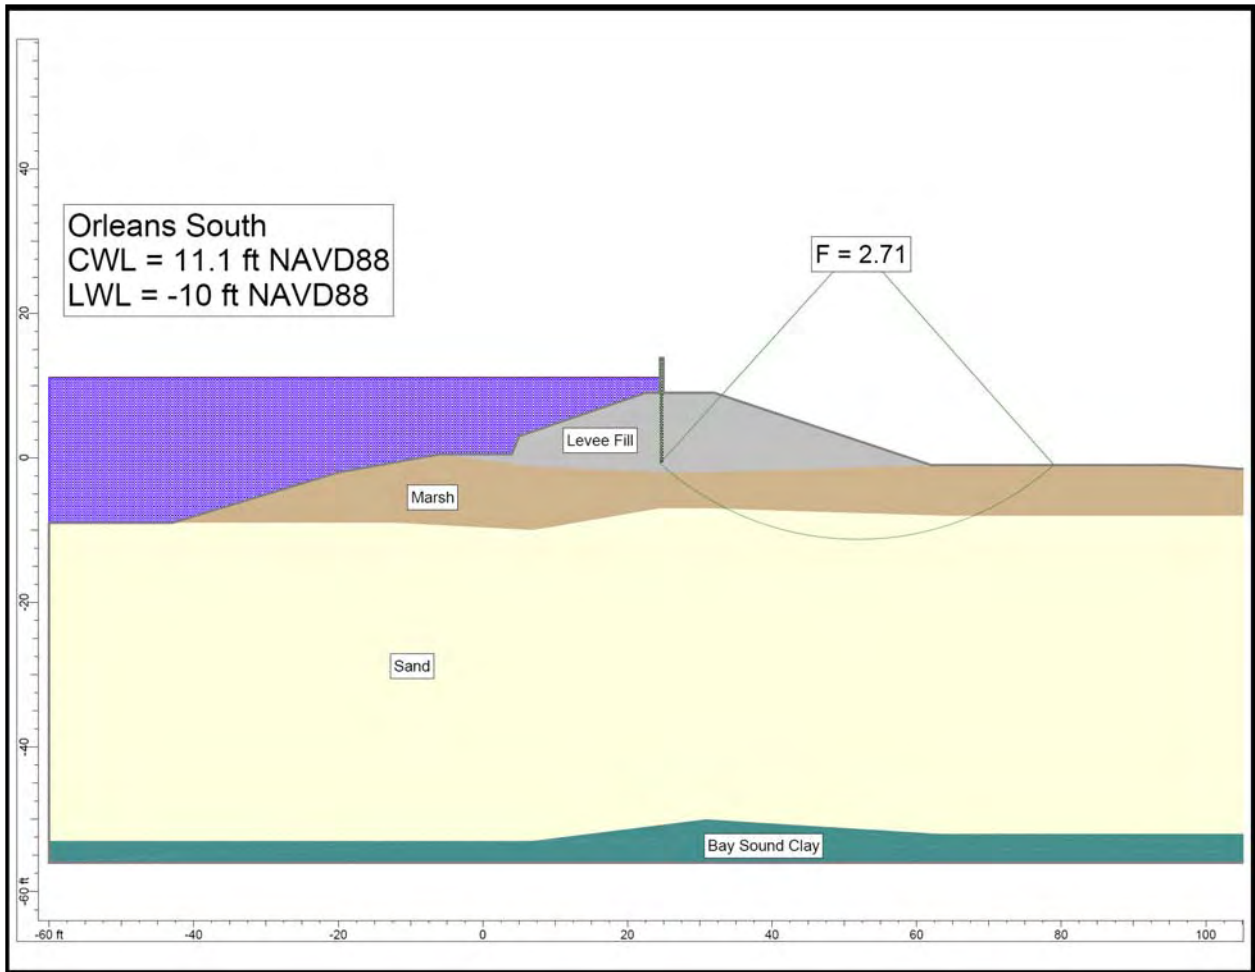
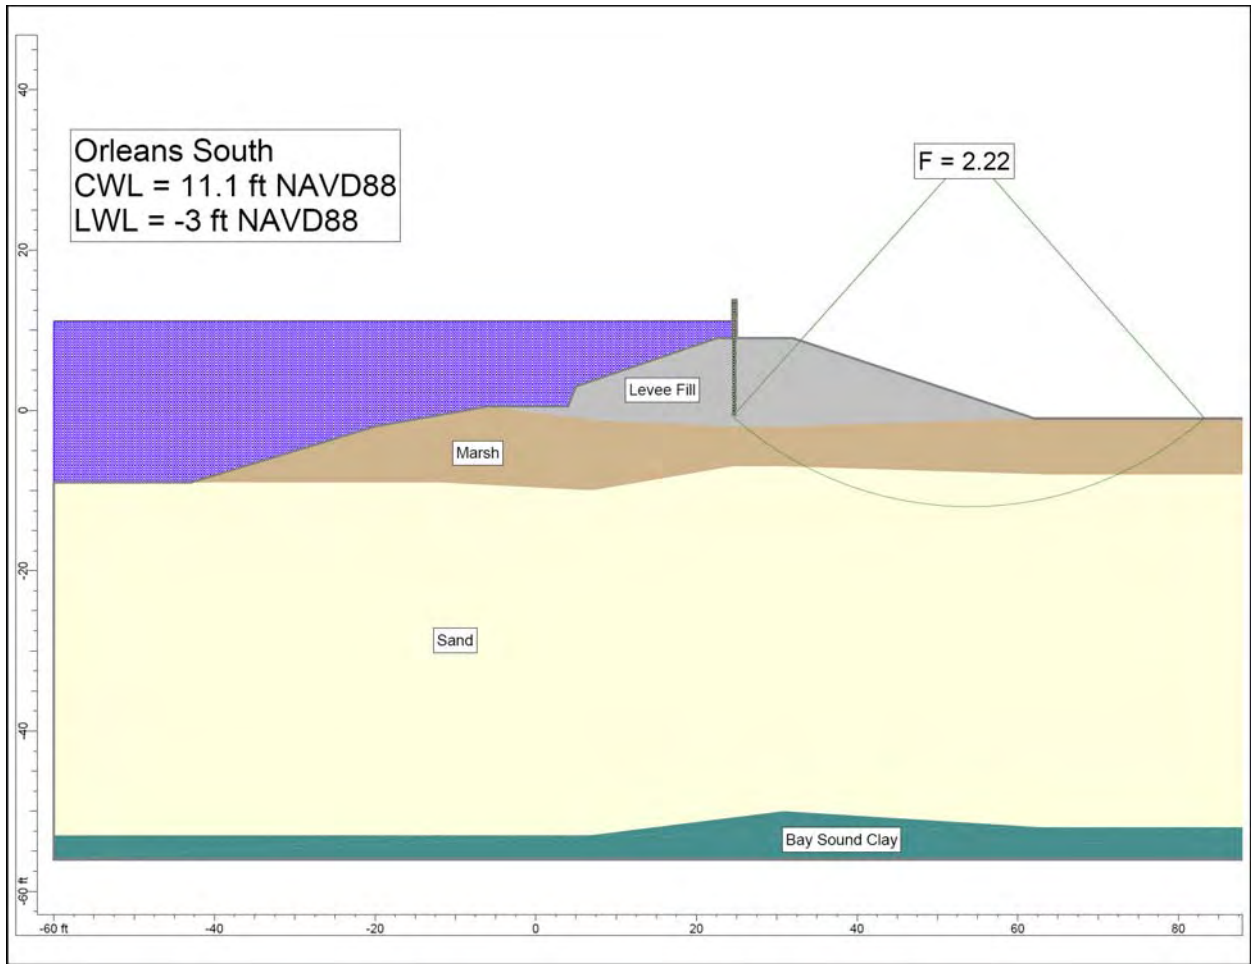
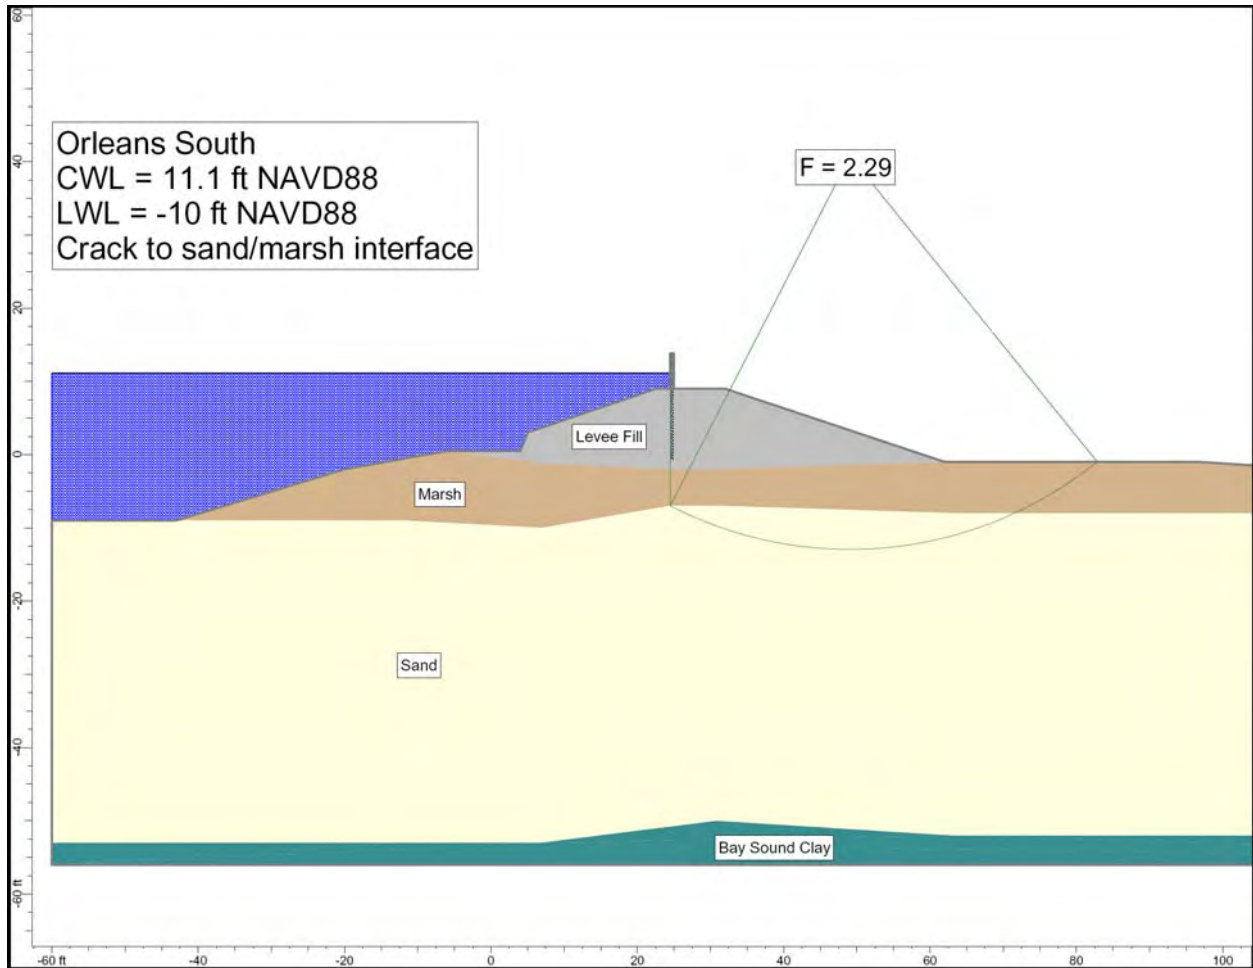
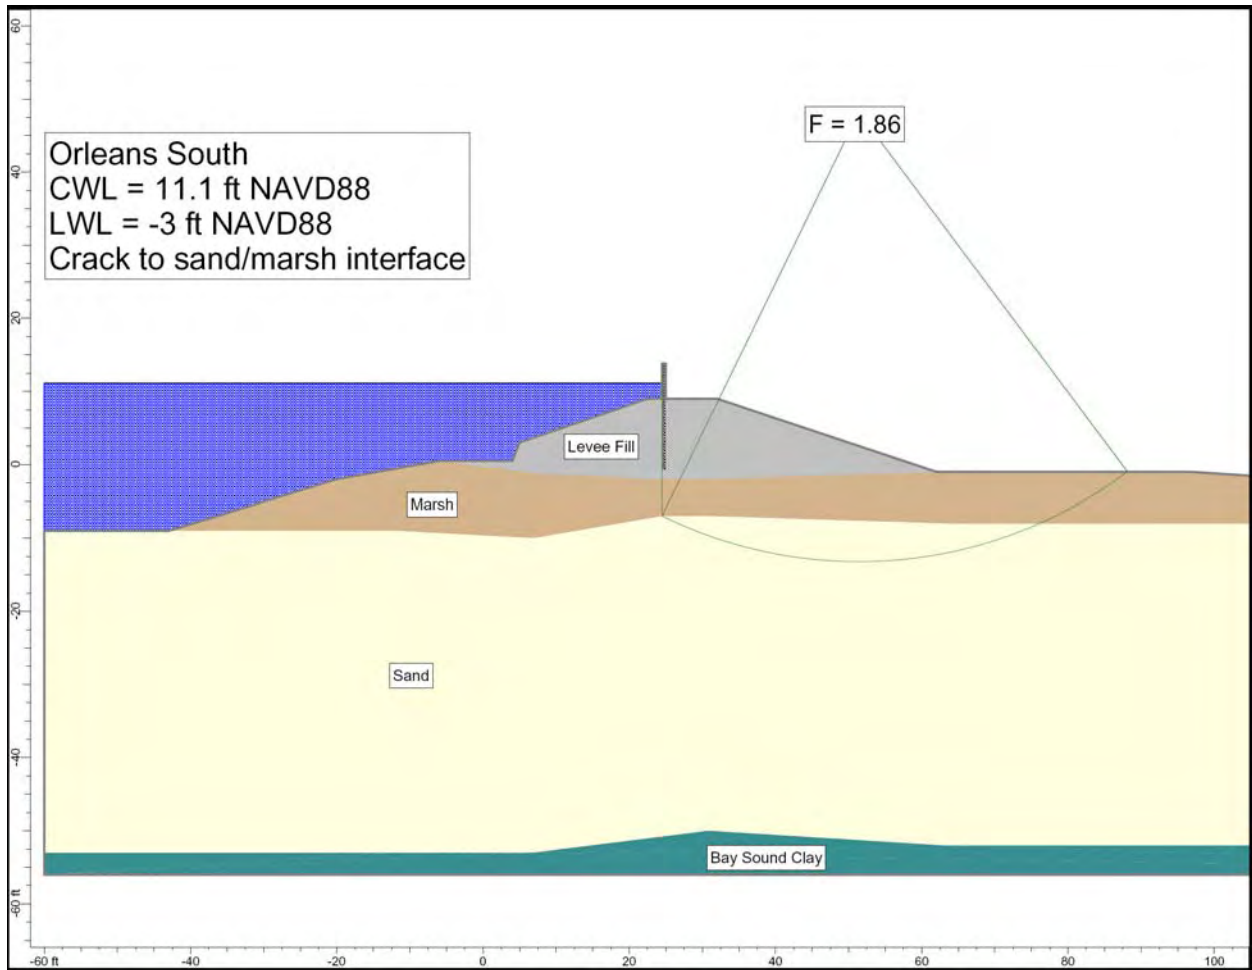
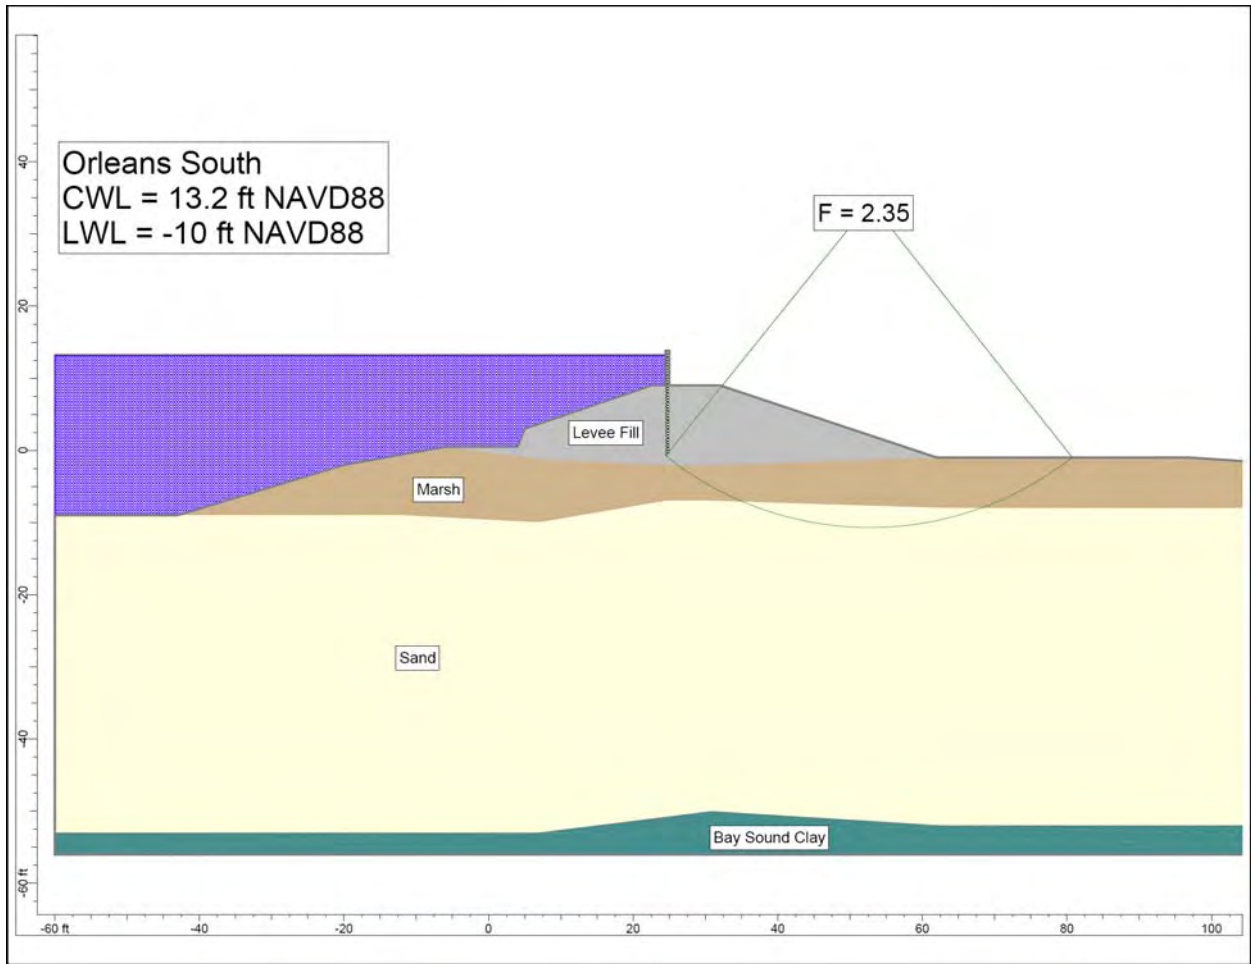
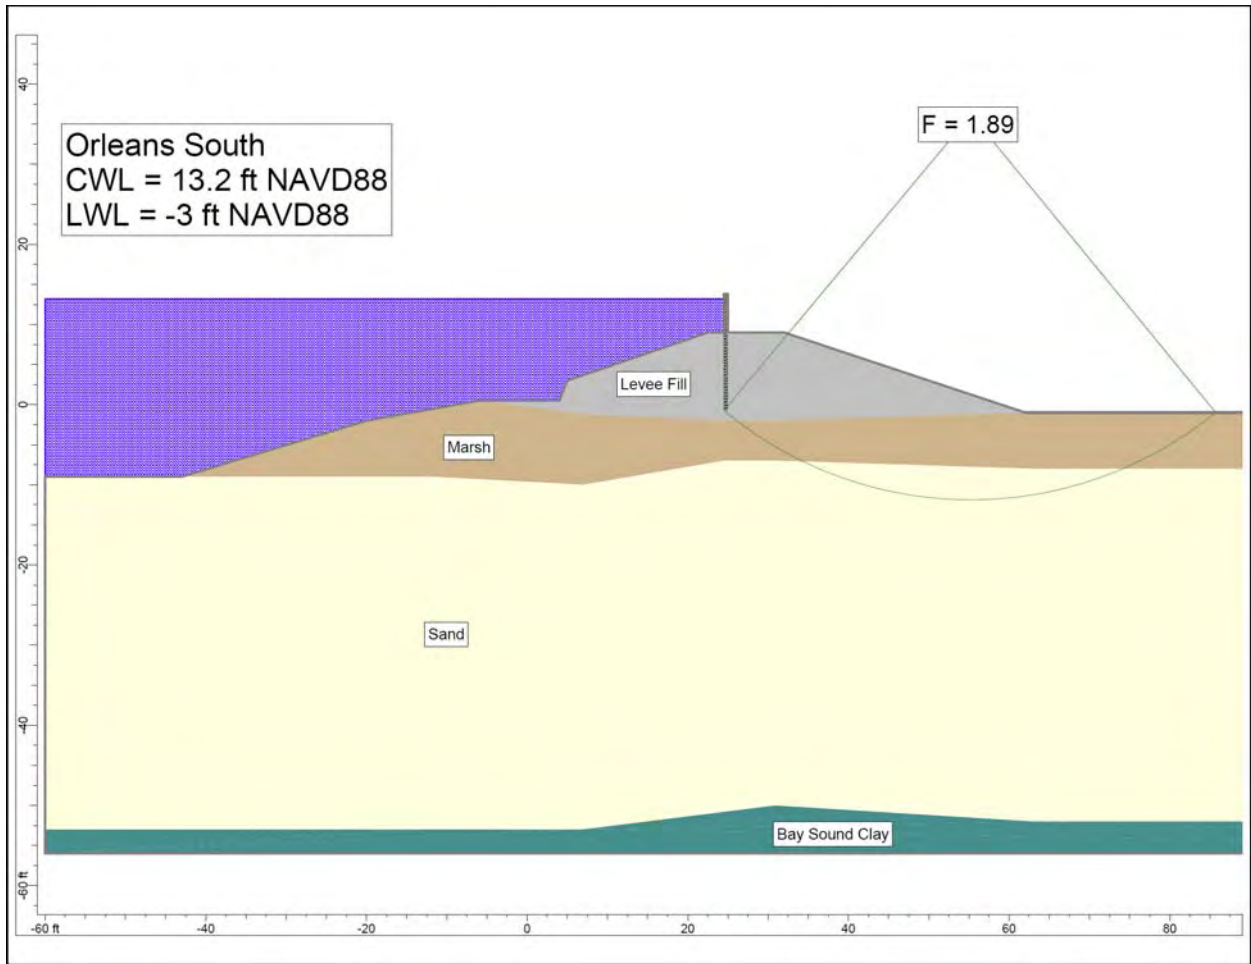
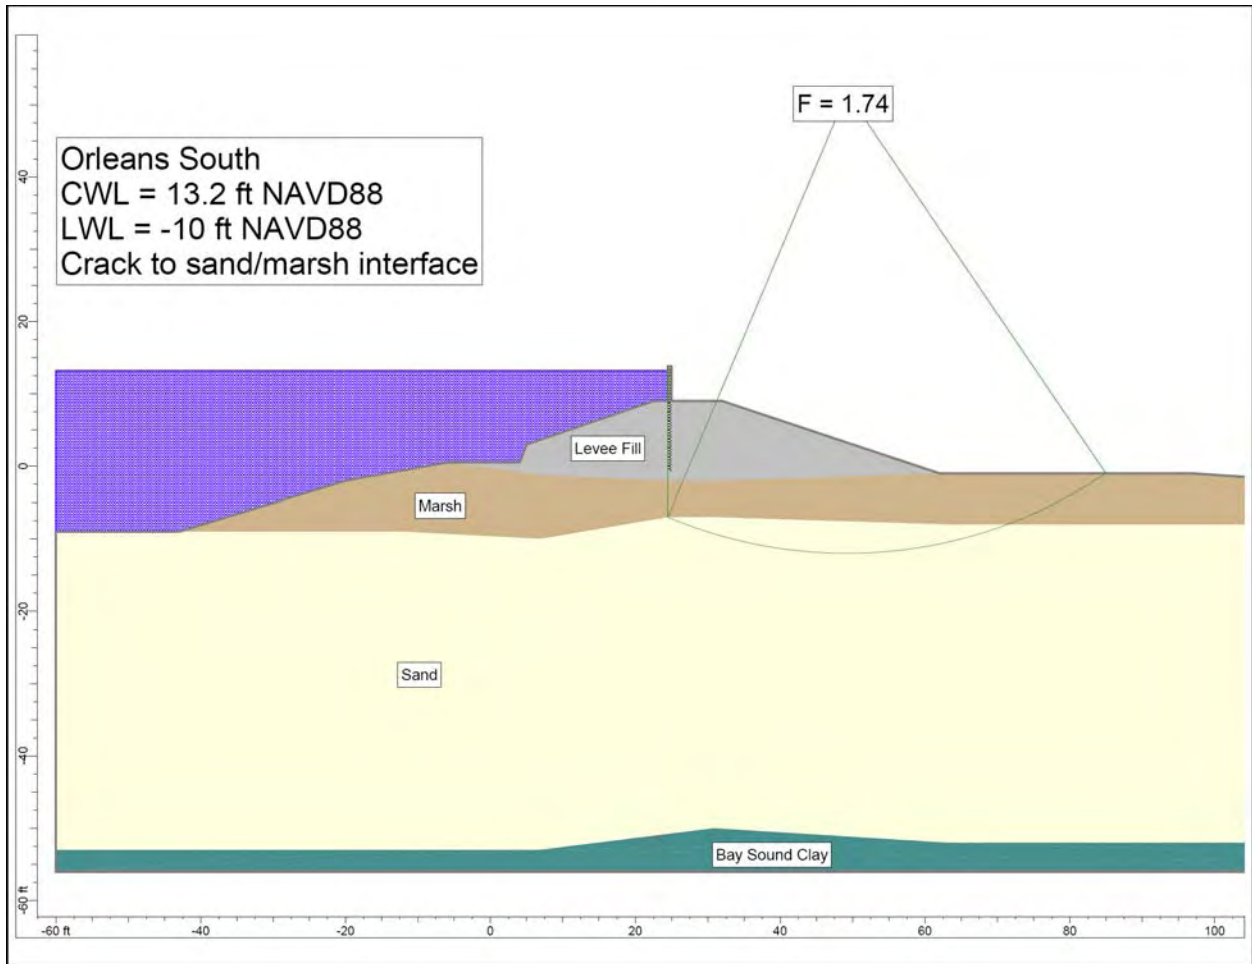
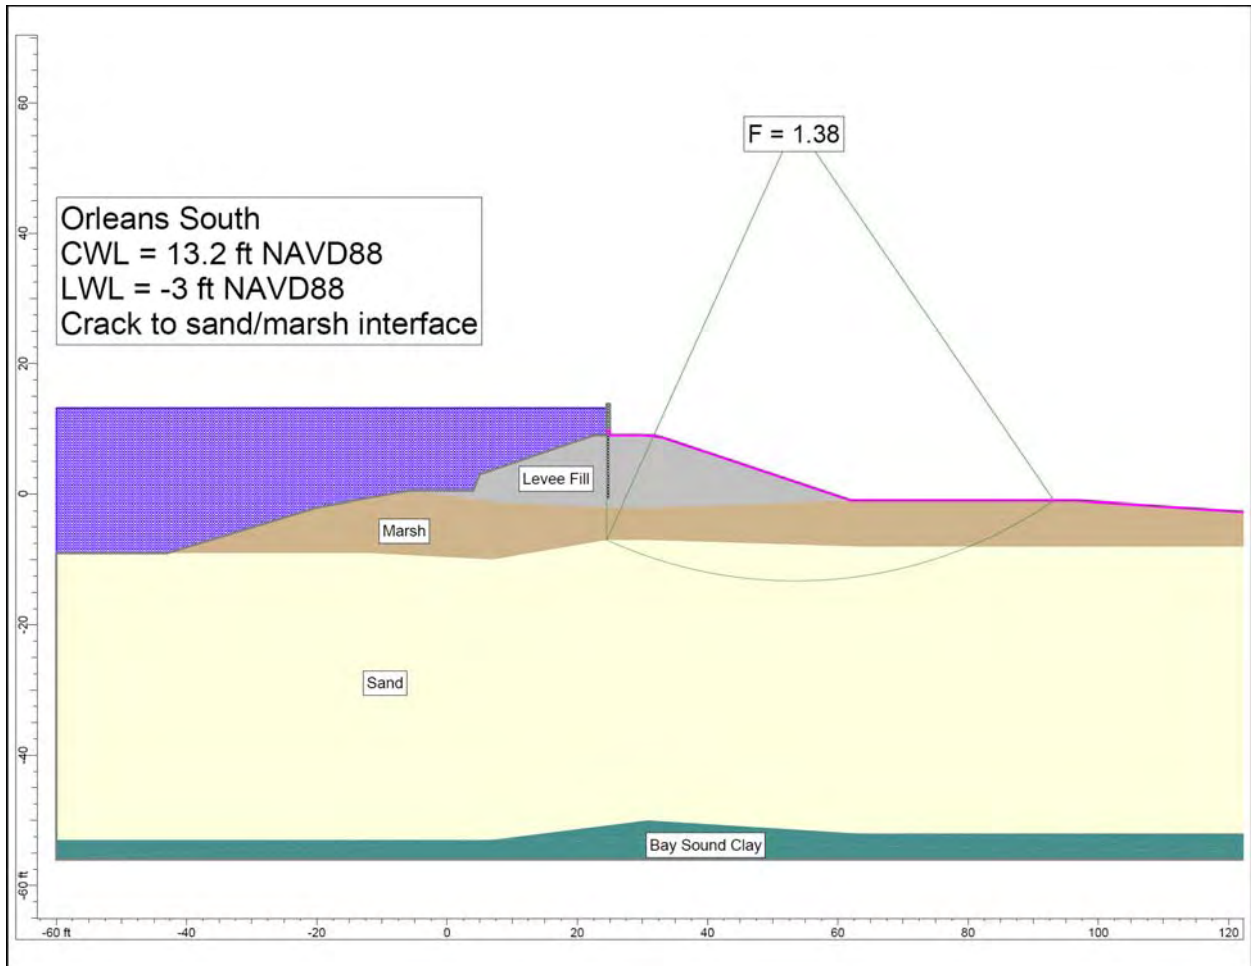
As discussed earlier, it was assumed in all analyses that deflection of the wall toward the land side would result in formation of a crack through the levee fill and the marsh in back of the wall, down to the bottom of the wall, or by hydraulic fracturing, down to the top of the sand. It was assumed that the crack would not extend below the top of the sand, because the sand is cohesionless, and would be expected to slump and fill any incipient crack. A crack to the bottom of the wall was assumed for Cases 1, 2, 5 and 6 (Figures 10-10, 10-11, 10-14 and 10-15), and a crack to the top of the sand was assumed for Cases 3, 4, 7, and 8 (Figures 10-12, 10-13, 10-16 and 10-17).

The factors of safety calculated in these analyses are shown in Figures 10-10 through 10-17, and are summarized in Table 10-4. The values range from 1.38 to 2.71. Thus, even under the most severe conditions of water loading and possible crack formation considered here, the results of the analyses indicate that the wall would remain stable. For the highest water level observed at the Orleans south area, the lowest computed factor of safety is 1.86, which exceeds the minimum allowable for most conditions.

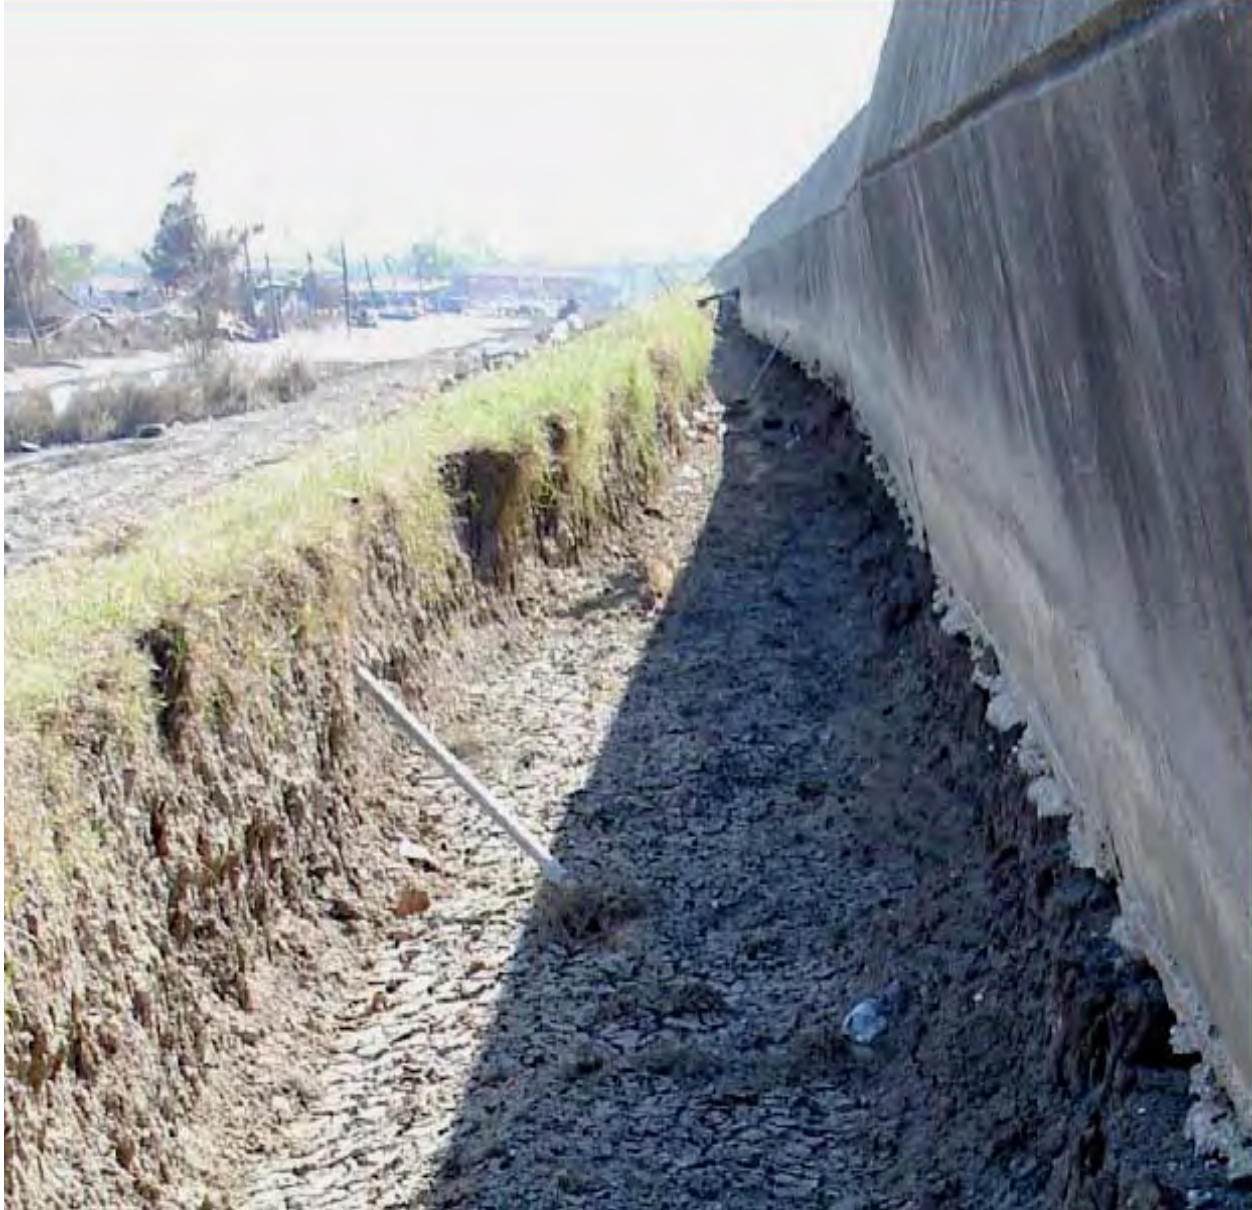
Figure 11-4. Scour and Erosion on the Protected Side of the IHNC Adjacent to the Ninth Ward in the Vicinity of the South Breach

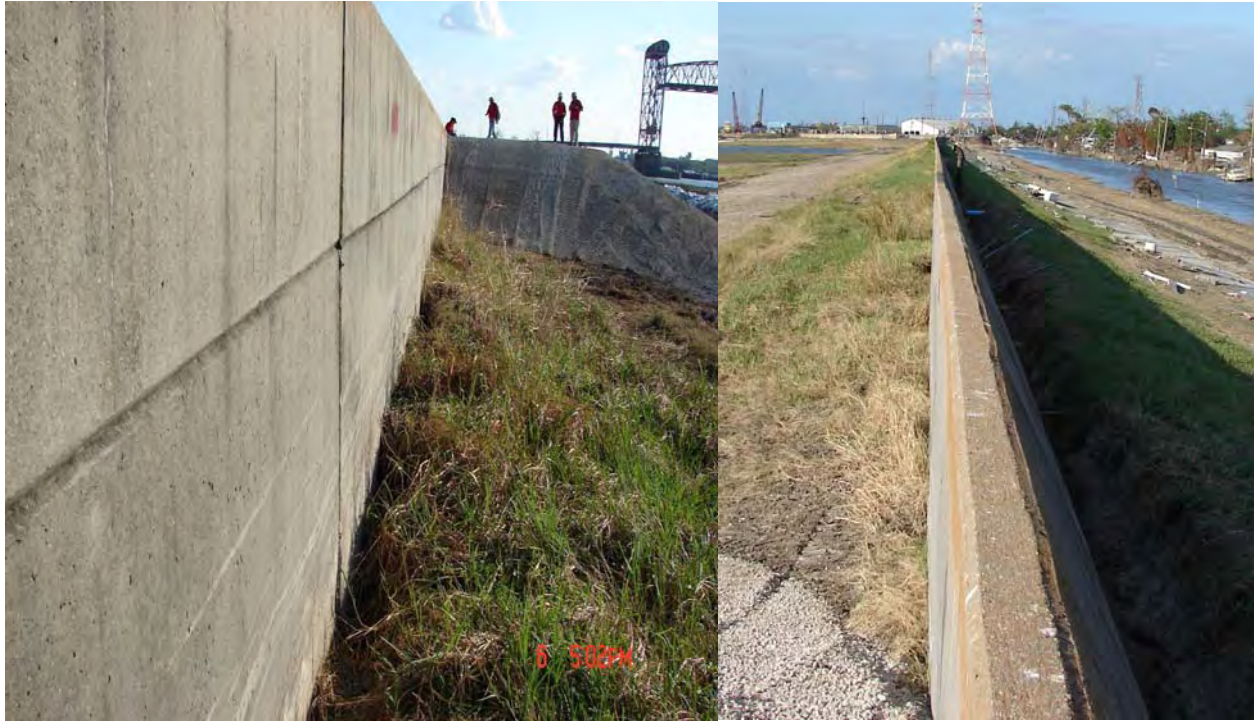
It is necessary to investigate the possibility of sliding instability to determine if the I-walls could breach as a result of shear through the foundation. The foundation conditions are similar to the 17th Street Canal. As shown in Figure 11-6, no significant wall movement was found in the wall sections adjacent the south breach. However, Figure 11-7 shows significant wall movement did occur in the wall sections adjacent to the north breach.

Figure 11-6. IHNC East Bank – South Breach – Wall Movement

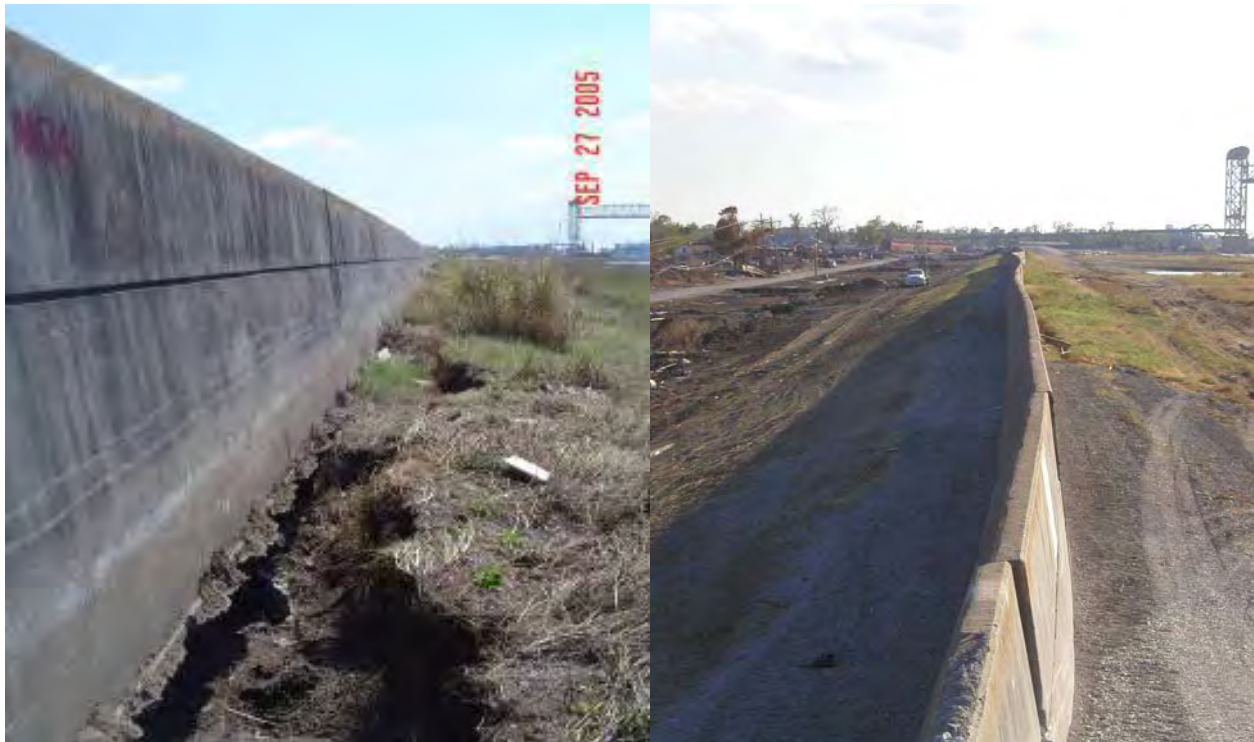
Figure 11-7. IHNC East Bank – North Breach – Wall Movement (View looking south)

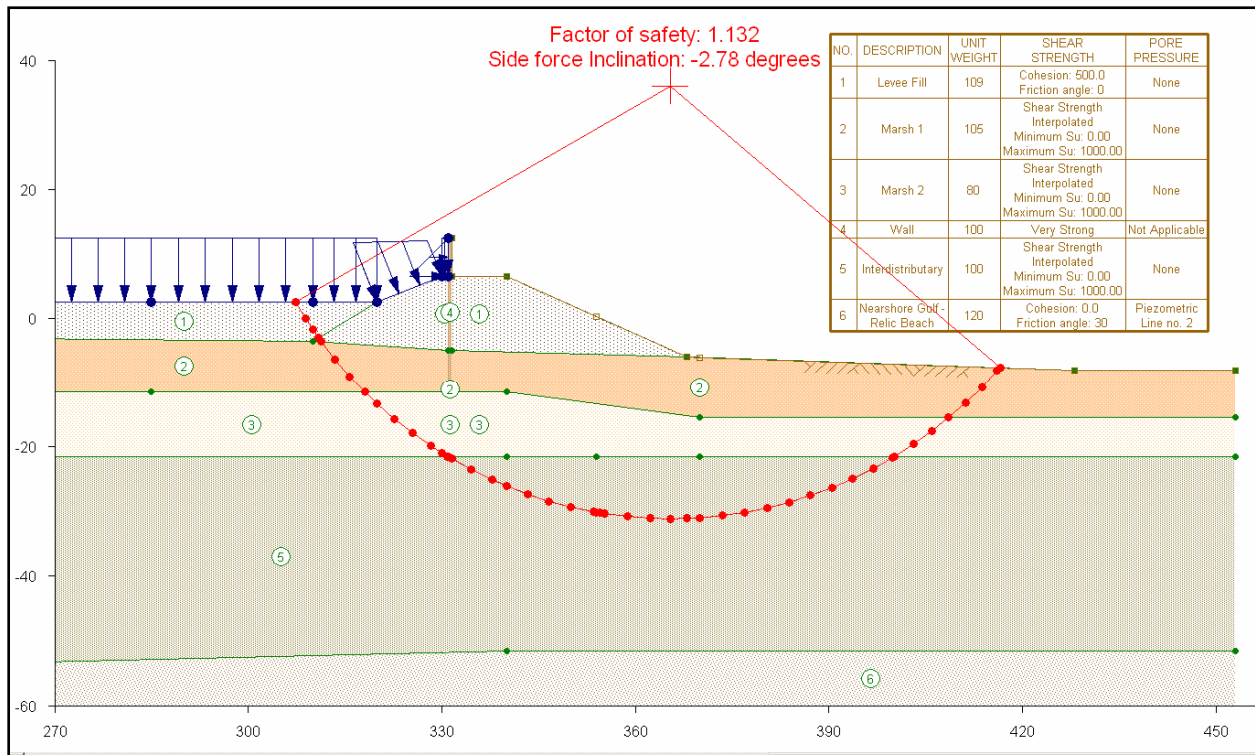
For the north breach (Station 55+00), with the canal water level at elevation 12.5 ft (top of the wall), the calculated factor of safety for the cracked condition is 0.96, as compared to 1.13 for the uncracked condition (Cases 5 and 5a). A canal water elevation of 11.2 ft produces a factor of safety of unity for the cracked condition (Case 4). Figures 11-20 through 11-25 show the critical circles from UTEXAS4 analyses for the north breach for Cases 1 through 5 and Case 5a.

Figure 11-24. IHNC – East Bank (North Breach), Case 5, Canal Water Level = Top of Wall = 12.5 ft (NAVD 88), with Crack

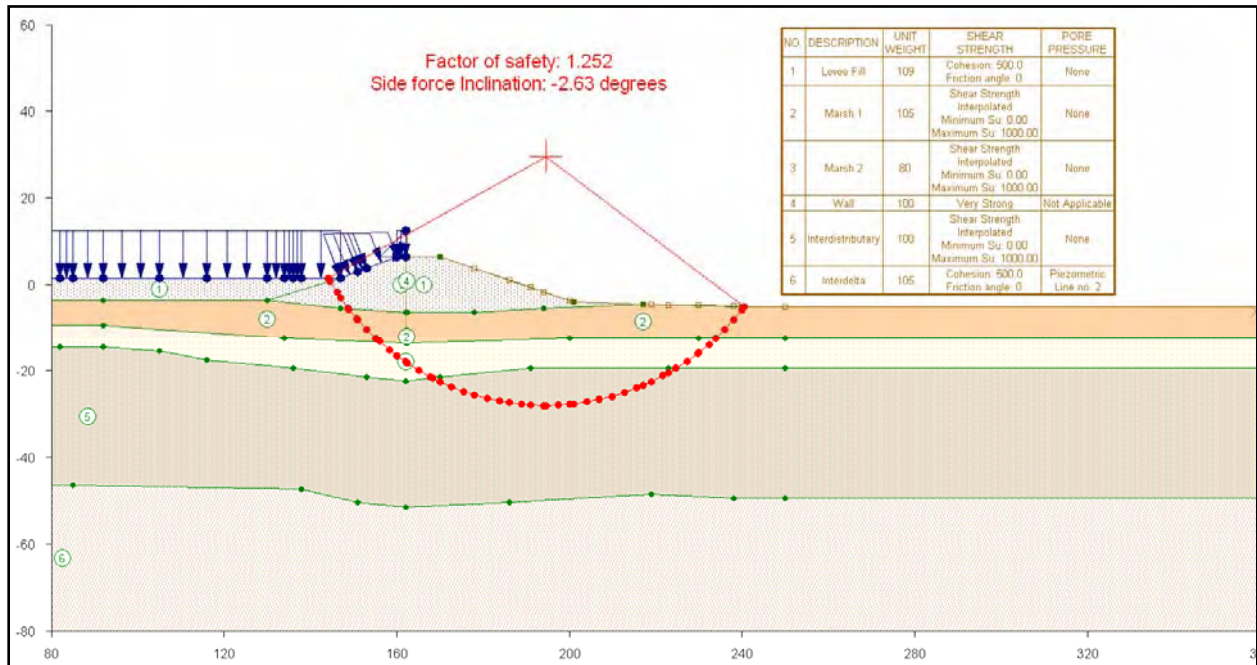
For the south breach (Station 26+00), the factor of safety was greater than unity for all canal water elevations analyzed using the IPET strength model. For the most extreme case of the canal water level at elevation 12.5 ft (top of the wall), the calculated factor of safety for the cracked condition is 1.10. The critical circles for the stability analyses performed on the south breach for Cases 1 through 5 are shown in Figures 11-26 through 11-30.

Figure 11-29. IHNC – East Bank (South Breach), Case 4, Canal Water Level = Top of Wall - 12.5 ft (NAVD 88), with Crack

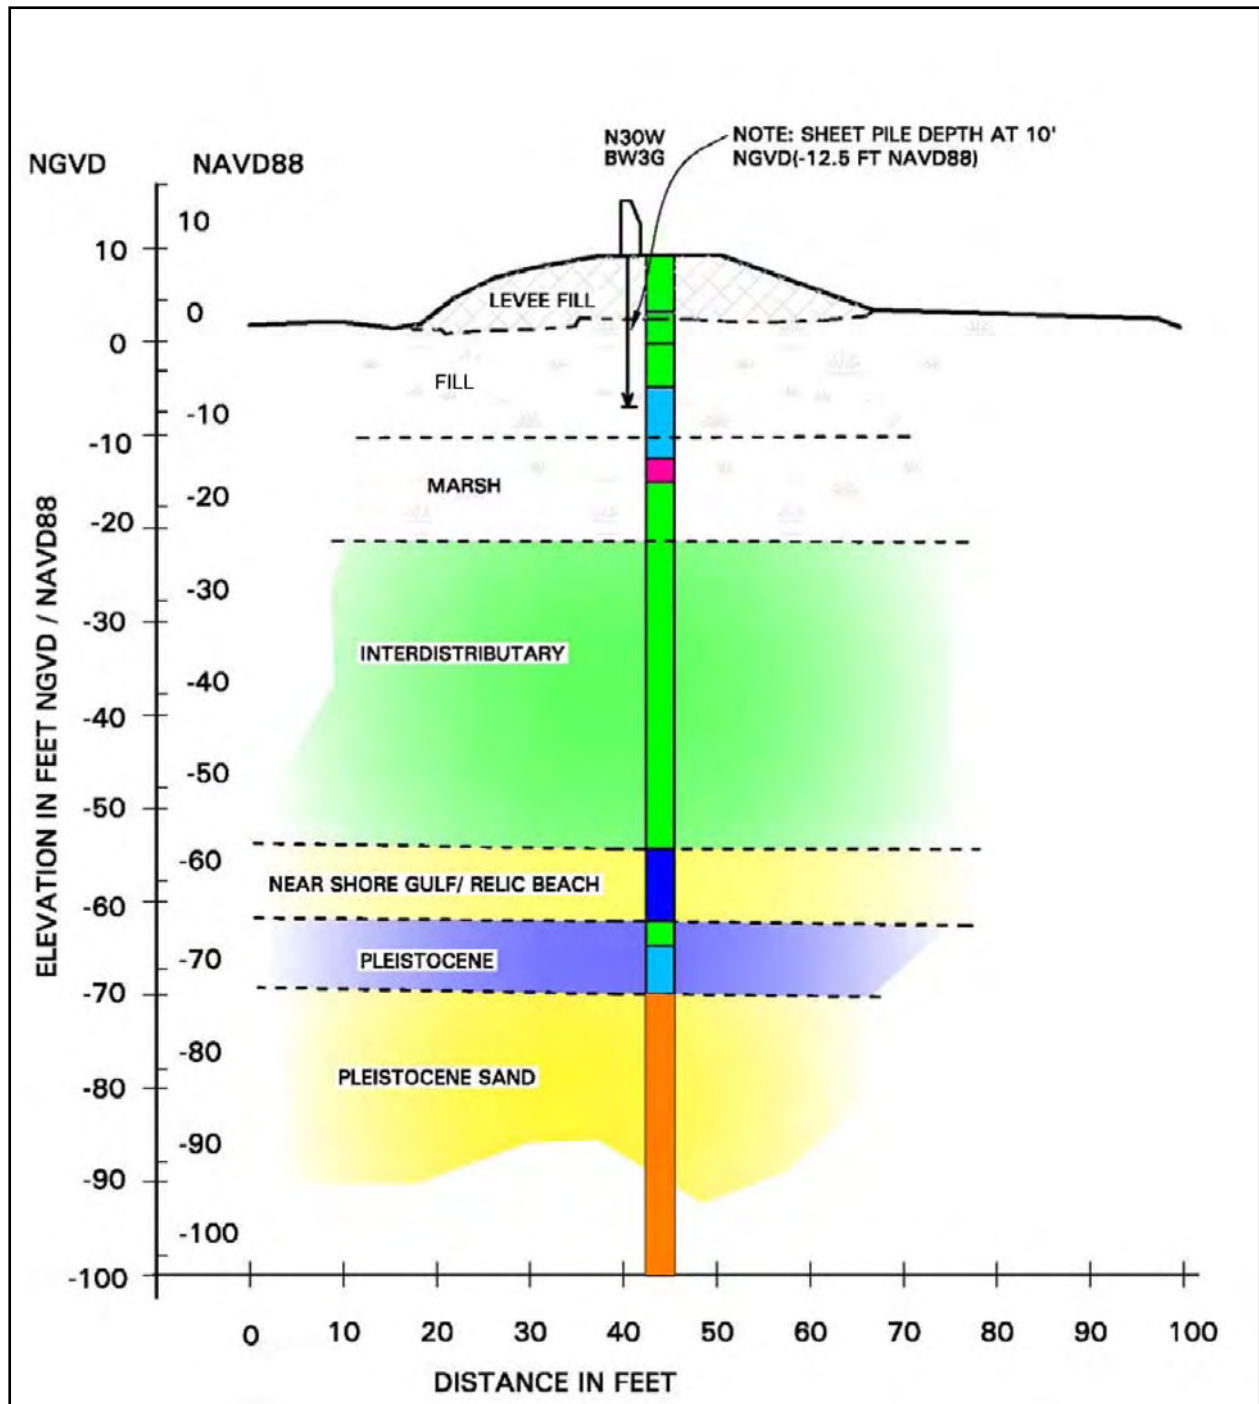
The northern breach, between Stations 195+00 and 196+40¹³, occurred after the I-wall at that location was overtopped, and soil supporting the wall was removed by erosion. The water elevation of the top of the wall was 12.5 ft, 1.7 ft lower than the peak elevation reached in the IHNC. A cross section through the levee and the I-wall is shown in Figure 11-35.

The levees at both locations were founded on about 8 ft to 10 ft of fill. The fill at the north breach was clay. At the south breach the fill consisted partly of silty sand and partly of clay, as shown in Figure 11-36. At both locations the fill was underlain by a layer of marsh material, about 11 to 12 ft thick, and a layer of normally-consolidated interdistributary clay 30 to 35 ft thick.

Figure 11-35. IHNC – West Bank – Cross Section of North Breach

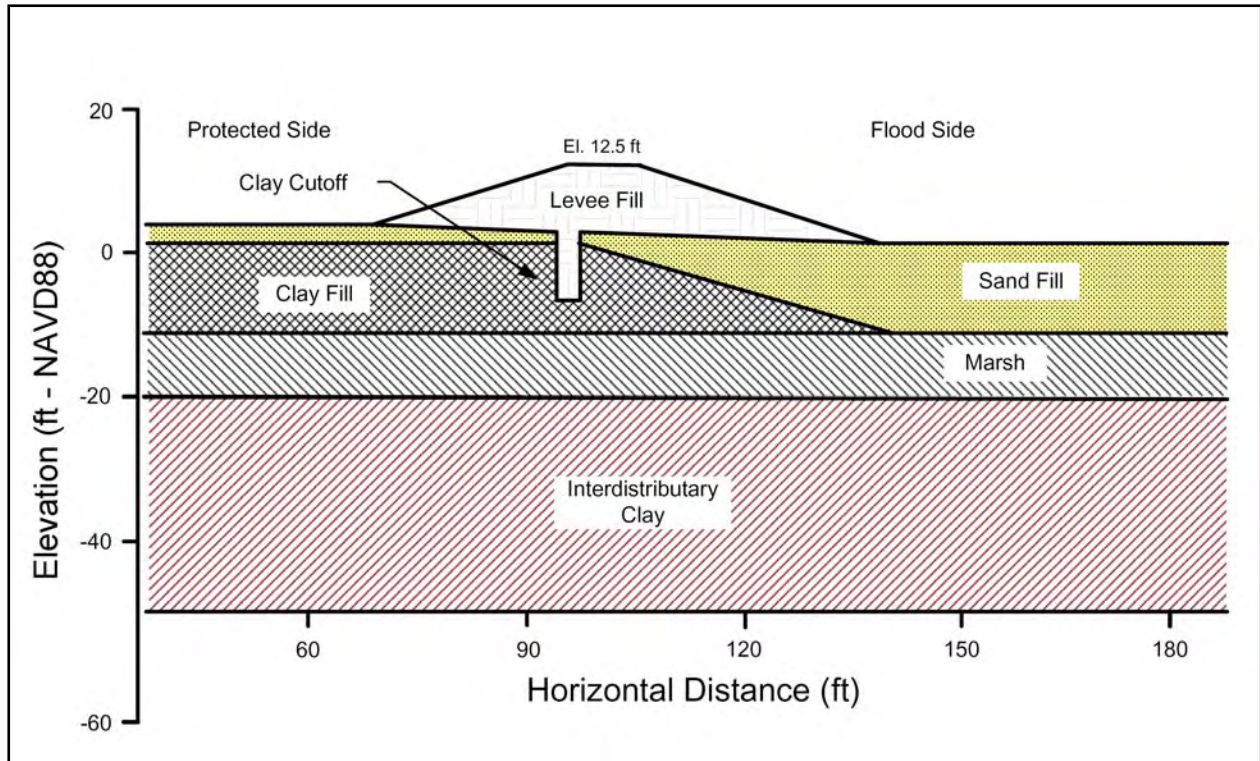
The southern breach, between stations 0+80 and 2+80¹⁴, occurred when the levee at that location was overtopped and eroded. There was no I-wall in this levee reach. The elevation of the top of the levee was 12.5 ft. A cross section through the levee is shown in Figure 11-36.

Figure 11-36. IHNC – West Bank – Cross Section of South Breach

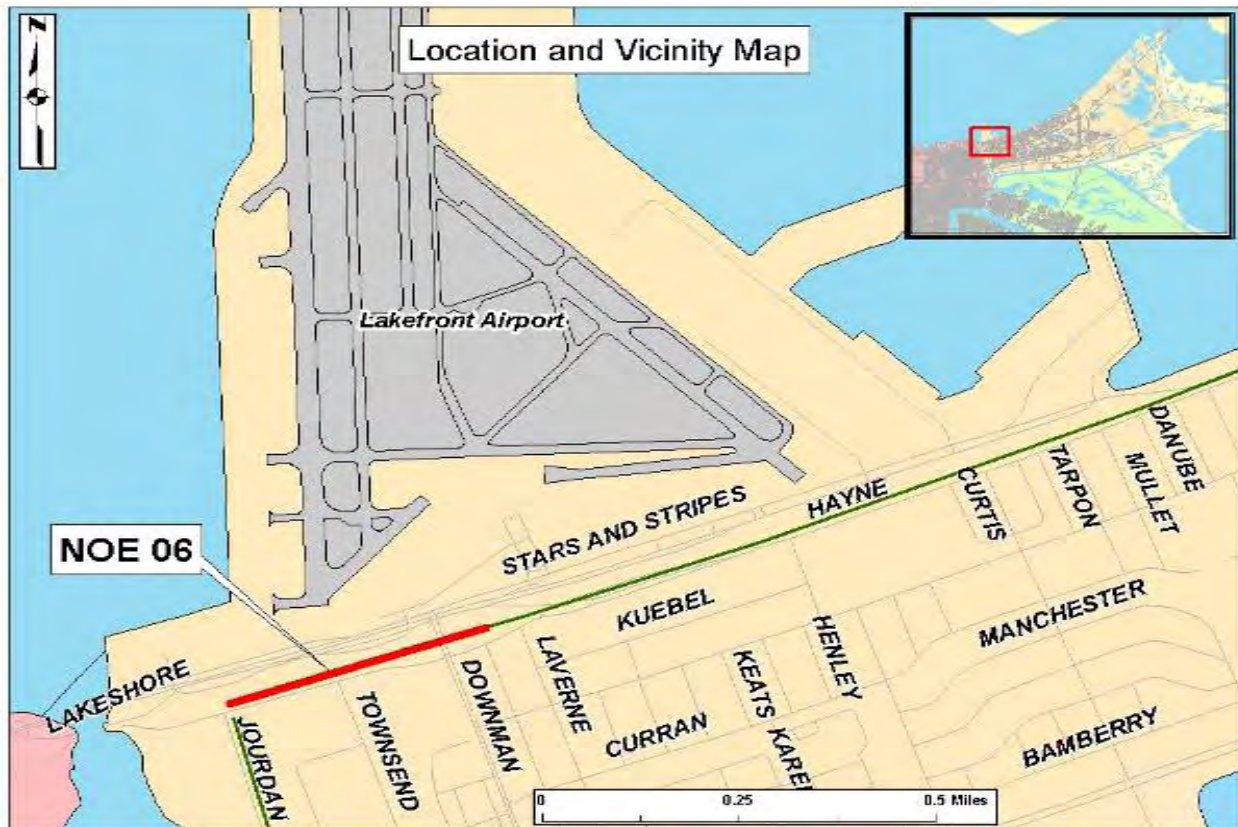
Figure 12-5. NOE6_A

Project NOE06 consists of filling in and paving over the scour holes next to the concrete wall. It also includes filling in the scour hole and paving the damaged road section with concrete at the interface of the Floodgate L-15 concrete wall and levee. The damage in this reach was primarily scouring along the landside of the floodwall and levee sections at several distinct locations. The severity of the scouring varies from minor to severe. Scouring occurred to some degree at each of the tie-in to the closure structures located within this reach. The total quantity of materials removed by scouring along the entire Lakefront reach is estimated to be less than 5000 cys. January 31, 2006 was scheduled completion date.

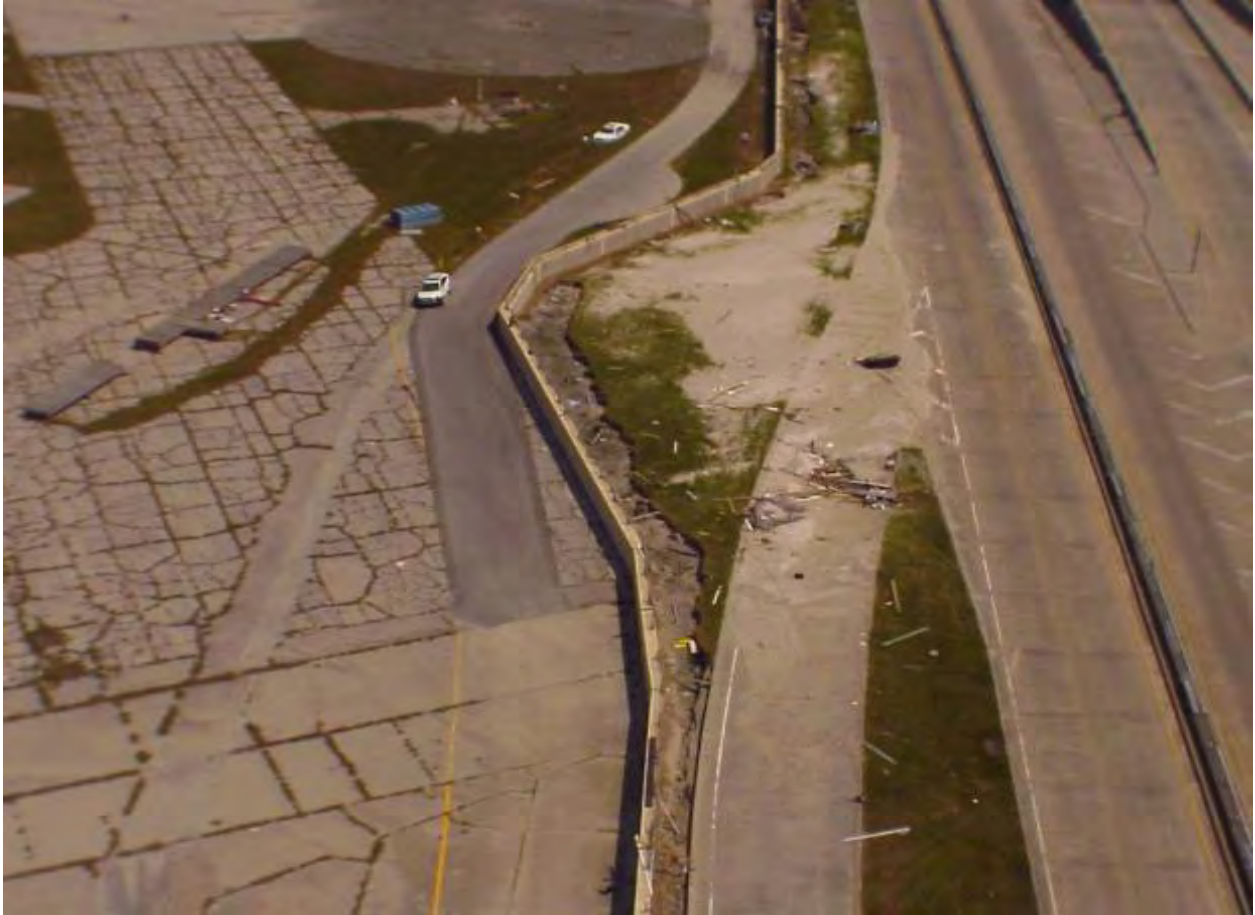
Figure 12-6. NOE6_B. Scoured Section on Protected Side at Lakefront Airport Floodwall

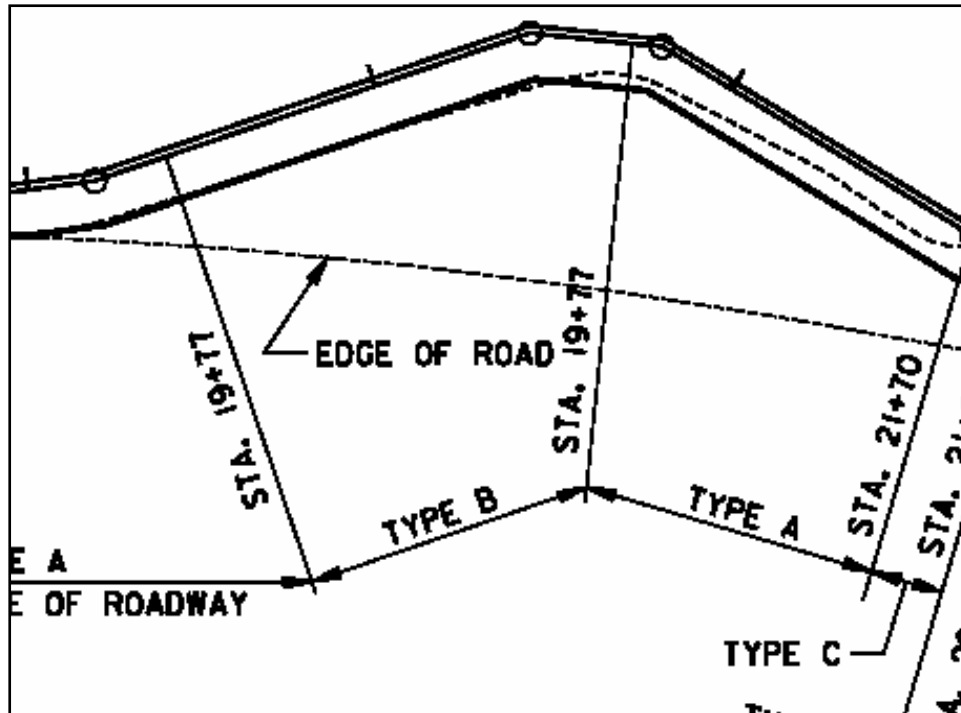
Figure 12-7. NOE6_C Rotated Plan View of Above Picture Defining Scour Extent and Type (from NOE6 Contract Solicitation drawing 4 of 9)

SCOUR DETAIL SCHEDULE				
Scour Detail	Station	Scour Width (feet)	Scour Depth (feet)	Distance (feet)
A	18+16	0	0	54
	18+70	7	3	47
	19+17	11	2.5	60
	19+77	12	3	62
B	20+39	14	3	17
	20+56	12.5	3	18
	20+74	10	3	96
A	21+70	3	3	
C	21+70 to 21+89 No Scour			19

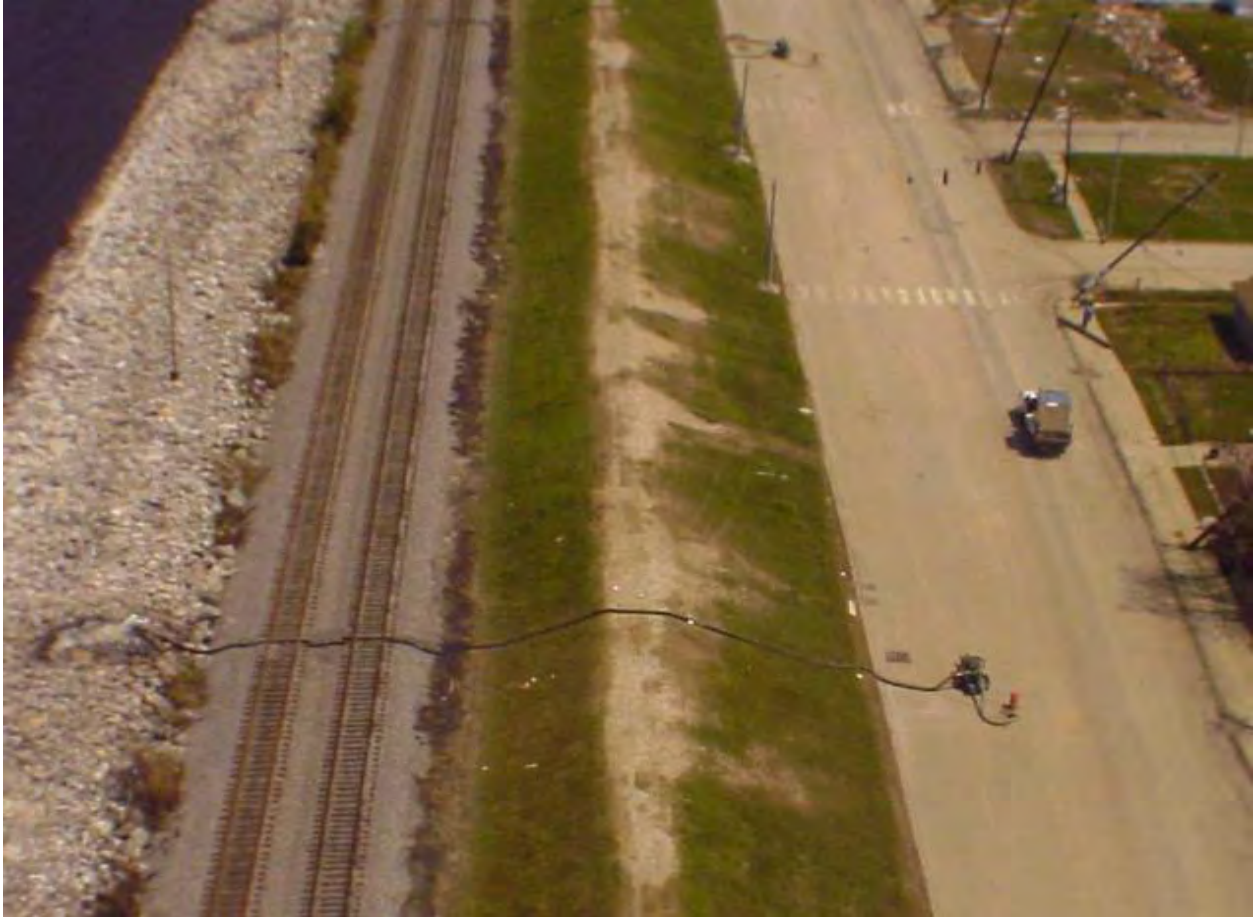
Figure 12-10. NOE7_B Typical Crown and Landside Scouring
