Appendix 1

Soil Data Report for 17th Street Canal

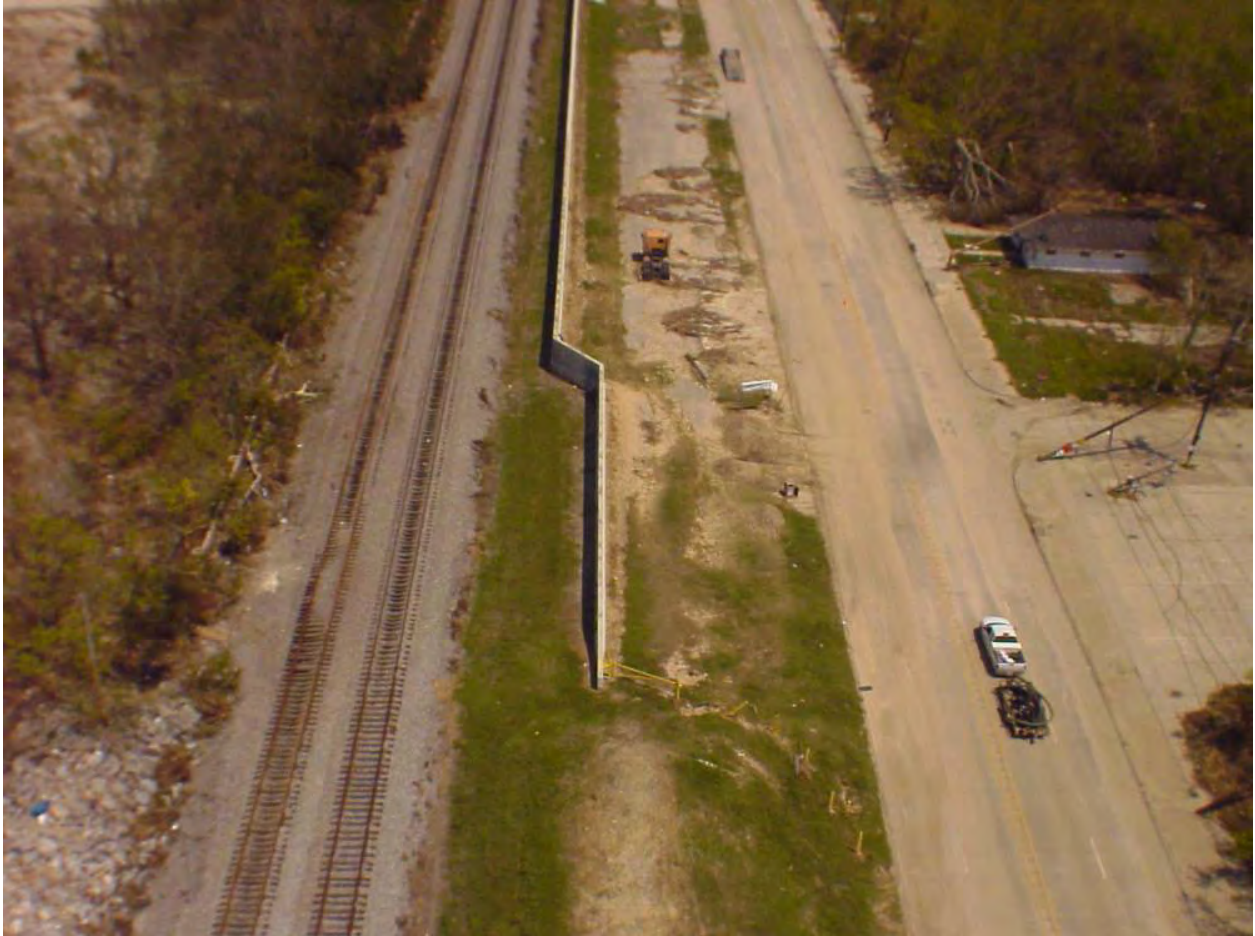
Figure 12-11. NOE7_C Floodwall Landside Scouring on Hayne Blvd. East of Downman Rd.

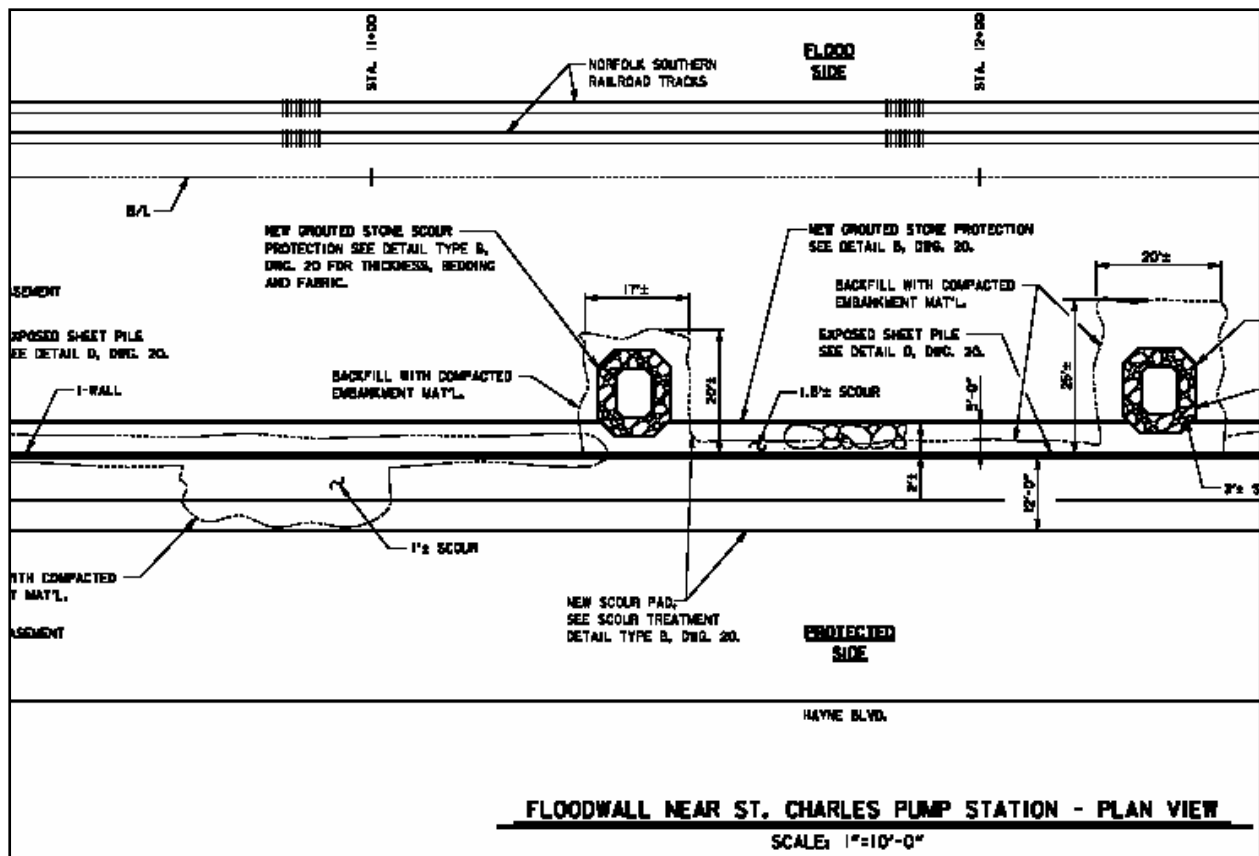
Figure 12-13. NOE7_E Scoured Areas Near St. Charles Pump Station (B/L Sta 74+00)

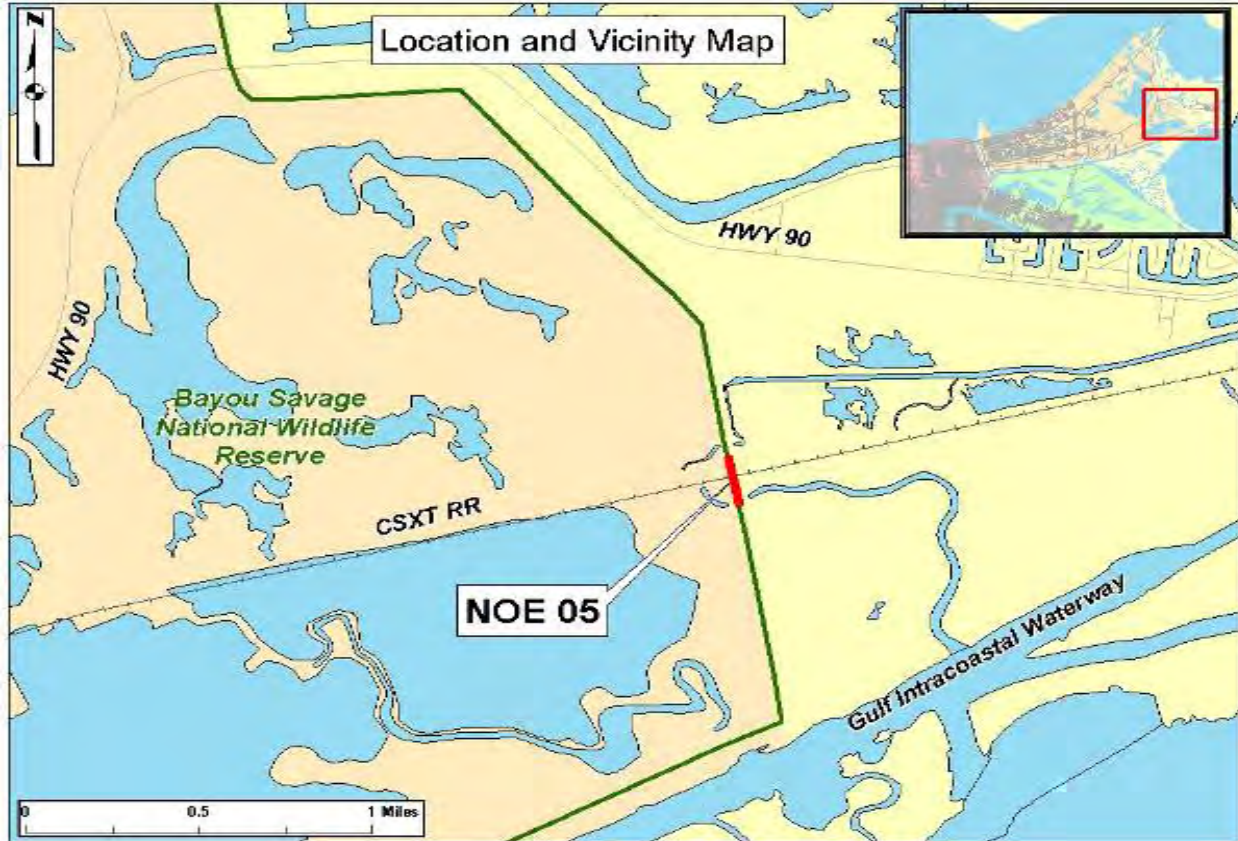
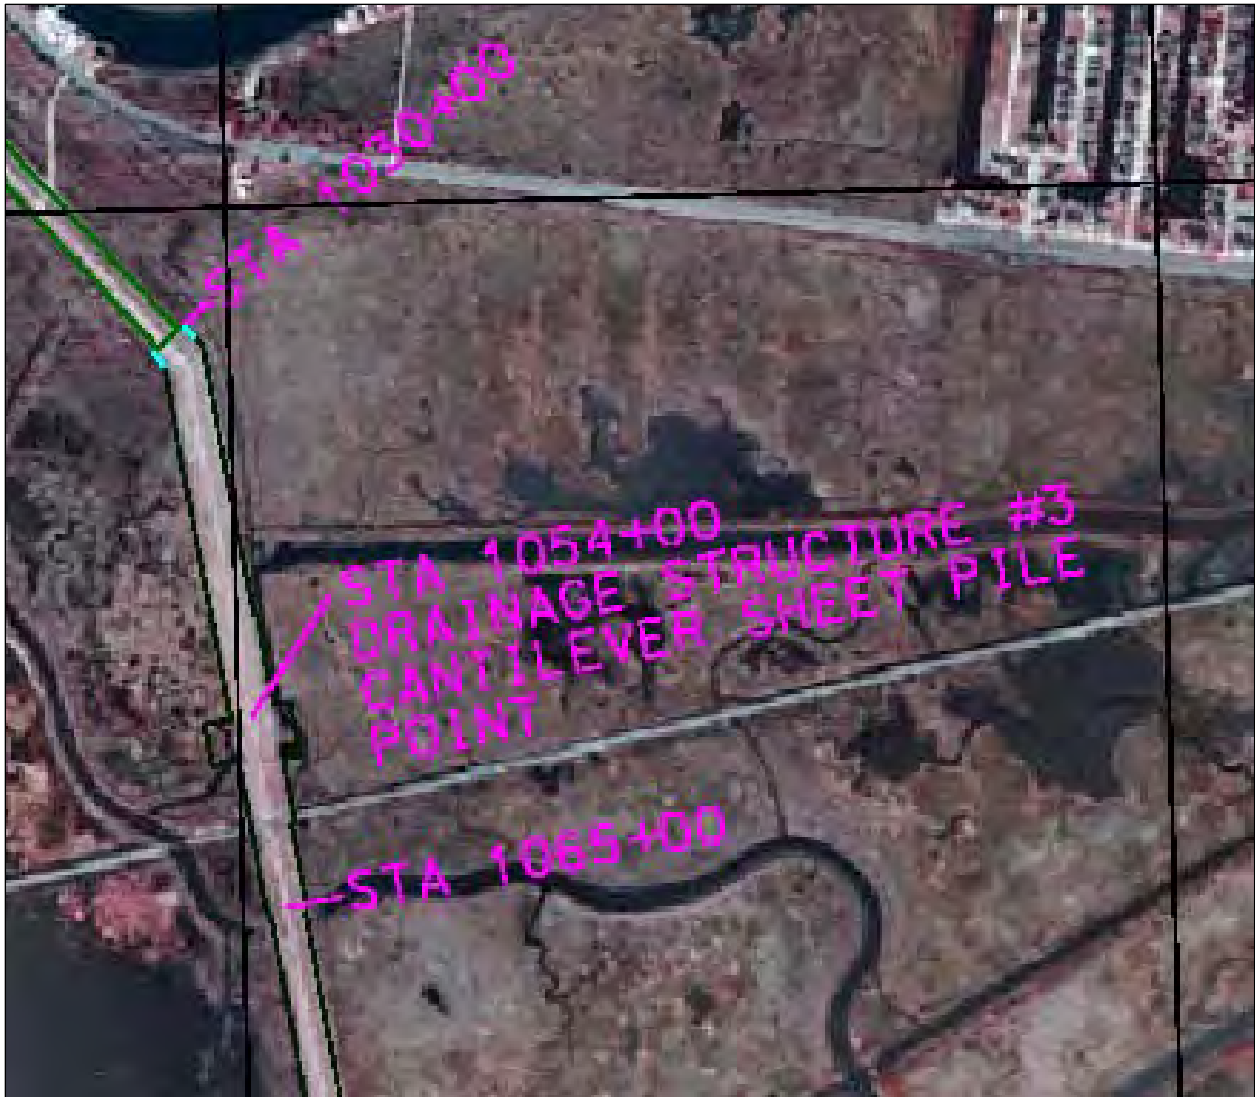
Figure 12-17. NOE5_A. Location 30 deg 03 min 24.03 sec N, 89 deg 49 min 56.76 sec W

Project NOE05 includes the removal of the existing concrete wall and railroad closure gate, filling the scoured areas, constructing a new closure gate and new concrete T-walls and I-walls, placement of rip rap, concrete slope paving and concrete roadway. The CSX railroad floodgate and adjacent section of the levee were damaged during the storm event. There was scour of the structural fill material resulting from overtopping of the closure gate and levee. April 1, 2006 is scheduled completion for repairs.

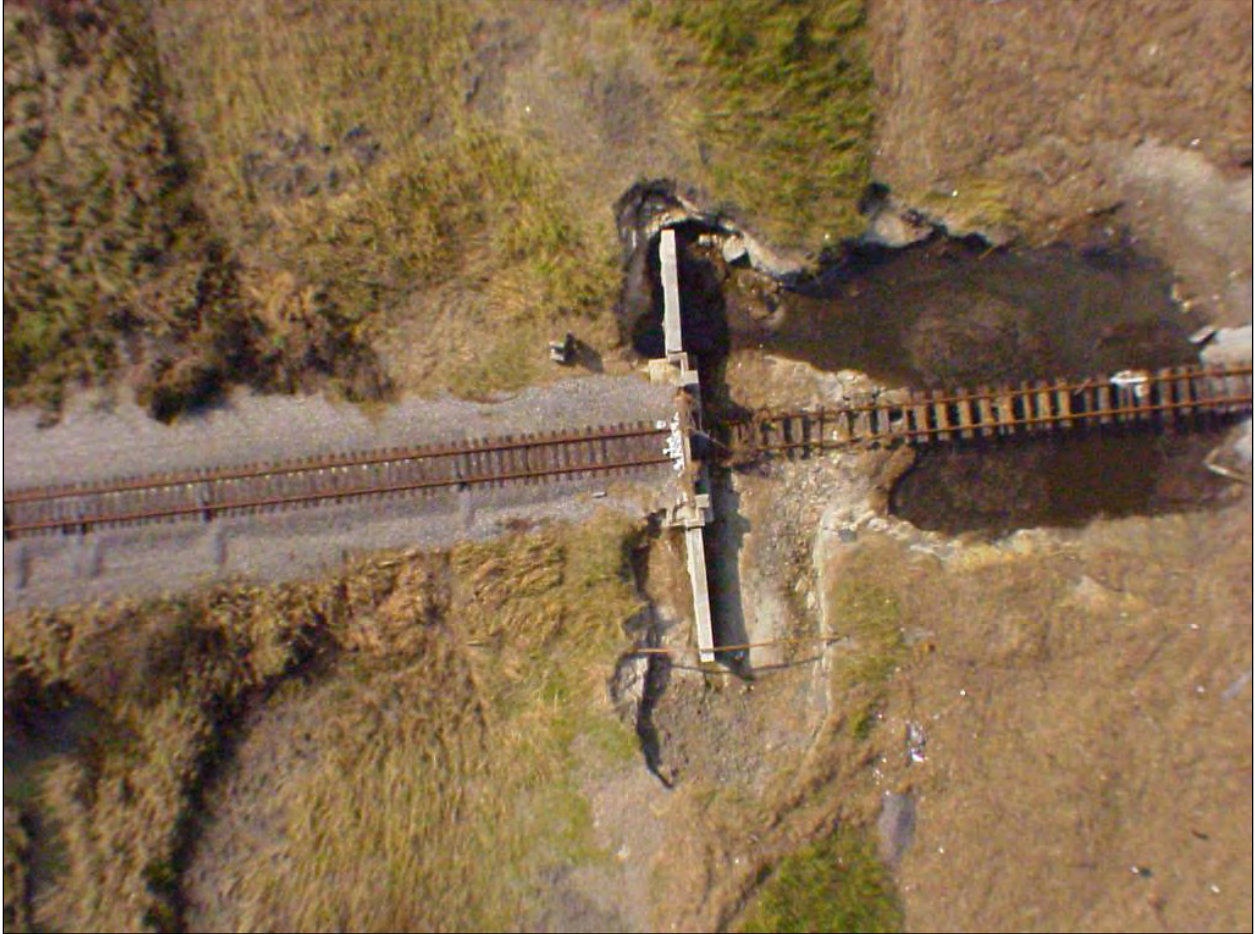
Figure 12-19. NOE5_C. View of Scour Around T-Wall

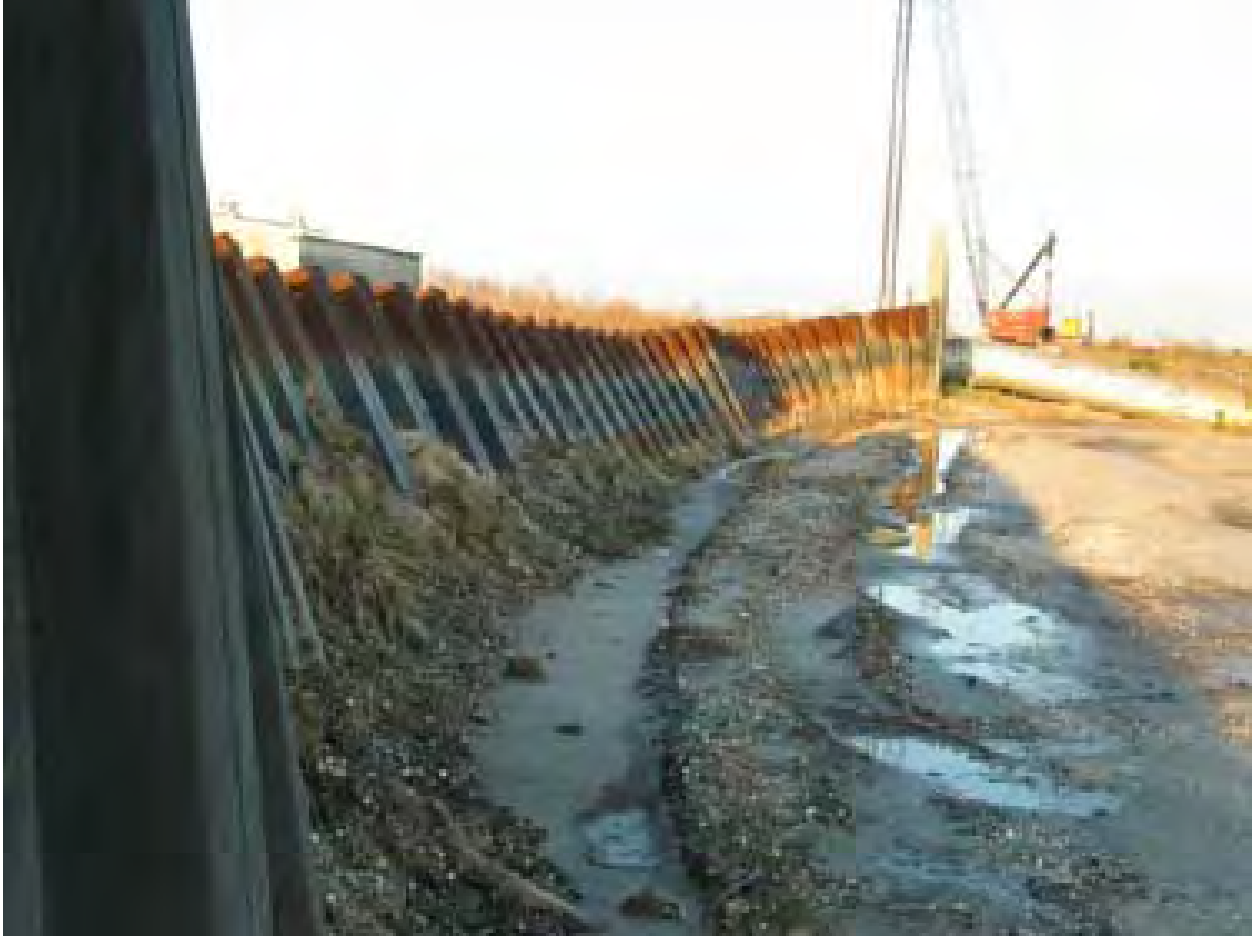
Figure 12-23. NOE2_C Closeup of Sheet Pile Damaged by Scour/Rotation/Sliding Failure

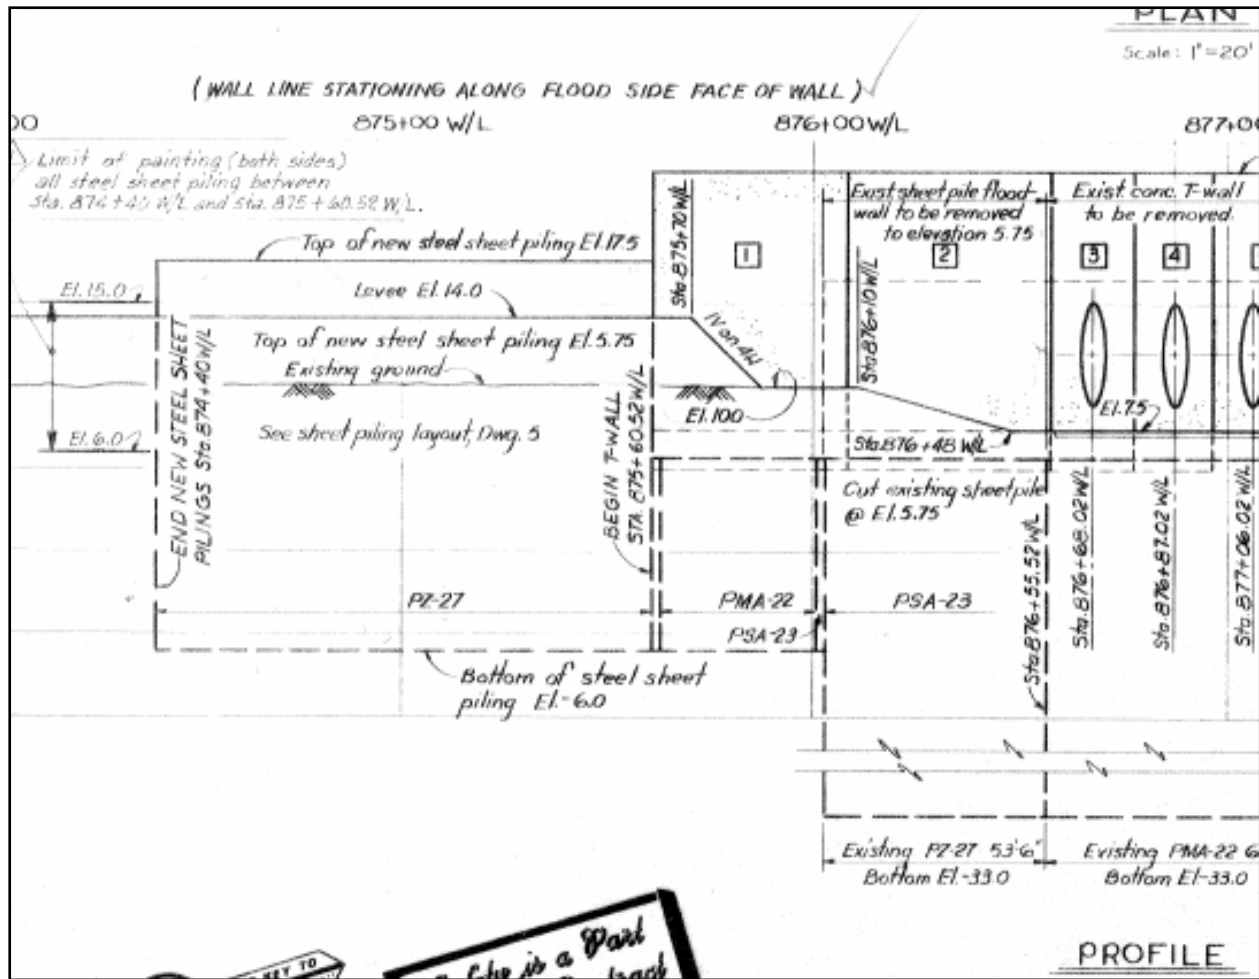
Figure 12-27. NOE2_G Profile View Showing 27' Difference Between Bottom Elevations of Existing (pre-1977) and Newer (1977 construction) Sheet Pile. Sections are from Plate 2 of 16, Mod P00001, Contract DACW29-77-C-0037

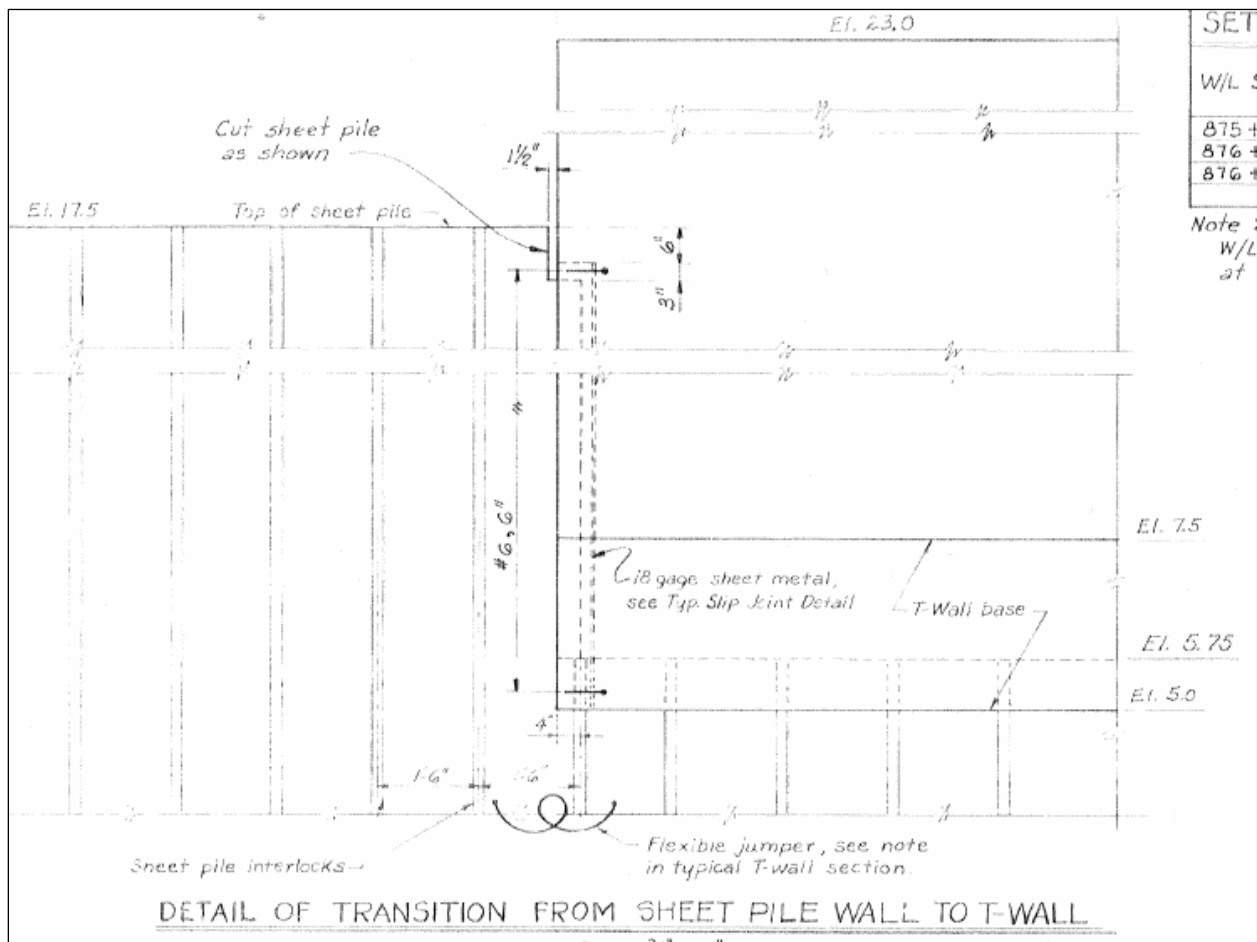
Figure 12-29. NOE2_I Top Elevation Difference of 5.5' Between Sheet Pile and T-Wall (plate 14 of 16 from above contract)

Figure 13-38. Pump Station 15 Top Elevation Difference of 5.5' Between Sheet Pile and T-Wall (plate 14 of 16 from Contract DACW29-77-C-0037, Mod P00001). If pre-Katrina sheetpile elevation was 17.5 ft and storm surge in the MRGO/GIWW was up to 18 ft, then there was minimal overtopping, and the sheetpile breach may have had contributing factors other than overtopping scour

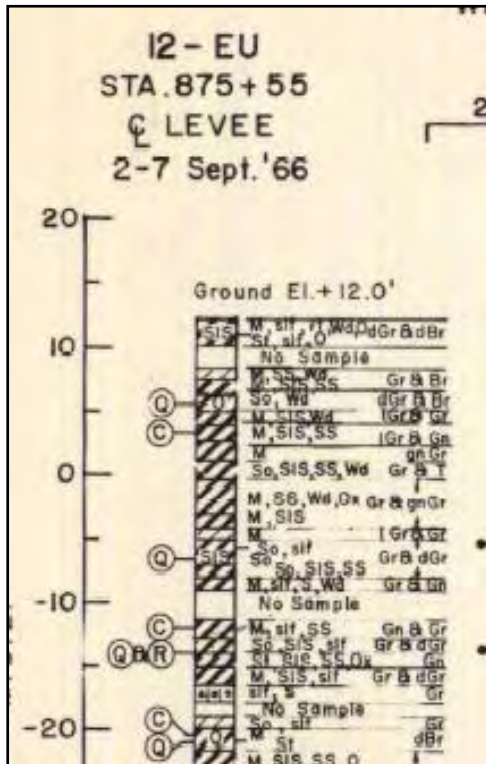
Figure 12-31. NOE2_K Nearest Boring Log (from plate 10 DM2 Sup 4) Showing Thin CL Layer in pre-1977 Levee

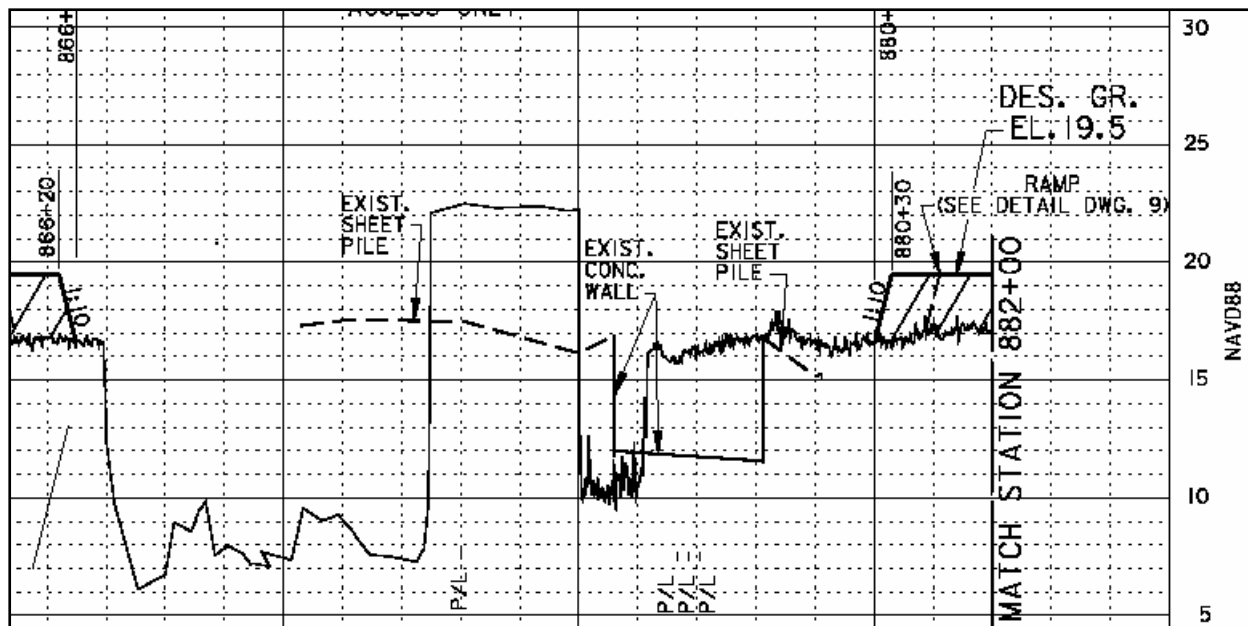
Figure 12-33. NOE2_M Plan and Post-Damage Scour Profile Immediately West of Pump Station 15 (from Contract Solicitation NOE1 drawing H-8-45594, sheet 3 of 16)

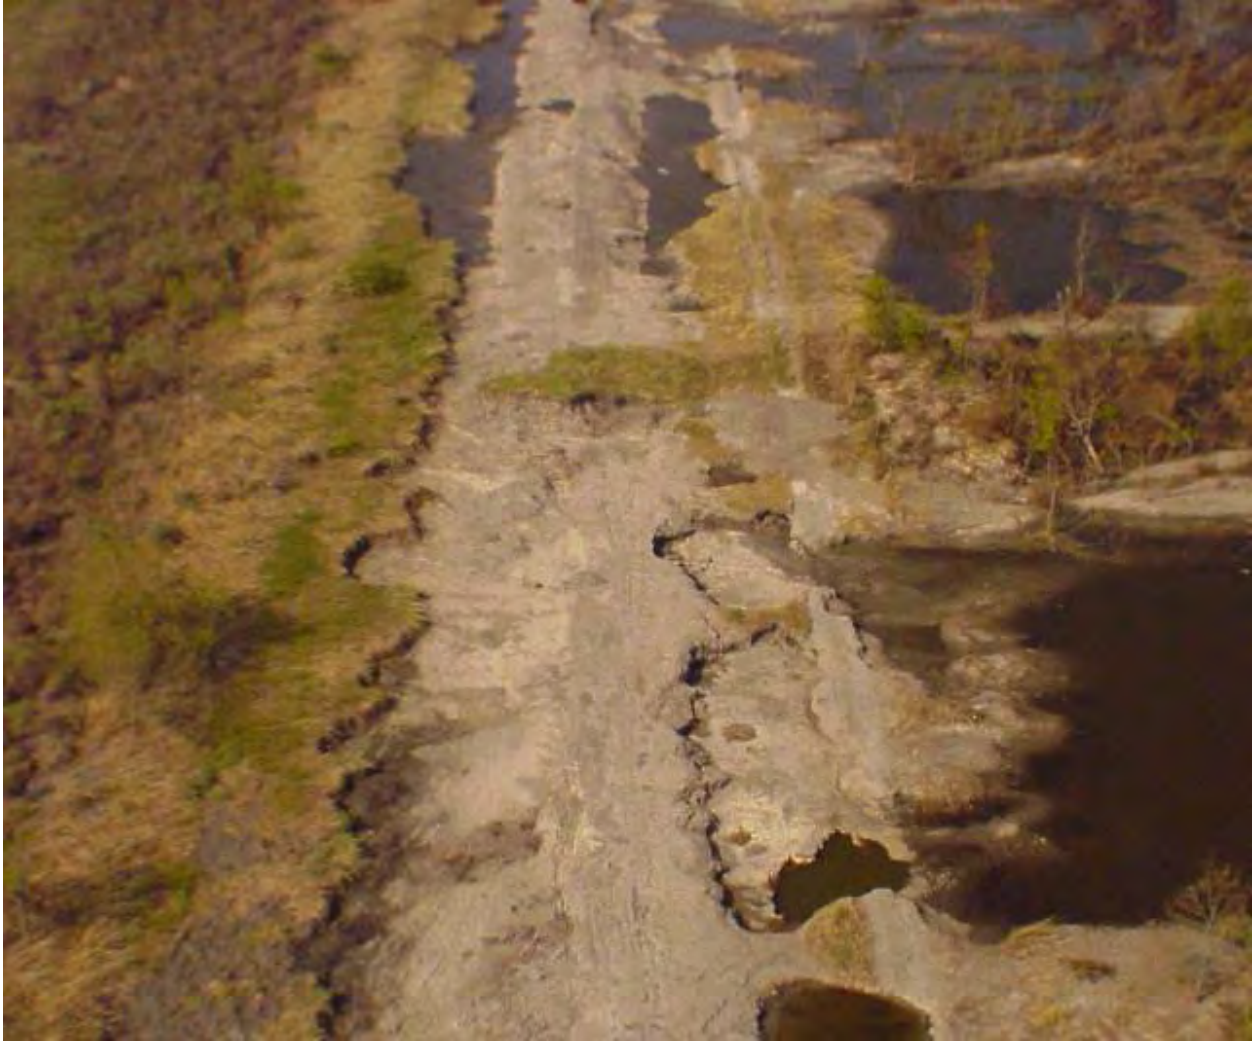
Figure 12-36. NOE1_C Complete Breach East of Pump Station 15

The remaining level of protection was EL 4.0. The entire reach of levee was brought up to an interim level of protection of elevation +10 by November 15, 2005. April 1, 2006 is scheduled completion date.

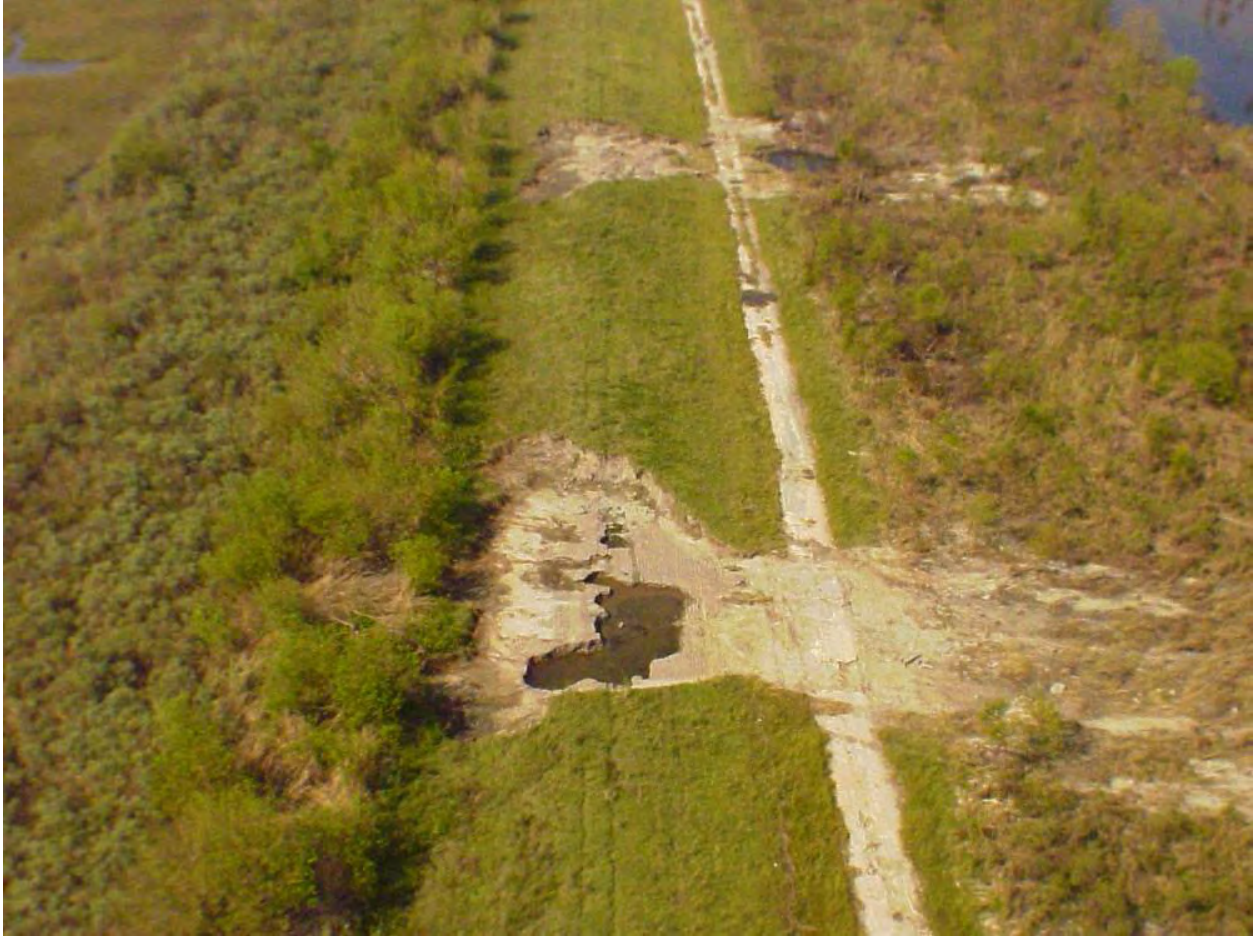
Figure 12-38. NOE1_E Partial Breach East of Pump Station 15

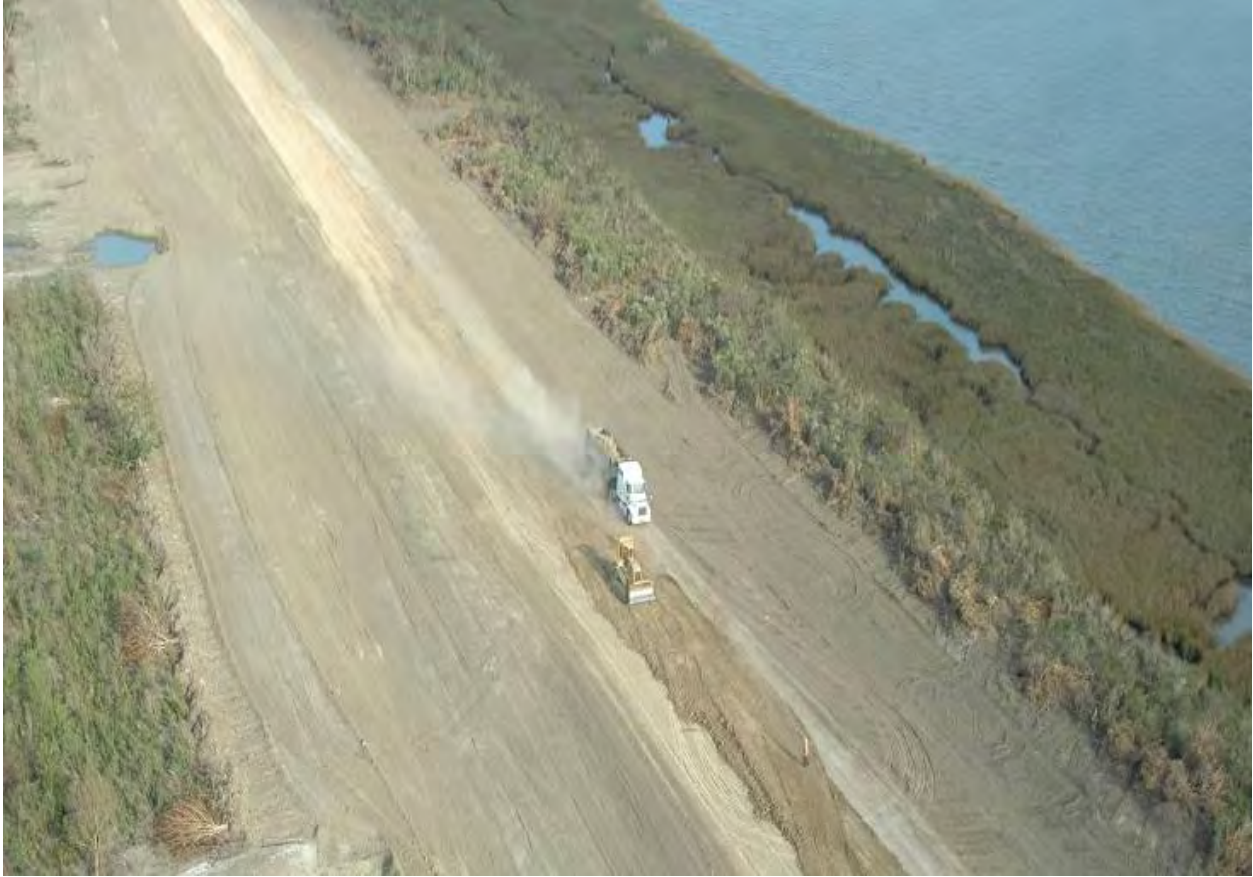
Figure 12-39. NOE1_F Rebuilding to Initial Elevation 10'

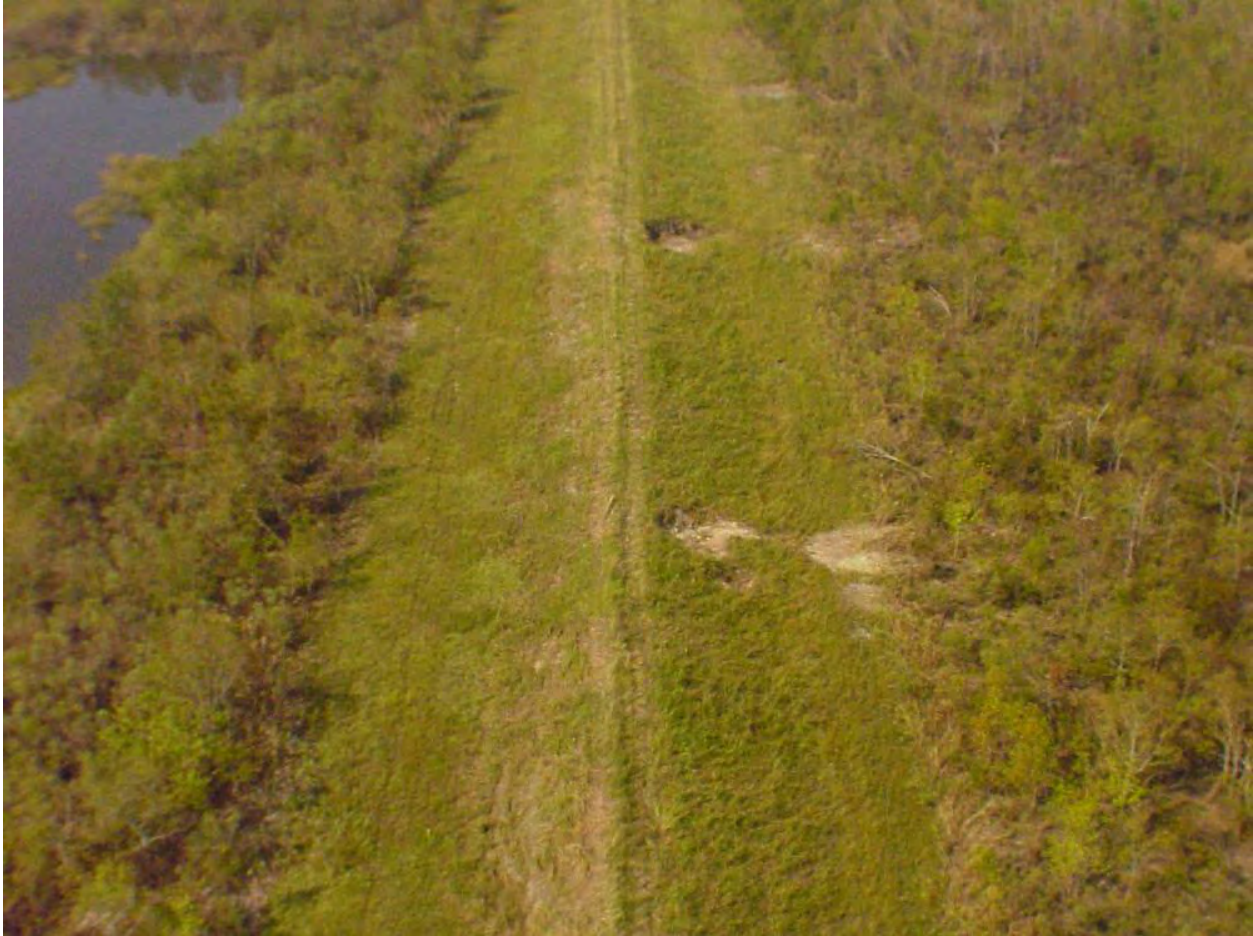
Figure 12-40. NOE1_G Localized Scour Typical of Several Locations

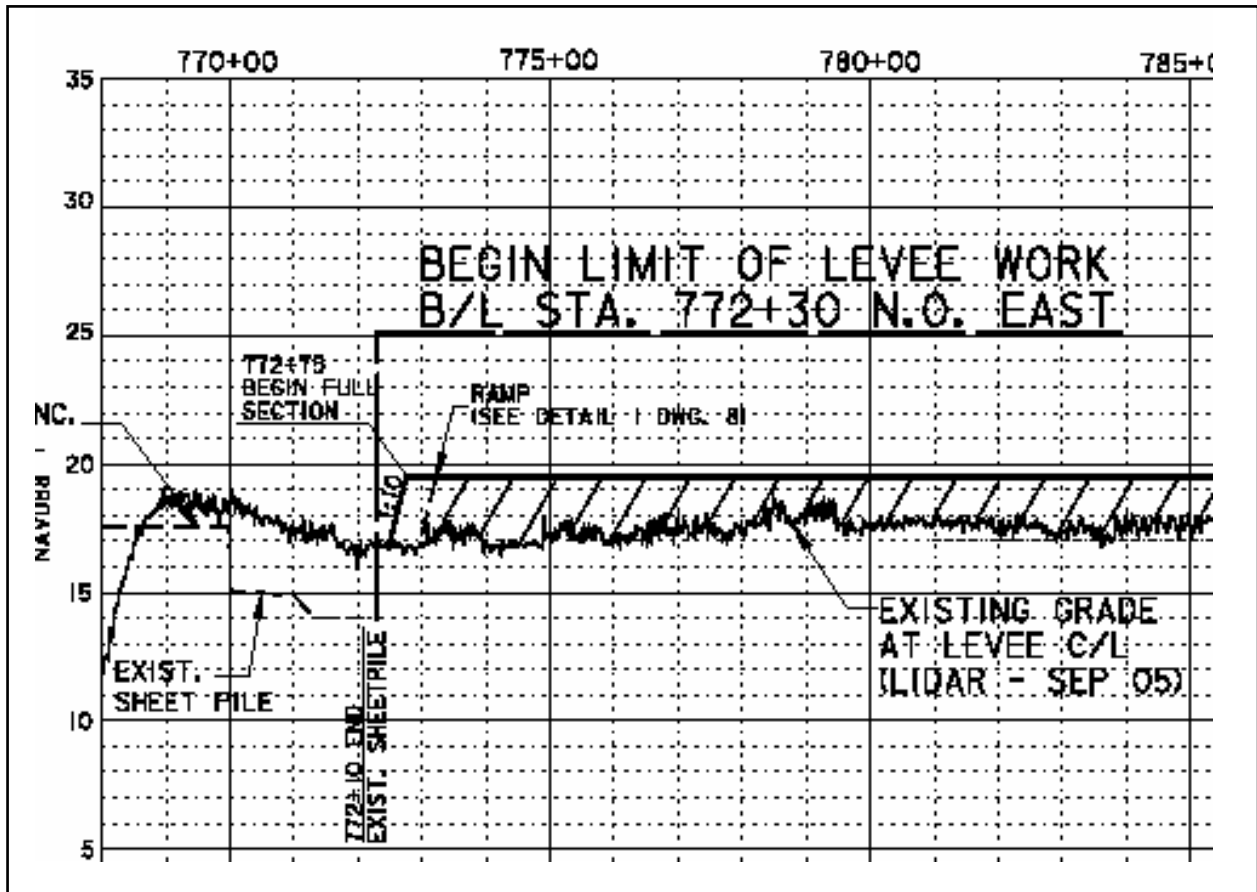
Figure 12-46. NOE3_F. Post-Damaged Lidar Elevations Show Scour Hole (approx Sta 768+00) Depth was About 8' deep (from Contract Solicitation NOE1 drawing H-8-45594, sheet 2 of 16)

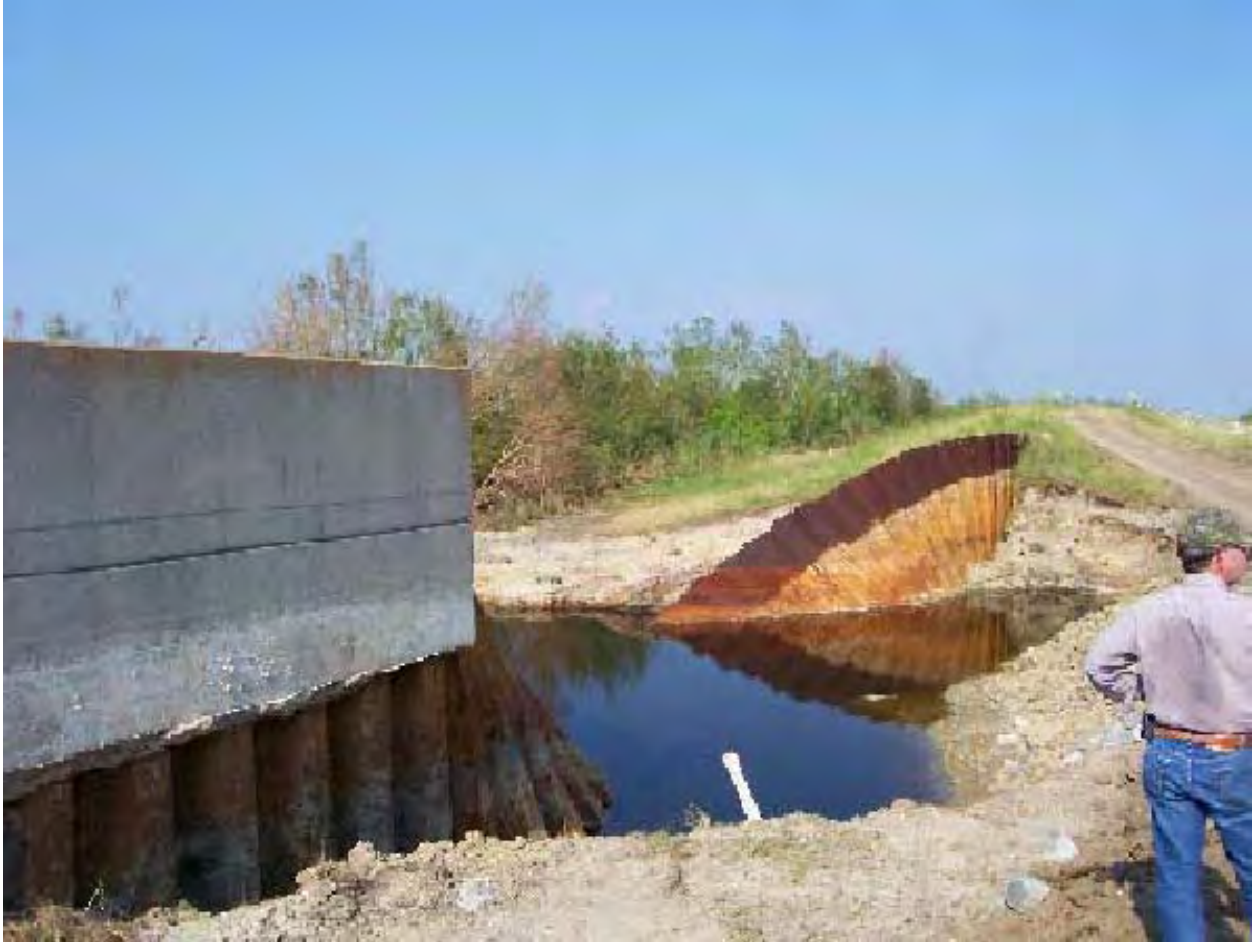
Figure 12-47. NOE3_G. West of Failure Looking East. Drawings from NOE3 Contract Solicitation Show Scour Depth And Outline

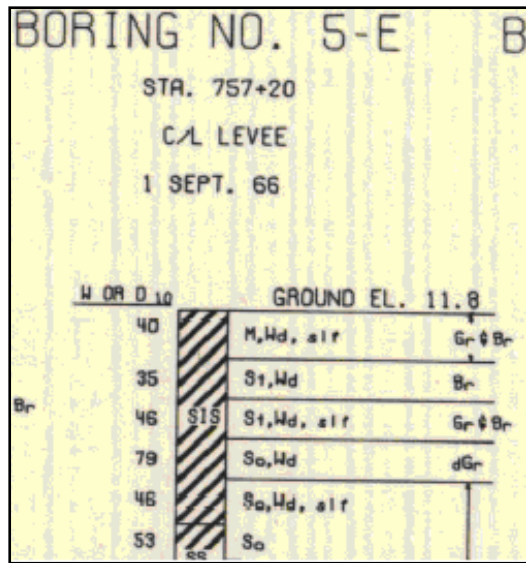
Figure 12-48. NOE3_H. Boring 5-E from plate 5, DM2 Supp 4 (March 1971) Shows CH Material in Pre-Existing 1965 Levee

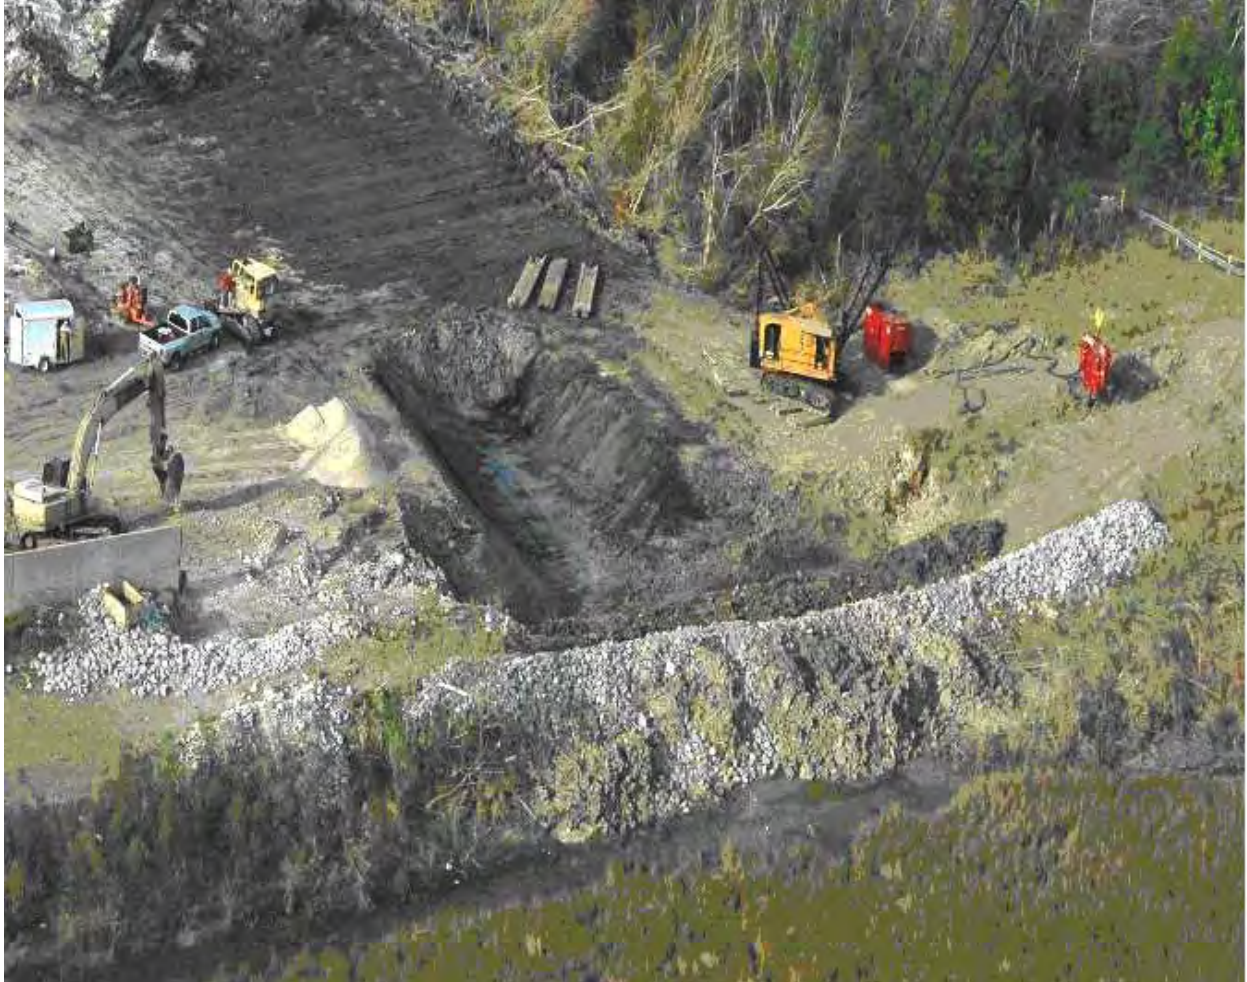
Figure 12-49. NOE3_I. Repair Progress

Project NOE03 includes removing the damaged concrete I-wall and steel sheet pile wall, filling in scour holes, installing a new concrete I-Wall, and raising the damaged levee to pre-hurricane Katrina elevation and then seeding and fertilizing. The damaged reach was first brought up to an interim level of protection of elevation +10 by November 15, 2005 before final repairs are made. Breach length was 300' at transition between sheet pile and concrete I-wall. April 1, 2006 is scheduled completion date.

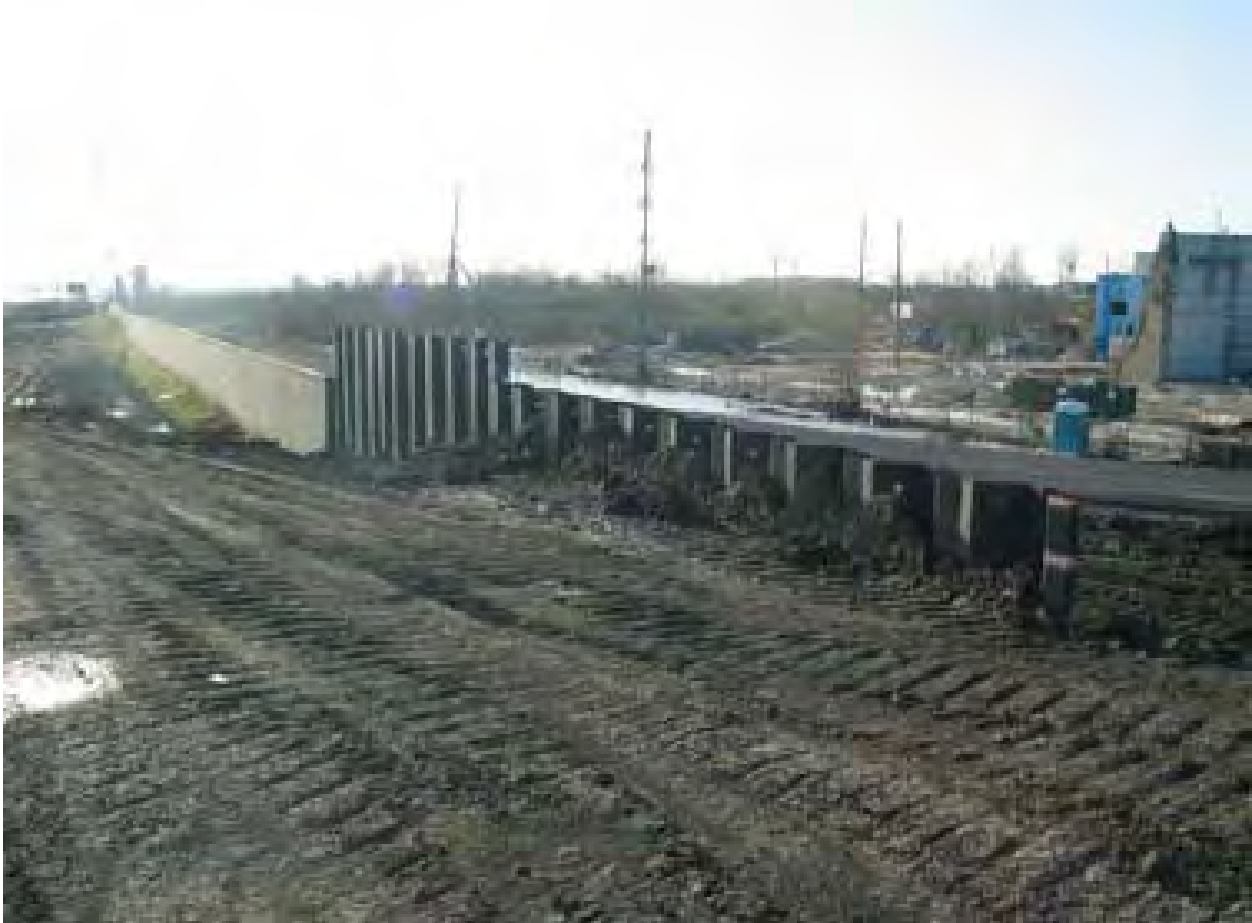
Figure 12-50. NOE3_J. Repair Sheetpile View to the West

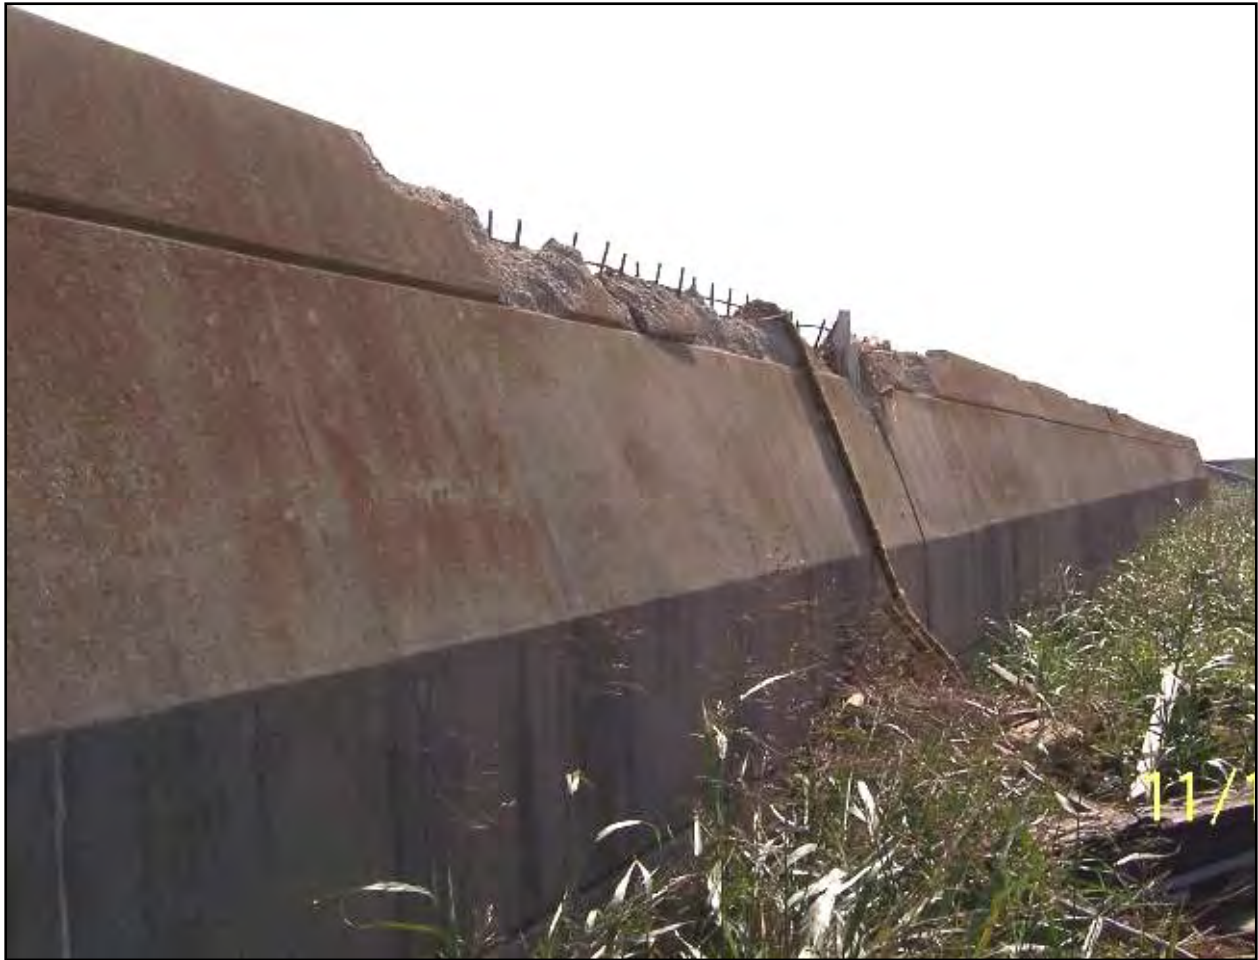
Figure 12-53. NOE9_C. I-Wall Damage Likely Due to Impact

Project NOE09 includes filling in the scour holes next to the wall with embankment material, installing bedding material, and concrete slope paving above the scour to prevent future erosion. Also includes adding an earthen stability berm on both flood and protected sides of the wall. The project also consists of intermittent repairs to damaged concrete and various joints and gates in the walls. April 1, 2006 is scheduled completion date.
