Appendix 1

Soil Data Report for 17th Street Canal

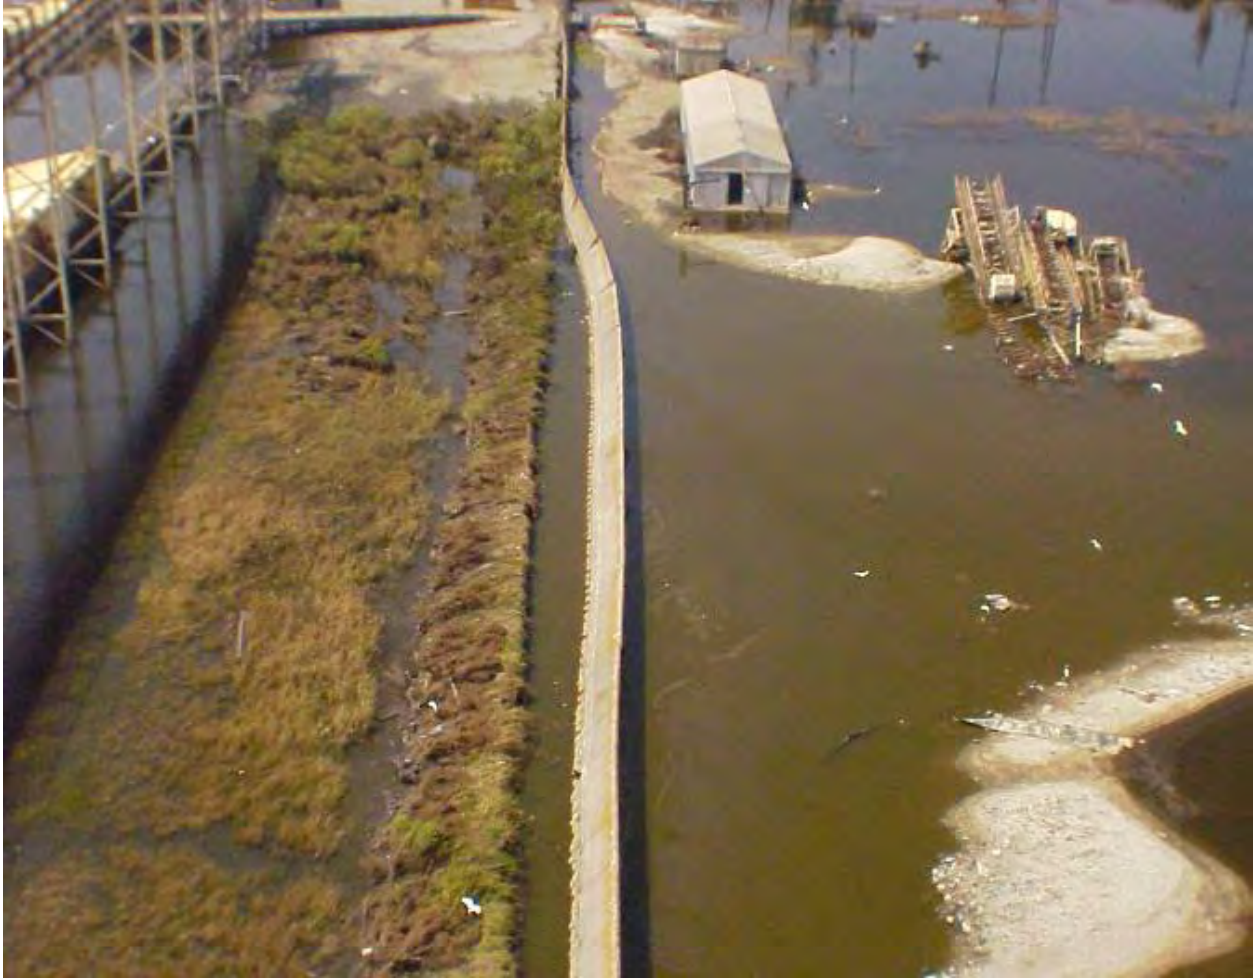
Project NOE04 includes removing the damaged concrete I-wall sections, filling in the scour holes, regrading the damaged levee, constructing new concrete wall, and putting in an earthen stability berm on the landside of the wall. The most severe damage in this reach is a 2000 ft. section of I-wall that failed by rotation, with attendant erosion and scouring. The extend of material below the water surface that has been removed by the scouring is unknown. Localized scouring occurred at several locations along this reach. The total quantity of material removed by scouring within this reach is estimated at 150,000 cys.

Figure 12-55. NOE4_B. Bulk Loading Terminal Facility I-Wall Failed by Rotation with Attendant Scour and Erosion (2000' near Elaine St. at GIWW), near Sta 271+55 B/L (Citrus Back Levee), Immediately Adjacent to the Tool Shed Metal Building

The repaired levee section and stability berm will be seeded and fertilized. The damaged reach was first brought up to an interim level of protection of elevation +10 by December 1, 2005 before final repairs are made. Geotechnical analysis has determined an earthen stability berm may be required which will require additional real estate. April 1, 2006 is scheduled completion date.

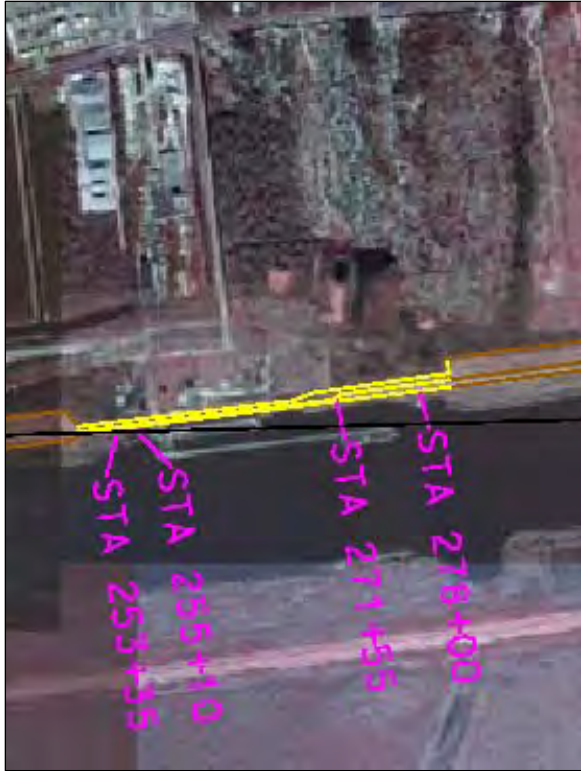
Figure 12-56. NOE4_C. Begin I-Wall Rotation at 30 deg 00 min 00.91 sec N, 89 deg 59 min 39.53 sec W.
Pre-Existing Wall Elevation was 15 ft and Levee Elevation was 14 ft

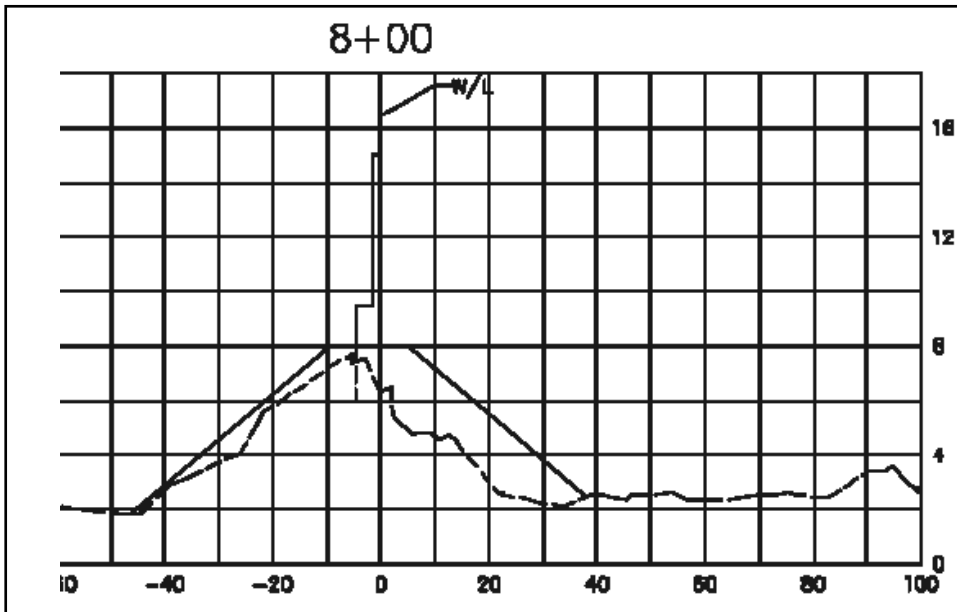
Figure 12-60. NOE4_G. Scour Pattern Along the I-Wall Immediately Adjacent to the Tool Shed Building

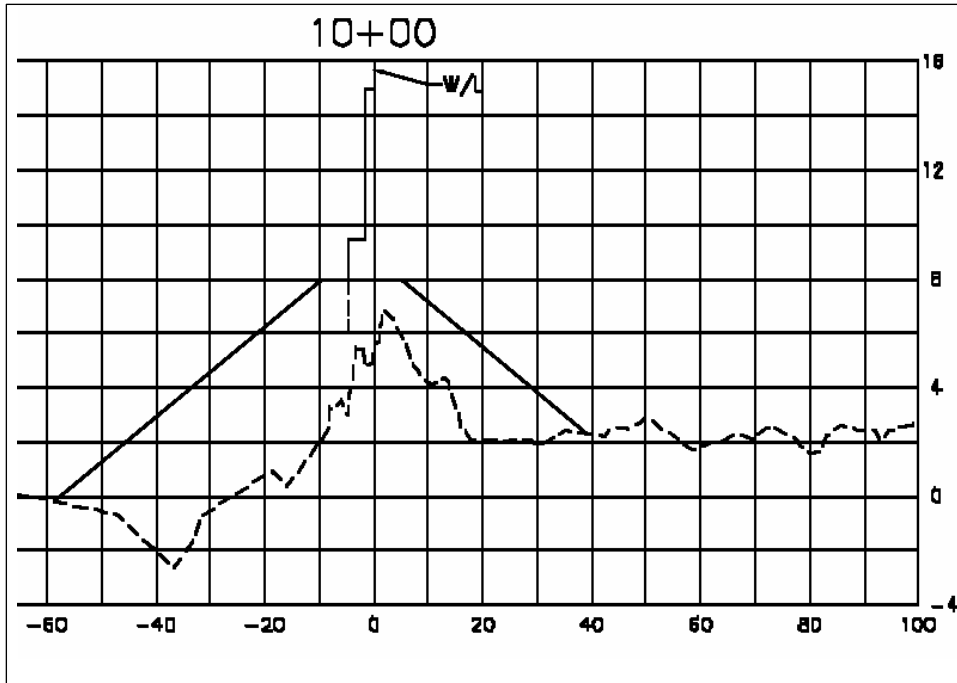
Figure 12-61. NOE4_H. Scour Pattern 200' to the East

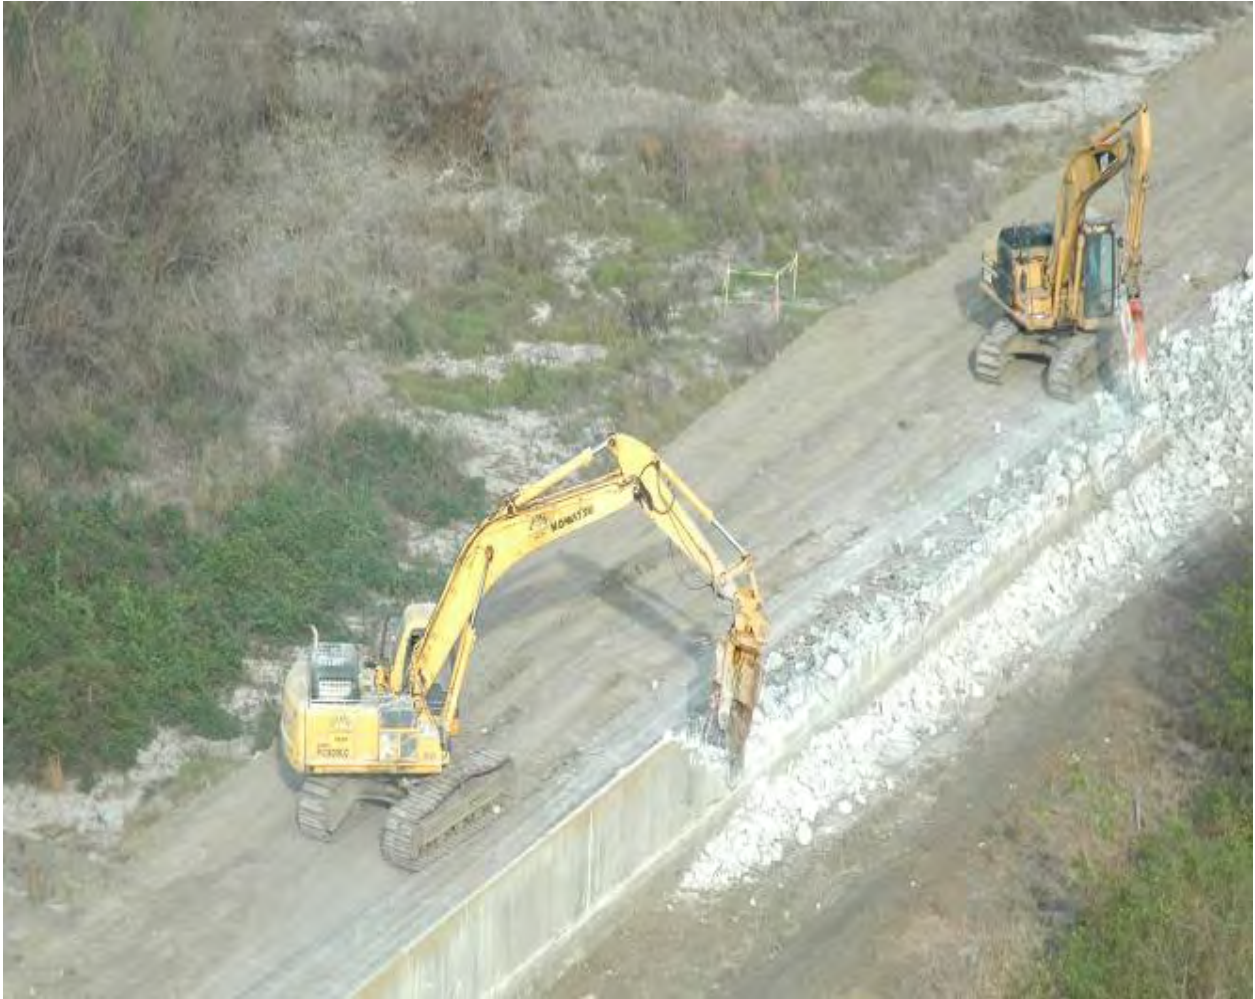
Figure 12-62. NOE4_I. I-Wall Demolition to Replace with New “L” Wall

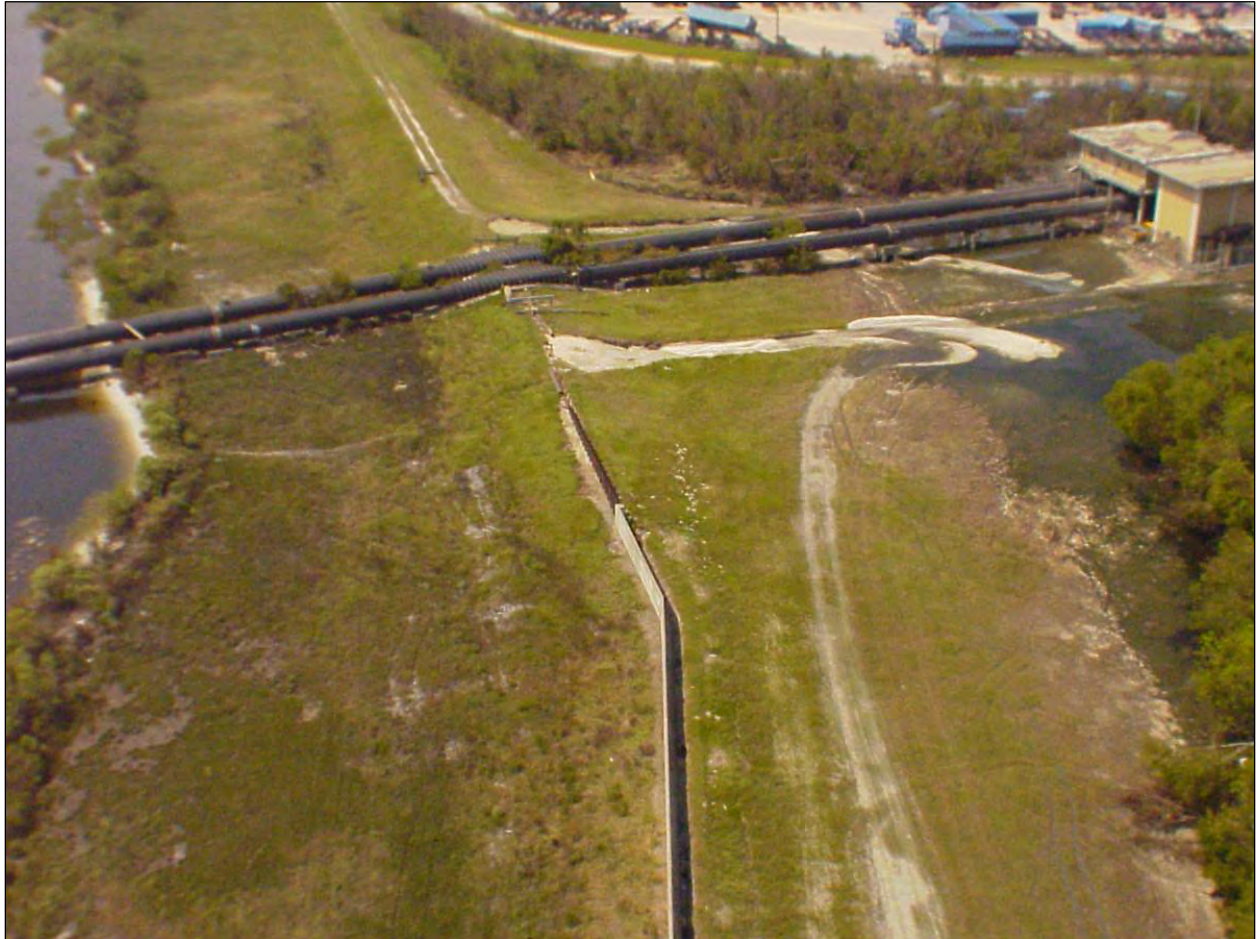
Figure 12-70. NOEX_Q. Amid Pump Station Landside Slope Erosion from Overtopping at Transition

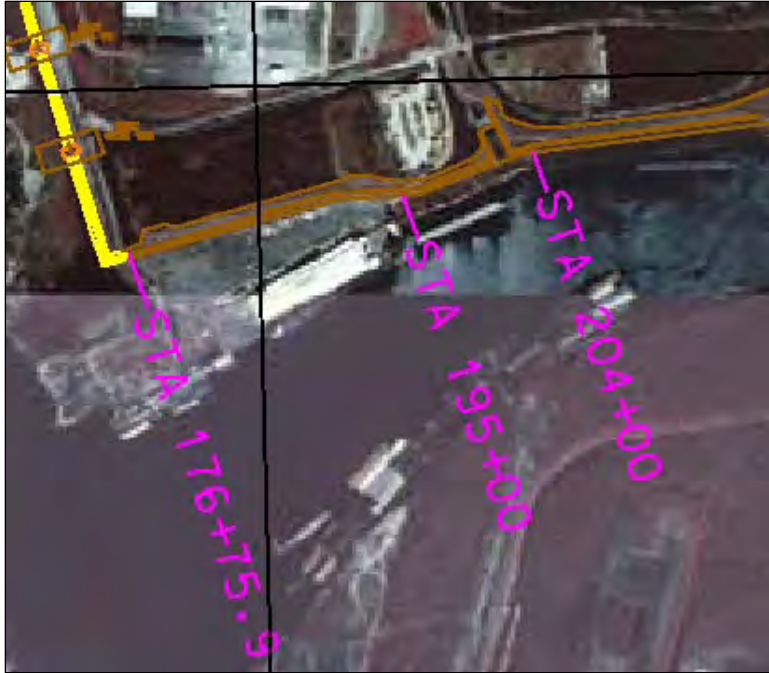
Figure 12-71. NOEX_R. Above Picture Taken Near GIWW/IHNC (coordinates 29 deg 59 min 55.37 sec N, 90 deg 00 min 41.62 sec W)

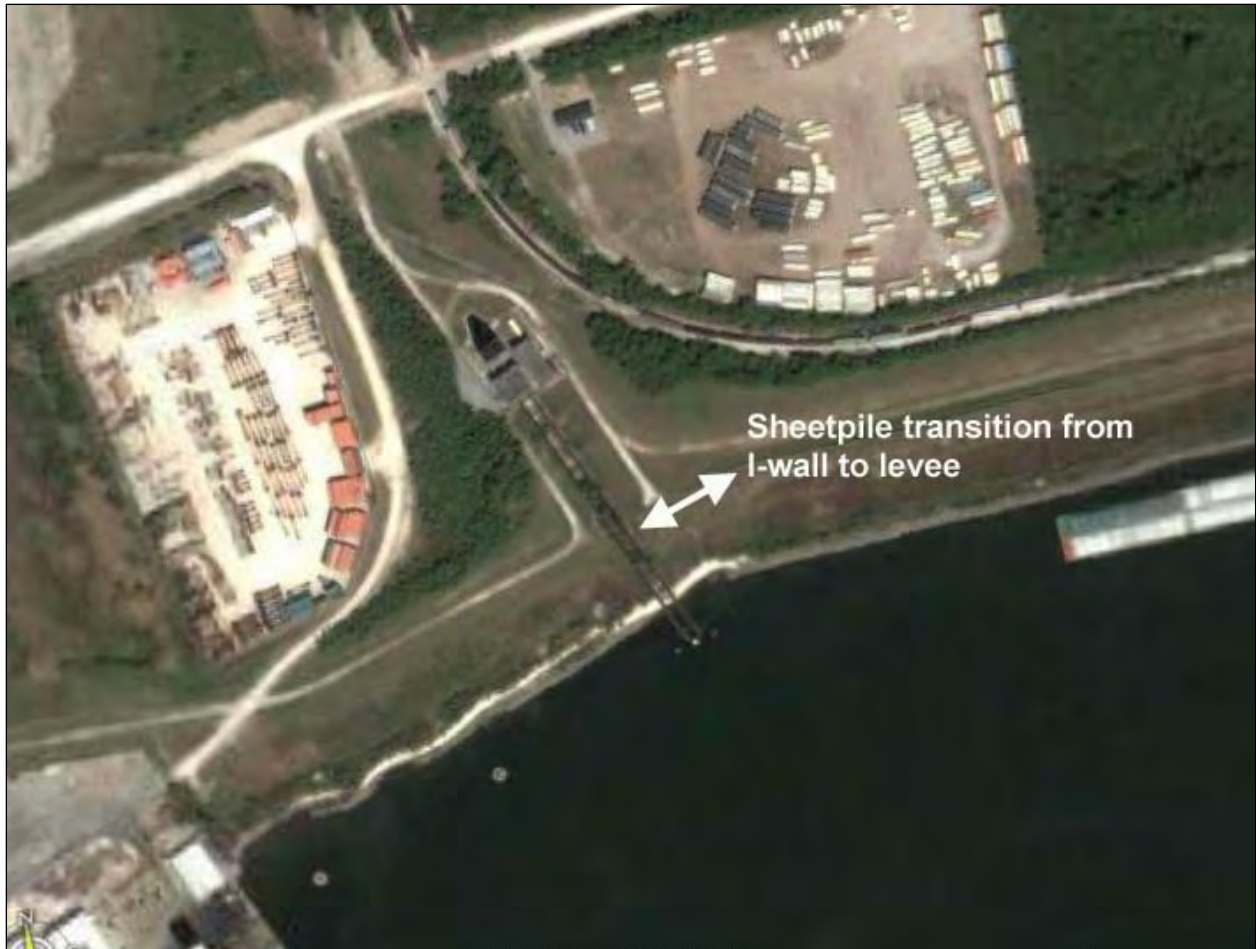
Figure 12-72. NOEX_S. Plate 2 of DM2-Gen Design Citrus Back Levee (Aug 1967) IHNC to NASA.pdf Shows Original Borings and Profile at Above Picture Location. Note that overtopping scour occurred at the intersection of the dirt road and levee crown as seen in Figure 12-NOEX-Q above

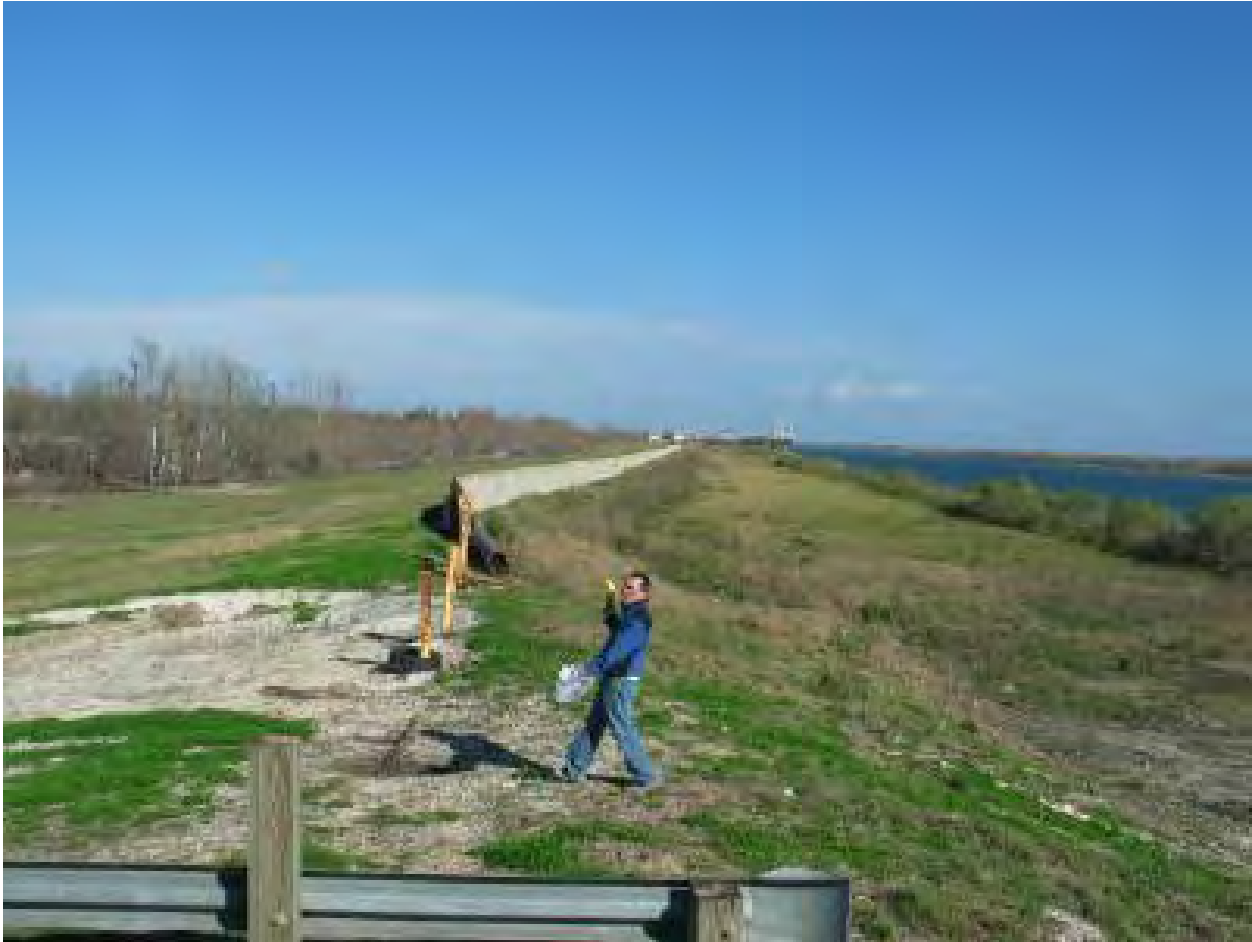
Figure 12-73. NOEX_T. Closeup of Scoured Road at Levee Crown, Amid Pump Station

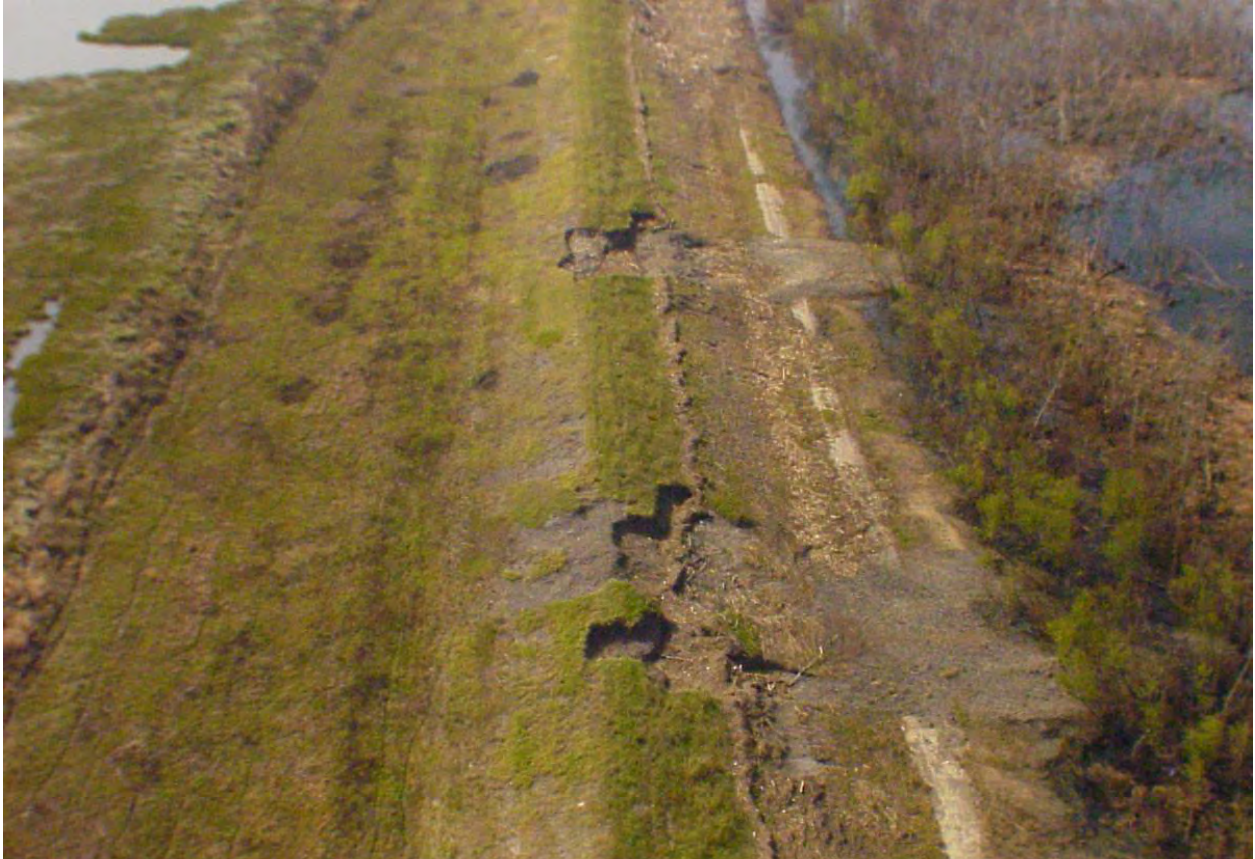
Figure 12-74. NOEX_U. Overtopping Erosion on Flood Side and Land Side

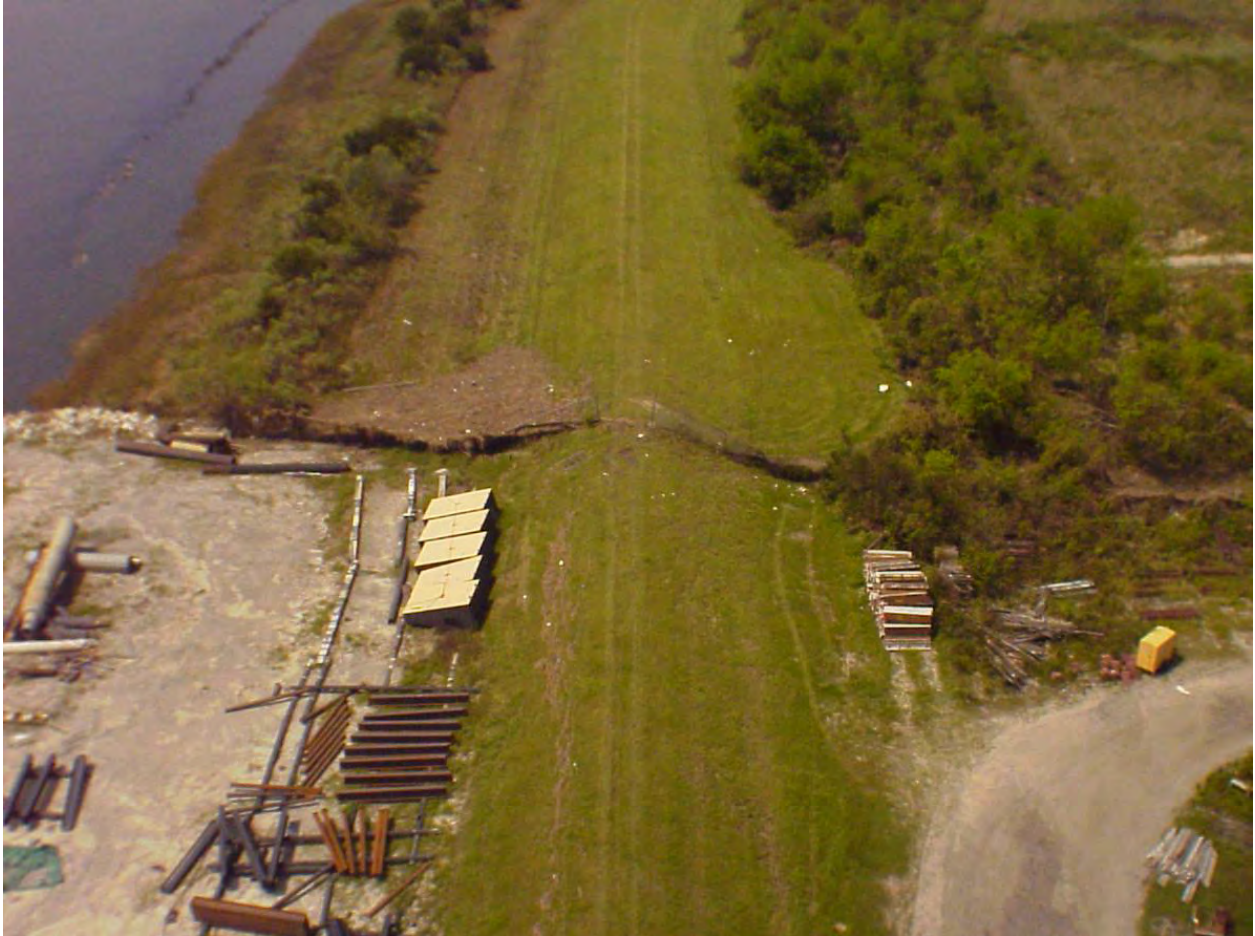
Figure 12-75. NOEX_V. Narrow Localized Breach at Pre-Existing Pipeline Crossing. Coords 30 deg 00 min 10.66 sec N, 89 deg 57 min 49.31 sec W (Approximate Sta 349+00 B/L)

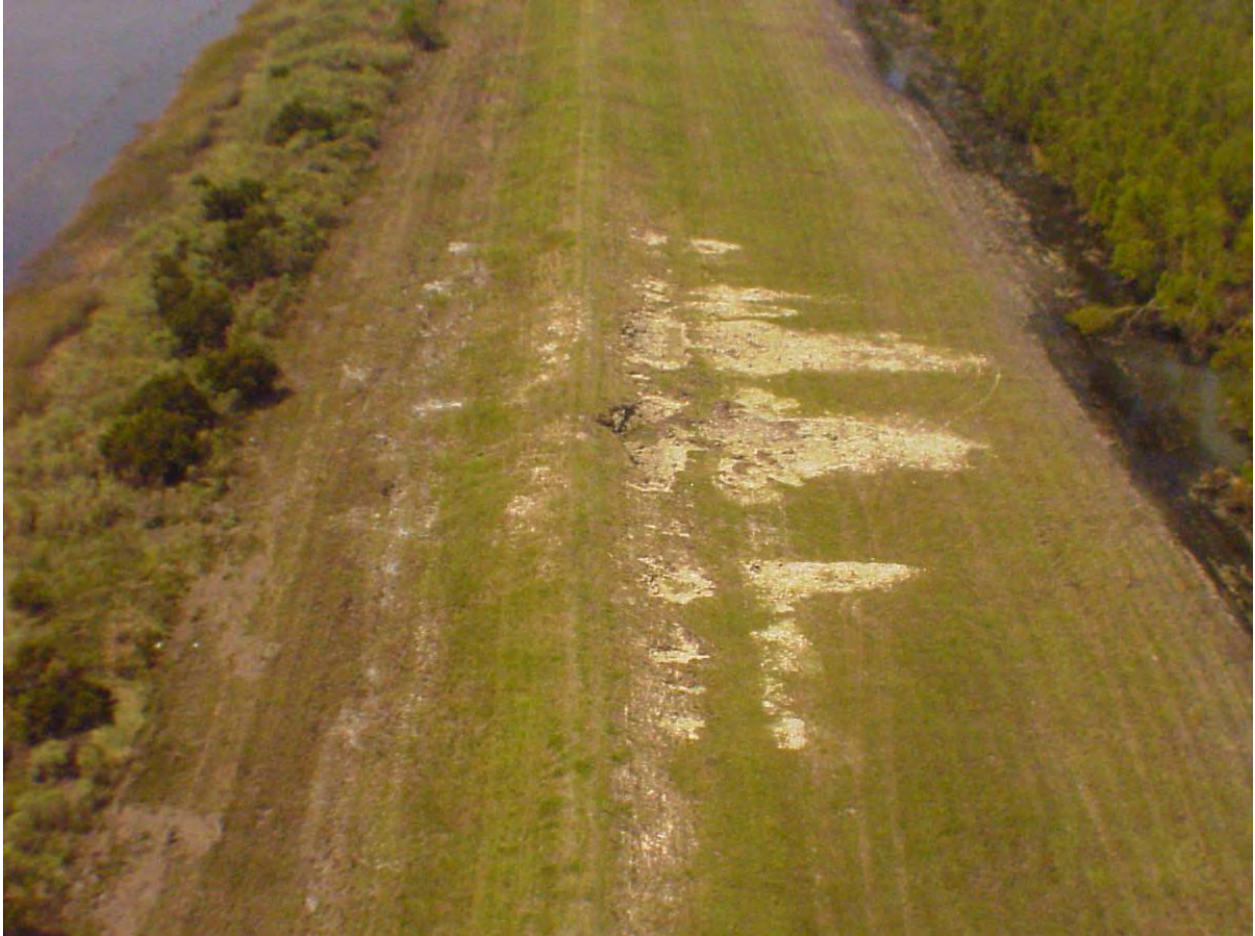
Figure 12-76. NOEX_W. 600' Reach of Levee with Landside Scouring

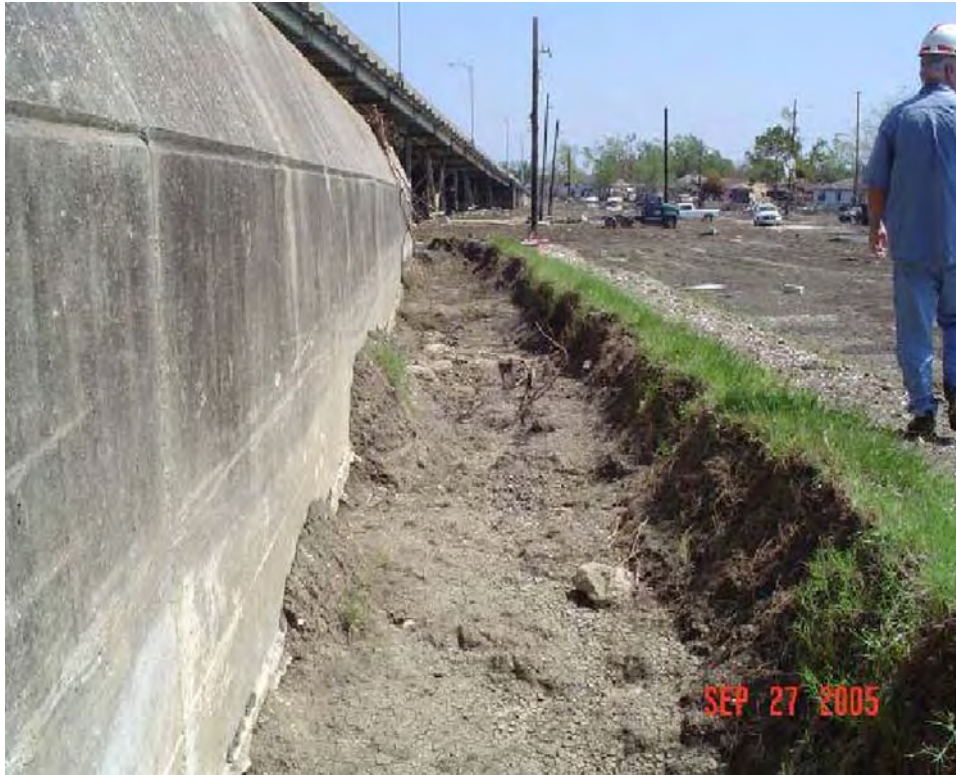
Figure 13-5 shows the I-wall along the east side of the IHNC at approximate B/L Sta 11+00 (DM3 Chalmette Area Plan), looking toward the Claiborne Avenue bridge. Depth of scour was to the bottom of the I-wall concrete cap (2 ft), and scour width was approximately 7 ft. The I-wall elevation was designed to height of 15 ft above mean sea level, the bottom of the concrete cap was elevation 7 ft, and the levee crown was elevation 9 ft. Actual wall height was reported to be 12.5 ft converted to local mean sea level, and the storm surge height was reported to be up to 15 ft. As an approximation of the overtopping water impact, a 2.5 ft crest of water cascaded from a 6-ft height onto the levee crown. Figures 13-3 and 13-4 show the estimated impact velocity was about 23 ft/sec and impact force was about 700 lb/ft. The water impact removed a portion of the levee crown, including all of the structural backfill zone adjacent to the concrete wall.

Figure 13-5. Scour Pattern "A" on East Side IHNC near N. Claiborne Ave. Bridge

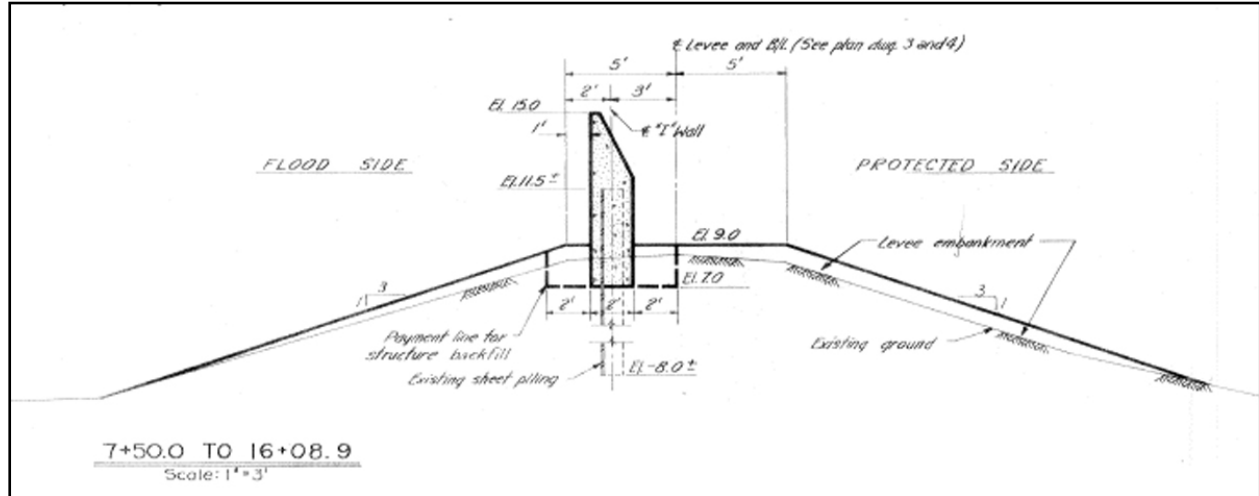
Figure 13-6. Existing Levee and I-Wall Drawing for IHNC East. Note that scoured soil included the "structure backfill" zone (from drawing file H-4-25157, IHNC East Levee from Lock to Florida Ave. Floodwall, sheet 12 of 15)

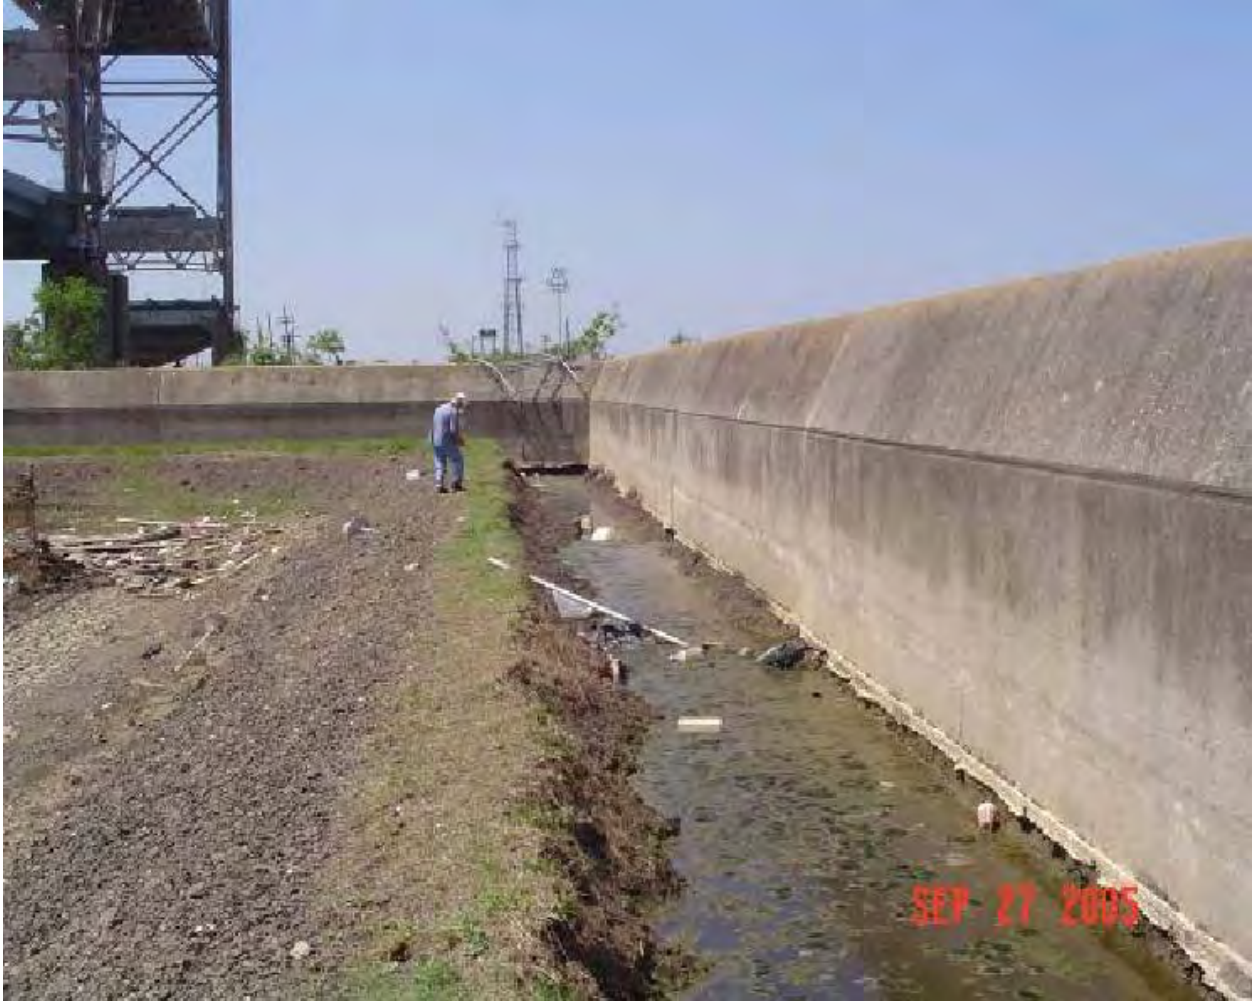
Figure 13-8. IHNC East, Approximate B/L Sta 7+00 (DM3 Chalmette Area Plan), North of the Claiborne Avenue Bridge. Depth of scour was to the bottom of the I-wall concrete cap. I-wall elevation was designed 15 ft above mean sea level (MSL), bottom of concrete was elevation 7 ft (MSL), and levee crown was elevation 9 ft (MSL). Actual wall height was reported to be 12.5 ft converted to local mean sea level (LMSL), and storm surge height was reported to be up to 15 ft. As an approximation of the overtopping water impact, a 2.5 ft crest of water cascaded from a 6-ft height onto the levee crown. Nearby soil boring 2U (Figure 13-9) indicates the upper 5 ft was fat clay (CH) with sand / silt lenses

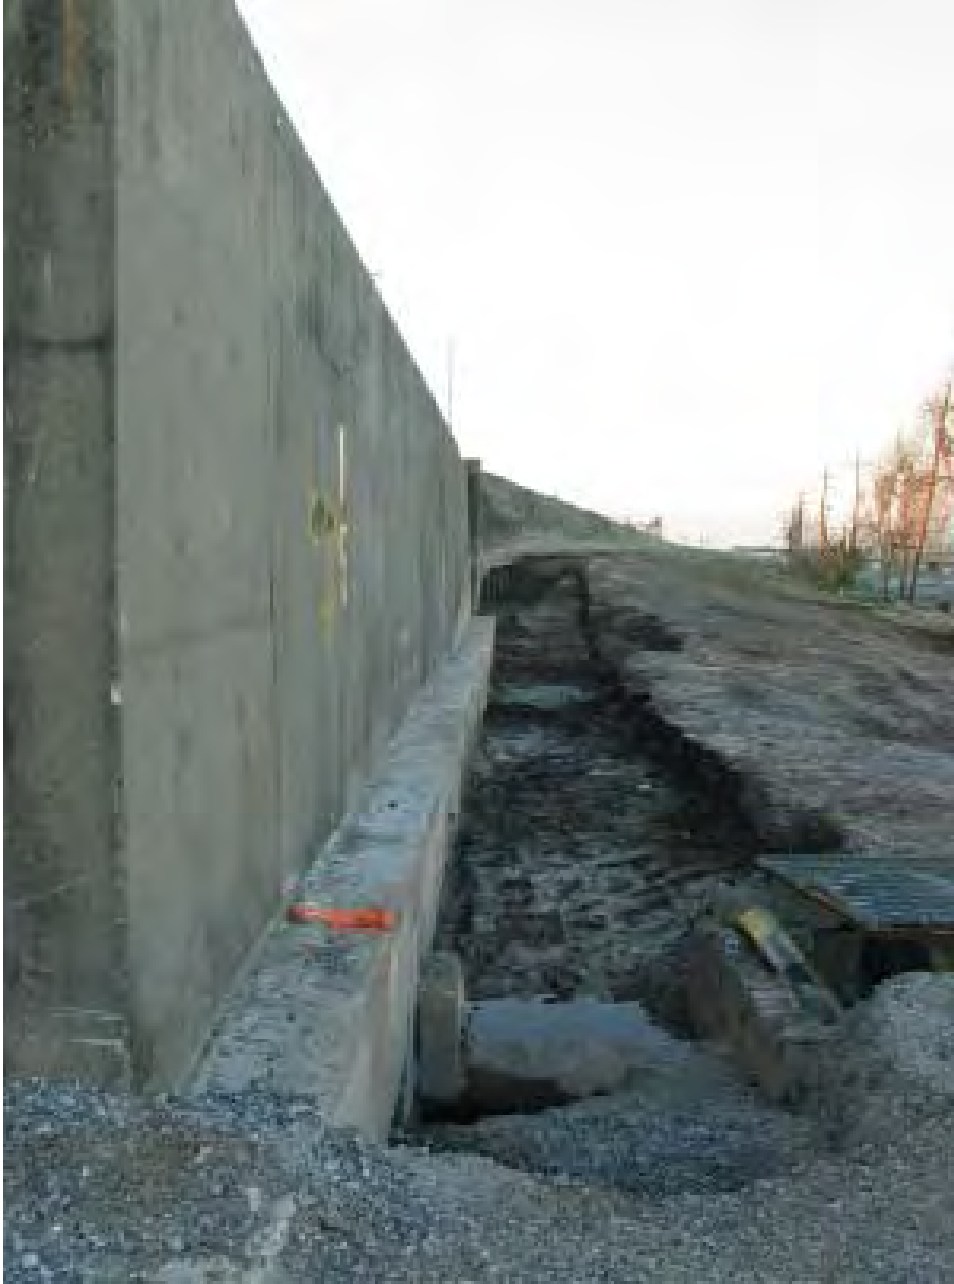
Soil scour within the structure backfill zone is also evident at other locations such as the T-wall on the north side of Gate 13E on the east side of the IHNC near Lakefront Airport at approximate W/L Sta 61+38 (DM2 Supplement 8 IHNC Remaining Levees). The top of T-wall elevation is 13.25 ft (MSL) and the existing top of ground elevation was 0.1 ft (MSL), from drawing file H-2- 24111, plate IV-20. Scour depth was 30in and width was approximately 8 ft caused by a 13-ft overtopping water impact (Figure 13-10). Figures 13-3 and 13-4 show the estimated impact velocity was about 30 ft/sec and impact force was over 700 lb/ft.

Figure 13-10. T-Wall Base Scour on Backside, East IHNC Near Lakefront Airport

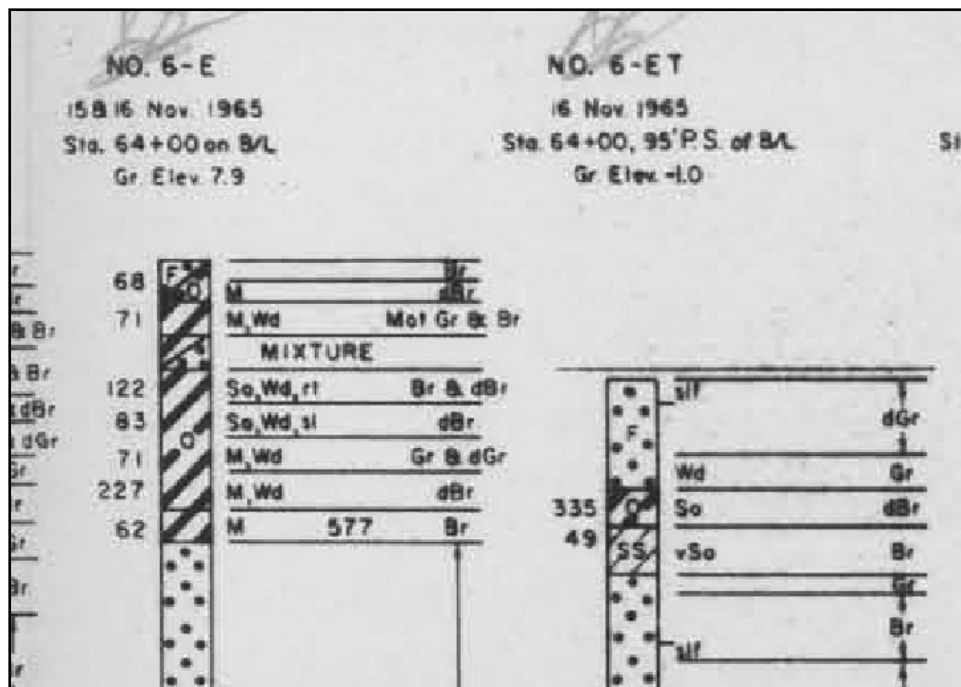
Figure 13-11. Nearest Soil Boring 6-E Shows Built-Up Levee at Elevation 7.9 ft (MSL), but Boring 6-ET, Offset 95 ft to the Protected Side of the B/L, Shows Original Ground Surface Elevation -1.0 ft (MSL) was Approximately a 10-ft Layer of Sandy Material (from drawing file H-2-24111, plate IV-34). The vertical and horizontal scour pattern indicates that the T-wall base structural backfill had lower erosion resistance than the original levee soil

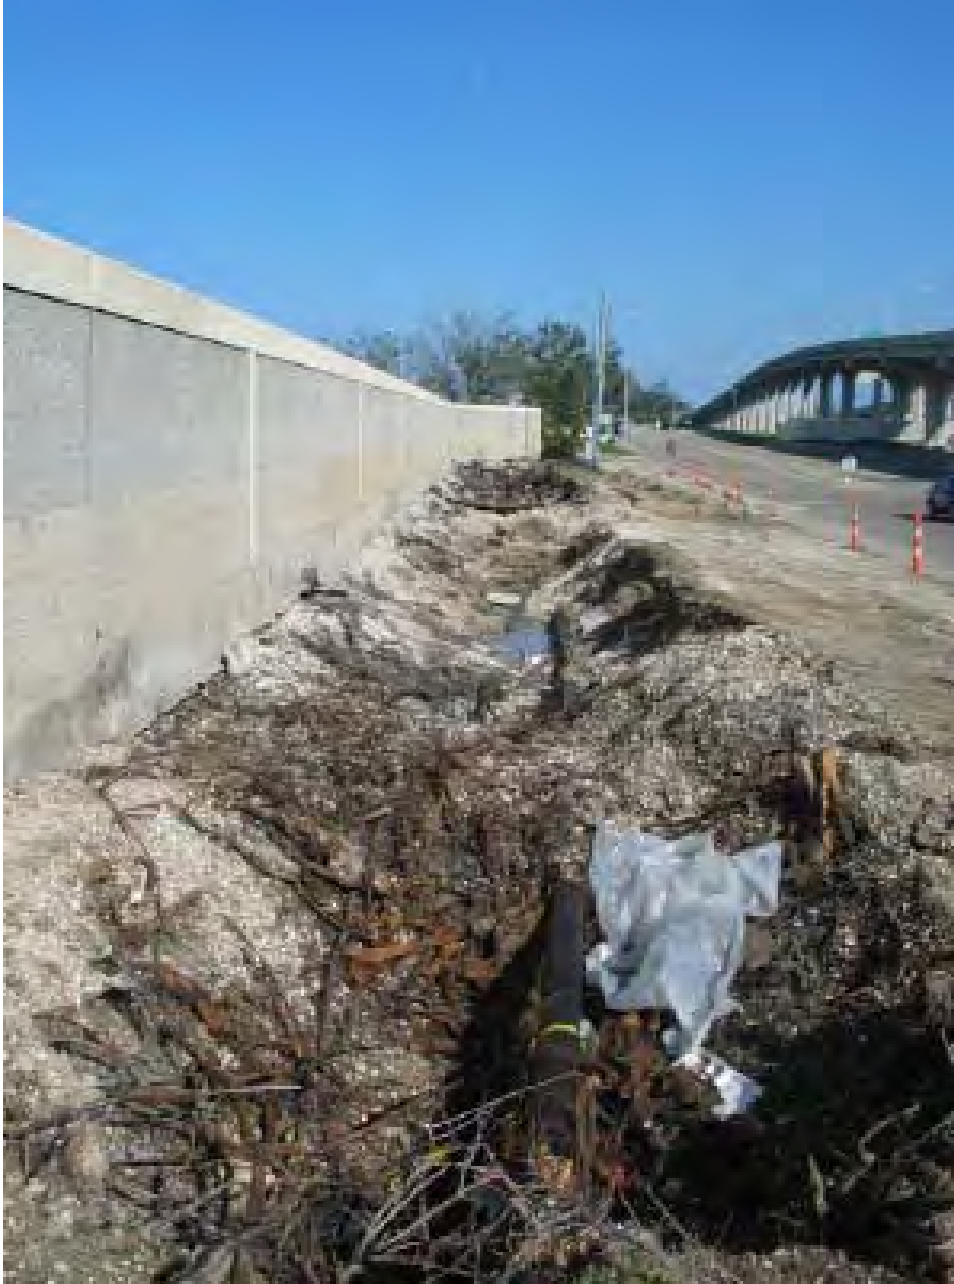
Figure 13-12. Scour Along Lakefront Airport Floodwall Measures 305' (L) x 14' (w) x 48" (d). Existing levee crown appears to be composed of sandy material, based on visual observation. Nearby soil boring 1-C (5/29/1969) at Sta. 8+85, 57 ft right of B/L shows sand, silt, and lean clay lenses to 9-ft depth. Soil boring 4-A (11/3/1970) at Sta 18+00, 200 ft landside of B/L also shows sand, silt, and lean clay lenses to 9-ft depth

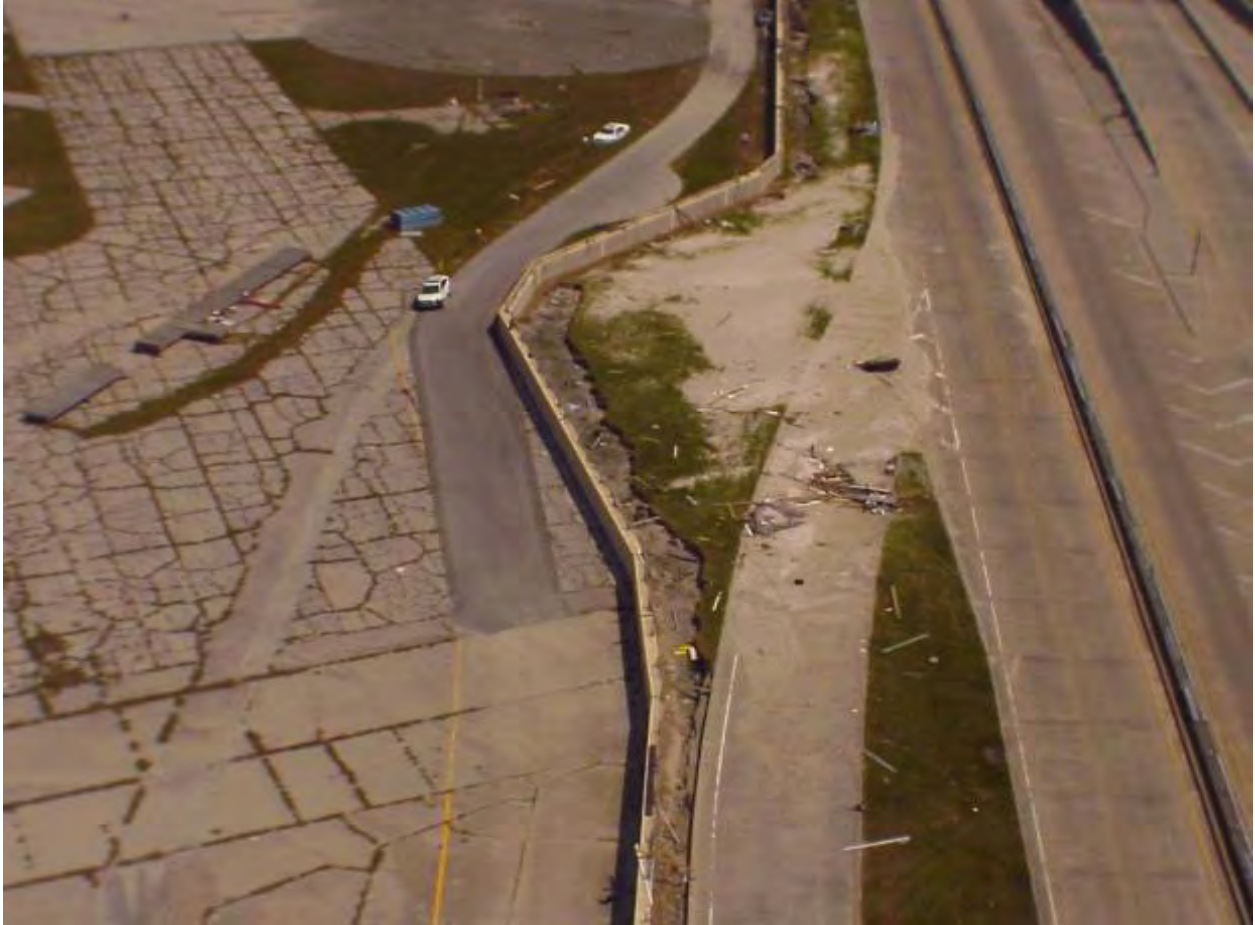
Figure 13-13. Lakefront Airport Floodwall. Scour is approximately 11 ft wide by 2 ft deep. Floodwall elevation is approximately 13.5 ft, ground elevation is approximately 6 ft, and wall height is approximately 7.5 ft

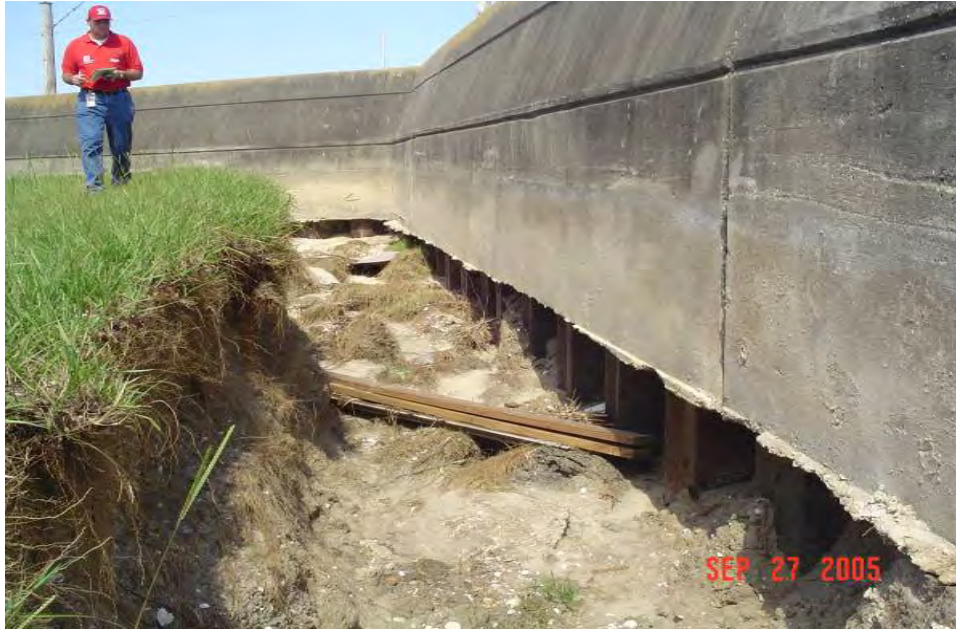
Figure 13-14. IHNC East, Approximate B/L Sta 101+00 (from drawing file H-2-24111, plate IV-23, DM2 Supp 8 IHNC Remaining Levees), North of Chef Menteur Hwy Bridge. Top of I-wall is elev 14.75, bottom of concrete is elev 7, and levee crown is elev 9. Nearest B/L boring is Sta 96+00 (No. 9EU), 500 feet distant. Approximate storm surge impact was a 2.5-ft water crest cascading over the 6-ft concrete wall. Note that the scour was deeper than the concrete base, indicating that the structural backfill and the original levee material eroded

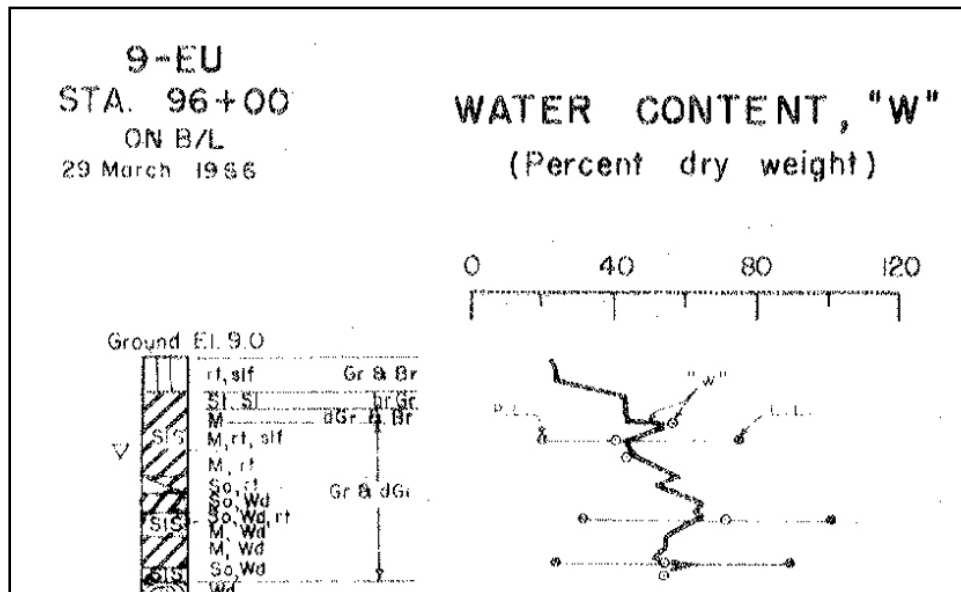
Figure 13-15. Boring 9EU (Sta 96+00 B/L, East Side IHNC) Shows a Top Layer of Silt at Levee Crown Elevation 9 ft, Possibly Explaining the Low Erosion Resistance of the Original Levee Material

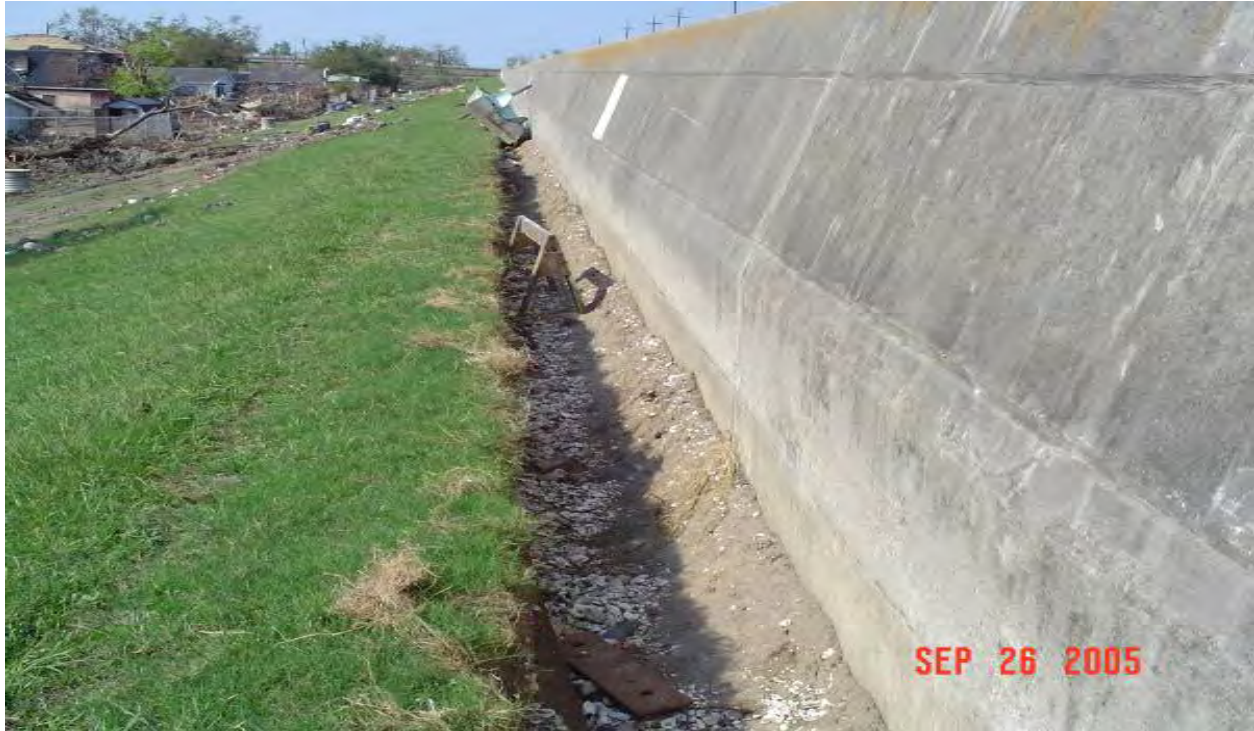
Figure 13-16. IHNC West Side Between Chef Menteur Hwy. and Hayne Blvd, Approx 8400 LF. Top of I-wall elevation is 14.75 ft(MSL), bottom of concrete is elevation 7 ft (MSL), and levee crown is elevation 8 ft (MSL). Borings in this reach (B/L Sta 31+06 to Sta 109+00, borings 1W to 14W) show the top 2 ft to 3 ft layer at crown elevation is composed of sandy and/or silty soil instead of fat clay
