Appendix 1

Soil Data Report for 17th Street Canal

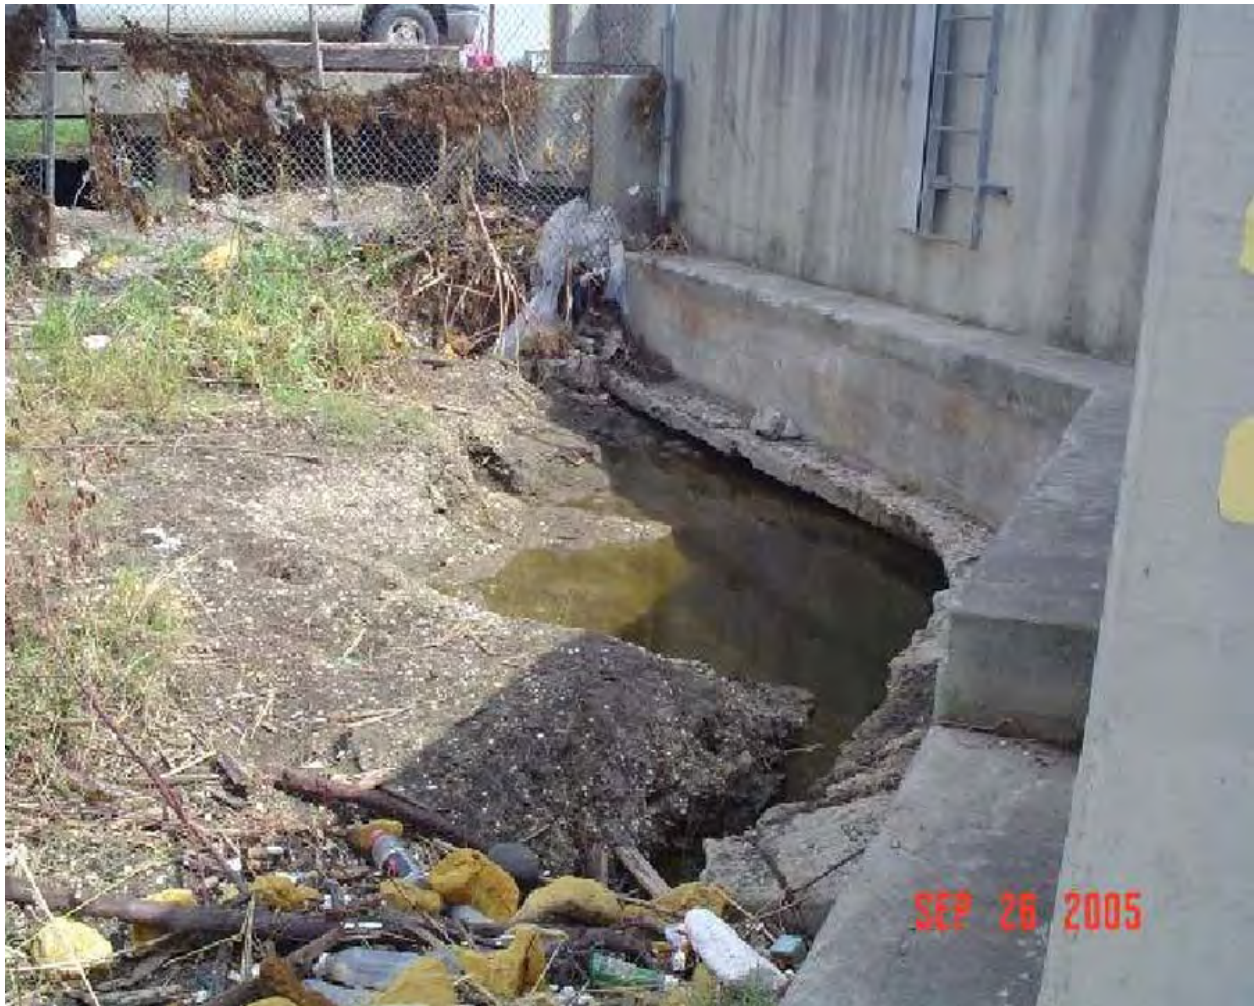
Figure 13-17. Scour at T-Wall Base of Gate W23, West Side IHNC

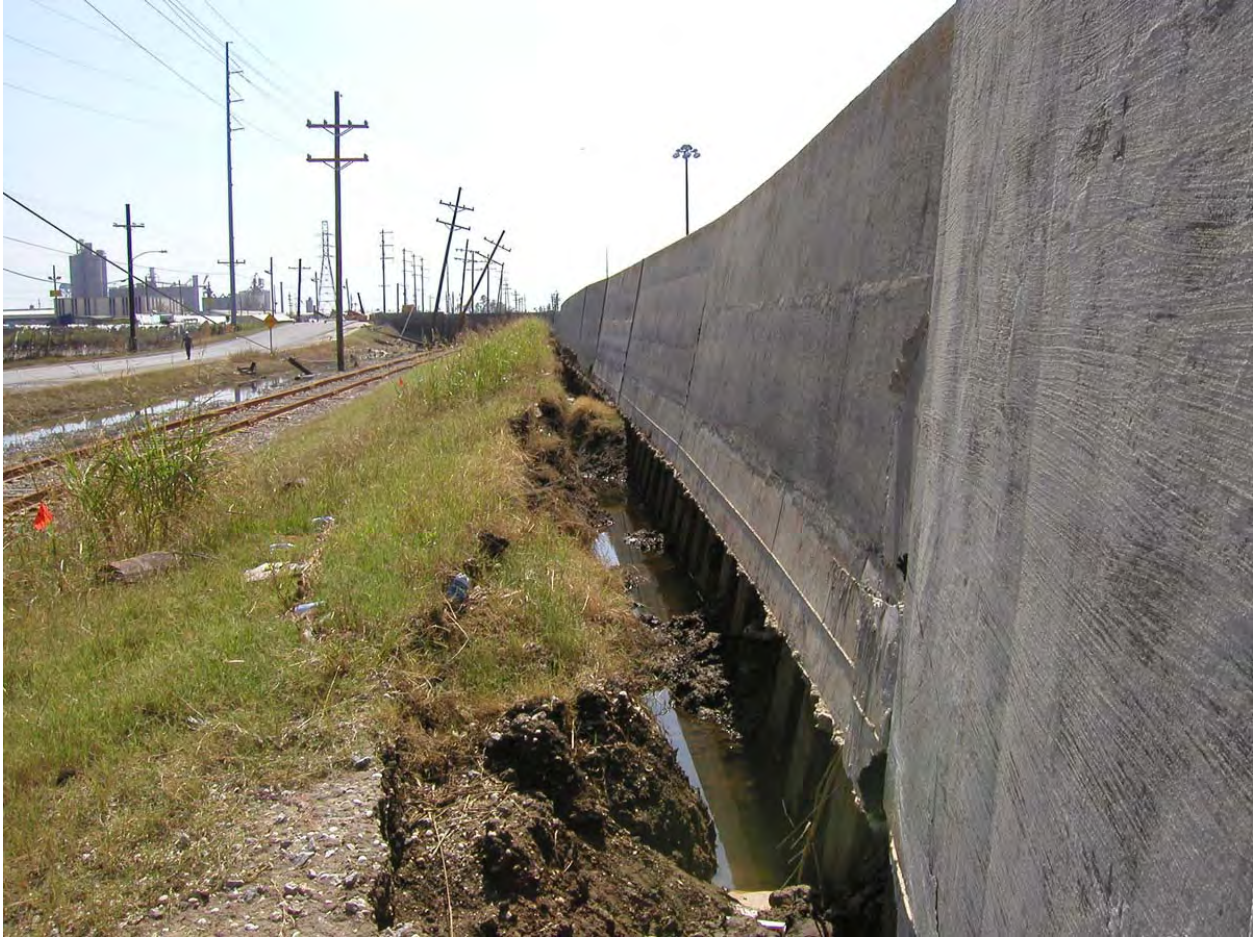
Figure 13-18. IHNC West Side, View South from Benefit St. Gate Toward France Rd Ramp. Approximate W/L Sta 5+56 (B/L Sta 205+44). Top of I-wall elevation 15 ft, levee crown 9 ft, bottom of concrete 7 ft, bottom of pre-existing Z-27 sheet pile (installed by the Orleans Levee Board) at -10ft (MSL). From drawing file H-2-24111, plate IV-15. Nearest soil boring (Figure 13-19) is 30W at B/L Sta 203+00. The I-wall rotated and floodside levee deformation occurred, probably as a result of sheetpile rotation opening up a floodside tension crack. This picture represents scour pattern "C" which is a pre-breaching failure mode

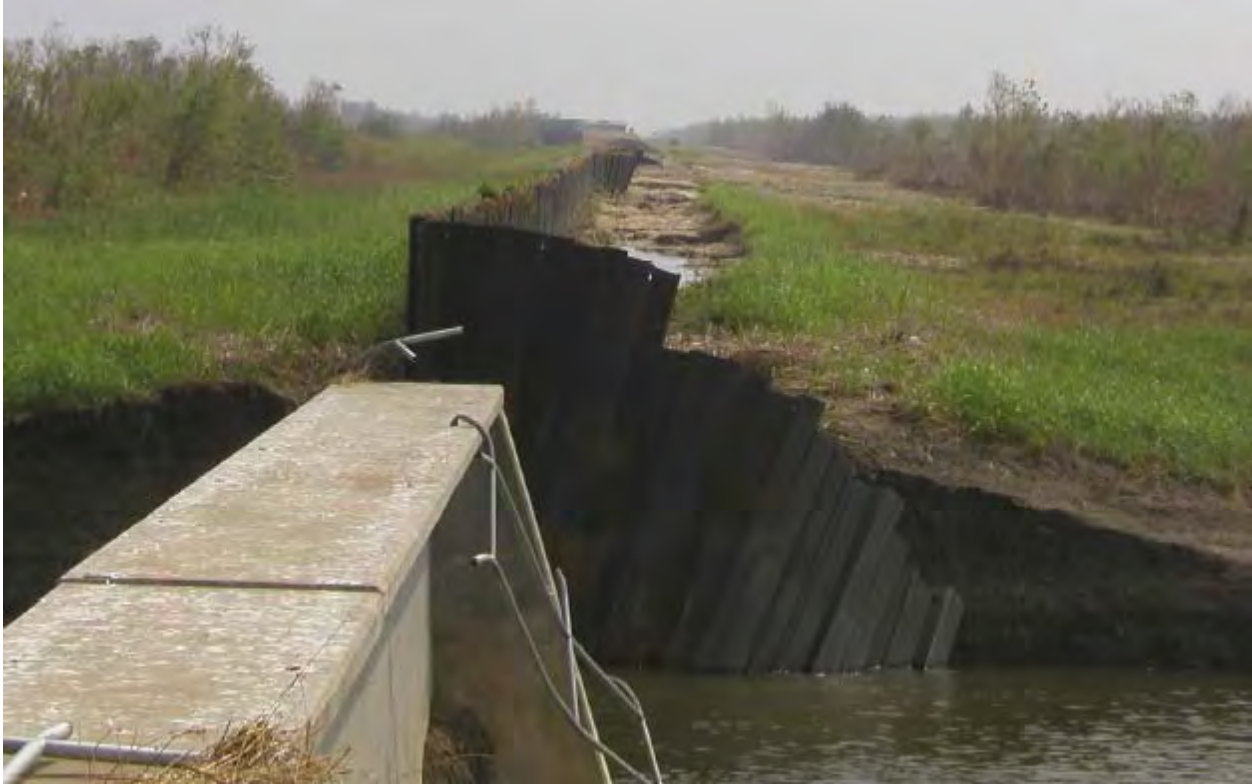
Figure 13-20. View Looking Southeast from the Bayou Bienvenue Control Structure Showing Backside Scour Beyond the Structure

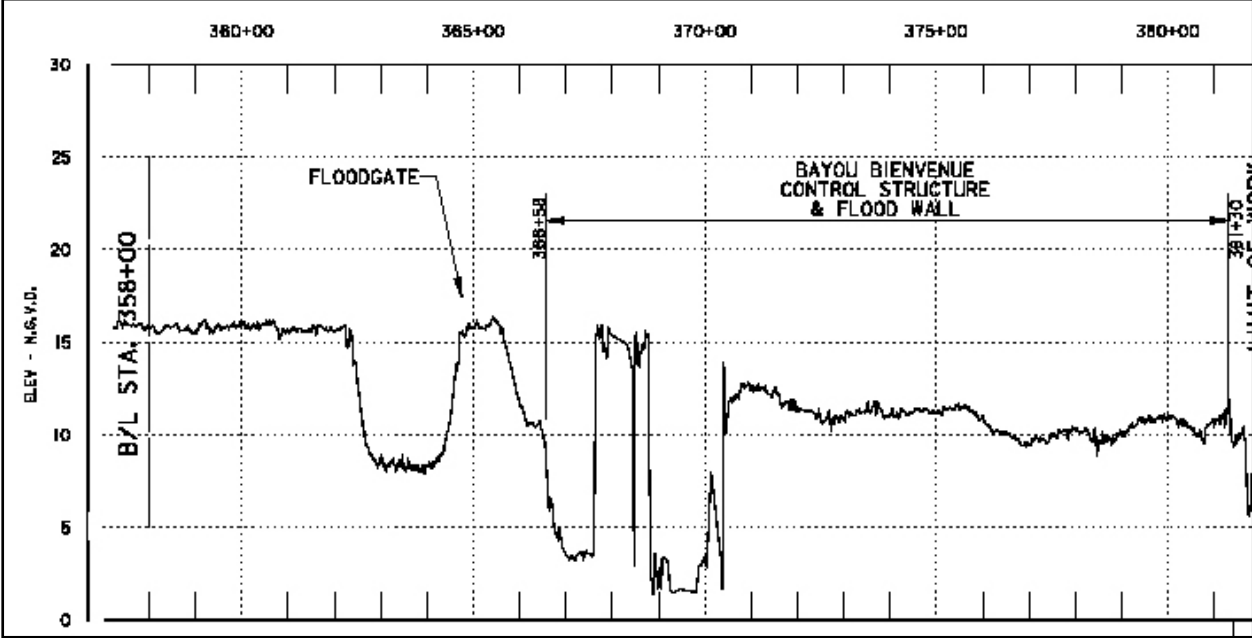
Figure 13-21. Centerline Scour Depths of Floodgate and Control Structure (from dwg 1 of 8, Emergency Restoration B/L 383+00 to 704+00 contract solicitation)

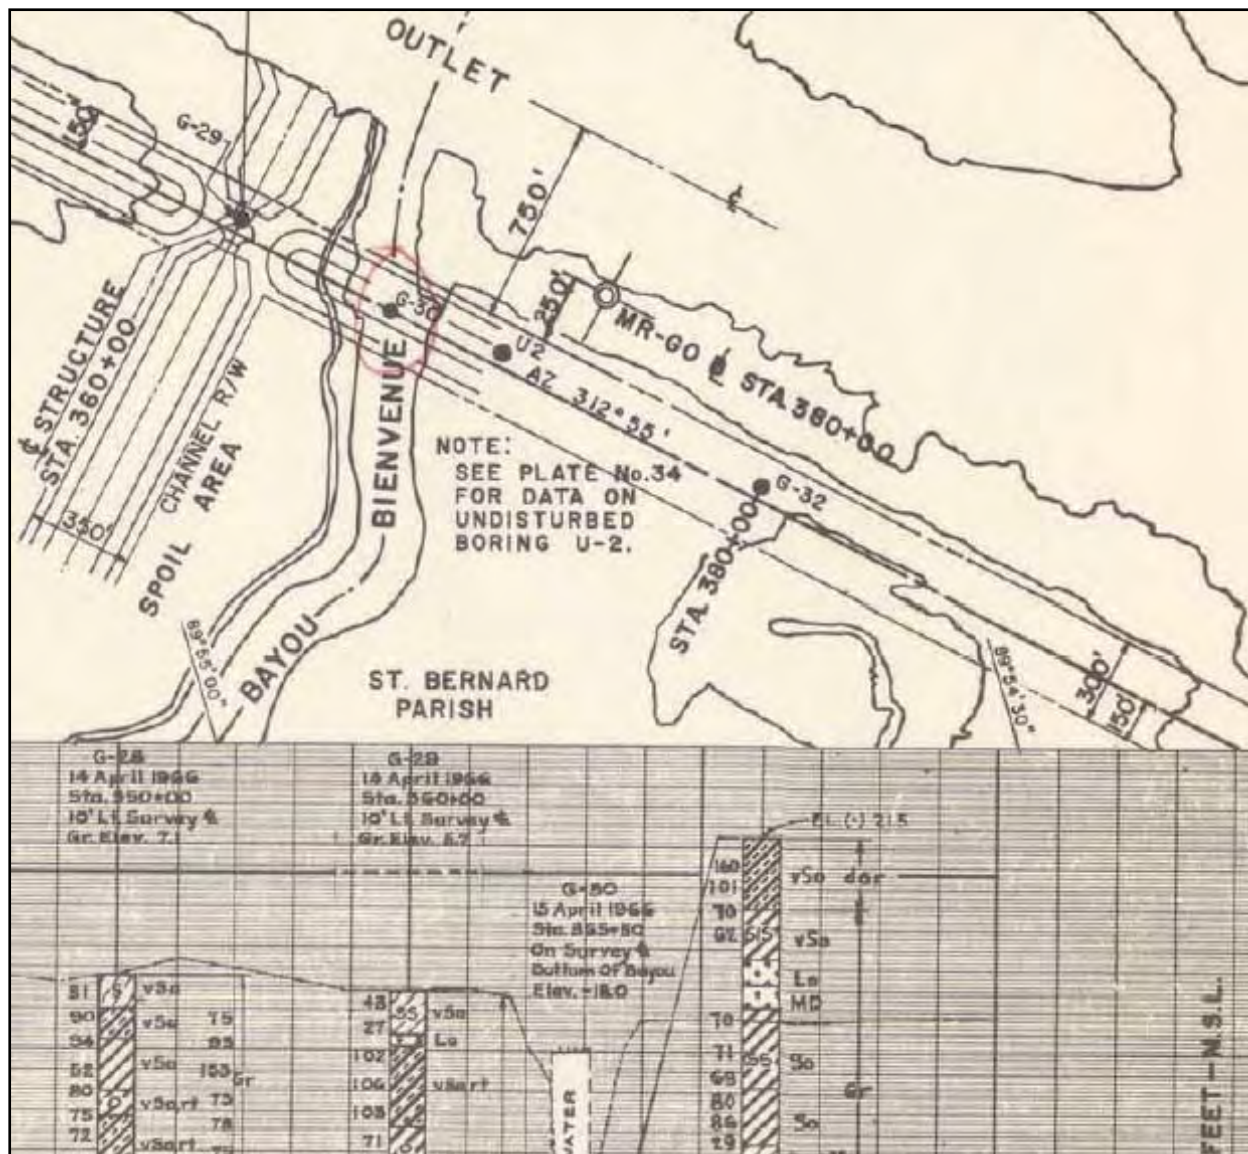
Figure 13-22. Original Ground Surface (1966) Had Sand / Silt Lenses Overlying Very Soft Organic Clay (plate 10, DM3). Note that the sheetpile east of structure (Figure 13-20 above) was driven to cut off the old Bayou channel in addition to reducing loading on the top layer of very soft organic clay seen in boring G-32.

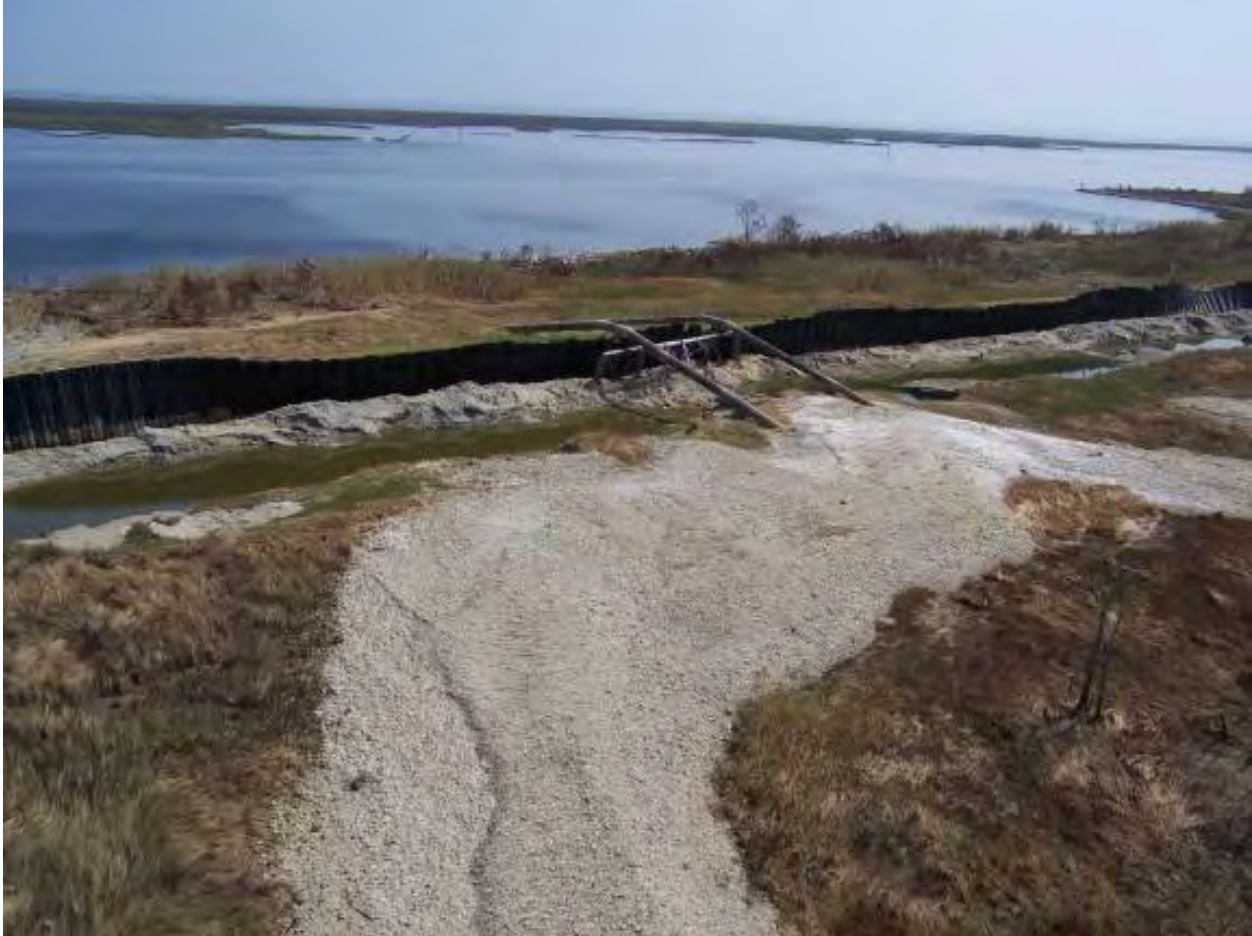
Figure 13-23 shows a section with 4300 ft of exposed sheetpile damage along MRGO between Bayous Bienvenue and Dupre, St. Bernard Parish. The damaged sheetpile section is near utility crossings, with scour on the protected side and levee crown. B/L Sta 590+70 is centerline of the two pipelines.

Figure 13-23. Pattern "A" Scour on the Backside of Exposed Sheetpile Wall Along the MRGO South Bank in St. Bernard Parish

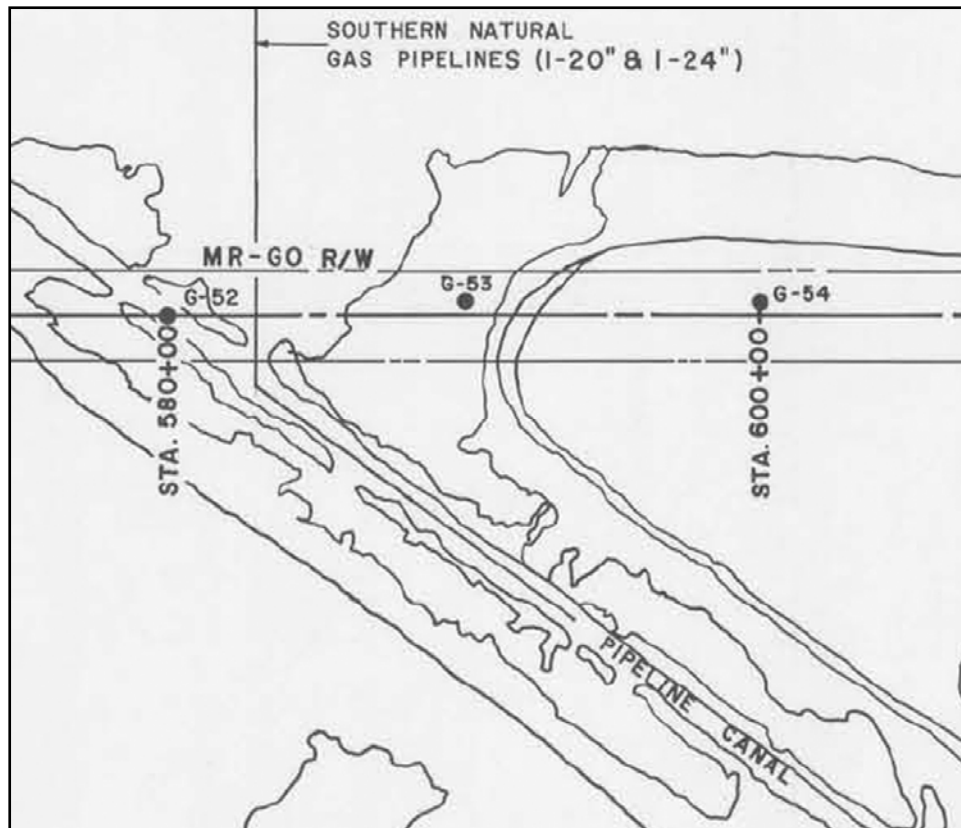
Figure 13-24. Original Pipeline Canal Prior to Backfilling and Sheetpile (from drawing file H-2-23820, plate 13)

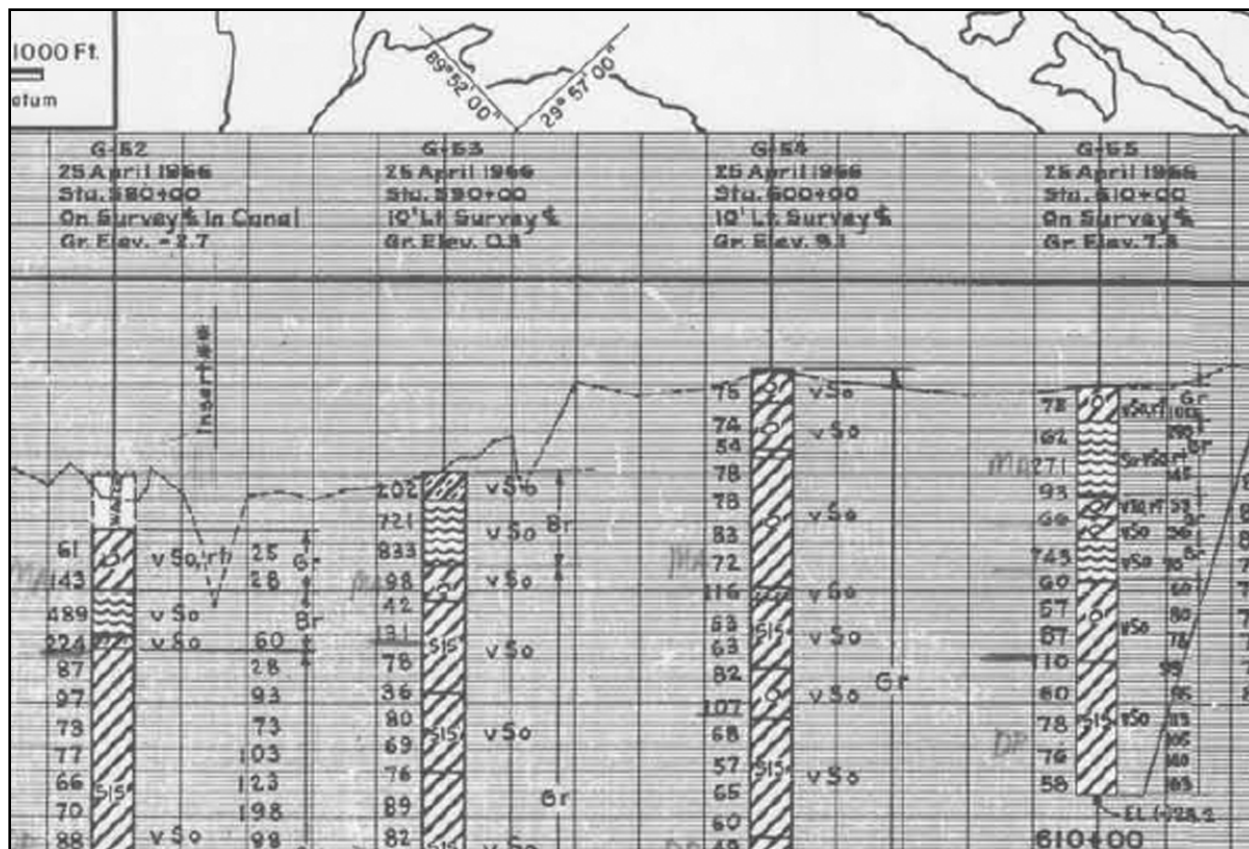
Figure 13-25. Adjacent Borings Show Very Soft Fat Clay and Peat Layer Stratification

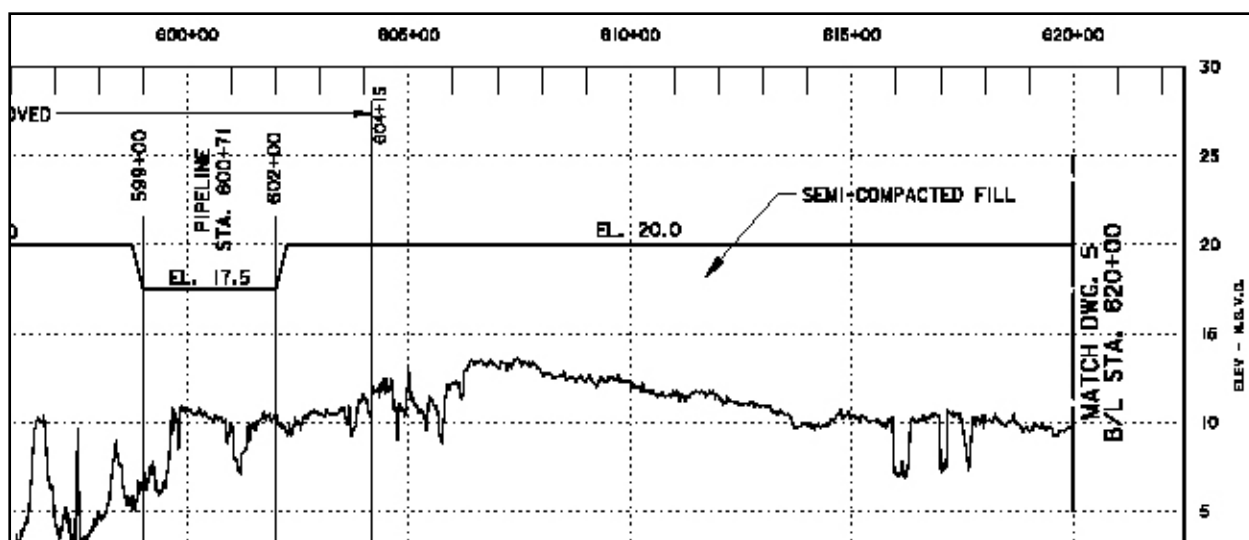
Figure 13-26. Scour Depths and Levee/Sheetpile Elevations Between B/L Sta 600+00 to 620+00 (from SB04 Contract Solicitation W912P8-05-R-0063, B/L 383+00 to 704+00 Emergency Restoration)

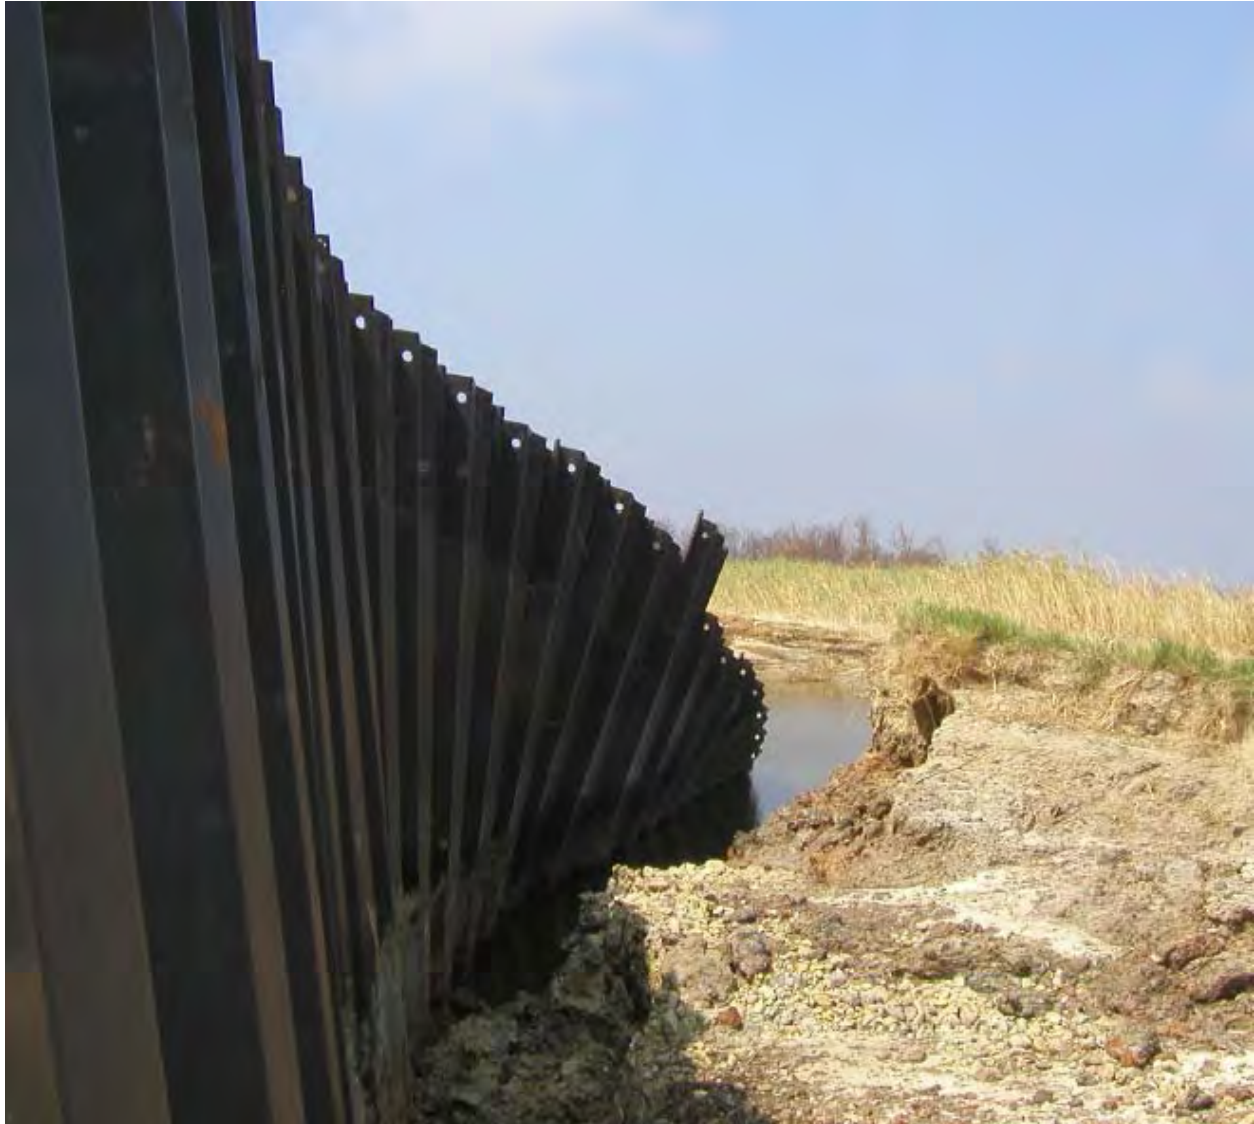
Figure 13-27. Closeup of Adjacent Breached Sheetpile with Backside Scour. Note the stratified layers in the soil profile representing existing hydraulic fill historically dredged from the MRGO

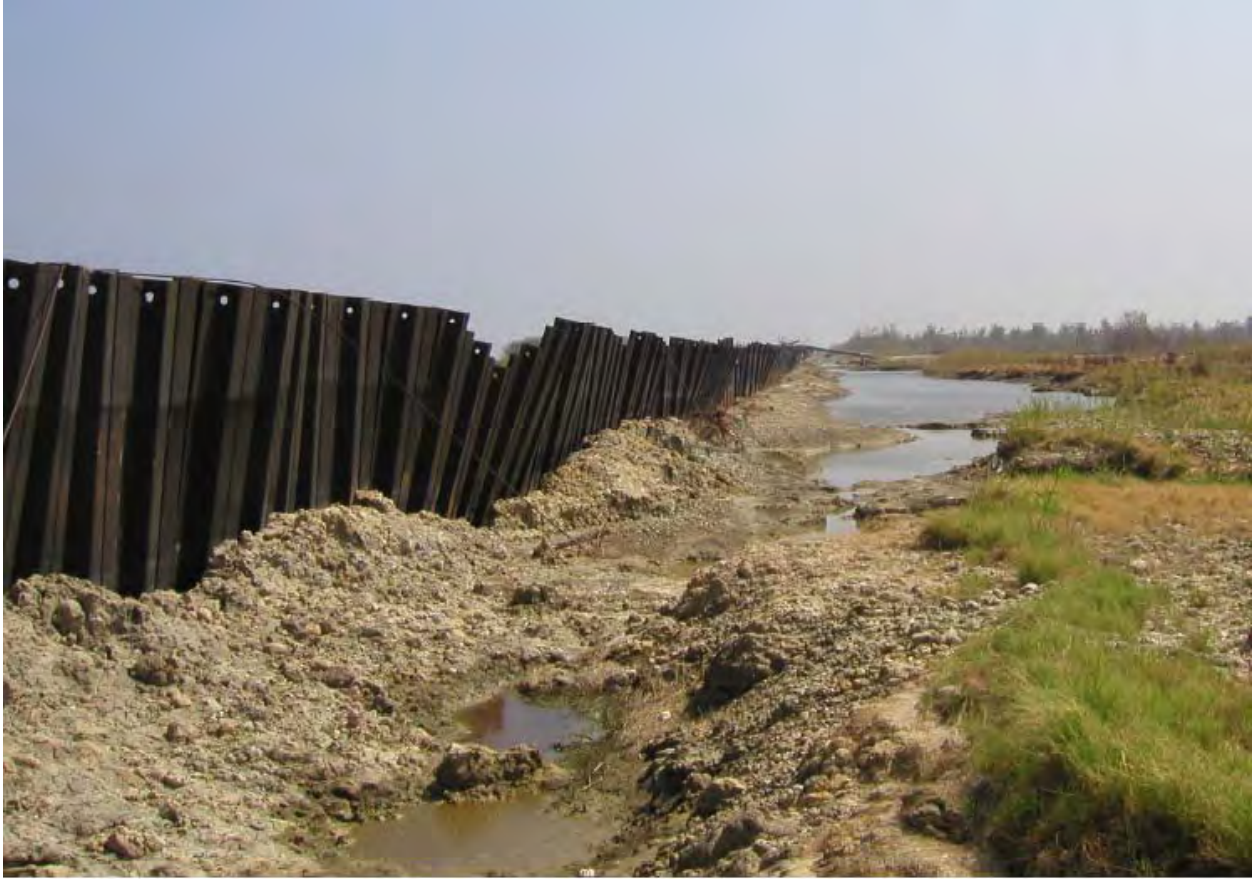
Figure 13-28. Sheetpile Between Bienvenue and Dupre Control Structures. Note the sheetpile elevation differences

Soil boring 18-UBD (91-02) from 1991 at B/L Sta 596+00 shows the top 5.8 ft of levee (at elevation 14.4) was composed of sandy silt (SM), with CH layers underneath. At a depth of 12 ft below the crown, a shear Q test indicated cohesion value 396 psf at 27% water content and 95 pcf dry density in a CL layer.

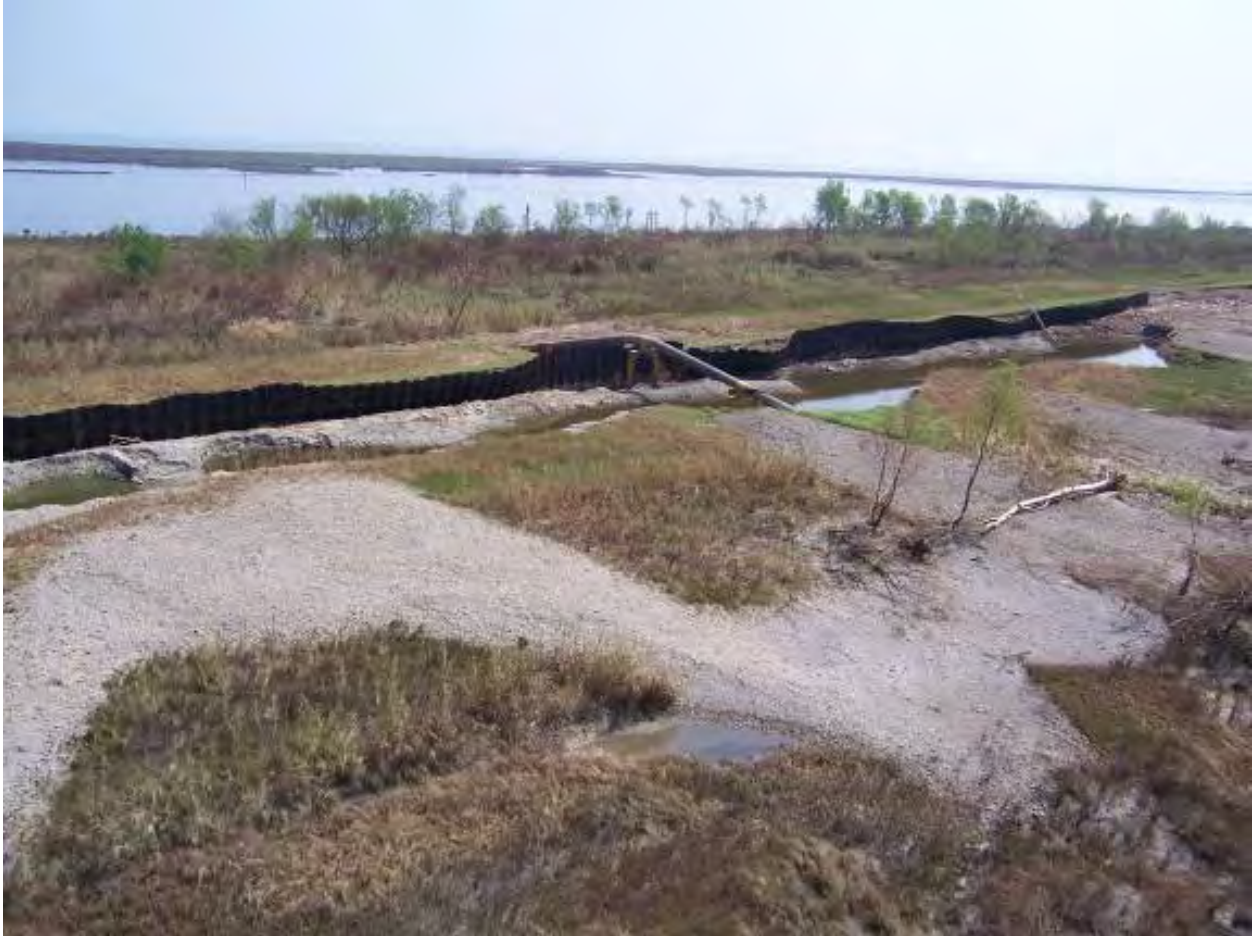
Figure 13-29. Sheetpile Reach Along the MRGO Southeast of Bayou Bienvenue at Approximate B/L Sta 600+00. Top of sheetpile was elevation 17 ft (MSL) and levee crown elevation was approximately 12 ft (MSL), for an exposed sheetpile height of approximately 5 ft. Storm surge on the MRGO was approximately 18 ft, resulting in approximate overtopping velocity of 20 ft per second with approximate 250 lbs/ft impact force. The end of the sheetpile section with transition to the severely eroded levee is approximate B/L Sta 604+15

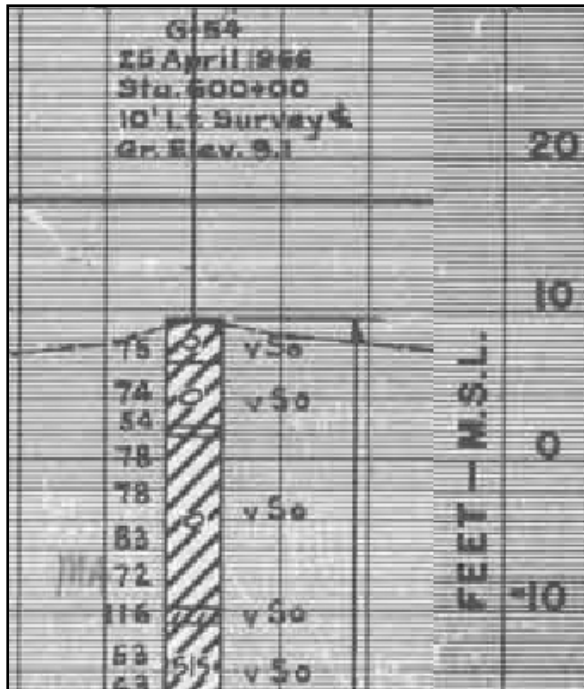
Figure 13-30. Nearest Boring at 10 ft Offset from B/L Sta 600+00 (from drawing file H-2-23820, plate 13) Shows 1966 Hydraulic Fill (dredge spoil) Surface at Elevation 10 ft Was Very Soft Fat Clay

Soil boring 13BU-CHBD (01-16834) taken in 2001 at Sta 614+00 (Martello Castle) shows the top 25 ft of levee (elevation 15.4) was composed of fat clay (CH), with organic clays and peats underneath. At a depth of 5 ft below the crown, a shear Q test indicated cohesion value 632 psf at 29% water content and 92 pcf dry density in the CH layer.

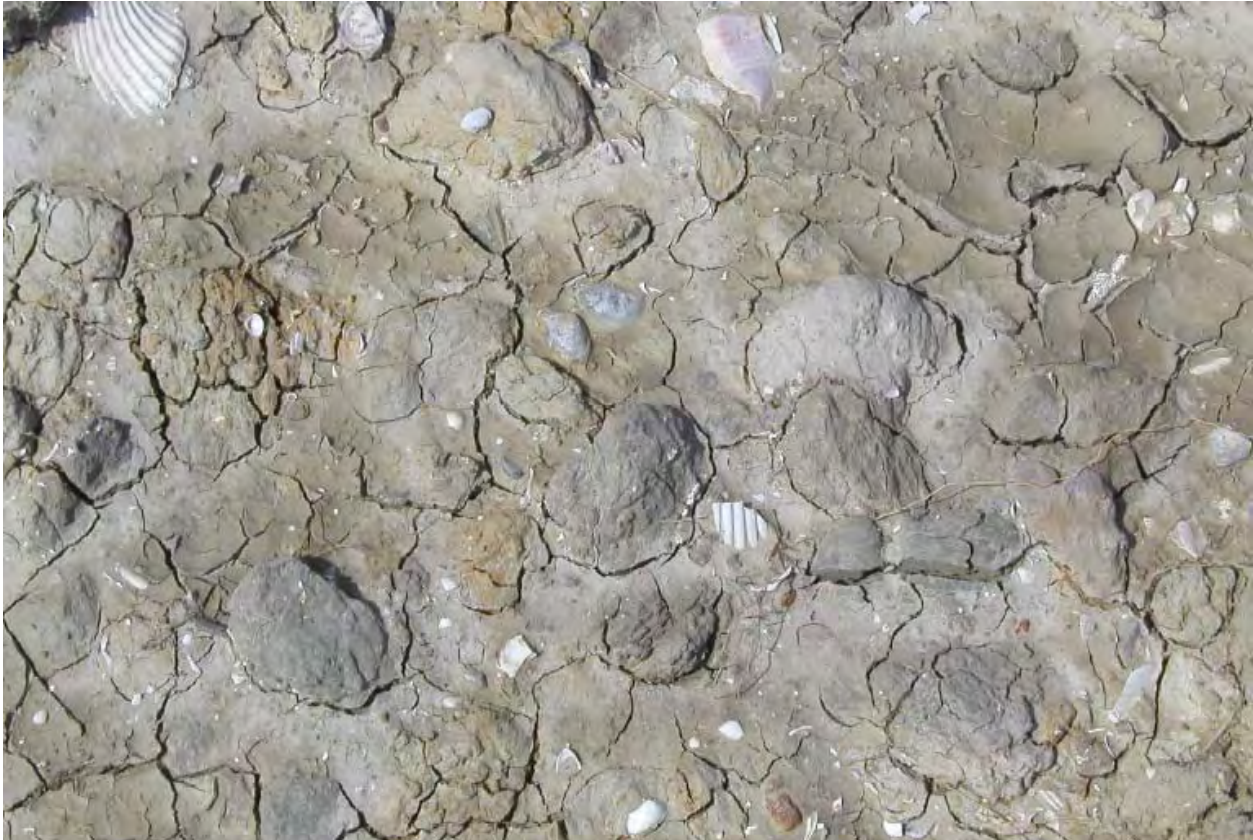
Figure 13-31. Exposed Soil Layer (final eroded surface) on Sheetpile Wall Backside Appears to be In-Situ Fat Clay with Embedded Shell Hash, Possibly an Exposed Estuarine Deposit

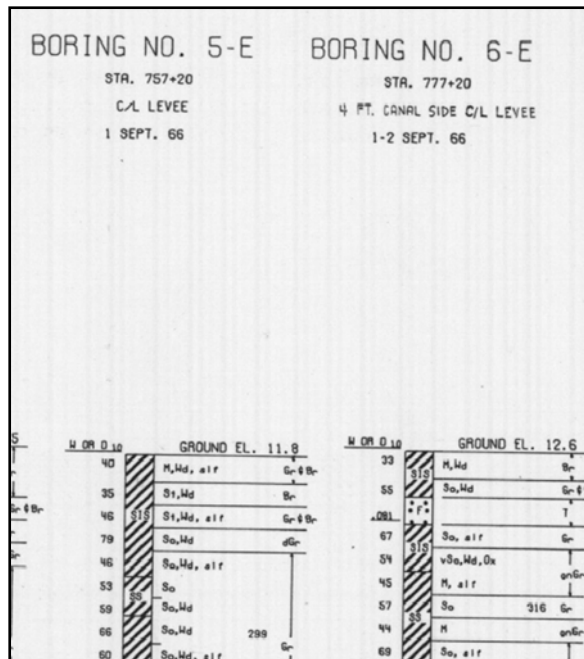
Figure 13-33. Nearest Borings on Either Side of the Breach, 5-E and 6-E (from plate 5, DM2 Supp 4, March 1971) Show CH Material With Sand / Silt Lenses in the Pre-Existing (1965) Levee at Crown Elevation ~12 ft, Prior to Sheetpile Wall. Storm surge in the GIWW was approximately 15 to 17 ft elevation

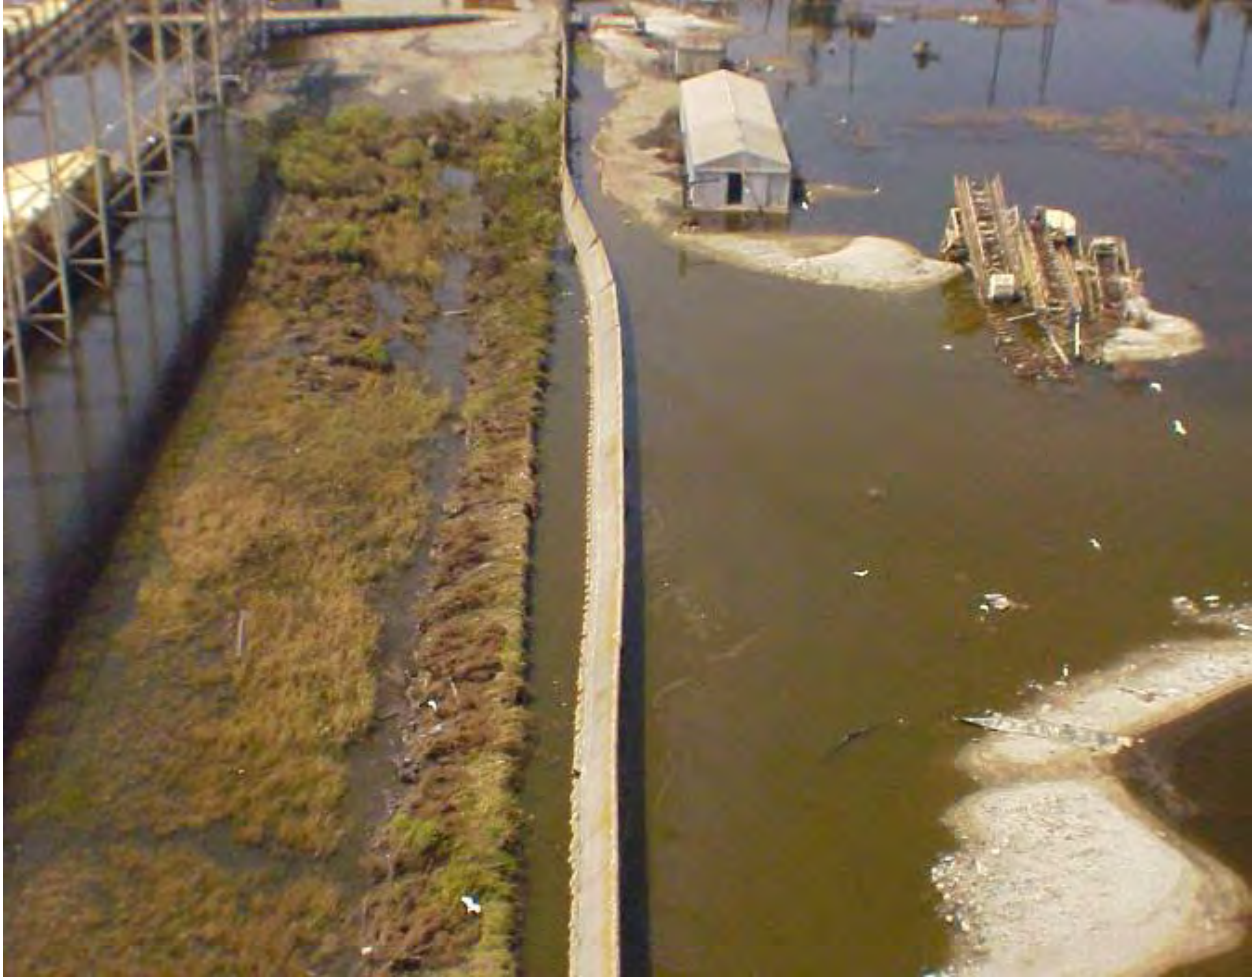
Figure 13-34. Bulk Loading Facility I-Wall Breach (2000' near Elaine St. at GIWW, near Sta 271+55 B/L, Citrus Back Levee, north bank GIWW). Scour depths were 6 to 10 ft on both floodside and protected side of the I-wall. Pre-existing wall elevation was approximately 15 ft (MSL), and levee elevation was approximately 9 ft (MSL), for an exposed wall height of approximately 6 ft. Storm surge ranged from elevation 15 to 17 ft

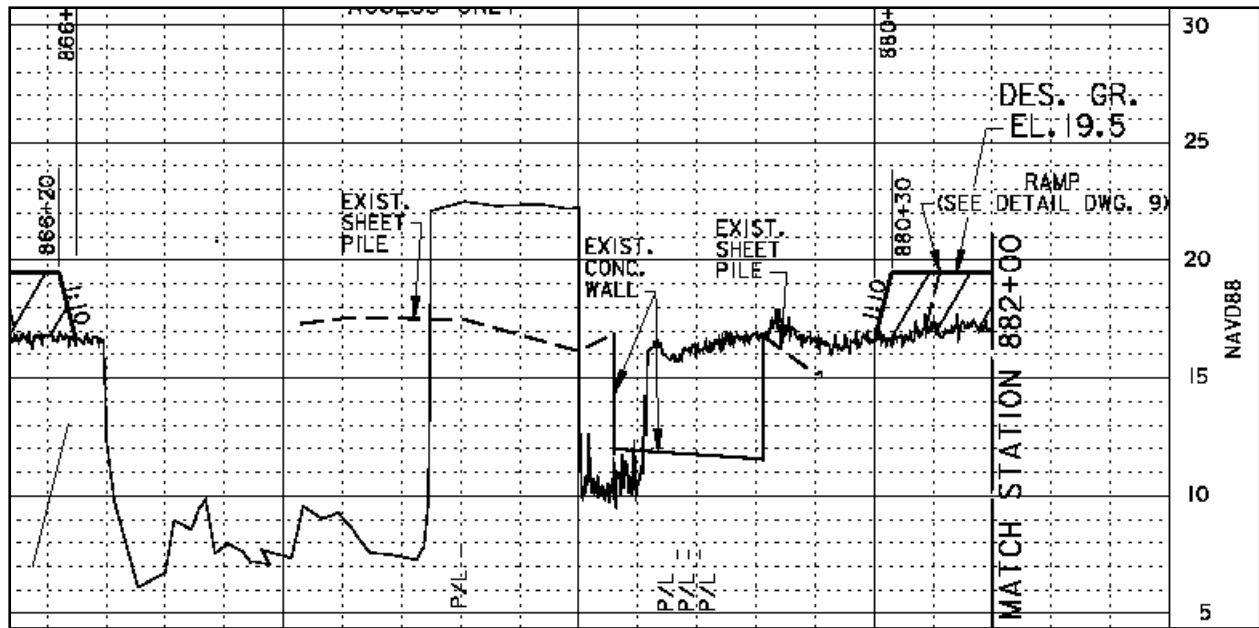
Figure 13-37. Plan and Post-Damage Scour Profile Immediately West of Pump Station 15 (from Contract Solicitation NOE1 drawing H-8-45594, sheet 3 of 16)

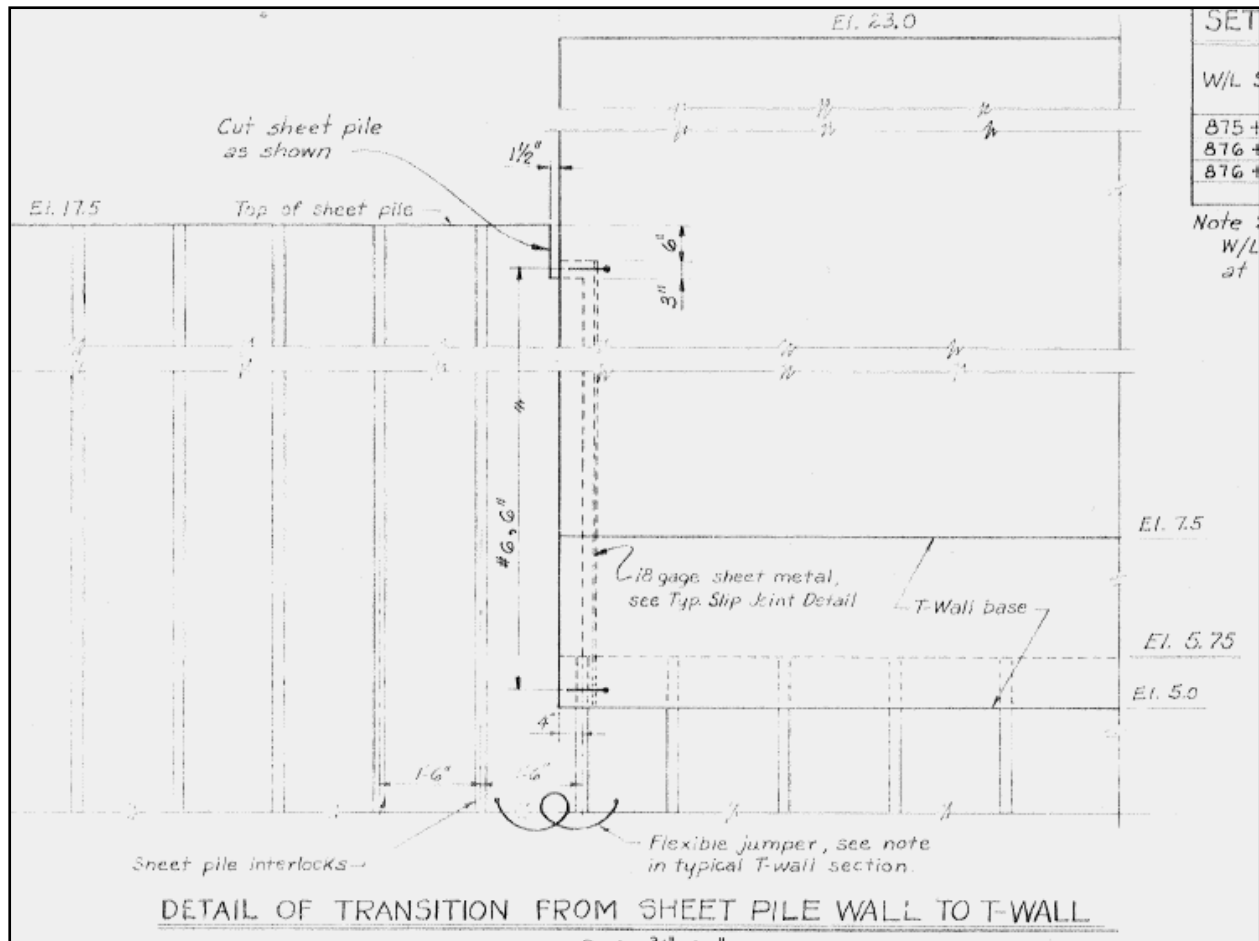
Figure 13-38. Pump Station 15 Top Elevation Difference of 5.5' Between Sheet Pile and T-Wall (plate 14 of 16 from Contract DACW29-77-C-0037, Mod P00001). If pre-Katrina sheetpile elevation was 17.5 ft and storm surge in the MRGO/GIWW was up to 18 ft, then there was minimal overtopping, and the sheetpile breach may have had contributing factors other than overtopping scour

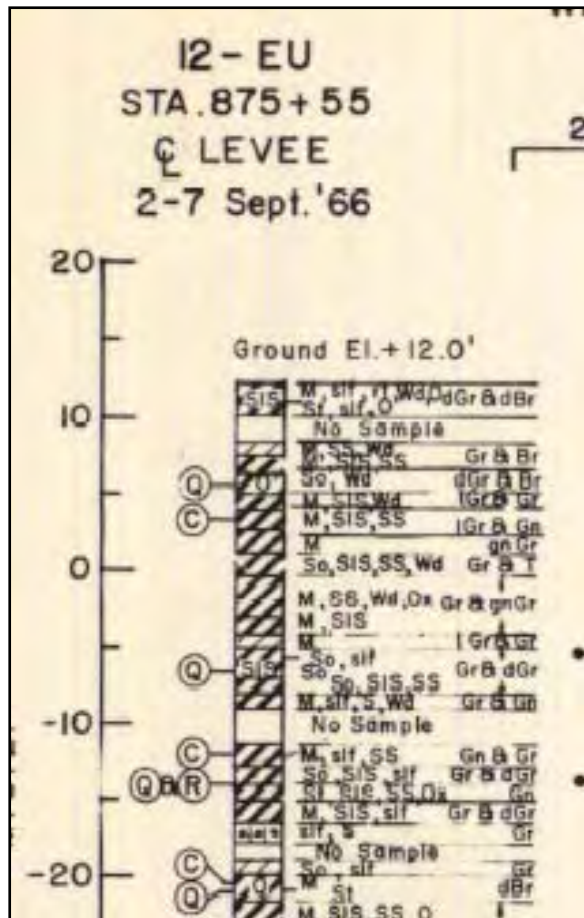
Figure 13-39. Pump Station 15 Nearest Boring 12EU Shows Levee Crown Elevation at 12 ft (MSL) with Fat Clay / Sand / Silt Lenses Overlying Lean Clay (CL) in the Upper 5 ft (from drawing file H-2-24625, plate 3)

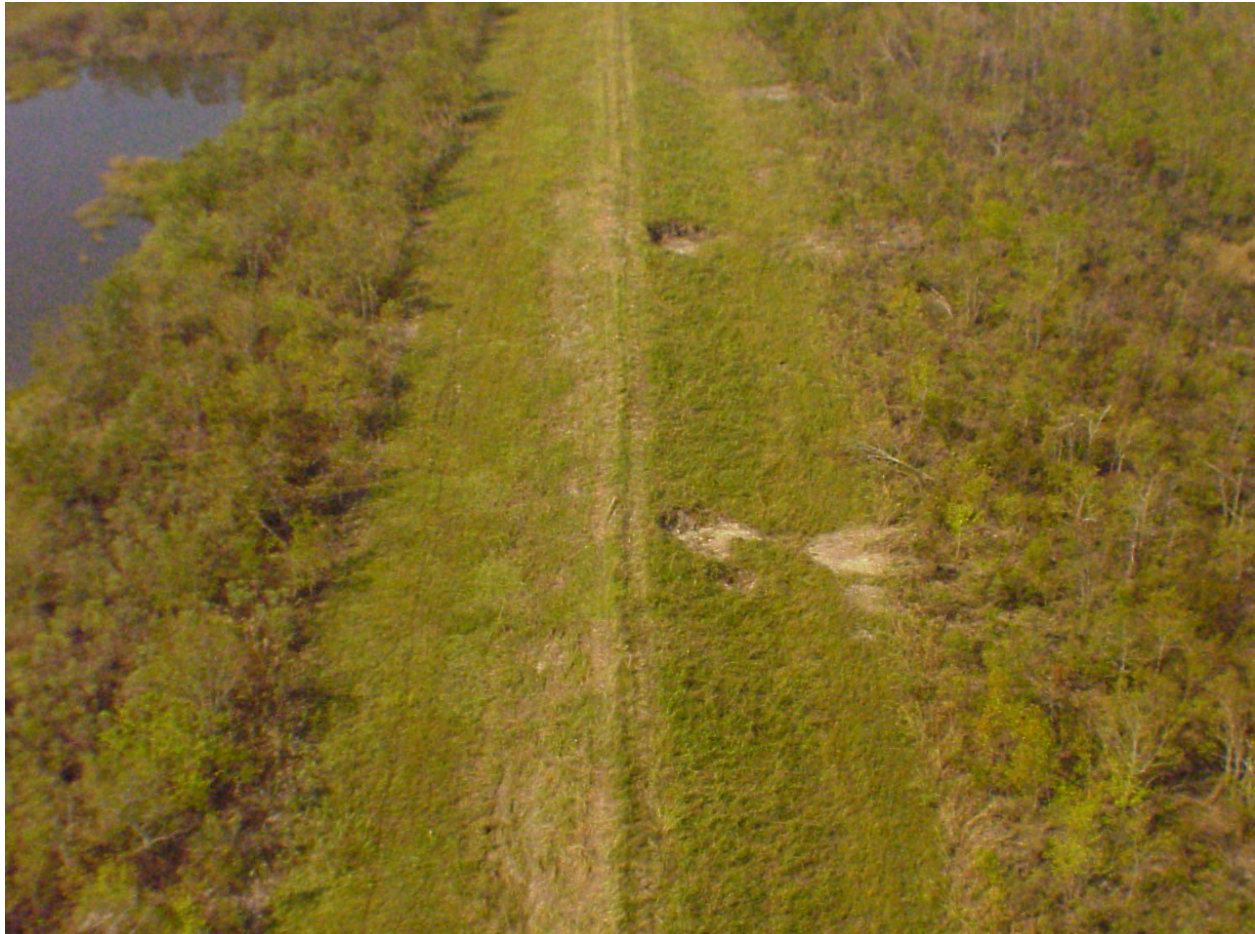
Figures 13-42 and 13-43 show examples of initial overtopping erosion on the Citrus Back Levee backside along the north bank of the GIWW in New Orleans East. The levee crown was elevation 14 to 15 ft and storm surge was 15 to 17 ft from the GIWW, so the overtopping crest

depth was approximately 1 to 2 ft. Approximate surge velocity down a 1:4 slope was 40 fps with shear stress 30 psf. Soil borings along this reach indicated non-homogeneity in the surficial layers of the levee crest and slopes, and cohesive soils with interbedded layers of silt and/or sand were typical.

Figure 13-42. Backside Levee Erosion Pattern “B” on the Citrus Back Levee, N.O. East

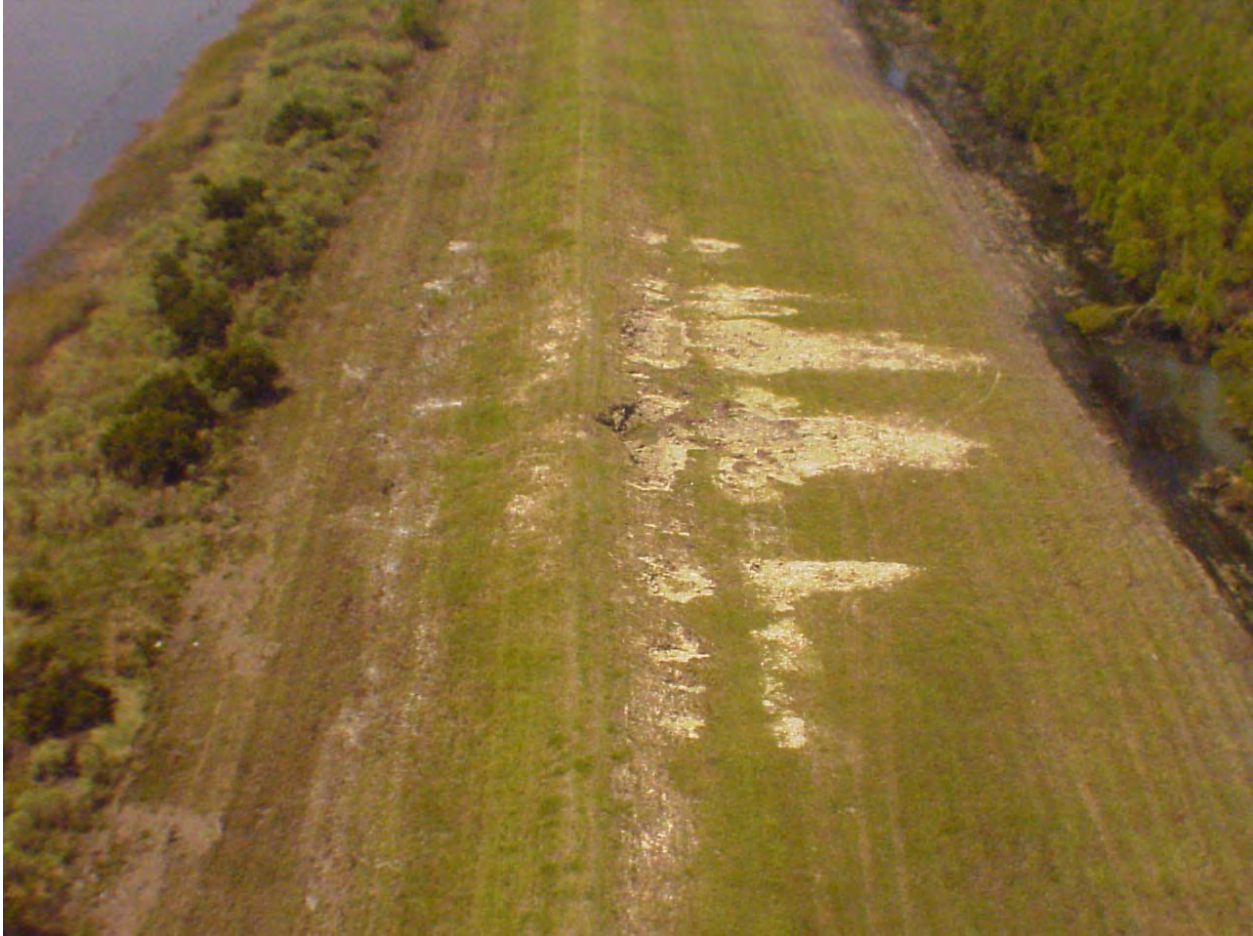
Figure 13-43. 600' Reach of Levee Along the North Bank of the GIWW (Citrus Back Levee, New Orleans East) Between Elaine Pump Station and Paris Road
