Appendix 1

Soil Data Report for 17th Street Canal

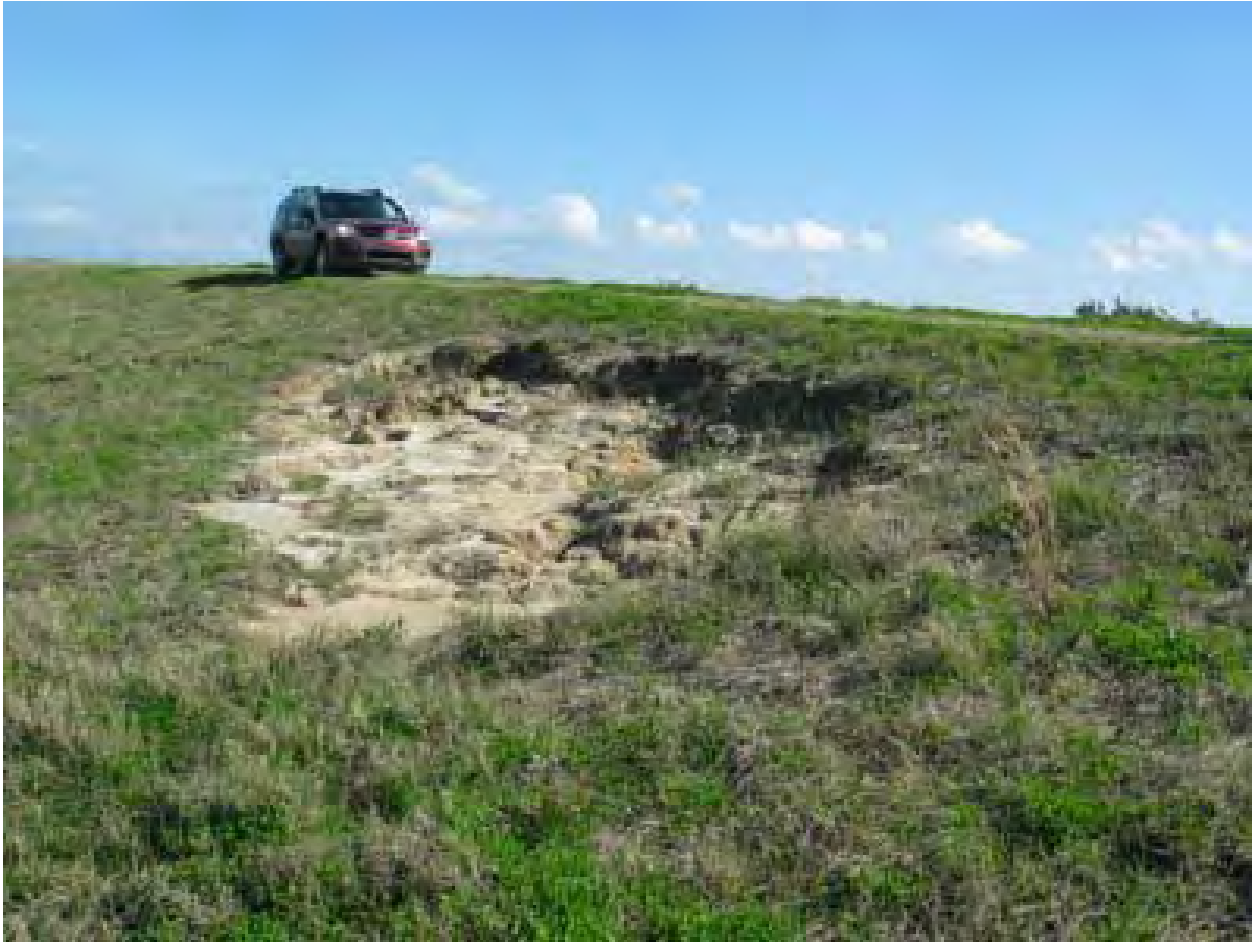
Figure 13-44 shows a closeup of landside slope scour between the Highway 47 (Paris Rd) overpass and the Elaine Pump Station from the north bank of the GIWW protected side looking east (Citrus Back Levee, New Orleans East). Erosion damage measured 24' (length) x 13' (width) x 8" (depth). Note the headcut that developed up the slope toward the crest.

Figure 13-44. Closeup of Landside Slope Erosion at N 30deg 0 min 2.29sec W 89deg 58min 27.29sec

There is a possibility that the Figure 13-44 erosion was pre-Katrina, as seen in pre-Katrina satellite photo below (Figure 13-45).

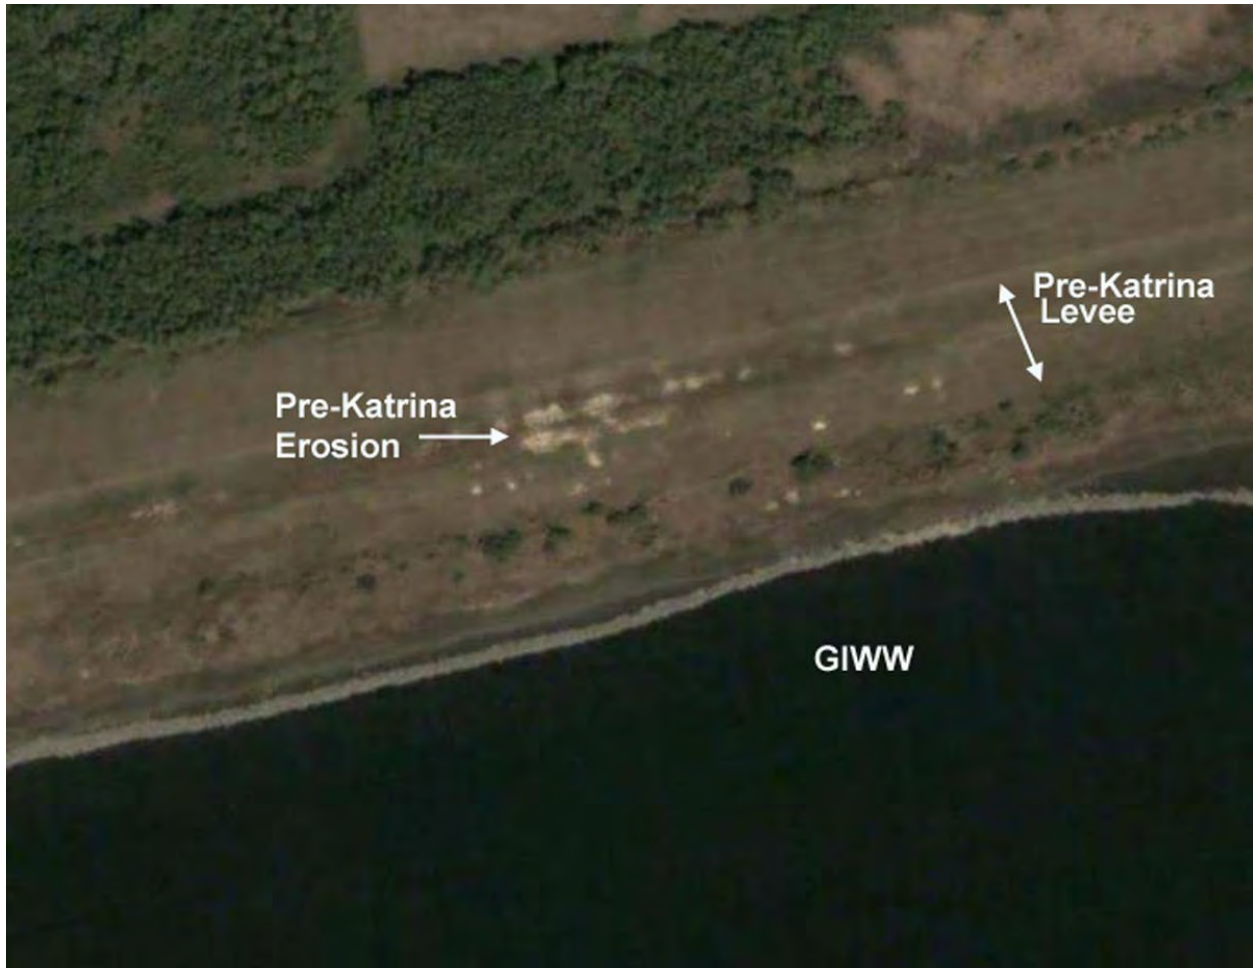
Figure 13-45. Possible Pre-Existing Surface Erosion on Levee Slopes Along the North Bank of the GIWW (Citrus Back Levee) at N 30deg 0 min 7 sec W 89deg 58min 31 sec. (pre-Katrina image from GoogleEarth website). Possible erosion is evidenced by vegetation distress and bare spots along the levee

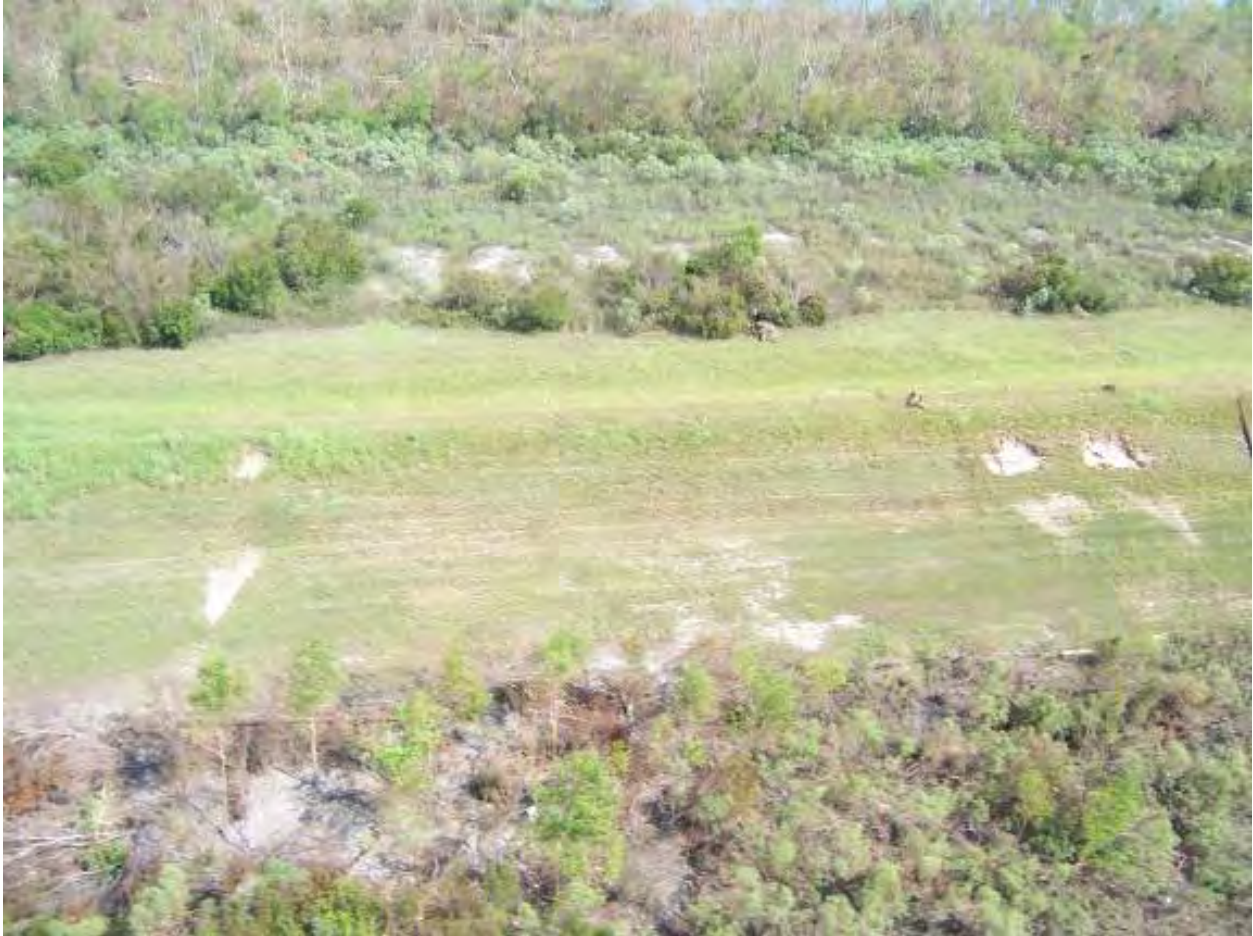
Figure 13-46 shows backside slope erosion and minor erosion on the stabilizing berm slope along the south bank GIWW levee between Sta. 65+008 and STA. 277+20 in St. Bernard Parish. The General Design section for the south bank GIWW indicated that the levee was built to approximate elevation +14 ft. circa 1970, and an additional lift up to elevation 19 was added circa 1985 (Figure 13-47). Post-Katrina LIDAR along the south bank GIWW shows the uneroded levee crown was up to approximate elevation 16 ft (Figures 13-48 and 13-49). Storm surge along the GIWW was approximately 15 to 17 ft, causing an estimated overtopping depth of approximately 1 to 2 ft and an approximate overtopping velocity of 40 fps. Drawing 9 of 19, New Orleans District file H-8-45533, shows several layers of hard lean clay (CL) at centerline top of levee (boring elevation 16.8 ft) from the 5/11/2000 soil boring 5A-CAU, B/L Sta 135+50 (Figure 13-51).

Figure 13-46. Scour on the Backside of the South Bank GIWW Levee Between STA. 65+008 and STA. 277+20, St. Bernard Parish, Minor Scour on the Protected Side Levee Transition Slope. The Paris Rd (I-510) high rise bridge is over approximate B/L Sta 270+00

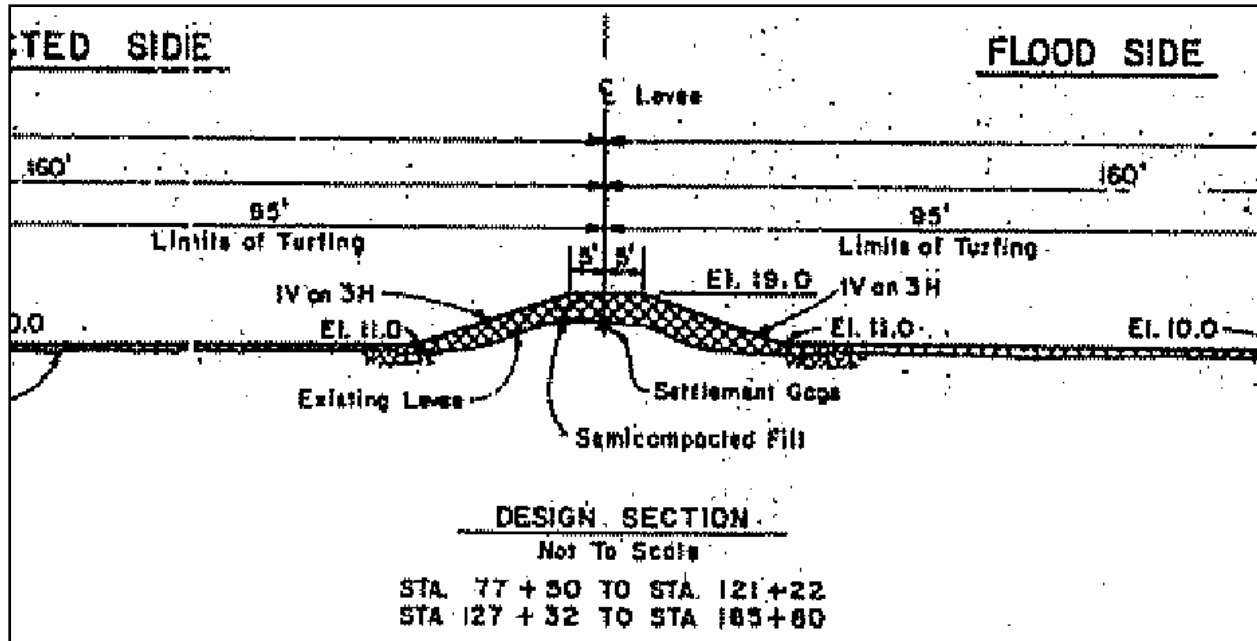
Figure 13-47. Design Section for South Bank GIWW Levee Enlargement in 1985. Levee was built to approximate elevation +14 ft. circa 1970. Additional lift up to elevation 19 was added circa 1985. Post-Katrina LIDAR along the south bank GIWW shows the unscoured levee crown was up to approximate elevation 16 ft. Storm surge along the GIWW was approximately 15 to 17 ft, causing an overtopping crest of 1 to 2 ft

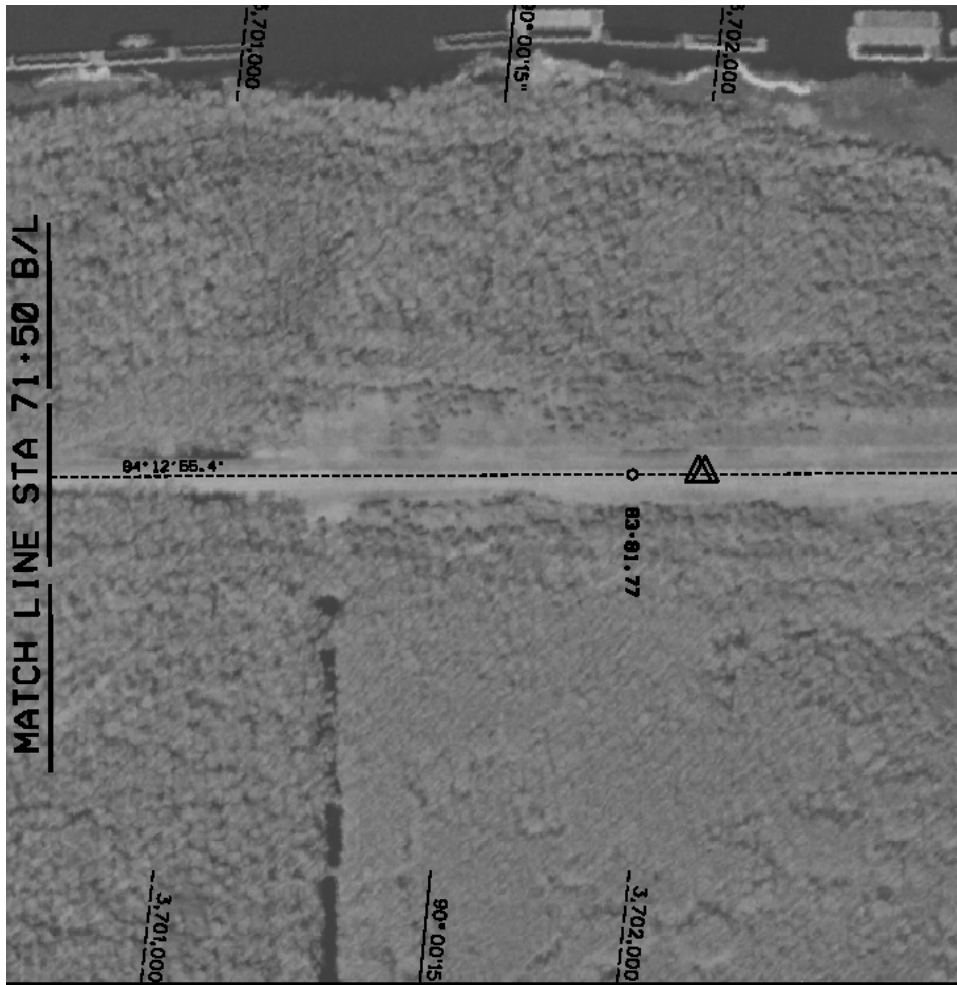
Figure 13-48. Scour Damage (Marked with Triangle) Identified East of B/L Sta 81+50 (from TFG Contract Solicitation W912PB-06-R-0022, drawing 3 of 12)

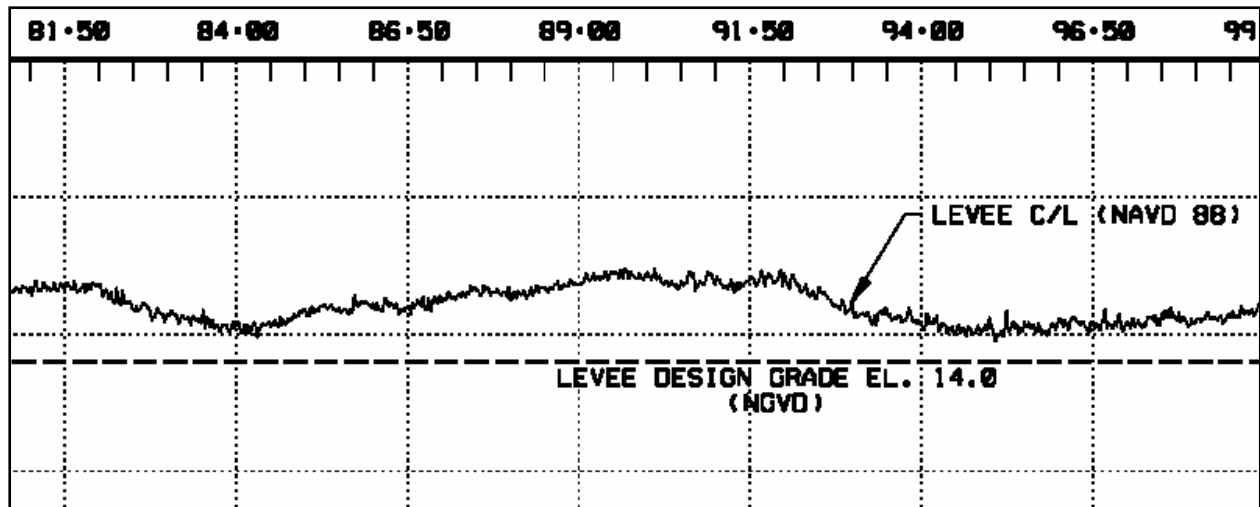
Figure 13-49. Levee Profile East of B/L Sta 81+50 (dwg 3 of 12). Note design grade elev 14 (NGVD) and lidar post-Katrina elev between 14 and 16 (NAVD 88). Also note crown grade change up to 2 ft along this 1750-ft reach

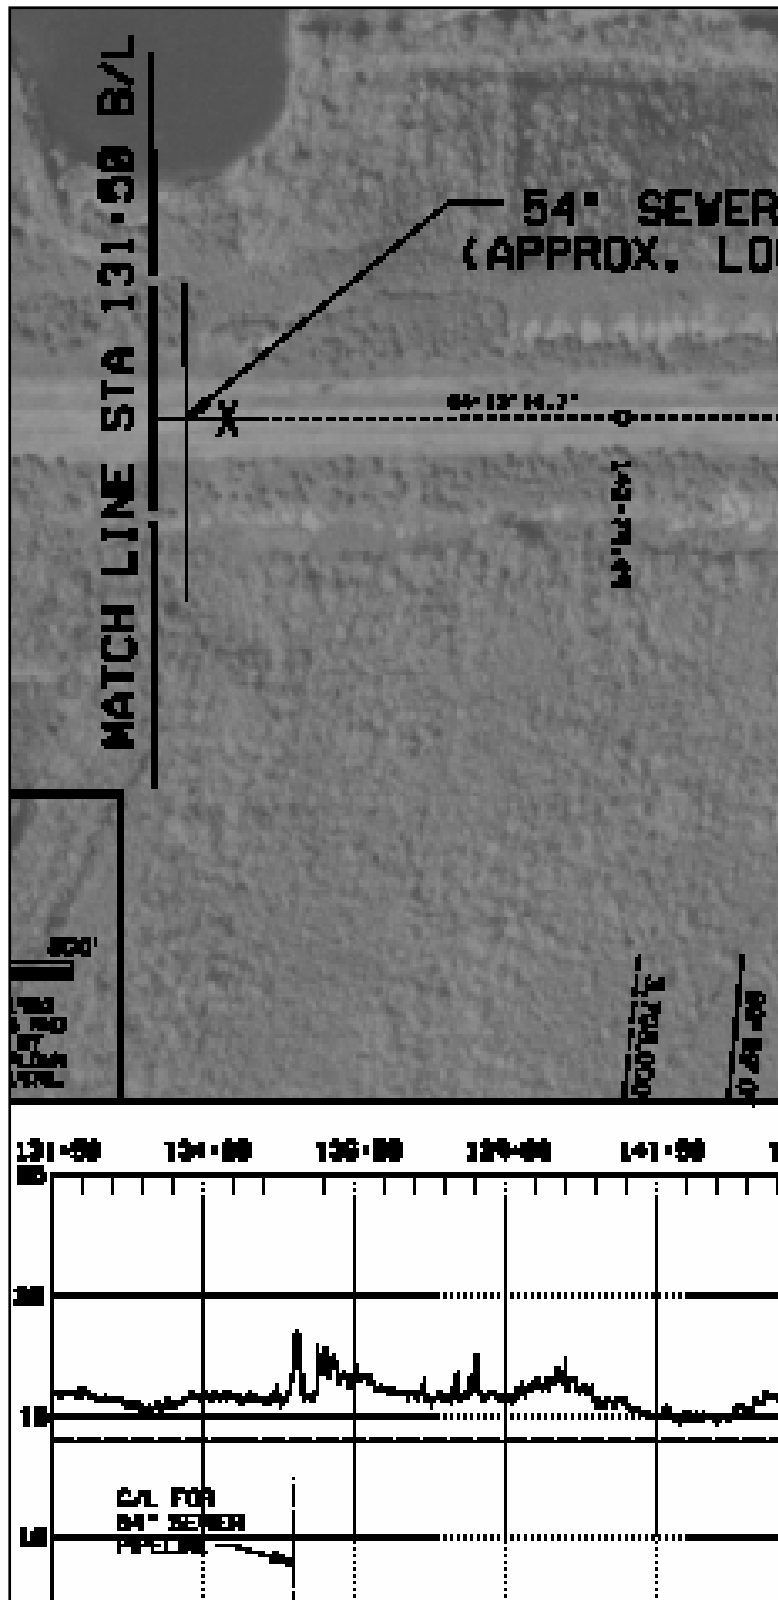
Figure 13-50. A Minor Scour Location on St. Bernard Parish South Bank GIWW Levee (marked with X) at B/L Sta 135+00 (from dwg 4 of 12, Contract Solicitation W912P8-06-R-0022)

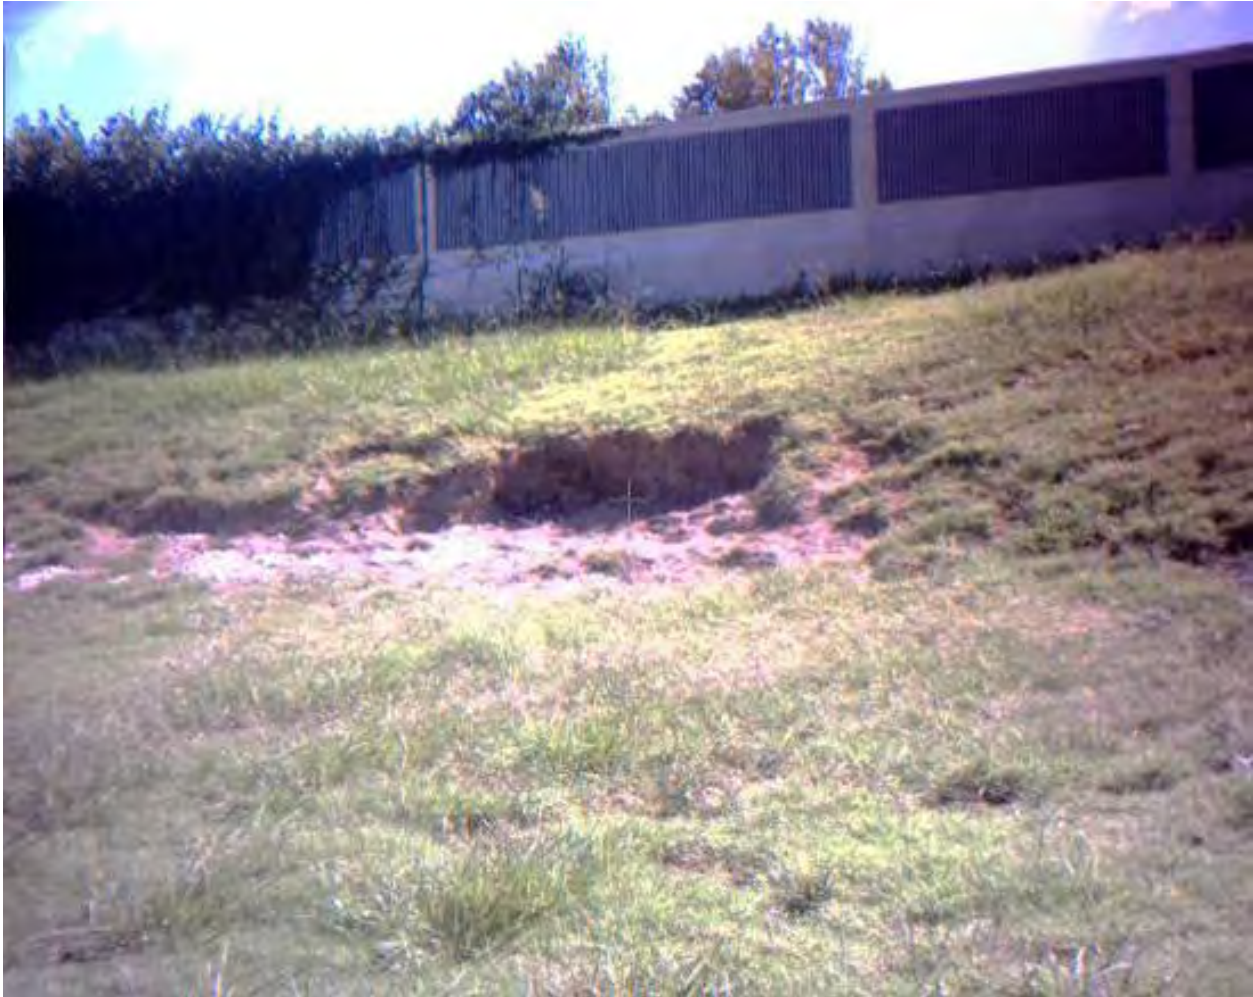
Figure 13-52. New Orleans East Bank Lake Pontchartrain Floodwall Scour, 20ft long x 10ft wide x 2ft deep. GPS coords N90 deg 05min 17.3 sec, W30deg 01 min 39.3 sec

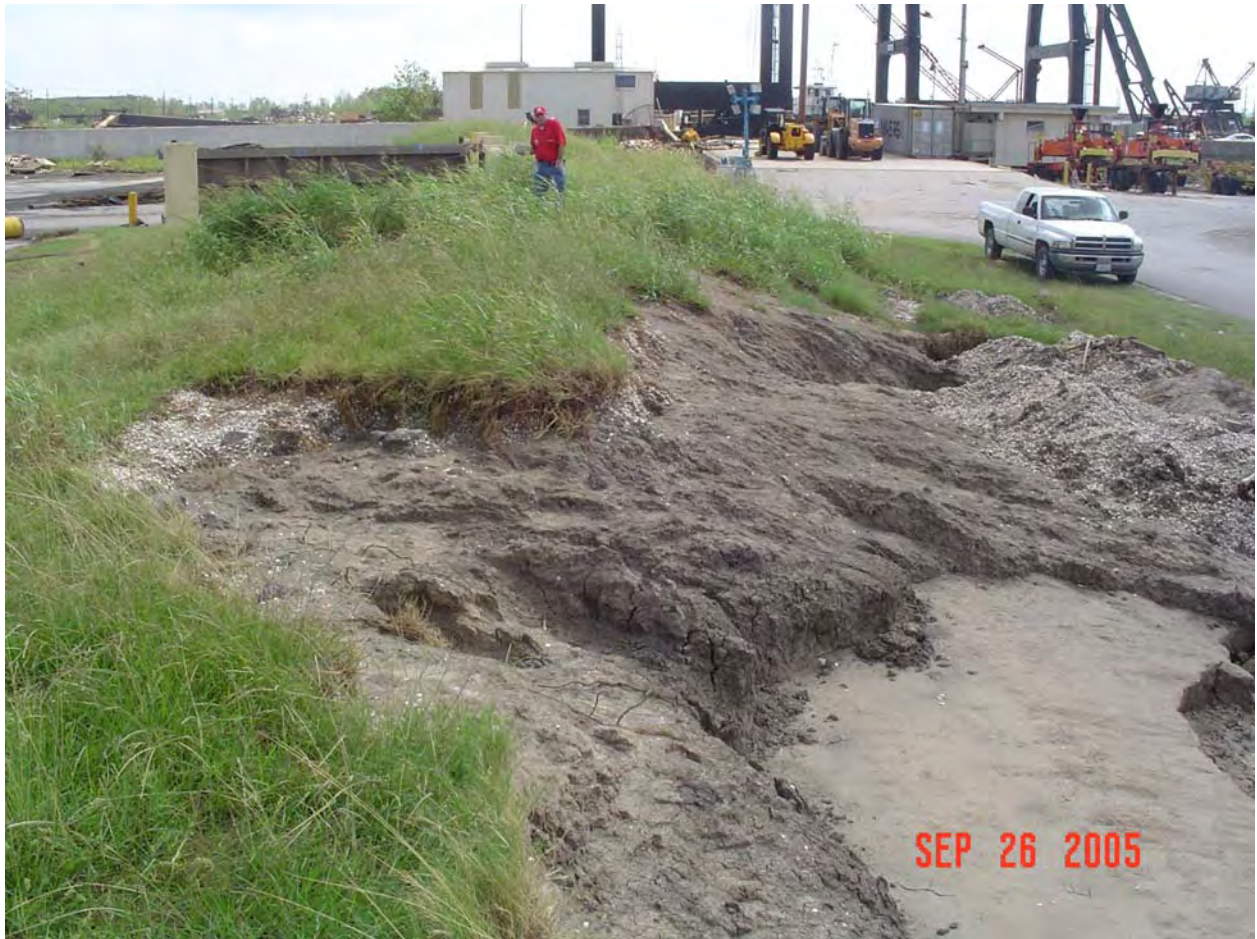
Figure 13-53 shows a short levee section with progressive erosion on the west side of the IHNC protecting the container terminal between France Rd. and IHNC. The headcut extends to the top crest elevation, and was beginning to cut through the crown. Although the nearest historical boring pre-dates the levee (Figure 13-54), the unscoured soil surface appears to be a fat clay and the eroded soil visually appears to be a shell hash mixture of clay and oyster shell fragments.

Figure 13-53. Eroded Levee Crown on the IHNC West Side at Container Facility

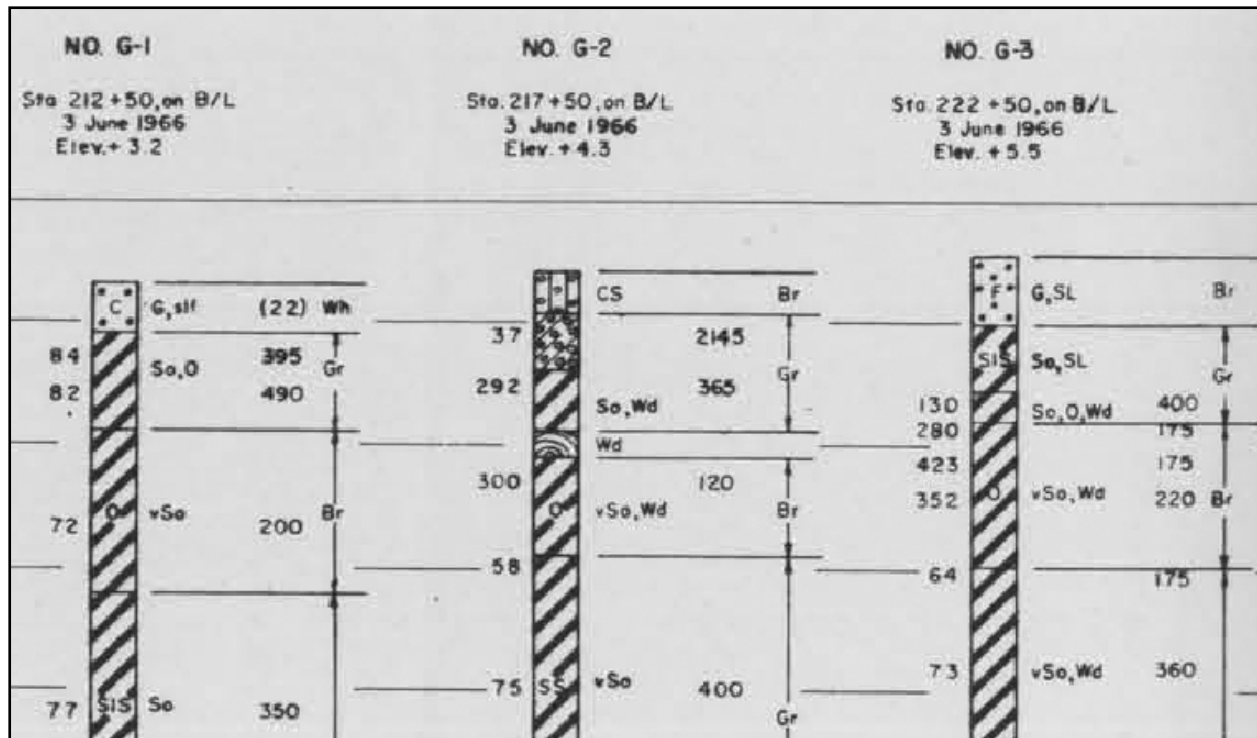
Figure 13-54. Nearest Boring, G-3, Shows Original Ground at Elev 5.5 ft is Sandy Soil

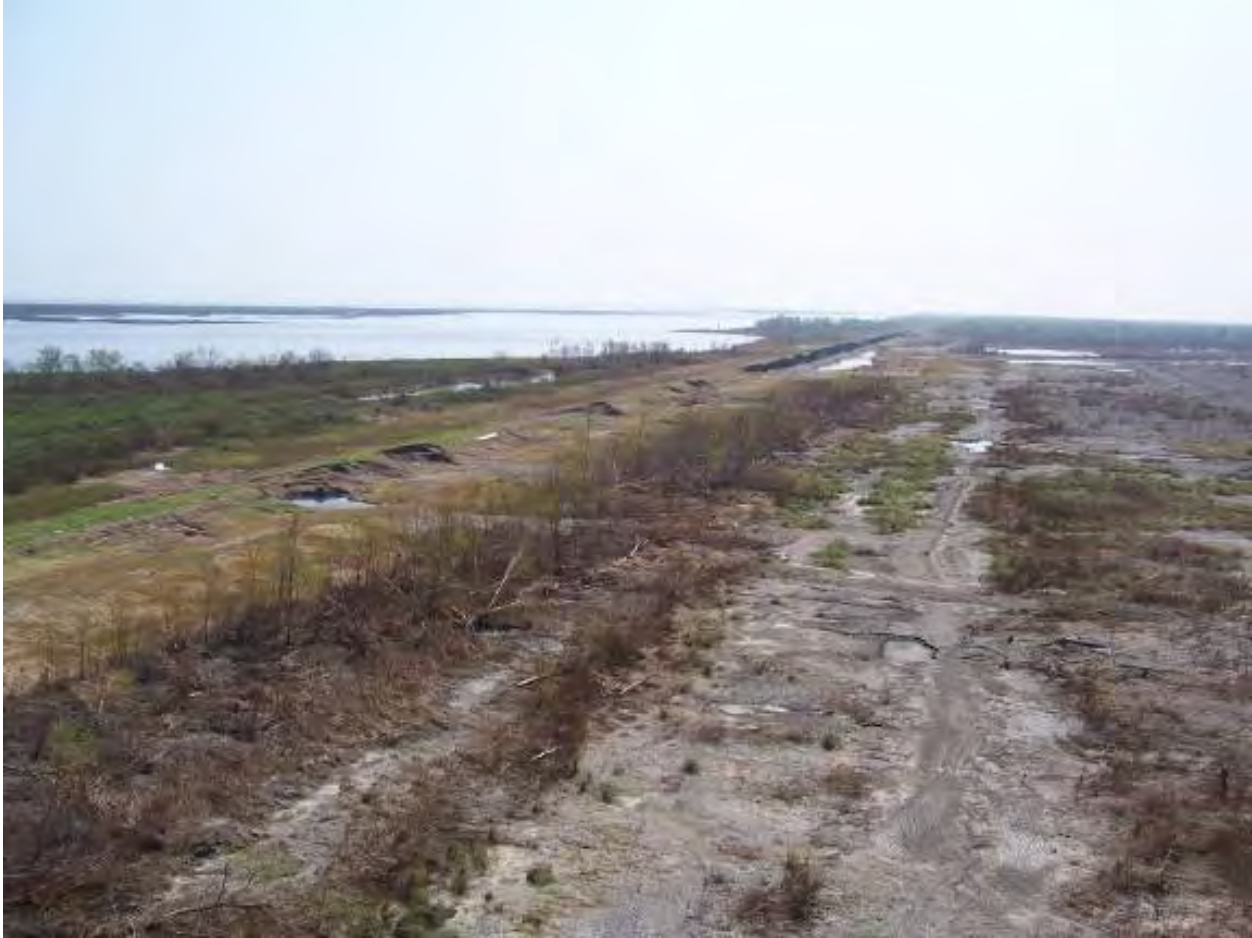
Figure 13-55. Levee with Eroded Crown Between Bienvenue and Dupre Bayous, View South From Approximate B/L Sta 570+00. MRGO is to the Left of Photo

Soil boring 12BU-CHBD (01-16834) from 2001 at Sta 570+00 (Martello Castle) shows the top 1.4 ft of levee (elevation 16) was composed of lean clay (CL), with CH layers underneath. At a depth of 8.5 ft below the crown, a shear Q test indicated cohesion value 270 psf at 51% water content and 68 pcf dry density in a CH layer. At a depth of 16.8 ft, cohesion was slightly higher (396 psf) at 62% water content and 62 pcf dry density, also in a CH layer.

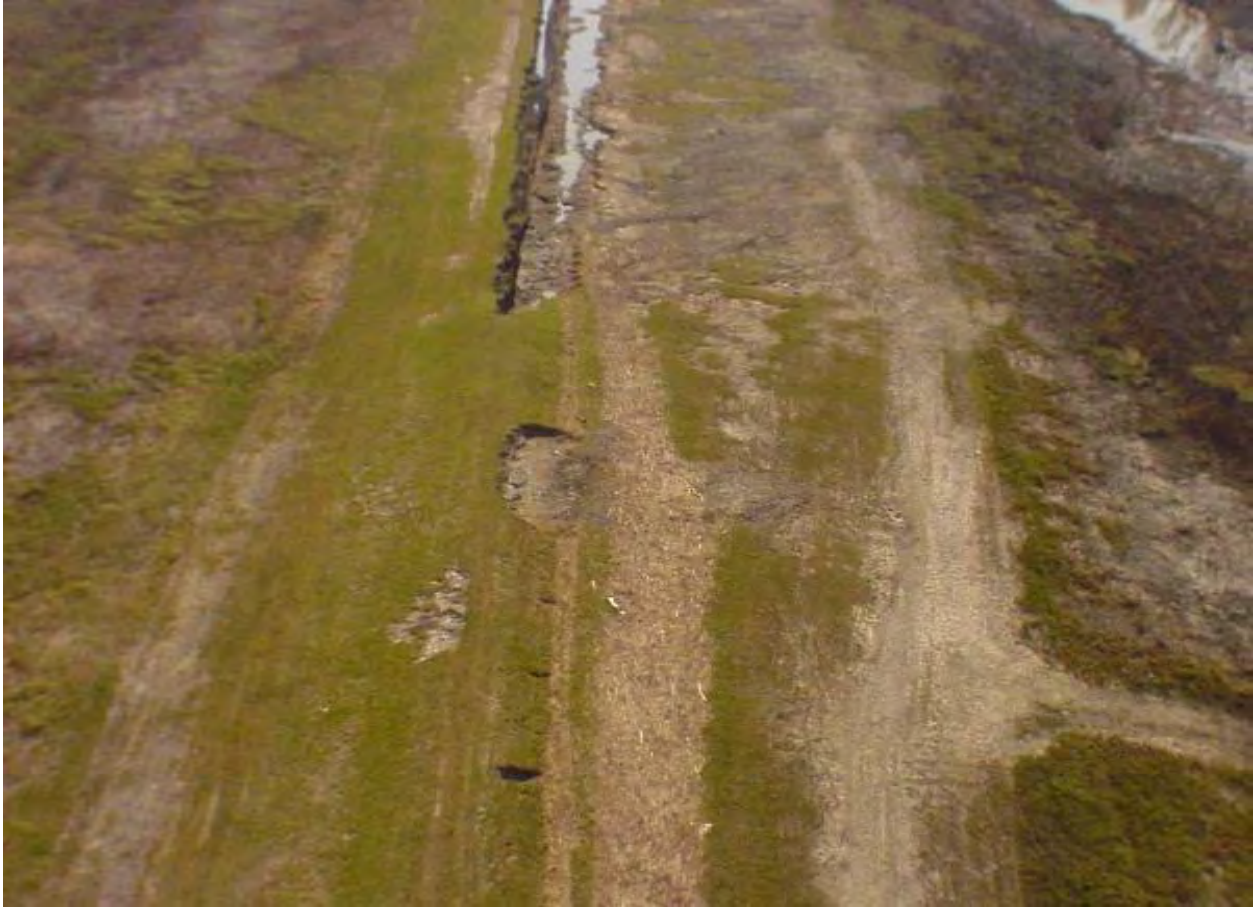
Figures 13-56 through 13-58 show progressive crown scour along approximate B/L Sta 1203+00 to Sta 1230+00 on the St. Bernard levee between the MRGO and the Mississippi River. Crown elevation was approximately 15 ft, but dropped to about 12 ft for about a mile in this eroded section. The levee along this reach was constructed of Mississippi River hydraulic sand fill, capped with local borrow material fat clay interbedded with silt and/or sand lenses, and shaped to grade with Mississippi River batture soil (truck-hauled fill). Similar to other levee’s construction materials and history, this section contains heterogeneous soil layering probably compacted to different densities over a half-century or so timeframe.

Figure 13-56. Crown Scour Along Approximate B/L Sta 1203+00 to Sta 1230+00, St. Bernard Levee Between MRGO and Miss. River. Crown was Approximate Elevation 15 ft

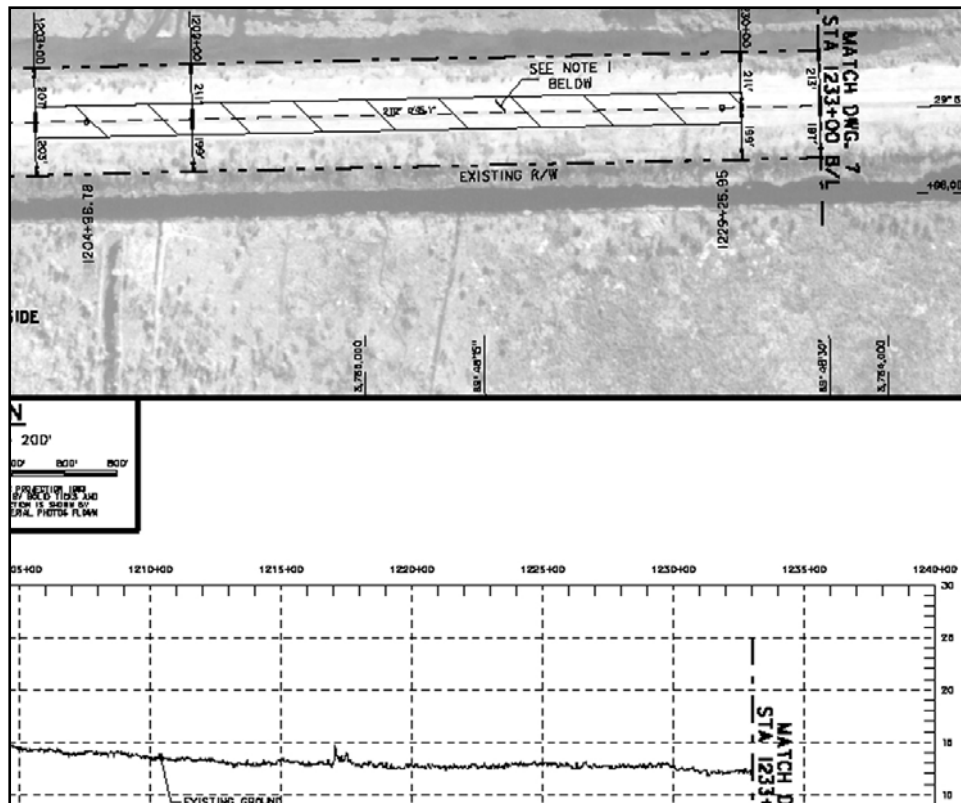
Figure 13-57. Levee Crown Elevation Drops from Elev 15 ft to Elev 12 ft in the Scour Area. Elevation 12 ft remains fairly constant along the reach for about a mile beyond the scour section. From Contract Solicitation STB08 W912P8-06-R-0094, drawing sheet C-06

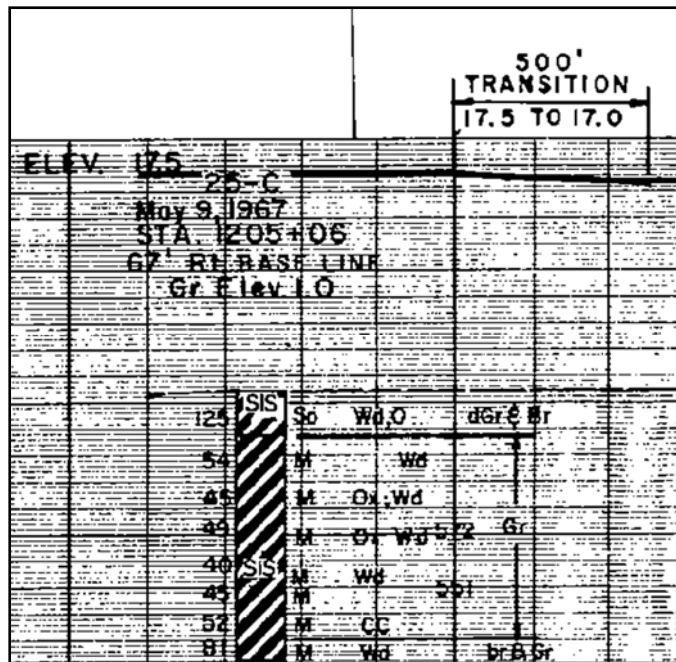
Figure 13-58. Original 1967 Boring at Ground Elevation 1 ft shows Fat Clay With Silt / Sand Lenses (from DM3 Chalmette Extension drawing file H-2- 24306, plate 7). The levee along this reach was constructed of Miss. River hydraulic sand fill, capped with local borrow clay, and shaped to grade with Miss. River batture soil (truck-hauled fill)

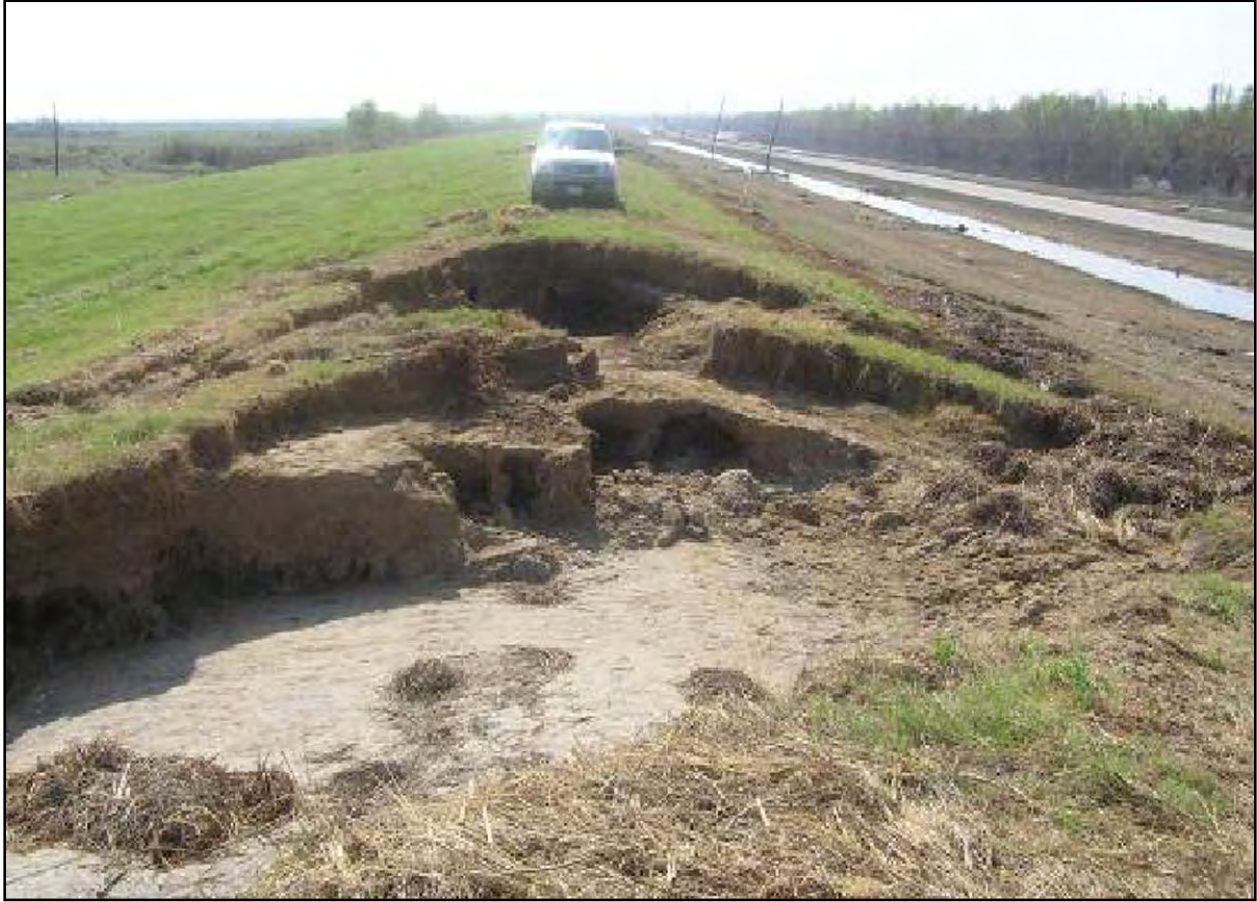
Figure 13-59 shows a section of Plaquemines Parish east bank back levee along Reach C (Phoenix to Bohemia, between river miles 59.3 and 44.3). Approximately 3 miles of crown erosion were noted along this 16-mile reach. This levee is approximate elevation 17 ft, and consists of a hydraulic-filled sand core with trucked-in clay blanket cap. Note the erosion has cut through the clay cap, moving clay blocks as erosion progressed downward to the sand layer.

Figure 13-59. Plaquemines Parish East Bank Back Levee Erosion

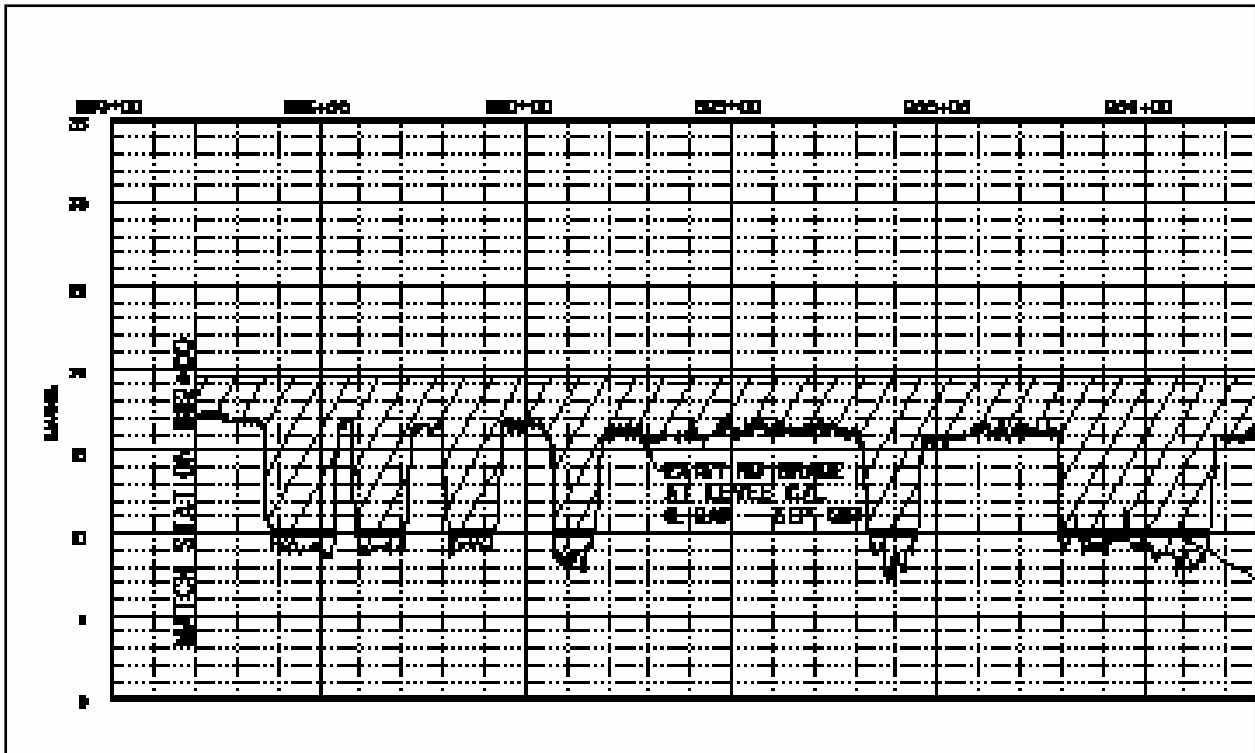
Figure 13-61. LIDAR Profiles of Levee East of Pump Sta 15 (from Contract Solicitation NOE1 drawings)

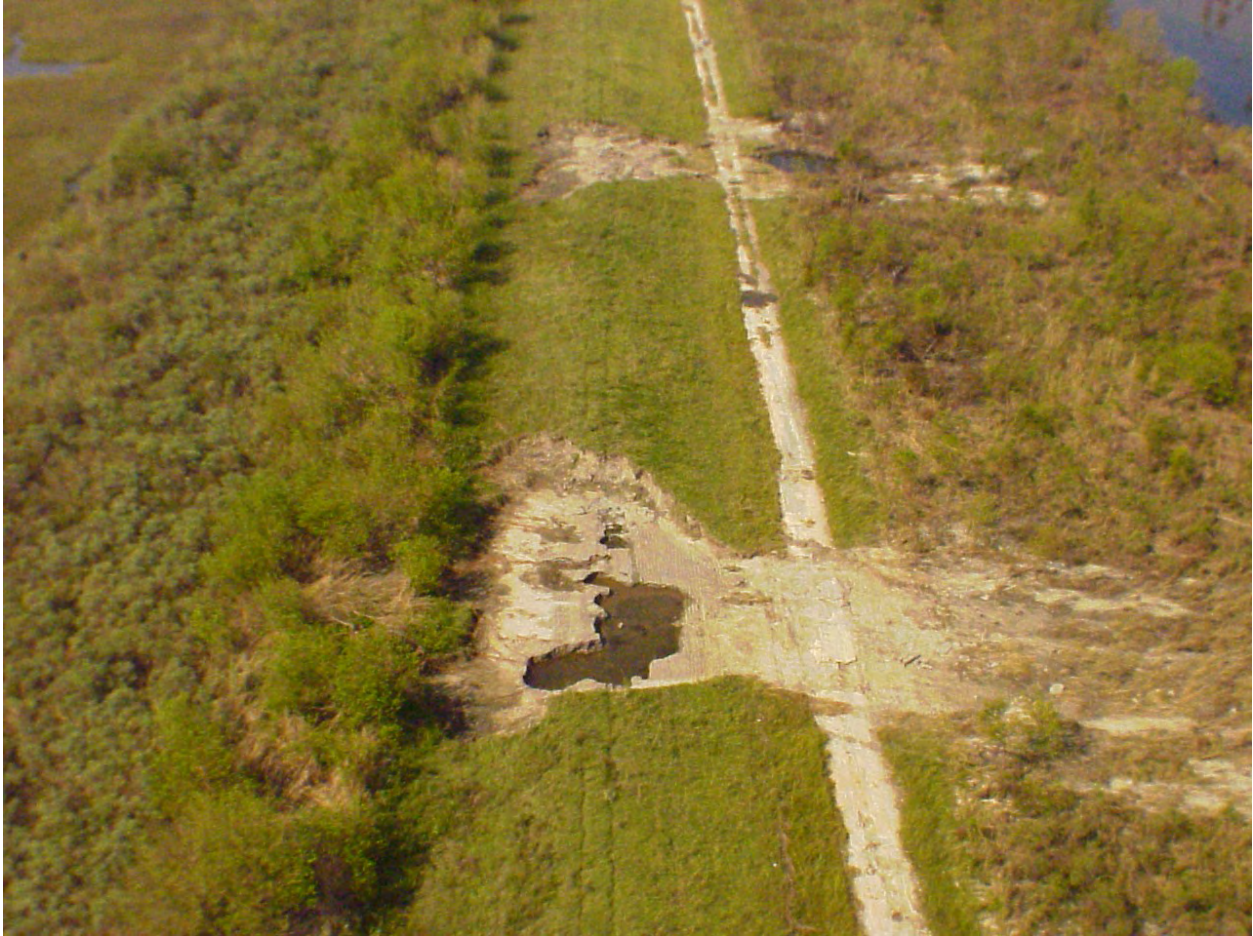
Figure 13-62. Partial Breach East of Pump Station 15

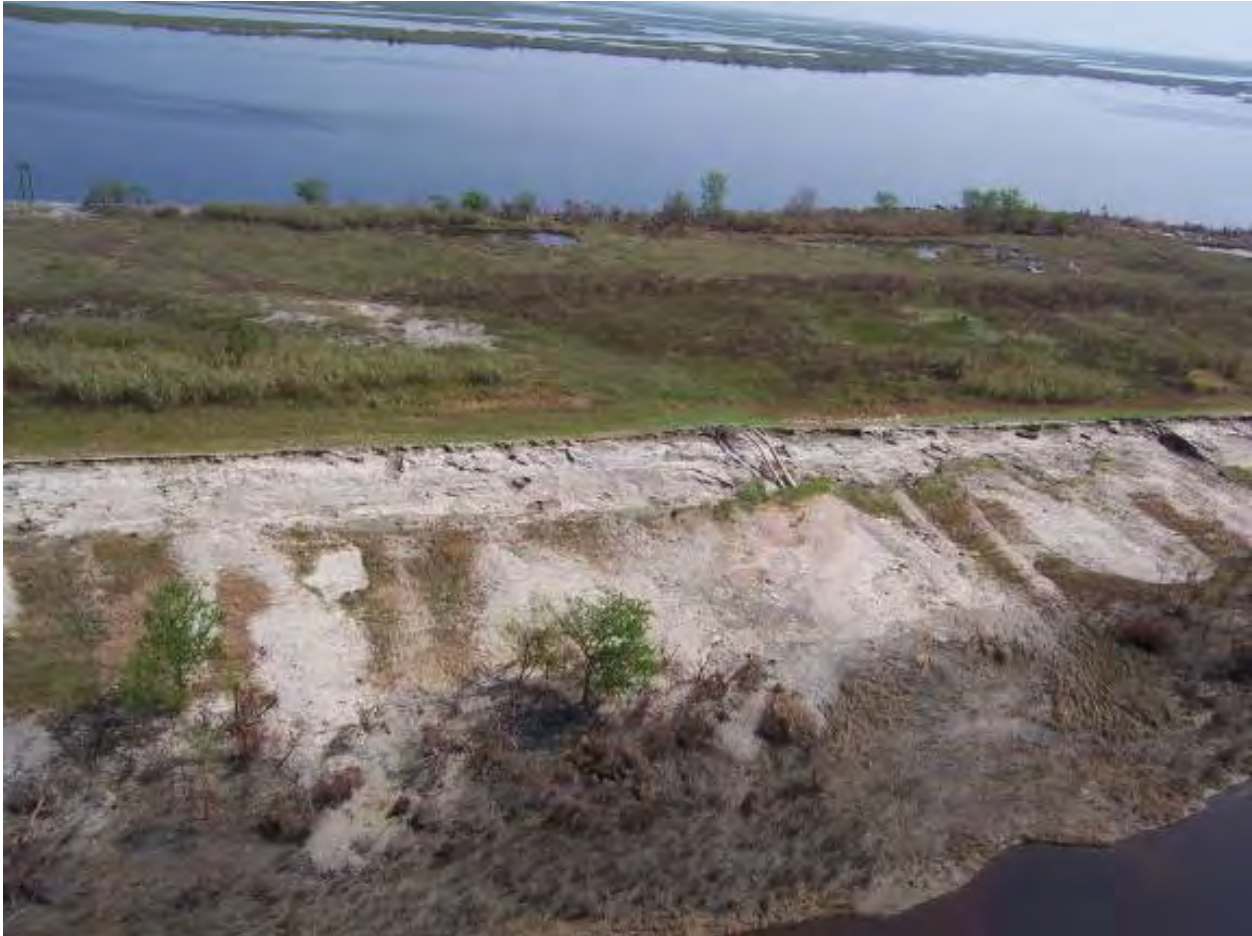
Figure 13-63. 19,000 ft. of Levee Between Bayou Bienvenue (Sta 383+00) and Bayou Dupre (Sta 704+00) Lost Approximately 12' of Levee Height From Original (design) Height 17.5 ft. Pre-Katrina elevation was approximately 12 ft, and storm surge along the MRGO was approximately 18 ft, causing an overtopping crest of up to 6 ft

Hydraulic fill from the MRGO channel formed the levee between Bienvenue and Dupre. Soil boring 9BU-CHBD (01-16834) from 2001 at Sta 445+00 shows the top 1.5 ft of the levee (elevation 18.1 ft) was composed of lean clay (CL). The underlying layers are mostly fat clay (CH) with interbedded lean clay layers. At a depth of 9.7 ft below the crown, a shear Q test indicated cohesion value 238 psf at 32% water content and 88 pcf dry density in a CH layer.

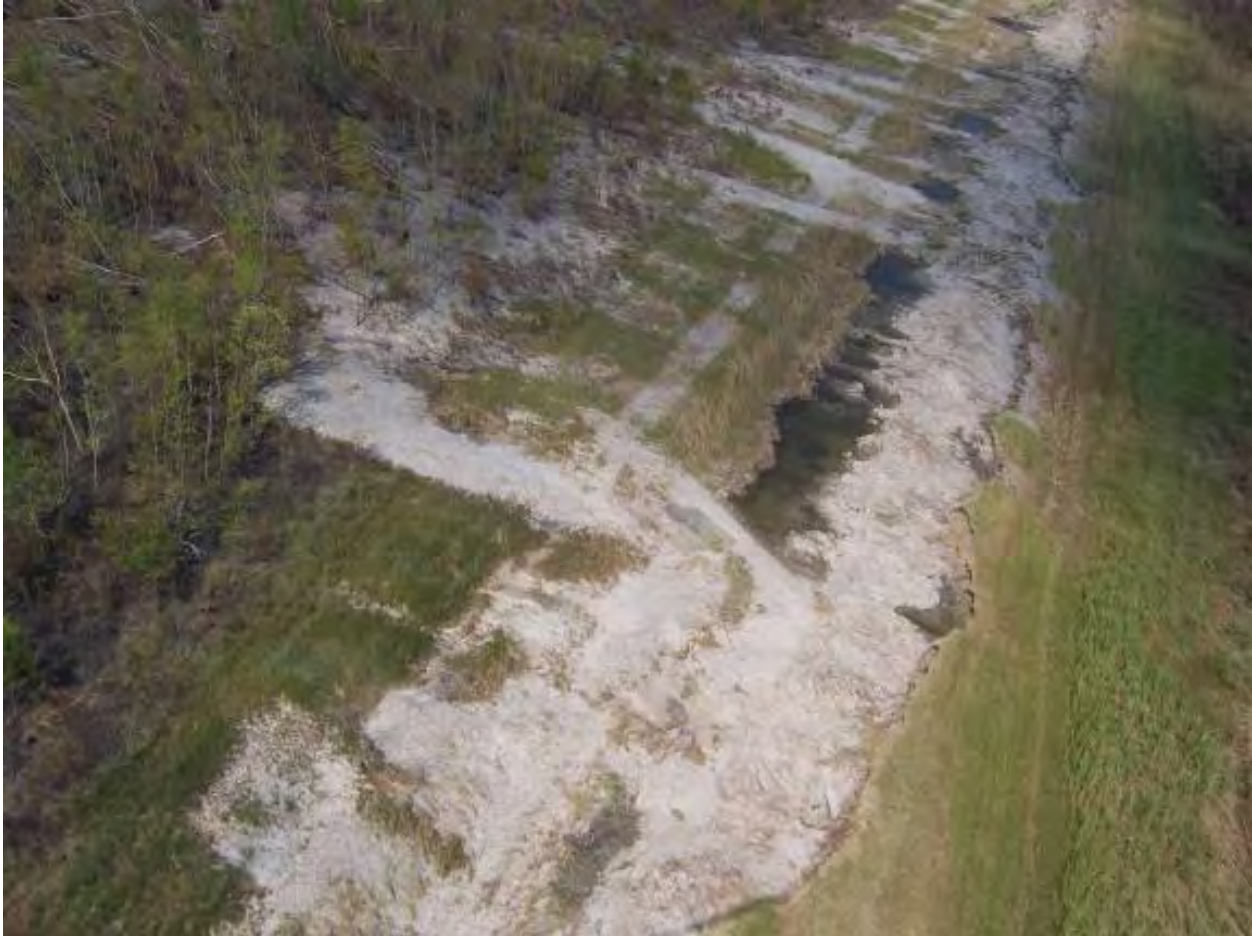
Figure 13-64. 2,300 ft. of Levee Between Bayou Bienvenue (Sta 383+00) and Bayou Dupre (Sta 704+00) That Only Lost 50% of Height

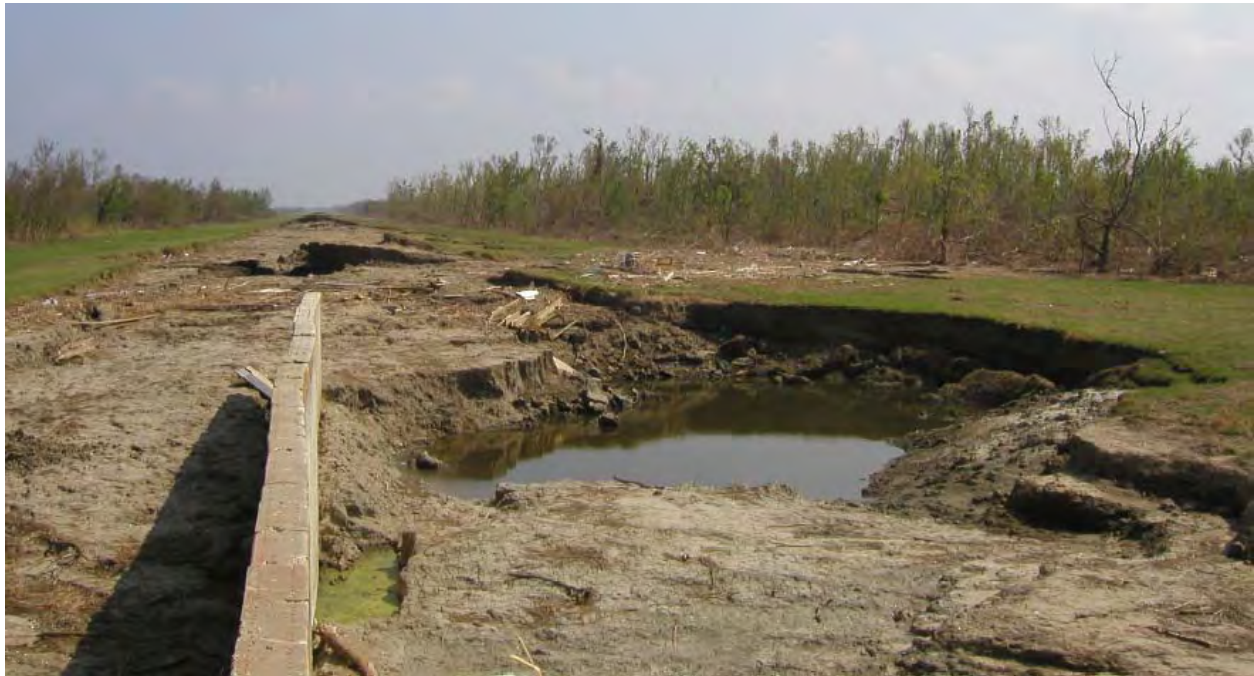
Figure 13-65. Wall / levee on the Southeast Side of Bayou Dupre Control Structure
