Appendix 1

Soil Data Report for 17th Street Canal

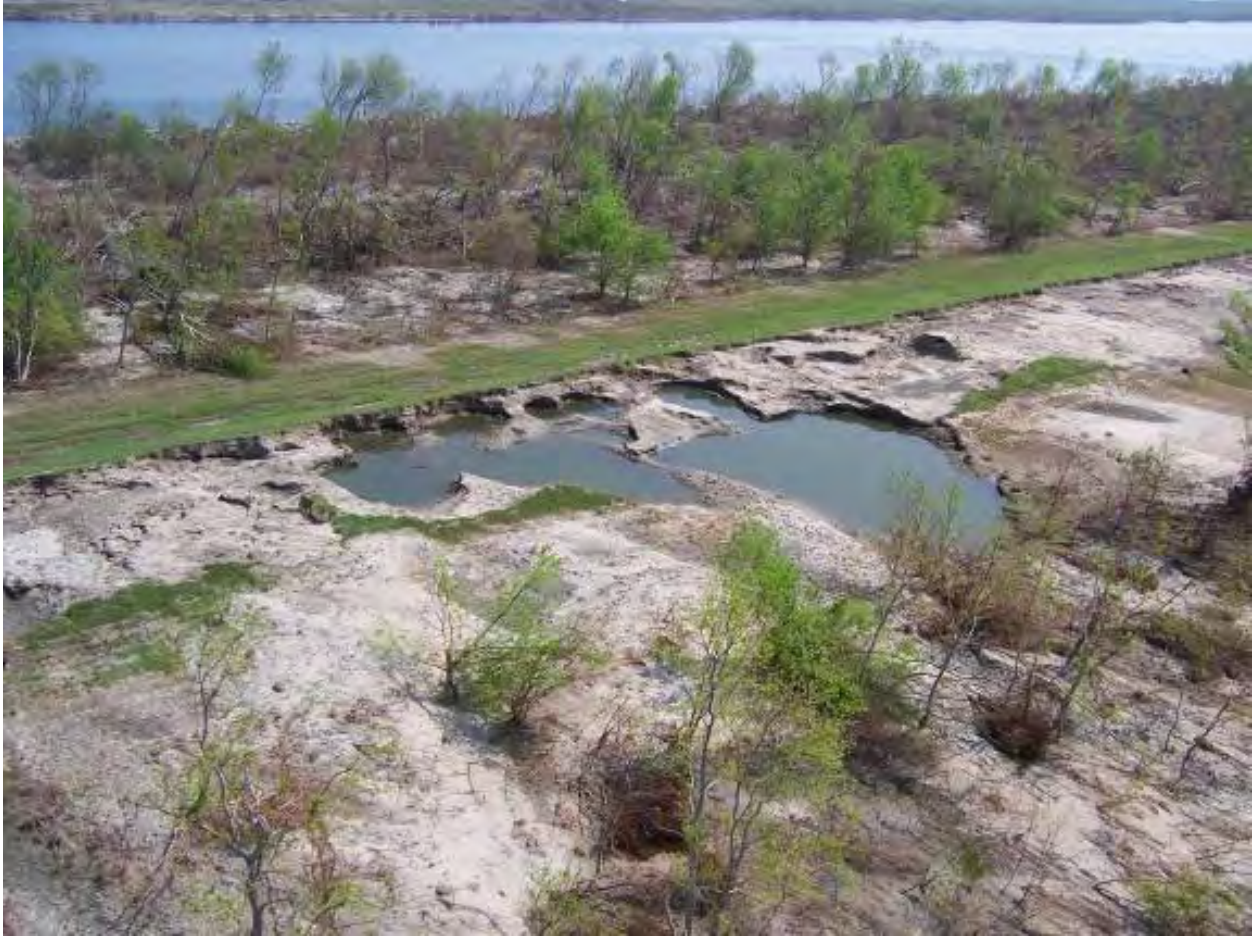
Figure 13-66. 8,000 ft. Section of the Levee Immediately Southeast of Bayou Dupre (St. Bernard Parish) That Was Severely Damaged and Not Only Lost Approximately 12 feet of Levee Height But Also Part of the Original Levee Foundation

The storm surge depth overtopping this section of levee (Figure 13-66) was approximately 6 ft. A nearby soil boring through the crown showed the top 3 ft consisted of lean clay (CL), fat clay (CH), silt (ML or MH), and interbedded lenses of silt and/or sand. Any of these soil materials may have contributed to erosion initiation and progression. It is interesting to note in this photo that large scour pools developed on the levee backside which could possibly indicate that slope failure occurred along semi-circular slip planes on the levee backside, and the weaker soil above the slip planes eroded concurrently with the breach erosion. In other words, there may have been a slope instability failure mode in addition to overtopping erosion.

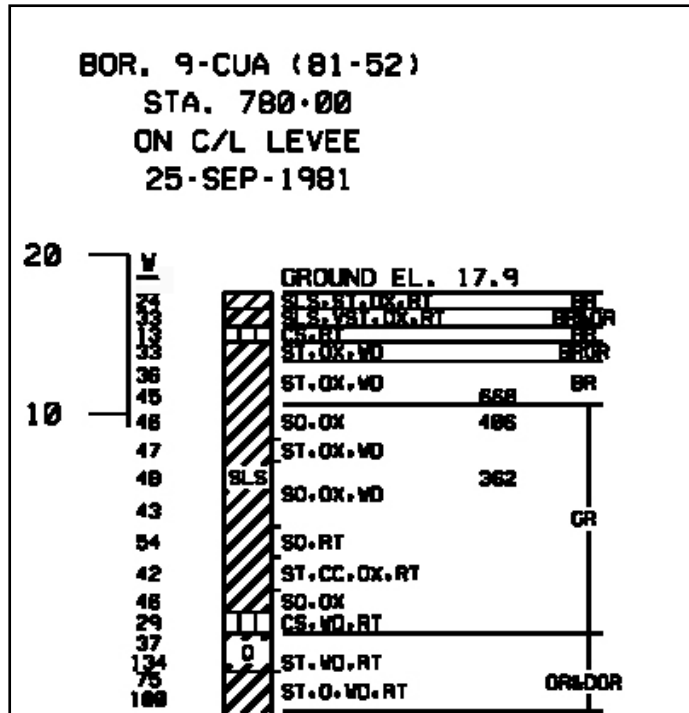
Figure 13-67. 1981 Soil Boring at Sta 780+00 Near Dupre Shows Top Layer of Lean Clay (CL) Underlain By Fat Clay (CH), Silt (ML or MH), and Silt / Sand Lenses (SLS) in the CH Material (from drawing 9 of 10, contract solicitation W912P8-06-R-0002)

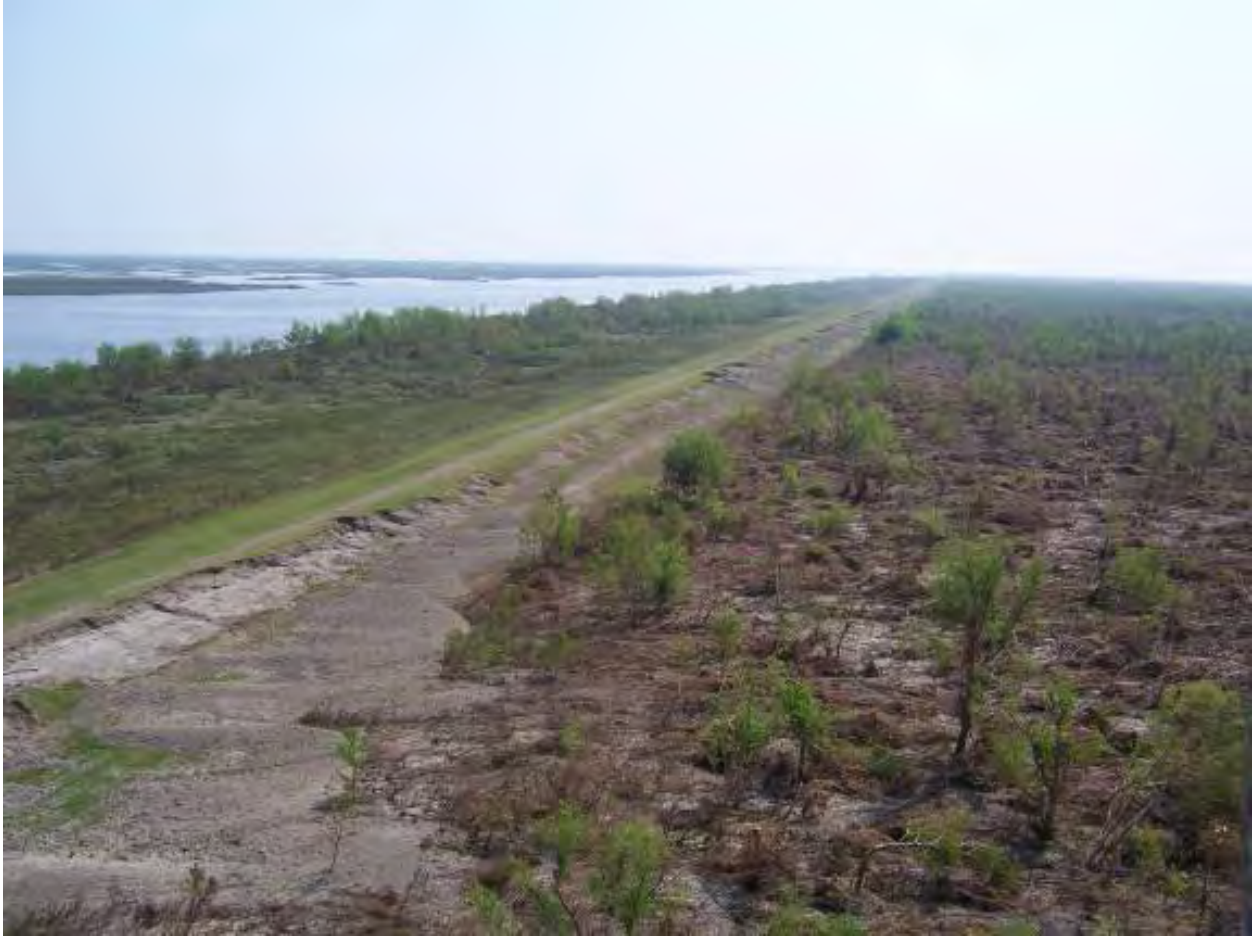
Figure 13-68. 2,500 ft. of Levee Along MRGO from Bayou Dupre to STA 1007+91 That Lost Approximately 8' of Elevation

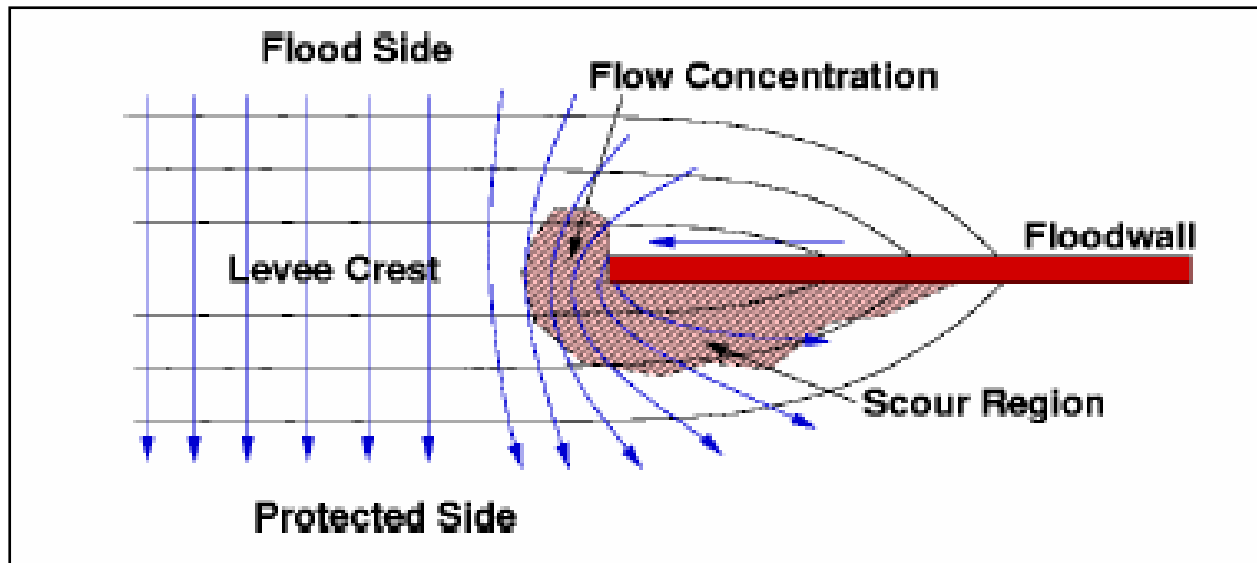
Numerous transition breaches were observed post-Katrina, and they overtopped due to elevation differences. After overtopping, the soil either scoured on the backside of the vertical structure or eroded the levee. The overtopping erosion / scour followed the progressive stages for the levee and/or the impact scour pattern for the floodwall, both as described above. Figure 13-69 is a diagram of the flow patterns that develop as overtopping occurs. The backside has increased erosion due to local increases in overtopping velocity, especially if the levee crest is lower than the floodwall. As the overtopping height increases above the floodwall height, backside erosion develops along the floodwall.

Figure 13-69. Diagram of Overtopping Erosion at Levee - Floodwall Transition (from Hughes 2006)

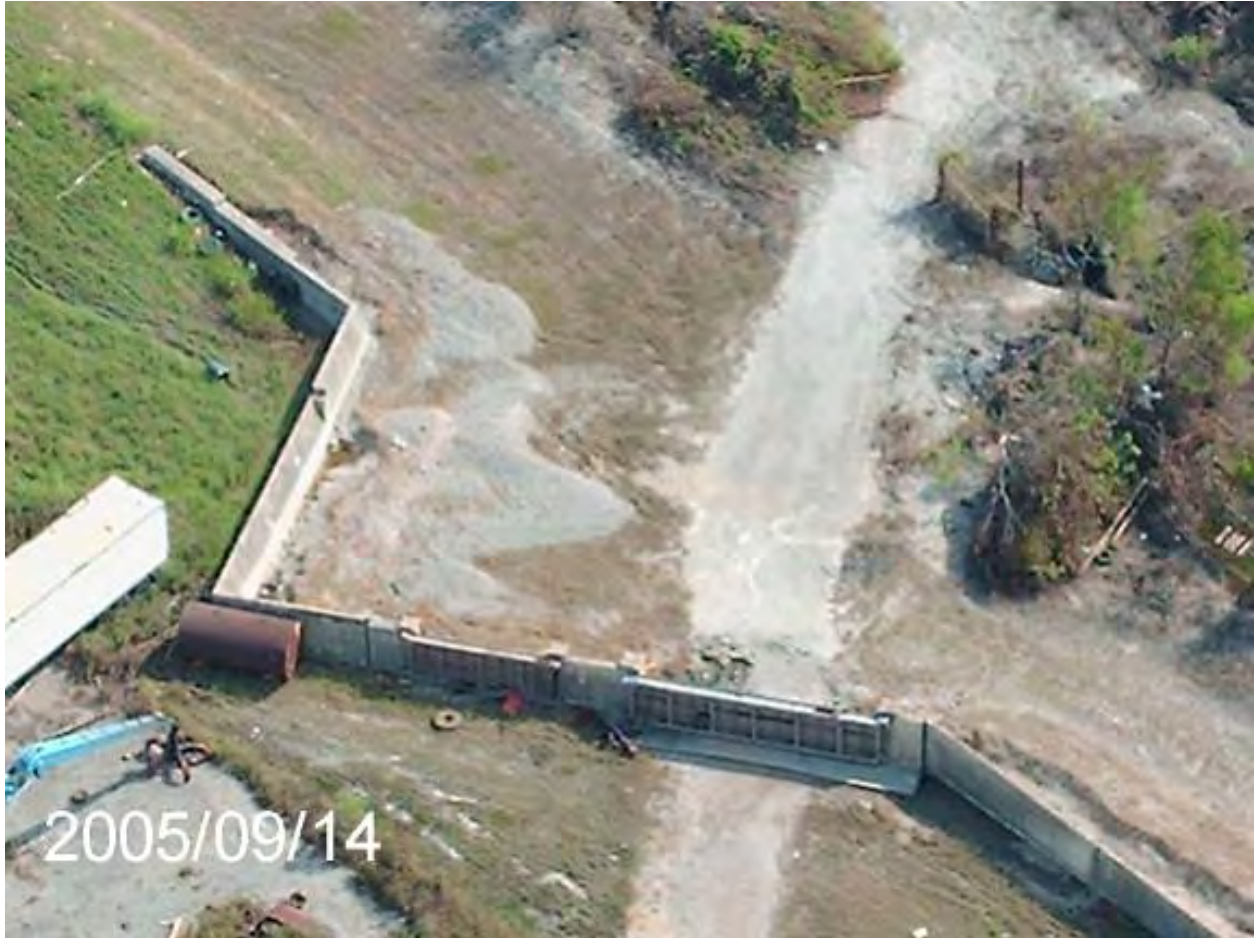
Figure 13-70. Southern Scrap Facility Gates S2 and S3

Figure 13-70 shows non-breaching scour caused by overtopping behind the concrete floodwall at closure gates S2 and S3 on the east side of the IHNC. Although the earthen levee abuts the concrete wall, the majority of scour occurred behind the concrete wall. Figure 13-71 depicts the scour pattern that developed along the levee slope behind the wall instead of the levee slope on the abutting earthen levee.

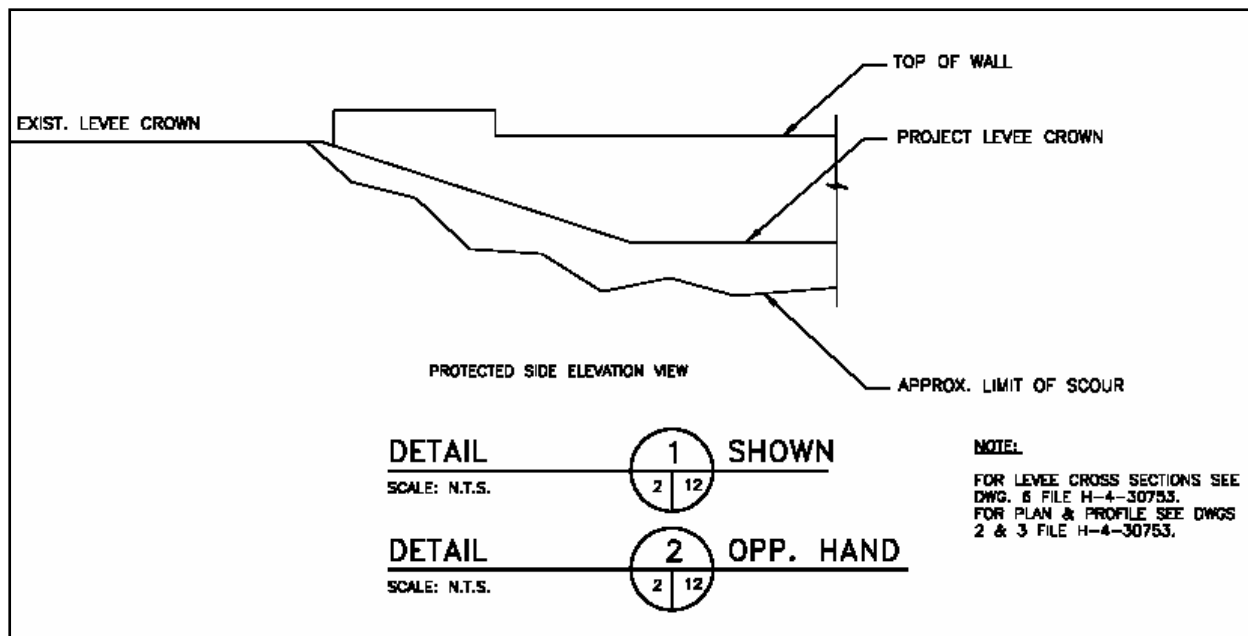
Figure 13-71. S2/S3 Erosion Pattern (From Levee Restoration, Misc. Gates and Floodwall Repairs, IHNC to Bienvenue, Chalmette Area Plan Emergency Restoration solicitation W912P8-06-R-0022, October 2005 contract drawing H-8)

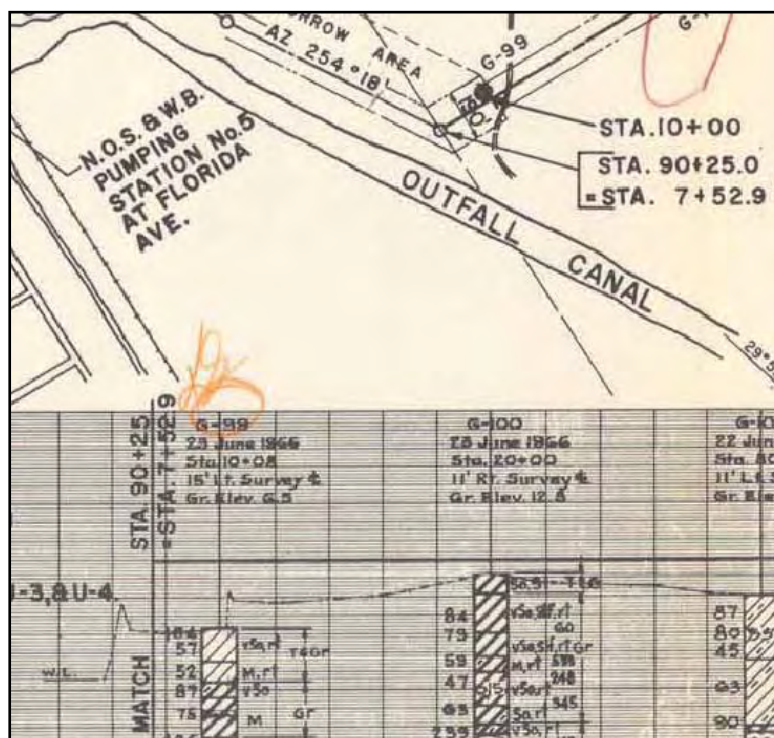
Figure 13-72. Boring G-99 Near Future Gates S2 and S3 Shows Lean Clay (CL) at Existing Ground Surface (Approximately 6' MSL). From plate 7, DM3

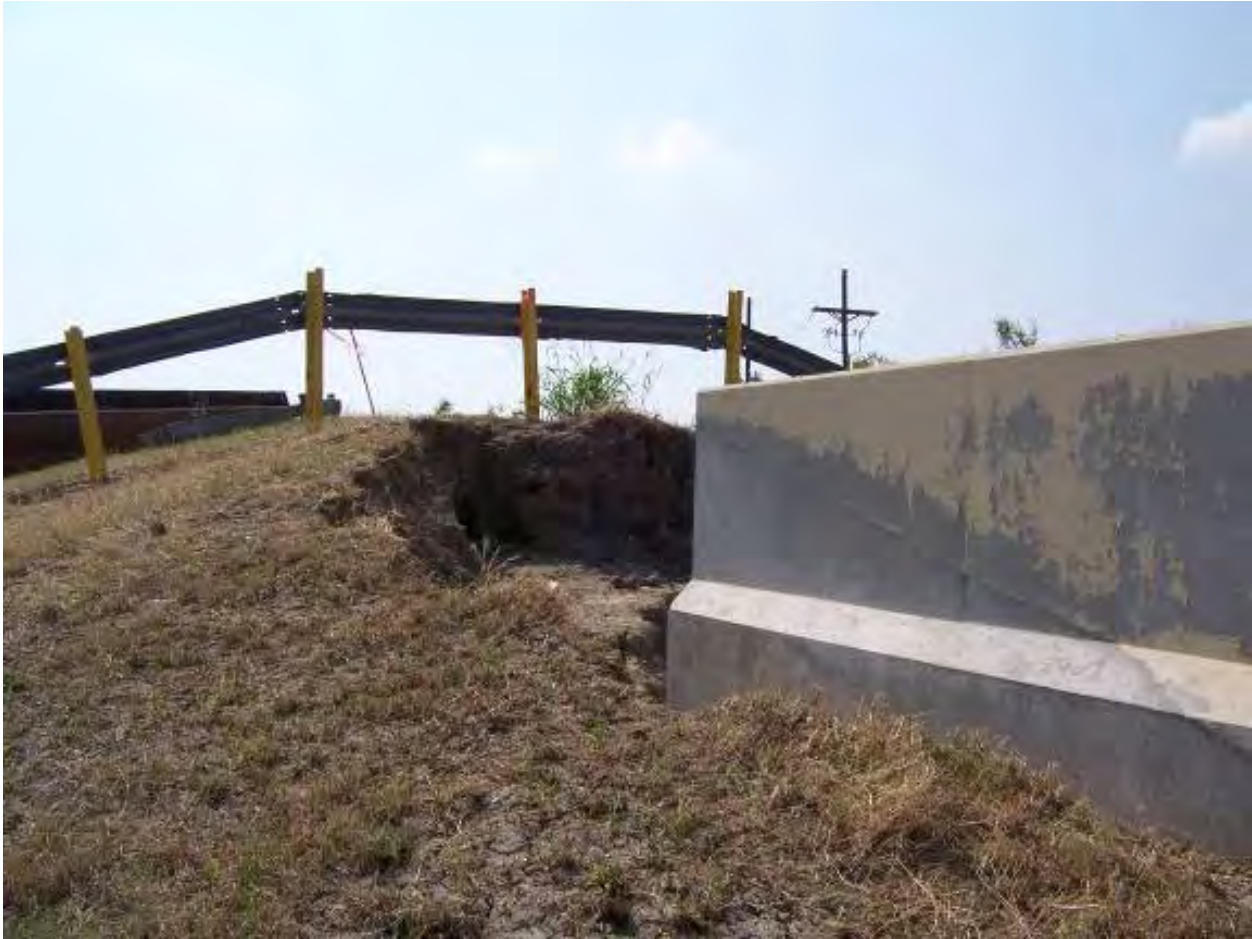
Figure 13-73. Floodgate S5 Near Bienvenue Control Structure

Figure 13-73 shows breached levee erosion at east end of floodgate structure S5, located about 100 yards west of the Bayou Bienvenue control structure. Although the levee was higher

than the wall (Figure 13-74) beyond the transition, it appears that the overtopping erosion began at the wall / levee transition where the wall was higher than the soil backfill.

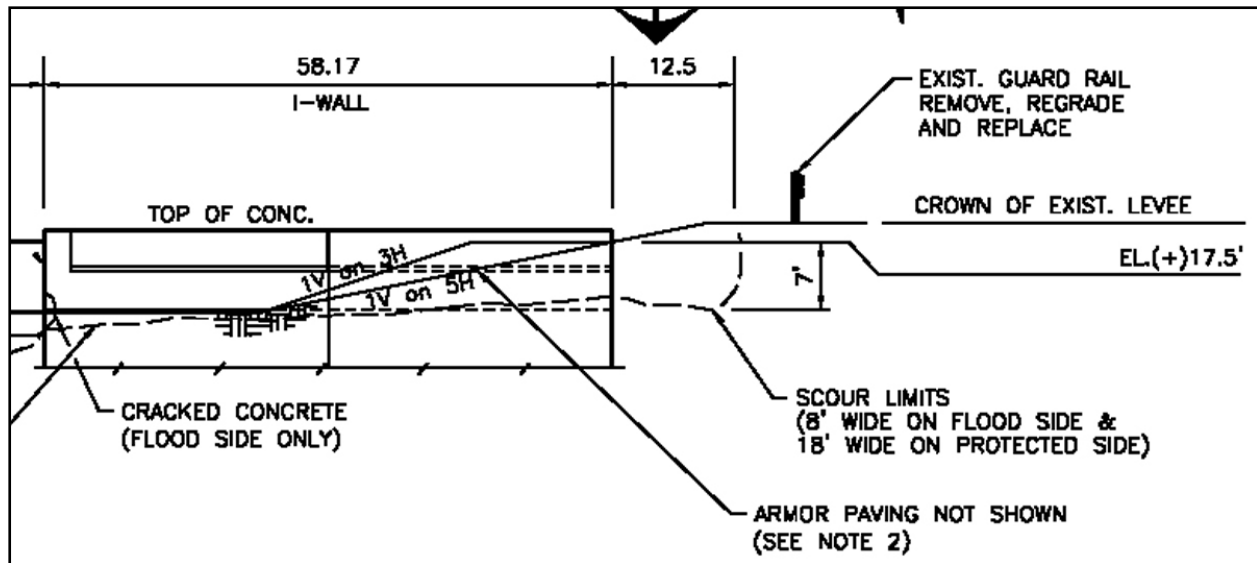
Figure 13-74. Scour pattern (From Levee Restoration, Misc. Gates and Floodwall Repairs, IHNC to Bienvenue, Chalmette Area Plan Emergency Restoration solicitation W912P8-06-R-0022, October 2005 contract drawing H-8)

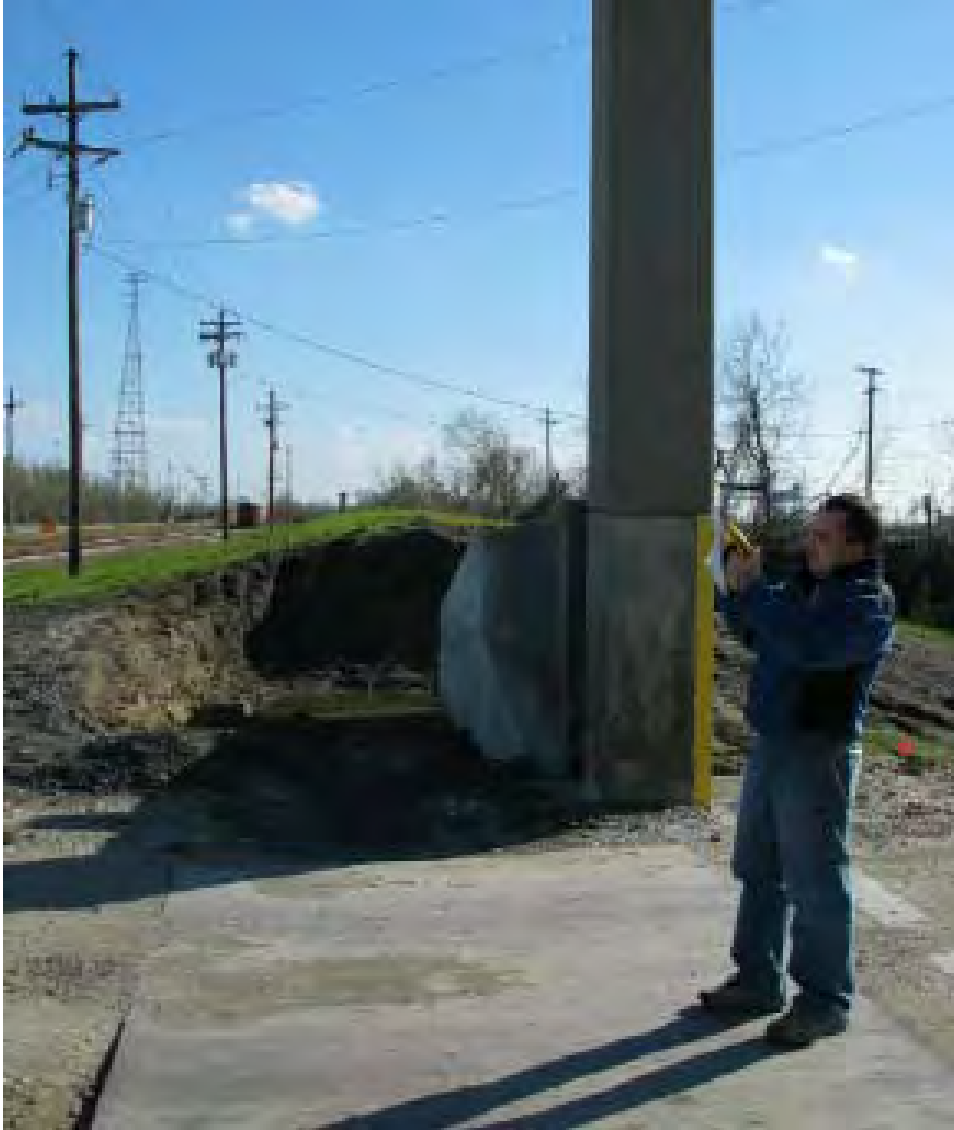
Figure 13-75. IHNC Floodgate E5 Transition to Levee

Figure 13-75 shows an earthen levee breach at east side IHNC floodgate E5 looking south from inside the protected area. Scour damaged 7' (w) x 7' (d) around the adjacent flood wall. Top of wall at gate is approximate elevation 13 ft.

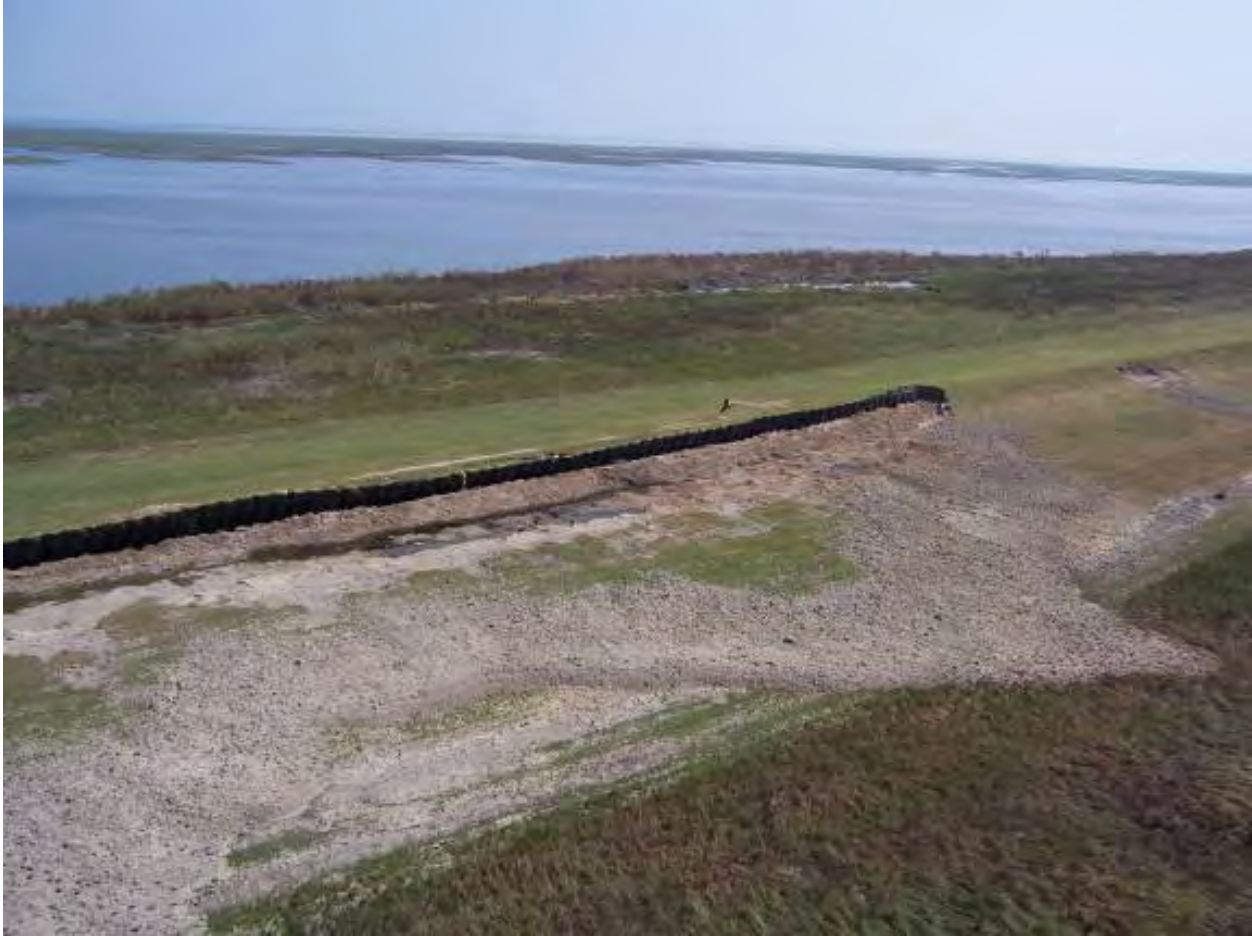
Figure 13-76. End of Sheetpile Wall at B/L Sta 980+58, Along the MRGO (St. Bernard Parish). Note that scour occurred along the sheetpile wall and minimally beyond the levee transition. Approximate sheetpile elevation was 17 ft and levee crown elevation was 13 ft. Beyond the transition, the levee crown elevation was approximately 17 ft. The approximate storm surge overtopping crest was 4 ft over the sheetpile and 1 ft over the transition levee

Pre-Katrina soil boring 10-CUHA (91-02) from 1991 at Sta 976+00 in the sheetpile reach shows the top 4 ft of levee (elevation 13) was composed of lean silt and clay (ML and CL) with CH layers underneath. At a depth of 4.6 ft below the crown, a shear Q test indicated cohesion value 770 psf at 45% water content and 75 pcf dry density in the uppermost CH layer.

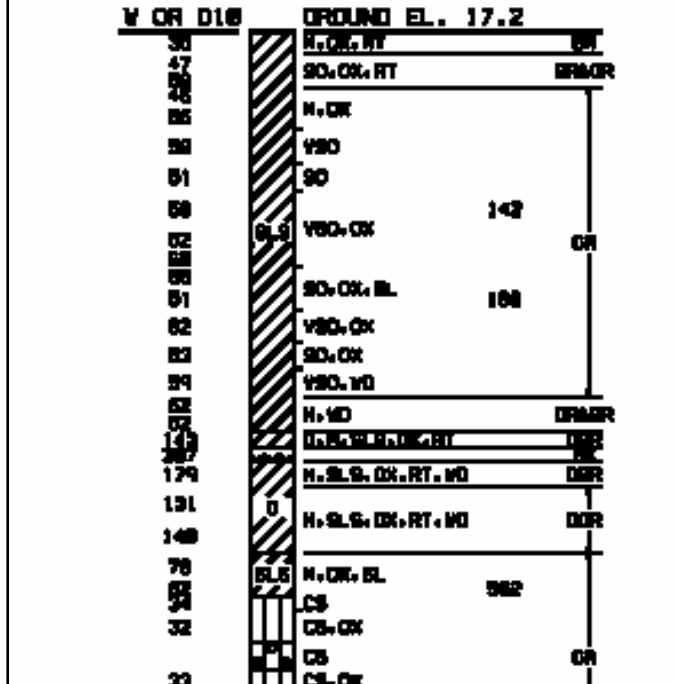
BOR. 10-CUI (85-38)
 STA. 989+00
 C/L LEVEE
 04-DEC-1985

Figure 13-77. Pre-Katrina (1985) Boring at Sta 989+00 (about 800 ft beyond the sheetpile/levee transition) Shows Levee Section With Fat Clay (CH) Cap and Core, With Interbedded Silt Lenses (SLS)

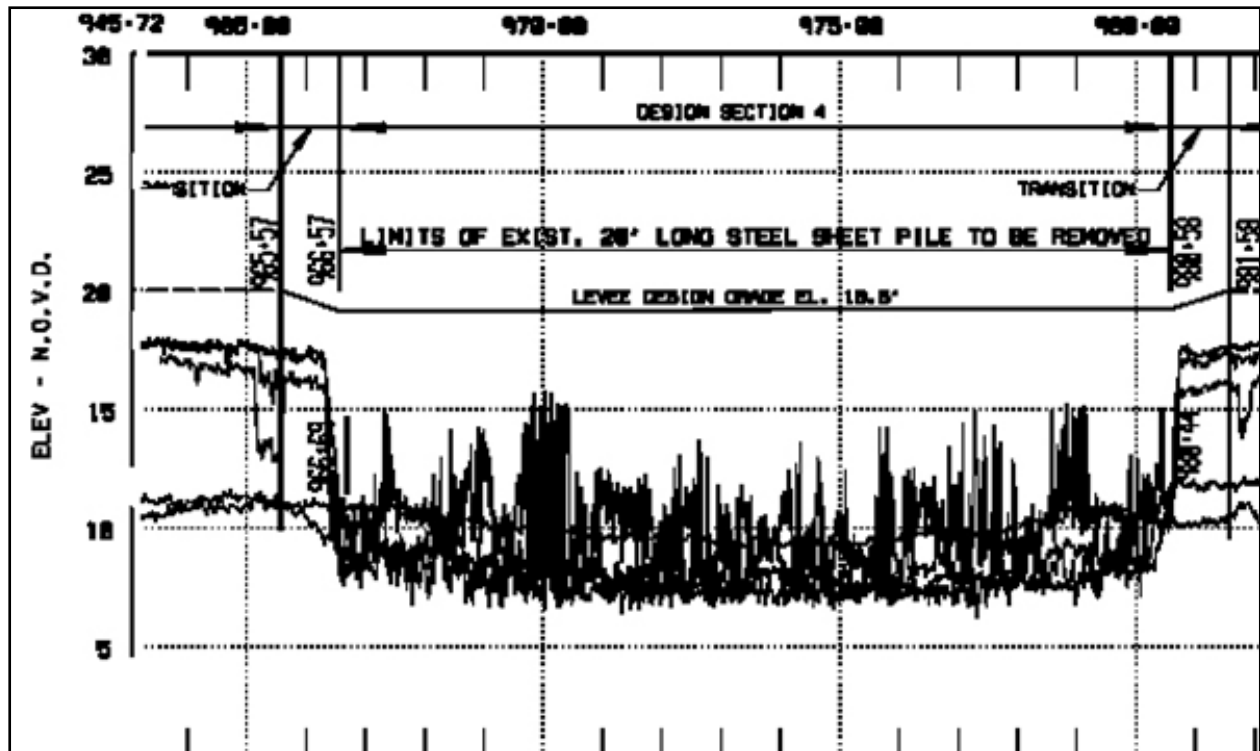
Figure 13-78. Scour Depths Along Sheetpile and at Transition to Levee. Note that scour occurred along the sheetpile reach, not at the sheetpile / levee transition (also seen in Figure 13-76), from drawing 7 of 10, contract solicitation W912P8-06-R-0002

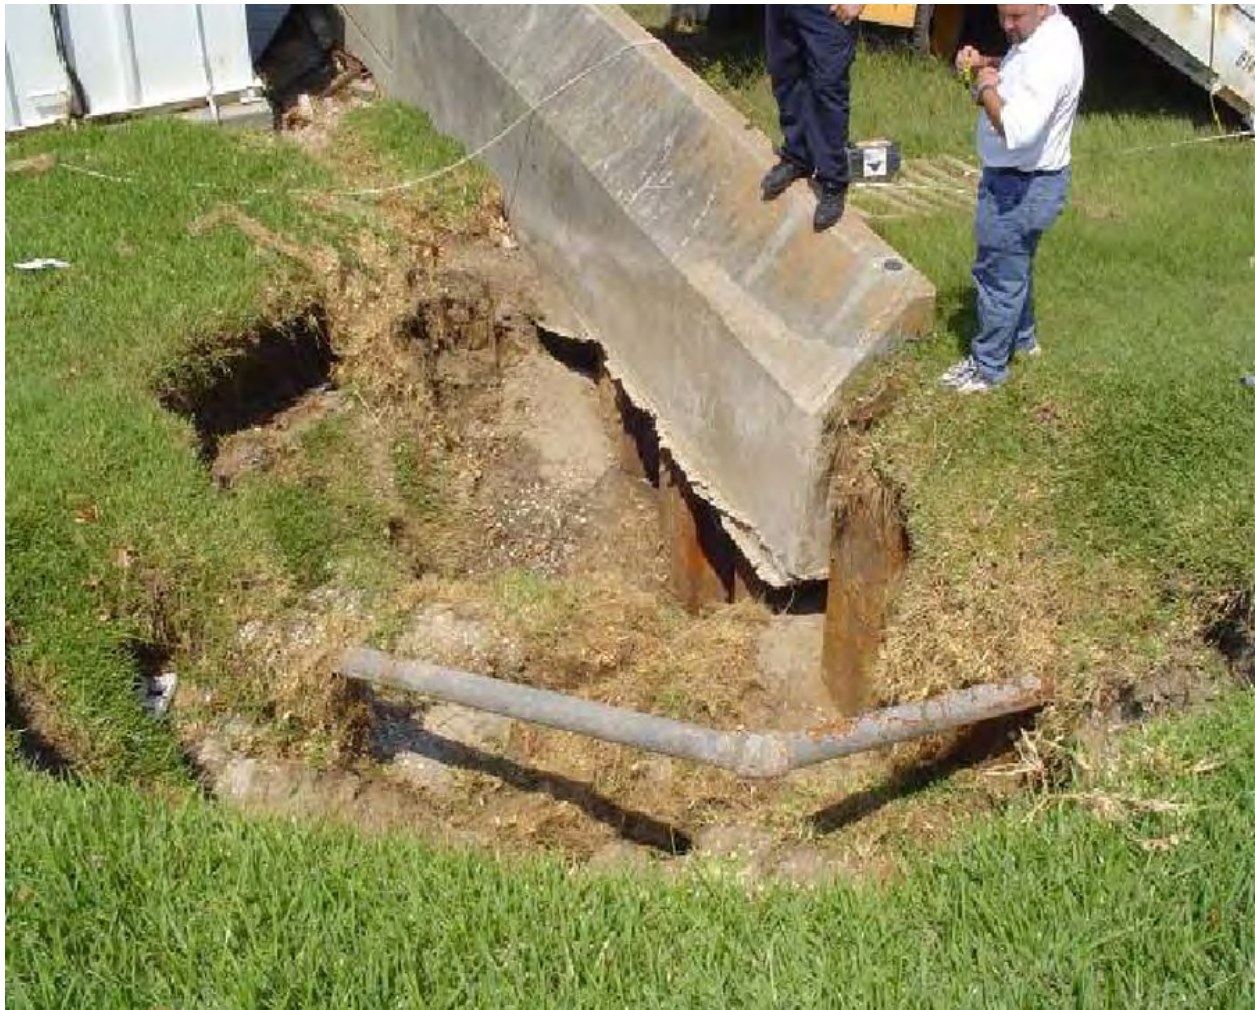
Figure 13-79. IHNC Lock I-wall transition to levee

Figure 13-79 shows the I-wall/levee transition on the east side of the IHNC at the IHNC Lock. In this case, the levee crest was about a foot lower than the I-wall top, and overtopping caused erosion and/or a scour hole on the backside. Visual observation indicates a non-cohesive surface soil type.

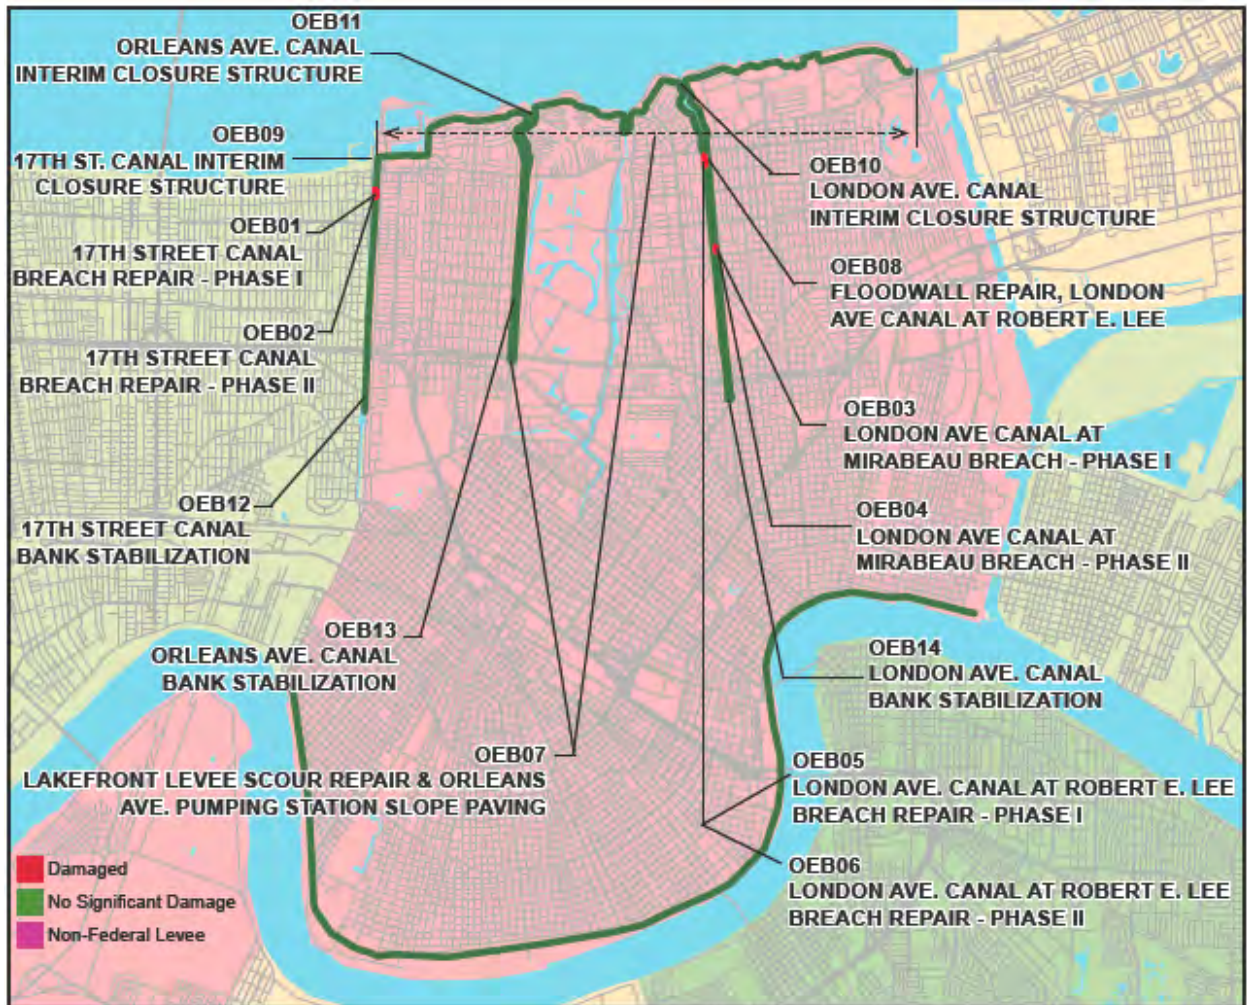
Figure 14-4. Damages and Repair Contracts – New Orleans East Bank

Primary damages to the flood protection in the Orleans East Bank basin consists of a 455- ft breach in the east side I-wall along 17th St. Canal, breaches on both the east side (425 ft) and west side (720 ft) I-wall along London Ave. Canal, breaches along the west side of IHNC floodwall and damages to all fifteen pumping stations.

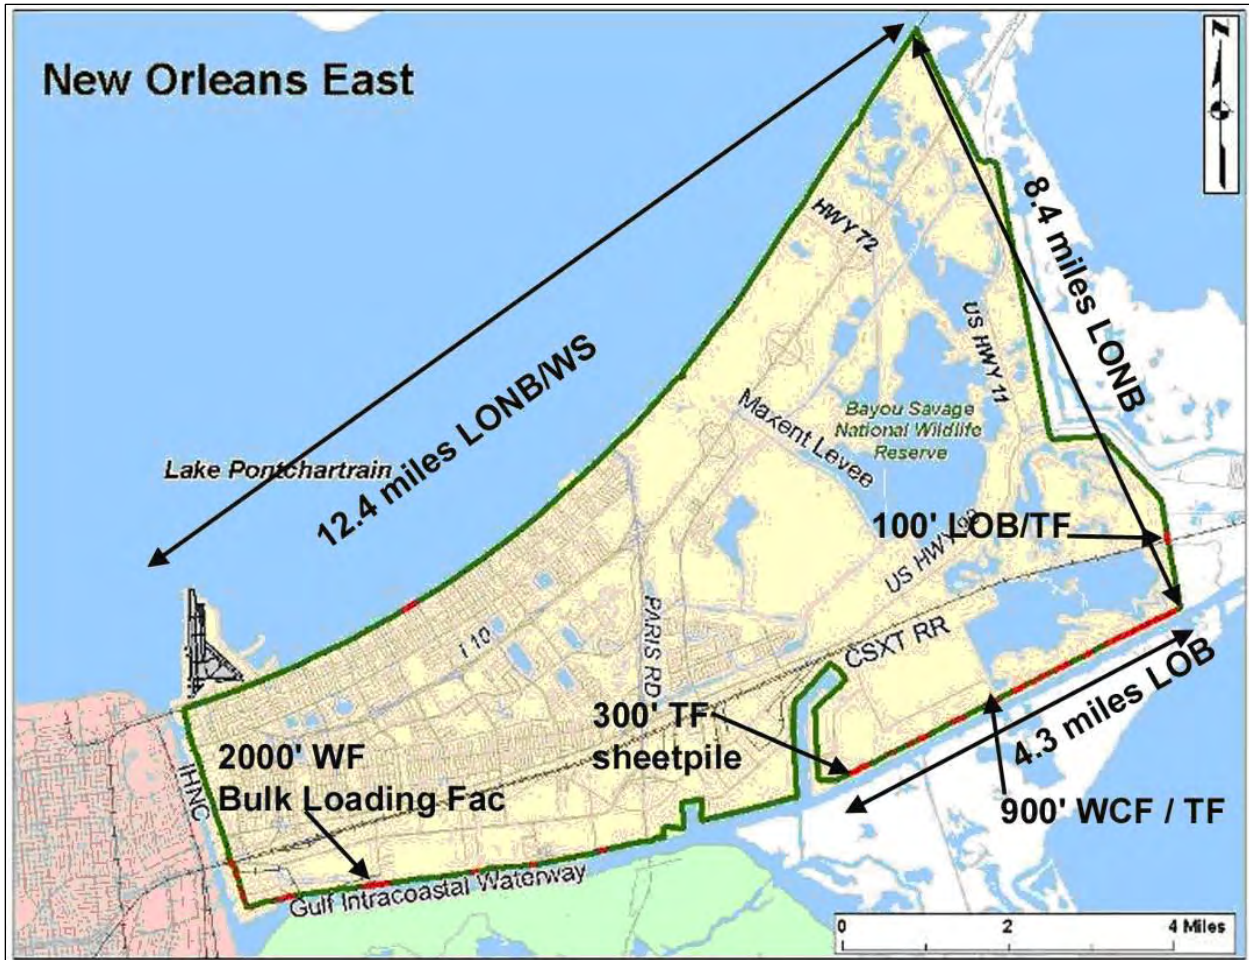
Figure 14-7. New Orleans East IPET Characterization of Damages

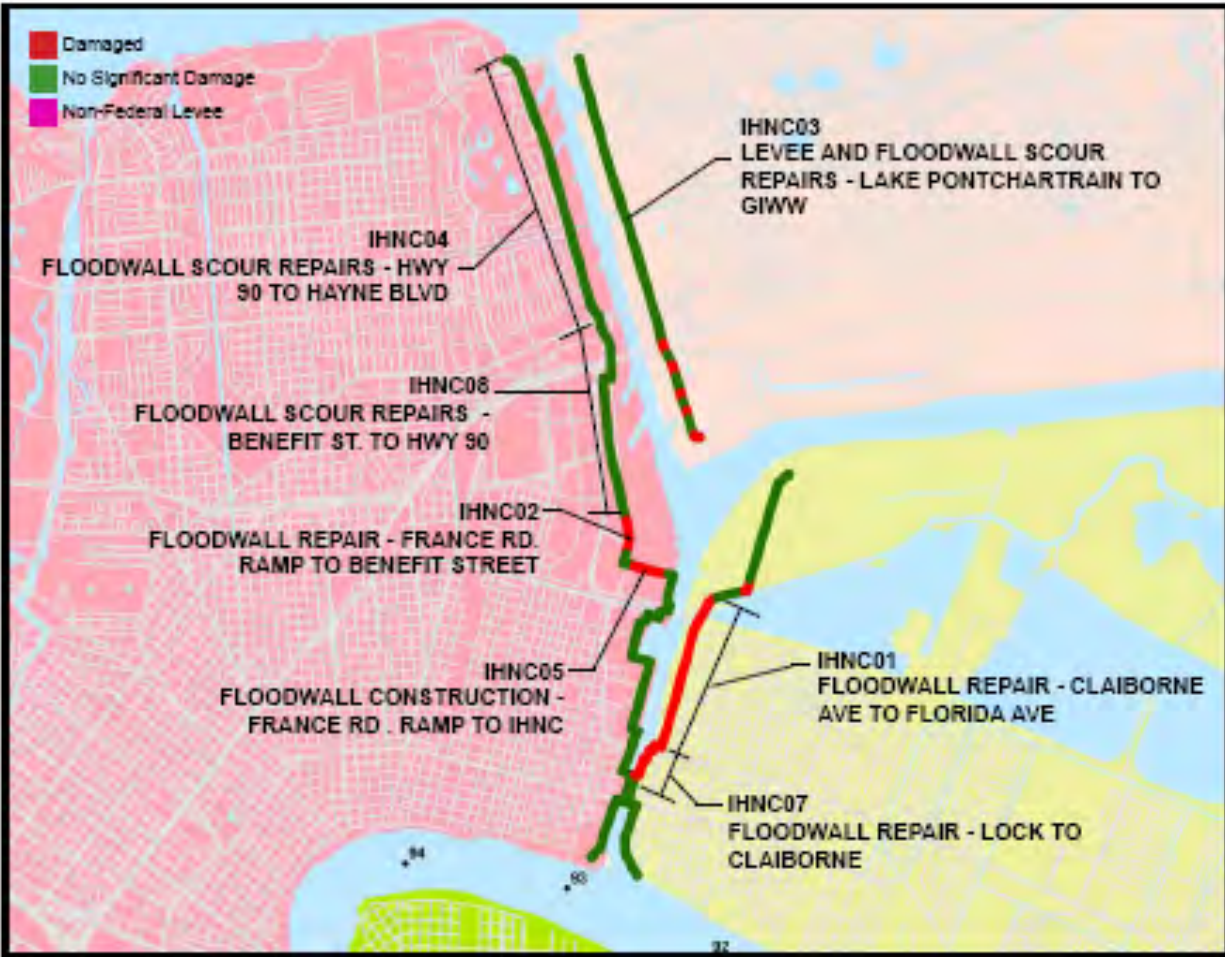
IHNC Damages. Overtopping of the hurricane protection by Hurricane Katrina was evident along nearly all portions of the canal. There were four breaches in the protection system, two on the east side and two on the west side. The east side breaches are both located in the lower 9th ward neighborhood and the west side breaches are both in the vicinity of France Road and Benefit Street.

Figure 14-8. Hurricane Protection Features and Damages– IHNC

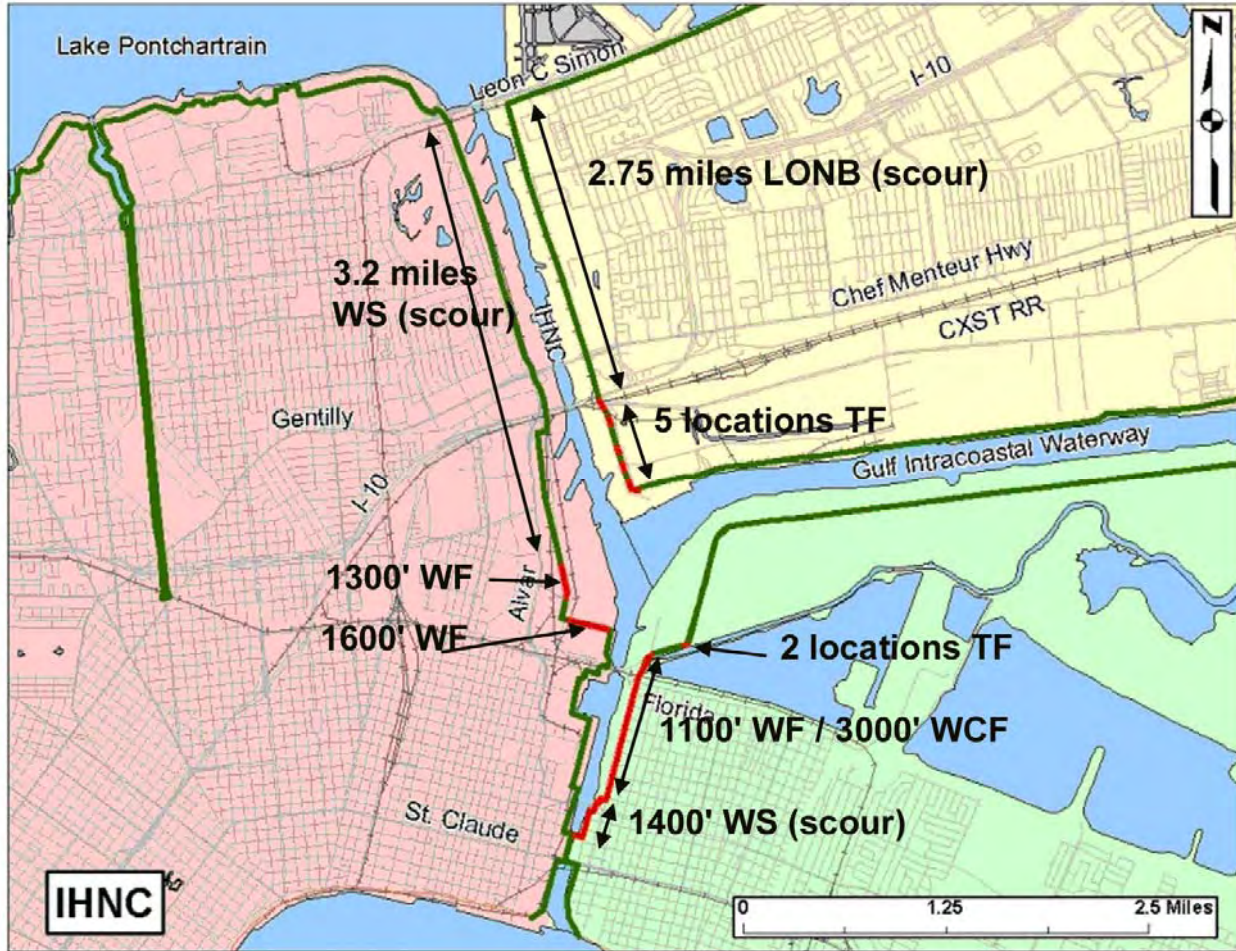
Figure 14-9. Damaged Areas Along the IHNC

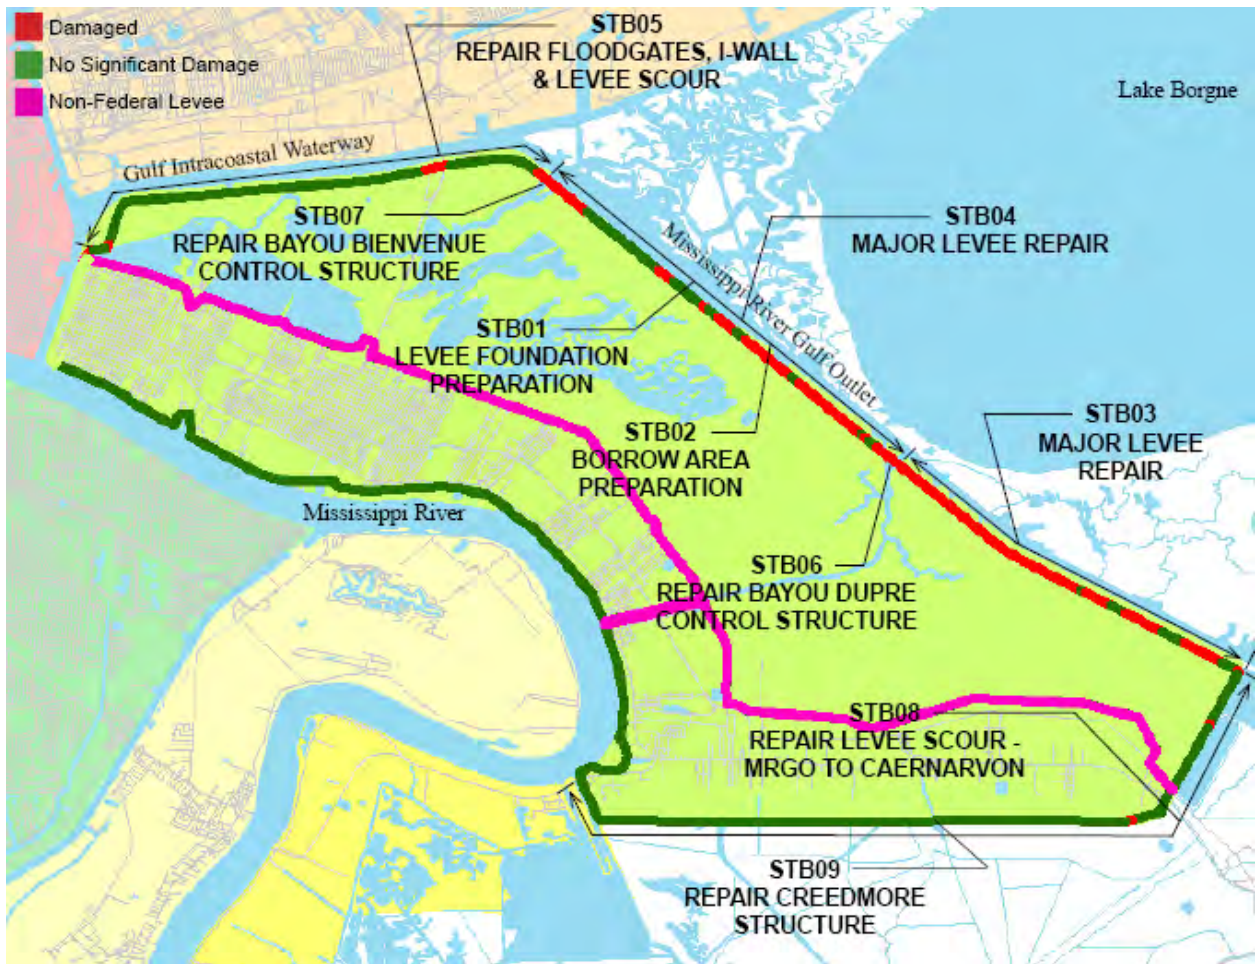
Figure 14-11. St. Bernard Damage and Contract Repair Areas

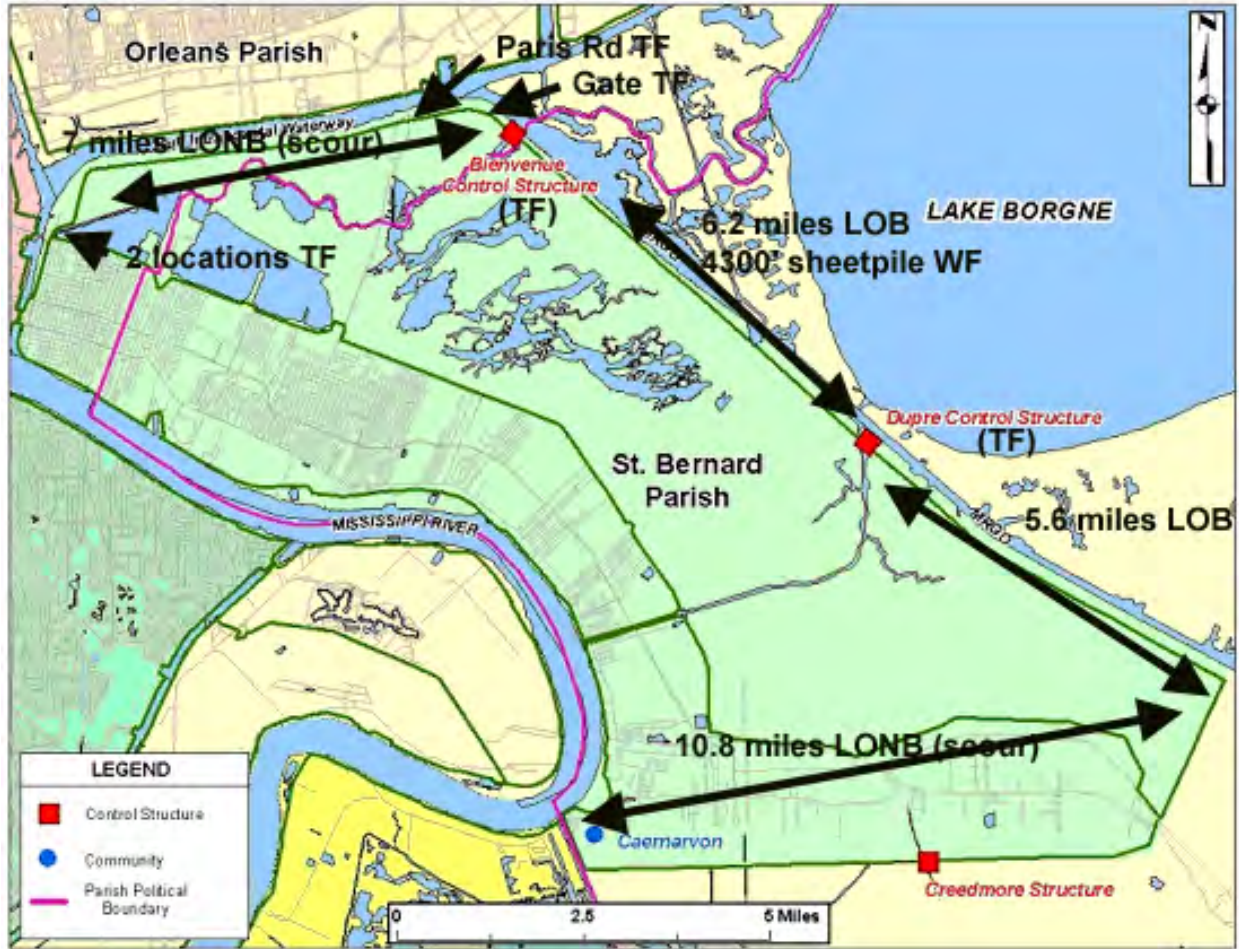
Figure 14-12. St. Bernard Parish IPET Damage Characterization

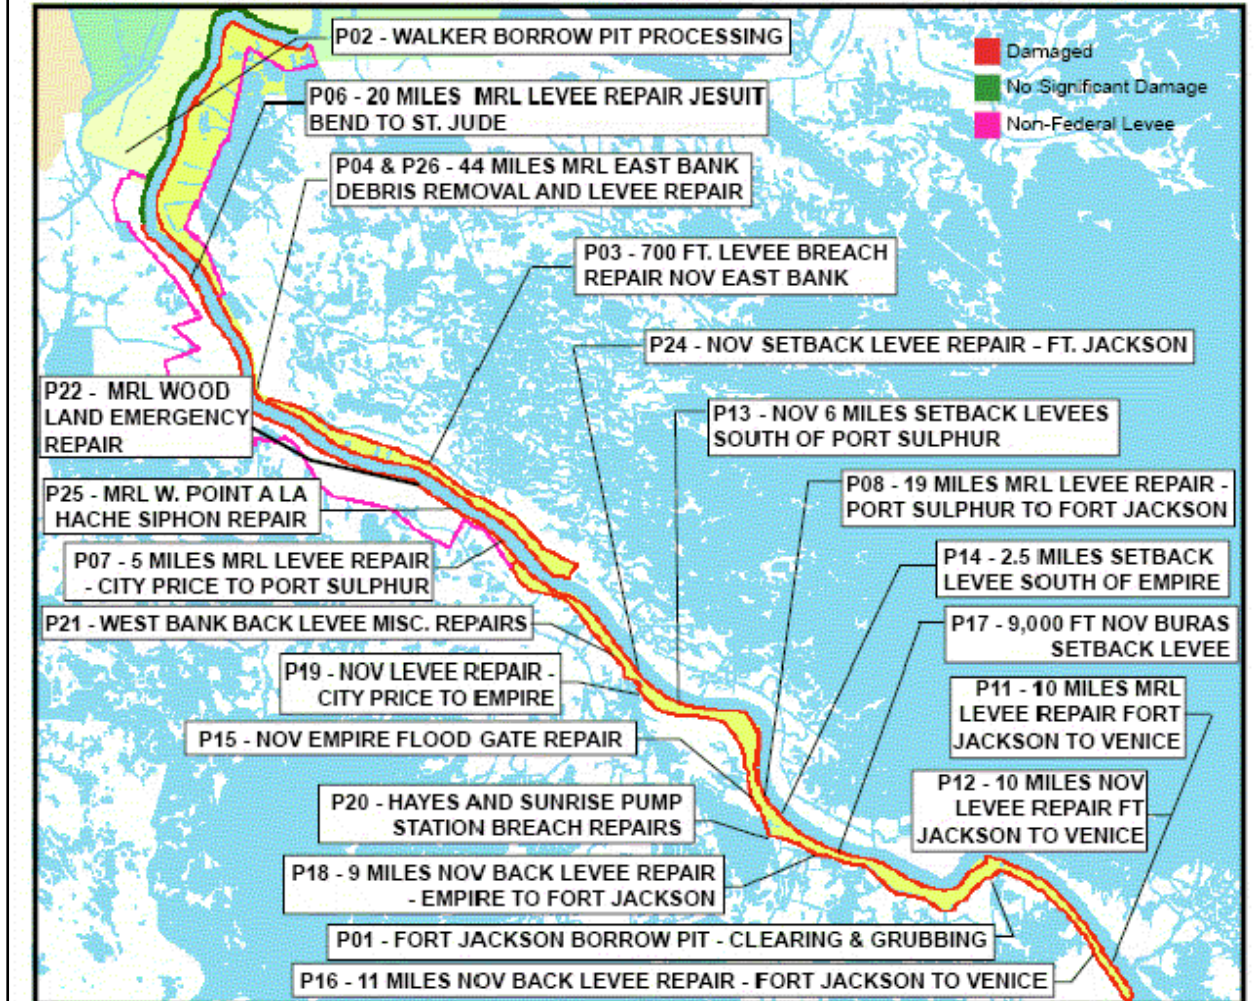
Figure 14-14. Damaged and Contract Repair Areas Along Plaquemine Parish
