Appendix 1

Soil Data Report for 17th Street Canal

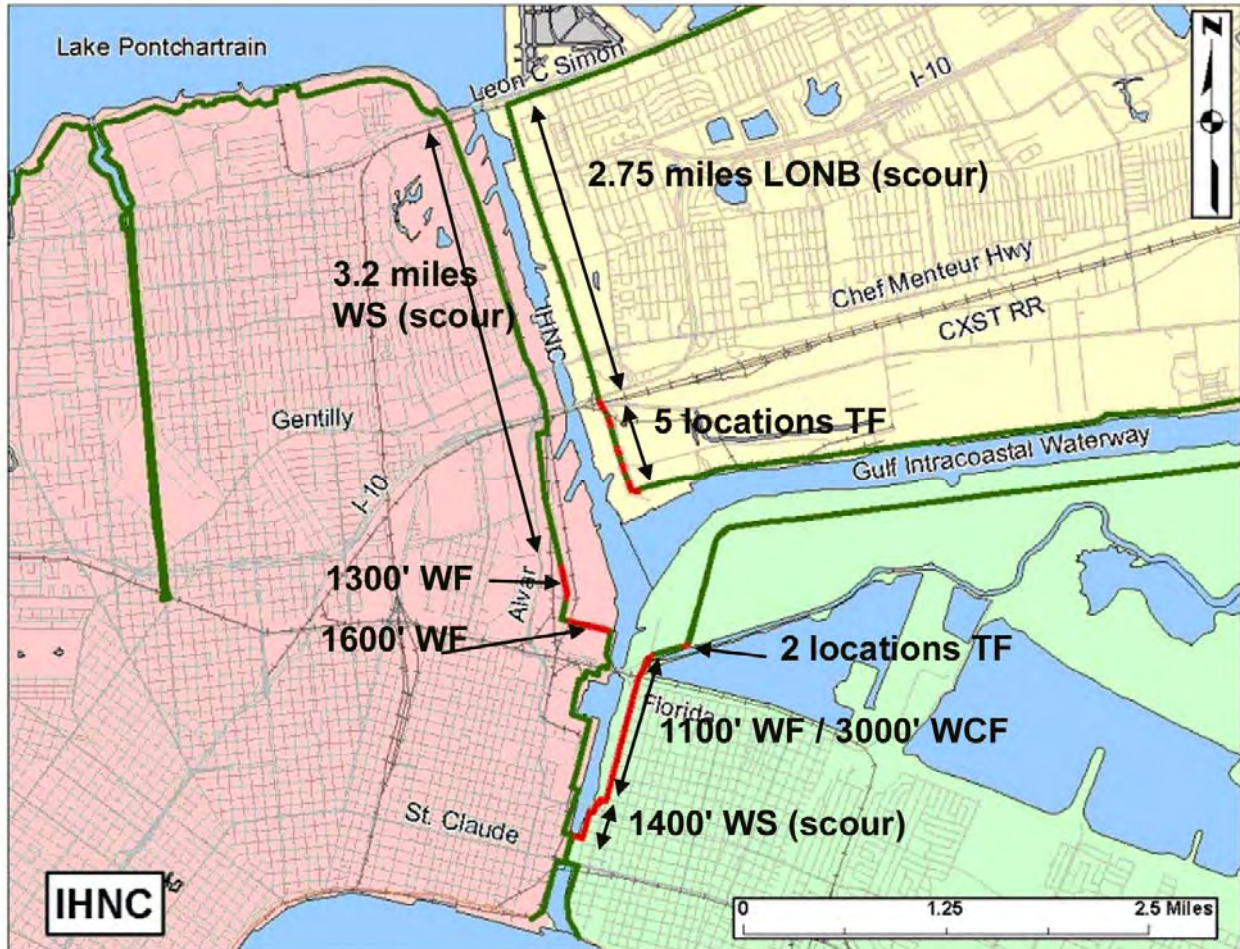
Figure 14-15. IHNC Flood Protection Damage

Overtopping was generally associated with varying degrees of scour (surface erosion), generally on the levee landside.

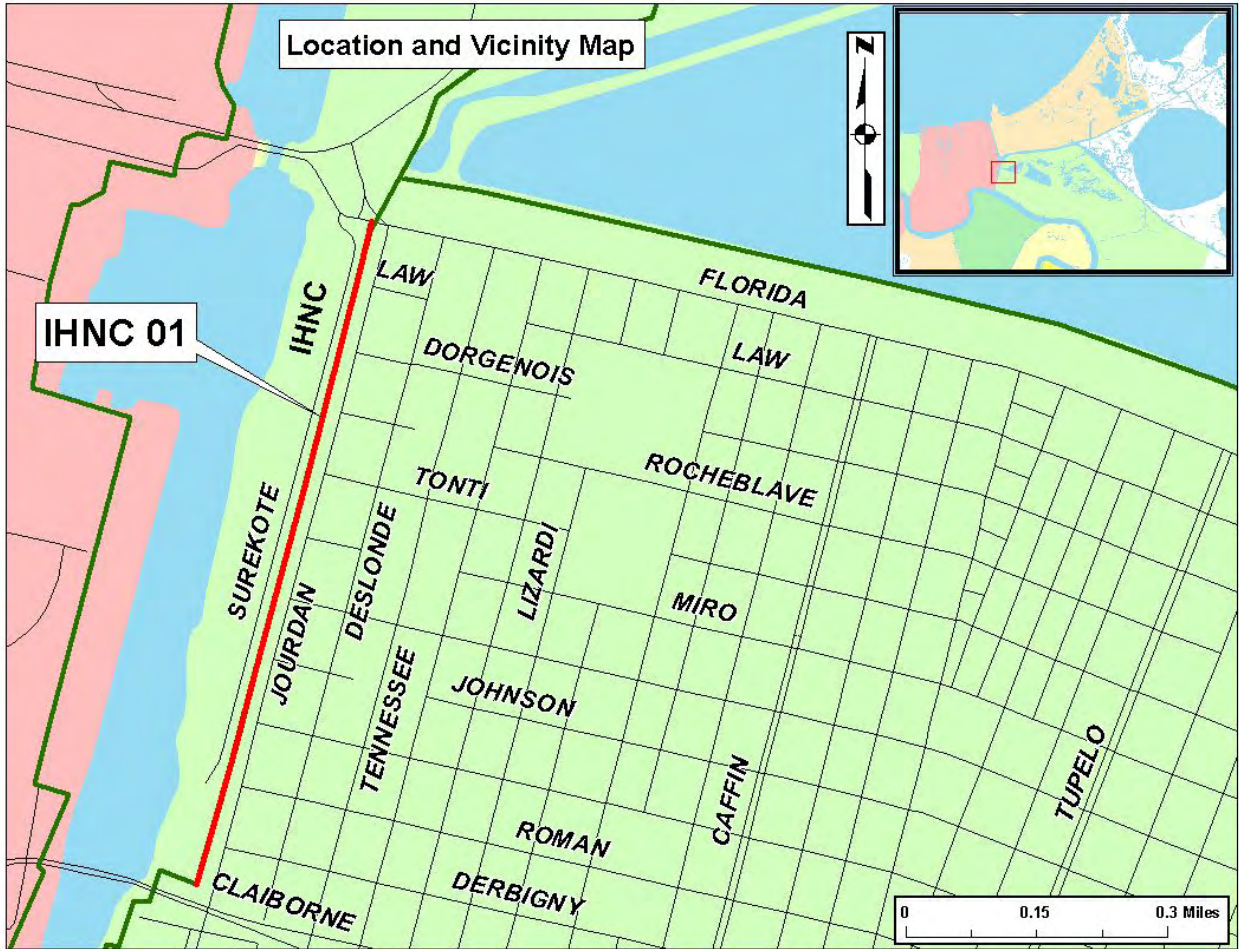
Description: There is approximately 4,000 lineal feet of concrete I-wall flood barrier along the east side of the IHNC Canal between North Claiborne Avenue and Florida Avenue. The damages in this reach consisted of a breach of the floodwall immediately south of Florida Avenue (250') and one approximately 100 yards north of Claiborne Ave (850') with the remaining portions of the floodwall having areas of severe scour and tilting of the I-wall. The work includes replacement of the concrete I-wall with a concrete T-wall, supported on H-piles and sheet piling. Scheduled construction completion is 15 March 2006.

- 250' breach (WF) I-wall, south of Florida Ave
- 850' breach (WF) I-wall, 100 yds north of Claiborne Ave.
- ~3000' (WNF / WCF)

Figure 14-22. East Side IHNC Between Claiborne Ave. and Florida Ave.

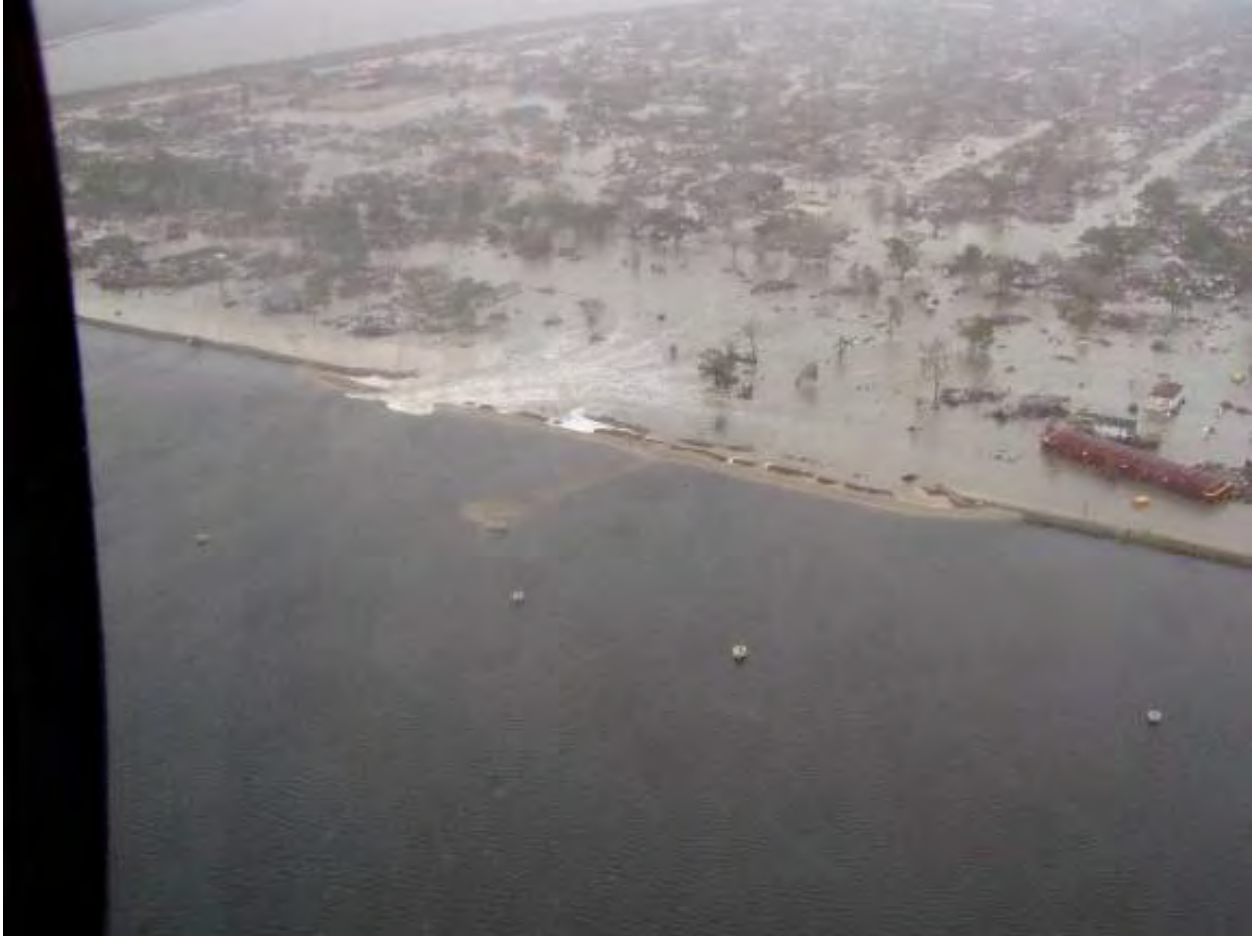
Figure 14-23. During Katrina; View to East Side of IHNC South of GIWW. Breach began approximately 300 ft north of Claiborne Ave.

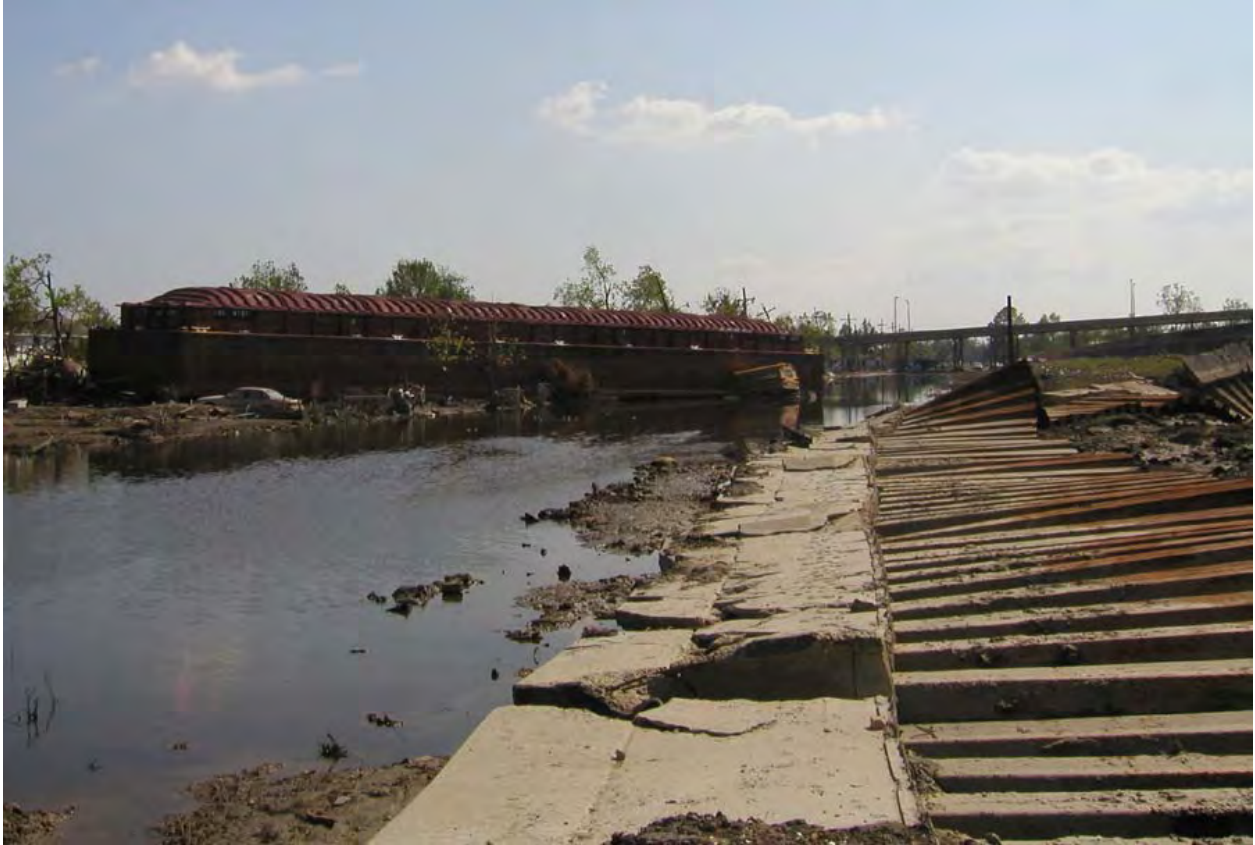
Figure 14-24. Closeup of Flattened I-Wall and Barge, View Toward Claiborne Ave.

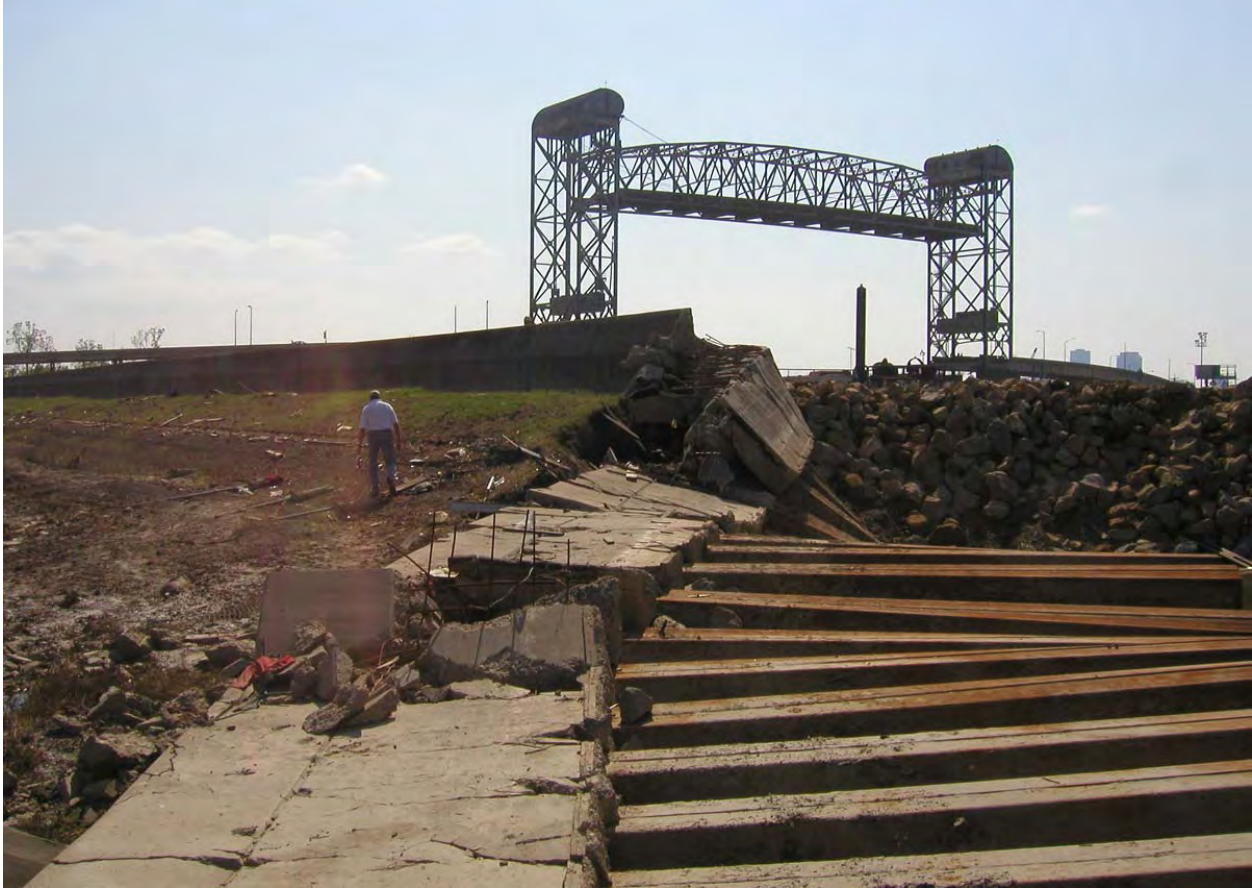
Figure 14-25. Transition From Failed Wall to Intact Wall, View Toward Claiborne Ave.

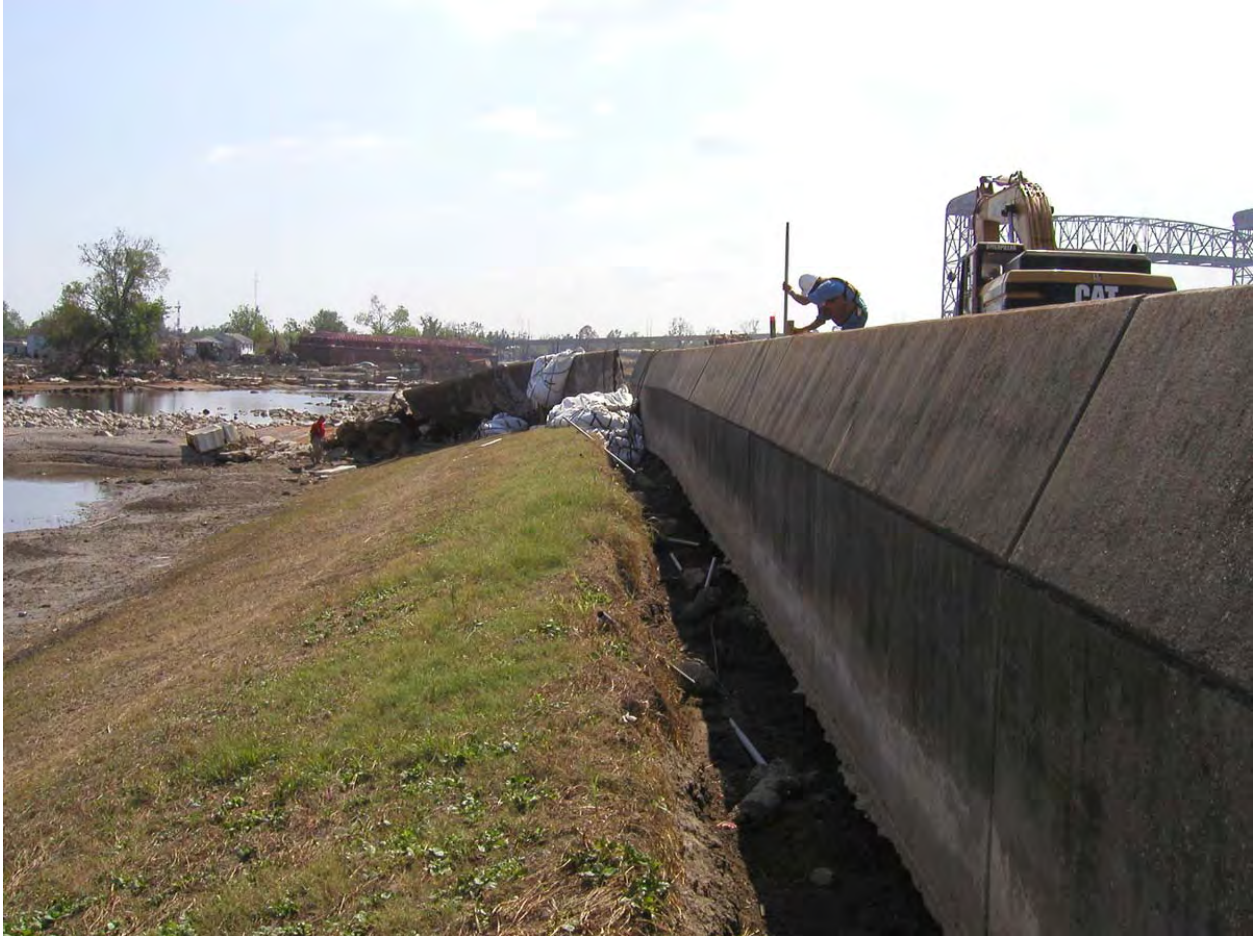
Figure 14-26. Northernmost Transition From Failed Wall to Intact Wall

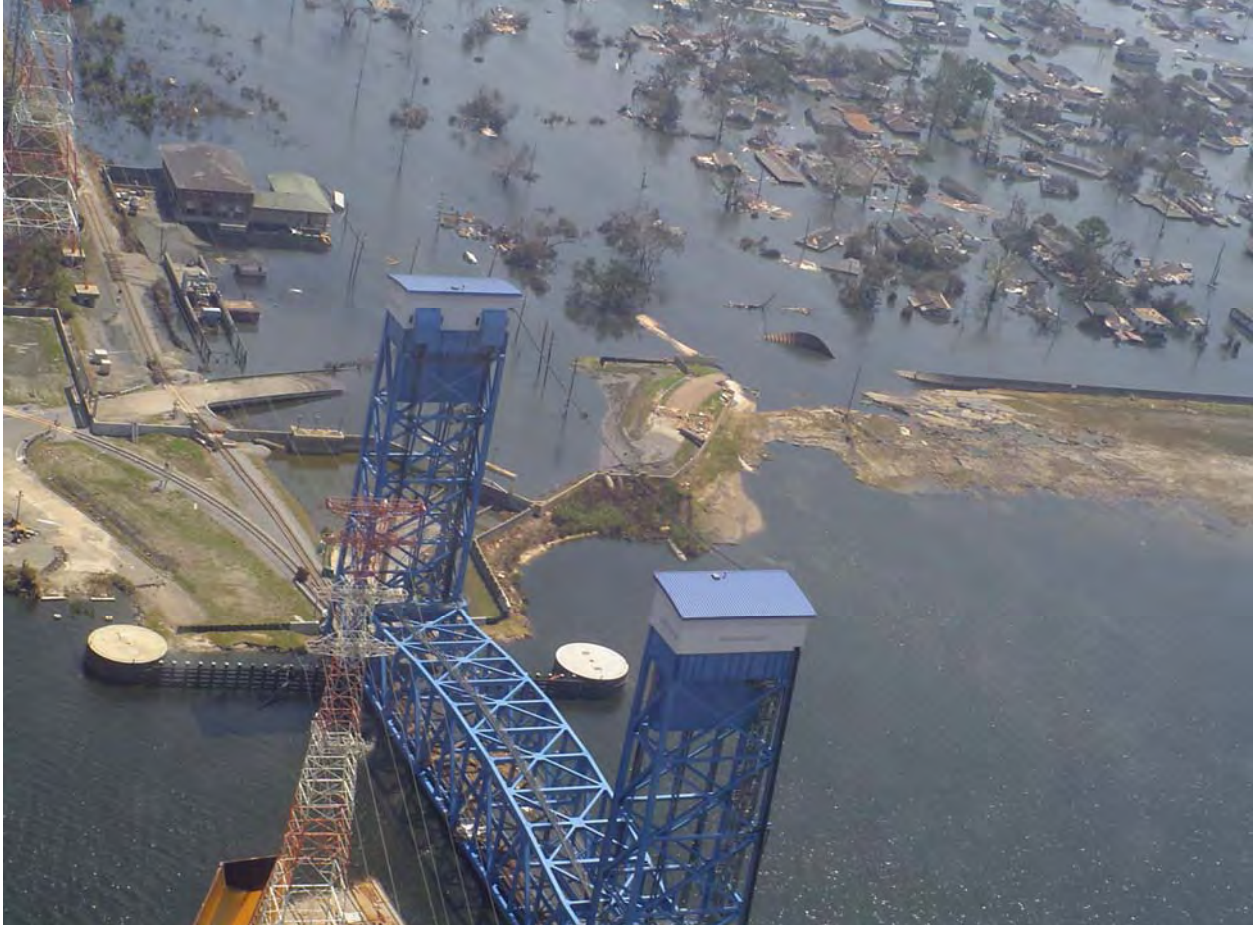
Figure 14-29. Florida Ave Bridge, View East. I-Wall Failure is Seen to Right of Bridge

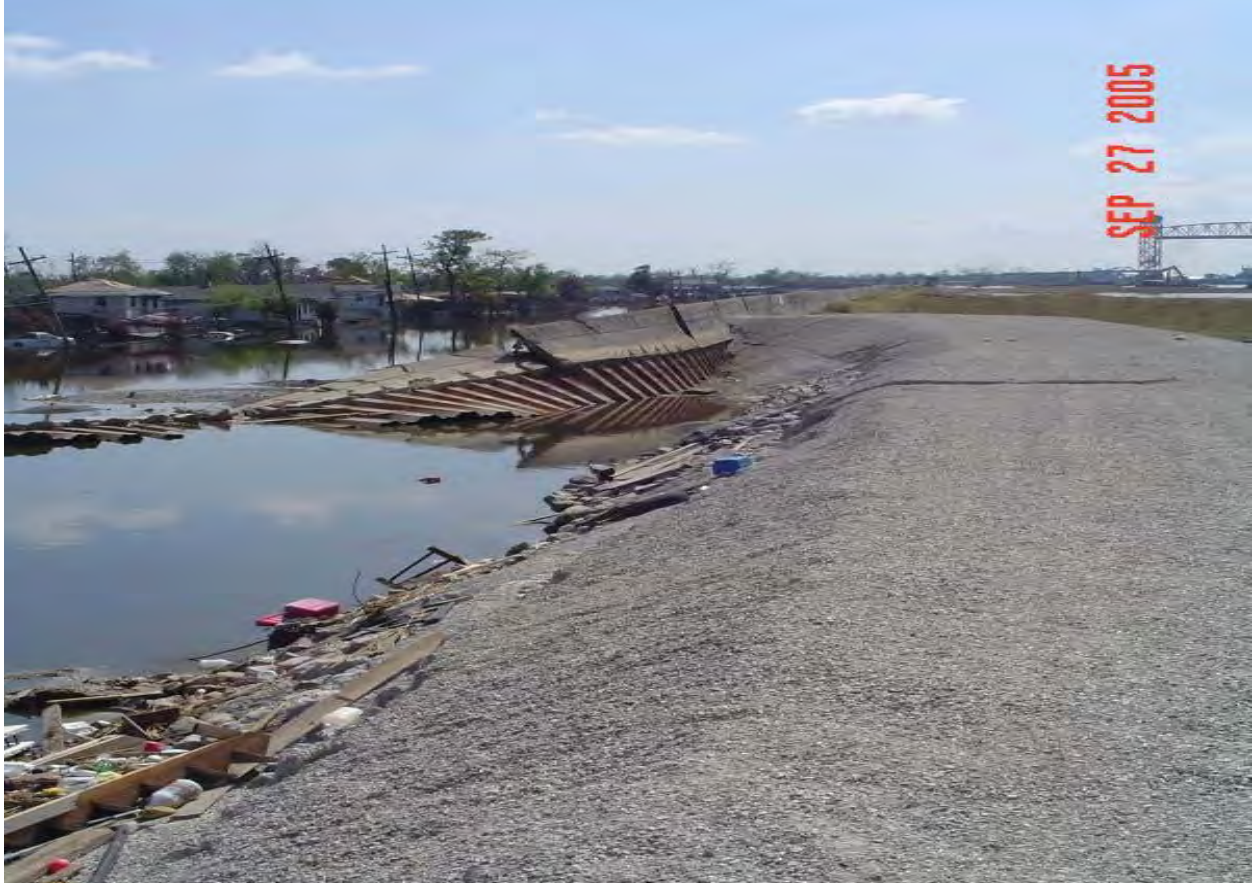
Figure 14-30. Southernmost I-Wall Failure Transition Between Florida Ave and Claiborne Ave.

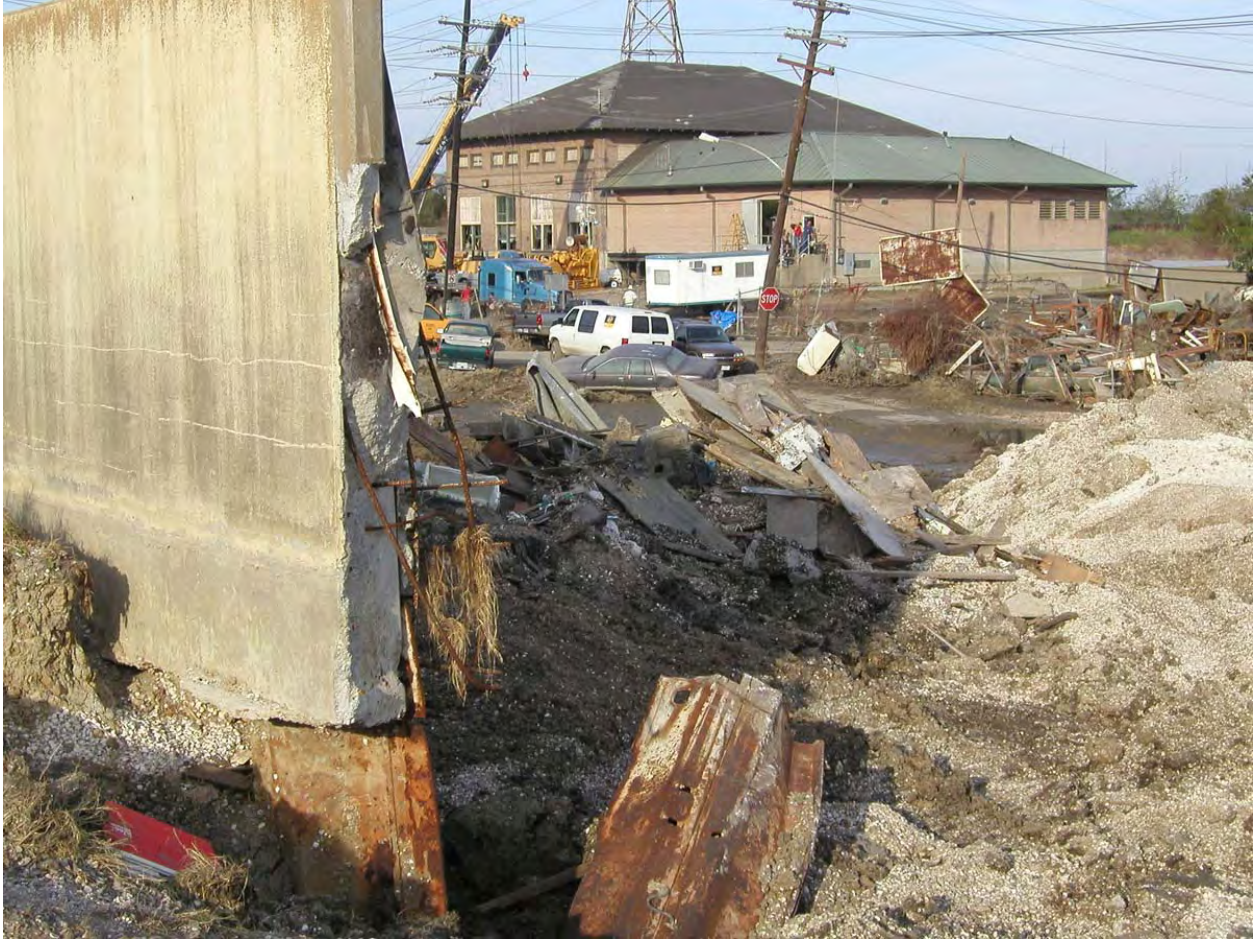
Figure 14-32. Northernmost I-Wall Failure Transition Between Florida Ave and Claiborne Ave., View Toward Pump Station on the Protected Side

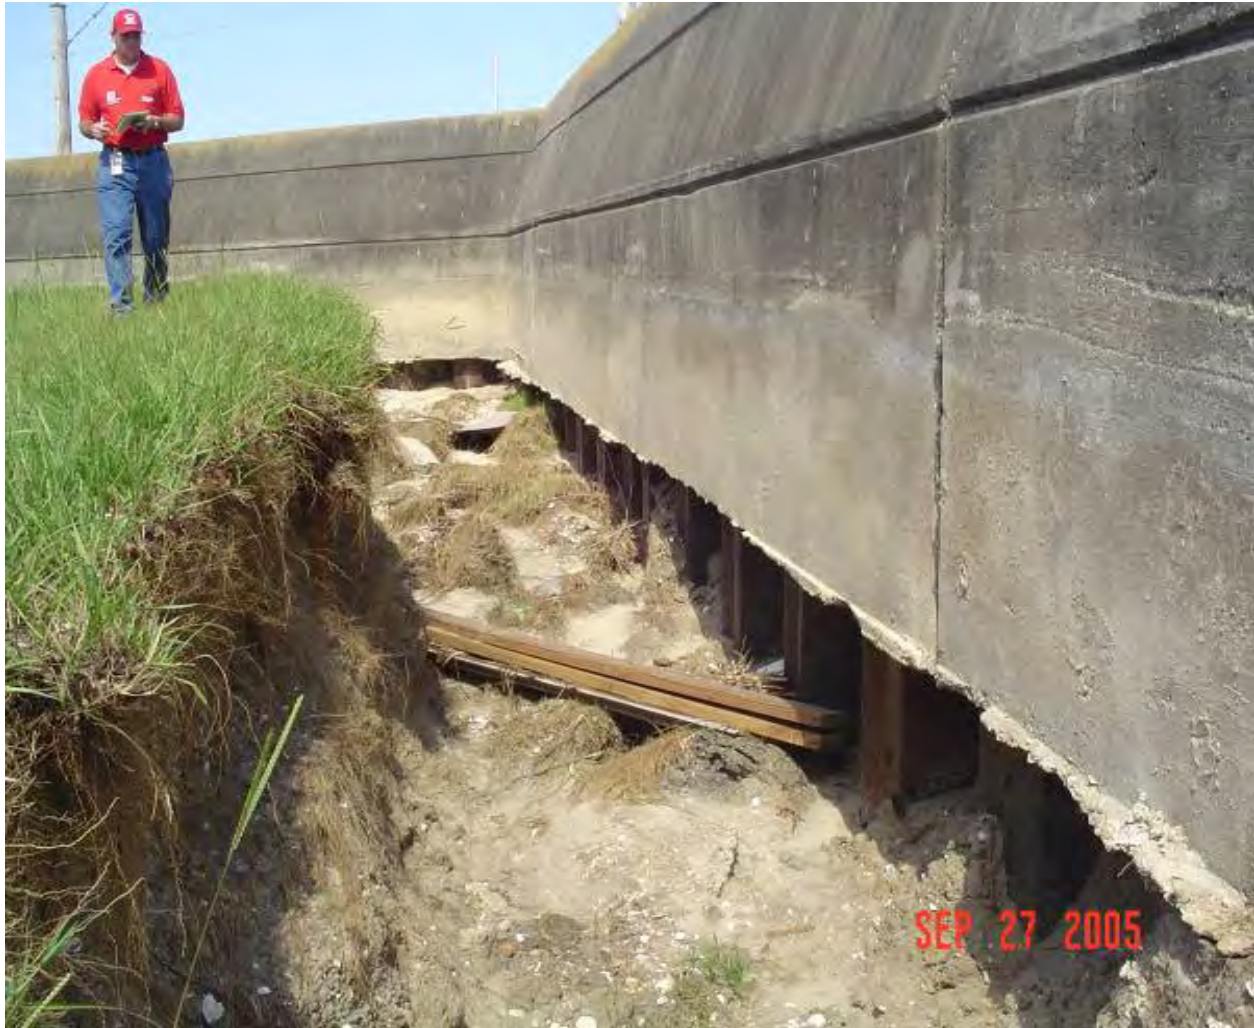
Figure 14-37. Approximate B/L Sta 101+00. Top of I-wall is elev 14.75, bottom of concrete is elev 7, and levee crown is elev 9. Nearest B/L boring is Sta 96+00 (No. 9EU), 500 feet distant

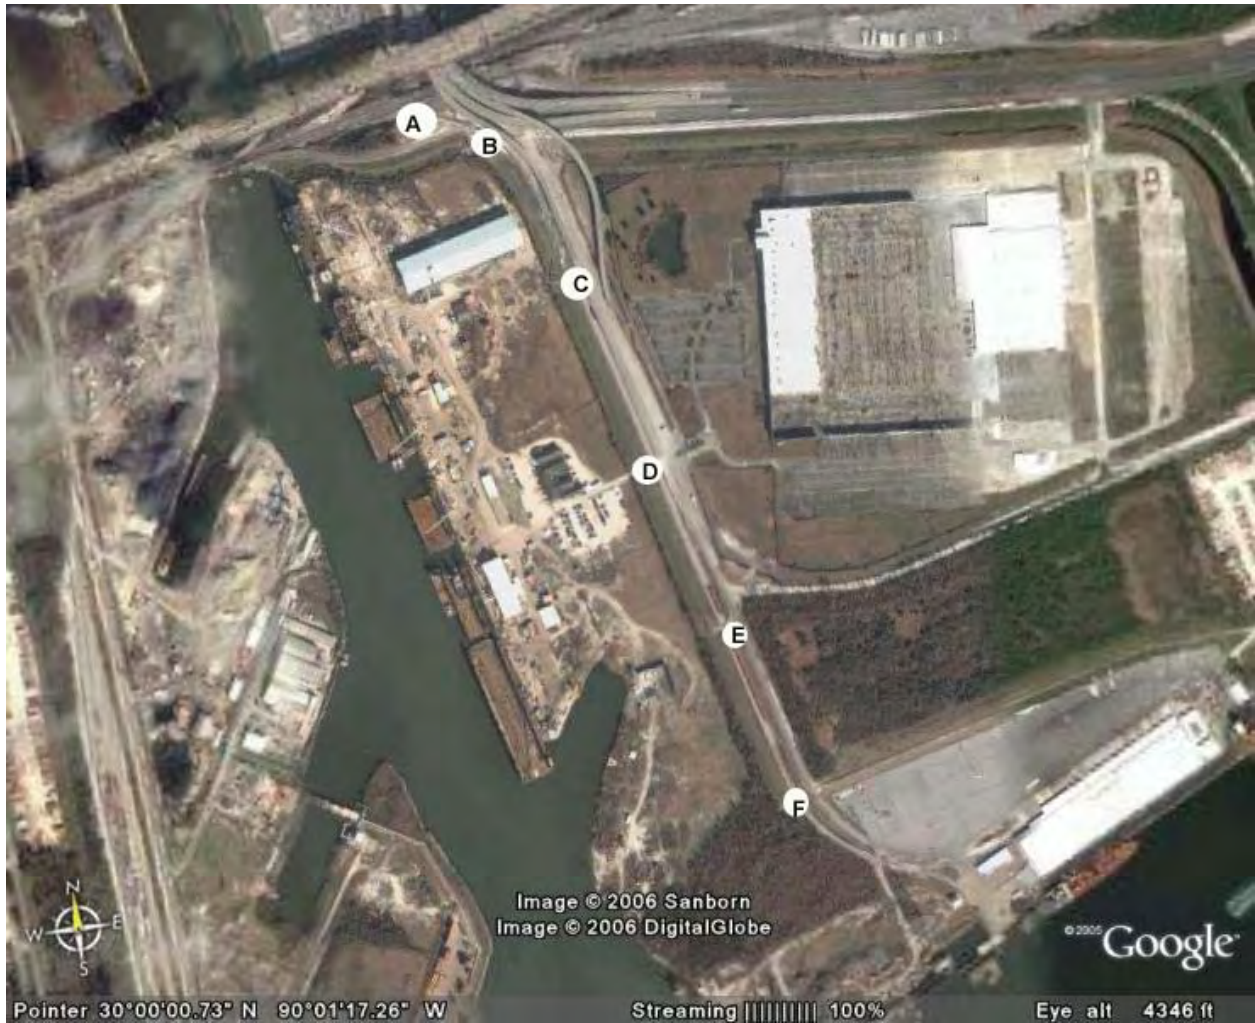
Description: There are approximately 2.75 miles of floodwall and levee along the east side of the IHNC Canal between the Gulf Intracoastal Waterway and Lake Pontchartrain. The damages in this reach consisted of intermittent scour of the levee and scour and damage at the wall/gate closures and at the wall/levee interfaces. The repairs consist of filling in the scour areas, repairing the gate concrete sills and seals, installing new sheet piling, placing rock and ballast, and placing stone erosion protection. Scheduled completion is April 1, 2006.

Figure 14-40. IHNC03 Project Repairs South of I-10 (WF / TF areas)

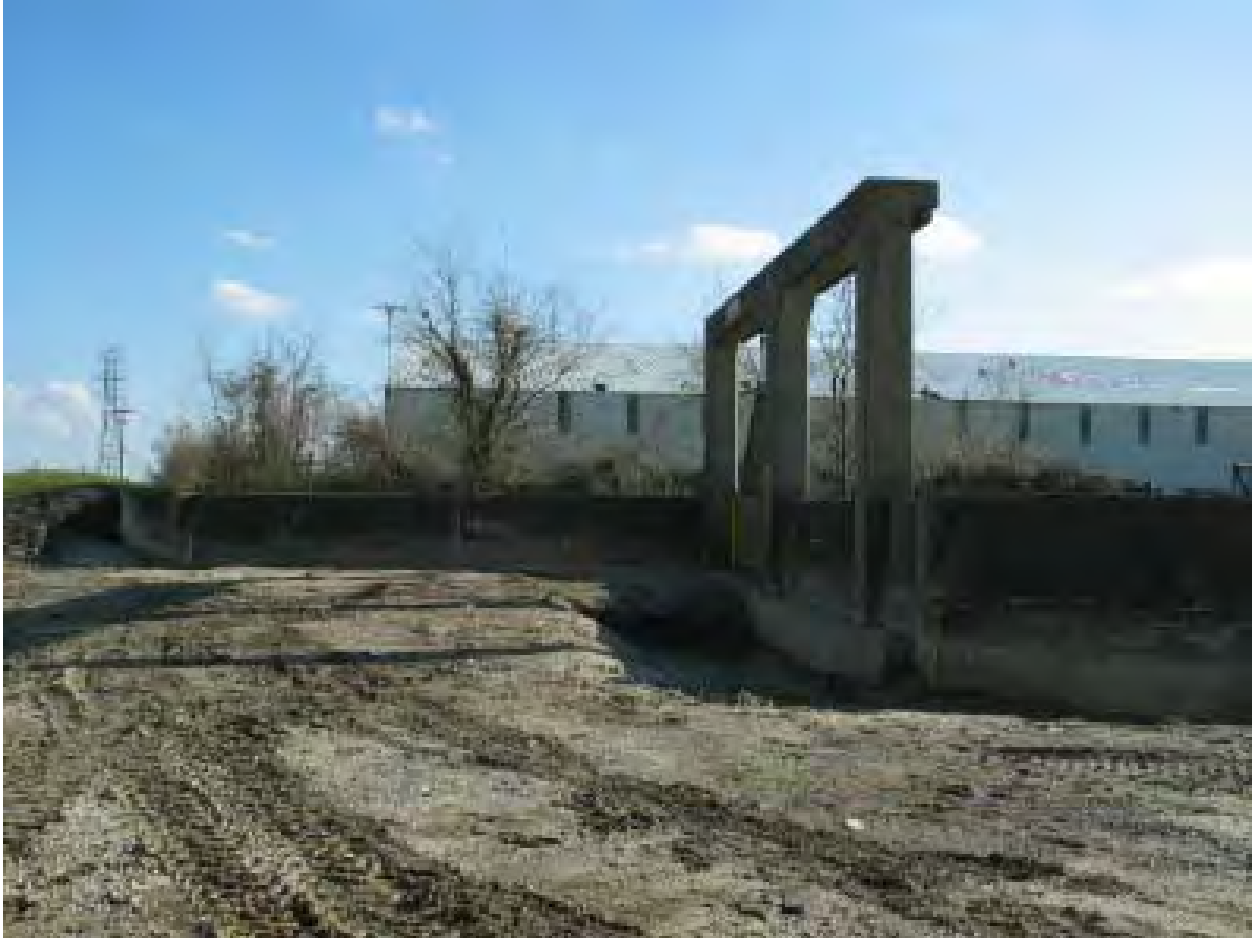
Figure 14-41. Scour at Gate 7E; Scour Measures 7' (w) x 30" (deep). Top of wall is at elev. 13.1 +/-

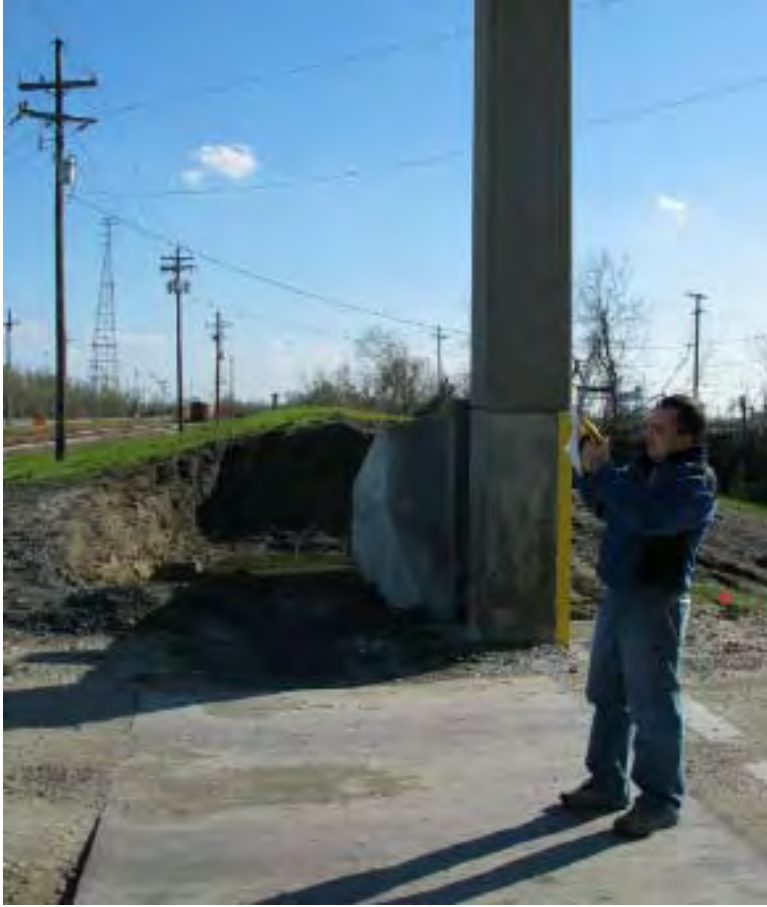
Figure 14-42. Gate E5 Looking South From Inside the Protected Area. Scour damage 7' (w) x 7' (d) around adjacent flood wall. Top of wall at gate is Elev. 13.2 +/-

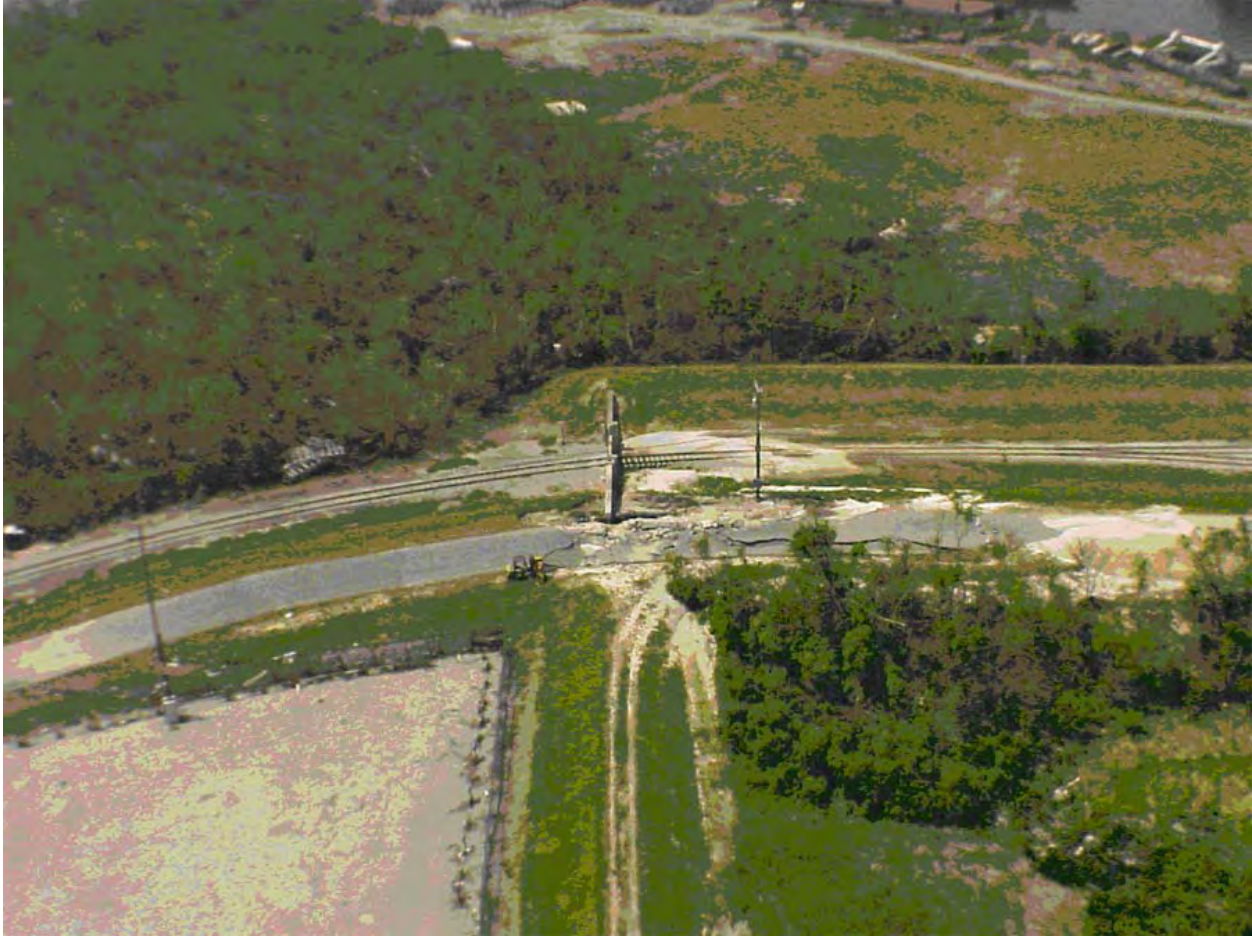
Figure 14-43. Scour at Railroad Gate Closure Structure E4 at Southernmost IHNC03 Project. 29 deg 59 min 48.76 sec N, 90 deg 01 min 11.6 sec W (Sta 176+75.9)

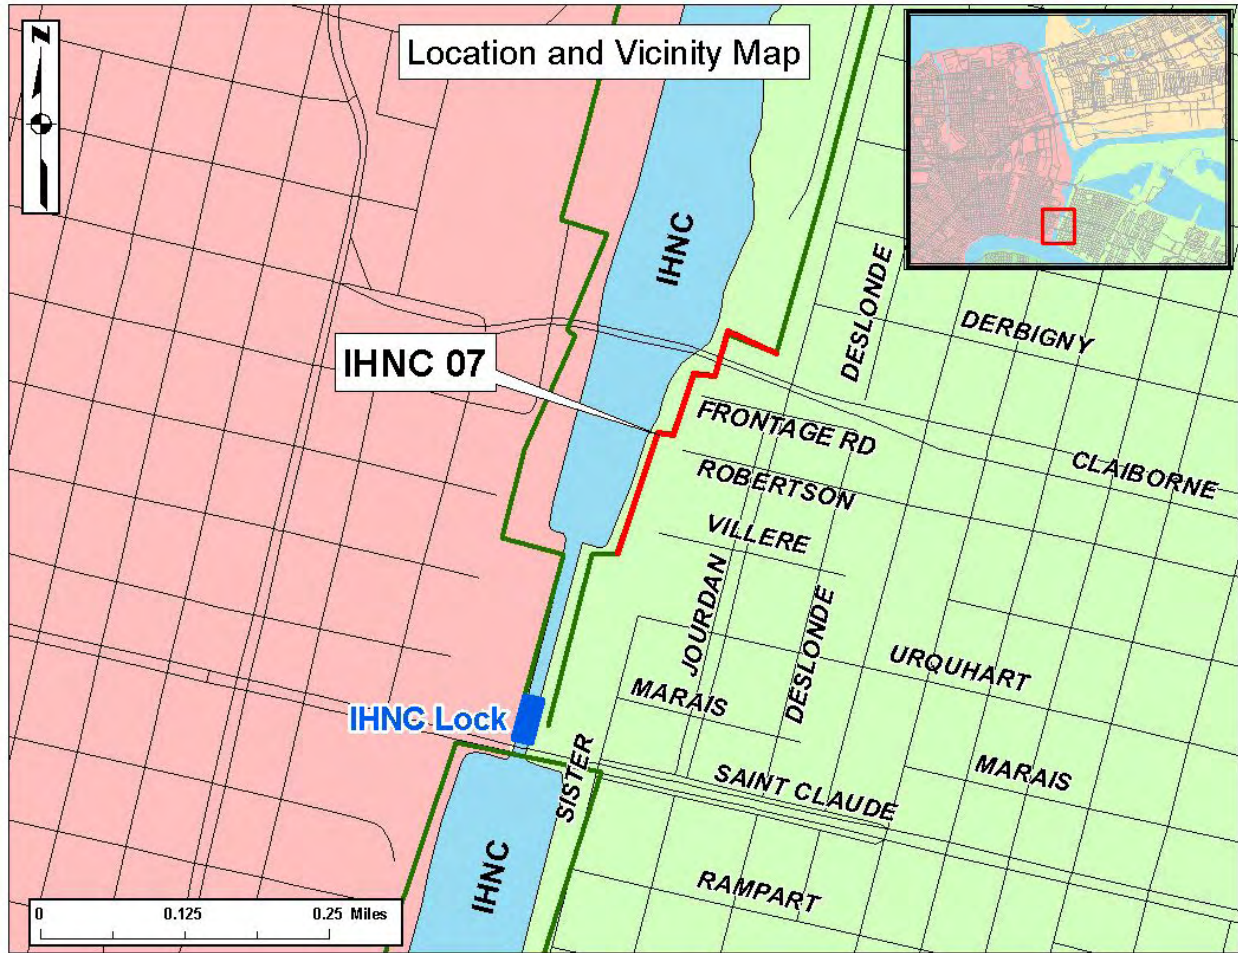
Figure 14-45.

Description: There is approximately 1,400 lineal feet of concrete I-wall flood barrier along the east side of the IHNC Canal between the IHNC lock and North Claiborne Avenue. The damages along this reach consisted of intermittent scour along the base of the floodwall. The work includes filling in the scour repairs and providing erosion protection. Contract Award NTP scheduled for early February, 2006.

1400' WNF / WS (base scour on landside)

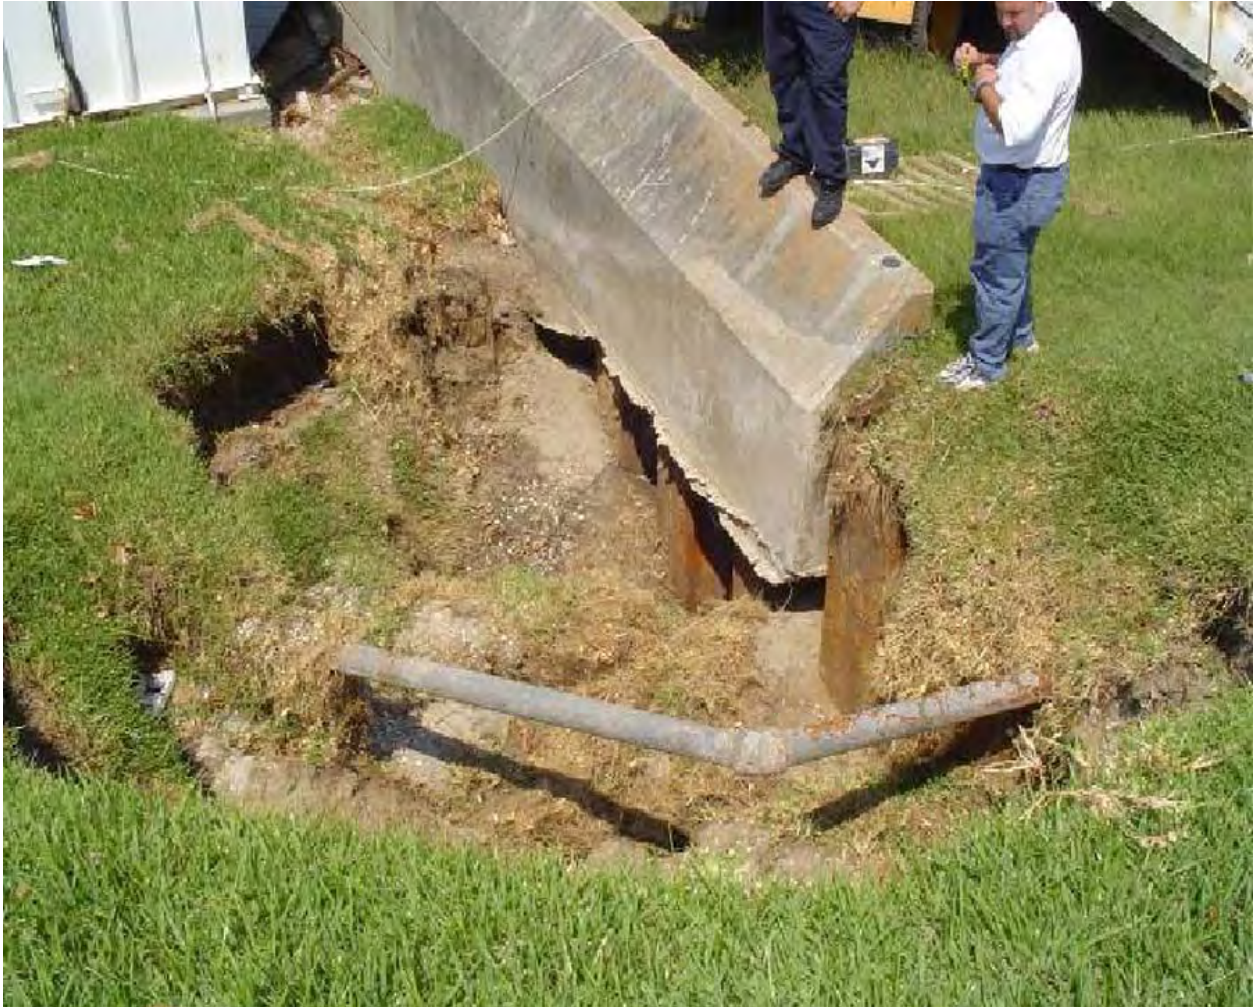
Figure 14-46. Scour at I-Wall / Levee Transition at IHNC Lock

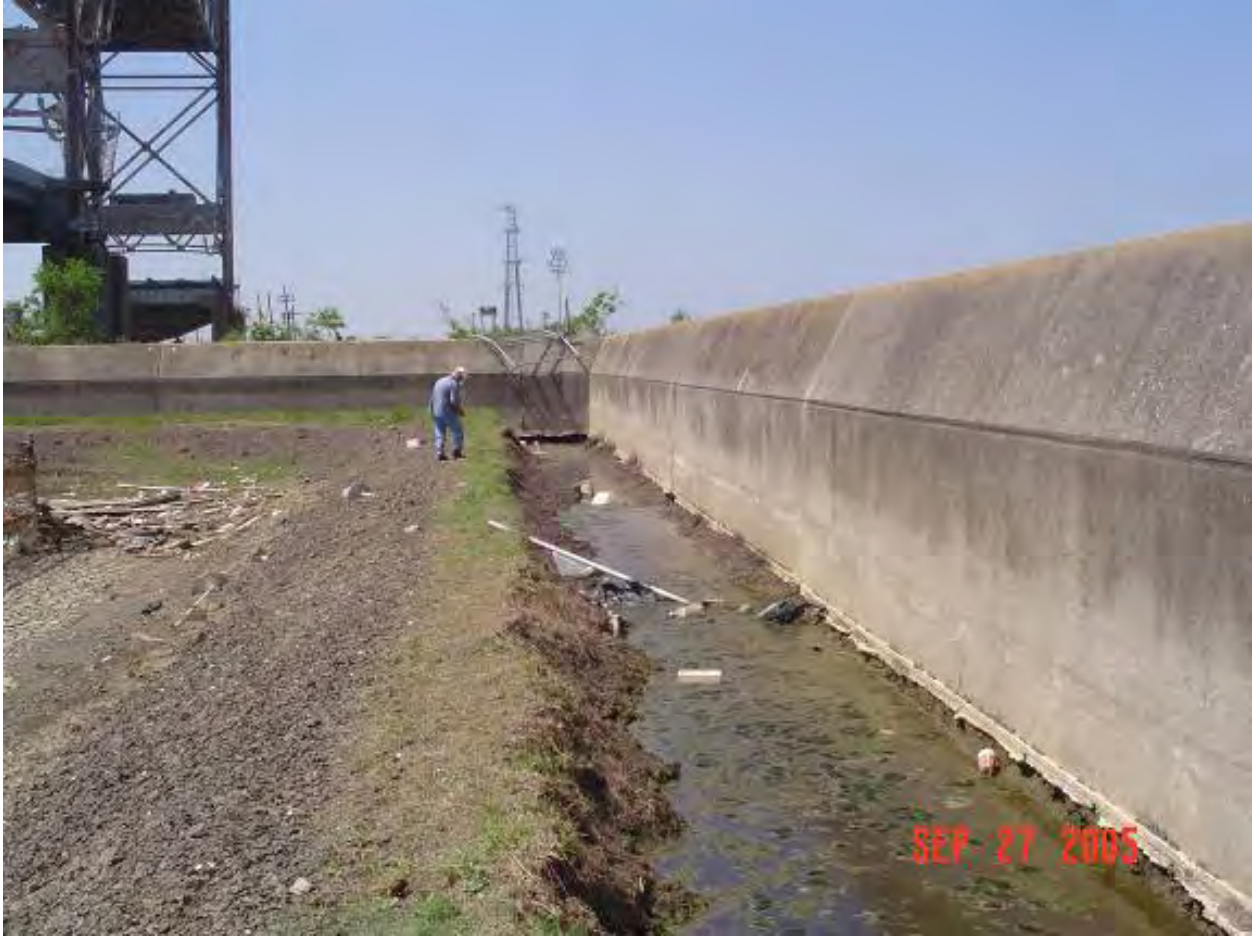
Figure 14-47. Approximate B/L Sta 7+00, View Toward Claiborne Ave. Bridge. Depth of scour was to the bottom of the I-wall concrete cap. Nearby soil boring 2U indicates the upper 5 ft was fat clay (CH) with sand / silt lenses

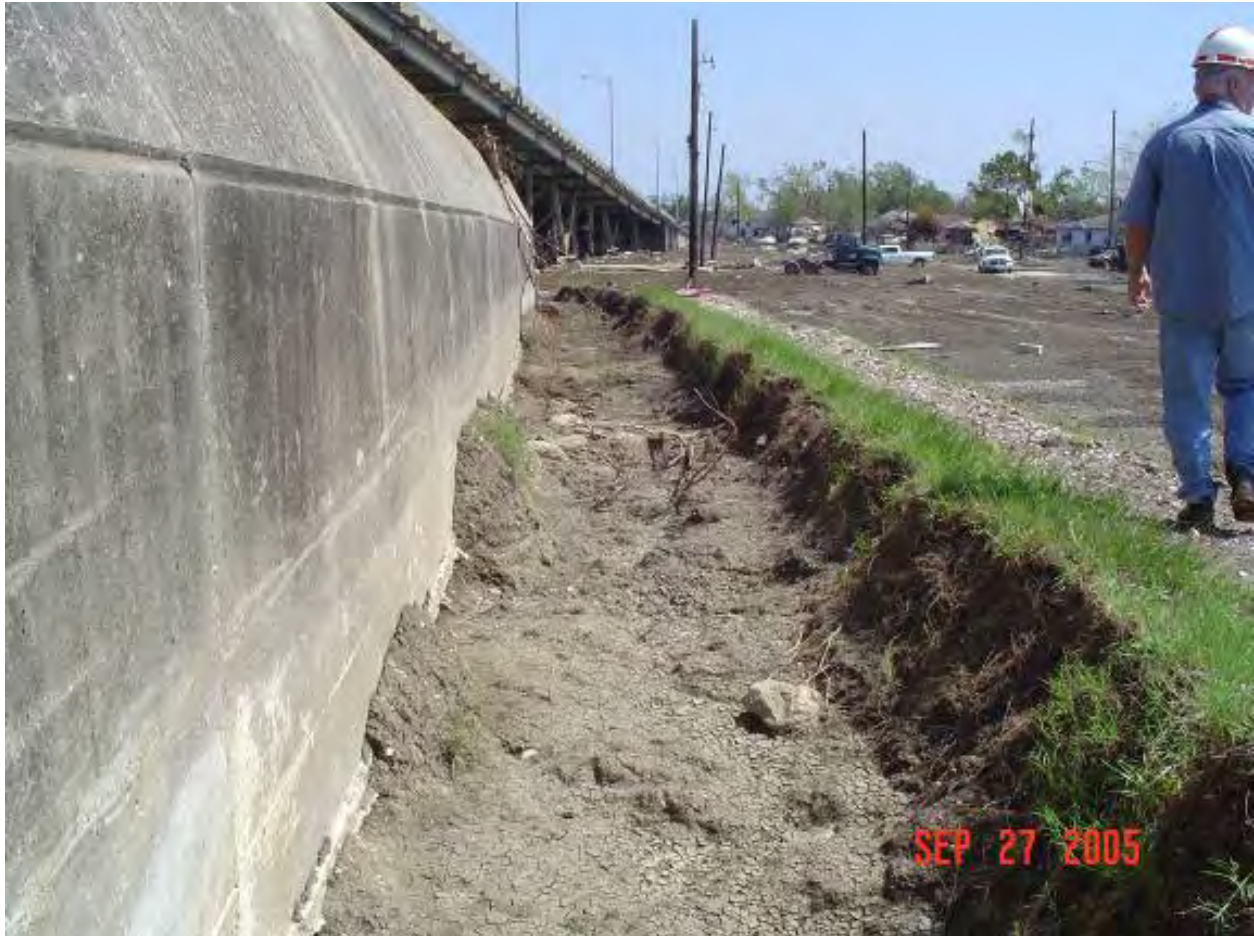
Figure 14-49. East Side IHNC Near N. Claiborne Ave, Approximate B/L Sta 11+00. I-wall elevation designed 15 ft (MSL), bottom of concrete elevation 7 ft (MSL), and levee crown elevation 9 ft (MSL). Nearest soil boring, No. 3, shows fat clay (CH) at surface

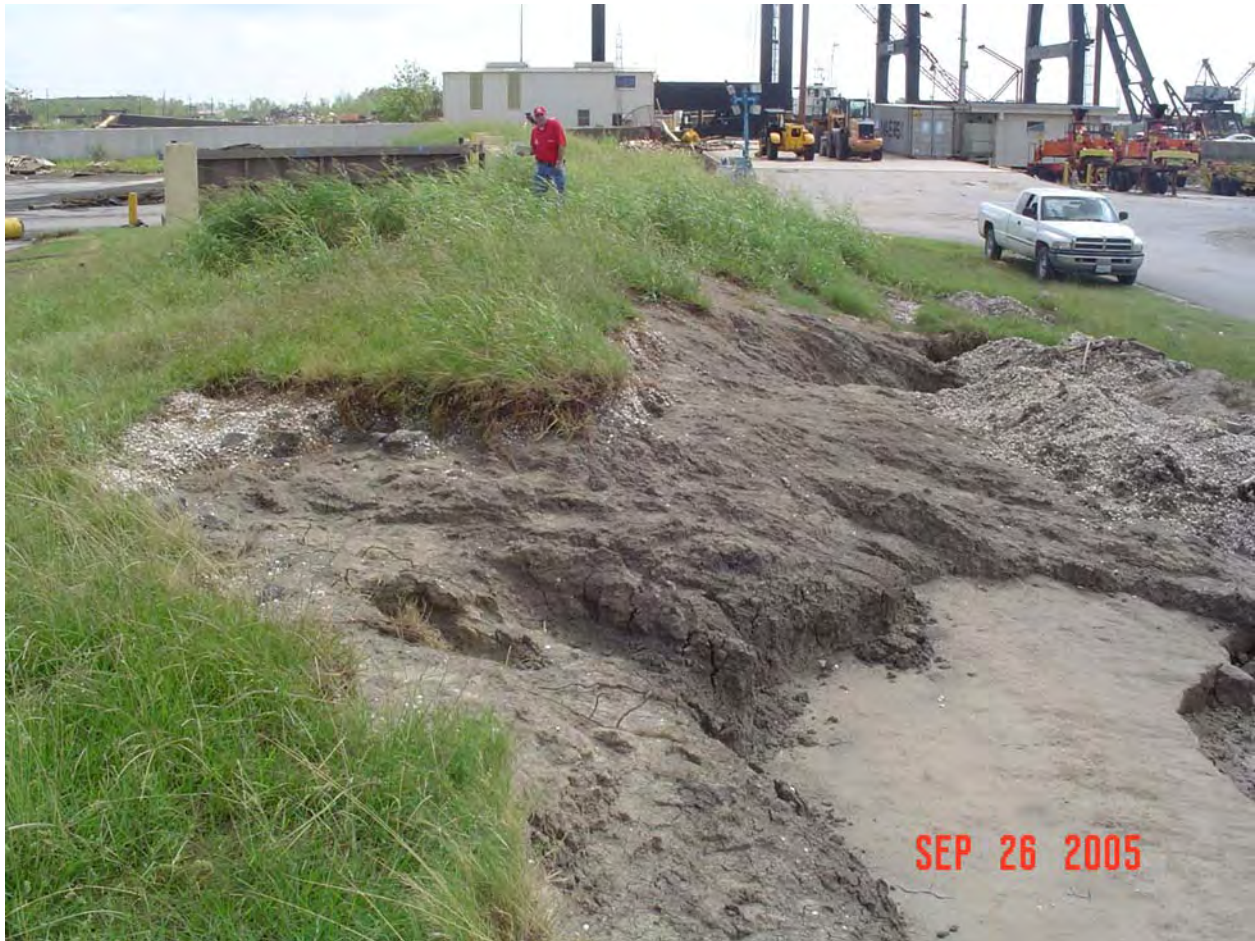
Figure 14-53. Overtopped Levee Section With Scour. View west from approximate CL Sta 14+00, B/L Sta 222+00

Description: This portion of the project consists of approximately 1,600 feet of existing levee and concrete floodwall that extends from the vicinity of France Road ramp towards the IHNC. This area was breached and experienced severe scour. The repair consists of replacement with a new concrete T-Wall. Scheduled completion is April 15, 2006.
