Appendix 1

Soil Data Report for 17th Street Canal

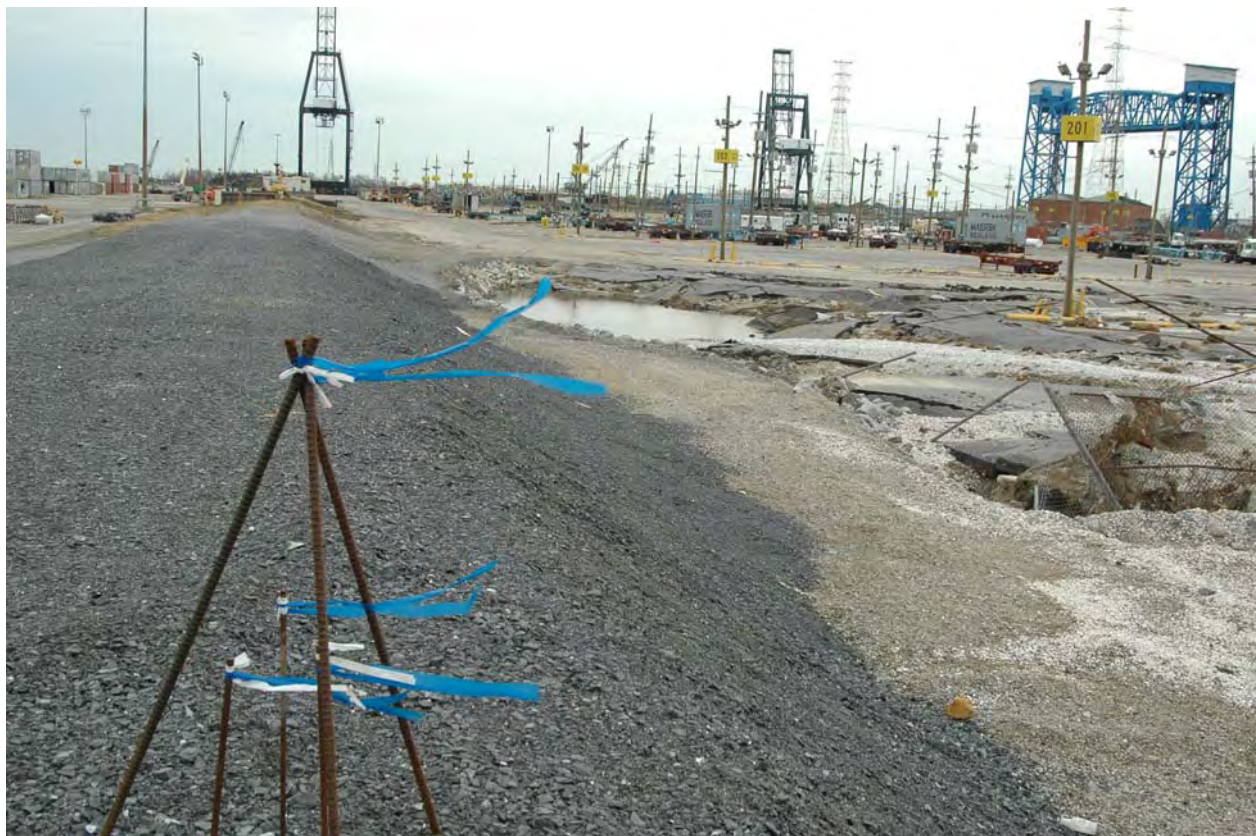
Figure 14-56. View West from France Rd. Ramp (approximate B/L Sta 212+00, C/L Sta 0+00). Remaining levee covered with fresh aggregate in preparation for new concrete wall construction

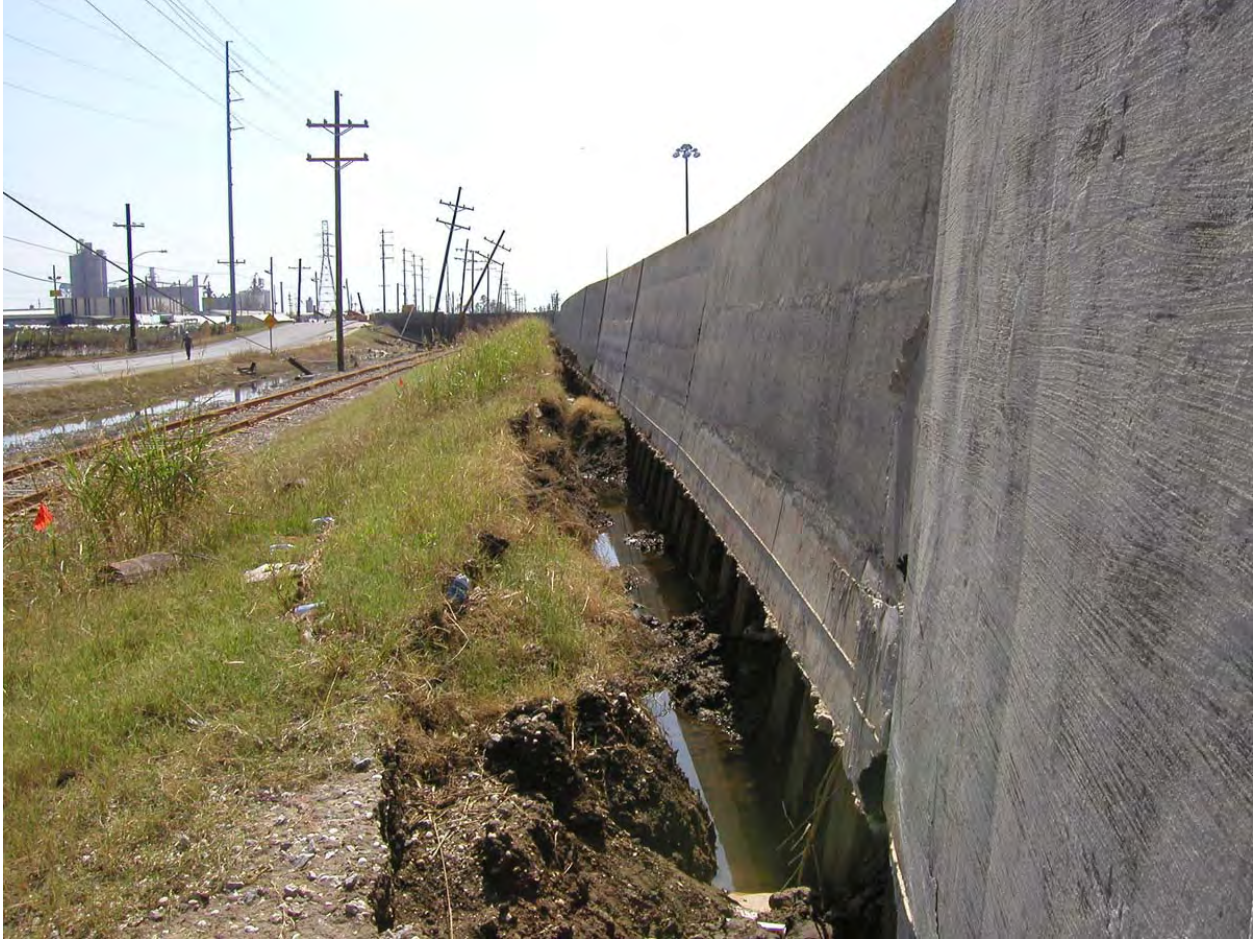
Figure 14-60. View South From Benefit St. Gate Toward France Rd Ramp. Approximate W/L Sta 5+56 (B/L Sta 205+44). Top of I-wall elevation 15 ft, levee crown 9 ft, bottom of concrete 7 ft, bottom of pre-existing Z-27 sheet pile (by Orleans Levee Board) at -10ft (MSL). From drawing file H-2-24111, plate IV-15. Nearest soil boring is 30W at B/L Sta 203+00

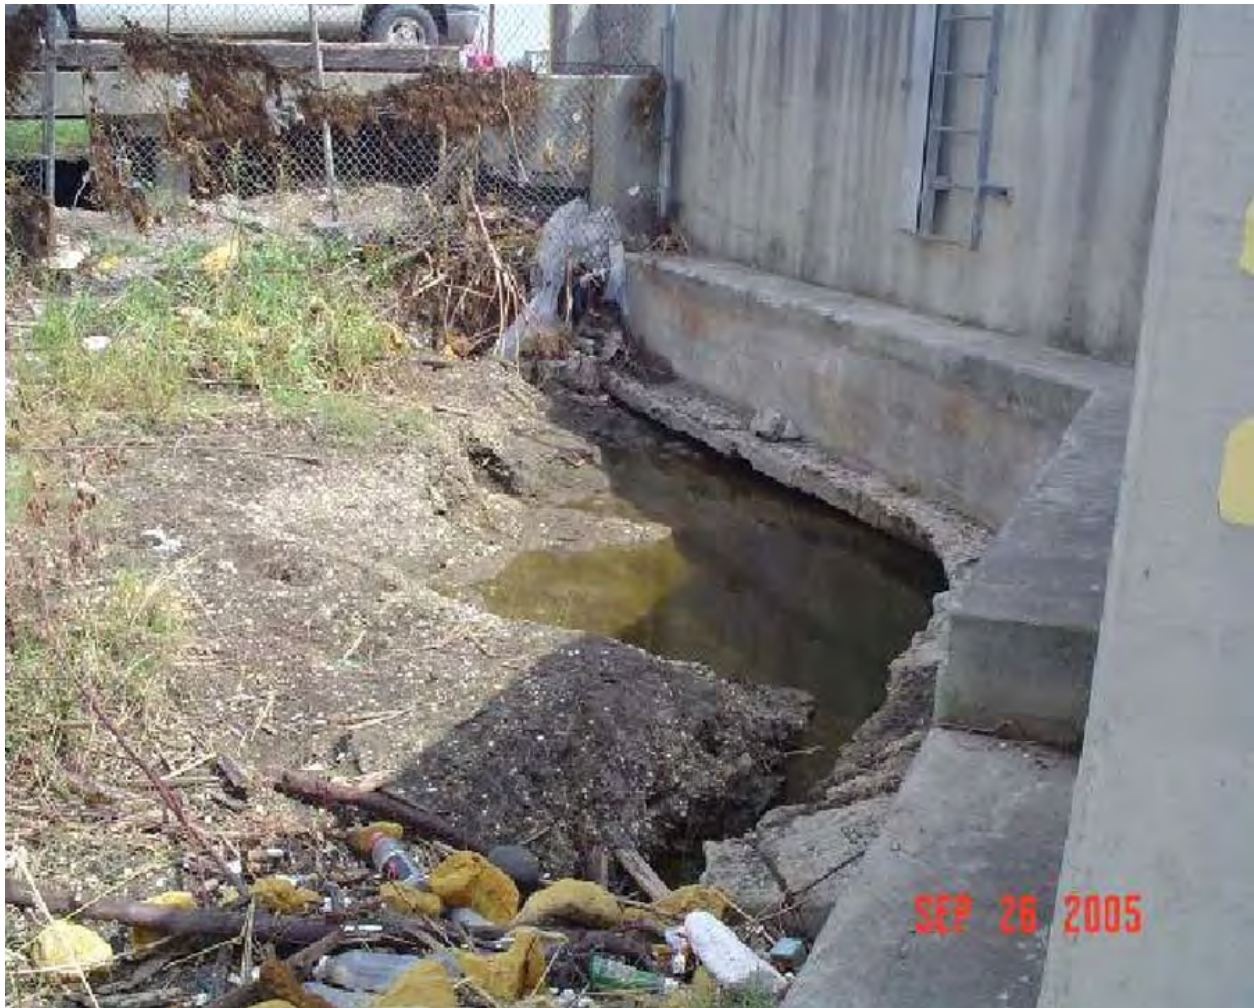
Figure 14-72. Scour at T-Wall Base of Gate W23

Description: This section of flood protection consists of concrete I-Wall embedded in compacted earthen levee embankment. The damages in this area consisted of scour along the base of the floodwall. The repairs consist of scour repair and erosion protection. Contract Award NTP scheduled for early February, 2006.

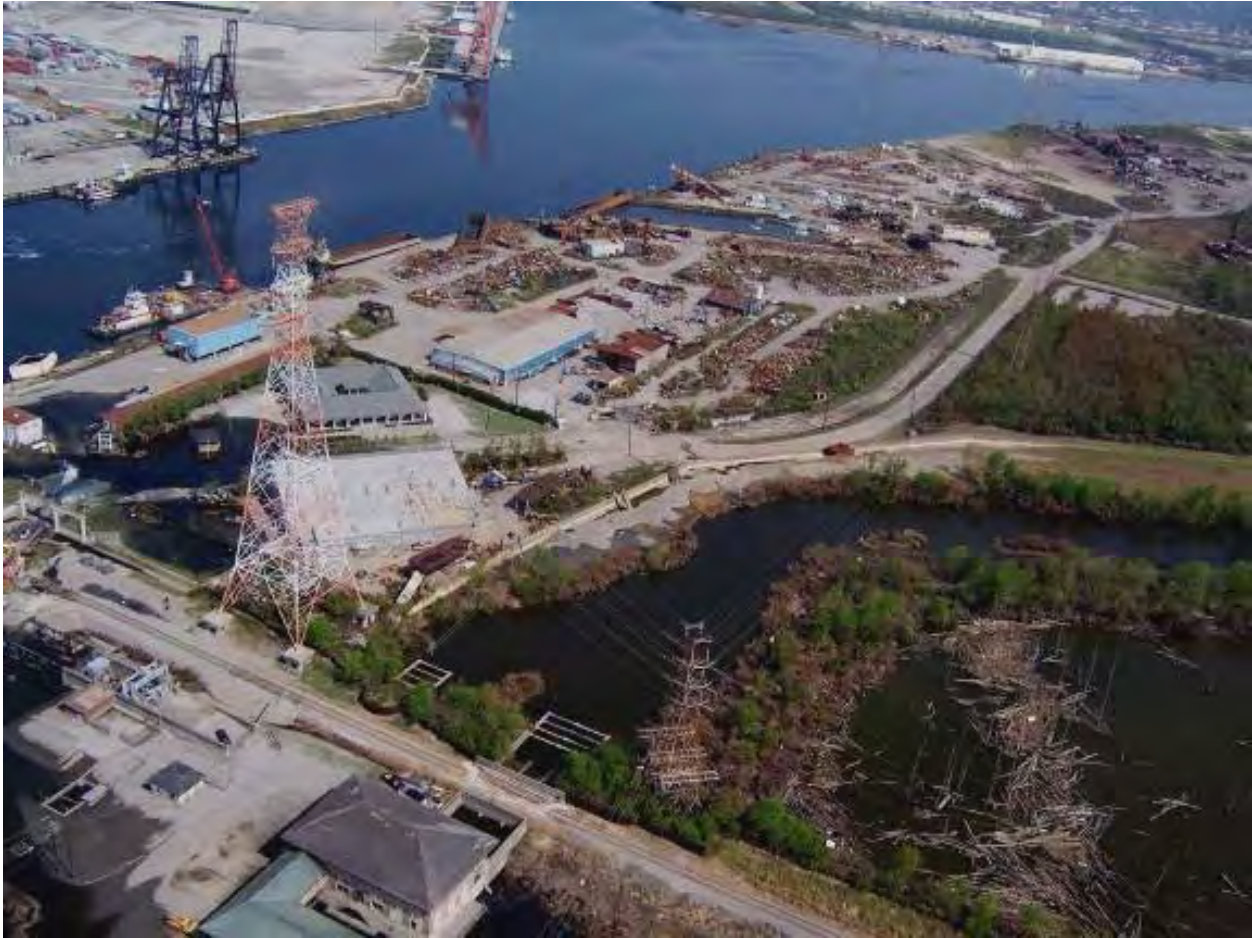
Figure 14-84. Floodwall Between Fla Ave (IHNC East) and Southern Scrap Facility

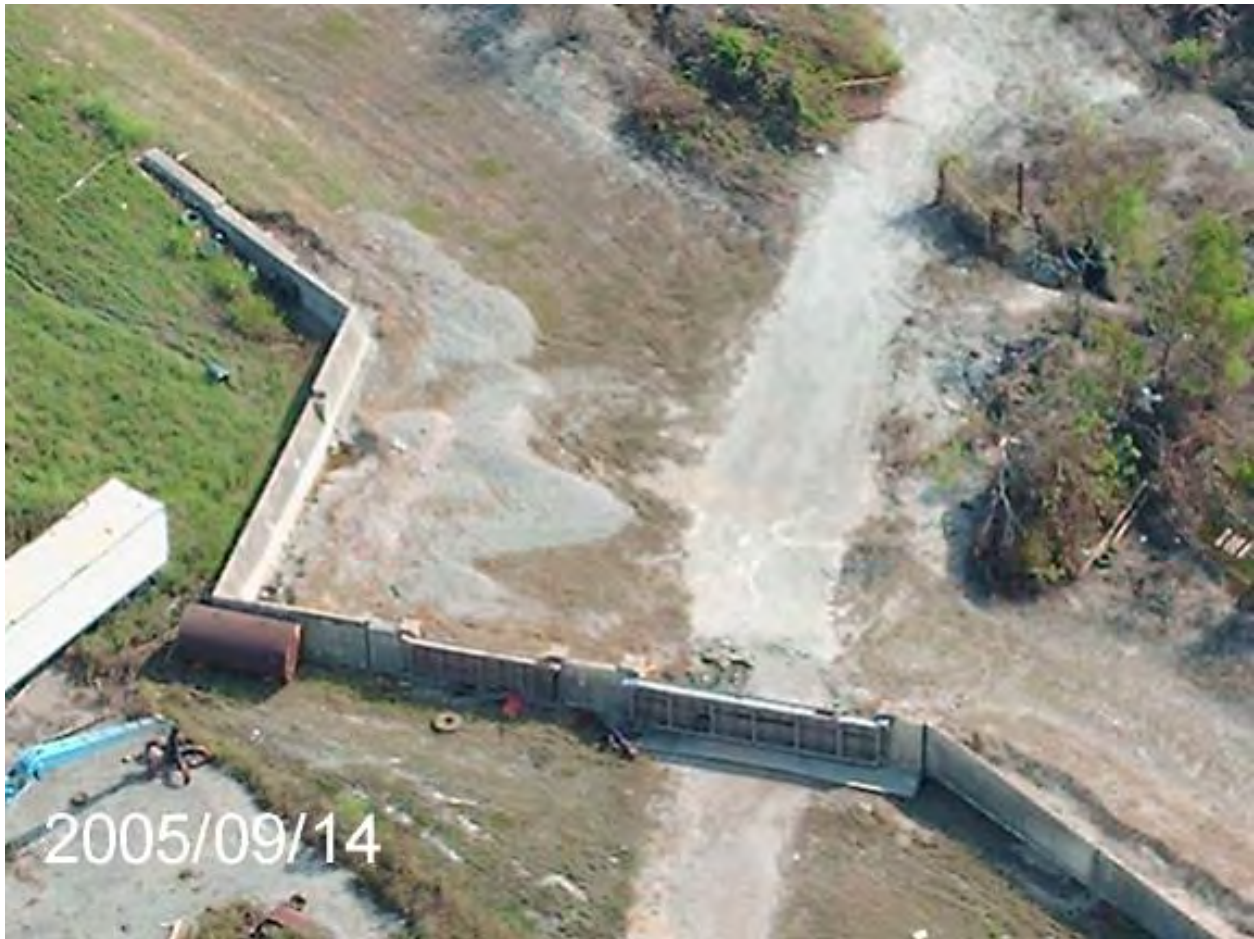
(1) Closure Structures Near Southern Scrap. There are two road closure structures that were damaged during the storm event. These closure structures are located at STA. 45+00 and STA. 67+94 at Orleans Rd. There was scour of the structural backfill resulting from overtopping of the floodwall and the closure gates.

Figure 14-86. View of Scour Outside Gates S2 and S3. IHNC/GIWW and Southern Scrap sites are on the left side of photo

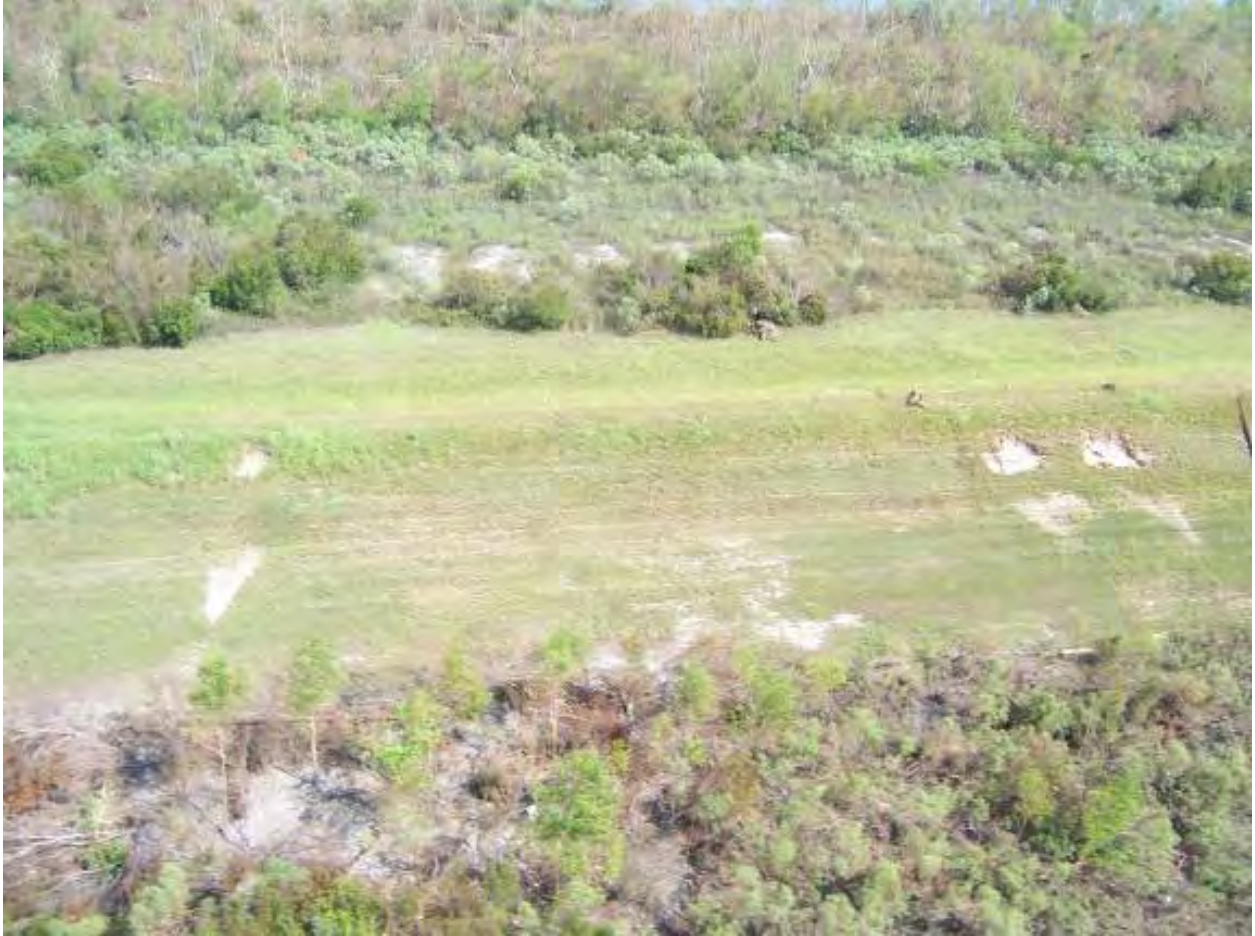
(2) Levee Damage Along Intracoastal Waterway (GIWW). There are small areas of scour on the backside of the levee between STA. 65+008 and STA. 277+20 (the Paris Rd high rise bridge is approximately over Sta 270+00). This scour was the result of localized overtopping of the levees in this reach.

Figure 14-91. Localized Scour on the Levee South of the GIWW, Between IHNC and Paris Rd.

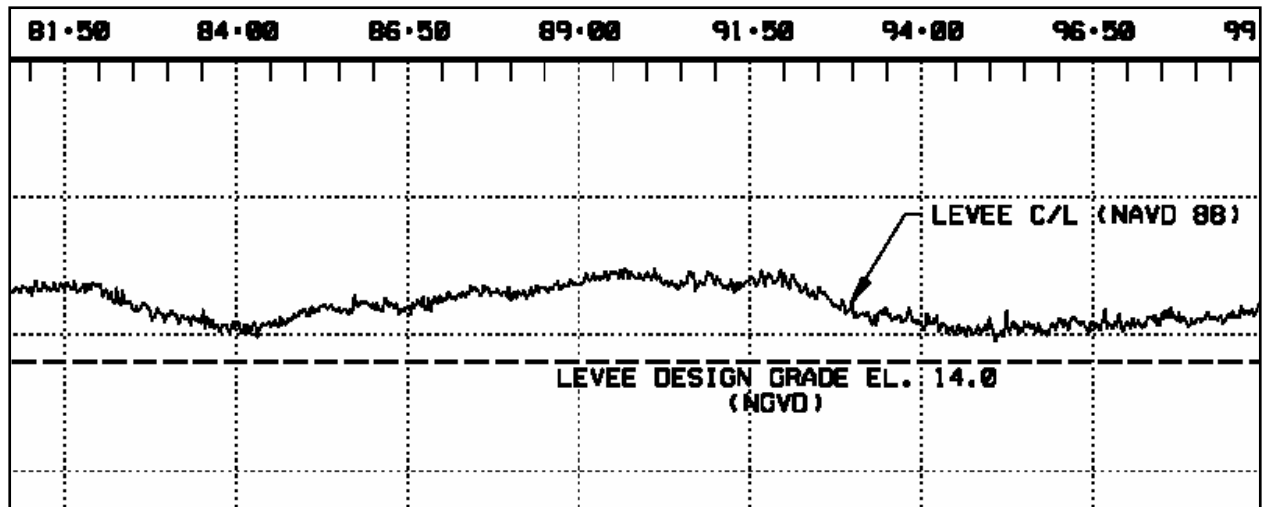
Figure 14-93. Levee Profile East of B/L Sta 81+50 (dwg 3 of 12). Note design grade elev 14 (NGVD) and lidar post-Katrina elev between 14 and 16 (NAVD 88)

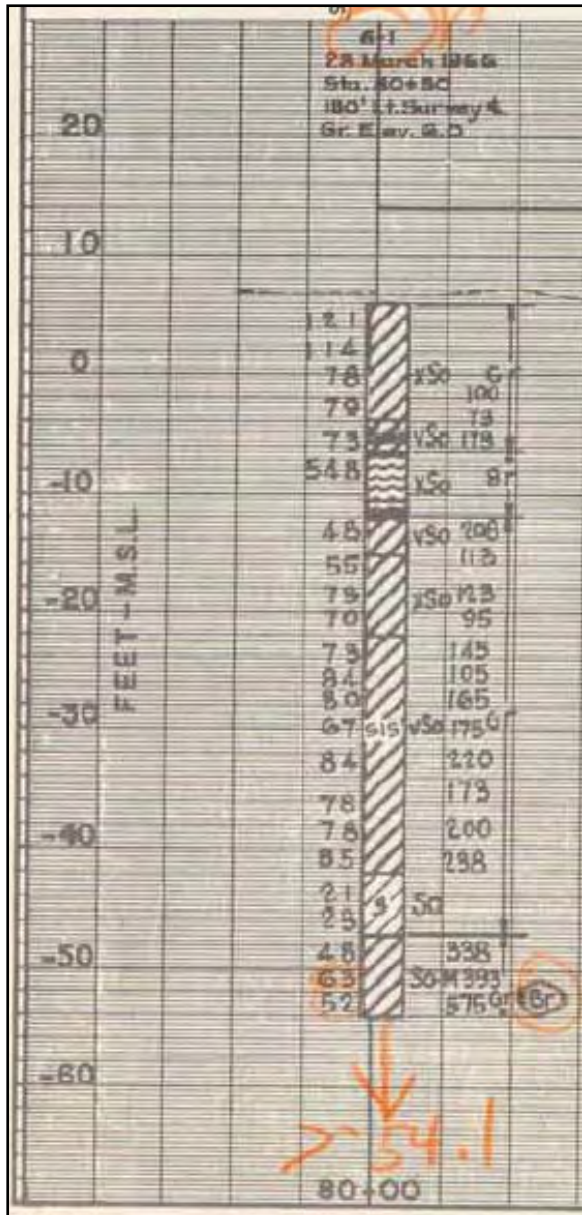
Figure 14-94. Nearest Boring at Sta 80+50, G-1, Circa 1966, From DM3, Plate 8. Original ground elevation was approximately 6 ft MSL, and surface soil was CH. Levee was built to approximate elevation +14 ft. circa 1970. Additional lift up to elevation 19 was added circa 1985

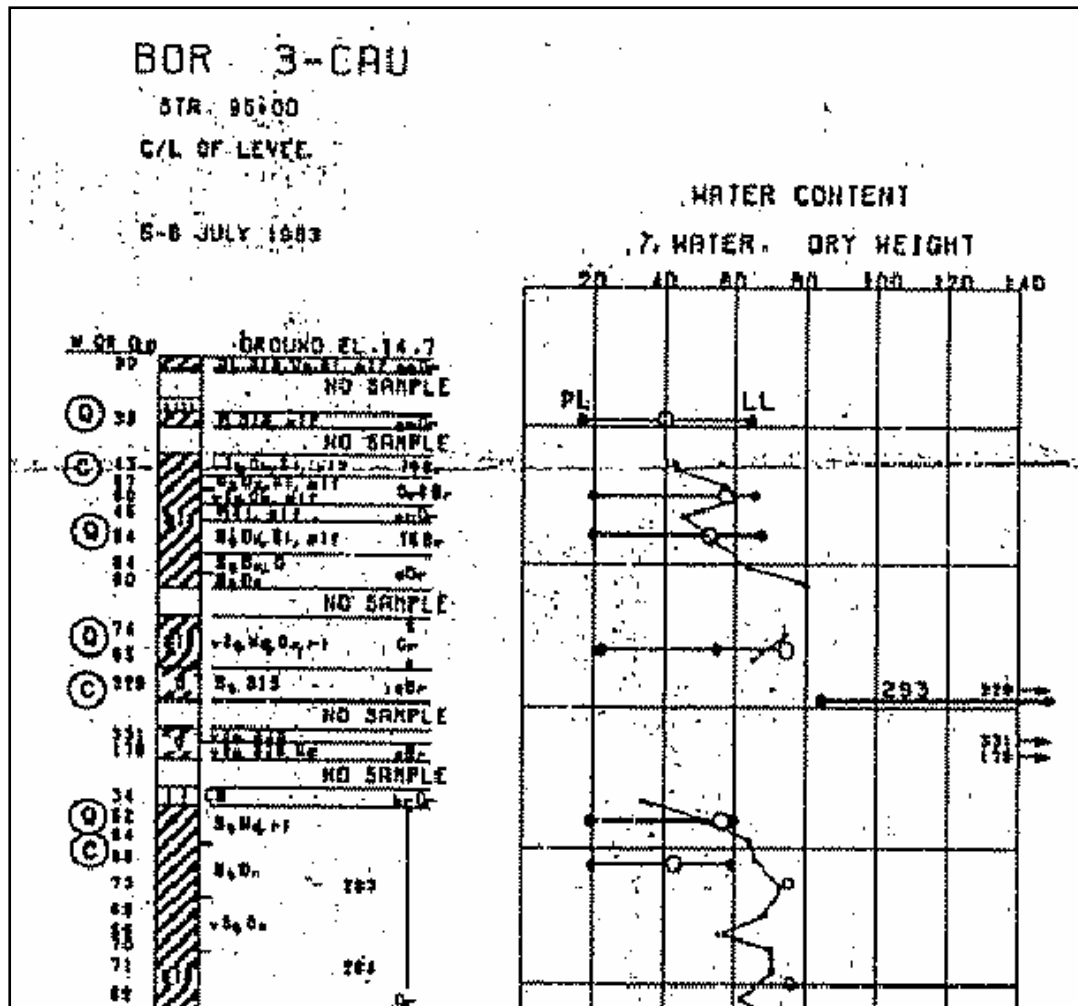
Figure 14-97. Sta 95+00 boring, 1983, shows CH soil at top of pre-existing 14' levee over a thin lens of sandy material. Note ground elevation (14.7 ft) comparison with lidar elevation (15 ft) at Sta 95+00 in Figure 14-93 above

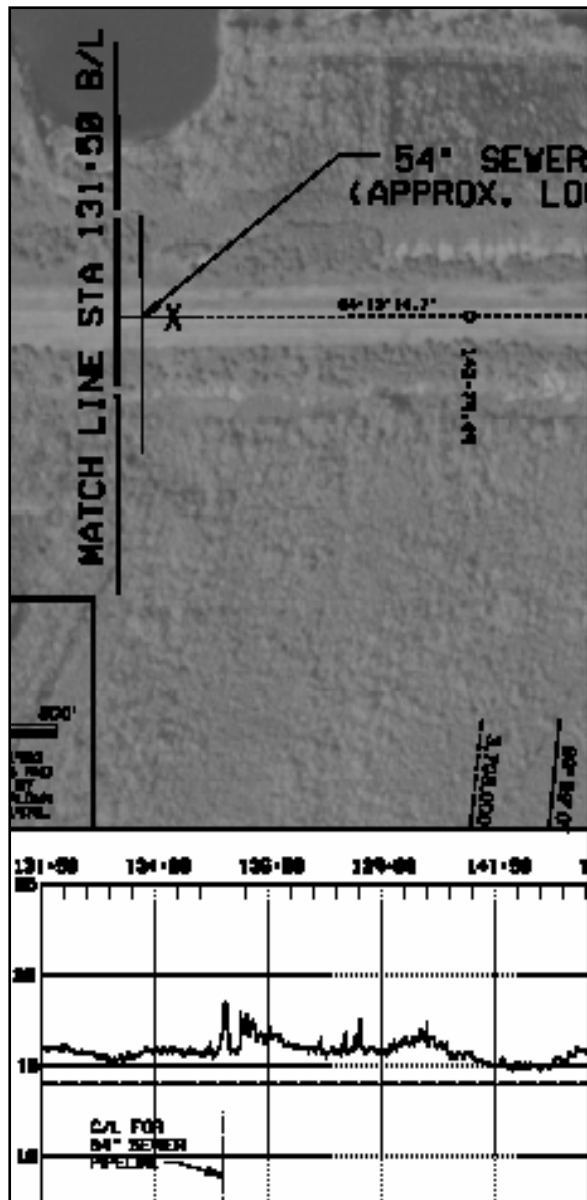
Figure 14-98. A Minor Scour Location (Marked With X) at B/L Sta 135+00 (from dwg 4 of 12, Contract Solicitation W912P8-06-R-0022)

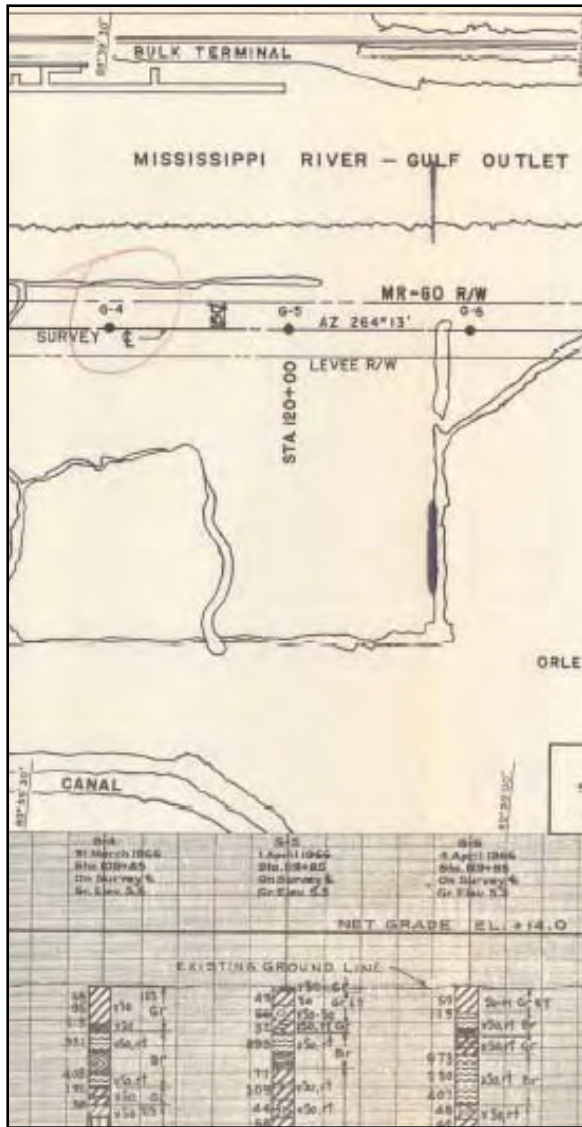
Figure 14-100. Plate 6, DM3 (1966) Soil Boring G-6 at Sta 129+80 at Levee Centerline Shows Fat Clay (CH) at Original Ground Surface

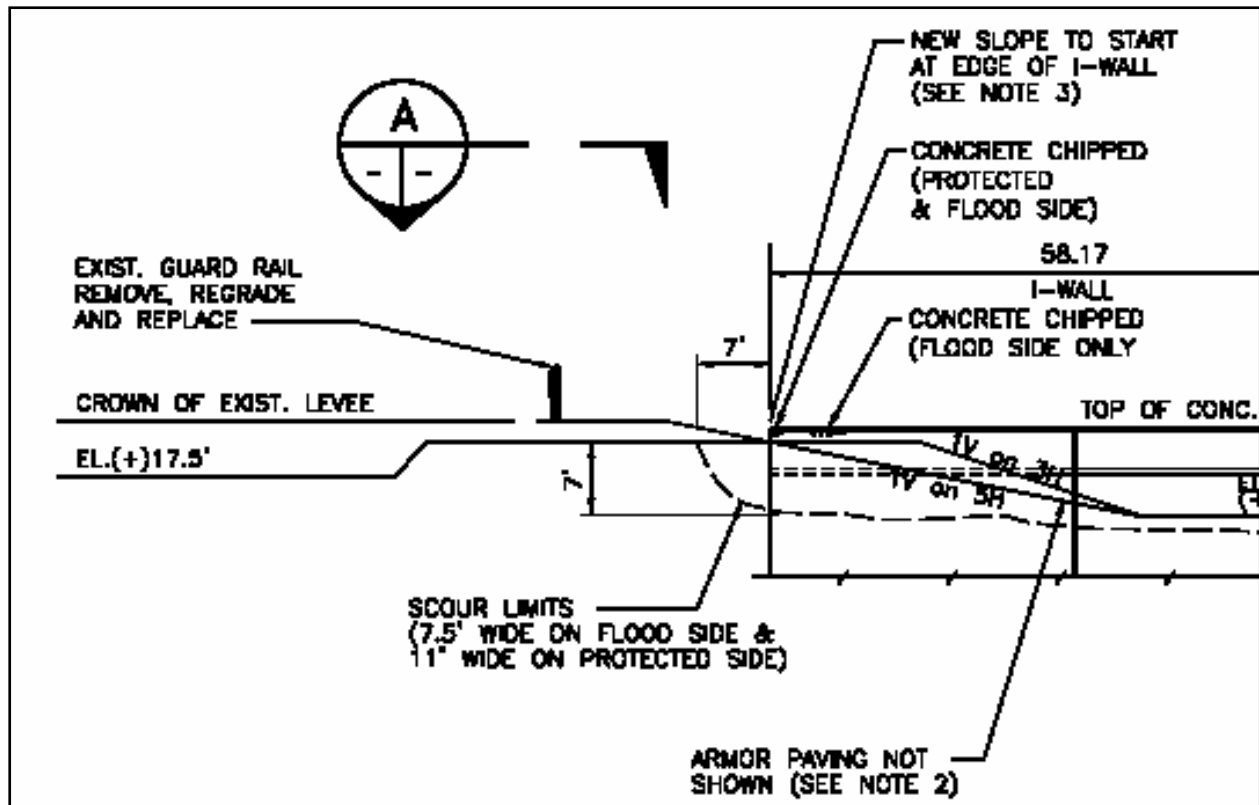
Figure 14-105. Gate S5 Scour Hole (From Levee Restoration, Misc. Gates and Floodwall Repairs, IHNC to Bienvenue, Chalmette Area Plan Emergency Restoration solicitation W912P8-06-R-0022, October 2005 contract drawing H-8)

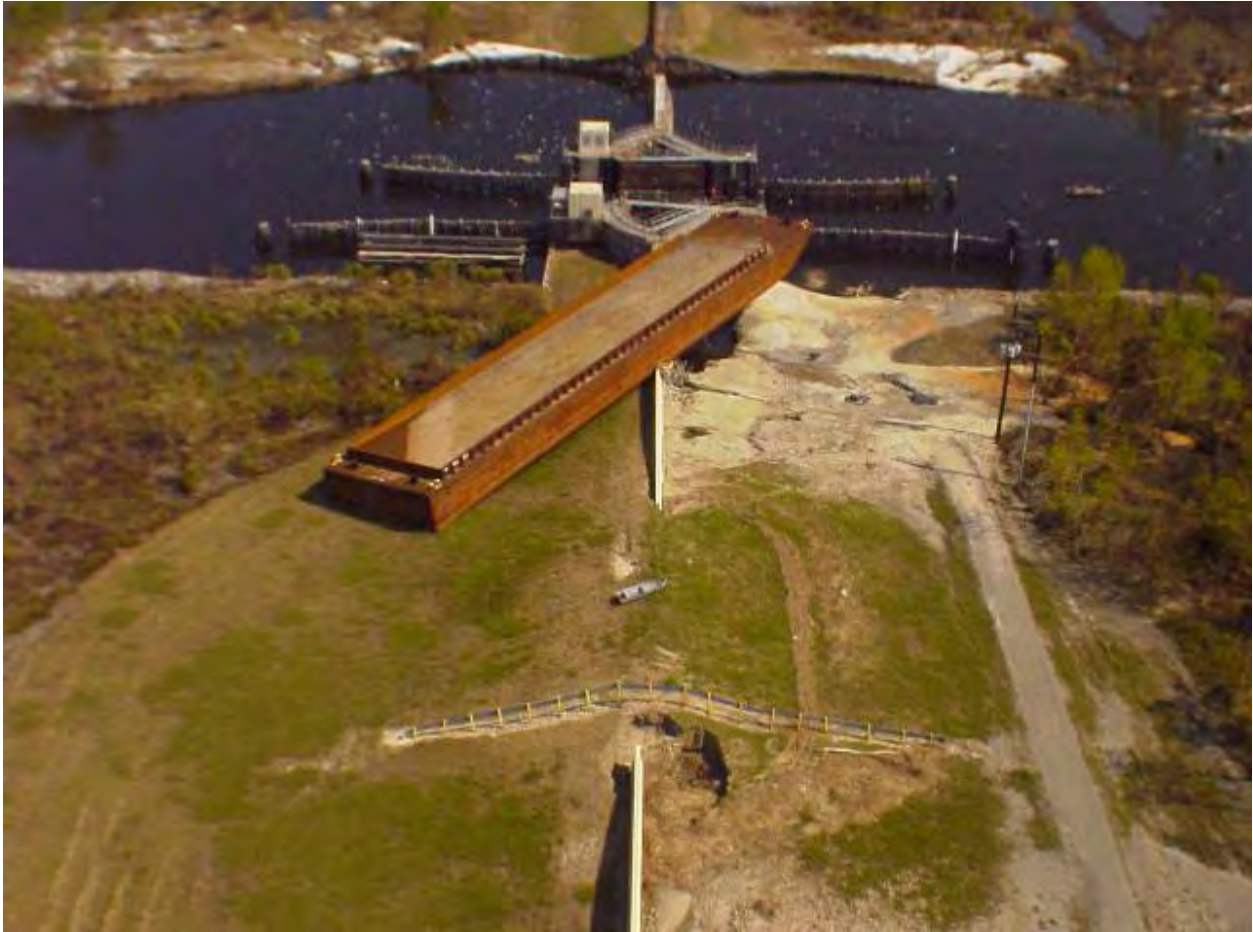
Figure 14-109. Post-Katrina. Note scour near guardrail shown in Figure 14-104

TFG Project **STB07** includes repair of structural damage and loss of structural backfill at the Bayou Bienvenue Control Structure. A significant scour hole is to be filled with 28,600 cubic yards of granular backfill and protected with grouted riprap. An estimated 32,100 tons of riprap and 3,400 cubic yards of embankment fill will be required for the repairs. All materials are to be furnished by the contractor, and scheduled completion is 1 April 2006.

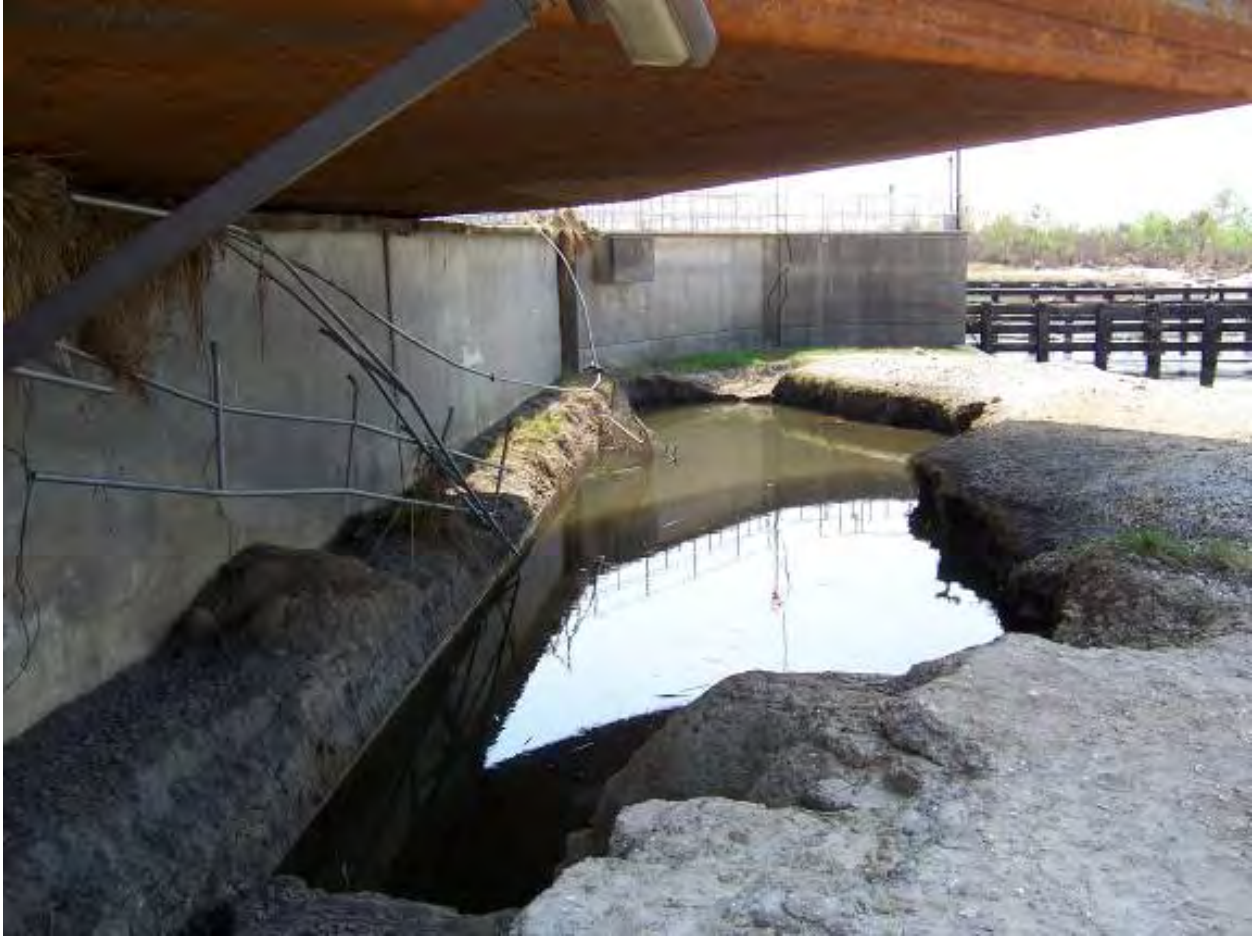
Bayou Bienvenue Control Structure. This control structure was damaged during the storm event. The adjacent floodwall was hit by a loose barge and the fill around the adjacent floodwalls was eroded away due to overtopping. In addition there was damage to the mechanical and electrical systems that operate the sector gates.

Figure 14-110. Barge Resting on T-Wall

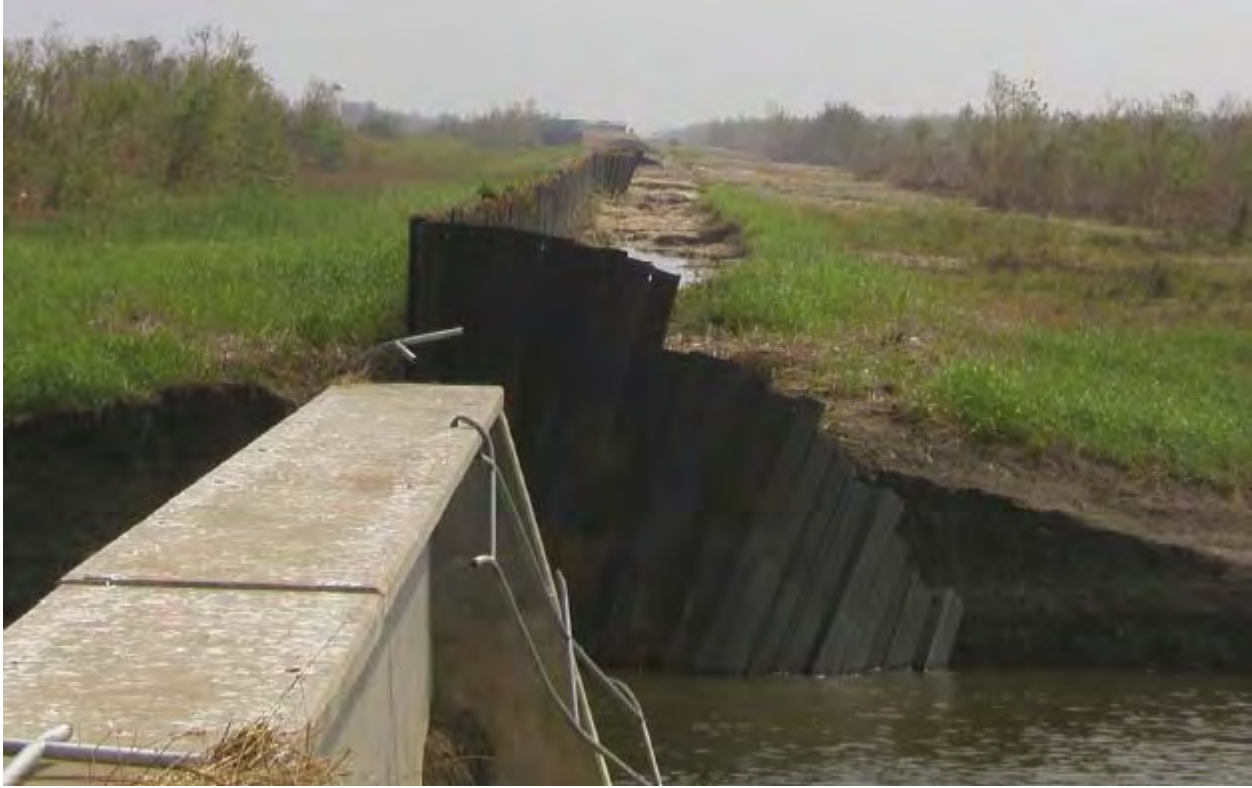
Figure 14-112. View Looking East of the Bayou Bienvenue Control Structure Showing Sheetpile Damage From Scour. From this picture there is no obvious layer stratification in the scoured section profile

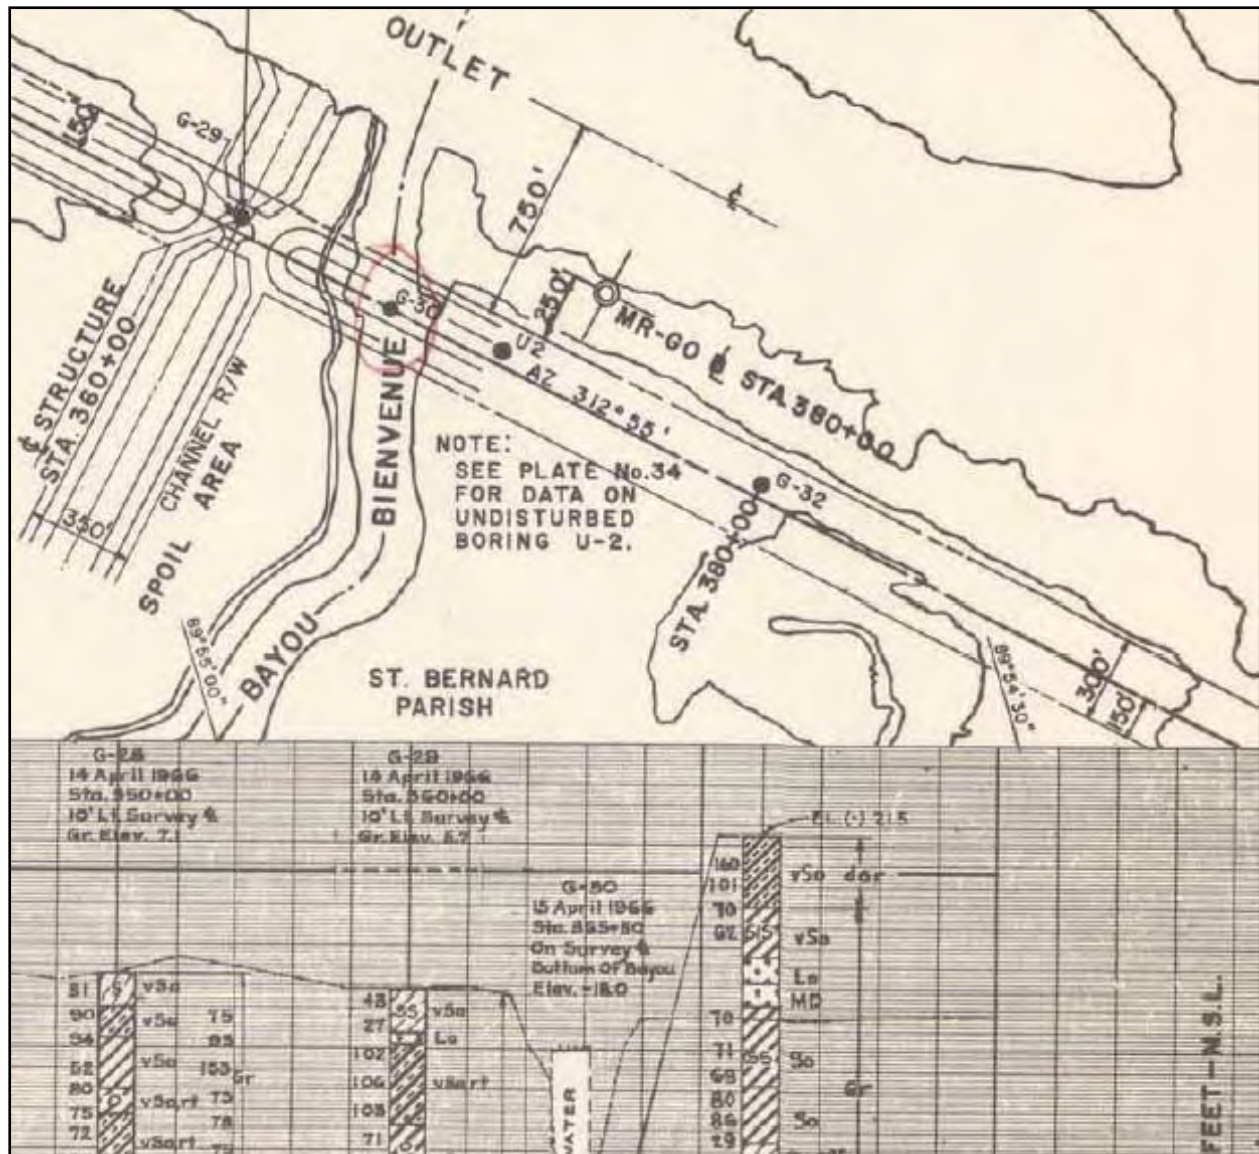
Figure 14-114. Original ground surface (1966) had sand / silt lenses overlying very soft organic clay (plate 10, DM3). Note that sheetpile east of structure (Figure 14-112) was driven to cut off old Bayou channel in addition to reduce loading on the top layer of very soft organic clay seen in boring G-32

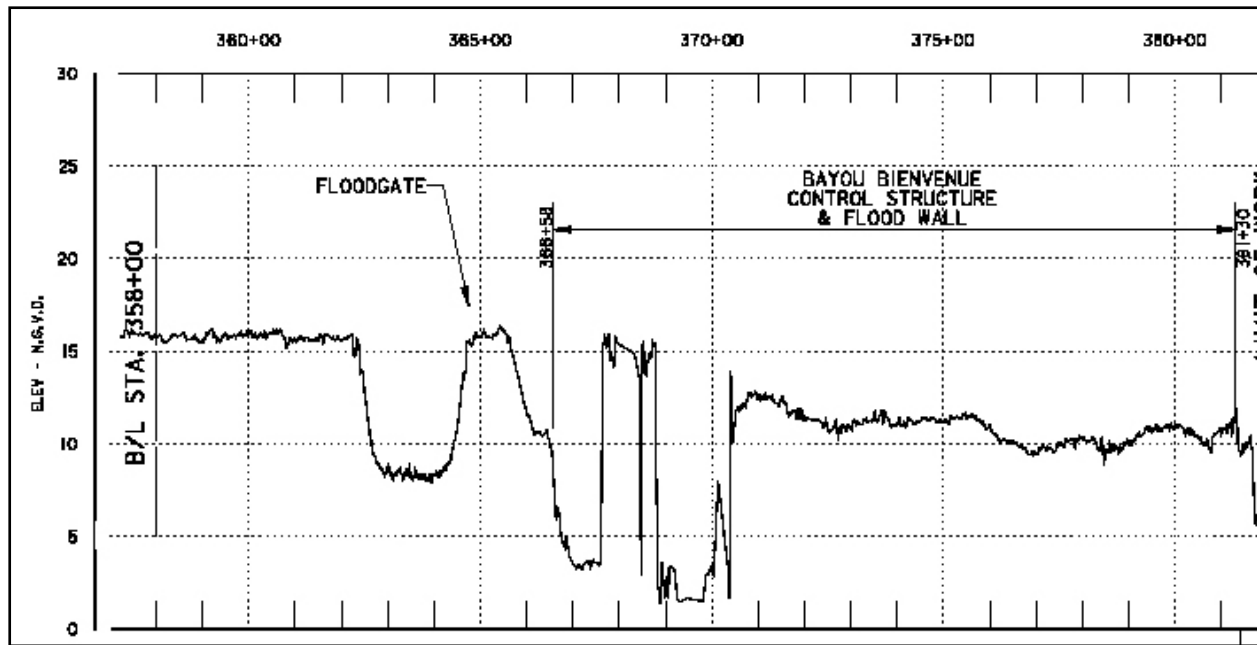
Figure 14-115. Centerline Scour Depths of Floodgate and Control Structure (From Dwg 1 of 8, Emergency Restoration B/L 383+00 to 704+00 Contract Solicitation)

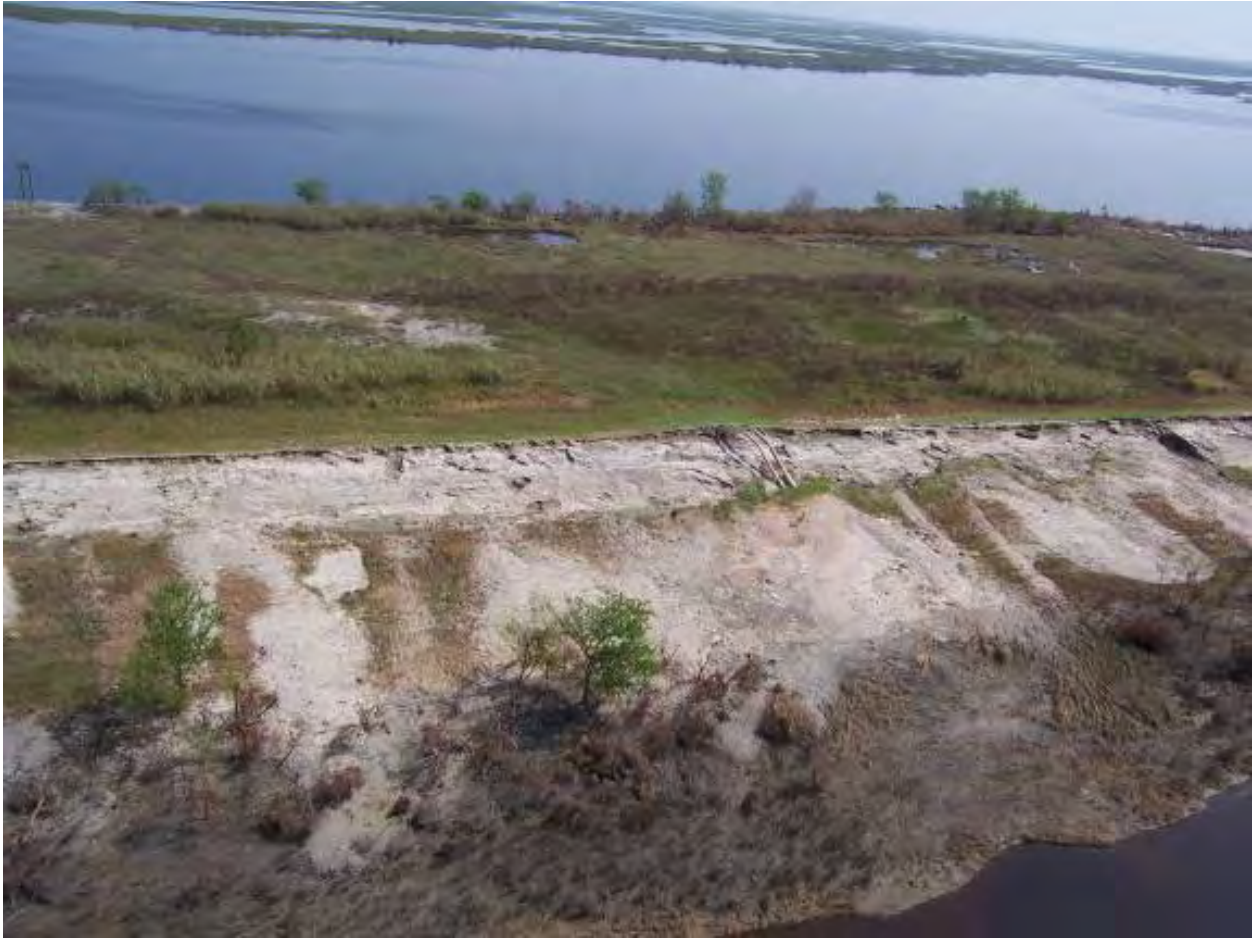
Hurricane Levee Between Bayou Bienvenue and Bayou Dupre. There is 19,000 ft. of levee between Bayou Bienvenue (Sta 383+00) and Bayou Dupre (Sta 704+00) that was severely damaged from overtopping and scour, and has lost approximately 12' of levee section and was at EL 5.0.

Figure 14-116. Levee Completely Eroded Away

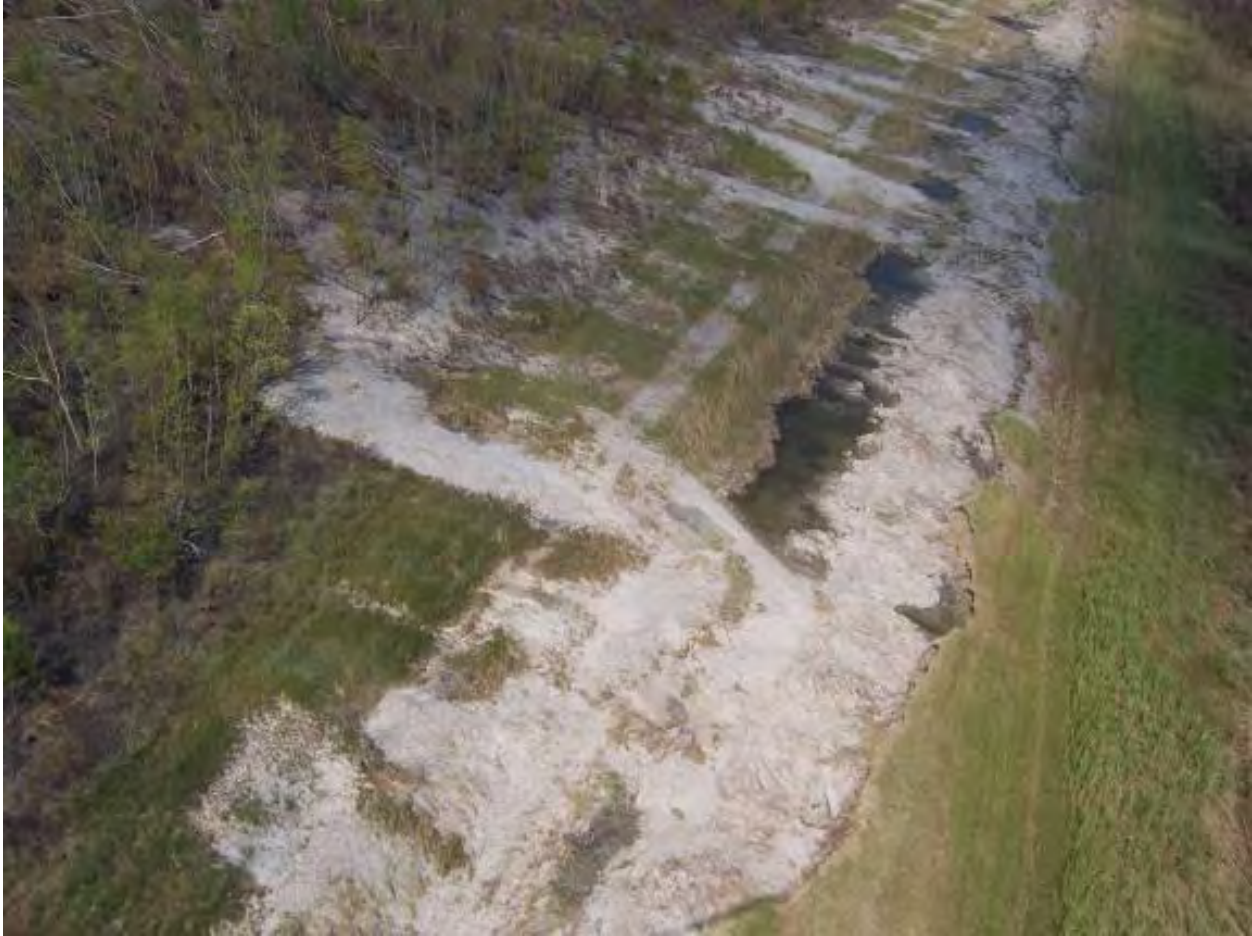
Figure 14-117. More Missing Levee

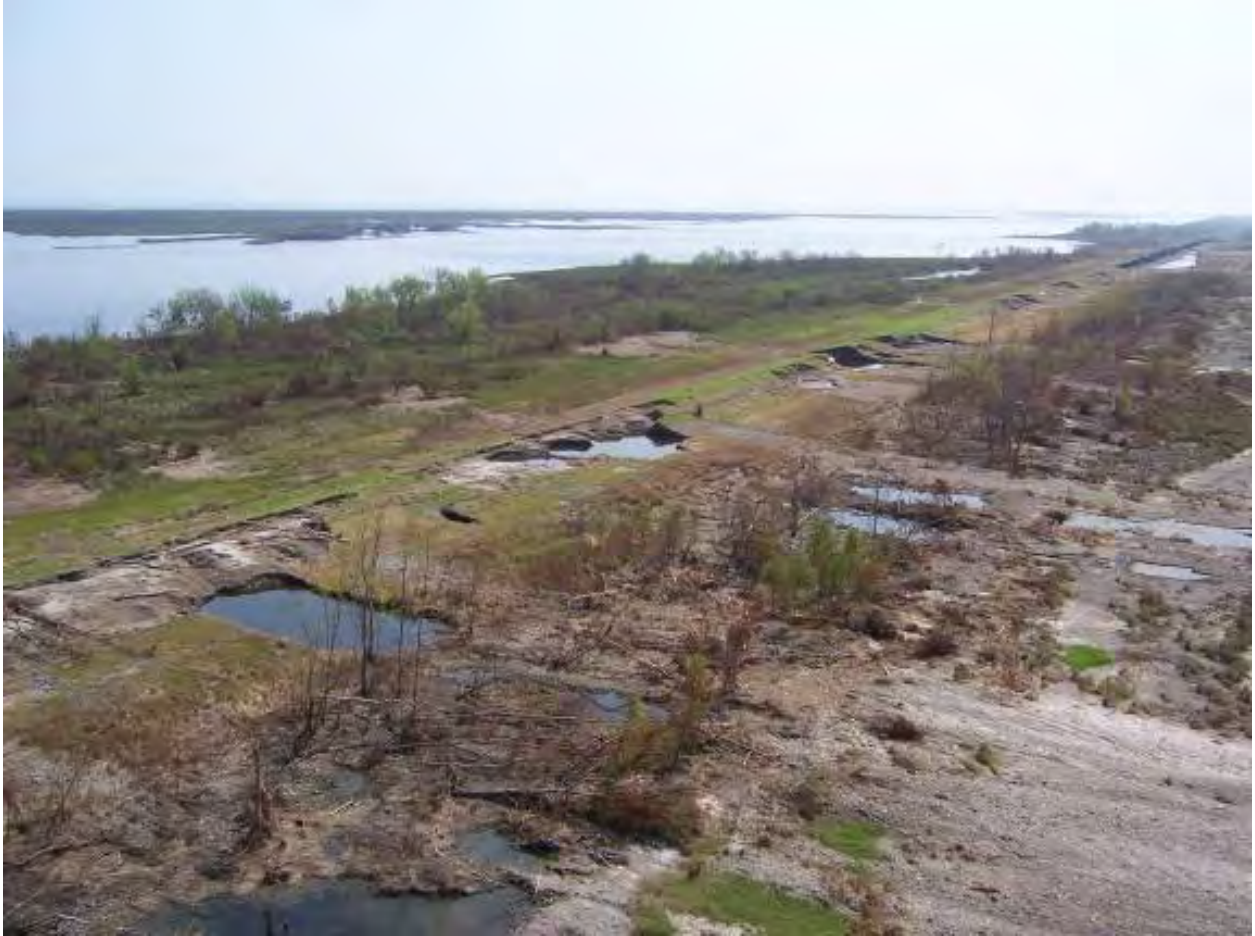
There is an additional 2,300 ft. of levee in this reach that has some damage (approximately 50% of the levee section was eroded away).

Figure 14-118. Partial Levee Eroded
