Appendix 1

Soil Data Report for 17th Street Canal

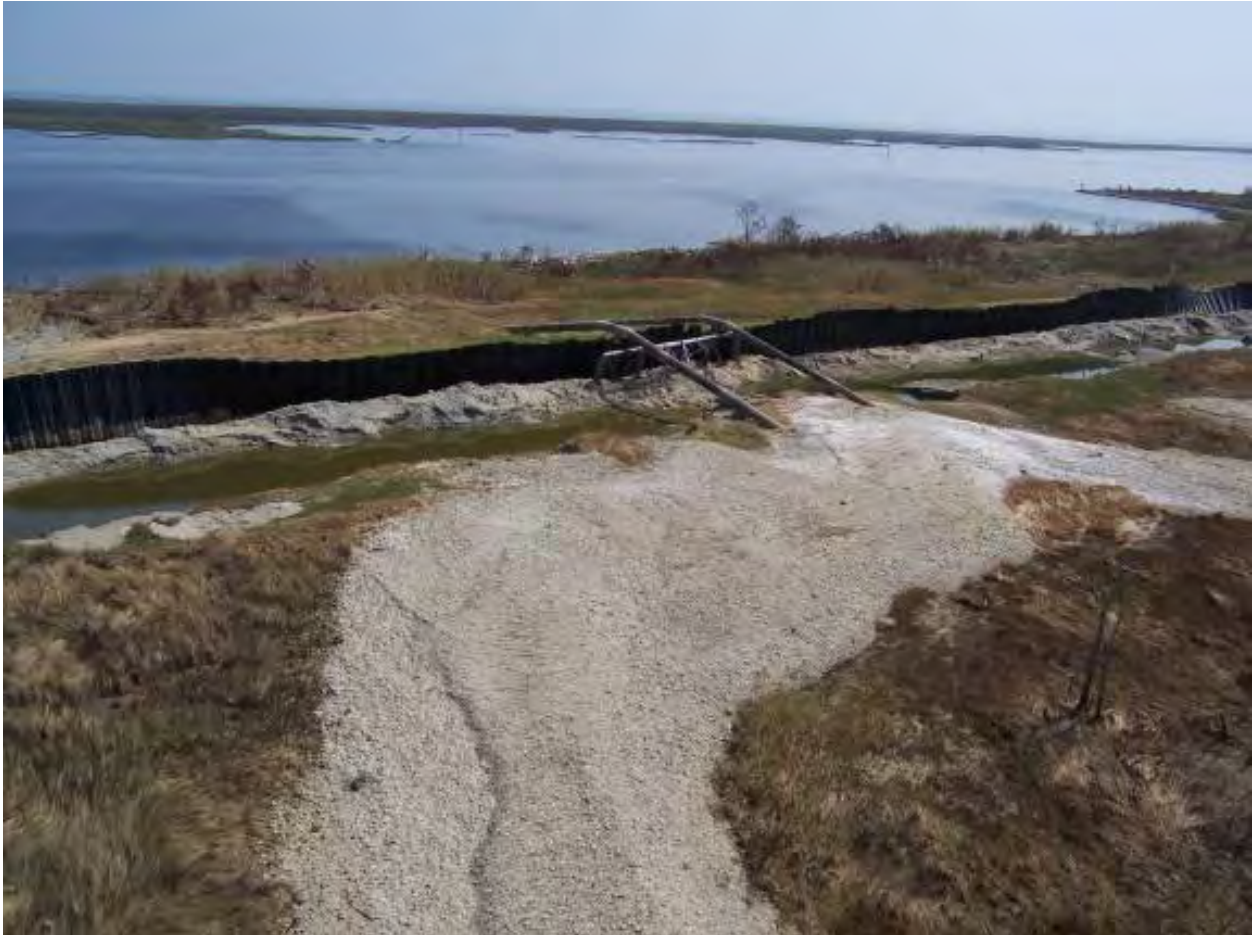
Figure 14-121. Damaged Sheetpile Section (Utility Crossing), With Scour on the Protected Side. B/L Sta 590+70 is centerline of the two pipelines

There is a total of 4,300 ft. of sheet pile floodwall in this reach that was badly damaged and will require replacement. There are three segments of sheetpile which makeup this quantity. These were initially planned to be replaced with 30’ sheets – see section below.

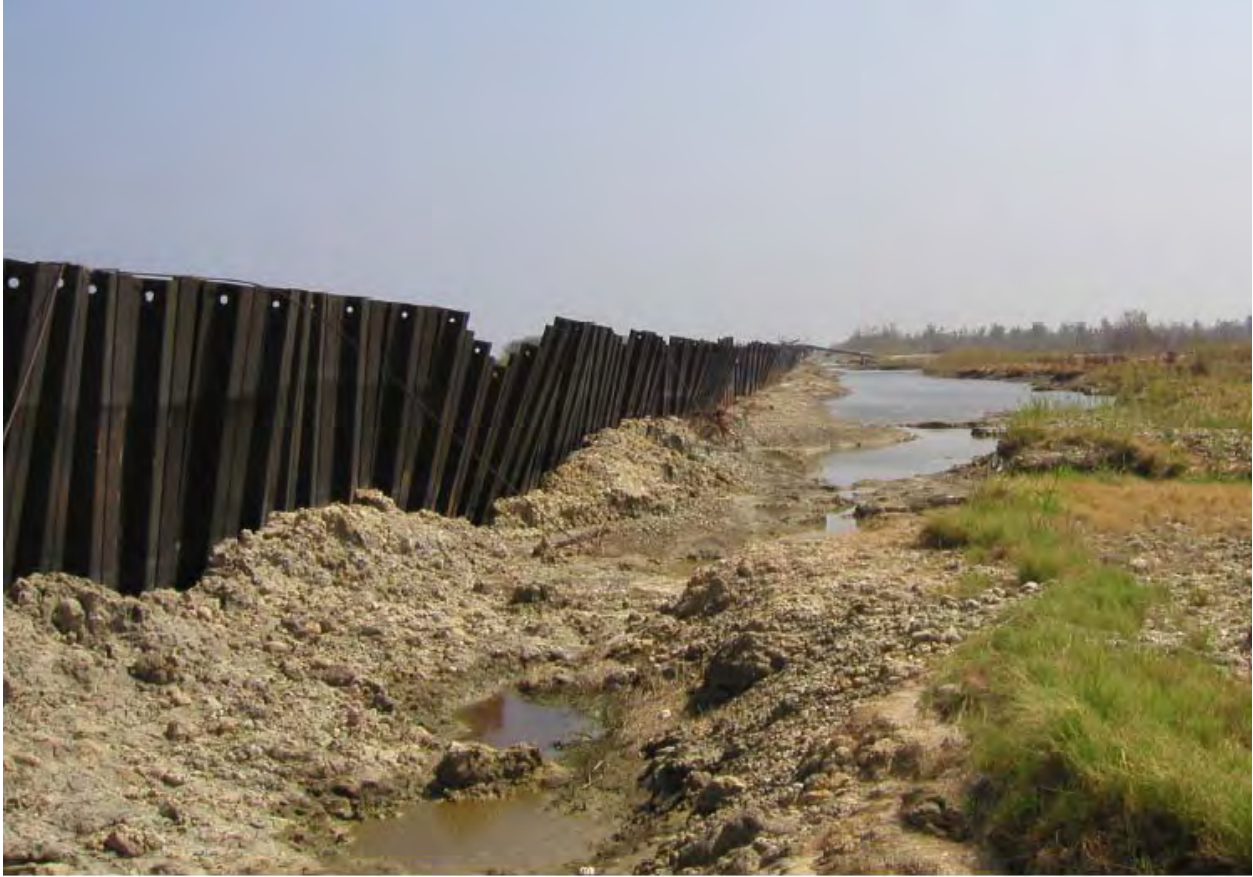
Figure 14-123. Note Sheetpile Elevation Differences

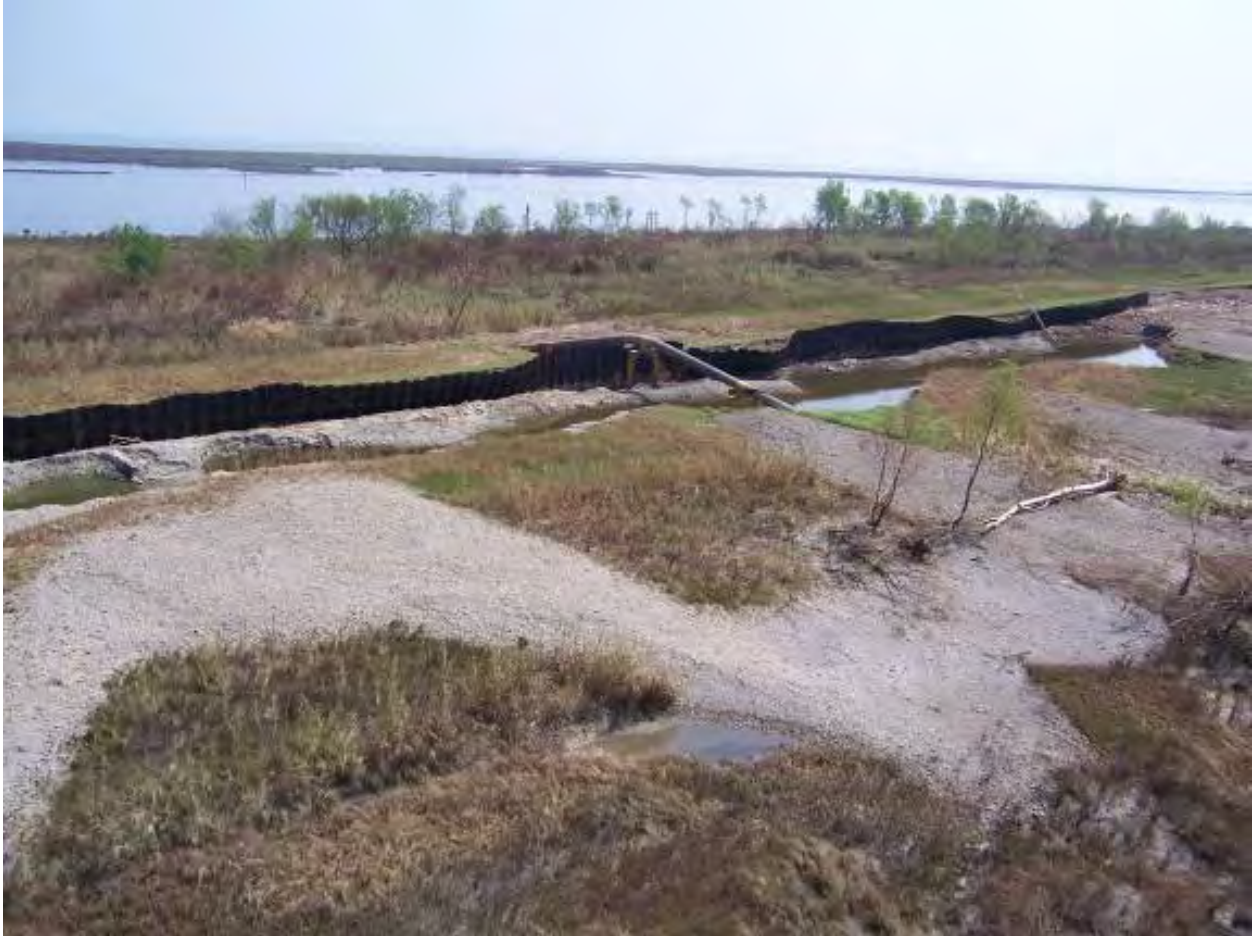
Figure 14-124. Additional Damaged Sheetpile at Utility Crossing, B/L Sta 600+00

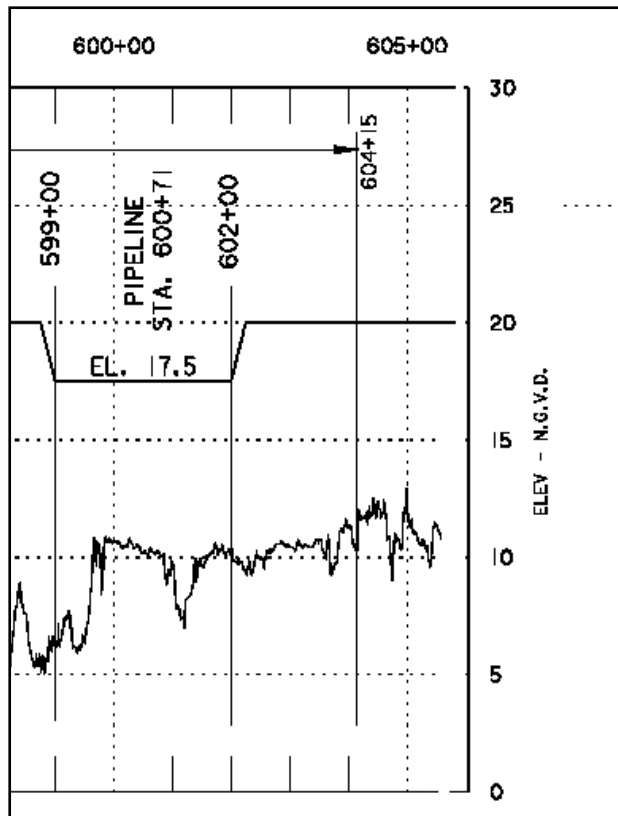
Figure 14-125. Scour Depths at Pipeline Crossing and End of Sheetpile (Sta 604+15) Transition to Levee

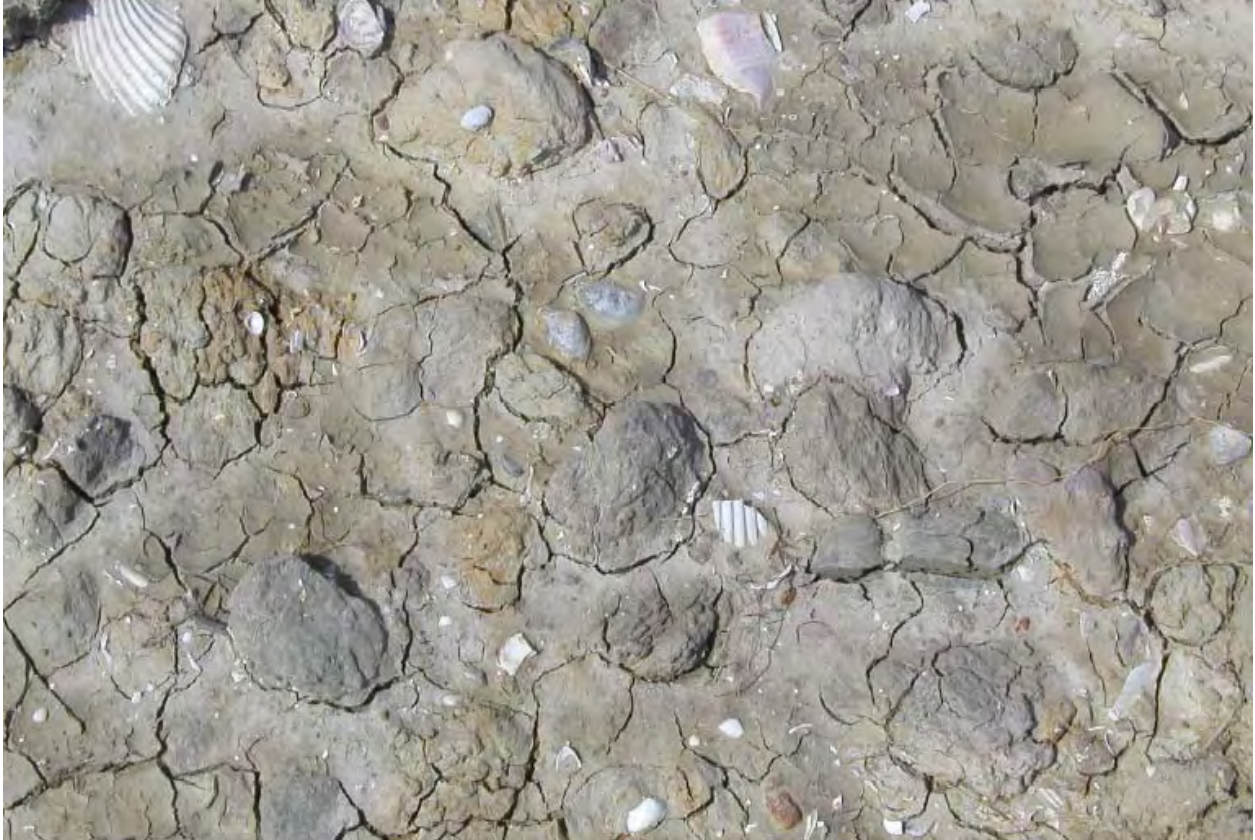
Figure 14-126. Exposed Soil Layer at Horizontal Scour Surface Appears to be In-Situ Fat Clay With Embedded Shell Hash, Possibly an Exposed Estuarine Deposit

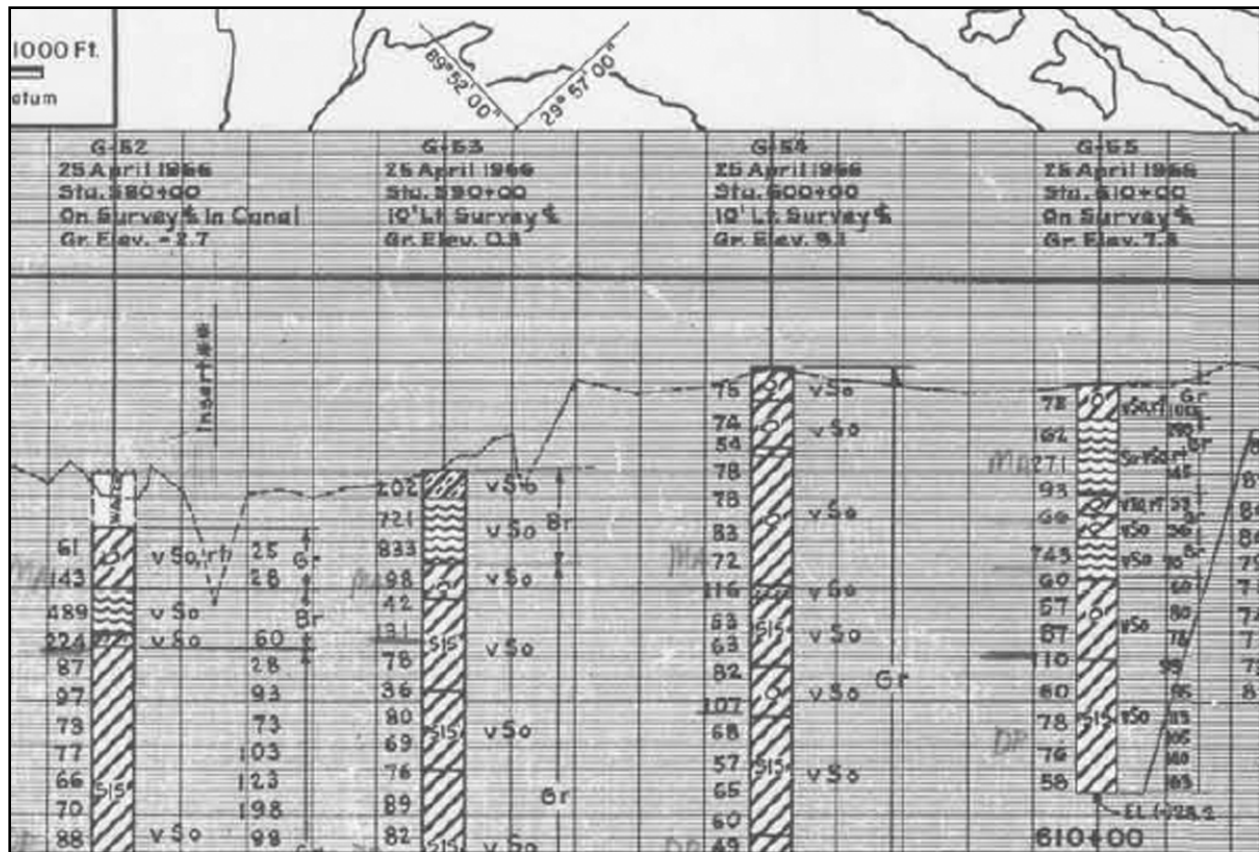
Figure 14-128. Original Borings Show Very Soft Fat Clay and Peat Layers (from drawing file H-2-23820, plate 13)

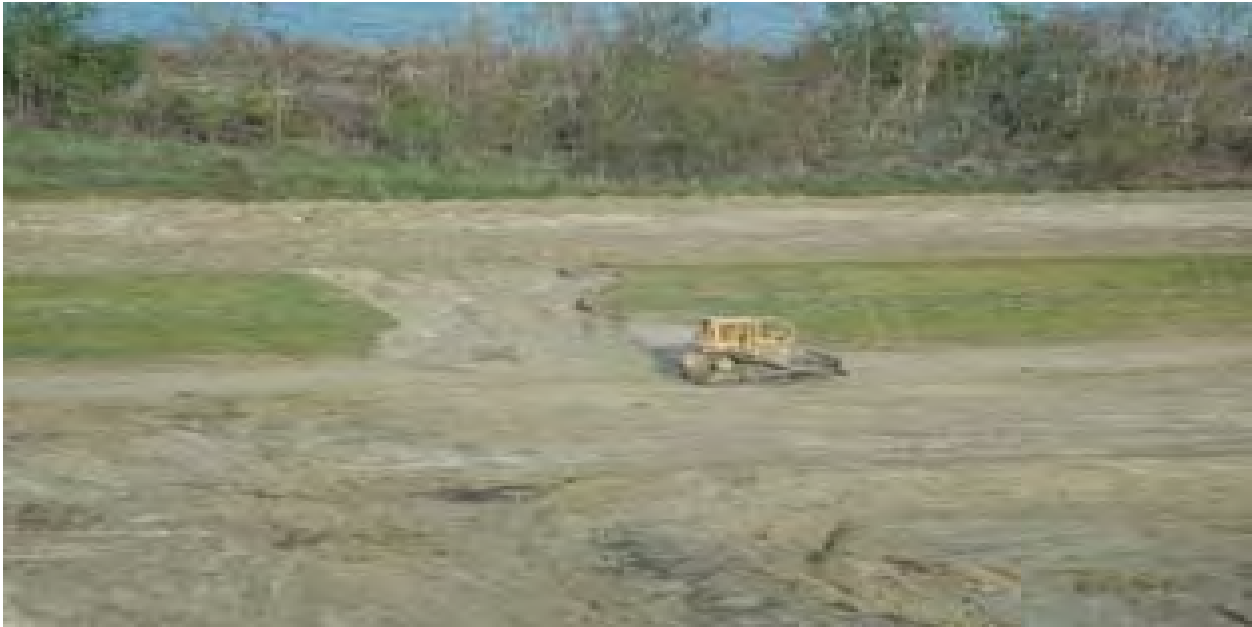
Figure 14-130. Repairs Underway, Filling Scour Holes

TFG Project **STB01** included site preparation work in the areas of levee damage between the Bayou Bienvenue and Bayou Dupre Control Structures. The contracted work (rental agreement contract) is complete.

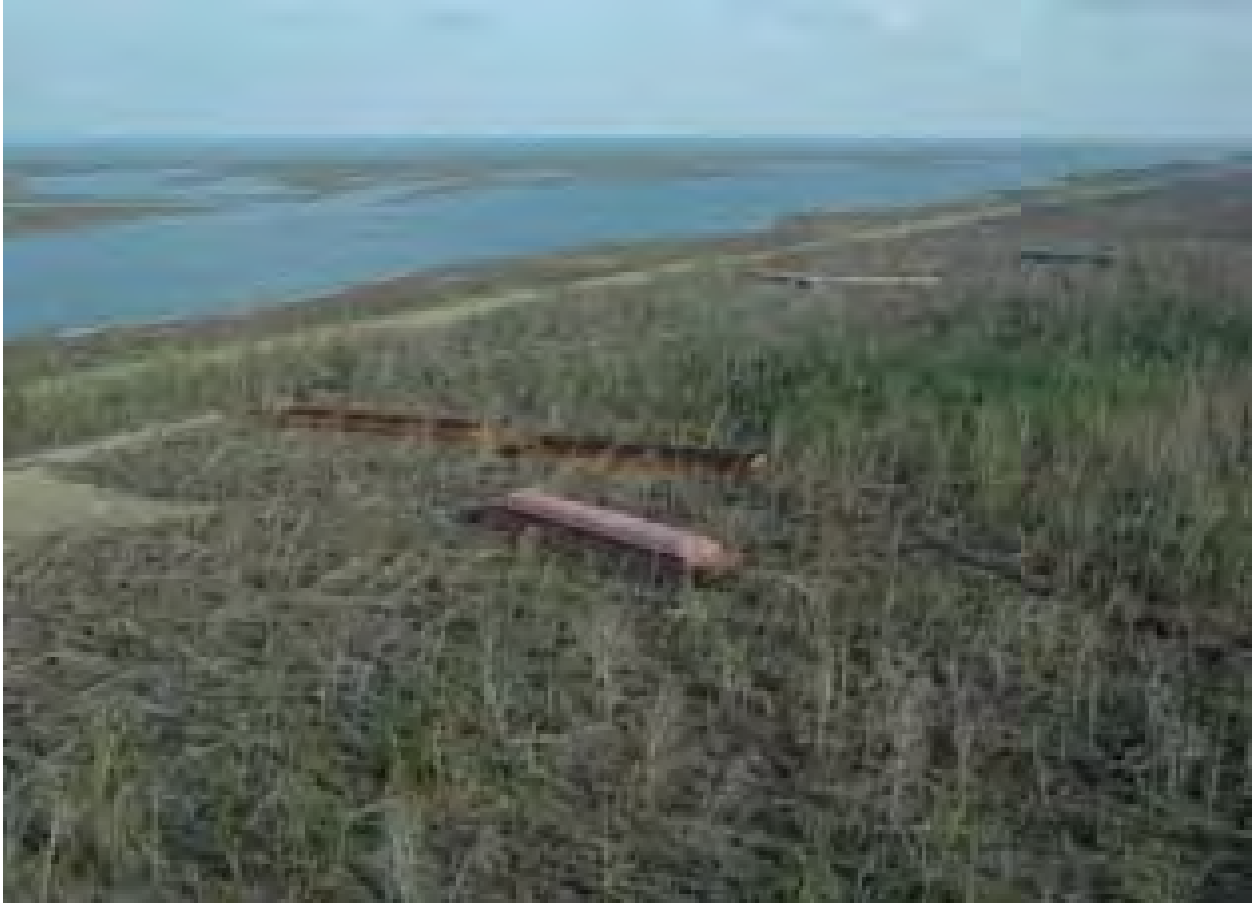
Figure 14-132. Barges From the MRGO

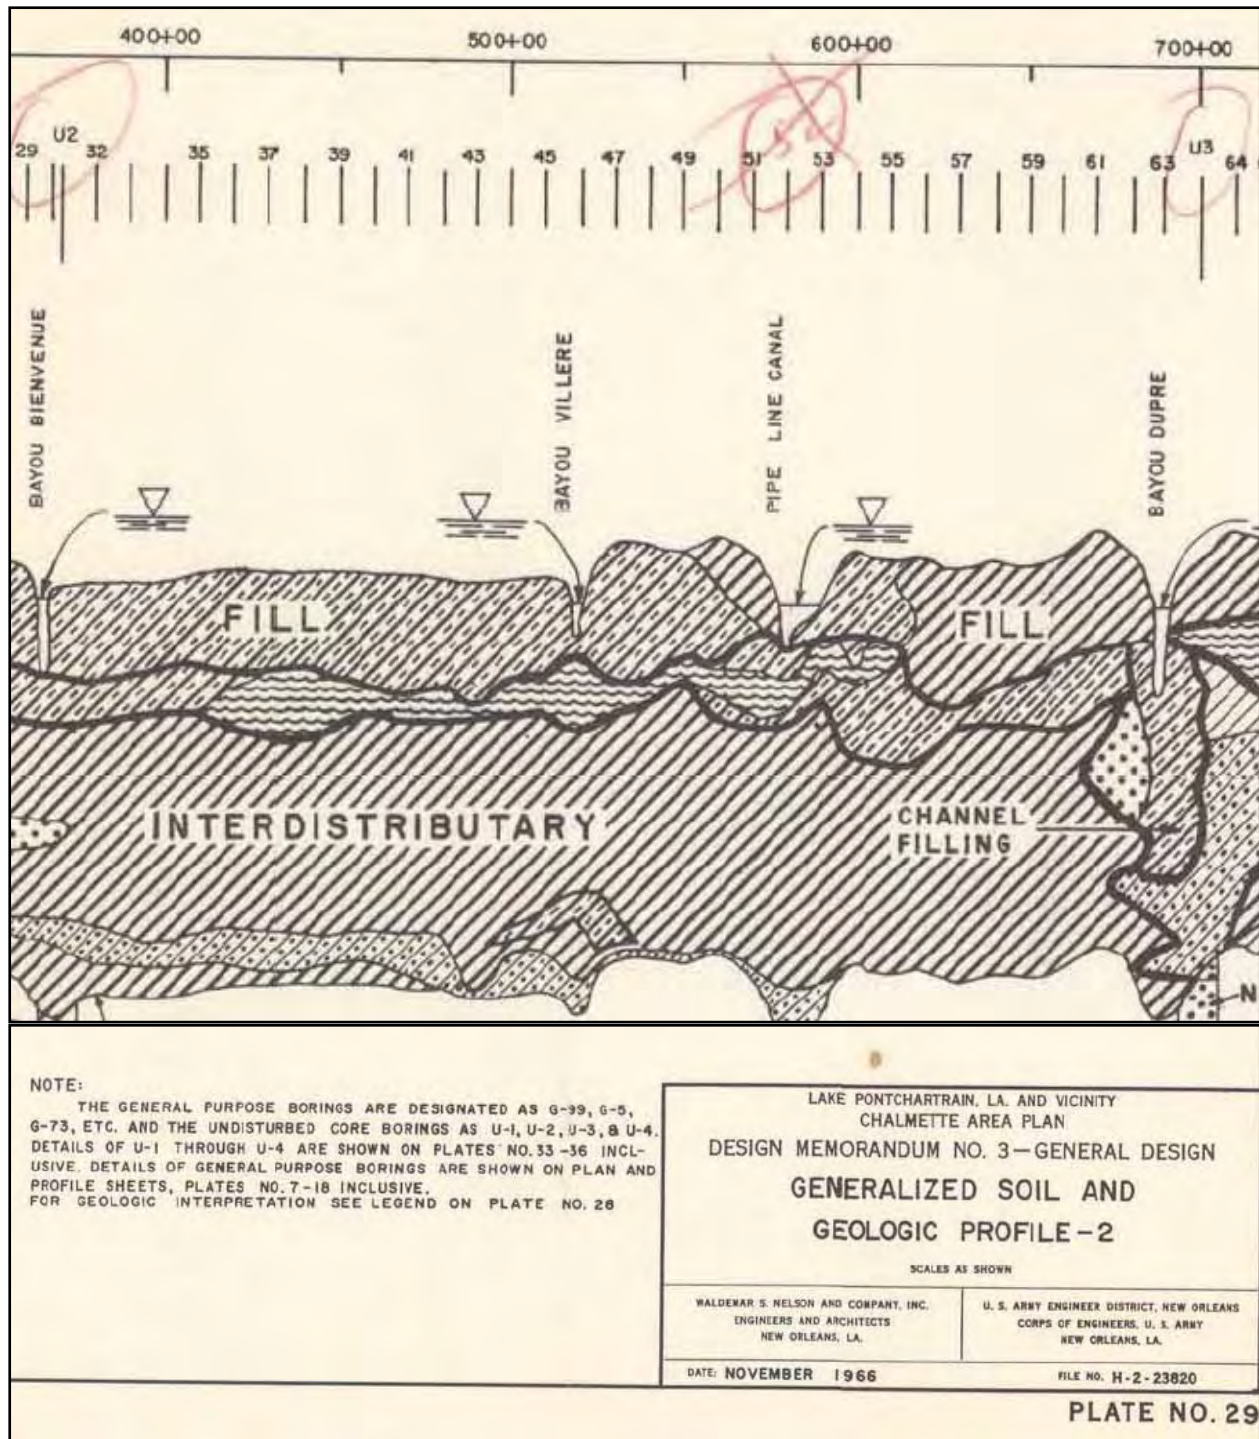
Figure 14-134. Pre-Existing Conditions Between Bienvenue and Dupre (from DM 3). The original ground surface was mostly organic clay (OH) southeast of Bayou Bienvenue. The original ground surface was fat clay (CH) between approximate Sta 612+00 and Bayou Dupre

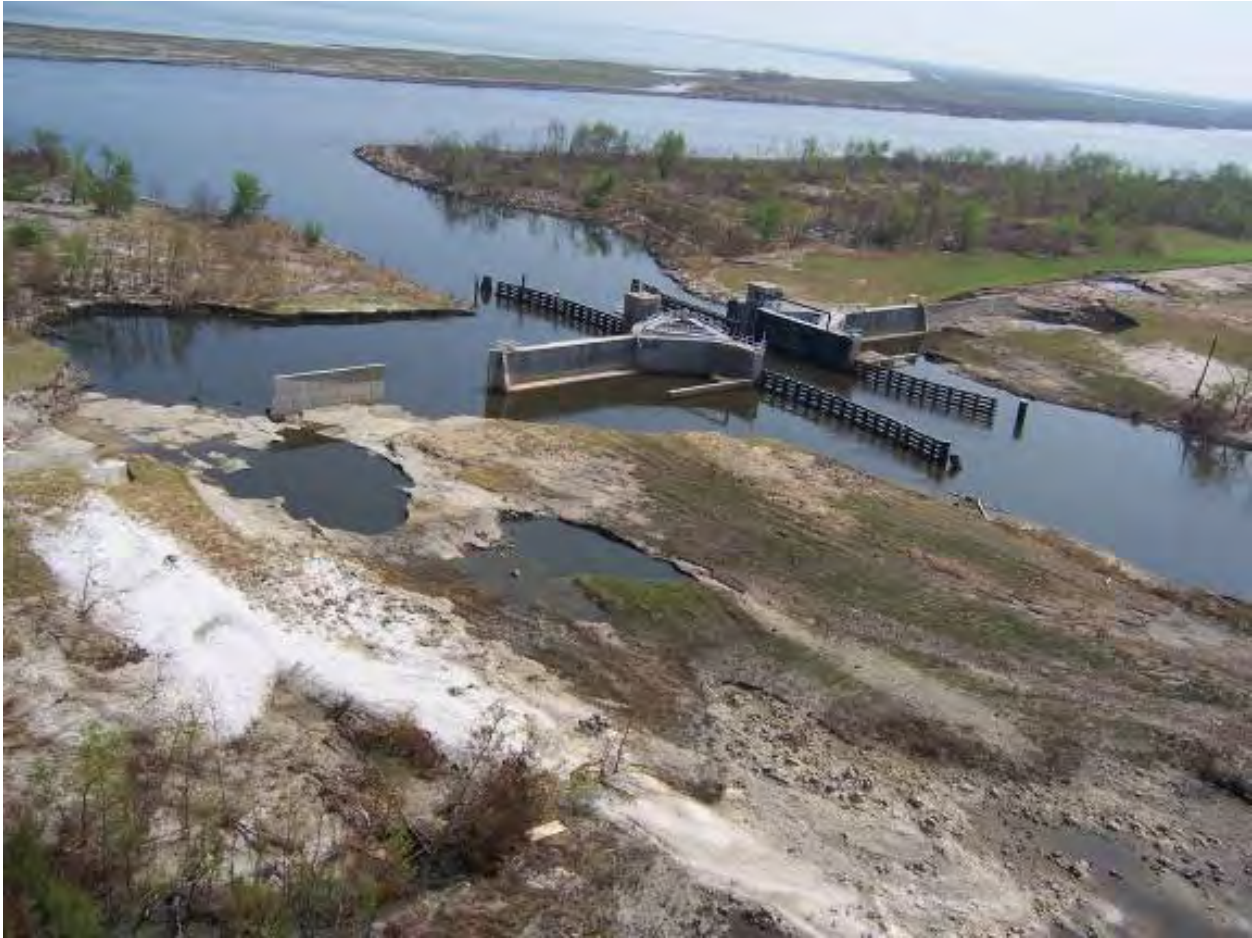
Bayou Dupre Control Structure. This control structure was damaged during the storm event. Adjacent sections of floodwall failed and the fill around other sections of floodwalls was eroded away due to overtopping. In addition there was damage to the mechanical and electrical systems that operate the sector gates.

Figure 14-139. Bayou Dupre Control Structure, Post-Katrina. View toward MRGO. Note the missing levees on both sides of the structure

TFG Project **STB06** includes repair of structural damage and loss of structural backfill at the Bayou Dupre Control Structure. A significant scour hole is to be filled with 17,500 cubic yards of granular backfill and protected with grouted riprap. An estimated 22,500 tons of riprap and 13,400 cubic yards of embankment fill will be required for the repairs. Scheduled completion date is 1 April 2006.

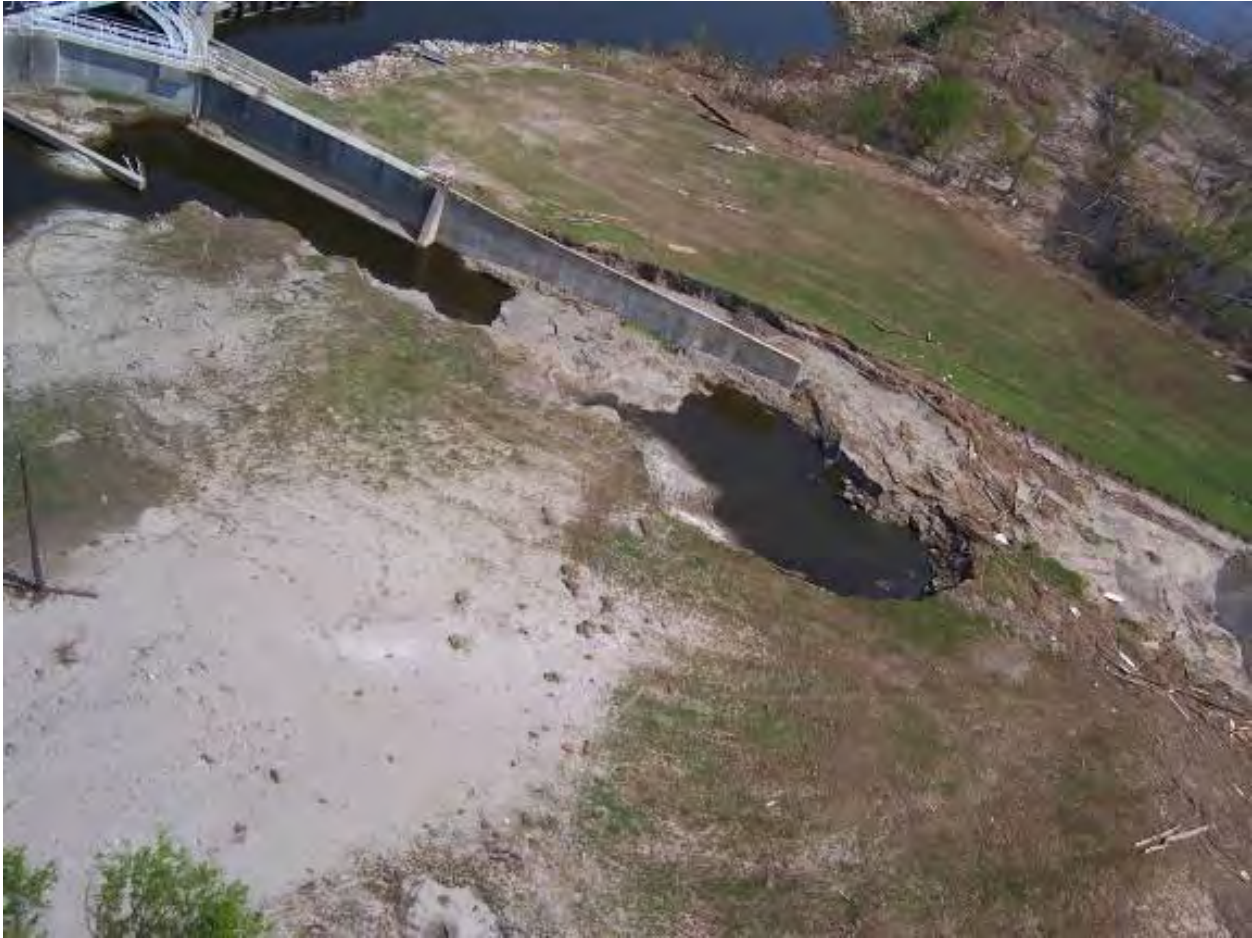
Figure 14-141. Severe Scour on East Side of Structure

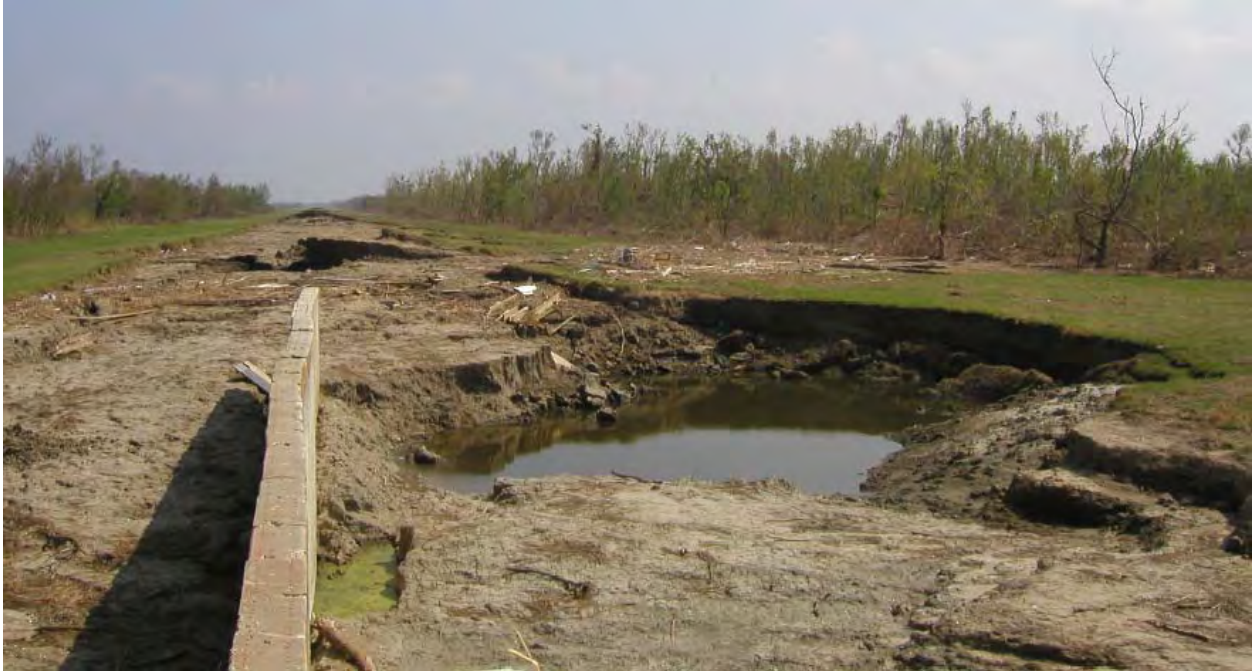
Figure 14-142. Closeup of East View, End of Concrete Wall, Showing Major Scour Holes and Complete Erosion of Levee

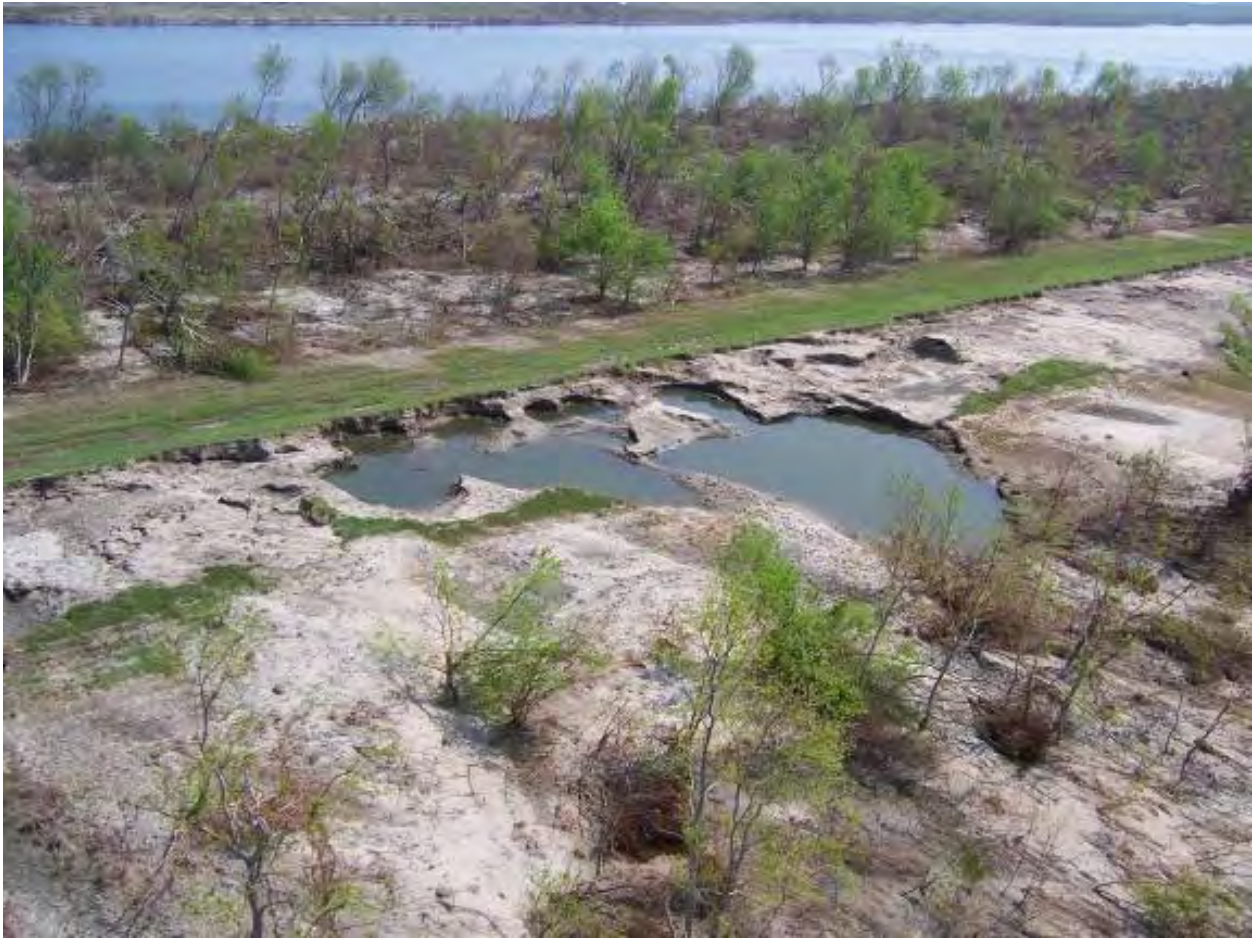
Hurricane Levee Between Bayou Dupre and STA. 1054+00. There is an 8,000 ft. section of the levee immediately southeast of Bayou Dupre that is severely damaged and has lost approximately 12 feet of levee section and is at approximately El. 5.0.

Figure 14-144. Major Scour on Levee Protected Side (Landside)

TFG Project **STB03** (Levee Restoration East of Bayou Dupre - MRGO Baseline Station 714+55 to 1007+91) includes repairing a 5.6-mile reach of levee along the MRGO extending east from the Bayou Dupre Control Structure. The entire levee reach will be restored to the design grade elevation (17.5'), requiring the placement of an estimated 1,120,000 cubic yards of fill material. The borrow area for this fill material is a strip of land adjacent to the levee, which was used as a disposal area during the construction of the MRGO canal. Scheduled completion date is 1 April 2006.

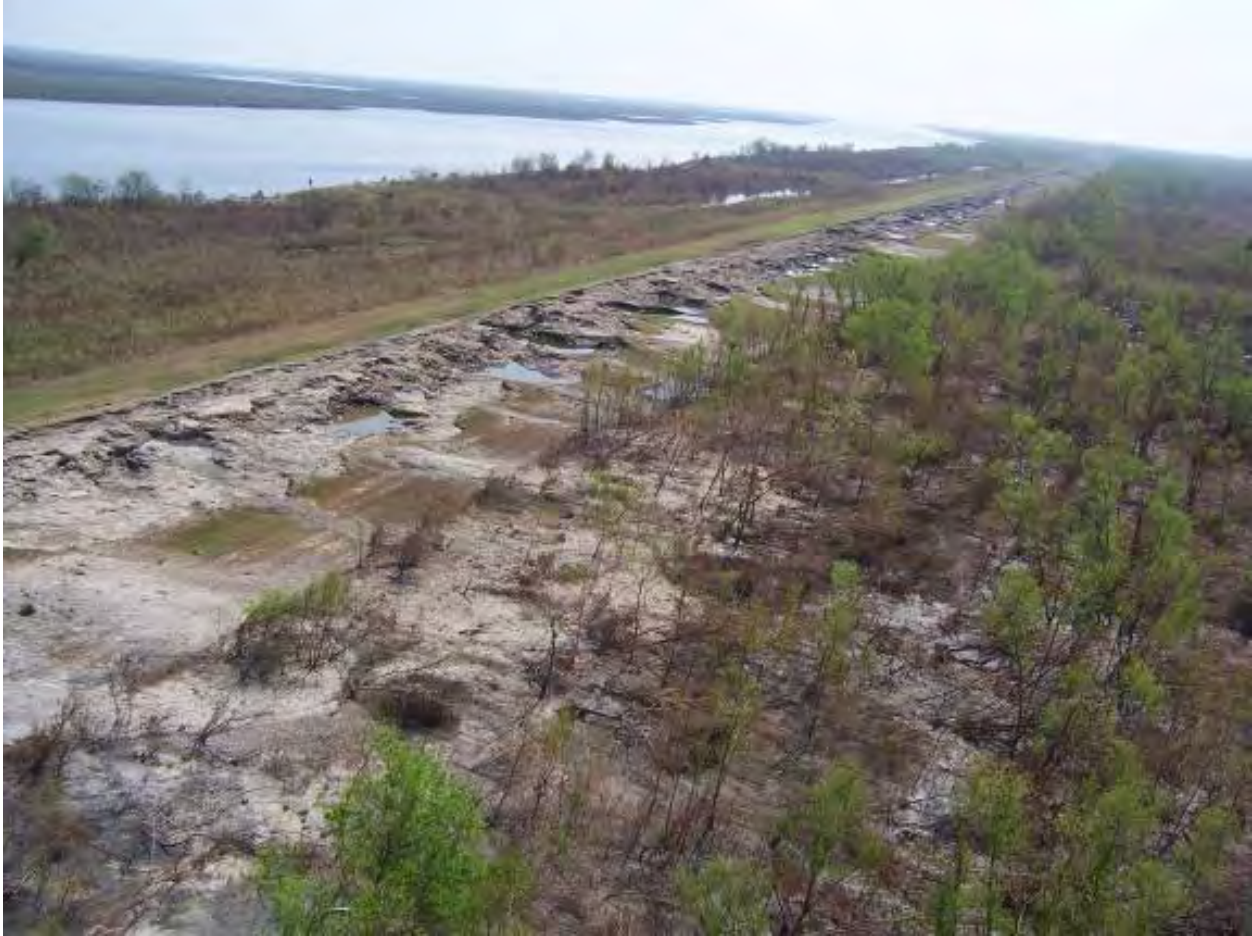
Figure 14-145. Scour Depths Below the Original Levee Footprint

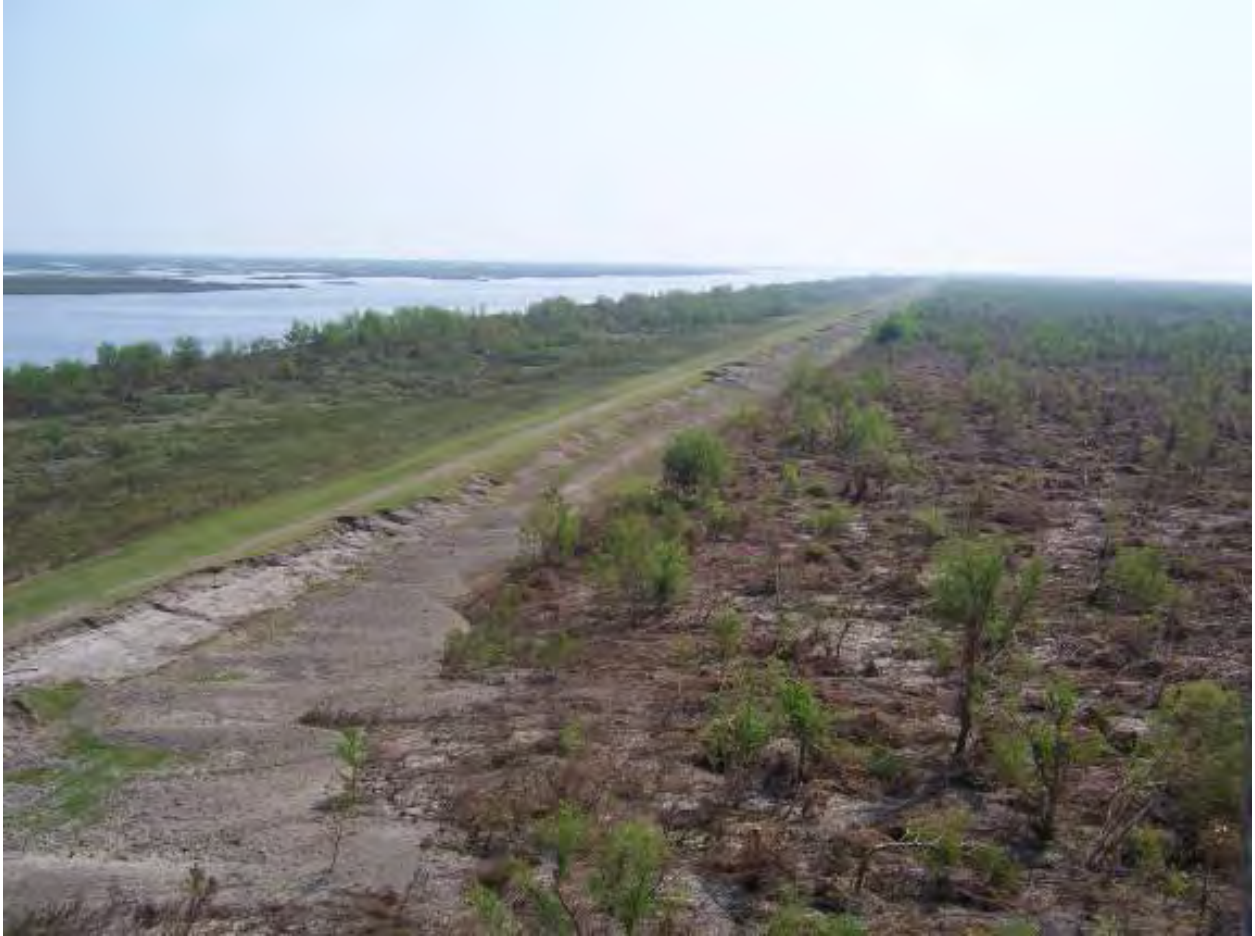
There is 2,500 ft. of levee from Bayou Dupre to STA 1007+91 that lost approximately 8' of elevation (assume that 50% of the levee section is gone).

Figure 14-146. Scour on Landside (Protected Side) of Levee

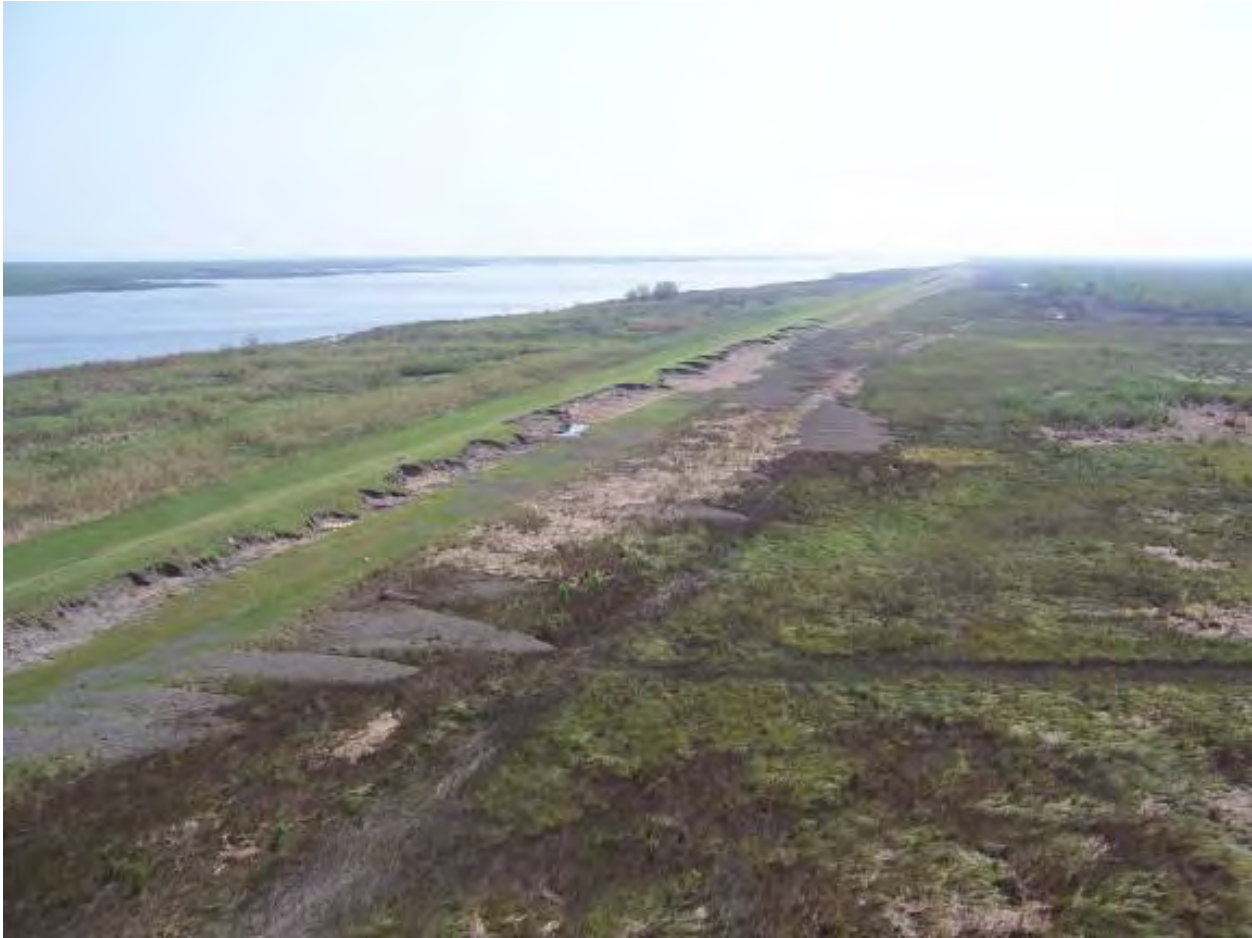
Figure 14-147. Major Scour on Protected Side of Levee

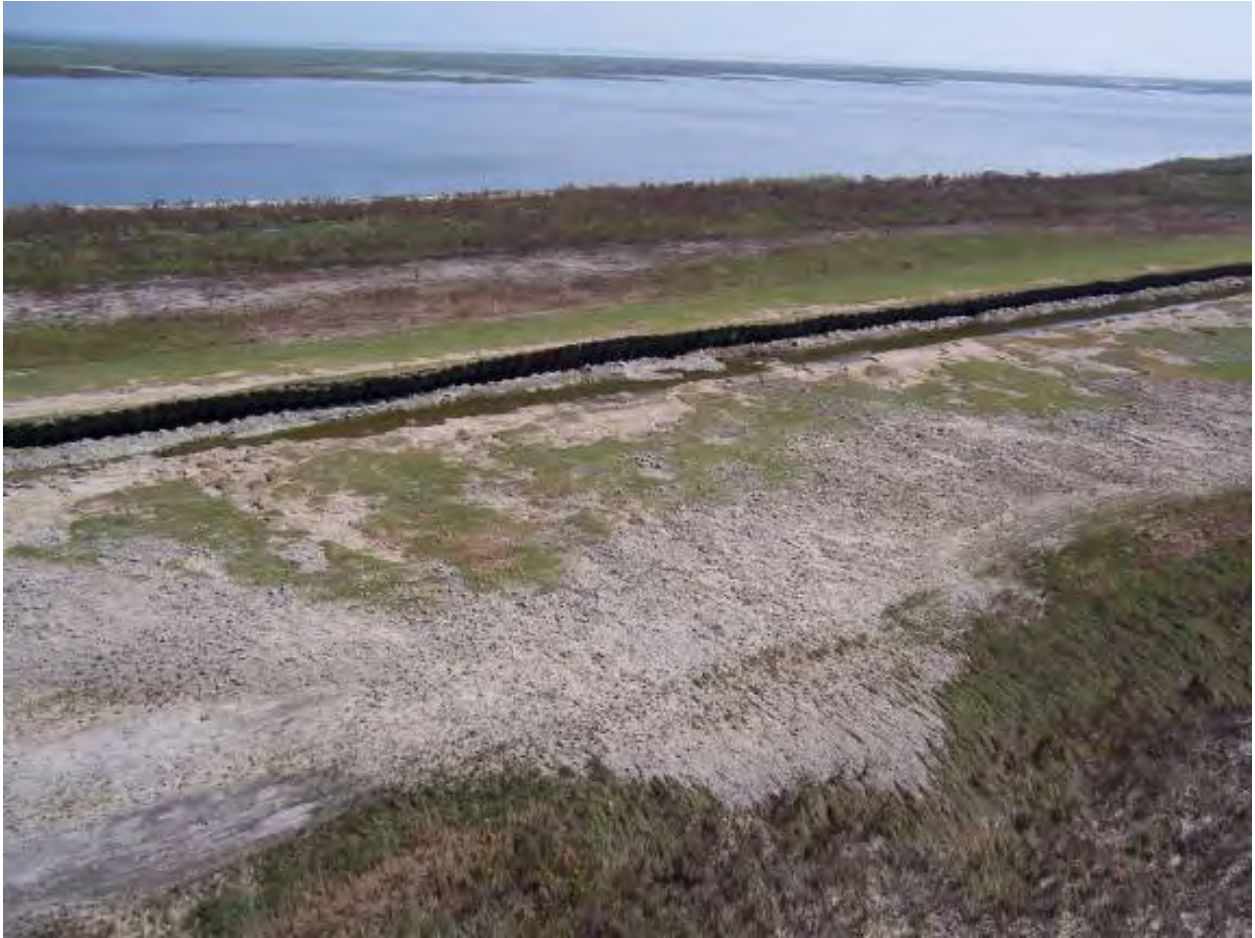
There is 700 ft. of this reach that is sheet pile floodwall that has been damaged and will be replaced with earthen levee. The above diagram was used to estimate required quantities.

Figure 14-150. Scour on Protected Side of Sheetpile Wall

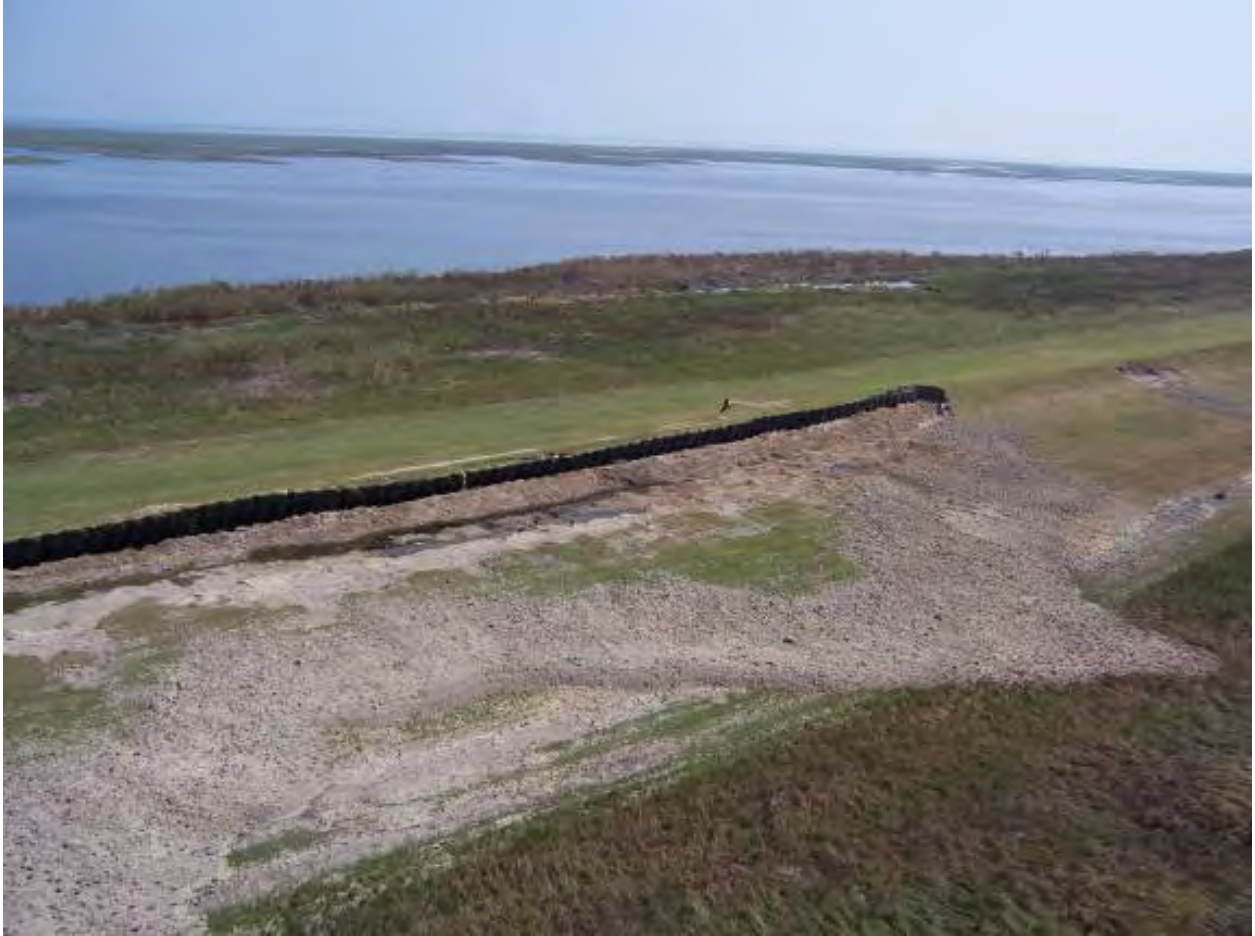
Figure 14-151. End of Sheetpile Wall at B/L Sta 980+58

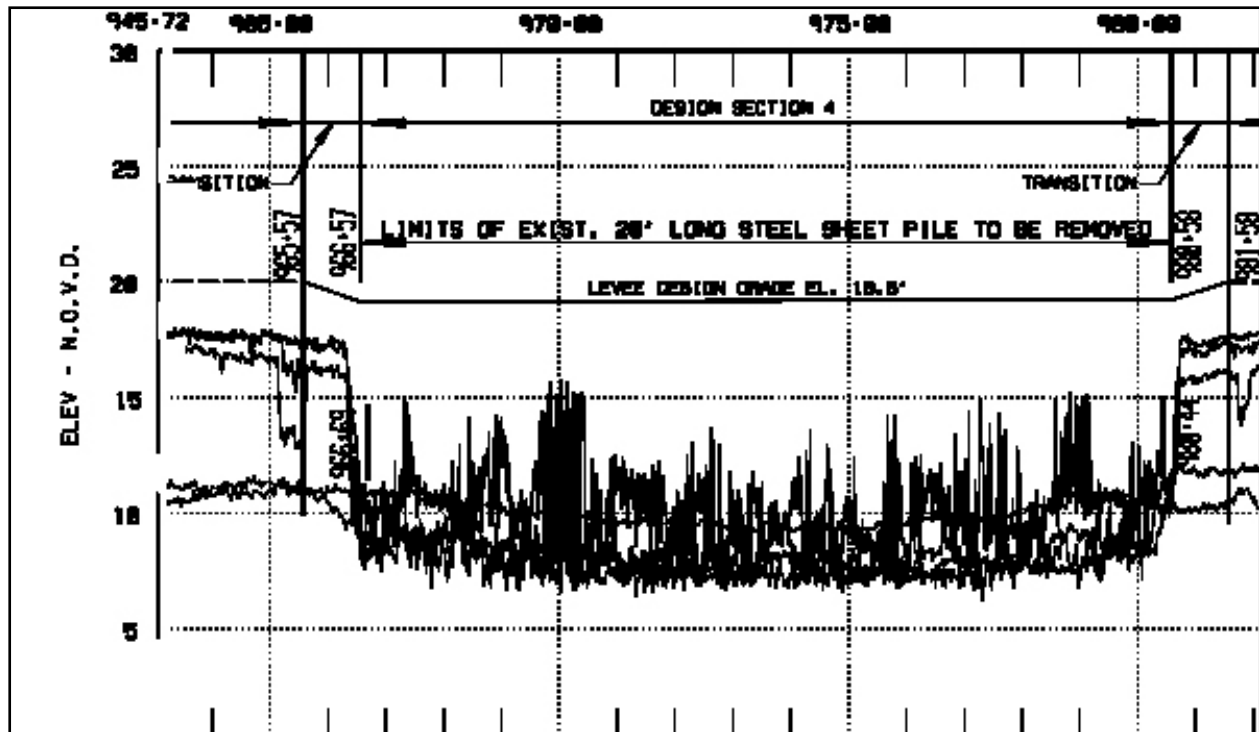
Figure 14-152. Scour Depths Along Sheetpile and at Transition to Levee. Note that scour occurred along the sheetpile reach, not at the sheetpile / levee transition (also seen in Figure 14-151), from drawing 7 of 10, contract solicitation W912P8-06-R-0002
