Appendix 1

Soil Data Report for 17th Street Canal

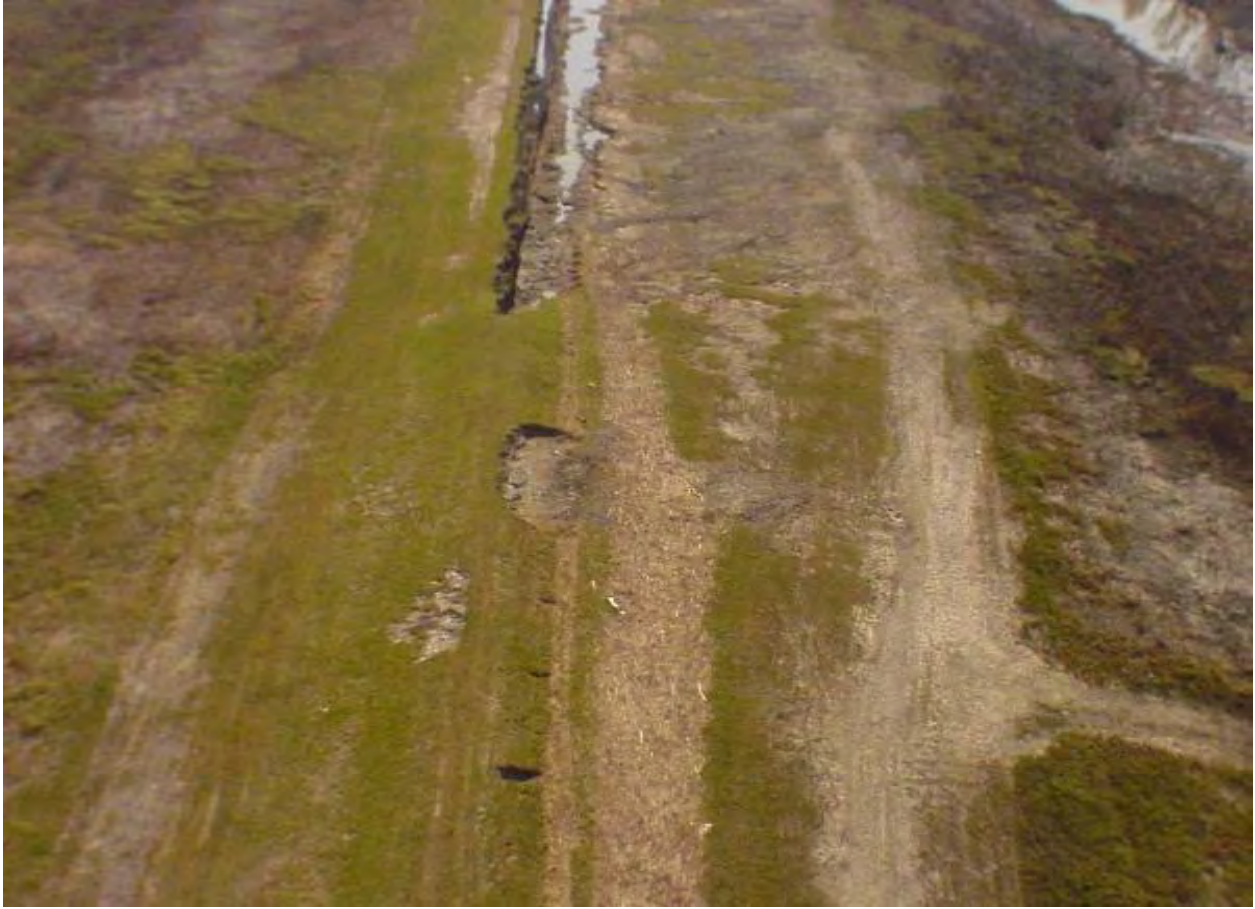
Figure 14-155. Crown Scour Along Approximate B/L Sta 1203+00 to Sta 1230+00

MRGO to Caernarvon Levee. TFG Project **STB08** (Miscellaneous Scour Repair) includes repair of minor scour on the backside of the levee from the Mississippi River Gulf Outlet (MRGO) to Caernarvon, which is about 10.8 miles in length. An estimated 36,000 cubic yards of fill material will be required for this work. Scheduled completion date is 15 April 2006.

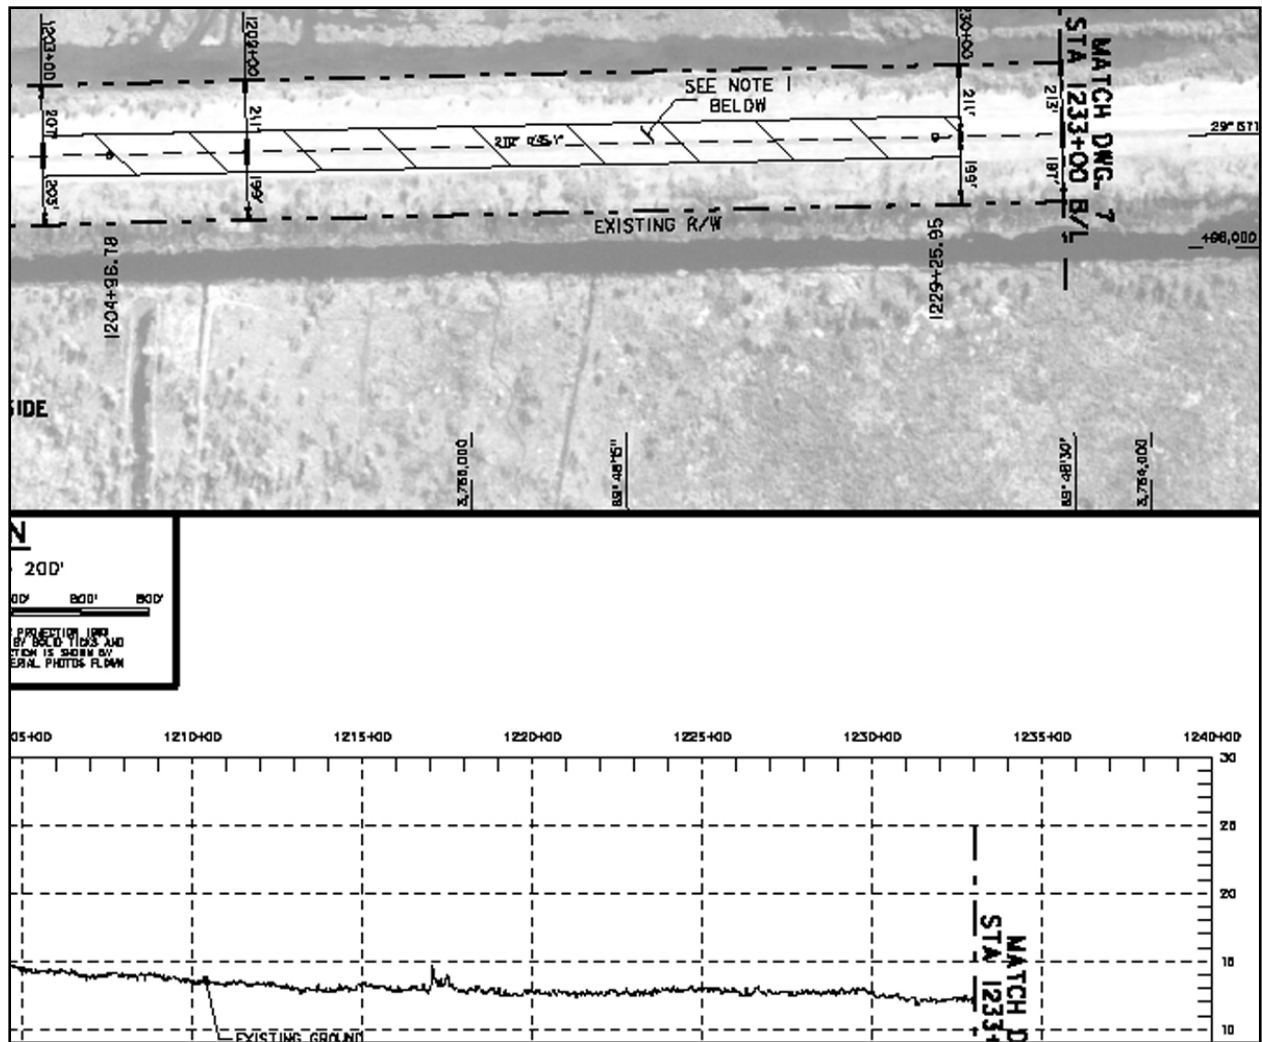
Figure 14-156. Levee Crown Elevation Drops From Elev 15 ft to Elev 12 ft in the Scour Area. Elevation 12 ft Remains Fairly Constant Along the Reach for About a Mile Beyond The Scour Section. From Contract Solicitation STB08 W912P8-06-R-0094, drawing sheet C-06

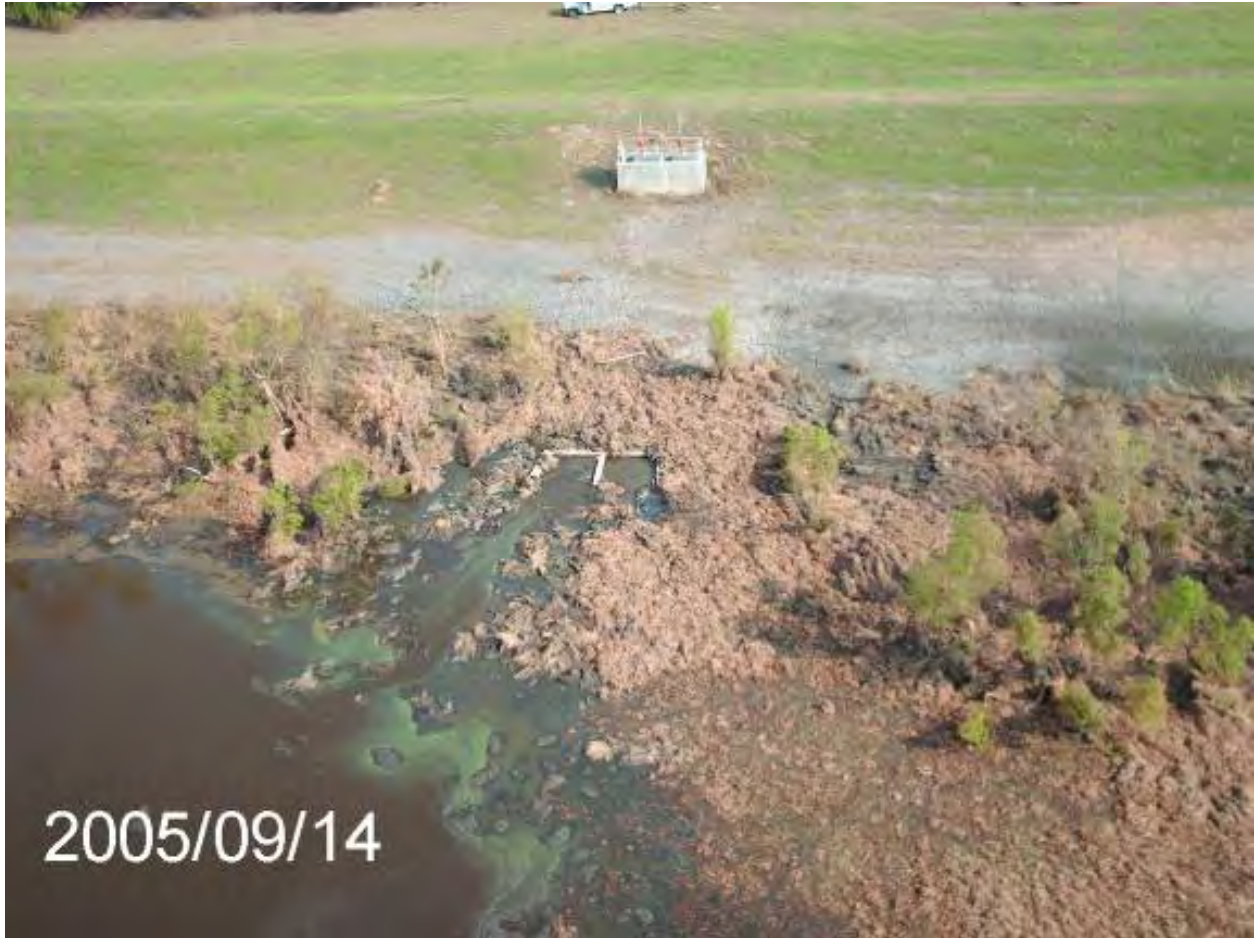
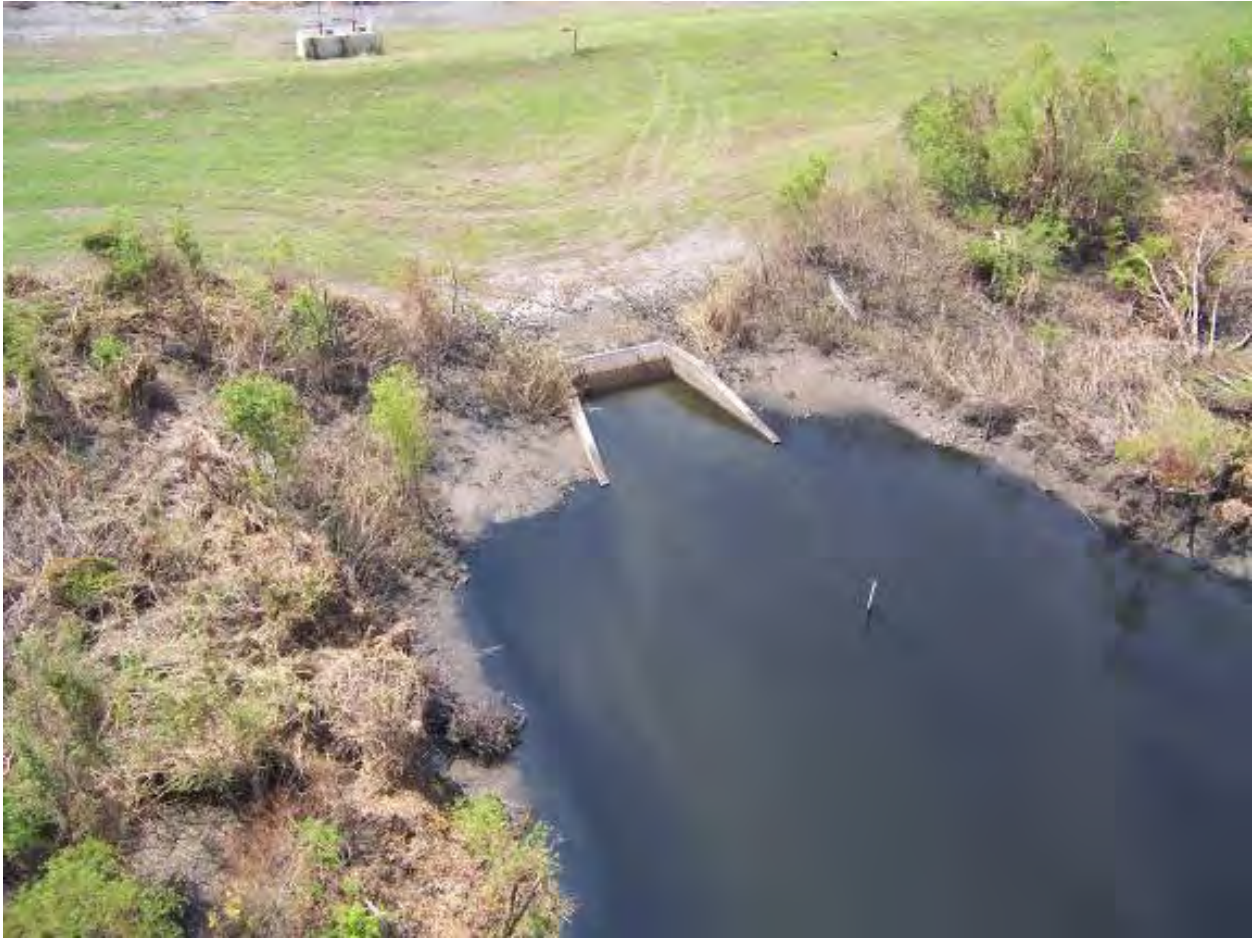
Creedmore Gravity Drainage Structure. The levee district has been unable to fully close the two 72-inch sluice gates on drainage structure. One sluice gate is approximately 50% closed and the other is approximately 90% closed. The cause of the sluice gates being stuck is apparently debris under the gate slides. Since there are trash racks on the inlet structure to these drains the debris must have come in through the outlet structure. While attempting to close the sluice gates against this debris the gate hoists were both damaged.

TFG Project **STB09** (Repair Creedmore Structure) includes constructing a cofferdam and removing debris from the structure to permit closure of the gates and inspection of the structure to determine if further repairs are necessary. Scheduled completion date is 1 April 2006.

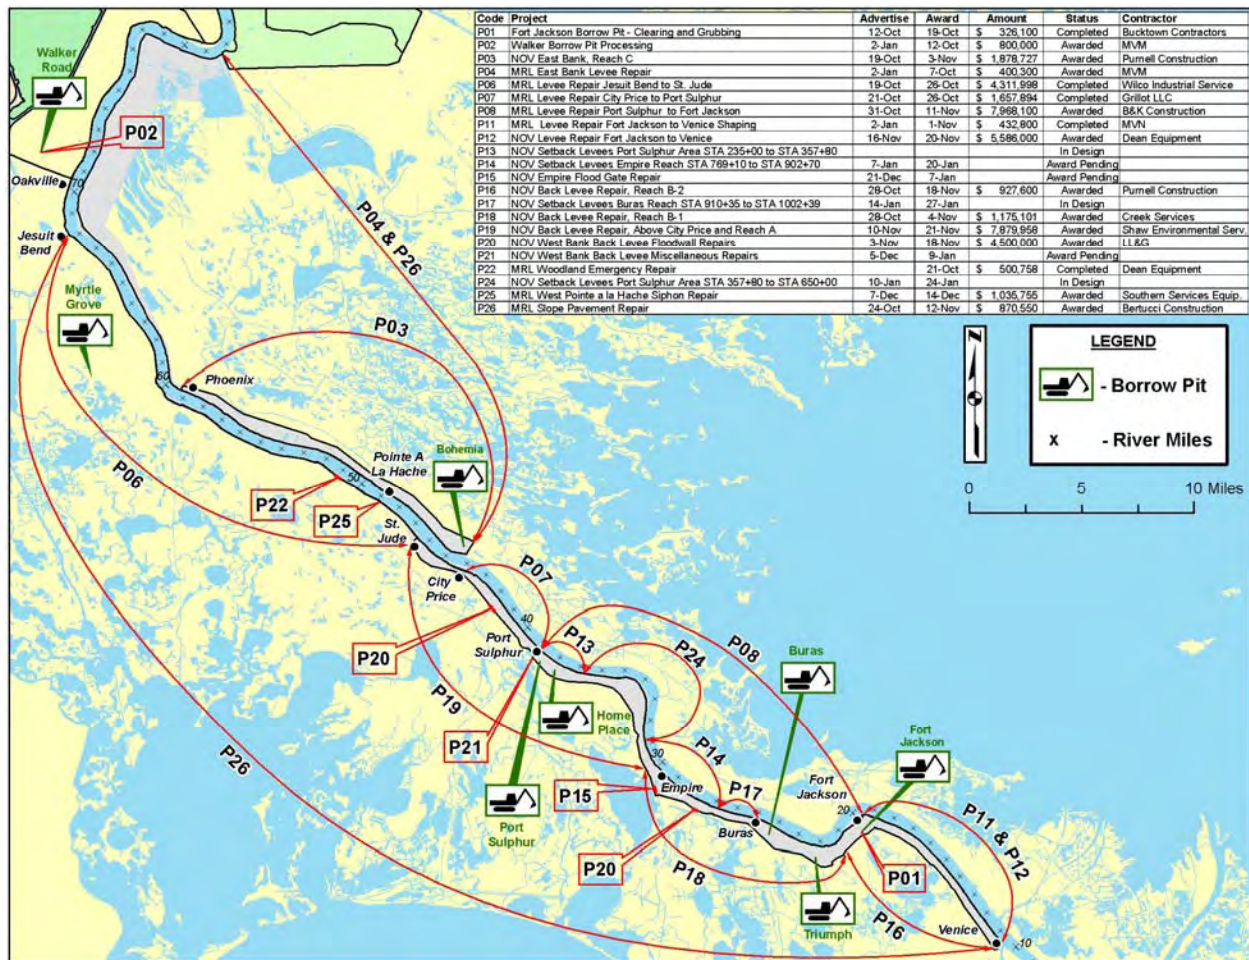
Figure 14-164. Repair Project Summary for Plaquemines Parish (TFG, Jan 2006)

P06 - Major scour at Woodlands Plantation and at a pipeline crossing at the West Pointe a la Hache (not sure if this is a sheetpile or levee failure)

P13 - Replace floodwalls with 6 miles of setback levees from station 114+57 to 426+99. Along the Port Sulphur Reach (south of Port Sulphur).

P14 - Replace floodwalls with 2.5 miles of setback levee along Empire Reach from Station 769+10 to 902+70.

P17 - Replace floodwalls with 9,000 feet of setback levee along Buras Reach Station 910+35 to 1002+39, severe scour behind wall

P20 – NOV, floodwall repair at Sunrise (next to Buras) and Hayes (next to Port Sulphur) pump stations. Emergency sheetpiling was installed at both locations.

P21 - West Bank, repair floodwalls at: Homeplace Marina (next to Port Sulphur), Gainard Wood Pump station-(south of Homeplace – 2 miles), and at Diamond Pump station (next to City Price). Floodwalls are I-walls and some are capped.

P24 - Replace floodwall from station 357+80 to 650+00. Port Sulphur Area just above Nairn

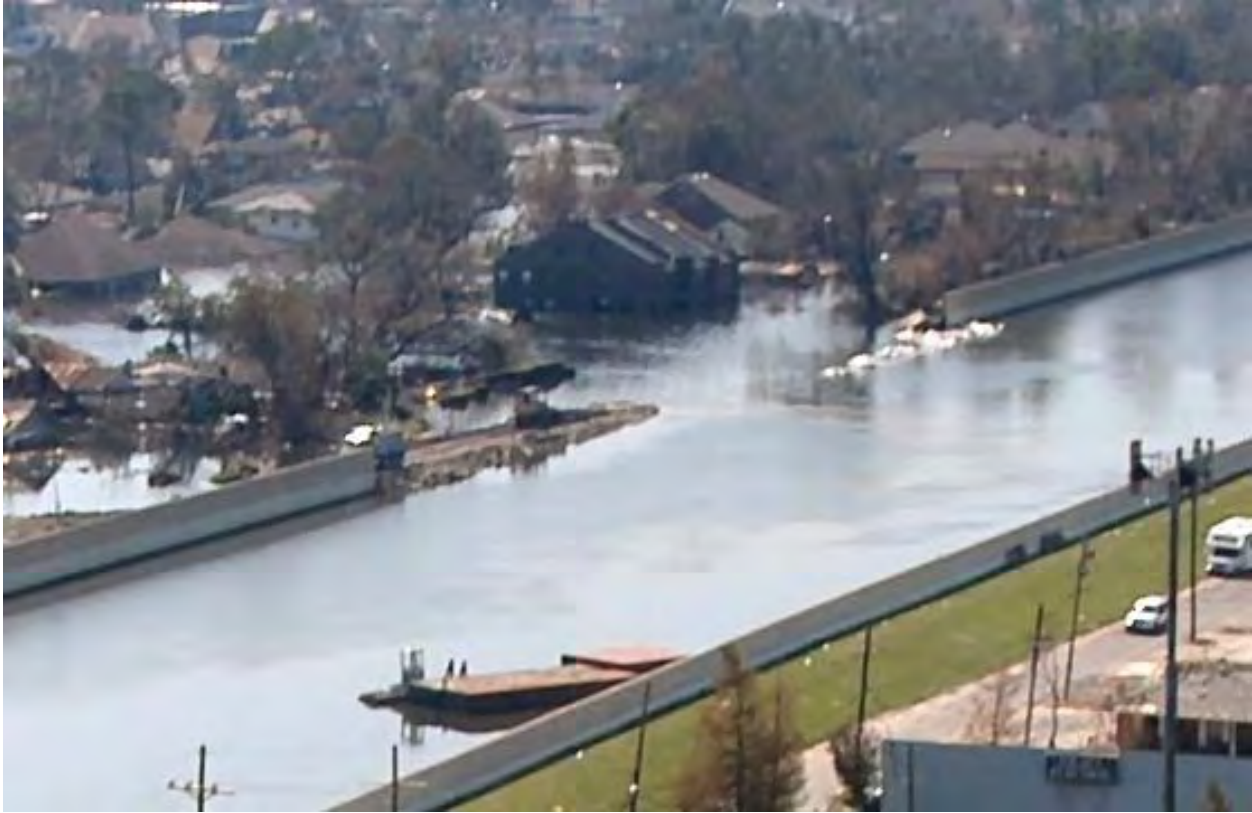
The 17th Street Canal breach is located on the east side of the canal just south of Hammond Highway. Figure 15-1 shows the breach shortly after Hurricane Katrina. The material samples were obtained from the (relatively) undisturbed I-wall sections at the north and south end of the breach. Concrete and rebar samples were obtained on Monday, 12 December and sheet piling were extracted on Tuesday, 13 December 2005.

Figure 15-1. 17th Street Canal Breach

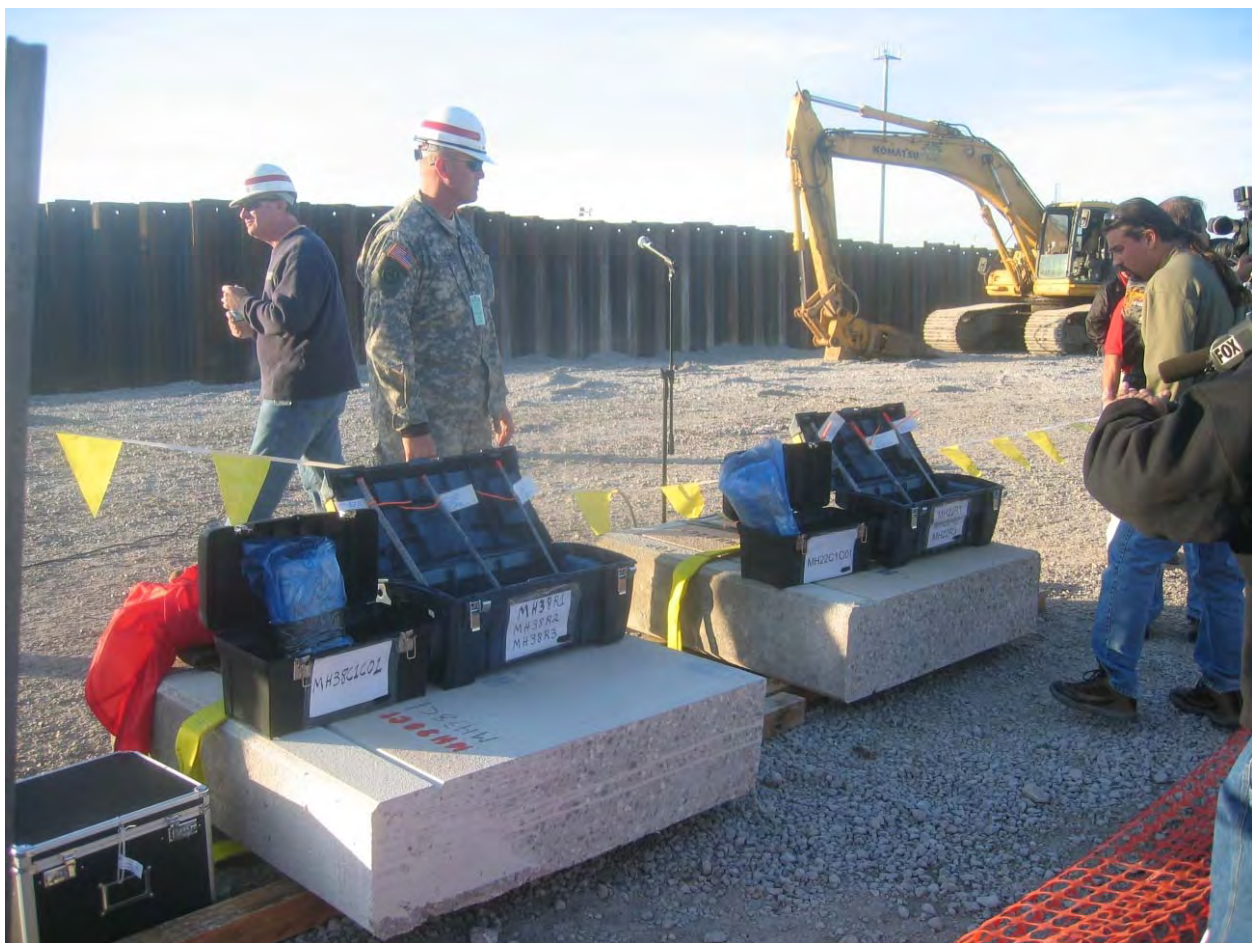
Figure 15-16 shows the wall panel samples, cores, and rebar samples collected on Monday, 12 December 2005. Note that the cores were placed in sealed plastic bags and each core and the 3 rebar samples from each of the two wall panels were placed in individual latching boxes. These samples were transported to a secure area at a warehouse at the Corps of Engineers' New Orleans District Office.

Figure 15-16. Wall Panel Samples, Cores and Rebar Samples

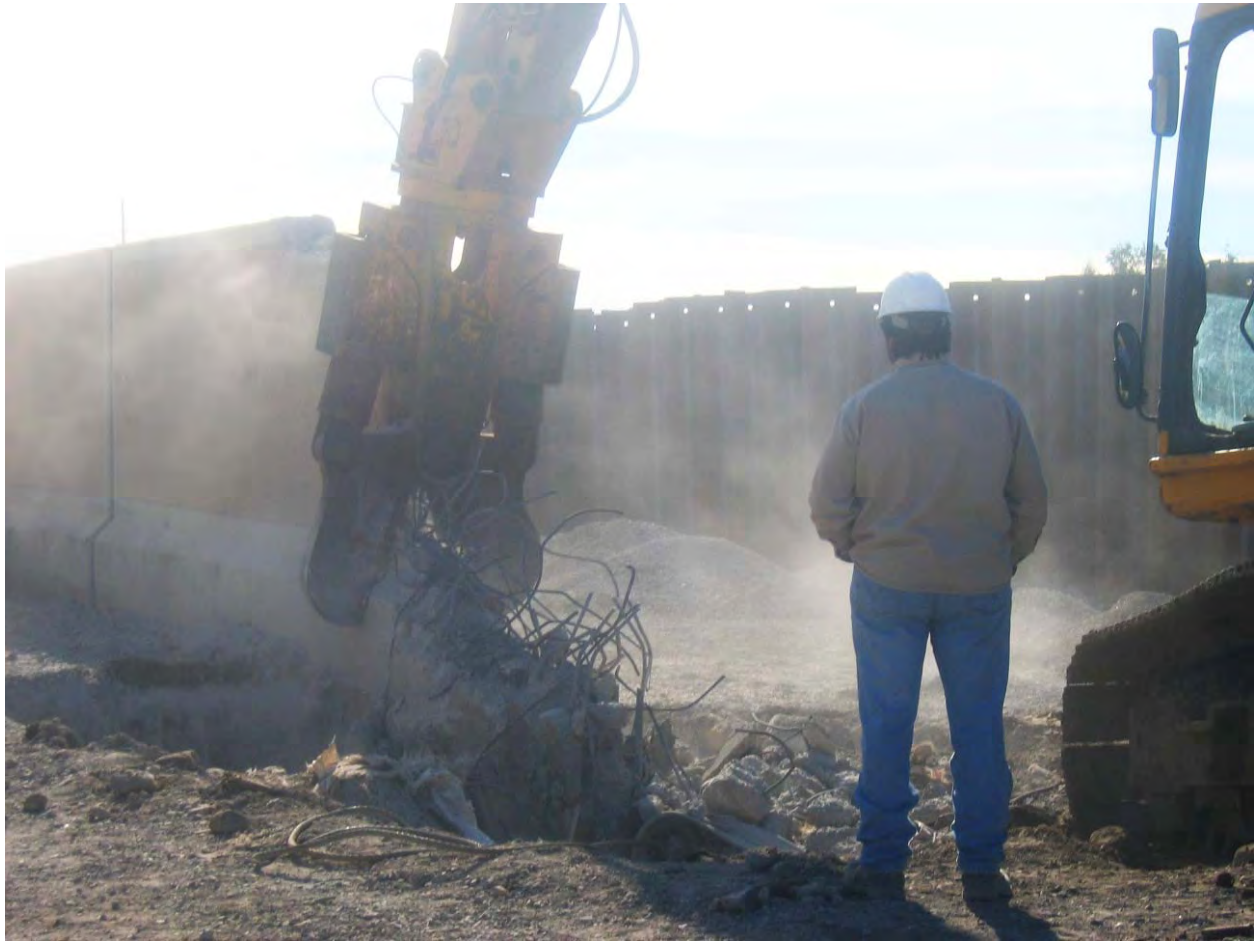
After the cores, wall panel and rebar samples were obtained the contractor began demolition of the wall panels to expose the top of the sheet piles for extraction. A scissor concrete crusher was used to demolish the upper portion of the wall panels as shown in Fig. 15-17. A hoe ram was then used to remove the lower portion of the of the wall panel around the sheet piling (Reference

Figure 15-17. Demolition of Top Portion of Wall Panel H38

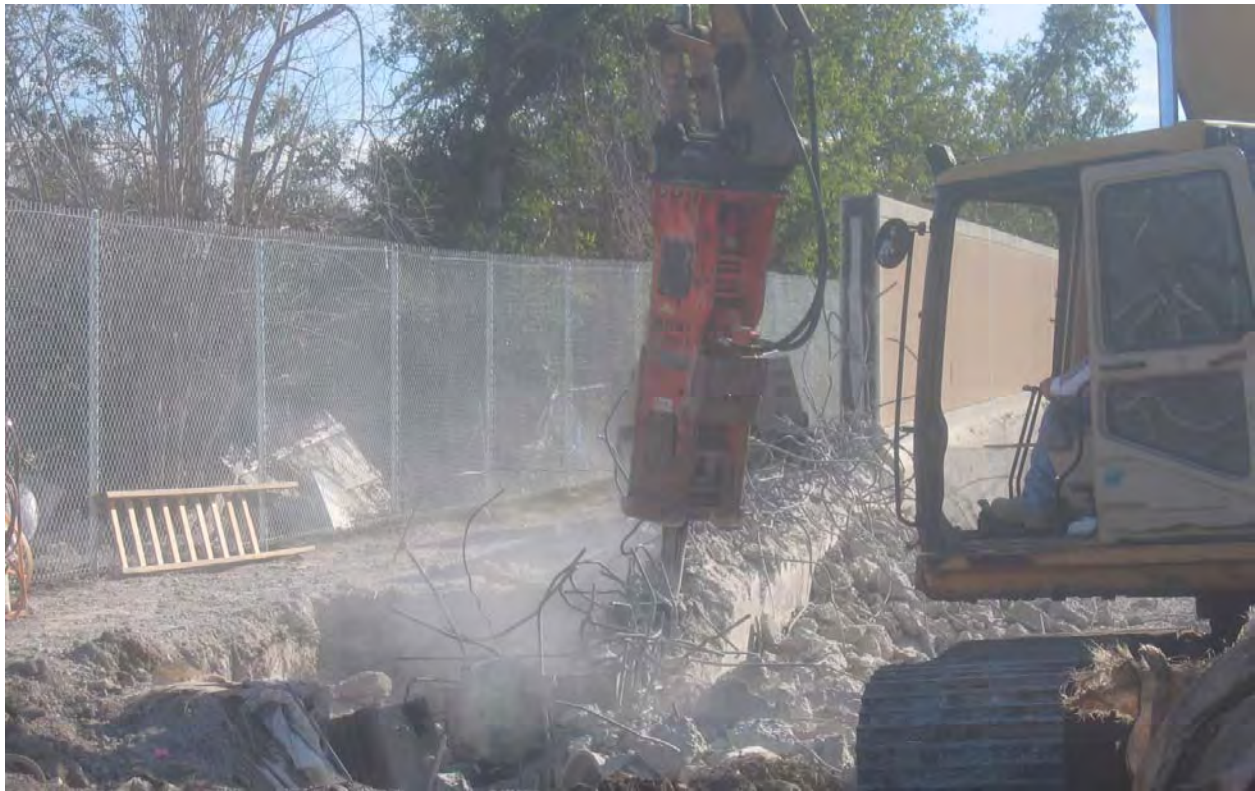
Figure 15-18. Hoe Ram Demolishing Lower Portion of Wall Panel H38

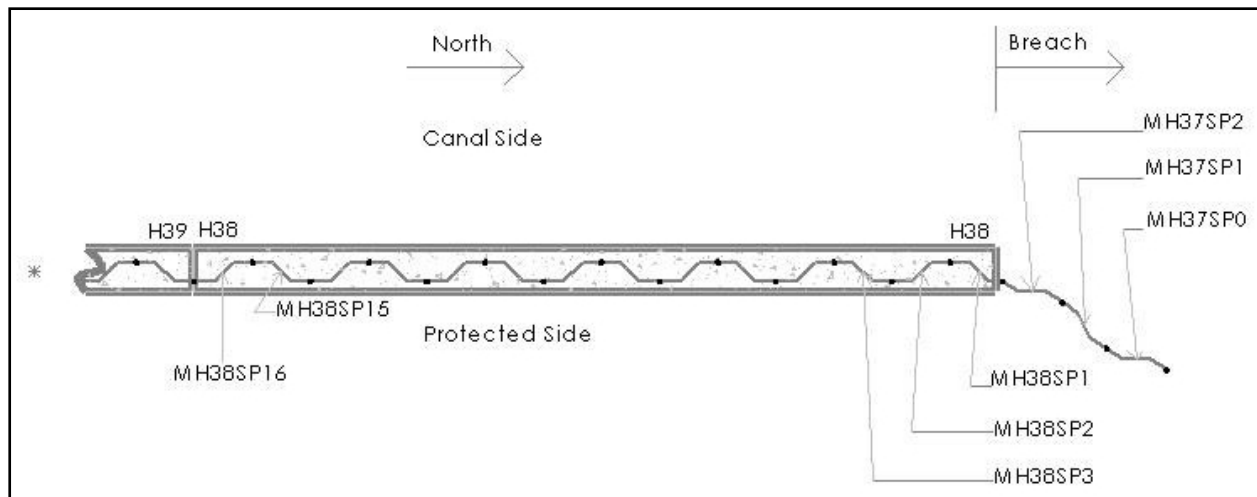
On Tuesday, 13 December 2005, sheet piles were extracted. The location of the sheet piles extracted at or adjacent to wall panel H38 is schematically shown in Fig. 15-19. Starting from the north end of panel H38, the piles are designated MH38SP1, MH38SP2, ..., MH38SP16 (the last number of the designation is incremented going from north to south).

Figure 15-19. Sheet Pile Designations at Wall Panel H38

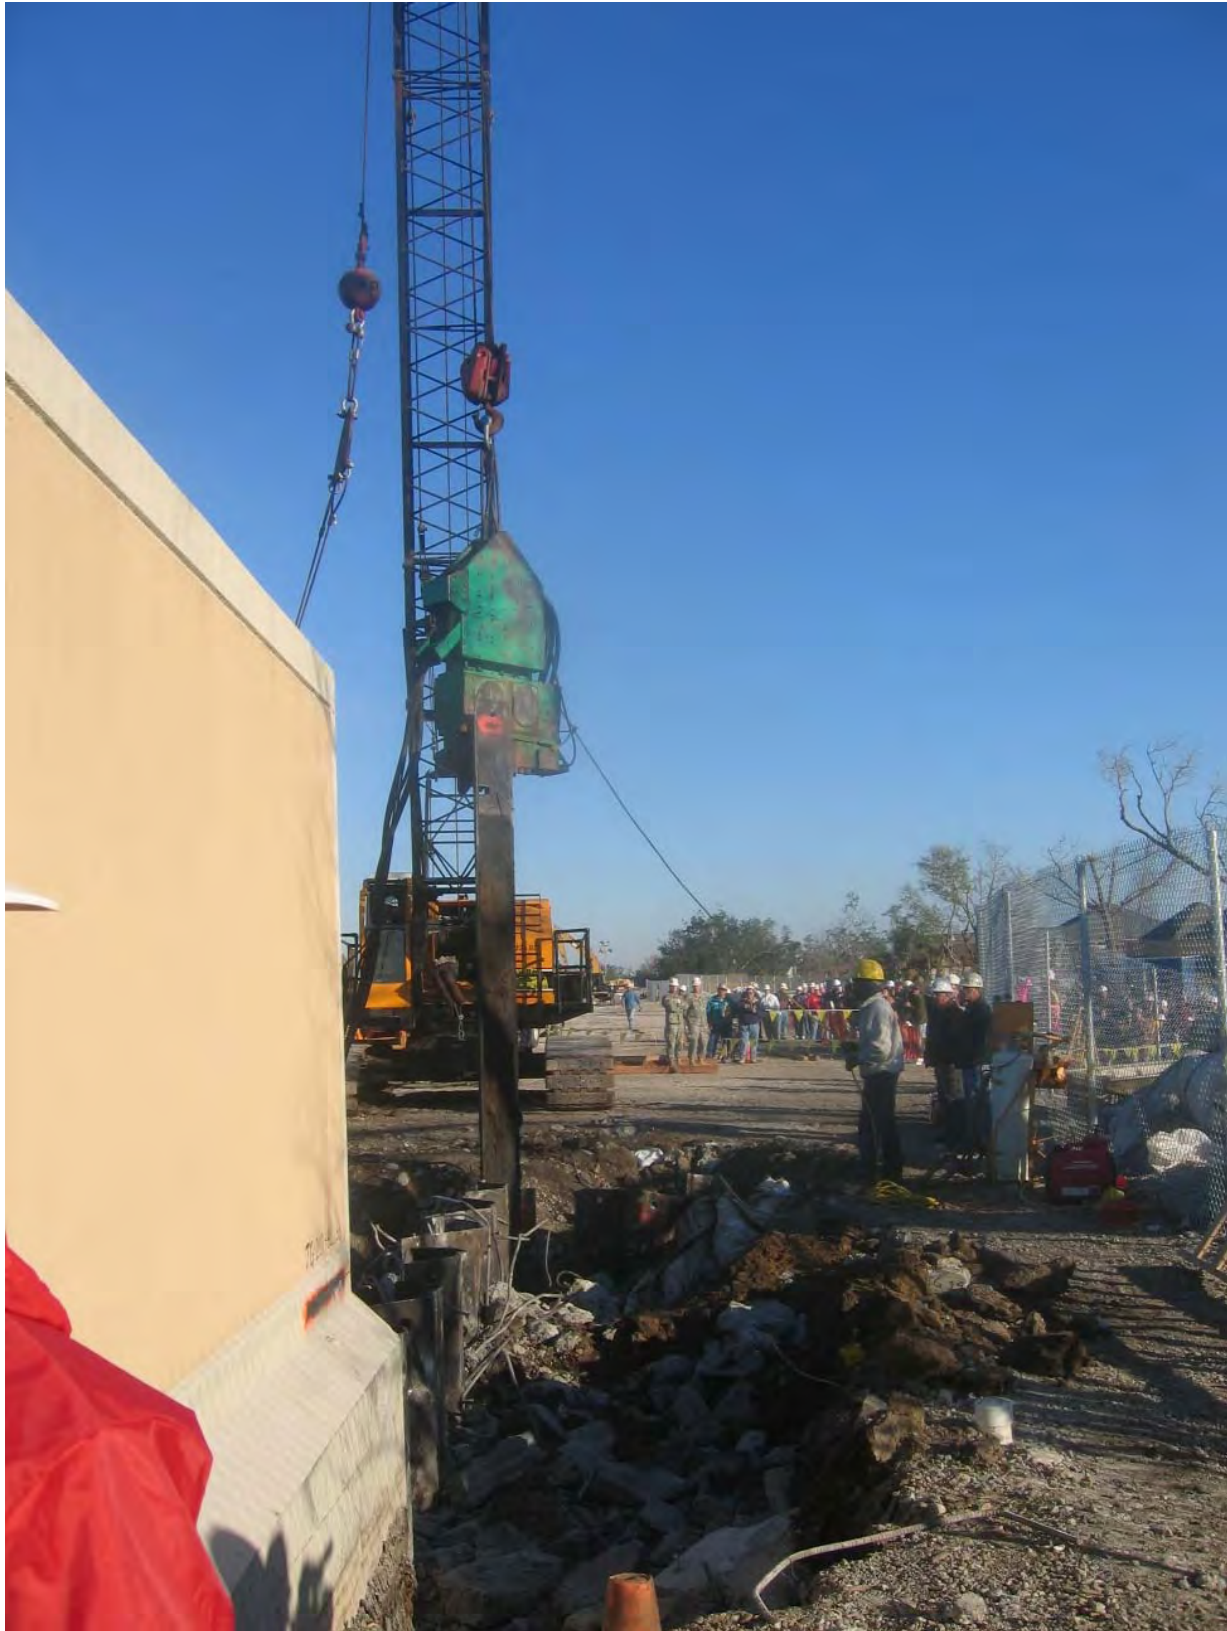
Sheet piles MH38SP2, MH38SP3 were extracted as a pair. Their lengths were approximately 23'-7" and 23'-8", respectively. MH38SP1 and MH37SP2 were then extracted as a pair. Their lengths were approximately 23'-3". The contractor then moved to the south end of wall panel H38 and extracted MH38SP15 and MH38SP16. Their lengths were approximately 23'-5". MH38SP15 and MH38SP16 were at a location corresponding to a soil boring hole where Parallel Seismic tests were conducted in an attempt to determine the length of the sheet pile in situ. The contractor then attempted to extract sheet pile MH37SP1 as a single pile, but MH37SP0 came with it. Their lengths were approximately 23'-6". Extraction of sheet piles at the south end of the breach is shown in Figs. 15-20 and 15-21. The out-of-plumb orientation (from displacement of the piling in the breach) of piles MH37SP1 and MH37SP0 is clearly evident in Fig. 15-21. Figure 15-22 shows measuring and tagging of sheet piling.

Figure 15-20. Extraction of Sheet Piles MH38SP2 and MH38SP3

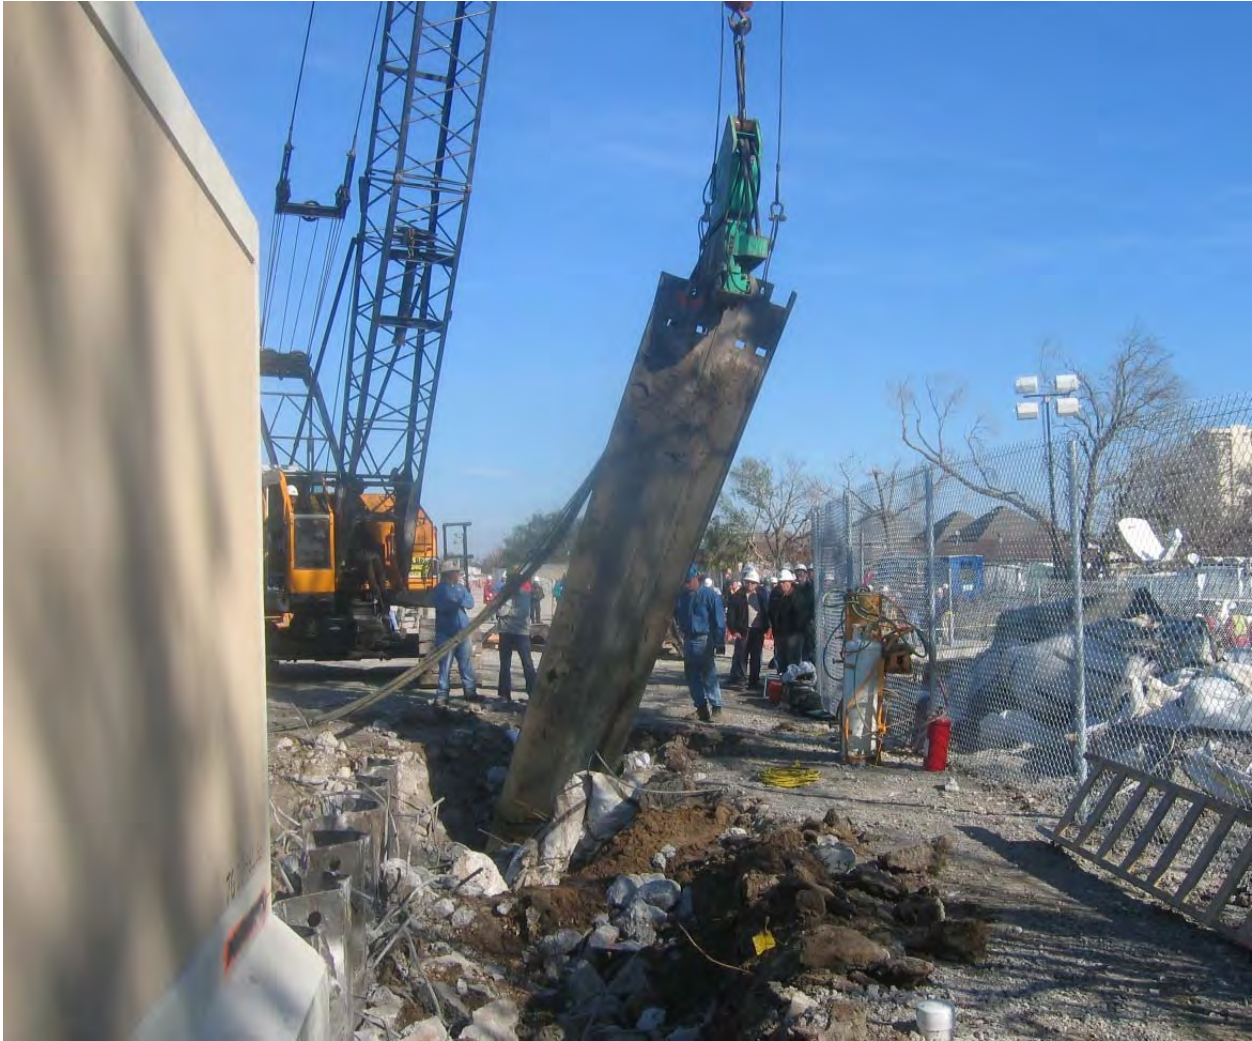
Figure 15-21. Extraction of Sheet Piles MH37SP1 and MH37SP0

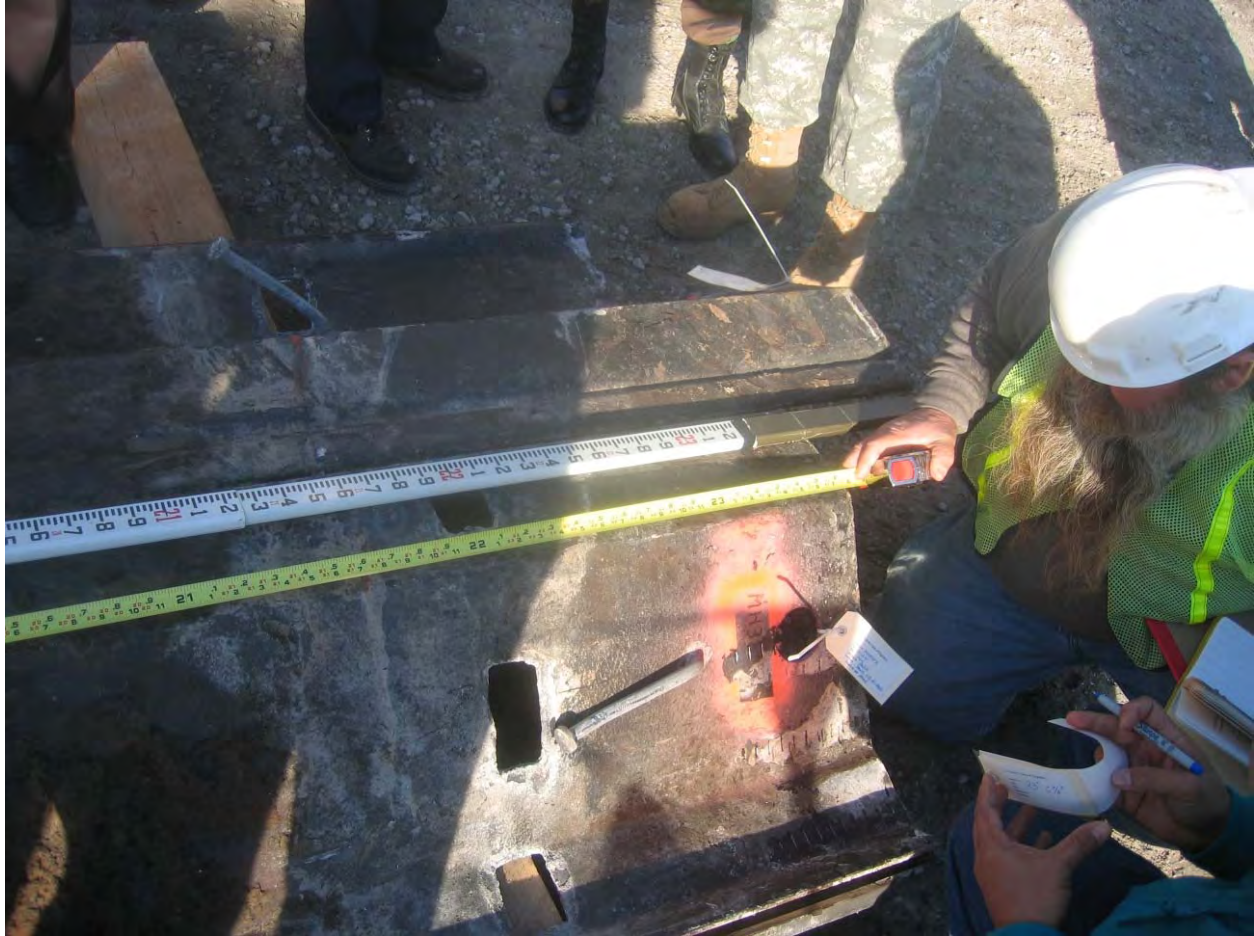
Figure 15-22. Measuring and Tagging of Sheet Piles

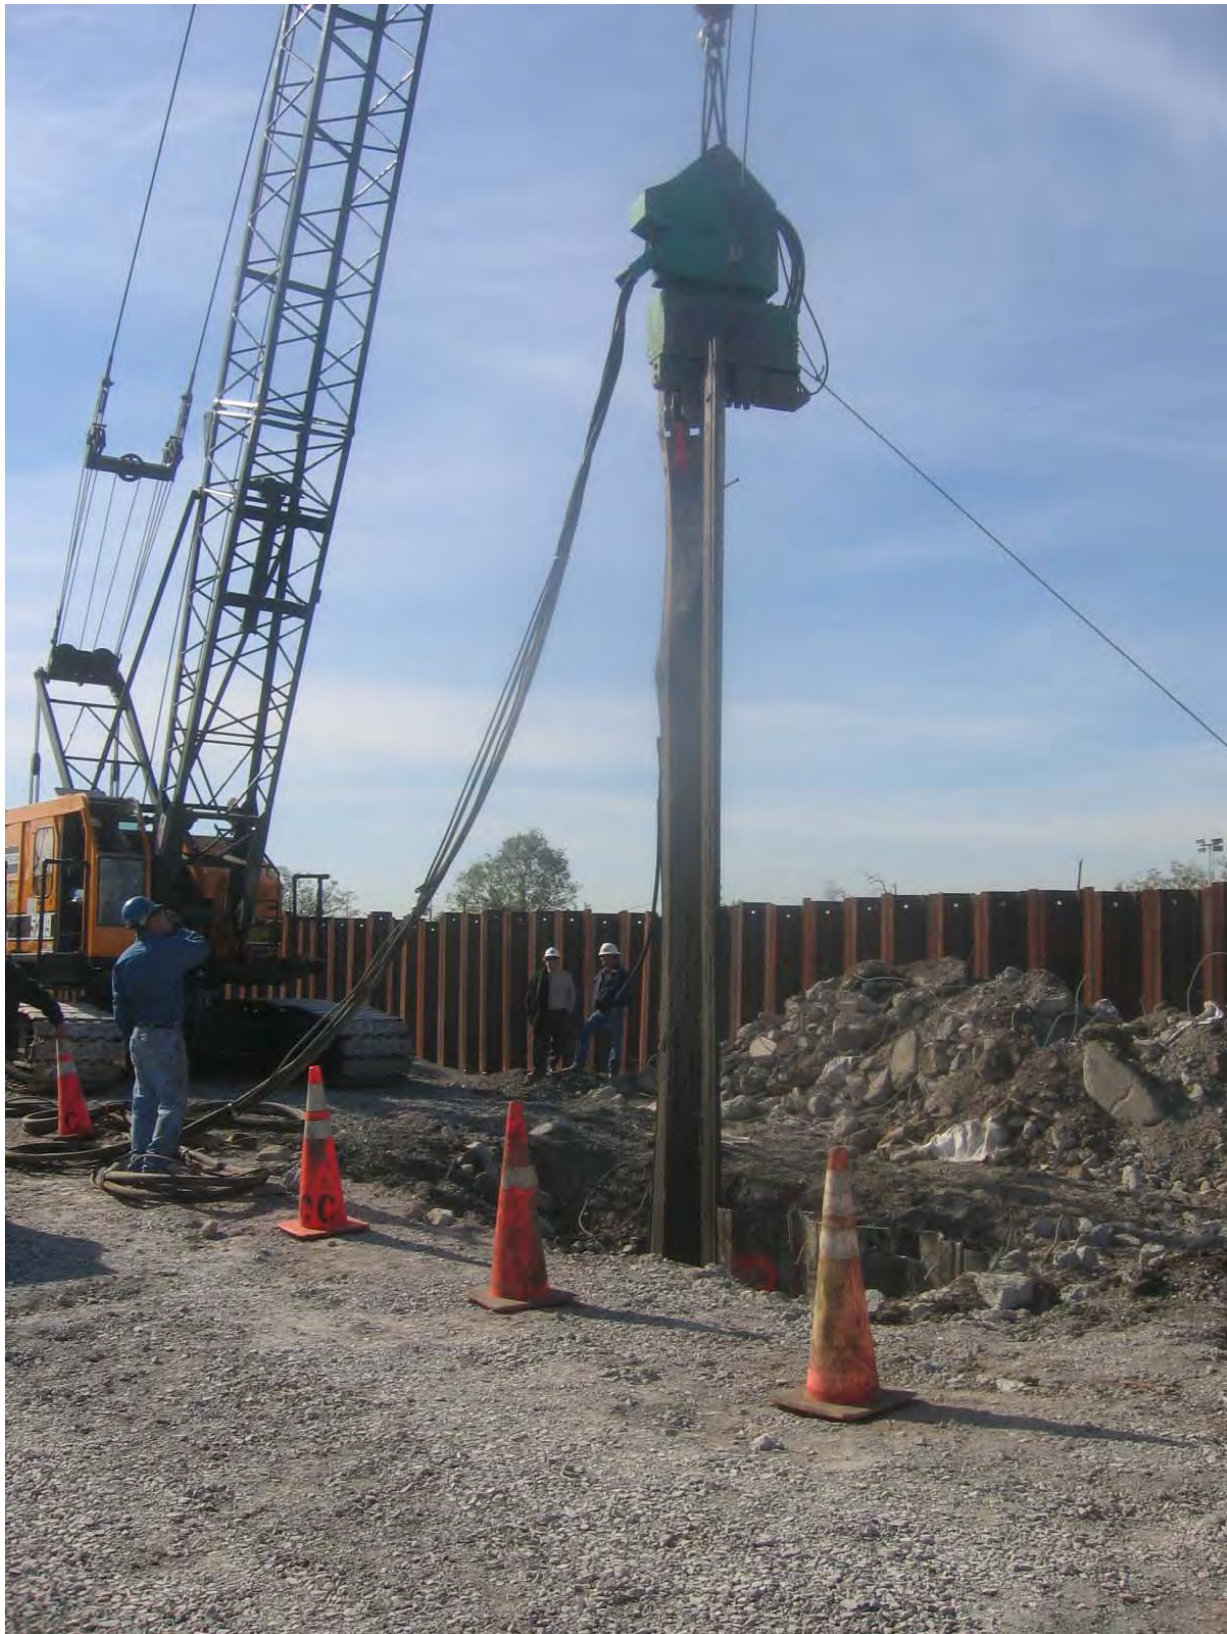
Sheet piles were then extracted at the location of wall panel H22, immediately north of the breach. Four sheet piles at the south end of wall panel H22 were designated MH22SP1, MH22SP2, MH22SP3 and MH22SP4. (The last number of the designation was incremented going from south to north.) Sheet piles MH22SP1 and MH22SP2 were extracted as a pair as shown in Fig. 15-23. These piles had a length of approximately 23'-7" and 23'-6", respectively. Sheet piles MH22SP3 and MH22SP4 were extracted as a pair and had a length of approximately 23'-7" and 23'-6", respectively. The contractor then pulled a pair of piles from just north of the north end of wall panel H22 at a location coincident with a boring hole where Parallel Seismic testing had been performed. These piles were designated MH21SP1 and MH21SP2. Both of these sheet piling had a length of approximately 23'-6".

Figure 15-23. Extraction of Sheet Piling MH22SP1 and MH22SP2

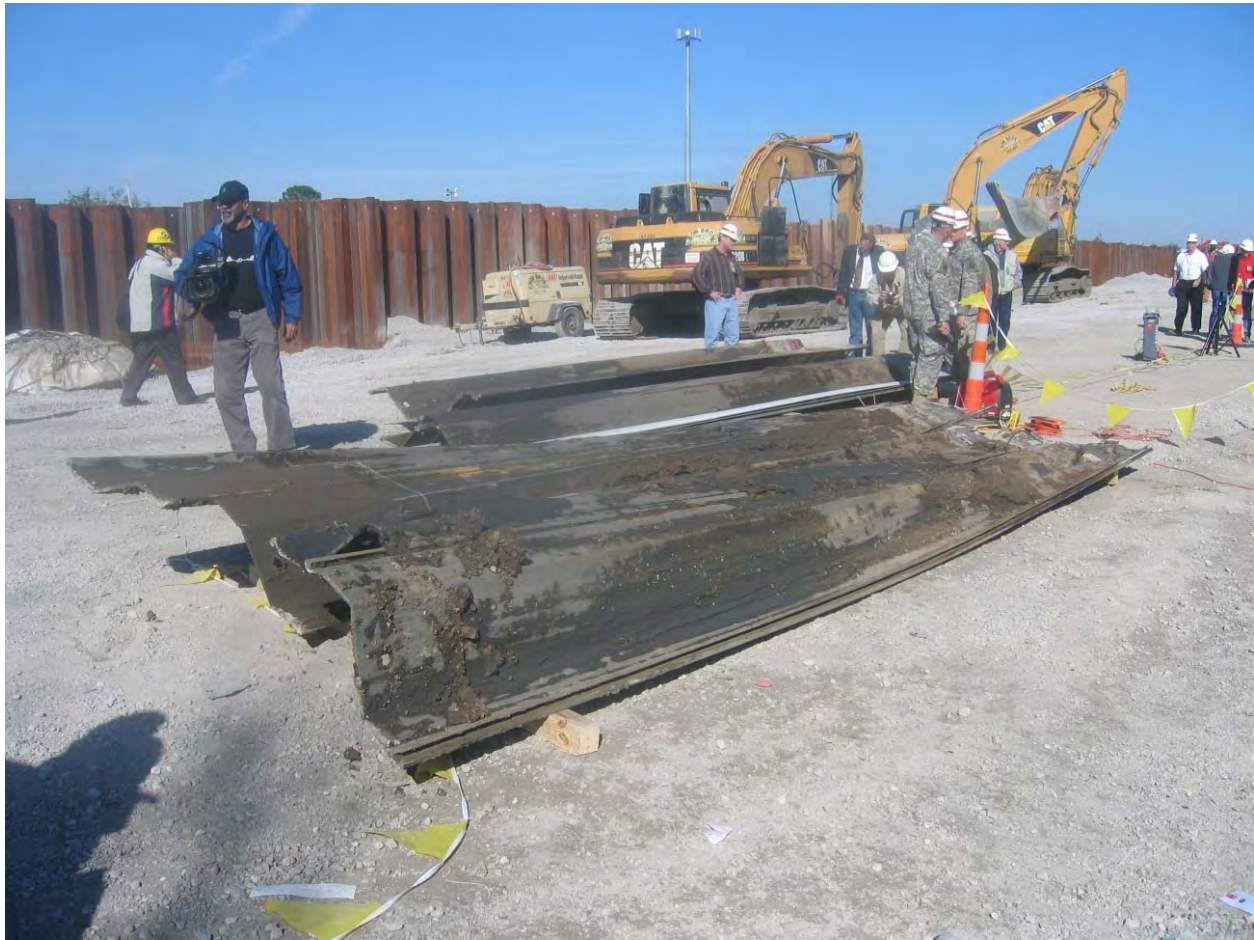
Figures 15-24 and 15-25 show the sheet piling extracted from the south and north ends of the breach, respectively. The sheet piles were loaded on a truck and transported to a secure location within a warehouse at the Corps of Engineers' New Orleans District Office.

Figure 15-24. Sheet Piling Extracted from South End of Breach

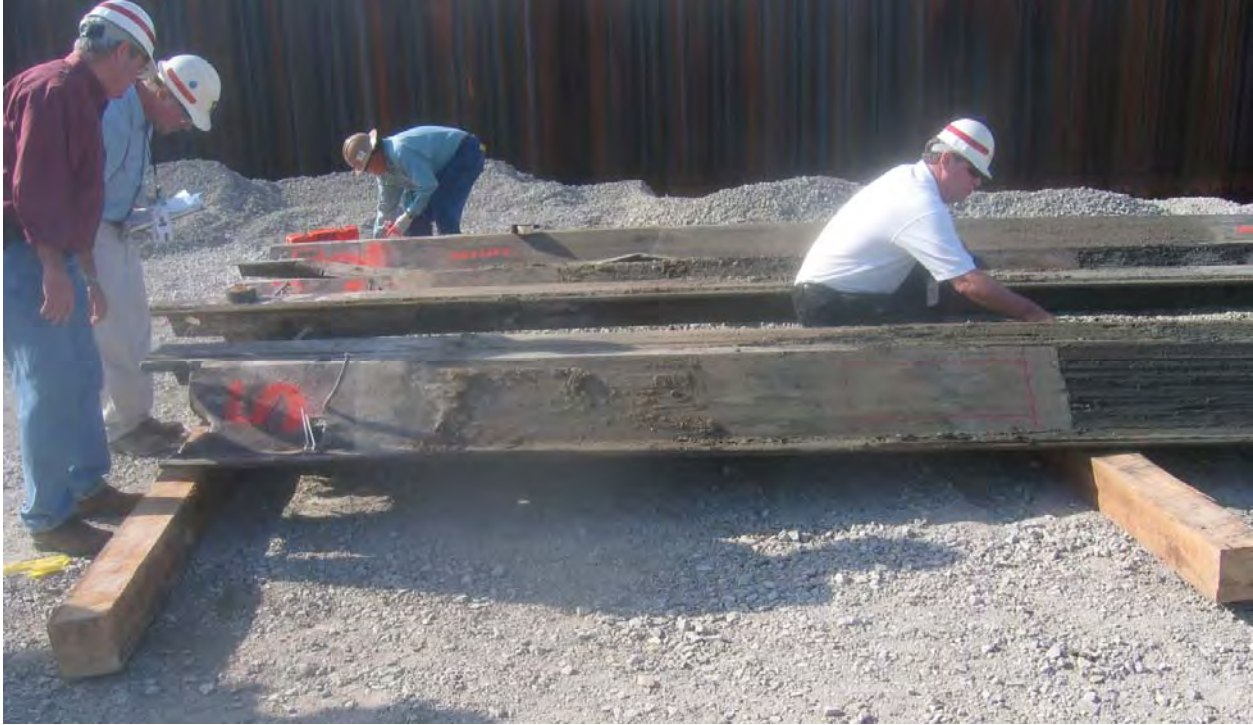
Figure 15-25. Sheet Piling Extracted from North End of Breach

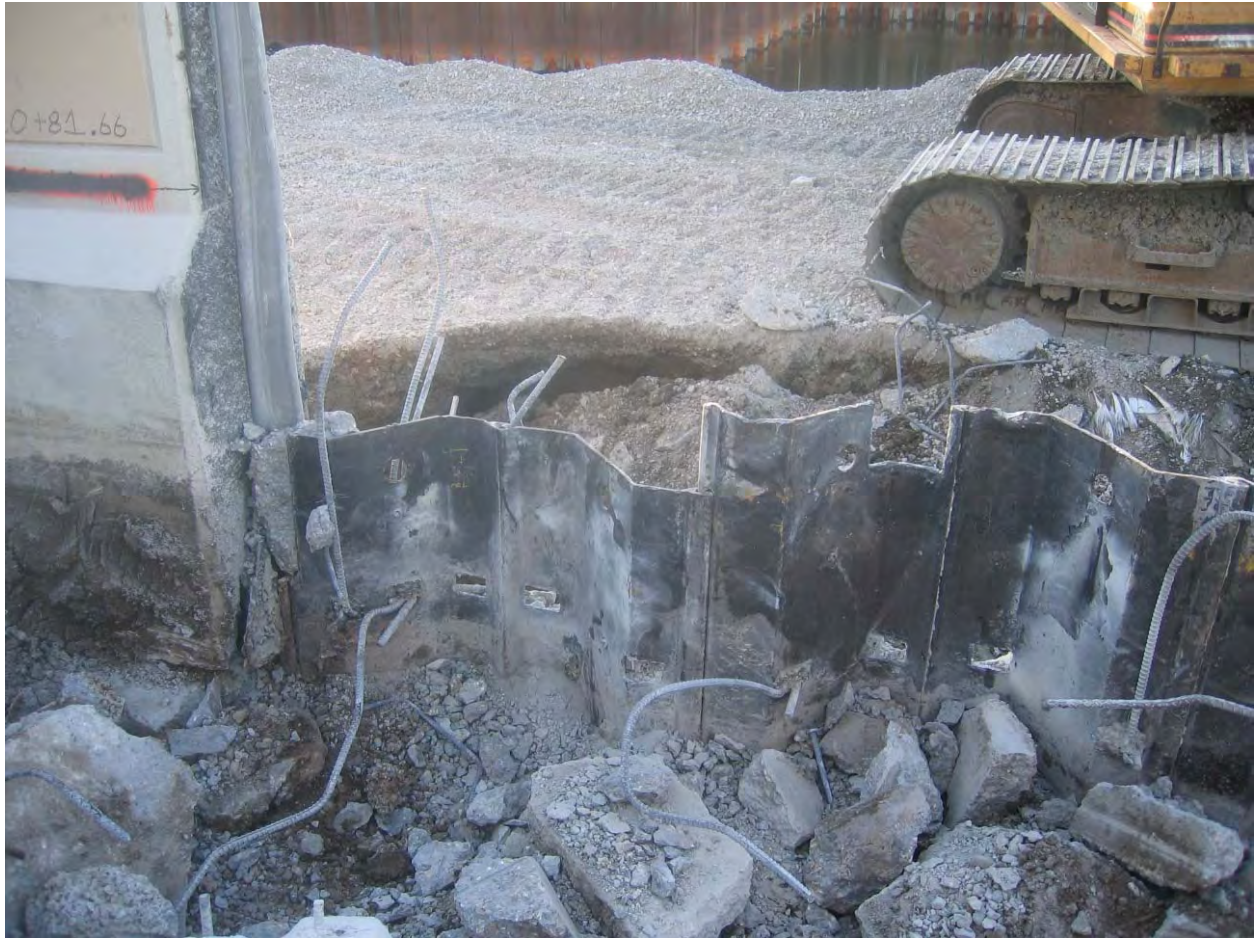
The sheet piling extracted from the 17th Street Canal breach site ranged in length from 23'-3" to 23'-8". The top of the pilings were at approximately elevation 6.25 ft. (The pilings adjacent to the expansion joints between wall panels were driven slightly lower as can be seen in Fig. 15-26. This was done to improve the performance and effectiveness of the expansion joint.) A 23'-3" piling length provides for a tip elevation of -17.0 ft. Obviously, piling driven with a lower top elevation have a correspondingly lower tip elevation.

Figure 15-26. Lower Top Elevation of Sheet Piling at Expansion Joint
