Appendix 1

Soil Data Report for 17th Street Canal

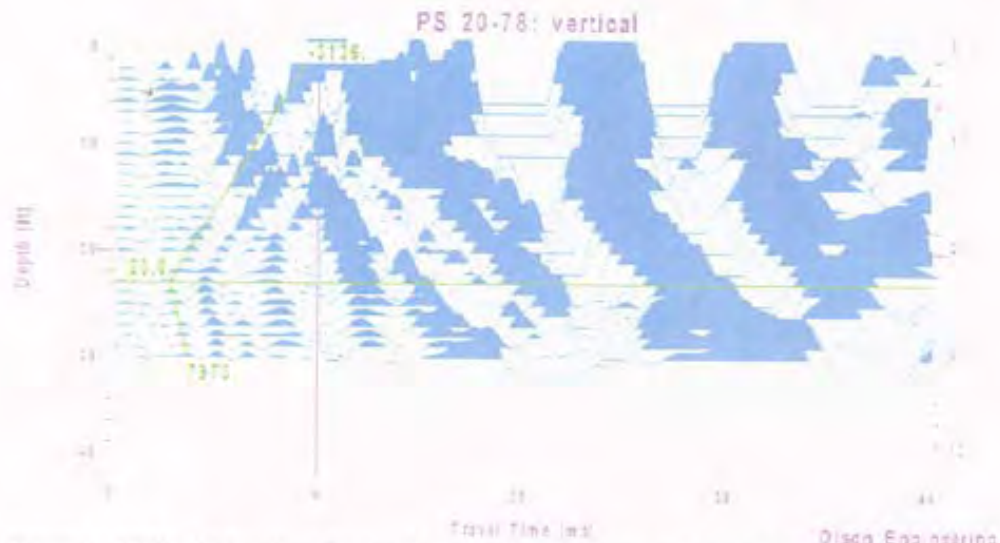
The PS data presented in Figures 1-5 were produced by 5 impacts which were averaged at each 1 ft test depth interval, filtered and normalized to the largest signal strength (global maximum display) to optimize the display of the diffraction events. Review of Figure 1 shows the diffraction event at 23.0 ft deep due to direct horizontal sheet pile impacts. There is also some energy occurring in advance of the diffraction event at shallower depths. In Figure 2 the horizontal impacts to the concrete wall also show a diffraction event at 22.7 ft deep, but a little less clear with more energy emitting from the concrete wall. By comparison, the diffraction event is clear at 21.8 ft deep for the angled downward impact to the chamfer in Figure 3. Apparently the more vertical impact to the chamfer put more energy down the sheet pile with less energy emitting from the wall. In Figure 4, the impacts to the top of the wall were further away from the ground and the sheet pile, so the diffraction event is quite clear at 21.5 ft. The impacts to the angled steel rod also produced a diffraction event at 22.6 ft as shown in Figure 5, but it was comparatively weaker, likelier due to less energy being imparted by the rod impacts.

Figure 1 - 17th St. PS Results at Station 20+78 - Sheet Pile impacted at ~ el. 1.5 (0.5 ft below bottom of levee concrete wall on protected side)

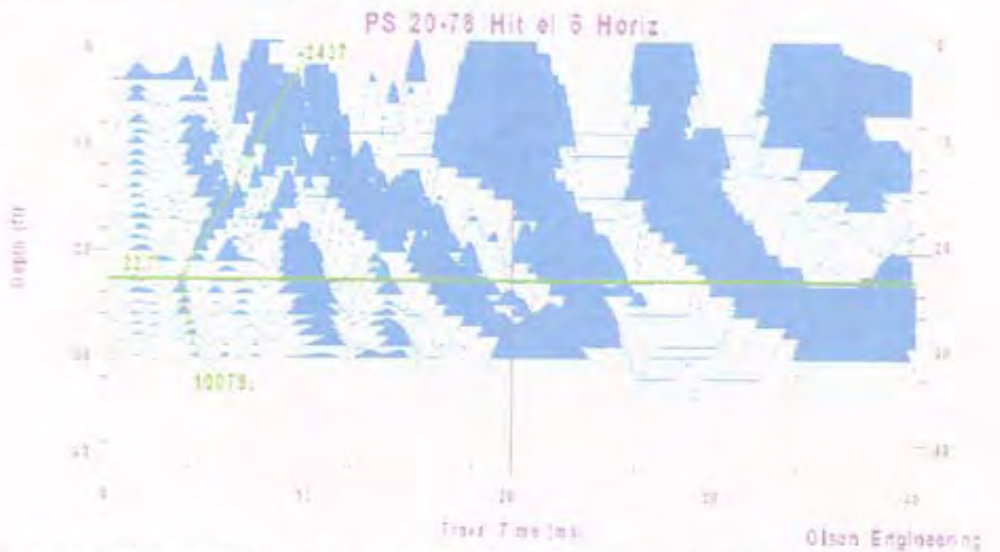
Figure 2 - 17th St. PS Results at Station 20+78 - Concrete Wall impacted horizontally at ~ el. 5 (~0.5 ft below chamfer edge on protected side)

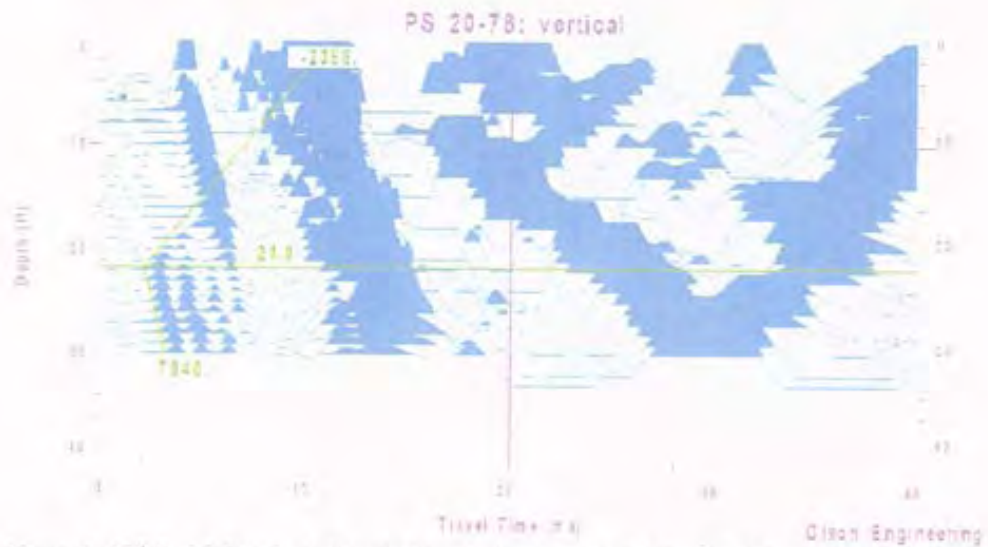
Figure 3 - 17th St. PS Results at Sta. 20+78 - Angled Impacts to Chamfer of Concrete Wall at Sta. 20+78 (~el. 5.75 on protected side)

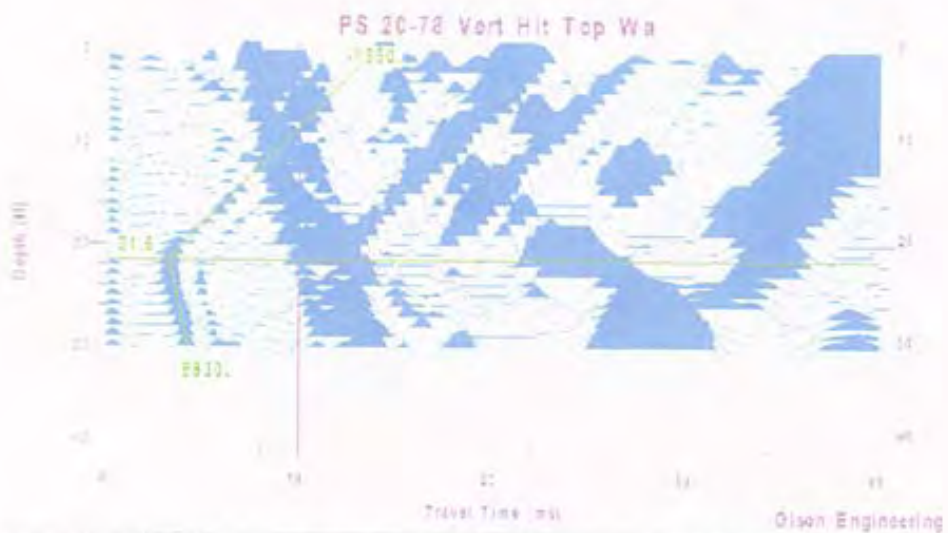
Figure 4 - 17th St. PS Results at Sta. 20+78 - Vertical Impacts to Top of Concrete Wall at Sta. 20+78

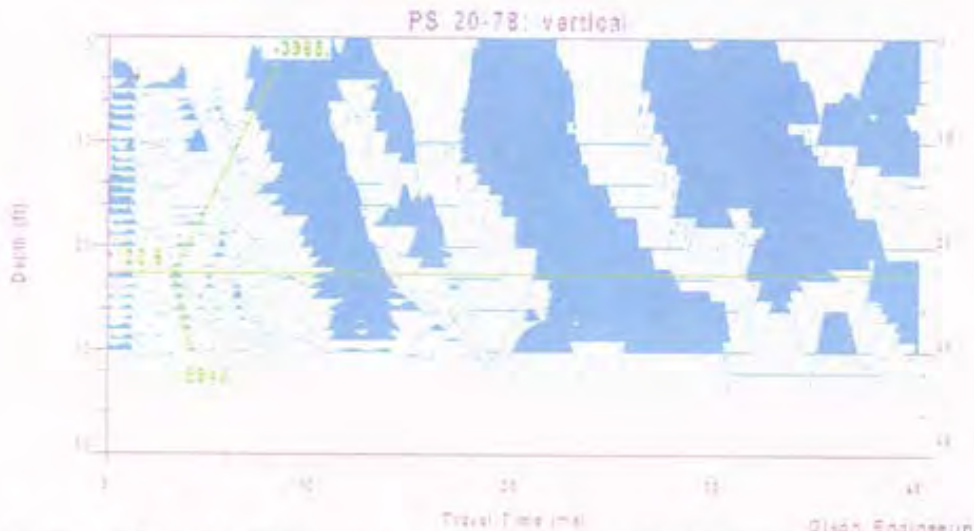
Figure 5 - 17th St. PS Results at Sta. 20+78 - Angled Impacts to 1 inch diameter, 6 ft long rod held against steel sheet pile at ~ el. 1.5 at 0.5 ft below concrete wall

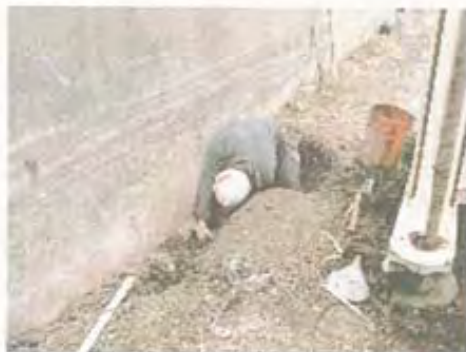
The IHNC re-tests were performed in an area of the wall that had been pushed back and the levee soils dropped down to expose a sheet pile on the canal side at Station 17+11 which was about 10 ft north of the USACE cased boring in this area. Shovels were used to expose enough of the sheet pile to impact it with the 3 lb impulse hammer as shown in Photo 9. The PS tests were done using a hydrophone in the 1 inch PVC casing installed by SESI with the Geoprobe rig as shown in Photo 10.

Photo 9 - IHNC 3-lb Impulse hammer impacts to sheet pile on canal side at Station 17+11

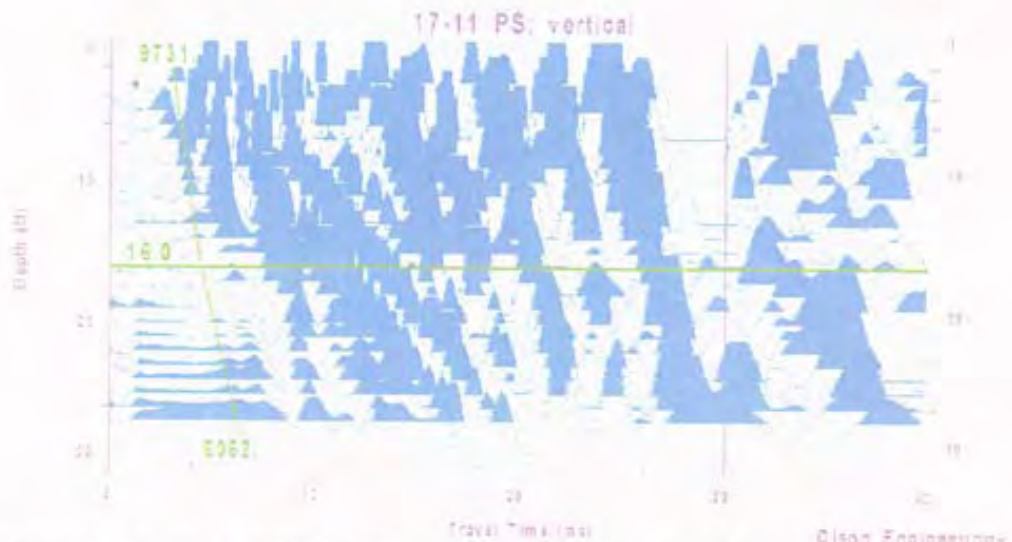
Review of Figure 6 for the case of direct horizontal impacts to the sheet pile shows a weak direct arrival wave front that is slower below the 16 ft depth of the sheet pile. However, no diffraction events are evident in this PS-based hydrophone test data. This may be due to the evident separation of the levee soil from the canal side of the wall due to the wall being pushed back by the breach forces. This apparent lack of tight contact between the sheet pile and the levee soils may have resulted in the diffraction event energy not being well coupled into the surrounding saturated soils.

Figure 6 - PS Results at IHNC Sta. 17+11 - Impact to Sheet Pile at ~0.5 ft below bottom of Concrete Wall on Canal Side

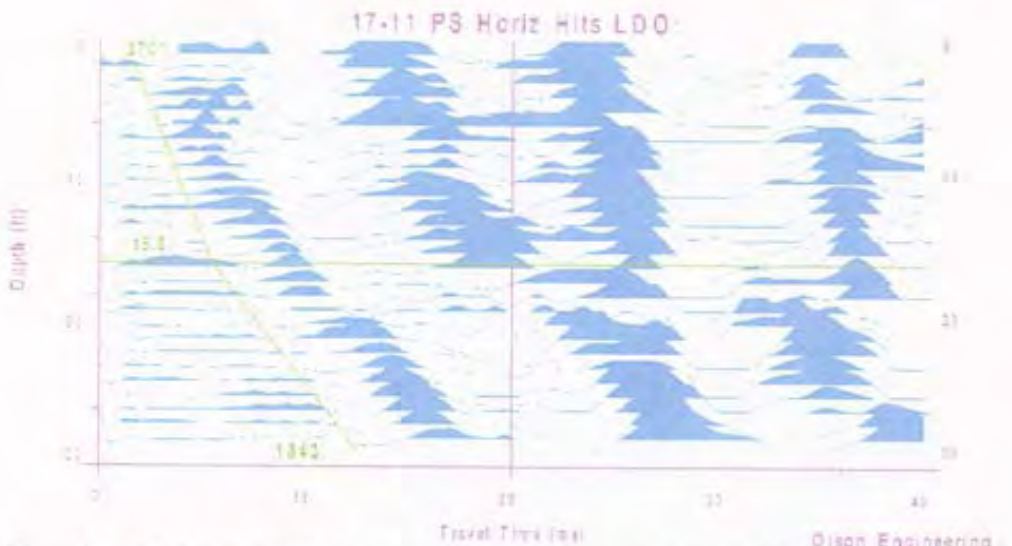
Review of Figures 7 and 8 for horizontal and vertical impacts to the concrete wall does not show clear direct arrivals when the apparent weak energy was picked as shown in the figures. No diffraction events are clearly evident in the figures either. These results further support the possibility that there is poor soil contact to the sheet pile on the canal side that diminished the diffraction effect in the IHNC re-tests.

Figure 7 - PS Results at IHNC Sta. 17+11 - Horizontal Impact to Concrete Wall at ~6.5 ft below top of Wall on Canal Side

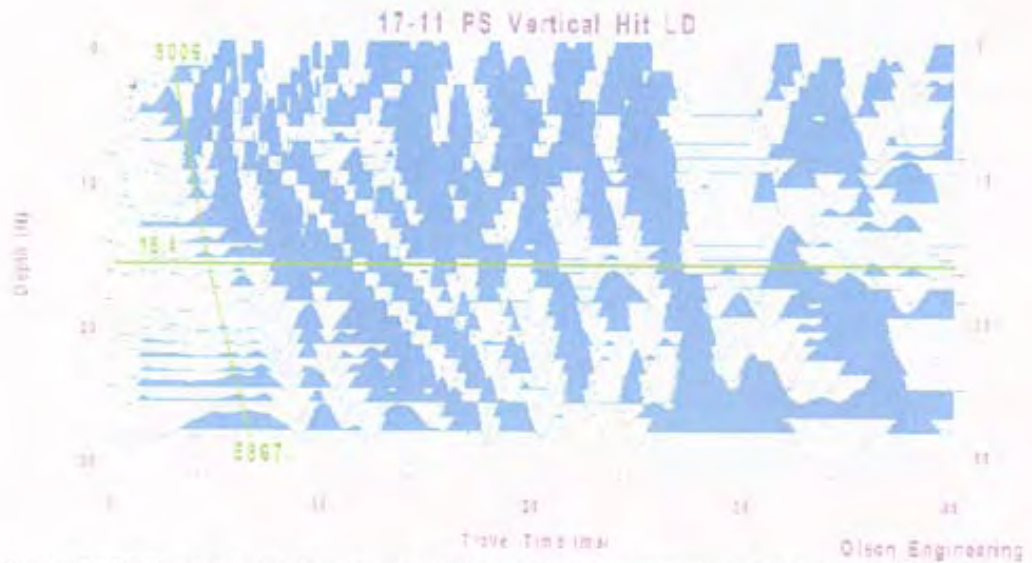
Figure 8 - PS Results for IHNC at Sta. 17+11 for Vertical Impacts to top of 8 ft tall Concrete Wall

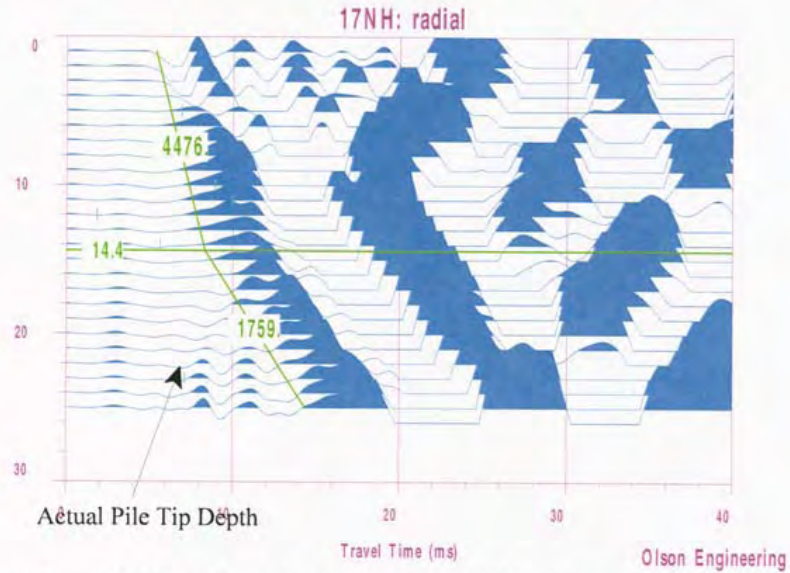
Figure 1 17th Street Levee North Site, Initial PS Data Interpretation

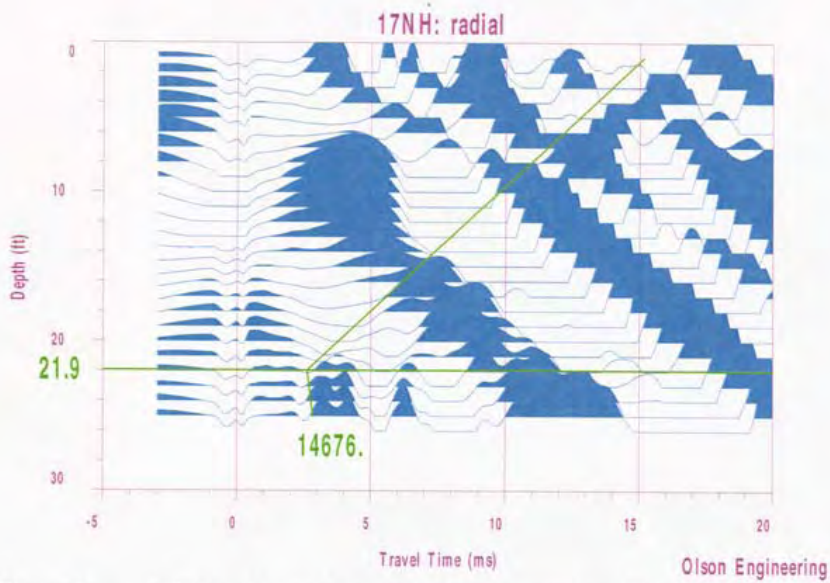
It is our understanding that four sheet piles at the north end and 4 sheet piles at the south end of the 17th Street levee breach area have been pulled, and that the our data interpretation of nearby PS results in north and south cased borings was shown to be incorrect. The actual embedded lengths were found to be approximately 17 feet below mean sea level (20-22 feet below the casing top elevation used in our investigation) with total sheet pile lengths of 23.5 ft.

Figure 2 17th Street Levee North Site, Re-interpretation of PS Results

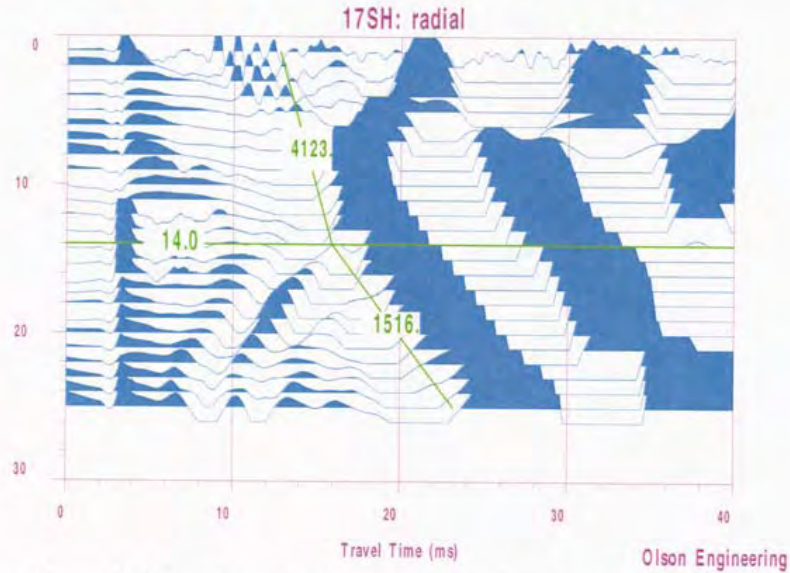
Figure 3 17th Street Levee South Site, Initial PS Data Interpretation

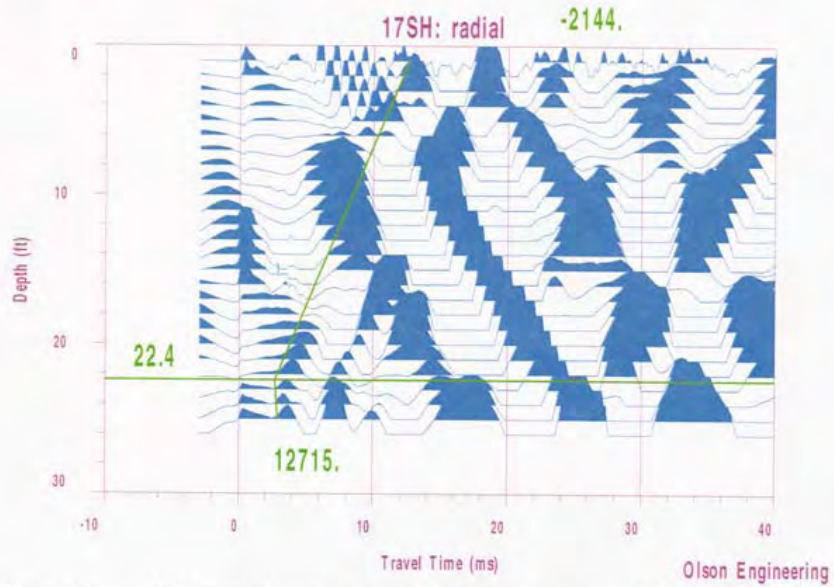
Figure 4 17th Street Levee South Site, Re-interpretation of PS Results

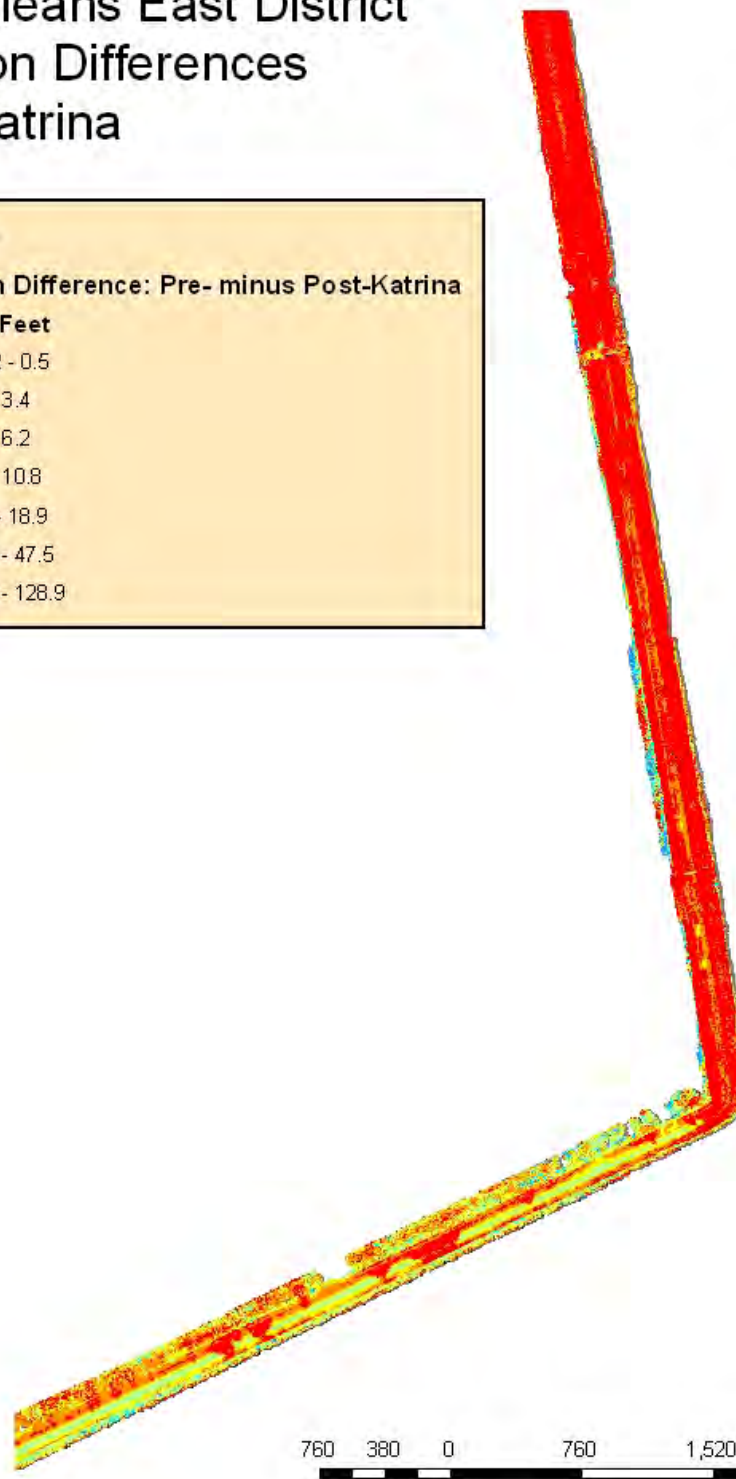
Figure 18-5. Hillshading from pre-Katrina LIDAR minus post-Katrina LIDAR, southeast corner of New Orleans East Basin. Figure created from raw LIDAR data, thus noise and outliers not removed from dataset. Red areas indicate less than 0.5 ft of scour

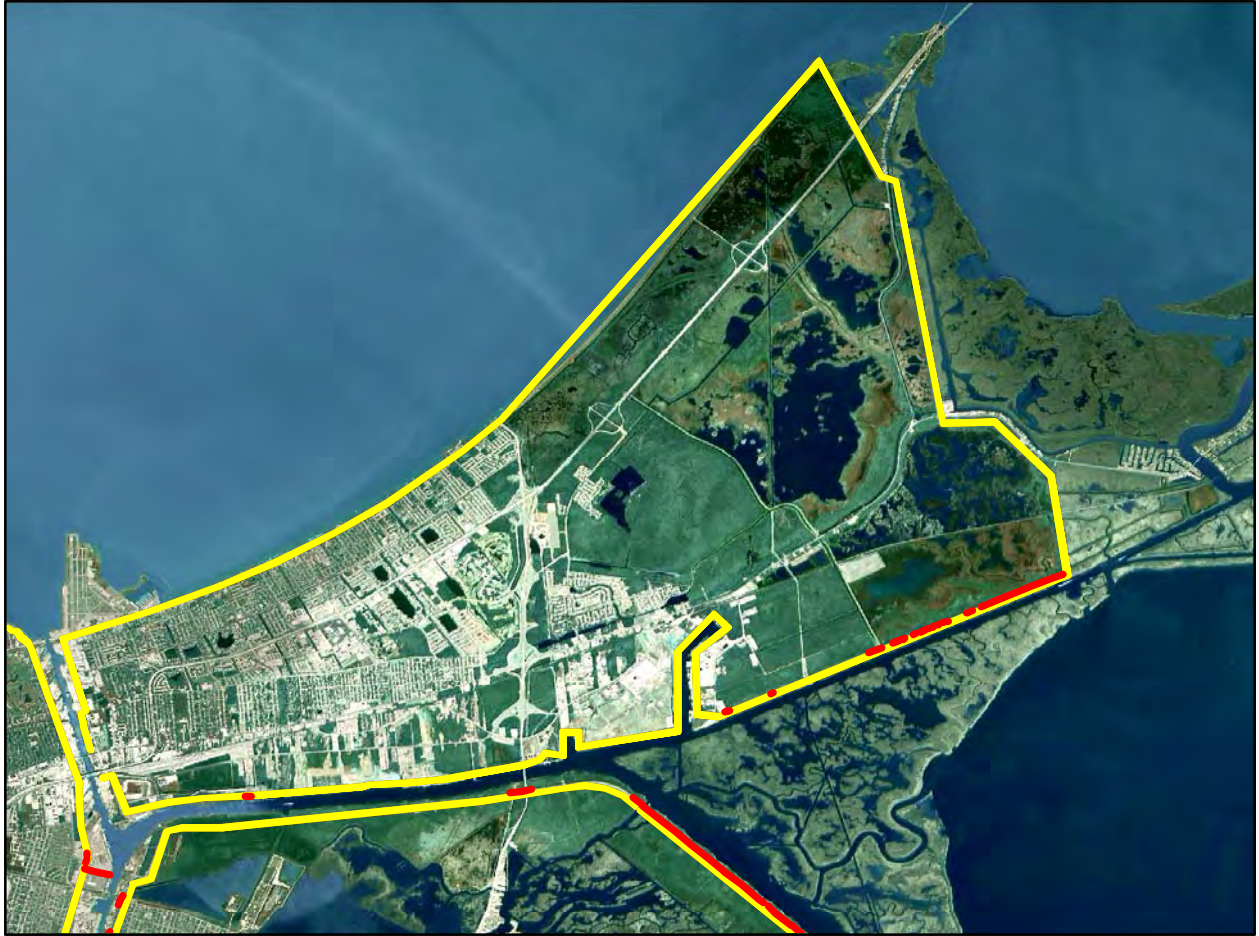
Figure 18-6. NOE Basin post-Katrina breaches

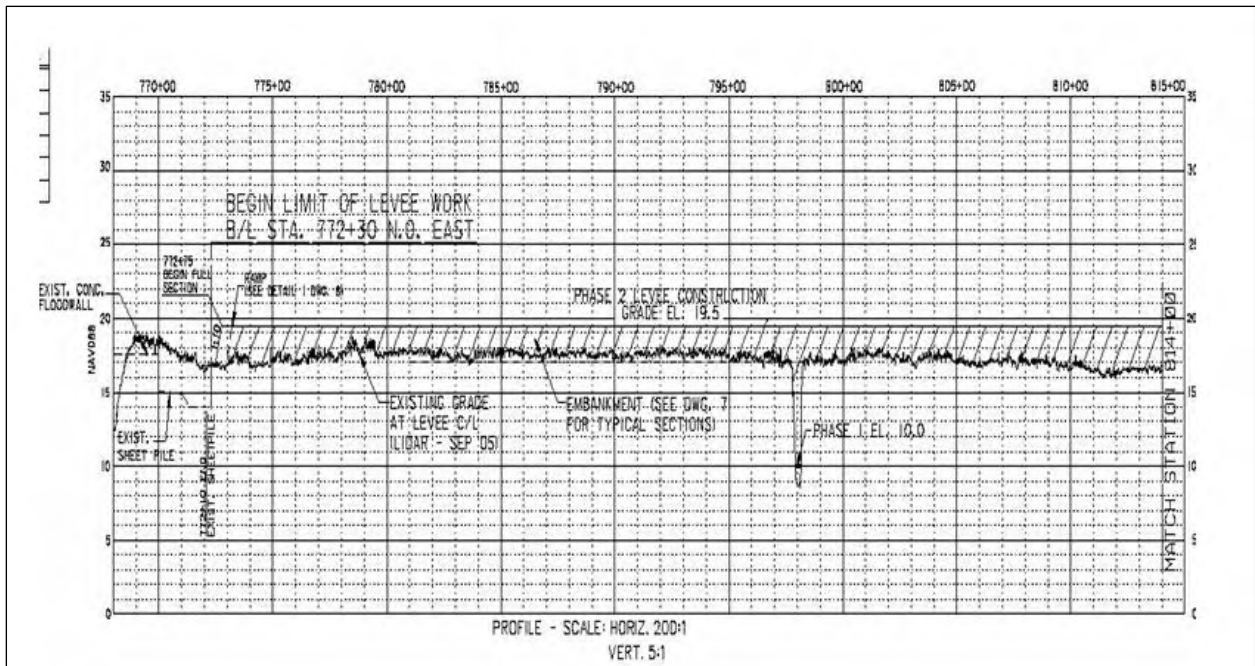
Figure 18-8. Post-Katrina profile along NOE Back Levee starting at Michoud Canal (Station 772 + 30) to Station 814 + 00 along the GIWW

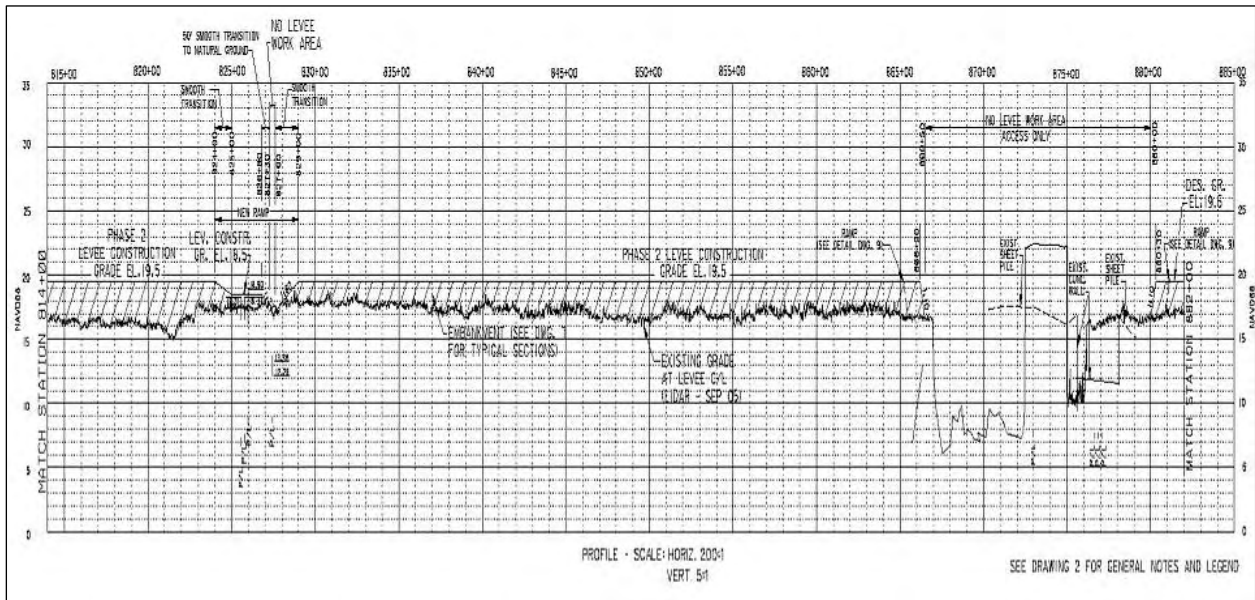
Figure 18-9. Post-Katrina profile along NOE Back Levee starting at Station 814 + 00 and ending at Station 882+00

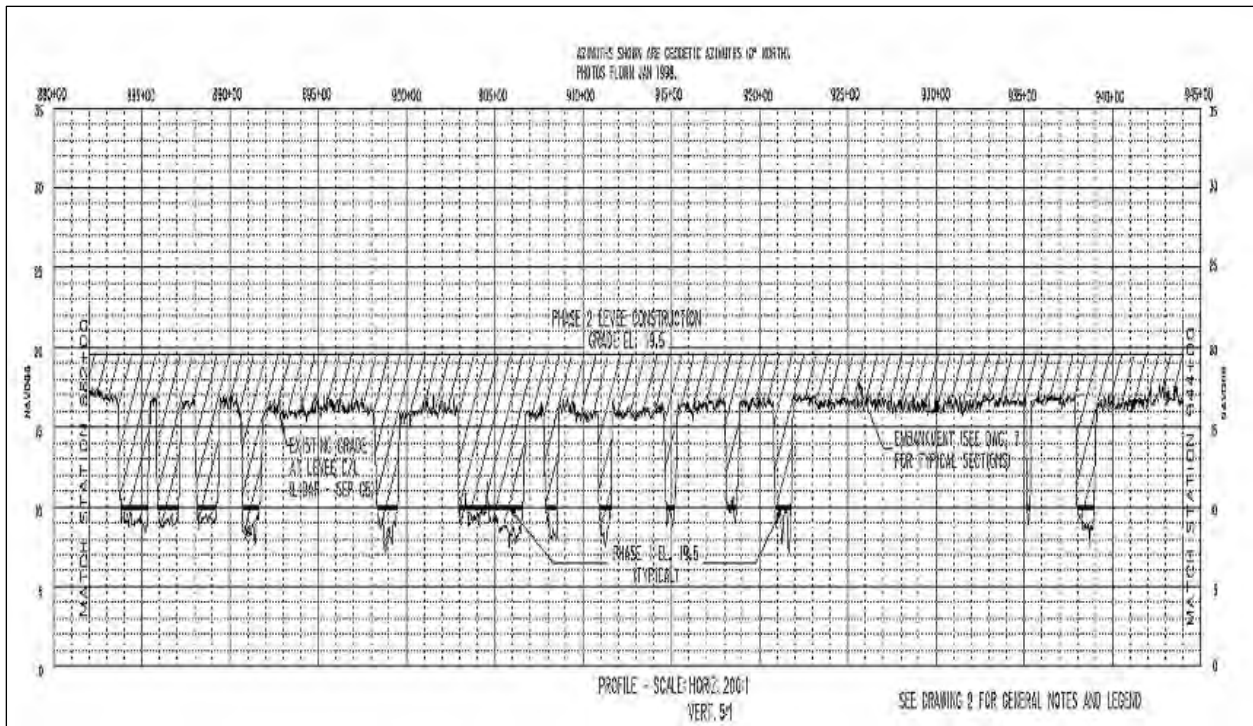
Figure 18-10. Post-Katrina profile along NOE Back Levee starting at Station 882 + 00 and ending at 944 + 00

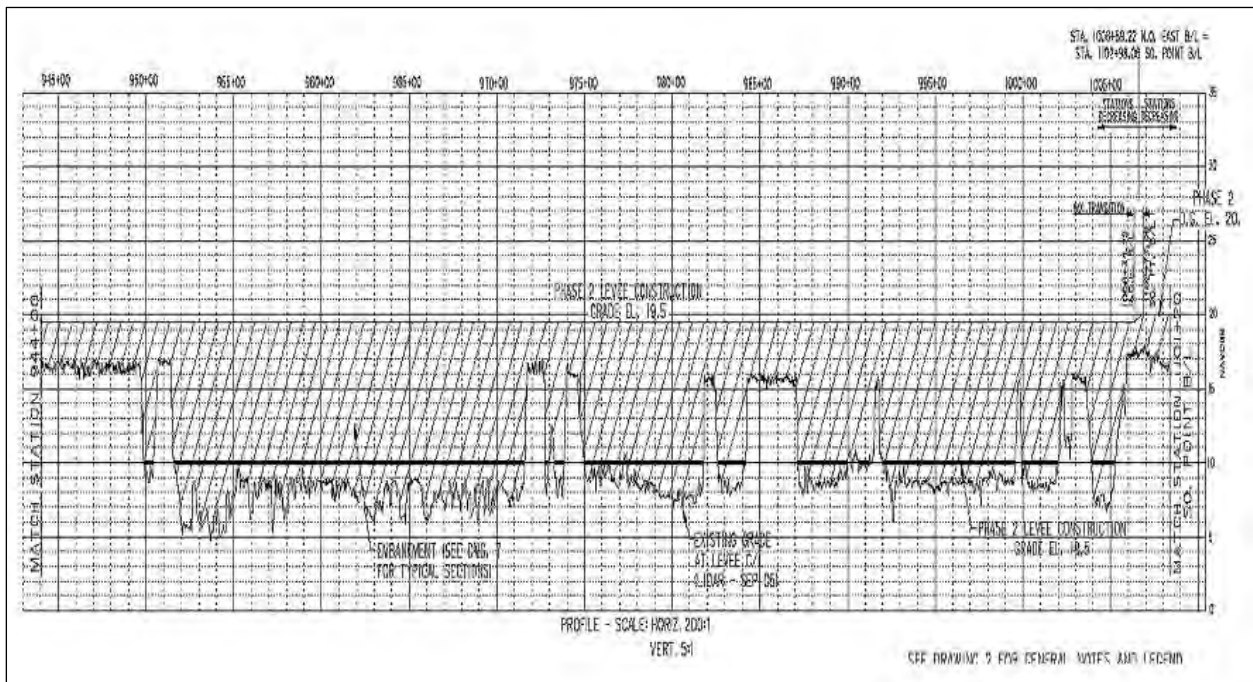
Figure 18-11. Post-Katrina profile along NOE Back Levee starting 944 + 00 and ending at station 1101 +20. Intersecting the South Point Levee

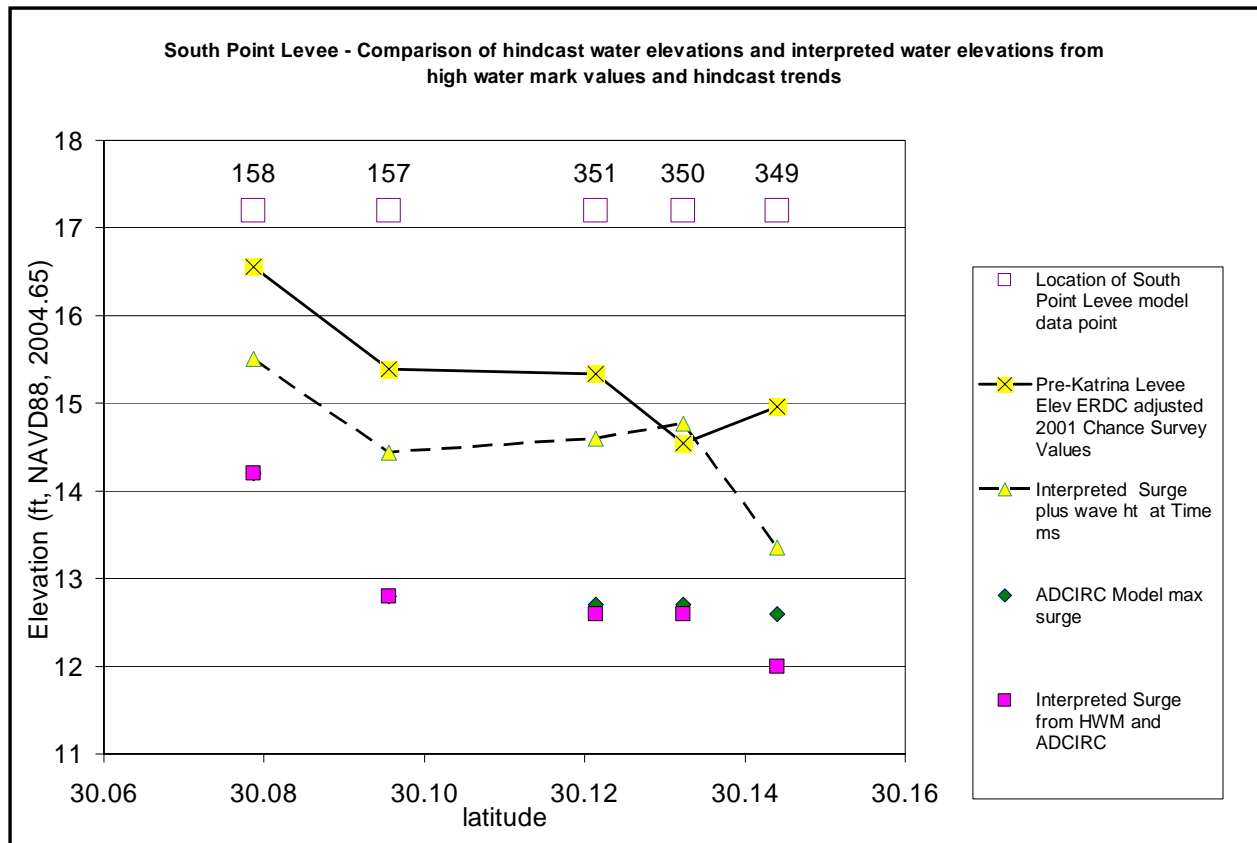
Figure 18-20. Data from Table 18-2 plotted with levee elevation derived from pre-Katrina LIDAR for Southpoint Levee

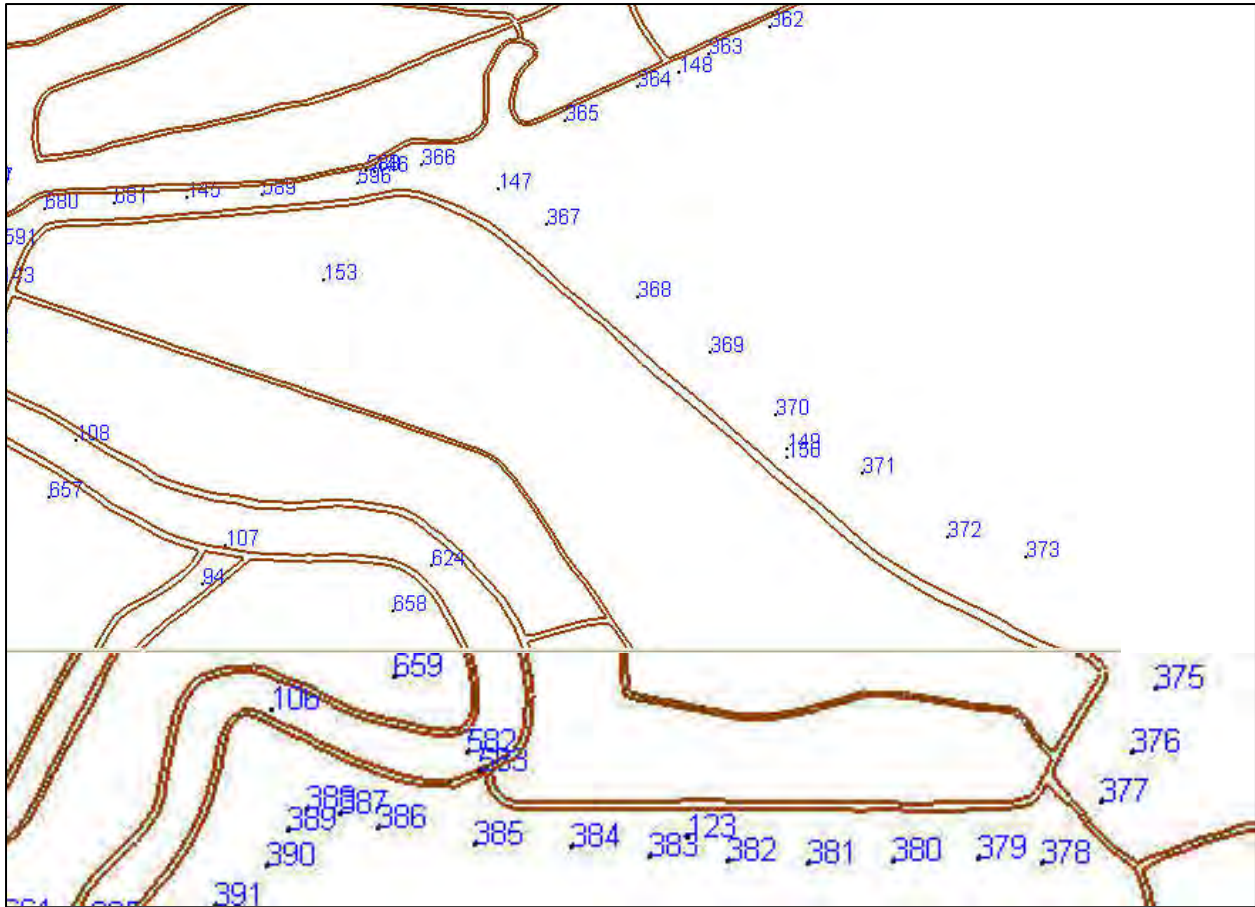
Figure 18-21. St. Bernard ADCIRC model points for hindcasting

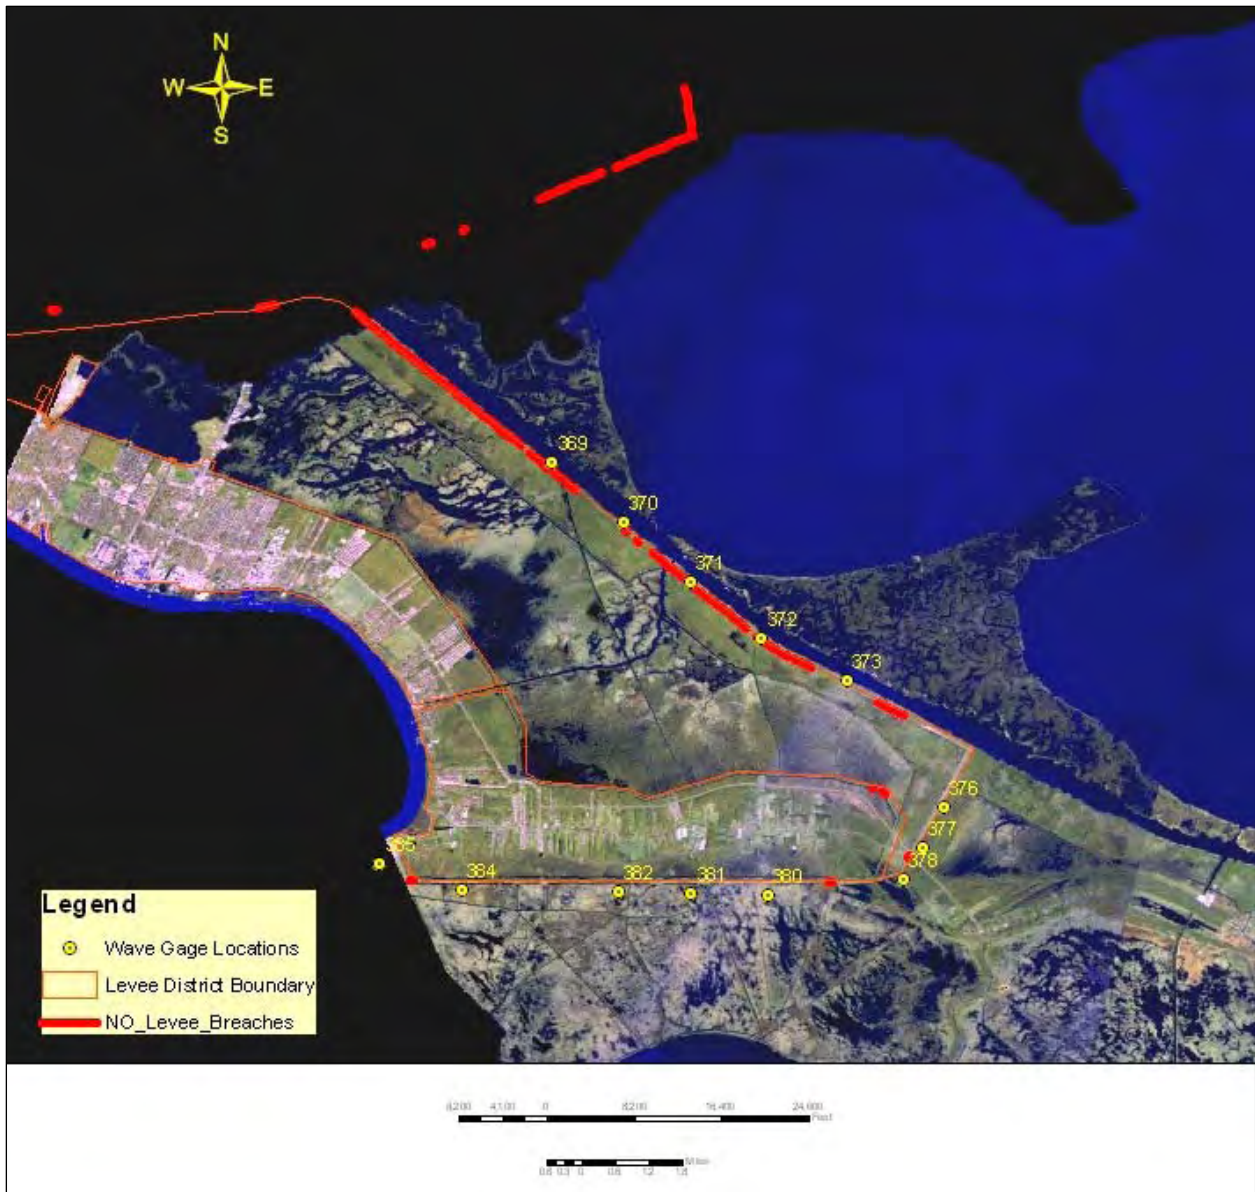
Figure 18-22. St. Bernard Parish, locations of breaches and ADCIRC model data points along MRGO and the Chalmette Extension Levees

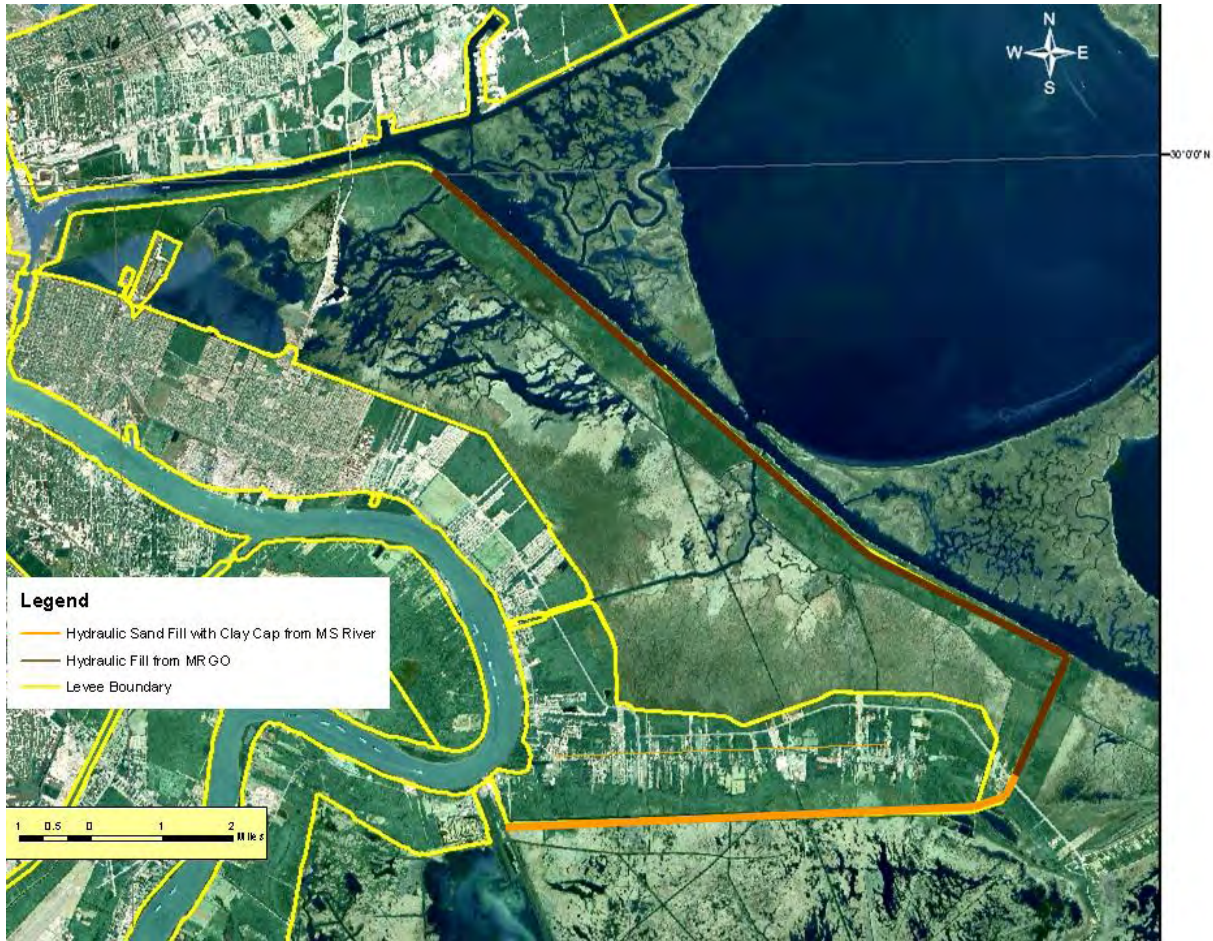
Figure 18-23. Locations of hauled fill correlate closely with locations of breaches in Figure 18-23

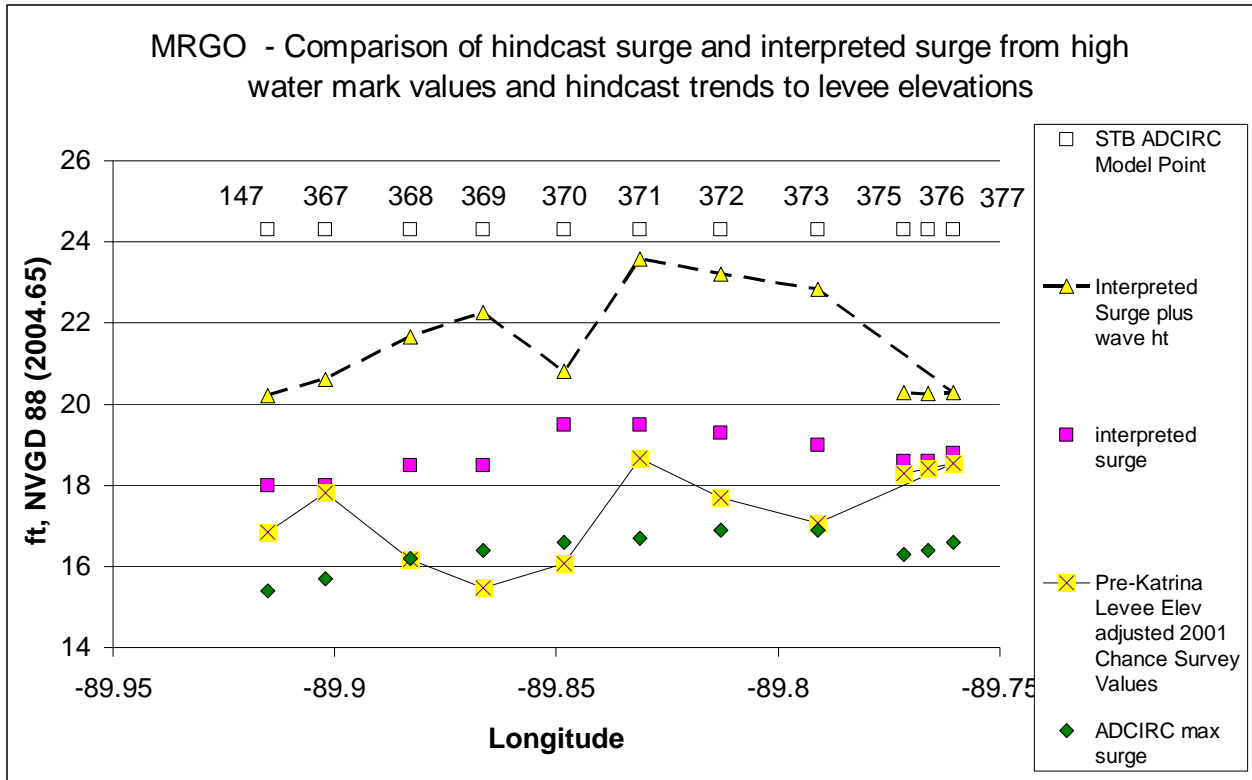
Figure 18-24. Estimated surges compared to levee heights along MRGO

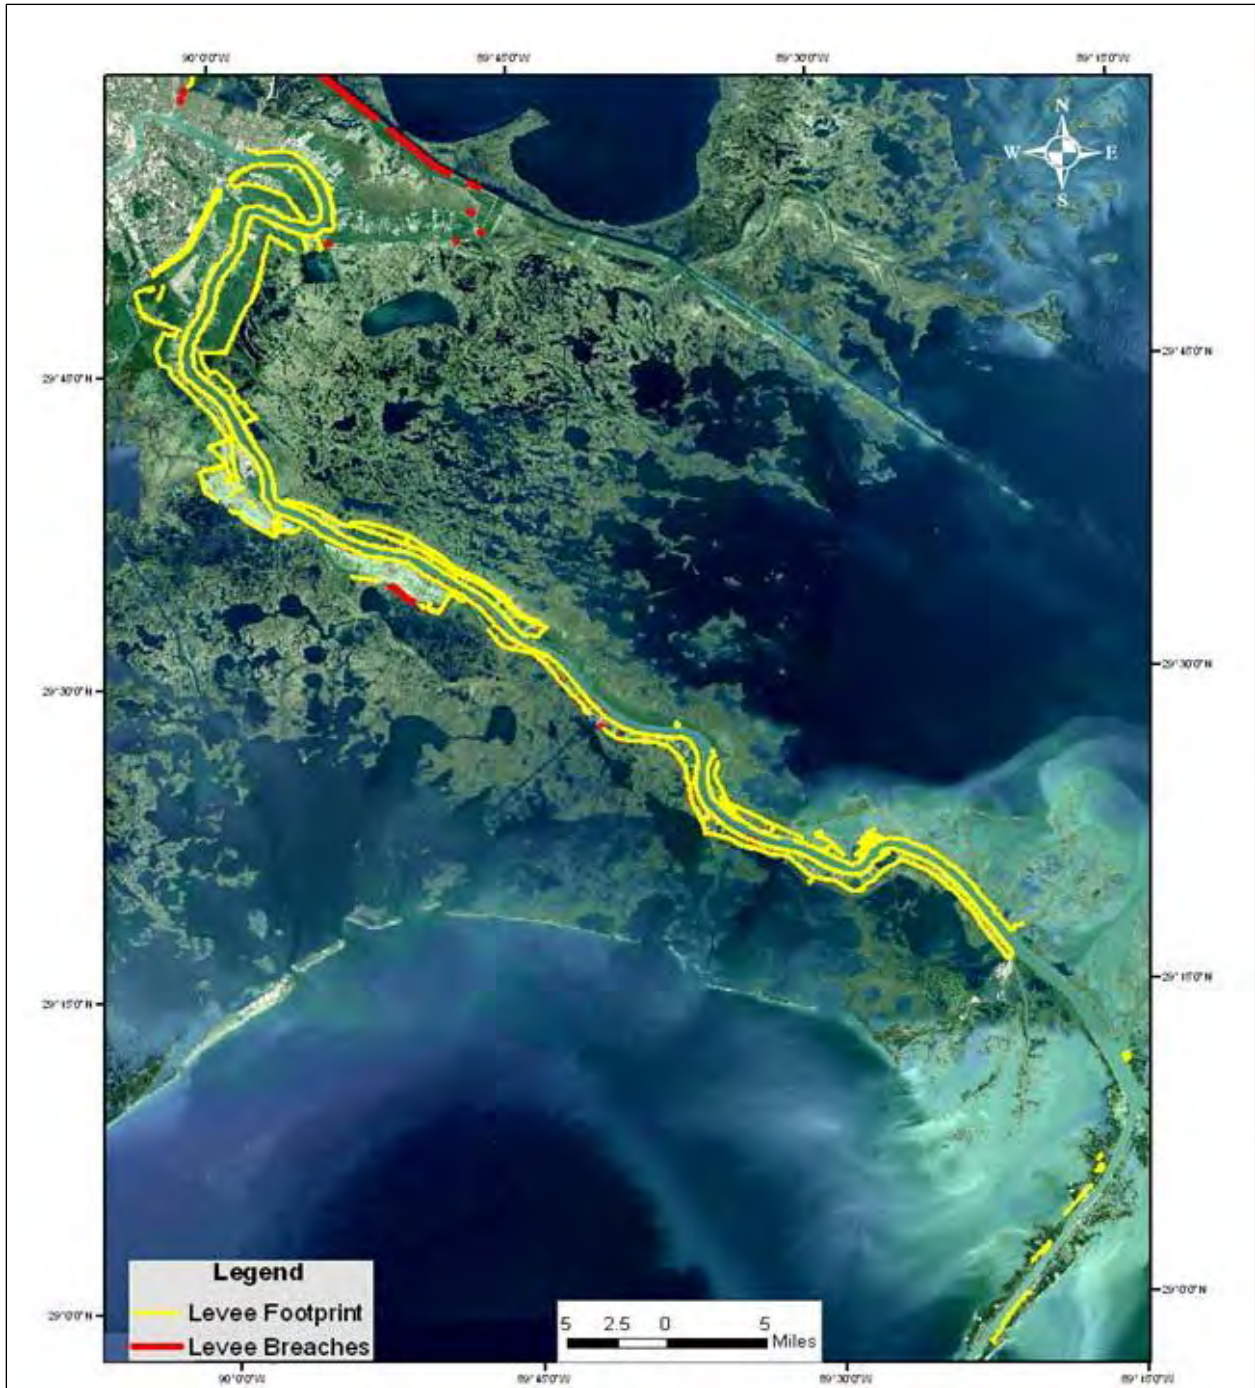
Figure 18-25. Breaches in Plaquemine Parish

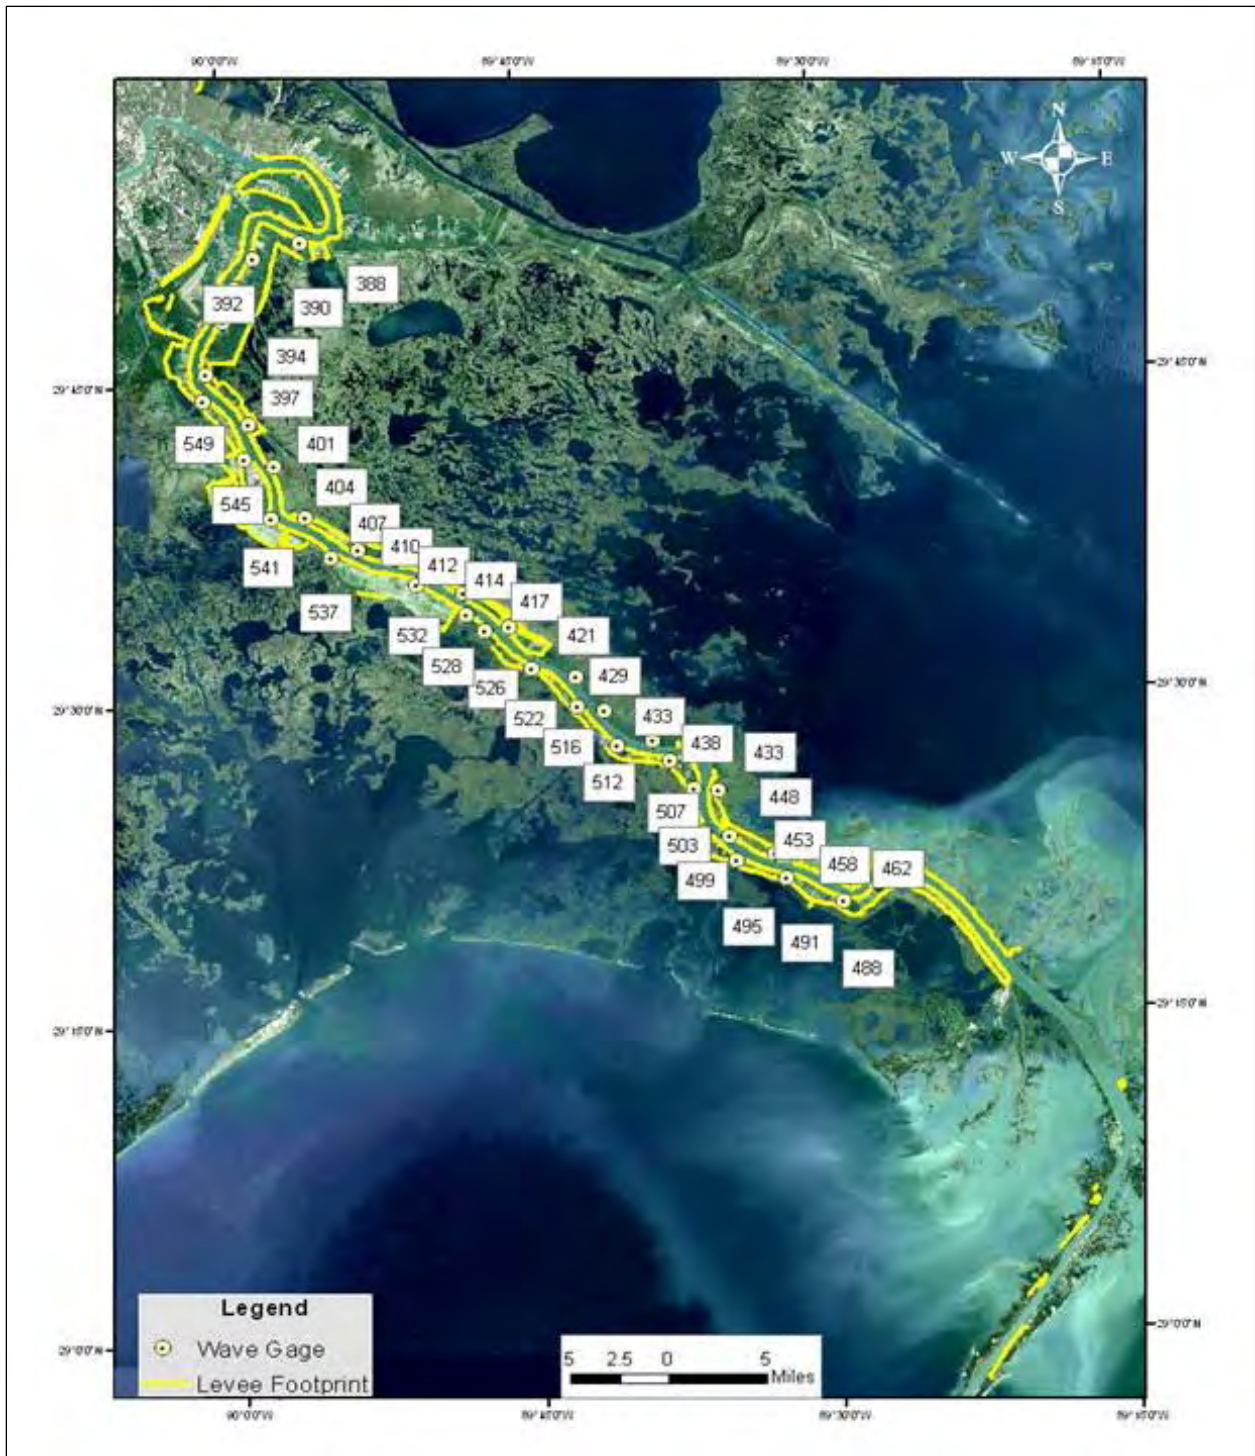
Figure 18-26. Selected ADCIRC model points for comparison of surge heights and levee heights
