Appendix 1

Soil Data Report for 17th Street Canal

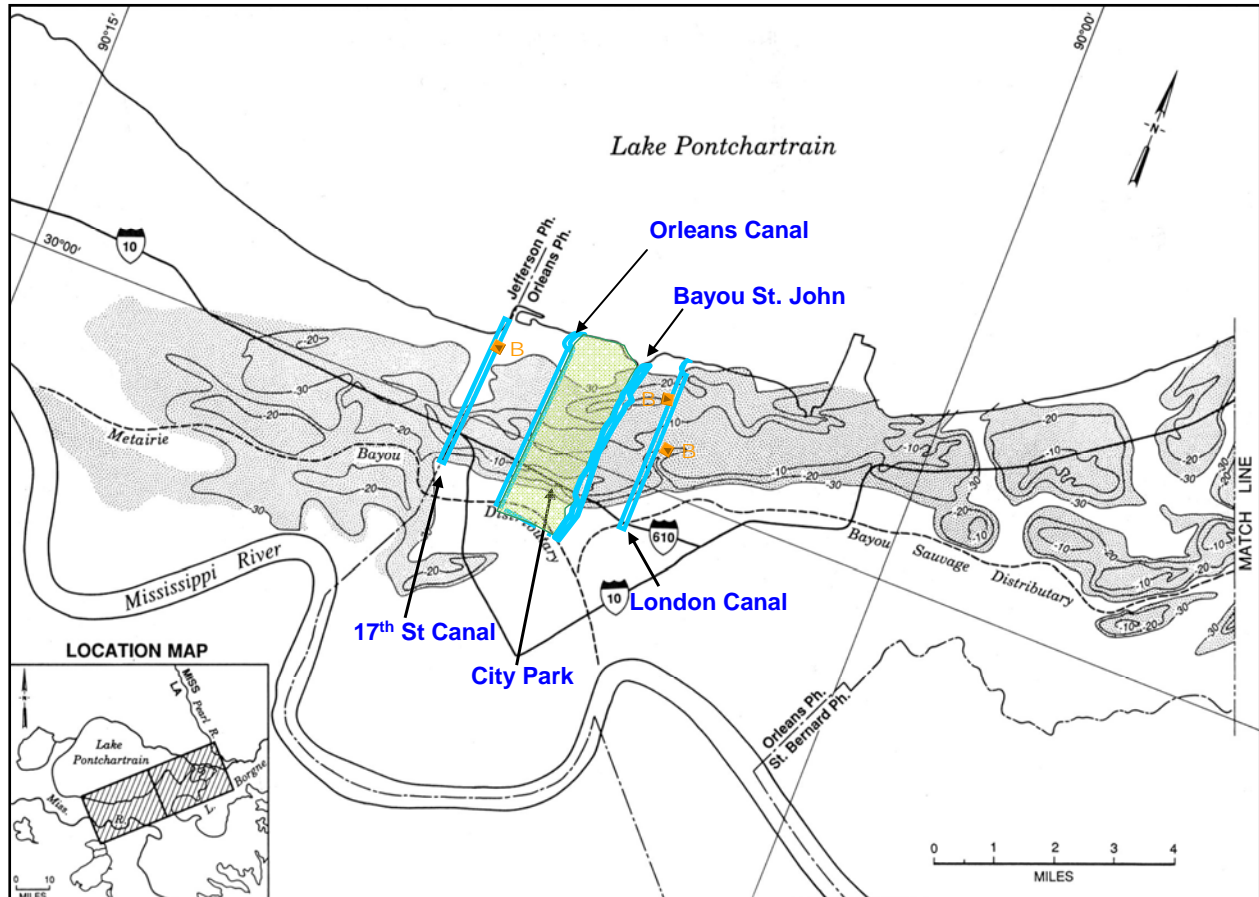
Figure 19-1. Location of breach sections analyzed plotted on a map of depth to beach sand deposit (showing why sands in foundation were important to London Canal breaches and probably not the 17th St. breach)

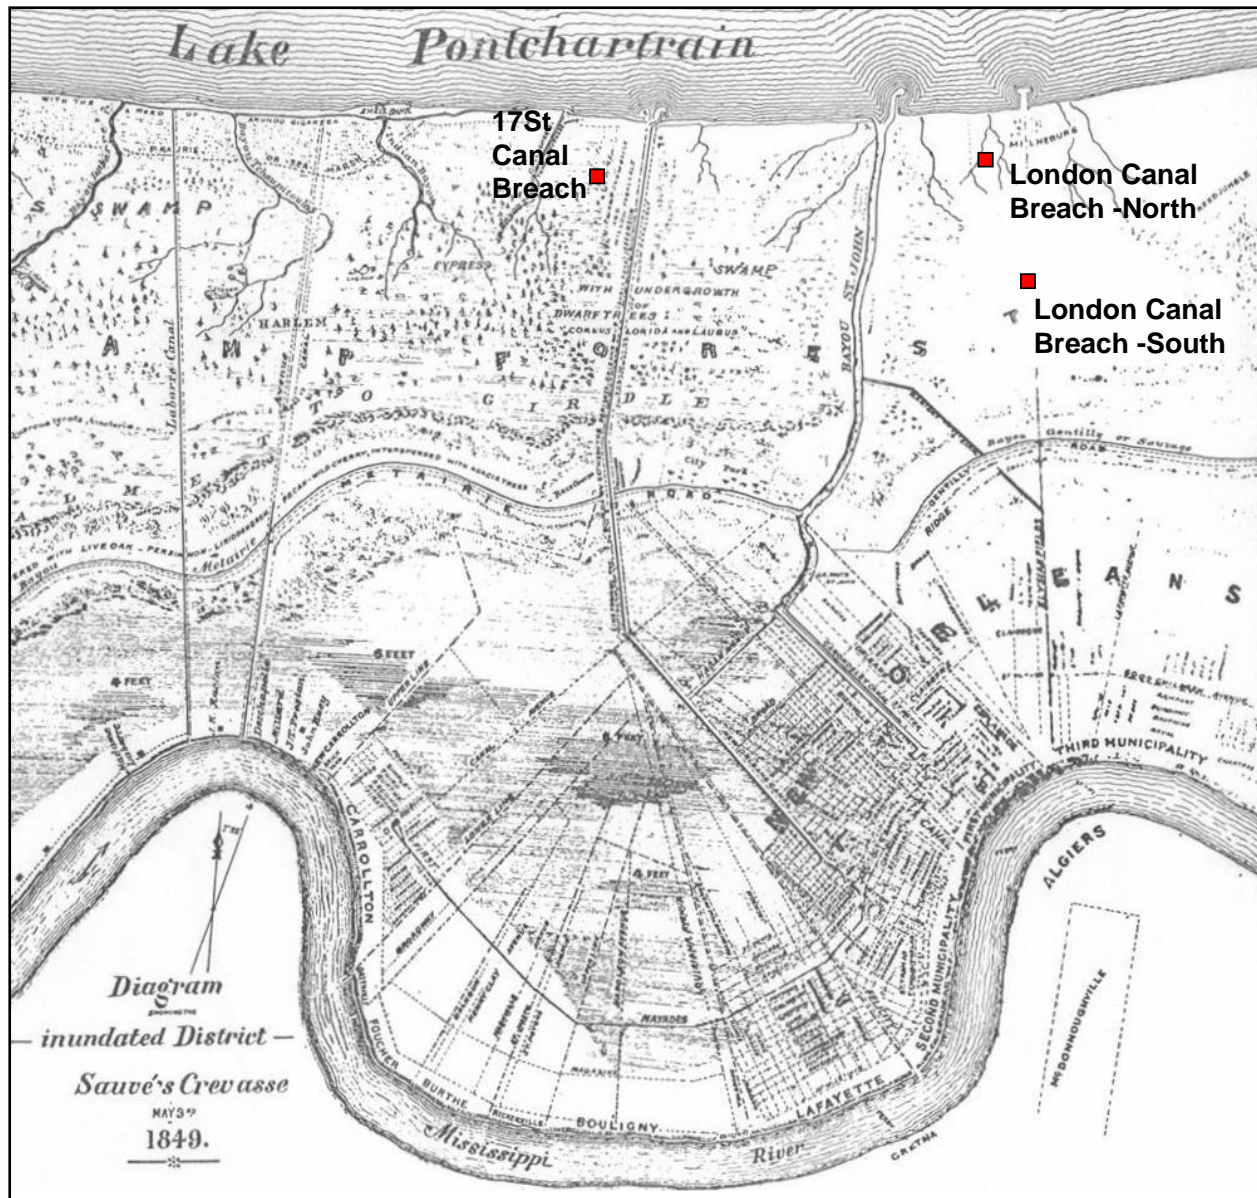
Figure 19-2. Near-surface geologic deposition environment and significant marsh-swamp peat and soft clay conditions

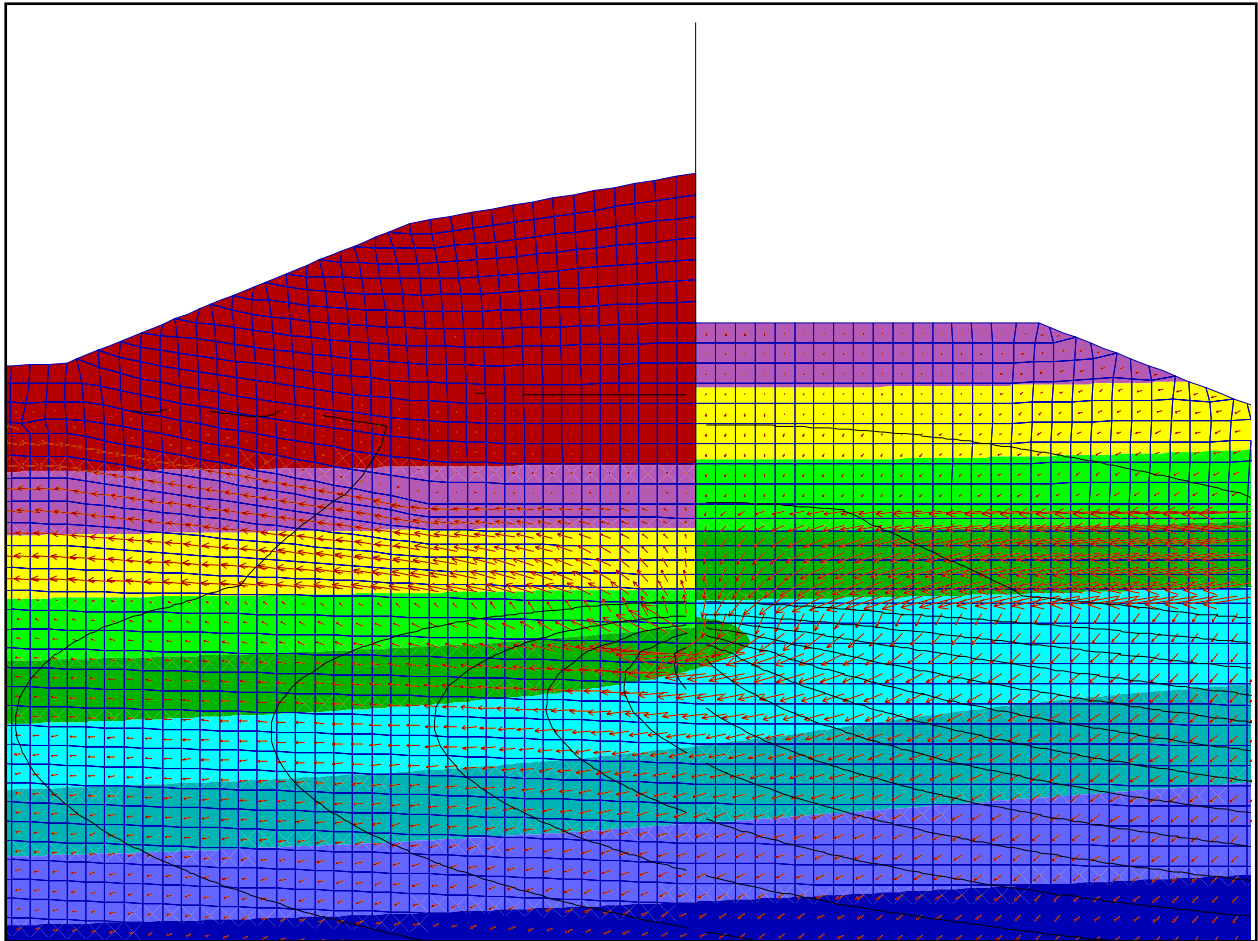
The steady state pore pressure distribution resulting from a canal water surface elevation of 1 ft was estimated using a seepage analysis. The boundary conditions were consistent with the Plaxis analysis and relative values of hydraulic conductivity were assumed. The seepage analysis produced a reasonable distribution of pore pressures across the grid as shown in Figure 19-4. The effect of the sheet pile wall on the pore pressures and flow vectors is clearly seen.

Figure 19-4. Estimated pore pressures, flow vectors, and contours of head at levee for 17th St. breach sta. 10+00

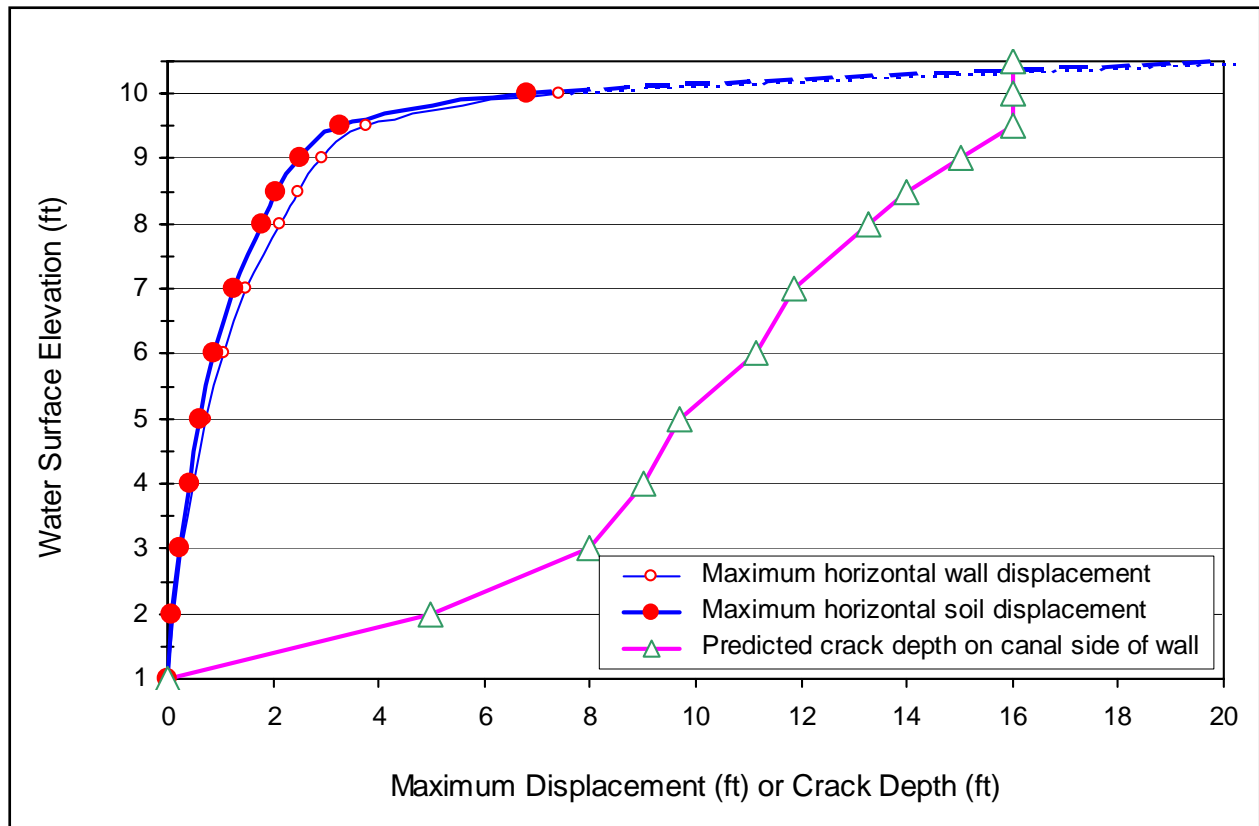
Using the assumptions for crack formation described above, the crack was estimated to initiate during the first flood increment which had a WSE of 2.0 feet. The initial crack or gap was 5 feet deep, which gradually increased to the full 16 foot depth when the WSE reached 9.5 feet. The initiation and growth of a crack is shown to greatly increase the displacements and leads to a response indicative of impending failure. Figure 19-7 shows the predicted maximum displacements of the wall and soil as well as crack depth versus WSE. In comparison, the Plaxis analysis used a different crack initiation criteria based on hydrostatic pressure exceeding total horizontal stress. This approach has the crack initiate at WSE of 6.5 ft and extend to the marsh-lacustrine clay interface which is 2 ft above the sheet pile tip. In this analysis, the crack started at a lower flood stage but developed slower, not reaching this depth until a WSE of 8.5 ft.

Figure 19-7. Predicted maximum horizontal displacement and crack depth versus WSE for 17th St. breach sta. 10+00

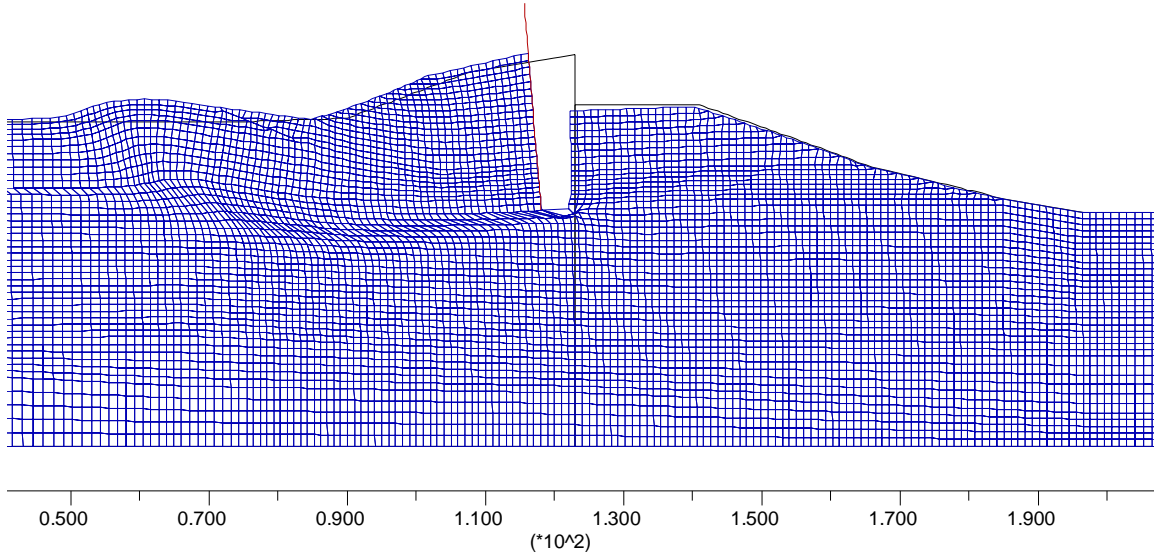
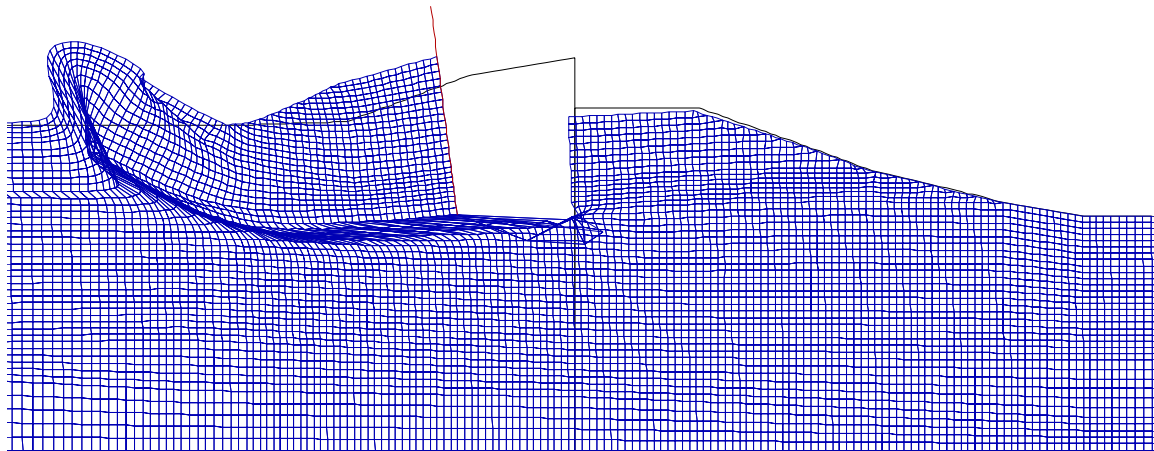
a. WSE = 10.0 feet (displacement shown at true scale, model at equilibrium)

b. WSE = 10.5 feet (displacement shown at true scale, model NOT at equilibrium)

Figure 19-8. Estimated deformed shape for 17th St. breach Sta. 10+00

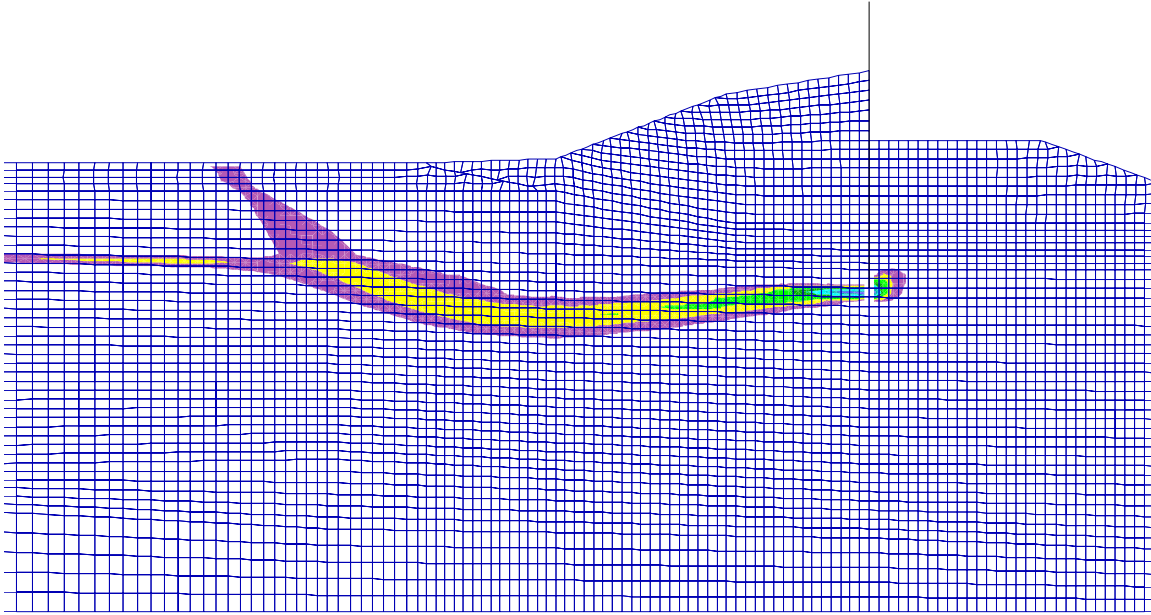
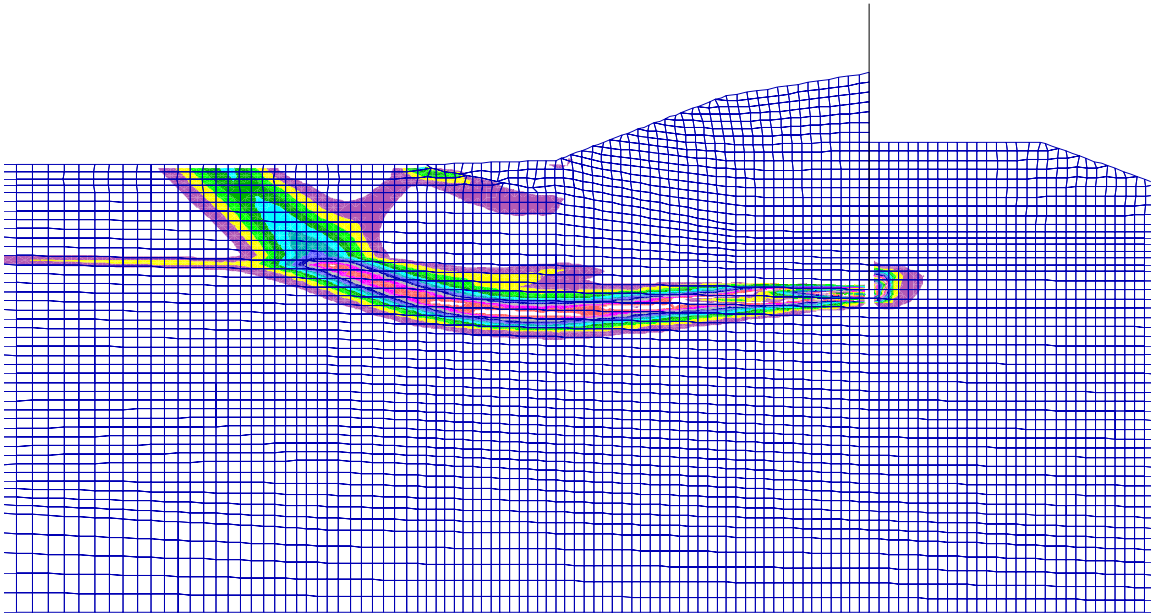
The predicted response following formation of a full depth crack to the tip of the sheet pile shows a failure surface beginning at base of sheet pile and extending horizontally near the top of the Lacustrine Clay layer until turning upward and exiting the surface roughly 60 ft from wall on protected side. This is illustrated in Figures 19-8 and 19-9 which show deformed shapes and contours of maximum shear strain. The model also predicts that at a WSE of 10 ft there is sufficient wall movement, approximately 7 ft, to assume the wall section is breached. Also, although the model was in equilibrium but certainly breached for 10 ft WSE, an additional 0.5 ft rise in the water level produced additional deformations, and the modeled section could not reach equilibrium. Furthermore, the predicted wall displacements at lower flood levels such as 8.5 ft are still considerable, greater than 2 ft, Figure 19-11, which may be sufficient to separate individual wall panels and initiate a breach before the unstable condition posed by the 10.5 WSE. Accommodating over 2 feet of displacement would require a broad smooth intact deformation of a section of wall panels. The field reconnaissance documented severe distress to the wall section directly across from the London north breach that was near failure and had a gap

of approximately 2 ft at the top of soil embankment. The predicted failure surface is clearly displayed in Figure 19-9 in contour plots of maximum shear strain.

Figure 19-9. Estimated contours of maximum shear strain Mohr-Coulomb model for 17th St. breach sta. 10+00

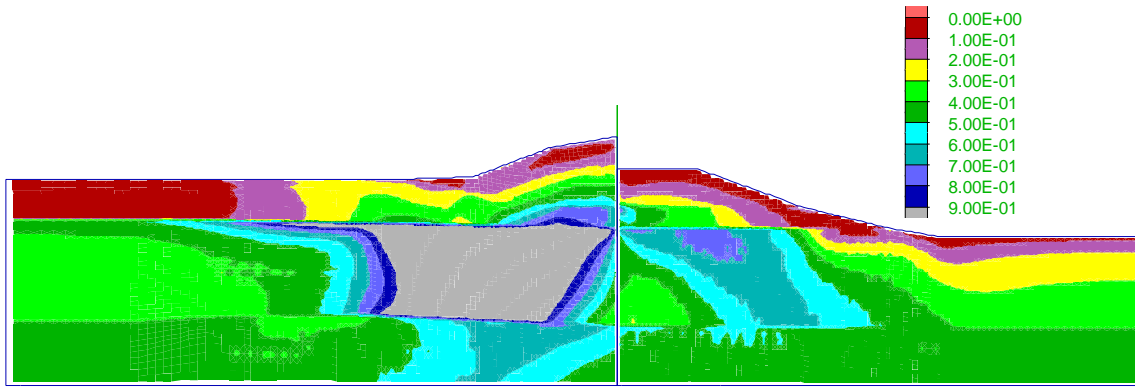
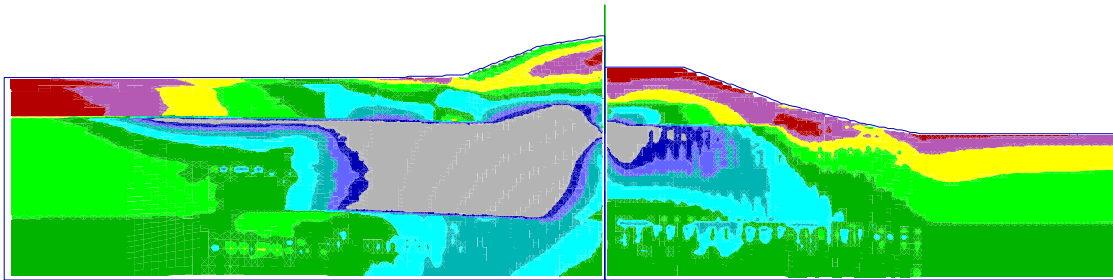
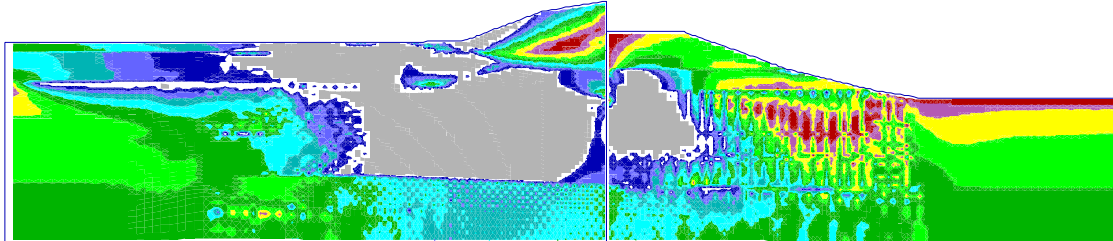
The development of the failure mode is further clarified in Figure 19-10, which shows estimated contours for the fraction of mobilized shear strength at three water levels: WSE = 4, 7, and 10.5 feet. Significant zones of the Lacustrine Clay are predicted to be highly stressed from the start of flood loading. Full instability of the section occurs as the marsh/peat and topsoil zones become highly stressed.

Figure 19-10. Estimated fraction of mobilized shear strength for 17th St breach sta. 10+00

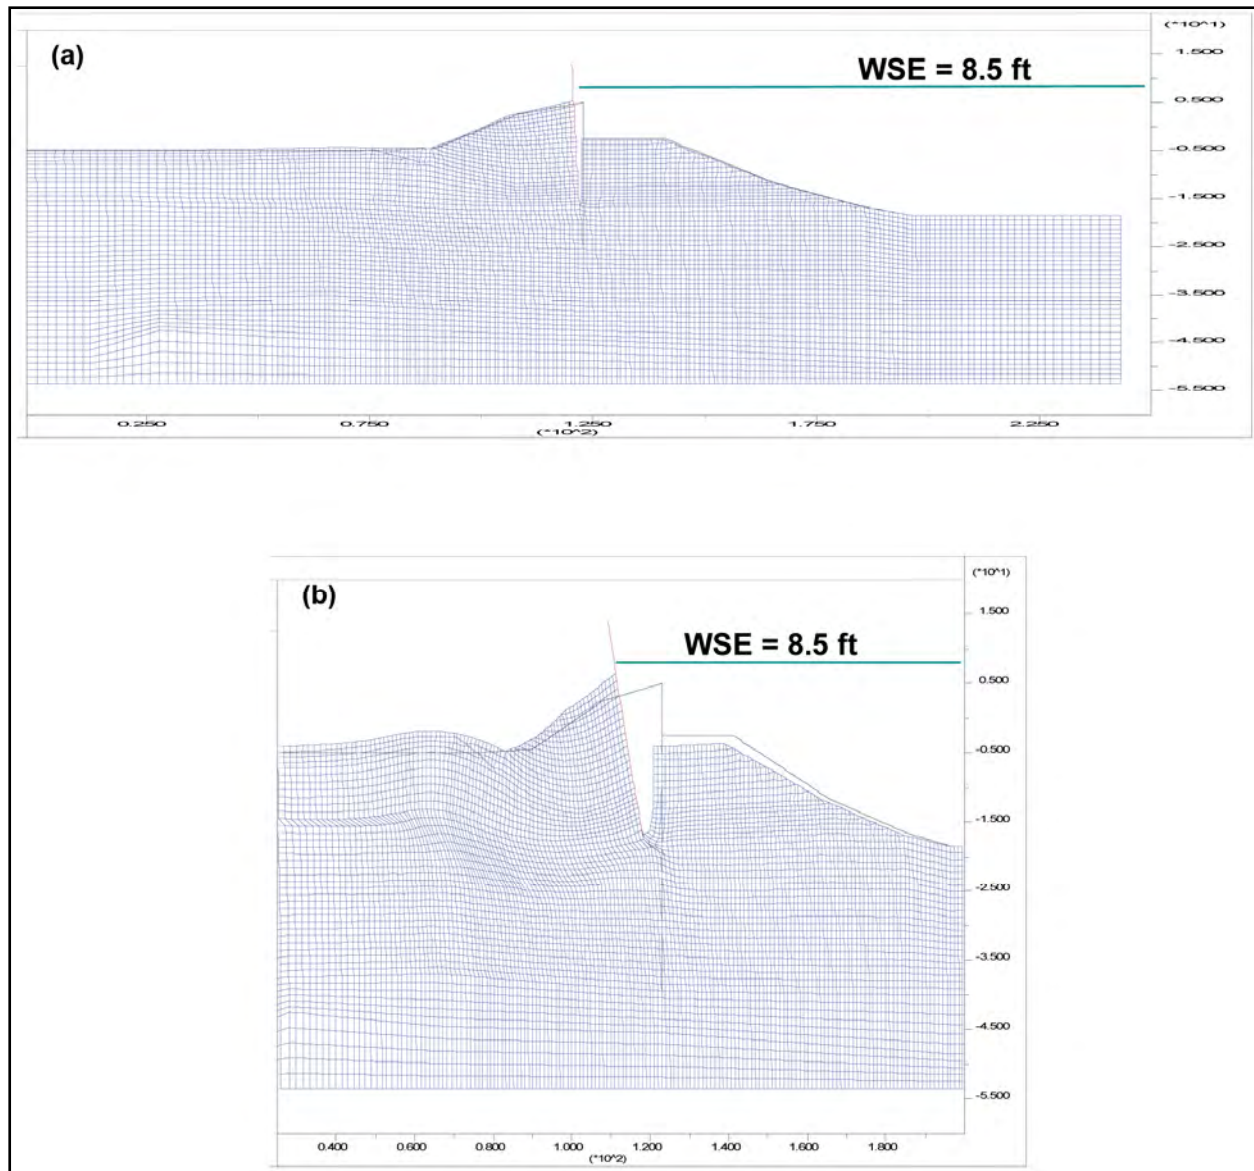
Figure 19-11. Estimated deformed shape for WSE=8.5 for entire model (a) and near levee crest with 5x exaggeration (b) for 17th St. breach sta. 10+00

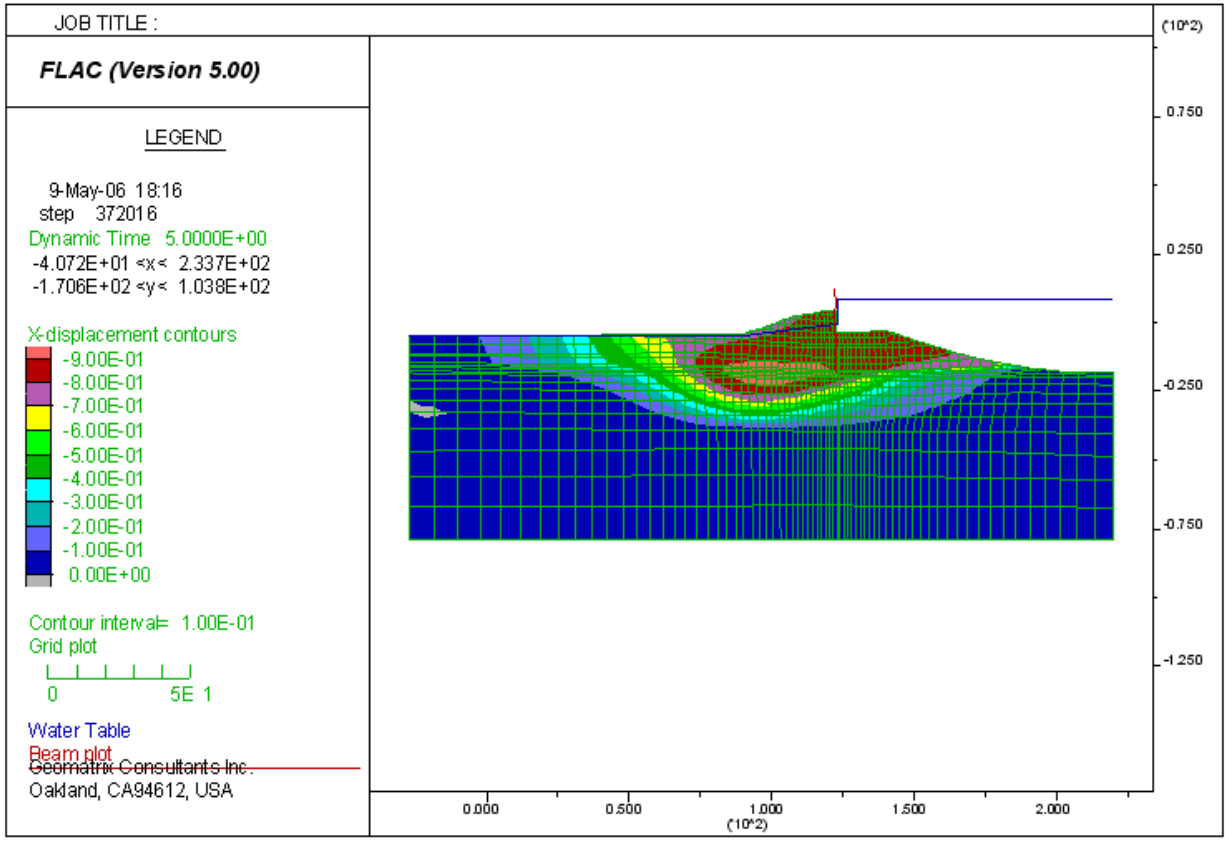
Computed displacements of the floodwall due to water levels associated with the high Katrina flood levels, but ignoring the effects of crack or gap formation between the floodwall and the levee berm (at the canal side) were less than 1 foot, but the levee slopes were stable with no indication of impending failure (Figure 19-17).

Figure 19-17. Contours of horizontal displacement, Katrina flood water level at El. +8.5 feet, non-linear model 17th St. breach sta. 10+00

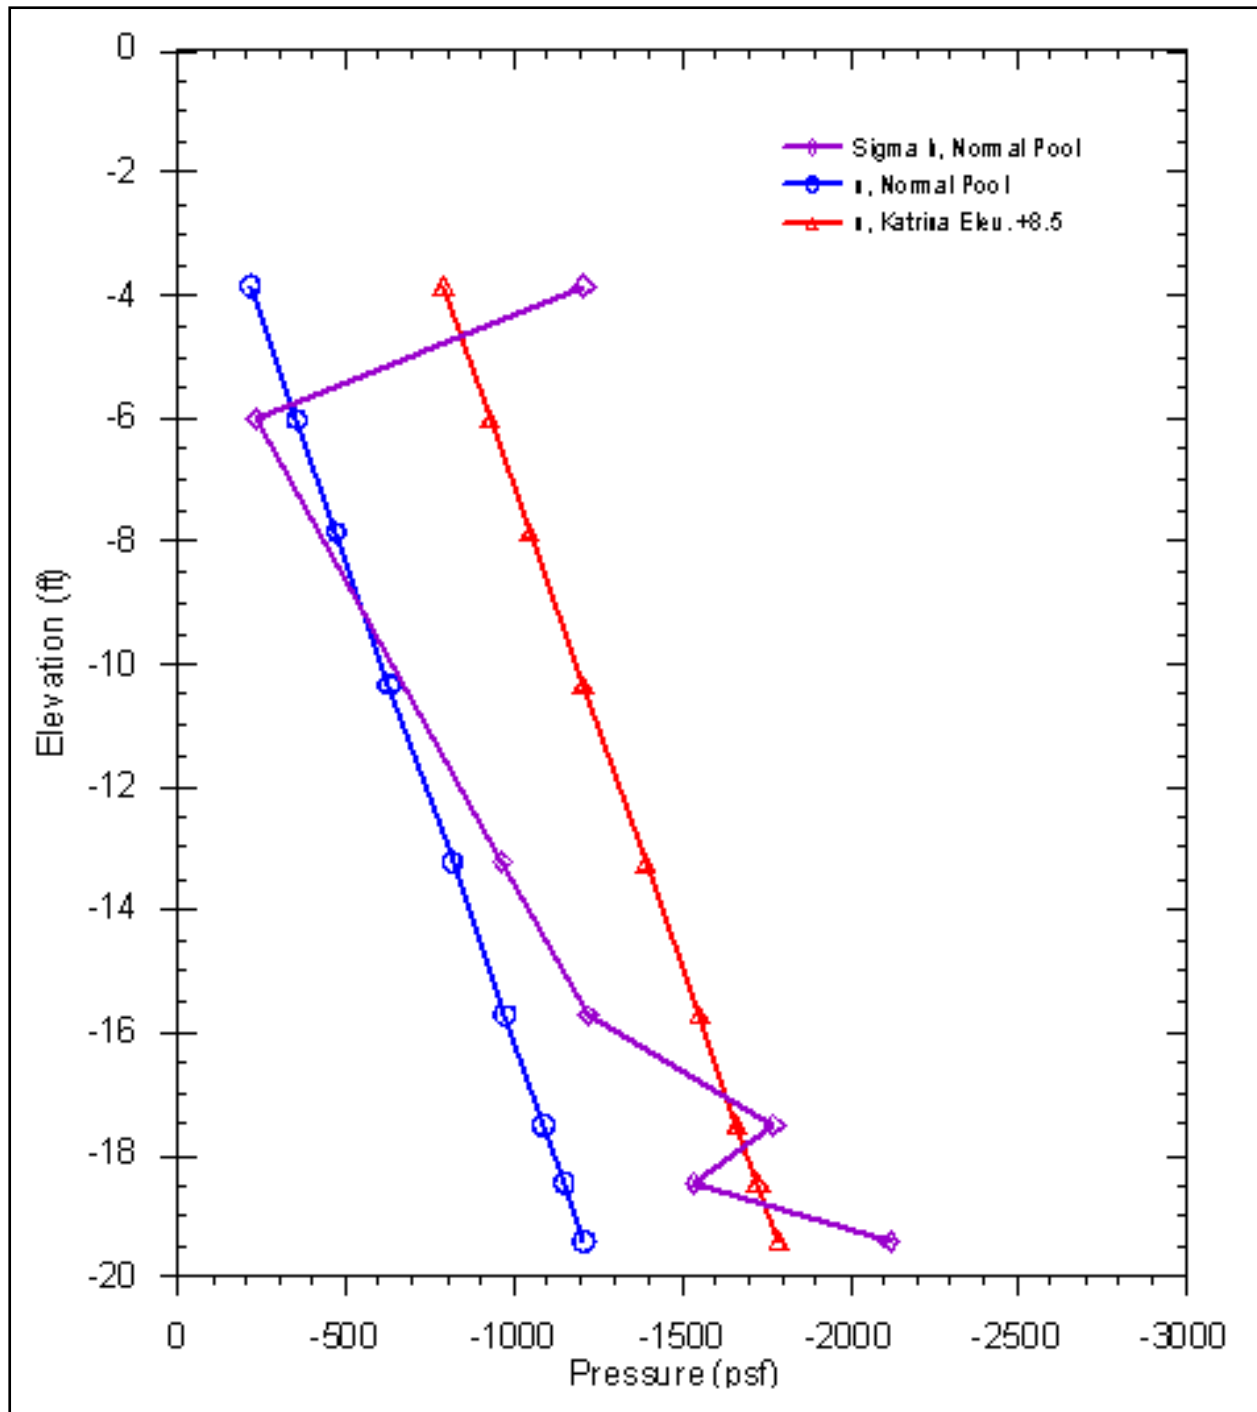
Pore water pressures associated with Katrina high flood water level exceeded the total horizontal normal stresses computed from normal pool water level in the clay layers down to about elevation 19 feet, indicating the potential for crack formation between the levee soil and the sheet pile wall (Figure 19-18).

Figure 19-18. Comparison of water pressure and horizontal total stress 17th St. breach sta. 10+00

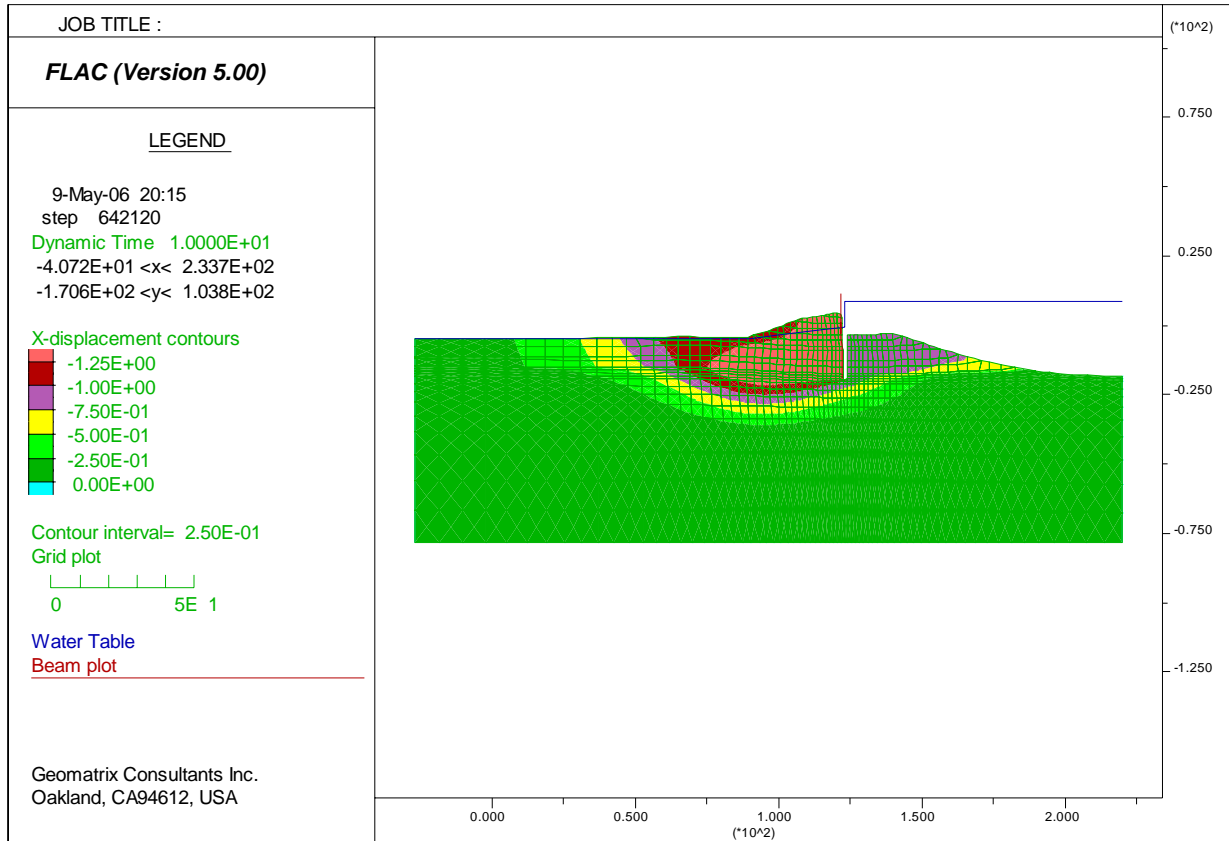
The possible crack formation was simulated in the analyses. The computed deformations of the pile wall and the levee slopes when simulating the effect of cracking resulted in horizontal deformation of about 1.2 ft (Figure 19-19).

Figure 19-19. Contours of horizontal displacement with crack simulation, Katrina flood water level at El. +8.5 feet, non-linear model 17th St. breach sta. 10+00

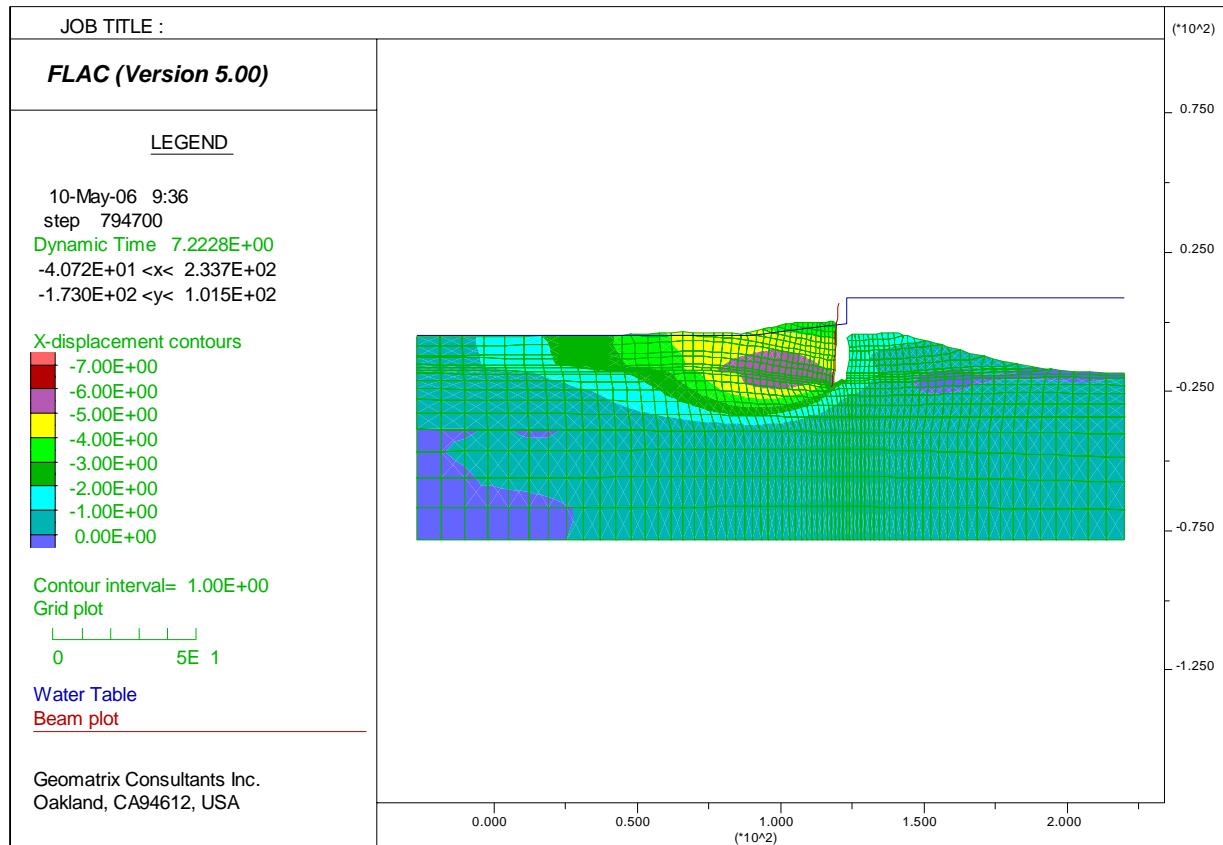
When incorporating a horizontal interface at the top of the soft lacustrine clay layer (at the elevation of pile tip), the computed deformation for the Katrina flood water level at El. 8.5 ft was about 5 to 6 ft, indicating the potential for failure (Figure 19-20).

Figure 19-20. Deformed grid (with crack simulation and interface) Katrina flood water level at El. +8.5 feet, non-linear model for 17th St. breach sta. 10+00

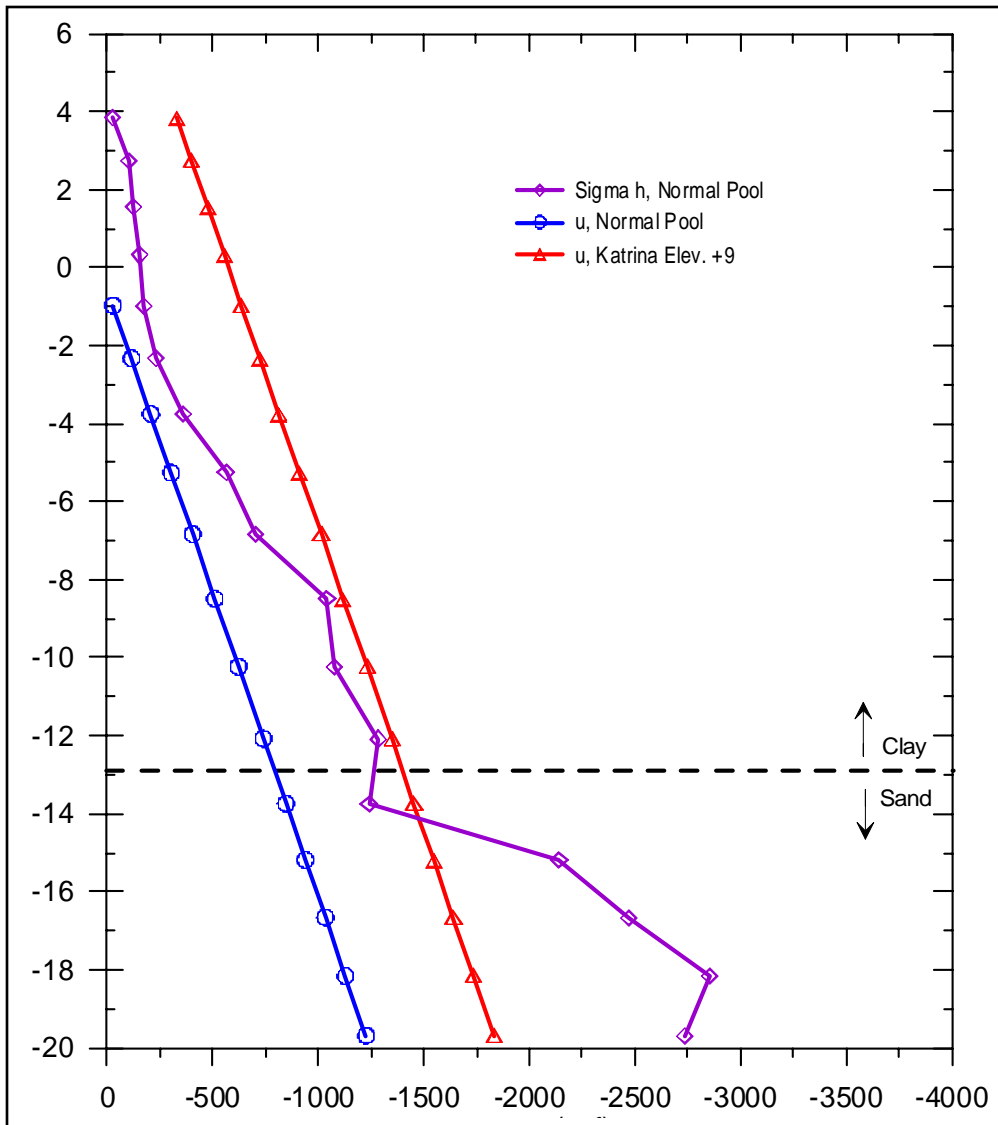
Pore water pressures associated with Katrina high flood water level exceeded the total horizontal normal stresses computed from normal pool water level in the clay layers down to about elevation 13 feet as shown in Figure 19-26, indicating the potential for crack formation between the levee soil and the sheet pile wall.

Figure 19-26. Comparison between water pressure and horizontal total stress for London north breach sta. 14+00

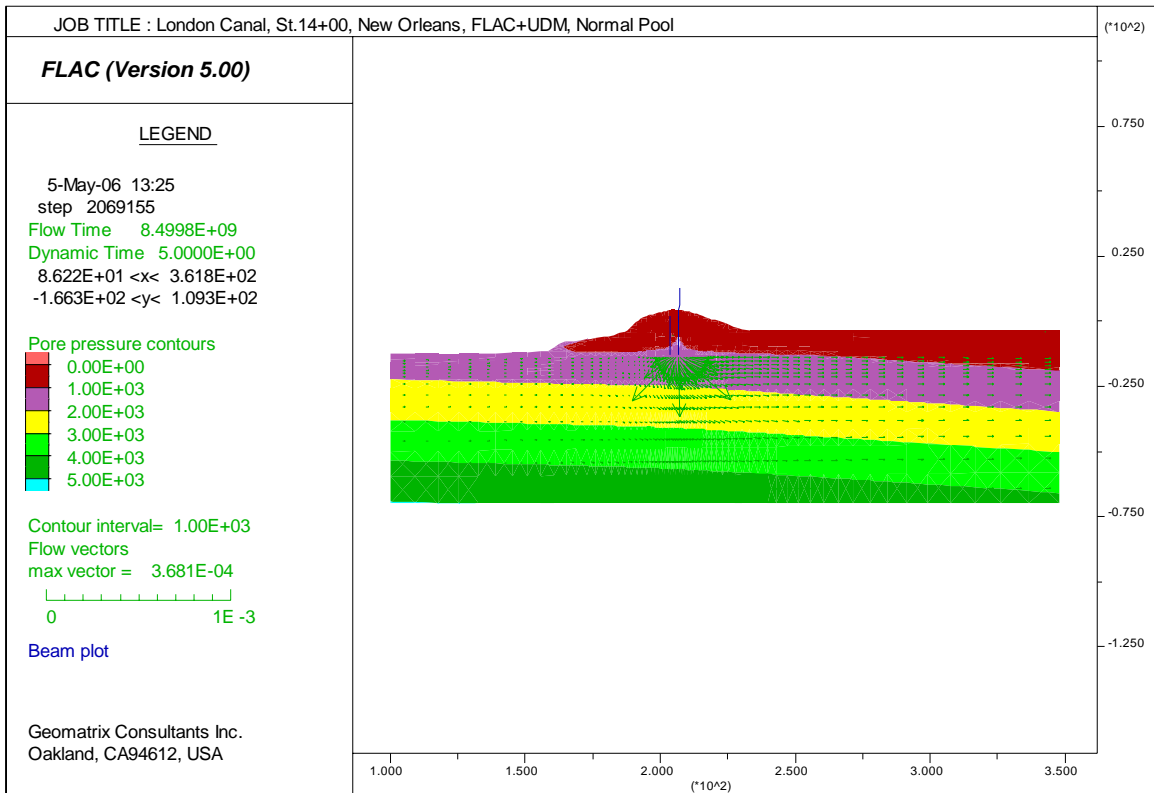
The possible crack formation was simulated in the analysis, and water flow into the underlying sand layer indicated significant increases in the pore pressures, and a corresponding reduction in effective stresses and shear strength. The water flow vector in the sand layers is presented in Figure 19-27. The detailed flow vectors and the simulated crack are presented in Figure 19-28.

Figure 19-27. Water flow vectors through the crack (behind the wall) into sand layer for London north breach sta. 14+00

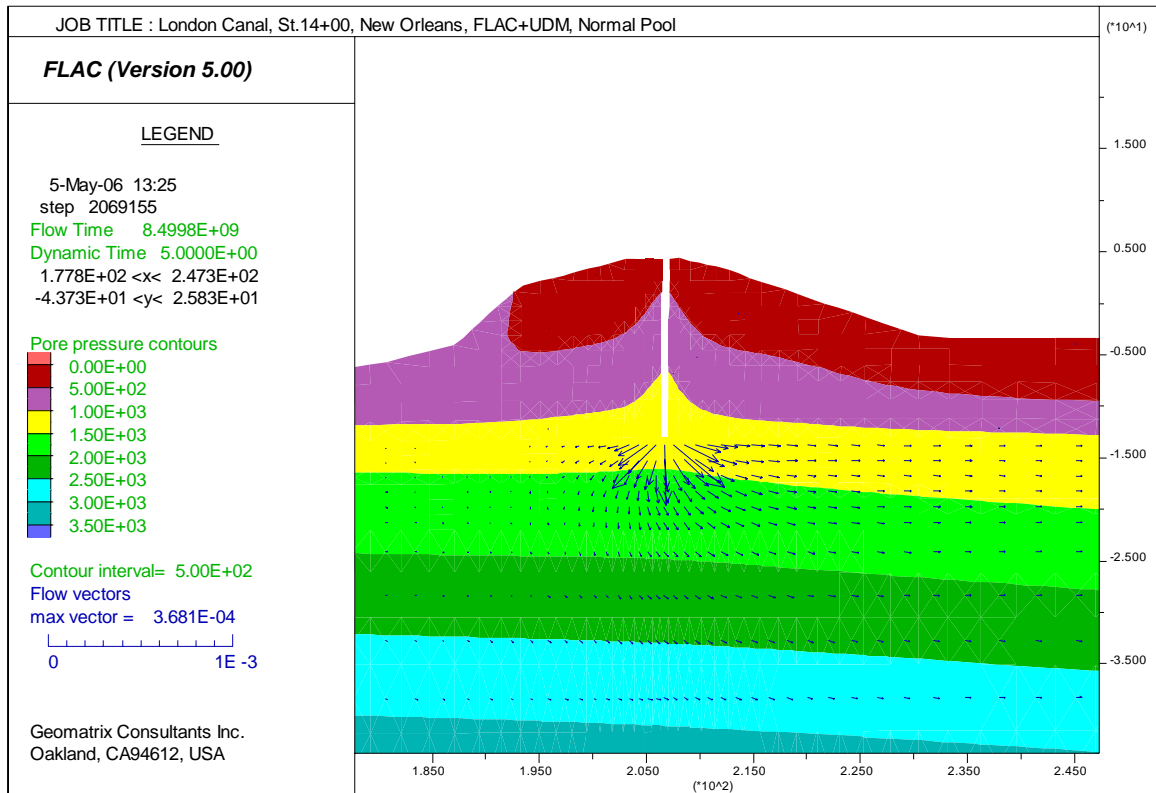
Figure 19-28. Detailed flow vectors from near tip of pile and into top sand layer for London north breach sta. 14+00

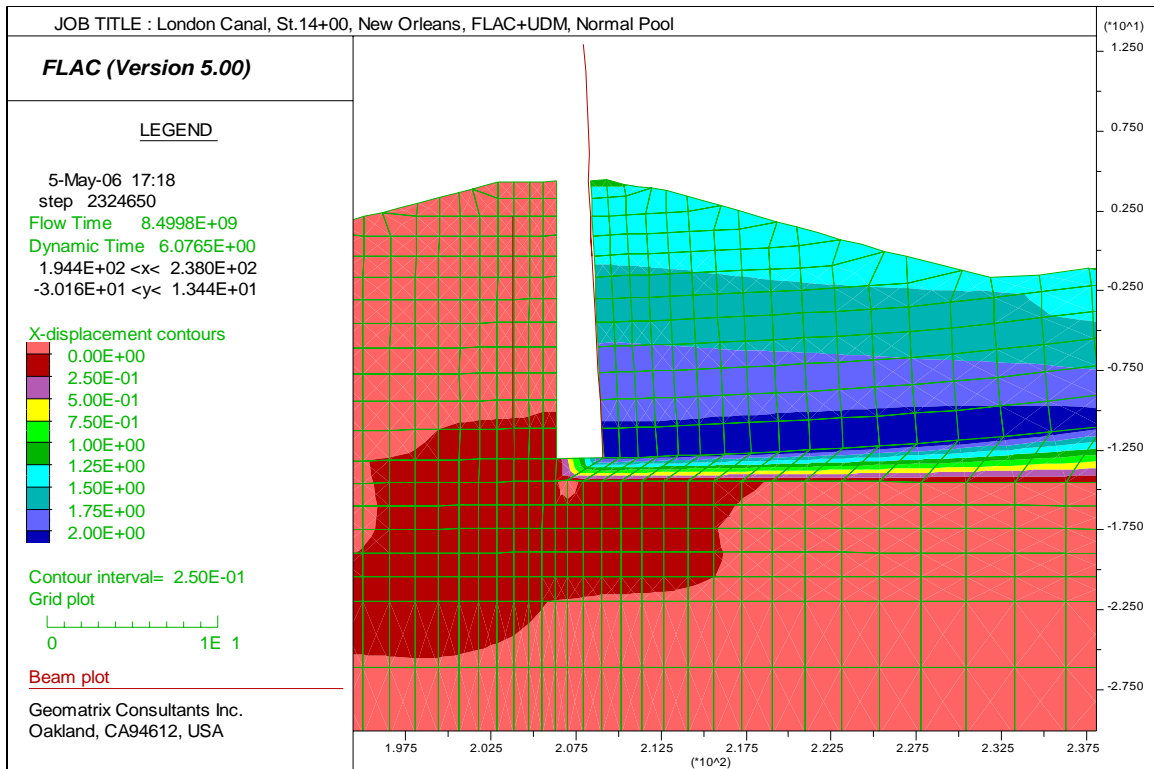
The computed deformations of the pile wall and the levee slopes when simulating the effects of cracking and seepage flow into the underlying sand layer resulted in horizontal deformations exceeding 4 feet as shown in Figures 19-29 and 19-30. The computations were terminated at about 4 feet due to numerical problems with distorted elements, prior to reaching a stable configuration, indicating the potential for continued large movements.

Figure 19-29. Wall moved two feet (computation terminated due to bad geometry at bottom of crack) for London north breach sta. 14+00

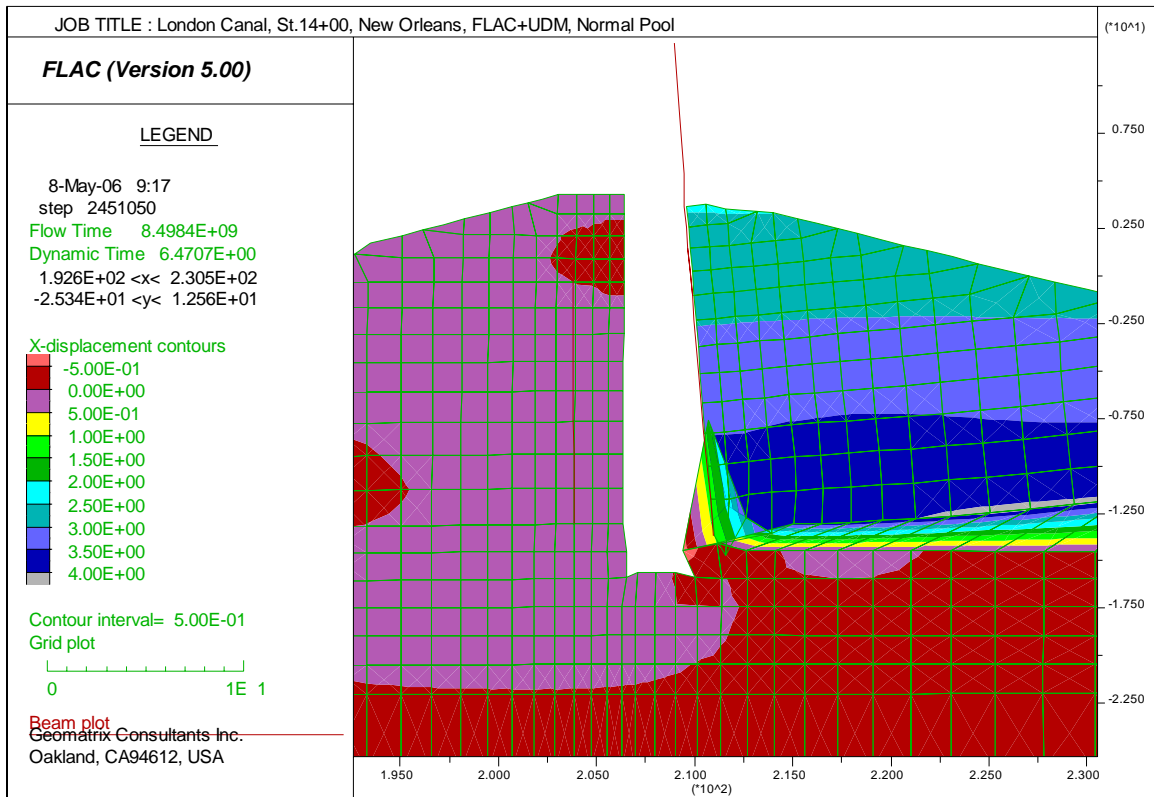
Figure 19-30. Wall moved four feet, unstable due to bad geometry at bottom of crack, (bad zones were removed to allow computation to continue) for London north breach sta. 14+00

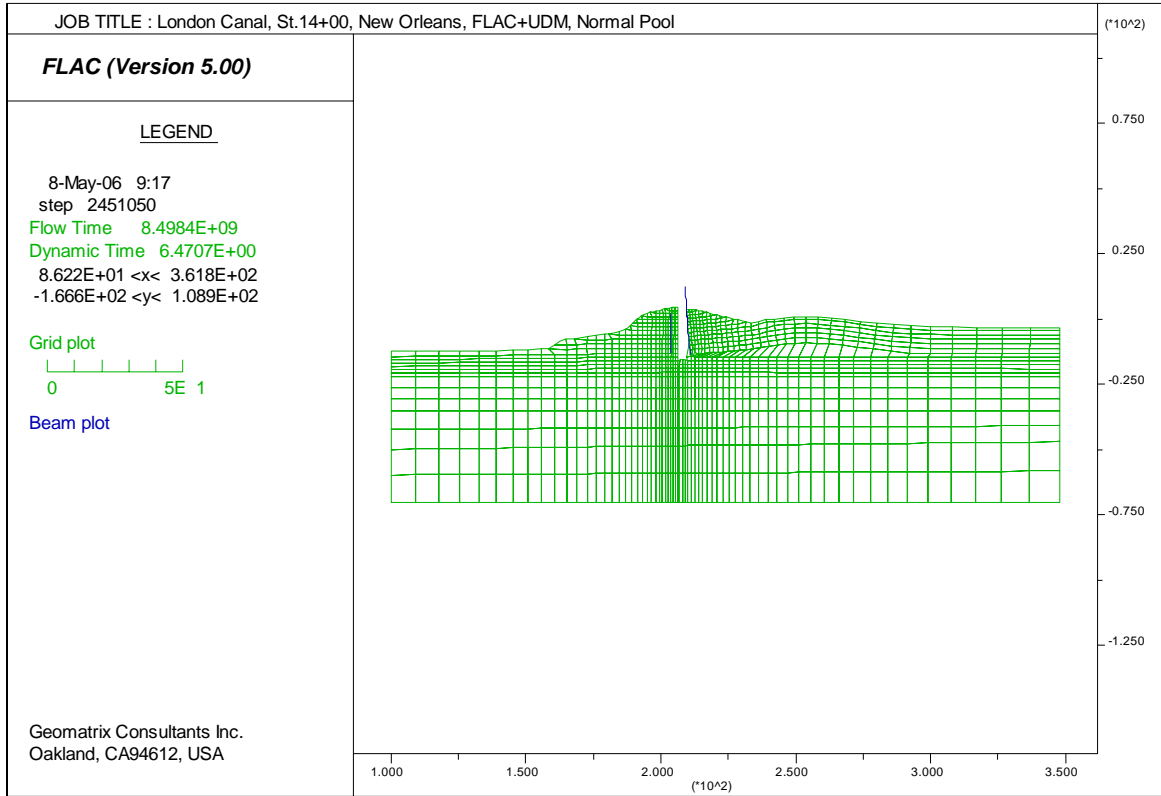
The deformed shape of levee profile indicates that there was about 4 feet of upwards movement (bulging) in the top soil at the protected site, beyond the toe of the levee as shown in Figure 19-31. This is believed to be induced by the pore water pressure due to water flow into the top sand layer through the crack behind the wall. This bulging could indicate rupture of the overlying clay layer that would result in piping and possible failure.

Figure 19-31. Deformed shape at wall movement of four feet showing bulging beyond the toe (computation terminated due bad geometry) for London north breach sta. 14+00.
