Appendix 1

Soil Data Report for 17th Street Canal

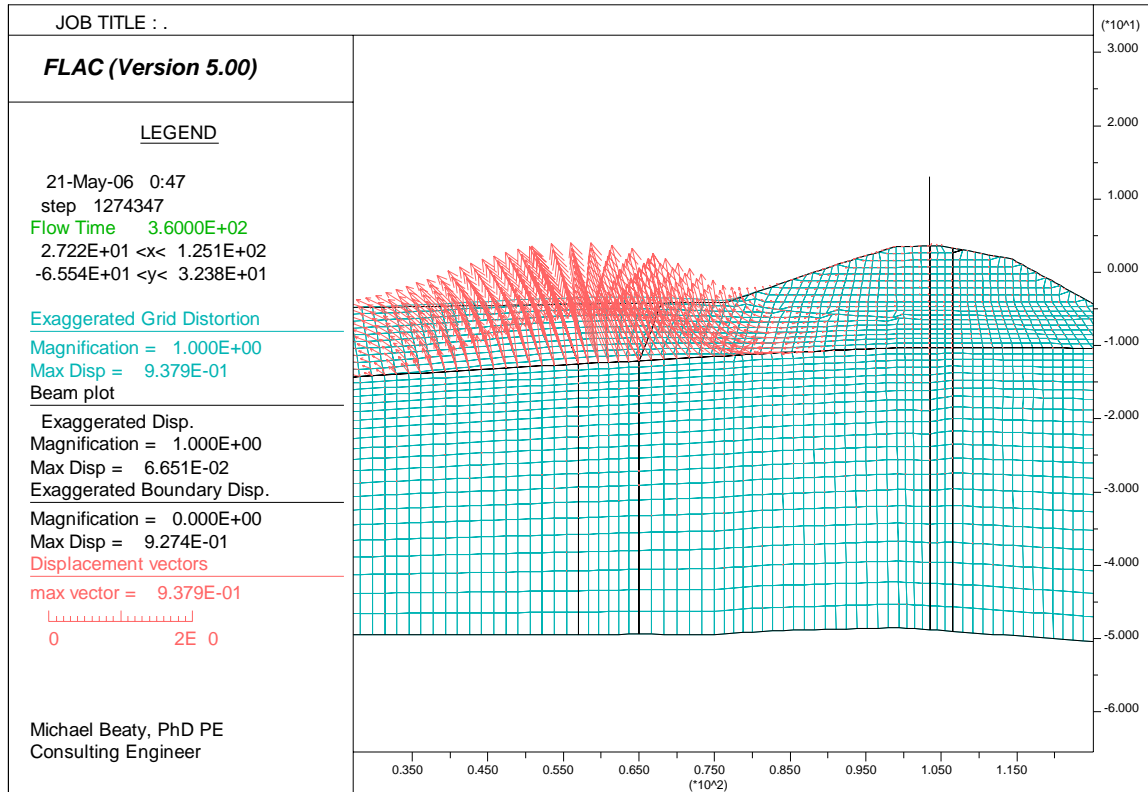
In the analyses completed to date, instability of the section appears to begin as the pore pressures along the top of the sand exceed the buoyant weight of the overlying material. This occurrence tends to begin somewhat below the toe of the levee. Unless the seepage is restricted by a silted layer in the canal, these high pressures occur at very low flood stages. An initial deformation response due to high pore pressures is shown in Figure 19-37.

Figure 19-37. Estimated of initial bulge in marsh-topsoil layer due to high pore pressures in underlying sand (assumes $K_v = 10x K_h$ in sand and WSE = 4.5 feet in canal) for London South breach sta. 53+00
