Appendix 1

Hydrograph and High Water Mark Analysis

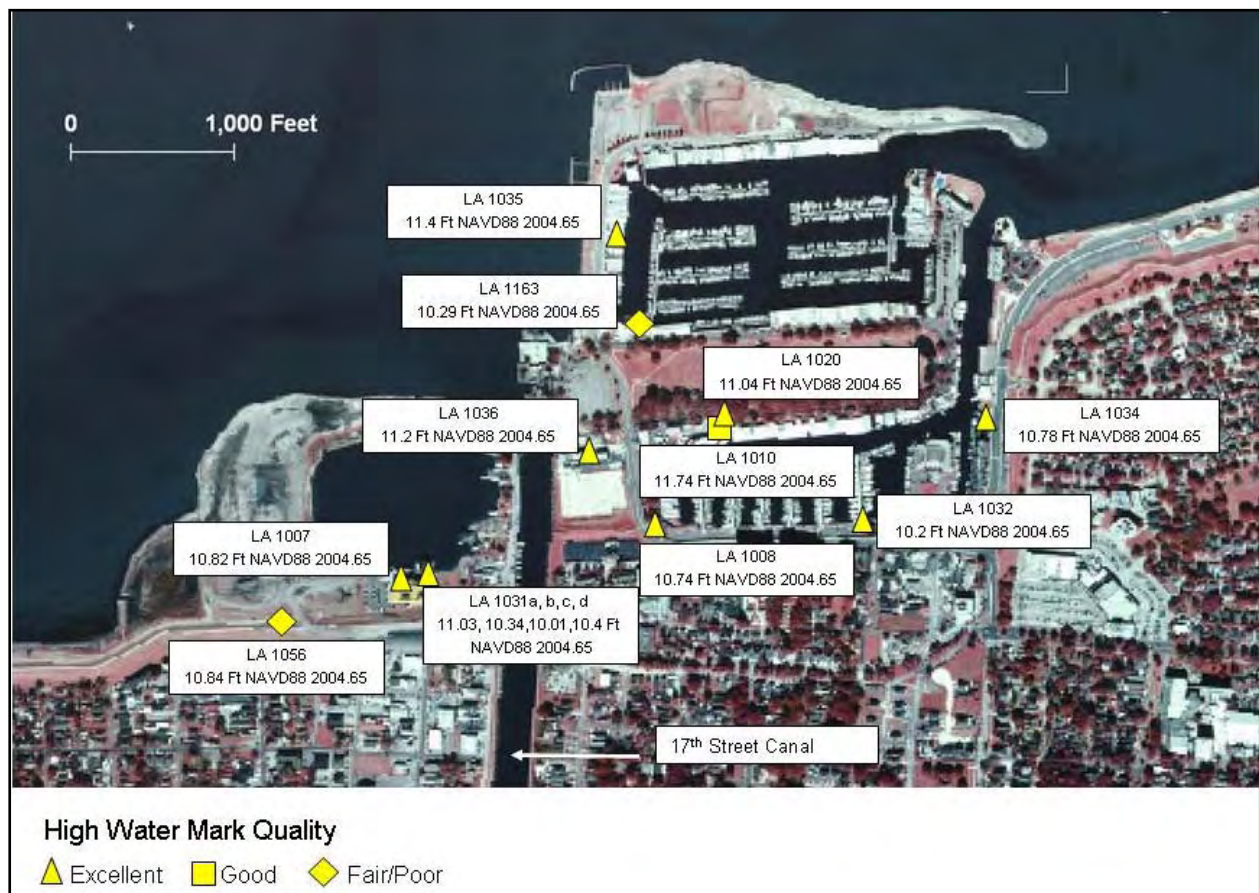
Figure 1-1 is an example image of a HWM presentation, which includes the HWM identifier, and water elevation. The shape of the HWM identifier indicates the HWM reliability. The setting in which a high water mark was collected is important in assessing the quality of a mark and those processes that might be reflected in the mark. Superposition of the mark on a photographic image aids in assessment and interpretation of HWMs in light of their geographic setting. Images 1 through 58 (two photo index images and 56 separate images with HWMs) at the end of this chapter show the HWMs in the metropolitan New Orleans vicinity and southeastern Louisiana area, which were utilized in this study. Images depict the location, elevation and reliability of all HWMs, focusing on unprotected areas.

Figure 1-1. Sample image of the 17th Street Canal Entrance showing locations of HWMs and water elevation for each mark.

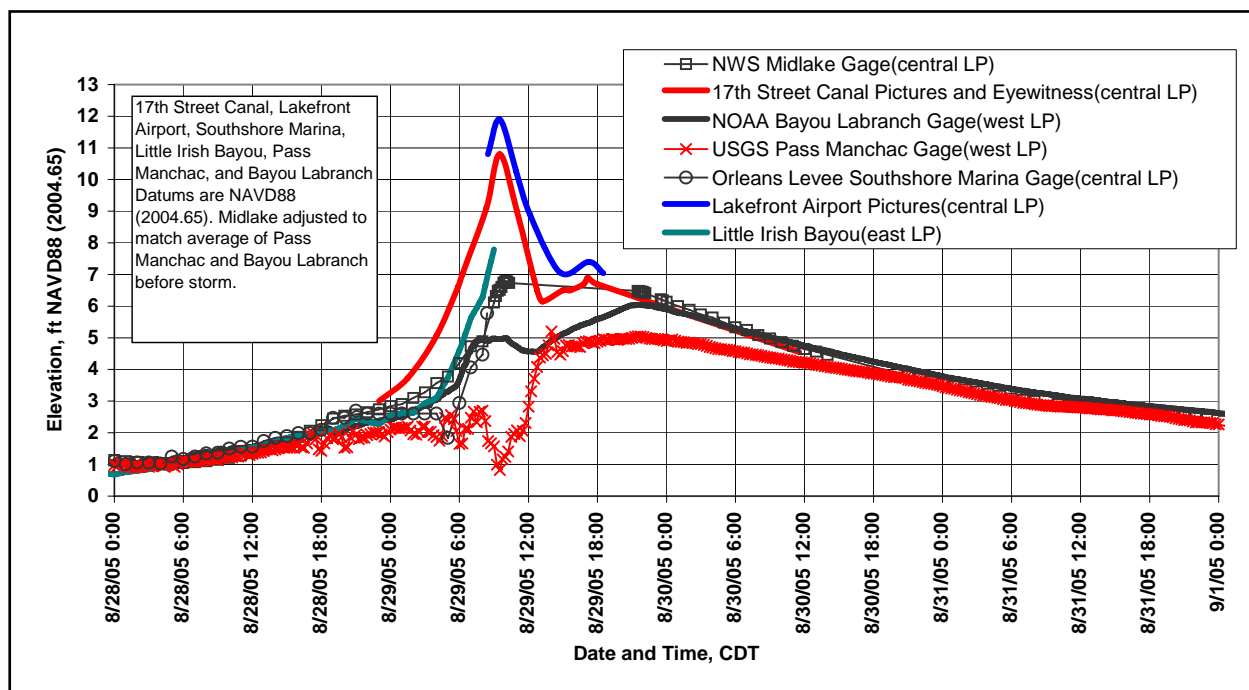
Figure 1-3 shows a plot of 5 gage hydrographs and two constructed hydrographs. Each hydrograph is labeled with a relative location in Lake Pontchartrain as either west, central, or east. The constructed hydrographs at the 17th Street Canal and the Lakefront Airport and the gage hydrographs at Southshore Marina, Little Irish Bayou, Pass Manchac, and Bayou Labranch are in NAVD88 (2004.65). The Midlake Gage was adjusted to NAVD88 (2004.65) by matching the average of the Pass Manchac and Bayou Labranch gage hydrographs before the storm.

Figure 1-3. Gage hydrographs and constructed hydrographs on Lake Pontchartrain.

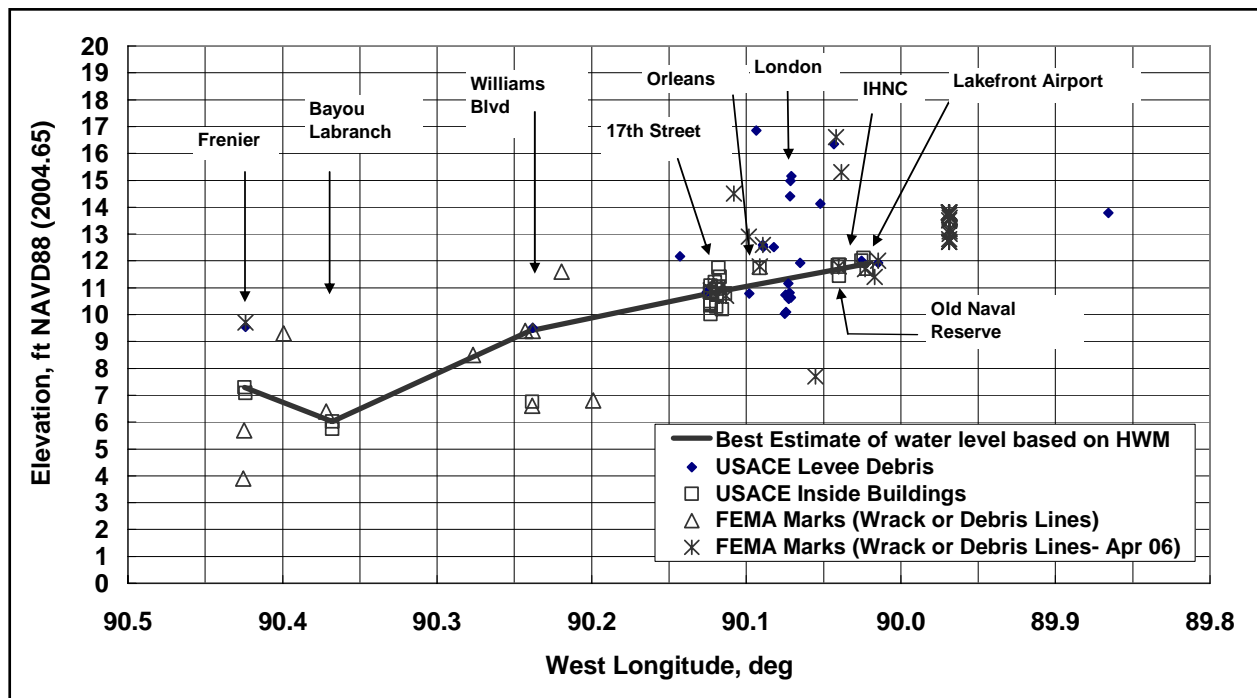
Figure 1-4 shows a plot of high water marks along the south shore of Lake Pontchartrain. The marks are separated into 3 categories of USACE marks inside buildings, USACE levee debris, and FEMA wrack or debris lines with the last two categories being essentially the same type of mark. The plot also shows a best estimate of peak storm water level based on the high water marks. With the exception of the Williams Boulevard location, the best estimate line is based on USACE marks inside buildings. At Williams Boulevard, there is a restroom that has all the characteristics of an excellent stilling well. The elevation of the mark (6.5 ft) in this restroom is much lower than the levee debris found by both the USACE and the FEMA teams. The 6.5 ft elevation is consistent with the elevations from Hurricane Rita. Any marks on Figure 1-4 less than about 7.5 ft and to the east of Bayou Labranch could reflect Hurricane Rita rather than Hurricane Katrina. The levee debris is accepted at this location because the foreshore slope between the levee debris and the lake is extremely flat and long that would have resulted in minor wave action at the location where the levee debris was deposited.

Figure 1-4. Variation of peak water level along south shore of Lake Pontchartrain based on high water marks.

Starting at Frenier on the west, the best estimate line is based on two excellent marks inside buildings. At the next point east at Bayou Labranch, the best estimate is based on two excellent marks inside buildings at 5.75 ft and 6.0 ft and the Bayou Labranch gage. Notice that the Bayou Labranch gage in Figure 1-3 peaks at an elevation of 6.0 ft. It is possible that the Bayou Labranch readings are affected by the fact that the gage and the HWMs are connected to the Lake by a channel that is about 0.5 mile long. An alternate estimate of water level along the south shore is to connect Frenier and the Williams Blvd points. The next point on the best estimate line at Williams Boulevard has already been discussed. From Williams Blvd to the next points at 17th Street Canal, the profile is assumed to be linear but water levels could have stayed high for some distance west of 17th Street before dropping to the level at Williams Blvd. The

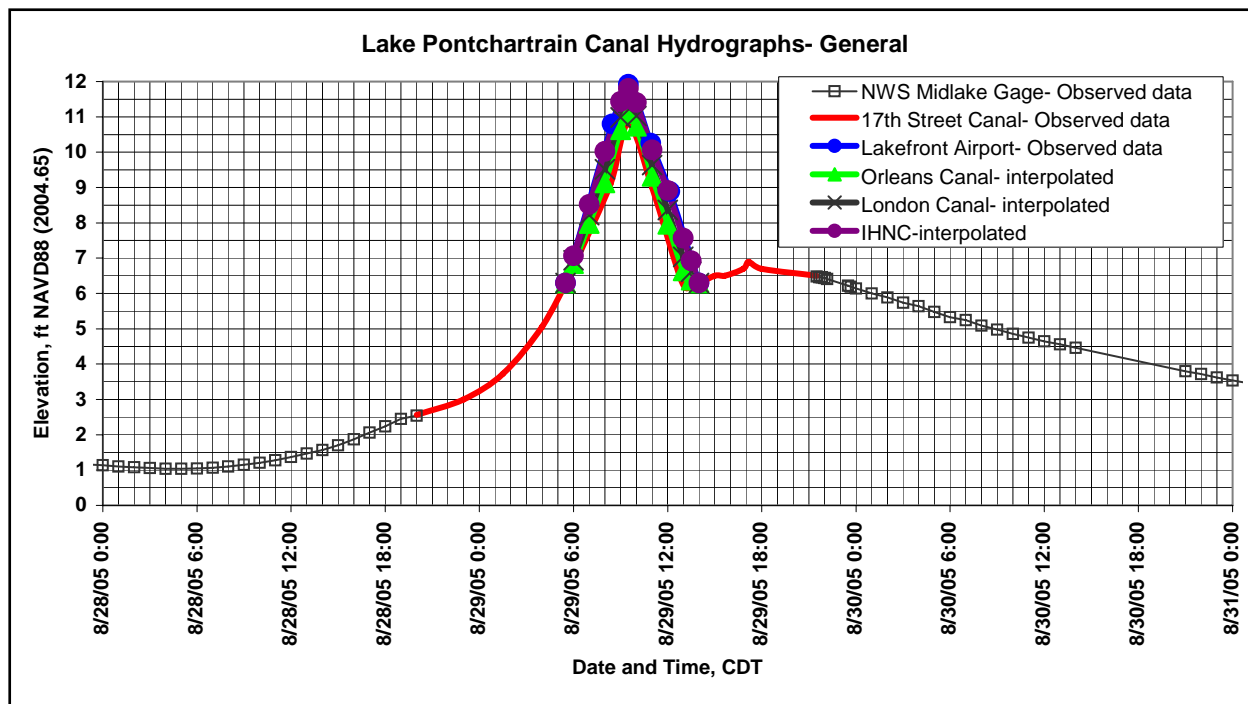
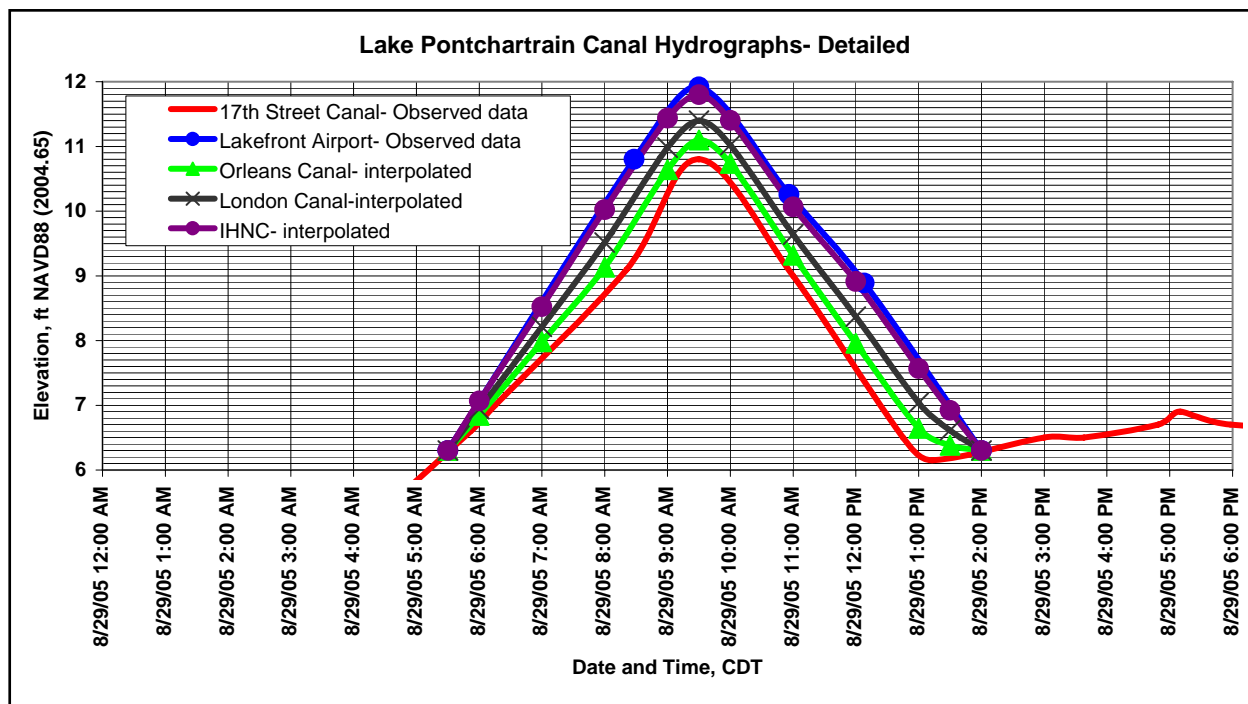
Using the best estimate curve, the 4 canals have the following values of peak water level: 1) 17th Street Canal at 10.8 ft, 2) Orleans Canal at 11.1 ft, 3) London Canal at 11.4 ft, and 4) IHNC at 11.8 ft. All elevations are in NAVD88 (2004.65). Using these peak water levels at the canal entrances along with the constructed hydrographs at 17th Street Canal and the Lakefront Airport (discussed in the following section), hydrographs were interpolated for Orleans, London, and the IHNC Canal entrances as shown in Figure 1-5 for a general plot and Figure 1-6 for a detailed plot.

Figure 1-5. Constructed and interpolated hydrographs at canal entrances- general view.

Figure 1-6. Constructed and interpolated hydrographs at canal entrances- detailed view.

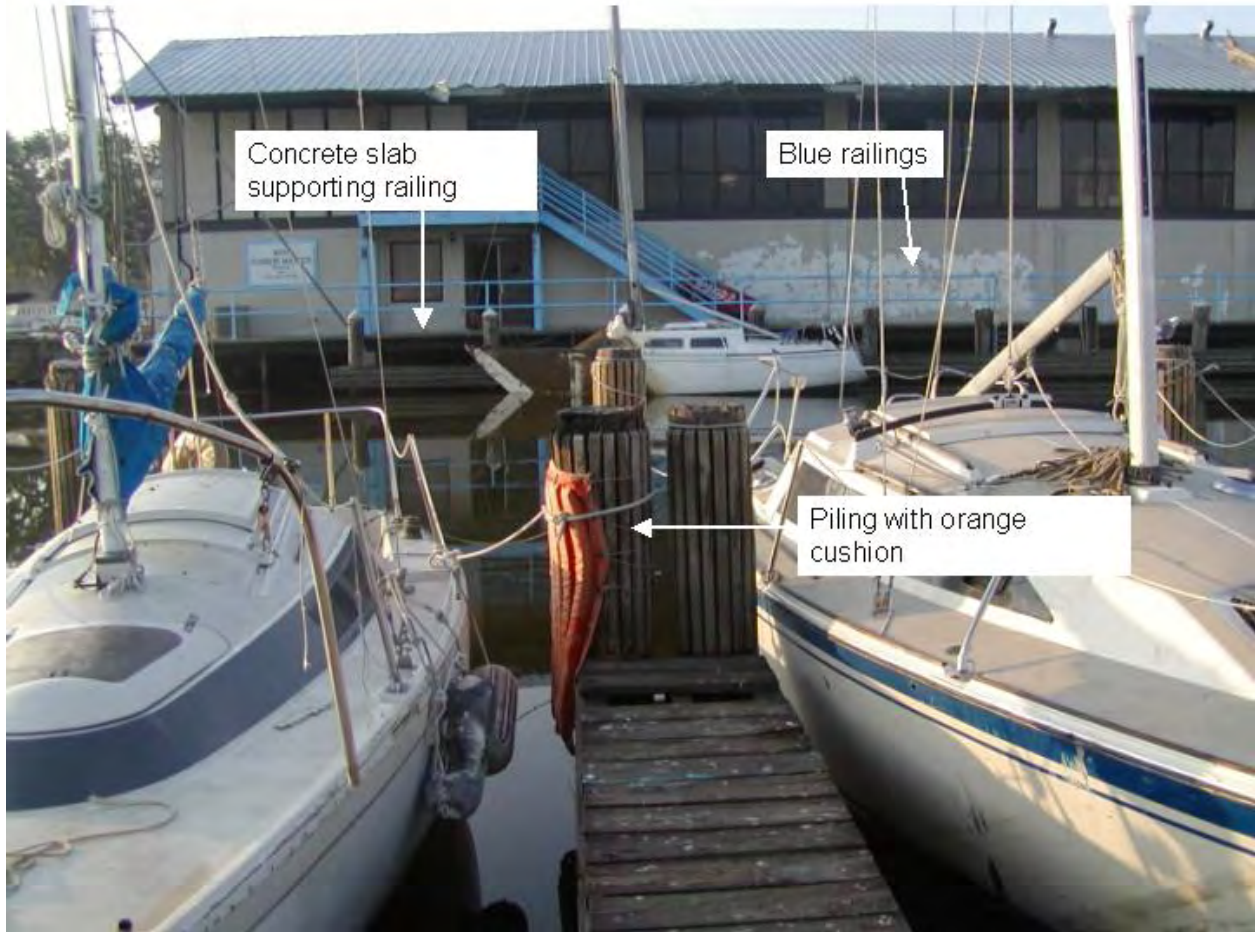
hulled trawler moored in the location shown on Figure 1-7. The boat was moored with multiple 2” diameter hawsers. Figure 1-8 shows a view looking south toward the MYH building that is located on the south side of the Harbor. Figure 1-8 also shows blue railing (background) and piling (foreground) that were used to define water surface elevation in the digital photographs. The blue railing has two levels above the concrete dock supporting the railing. The center of the lower rail is 1.95 ft above the concrete dock. The center of the higher rail is 3.85 ft above the concrete dock. The rails are 0.2 ft in diameter. Table 1-1 shows various surveyed elevations pertinent to determining elevations from the photographs including the average tops of pilings looking northeast from the position of the boat. These pilings are shown in subsequent pictures labeled “looking northeast” and were relatively consistent in top elevation and only visible at elevations less than about 6.9 ft. The points taken from the digital pictures were initially surveyed in November 2005. These points were resurveyed by a different company in March 2006 and found to be correct.

Figure 1-8. Railings, pilings, and other features near Municipal Yacht Harbor Building. Looking south

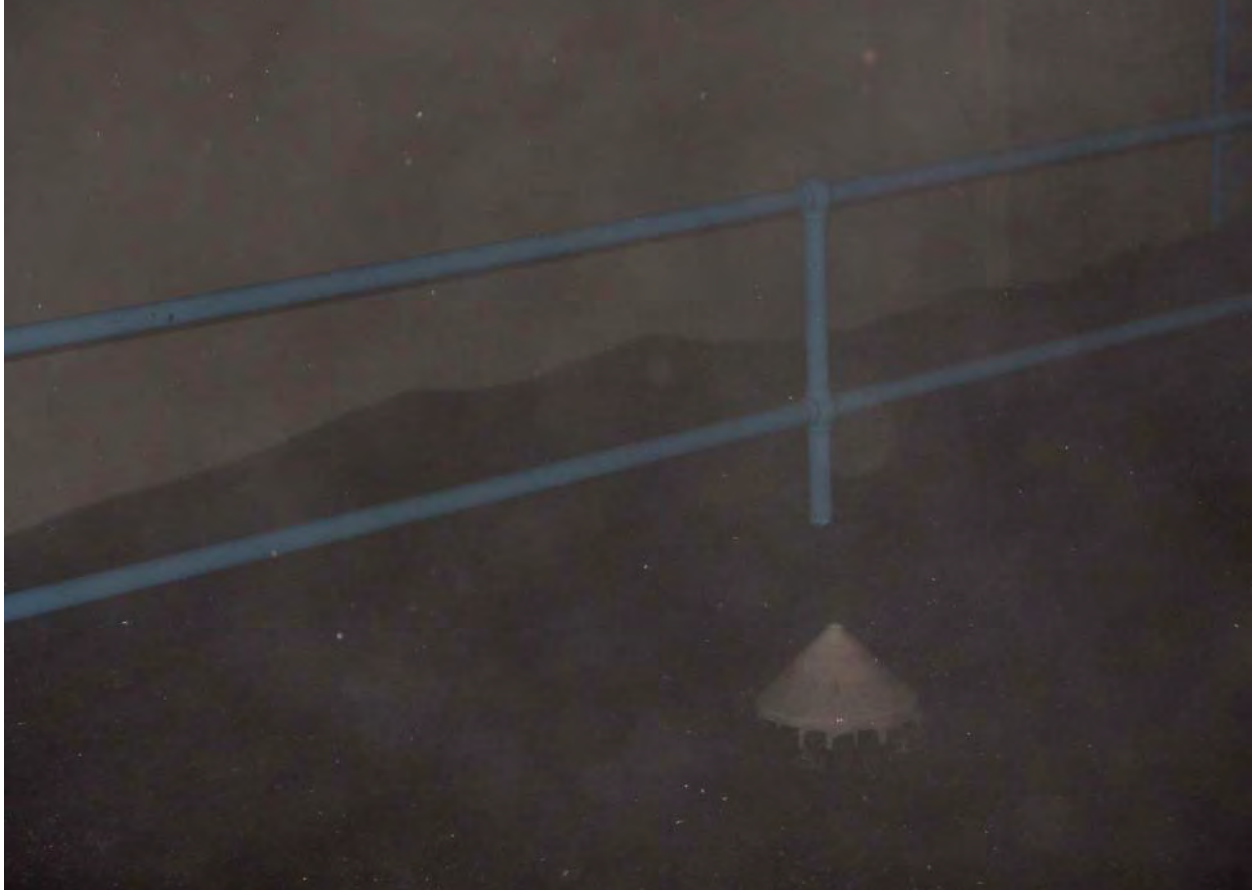
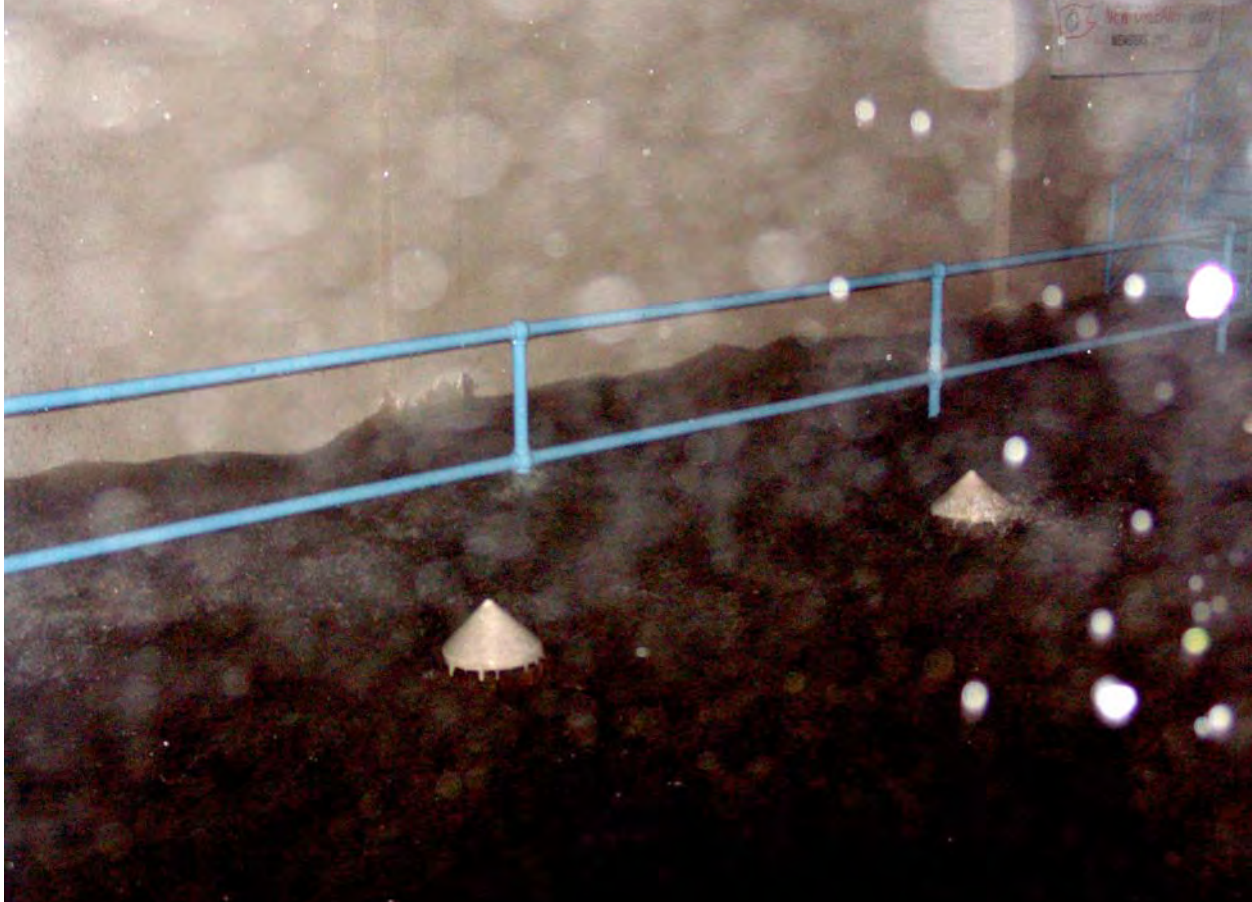
- a.* 0552 (CDT) on 8/29/05, elevation 6.6 ft: Figures 1-9 and 1-10 show pictures taken of the blue rail at 0552 (CDT). By knowing the distance between the top and bottom rails and the elevation of both rails, the distance from the bottom rail to the water surface can be determined using the ratio of distances in the photograph. In Figure 1-9 the water level is 1.0 ft below the lower rail. In Figure 1-10, the water levels at the 3 vertical posts are 0.2, 0.6, and 0.7 ft below the lower rail. The differences in distance below the lower rail is the result of wave action that has a wave height (trough to crest) of at least 0.8 ft based on these two pictures. By averaging the distances, the wave effects are reduced but not eliminated. Averaging all 4 yields an average distance below the lower rail of 0.6 ft for a water surface elevation of $7.2 - 0.6 = 6.6$ ft.

Figure 1-9. Picture DSC02231.JPG taken at 0552:00 CDT on 8/29/05, elevation 6.6 ft. Looking southwest. Water level is 1.0 ft below lower rail.

Figure 1-10. Picture DSC02232.JPG taken at 0552:22CDT on 8/29/05, elevation 6.6 ft. Looking southwest. Left vertical post: water level 0.2 ft below lower rail. Center vertical post: water level 0.6 ft below lower rail, right vertical post: water level 0.7 ft below lower rail. Average of all observations from DSC02231 and DSC02232 is 0.6 ft. Picture brightness and contrast adjusted.

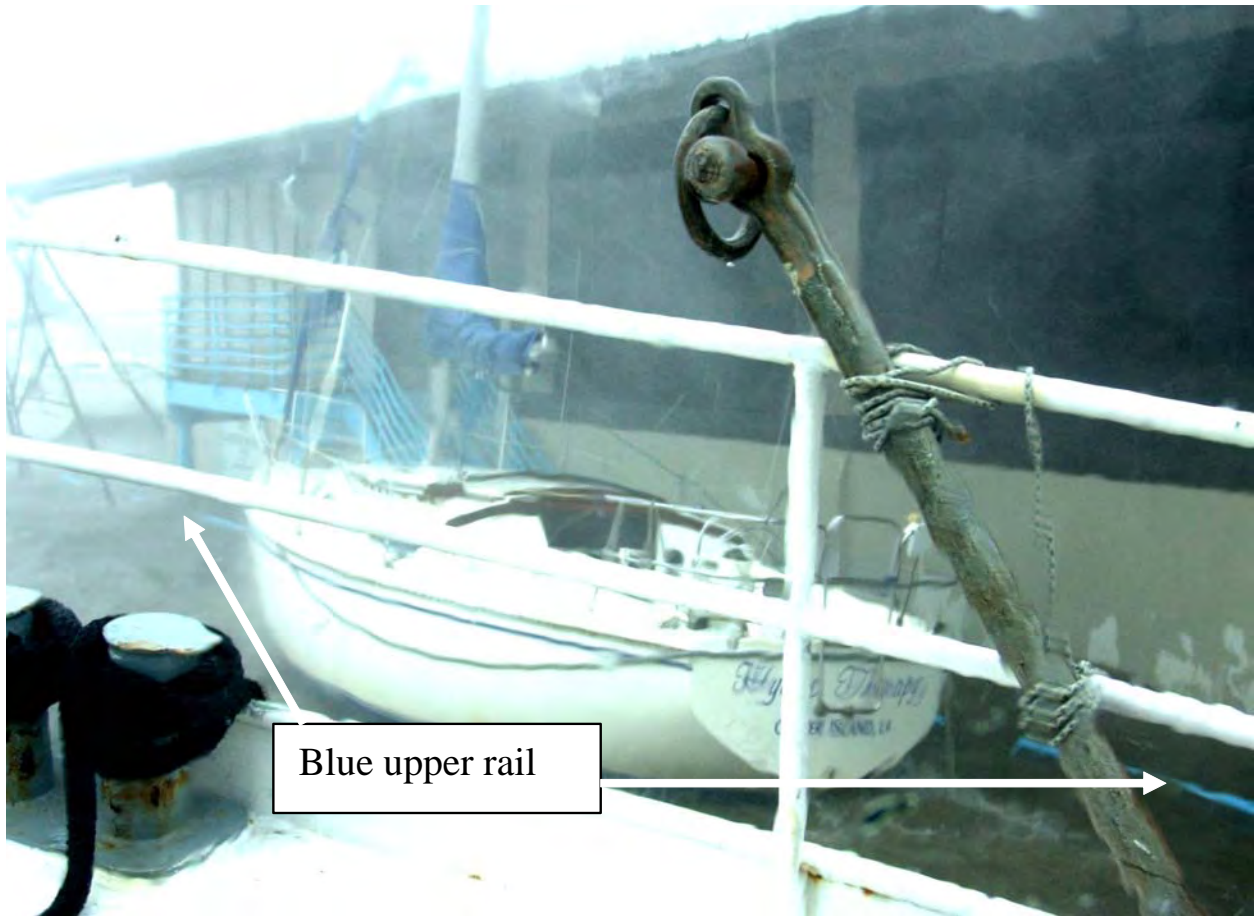
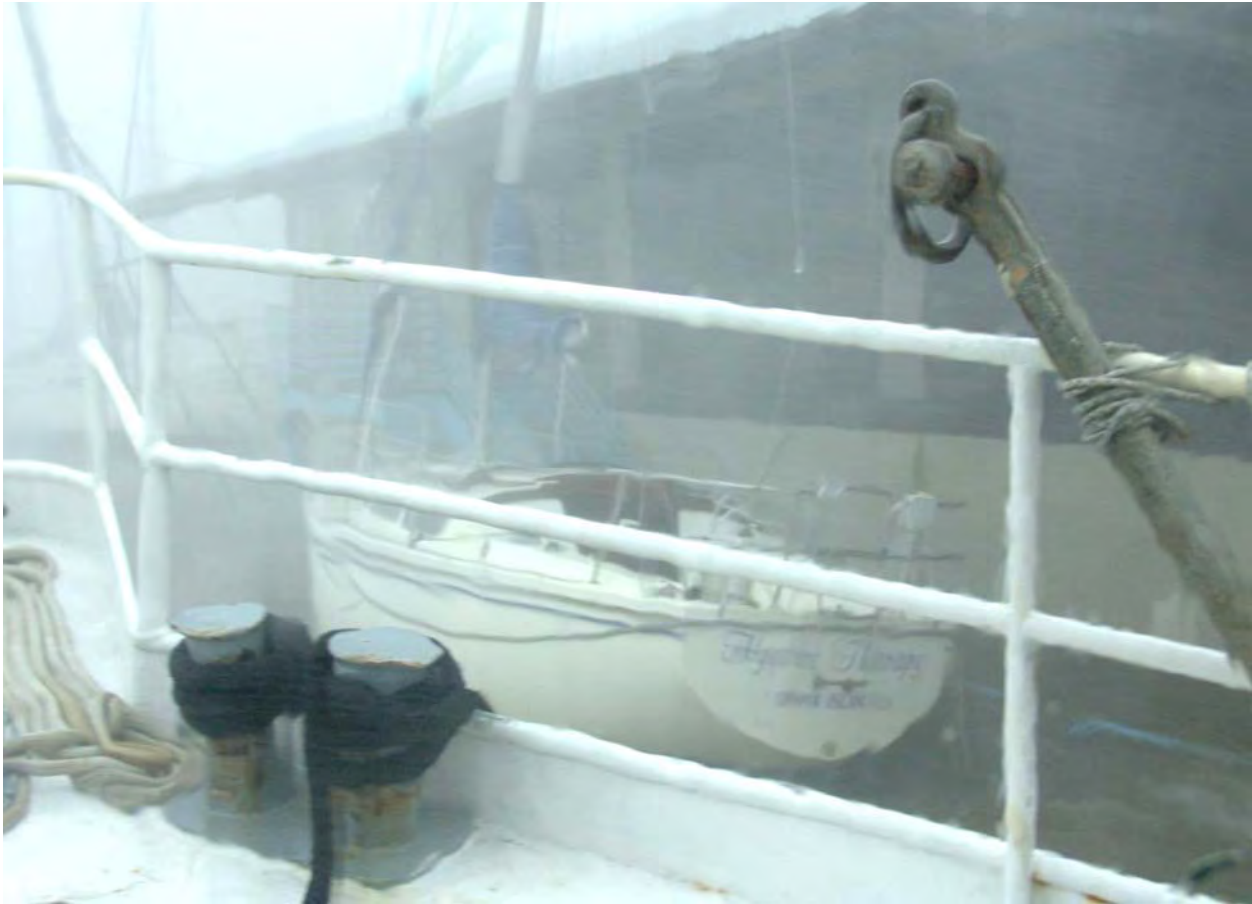
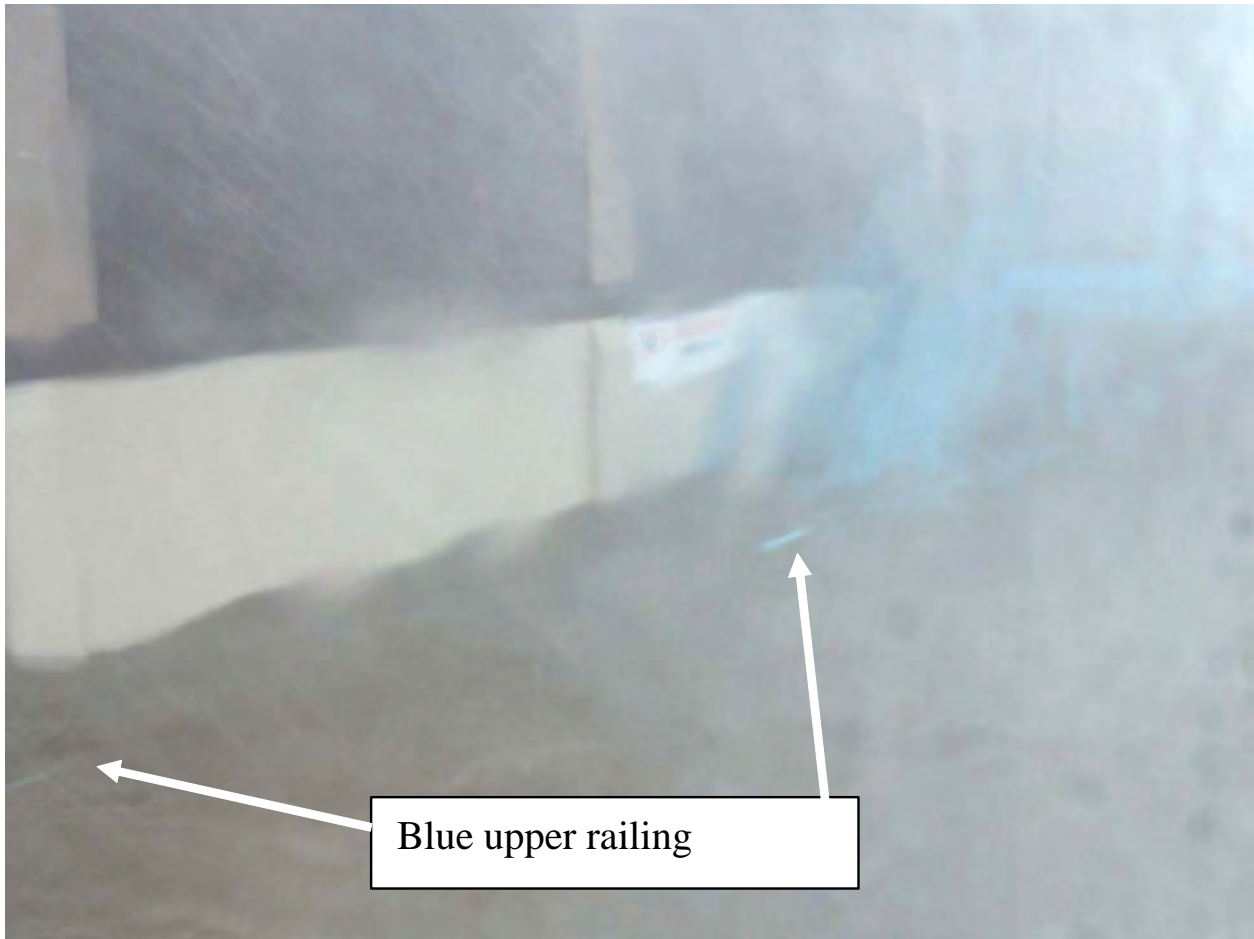
- b.* 0814 (CDT) on 8/29/05: Pictures DSC02233-DSC02236 show the harbor with no tops of piling visible but no elevations can be determined.
- c.* 0816 (CDT) – 0826 (CDT) on 8/29/05, elevation 9.1 ft: Figures 1-11 to 1-15 (pictures DSC02237-DSC02241) show the water level at the top rail in all available pictures. Figure 1-14 shows the double door in the middle of the north wall of the MYH building. The boat owner said the double door was knocked down sometime on the 8/29/05. Elevation of the top rail is 9.1 ft.

Figure 1-11. Picture DSC02237.JPG taken at 0816:22 (CDT) on 8/29/05, elevation 9.1 ft. Looking southeast. Water level at upper rail. Brightness and contrast adjusted.

Figure 1-12. Picture DSC02238.JPG taken at 0816:28 (CDT) on 8/29/05, elevation 9.1 ft. Looking southeast. Water level at upper rail. Brightness and contrast adjusted

Figure 1-13. Picture DSC02239.JPG taken at 0816:52 (CDT) on 8/29/05, elevation 9.1 ft. Looking southeast. Water level at upper rail. Brightness and contrast adjusted.

Figure1-14. Picture DSC02240.JPG taken at 0826:32 (CDT) on 8/29/05, elevation 9.1 ft. Looking south. Water level at upper rail.

Figure 1-15. Picture DSC02241.JPG taken at 0826:36 (CDT) on 8/29/05, elevation 9.1 ft. Looking south. Water level at upper rail. Brightness and contrast adjusted.

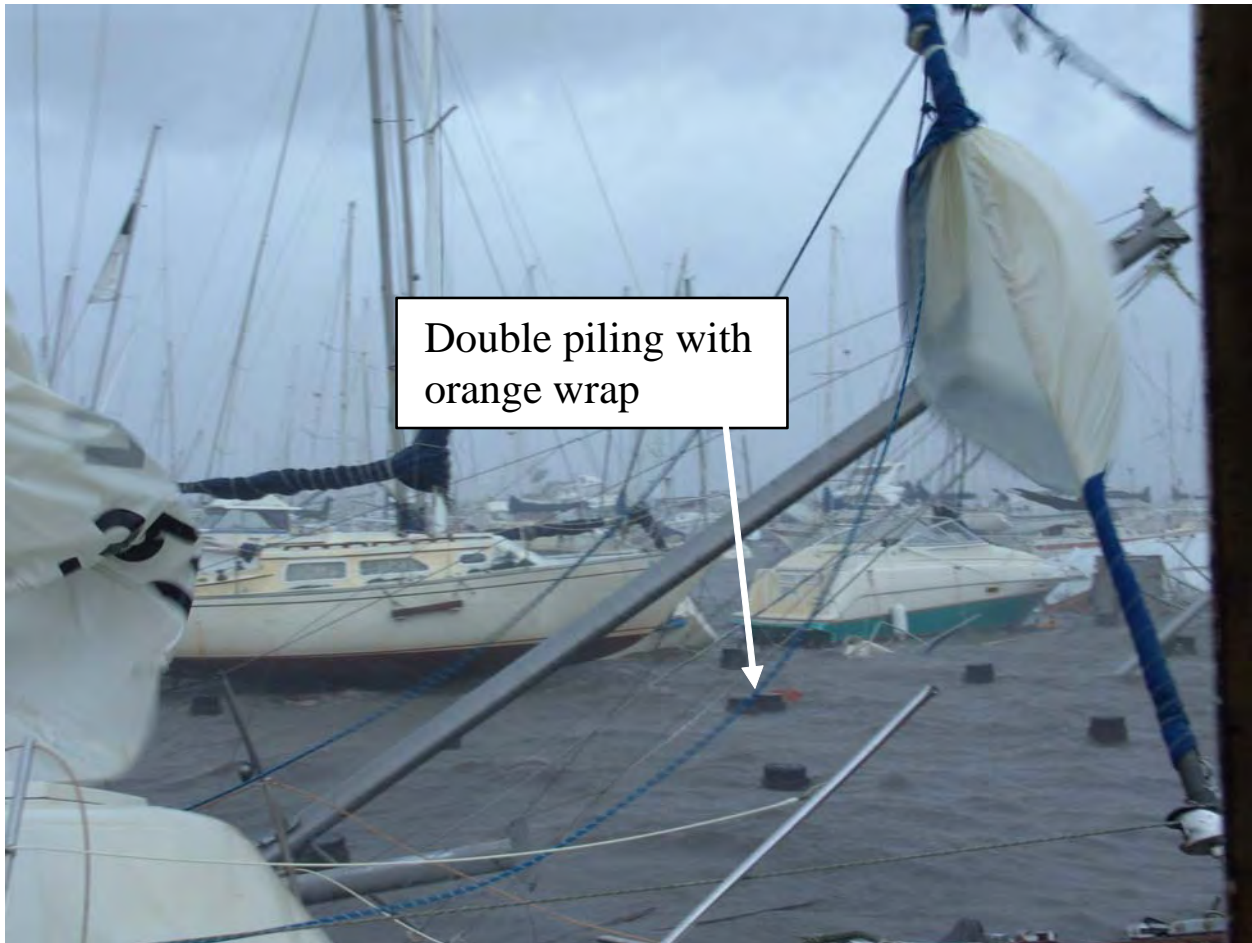
- f.* 1312 (CDT) – 1313 (CDT) on 8/29/05, elevation 6.3 ft: Pictures DSC02251-DSC02256 show pilings in the harbor. Figure 1-16 (DSC02255) shows a double piling with some orange visible beside the piling. At the site visit, only one double piling had an orange wrap that was loose at the bottom and would have floated up during the higher water level. A mark was placed on this piling at the water level estimated from the picture. The mark was 0.5 ft below the top of the piling. This mark was surveyed and found to be at elevation 6.2 ft. Other pilings in the picture were also about 0.5 ft below the top of piling providing an elevation of 6.4 ft. A value of 6.3 ft is used for this time.

Figure 1-16. Picture DSC02255.JPG taken at 1313 (CDT) on 8/29/05, elevation 6.3 ft. Looking northeast

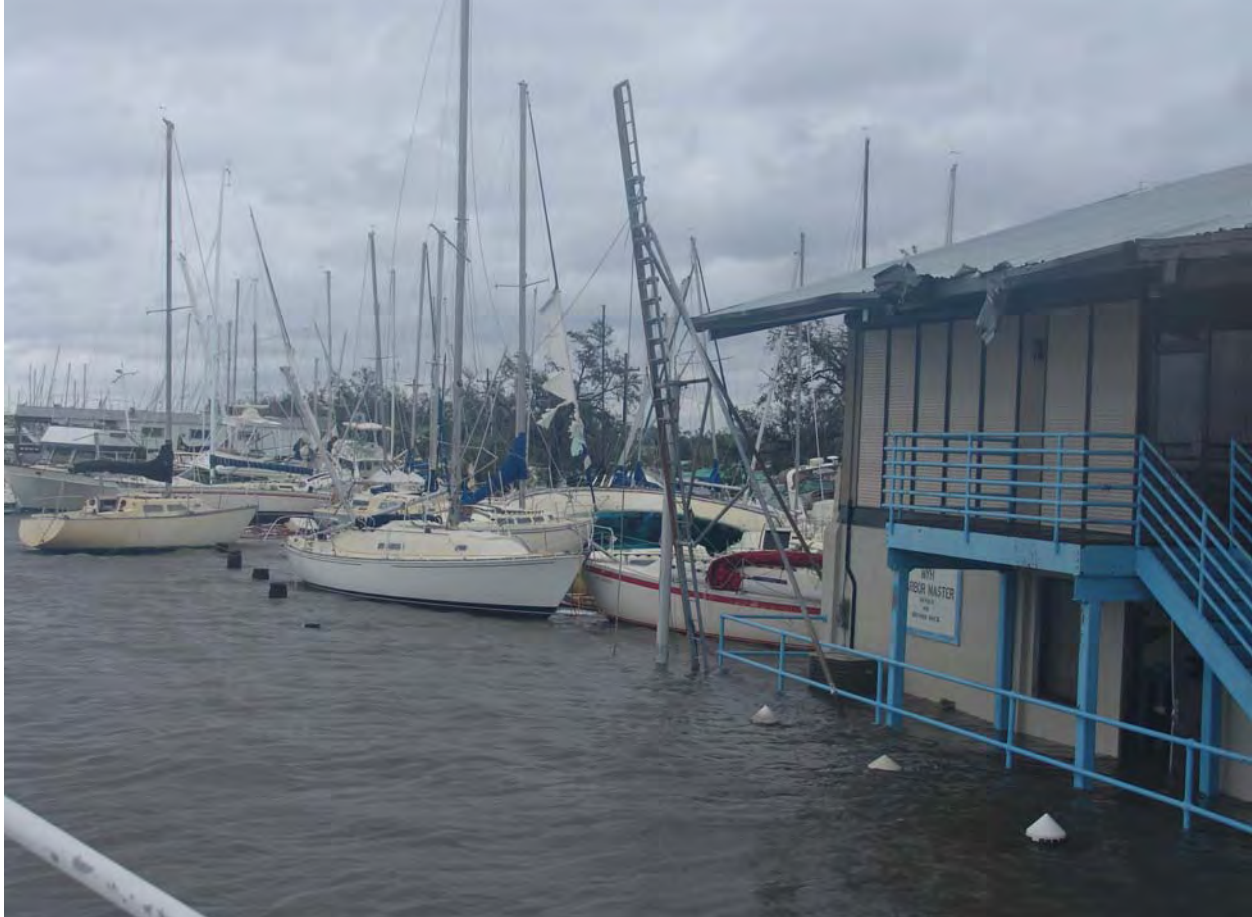
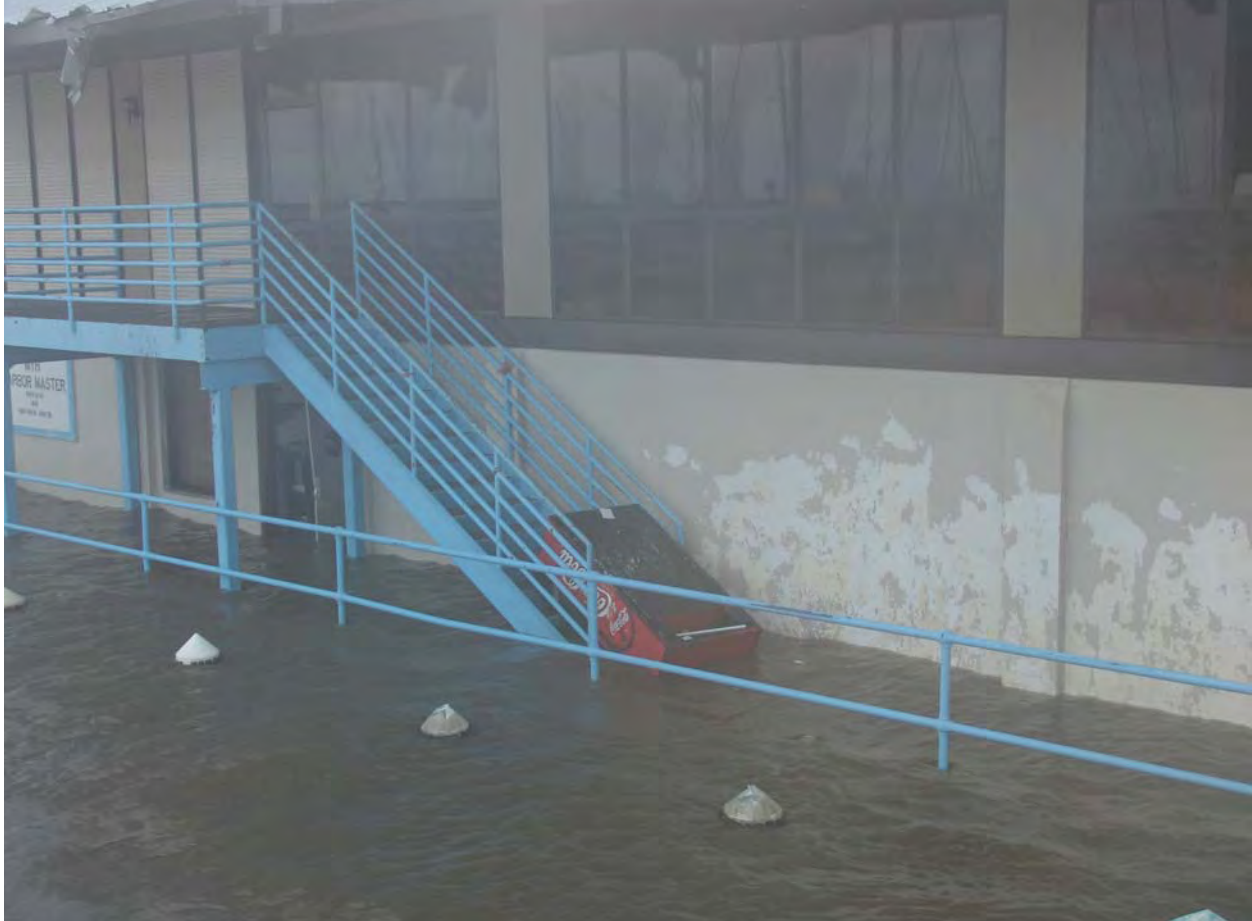
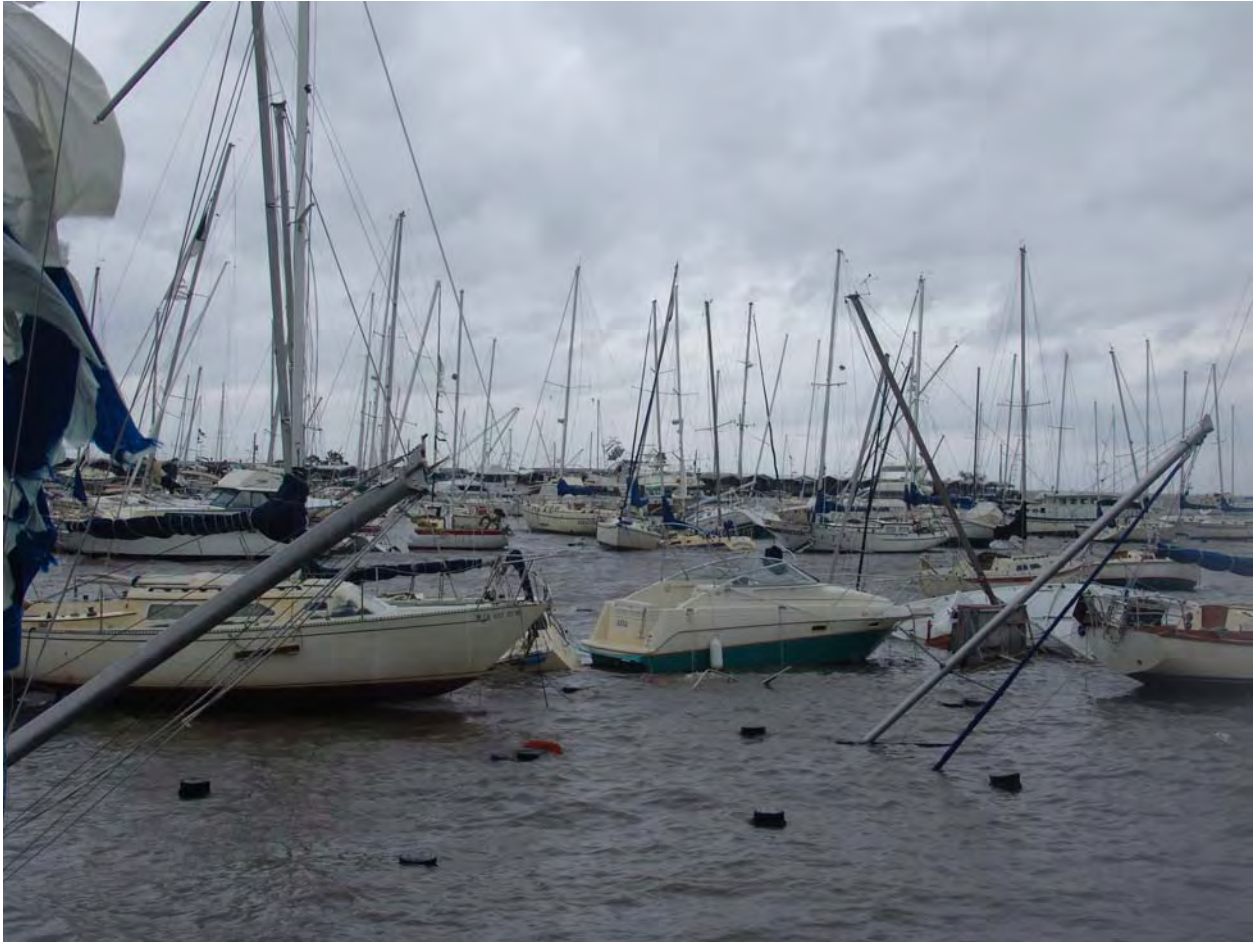
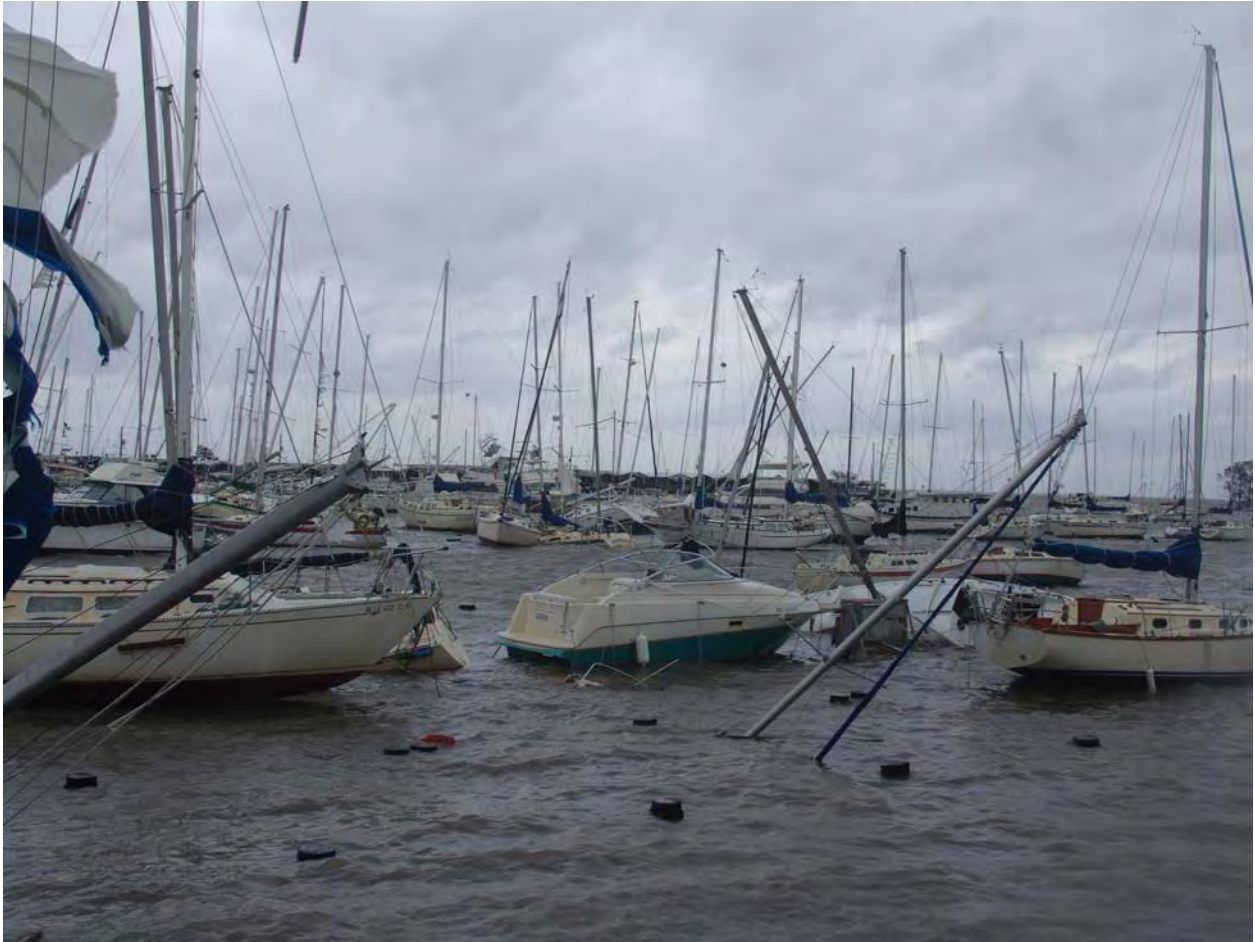
- g. 1537 (CDT) – 1543 (CDT) on 8/29/05, elevation 6.5 ft: Numerous pictures provide rail evidence and top of piling evidence. Figure 1-17 (DSC02262- 1538:44) shows the water level at 5 vertical posts at 0.7, 0.8, 0.8, 0.7, and 0.6 ft below the lower rail that averages 0.7 ft. Figure 1-18 (DSC02263- 1538:54) show the water level at 4 vertical posts at 0.5, 0.7, 0.7, and 0.9 ft below the lower rail that averages 0.7 ft below the lower rail that gives an elevation of $7.2 - 0.7 = 6.5$ ft. Figures 1-19 (DSC02267- 1539:34) and 1-20 (DSC02269- 1539:56) show the double piling with the orange cushion. Based on the photographs, the water level is about 0.1 ft below the top of piling giving an elevation of 6.5 ft.

Figure 1-17. Picture DSC02262.JPG taken at 1538:44 (CDT) on 8/29/05, elevation 6.5 ft. Looking east-southeast. From left to right vertical posts, water level is 0.7, 0.8, 0.8, 0.7, and 0.6 ft below the center of the lower rail.

Figure 1-18. Picture DSC02263.JPG taken at 1538:54 (CDT) on 8/29/05, elevation 6.5 ft. Looking southeast. From left to right, water level is 0.5, 0.7, 0.7, and 0.9 ft below the center of the lower rail.

Figure 1-19. Picture DSC02267.JPG taken at 1539:34 (CDT) on 8/29/05 elevation 6.5 ft. Looking northeast.

Figure 1-20. Picture DSC02269.JPG taken at 1539:56 (CDT) on 8/29/05, elevation 6.5 ft. Looking northeast.

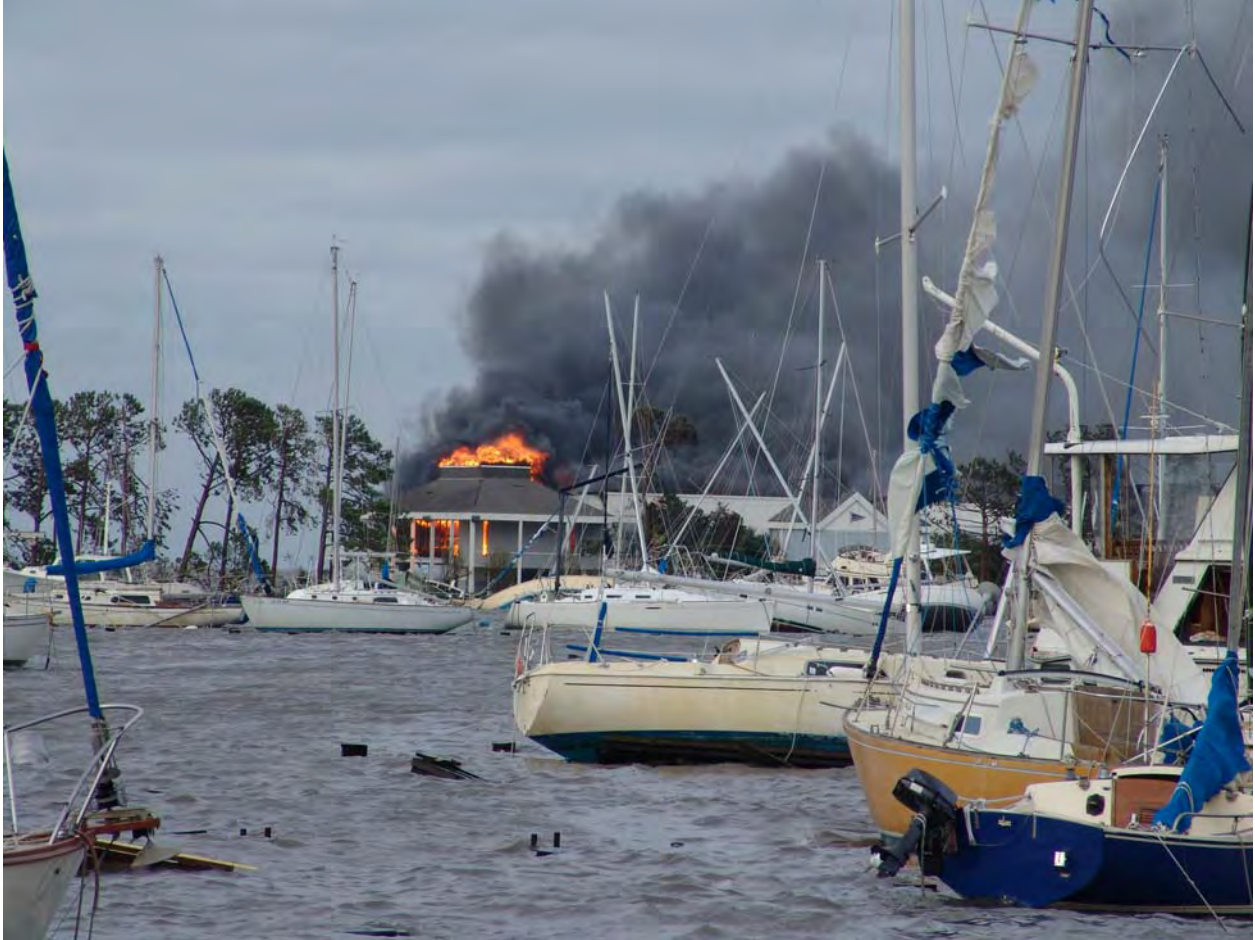
- j.* 1757 (CDT) – 1758 (CDT) on 8/29/05, elevation 6.7 ft: Pictures DSC02328- DSC02337 show the water level at about 0.2 ft below the tops of the highest pilings giving an average elevation of about 6.7 ft. Figure 1-24 (DSC02333) shows a typical top of piling picture.

Figure 1-24. Picture DSC02333.JPG taken at 1757 (CDT) on 8/29/05, elevation 6.7 ft. Looking northeast

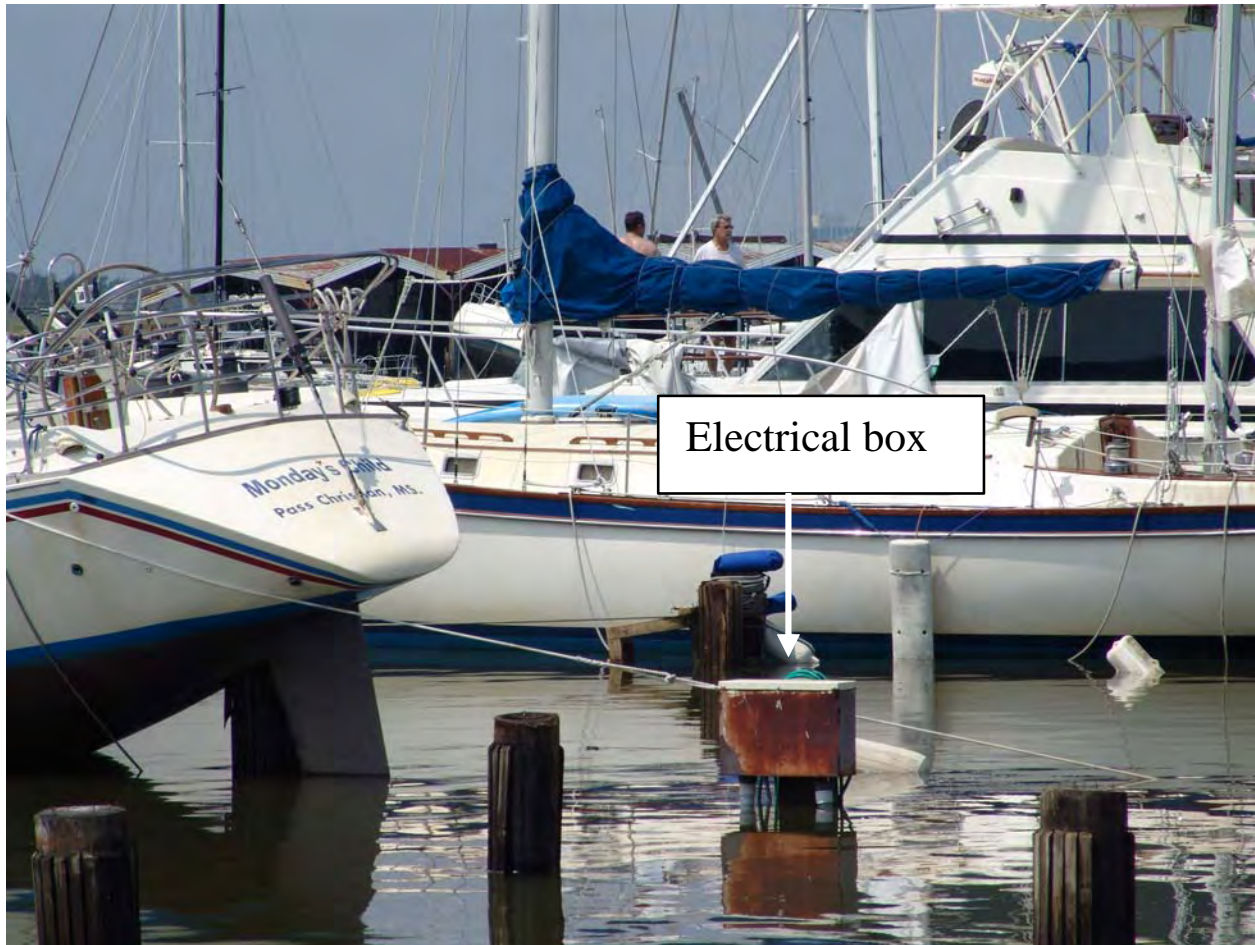
- k.* 1132 (CDT) on 8/30/05, elevation 4.55 ft: Figure 1-25 (DSC02338) shows electrical box where the water level on 8/30 is 4.0 ft above the water level on 11/8 based on measuring the location of the water on the box in the picture down to the water level on 11/8. This point was not surveyed in the initial survey. The electrical box is located on the east end of the third row of docks. The water level on 11/8 was 5.8 ft lower than a surveyed mark on a piling that was at elevation 6.15 giving a water level of $6.2 - 5.8 = 0.4$ ft on 11/8. The water level on 8/30 = $4.0 + 0.4 = 4.4$ ft. In the resurvey in 2006, this point was at an elevation of 4.55 ft.

Figure 1-25. Picture DSC02338.JPG taken at 1132 (CDT) on 8/30/05 elevation 4.4 ft. Electrical box at east end of third row of docks
