Appendix 1

Hydrograph and High Water Mark Analysis

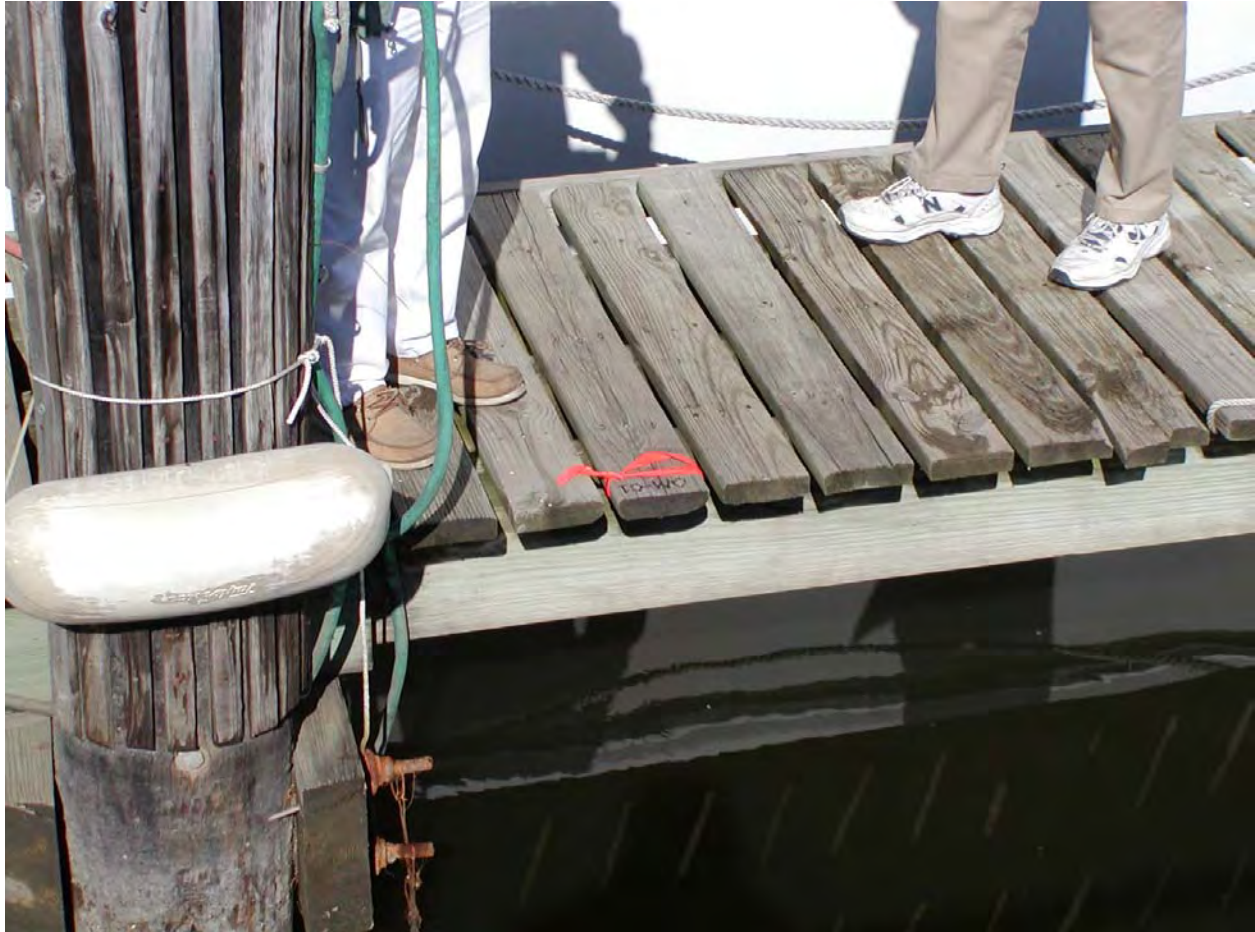
- a. Sunday 8/28/05, 16:00 hrs: Water level 1 ft above normal. No mark will be surveyed because uncertain how to quantify “normal.”
- b. Sunday 8/28/05. 23:00 hrs, elevation 3.0 ft: Water level at bottom side of the 2X6’s covering the deck of the finger pier. Survey point OM-01, Figure 1-26.
- c. Monday 8/29/05,01:30, elevation 3.7 ft: Water level at top of 1st step up from finger pier. Survey point OM-02, Figure 1-27.
- d. Monday 8/29/05,04:00, elevation 5.1 ft: Water level at top of concrete pile cap. Survey point OM-03, Figure 1-28.
- e. Monday 8/29/05,06:00, elevation 5.6 ft: Water level at top of steps equal to top of main concrete dock in Figure 1-28. Survey point OM-04.
- f. Monday 8/29/05,06:15, elevation 7.0 ft: Water level at 1st rail. Survey point OM-05, Figure 1-29.

Figure 1-26. Time 23:00 on 8/28/05, elevation 3.0 ft. Bottom of 2X6 deck board

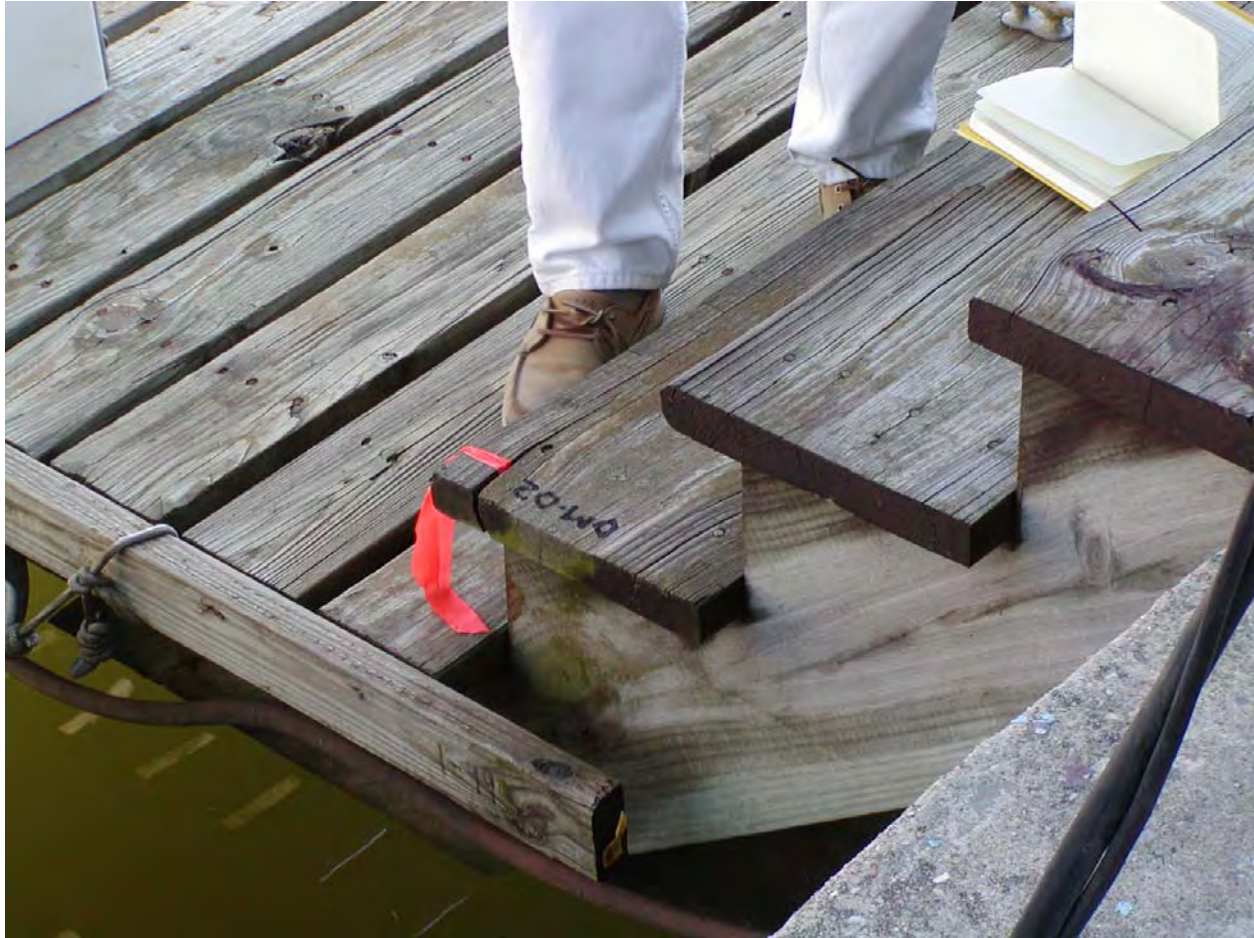
Figure 1-27. Time 1:30 on 8/29/05, elevation 3.7 ft. Top of first step on finger dock

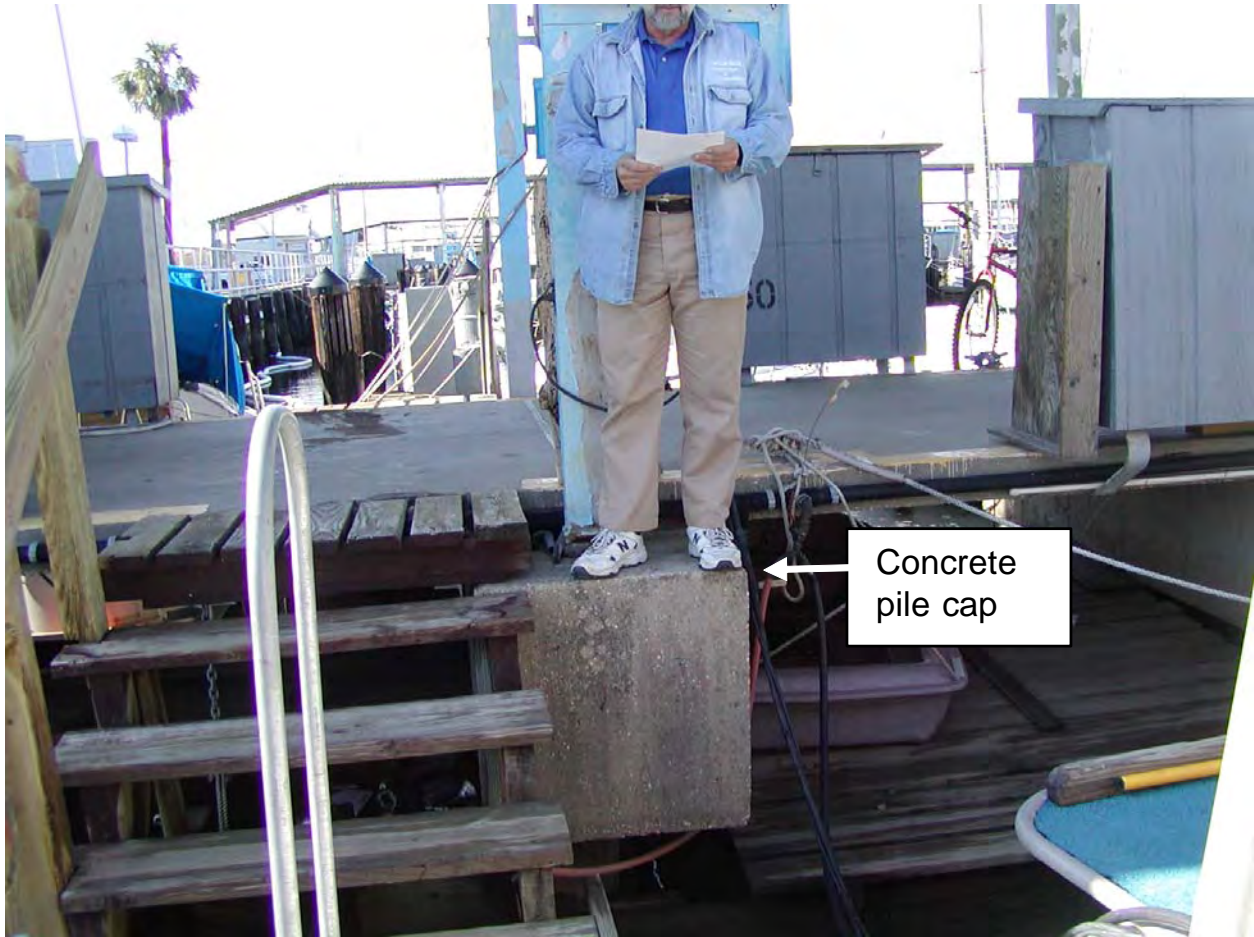
Figure 1-28. Time 4:00 on 8/29/05, elevation 5.1 ft. Top of concrete pile cap next to steps

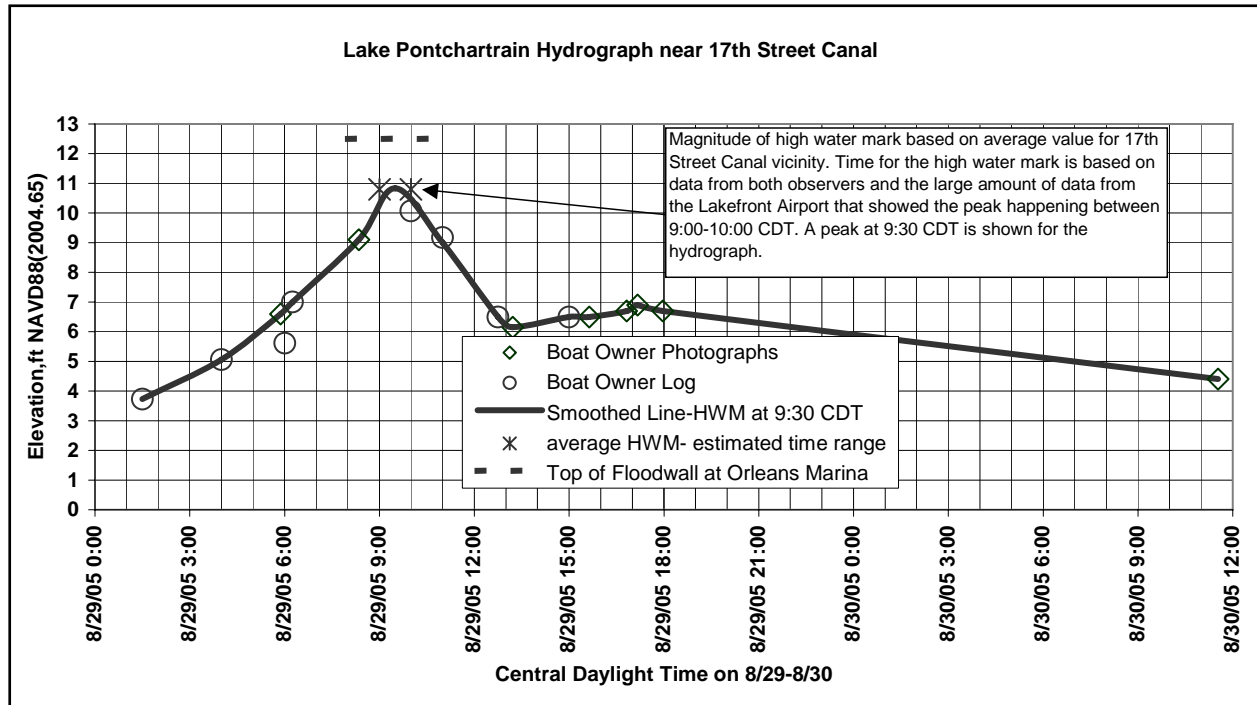
Based on the above averaging techniques, a high water mark value of 10.8 ft is recommended for the 17th Street Canal entrance. Using all values in Table 1-2, the high water mark data has a standard deviation of 0.5 ft.

The timing of the high water mark is needed to position the high water mark in the hydrograph. Based on ADCIRC model results, the timing of peak high water at the 17th Street Canal and the Lakefront Airport is within 15-20 minutes of each other. The photographic record at Lakefront Airport is the best data available concerning when the peak occurred. Based on data from the Lakefront Airport and both marinas discussed herein, the peak water level occurred sometime between 9:00 AM and 10:00 AM. This time range will be shown on the hydrograph. This high water time range also agrees with the time estimate of an Orleans Avenue Canal Pump Station #7 operator who stated the short wall connecting the pump station to the floodwall started overflowing at 8:30-9:00 and lasted for about 1.5 hours.

Hydrograph Plot- The data derived from the boat owner pictures, log, and the high water mark are plotted in the Figure 1-32 hydrograph.

Figure 1-32. Hydrograph for Lake Pontchartrain at 17th Street Canal based on digital photographs, log of events, average HWM in vicinity, and HWM time based on boat owners and Lakefront Airport data.

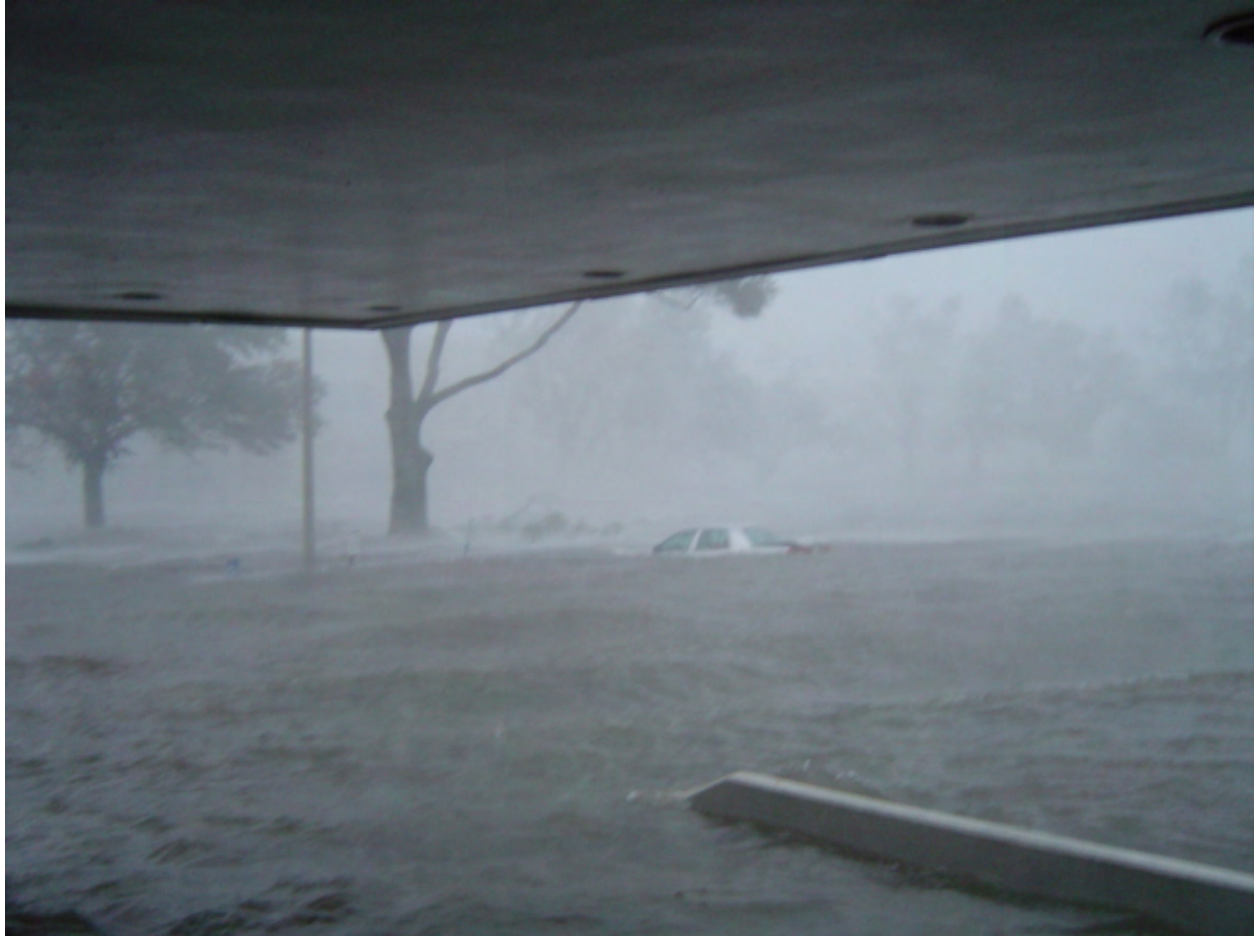
Figure 1-34. Time 7:29 AM, APH-01.

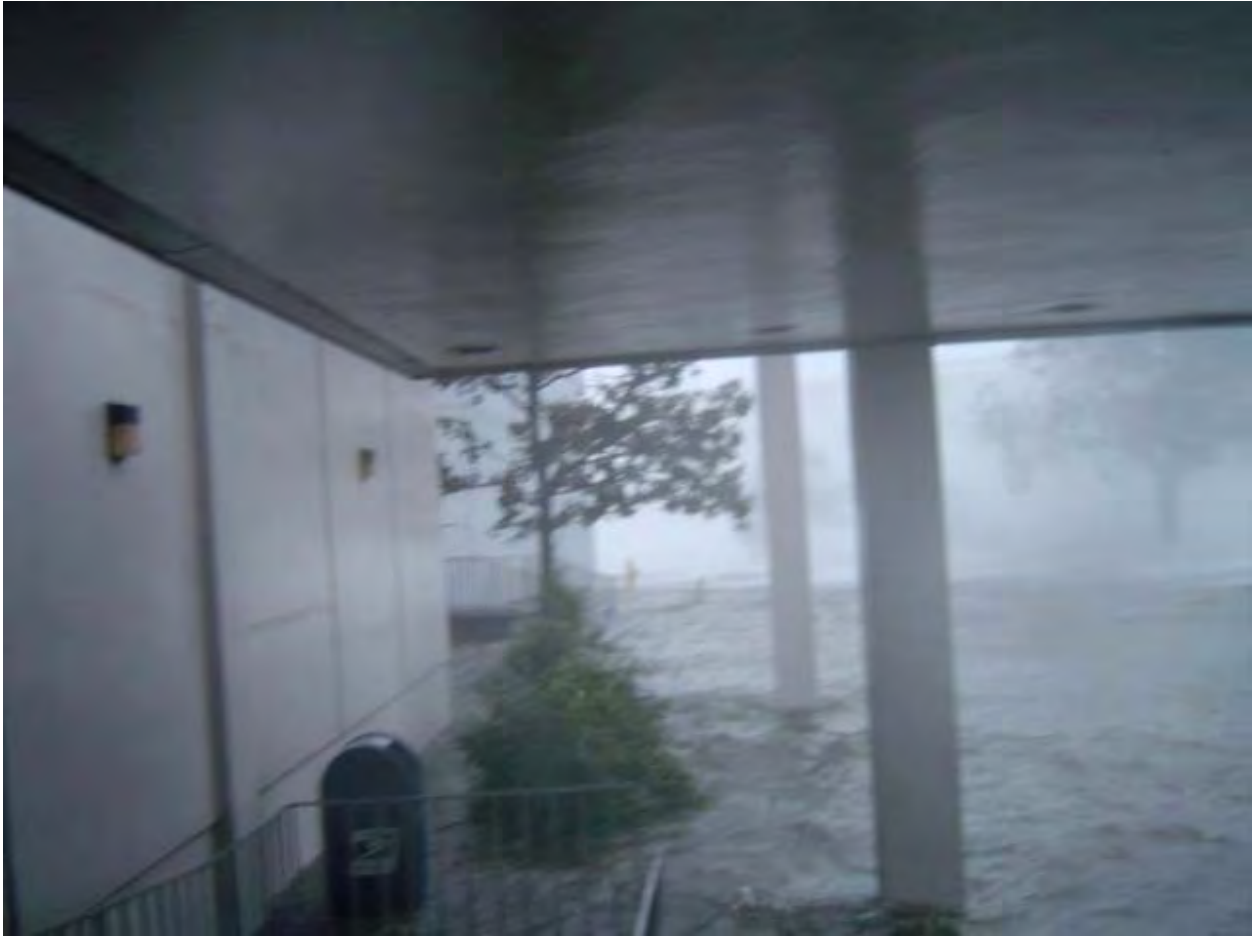
Figure 1-35. Time = 7:29, APH-22. Wall on south side of terminal building, east walkway

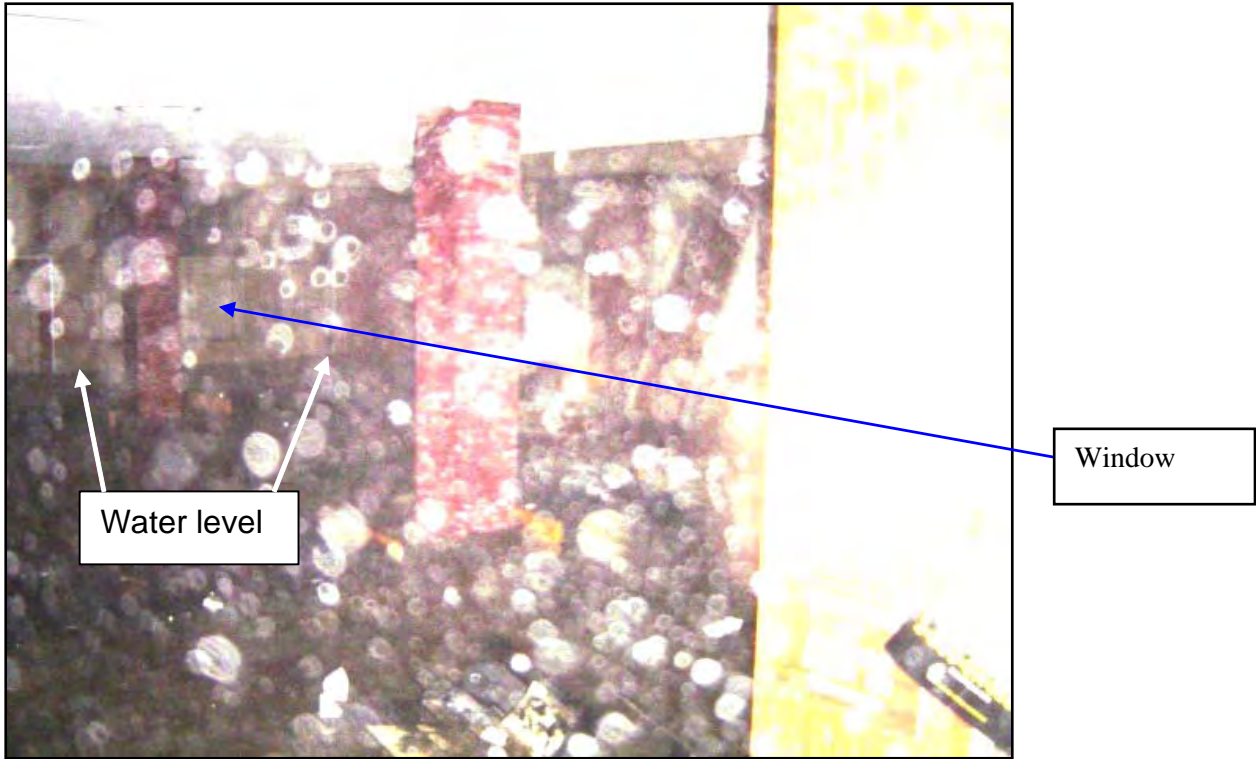
Figure 1-36. Time 8:27 AM, APH-21.

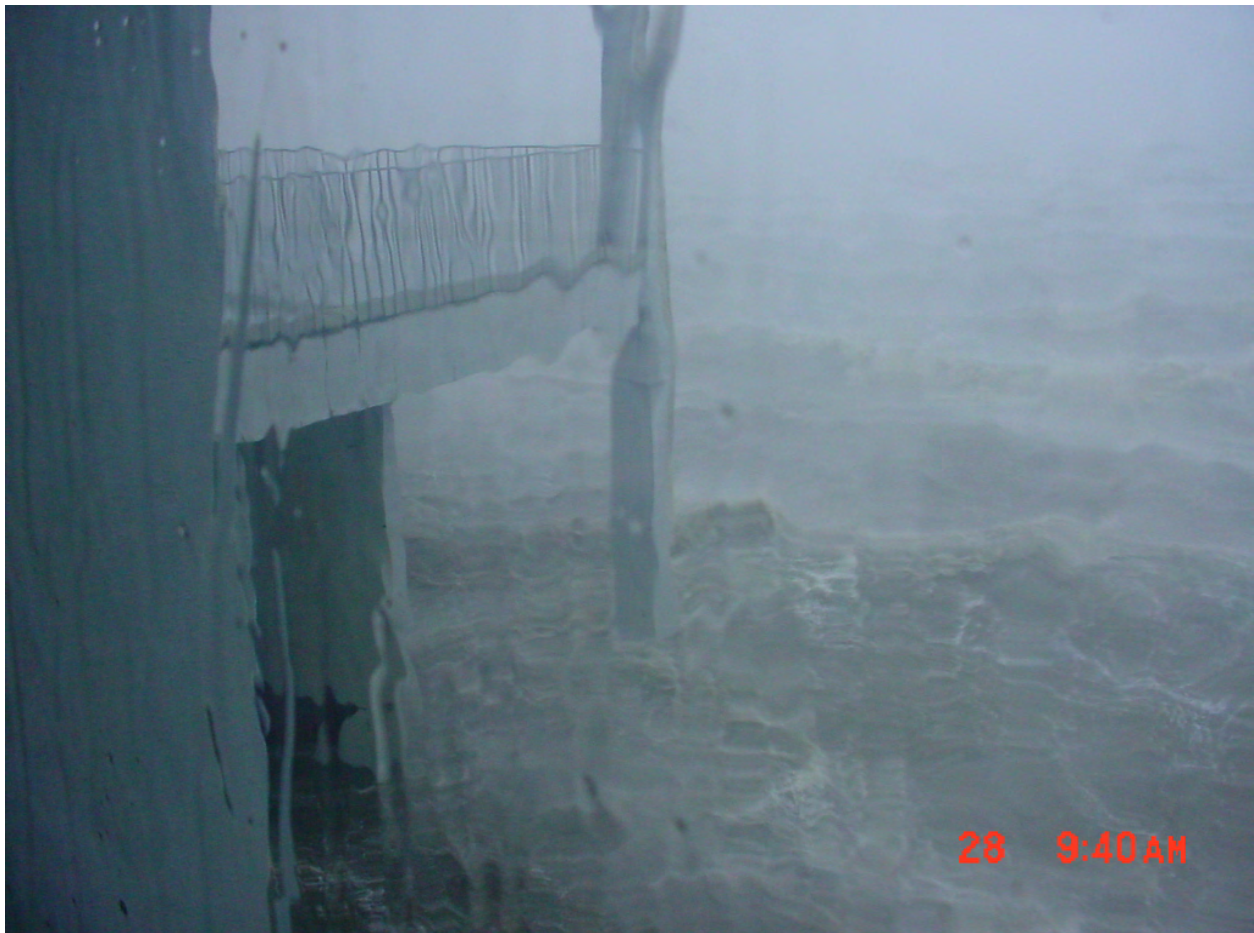
- e.* Time = 9:40 AM, APH-04, elevation 11.7 ft, Figure 1-38. On column outside northeast of lobby of terminal building. This mark was determined by measuring from the top of the metal rail to the bottom of the beam supporting the deck (a distance of 5.4 ft). The photograph was used to scale this distance in the photograph to the distance from the bottom of the deck beam to the water level. The distance from the photograph was 9.6 ft and this location on the column was surveyed as 12.0 ft. This value must be adjusted because the actual distance from the location of the camera and the 5.4 ft measurement is less than the actual distance from the camera location to the 9.6 ft measurement. Based on site measurements, the distance from the camera to the center of the 5.4 ft measurement is 47.2 ft versus the distance from the camera to the center of the 9.6 ft measurement was 48.4 ft. The actual distance of the 9.6 ft scaled from the photograph is $9.6 \times 48.4 / 47.2 = 9.9$ ft. The location surveyed on the column should have been 0.3 ft lower resulting in an elevation of 11.7 ft. This was the only mark in the data set where the distance correction was felt to be important. The elevation of this mark has significant uncertainty because it is exposed to high wave activity (see Figure 1-38).

Figure 1-38. Time = 9:40 AM, APH-04. Water level on column northeast of lobby.

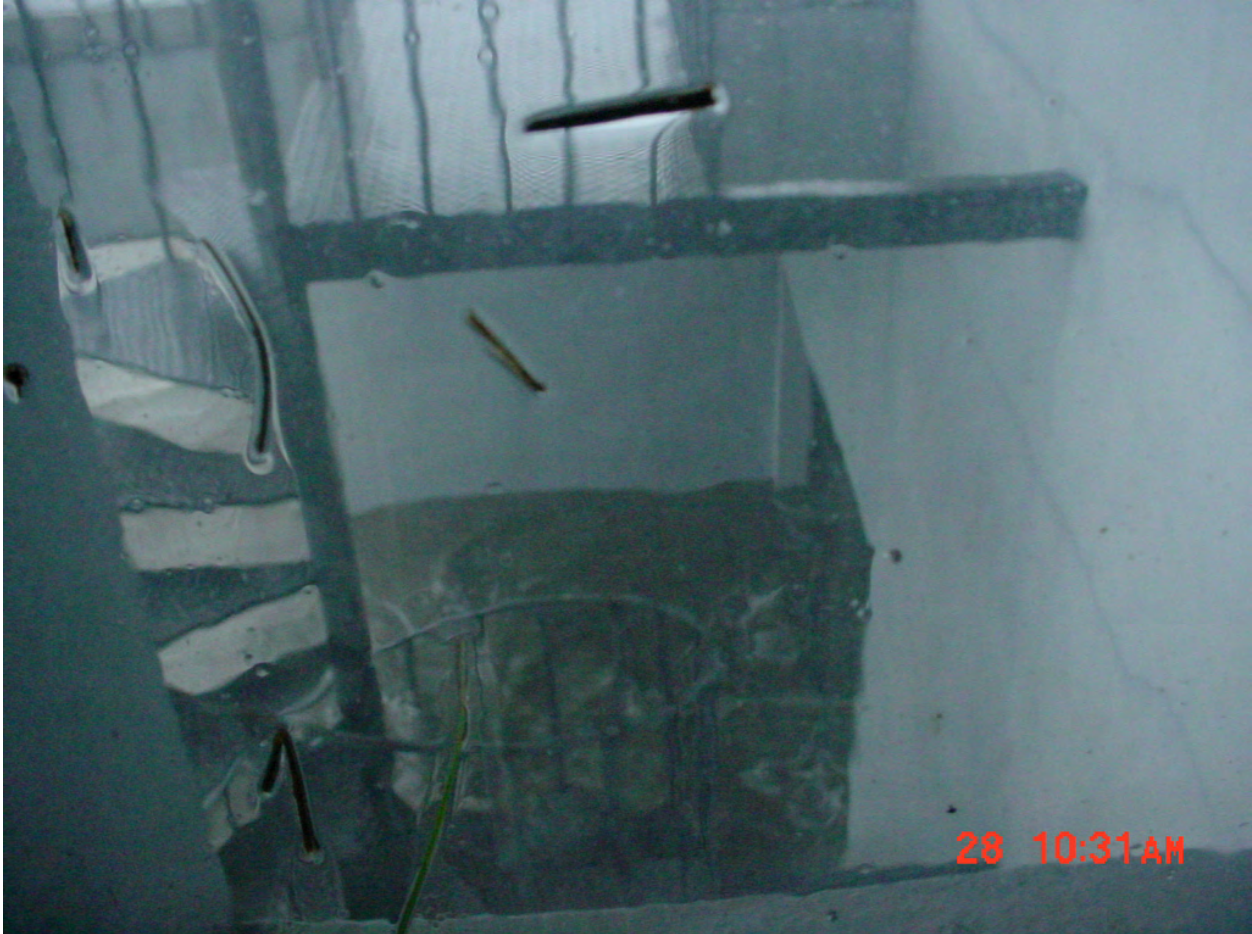
- j.* Time = 10:31 AM, APH-02, elevation 9.5 ft, Figure 1-43. On outside wall north of west spiral staircase. This mark is exposed to high wave activity. This mark was difficult to locate because the wall had no defined points to relate to the water level. One IPET member positioned himself in the window where the picture was taken and another IPET member placed his hand on the wall until his hand in the actual viewing and the water level in the photograph were at the same vertical position on the wall. This mark has significant uncertainty because of the method just described and the high waves present.

Figure 1-43. Time = 10:31 AM, APH-02. Wall north of west spiral staircase.

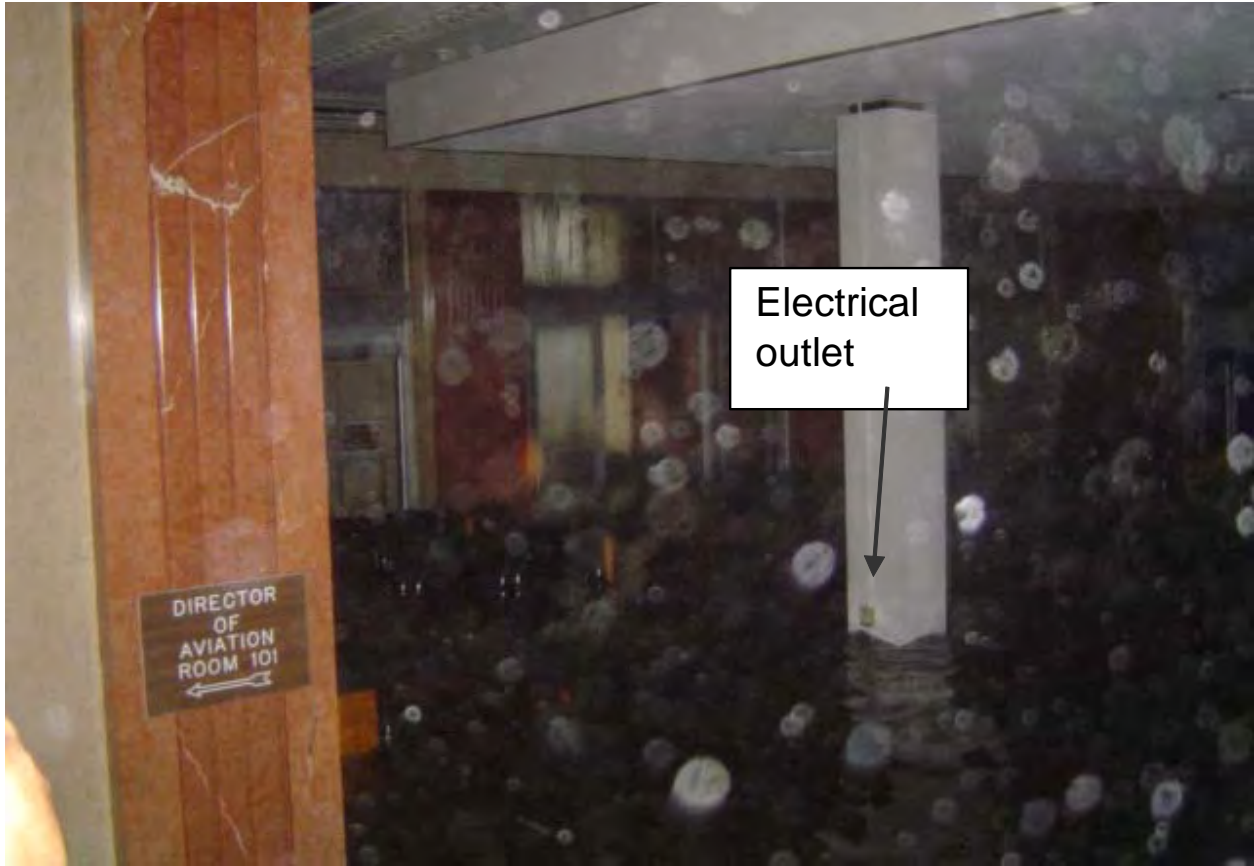
- k.* Time = 10:56 AM, APH-08, elevation 10.2 ft, Figure 1-44. Located on the column just below the electrical outlet in the lobby of the terminal building. The mark was determined by scaling from the photograph the height of the outlet and the distance from the bottom of the outlet to the water surface. The height of the outlet was measured at the airport and the ratio of the photograph measurements were used to position the mark. The broken doors on the north side of the building provided limited openings to this room that should have resulted in low wave activity and low uncertainty of this mark. Some wave action is apparent in Figure 1-44.

Figure 1-44. Time = 10:56 AM, APH-08. Column in terminal building lobby.

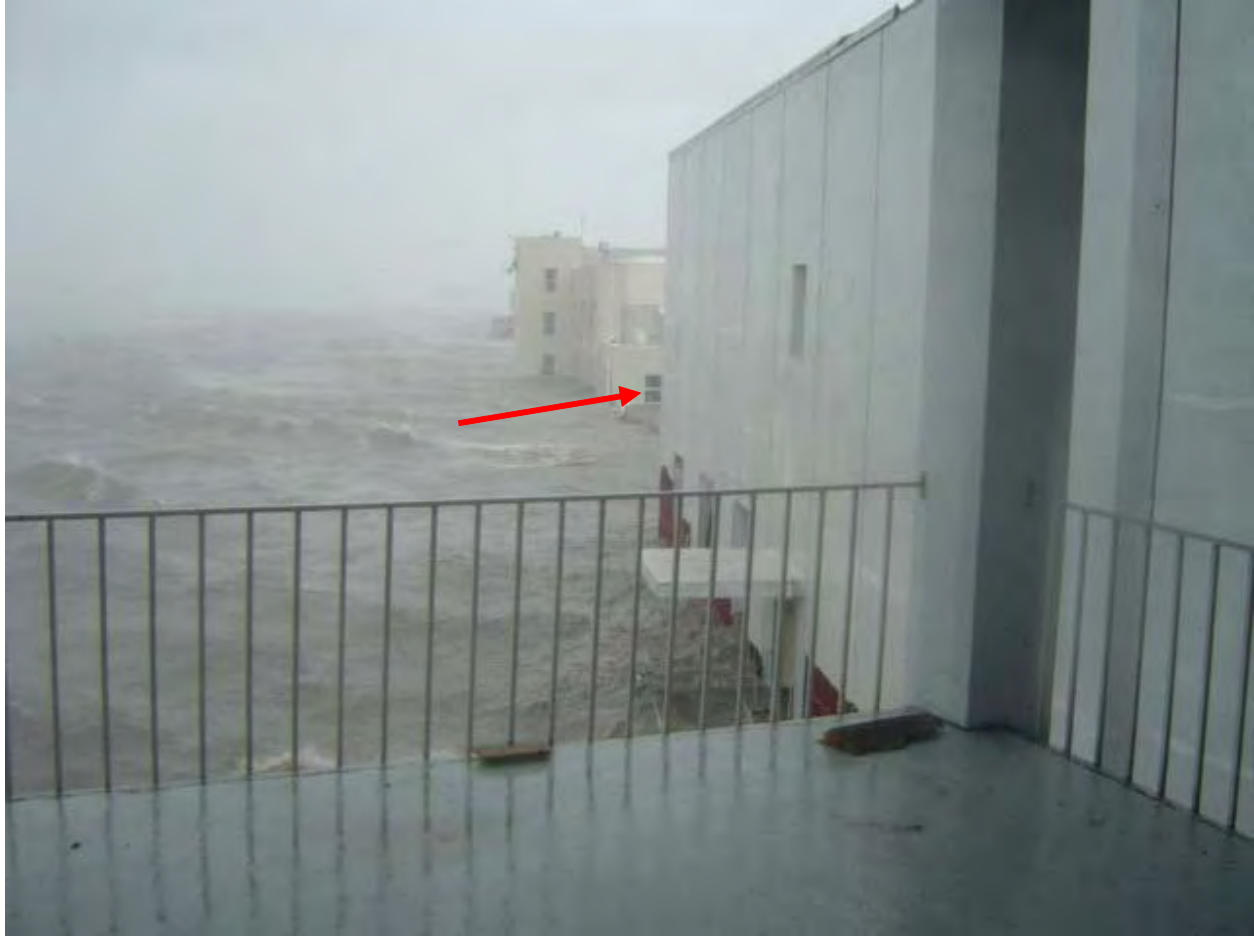
- m.* Time = 11:48 AM, APH-18, elevation 10.3 ft, Figure 1-46. On the west side of the building east of the terminal building, the water level is at the top of the lowest window.

Figure 1-46. Time = 11:48 AM, APH-18. Top of lowest window on building east of terminal building.

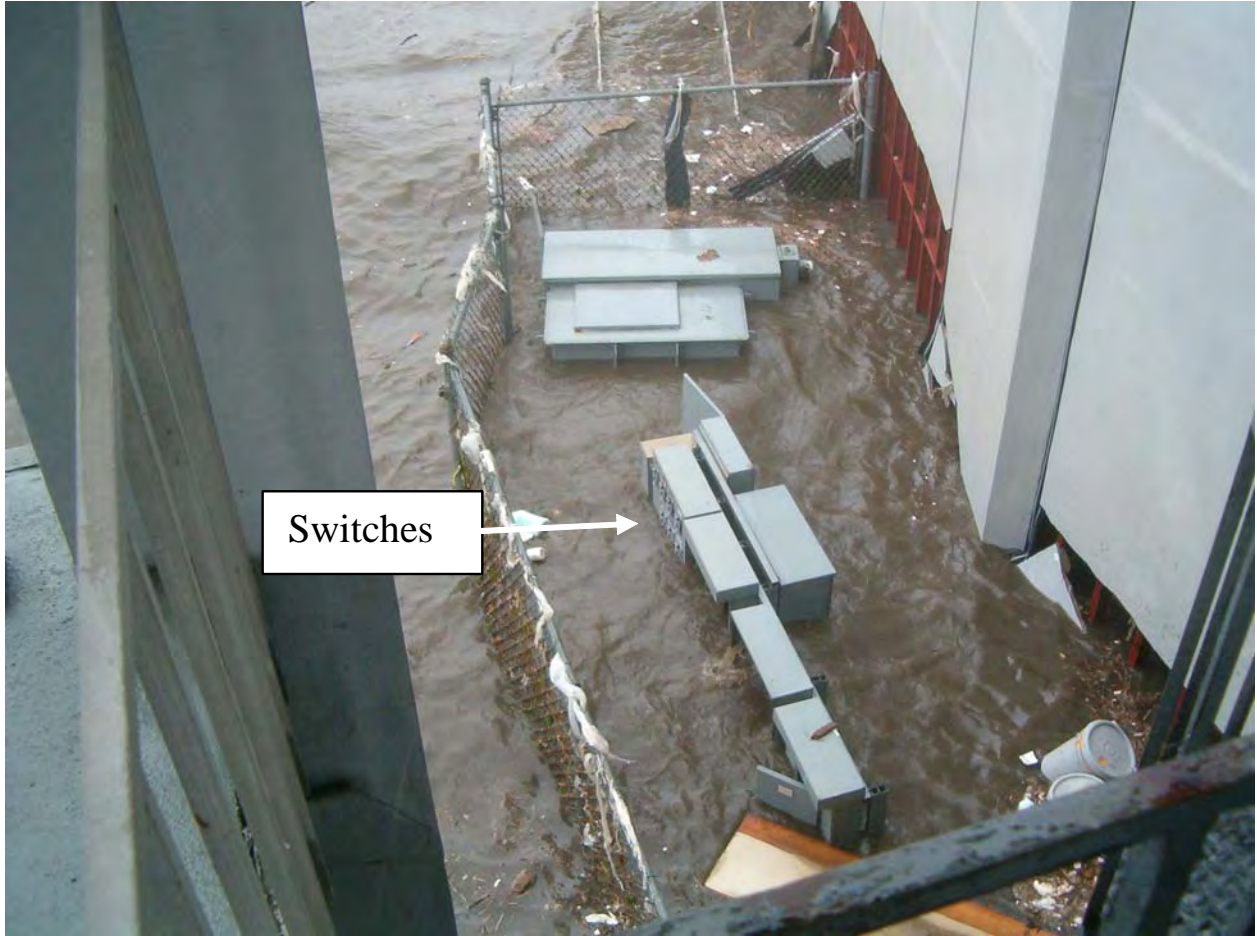
- n.* Time = 11:49, APH-06, elevation 9.7 ft, Figure 1-47. Inside the chain link fence of the north side of the building east of the lobby of the terminal building. By zooming the picture, the water level is just below the 2nd row of switches on the electrical box in the middle of the picture. The location of the switches on the north side of the airport building and the 11:48 AM picture in Figure 1-46 show this point is exposed to significant wave activity.

Figure 1-47. Time = 11:49 AM, APH-06. On switchbox in middle of picture.

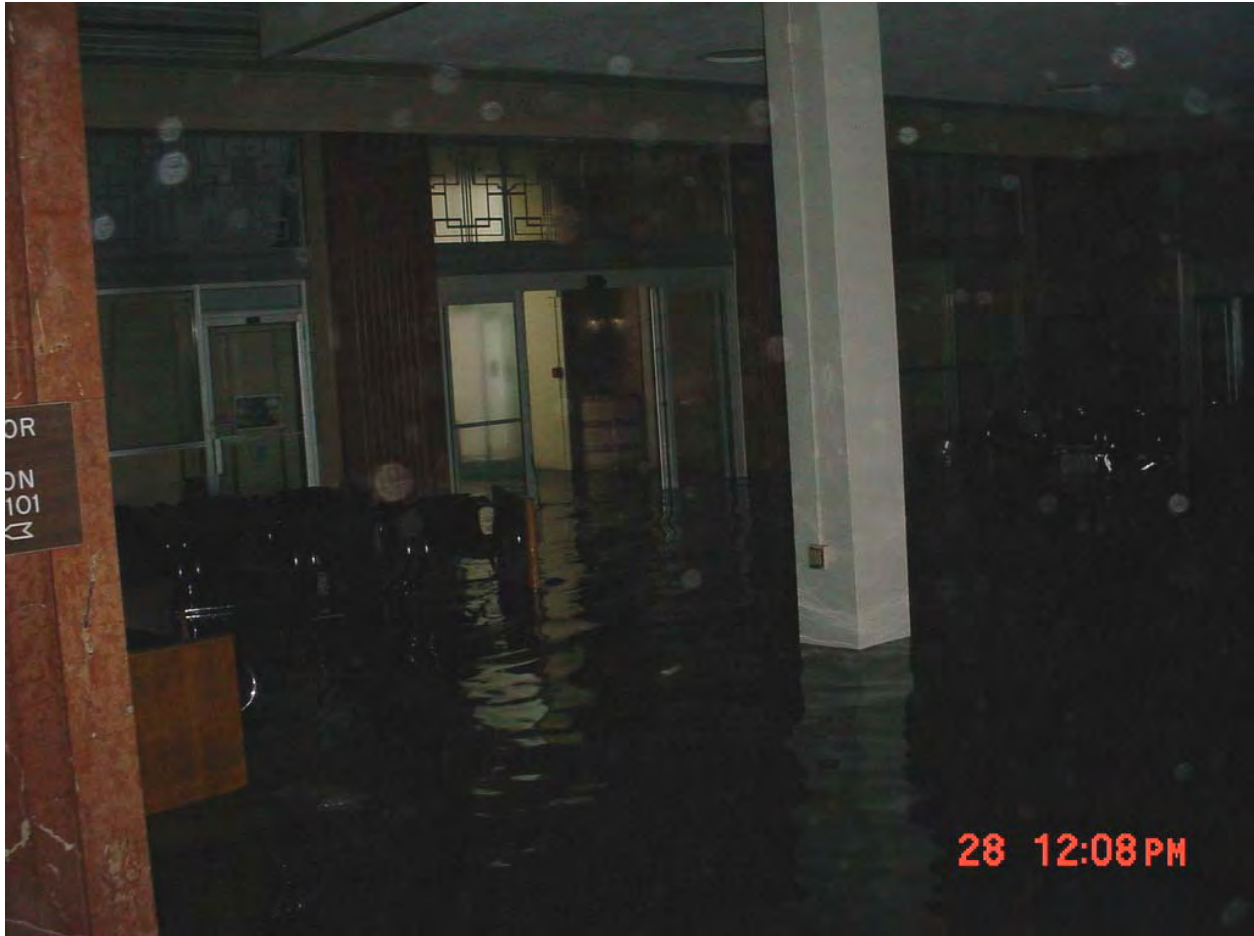
- o.* Time = 12:08 PM, APH-09, elevation 8.9 ft, Figure 1-48. Used technique described for APH-08. Since water depth over lobby floor of the terminal building was about 0.5 ft and the lobby has limited door openings, waves in the lobby should be minor and this point has low uncertainty. The water surface around the column in Figure 1-48 has less wave activity than the earlier time in Figure 1-44.

Figure 1-48. Time = 12:08, APH-09. On column in terminal building lobby.

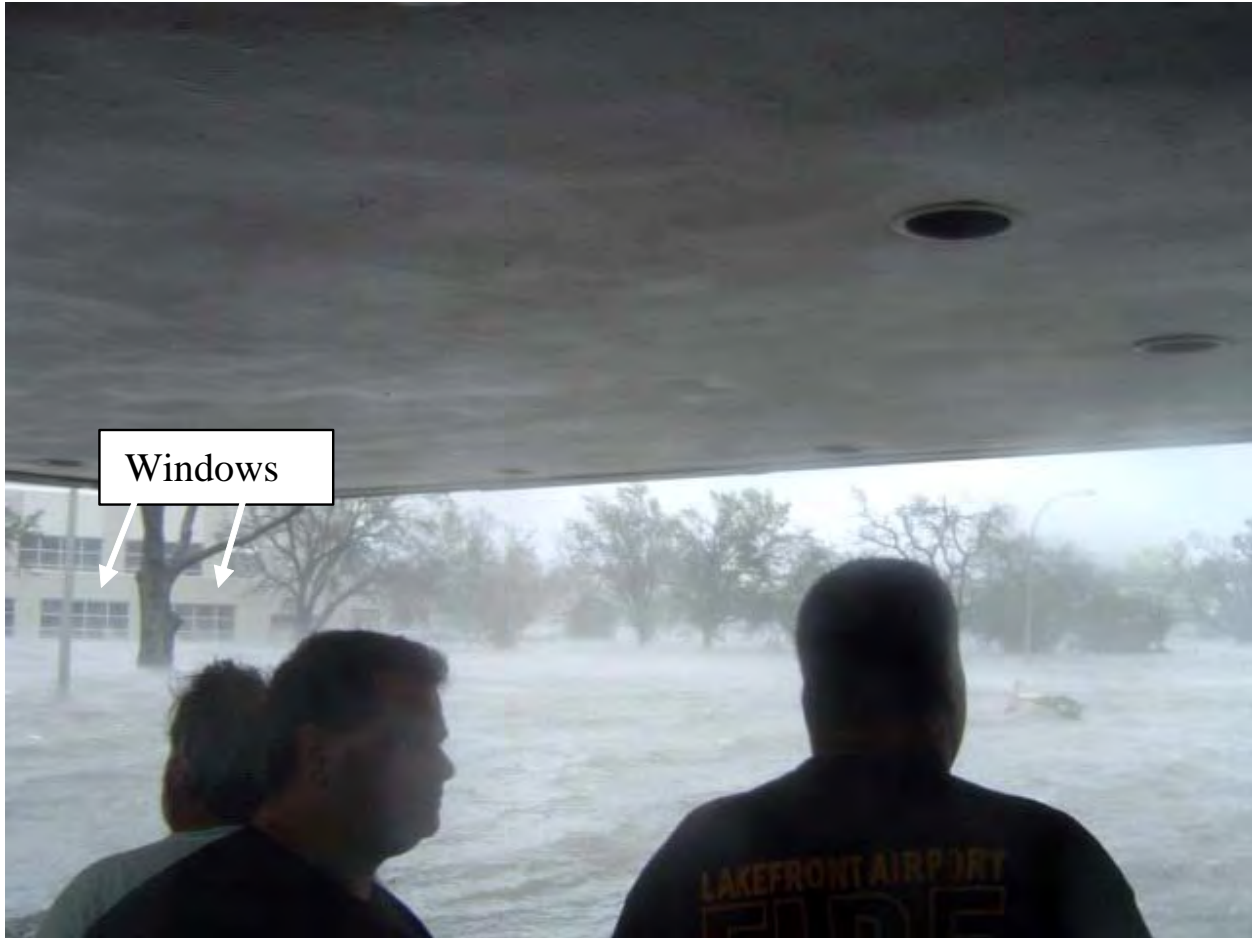
- p.* Time = 12:31, APH-19, elevation 8.8 ft, Figure 1-49. The left side of the photograph was zoomed to the windows on the building east of the airport. Mark to be surveyed was determined by scaling from the photograph the height of the window and the distance from the top of the lowest window to the water surface. The height of the window (2.5 ft) was measured at the airport and the ratio of the photograph measurements were used to position the mark. The size of the windows and the haziness in the photograph along with the wave activity cause significant uncertainty in this mark.

Figure 1-49. Time = 12:31 PM, APH-19. Windows on building just east of terminal building.

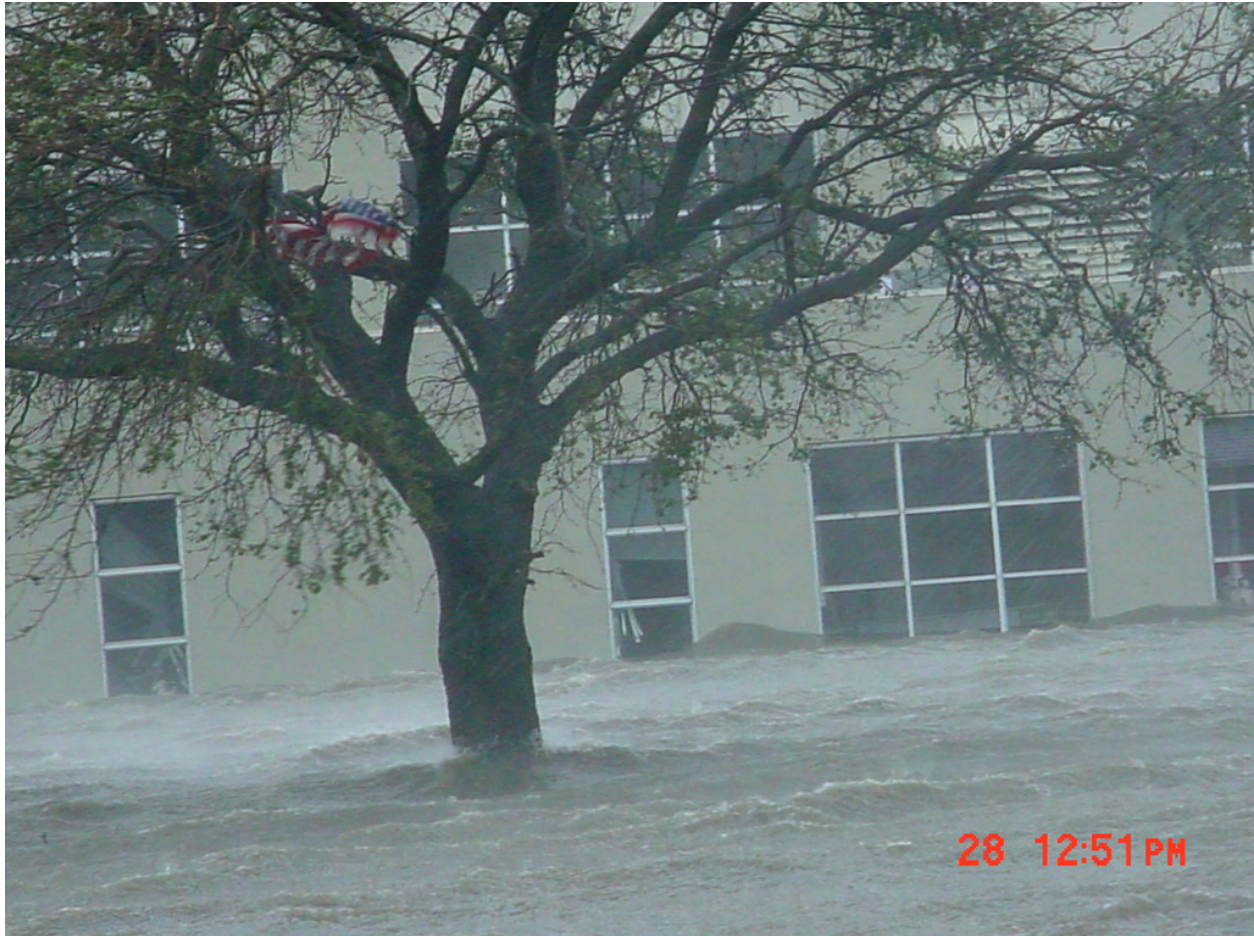
- q.* Time = 12:51 PM, APH-13, elevation 8.3 ft, Figure 1-50. Mark is on the windows on the building east of the terminal building. The mark to be surveyed was determined by scaling from the photograph the height of the window and the distance from the top of the lowest window to the water surface. The height of the window (2.5 ft) was measured at the airport and the ratio of the photograph measurements were used to position the mark which was 2.0 ft below the top of the lowest window. Even though wave activity is present, the water level can be determined at several windows that results in low uncertainty in this mark. The good agreement of this mark and the best fit line presented subsequently supports the validity of the assumed timing on the FDMAVICA camera.

Figure 1-50. Time = 12:51 PM, APH-13. Windows on building east of terminal building.

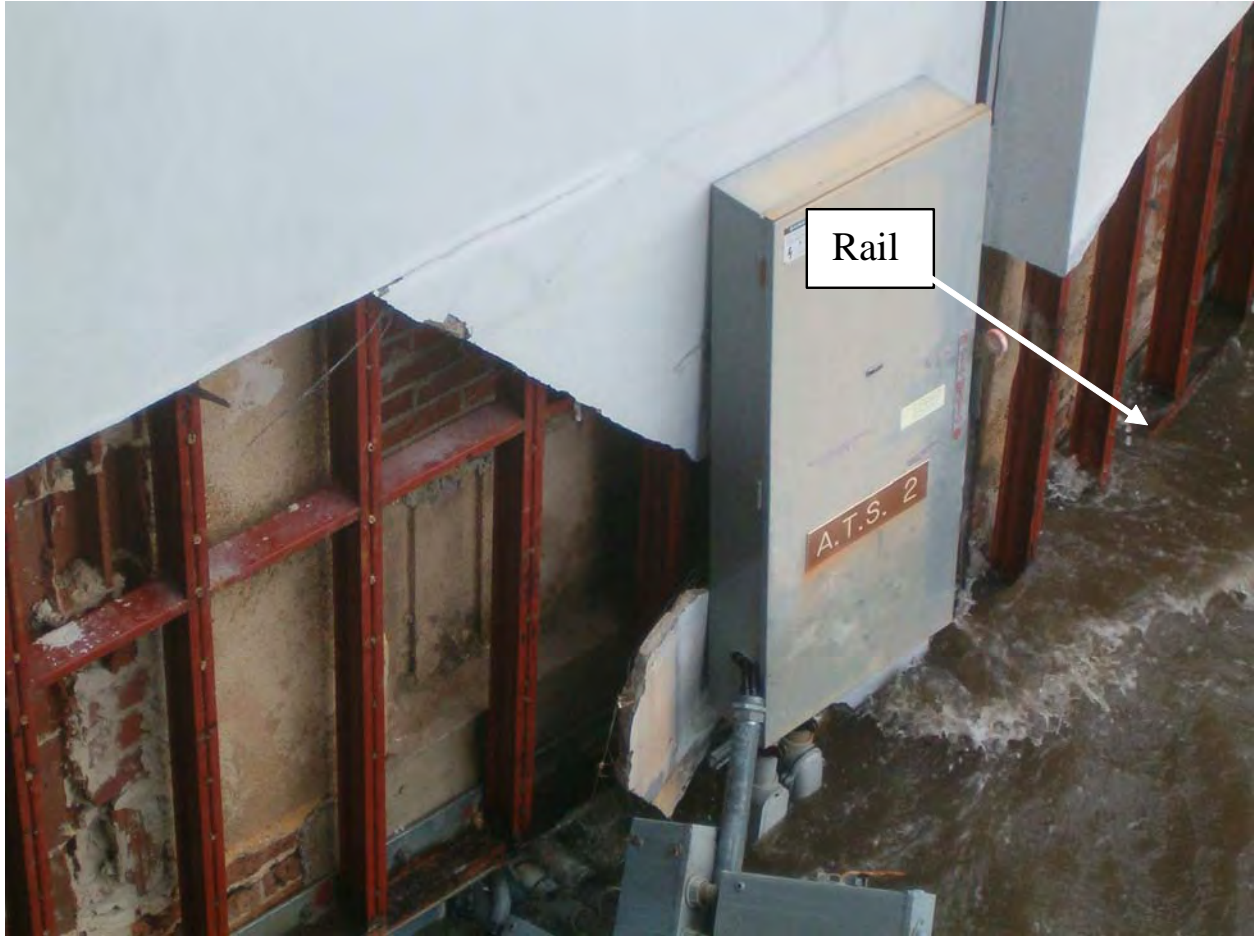
- t. Time = 5:30 PM, APH-11, elevation 7.4 ft, Figure 1-53. Located on north side of terminal building, west of lobby. Water level is at horizontal framework just to the west or right of the electrical panel box. Wave activity was low.

Figure 1-53. Time = 5:30 PM, APH-11. Bottom of horizontal rail to right of electrical panel box on north side of terminal building, east of lobby.

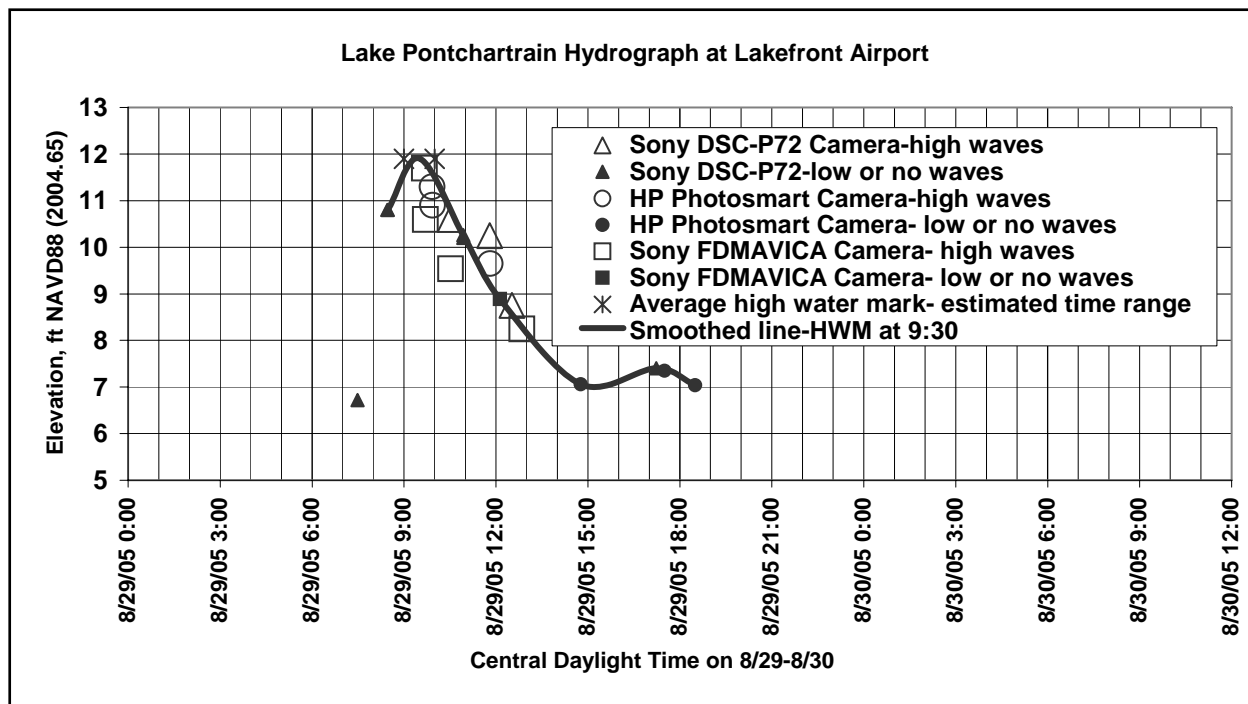
Figure 1-55. Constructed hydrograph at Lakefront Airport. Note that the point at 7:28 AM is not considered representative of Lake Pontchartrain because of relatively high topography around airport building (elevated runways) and is not included in the smoothed line of the hydrograph. The recession side may also have some of this effect but the lower rate of fall may reduce the impact.

Hydrograph Plot. The above data was used to construct a hydrograph as shown in Figure 1-55. Solid points are used to signify points with little or no wave effects. Larger open data points are used to signify points with significant uncertainty in elevation due to factors such as wave effects. Note that these open symbol points can be either high or low estimates of storm surge depending on the timing of the photograph relative to the wave crest or trough. The time of the high water mark in Figure 1-55 is based on extrapolating the digital photograph points along the recession of the storm surge up to a level of 11.9 ft while considering the 8:28 time of the two points at 10.8. The resulting time of peak storm surge is between 9:00 and 10:00. The smoothed line hydrograph is shown with a time of 9:30 AM on the plot. Due to the rapid rise of the storm surge and the presence of the runways and other high topographic features, the data at 7:28 AM should not be used in developing a hydrograph to represent levels in Lake Pontchartrain. The recession side of the hydrograph may have some effects of the high topography but the lower rate of fall may reduce these effects.
