Appendix 1

Hydrograph and High Water Mark Analysis

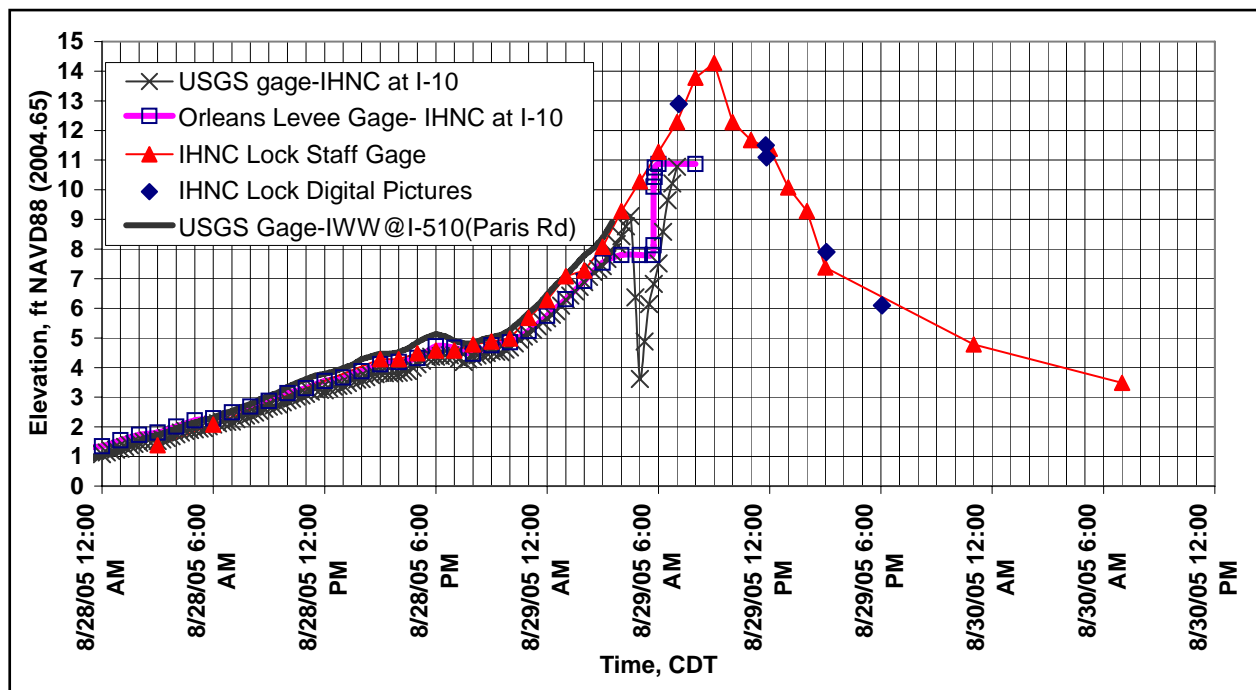
Recorded Hydrographs at IHNC Lock. Figure 1-56 shows a plot of data from two self-recording gages at I-10 on the IHNC, a self-recording gage at Paris Road (I-510) on the MRGO, staff gage readings at the IHNC Lock, and water levels derived from digital pictures taken at the IHNC Lock. Each source of data in Figure 1-56 is described in the following paragraphs.

Figure 1-56. Hydrographs on the IHNC.

As shown in Figure 1-56, the USGS gage at I-10 on the IHNC (1-65) experienced a 5 ft drop in stage at about 4:30 AM on August 29 when the stage was about 9.5 ft. At first, this drop was interpreted to mean that a breach on the IHNC occurred at this time but most people doubted that the water level dropped 5 ft. Figure 1-64 shows that the white PVC pipe holding the USGS gage has a top elevation of about 9 ft on the staff gage. The larger PVC pipe is the OLD gage. The electronic cable holding the USGS pressure transducer inside the PVC pipe is exposed above the top of the pipe. One possible explanation of the 5 ft drop is that the high velocities through the railroad/I-10 bridge opening, along with debris, snagged the cable and pulled the transducer up out of the pipe giving it an apparent drop in water level. The OLD gage is a float gage and experienced identical 7.8 ft readings at 4:00 AM, 5:00 AM, and 5:40 AM followed by a rapid rise in 8 minutes to about 10.9 ft. The 10.9 ft reading is in agreement with the IHNC Lock readings. The constant readings followed by the rapid rise is consistent with a float gage that became stuck. Whether the OLD gage got stuck or the level readings indicate the time of a breach is unknown. Because the OLD and USGS gages are within 10 ft of each other, the difference in water levels after about 4:30 raises concerns about readings on both gages.

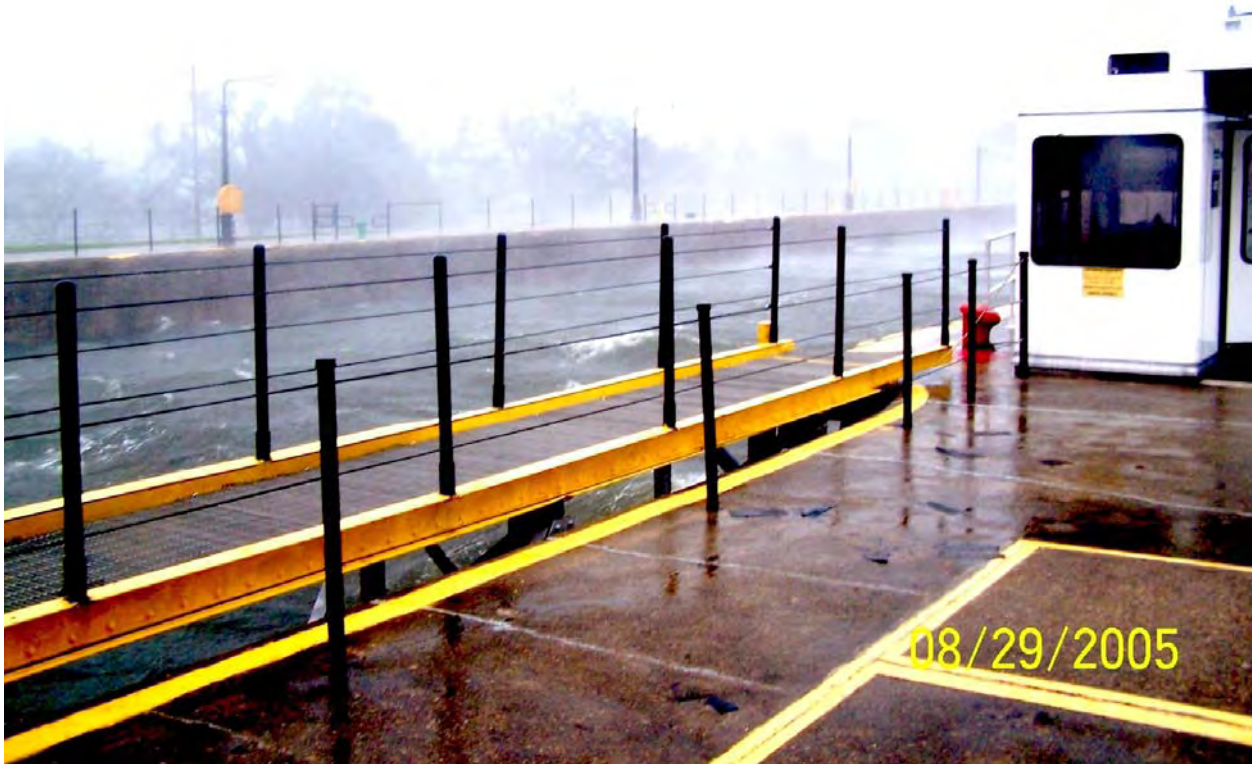
- a. File time 7:06 AM, Picture 100_0498, Figure 1-59, looking southeast. Water level was based on distance below top of lockwall on east side of lock. Top of lockwall surveyed at 19.9 ft. Used height of post (3.55 ft) and height of top of yellow box (5.56 ft) to scale down to water surface at 4 points along wall. Distances below top of wall were 6.6 ft, 7.8 ft, 7.1 ft, and 6.5 ft for an average distance of 7.0 ft and a water level of 12.9 ft. The range of water level of 1.3 ft provides some information about wave height along the wall.

Figure 1-59. Time 7:06, file 100_0498. Picture brightness and contrast adjusted to show water level. Looking southeast.

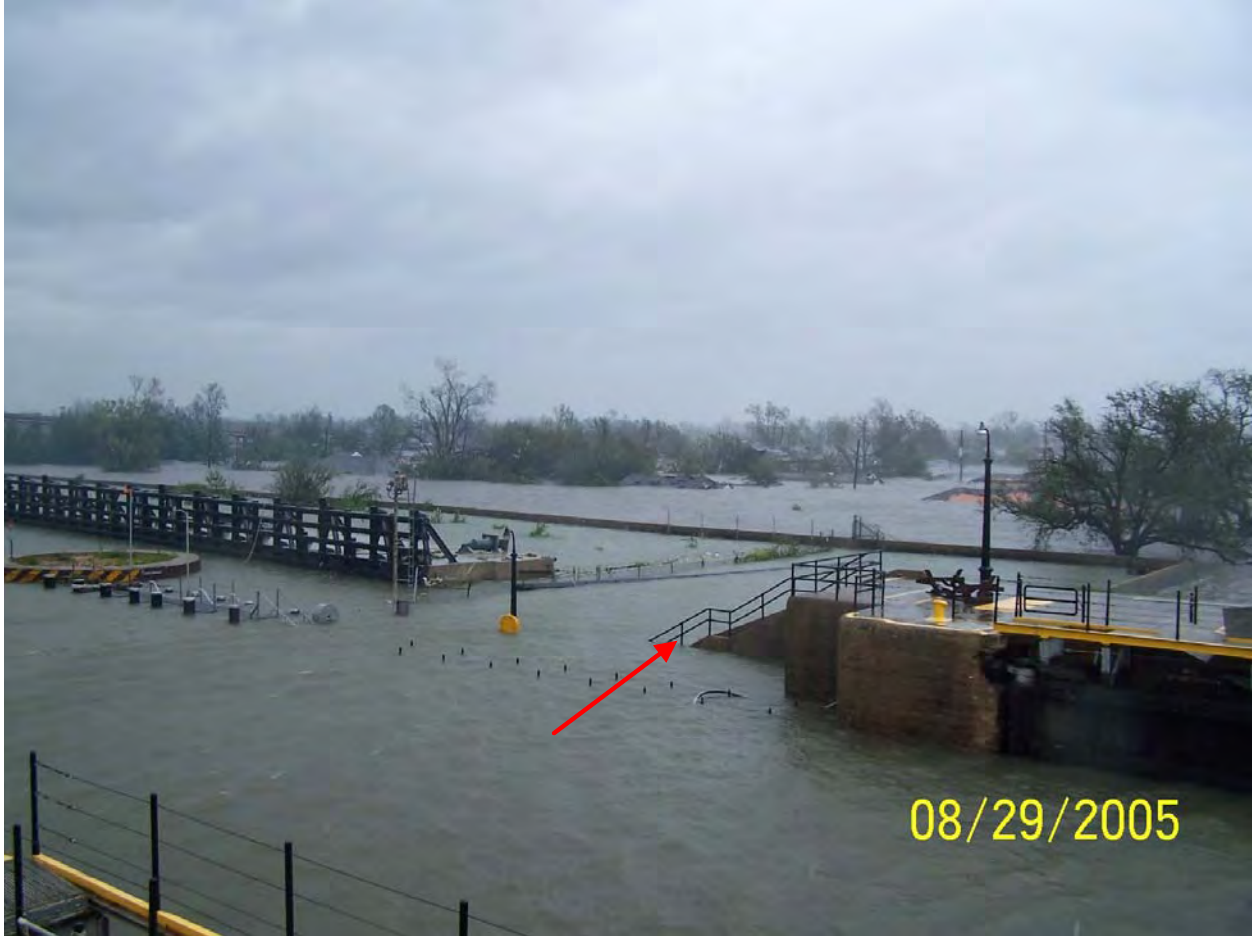
- b.* File time 11:47 AM, Picture 100_0502, Figure 1-60, looking east-northeast into Lower Ninth Ward. Water level at location of sloping handrail. Elevation = 11.5 ft.

Figure 1-60. Time 11:47, picture 100_0502. Red arrow shows location surveyed. Looking east-northeast into Lower Ninth Ward.

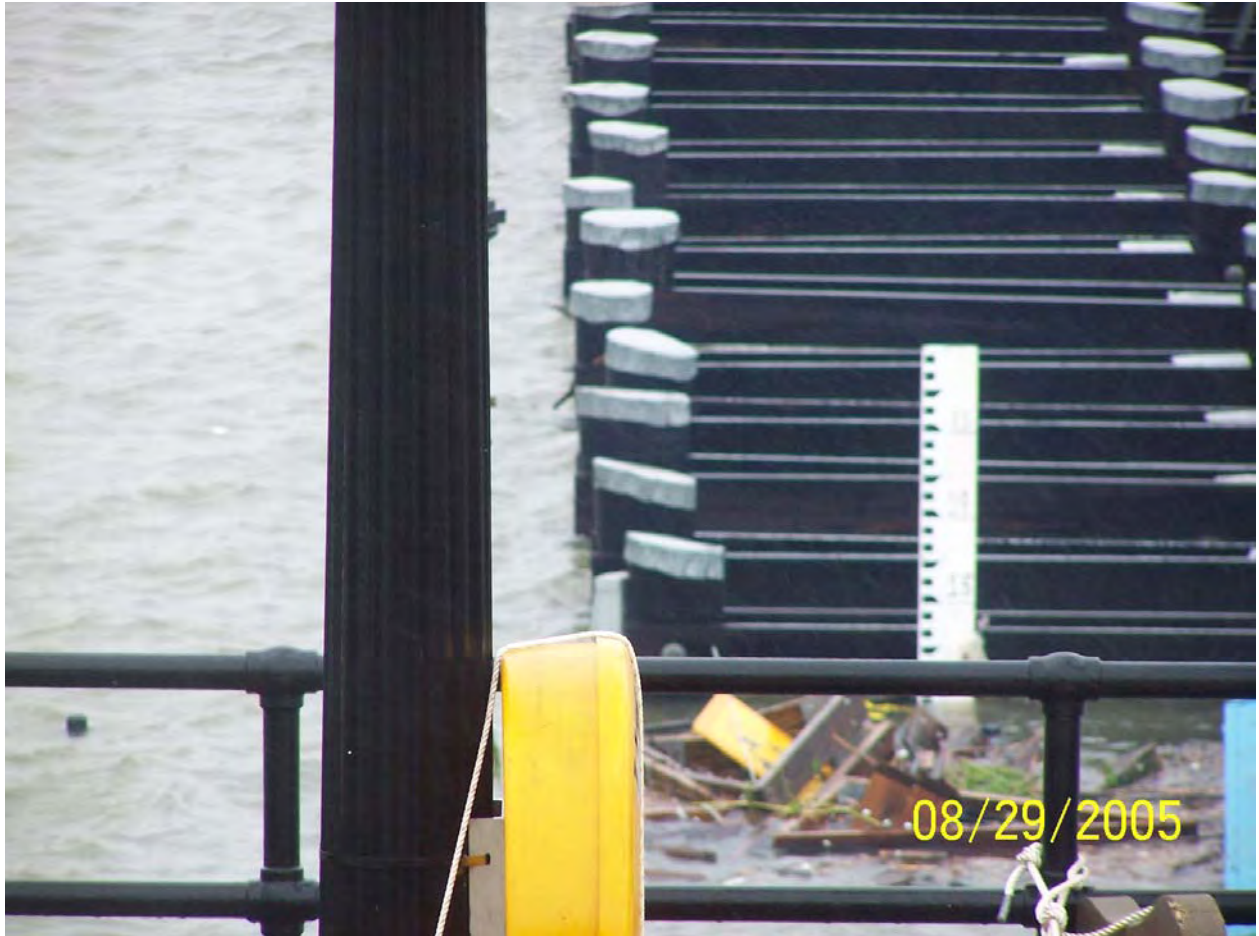
- c.* File time 11:50 AM, picture 100_0507, Figure 1-61, looking north. Shows staff gage where water level is almost hidden by handrail. Using other objects in the picture such as tops of handrails, the staff gage reading is 11.8 ft, that is an elevation of 11.1 ft.

Figure 1-61. Time 11:50, picture 100_0507, looking north.

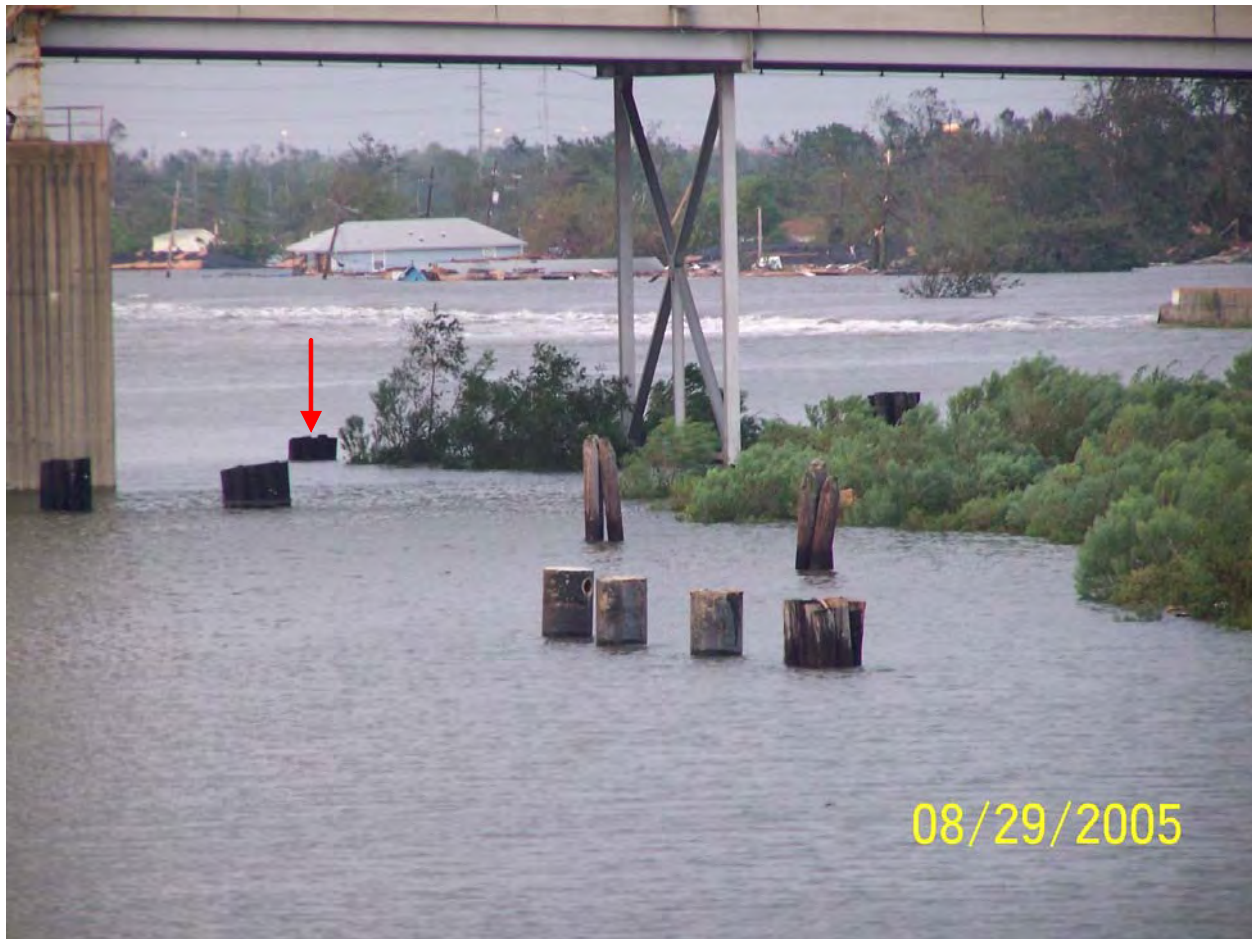
- e.* File time 6:03 PM, Picture 100_0509, Figure 1-63, looking northeast into Lower Ninth Ward. Top of highest pile in cluster under arrow is at elevation 8.7 ft. Based on width of pile cluster of 4.8 ft, water level is 2.6 ft below top of highest pile for an elevation of 6.1 ft.

Figure 1-63. Time 6:03 PM, file 100_0509. Breach on east side of IHNC in background. Looking northeast into Lower Ninth Ward.

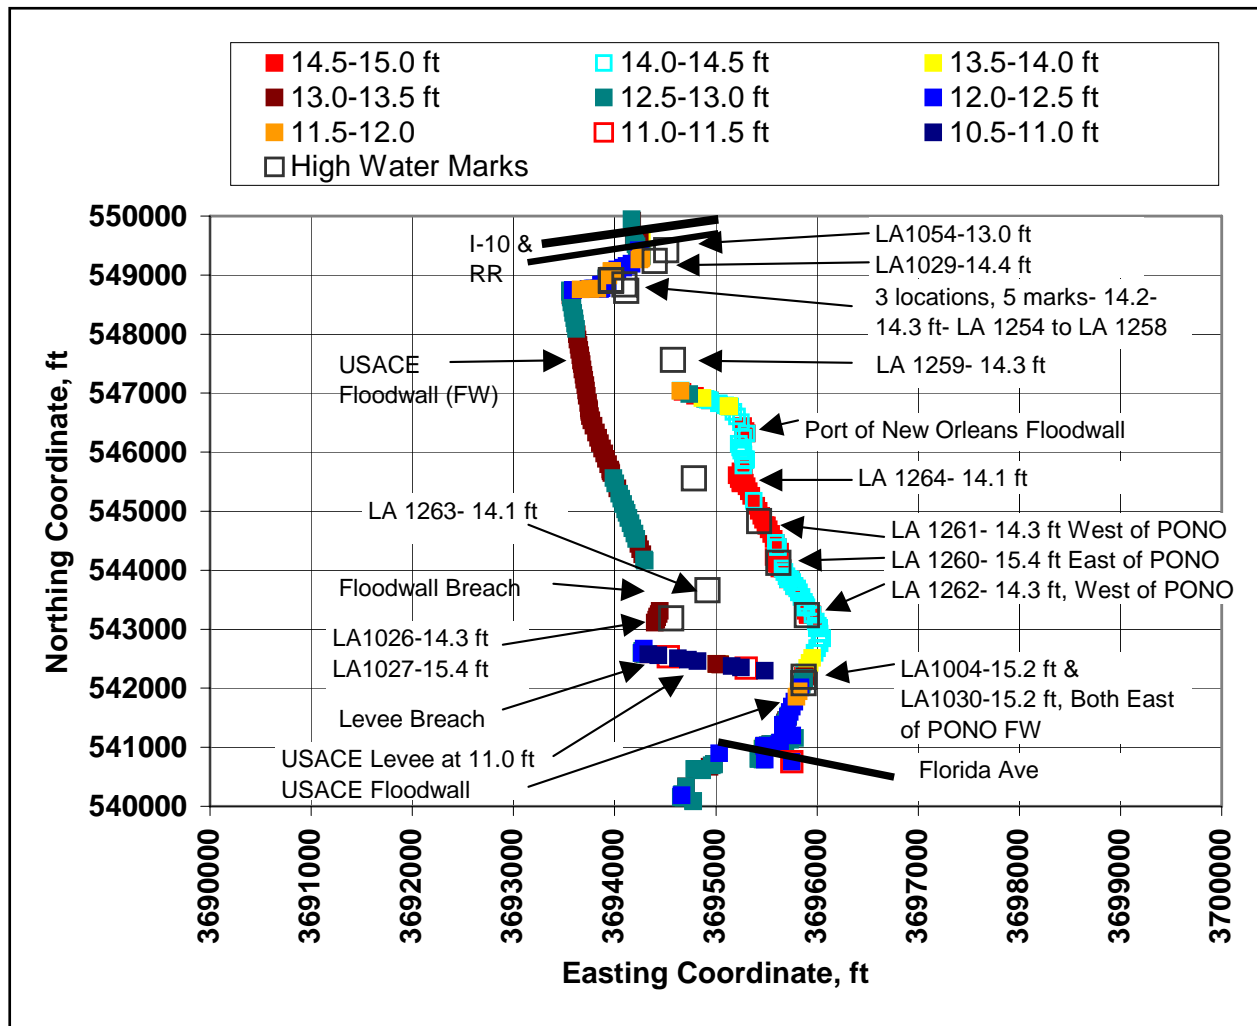
Figures 1-65, 1-66 and 1-67 show high water marks and a layout of the USACE protection along the west side of the IHNC. Figure 1-66 shows the layout of the PONO floodwall. On Figure 1-66 at the railroad south of I-10 on the west side is the floodwall opening that was

sandbagged prior to Katrina and failed sometime during Katrina. High water mark LA 1054 at 13.0 ft is close to this opening and may have been affected by the sandbag failure. The other marks in this area of 14.2-14.4 ft are believed to better represent water levels immediately south of the railroad bridge just south of the I-10 bridge. The railroad bridge was in the down position during Katrina. High water marks on the north and south sides of the railroad bridge show about a 1.5 ft drop in water level across the bridge. Evidence on the ground (Figure 1-68) showed vegetation laid down indicating high velocity through the I-10/railroad area of the IHNC.

Figure 1-66. Floodwall layout, wall elevations, and high water marks along the west side of IHNC, I-10 to Florida Avenue railroad bridge.

One location west of the PONO floodwall has a single high water mark (LA 1027) that does not agree with the other high water mark data (See Figure 1-66). Mark LA 1027 is also shown on Figure 1-70 at latitude 29.987. Mark LA 1027 at elevation 15.4 ft is located in the same building as LA1026 at elevation 14.3 ft. Neither mark is a well-defined seed/debris line as are the other

marks in this area. Both marks are based on debris in the rafters of a heavily damaged building that is close to the floodwall and levee breach on the west side of the IHNC. Both LA 1026 and LA 1027 were described as possibly low. Subsequent visits to this building by other IPET members has not resolved the peak water level in this building. The agreement of LA 1026 at elevation 14.3 ft with 4 other marks west of the PONO is the reason LA 1027 is not accepted.

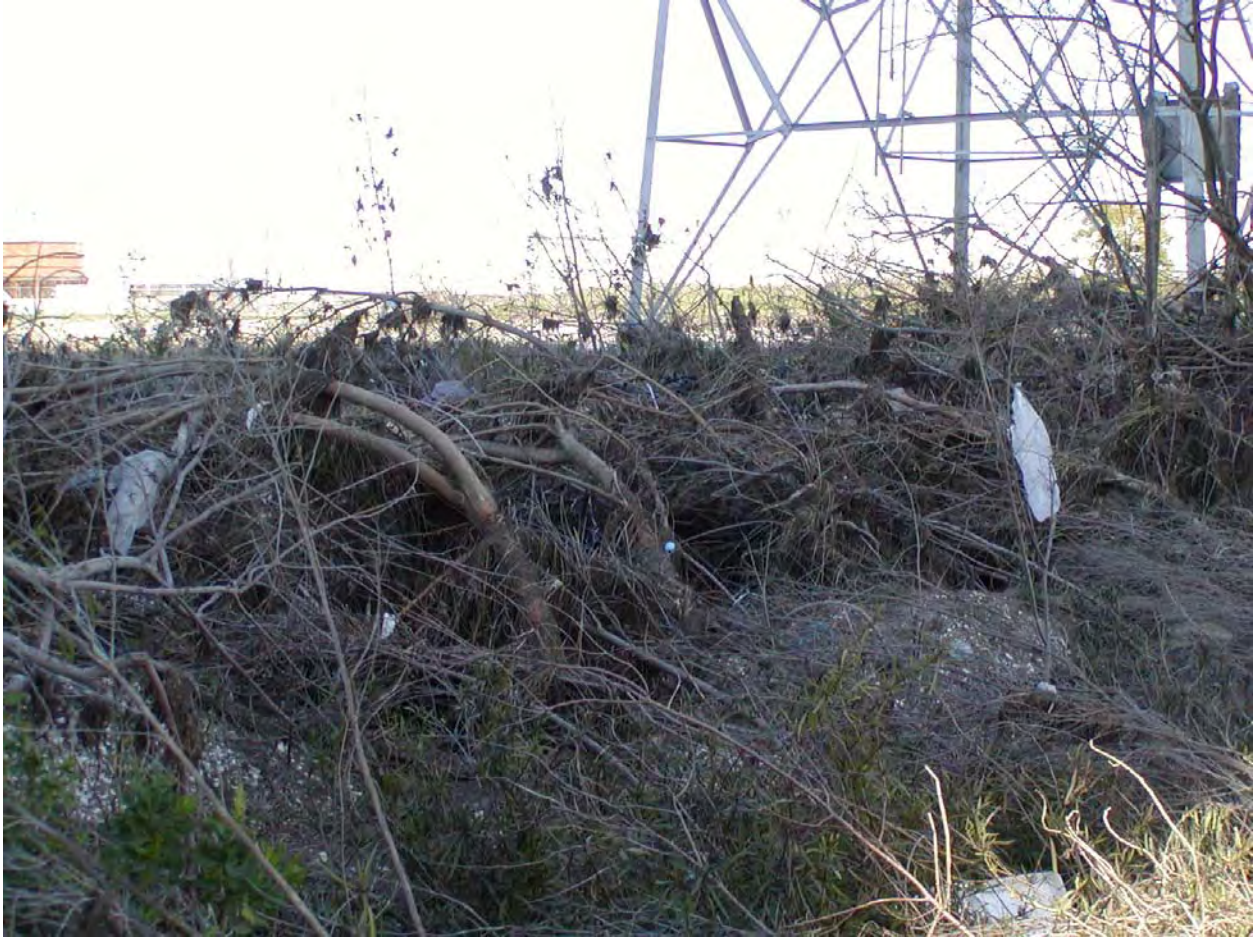
Figure 1-68. Vegetation at I-10 laid down in a northerly direction by flow in IHNC.

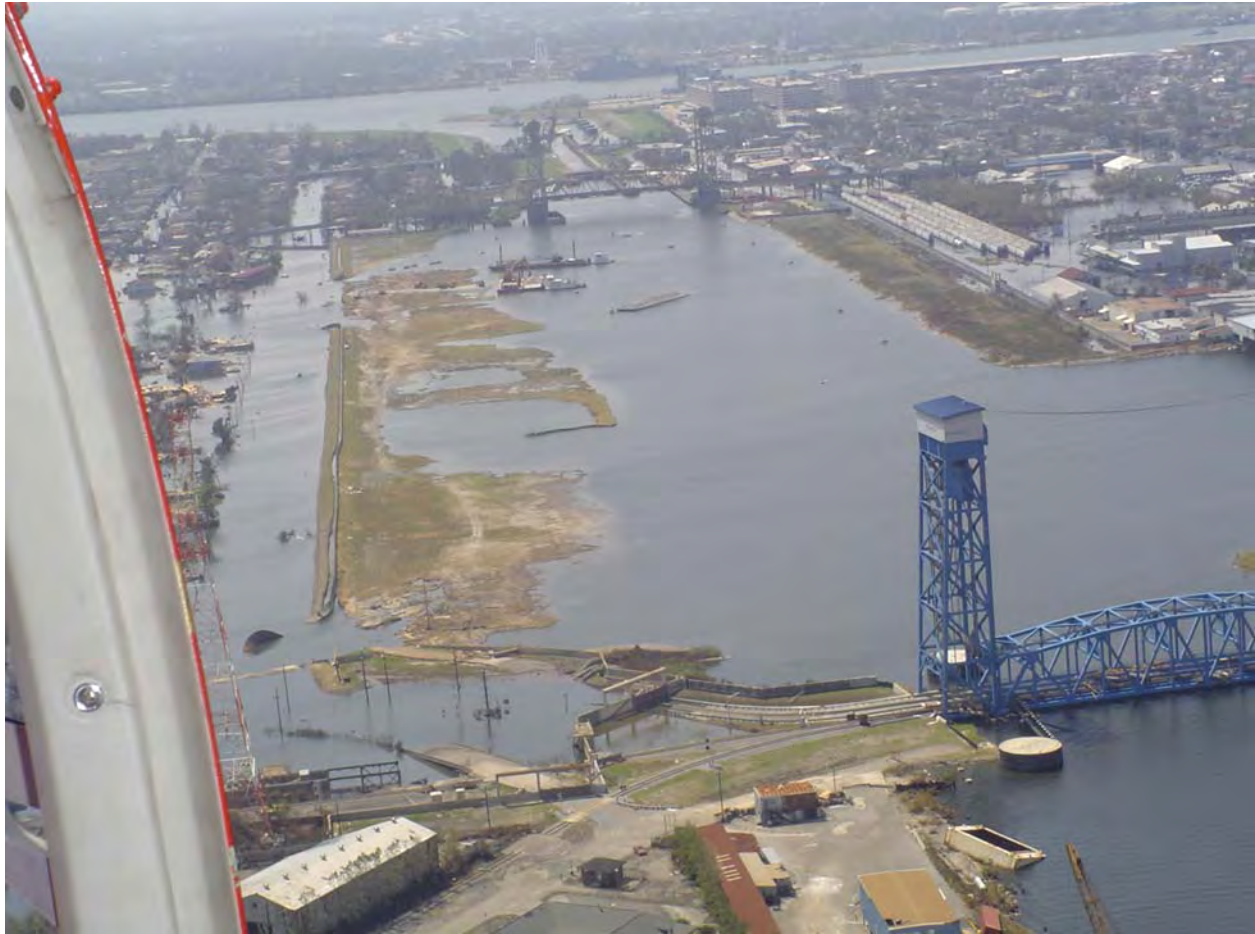
during the storm. Figure 1-69 shows the Florida Avenue Railroad bridge (blue bridge in foreground) in the down position on 7 Sept 05.

Figure 1-69. Florida Avenue railroad bridge (blue), two breaches on east side of IHNC into Lower 9th Ward, and IHNC lock at top of picture. Picture looking south-southwest. Note debris on railroad bridge.

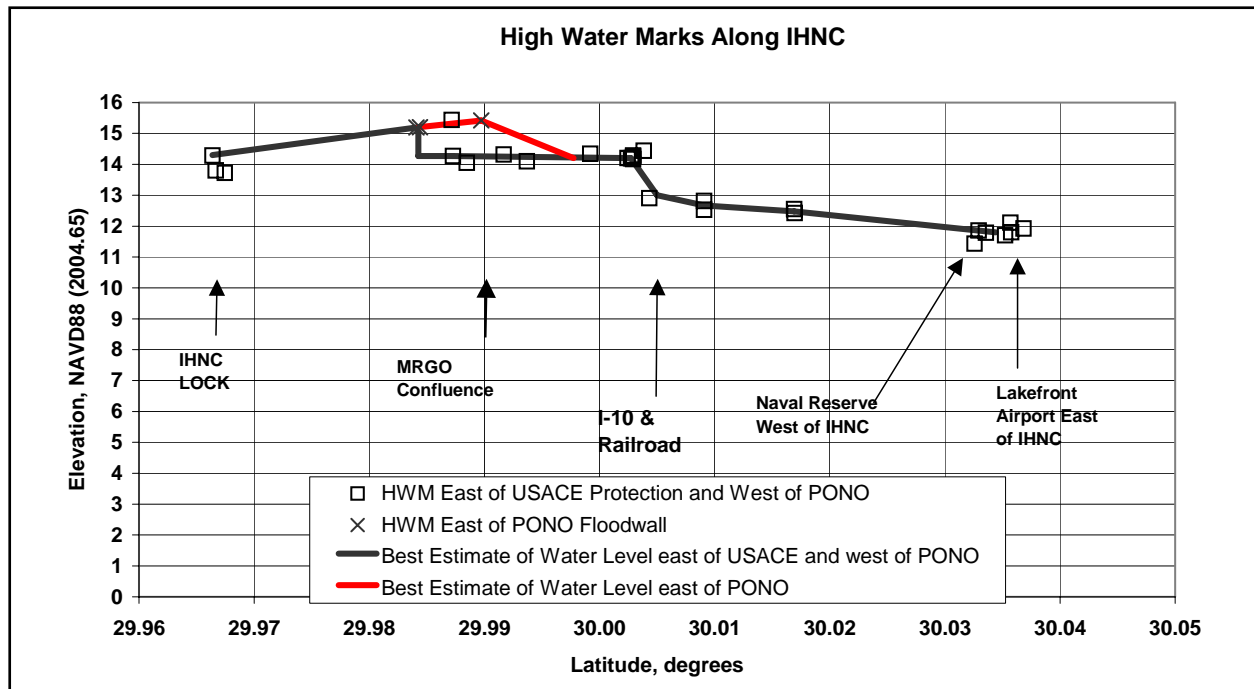
Figure 1-70 shows the variation of peak water level along the IHNC based on high water marks. Note that the area west of the PONO that experienced a levee and floodwall breaches is shown to have experienced a peak water level of about 14.2 to 14.3 ft. On the east side of the PONO, peak water levels were up to 15.4 ft at the junction of the MRGO. The difference in peak water level across the PONO floodwall is likely due to (1) the 1600 ft long east-west earth levee on the west side of the PONO that was at an elevation of about 11.0 ft and (2) USACE floodwall overtopping all along the reach west of the PONO.

Figure 1-70. Variation of peak water level along IHNC based on high water marks. Red line is Port of New Orleans (PONO) Floodwall that is not complete and is not tied in to the USACE protection on the north end.

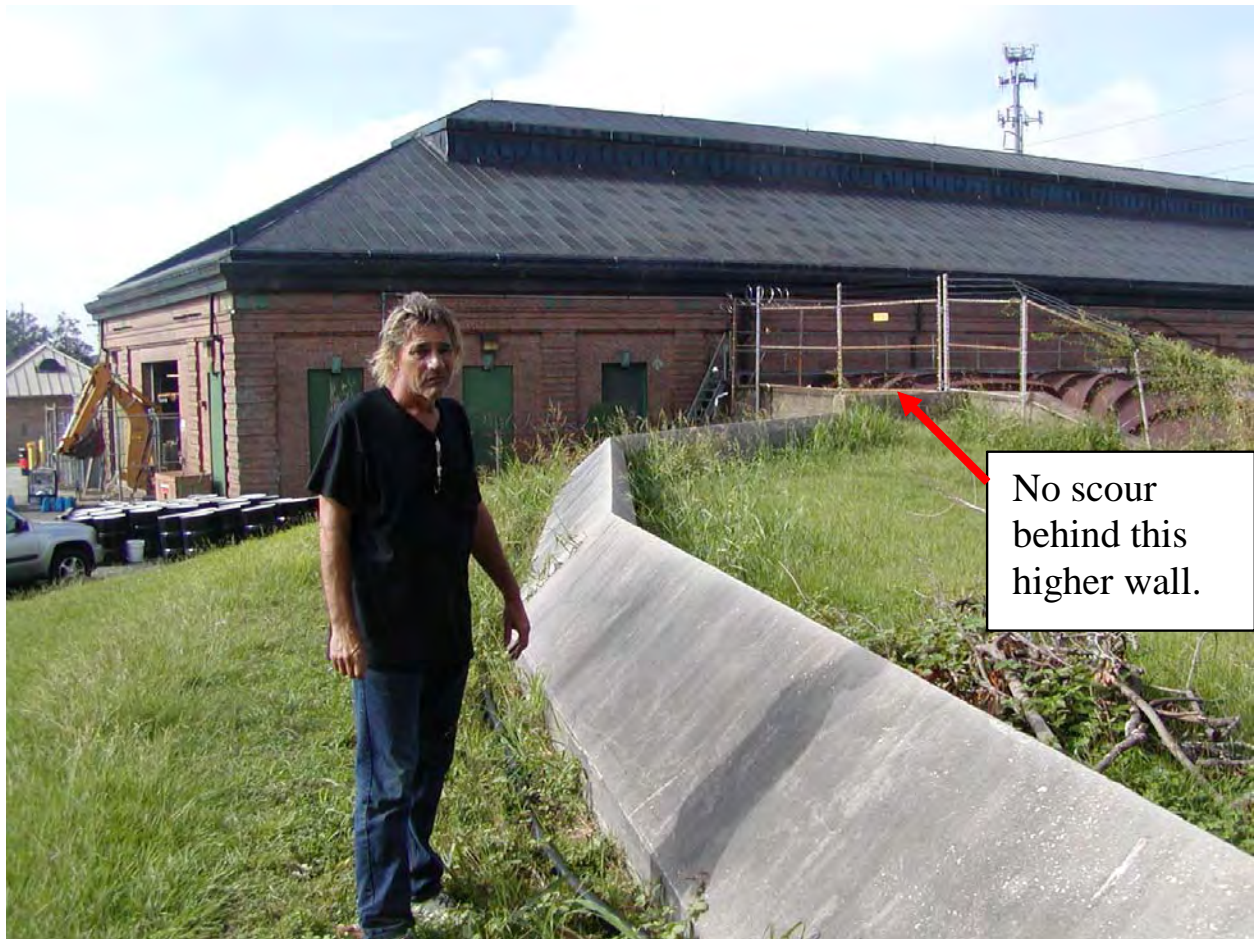
An operator who stayed at pump station OP#7 during the storm was interviewed on 9/29/05. Figure 1-71 shows the low pump station wall that connects OP#7 to the floodwall. Figure 1-72 shows a picture of the low wall, the earth levee, and the south end of the east floodwall. Figure 1-73 shows the low wall looking south towards the pump station. Figure 1-74 shows the layout of the wall around the station along with elevations. The low pump station wall is at about elevation 9.7 ft. The floodwall north of OP#7 is at elevation 14.0 ft. The earth levee on the east side connecting the low wall to the floodwall is at about elevation 8.3-8.7 ft. Future frontal protection at Orleans Avenue Canal Pump Station OP#7 will raise this wall and add valves/gates to prevent backflow through the pumps. The operator stated that the low pump station wall overtopped by about 6-12" (the 6-12" amount is based on an estimate of how high the operator held his hand above the low wall) and had flow over the wall for about 1½ hours starting at about 8:30 to 9:00 am on Monday. If the 1½-hour is assumed to begin at 8:45 AM, the flow over the wall lasted until 10:15 and the peak would have occurred at about 9:30 AM. This timing is consistent with the peak high water timing developed from digital photographs and an event log at the Marinas at the 17th Street Canal entrance and the Lakefront Airport. The water surface elevation based on 6-12" estimate would be about 10.2-10.7 ft that is consistent with an 11.1 ft peak water level at the Orleans Avenue Canal entrance that was estimated from high water marks along Lake Pontchartrain. A difference in water level between the lake and the pump station may have been due to a) drawdown from flow over the wall, b) possibly drawdown from backflow through the pumps, c) the low area in the levee profile just north of Robert E Lee Bridge (presented subsequently) if that area was low during Katrina, and d) losses at the bridges.

Figure 1-71. Low pump station wall at Orleans Avenue Pump station OP#7.

Another operator on another visit to OP#7 stated that the wall did not overtop. Water levels in Lake Pontchartrain, scour, and limited high water marks near the pump station show the wall did overtop. Although not easily seen in Figure 1-71, minor scour occurred below the low wall on the east side of the station. Note the rise of about 1 ft in the low wall in Figure 1-71 behind the individual in the picture. The walls adjacent to the low wall that are at elevation 10.8 ft on the east side and elevation 11.3 ft on the west side had no evidence of scour on the protected side of the wall supporting the first operator's account of the maximum amount of flow over the wall being about 1 ft. Figure 1-75 shows scour between the columns that could only have come from flow down the concrete slope that is adjacent to the low wall on the east side of the channel. Figure 1-76 shows scour around a power pole below the earth levee on east side of Orleans Ave Canal. Figure 1-77 shows scour below the concrete apron that is below the low wall on the east side of the canal. Figure 1-78 shows greater scour behind the low wall on the west side of Orleans Canal. Note that the west low pump station wall has a larger fall to the ground that is important in determining the amount of scour. Figure 1-79 shows where the west low wall ties into the higher pump station wall. Based on debris trapped in the vegetation, flow overtopped this wall by about 6" that supports the pump station operator's lower estimate of 6-12" of flow over the wall.

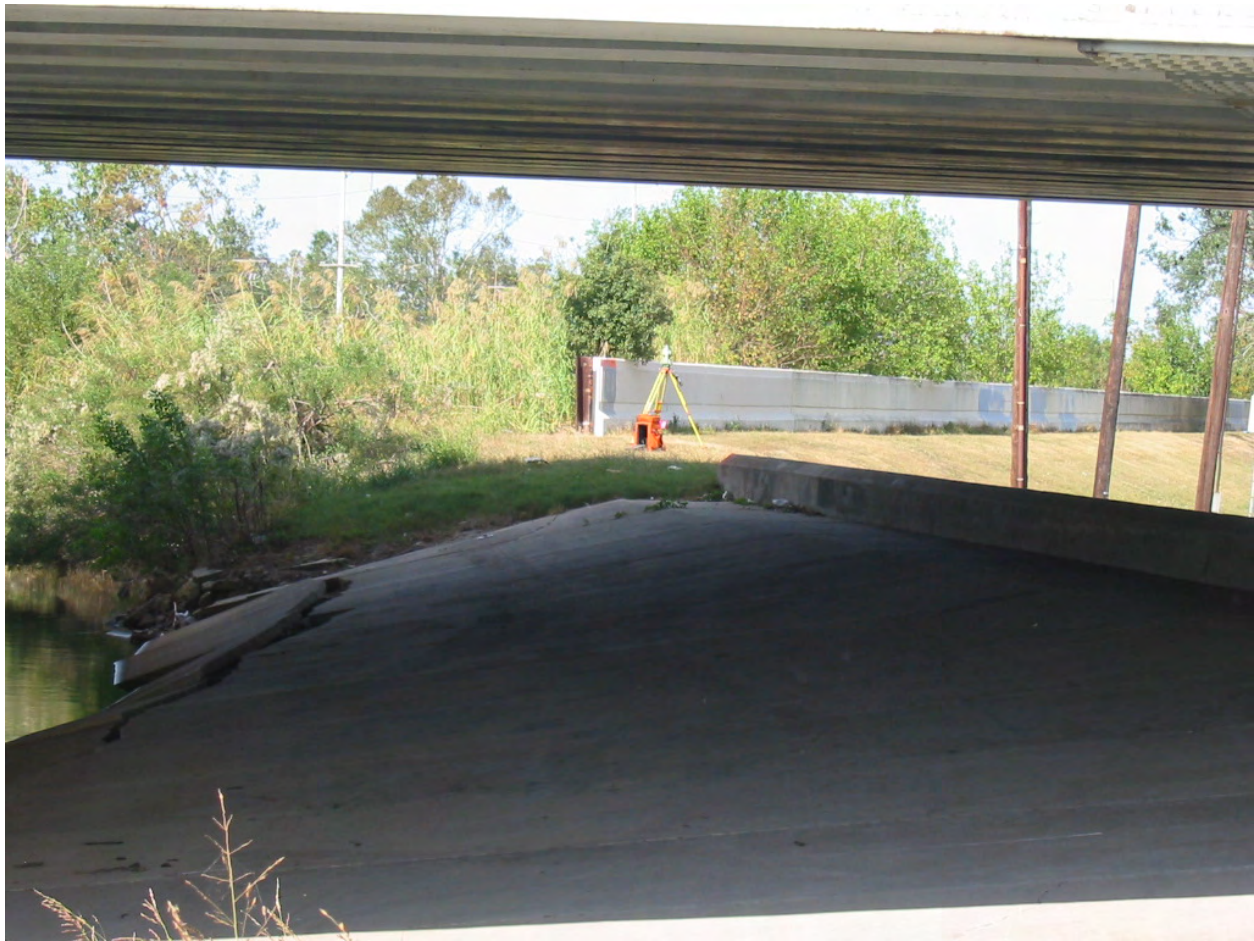
Figure 1-72. Low wall, earth levee, and floodwall in background on east side of Orleans Avenue Canal just north of pump station. Looking northwest.

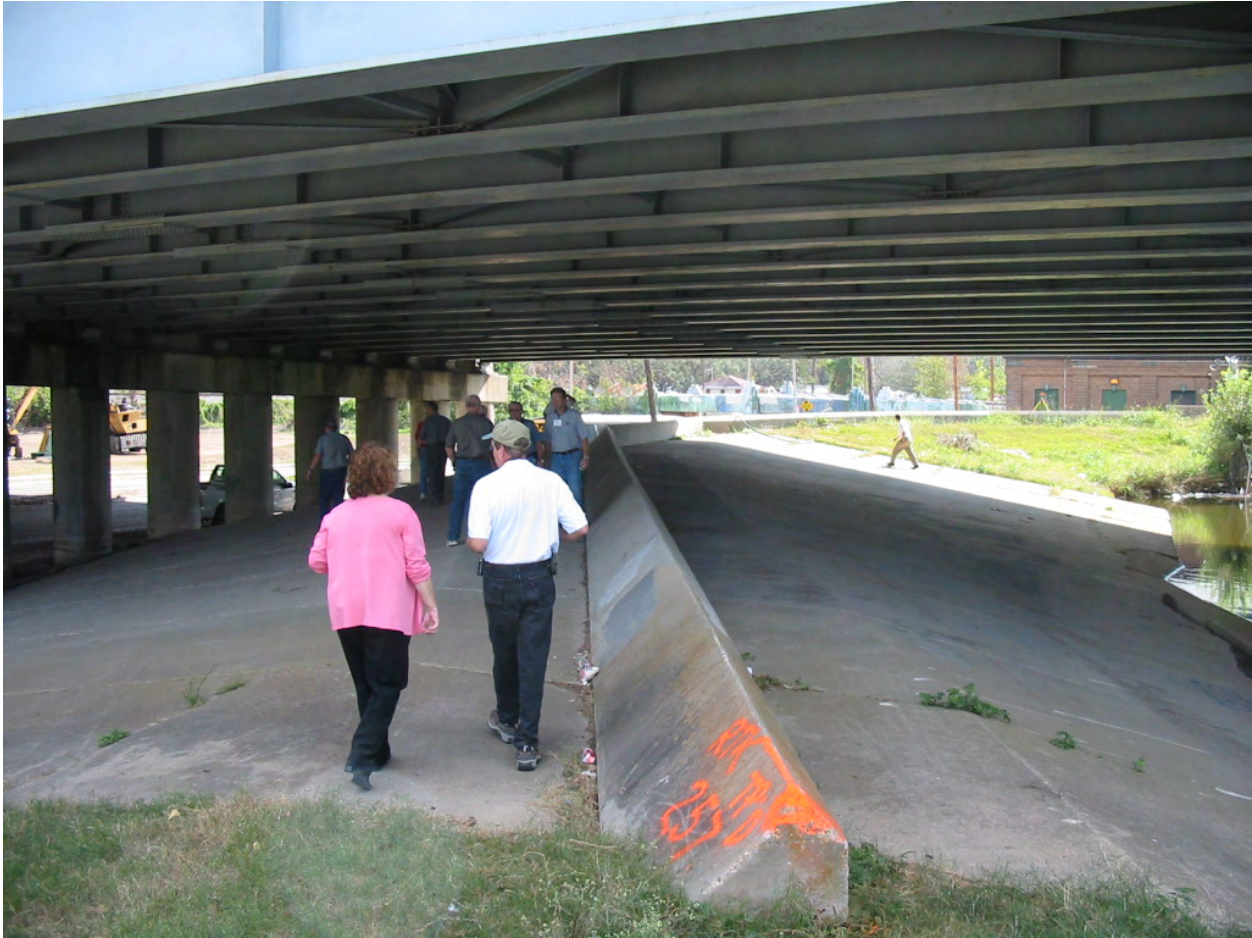
Figure 1-73. Low wall that connects to OP#7 at Orleans Avenue Canal looking south-southeast standing on earth levee.

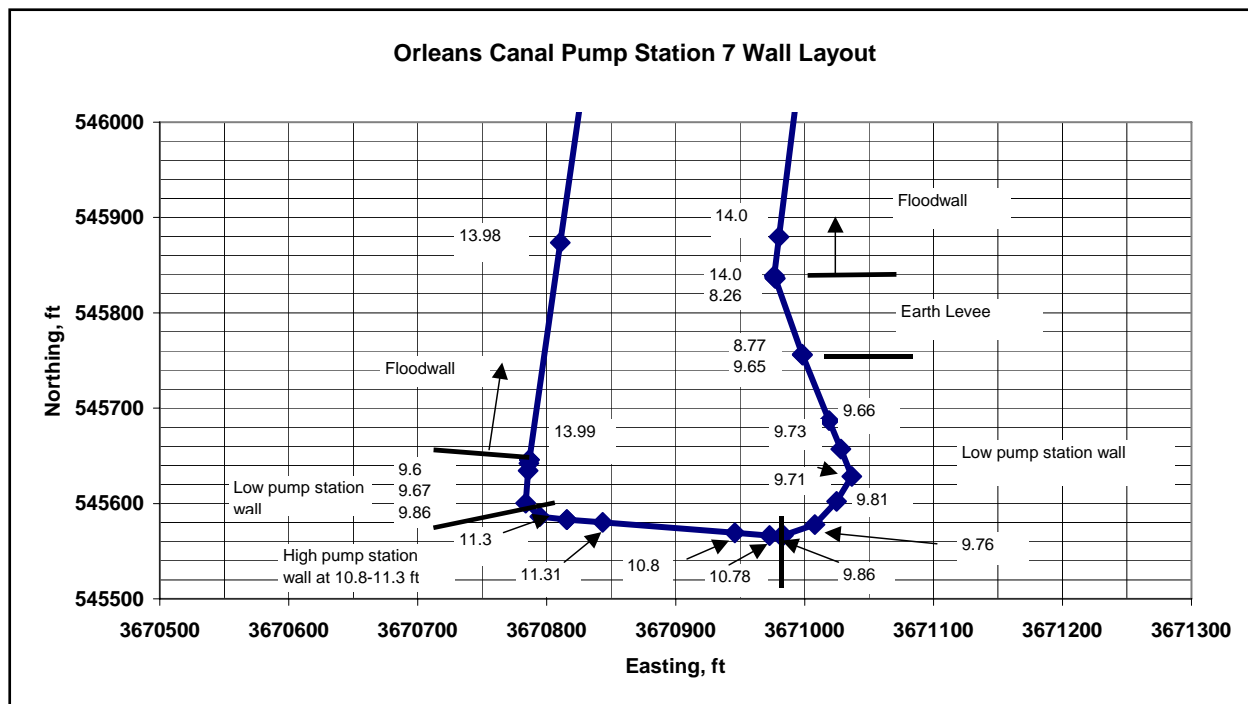
Figure 1-74. Floodwall, levee, and pump station wall elevations at OP#7.

The only high water mark at the pump station was debris around the south end of the east floodwall. The mark LA 1052 at 9.5 ft is a poor mark and represents a minimum level of the peak water.

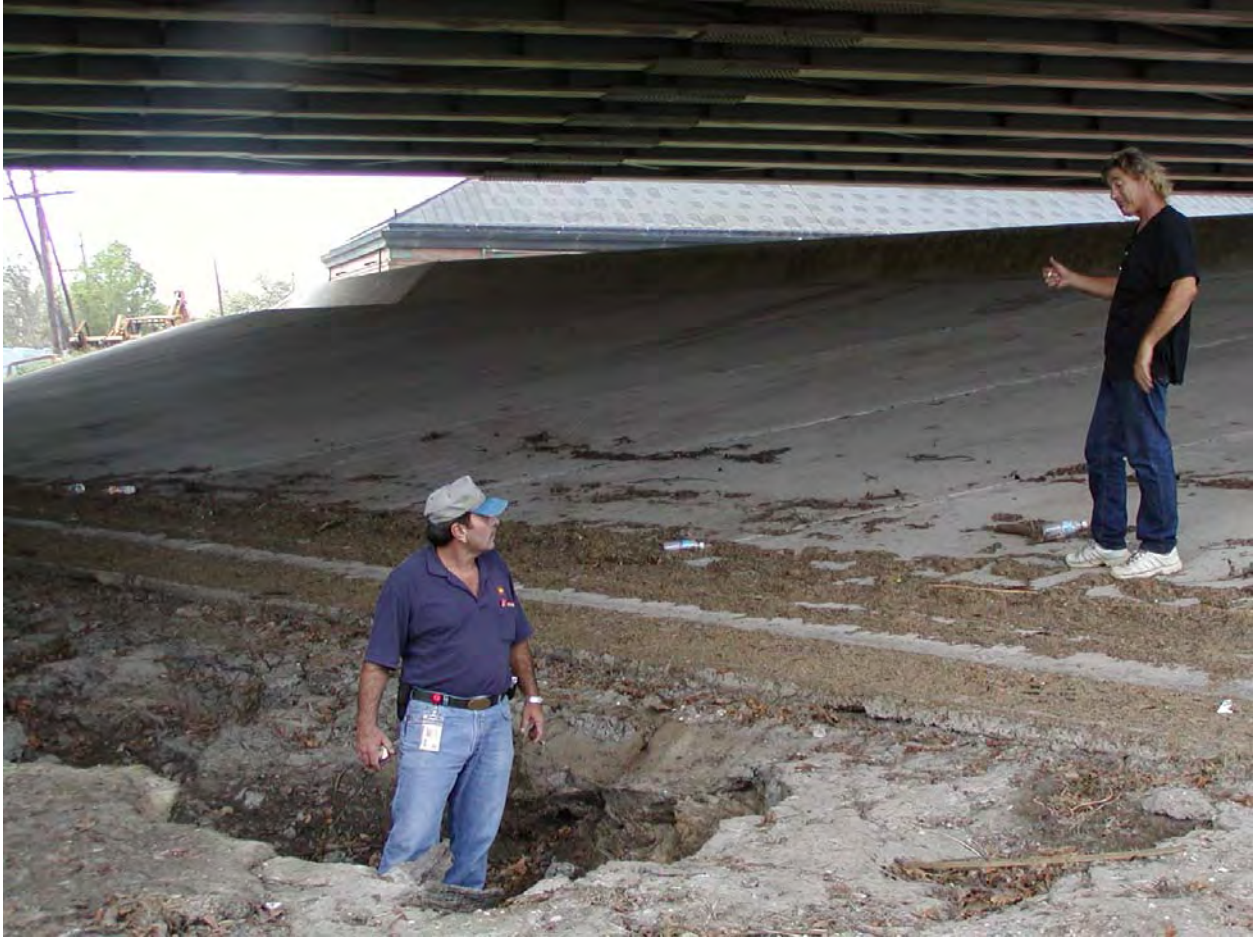
Figure 1-77. Scour below concrete apron that is below low pump station wall on east side of Orleans Ave Canal.

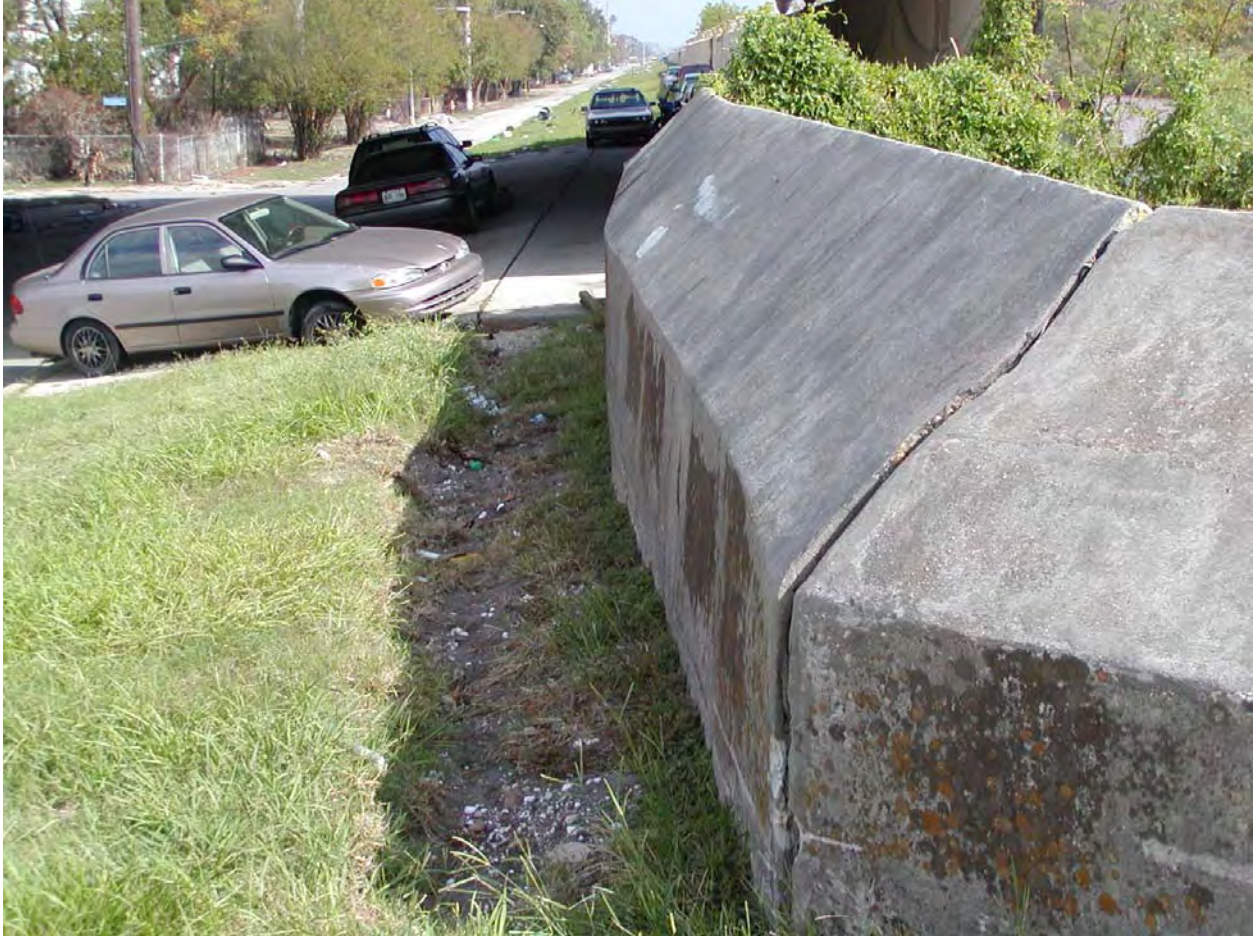
Figure 1-78. Scour below OP#7 low pump station wall on west side. Note that fall distance and scour is greater on this side than on the east side. Note floodwall in background that is about 4.3 ft higher.

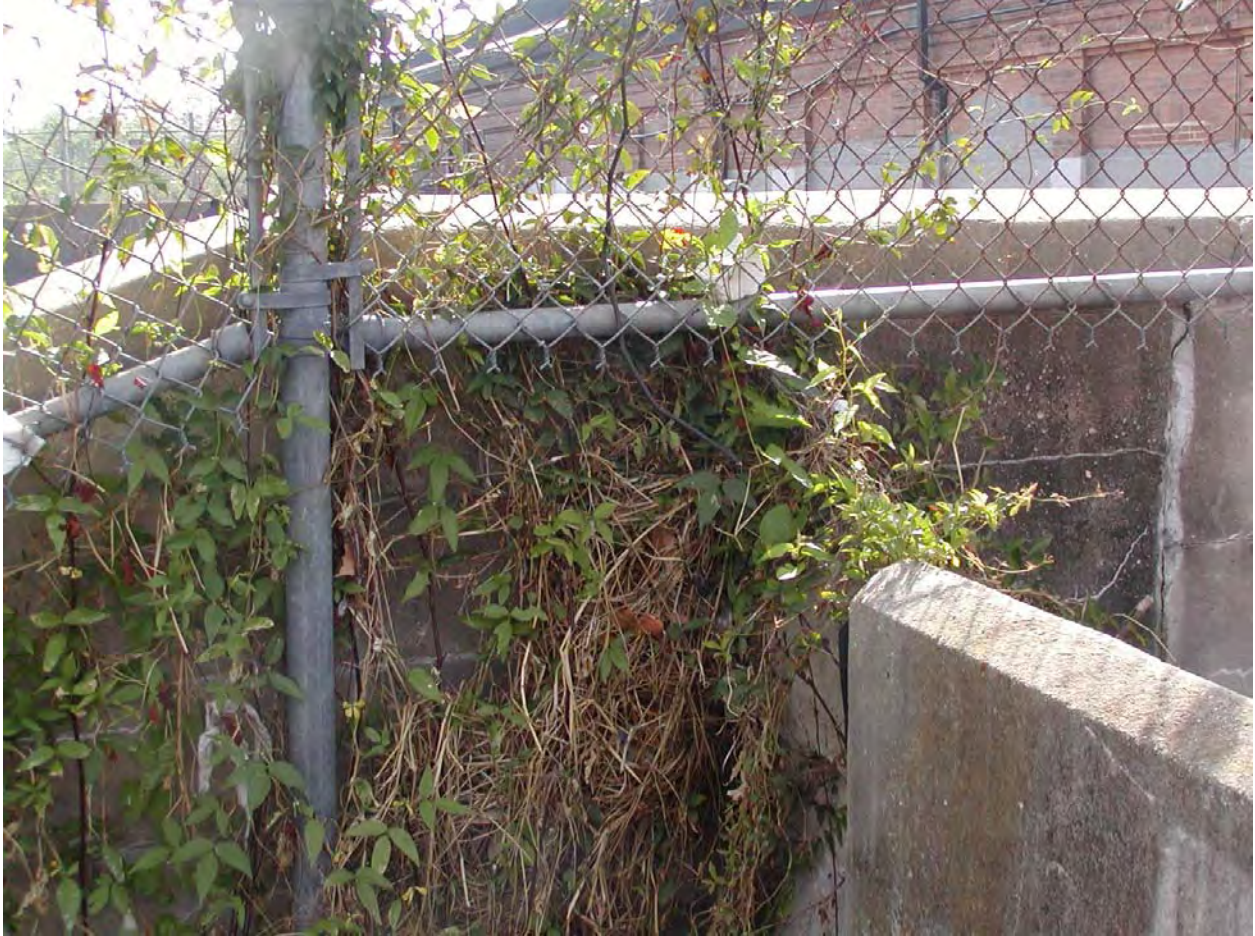
Figure 1-79. Debris caught in vegetation showing flow over low wall at OP#7. About 6" above low wall on west side.

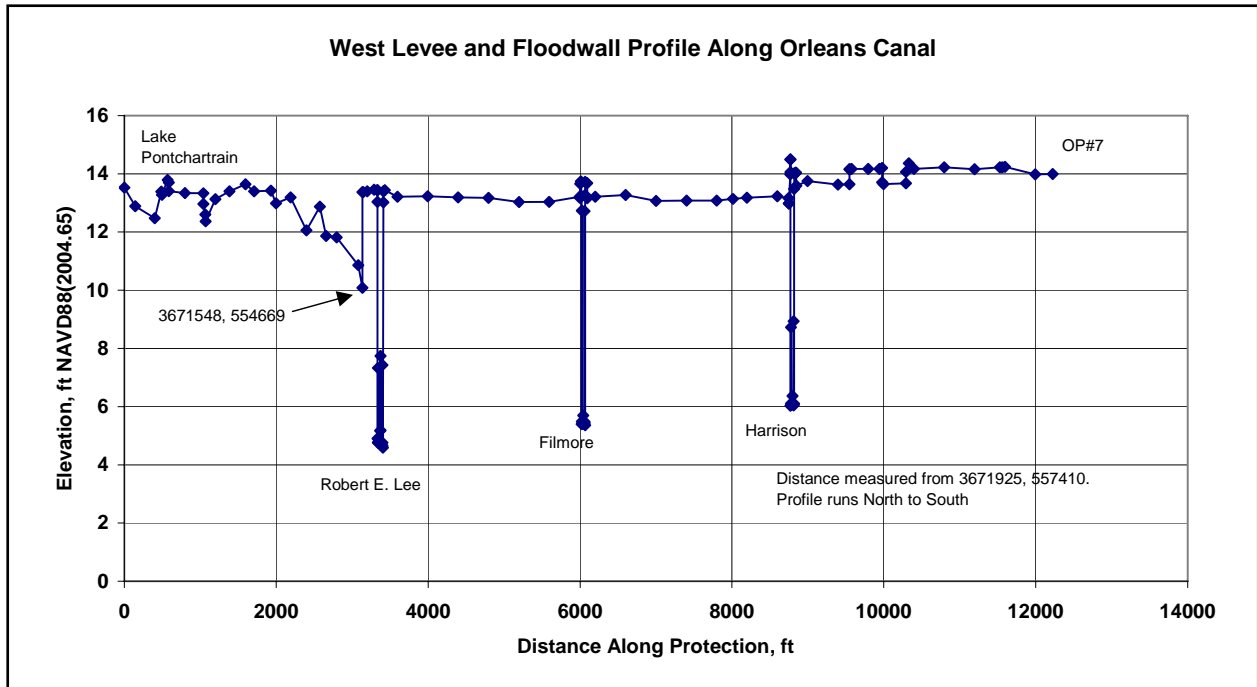
Figures 1-80 and 1-81 show wall profiles along the west and east sides of Orleans Avenue Canal, respectively. The low levee elevation on the west side of the canal just north of Robert E. Lee bridge suggest that water may have flowed over the levee at this location since the peak water levels were about 11.0 ft.

Figure 1-80. West Levee and Floodwall Profile for Orleans Avenue Canal. Note that low areas at bridges and pump stations are floodgate openings that were closed during the storm.
