Appendix 1

Hydrograph and High Water Mark Analysis

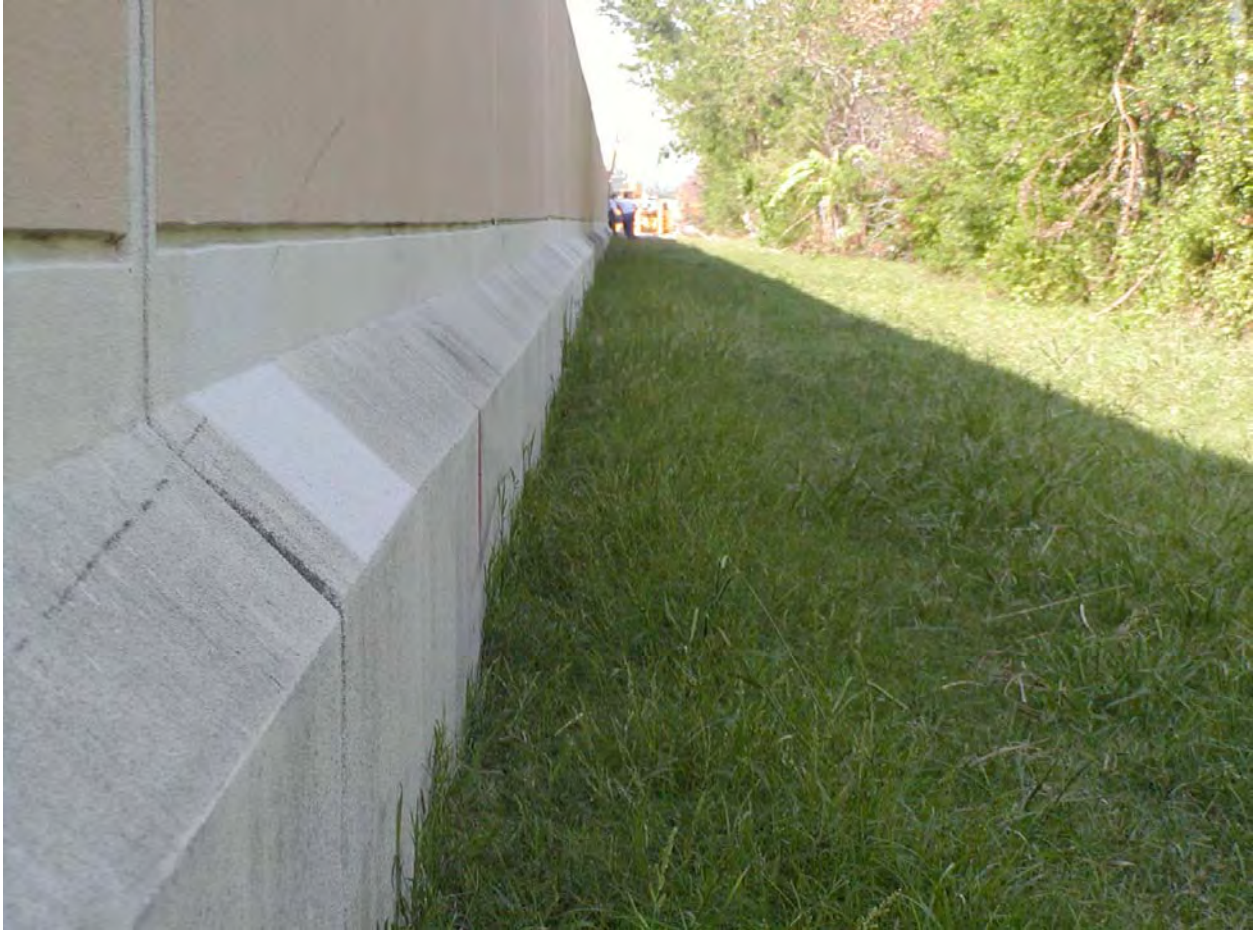
On 9/29/05, a location was observed about 200 ft south of the 17th Street Canal breach looked like ground that had flow over it. Further south of this location on the east side of the canal are the lowest wall elevations on 17th Street Canal of about 12.1 ft. The scour was possibly the result of minor wave overtopping but no visible scour was observed. A picture (Figure 1-82) was taken in this area but the effect on vegetation was so minor it does not show up.

Figure 1-82. Attempt to show possibility of minor scour along west floodwall, south of 17th Street Canal breach.

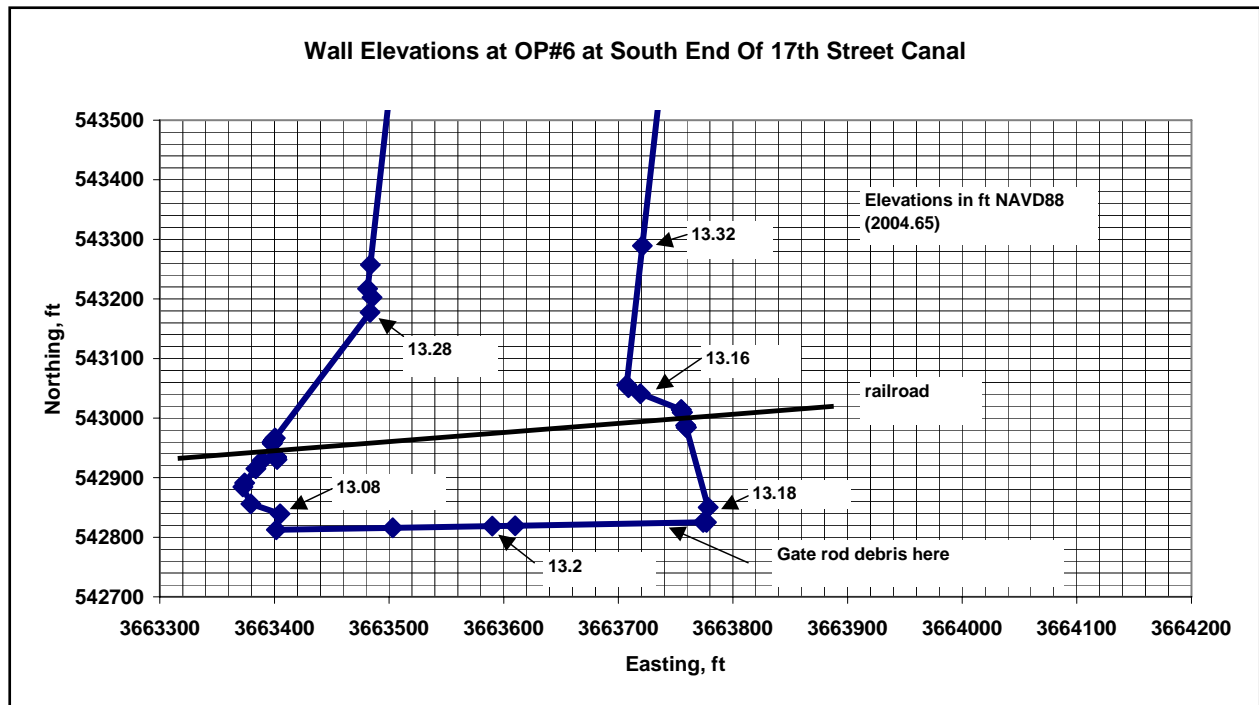
The floodwall and fronting protection walls at the pump station OP#6 are at about elevation 13-13.2 ft as shown in Figure 1-83. On 9/29/05, debris was observed at the top of the fronting protection wall as shown in Figure 1-84. This debris was only observed at the center portion of the fronting protection wall as shown on Figure 1-83, a location where waves coming down the canal would be largest. On 11/9/05, a debris HWM LA 1252 was found (Figure 1-85) around two gate rods, both at about 2.1 ft below the top of the floodwall for an elevation of about 11.1 ft. This type of mark is best described as “at least this high” because the debris can wrap around the gate rod at a higher water level and fall down when the stage drops/waves subside and settle on the gate rod support. The location of this HWM is 50-ft east of the point on the fronting protection wall that is inline with the east floodwall (Figure 1-83). This high water elevation was confirmed at another HWM LA 1251 found on 9/29/05 and located in an area on the west side of the discharge area where top of debris at a crack in the wall was found at 2.2 ft below top of floodwall (at the 13.08 ft point in Figure 1-83) for an elevation of 10.9 ft. Both marks, LA 1251 and 1252 were in areas exposed to some wave action. A picture (Figure 1-86) taken in 4/06/06 shows the location of LA 1251. In this picture the debris in the crack was no longer at the level of 2.2 ft below the top of the wall. A third HWM LA 1019 at this general location was levee debris at 9.0 ft. Levee debris high water marks have been inconsistent when compared to nearby marks inside structures.

Figure 1-83. Wall elevation at OP#6 at south end of 17th Street Canal.

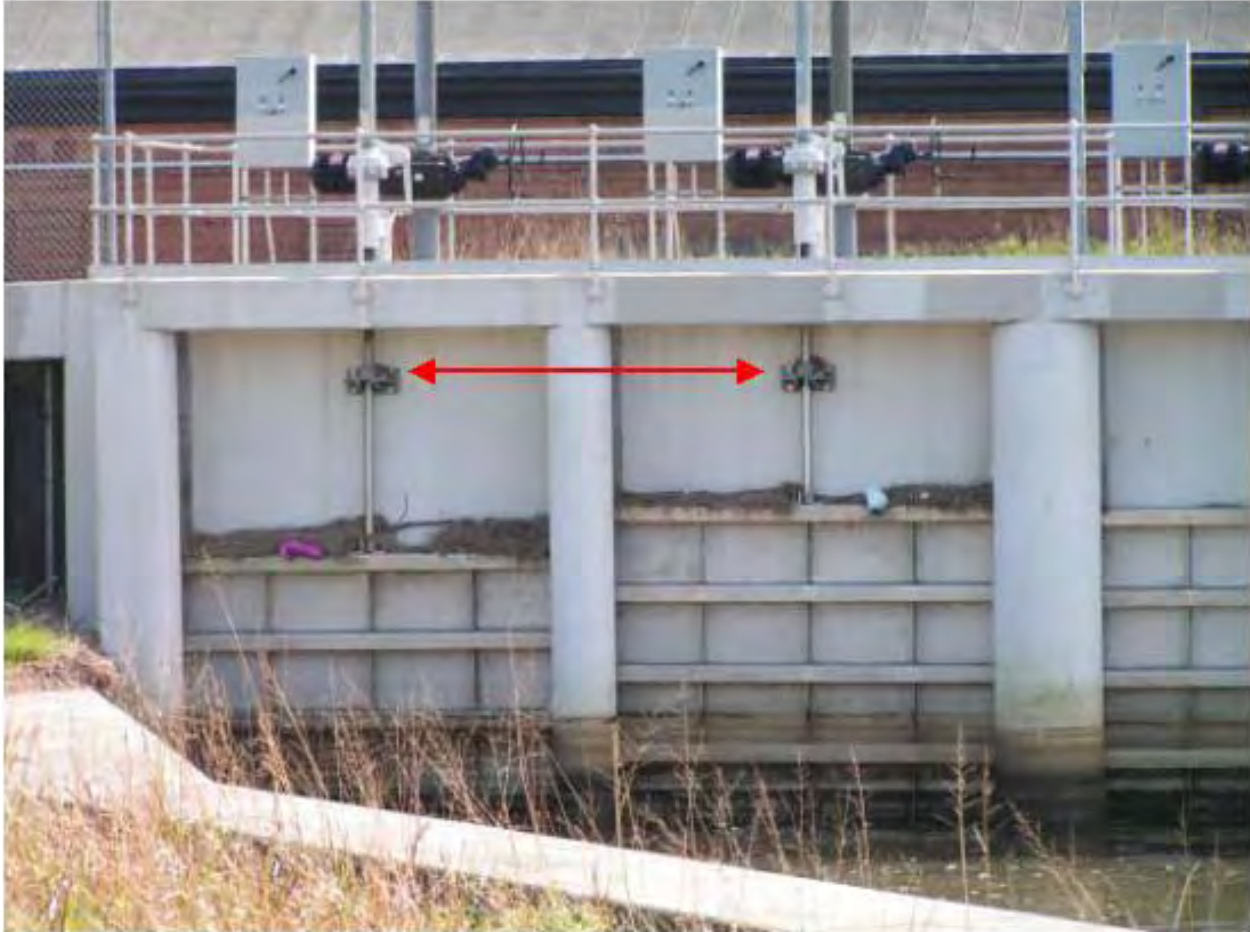
Figure 1-85. Debris high water mark at top of brackets holding gate rods on east side of discharge area.

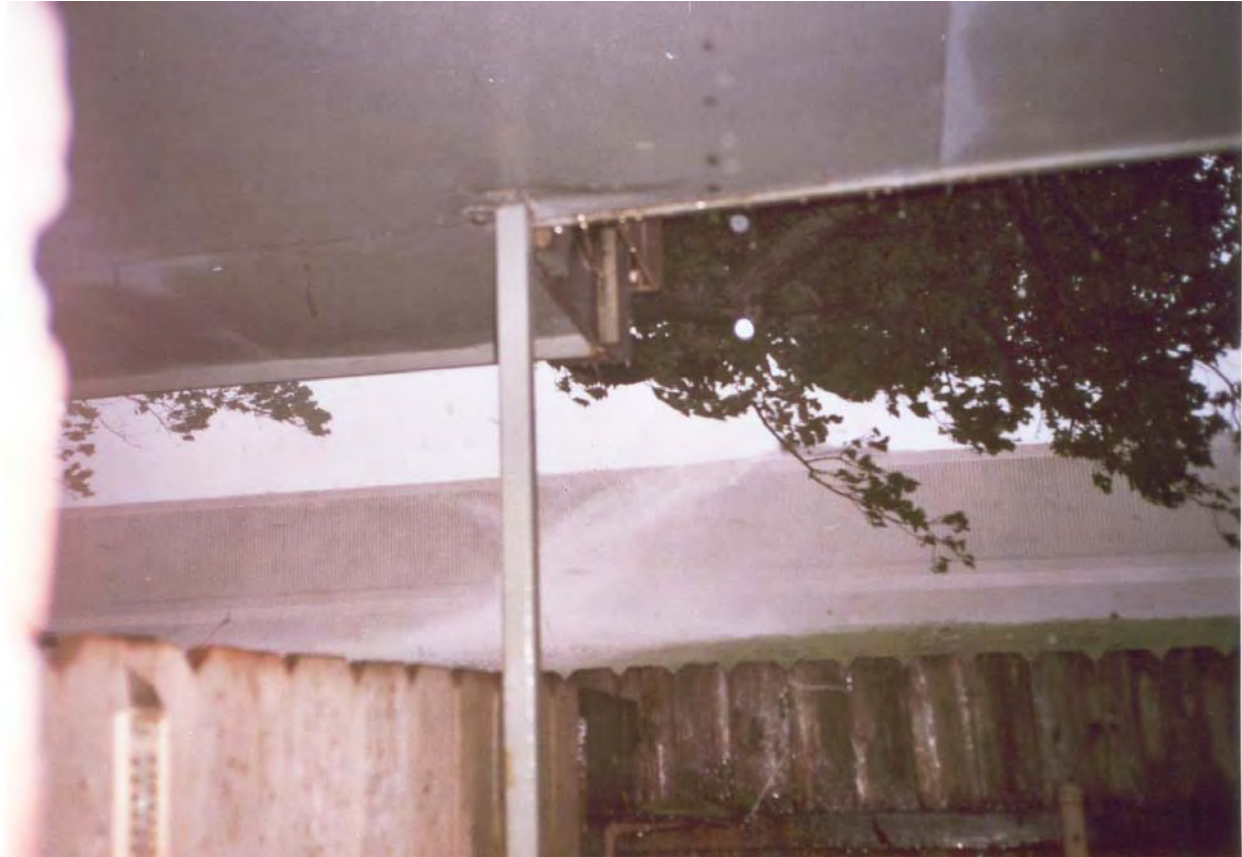
Figure 1-87. Wave spray or splash (left of tree limb) at west wall of 17th Street Canal north of Veterans Blvd and 1.0 mile south of Hammond Hwy. The individual who took this picture stated that the tree limb obscures the crest of a wave.

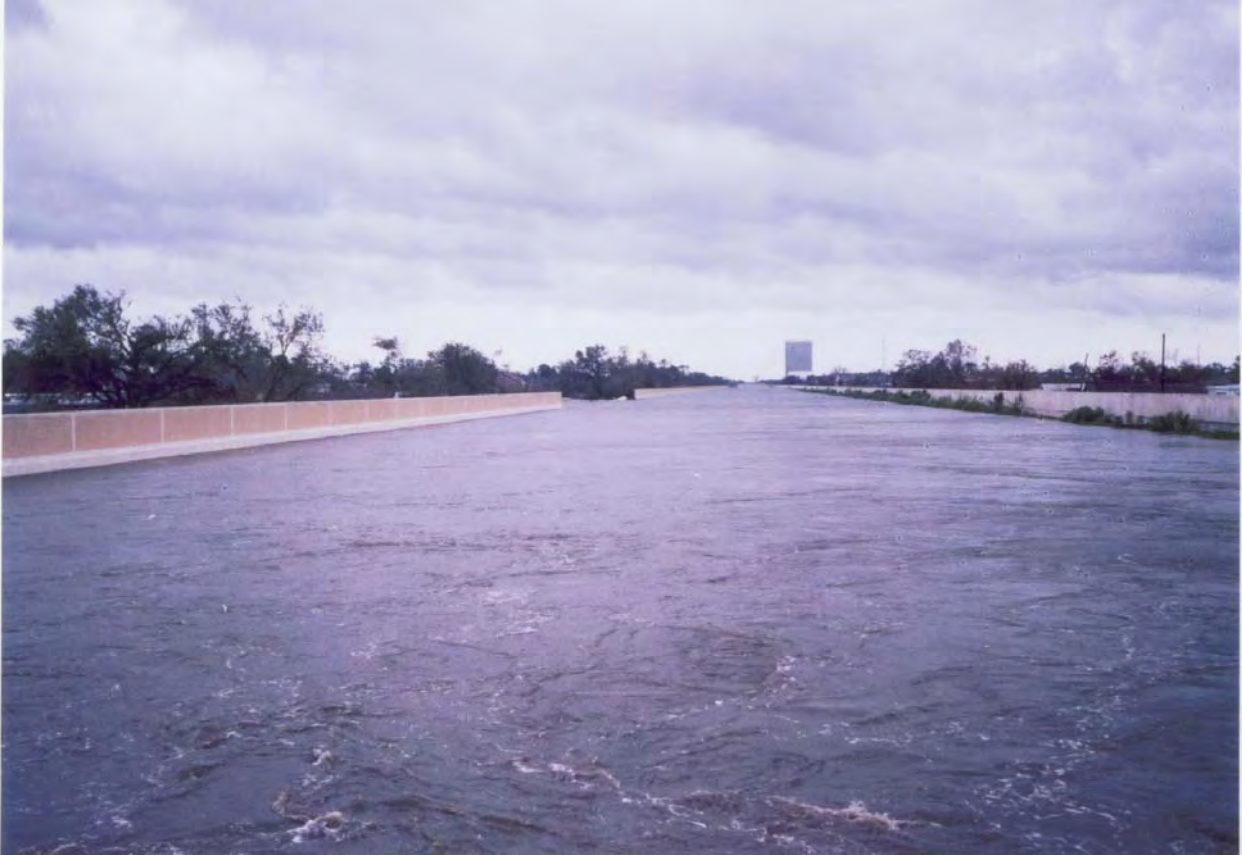
Figure 1-88. 17th Street Canal and breach at 2 pm on 8/29/05. Looking south.

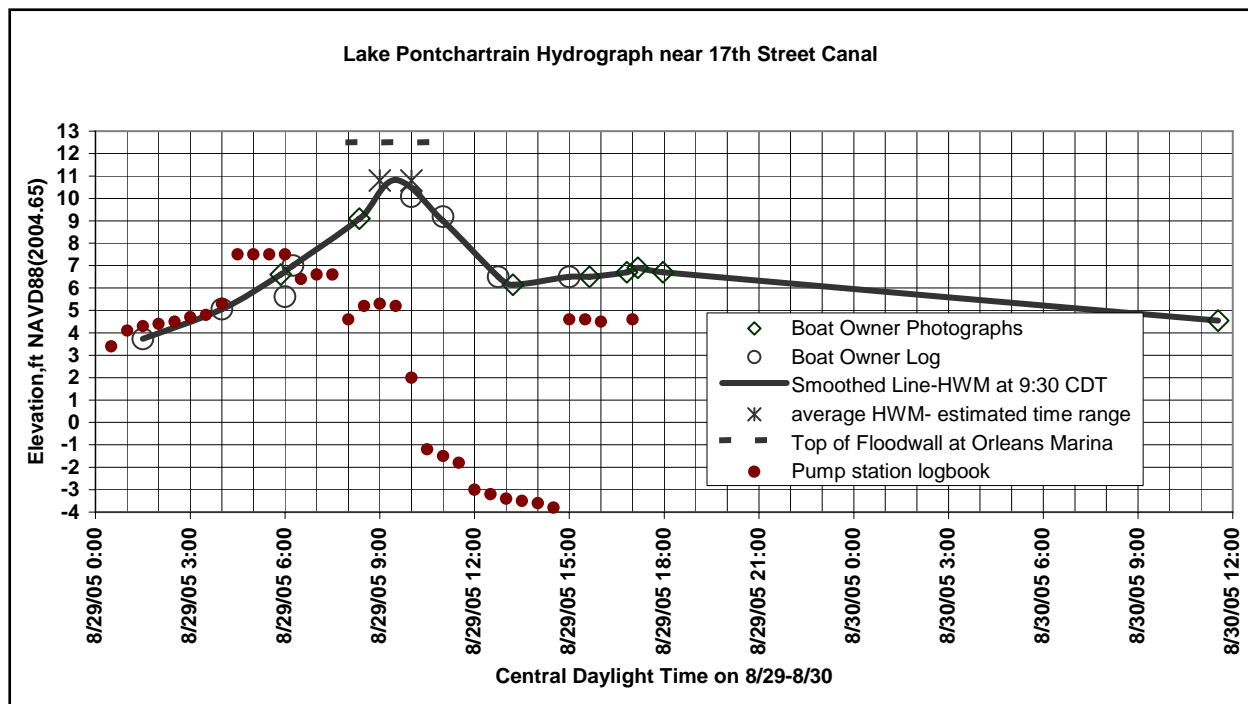
If valid, the most complete information on the canal water levels is the log of water levels recorded at OP#6 on the south end of the 17th Street Canal. The water levels at the pump station differ significantly from the constructed hydrograph for the 17th Street Canal entrance as shown in Figure 1-90. The IPET data collection team spent considerable effort to determine if the logbook readings correctly describe the water level in the 17th Street Canal during Hurricane Katrina on the morning and afternoon of 8/29/05. The logbook data shows that the water level in the canal peaked at an elevation of 7.5 ft between 4:30 AM and 6:00 AM and fell after that time. The datum of the pump station logbook data was established using Lake Pontchartrain hydrographs that have water surface elevations in NAVD88 (2004.65). From 12:00 AM to 12:00 PM on 8/28/05, the Orleans Levee District gage at Southshore Marina averaged 1.25 ft, the Pass Manchac gage averaged 1.09 ft, and the Bayou Labranch gage averaged 1.27 ft. Based on averaging the 3 gages, Lake Pontchartrain averaged an elevation of 1.20 ft from 12:00 AM to 12:00 PM on 8/28/05. During this time, no significant pumping was taking place at OP#6. Based on the pump station logbook for the same time interval, the average reading at OP#6 was 22.6 ft in the Cairo datum. The conversion from Cairo datum to NAVD88 (2004.65) is $22.6 - 1.2 \text{ ft} = 21.4 \text{ ft}$ for OP#6 logbook readings on the discharge side of the pump station. This conversion value is considered to be valid for this location in the system. The conversion is used in Figure 1-90 and the derived hydrograph at the Lake and the pump station log are in fair agreement on the morning of 8/29/05 before 4:00 AM.

Figure 1-90. Pump station logbook values and constructed hydrograph at 17th Street Canal entrance.

As shown in Figure 1-90, the system appears to rebound to about correct values at about 3:00 PM. This appears impossible because the air compressor did not regain power. Close inspection of the logbook numbers indicated the possibility that a 2 had been written over the 1 in the logbook. For example, a value of 16 in the logbook became 26. It is possible that the outside staff gage was being read because winds had died down by this time.

Summarizing the bubbler system, the loss of electrical power beginning sometime between 4:00 to 5:00 AM on 8/29/05 along with the 2.2 ft increase in stage above the lake level from 4:00 AM to 4:30 AM followed by four identical 7.5 ft readings causes concern with the bubbler system. The rapid loss of pressure of the bubbler system when tested on 03/02/06 also causes concern for the 8/29/05 readings. Readings of the bubbler system below the berm elevation of 0 to -1 ft are likely not possible. These three problems with the bubbler system cast doubt on the entire set of readings after power was lost.

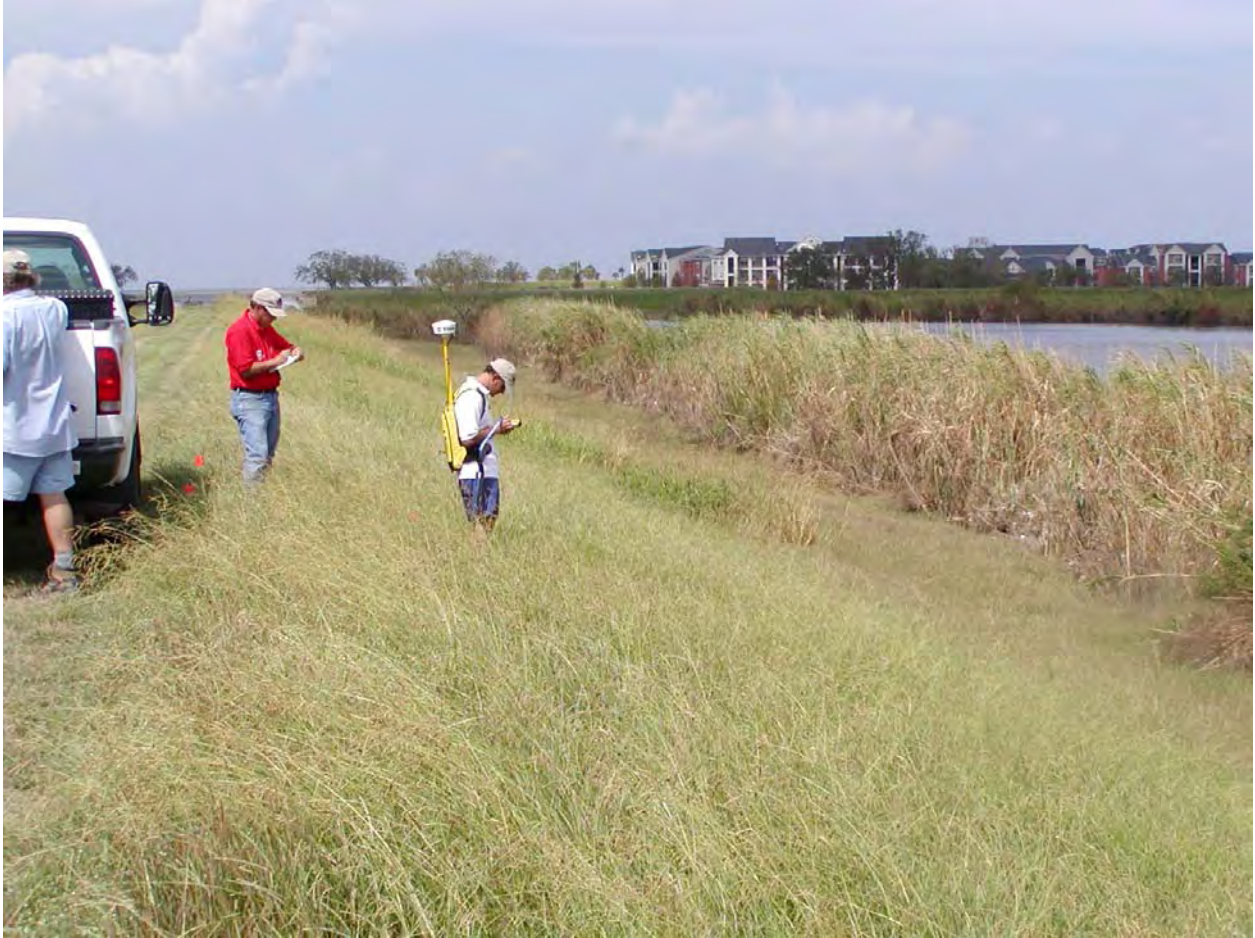
- a.* LA 1015- 10.8 ft- Levee debris on west side of canal north of Robert E Lee Bridge. Figure 1-94 shows the location of this mark and demonstrates the difficulty of providing good photographs with the high grass. The debris line could be easily seen by looking straight down into the high grass.
- b.* LA 1017- 7.6 ft- Levee Debris on west side of canal south of Lakeshore Drive- ASCE COPRI felt a better mark was found south of this location.
- c.* LA 1018- 7.9 ft- debris on area near railroad track at OP#3, east side of discharge area. This area is shown in Figure 1-95.
- d.* LA 1022- 10.6 ft- this is the ASCE COPRI mark near LA 1017. See Figure 1-96.
- e.* LA 1059- 11.2 ft- Levee Debris on west side of canal just north of Leon C Simon Bridge.

Figure 1-94. Debris high water mark LA 1015 located on 10/02/05 on west side of London Avenue Canal. Looking north between Lakeshore Drive and Leon Simon Drive.

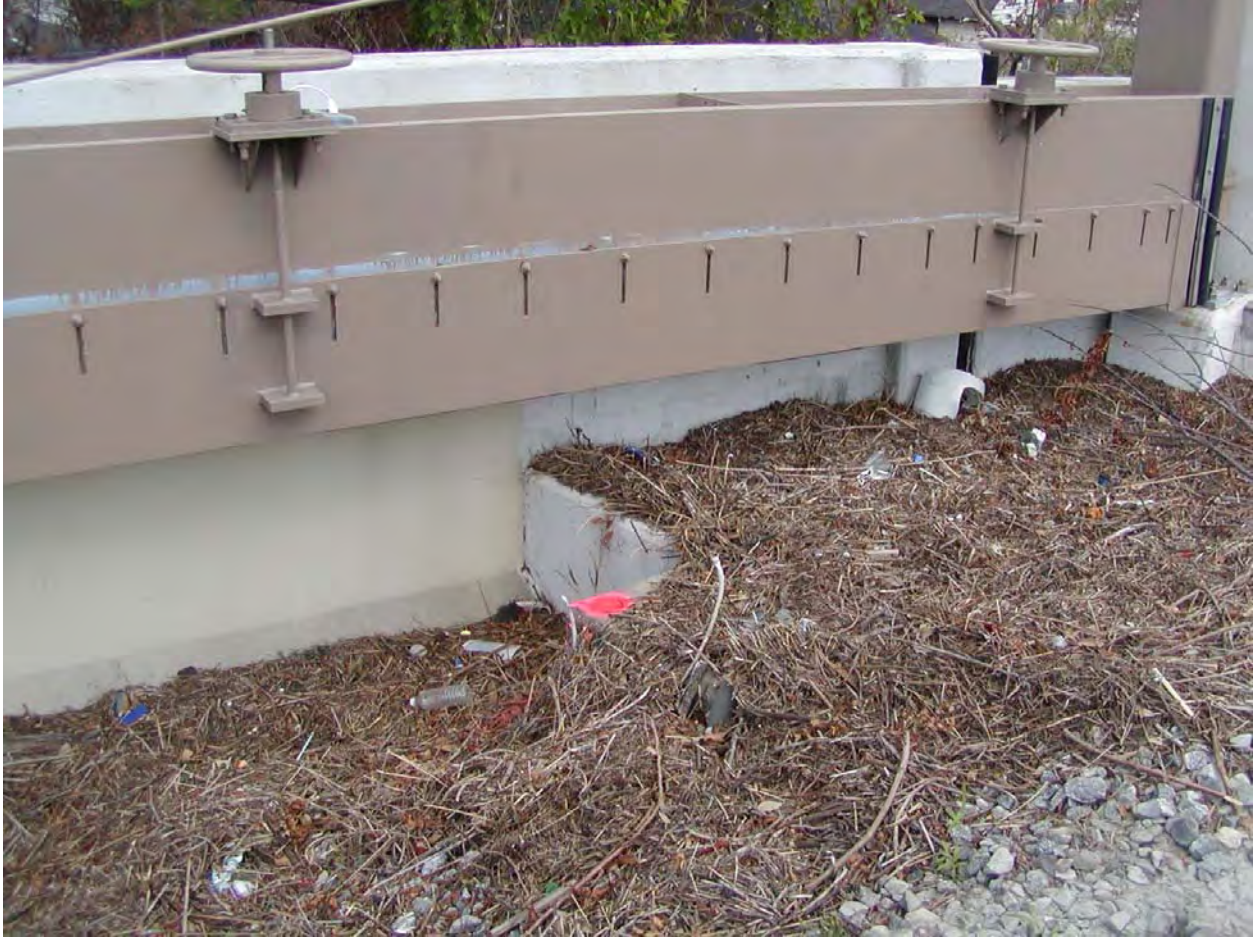
Figure 1-95. East floodgate at OP#3 at south end of London Avenue Canal. High water mark LA 1018 at top of painted concrete wall.

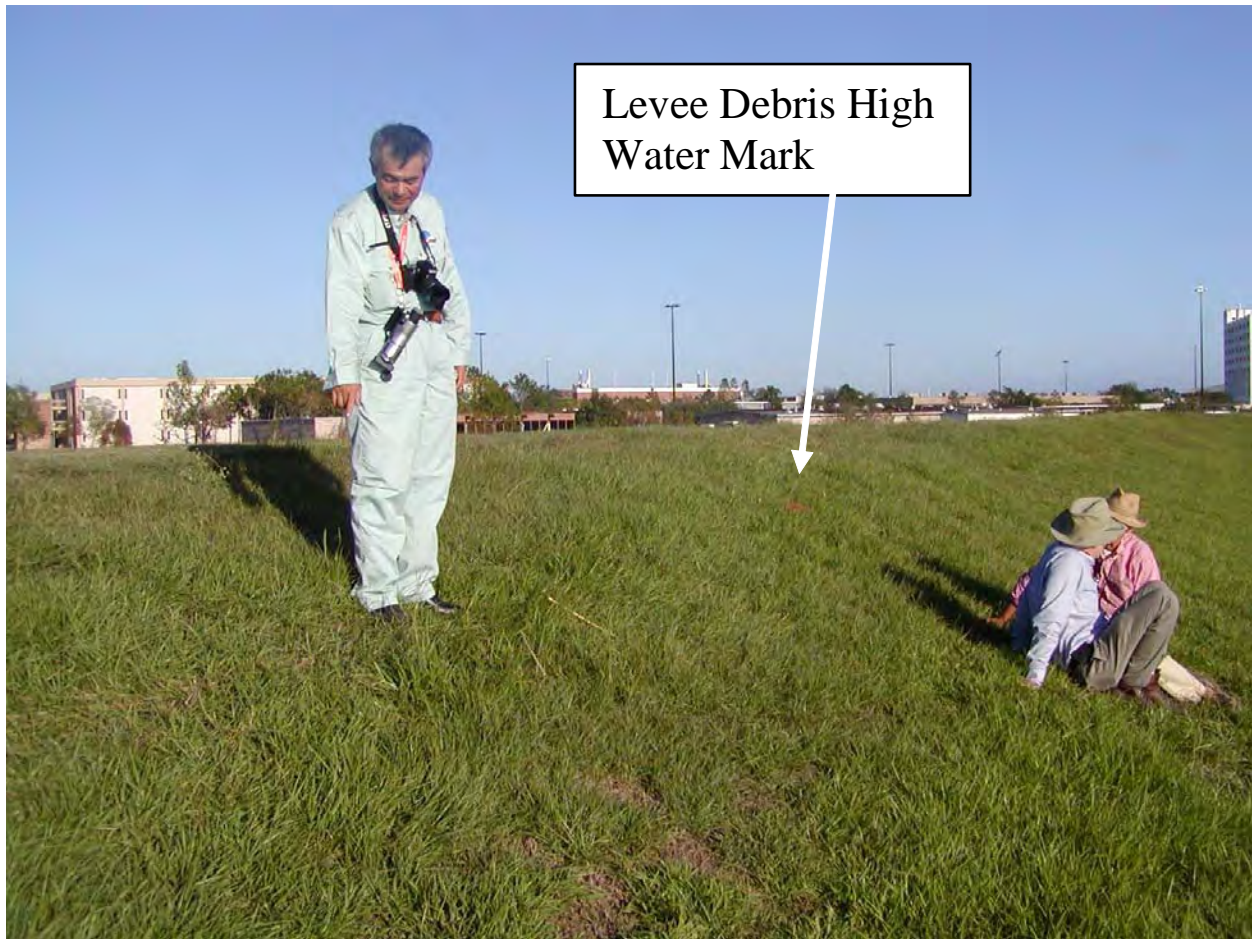
Figure 1-96. Debris high water mark LA 1022 on east levee of London Avenue Canal north of Leon C Simon Drive.

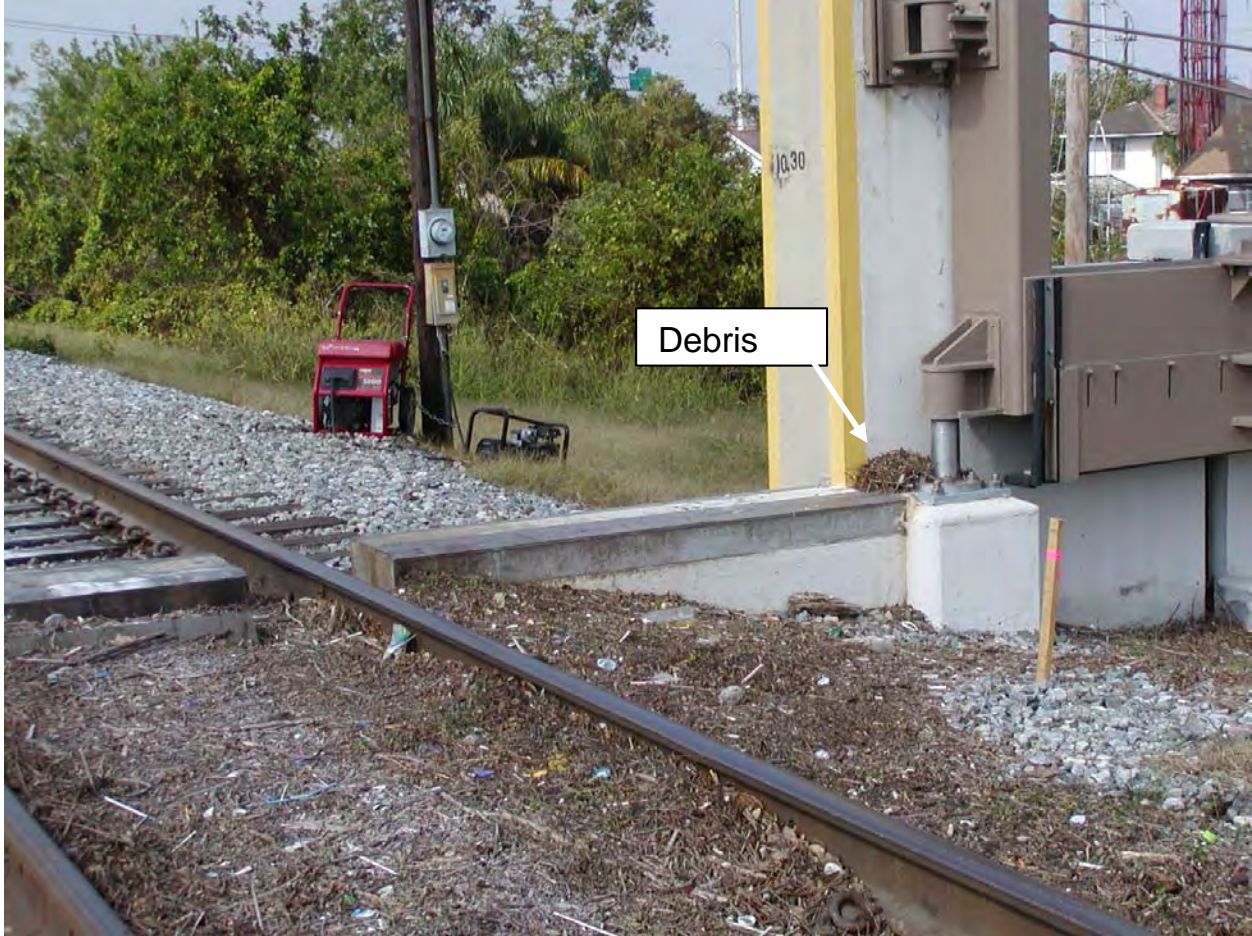
- j.* LA 1228- 10.0 ft- this mark is a debris mark on the west side of the discharge area. Debris is on a support for the floodgate and somewhat protected from any wave action in the canal as shown in Figure 1-98. The water level could have been higher as the debris may have been left behind as the water level dropped.

Figure 1-98. West floodgate at OP#3 at south end of London Avenue Canal. High water mark LA 1228 based on debris on top of sill at floodgate opening.

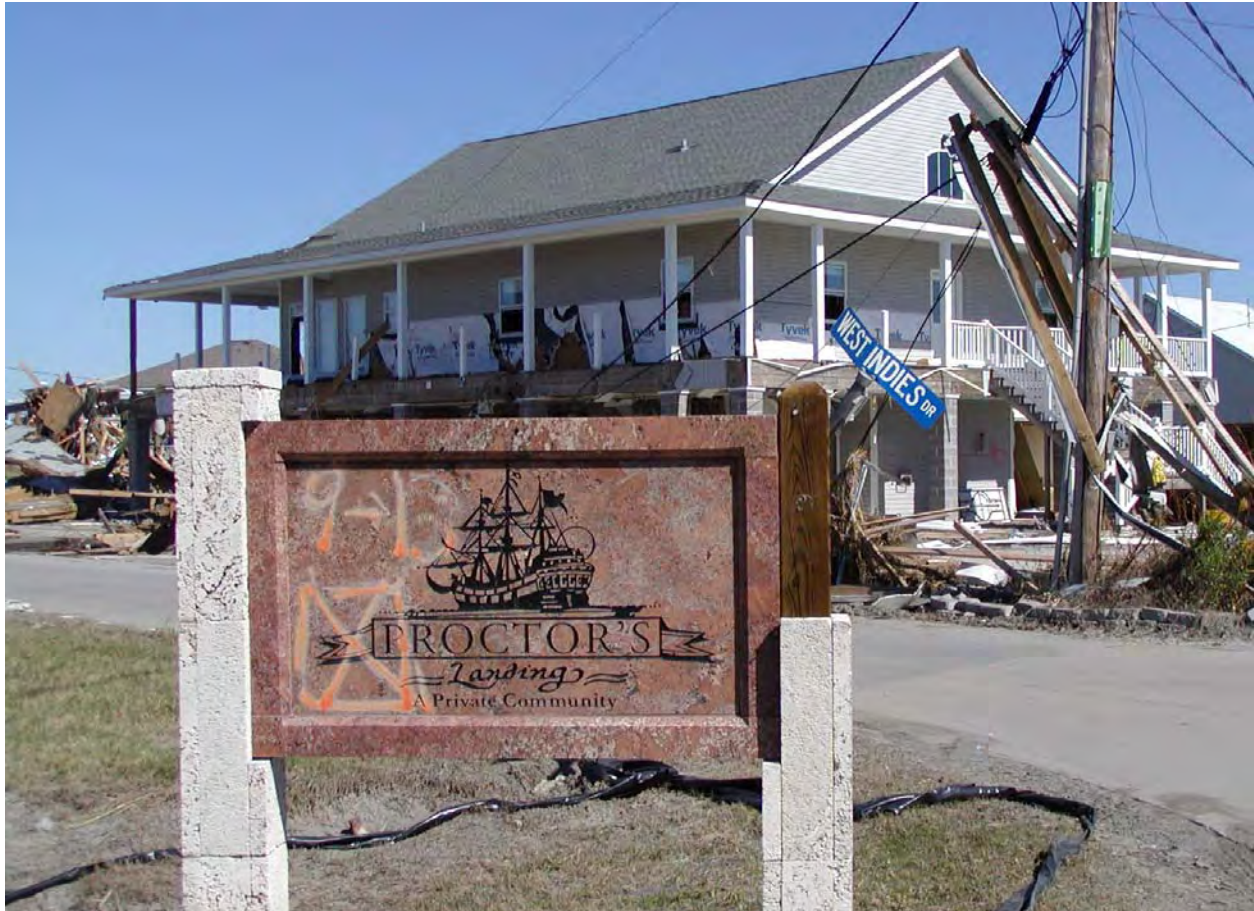
Figure 1-103. Home in Shell Beach containing high water mark LA 1087 at 31" above second level floor.

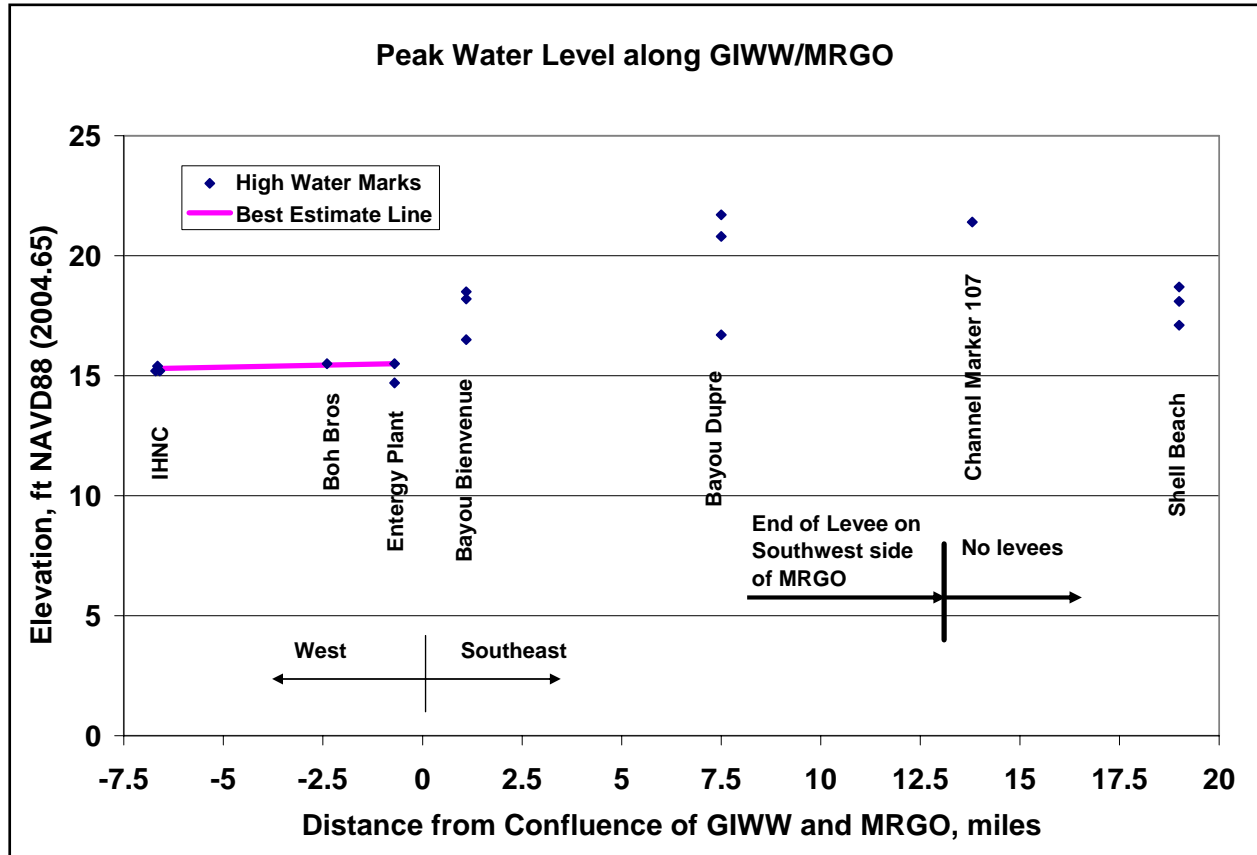
Figure 1-104 shows a plot of the high water mark data along the GIWW/MRGO along with a best estimate line. The best estimate line ends at the Entergy Plant because of uncertainty of high water marks at Bayou Bienvenue and Bayou Dupre, the large wave component at channel marker 107, and the fact that Shell Beach is beyond the levee protection. Of all the marks southeast of the GIWW/MRGO junction, the marks at Shell Beach are the most reliable estimates of the peak “still” water level.

Figure 1-104. Peak water level along GIWW and MRGO based on high water marks.

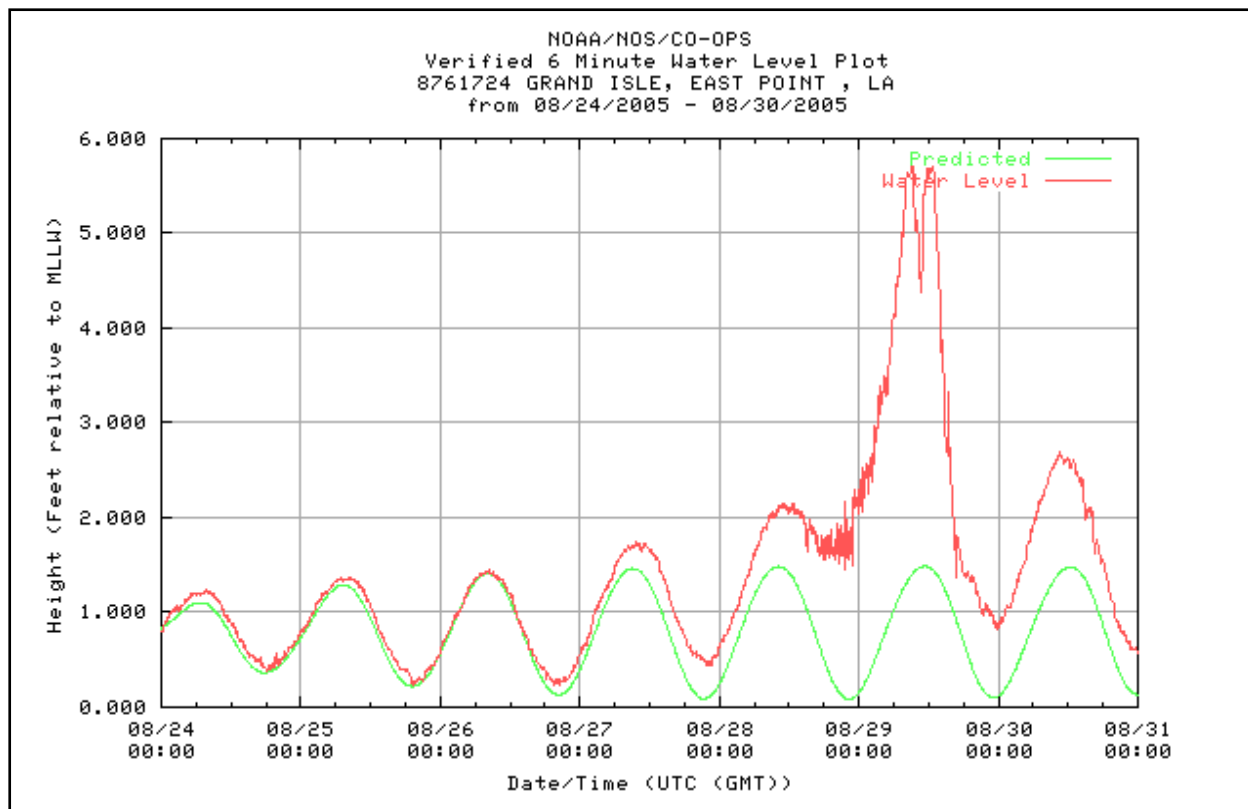
Figure 1-105. Hydrograph for NOAA National Ocean Service station at Grand Isle, Louisiana. Vertical datum relation between MLLW and NAVD88-2004.65 is uncertain.

Note the double peak in the Grand Isle hydrograph. There was initial concern that the double peak may have been caused by movement of the gage or supporting structure. Inspection of the station shortly after Katrina's passage showed the gage and supporting structure to be intact and the gage vertical datum was confirmed as correct. The simplest, most obvious meteorological explanation for the double peak is a sudden, temporary shift in the local winds, but this has not been verified at this time. The data of these hydrographs have been verified as conforming to NOS standards.
