Appendix 1

Hydrograph and High Water Mark Analysis

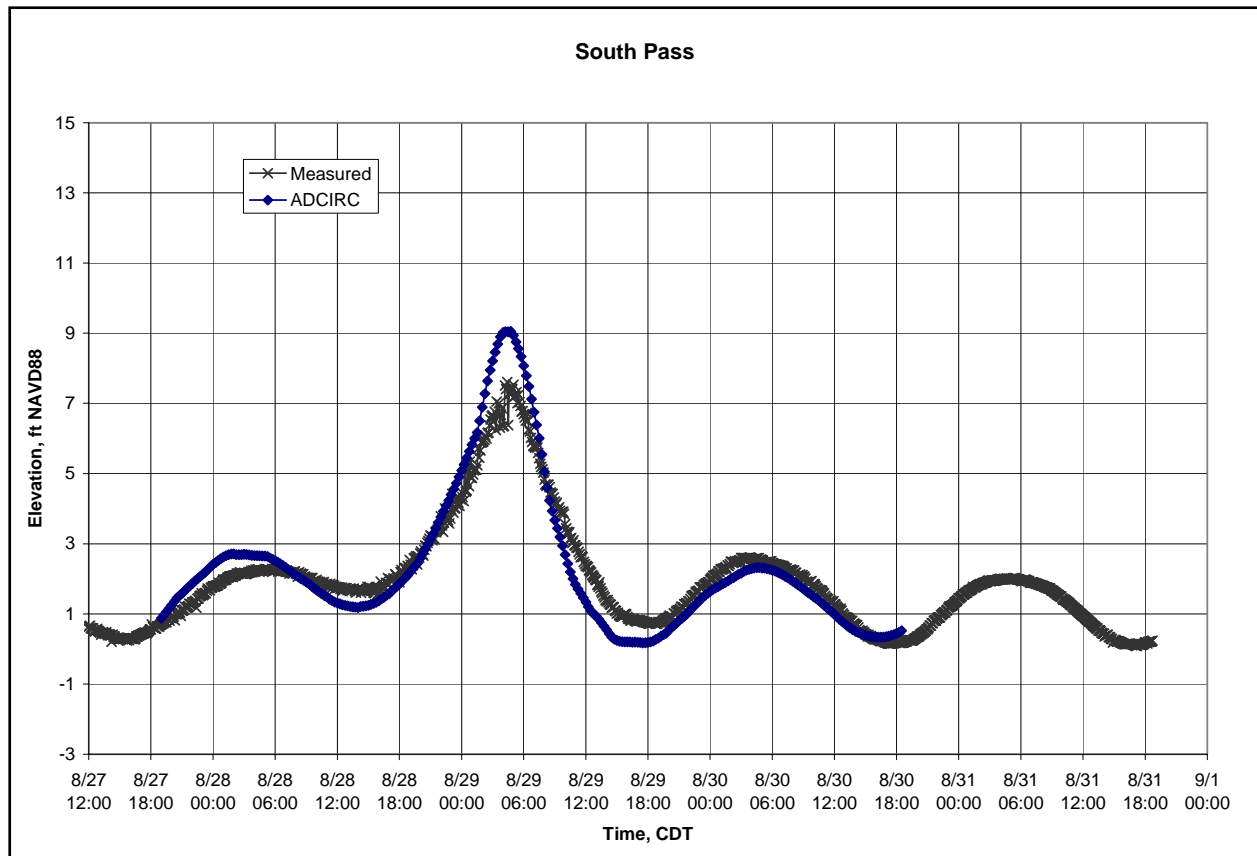
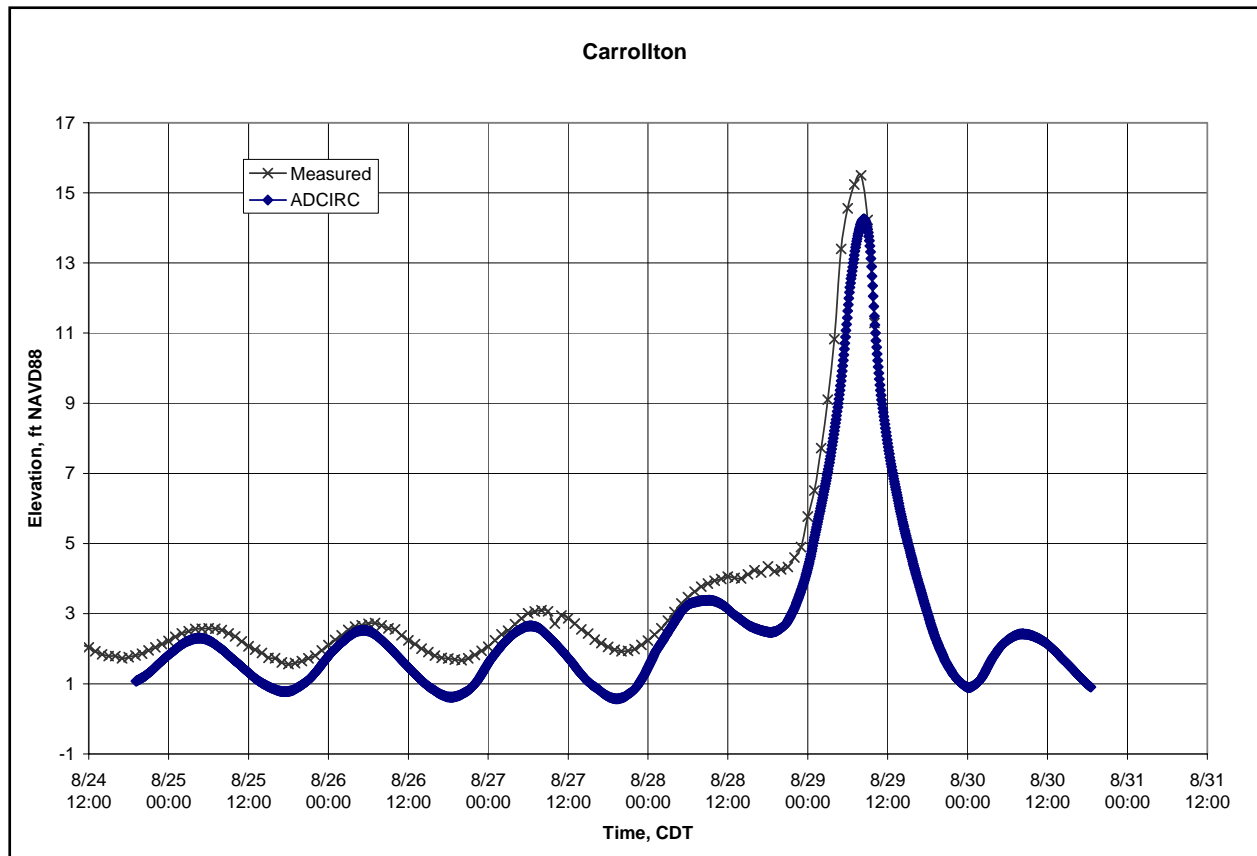
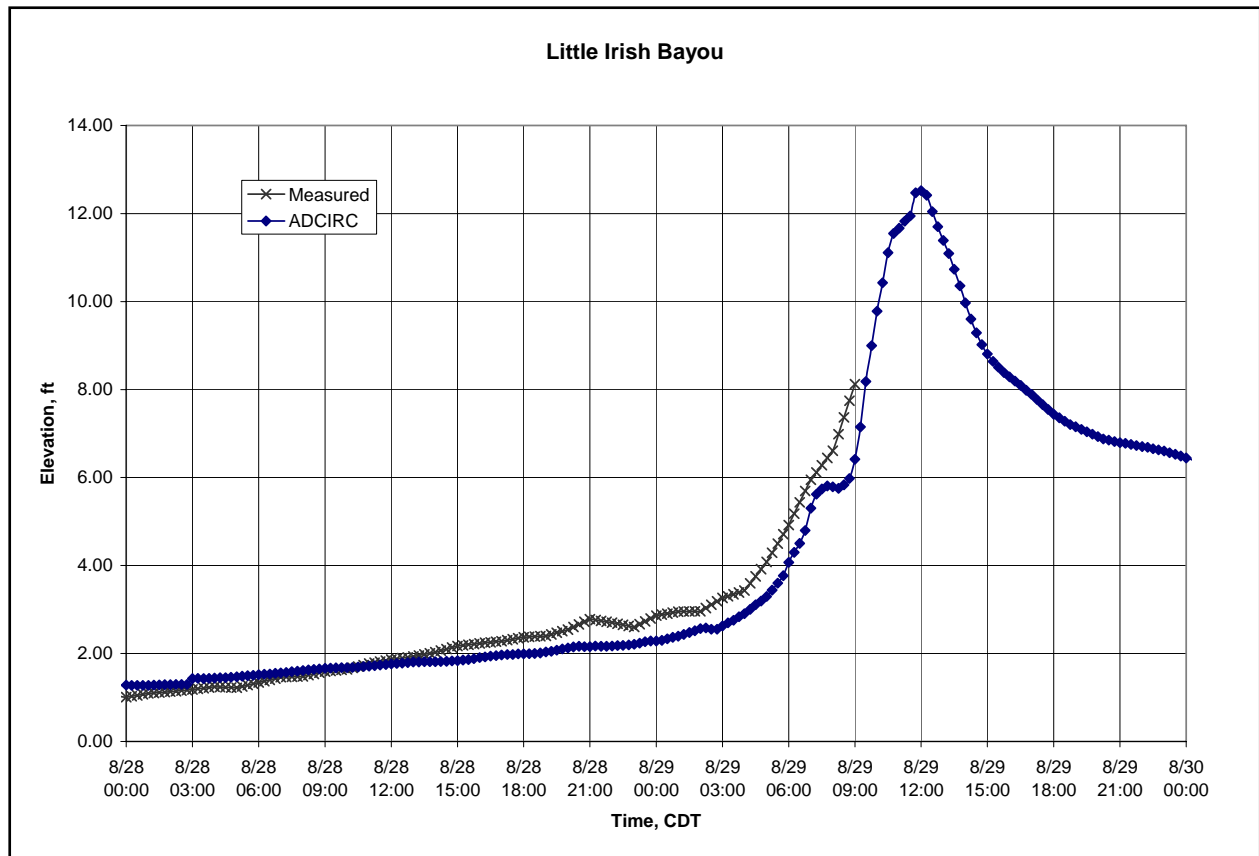
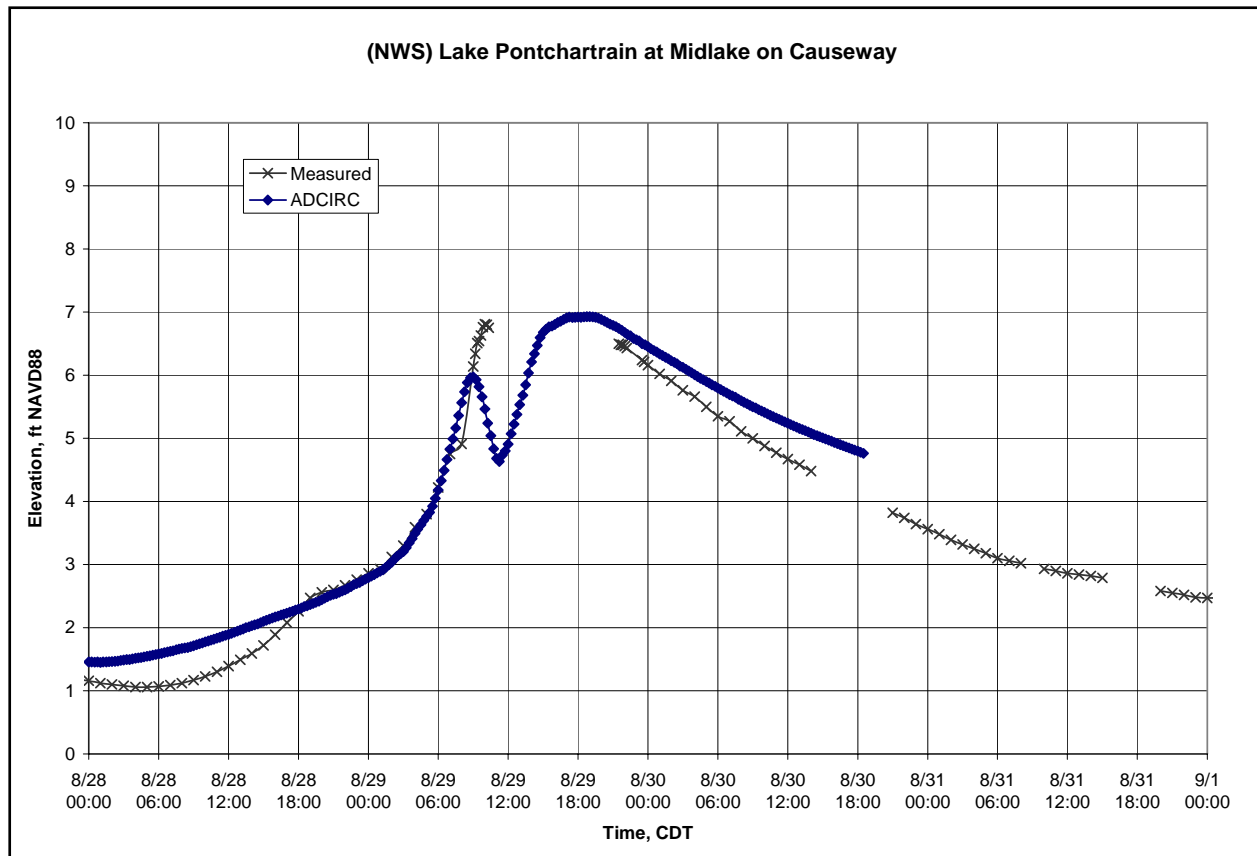
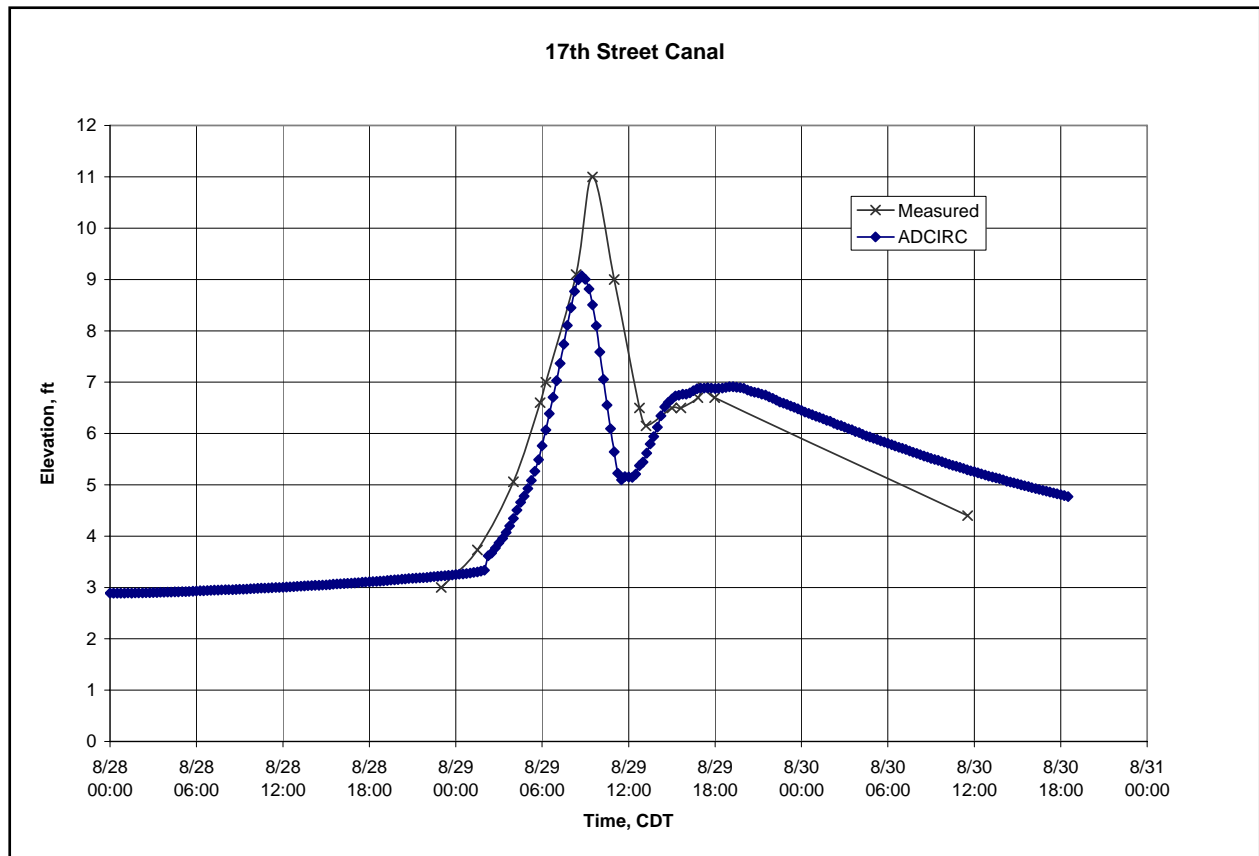
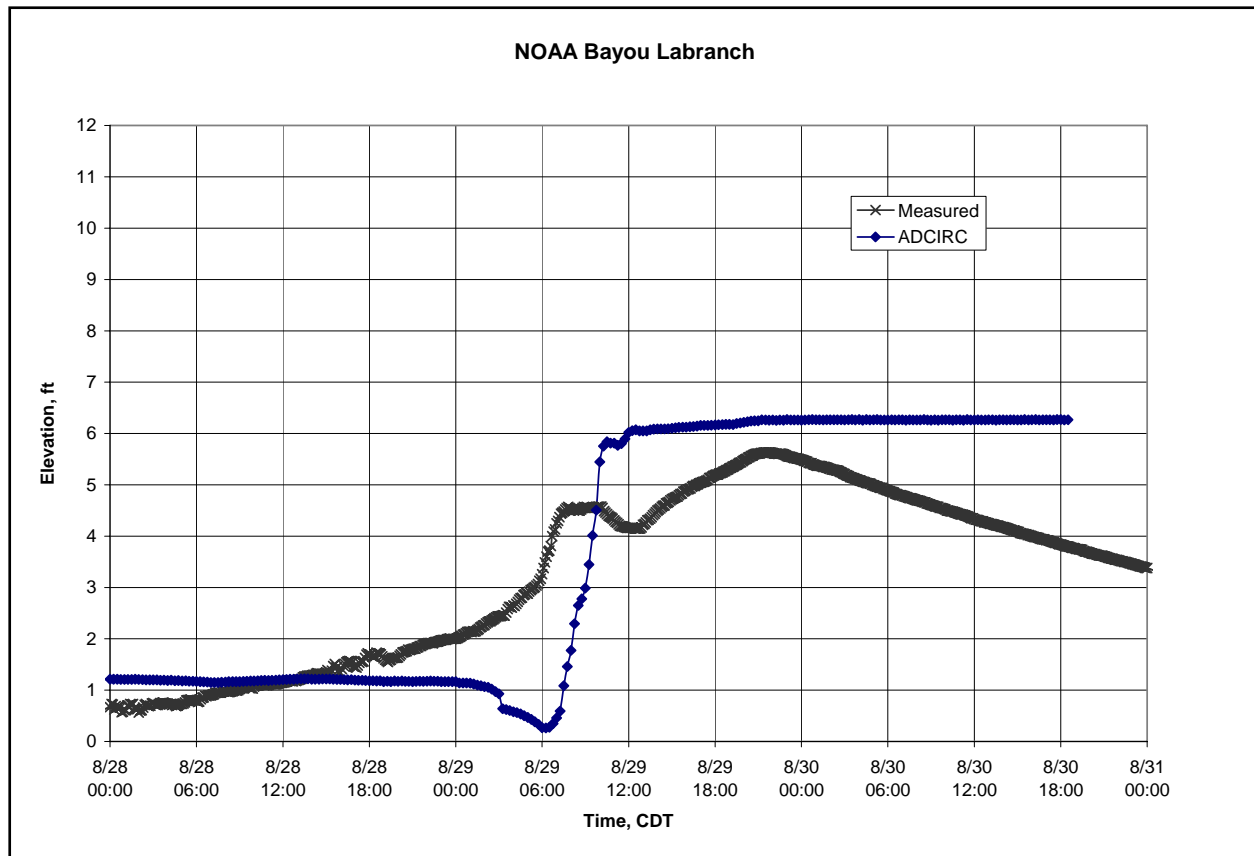
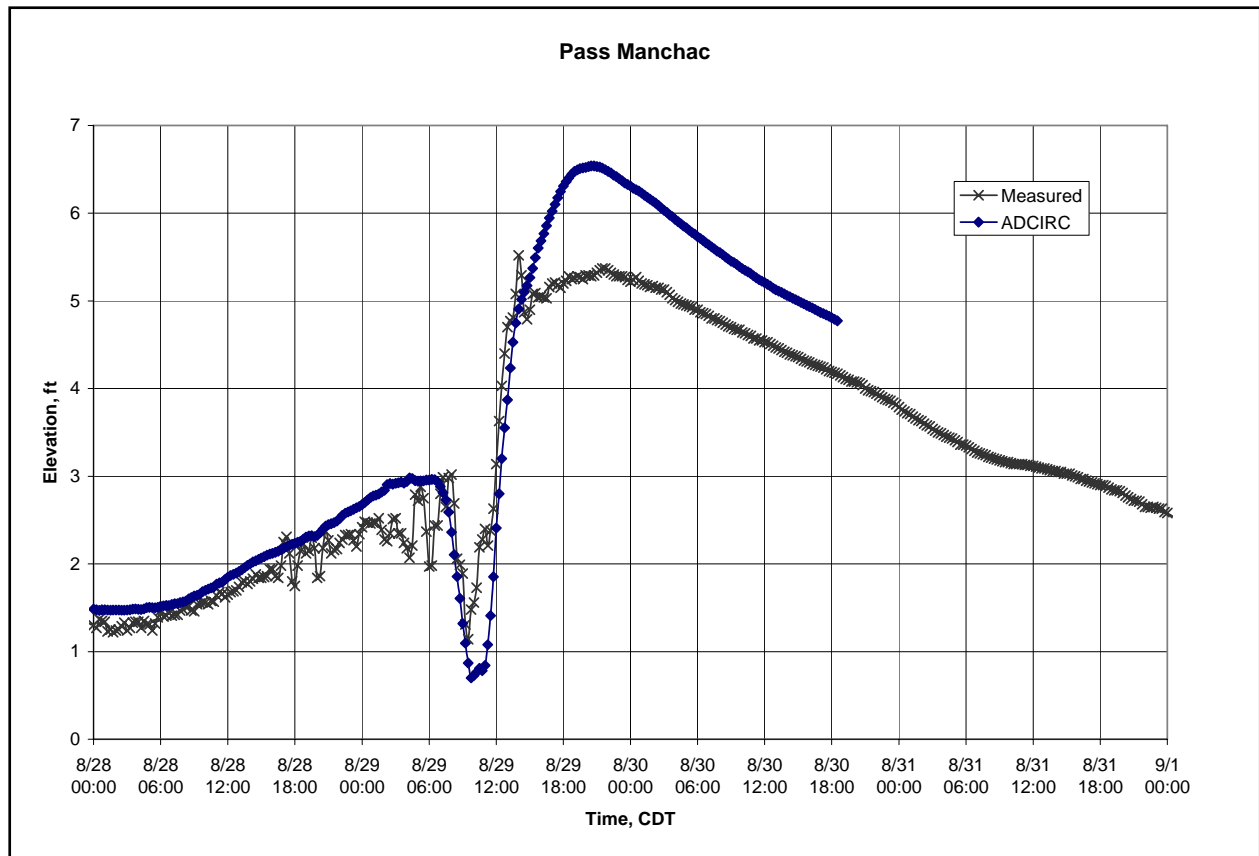
Time series of model response during Hurricane Katrina are compared to water level data at the tidal and river gauges. Hydrographs at 7 stations are plotted with the data records and model output in Figure 5-10. The model shows a very good match to both the tidal signal and the storm surge. Furthermore the datums appear to be well matched. The comparison at the mouth of the Mississippi River at South Pass indicates that the modeled tides are well represented in the region. The peak storm surge is under-predicted by about 1.8 ft. However nearby high water marks indicate that the observed peak value may somewhat under-represent the surge in the region. Specifically there are three nearby high water marks that indicate peak still water levels of 8.9, 8.6 and 8.5 ft. This more closely matches the ADCIRC predicted value. The gauge at Carrollton in the Mississippi River adjacent to New Orleans indicates that the model correctly captures the propagation of tides and surge up the Mississippi River. The tides are slightly under-damped; the computed peak water level is approximately 1.5 ft less than the measured value. It is noted that the recording station failed after the peak surge passed New Orleans. The

model results at Little Irish Bayou on Lake Ponchartrain side of Chef Menteur Pass shows rising water levels matching recorded levels. This gauge failed well before high water levels were reached. Model results at the location of the gauge in Lake Ponchartrain, Midlake, appear to match with the portion of the record that is available. The gauge failed in the middle of the storm but started recording again. It is noted that the ADCIRC model shows two peaks occurring in the lake. The first corresponds to high water being driven by winds from the north and northeast piling water against the south shore of the lake. The second and slightly larger and broader peak corresponds to the massive intrusion of water coming in from Lake Borgne driven by high waters associated with the second landfall of the storm on the Louisiana – Mississippi coast. It is noted that the drainage rate at Midlake is slightly slower in the model than the measured rate. The comparison at the 17th Street Canal indicates that the model is under-predicting peak surge by about 2 ft. More detailed local Boussinesq models have indicated that there is more wave set up than computed with this regional model, as much as 1.5-2 ft. Note that simulating wave setup properly would require grid resolution on the order of 3 to 10 m (10 to 30 ft) in order to capture the interaction of the breaking waves with the local roads (e.g. Lake Shore Drive), topography and the levee structures themselves. For this study, that interaction was considered in the high resolution hydrodynamics component of the project. The measured hydrograph compared to the ADCIRC hydrograph does show a good correspondence between the timing of the two peaks. The first is again associated with the wind driven peak from the westerly and northerly winds while the second is associated with the intrusion of high water from Lake Borgne. Again modeled drainage rates are slightly lower than measured. The comparison at Bayou Labranche is markedly different. While the model indicates that water levels abruptly rise and do not recede, the measured water levels indicate a gradual rise and a gradual recession. This is related to the fact that the TF01x2 model has included the railroad that runs along Lake Ponchartrain between the Kenner's western protection levee and the Bonnet Carre Spillway as a solid structure. The actual railroad includes a number of porous truss/piling based openings to the lake. Note that this also affects water levels against the protection levee to the west of Kenner since water is being unrealistically kept within the system, more water can be blown up against the system when winds are coming from the west towards the end of the storm. Finally water levels at Pass Manchac on the west side of the Lake compare to within 1 ft of the measured values, showing excellent agreement in terms of timing and reproduction of all hydrograph features.

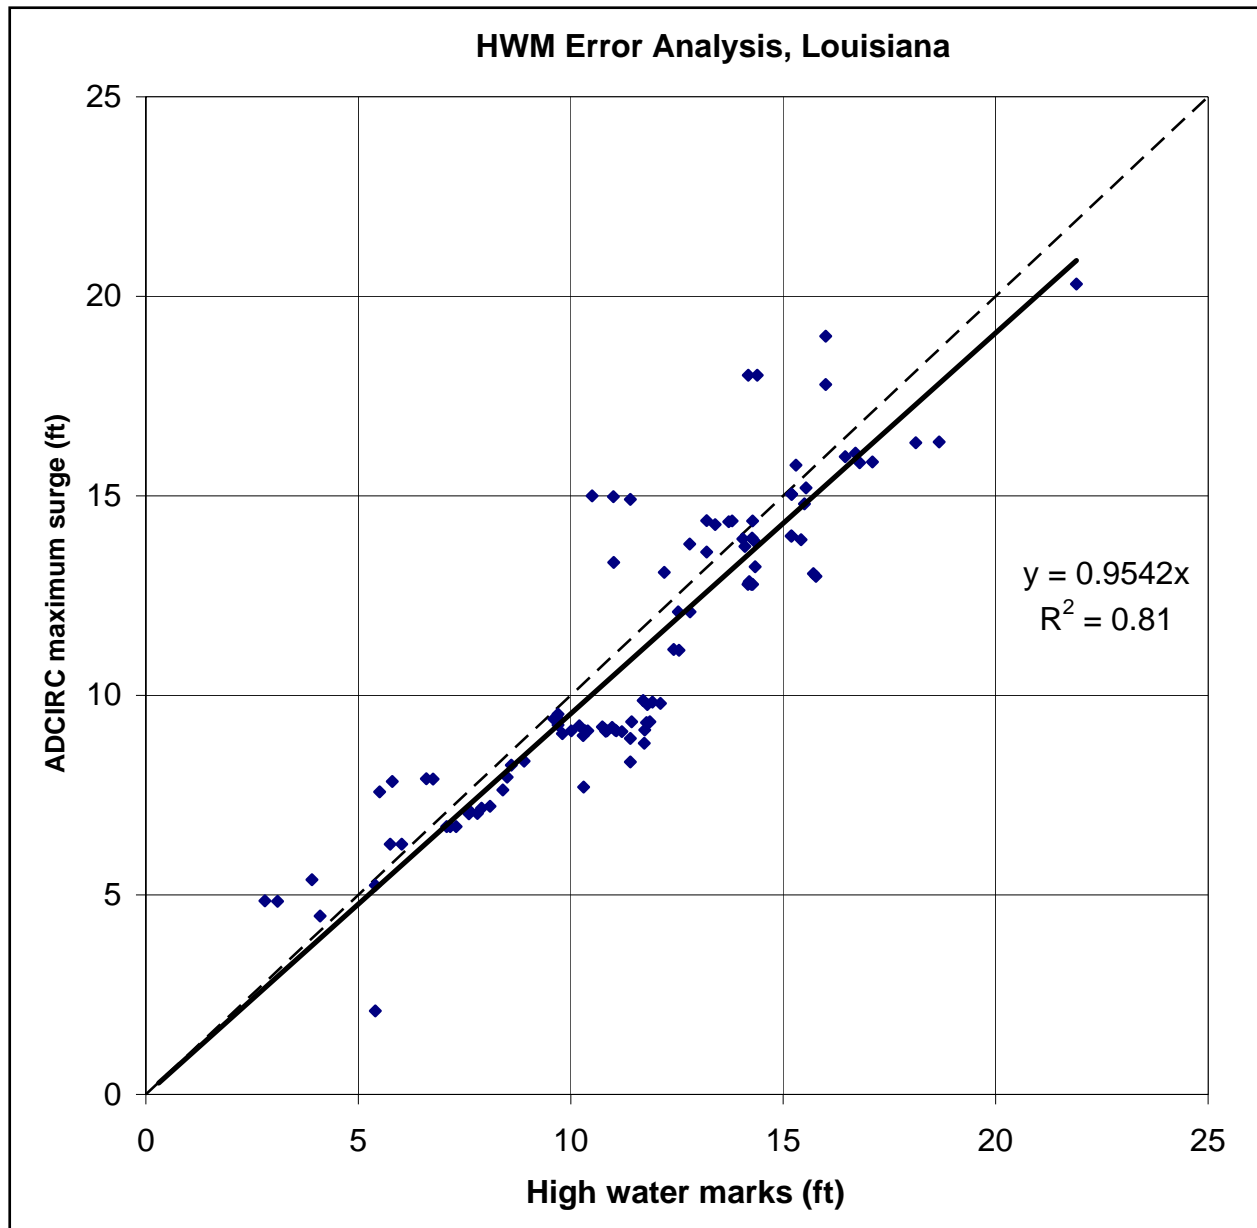
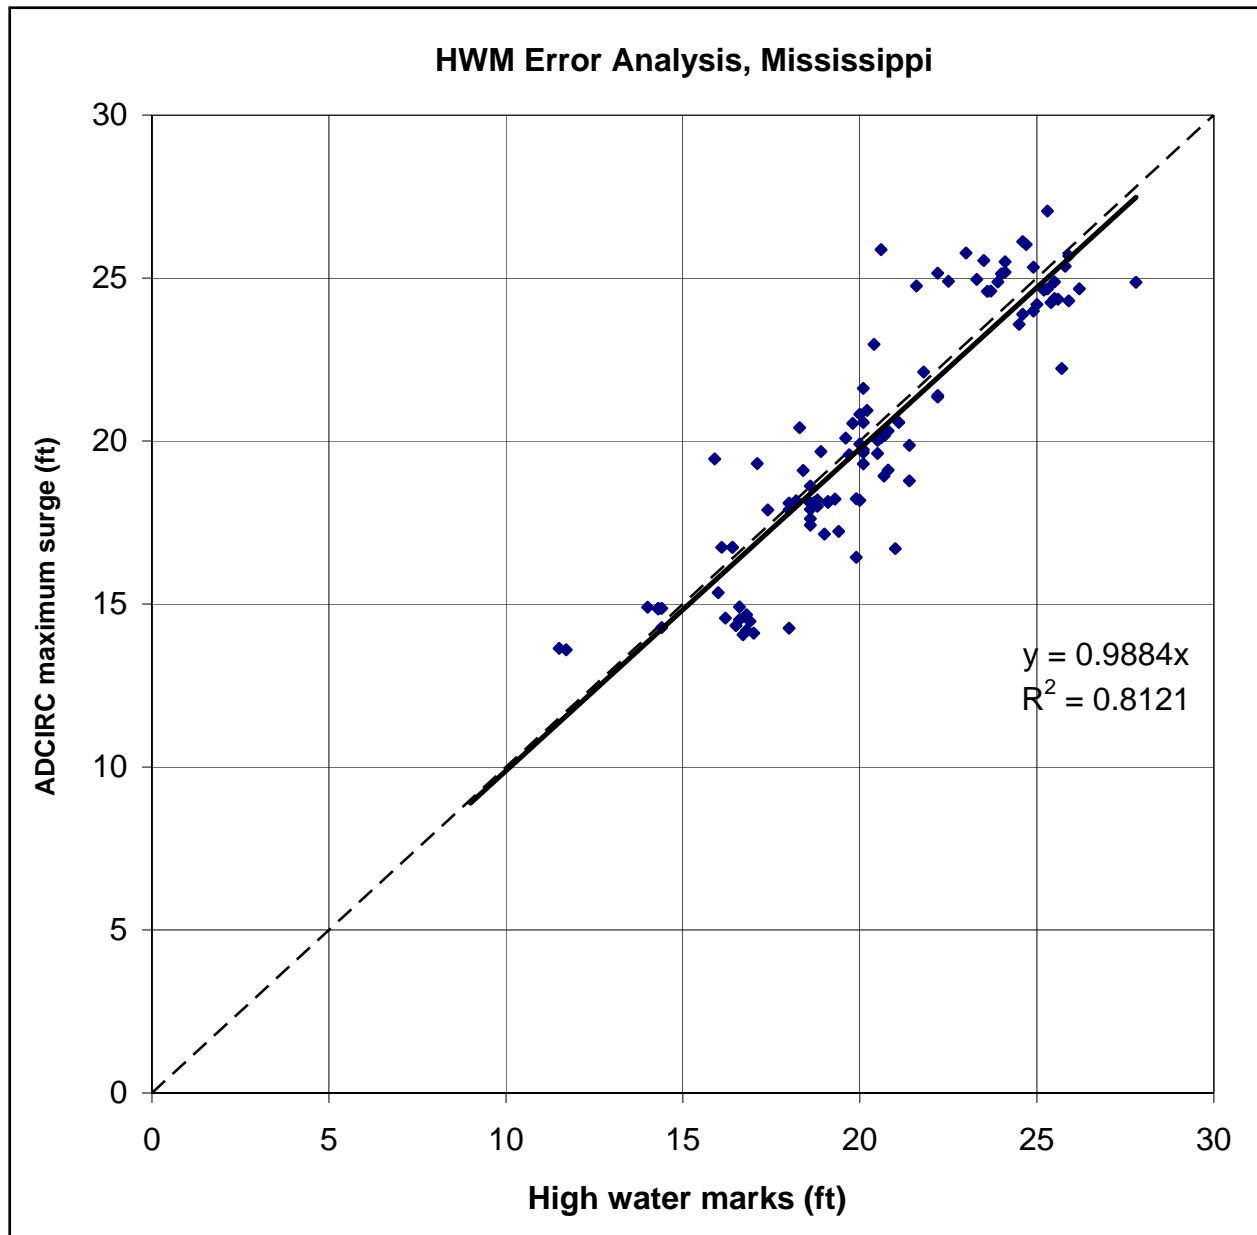
Plots of modeled versus recorded peak storm surge values at all Katrina high water mark locations identified as either excellent or good are presented in Figures 5-11 for Louisiana and Mississippi. The data points are expected to lie along a 1:1 line. If a data point is above this line it indicates over-prediction in storm surge by the model, and a point under the line indicates under-prediction. Linear regression analysis of the data is used to generate a best fit line through the data and the origin. The results of this analysis can be used to compare the slope of the best fit line to the expected 1:1 line. This best fit line is generated in a least squares manner, and the overall quality of fit is given by the correlation coefficient R^2 . For Louisiana, comparisons were made to 101 high water marks and are shown in Figure 5-11a. The slope of the line through all data points is 0.954, indicating that the model is on average under-predicting surge by 4.6 %. The average error is -0.48 ft while the average absolute error is 1.4 ft. The correlation coefficient (R^2) is 0.81 for the entire Louisiana data set, demonstrating that the modeled peak surge is closely related to the recorded peak surge and the results are clustered about the 1:1 line. For Mississippi, comparisons were made to 105 high water marks which are shown in Figure 5-11b.

The slope of the line through all data points is 0.99, indicating that the model is on average under-predicting surge by less than 1%. The average error is -0.23 ft while the average absolute error is 1.3 ft. We note that in general surge values in Mississippi were quite high falling between 15 ft and 26 ft. The correlation coefficient (R^2) is 0.81 for the entire Mississippi data set.

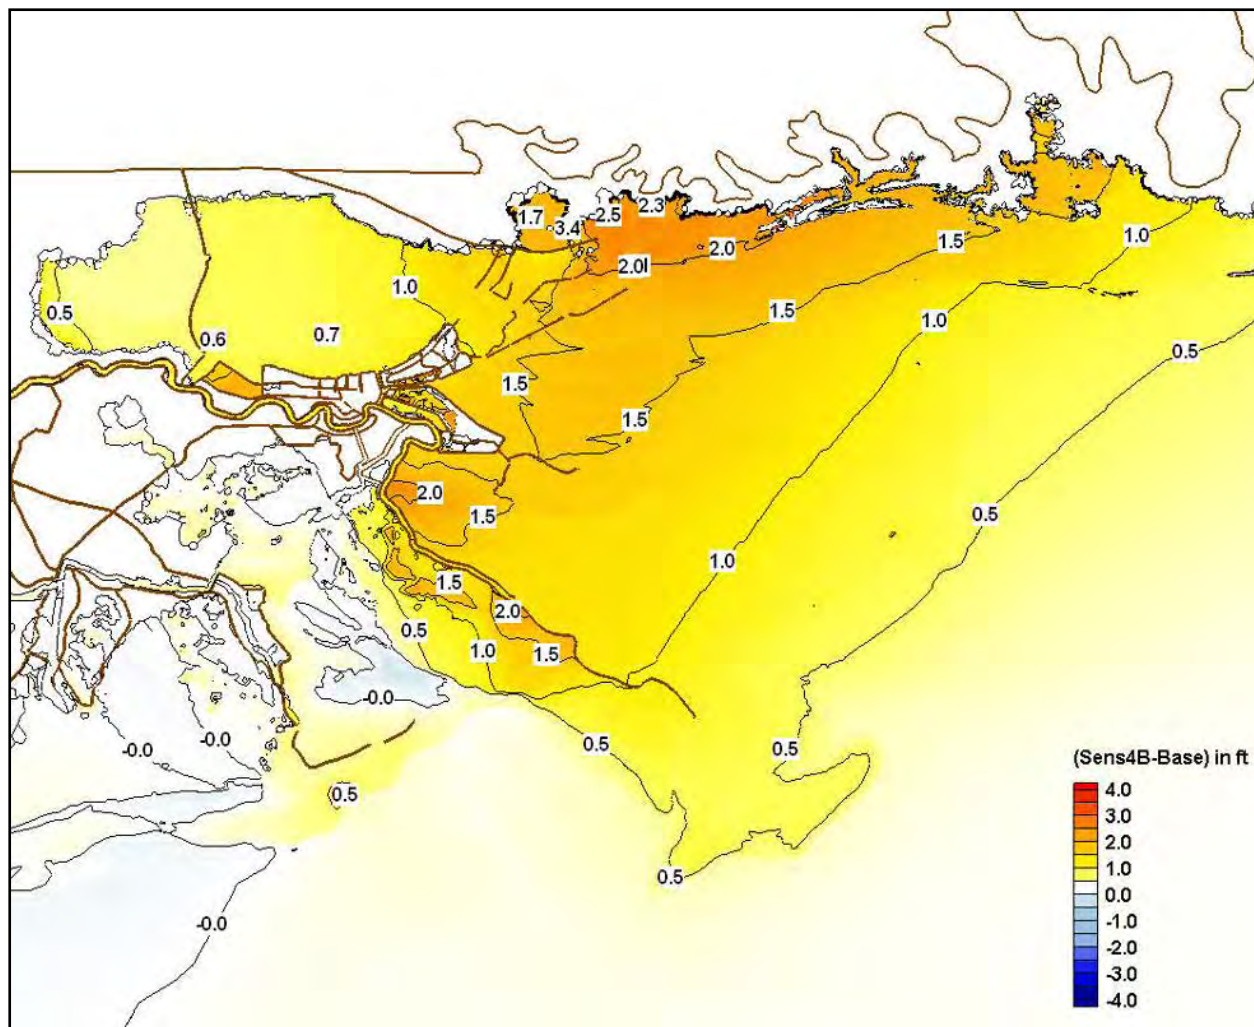
Figure 5-16. Difference in peak surge between sensitivity simulation with 5% increase in wind speed and the base simulation

Increasing the wind speed by 5% increases peak surge by 1-3 ft throughout the Hurricane Katrina impacted area, with the greatest increases in water level occurring along the Mississippi coast (Figure 5-16). The maximum surge for the Mississippi coast near Hurricane Katrina landfall is approximately 2.5-3.4 ft greater than maximum surge for the base condition. The peak surge away from the center of the storm is 1.0-2.0 ft higher with the increased wind speed. Peak surge in Lake Pontchartrain is increased by 1.0 ft or less with the increased wind speed. Decreasing the wind speed by 5% has the opposite effect, decreasing water levels 1-5 ft

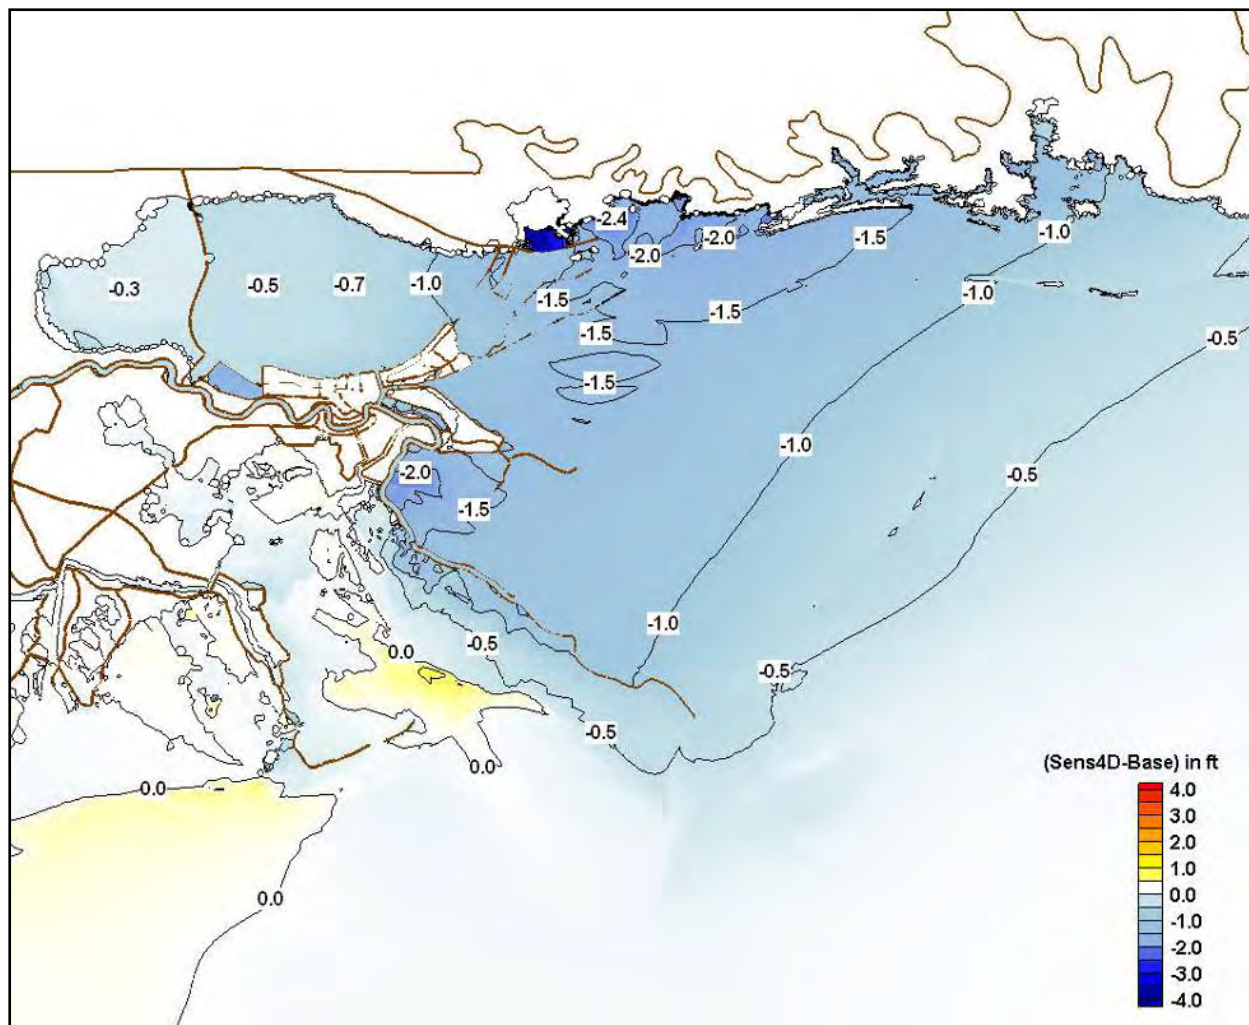
Figure 5-17. Difference in peak surge between sensitivity simulation with 5% decrease in wind speed and the base simulation

throughout the Hurricane Katrina impacted area (Figure 5-17). The greatest decreases in water level are along the Mississippi coast.

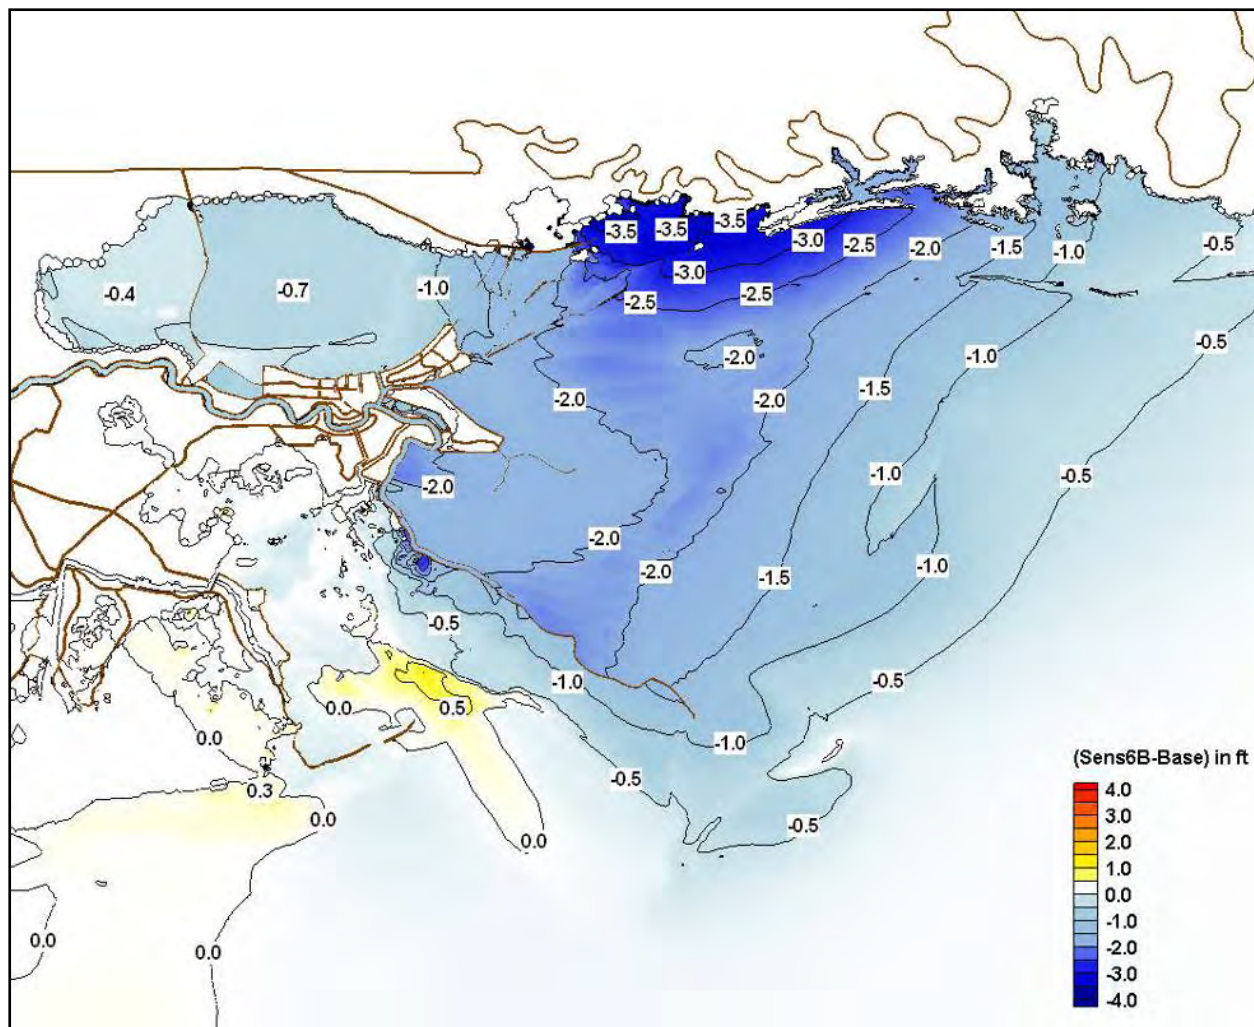
Figure 5-18. Difference in peak surge between sensitivity simulation with wind drag cutoff and the base simulation

Applying a wind drag cutoff decreases peak surge of 1-4 ft, with the greatest decreases along the Mississippi coast (Figure 5-18). The decrease in peak surge near St Bernard Parish is 1-2 ft and the decrease near Plaquemines Parish is approximately 2 ft. Applying an alternative wind stress formulations (Amorocho and Devries, 1980) results in a slightly smaller reduction in peak surge than the wind drag cutoff reduction in water level, but the overall pattern is quite similar (Figure 5-19). All changes in the wind forcing cause the greatest change in peak surge along the Mississippi coast, and similar patterns of change in Plaquemines Parish, St Bernard Parish, and Lake Pontchartrain.

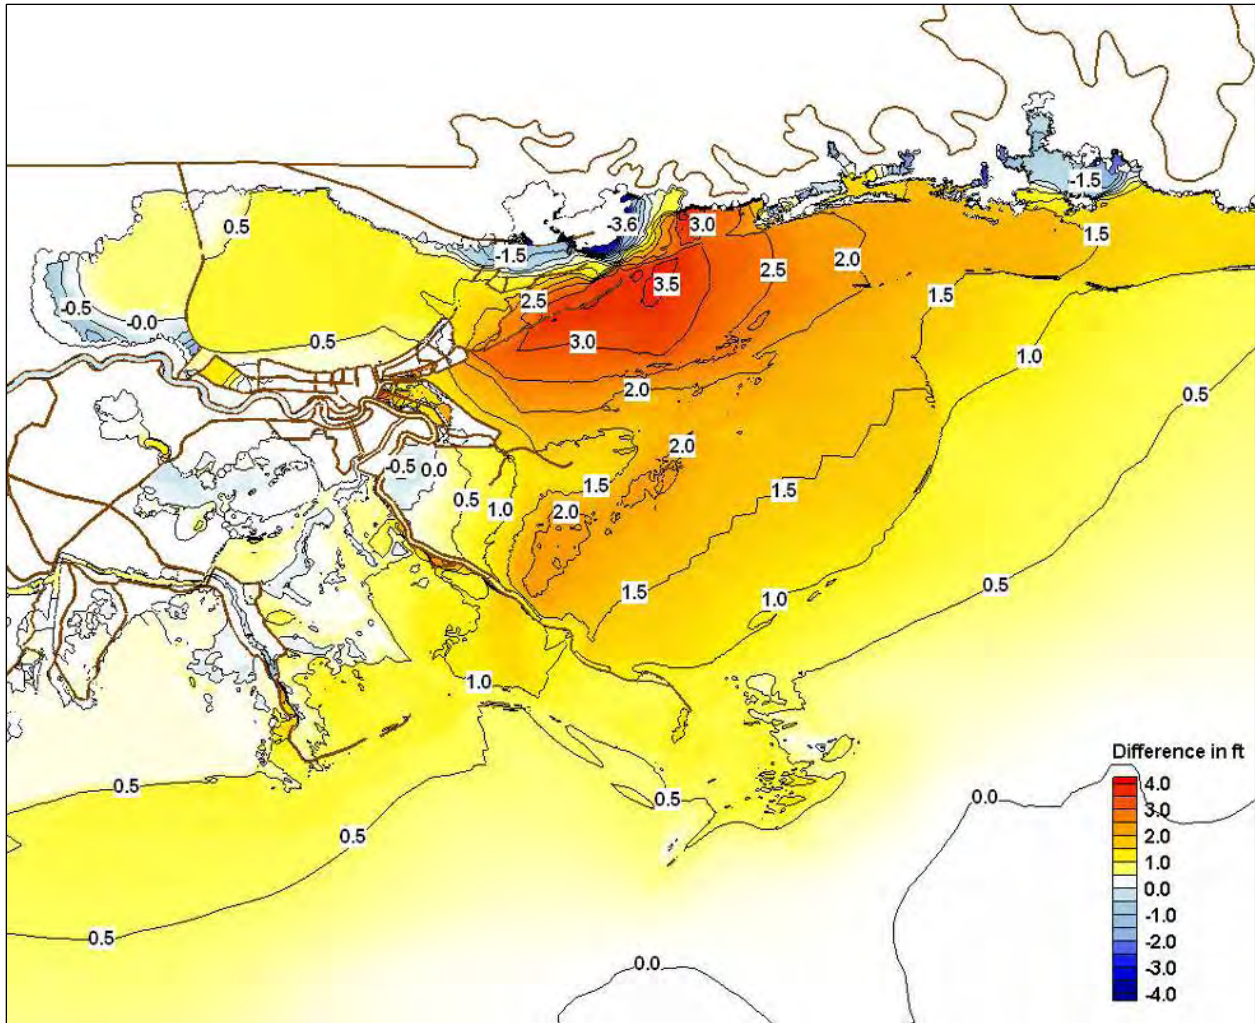
Changing the Pre-Katrina friction formulation from a single value to a spatially-varying friction field to represent Pre-Katrina vegetation, results in an increase in peak water level in deeper water and a decrease in water level in the overland areas (Figure 5-22). This is related to the decrease in bottom friction in open waters with the Manning n specified equal to 0.020 there and the increase in frictional resistance in due to high Manning n values inland. Note that the extensive network of connecting channels that occur throughout the marshes, cyprus forests and other regions in Southern Louisiana were not considered in these simulations.

Figure 5-23. Difference in peak surge between sensitivity simulation with Post-Katrina variable friction and the base simulation

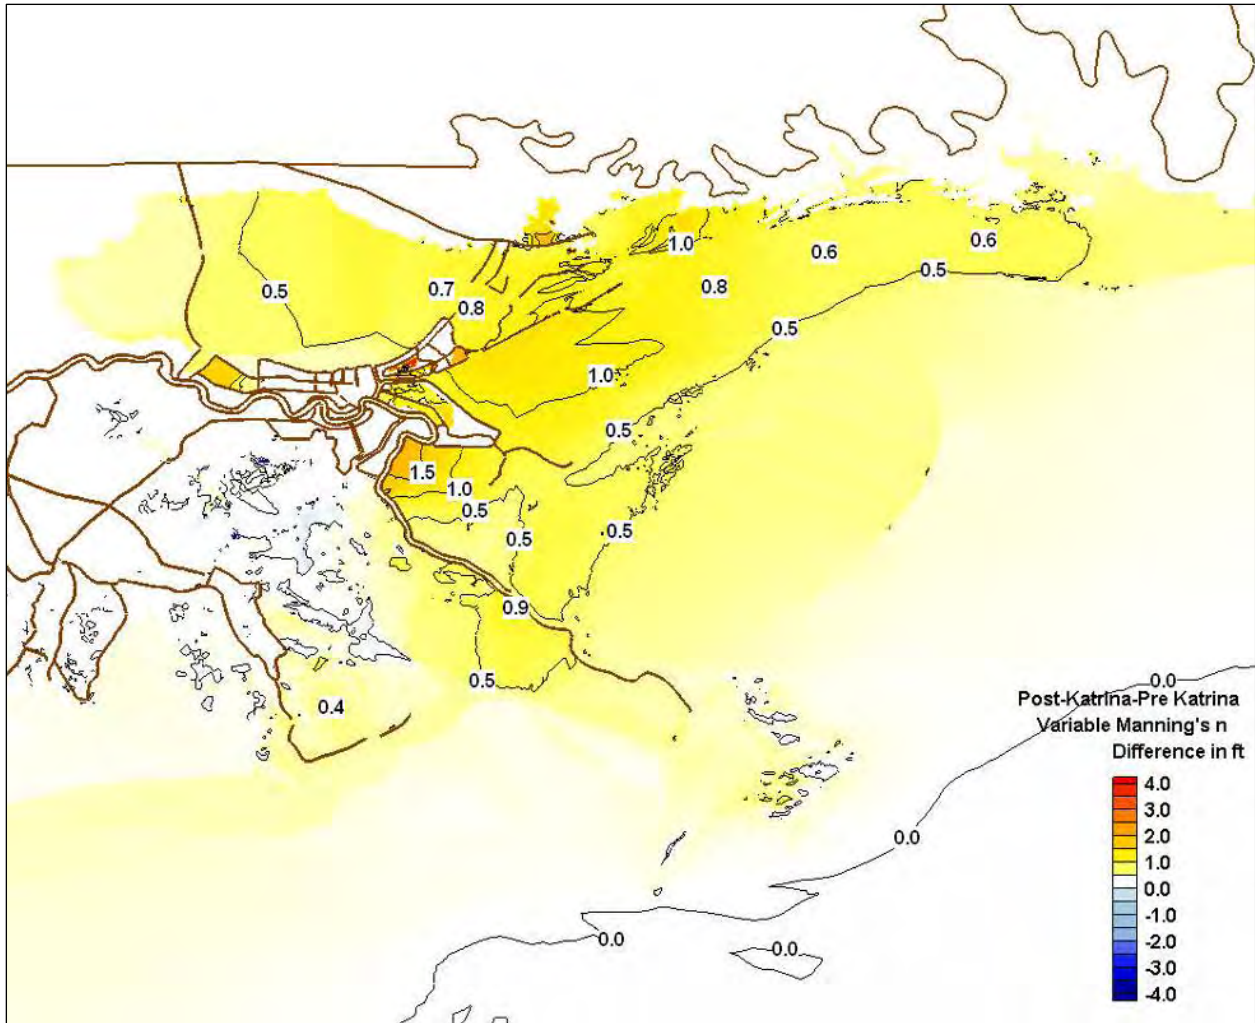
(Figures 5-22 and 5-23). Changing the friction formulation from a single value to a spatially-varying friction field to represent Post-Katrina vegetation, results in an increase in peak water level in deeper water and a decrease in water level in the overland areas. The increase in peak surge for Post-Katrina variable friction compared to the Base simulation (Figure 5-23) is greater than the increase in surge for the Pre-Katrina variable friction compared to the Base simulation (Figure 5-22). The comparison of Pre-Katrina and Post-Katrina peak surge (Figure 5-24) shows the reduction in vegetation (increase in open water) results in an increased peak surge of 0.5-1.5 ft.

Figure 5-24. Difference in peak surge between sensitivity simulation with Post-Katrina variable friction and Pre-Katrina variable friction

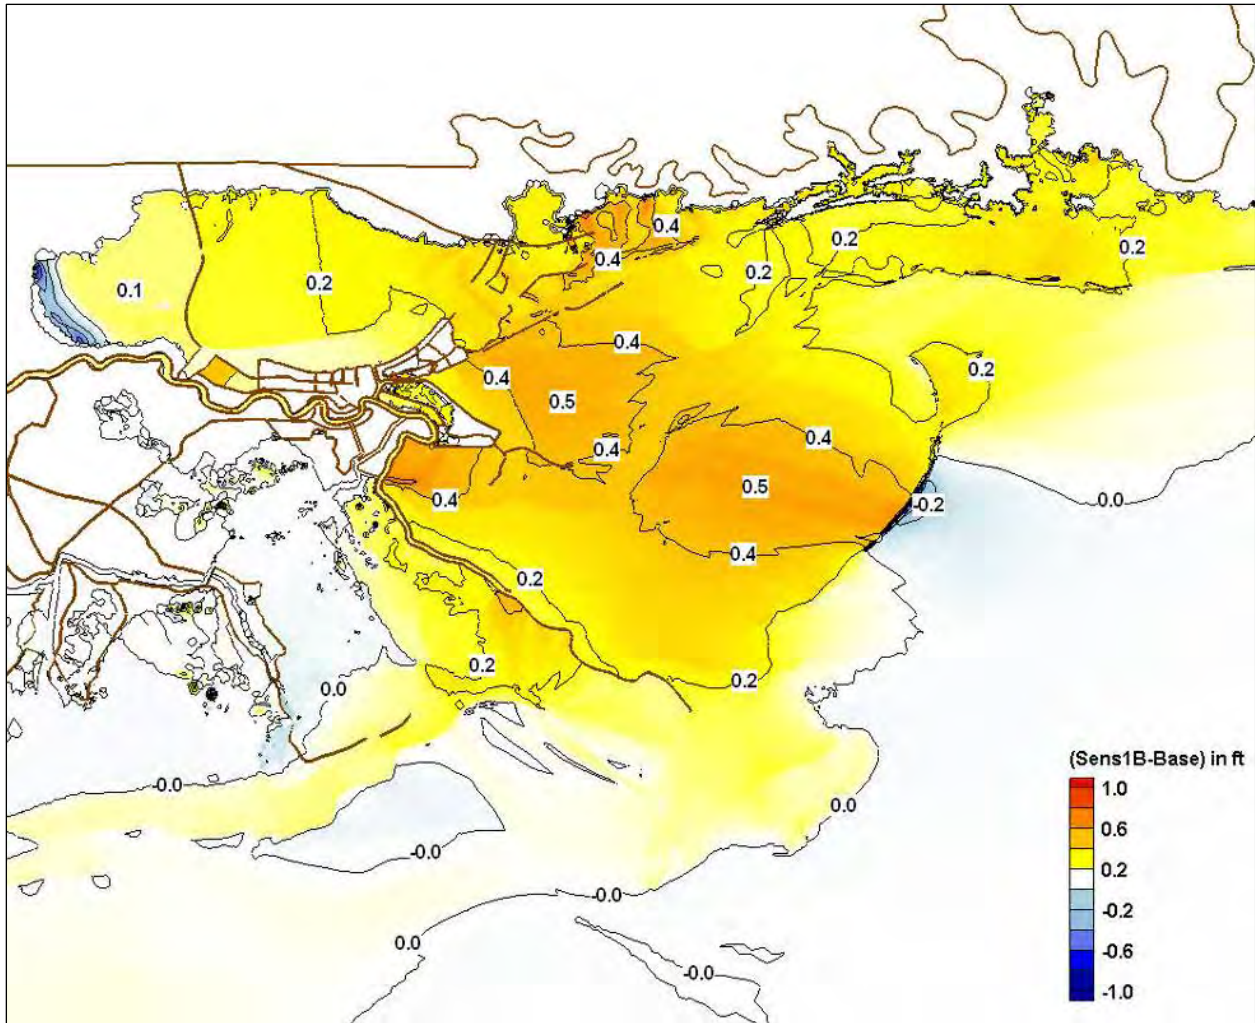
Deflation of the protective barrier islands along the Mississippi and Louisiana coast may leave these coastal regions more vulnerable to inundation from future storms. This supposition was examined by changing the bathymetric configuration of Chandeleur Island to the post-Katrina condition and repeating the ADCIRC simulation of Hurricane Katrina. A SHOALS survey of the barrier island was collected after Hurricane Katrina (Fall 2005) and shows that approximately half of the barrier island that was previously emergent had submerged after Hurricane Katrina (Figure 5-25). The majority of the loss of emergent area was from the southern end of the island. The post-Katrina configuration of Chandeleur Island was incorporated into the ADCIRC mesh for the sensitivity simulation. The results shown in Figure 5-26 indicate that deflation of Chandeleur Island provided a means for a greater volume of water to pass over the deflated island and increase water levels landward of the island. In general, peak water levels for the Chandeleur Island sensitivity simulation are 0.5 ft greater than the base conditions simulation.

Figure 5-26. Difference in peak surge between sensitivity simulation with Post-Katrina configuration of Chandeleur Island and the base simulation

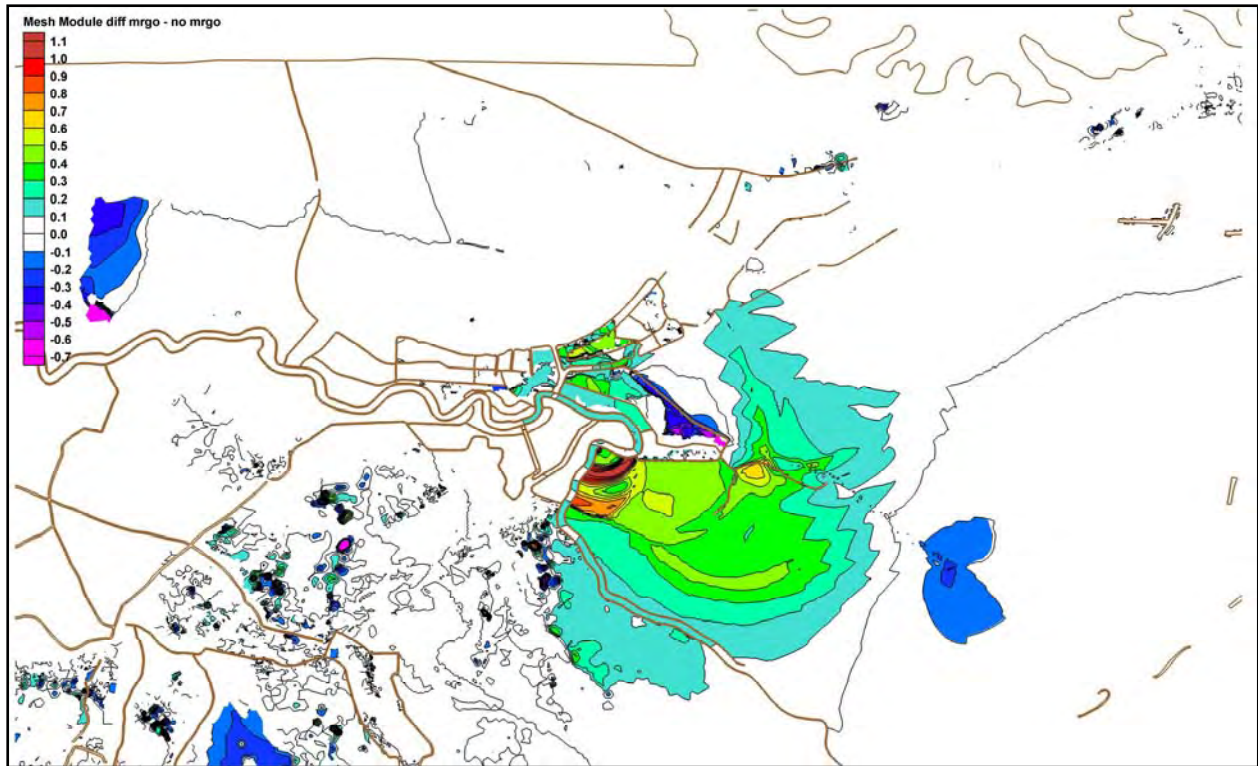
The simulation without the MRGO/Reach 2 results in very similar water levels in most of the domain for the Katrina event. Differences in the maximum Katrina event water levels with and without the MRGO in place are shown in Figures 4a and 4b. Notable differences with the MRGO Reach 2 channel in place are as follows: there is a reduction of water level of up to 0.2 ft at the entrance to the MRGO's inland cut; there is an increase of 0.3 to 0.4 ft in the marshes west of the MRGO in the region delineated by Pointe a la Hache, Carlisle, Stella, Caernarvon and Verret; a maximum increase of approximately 1.1 ft locally east of English Turn; in Lake Borgne along the MRGO there is a 0.1 to 0.2 ft increase; there is a 0.1 to 0.2 ft decrease along the St. Bernard Parish/Chalmette protection levee; and finally there is a 0.1 to 0.2 ft increase in a portion of the GIWW/MRGO/Reach 1. In all other regions, including in the IHNC, differences are less than 0.1 ft. In addition, the New Orleans and vicinity protection system is not impacted

Figure 4a. Maximum Hurricane Katrina event differences in ft, for simulations with and without the MRGO in place. Positive differences indicate increased elevations with the MRGO in place while negative differences indicate decreased water levels with the MRGO in place
