Appendix 1

Hydrograph and High Water Mark Analysis

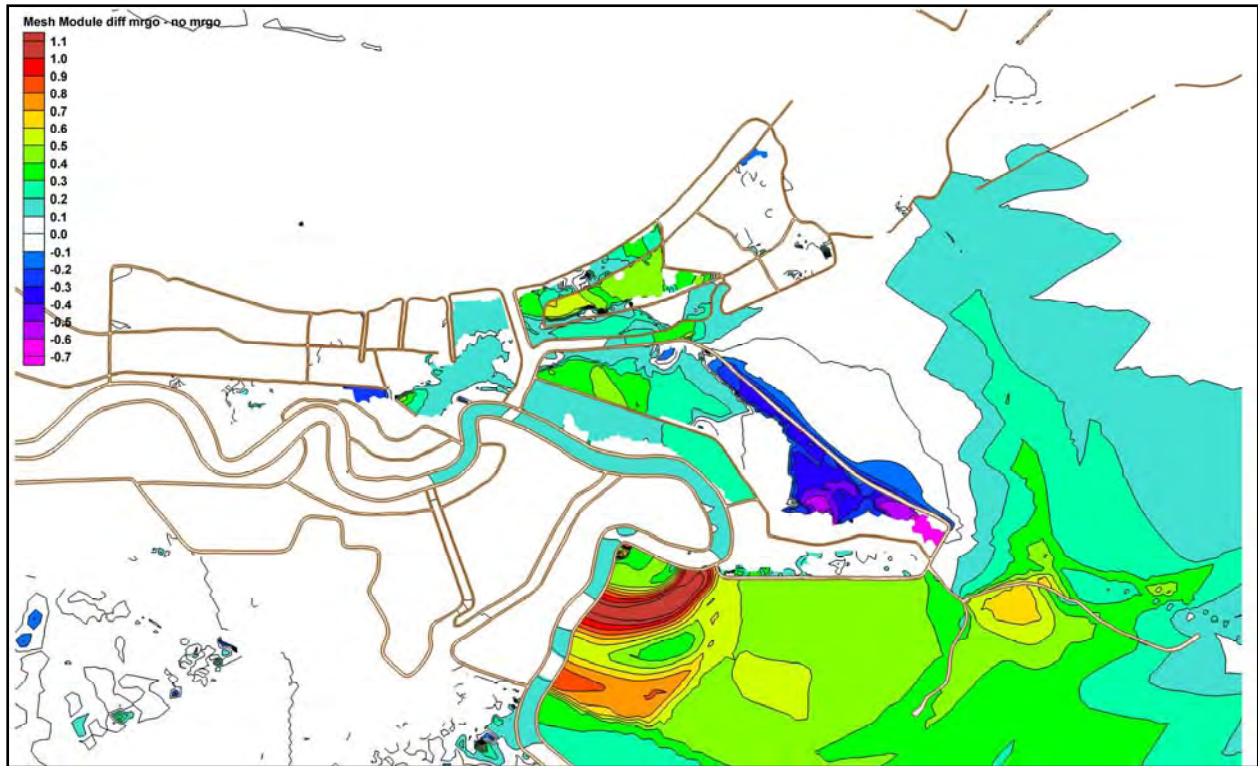
The simulation without the MRGO/Reach 2 results in very similar water levels in most of the domain for the Katrina event. Differences in the maximum Katrina event water levels with and without the MRGO in place are shown in Figures 4a and 4b. Notable differences with the MRGO Reach 2 channel in place are as follows: there is a reduction of water level of up to 0.2 ft at the entrance to the MRGO's inland cut; there is an increase of 0.3 to 0.4 ft in the marshes west of the MRGO in the region delineated by Pointe a la Hache, Carlisle, Stella, Caernarvon and Verret; a maximum increase of approximately 1.1 ft locally east of English Turn; in Lake Borgne along the MRGO there is a 0.1 to 0.2 ft increase; there is a 0.1 to 0.2 ft decrease along the St. Bernard Parish/Chalmette protection levee; and finally there is a 0.1 to 0.2 ft increase in a portion of the GIWW/MRGO/Reach 1. In all other regions, including in the IHNC, differences are less than 0.1 ft. In addition, the New Orleans and vicinity protection system is not impacted

Figure 4b. Maximum Hurricane Katrina event differences in ft in metropolitan New Orleans and vicinity, for simulations with and without the MRGO in place. Positive differences indicate increased elevations with the MRGO in place while negative differences indicate decreased water levels with the MRGO in place

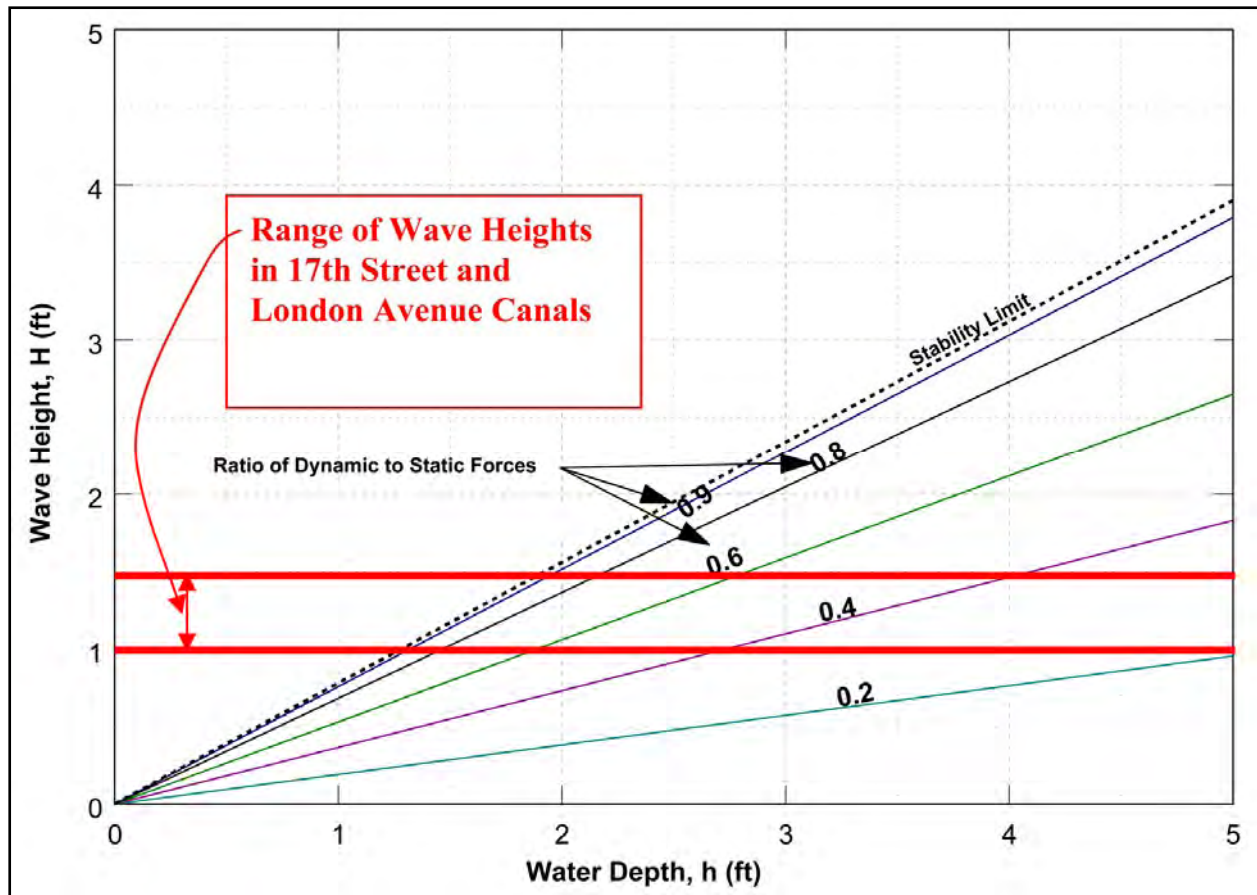
Figure 8-2 presents the ratio of dynamic to static forces versus water depth and wave height. The stable shallow water wave height limit of $H/h = 0.78$ is also shown. The range of wave heights from 1 ft to 1.5 ft is highlighted as the approximate wave height range determined to occur at the 17th Street and London Avenue floodwalls during Katrina. It is seen that for a water depth against the floodwall of, say, 4 ft, and a wave height of 1 ft to 1.5 ft, the *total force* ranges between approximately 128% and 140 % of the static force component.

Figure 8-2. Isolines of Constant Values of the Ratio of Dynamic to Static Force Components, R_F versus water depth, h , and wave height, H

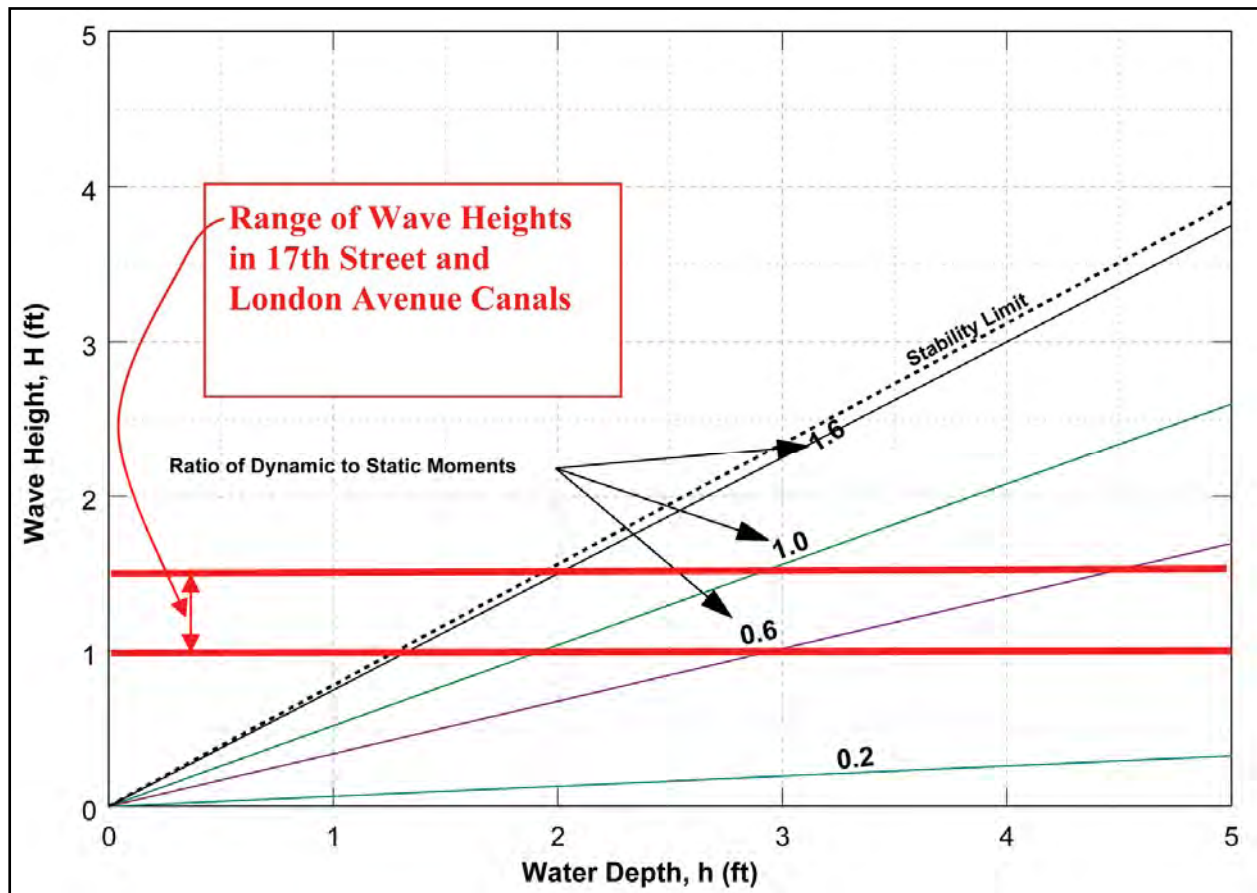
Figure 8-3 presents the ratio of dynamic to static moments versus water depth and wave height. The stability limit of $H/h = 0.78$ is also shown. It is seen that the ratios of dynamic to static moment components are larger than their force counterparts (Figure 8-2). Again for a water depth against the floodwall of 4 ft, and a wave height range of 1 ft to 1.5 ft, the corresponding range of *total moments* would be approximately 145% to 165% of the static moment component.

Figure 8-3. Isolines of the ratio of dynamic to static moment components, R_M versus water depth, h and wave height, H

The magnitudes of these ratios are such that the dynamic forces and moments associated with the presence of waves should be taken into account in floodwall design and analysis.

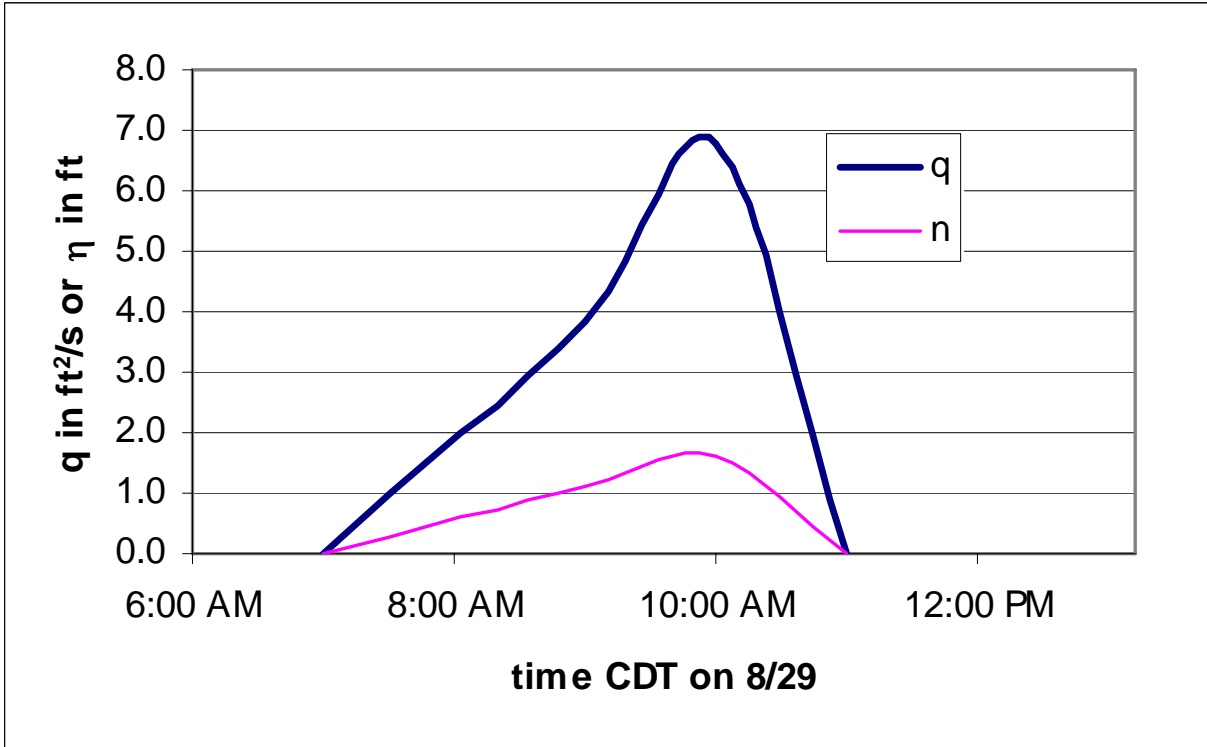
Figure 9-6. Overtopping flowrate at floodwall along IHNC at Lower Ninth Ward during Hurricane Katrina using Equations 4 and 5. Floodwall height used was 12.6 ft.

For overtopping of the Lower Ninth Ward floodwall, this velocity ranges from 0 to 22 ft/s. This indicates that the jet impacts over a relatively small footprint with a high velocity. Seiffert and Philipse (1990) showed experimentally that water velocities of 13 ft/s, running essentially parallel to the grass mats on the Dutch dikes, would cause erosion. Also, as the total head increases, the obliquity of the impacting jet to the ground increases. This results in a wider area of damage. Finally, as the jet impacts the ground it spreads and creates a wide area of damage on the lee side of the floodwall.

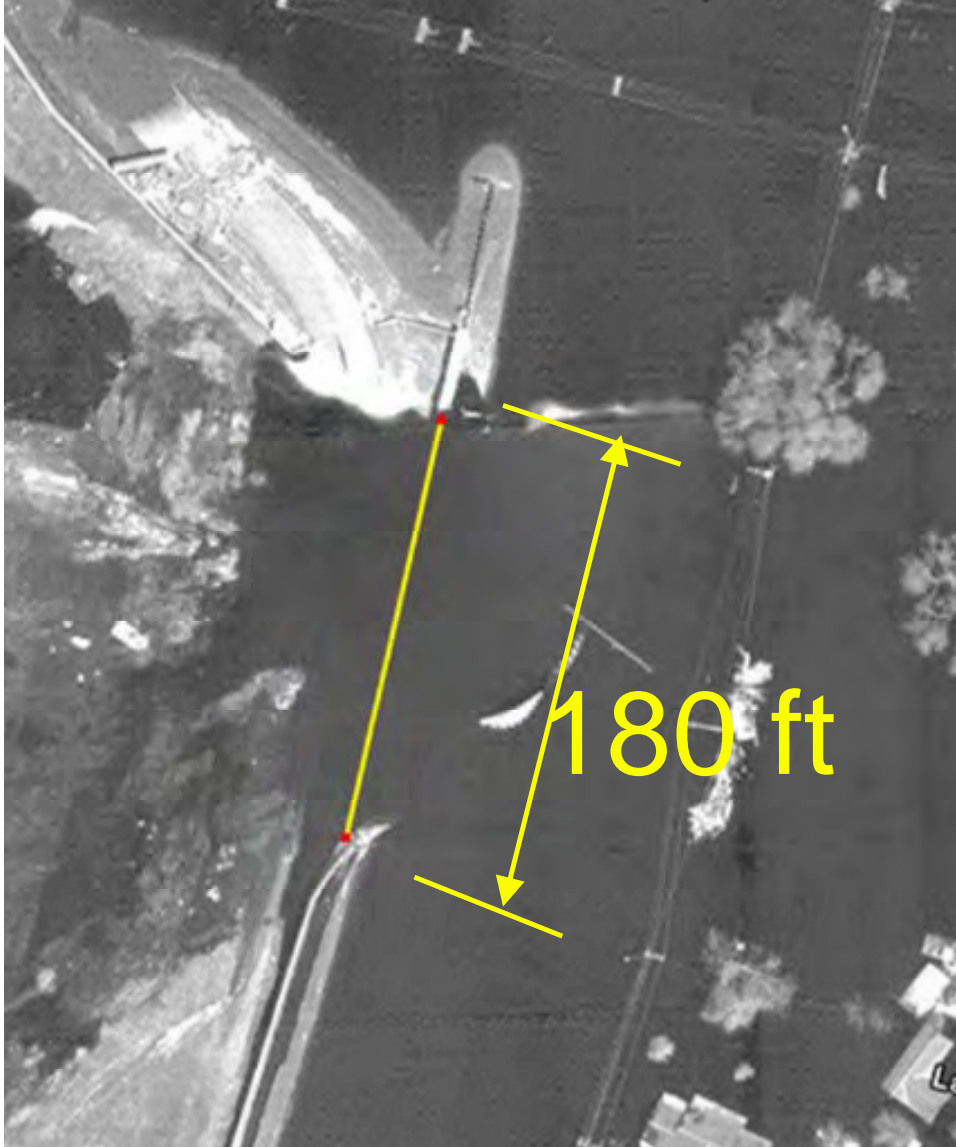
Once the IHNC floodwalls along the Lower Ninth Ward were breached, the flow into the area increased significantly. The breach sill heights appeared to be at elevation of roughly $+1$ ft. The flow through the breaches at the IHNC can be approximated.

Figure 9-7. North breach on IHNC at Lower Ninth Ward

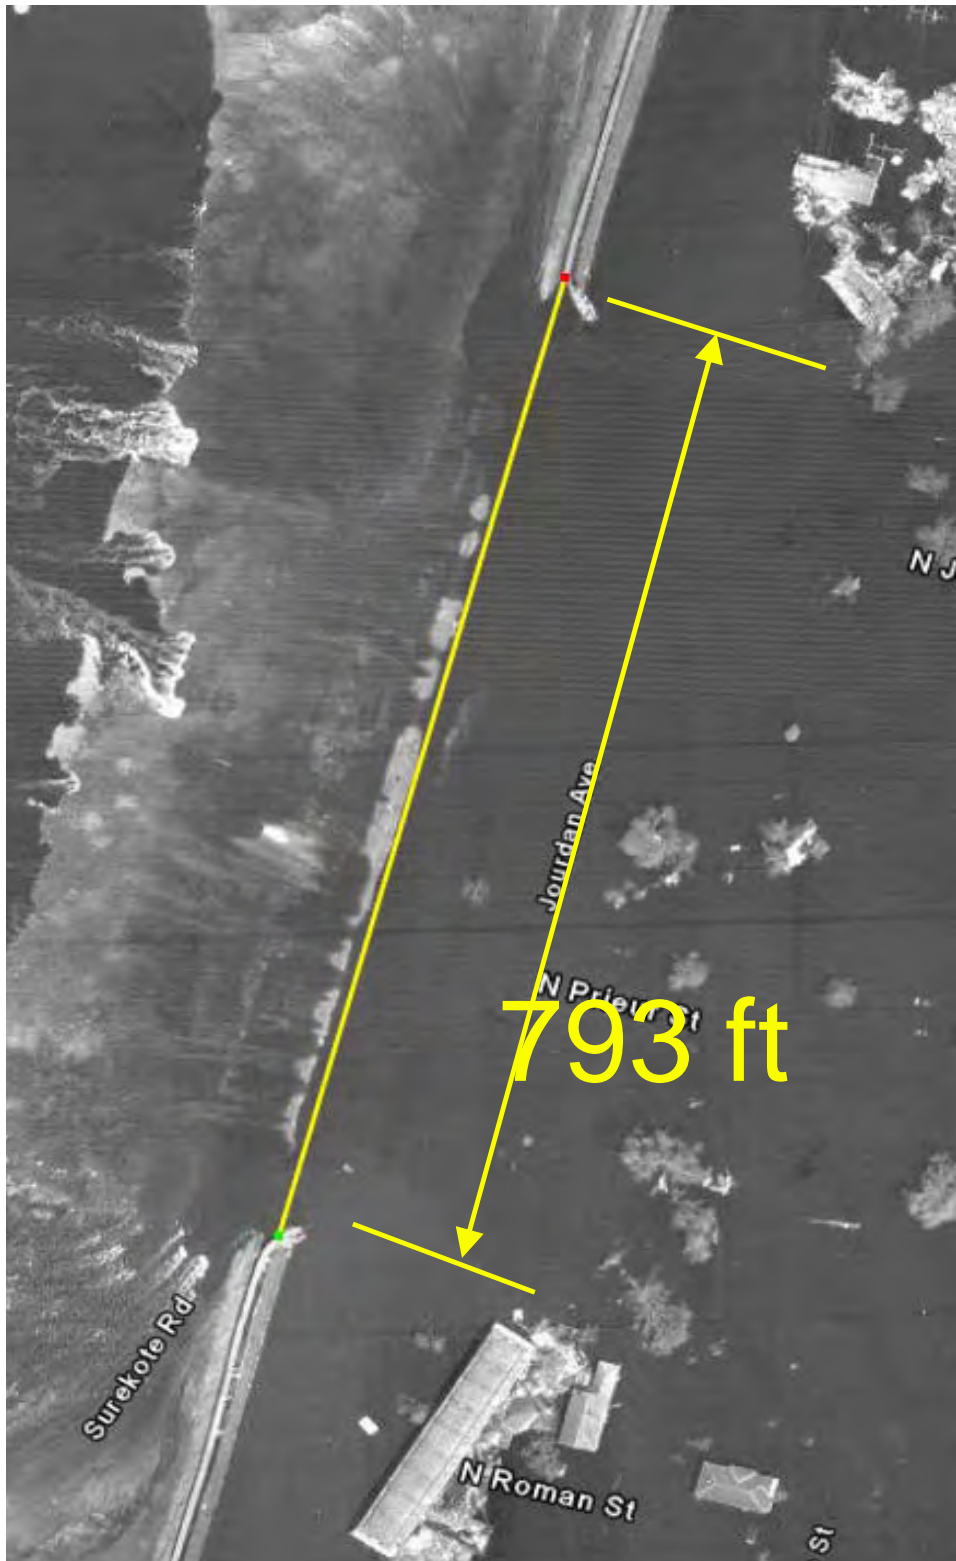
Figure 9-8. South breach on IHNC at Lower Ninth Ward

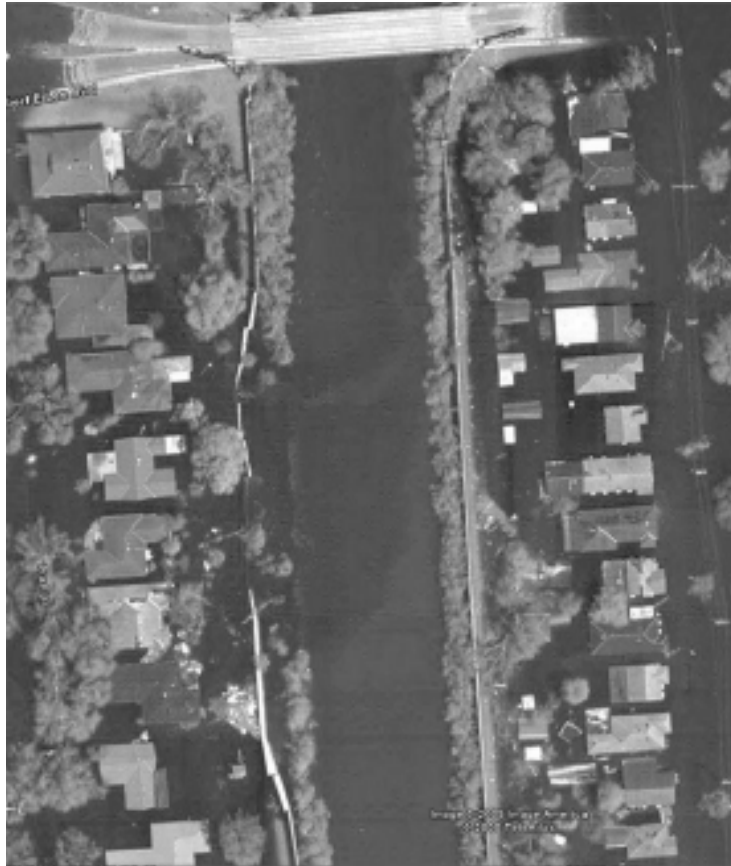
(a) North breach near Robert E. Lee Bridge
 Figure 11-1. London Avenue Canal breaches

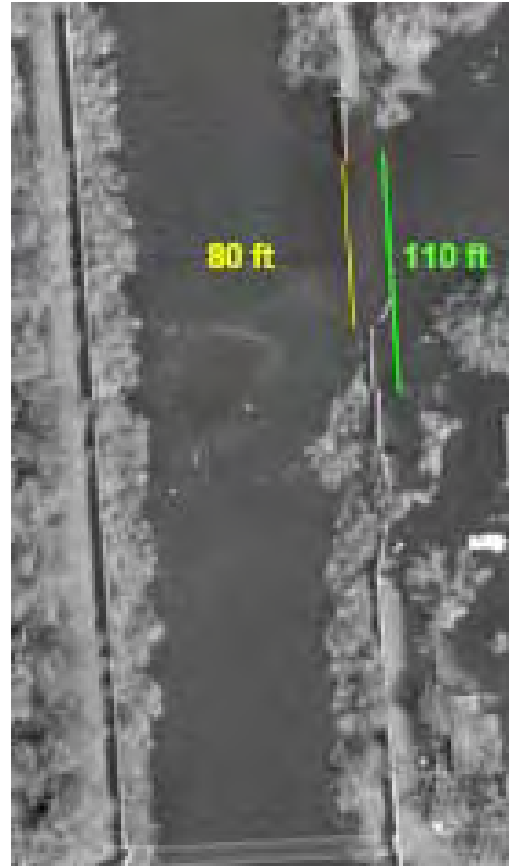
(b) South breach at Mirabeau Avenue

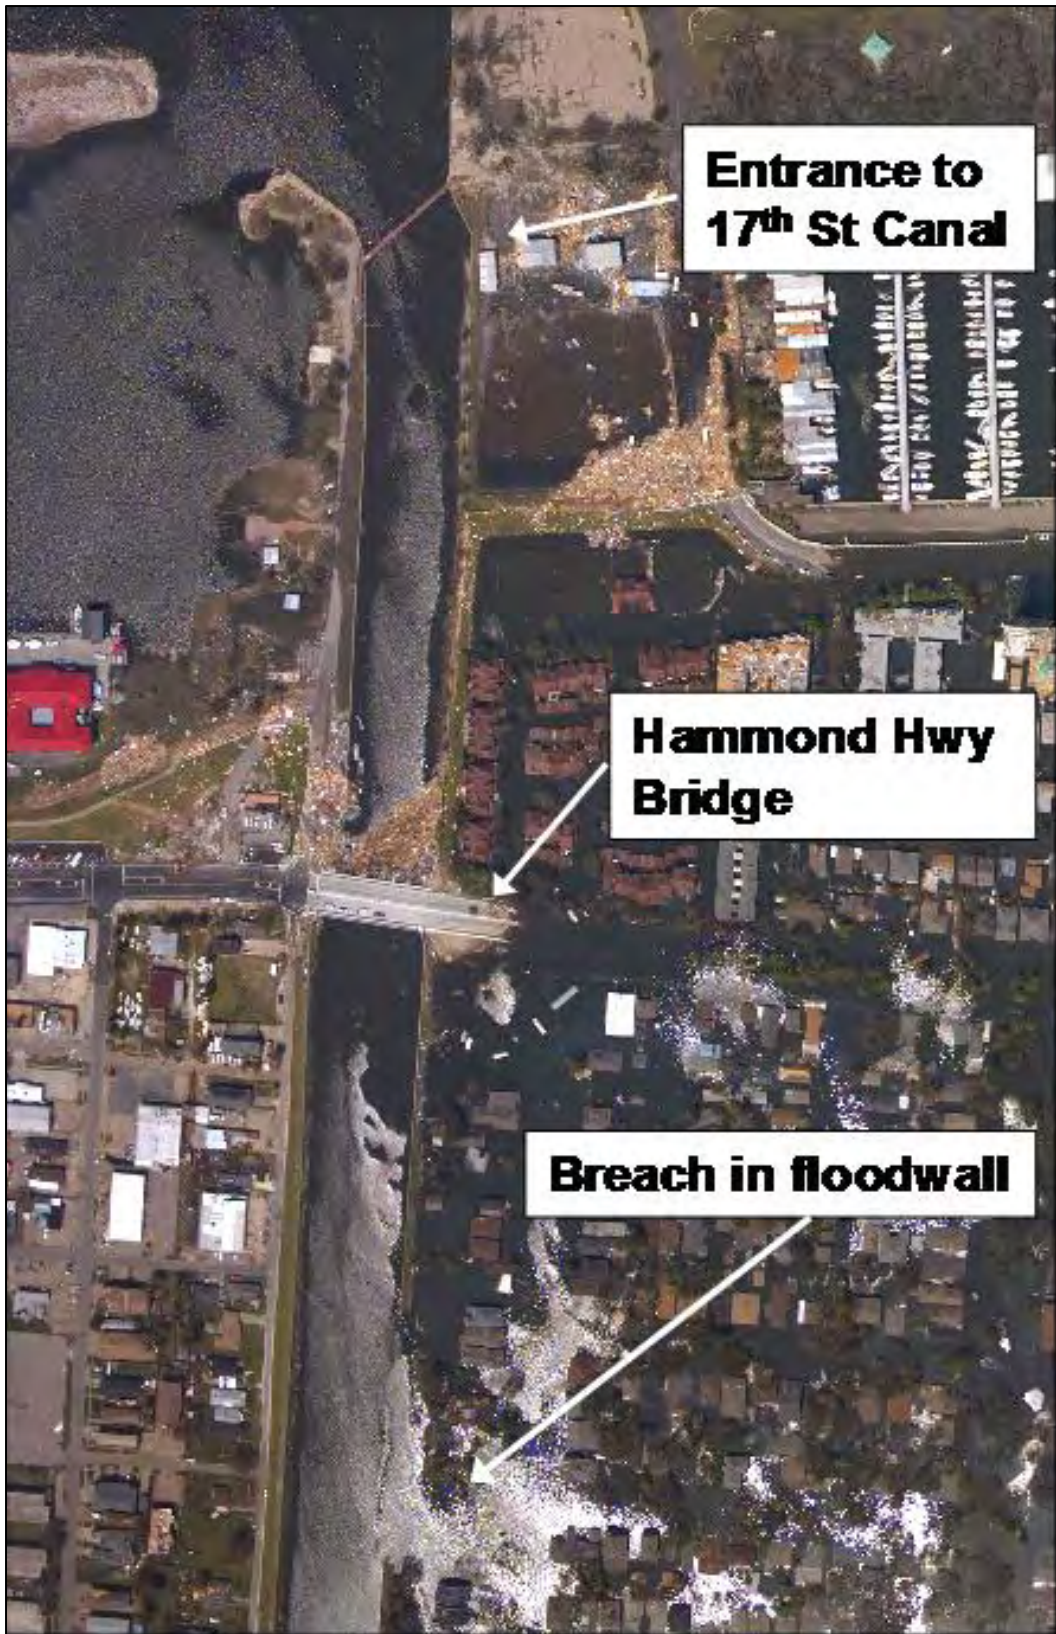
Figure 12-1. 17th Street Canal entrance region, Hammond Highway Bridge, and breach location

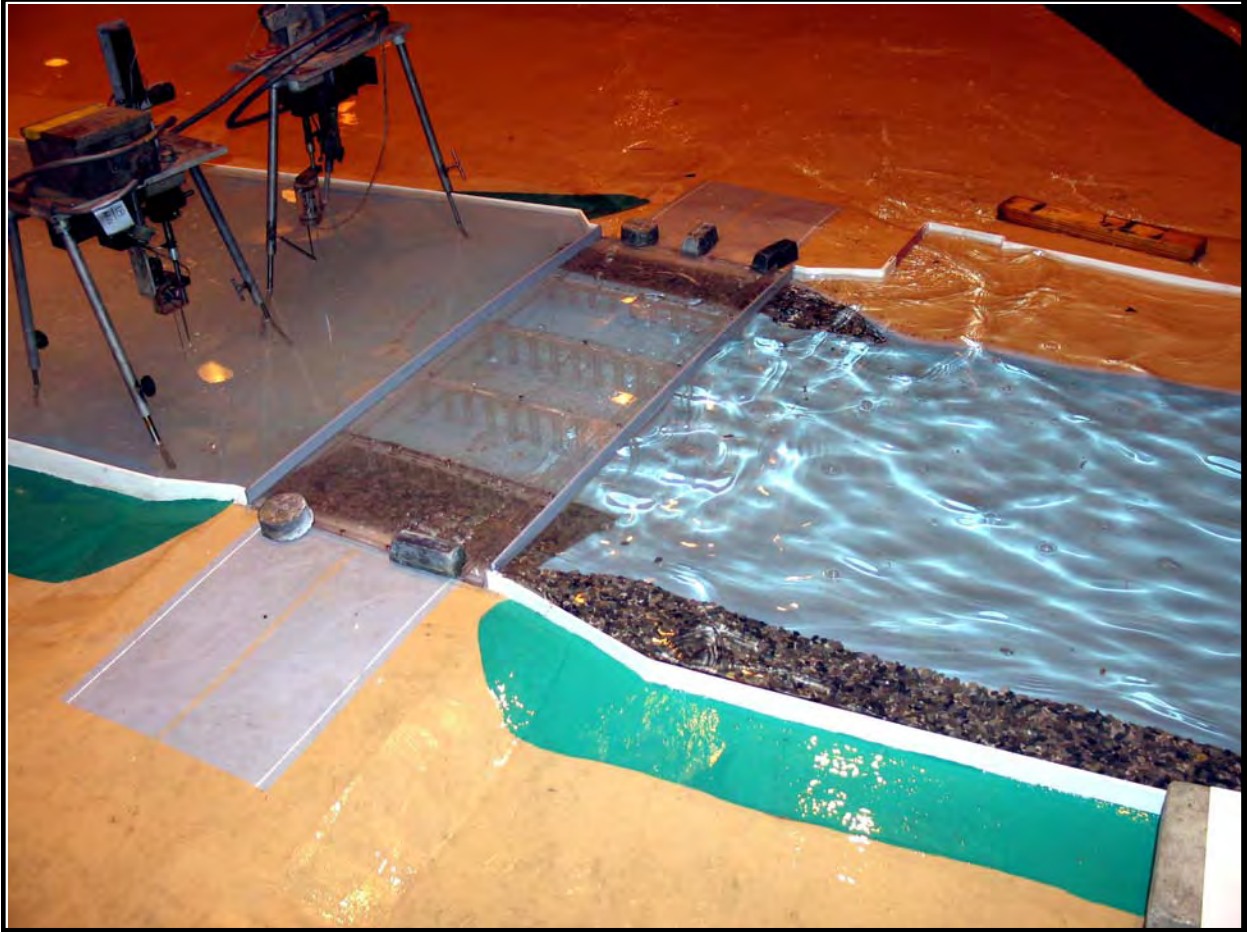
Figure 12-12 presents a photograph of the model in the region straddling the bridge. The rough water surface on the right-hand (north) side is indicative of reflected wave energy, whereas the left side is relatively quiescent. The results of reflection analyses, shown in Figure 12-13, indicate that as the hurricane surge rises, the reflection coefficient jumps from about 10 percent to nearly 35 percent. Figure 12-14 shows the change in wave behavior across the bridge as a function of time during the Katrina simulation.

Figure 12-12. Wave reflection at the Hammond Highway Bridge. Region to right of bridge is lake-side (north side)

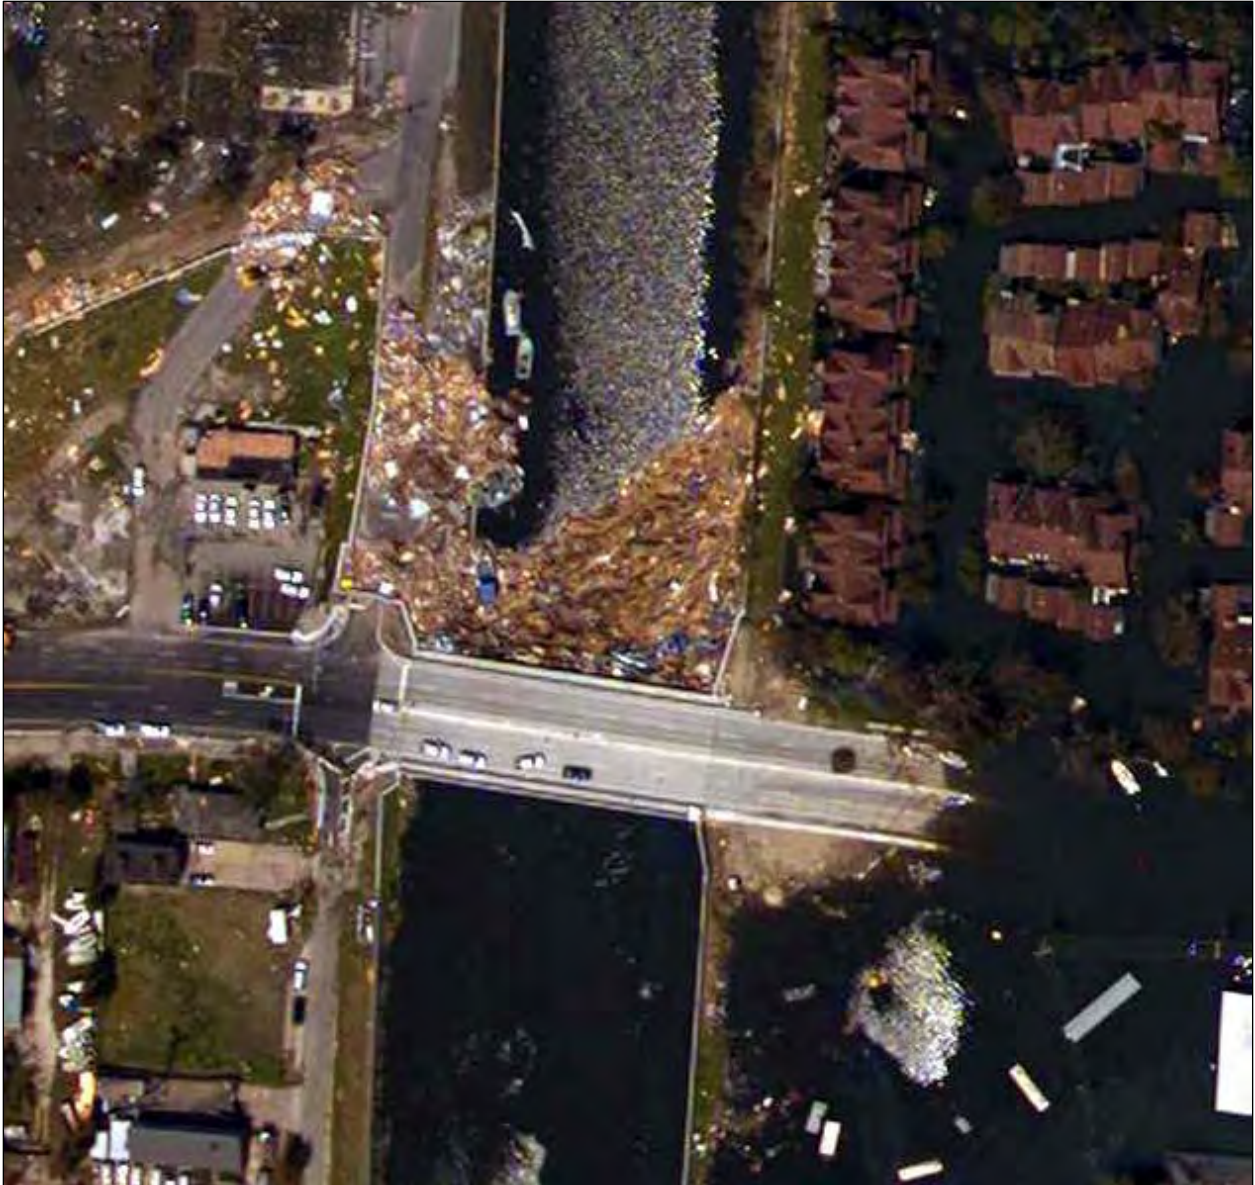
Post-storm aerial photos showed a large debris field jammed against the lake side of the Hammond Highway Bridge (see Figure 12-19). It reasonable to conclude that a major portion of the debris material was derived from structures that were on piles just north of the canal entrance, and that most likely debris started gathering at the bridge when flow through the breach was strong enough to draw water from Lake Pontchartrain. Initial tests of the physical model were conducted to determine the effect of the debris plug on wave transmission. Because it was unknown exactly when the material was deposited at the bridge, model data were collected from 0500 to 1100 hrs for two idealized debris conditions.

Figure 12-19. Post-storm debris at Hammond Highway Bridge. The triangular wedge is about 200 ft across at bridge

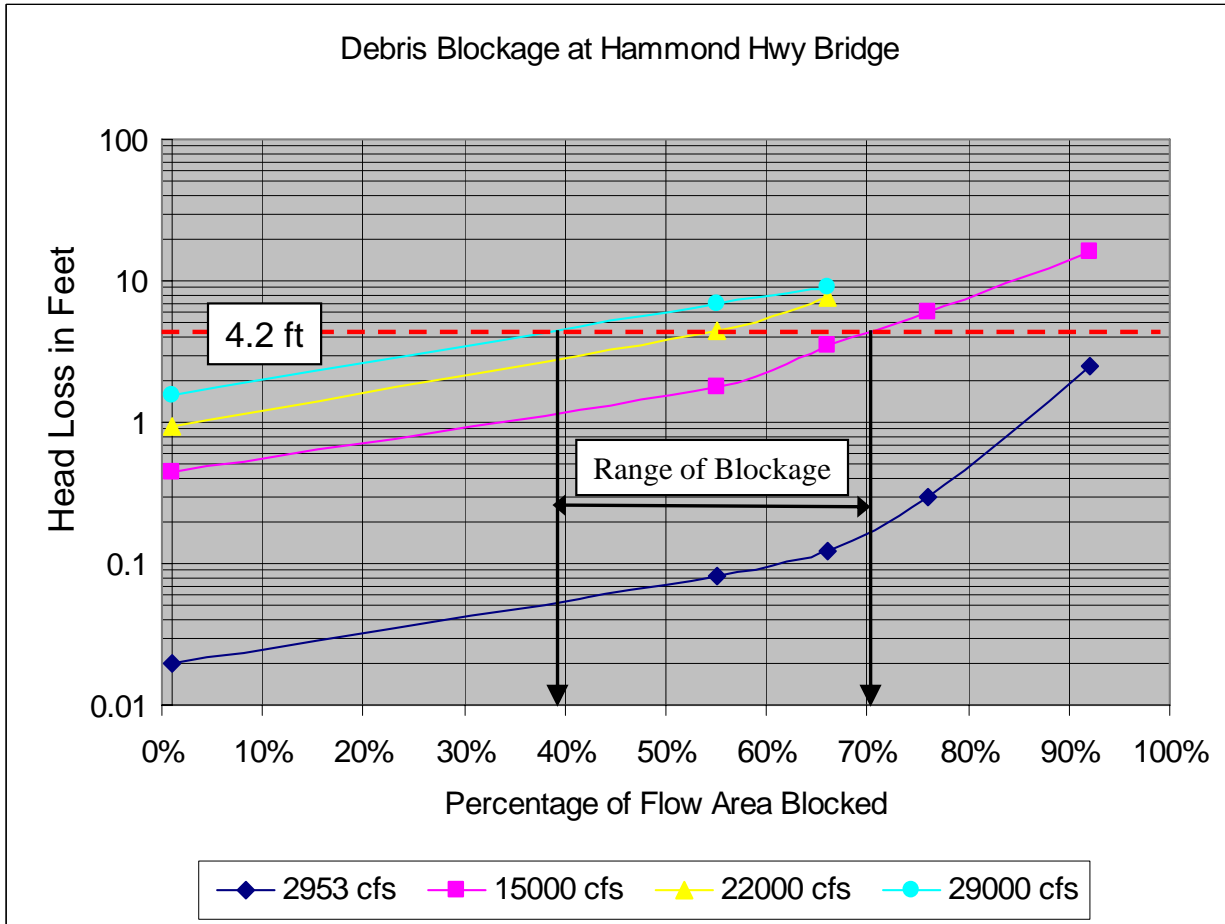
Based on a photograph taken at 1100 CDT looking through the actual breach into the canal, a graph may be created to estimate the blockage that occurred during the storm. From the photograph, the water elevation in the canal is estimated to be at approximately +3.0 ft. At 1100, Lake Pontchartrain was at elevation +7.2 ft, indicating a head difference of 4.2 ft. Re-plotting the data from Figure 12-26 in the manner shown in Figure 12-27, and assuming a flow range of 15,000 to 29,000 cfs through the breach (this range is representative of breach flow conditions based on analytical work performed in this task area and discussed in Appendix 10. Figure 12-27 shows the flow area blockage by the debris would be in the range of 40 to 70 percent.

Figure 12-27. Estimated blockage of 17th St Canal by debris at the Hammond Highway Bridge

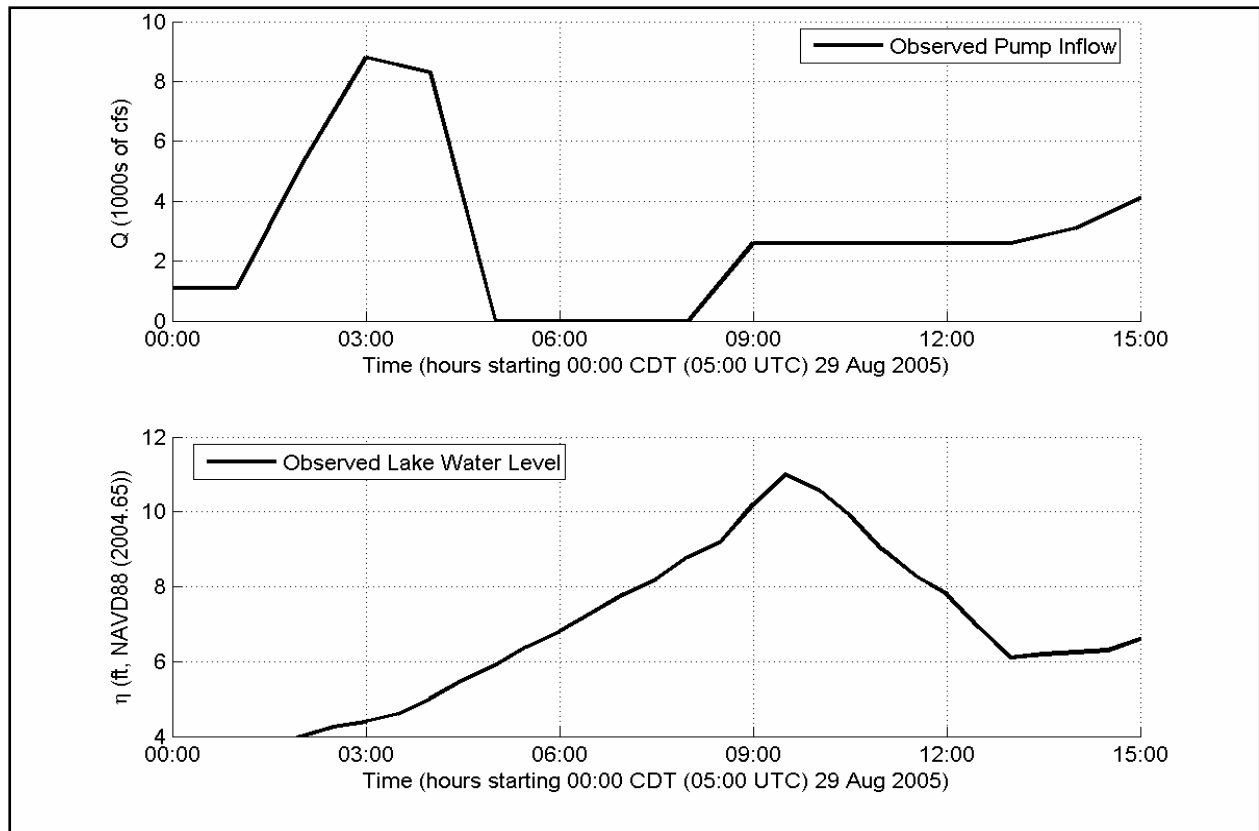
Based on operator interviews and logs at the 17th Street pump station, a time series of pump operations was constructed by IPET Task 1. Figure 13-4 presents the time series of pump operations (top) as synchronized in time with the observed water level (bottom) at the lakefront. Due to 60 and 25 Hz power failures, respectively, Figure 13-4 shows that the pump operation was irregular and not to the station capacity.

Figure 13-4. Synchronized time series of the 17th Street pump station flows and the observed water levels at the lakefront

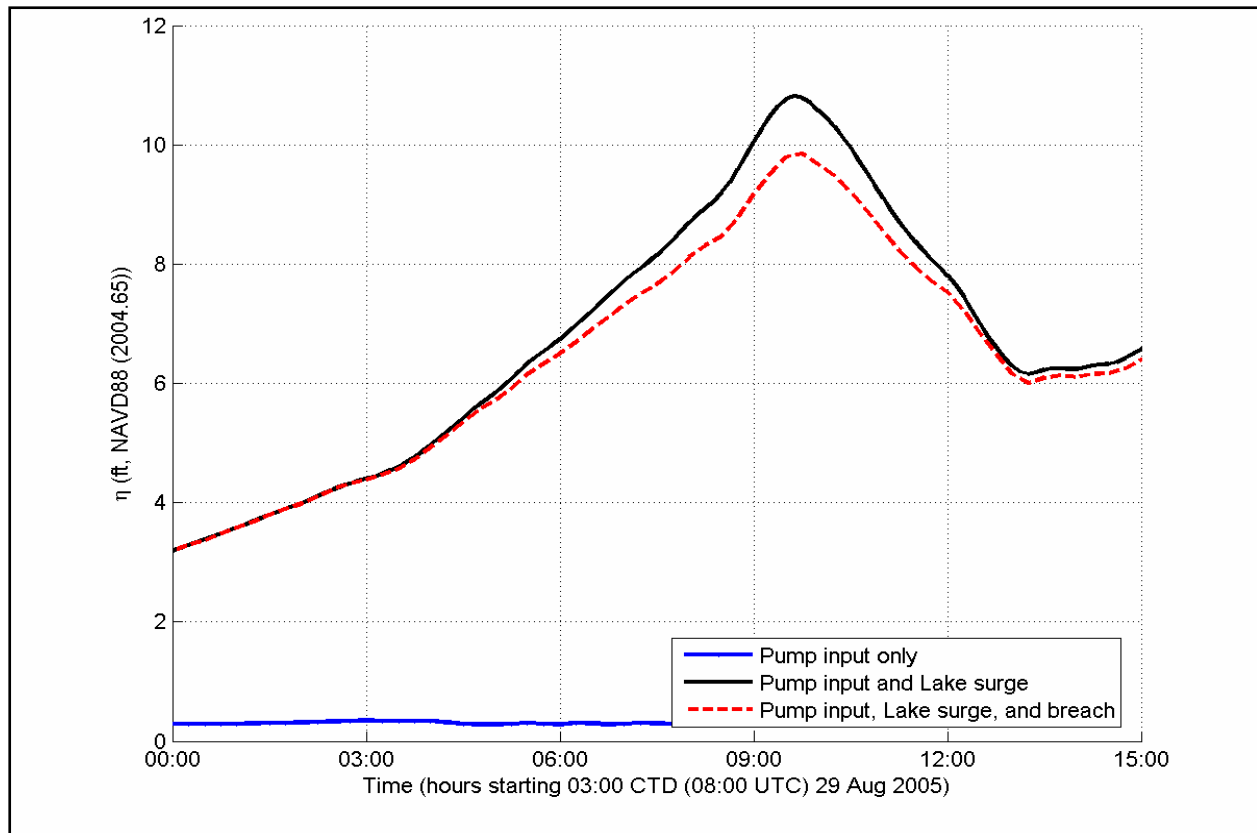
With pump operation and the lake WSE boundary enabled, the maximum currents speeds near the breach location decreased to 0.35 fps to 0.50 fps. At the breach location, simulated WSE time series for this simulation (Figure 13-5) is nearly identical to that simulated without pump operation but with the lake WSE forcing (Figure 13-2a). Peak WSE at the breach location for this simulation is 10.8 ft.

Figure 13-5. Time series comparing predicted water surface elevation change due to the pump, lake surge, and breach

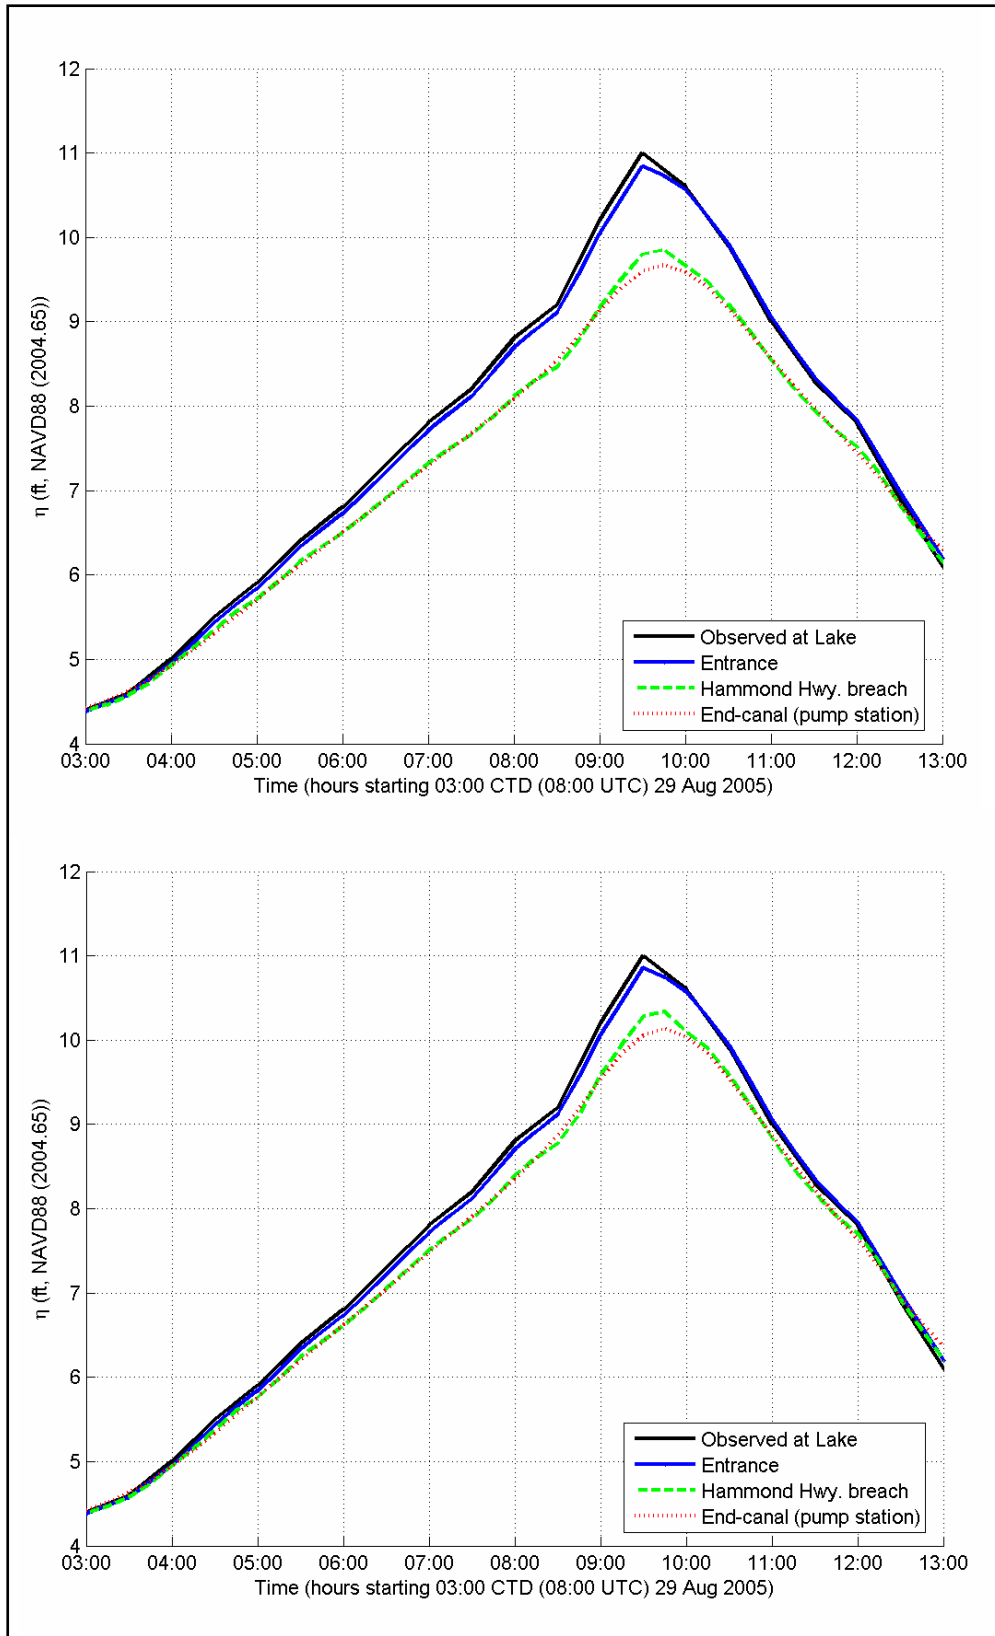
As expected, there were measurable differences between the peak discharge through the breach for configurations A and B. However, differences between the peak discharge through the breach for configurations B and C were comparable. There were some differences in the simulated discharge time series between 06:00 CDT and 09:00 CDT between configurations B and C. The remainder of the discussion herein will focus on configuration C, as it appears to reasonably represent the breach within ADCIRC, particularly during peak flows at the time of final levee wall failure.

Figure 13-6. Comparison of water surface time series throughout the 17th Street Canal for bracketing values of the discharge coefficient: 1.76 (top panel) and 1.12 (bottom panel)

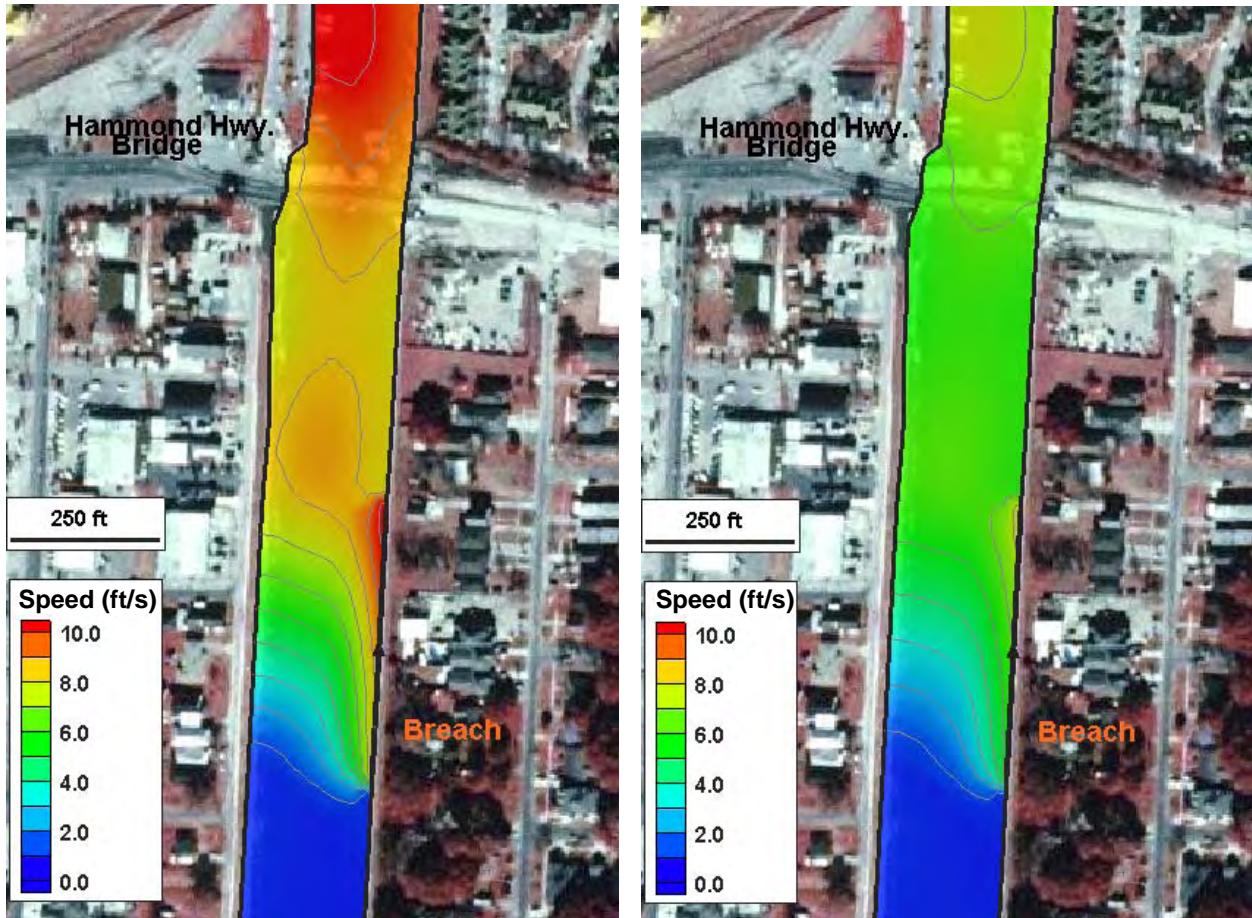
Figure 13-7 presents a comparison of contour snapshots of peak current speed as a function of discharge coefficient. The contour plots show that the upper and lower values of the discharge coefficient result in currents speeds that are on the order of 10 and 7 fps, respectively. Figure 13-8 presents snapshots of the current field near the breach at various times in the simulation for the upper discharge coefficient case. For this case, maximum current speeds in the canal ranged from 4 fps to 6 fps during the initial outflow of the breach (06:00 CDT) to 8 fps to 10 fps at the storm peak (09:30 CDT), respectively.

Figure 13-7. Maximum current speed with breach discharge for simulations with the upper (left) and lower (right) discharge coefficients

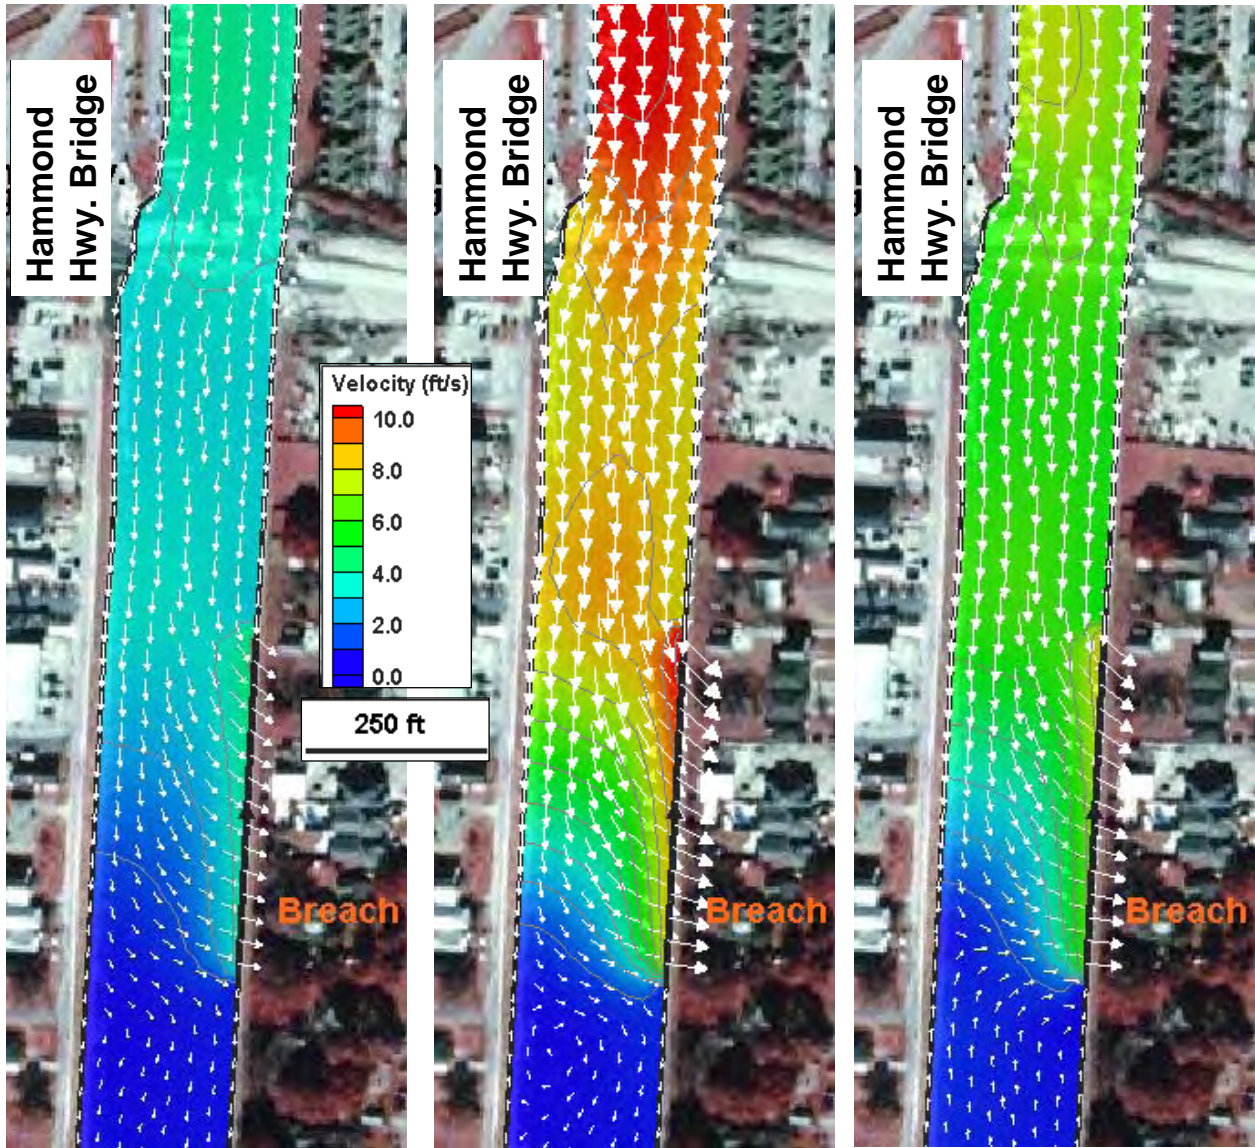
Figure 13-8. Snapshots of simulated current field during 17th Street breach event at 0600 CDT (left), 0930 CDT (center), and 1100 CDT (right)

In the 17th Street canal, model tests indicate that pump operations had negligible impacts on the flow field and WSE within the canal. With a breach open south of the Hammond Highway Bridge, flow conditions change dramatically, with peak currents as high as 10 fps, while peak WSE drops by almost 1.5 ft relative to the peak lake WSE.
