Appendix 1

Hydrograph and High Water Mark Analysis

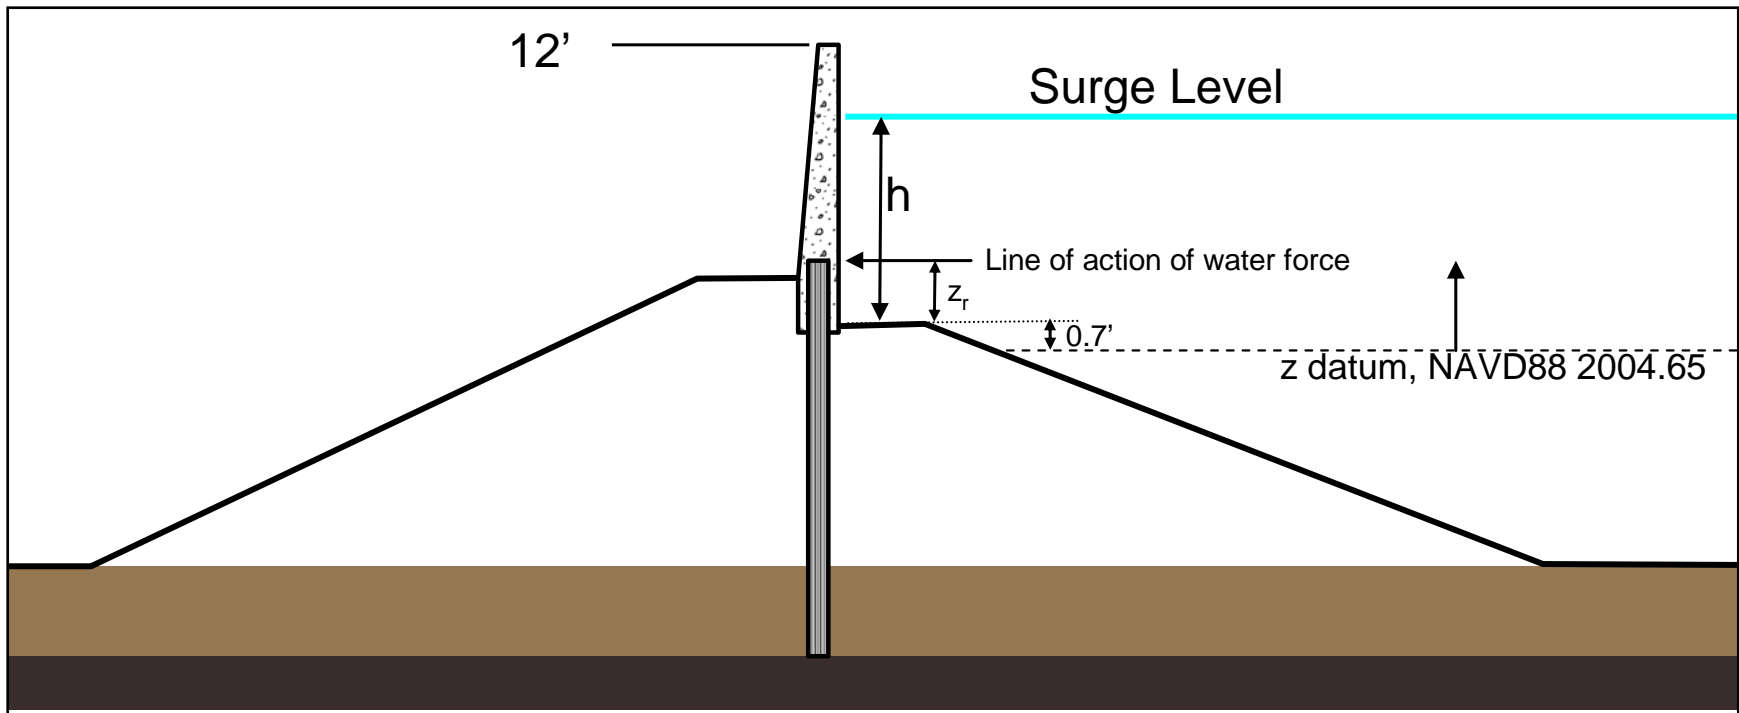
Water forces and lines of action are summarized in the table below. In the table, the force, F_{nw} , is the force that would result from a static water column of height, h . Note that even though significant wave heights are about 1ft or less, the additional force due to the 2 percent wave can be significant. Also, the 2 percent exceedance forces correspond to crest elevations that are approximately 80-90 percent of the local significant wave height.

Figure 15-16. Cross-sectional schematic for 17th Street Canal walls near failure location

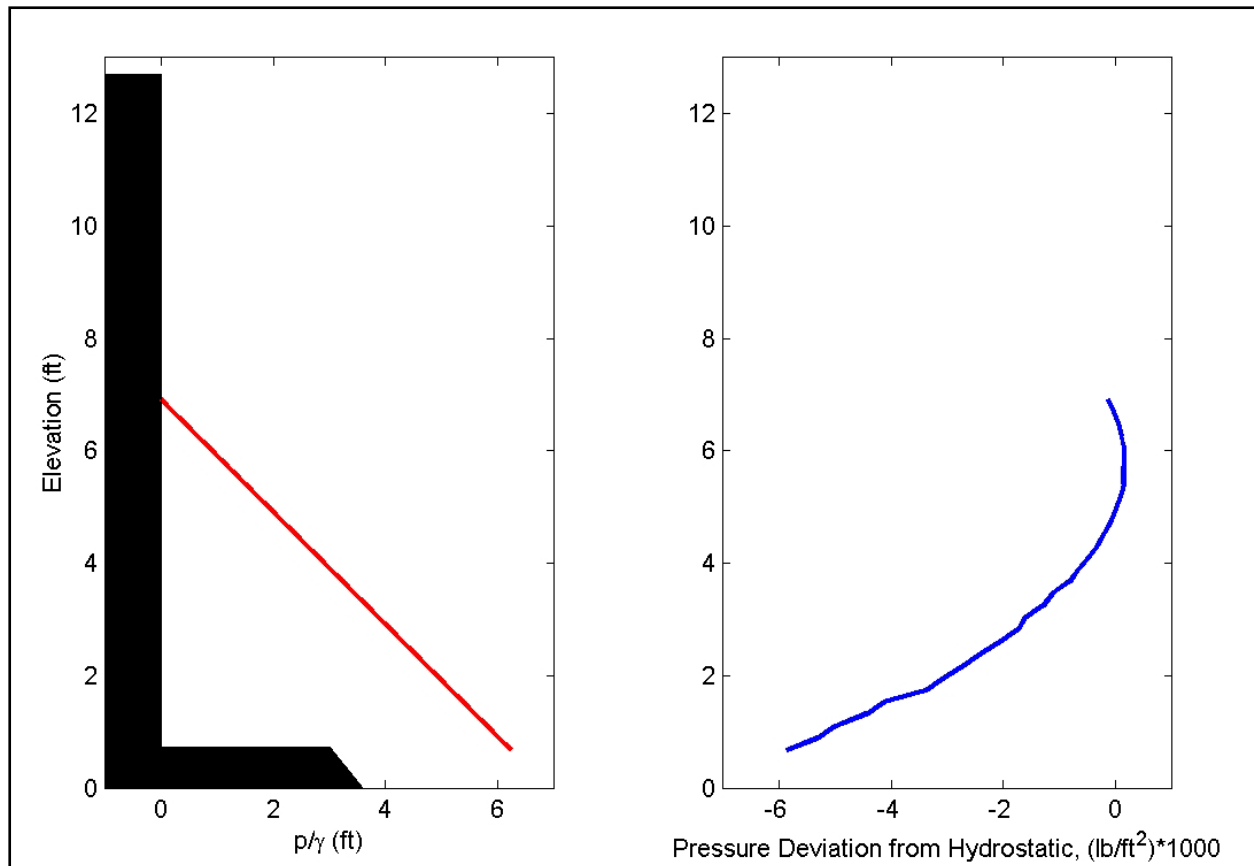
Figure 15-17. Example of numerically predicted vertical distribution of pressure under a wave crest near 17th Street Canal failure location at 0700 CDT. The red line in the left plot shows the distribution, while the plot on the right gives the deviation from hydrostatic pressure based on the instantaneous water surface elevation. Note that the units on the right plot are pounds per square foot*1000, thus the deviation is very small

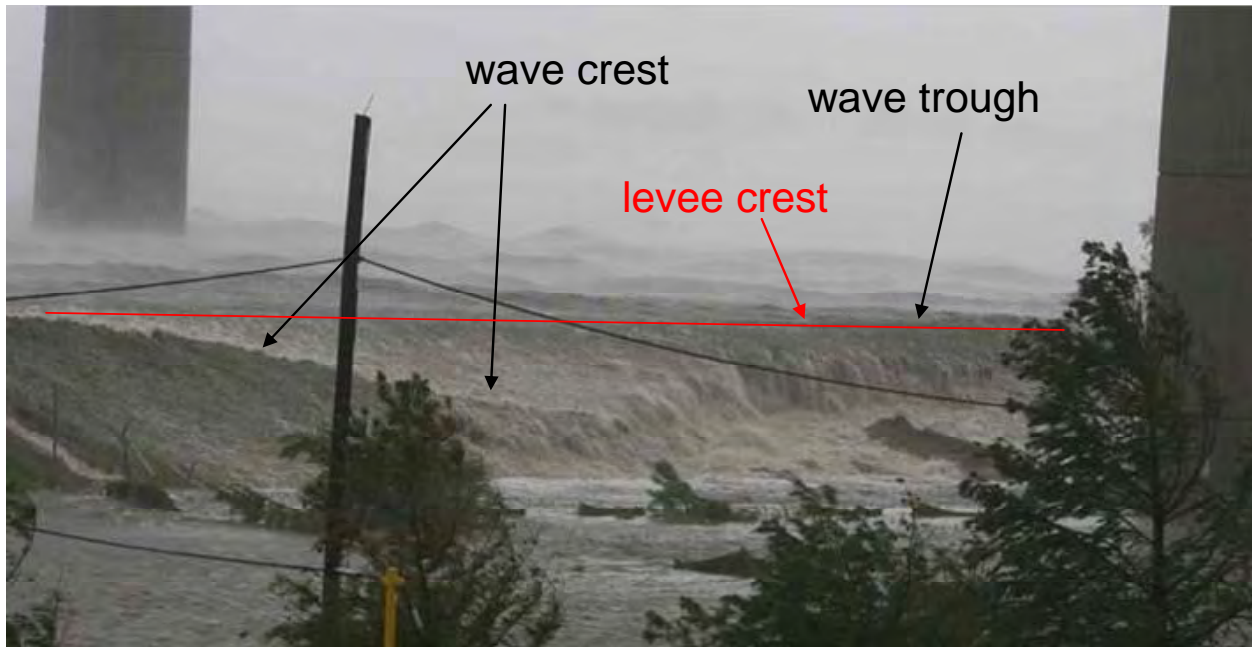
Since only the conditions at the peak surge are being simulated at the eastern location, the water level provided by measured high water marks is used. High water marks near this levee are 15.7'. At the Paris Road Bridge, simulated conditions are meant to recreate those shown in the photograph (Fig. 2), such that simulation numbers may be approximately associated with the energetics shown in the photo. It is postulated that in this photo, waves are dominating the overtopping, as hinted at by the apparent low overtopping flux region (wave trough) adjacent to the high flux region (wave crest). These regions are denoted in Figure 15-39. In addition, while the time of the photograph is not known, judging from the natural light in the photo, the time is estimated as 0700-0800 local time. In accordance with this time, it can be estimated that the surge is about 1' less than the peak surge of 15'. Thus it is expected that the surge elevation is near the levee crest elevation, and will be set 0.5' above the levee crest.

Figure 15-39. Photograph showing overtopping of levee under the Paris Road Bridge. Time of the photo is not known with certainty. View is from the north side of the levee, looking towards the southwest. Waves are traveling from the east (left side of photo) towards the IHNC

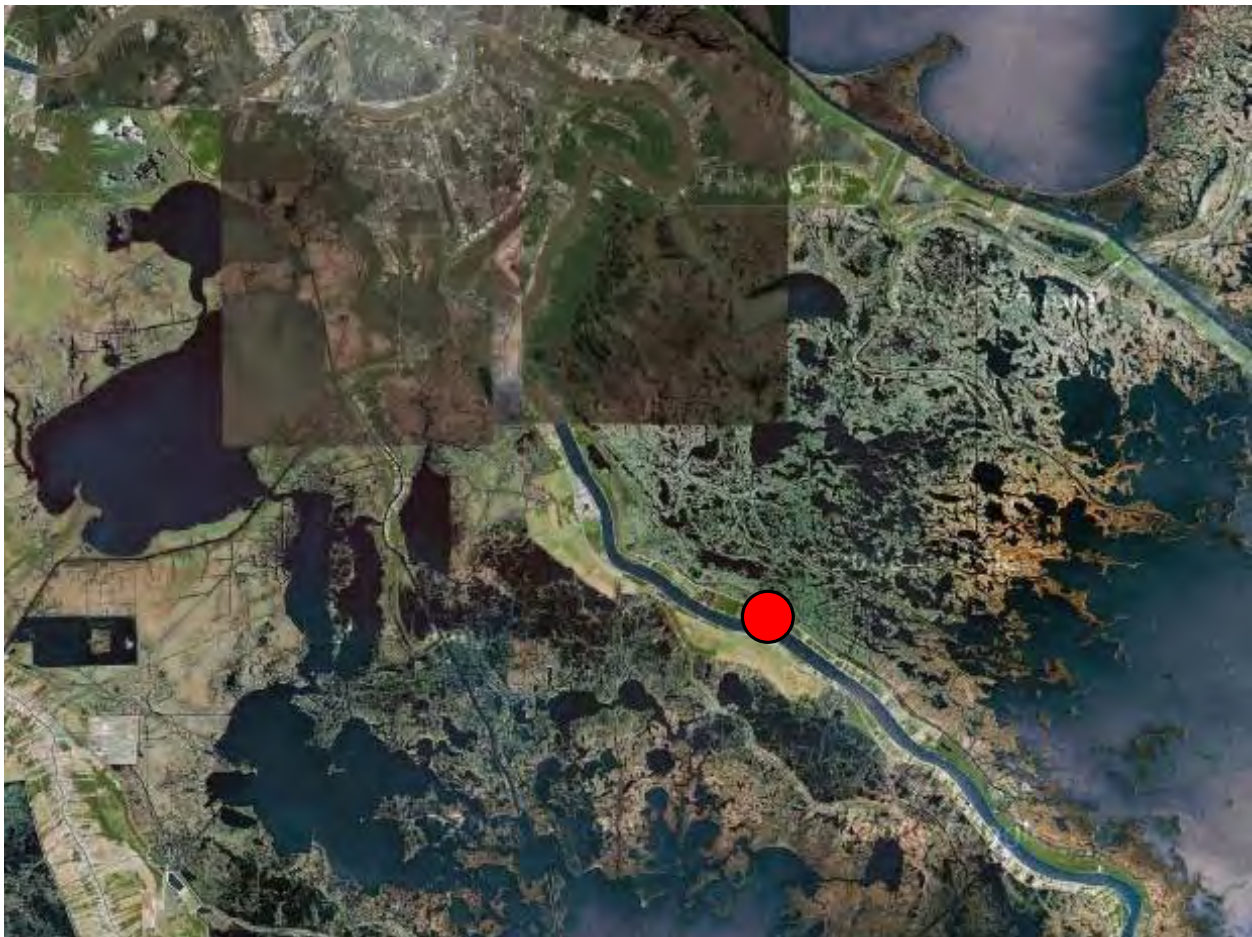
Herein, wave and surge impact are investigated at a single location along the Mississippi River in Plaquemines Parish. The location is near Davant, shown in Figure 15-43. The structure profile here is taken as a T-wall on an earthen levee. The T-wall extends above ground from +10' to +17' elevation. The surge is set as 20'. Wave conditions are taken from STWAVE at the time of the surge peak. These conditions are $H_{mo}=5.4'$ and $T_{peak}=15$ s.

Figure 15-43. Photograph showing the location of the simulation conducted in Plaquemines Parish

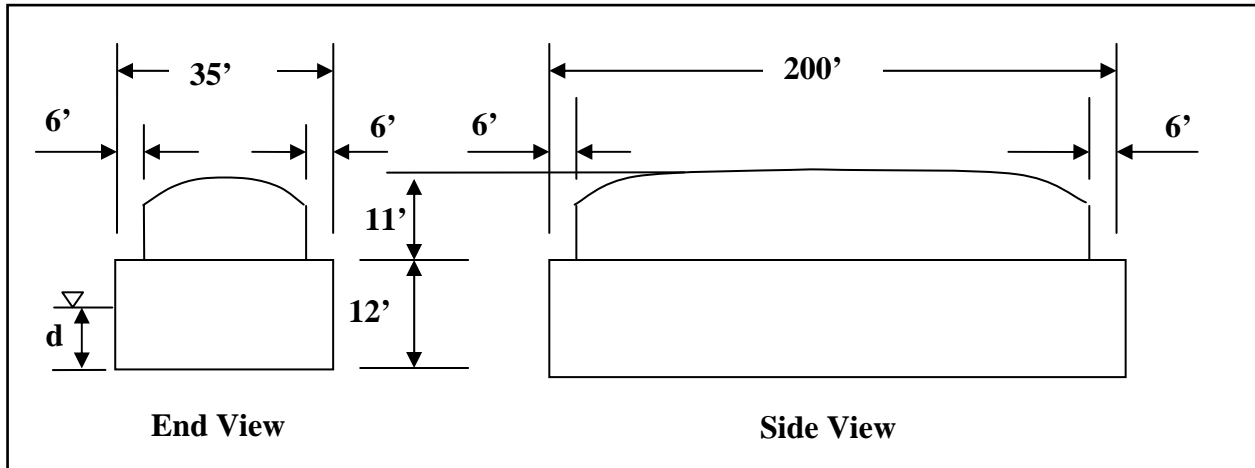
Figure 17-2. Estimated dimensions of barge observed on site visit to Lower Ninth Ward

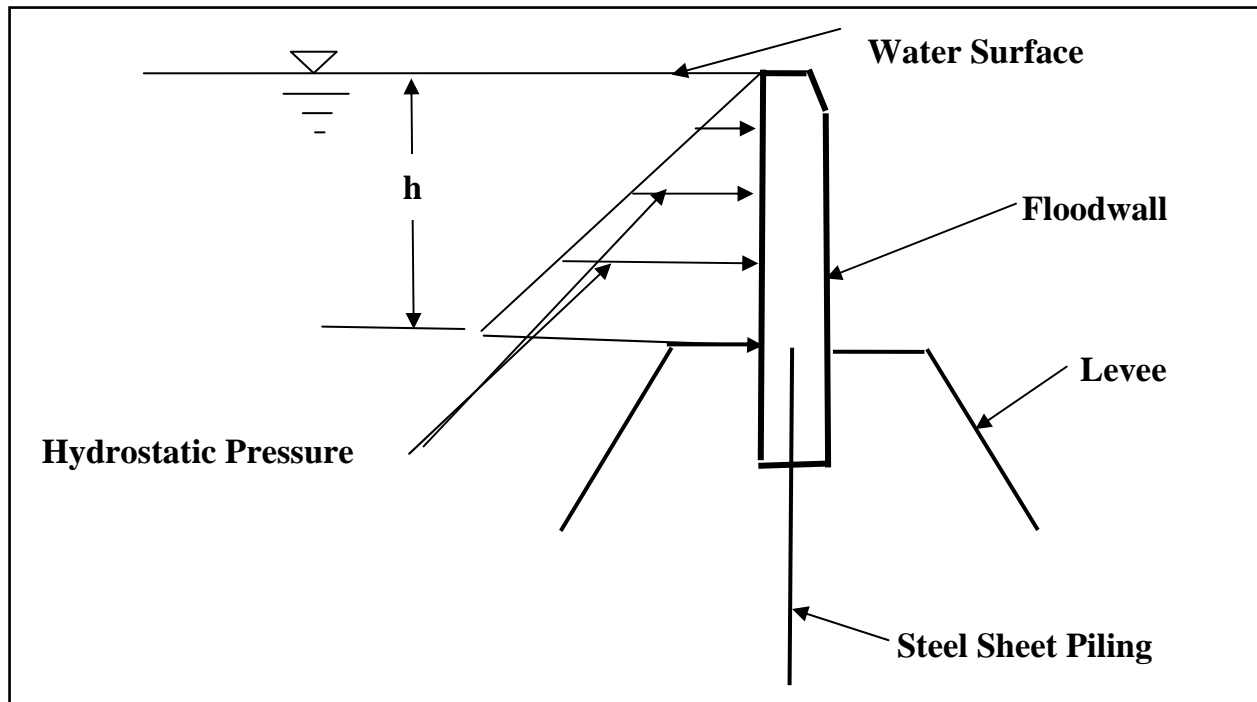
Figure 17-3 depicts a typical section of the flood wall at an imminent overtopping condition. The hydrostatic force, F_{HS} on the floodwall per unit floodwall length for the imminent overtopping condition shown in Figure 17-3 is

Figure 17-3. Definition sketch for east floodwall at imminent overtopping condition
