MOVEMENT ALONG THE BATON ROUGE FAULT

Submitted to the Graduate Faculty of the
Louisiana State University and
Agricultural and Mechanical College
in partial fulfillment of the
requirements for the degree of
Master of Science in Civil Engineering

The Department of Civil and Environmental Engineering

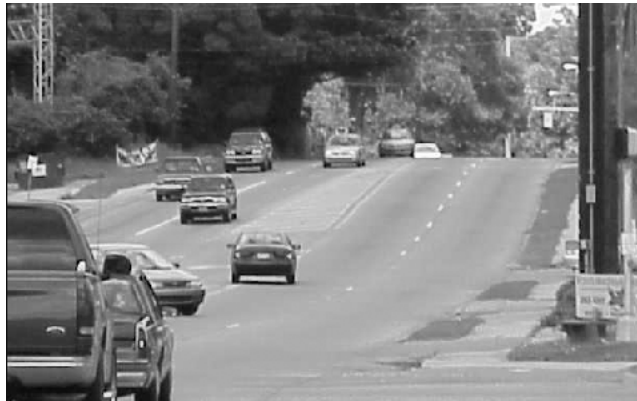
Fig 1.2 Fault escarpment near the intersection of College Drive and Corporate Blvd

along the fault since the underlying surface material was deposited. The fault is also considered to extend west into the West Baton Rouge Parish but has not been mapped on the surface [1]. The height of the escarpment ranges from 4 to 7 meters along the fault [1].

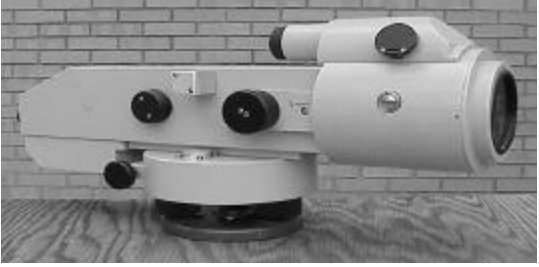
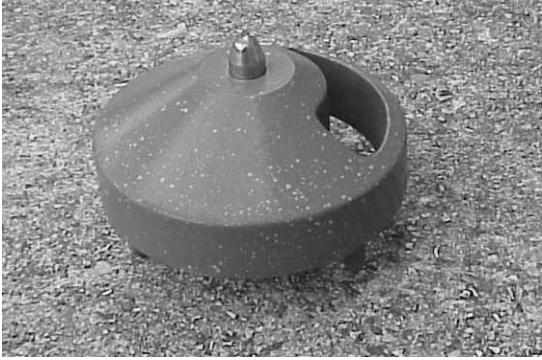
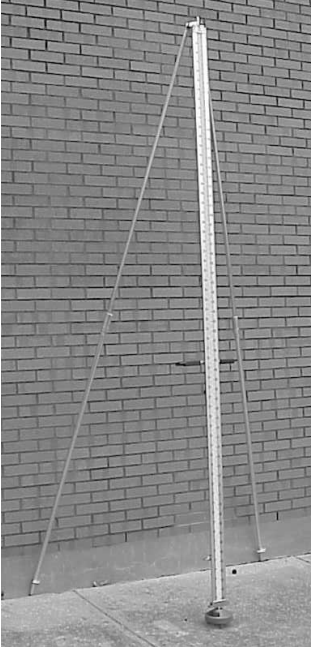
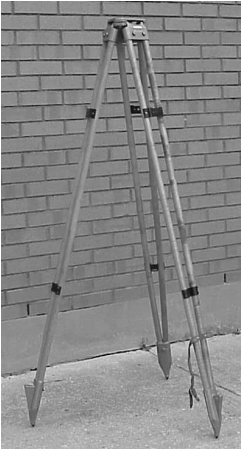
<p>a. Leveling instrument</p>	<p>b. Turning plate</p>

<p>c. Leveling rod with bipod</p>	<p>d. Tripod</p>

Fig 3.2 Equipment

Leveling rods provide accurate heights above turning and control points (benchmarks). Two 3.5m, half-centimeter Invar (Steel-nickel alloy) rods were used in the study. Invar rods have a very small coefficient of thermal expansion. Half-centimeter refers to the interval indicated by the graduations on the rod, termed rod units. It is the recommended interval for geodetic leveling [16]. The interval is compatible, as required, with the units of the micrometer in the leveling instrument used in the study (Zeiss Ni1).

A wooden tripod with non-adjustable legs was used in this study, as recommended by NGS [14]

A turning point is the temporary support on which a leveling rod is placed during a setup. The foresight point for one setup becomes the backsight point for the next, holding the elevation while the leveling instrument is moved between setups. In this study two metal turning plates were used as turning points.

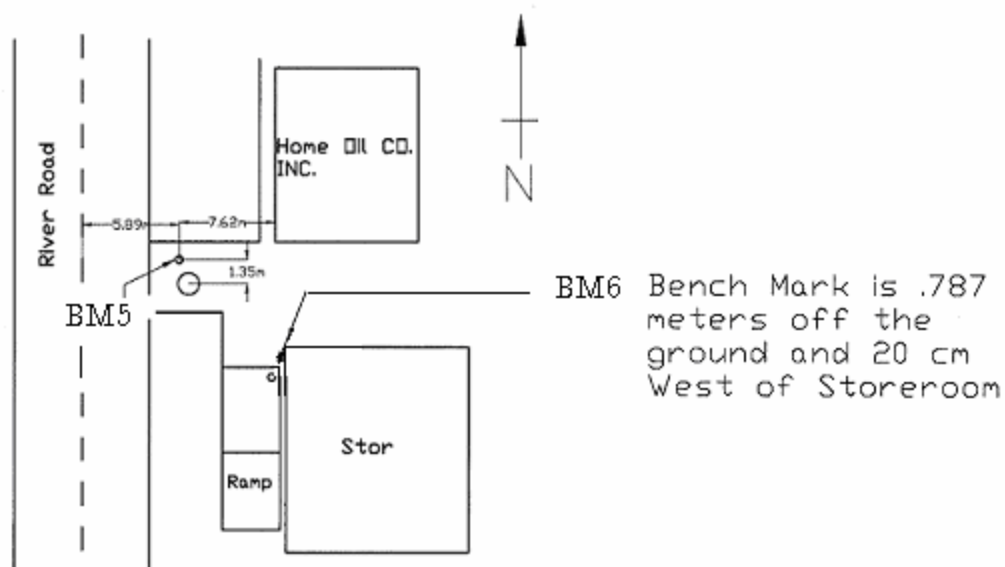
Fig A.6 BM5 and BM6

The benchmarks are located 0.6 Km south along River Road from the Interstate Highway 10 bridge overpass. BM5 is set in top of the northeast end of the concrete ramp and loading platform at the north end of Garig warehouse, 0.3 m west of the west side of metal building, 12.0 m east of the center line of River Road, 9.3 m of power pole number 21 with lines running north and south and west, 3.2 m south of the south side of the white block Phillips 66 Home Oil Company Incorporated, 3 m north of the center line of the first loading door.

BM6 is set 0.3 m west of the west side of metal building, 12.0 m east of the center line of River Road, 9.3 m from power pole number 21 with lines running north and south and west, 3.2 m south of the south side of the white block Phillips 66 Home Oil Company Incorporated, 3 m north of the center line of the first loading door.

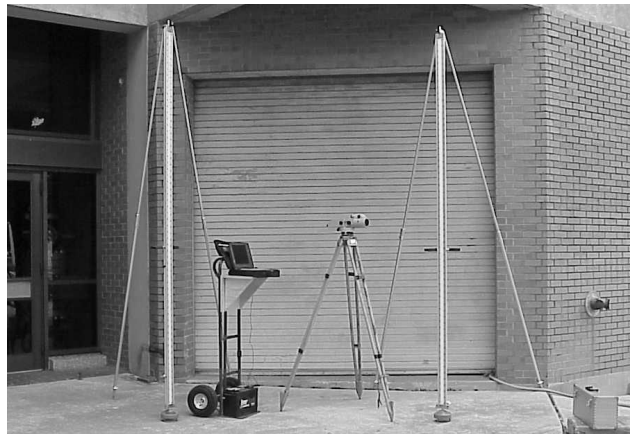
- 1 leveling instrument – Zeiss Ni1
- 1 wooden tripod
- 2 leveling rods, in wooden protective storage box
- 2 heavyweight turning plates

Fig B.1 Field equipment

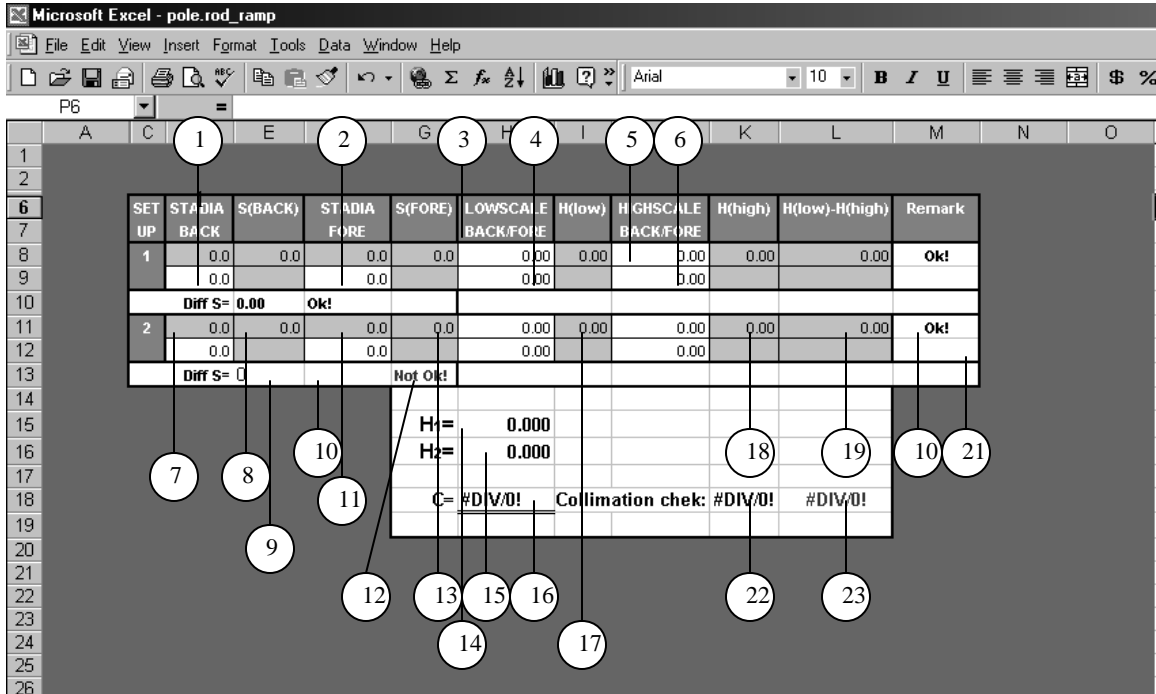
Fig C.4 Collimation check form
